Principal Investigator Edwin D. Clarkson, WV PSC
Region Director Byron Coy
Date of Report 8/2/2011
Subject Failure Investigation Report – Columbia Gas Well Line Rupture

Failure Investigation Report – Columbia Gas Transmission Well Line Rupture
Failure Date: 01/04/2009

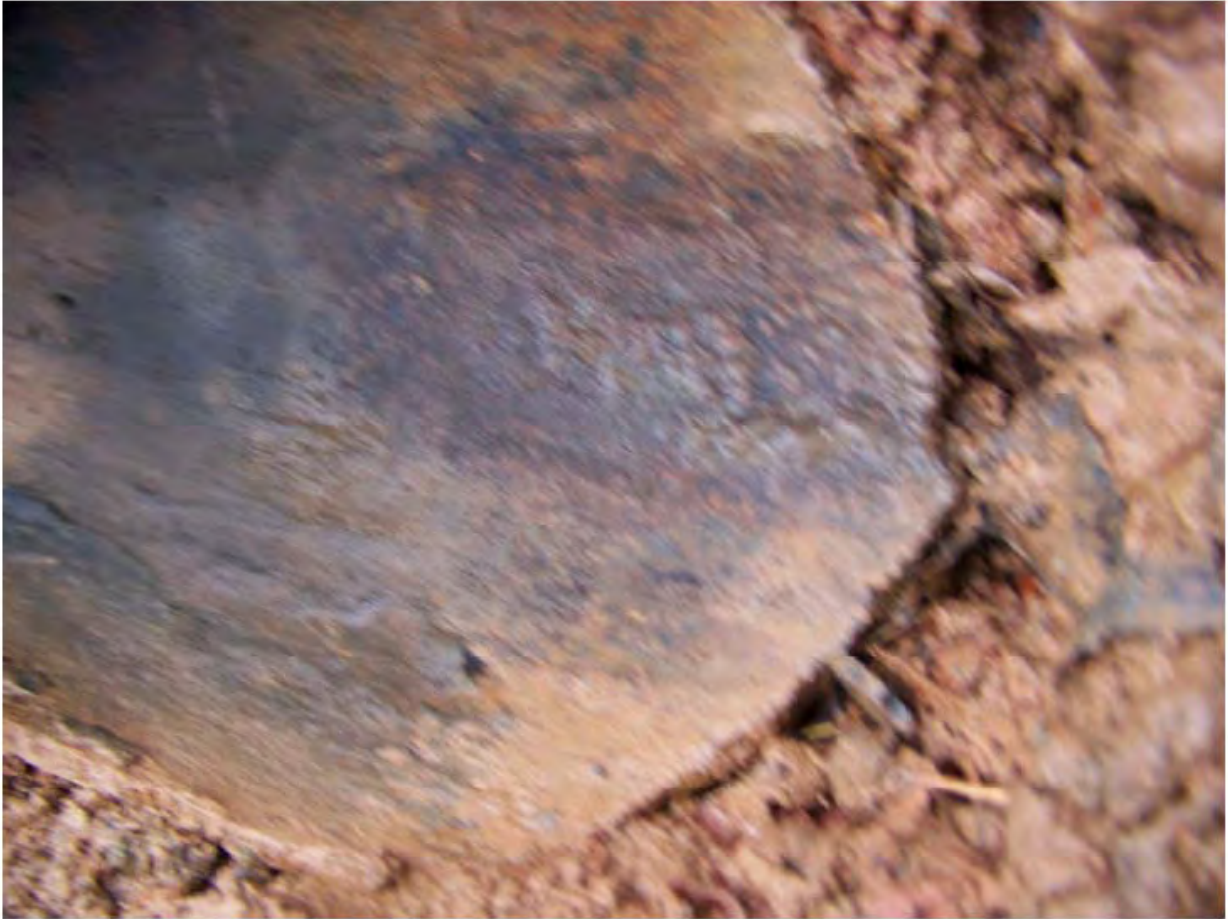
Description of photo – Pipeline indicates internal corrosion.

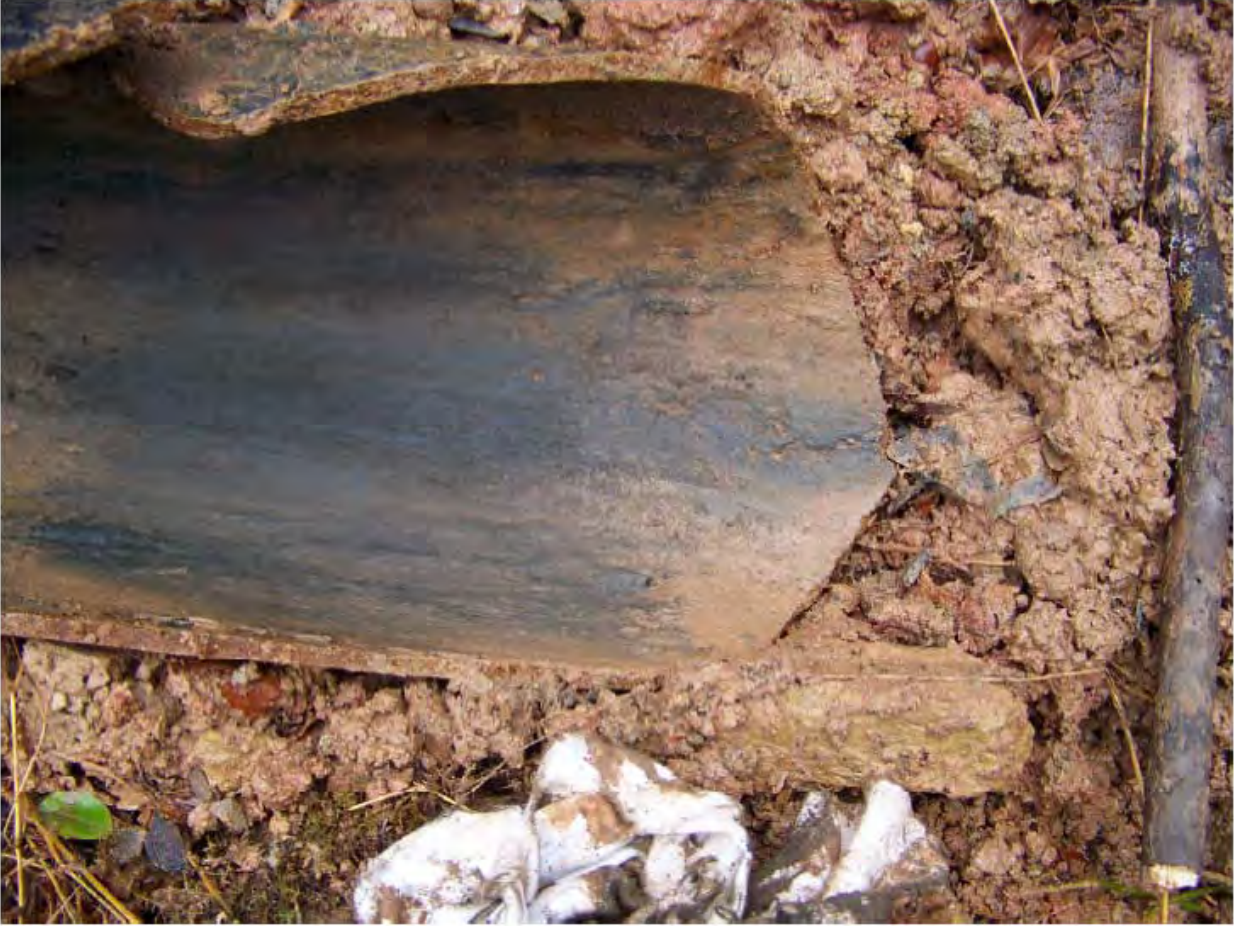
Description of photo – Pipeline indicates internal corrosion.

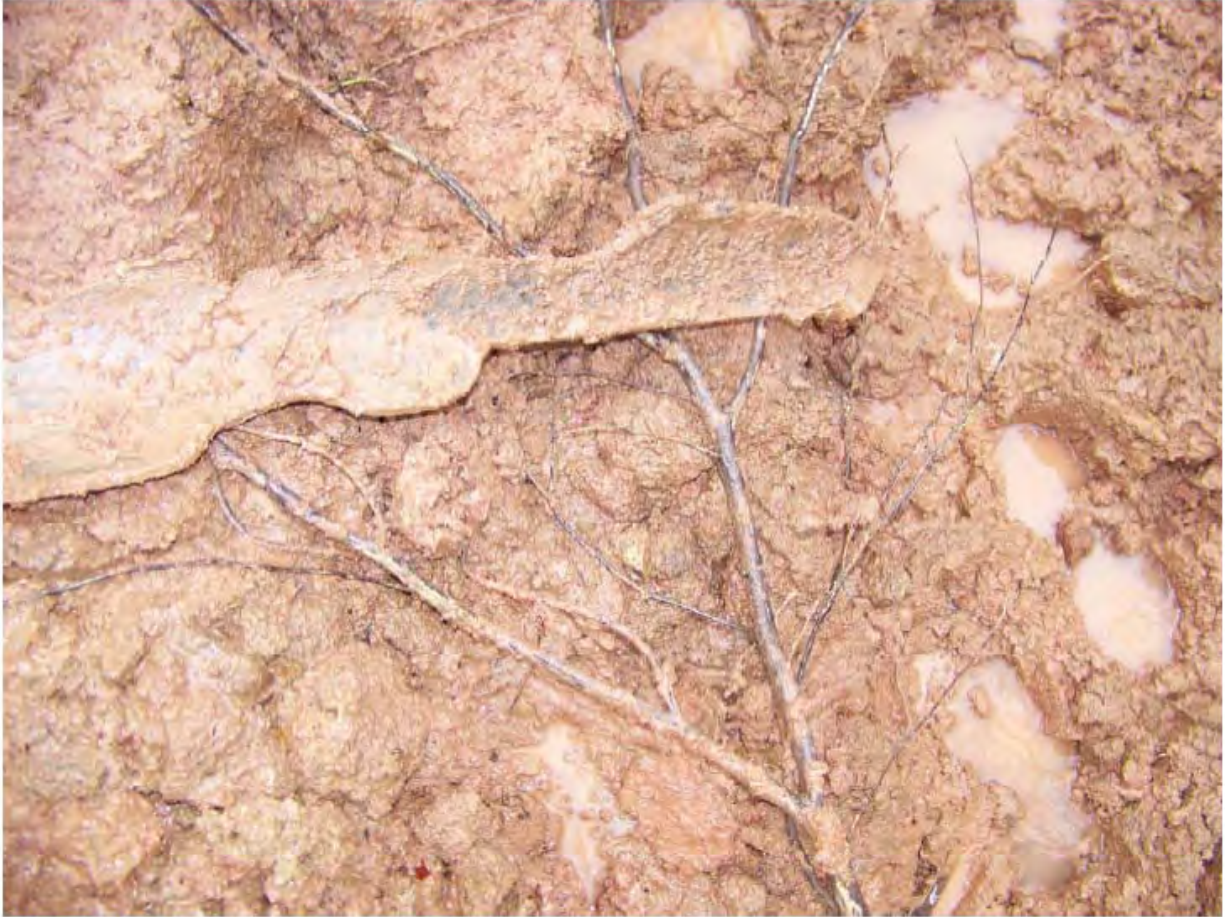
Description of photo – Short section of line 7329 indicating brittle fracture

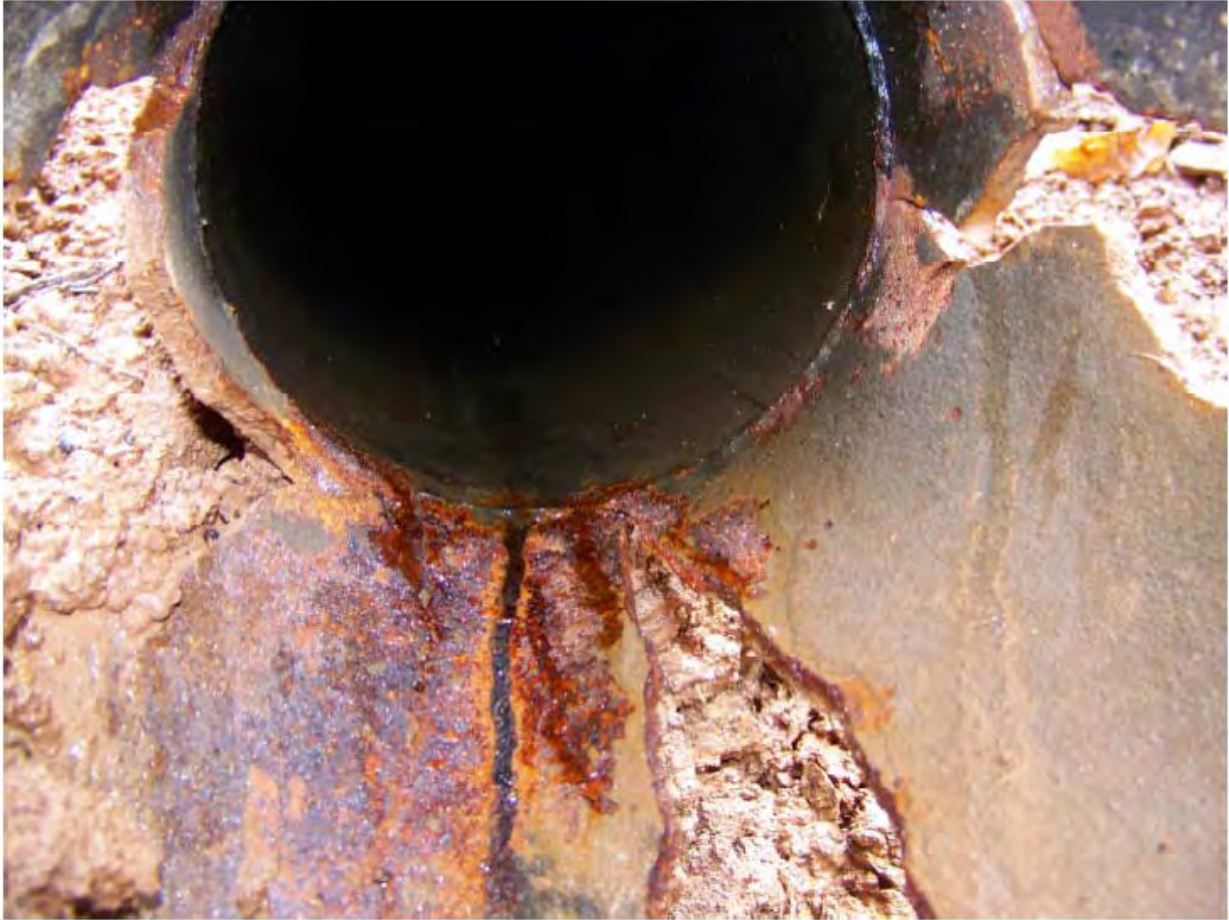
Description of photo – Tie in side where the fracture stops at a weld

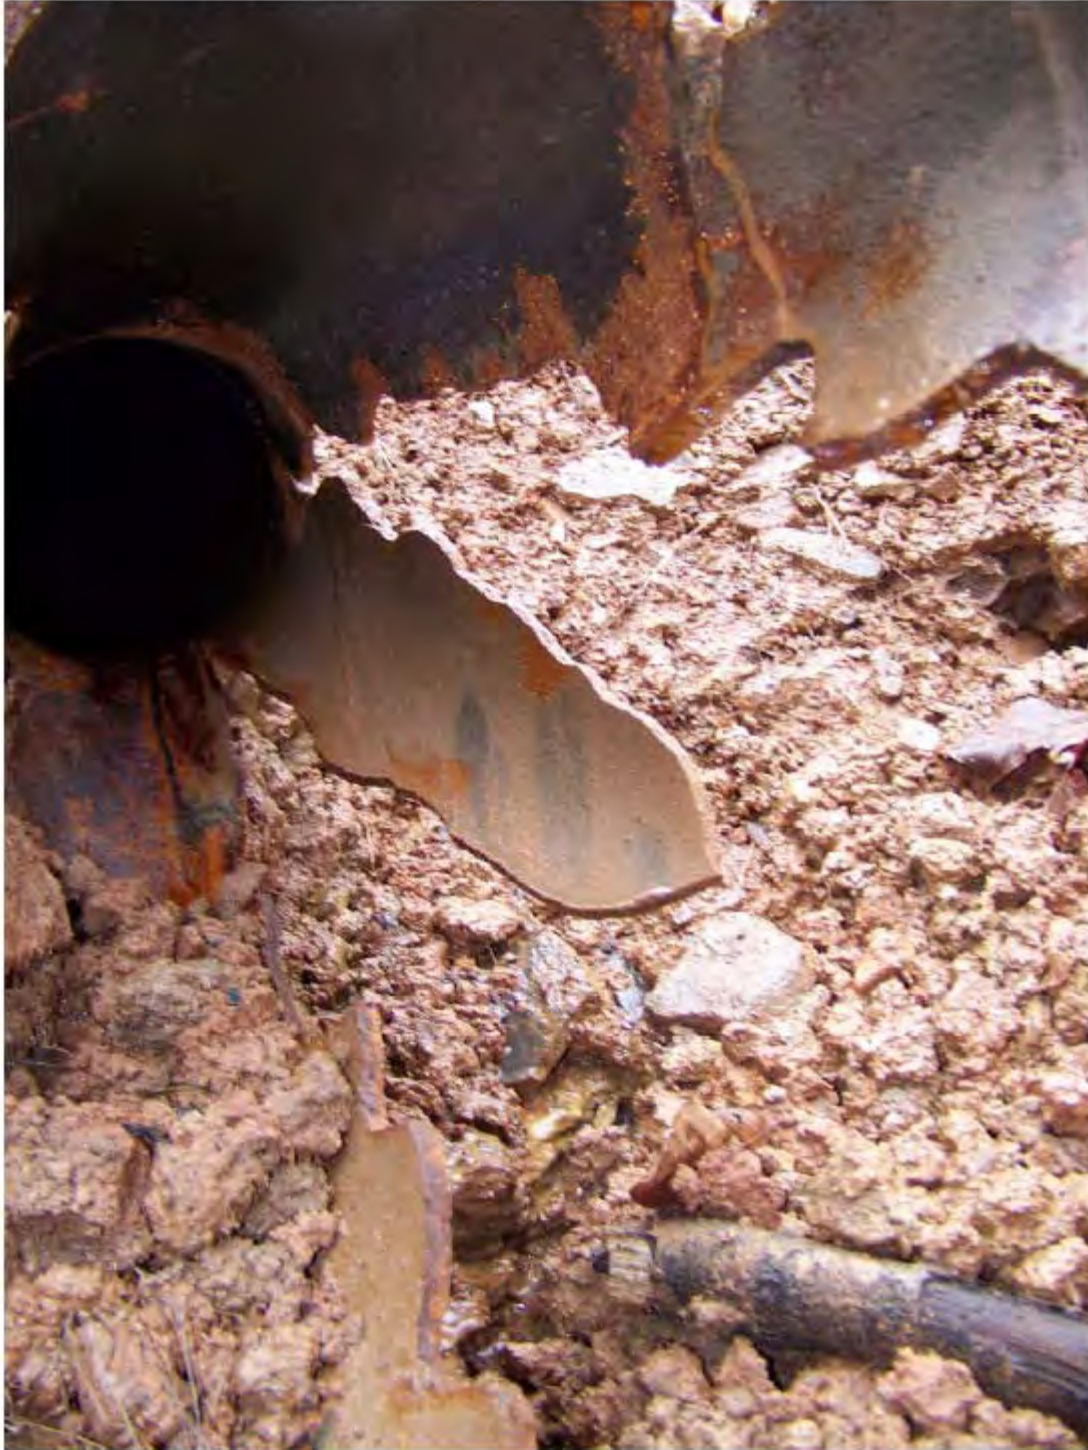
Description of photo – Short section of line 7329 indicating brittle fracture

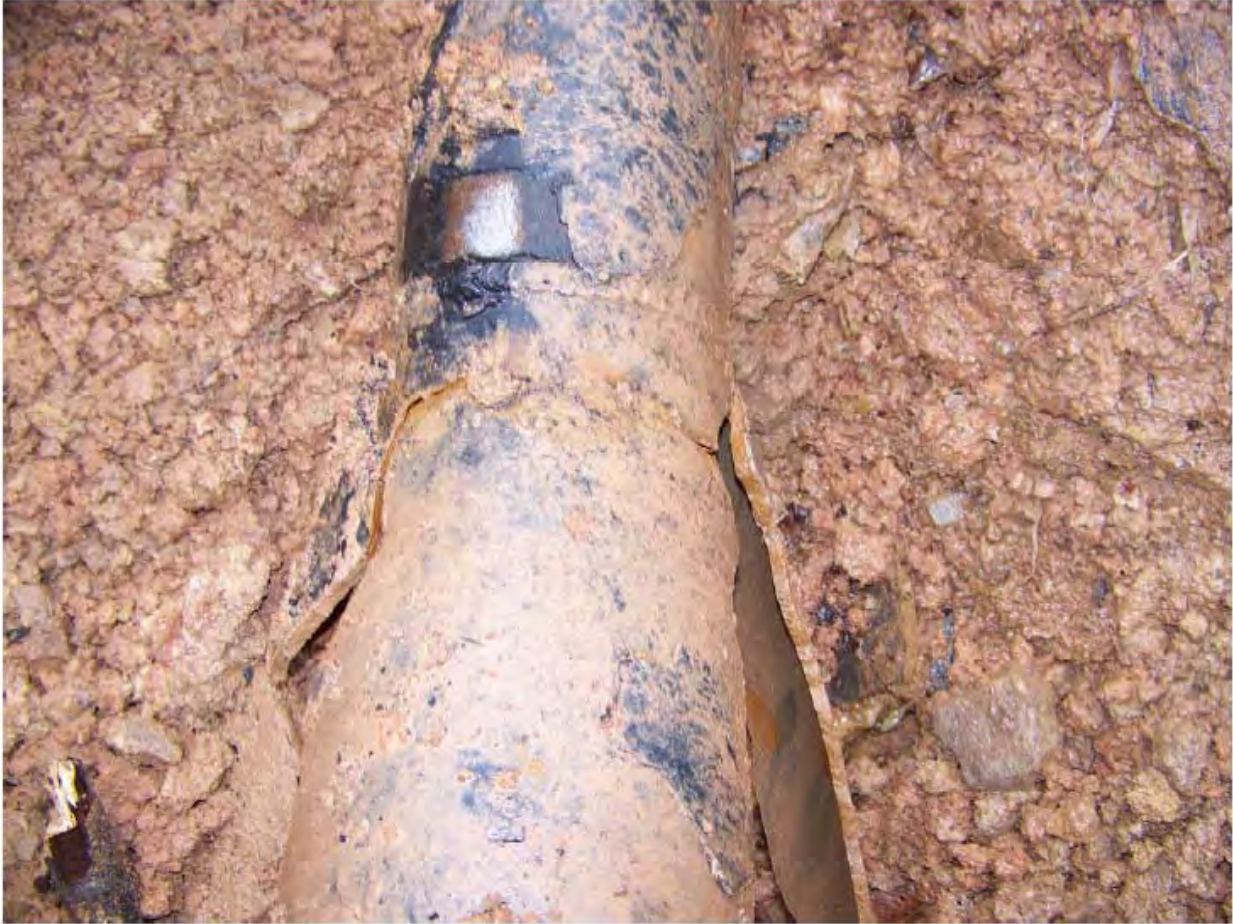
Description of photo – Tie in side where fracture stops at weld

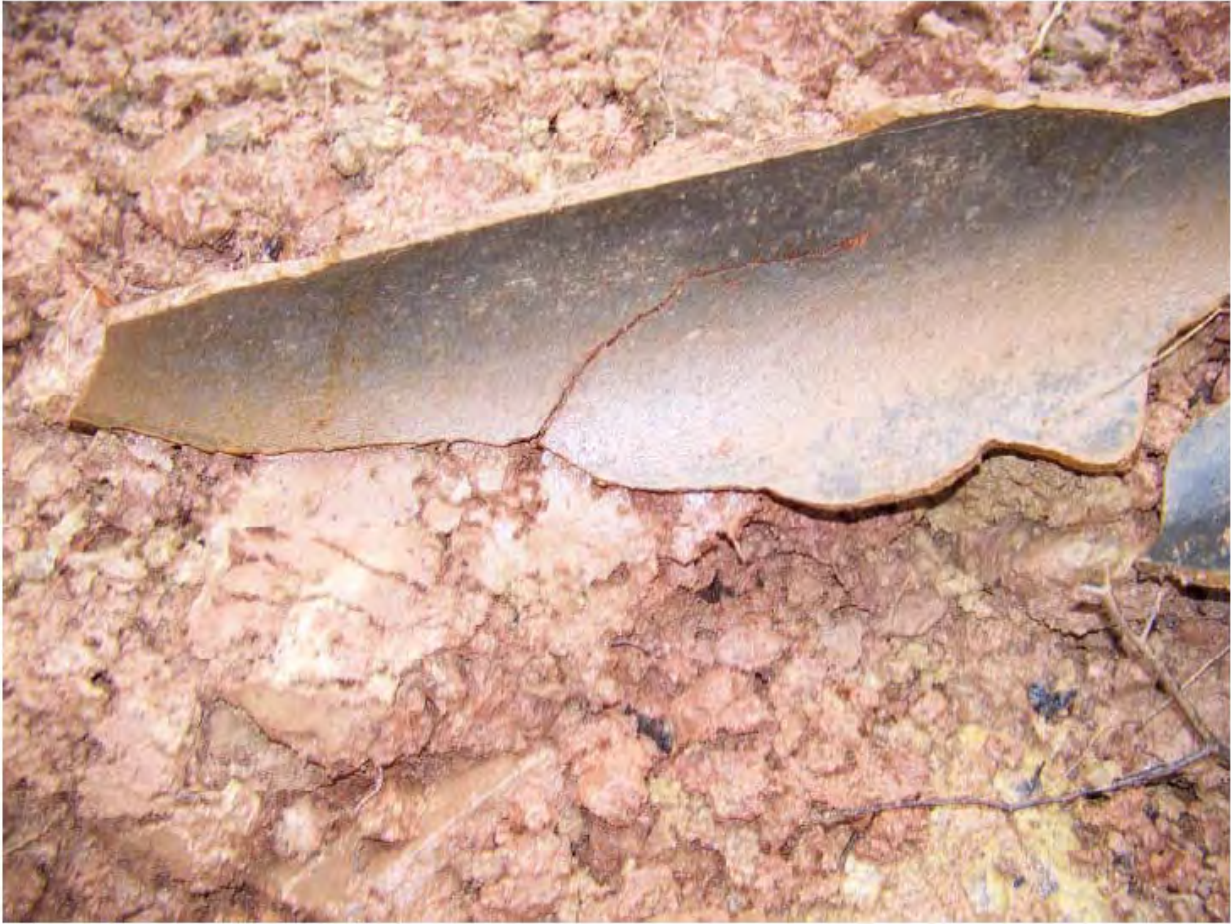
Description of photo – Short section of line 7329 indicating brittle fracture

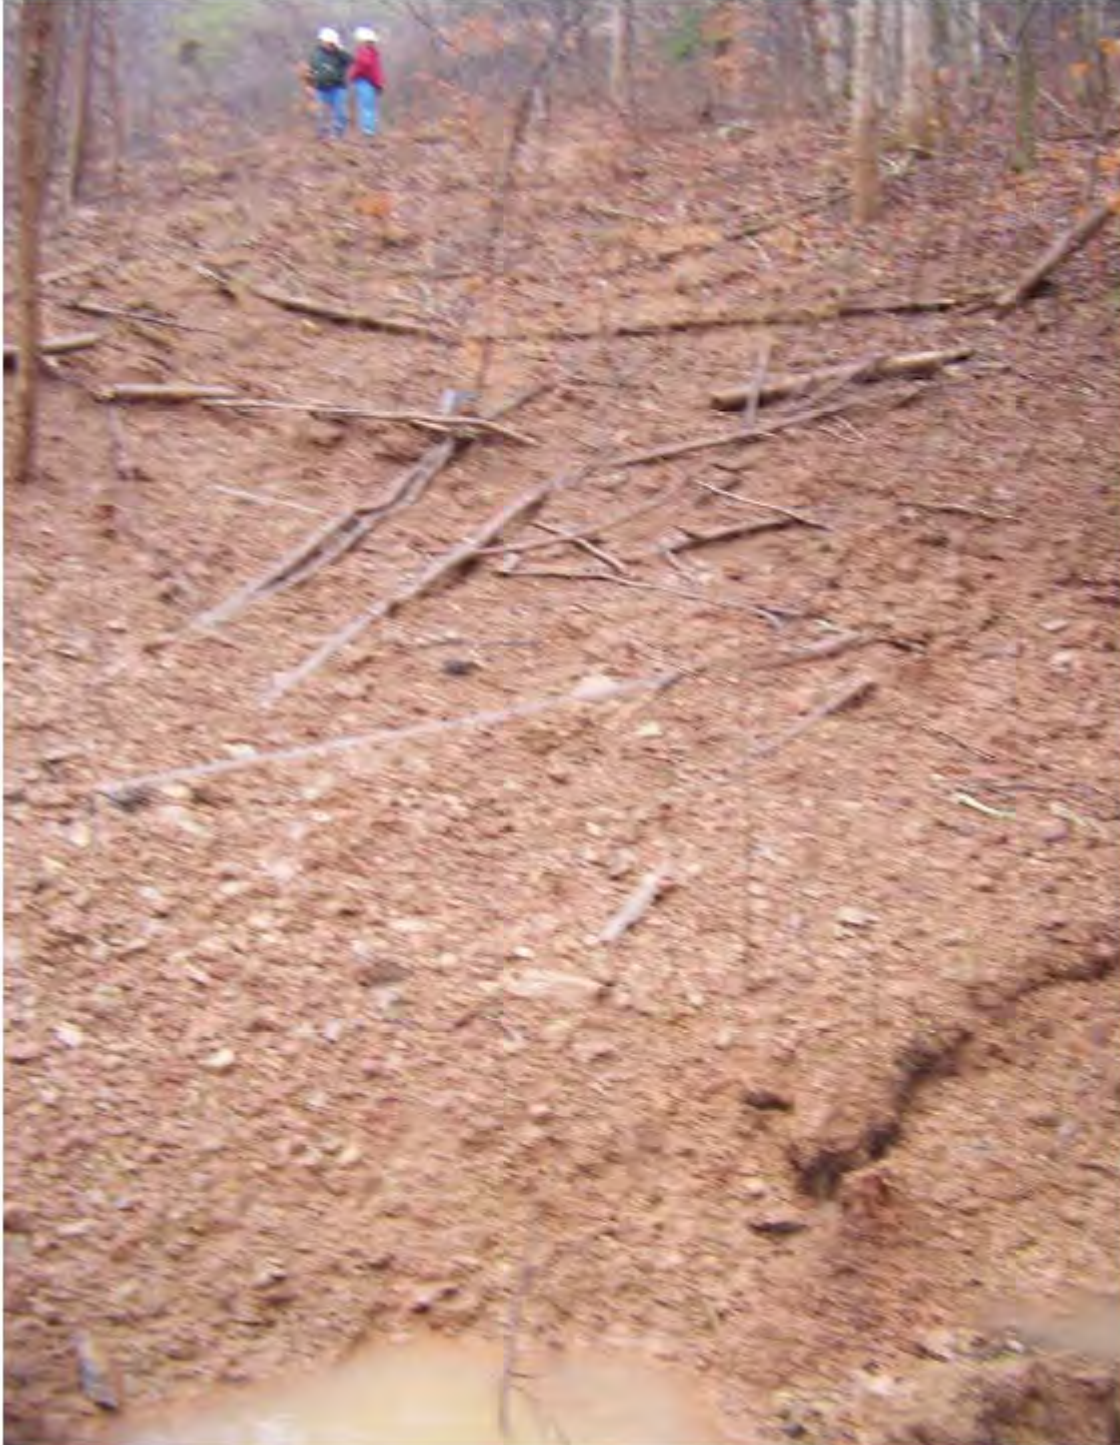
Description of photo – Overview of well side

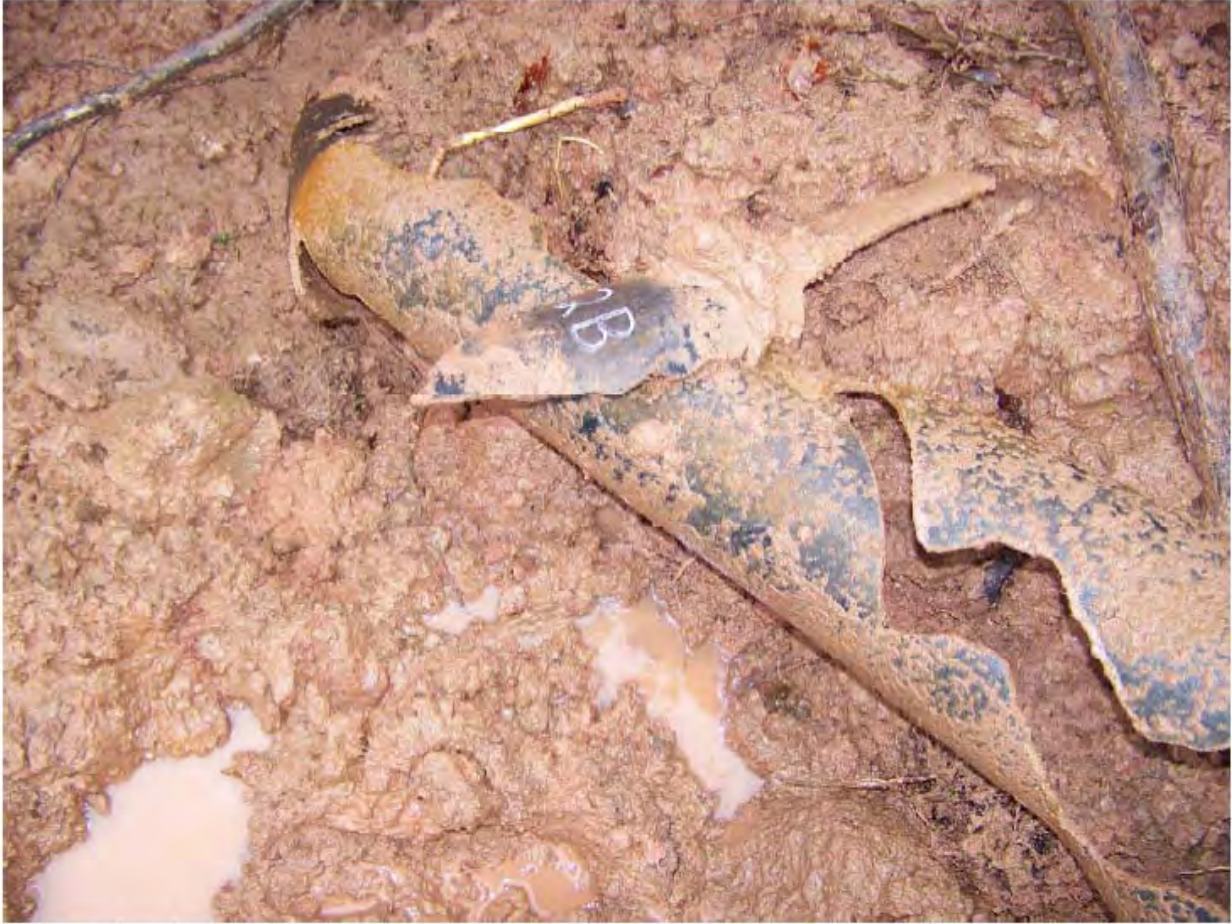
Description of photo – Short section of line 7329 indicating brittle fracture
