Enbridge Mackinac Straits ILI Review

NPS 20 Pipeline
Enbridge Line 5;
East and West Mackinac Straits

Report May 12, 2016

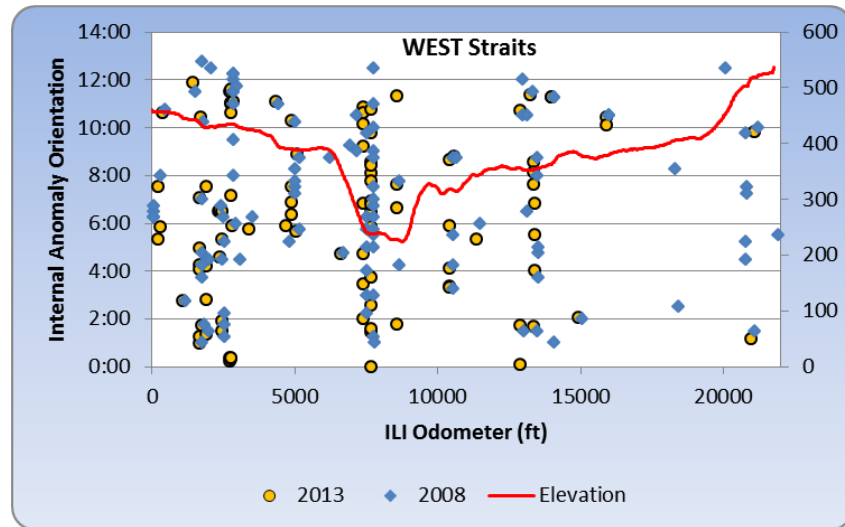
The potential internal corrosion noted above would typically be seen to occur about a preferred orientation which is not the case. It is seen, particularly in Figure 8 that the metal loss orientation is spread throughout the full circumference of the pipe. This then signifies that it is a manufacturing issue. Seamless pipe is known to cause minor metal loss anomalies to be delineated in areas where the wall thickness is non-uniform due to the pipe manufacturing process.

Figure 8. Orientation of internal metal loss anomalies in the West Straits.

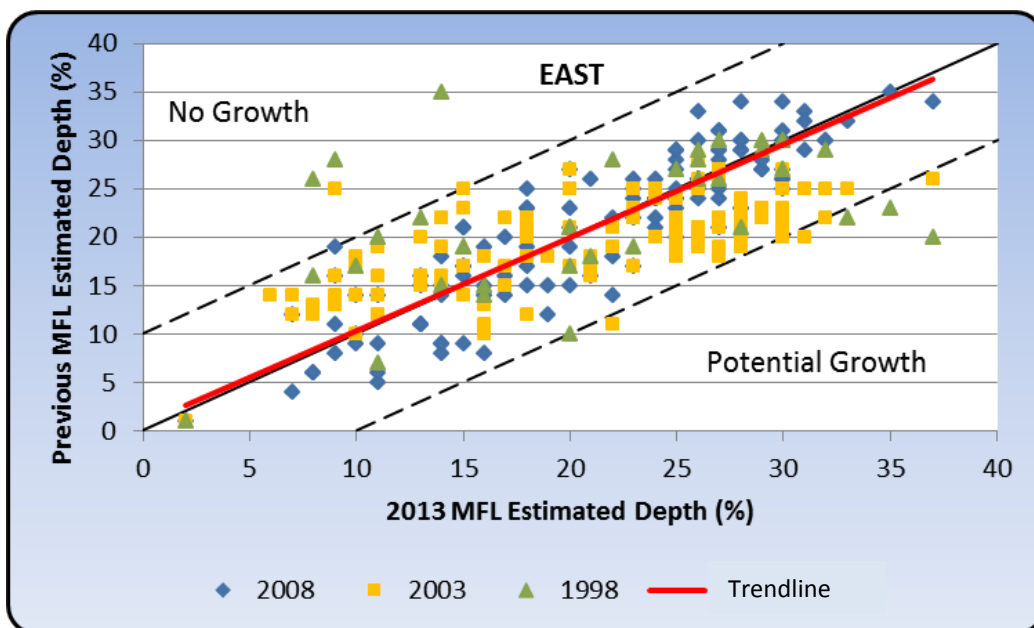
Corrosion growth rates were investigated by analyzing the growth of matched metal loss anomalies between the 2008 MFL and 2013 MFL inspections. All variances in depth were found to be within the ±10% error of the tool. Therefore considering tool error there is no

growth as would be expected if these are all manufacturing anomalies. The trendlines for both the East and West segments approximate unity seen in Figures 9 and 10.

Figure 9. 1998, 2003 and 2008 vs 2013 metal loss depths East segment.

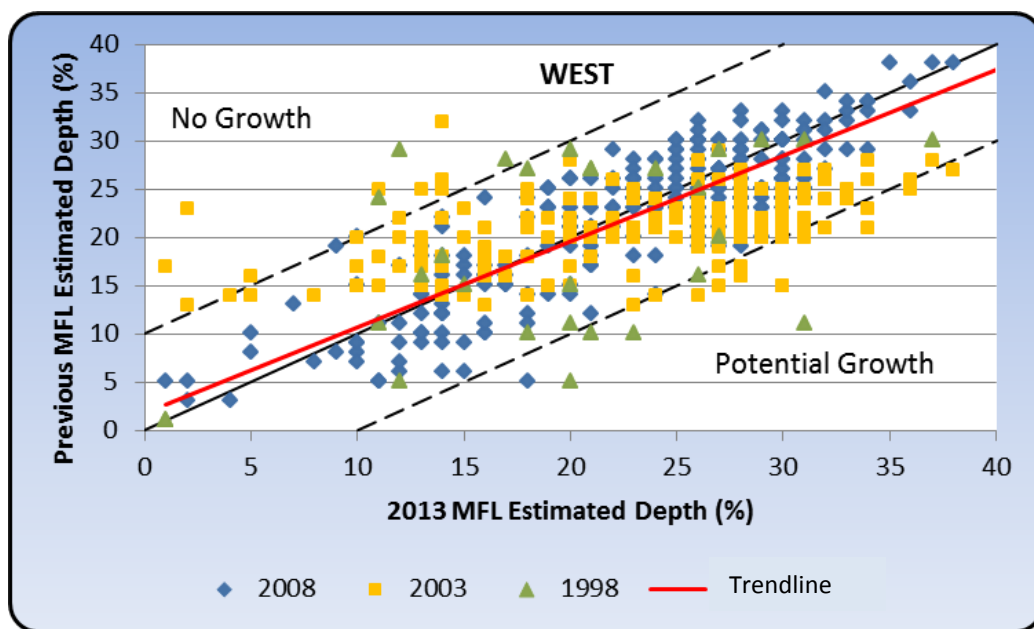
Figure 10. 1998, 2003 and 2008 vs 2013 metal loss depths West segment.

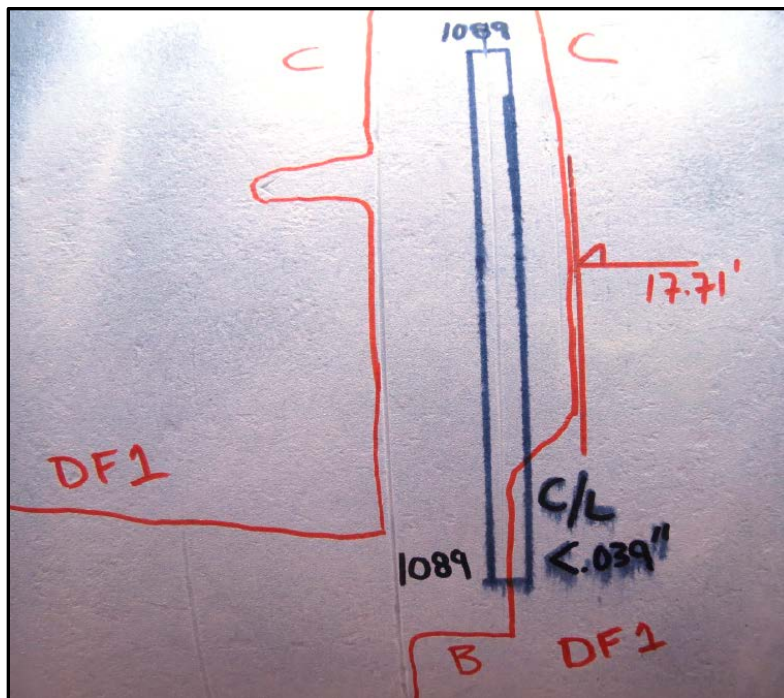
The NDT Global UCc tool employs shear wave UT sensors to examine the full length and circumference of the pipeline in high resolution for circumferentially oriented crack-like anomalies. The NDT UCc tool examined the entirety of each full crossing. The circumferential “crack-like” anomalies identified in 2014 were all at the minimum tool reporting depth of 5%, save one at 6%. There were 35 locations delineated, 14 in the East segment and 21 in the West. Sixteen were described as potential notches. Three were excavated for field interpretation and found to be innocuous manufacturing related marks on the pipe; one location is shown in Figure 15. None of these three were noted as possible notch-like.

Figure 15. Excavated "crack-like" anomaly.

No further action is deemed necessary based on the NDT UCc findings. Should there be abrupt pipe movement in the future, imparting a high strain on the pipe, it would be prudent to re-inspect for circumferential cracking.

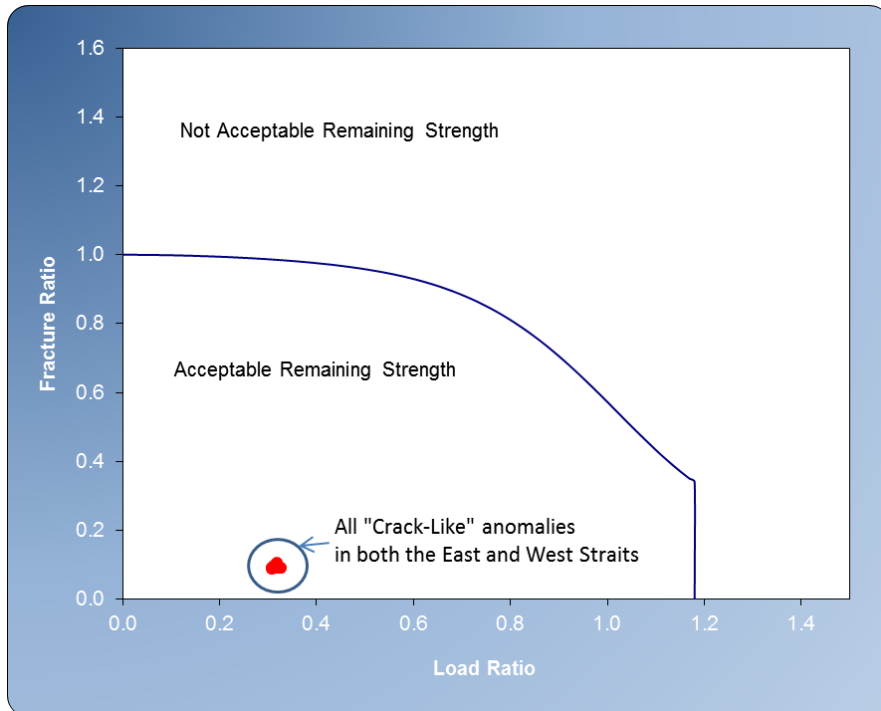
A fatigue analysis was made employing the most recent years' operating pressures (Figure 16) and considering the dimensions of the crack-like indications. All of the 35 delineated anomalies had a remaining life of greater than 50 years using ASME FFS/API 579. API Recommended Practice 579 (RP579), Fitness-For-Service, provides guidance for conducting Fitness-For-Service (FFS) assessments using methodologies specifically prepared for equipment in the refining and petrochemical industry. FFS assessments are quantitative engineering assessments which are performed to demonstrate the structural integrity of an in-service component such as pipe, containing a flaw or damage. The results of the ASME FFS/API 579 assessment are shown in the Failure Assessment Diagram in Figure 17. All of the anomalies are grouped in a tight area as a result of the similar dimensions, particularly depth, of each “crack-like” anomaly.

Figure 17. Failure Assessment Diagram of all 35 circumferential "Crack-Like" anomalies in the East and West Straits as identified by the NDT UCc tool.

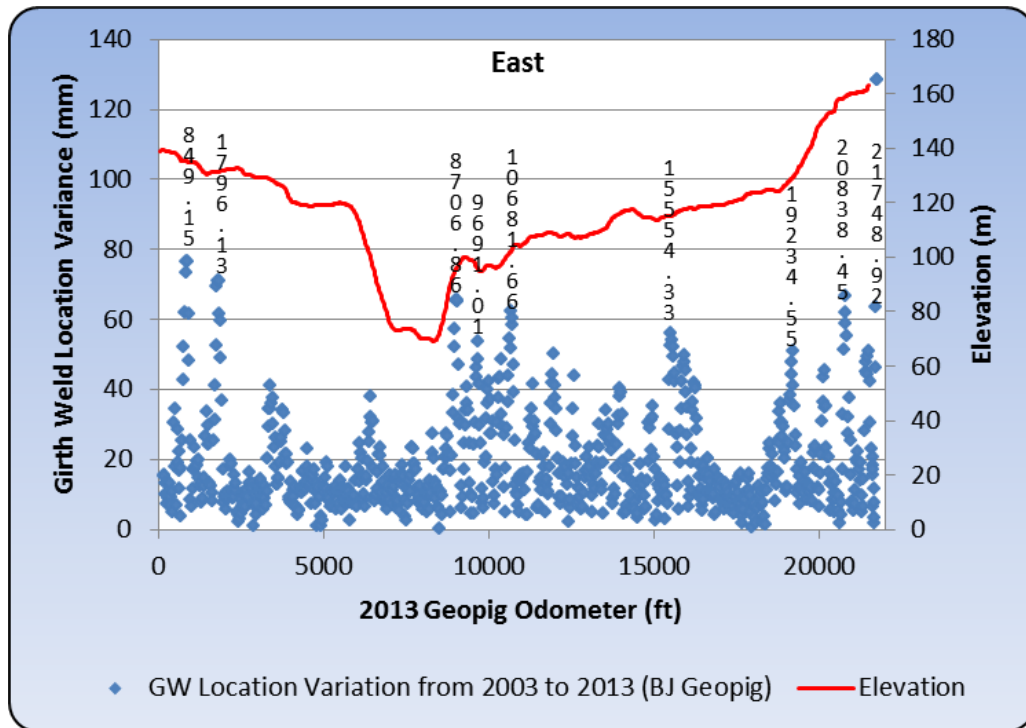
Comparing previous Geopig inspections to the 2013 data it was found that the greatest horizontal displacement in the data was noted in the East segment (Figure 17) at the end of the inspection and was 163mm (6.4") and in the West segment (Figure 18) at the beginning of the inspection and was 172mm (6.8"). This amount of deviation has been determined to impart less than 0.02% strain as it acts over a long length. Both of these locations are onshore. The 2013 odometers for the greatest deviations are noted in the figures.

Figure 18. Pipeline horizontal movement as measured by the BJ Geopig in the East crossing.

Continued vigilance with respect to pipe movement is warranted. Unless a specific event occurs which may cause pipe movement, the present inspection frequency is appropriate.

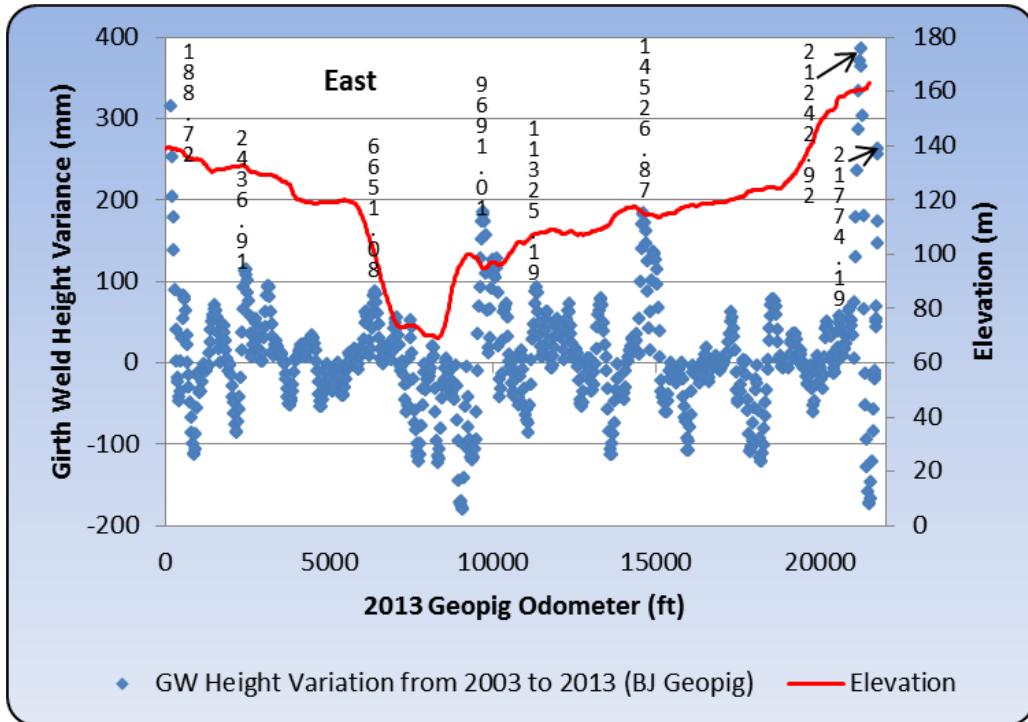
The vertical deviations are slightly greater. The greatest vertical deviation in the data was noted in the East segment (Figure 19) at both ends of the inspection with the greatest being 370mm (14.6") and in the West segment (Figure 20) at one third of the inspection length and was 214mm (8.4"). Note that all of the horizontal and vertical deviations include many pipe joints. These are smooth transitions as many joints over 100's of feet are moving. The pipe therefore has negligible added stress or strain imparted. Some of the underwater variations in height may have been corrected during 2014 maintenance in which both segments had new anchor points installed so as to have no unanchored spans greater than 75' in length.

Figure 20. Pipeline vertical movement as measured by the BJ Geopig in the East crossing.
