Principal Investigator Karen Butler/James Bunn
Region Director David Barrett
Date of Report 6/20/2012
Subject Failure Investigation Report – Amoco Insulating Flange Leak,
Granger, IN

Failure Investigation Report – Amoco Insulating Flange Leak, Granger, IN

Failure Date 8/18/2005

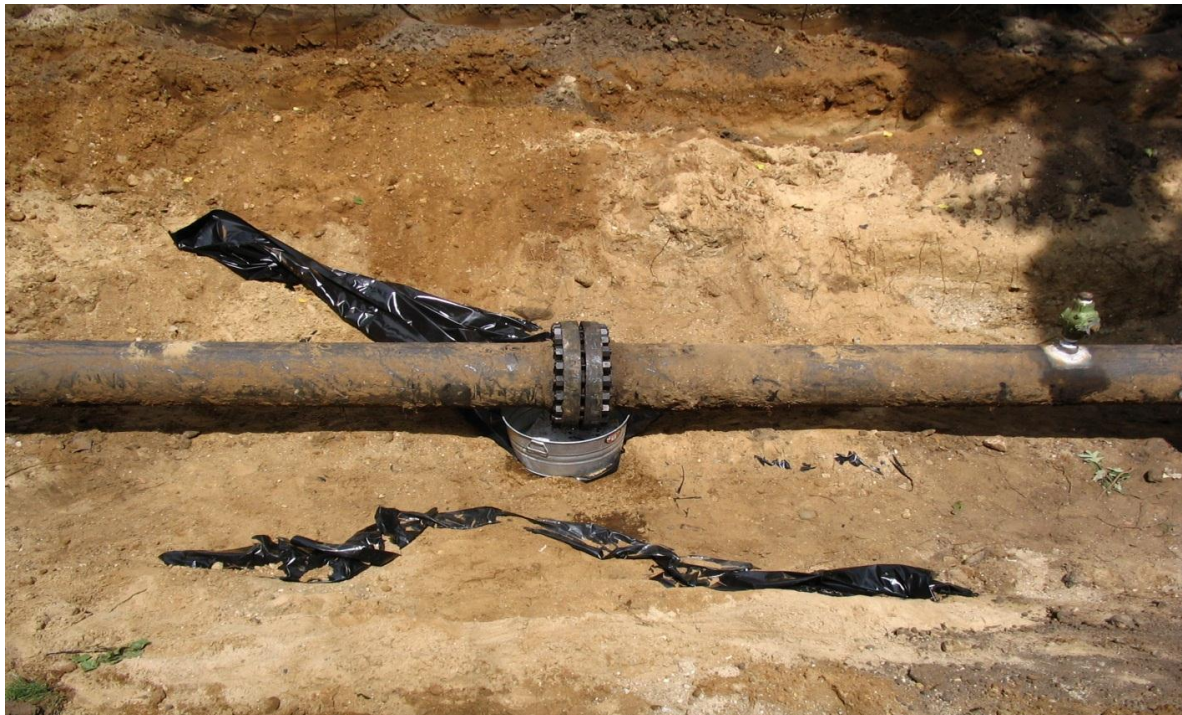
The Leaking Flange Excavated

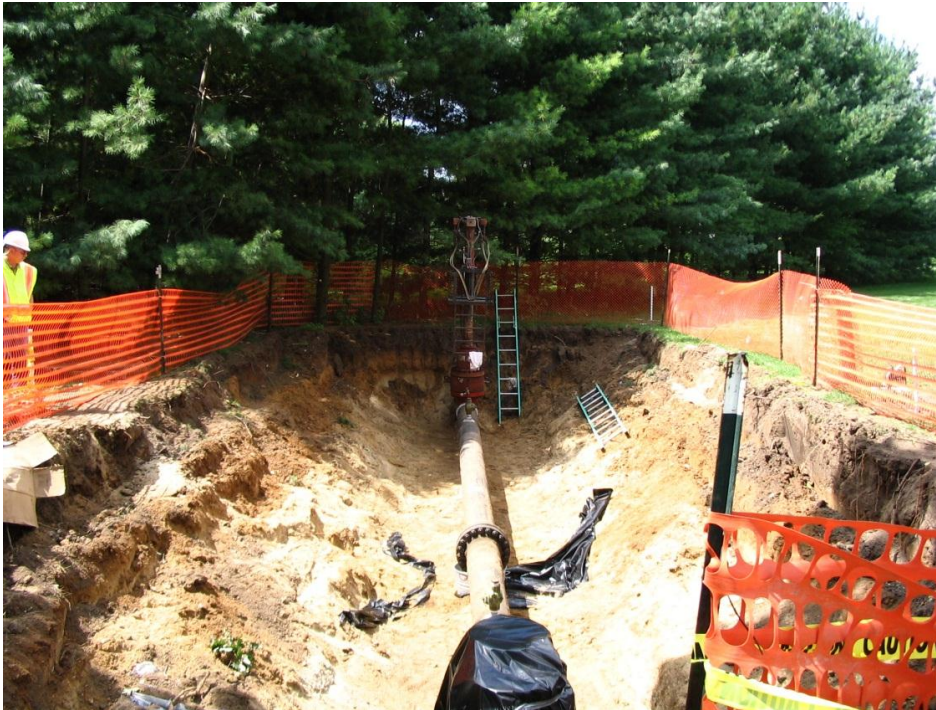
The Leaking Flange Facing West

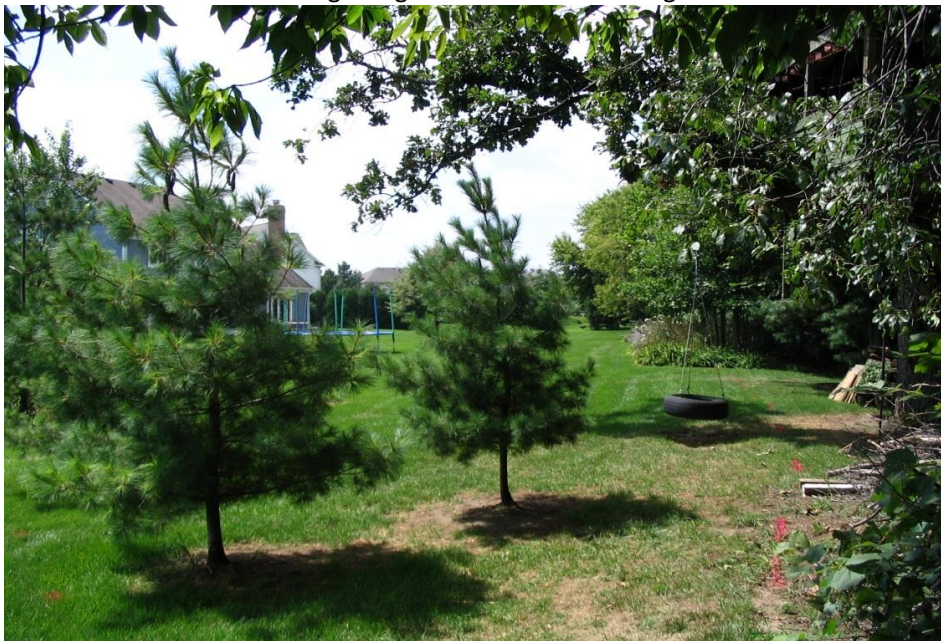
Residential Area Looking West
Leaking Flange Is Located Bottom Right

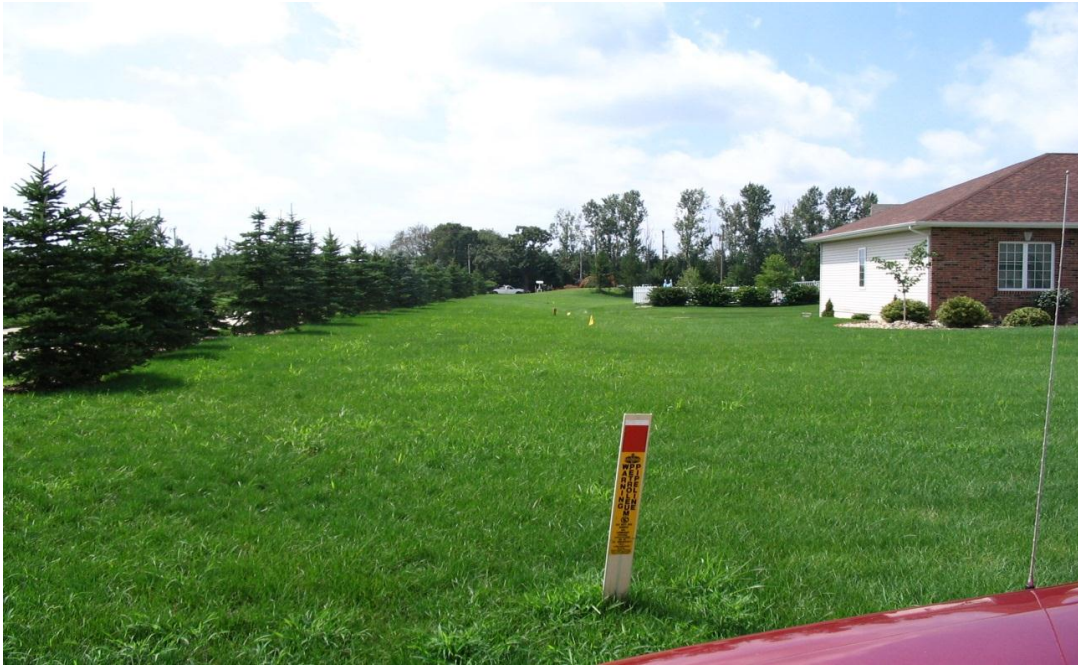
Looking East to the Leak Site

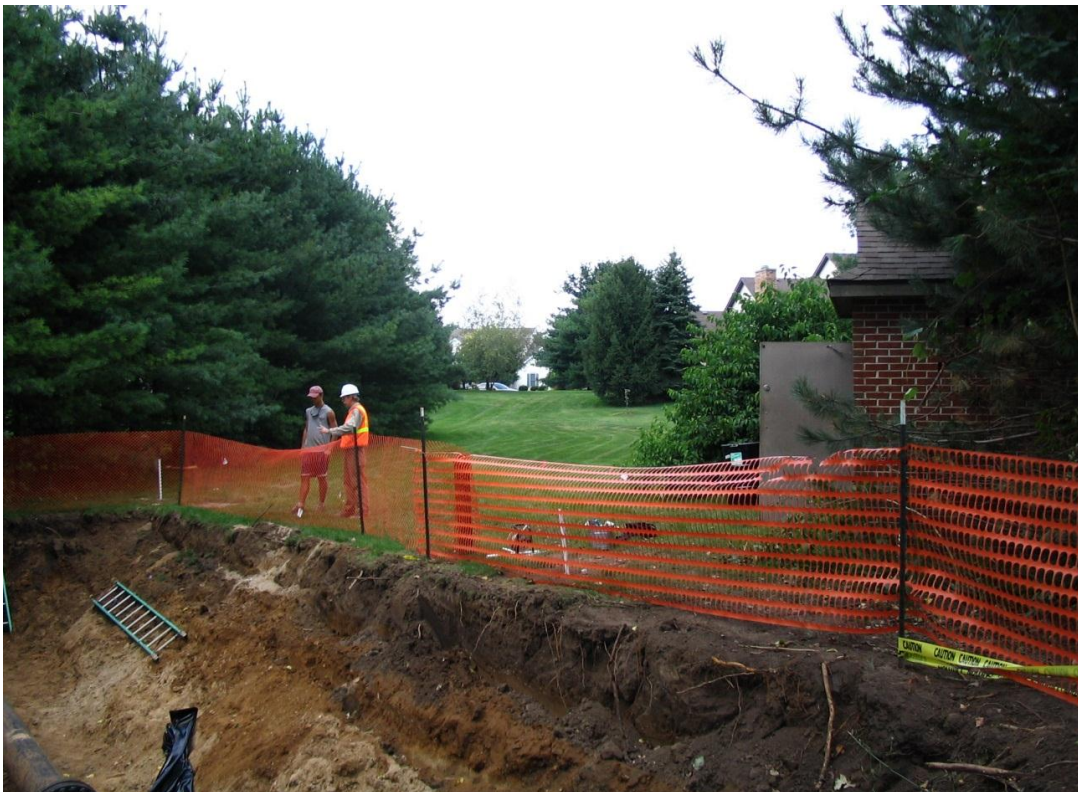
Failure Location (Northwest)
