**Principal Investigator** Peter J. Katchmar/John Haddow  
**Regional Accident Coordinator** Peter J. Katchmar  
**Region Director** Chris Hoidal  
**Date of Report** 4/13/2012  
**Subject** Failure Investigation Report – Suncor Energy (USA) Pipeline Company  
(Suncor) Tank # 1168 Overfill

**Date of Failure** 6/14/2010  
**Commodity Released** Crude Oil  
**City/County & State** Cheyenne/Laramie, WY  
**OpID & Operator Name** 31822 - Suncor Energy (USA) Pipeline Company  
**Unit # & Unit Name** 3945 – Rocky Mountain Crude System  
**SMART Activity #** 130287  
**Milepost / Location** MP-78 - Cheyenne Pump Station  
**Type of Failure** Break Out Tank Overflow  
**Fatalities** 0  
**Injuries** 0  
**Description of area impacted** Inside operator controlled pump station and tank farm  
**Property Damage** \$45,375

## Failure Investigation Report – Suncor Tank Overfill

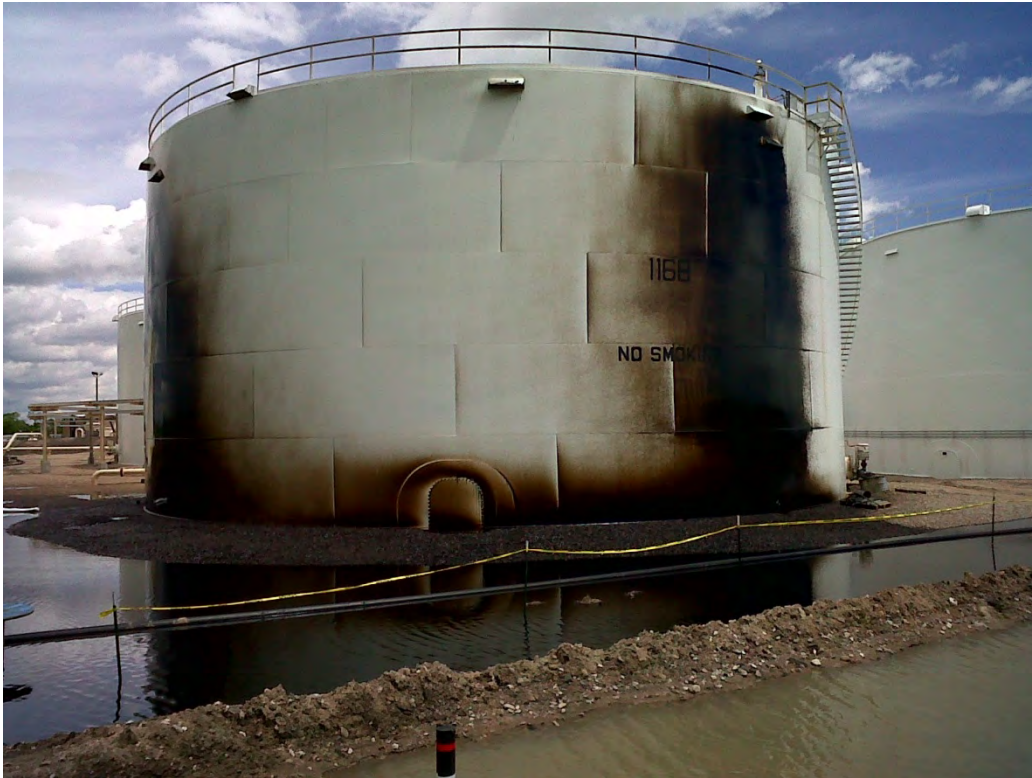
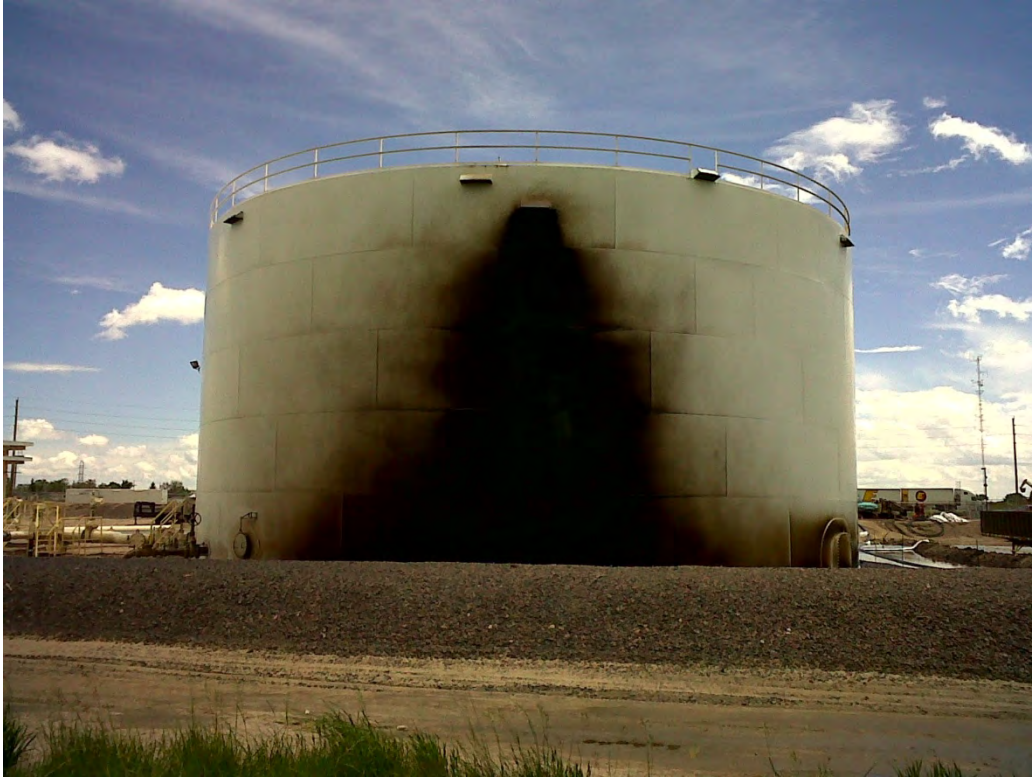
Suncor Tank 1168 Overfill.

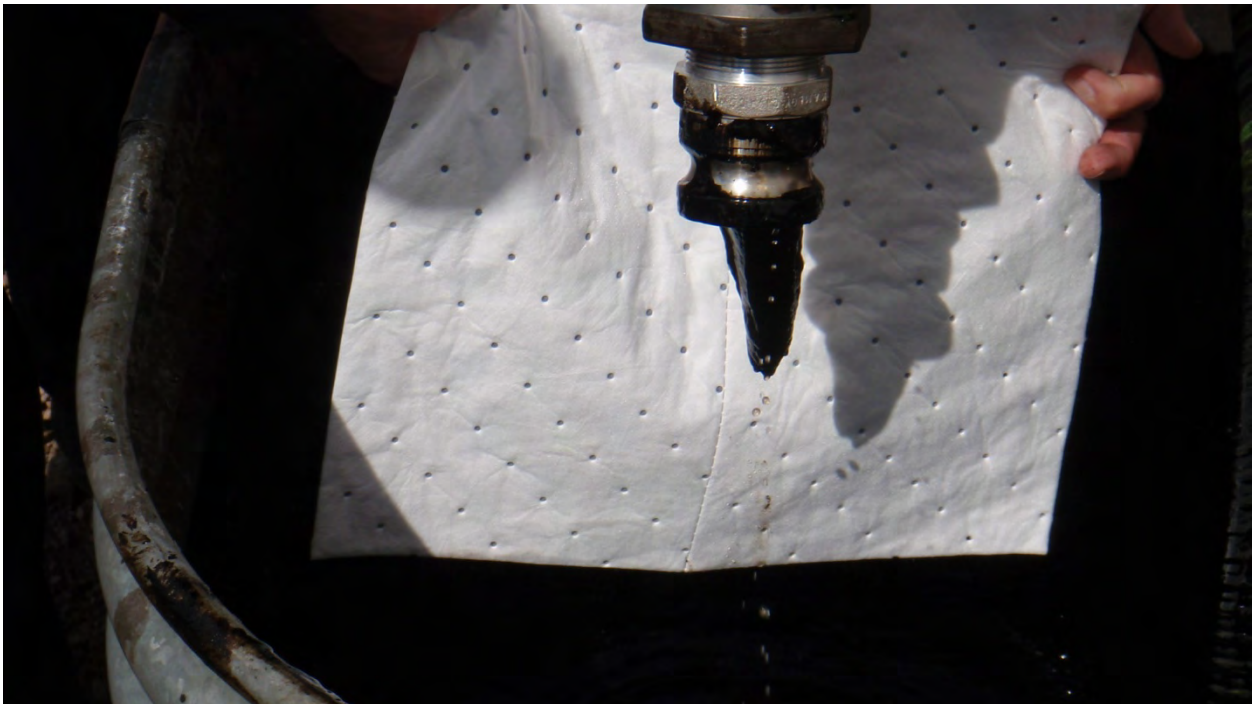
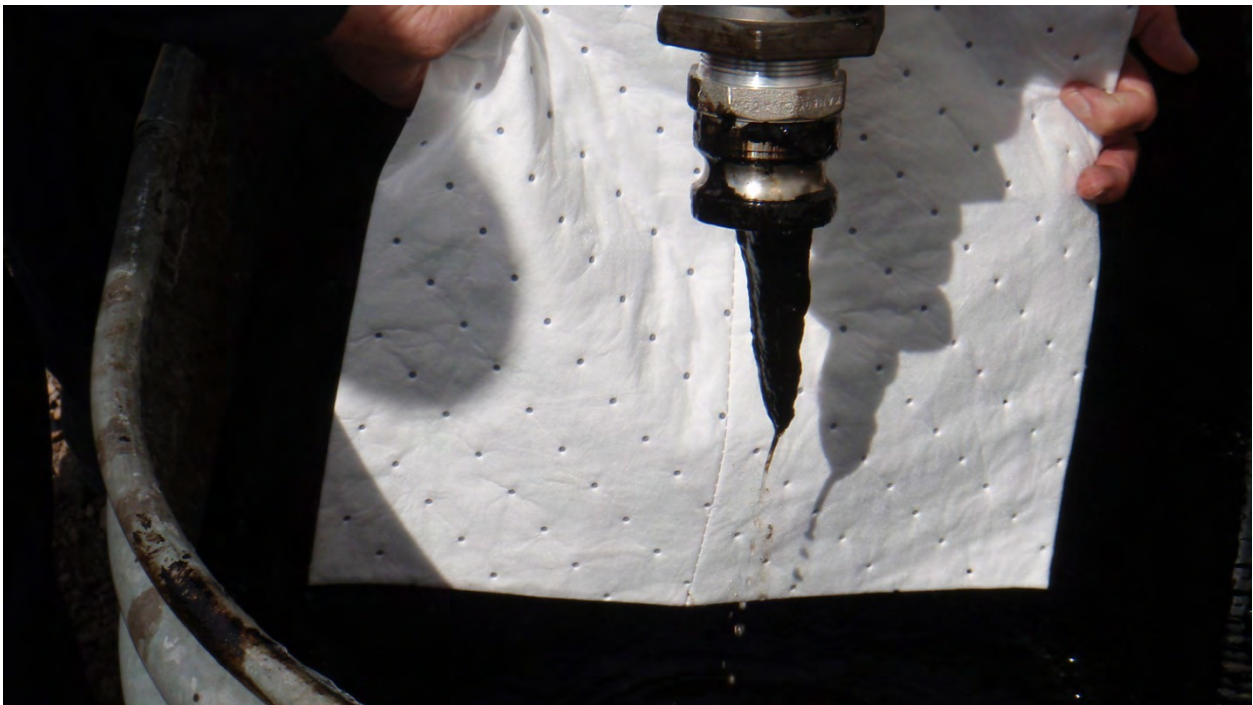
Suncor reported that they have had some problems with the equipment on their pipeline system becoming clogged with a sludge that they think is an excess amount of DRA mixed with basic sediment and water (BS & W). Over the years, Suncor thinks that this sludge dropped out of the crude while in tank 1168 and accumulated to the point of filling the sump and the outer rim of the tank. Once this sludge accumulated to the point of the level of the bottom of the gauge tube, a slug of the sludge entered the gauge tube.

Sludge being drained from the water draw sump. Water can be seen dropping out of the sludge.

Suncor lowered the working tank capacity of the tank that overfilled and moved up the API 653 out-of-service tank inspection that was already scheduled for 2012. The tank was checked and deemed suitable for continued service. Plans were developed to change the service of the tank to not receive crude oil from the Butte Pipeline system as this was thought to be where the viscous fluid came from.

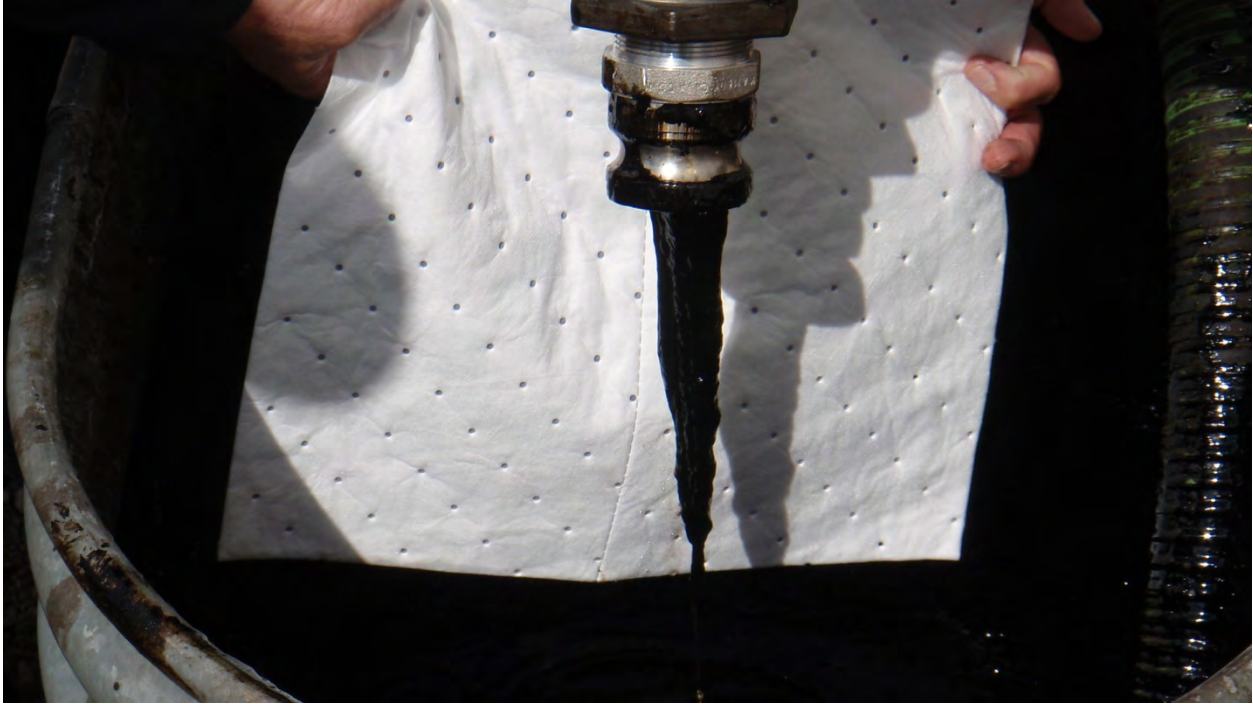
Sludge being drained from the water draw sump.

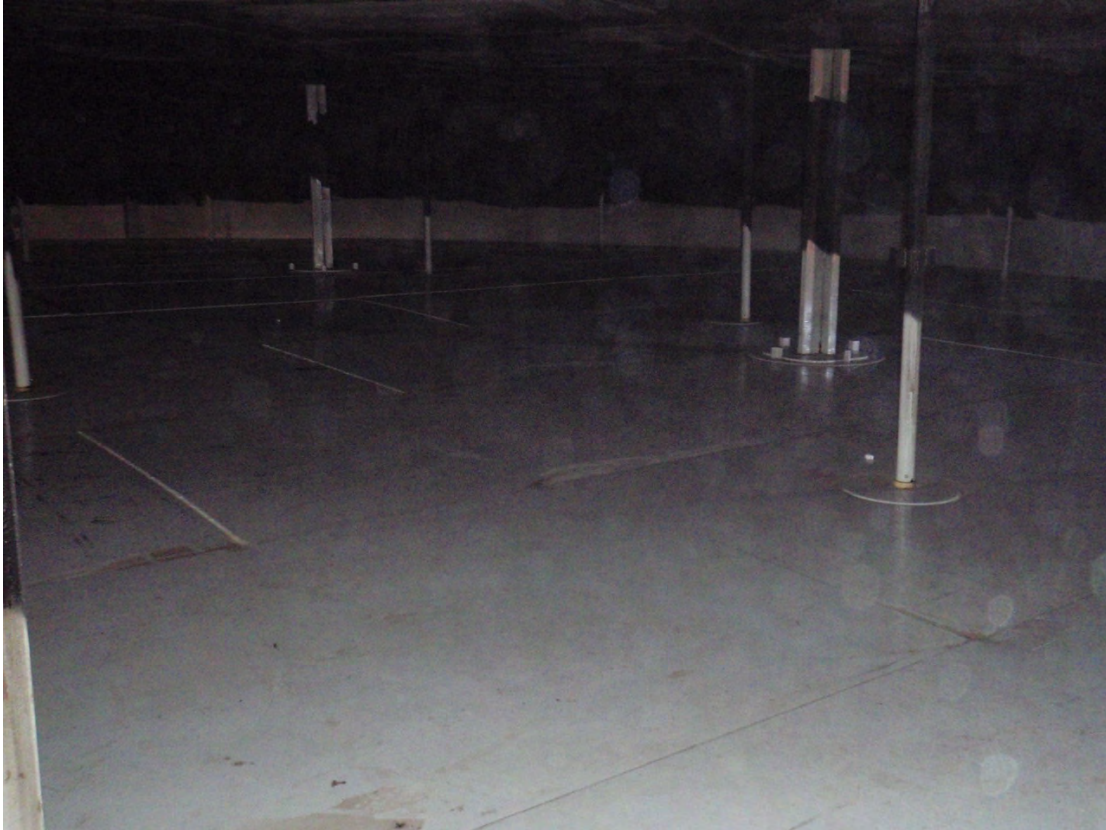
Inside floor of tank 1168. The gray is an internal liner.

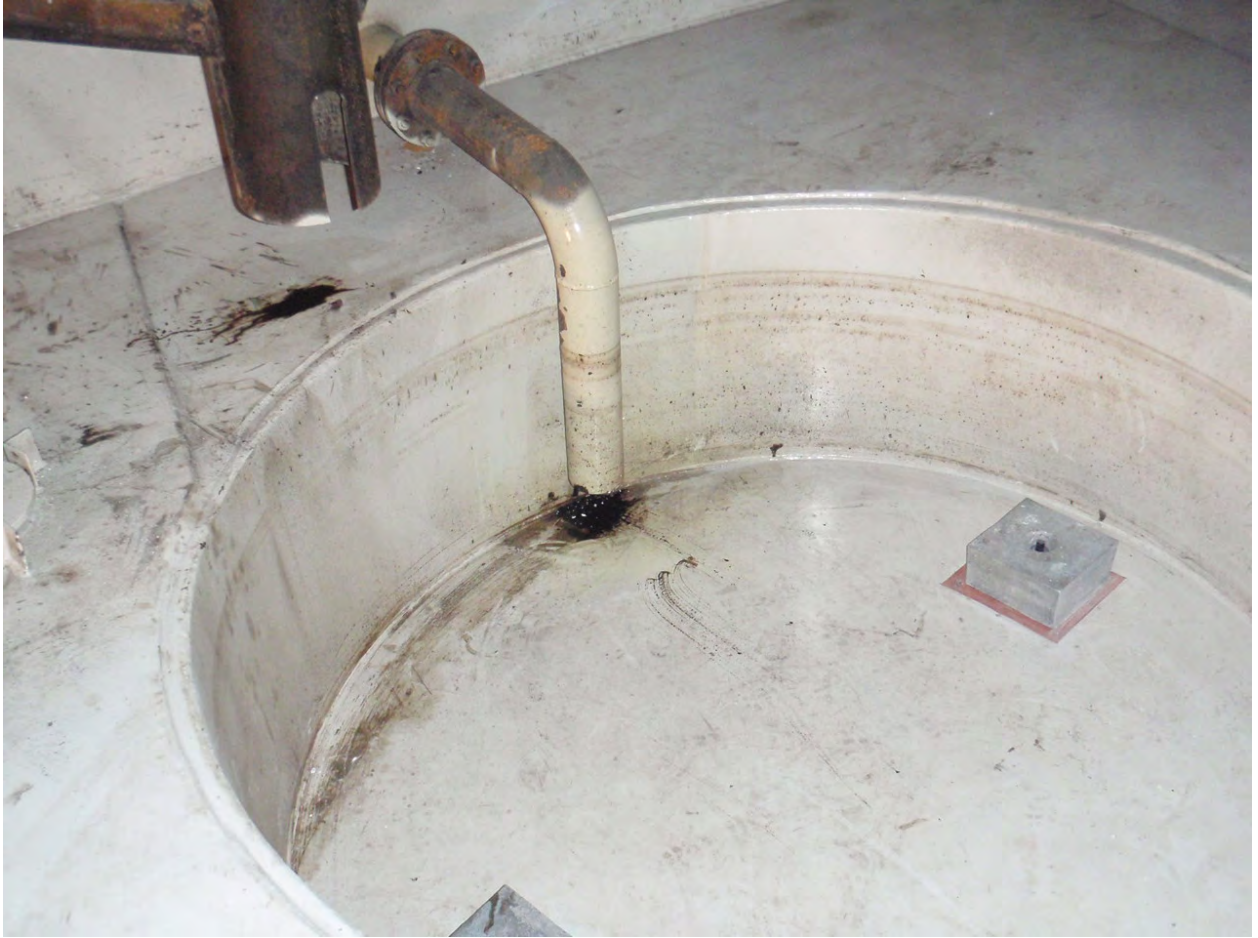
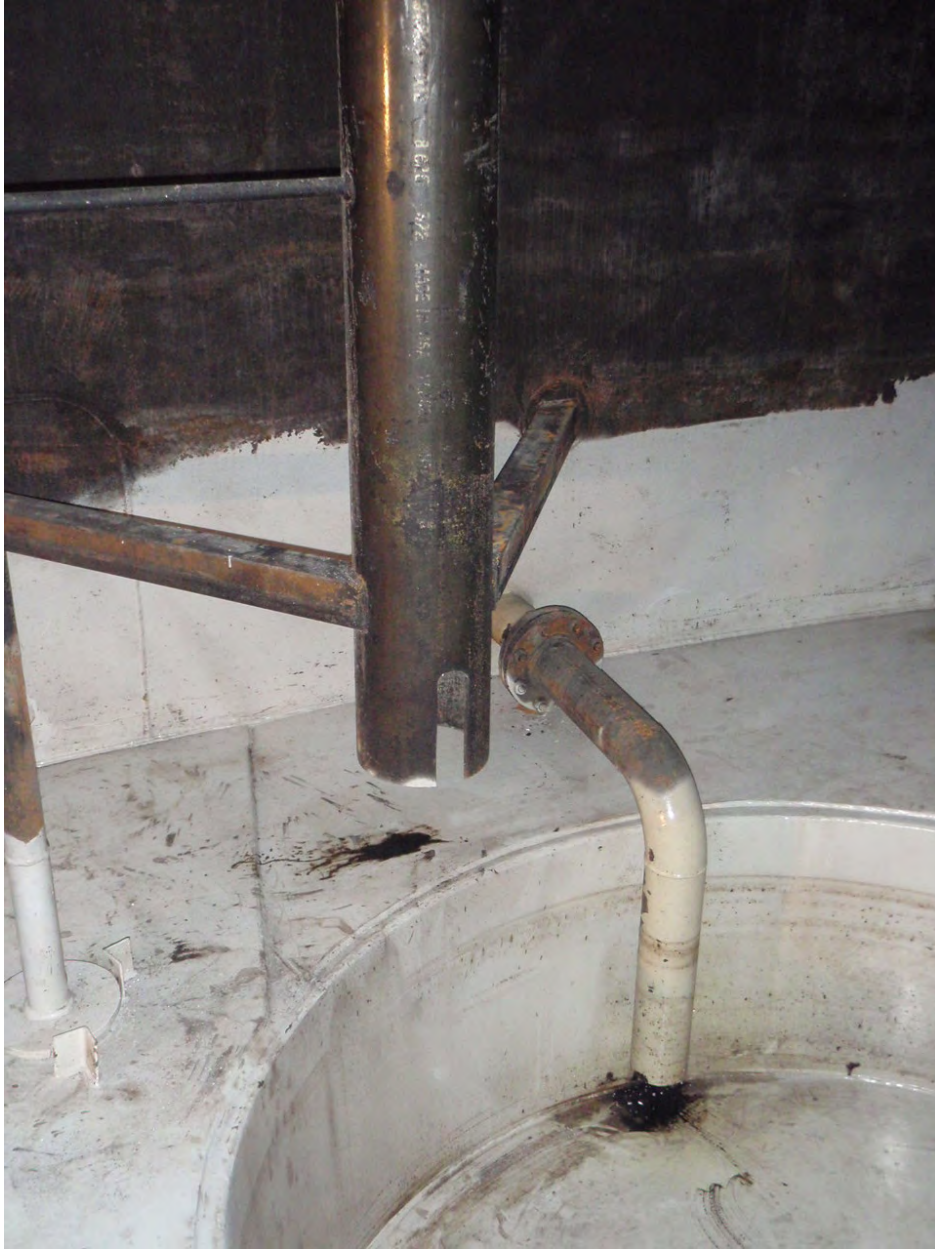
The gauge tube is fitted with a radar gauge which works on the principal of a reflective signal. The tank level (distance from the radar) is derived from the time delay of the reflected signal. Conjecture is that the column of sludge moved up and down the 8 inch gauge tube slower than the tank actually filled and drained. The gauge tube is an older design and was not slotted.

The design of the inside of the tank also contributed to the overfilling of the tank. The gauge tube was placed directly over the two foot deep sump area in the bottom of the tank floor. There is a datum plate that extends four inches across the eight inch gauge tube and is located 6 inches above the tank bottom. This datum is where a gauge line is supposed to land when a person is manually gauging this tank. Back in 2002, there is a record of the hydrotest of this tank after modifications were made. The tank was overfilled at that time too. The engineer manually gauged the tank in an attempt to understand why the tank was overfilling. He reported that the gauge level at 37' 11" which could only be accurate if the gauge was at the bottom of the sump.

Water draw sump inside the tank. Gauge tube can be seen.
