**Failure Investigation Report – Williams (Transco) Corrosion Failure
April 26, 2010**

Principal Investigator Jon Manning
Region Director R.M. Seeley
Date of Report 3/31/2011
Subject Failure Investigation Report – Williams (Transco) Corrosion Failure

Date of Failure 4/26/2010
Commodity Released Natural Gas
City/County & State Kleberg County, TX - near Kingsville
OpID & Operator Name 19570 Williams Gas Pipeline - Transco
Unit # & Unit Name 13314 Transco South Texas District
SMART Activity # 129876
Milepost / Location Milepost 97.53
Type of Failure Leak caused by External Corrosion
Fatalities 0
Injuries 0
Description of area impacted Ranch Property
Property Damage \$57,084

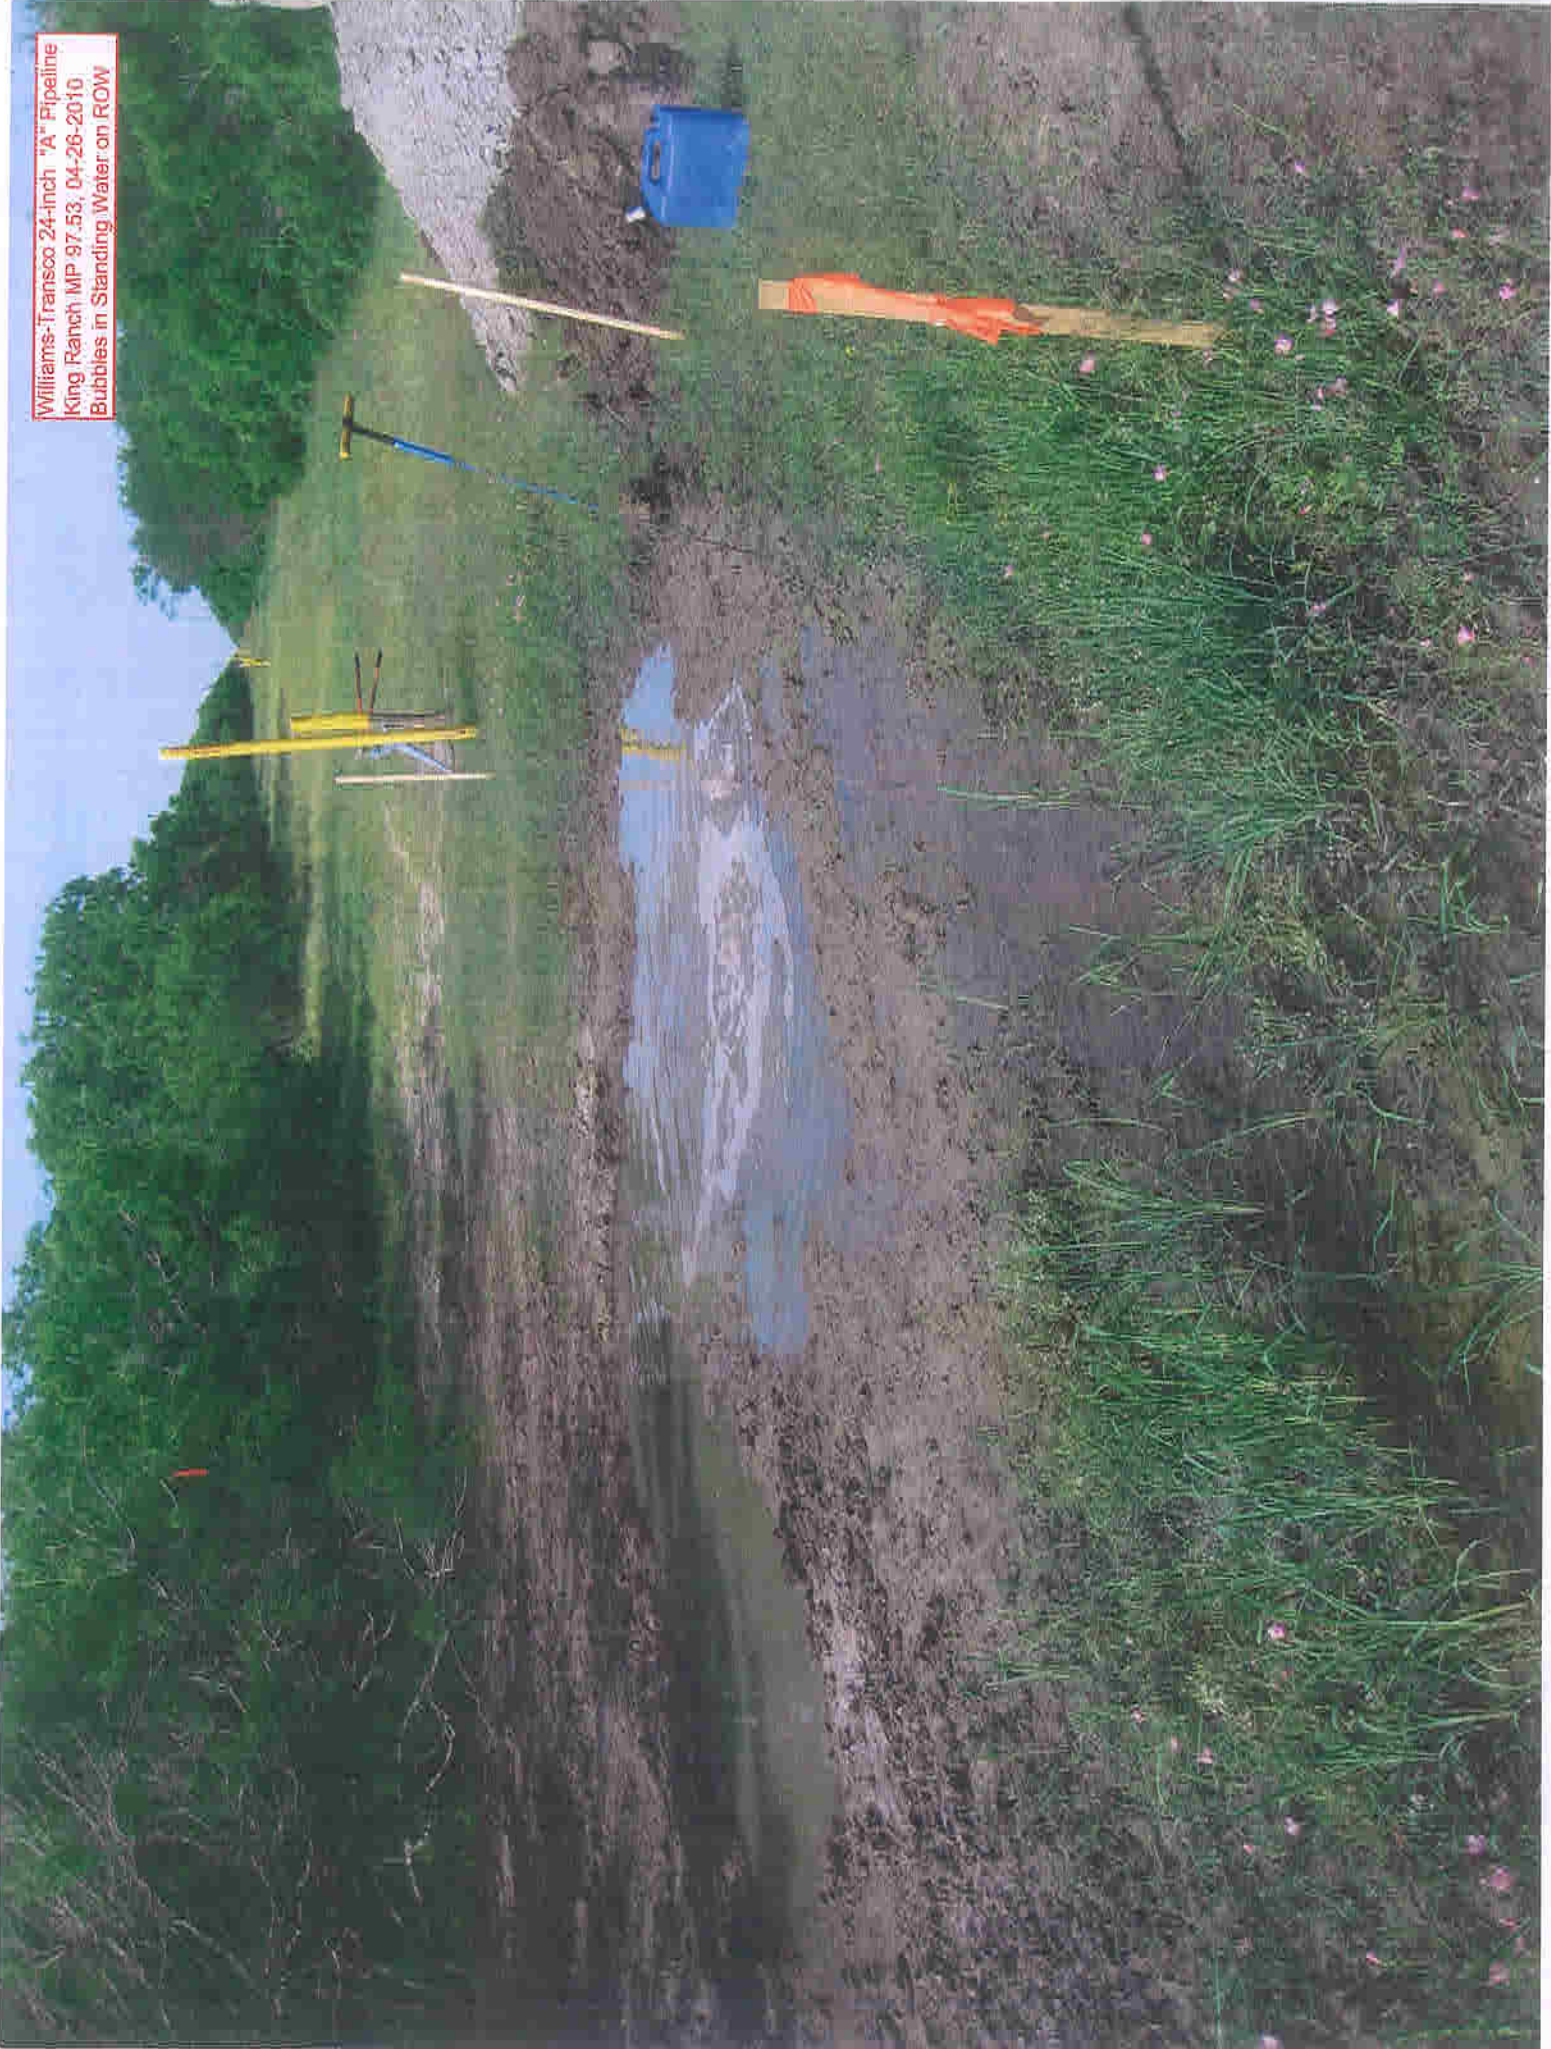
Williams-Transco 24-inch "A" Pipeline
King Ranch, MP 97.53, 04-26-2010
Bubbles in Standing Water on ROW

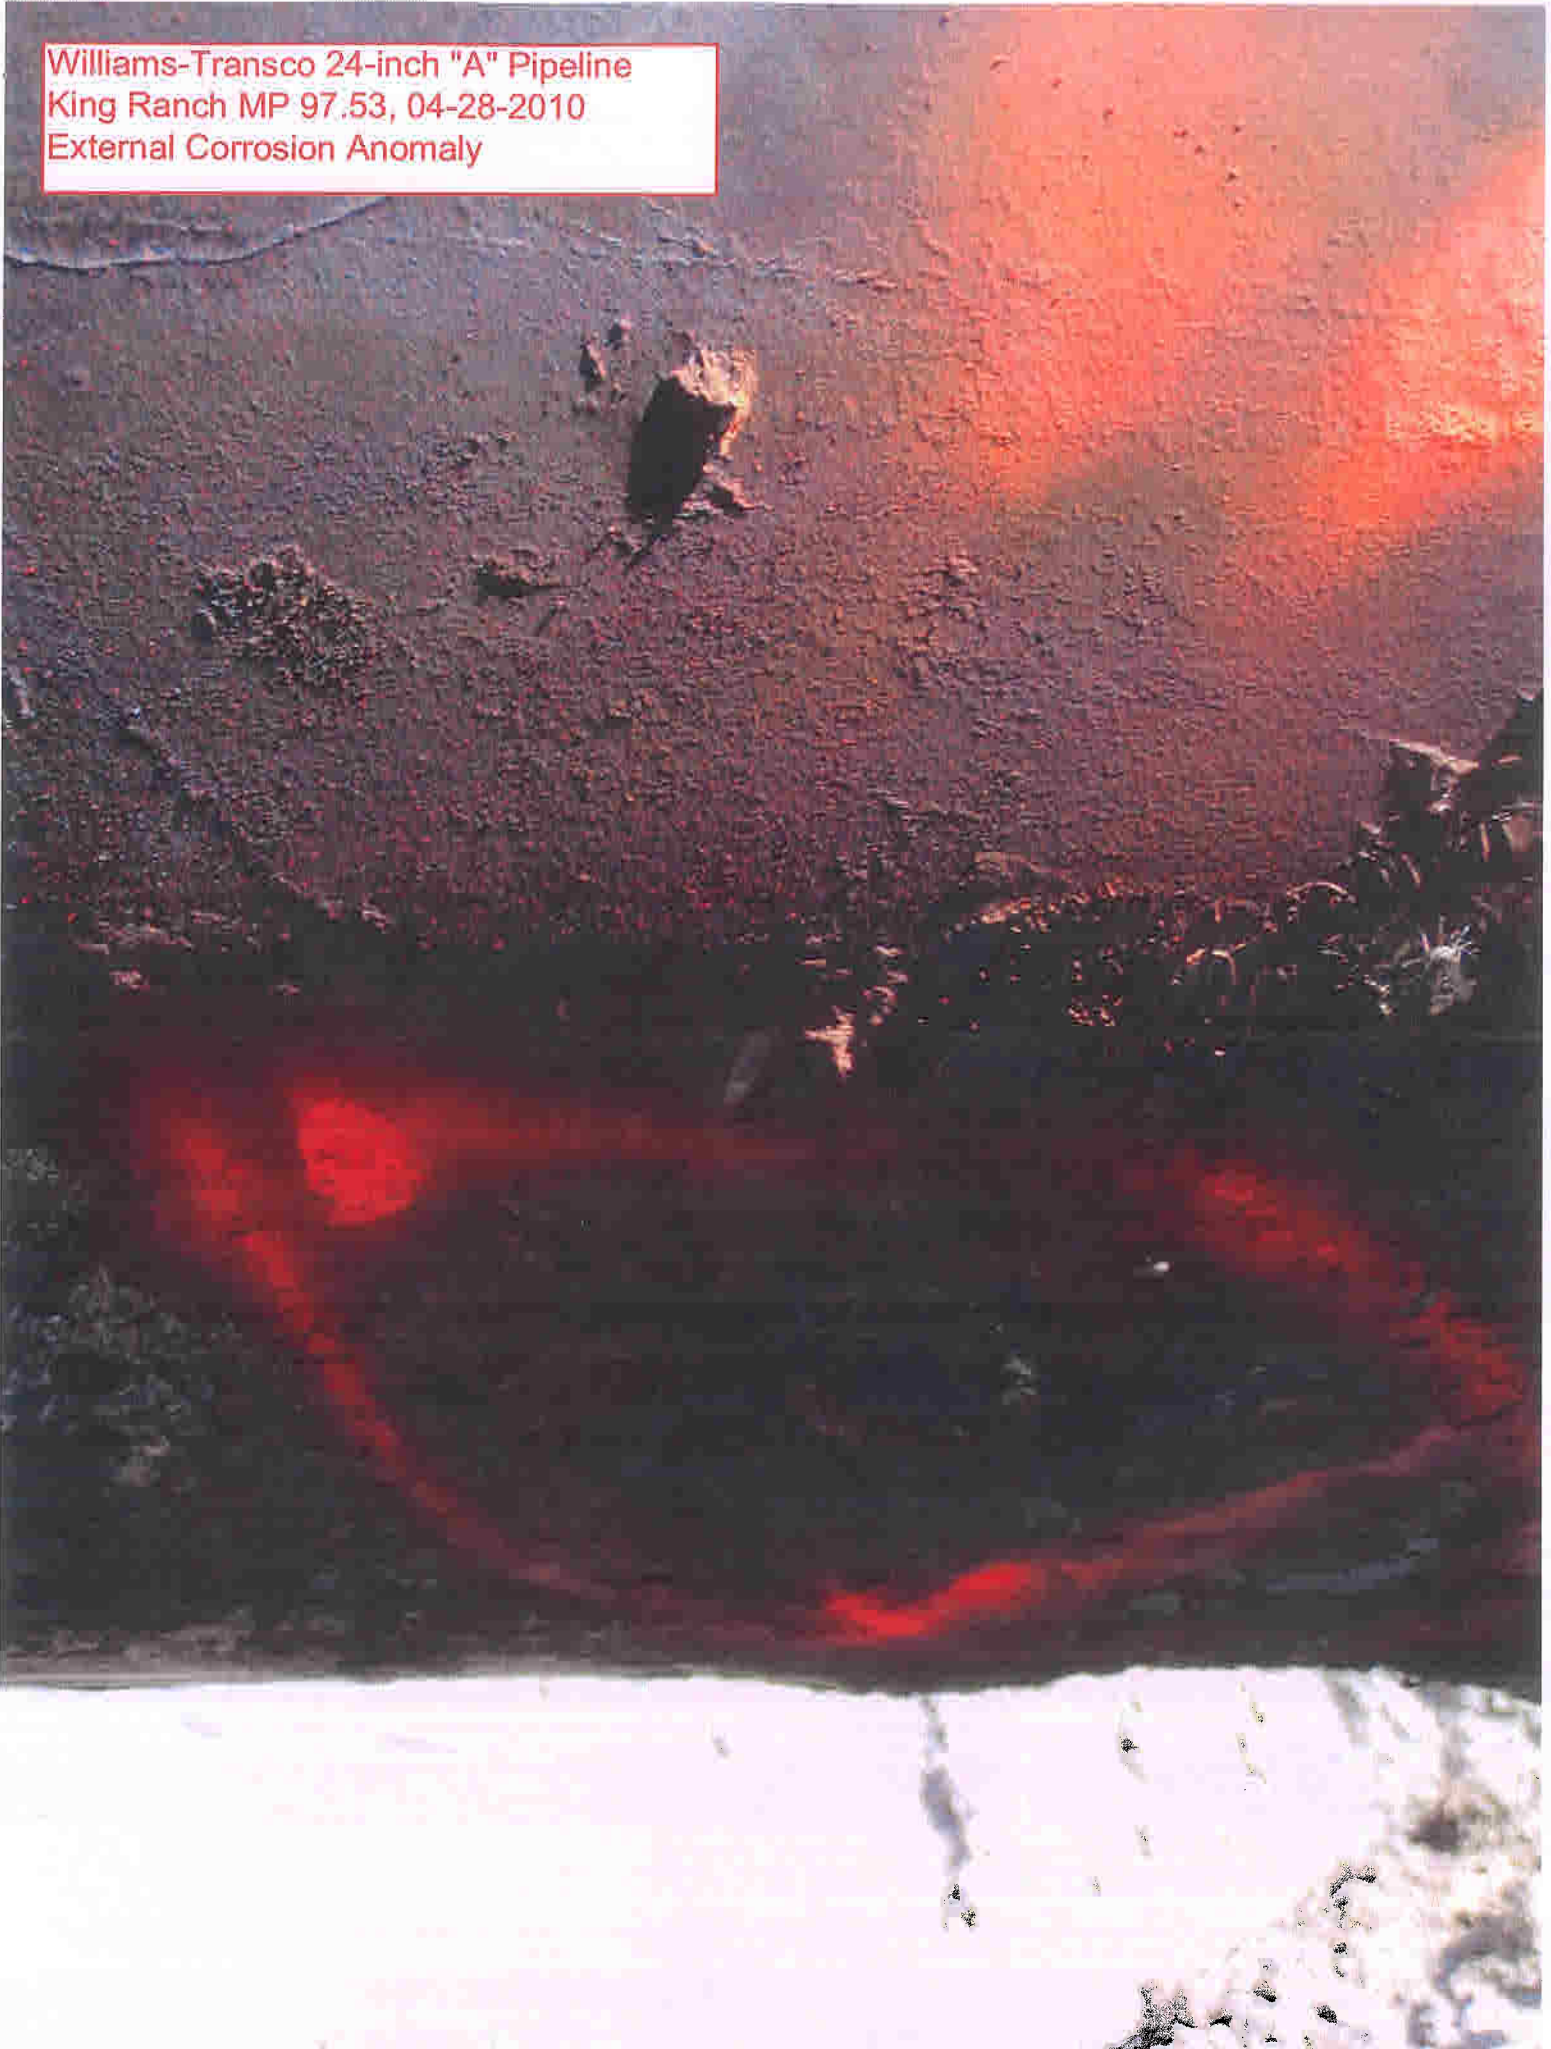
1. The “A Pipeline” was leaking from a small corrosion anomaly (approximately ¼ inch diameter) at approximately the 5 o’clock position on the pipeline.
2. With the exception of the area around the leak, the coating appeared to be intact.
3. The process of obtaining permission and permits to excavate on the King Ranch property resulted in the time delay between the initial discovery on April 22 and confirmation on April 26. The telephonic report was made by the Operator after confirmation.

Williams-Transco 24-inch "A" Pipeline
King Ranch MP 97.53, 04-28-2010
External Corrosion Anomaly

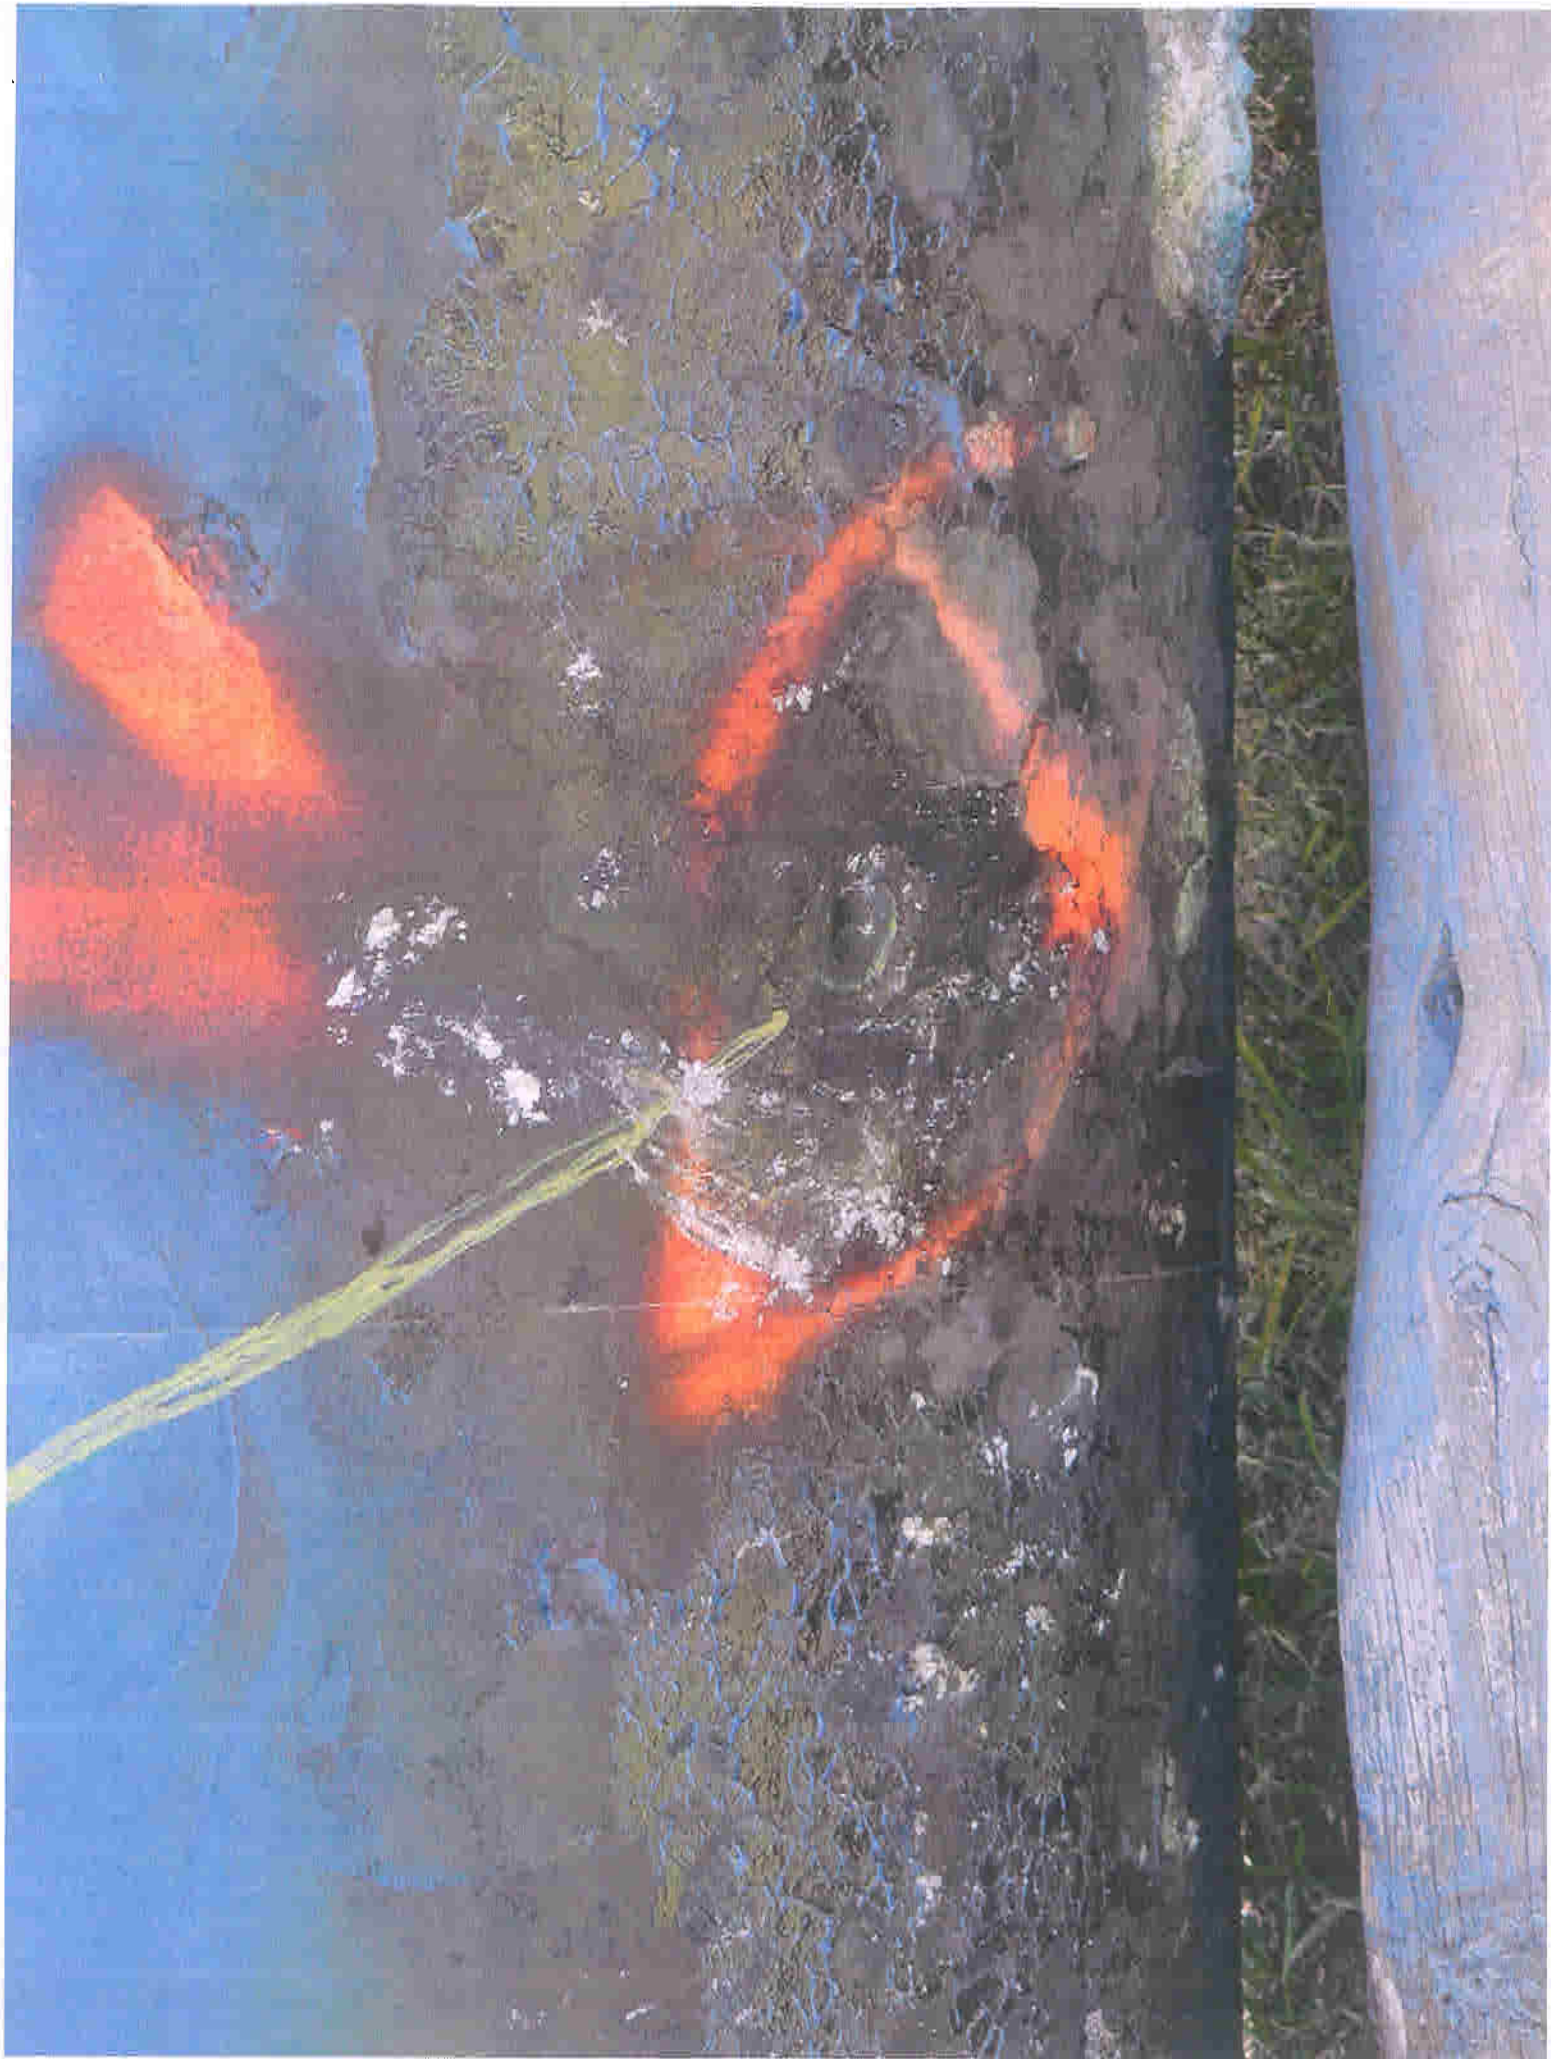
Williams-Transco 24-inch "A" Pipeline
King Ranch MP 97.53, 04-28-2010
External Corrosion Pit at 7 O'Clock Approximately 15' From
Leak Requiring Removal of Additional Length of Pipe

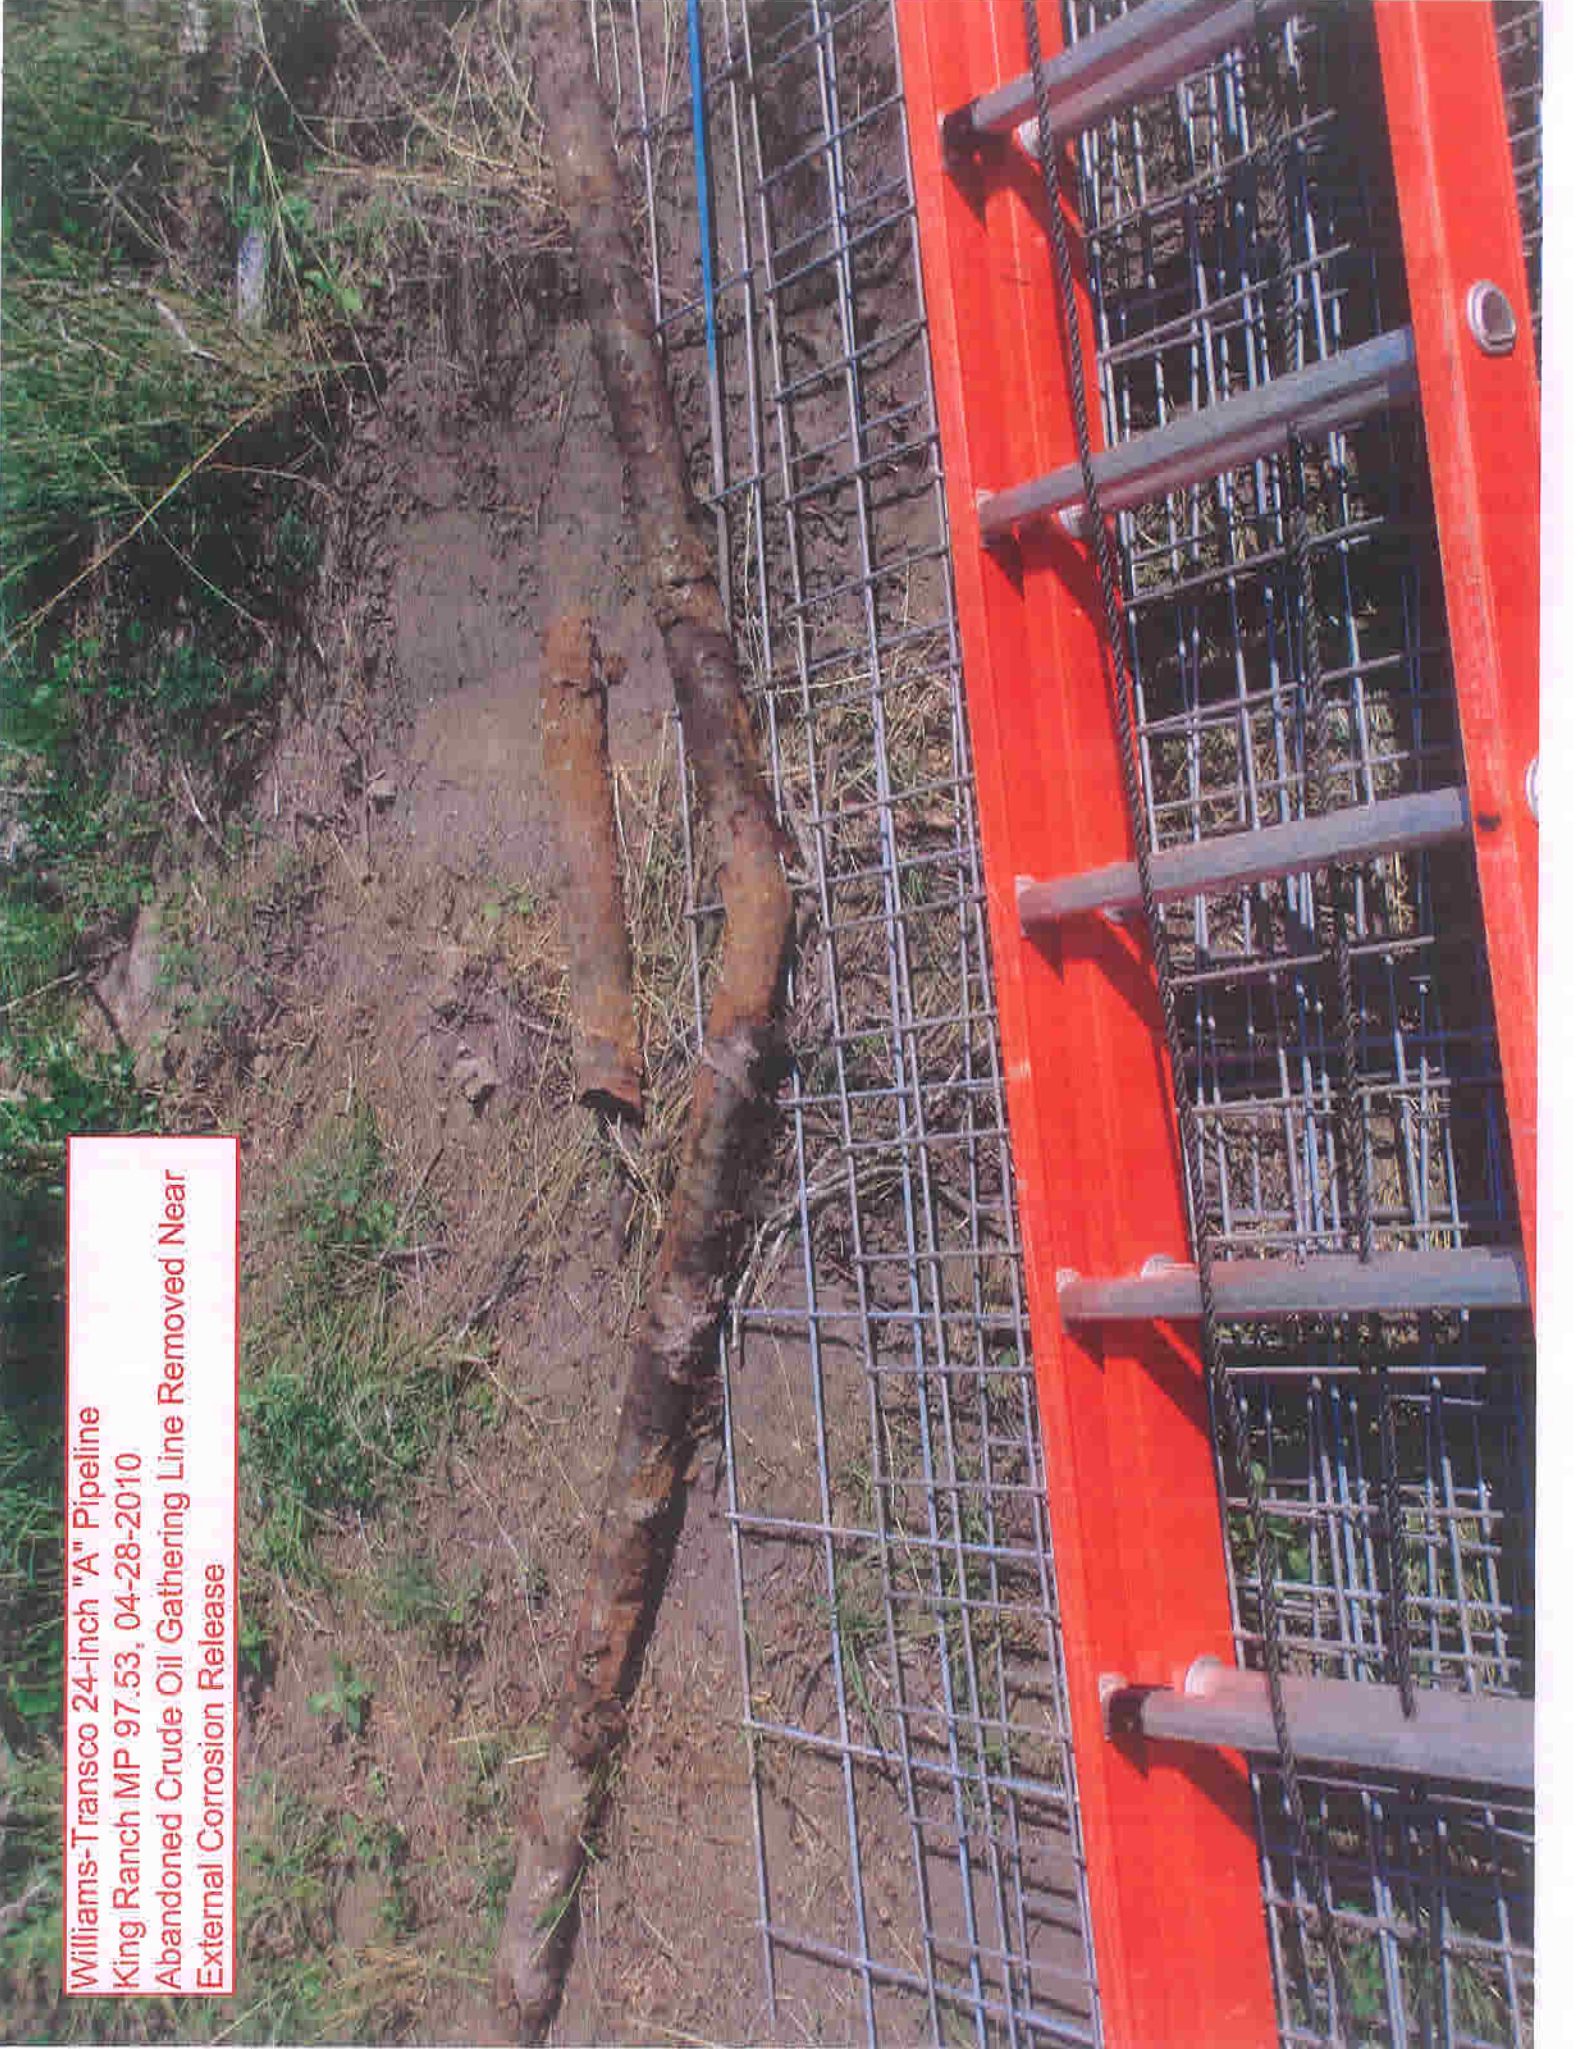
The area on King Ranch where the leak occurred is crisscrossed by several crude oil gathering pipelines, most of which are operated by ExxonMobil. These unregulated pipelines are old, not well marked, not mapped, and are not cathodically protected. Transco personnel reported a strong hydrocarbon smell in the area and initially suspected the leak was from one of the gathering pipelines. However, the Transco release was visually confirmed when the pipe was excavated.

Williams-Transco 24-inch "A" Pipeline
King Ranch MP 97.53, 04-28-2010
Abandoned Crude Oil Gathering Line Removed Near
External Corrosion Release

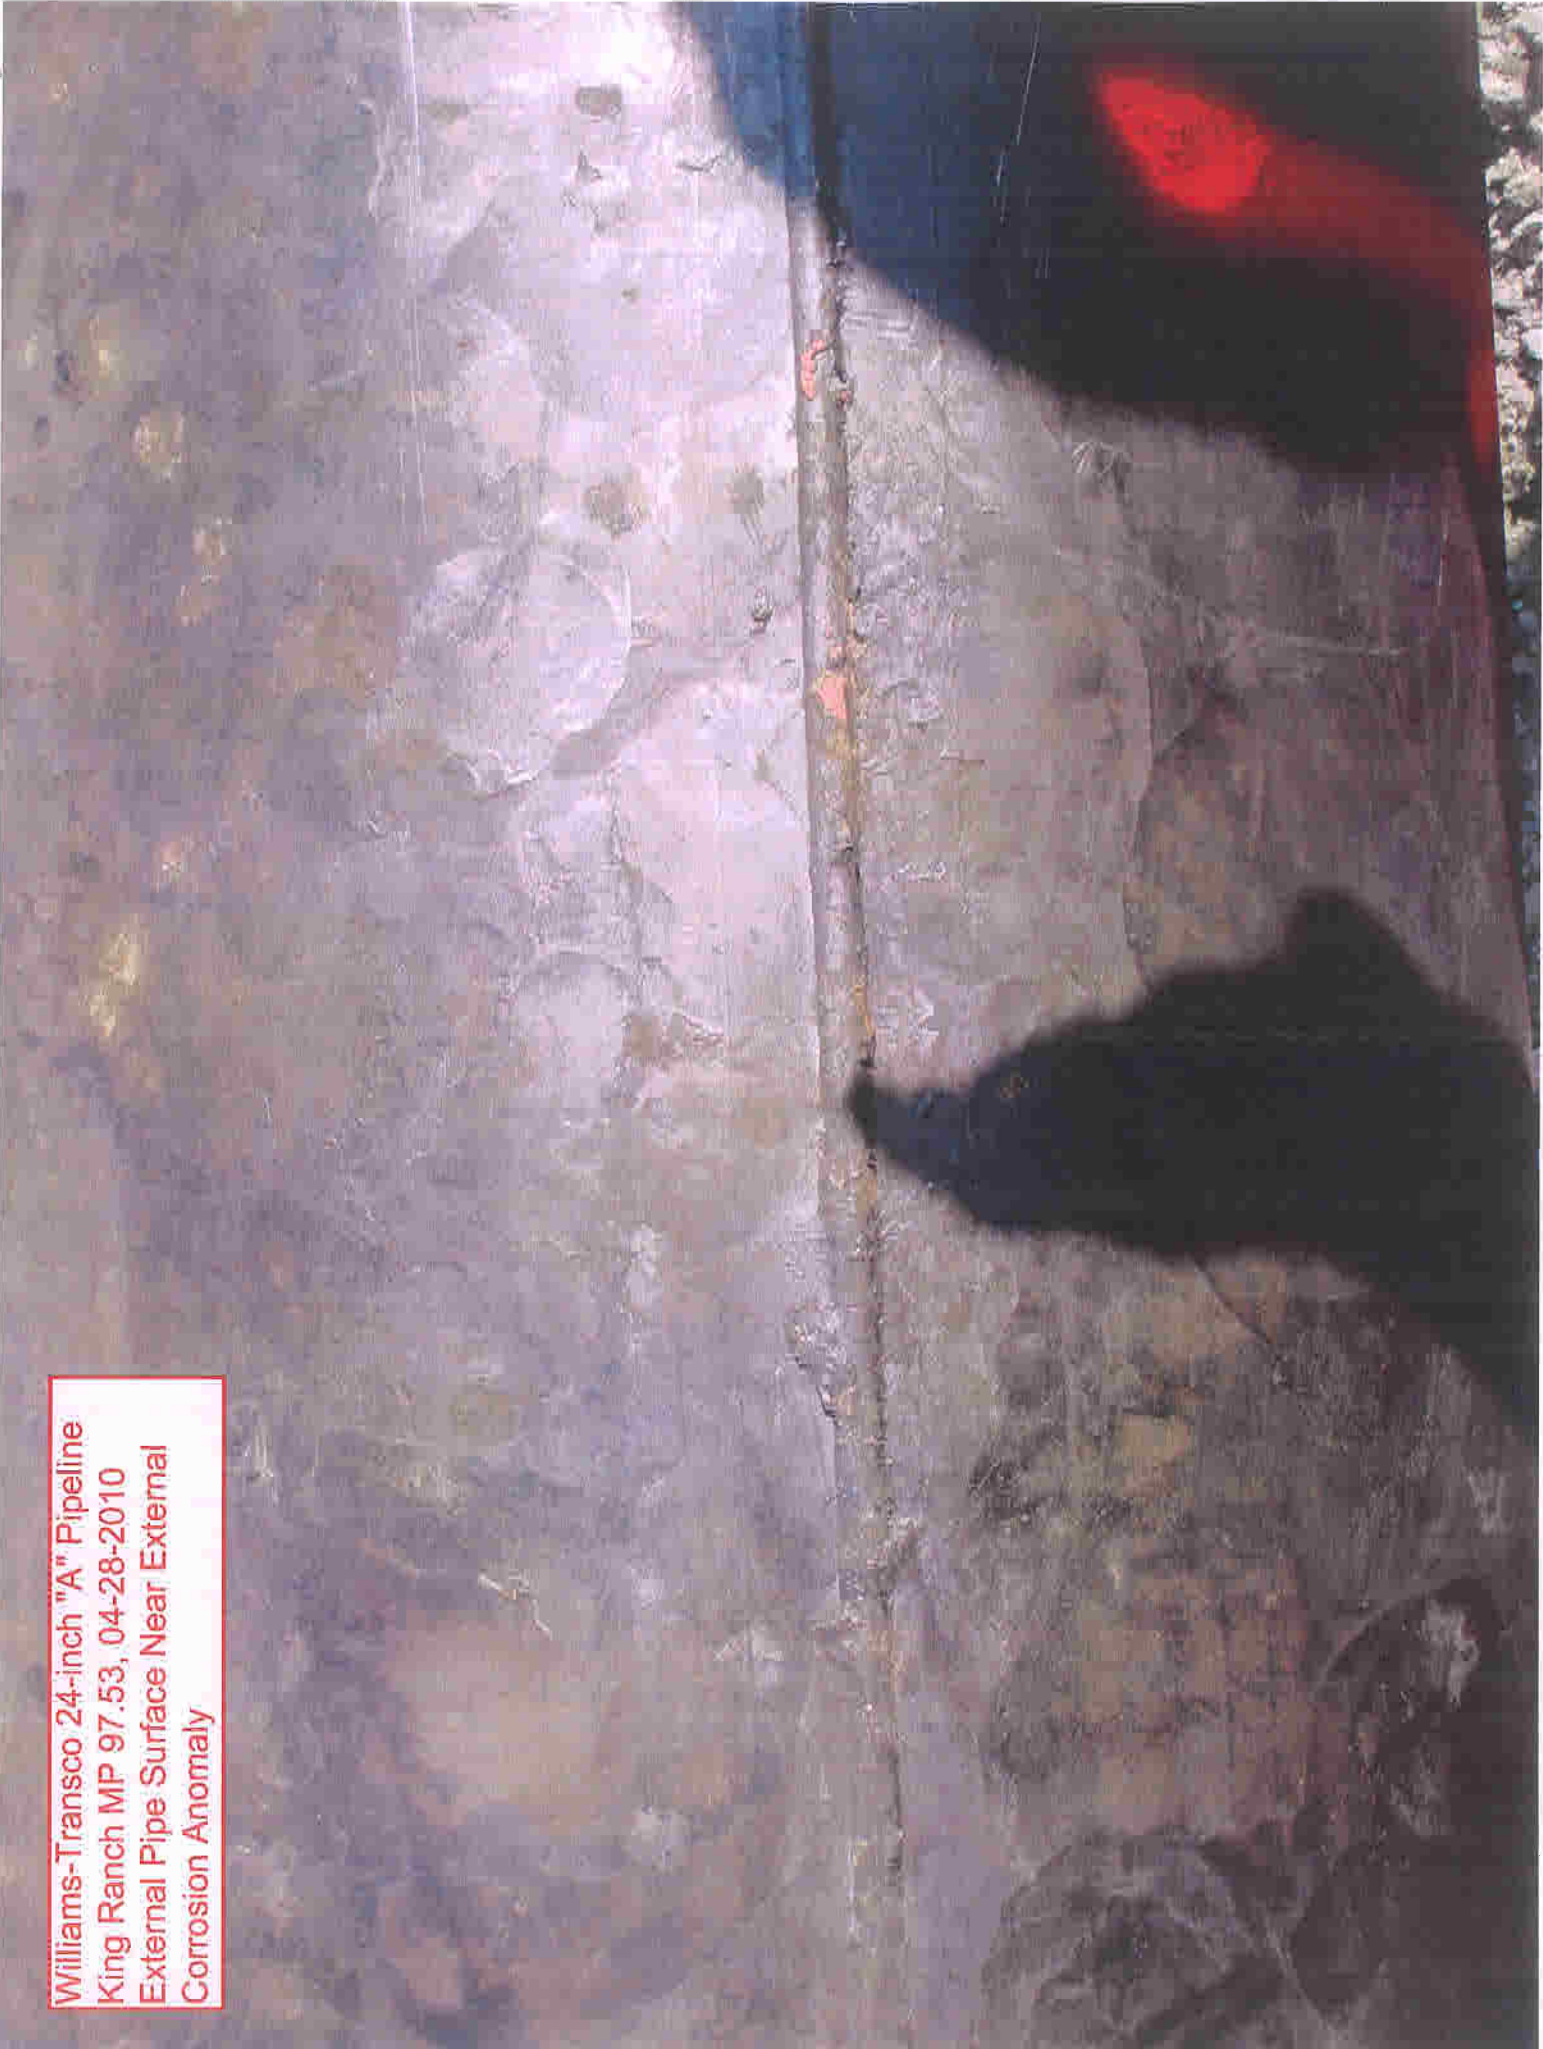
Williams-Transco 24-inch "A" Pipeline
King Ranch MP 97.53, 04-28-2010
External Pipe Surface Near External
Corrosion Anomaly

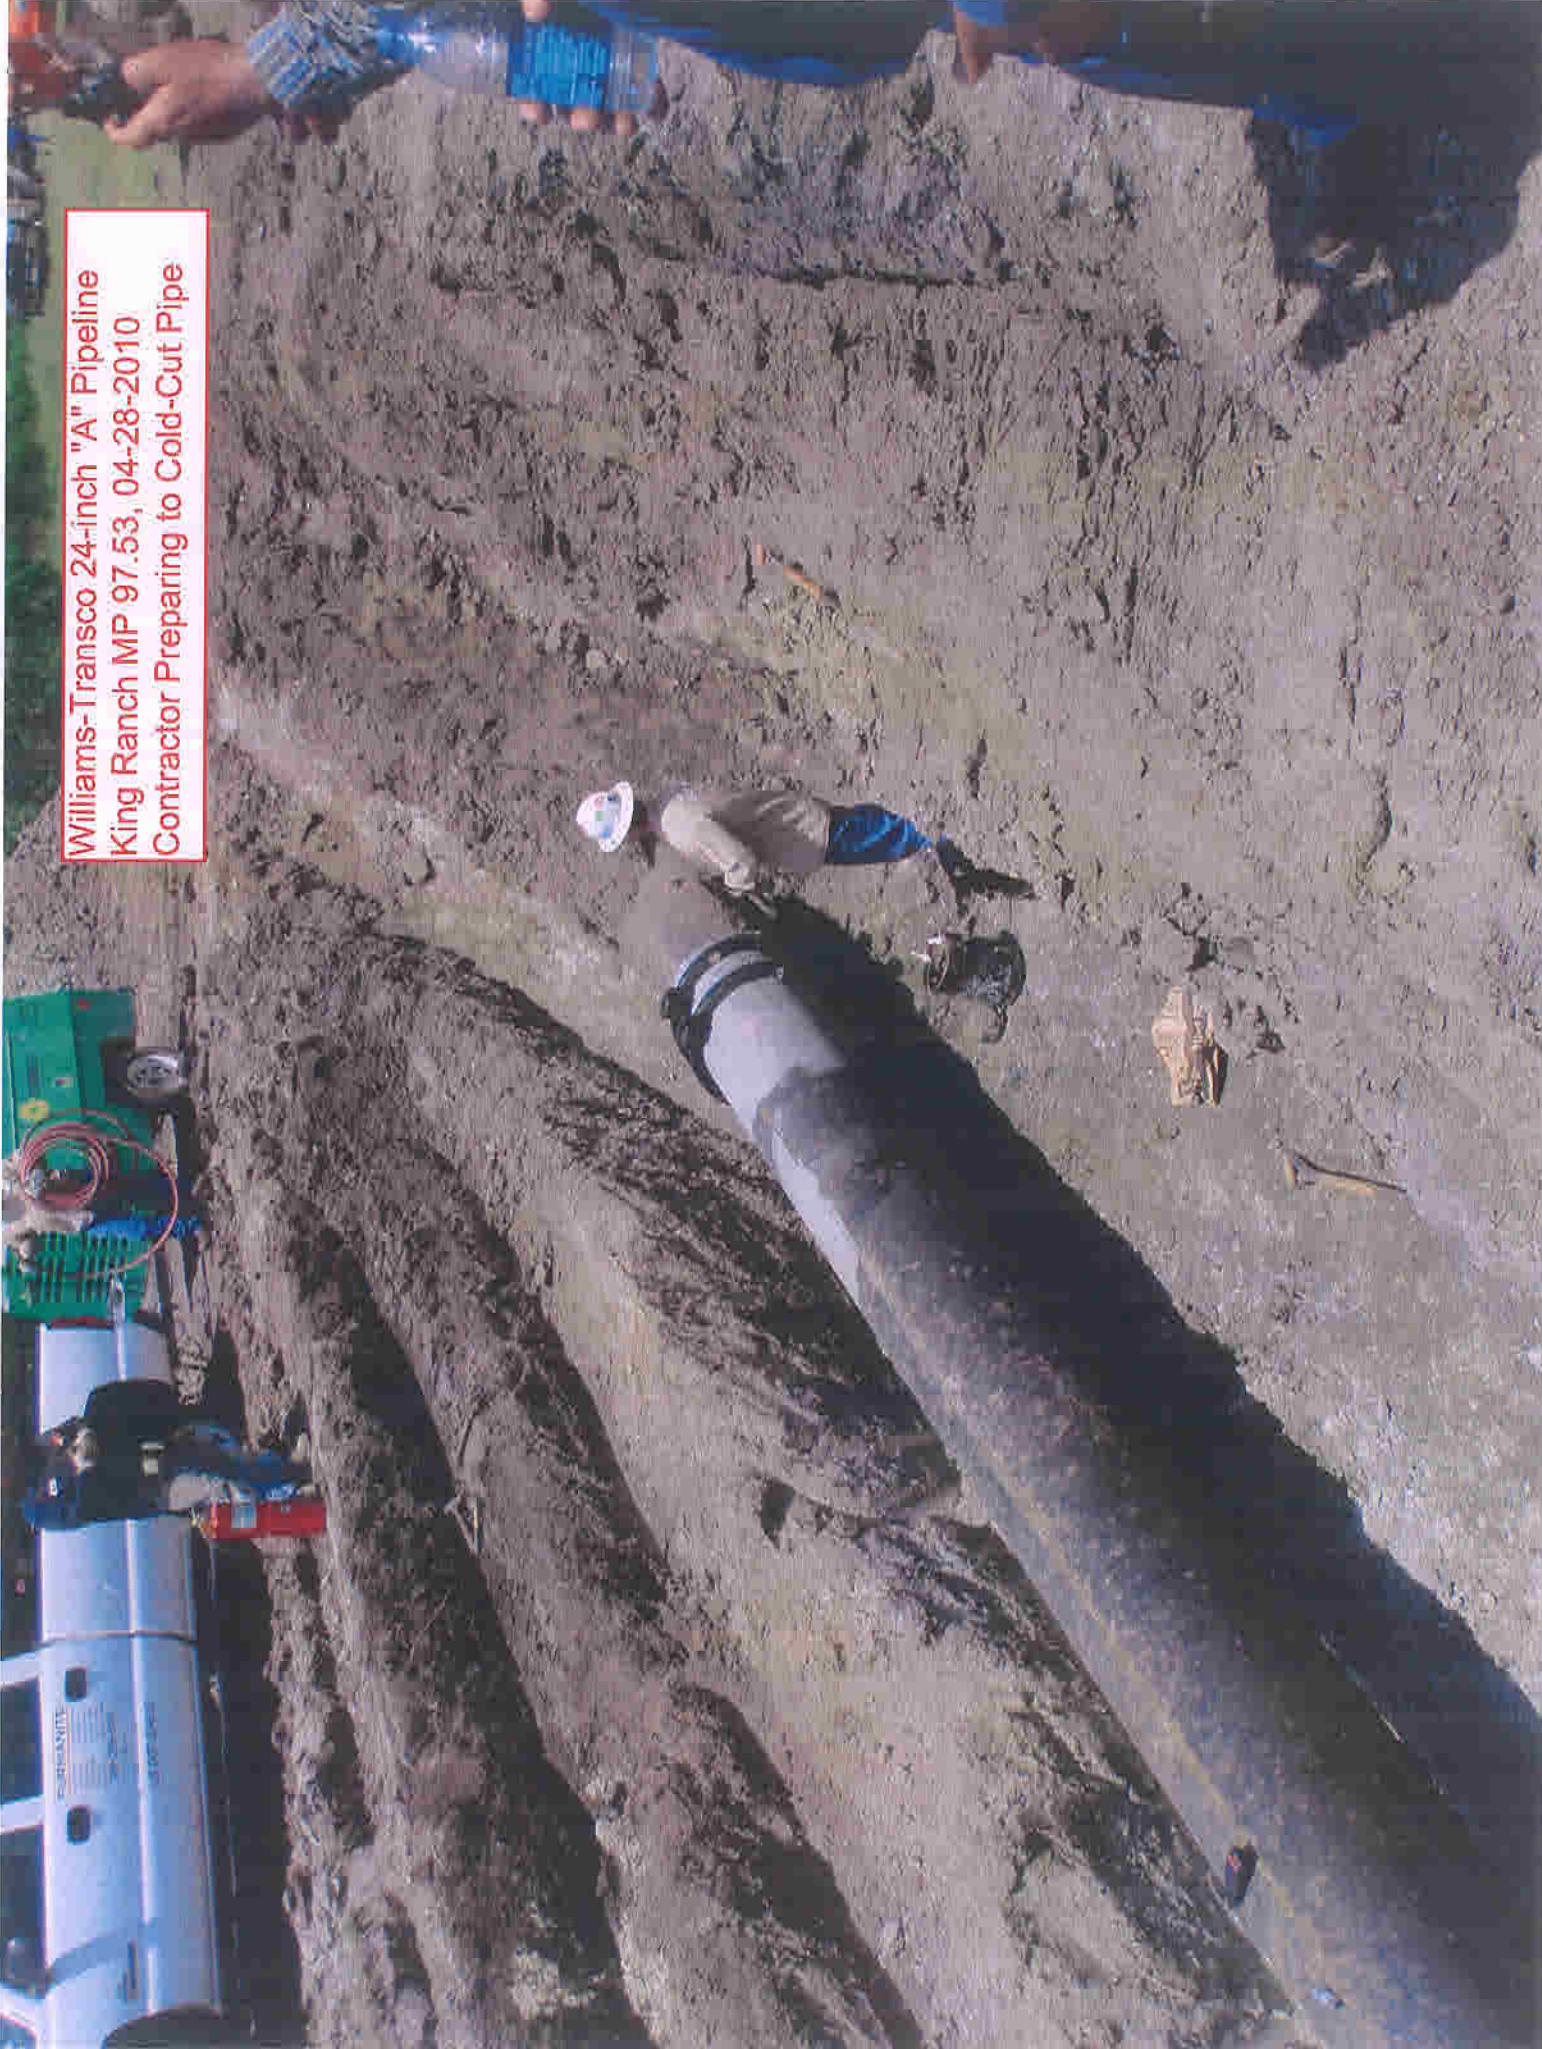
Williams-Transco 24-inch "A" Pipeline
King Ranch MP 97.53, 04-28-2010
Contractor Preparing to Cold-Cut Pipe

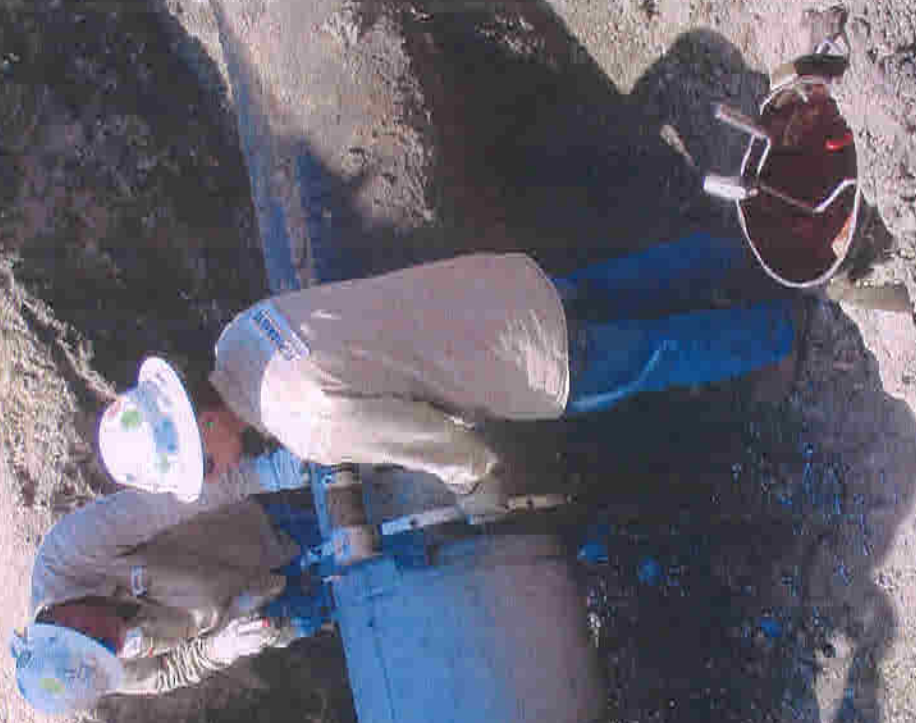
**Williams-Transco 24-inch "A" Pipeline
King Ranch MP 97.53, 04-28-2010
Cold-Cutting 24-inch Pipe
Note: Bonding Cable Attached to Equalize
Electrical Potentials on Each Side of Cut**
