**Failure Investigation Report – Williams (Transco) Corrosion Failure
April 26, 2010**

Principal Investigator Jon Manning
Region Director R.M. Seeley
Date of Report 3/31/2011
Subject Failure Investigation Report – Williams (Transco) Corrosion Failure

Date of Failure 4/26/2010
Commodity Released Natural Gas
City/County & State Kleberg County, TX - near Kingsville
OpID & Operator Name 19570 Williams Gas Pipeline - Transco
Unit # & Unit Name 13314 Transco South Texas District
SMART Activity # 129876
Milepost / Location Milepost 97.53
Type of Failure Leak caused by External Corrosion
Fatalities 0
Injuries 0
Description of area impacted Ranch Property
Property Damage \$57,084

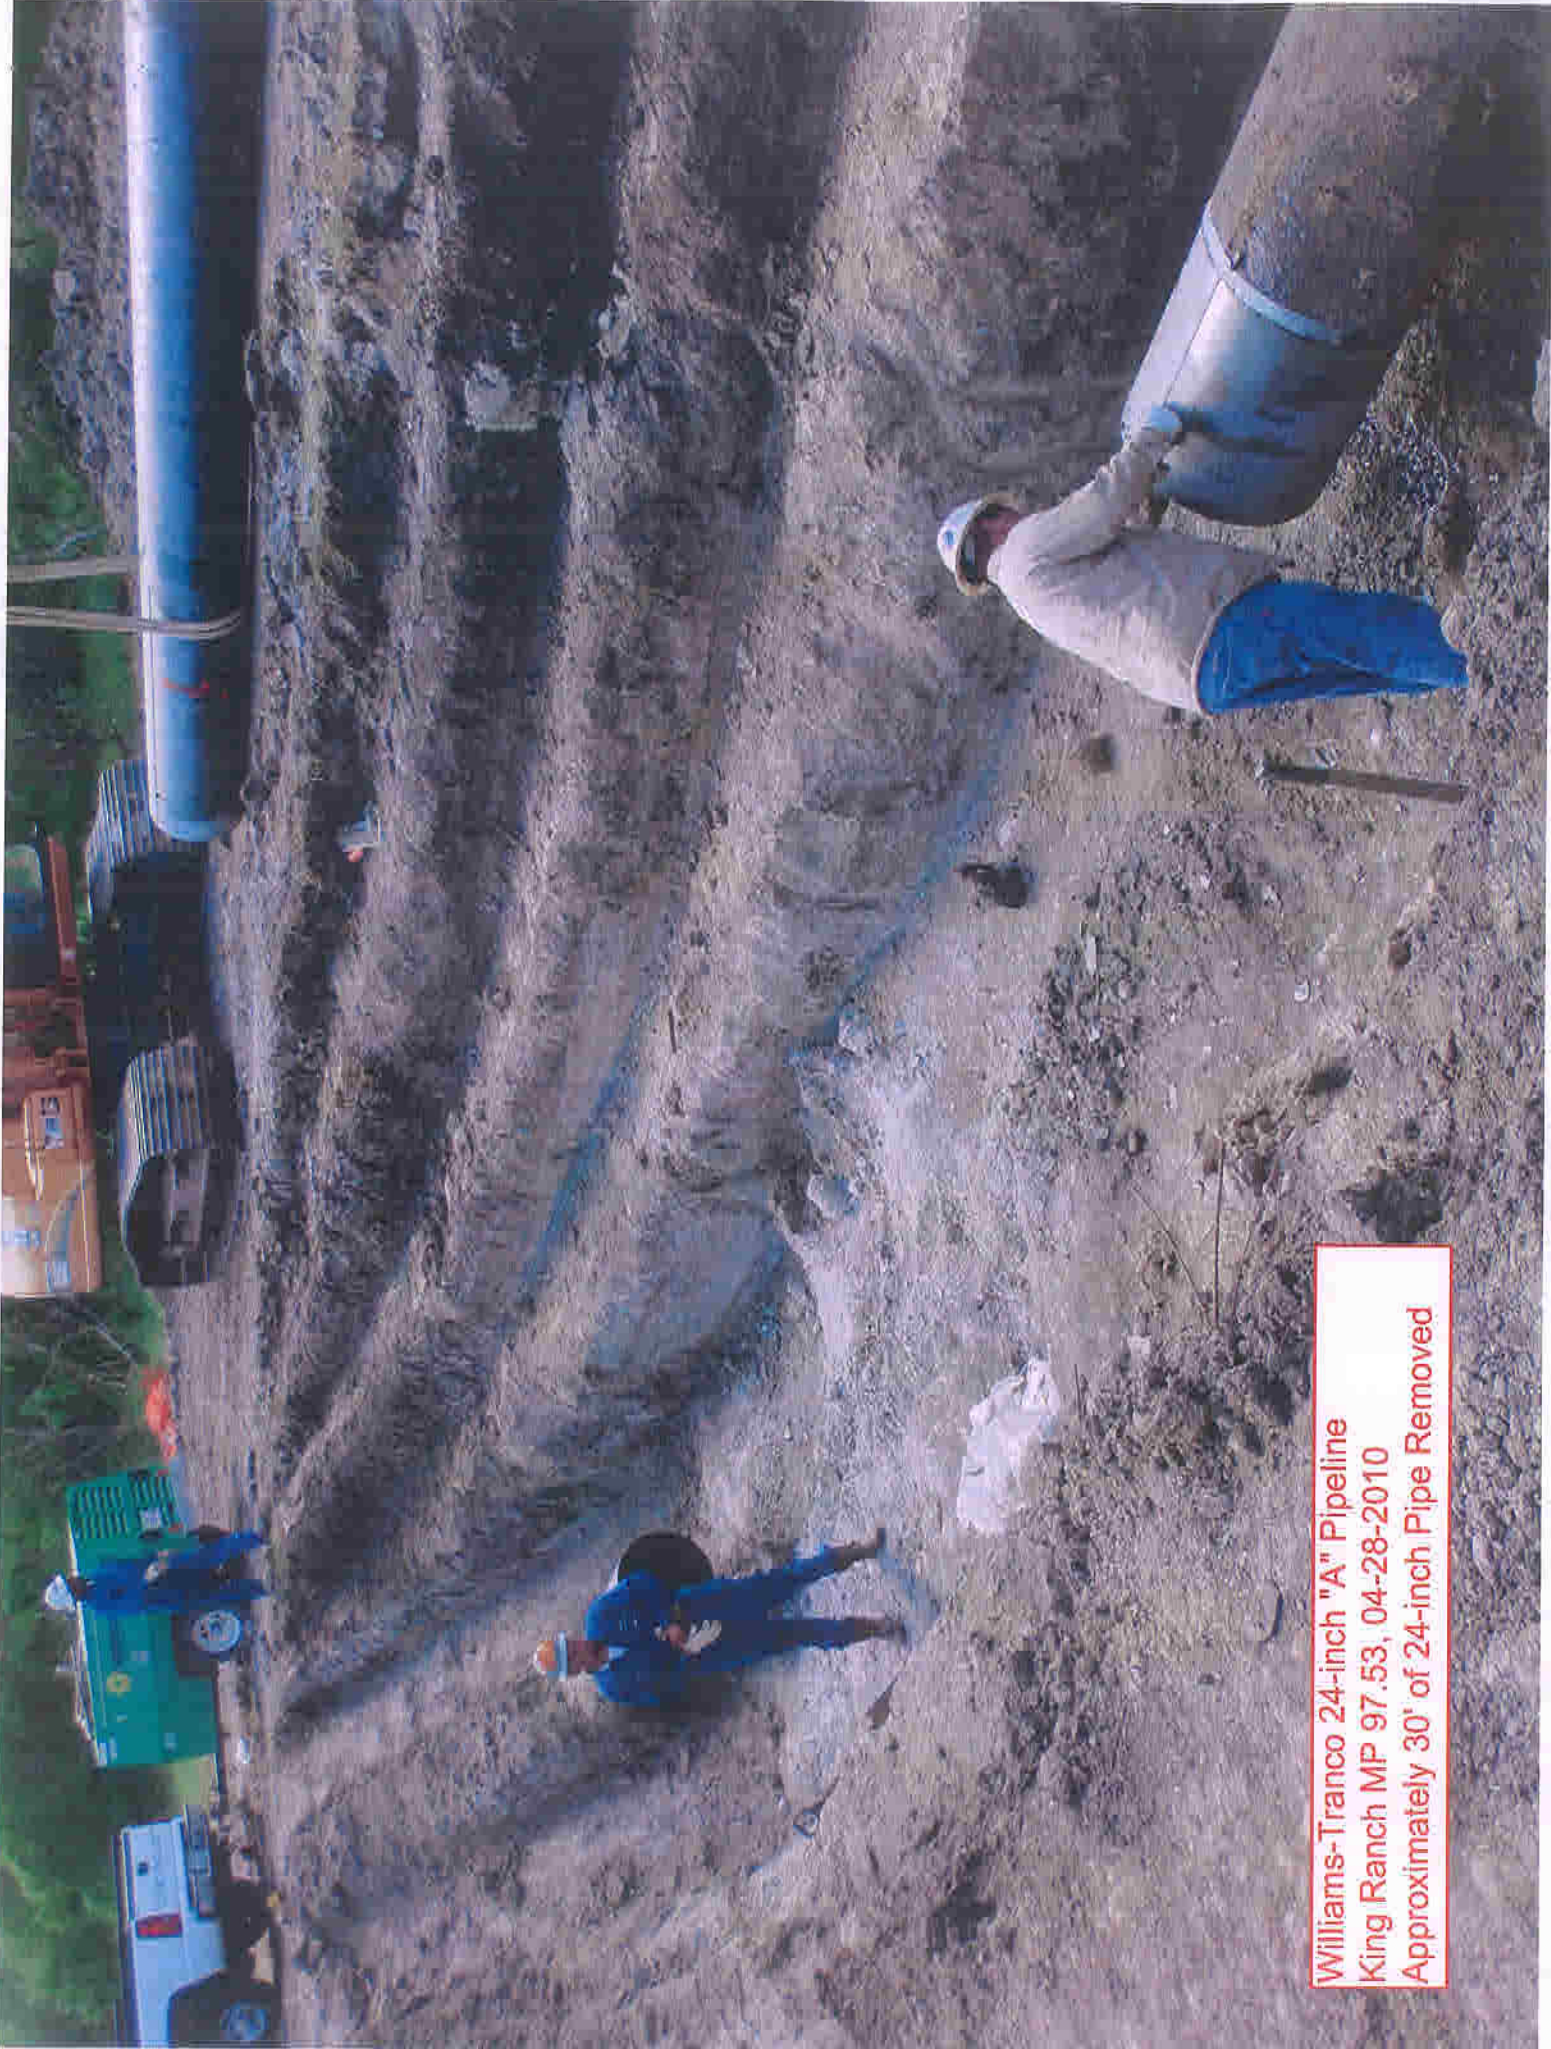
Williams-Tranco 24-inch "A" Pipeline
King Ranch MP 97.53, 04-28-2010
Approximately 30' of 24-inch Pipe Removed

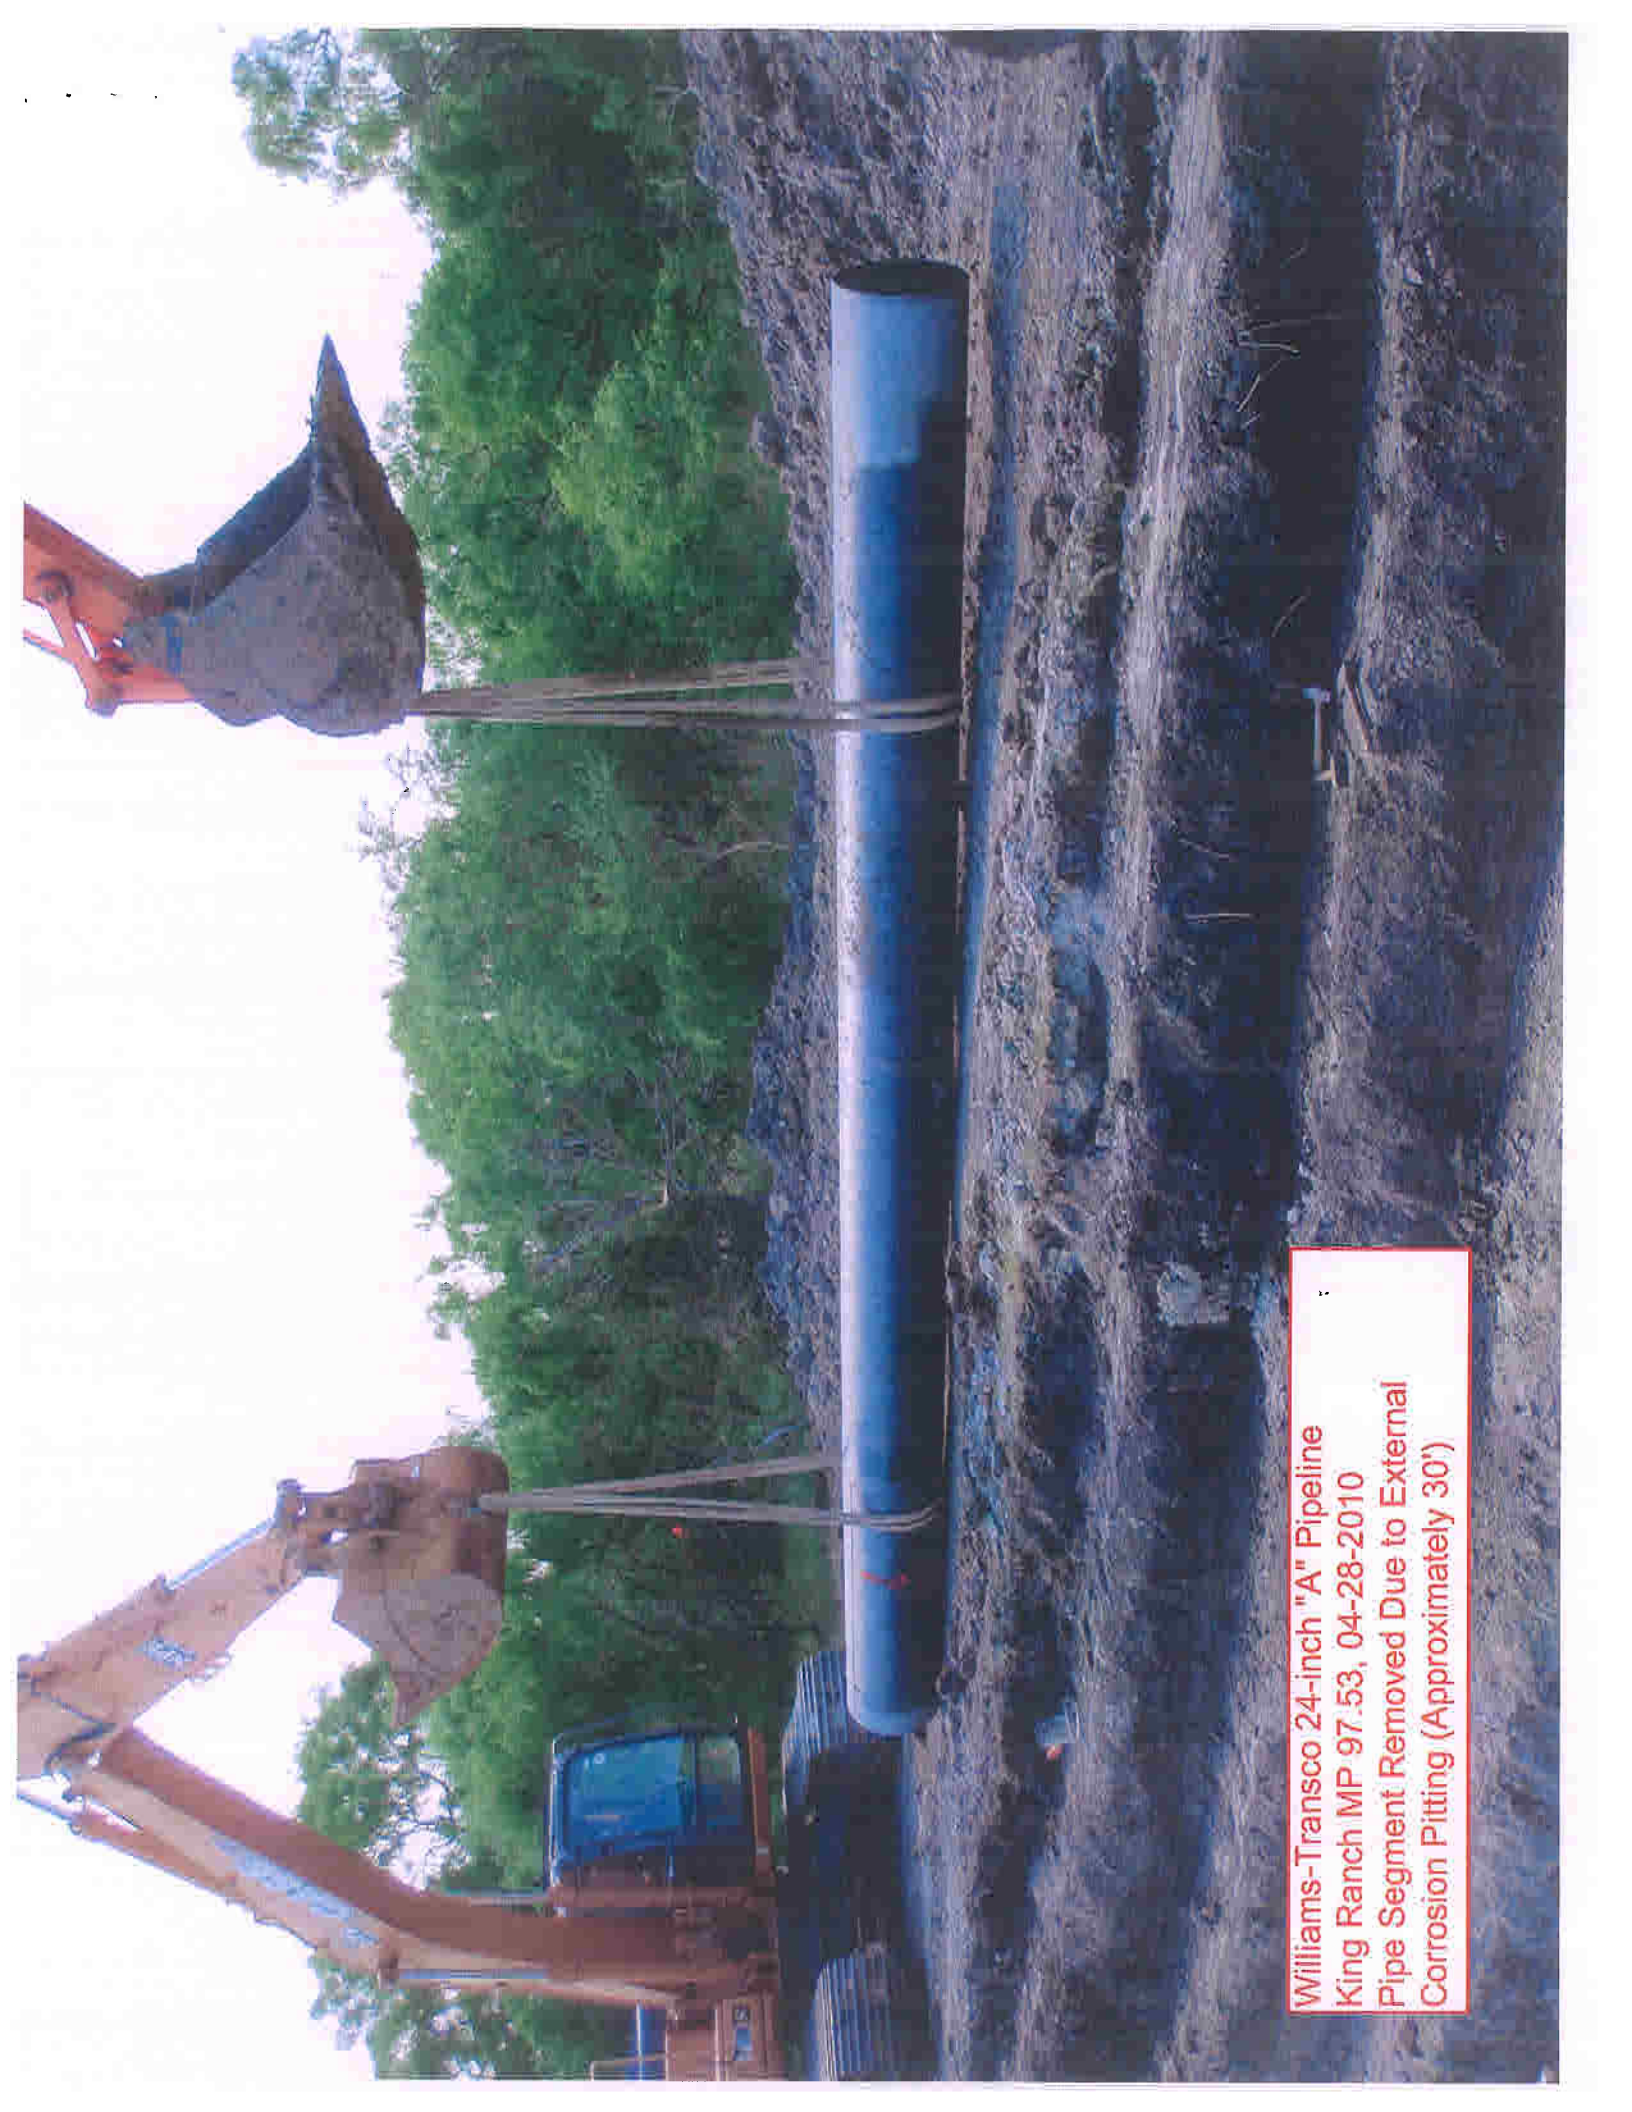
Williams-Transco 24-inch "A" Pipeline
King Ranch MP 97.53, 04-28-2010
Pipe Segment Removed Due to External
Corrosion Pitting (Approximately 30')

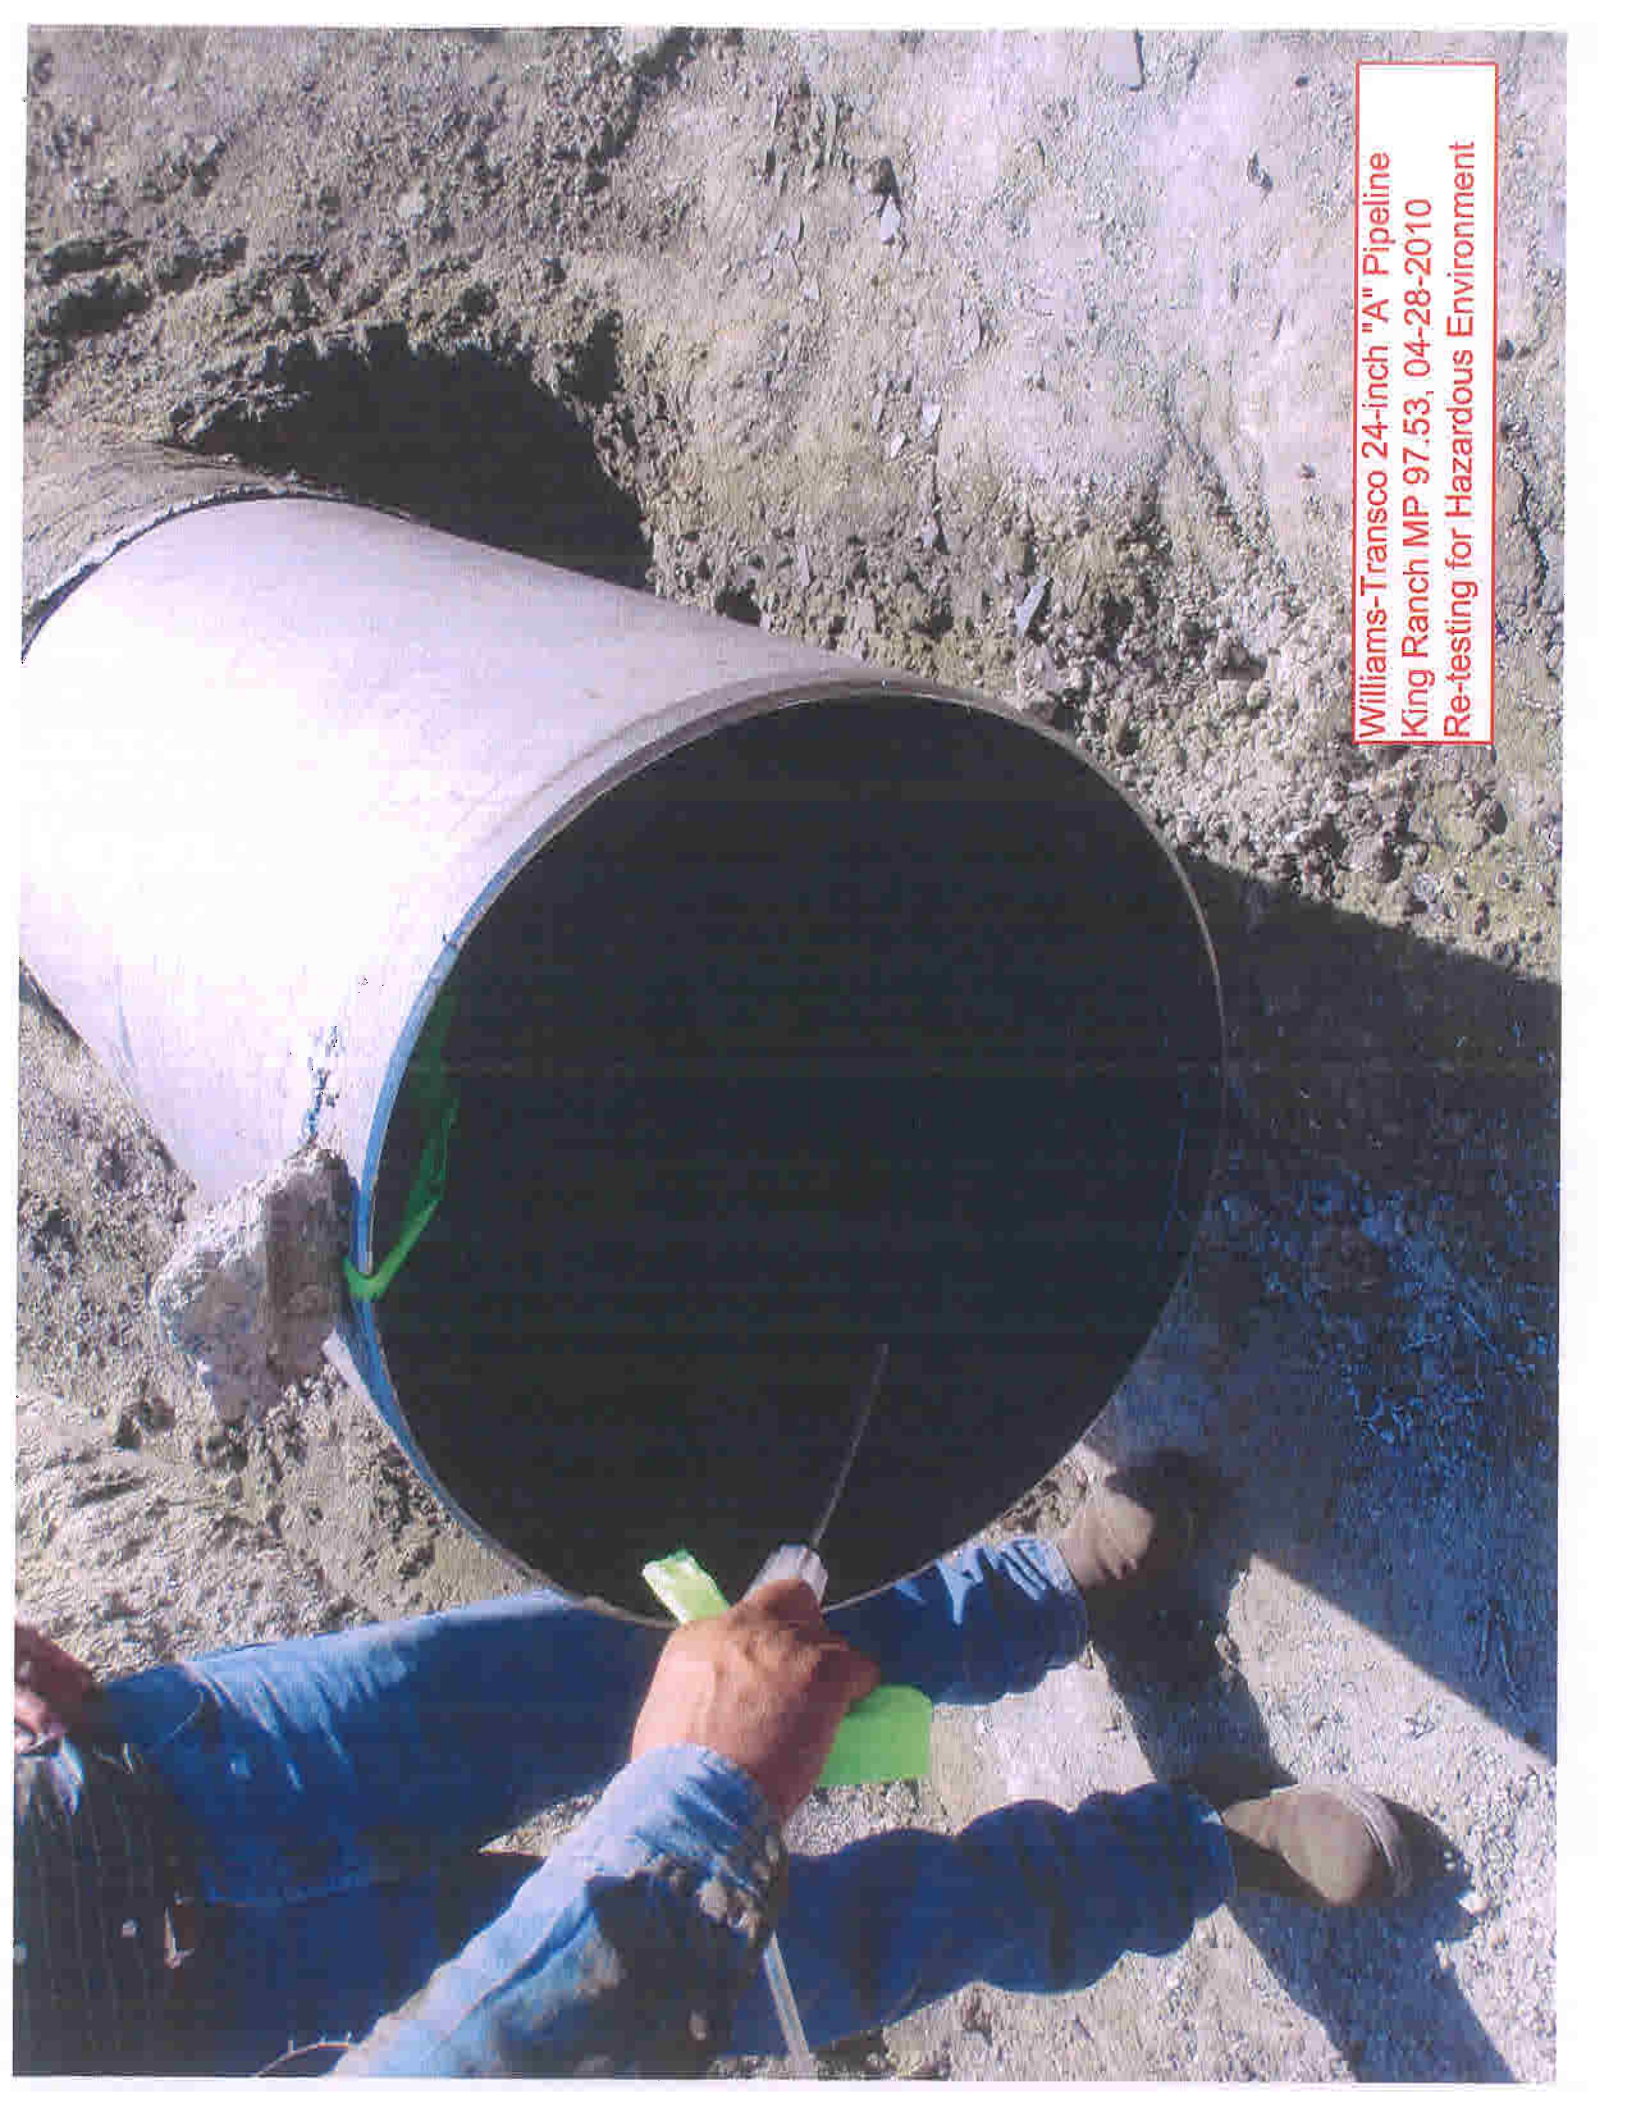
Williams-Transco 24-inch "A" Pipeline
King Ranch MP 97.53, 04-28-2010
Re-testing for Hazardous Environment

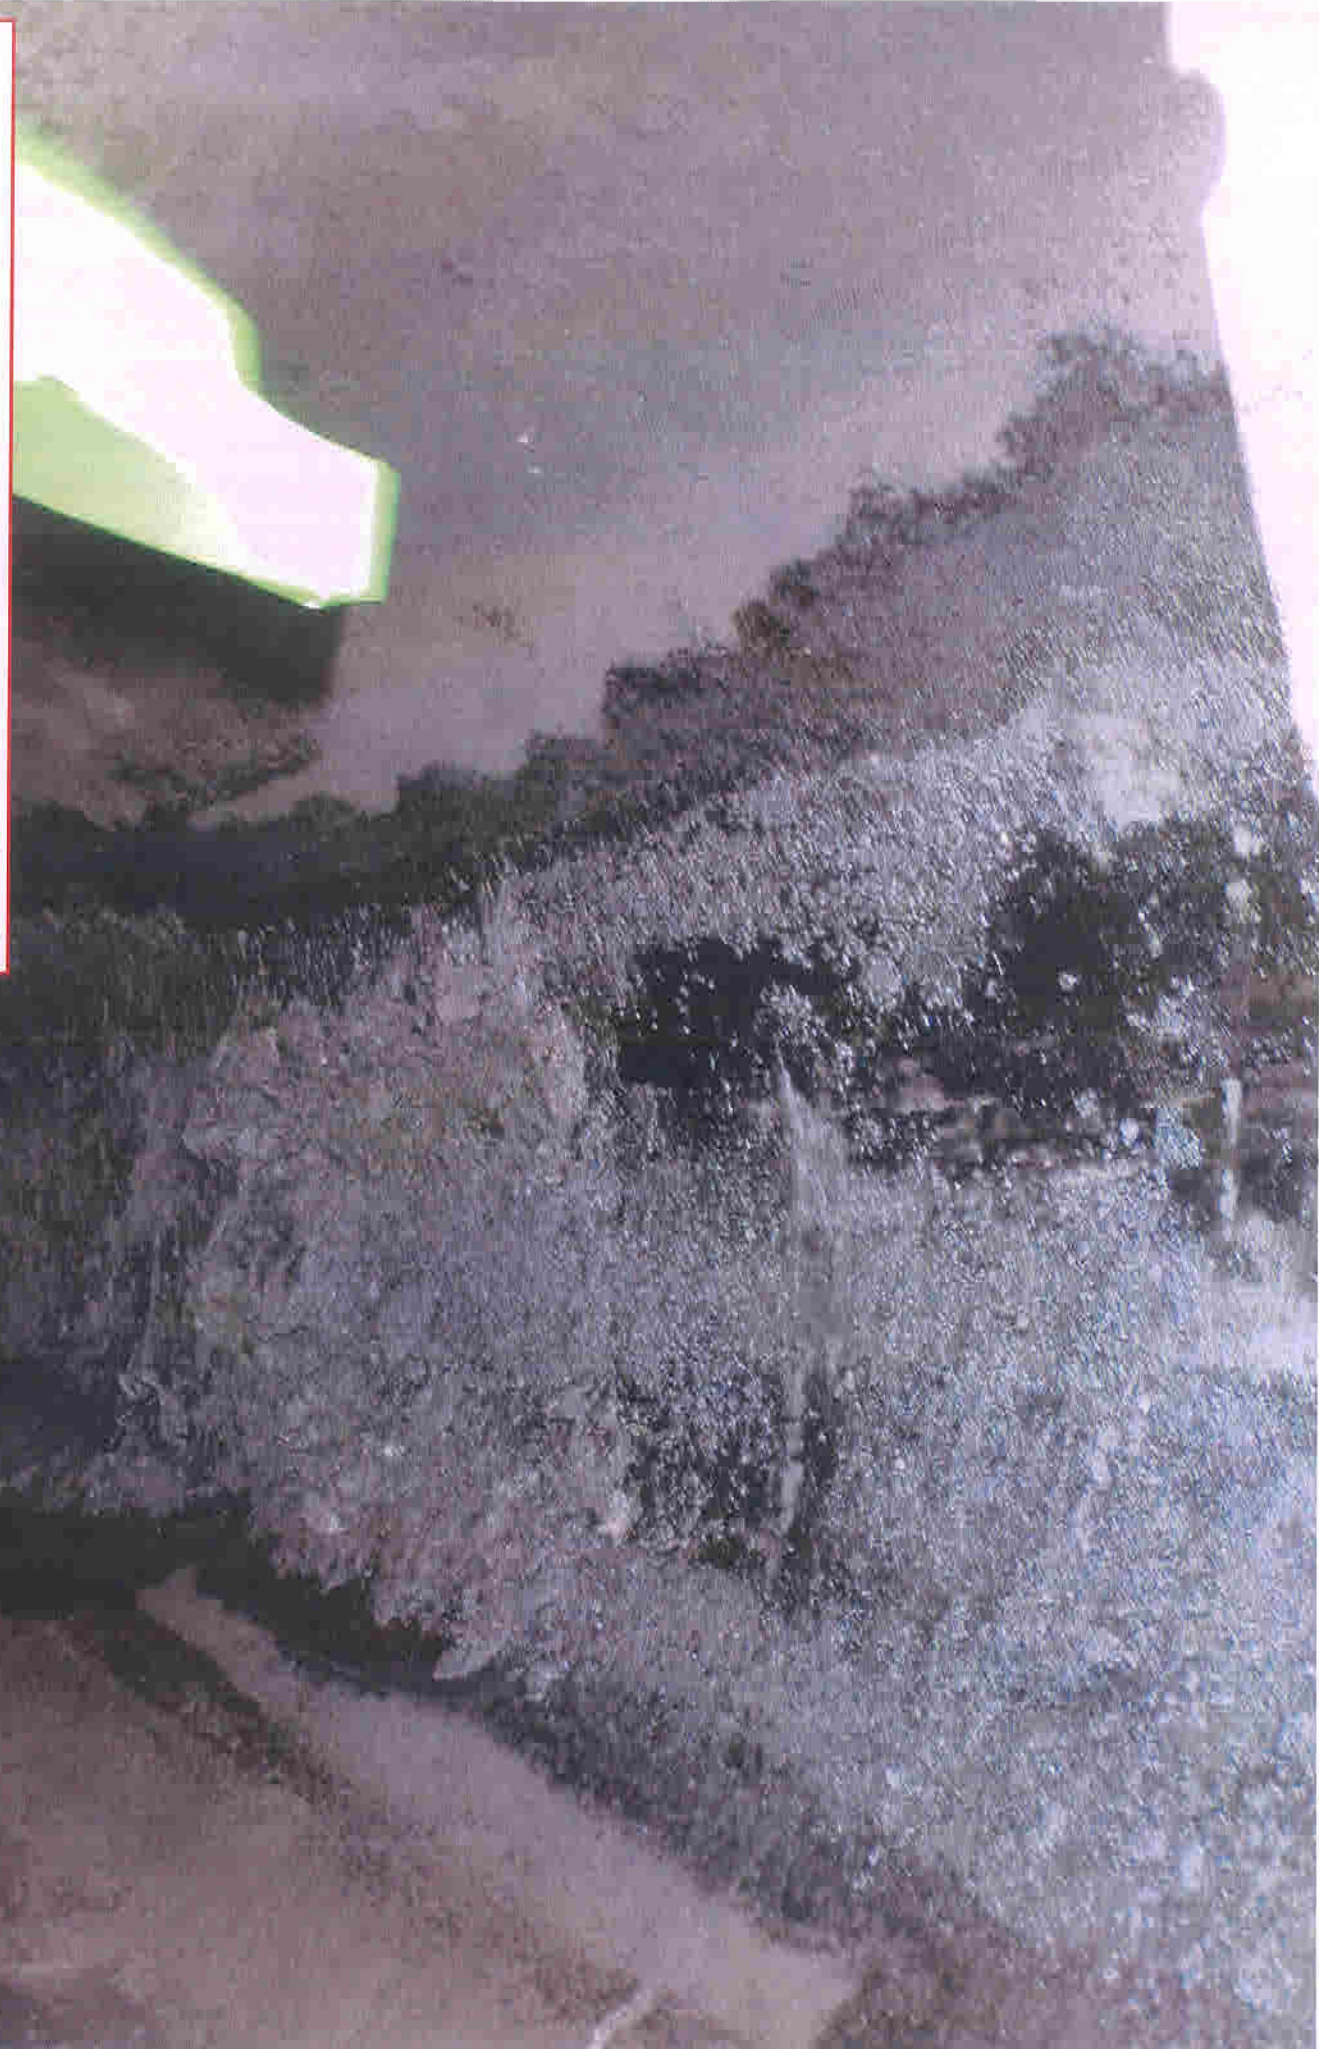
During the repair of the pipeline a significant quantity of black powder was found on the inside of the pipeline. Black powder may be an indication of internal corrosion as it is a form of iron oxide. During the investigation PHMSA reviewed the SCADA information. Pressure monitoring was inconclusive at the time of the leak so the Operator decided to excavate to confirm the source of the leak. A subsequent review of the data after the failure was also inconclusive. Typically, small leaks of this type are difficult to detect through normal SCADA monitoring.

Williams-Transco 24-inch "A" Pipeline
King Ranch MP 97.53, 04-28-2010
Residue Found Inside of Pipeline During Replacement of 30'
Pipe Segment Due to External Corrosion

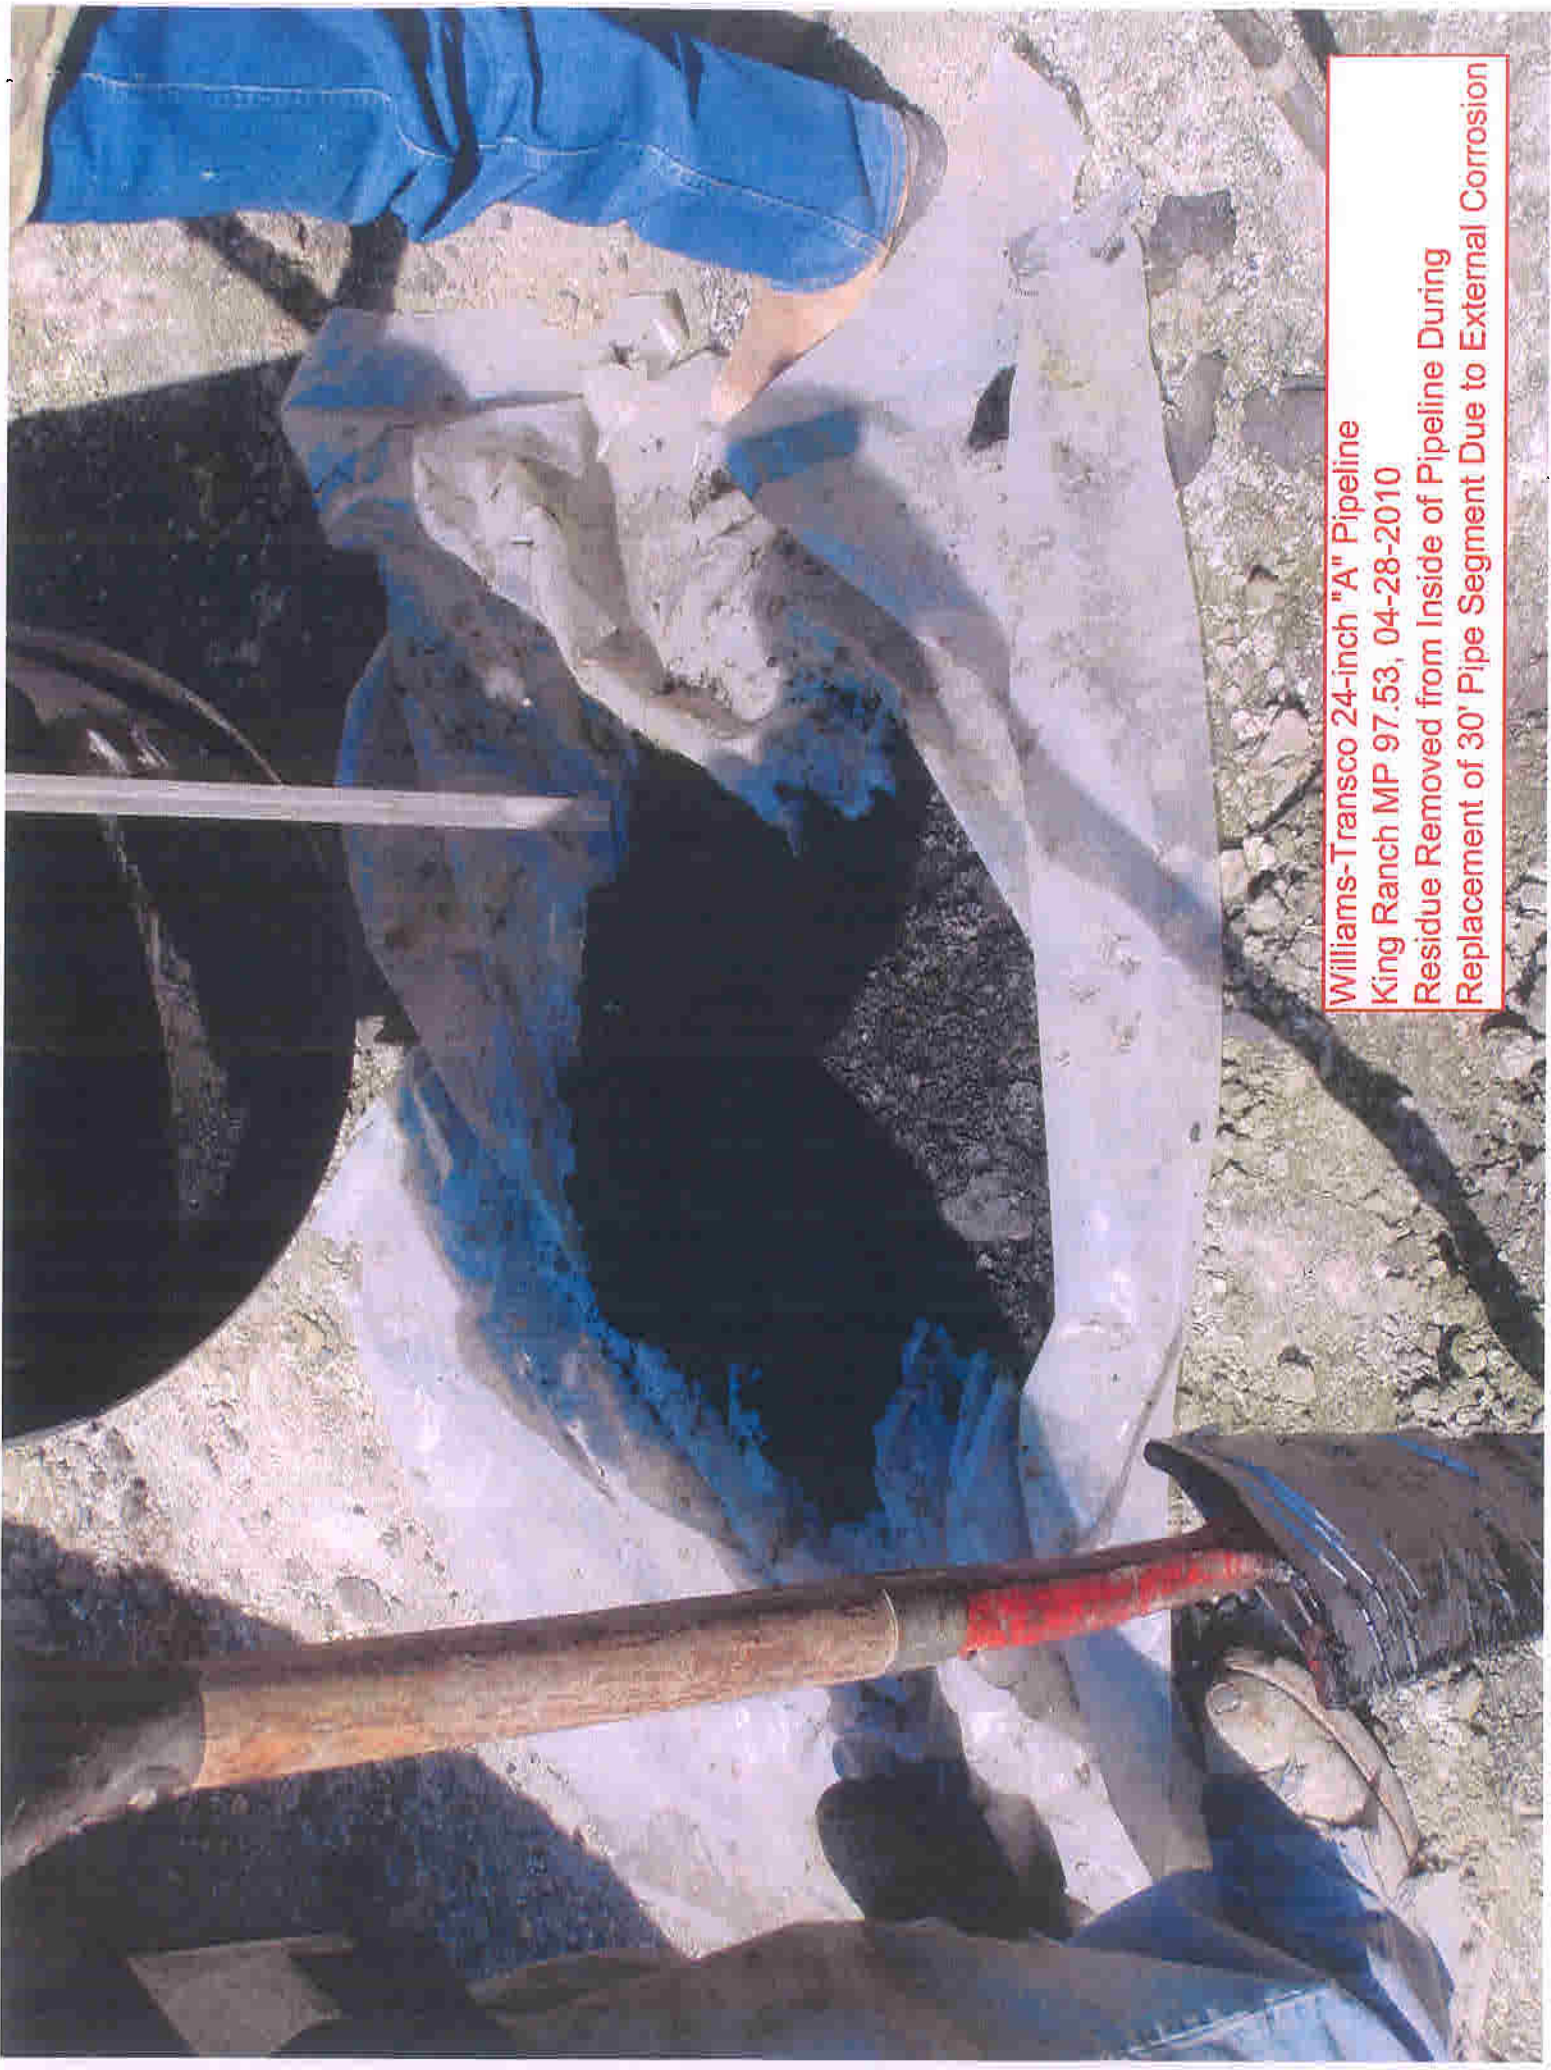
Williams-Transco 24-inch "A" Pipeline
King Ranch MP 97.53, 04-28-2010
Residue Removed from Inside of Pipeline During
Replacement of 30' Pipe Segment Due to External Corrosion

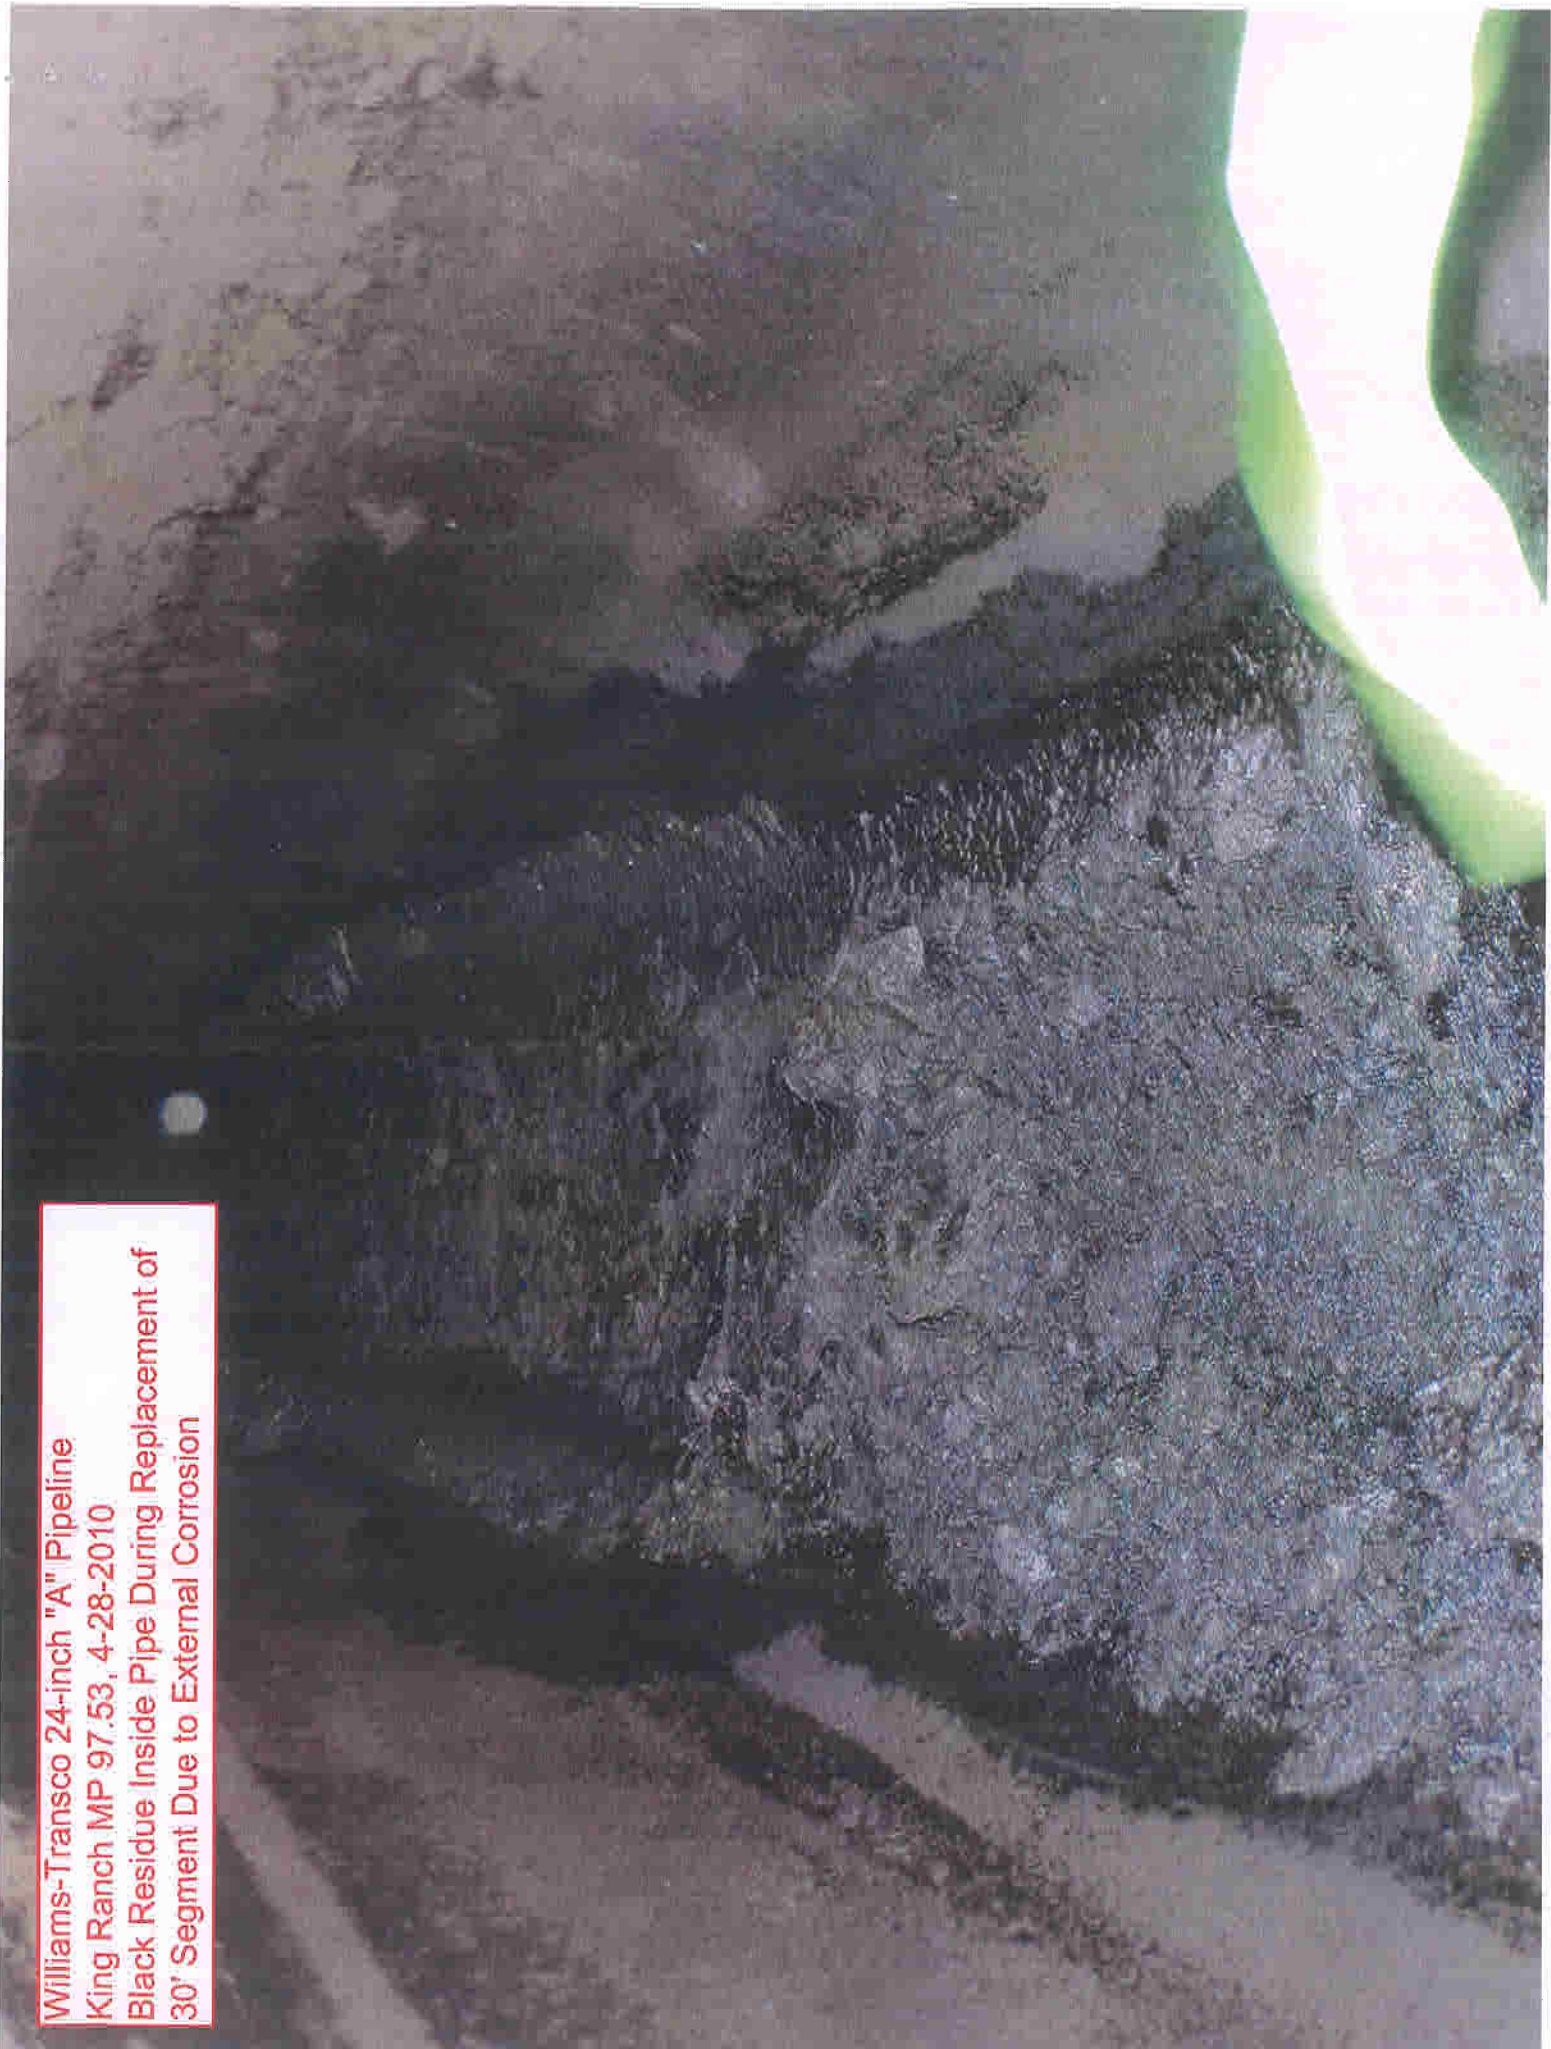
Williams-Transco 24-inch "A" Pipeline
King Ranch MP 97.53, 4-28-2010
Black Residue Inside Pipe During Replacement of
30' Segment Due to External Corrosion

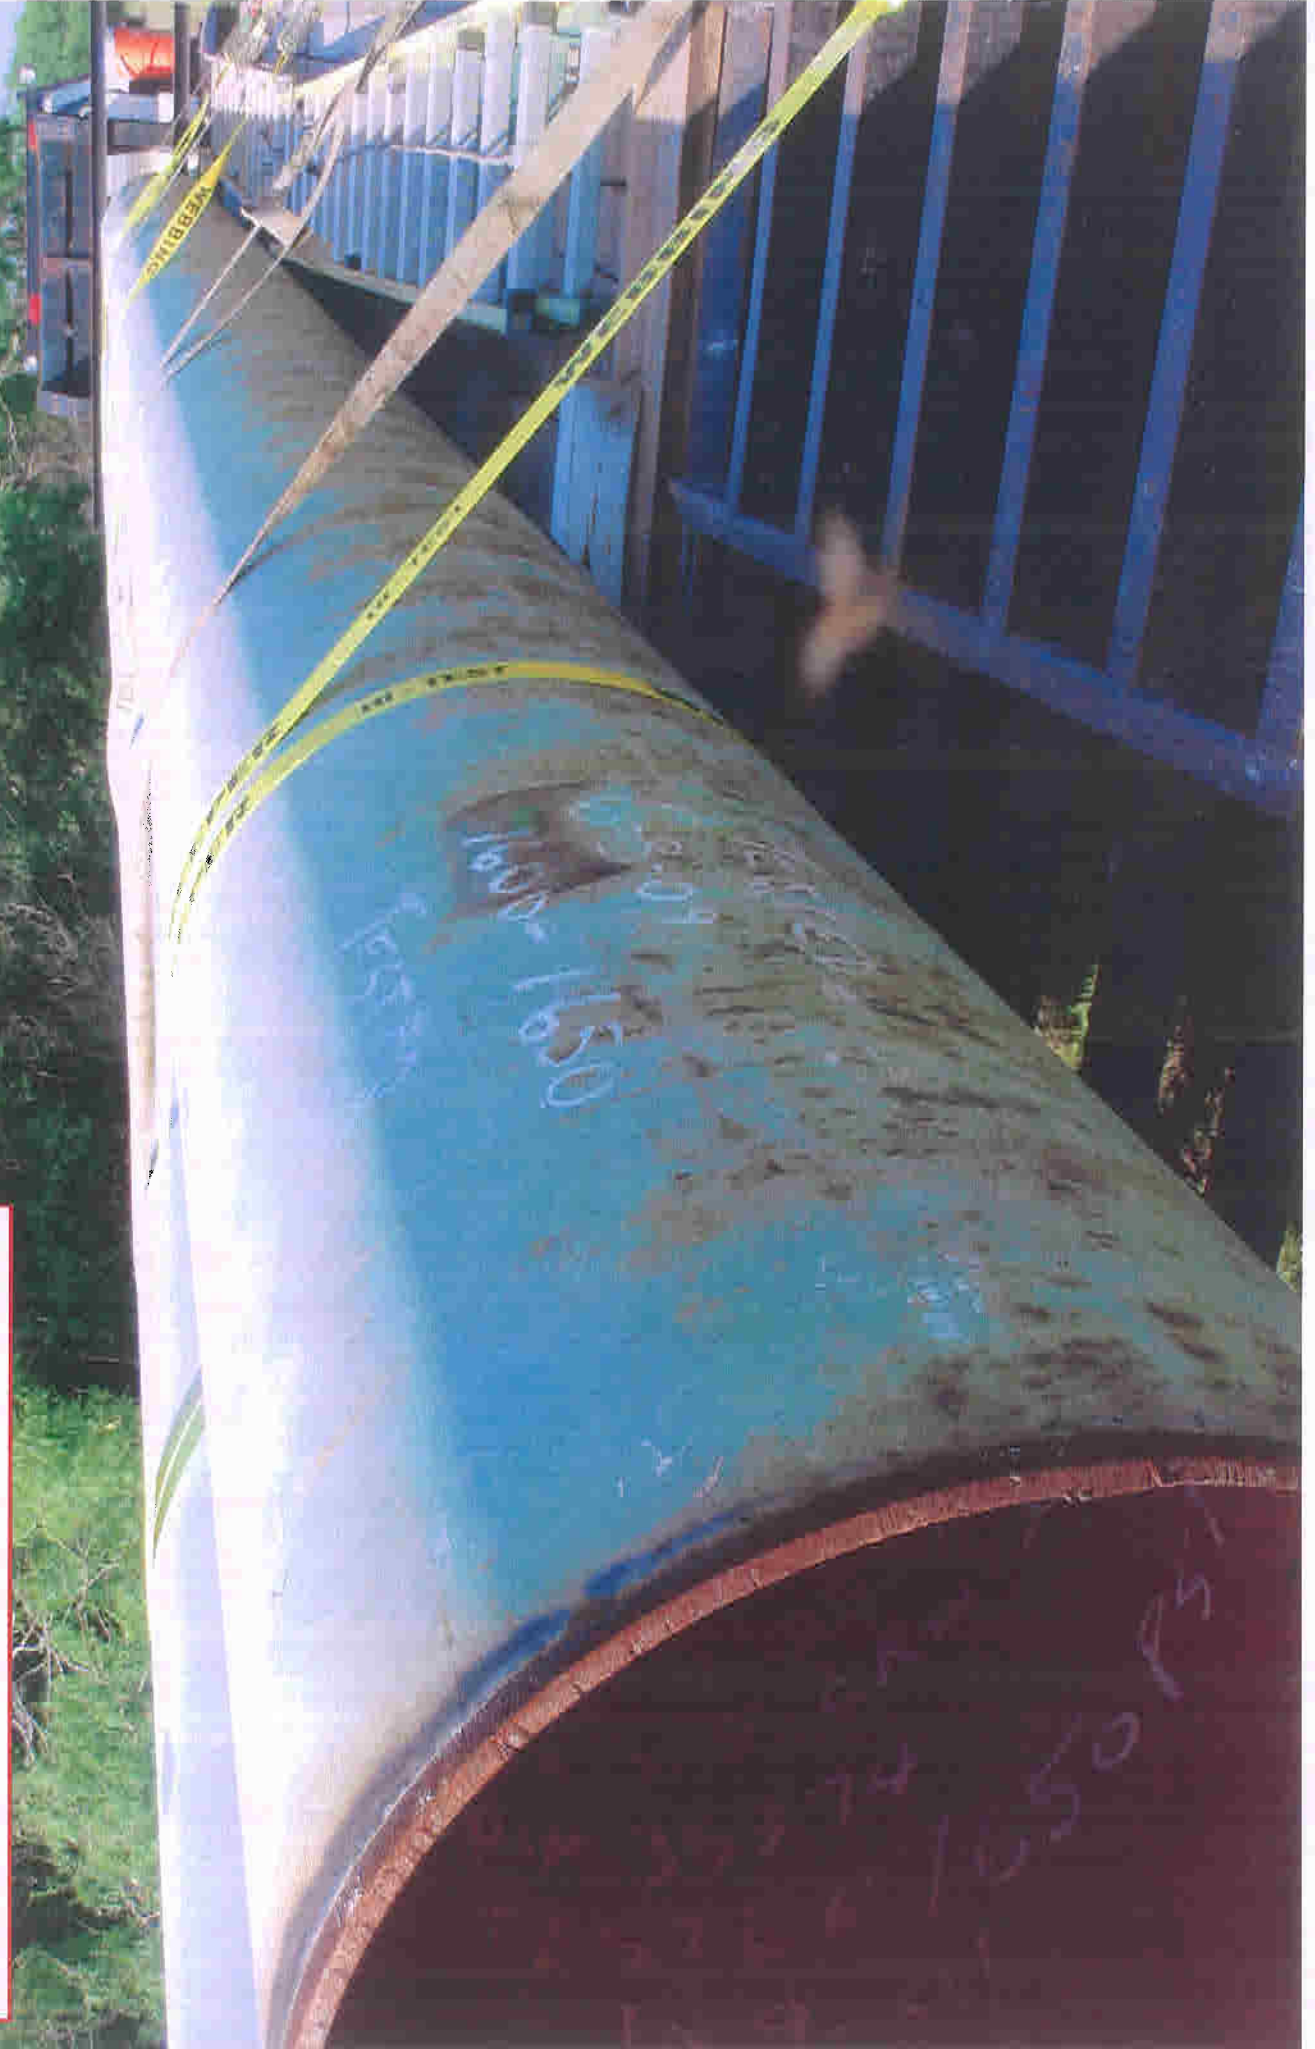
Williams-Transco 24-inch "A" Pipeline
King Ranch MP 97.53, 04-28-2010
Pre-tested Replacement Pipe

Note: Poor Coating Condition Required Surface
Preparation and Re-Coating with Denso Protal
