**DOT** US Department of Transportation  
**PHMSA** Pipelines and Hazardous Materials Safety Administration  
**OPS** Office of Pipeline Safety  
Southwest Region

**Senior Accident Investigator** Richard J. Lopez  
**Region Director** R. M. Seeley  
**Date of Report** 06/16/2011  
**Subject** Failure Investigation Report – Whitecap (Chevron), 18” Offshore Failure

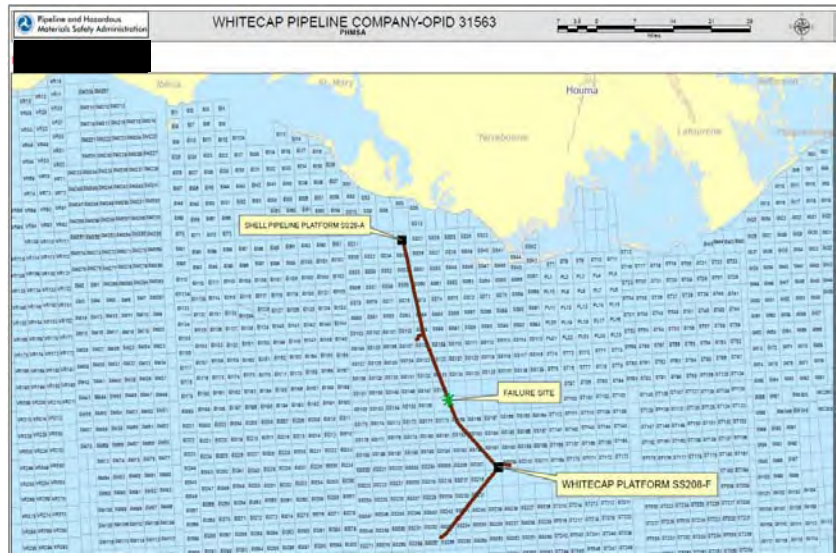
Figure 1: Whitecap Pipeline Showing accident location.

The accident occurred at a pipeline crossing at a water depth of 50-feet. The distance to an upstream launcher is 15.15 miles and 29.32 miles to a downstream receiver. The crossing of the TGP and the Whitecap line was installed per drawings and specifications prepared at the time of construction in 1968. The point of failure was at the 1:00 o'clock position. A 7-inch crack in a flattened area 1-inch deep, 16-inch wide and 6-ft 11-inch long on the 18-inch CPL pipeline was found by the divers.
