**Principal Investigator** Chris Taylor  
**Region Director** Wayne T. Lemoi  
**Date of Report** June 26, 2013  
**Subject** Failure Investigation Report – Columbia Gulf Transmission, Line 200 Rupture in Estill County Kentucky

# Failure Investigation Report – Columbia Gulf Transmission, Line 200 Rupture in Estill County, Kentucky

Failure Date - January 2, 2012

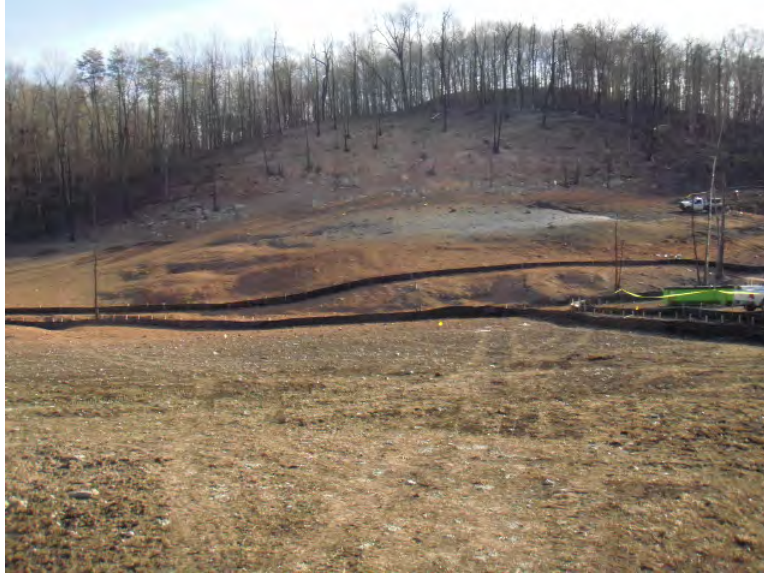
The rupture created a crater approximately 86 feet long by 22 feet wide and expelled a number of pieces of pipe as far as 800 feet from the rupture centerline. The escaping natural gas ignited and burned adjacent trees and farmland. The heat from the fire also deformed the vinyl siding on a mobile home trailer over 800 feet away. Local authorities blocked a 1.3-mile section of Kentucky Highway 89 (Winchester Road) until the fire fighters extinguished the fire.

Figure 5. Burned vegetation at Line 200 rupture location

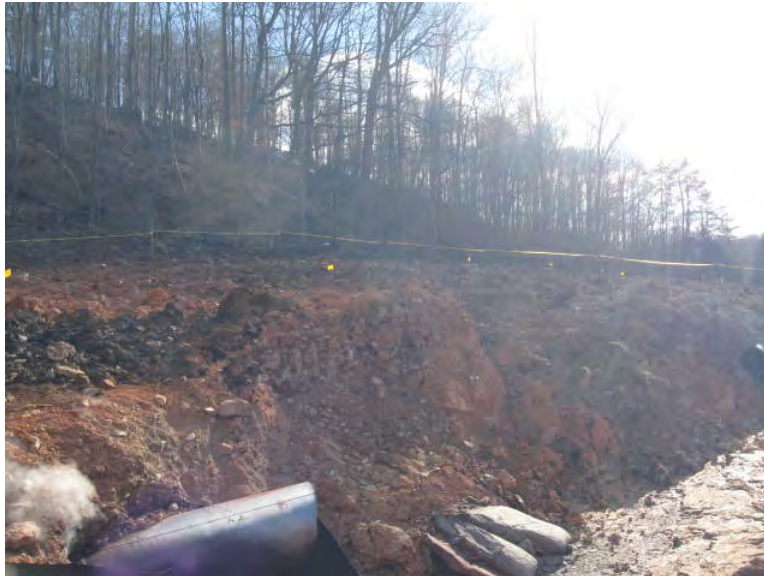
Figure 6. Bottom left of photograph is downstream pipeline failure terminus. The middle/far right of photograph is the upstream pipeline failure terminus

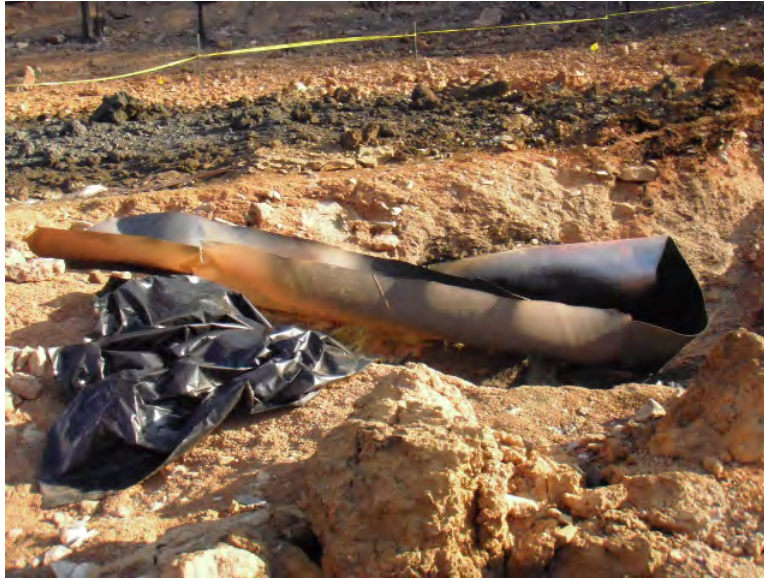
The High-Energy Rupture of Line 200 occurred in a pipe buckle between the 10 o'clock and 3 o'clock pipe positions. The buckle was within a pipe segment that contained a field fabricated side bend/under bend. The pipeline was originally constructed in the 1960s on the side of a hill and DNV concluded that

DNV determined the origin of the high-energy rupture was near a girth weld in an area of what appeared to be circumferential expansion caused by the pipe buckle and explained the role of the pipe buckle in this rupture:<sup>8</sup>

*“The results of the analyses indicate that the high-energy rupture initiated near a field weld in an area of circumferential pipe expansion, likely due to buckling...The rupture occurred at one of the peaks in the buckle and the mode of crack propagation was ductile tearing...The location of the failure (i.e. on the side of the hill) and the surrounding terrain are consistent with possible exposure of the pipeline to side loading and/or top loading from lack of support.”*

Figure 7. Downstream terminus – High Energy Rupture

CGT repaired the pipeline by replacing approximately 160 feet<sup>5</sup> of pipe with two new pipe sections having the following specifications.

CGT welded, X-rayed, and hydrostatically pressure tested the joints of Berg pipe separately from the joints of Kawasaki pipe. CGT then “tie-in” welded each new section of pipe to the existing Line 200 and then X-rayed the tie-in welds.

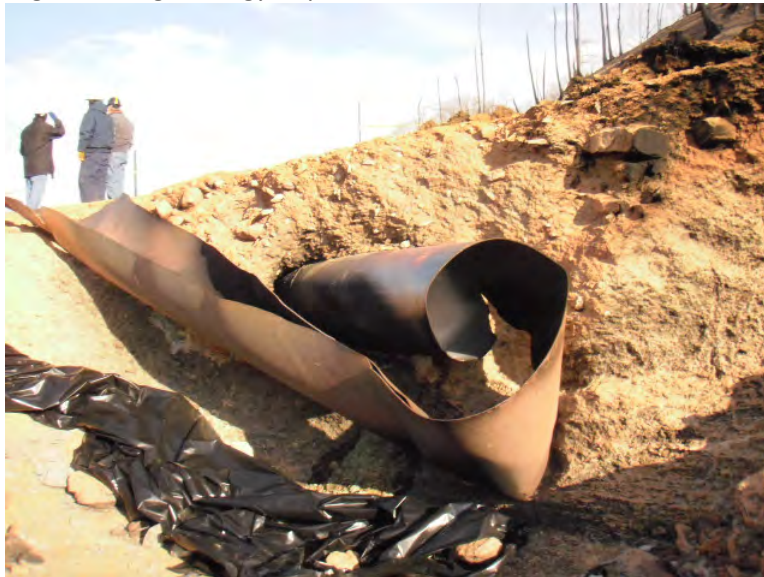
- CGT’s Line 200 experienced a *High-Energy Rupture* on January 2, 2012, due to failed axial and circumferential cracks in a pipe buckle. The pipe buckle was approximately 3-inches “high” and located in the 10 o’clock through 3 o’clock pipe position.

- The DNV metallurgical report indicated the pipe failure origin was near a girth weld in an area of circumferential expansion likely due to the pipe buckle. The pipe failure origin was also near an existing pipe side bend/under bend configurations that DNV believed might have initially facilitated the formation of the pipe buckle.

Figure 8. High Energy Rupture section

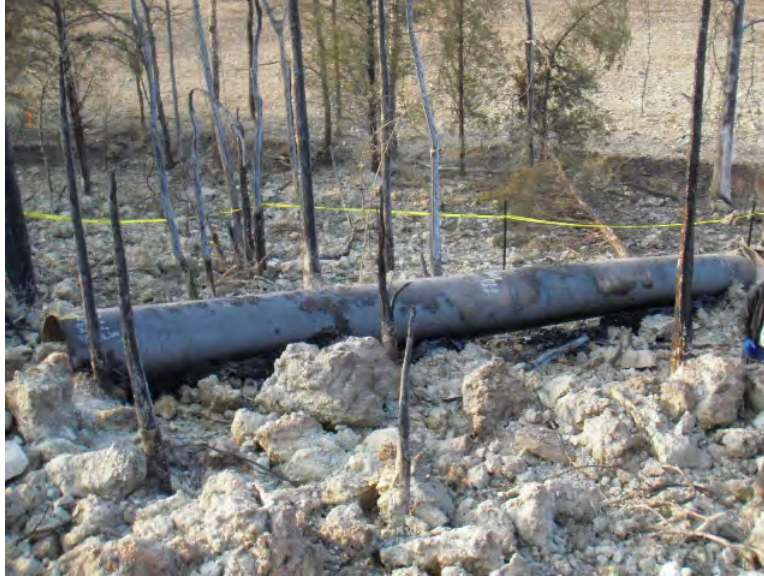
DNV concluded the high-energy rupture occurred initially and that the resultant axial stresses from the force of the high-energy rupture acted on the existing girth weld crack described above, which resulted in the low-energy failure. That is, DNV concluded that a pre-existing crack<sup>9</sup> located in a girth weld at Station Number 3609+26 initiated the low-energy failure of Line 200 after, and as a result of, the high-energy rupture. DNV discovered additional pre-existing cracks in the girth weld ranging from 1½ -inches to 12-inches in circumferential length. The cracks originated from the inside diameter surface at the toe of the root pass weld<sup>10</sup> in the heat-affected zone. The maximum depth of the pre-existing cracks was 0.197- inches, which was 42.8% of the pipe weld thickness. DNV further stated the morphology of these cracks was typical of hydrogen-assisted cold<sup>11</sup> cracking as supported by the following evidence:

1. A relatively high carbon equivalent (CE) of the line pipe steel
  - a. The CEs of the upstream and downstream pipe joint from the failed girth weld were 0.46 and 0.51, respectively. At the time of this pipe manufacture, the API 5L<sup>12</sup> standard did not specify a carbon equivalent limit. The current edition of API 5L<sup>13</sup> sets a CE limit of 0.43 for the same grade of line pipe that failed.
2. The mixed mode cracking on the fracture surfaces
  - b. During the failure, the crack propagation occurred in the weld metal, and to a lesser degree through the parent metal.

Figure 9. Low Energy Failure pipe section

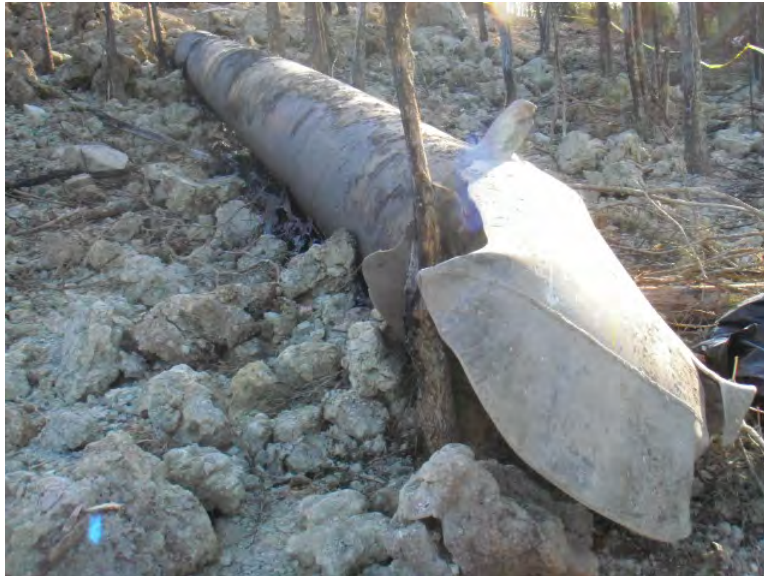
- The DNV metallurgical report stated that the *High-Energy Rupture* of Line 200 at the pipe buckle led to a nearly instantaneous *Low-Energy Failure* of a nearby girth weld cold crack. The girth weld cold crack failure was approximately 40 feet upstream from the pipe buckle failure.

Figure 10. Low Energy Failure pipe section – fractured pipe portion shown mates to the High Energy Rupture section

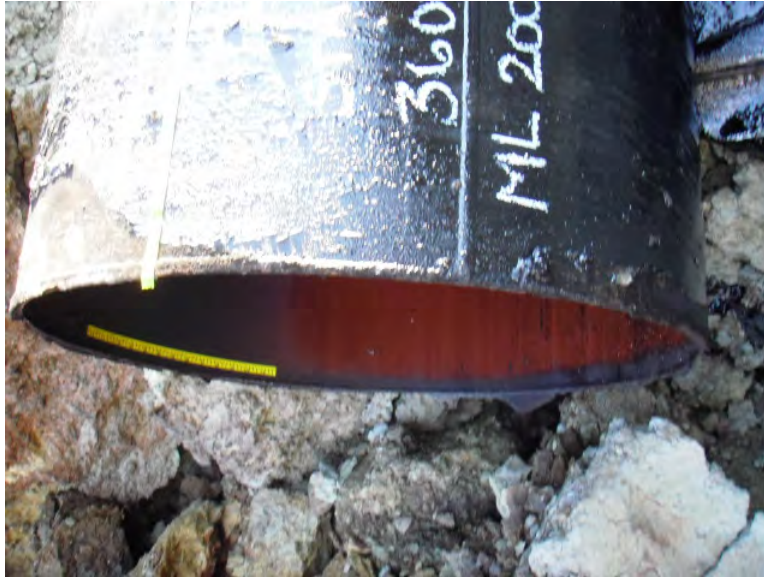
Figure 11. Clean fracture in the girth weld at the upstream pipe terminus – this was location of the Low Energy Failure origin

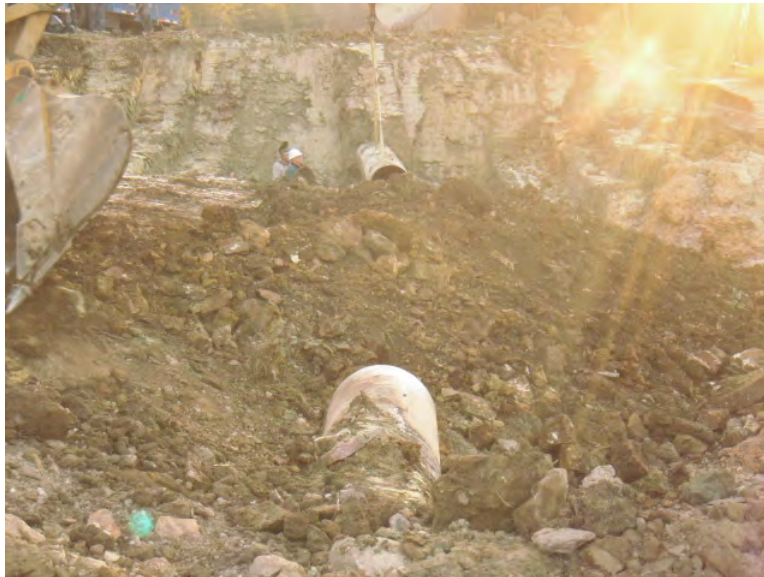
Figure 12. Line 200 looking downstream – The offset between the upstream and downstream termini necessitated the over bend and side bend during the original construction

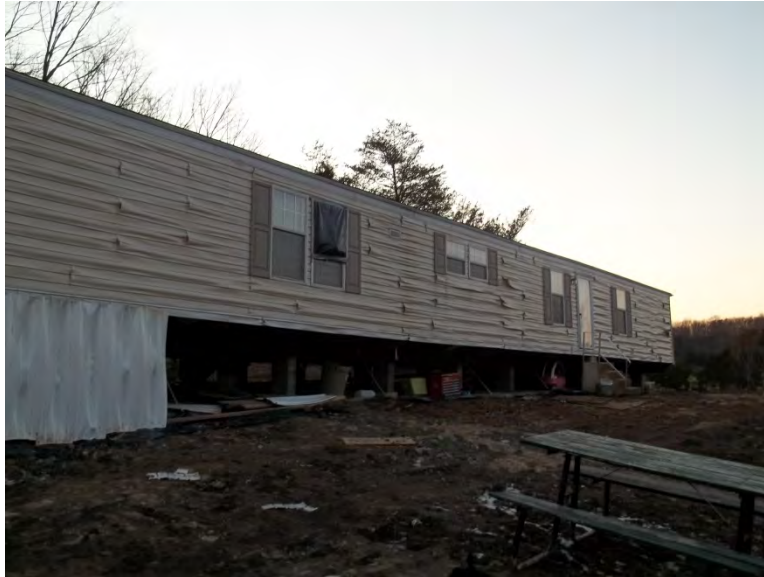
Figure 13. Trailer located over 800 feet from the rupture centerline, south of KY Highway 89 (Winchester Road)

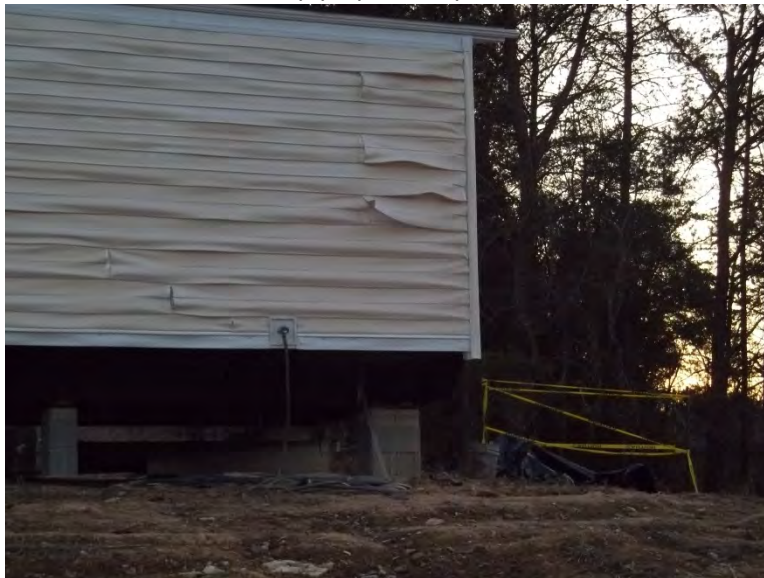
Figure 13. Closer view of heat damage – the yellow tape indicates the location of Line 200 pipe piece expelled from rupture area

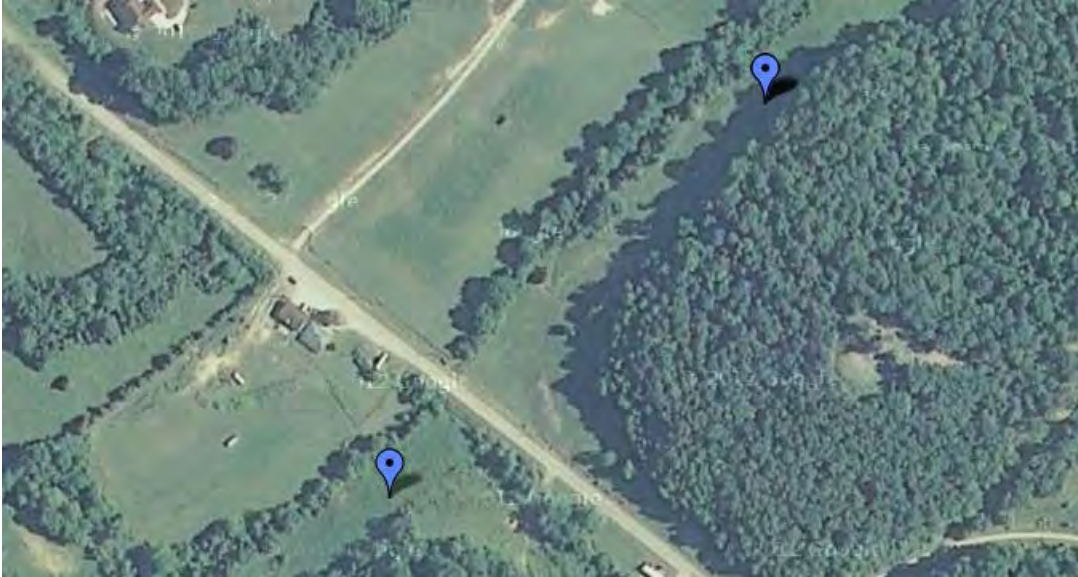
In its final report to CGT, Terracon listed 60 occurrences of slope instability it observed along the CGT ROW between the Clementsville Compressor Station and Stanton Compressor Station. The instability ranged from eroded/washed-out areas at non-vegetated slopes to signs of past landslides and/or creep movement. The most severe occurrence Terracon noted in its report was a landslide at MP 68.1, which

was approximately 1,100 feet upstream of the January 2, 2012, rupture centerline.<sup>15</sup> (Appendix A, Figure 14)

Figure 14. The top right marker indicates the January 2, 2012 rupture location centerline at MP 68.3, the bottom left marker indicates the location of a small land slide discovered by Terracon Consultants, Inc. at MP 68.1

As recommended by GAI and Terracon, CGT installed slope monitoring devices at MP 68.1, which was the location of the active ground movement. Terracon installed the devices on May 18, 2012, and CGT now monitors these devices for ground movement at an interval established by Terracon.
