Failure Investigation Report – Liquefied Natural Gas (LNG) Peak Shaving Plant, Plymouth,
Washington

Principal Investigator Scott Rukke, WUTC
Senior Accident Investigator Peter Katchmar, PHMSA
Region Director Chris Hoidal, PHMSA
Date of Report 4/28/2016
Subject Failure Investigation Report – Liquefied Natural Gas (LNG)
Peak Shaving Plant, Plymouth, Washington
Operated by Williams Partners Operating, LLC

Date of Failure 03/31/2014
Commodity Released Natural Gas (both in liquid and gaseous states)
City/County & State Plymouth (Unincorporated)/Benton County, WA
OpID & Operator Name 39054 - Williams Partners Operating LLC
Unit # & Unit Name 1155 – Williams Partners, Plymouth LNG
SMART Activity # 149816
Milepost / Location Milepost 175.0
Type of Failure Operator Error - Vessel and piping failure from detonation caused by internal auto-ignition due to a purge that failed to remove a gas-air mixture from the system.
Fatalities 0
Injuries 5
Description of area impacted Contained within the plant grounds except for some ejected debris that caused damage to the adjacent railroad tracks.
Total Costs \$45,749,300

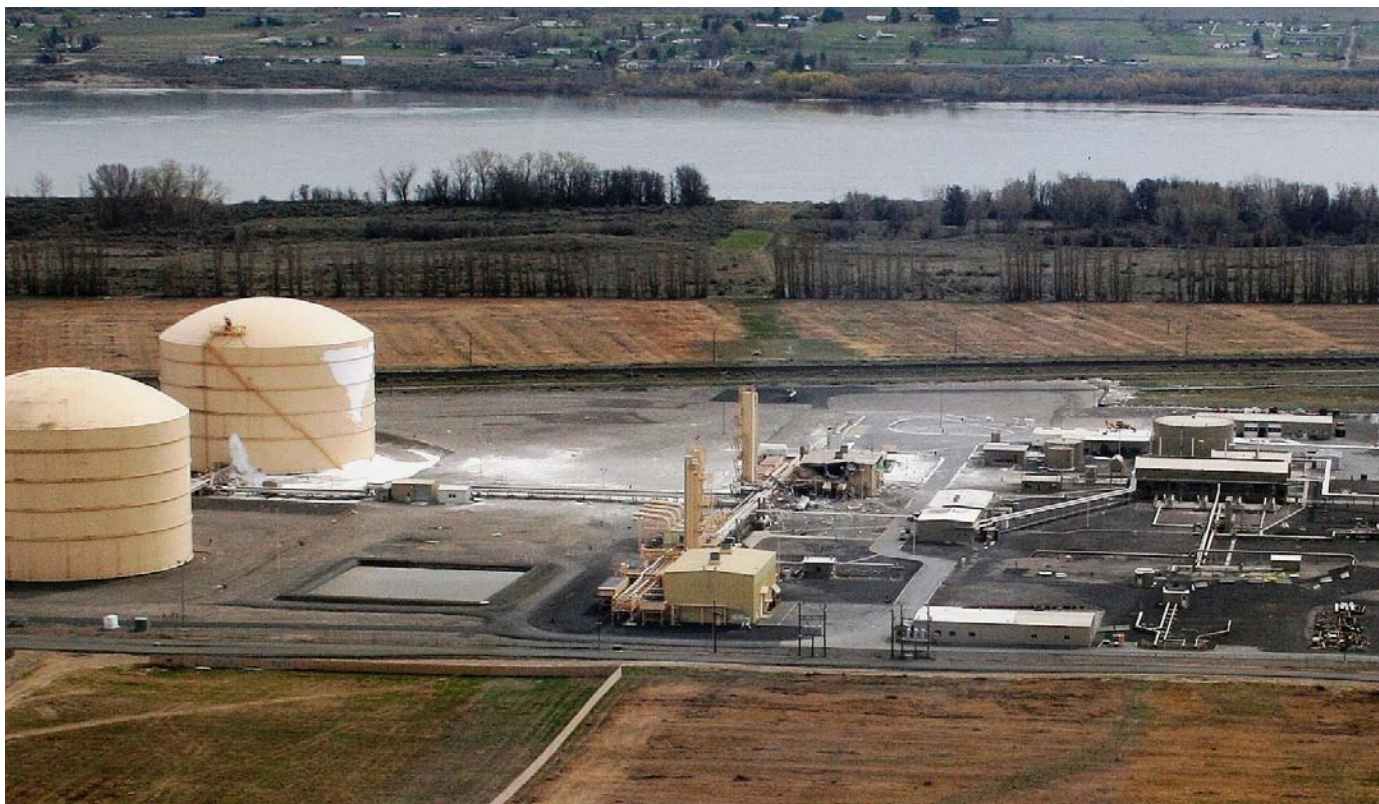
Aerial view taken shortly after the failure. Looking South toward Columbia River.

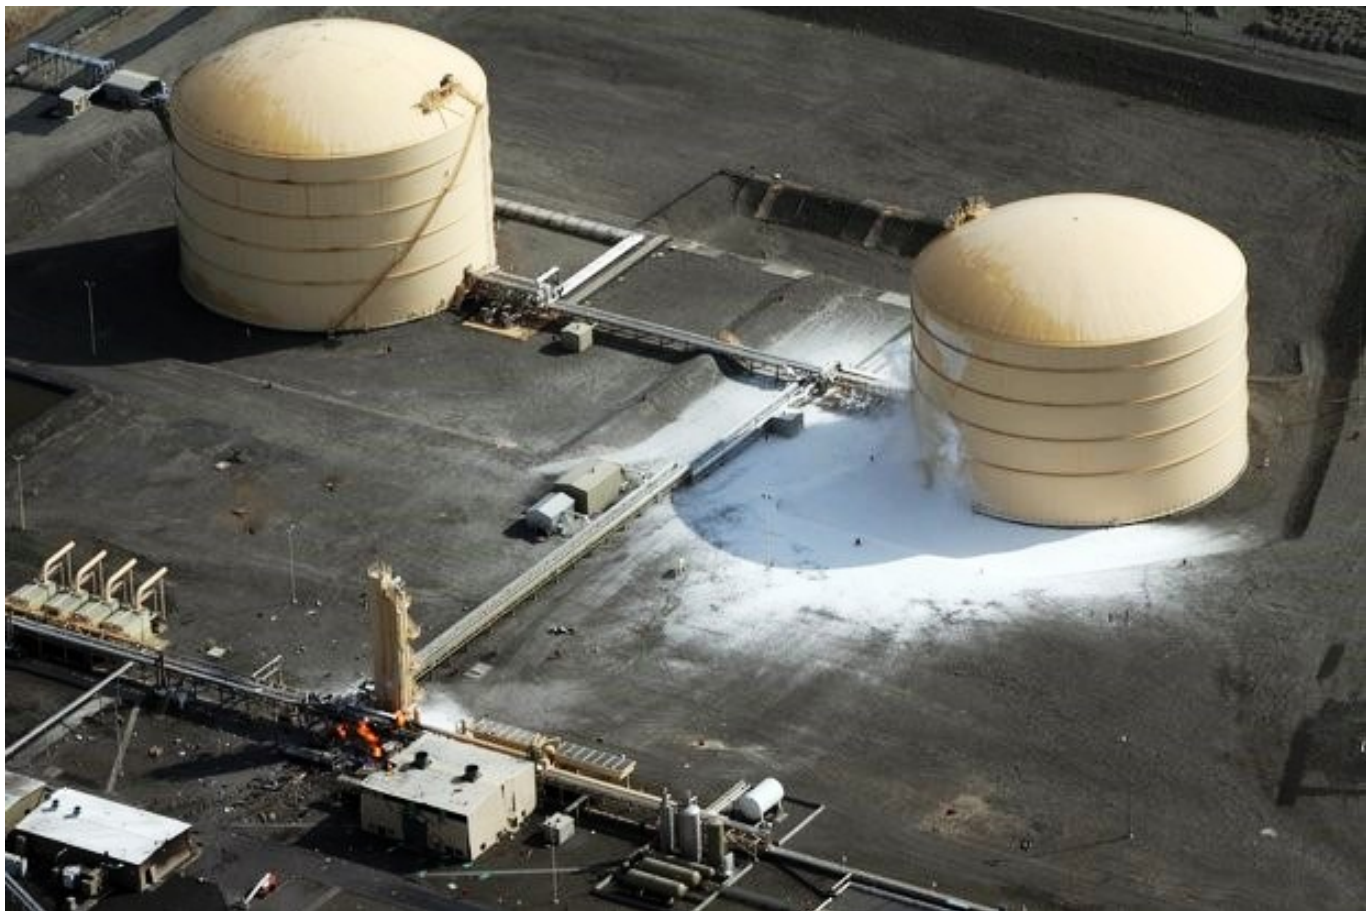
The penetration of the outer shell of the LNG-1 storage tank caused the Perlite insulation between the annulus of the inner and outer tanks of the storage tank to be compromised, thereby allowing LNG "boil-off" gas to escape. Boil-off gas is the product of the constantly vaporizing LNG present in the inner tank which is open at the top. It was unknown whether boil off gas was originating directly from a debris-caused penetration of the inner tank shell of LNG-1 or was migrating through the top of the inner tank, through the annulus between the two tanks, and out the penetration of the outer tank. Regardless, a decision was made to evacuate the town of Plymouth and the surrounding communities within a two-mile radius. It was later confirmed that the inner tank of LNG-1 was not penetrated. The inner tank did sustain a minor dent, which was repaired.

Aerial view taken shortly after the failure. Fires still burning. Perlite insulation leakage from the penetrated outer LNG-1 storage tank. Control room lower left.

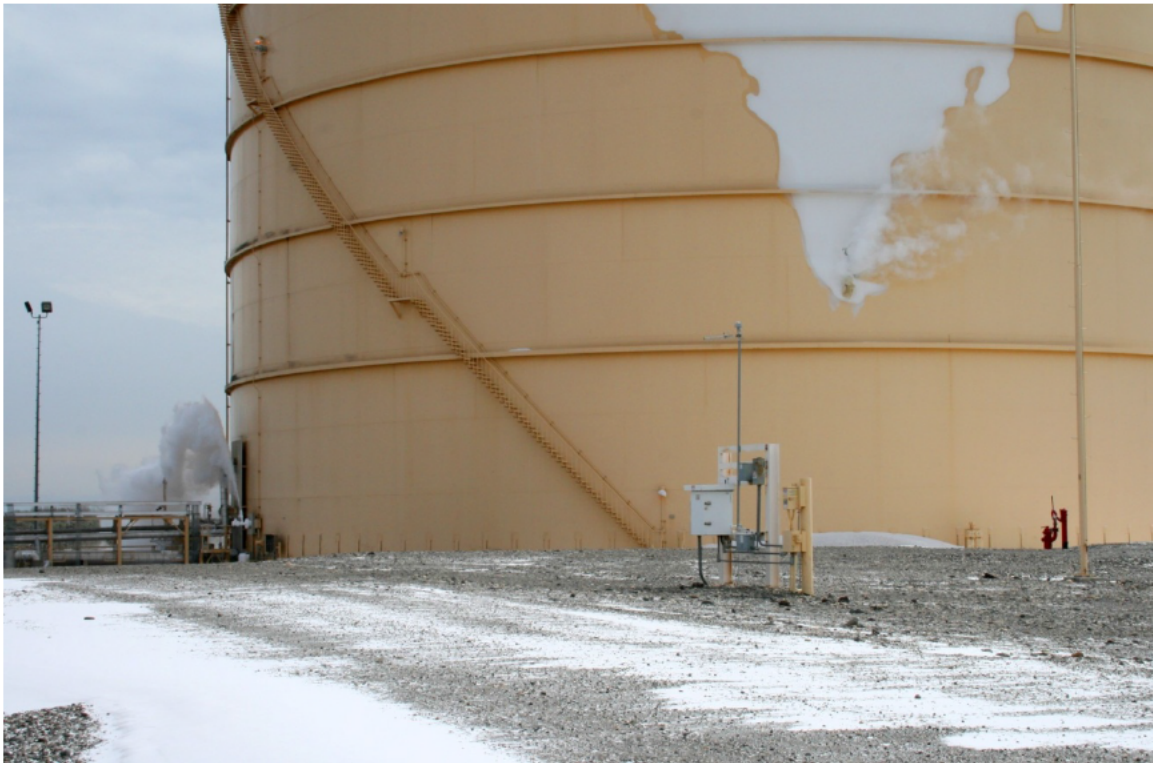
Additionally, a protruding one half-inch diameter instrumentation pipe located near the bottom of the LNG-1 tank was damaged. This allowed LNG to release in a spray and vaporize. There was no pooling of the LNG and there was no resulting vapor (methane) cloud that left the plant. As soon as the plant was made safe, Williams' personnel donned cryogenic suits, entered the facility and closed the valve between the damaged pipe and LNG-1 tank wall, shutting off the LNG release at the tank. The release continued for approximately 25 hours and an estimated 9.3 barrels per hour or a total of 234 barrels was released.

View of the outer shell penetration of the LNG-1 storage tank, looking east. Leaking 1/2-inch LNG instrument line lower left side of tank. V-shaped ice formation above outer shell penetration. Perlite insulation on ground lower left.

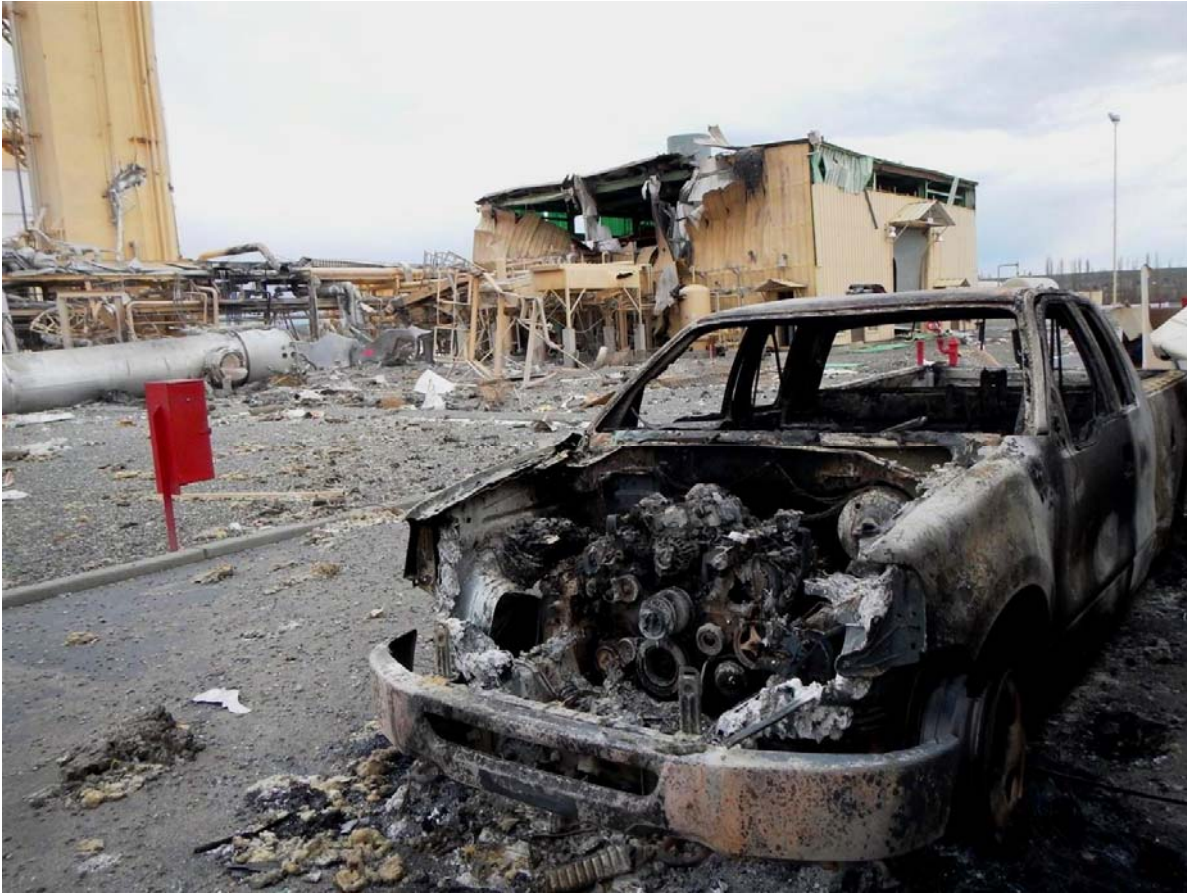
Looking SE towards the failure site from in front of the Control Room. One of the twin adsorbers lying on its side. Compressor building in center-back. Refrigerant tower top-left. Use burned truck as reference.

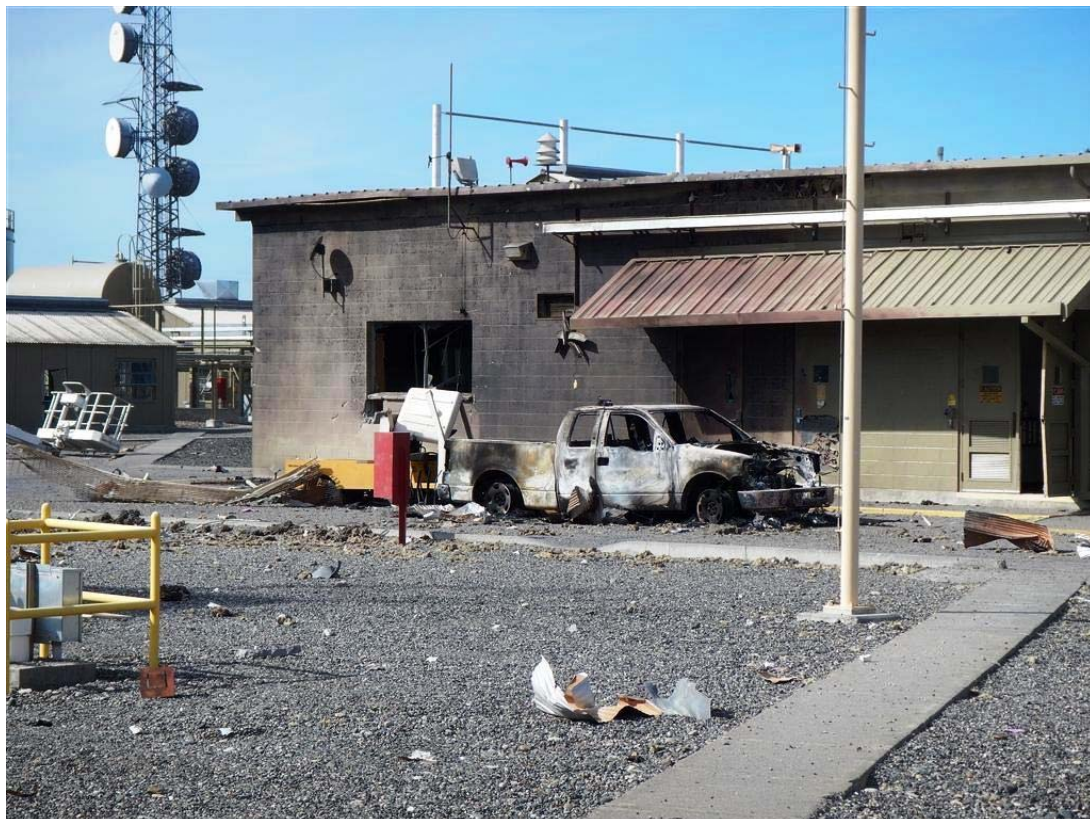
View of the control room looking west. Use burned truck as reference.

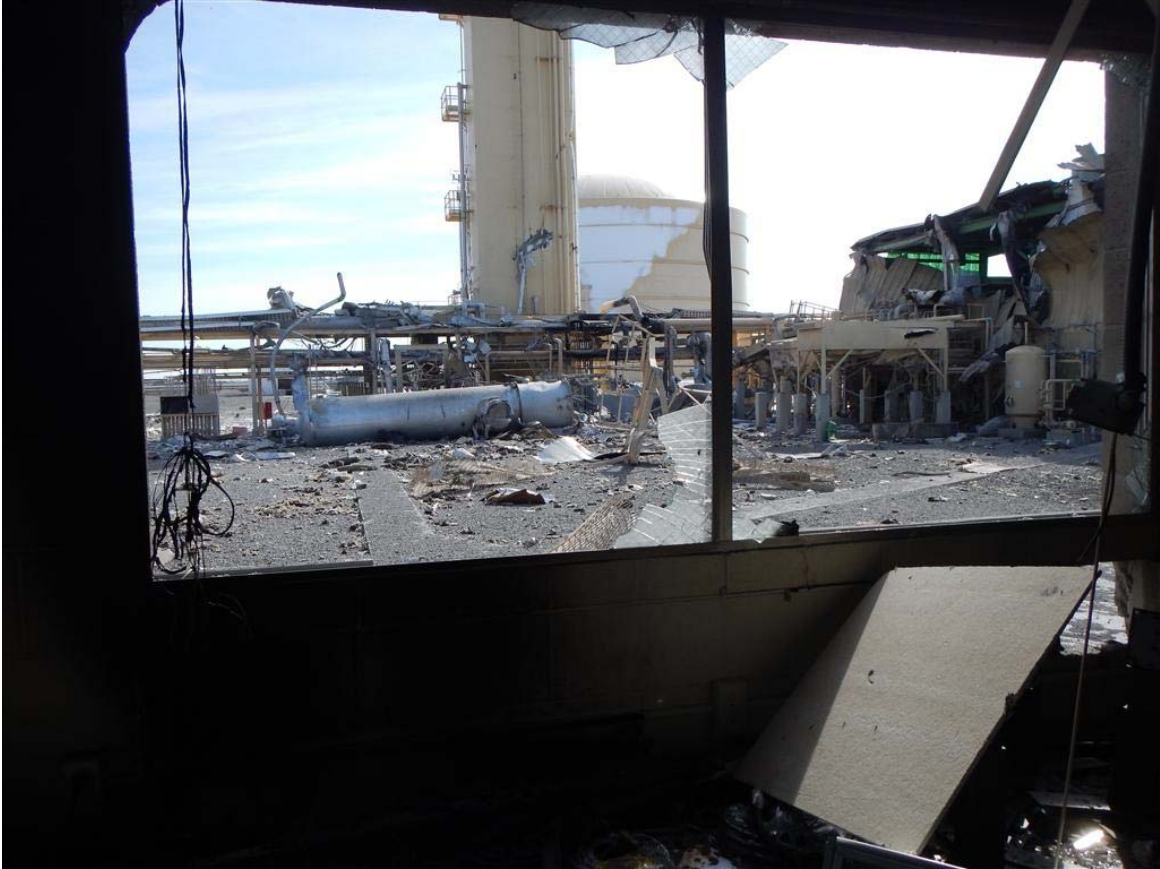
View of the failure site looking east from inside the control room.

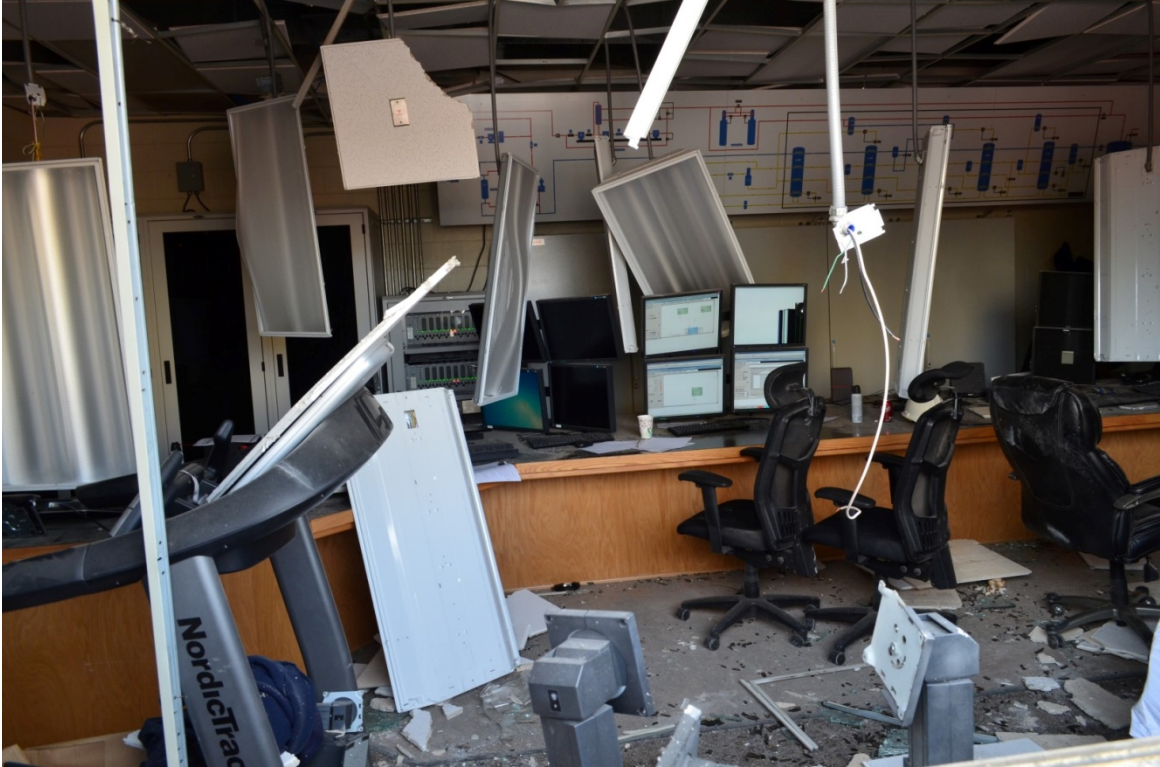
Inside of the control room view through the window. Looking west.

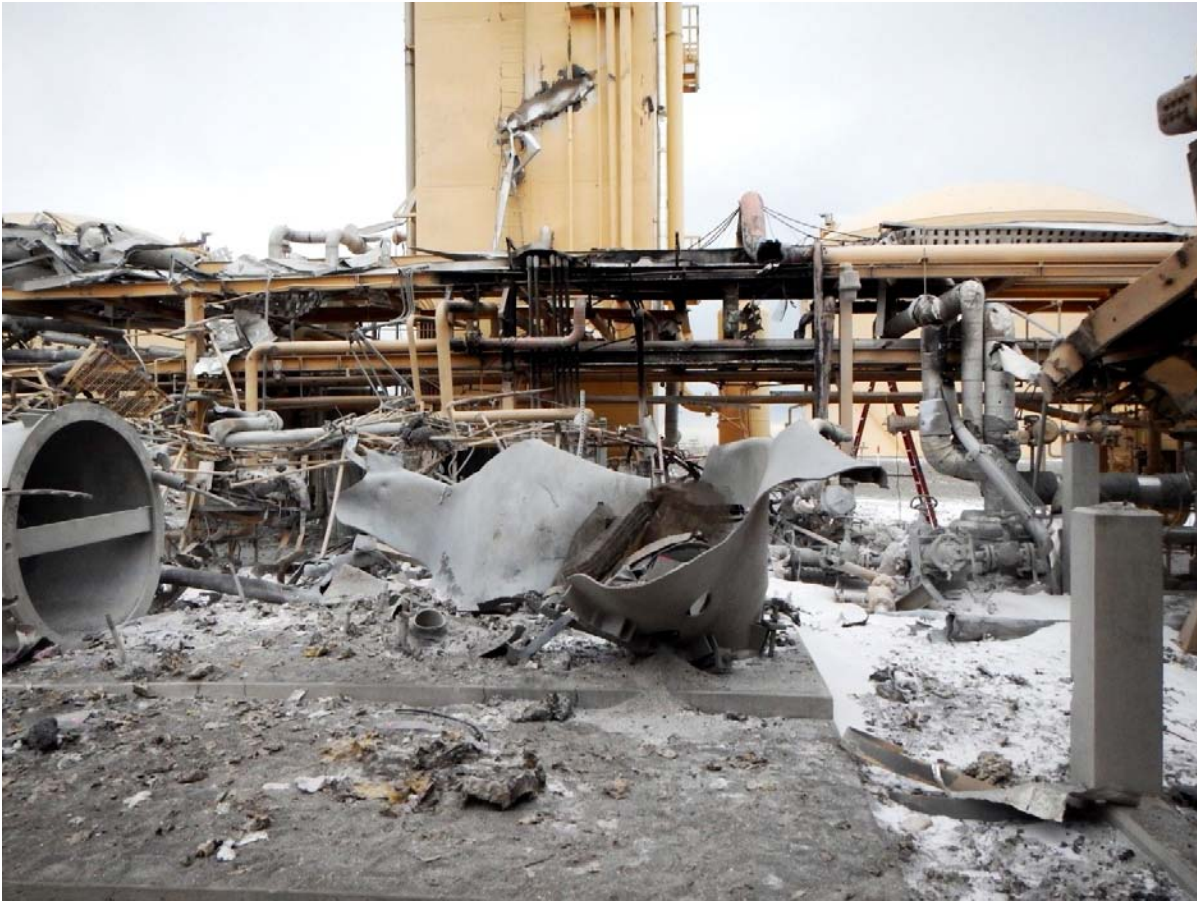
Remnants of the failed adsorber base center. Refrigerant tower top center. Large piece of debris from the failed adsorber embedded in the center of tower.

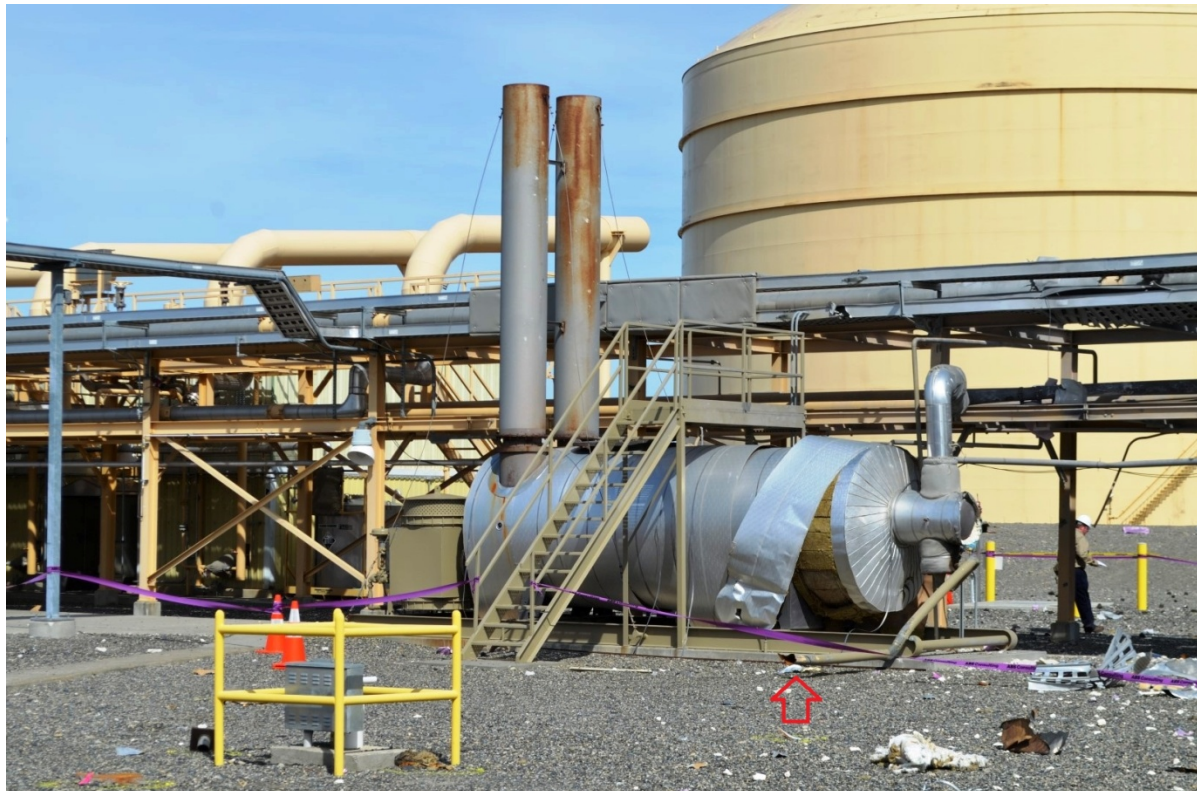
The primary cause of this failure was a substandard purge performed after leaving the LNG-1 purification loop open to the atmosphere from November 1, 2013, to March 18, 2014. A flammable gas-air mixture remained in the system which then entered the salt bath heater and auto-ignited during start-up.

LNG-1 Salt Bath Heater where auto-ignition initiated. Red arrow indicates a failure point in the 4-inch heater gas inlet. The piping is blown outward and down. It would normally be behind the heater and up on the pipe rack. Looking Northeast. The LNG-2 storage tank in the background.

3. Removal of the salt bath heater involved in the incident and replacement with a new “tight wound helical coil” heater that does not use a salt bath. This allows for more consistent heat distribution to the gas.

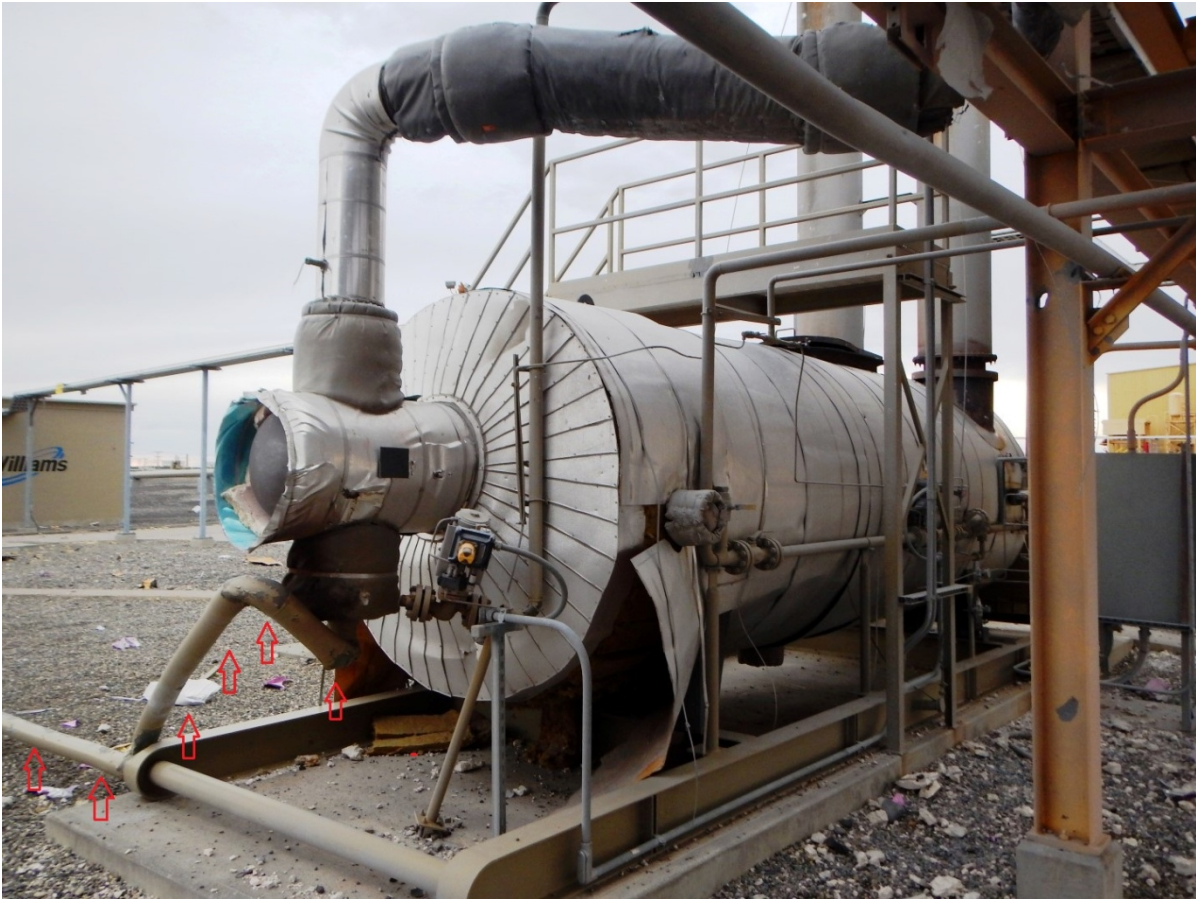
Another view of the Salt Bath Heater. The 4-inch gas inlet piping denoted with red arrows. The piping is blown to the left of the heater. Looking northwest.

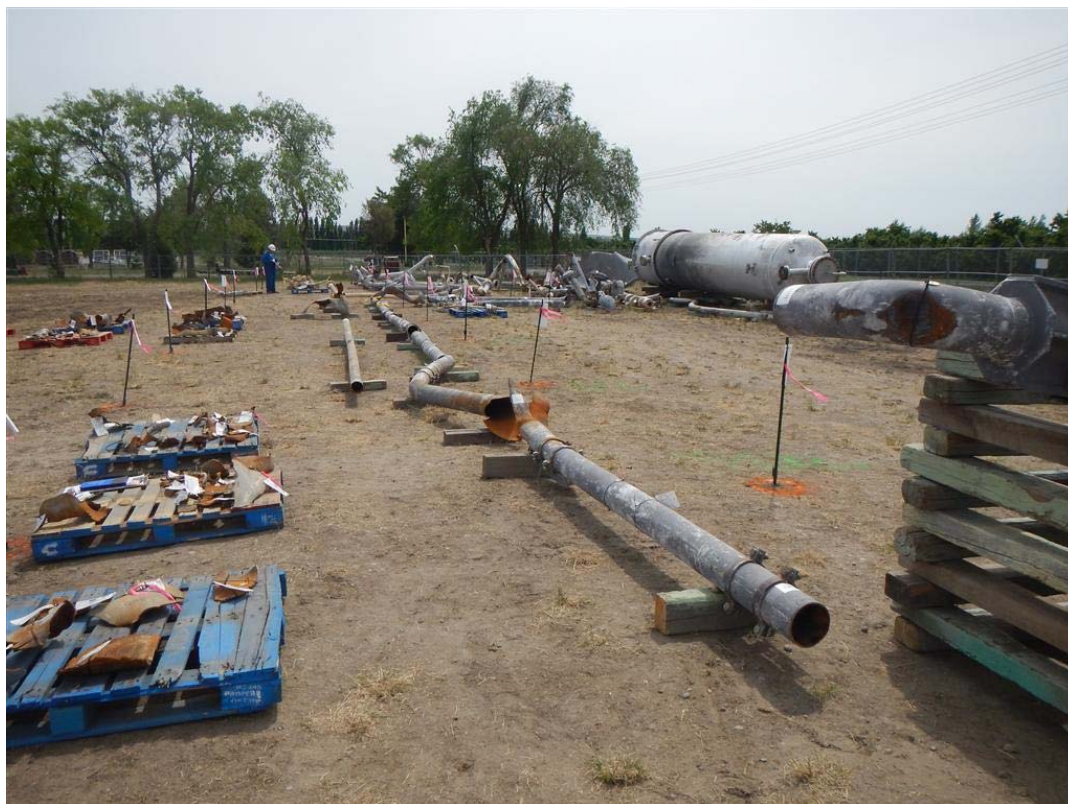
This picture is in the opposite direction as the last picture. Notice the adsorbers in the background.
