DOT US Department of Transportation
PHMSA Pipelines and Hazardous Materials Safety Administration
OPS Office of Pipeline Safety
Southwest Region

Principal Investigator Gene Roberson
Region Director R. M. Seeley
Date of Report 09/12/2013
Subject Failure Investigation Report – Enterprise Products Pipeline – Rio Grande PL Girth Weld Failure

**Failure Investigation Report – Enterprise Products Operating LLC – Girth Weld Failure
12/27/2011**

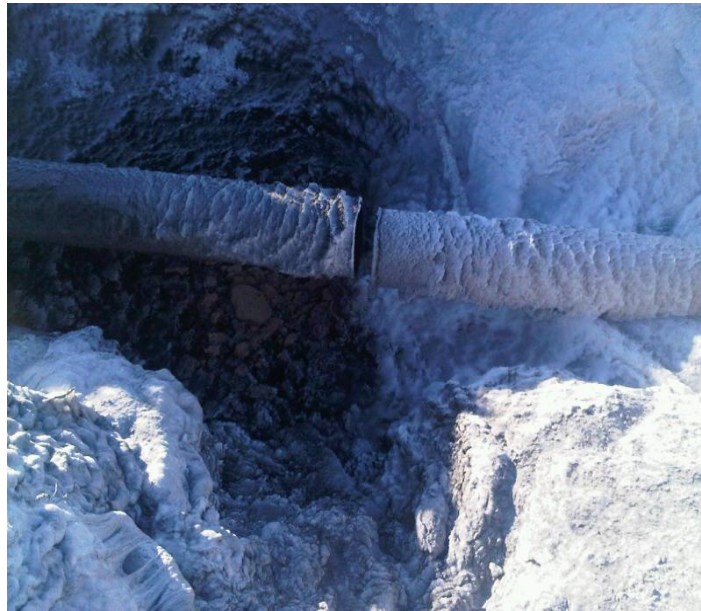
Failed Girth Weld

- The fracture initiated at an area of incomplete penetration in the acetylene weld, in a ductile manner, and propagated within and around the circumferential weld.
- The cause of the girth weld failure was due to external stresses on the pipeline. This was the conclusion since no evidence of time-dependent degradation was identified on the pipe.
- The failure mechanism was longitudinal in nature (geotechnical soil shift/ thermal expansion).
- No failure would have occurred in the girth weld without the applied longitudinal stresses.

A failure occurred in an acetylene girth weld that completely separated from the 8-inch Rio Grande Pipeline. The separation began in a location of incomplete penetration within the weld due to the application of external forces on the pipeline. The flash fire and injuries were a result of incorrect operation and failing to follow procedures associated with hot work on the pipeline.

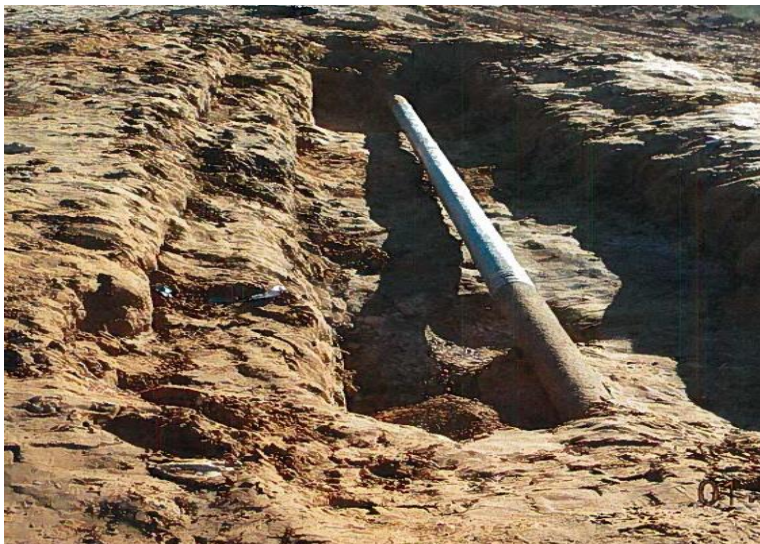
Pipe Replacement

On December 30, 2011, following the development and implementation of a work plan and work permits, the failed section was cut out and replaced with 24 feet of new pipe. The pipeline was then purged and returned to service at 80 percent of the operating pressure at the time of the incident while the investigation continued into the cause of the failure. The removed pipe was then sent to Kiefner and Associates, Inc. for metallurgical analysis.

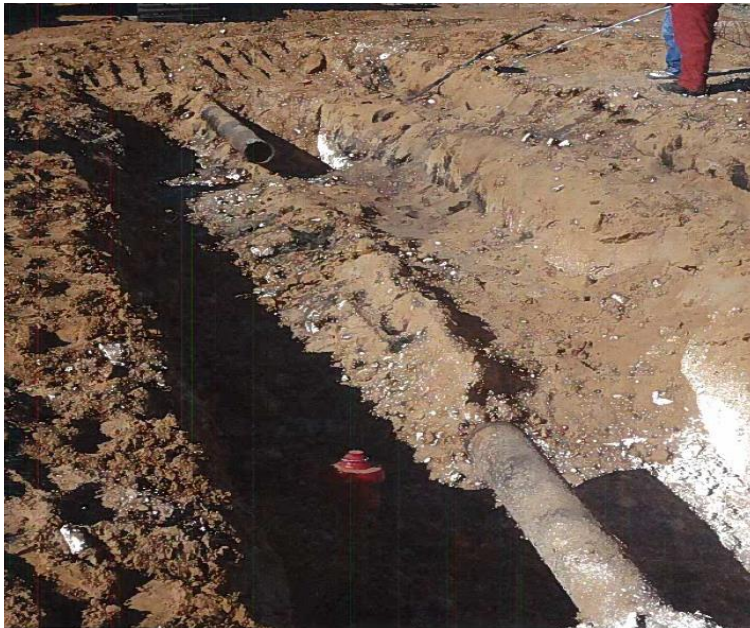
At approximately 5:00 p.m. on December 28, 2011, a flash fire occurred in the trench when a concentration of hydrocarbons exceeding the Lower Flammability Limit (LFL) for the hydrocarbon mixture ignited. Two Enterprise employees and four contractors were in the trench working on various tasks, such as removing additional soil with shovels, taking measurements, and evaluating the amount of additional pipe that needed to be removed from the west side of the weld failure, when the flash fire occurred. Three individuals were injured as a result of the flash fire. Enterprise discontinued all repair activities.

Site After Flash Fire
