DOT US Department of Transportation  
PHMSA Pipeline and Hazardous Materials Safety Administration  
OPS Office of Pipeline Safety  
Southwest Region

**Principal Investigator** Gene Roberson  
**Region Director** R. M. Seeley  
**Date of Report** 3/1/2013  
**Subject** Failure Investigation Report – Gulf South Pipeline Carthage Junction Compressor Station

Failure Investigation Report –Gulf South Pipeline Carthage Junction Compressor Station  
Failure Date 02/14/2011

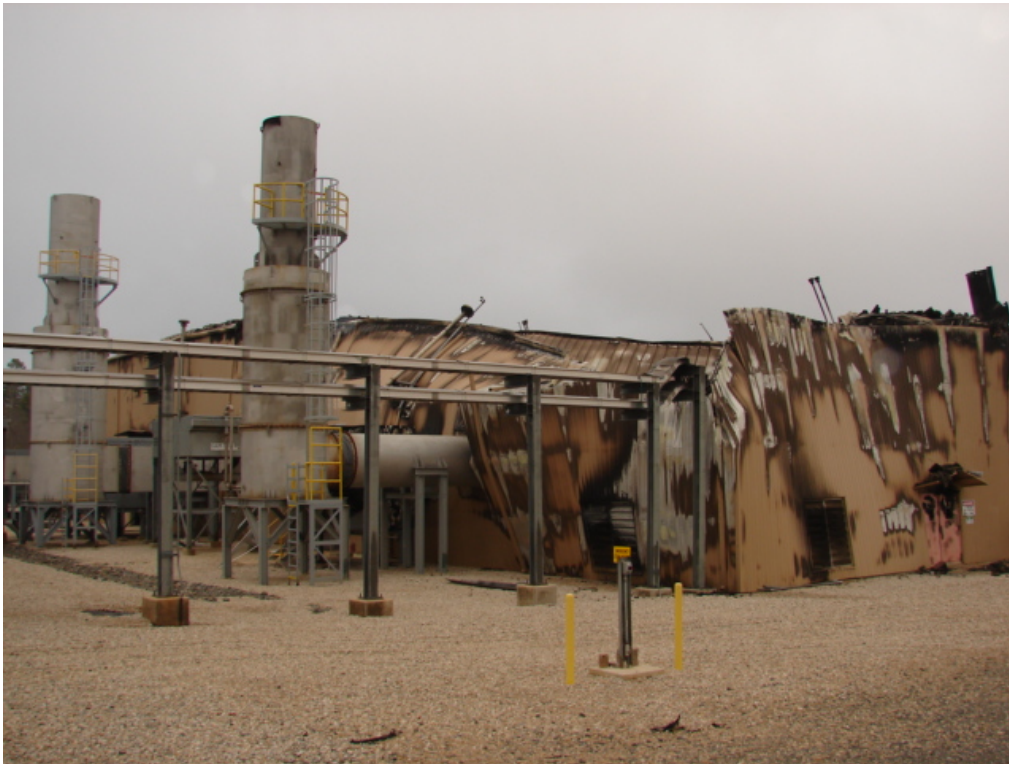
At approximately 10:22 p.m. Central standard time (CST), on February 14, 2011, an explosion and fire occurred at the Gulf South Pipeline Company, LP (Gulf South) Carthage Junction Compressor Station in Panola County, Texas. The PHMSA Southwest Region conducted an onsite investigation of the incident. At the time of the incident, Gulf South was in the process of shutting down their T-7 compressor unit. The investigation identified a failed check valve on the compressor discharge, which prevented the unit discharge valve from closing during the shutdown. The failure of the valve and the ineffectiveness of the Emergency Shutdown system (ESD) contributed to the incident. The Gulf South system is monitored and controlled by gas control in Owensboro, Kentucky. Local emergency personnel responded to the scene. There were no injuries, road closures, or resident evacuations associated with this incident. The station ESD was finally activated and the resulting fire burned itself out by February 15, 2011, 2:30 a.m. CST.

Figure 1-Carthage Junction Compressor Building

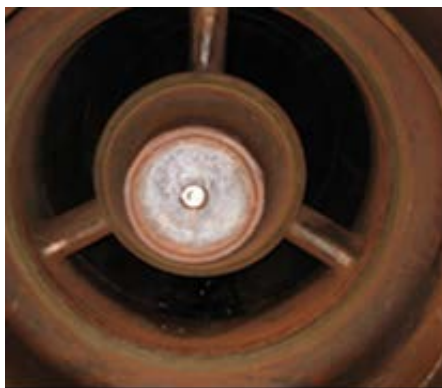
**Figure 2 - Check Valve Center with sheared bolt**

The lab concluded that the central assembly bolt in the check valve failed, releasing the internal parts, which then traveled downstream into the compressor station discharge valve. As a result of their findings, Cameron issued an “ENTECH Product Notification Letter” to inform its customers of the possible issues associated with the 24-inch EMTECH nozzle check valve due to possible over-torquing of the central tie bolts during assembly in 2007 and 2008. Cameron later issued a second “ENTECH Product Notification Letter” to offer replacement valves for the valves manufactured in their Hammond, Louisiana, plant during 2007 and 2008. Gulf South replaced all eight similar check valves installed in their East Texas to Mississippi expansion project.

Gulf South replaced 8 24-inch ENTECH check valves within their East Texas to Mississippi project. The failed check valve and elbow fitting were sent to Stress Engineering for evaluation and testing.

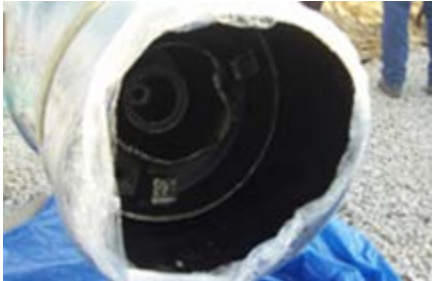
Figure 3 – Check Valve Plug

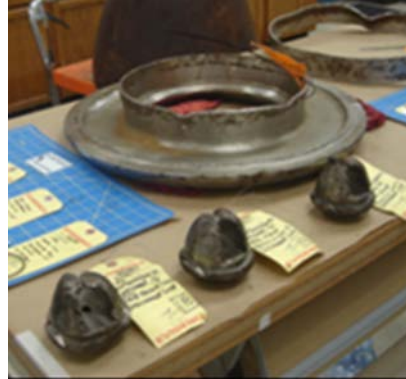
Figure 4 – Damaged Parts

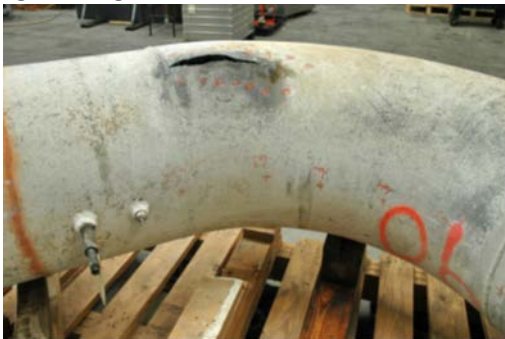
- The failure consisted of an approximately 14-inch-long longitudinal rupture at the 9-10 o'clock position of the elbow adjacent to the girth weld.
- Small oxide inclusions were present in the area of the failure and were deemed not enough to cause the failure, but they did contribute to the failure.
- Heat impingement in the area of inclusions caused the failure.
- Maximum line pressure at failure was 85 percent of MAOP.
- No measurable external and/or internal corrosion was observed on the pipe segment.
- The chemical composition and mechanical properties of the pipe base metal near the origin, but outside of the failed area, met typical requirements for line pipe steels of the era.
