DOT US Department of Transportation
PHMSA Pipelines and Hazardous Materials Safety Administration
OPS Office of Pipeline Safety
Southern Region

Principal Investigators Don Murphy, Derick Turner and Chris Taylor
Region Director Wayne T. Lemoi
Date of Report June 16, 2011
Subject Failure Investigation Report – Southern Natural Gas, 2nd North Main Pipeline, Louisville, MS

Failure Investigation Report – Southern Natural Gas 2nd North Main Pipeline

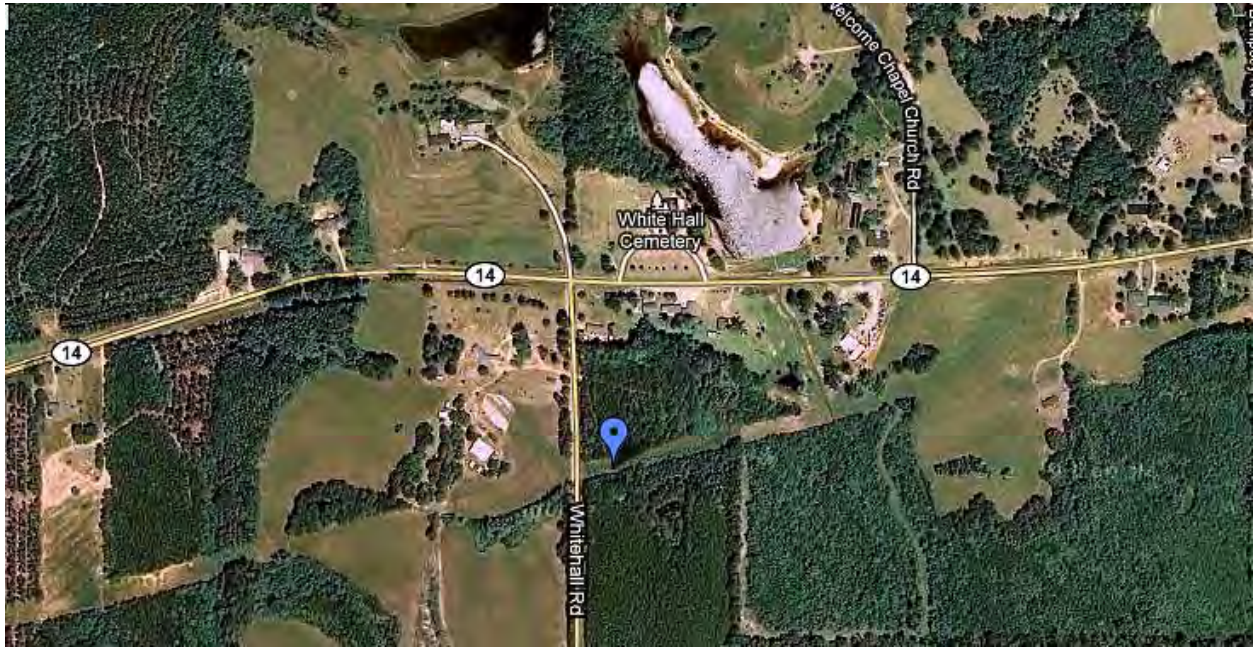
Aerial view of 2nd North Main Line rupture location

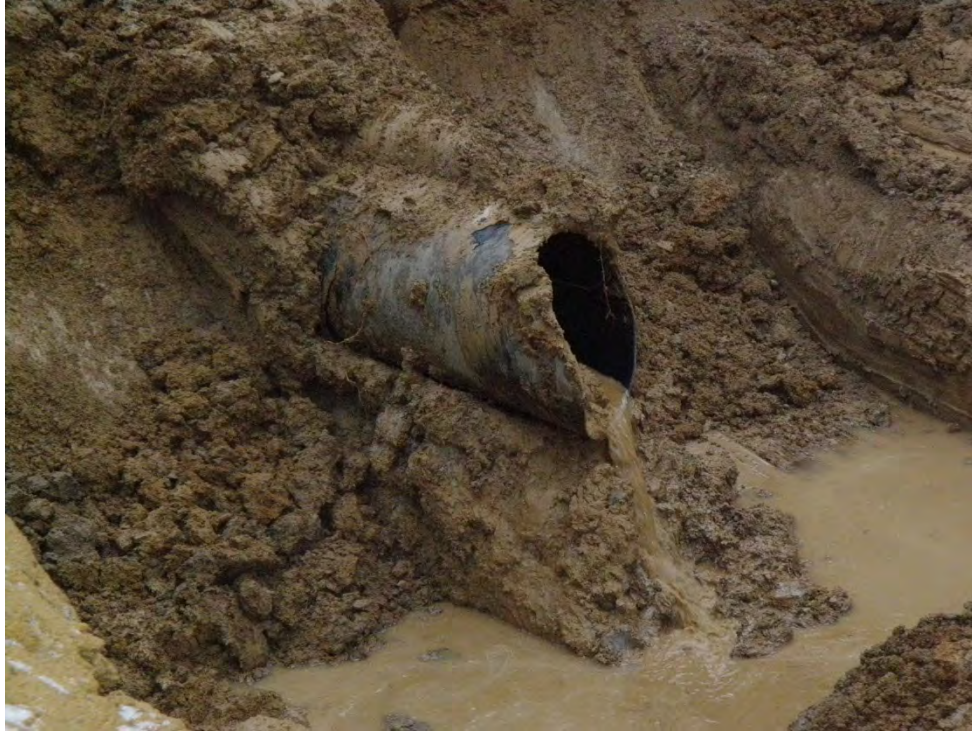
2nd North Main Line upstream terminus

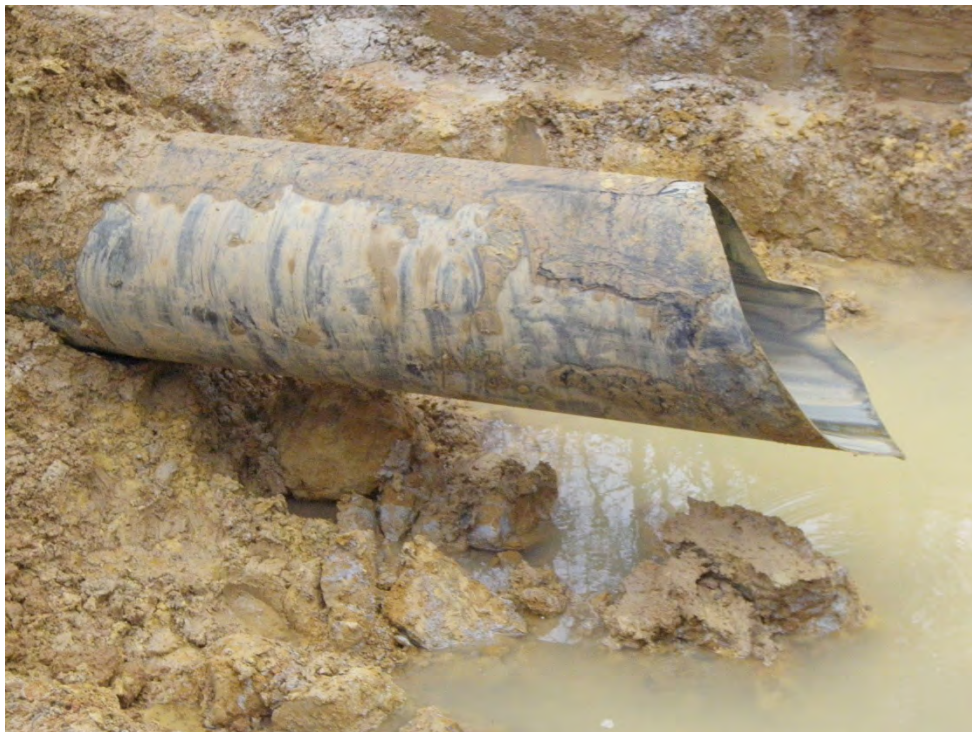
2nd North Main downstream terminus

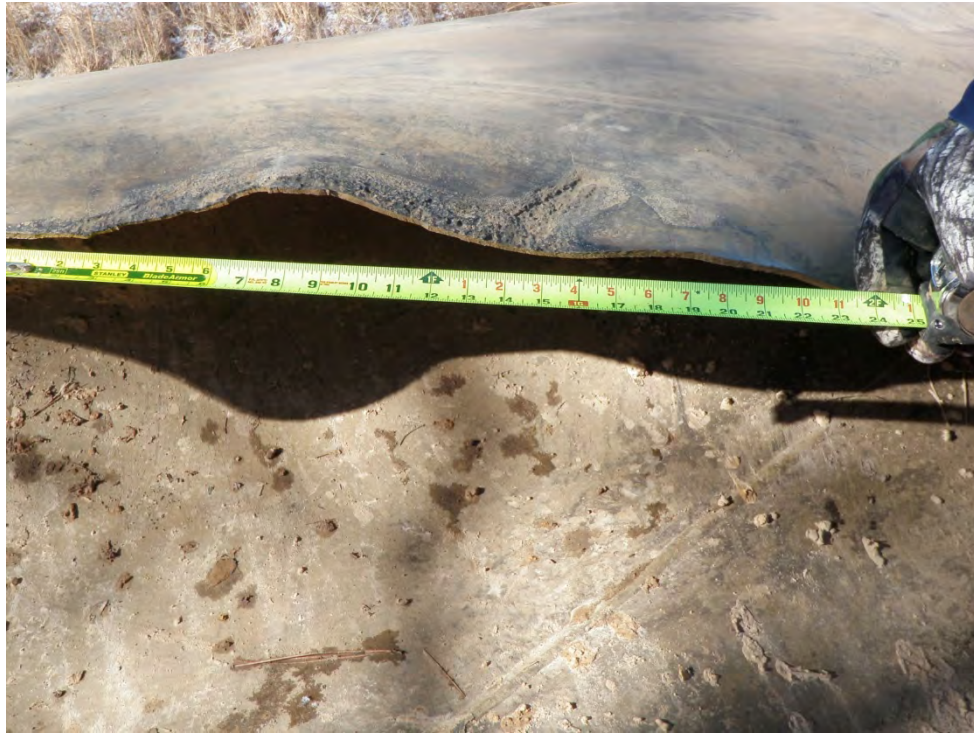
The 24-in 2nd North Main Line failure was caused by a cluster of external corrosion pits with subsequent near-neutral pH stress corrosion cracking (SCC) confined within a localized area of the most severe corrosion.

External corrosion initiated this failure and allowed electrochemical corrosion to reduce the pipe wall, increasing the localized stresses. This crossed the threshold for SCC to initiate and propagate until the remaining pipe wall could no longer support the operating pressure of 740 psig and ruptured.

Corrosion pitting in a section of expelled pipe

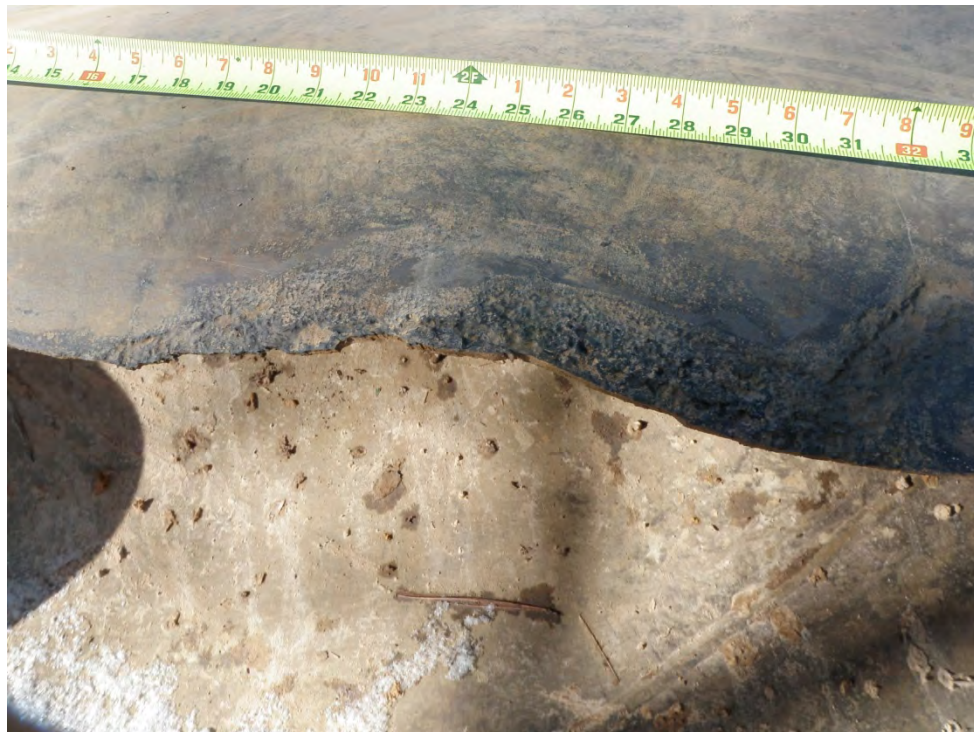
Corrosion pitting, same pipe section (zoomed-in)

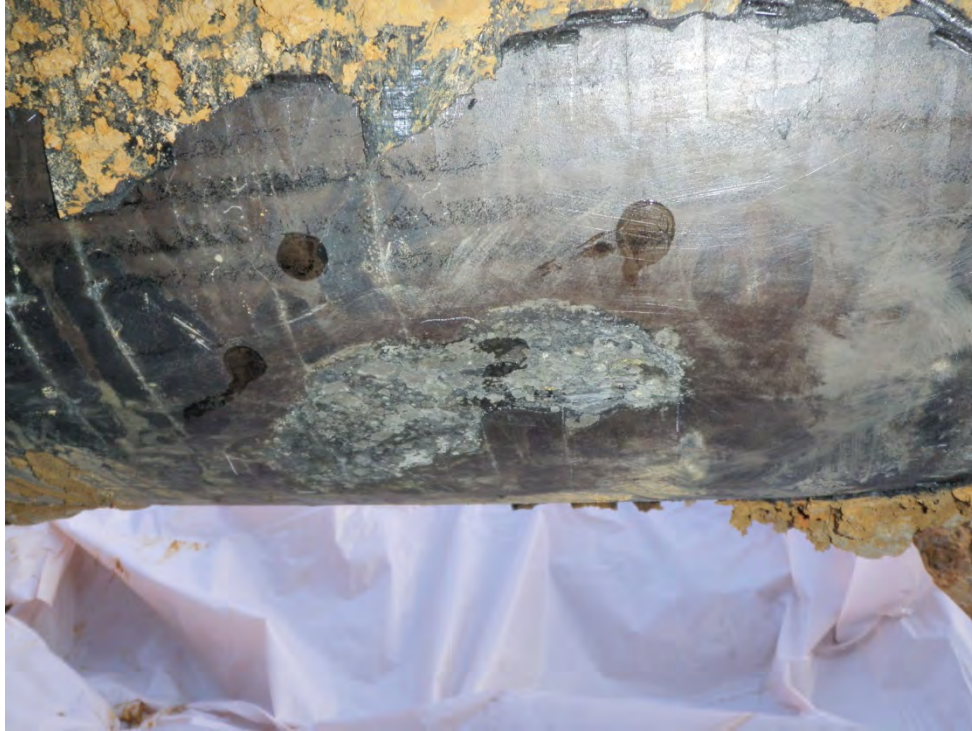
Anomaly discovered on remaining downstream pipe section

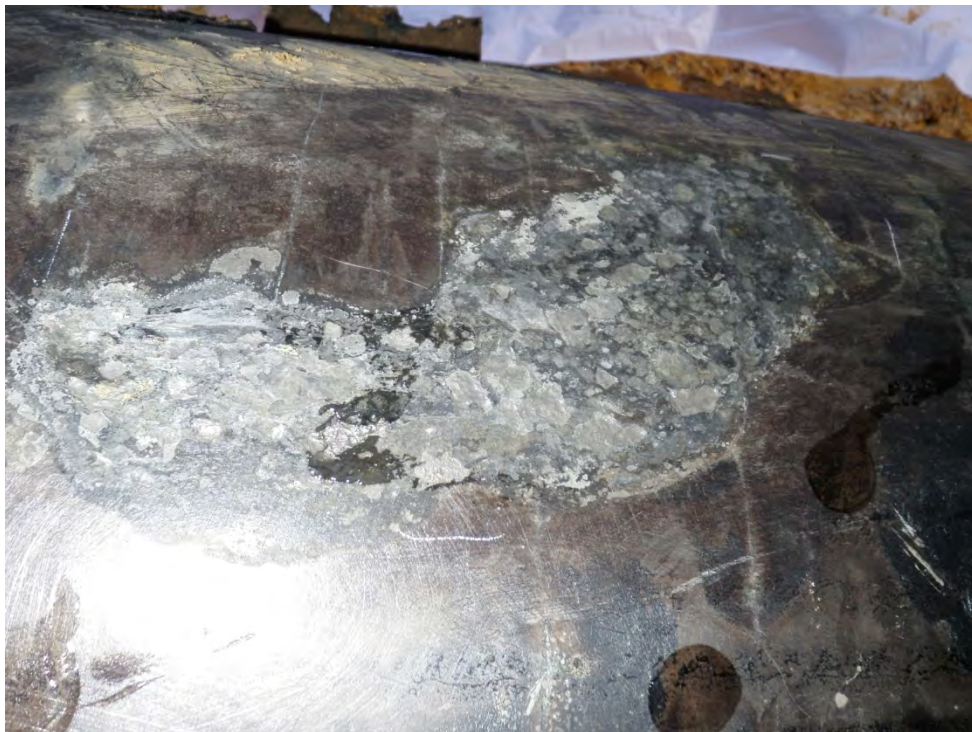
Same anomaly from above, zoomed in and rotated 180°

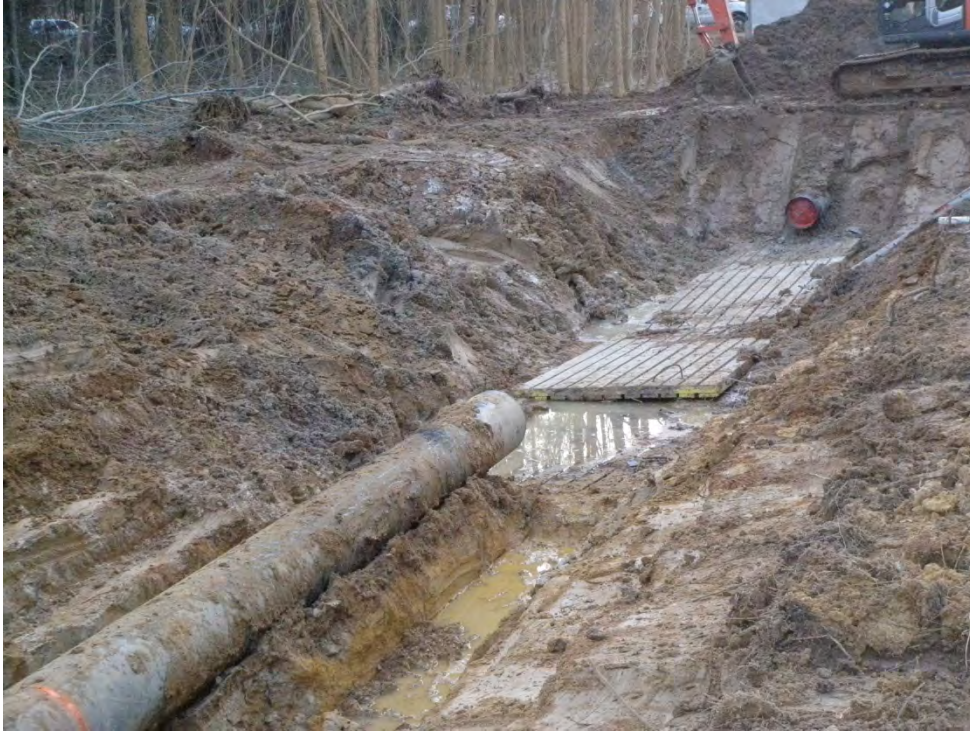
2nd North Main Line failure area getting prepared for repair

The rupture force expelled a total of 53 ft 4 in of pipe from the ground; SNG flame cut an additional 5 ft of pipe from both the upstream and downstream termini which was used for metallurgical sampling for a total of 63 ft 4 in. The complete repair required SNG to replace 100 feet of pipe. The replacement pipe specifications are as follows:

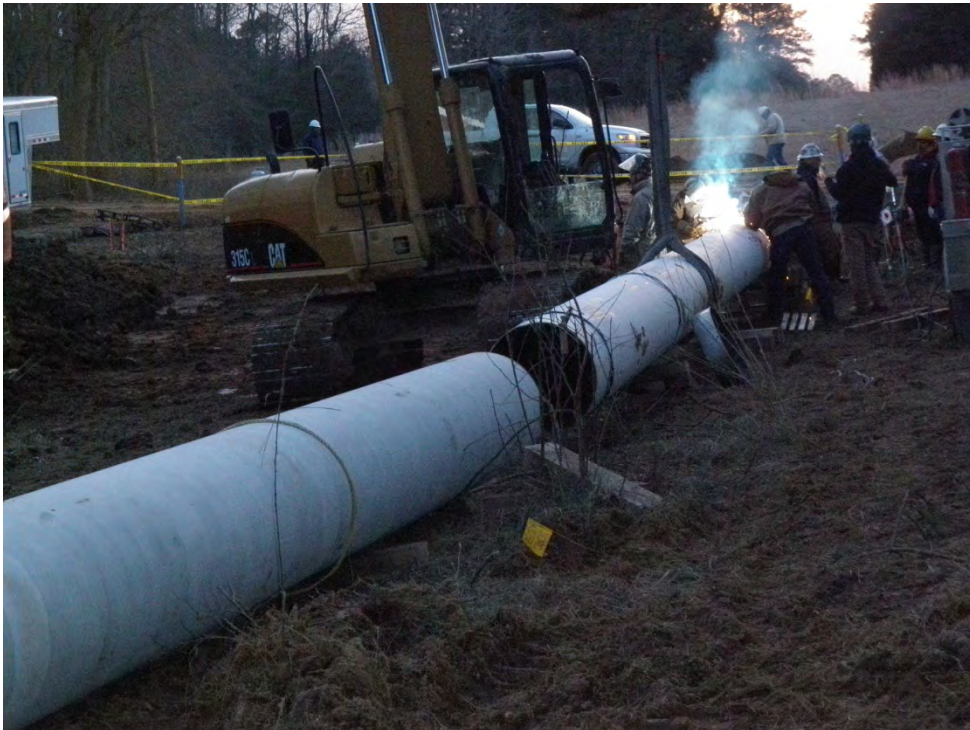
Welding of new replacement pipe
