DOT US Department of Transportation
PHMSA Pipelines and Hazardous Materials Safety Administration
OPS Office of Pipeline Safety
Southern Region

Principal Investigators Gabriel Kotsis and Chris Taylor
Region Director Wayne T. Lemoi
Date of Report April 21, 2011
Subject Failure Investigation Report – Southern Natural Gas Wrinkle Bend Failure

Failure Investigation Report – Southern Natural Gas, Wrinkle Bend Failure

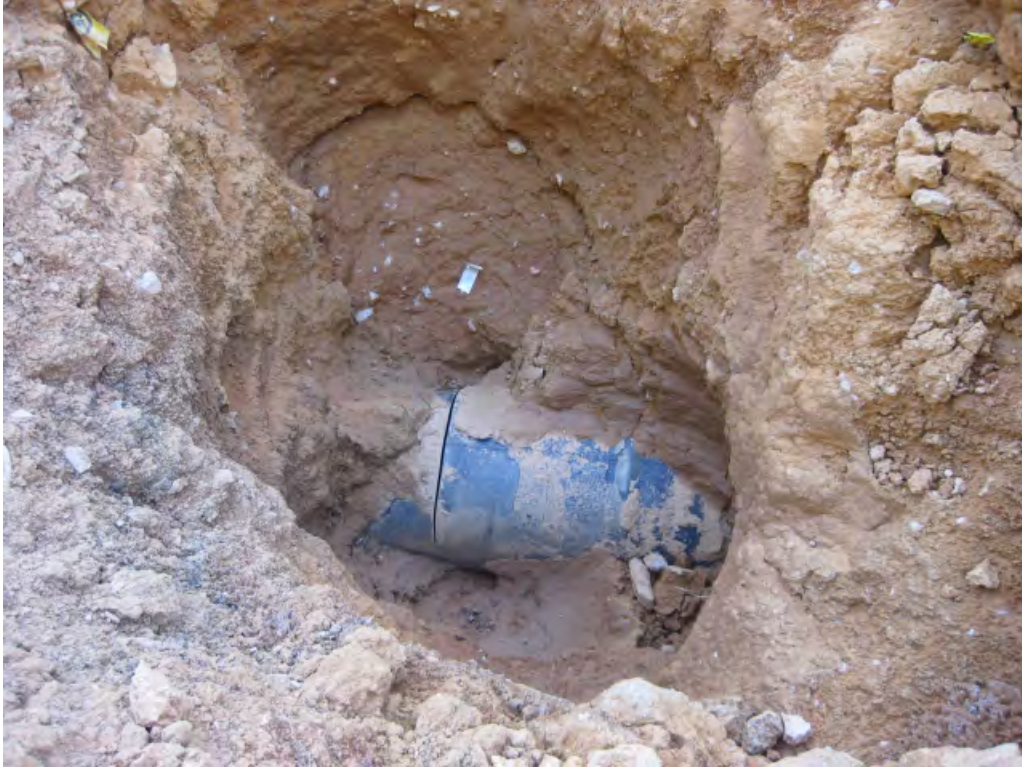
- During the field portion of this incident investigation, PHMSA investigators and SNG personnel observed a circumferential split along a wrinkle bend in the 24-inch North Main Loop pipe at the location of the failure. The split appeared to run from the 9 o'clock to 3 o'clock position around the pipe. The pipe's DSAW longitudinal seam (long seam) appeared to be near the center of the wrinkle bend.
- As SNG crews completed the initial cut to remove the failed pipe section, the failed section shifted (sprang) upward. The centerline of the pipe was offset by about 1½ inches from the centerline of the un-deflected pipe, indicating the pipeline had been subject to external forces that may have contributed to the failure (Appendix A).

24-in North Main Loop Failed Wrinkle, MP 399.642. One of four wrinkles in underbend configuration.

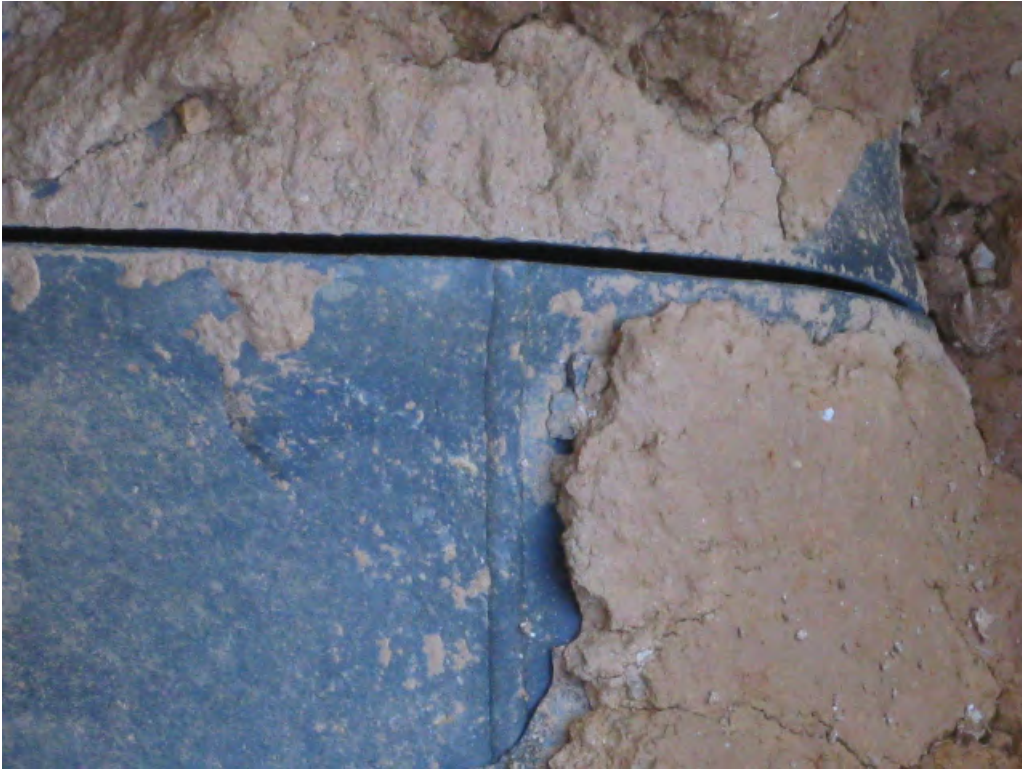
- 1) Stresses due to the wrinkle bend containing the pipe longitudinal seam.
El Paso's Metallurgy Laboratory examined the failed pipe's longitudinal seam and determined the fracture started on (or near) the inner pipe diameter surface in the center of the long seam. The metallurgical testing determined the long seam welds were more brittle than the base metal and the yield strength was considerably higher (72,600 psig for long seam vs. 56,200 psig for base metal). El Paso also conducted micro-hardness evaluations on the base metal outside of any wrinkled areas as well as from the wrinkle bend decay to the fracture surface. The hardness values were highest in the wrinkle bends due to slight strain hardening that occurred during bending.

Pipe's DSAW longitudinal seam is perpendicular and roughly centered in failed wrinkle bend.

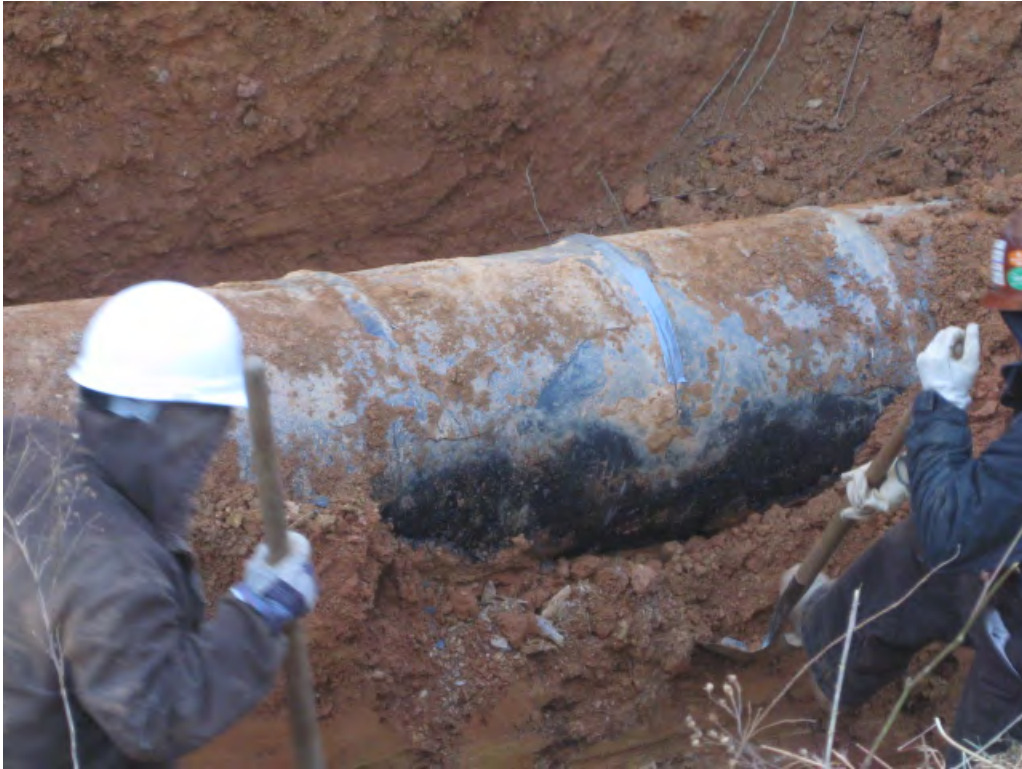
While excavating the pipeline to expose and remove the failed wrinkle bend section, SNG crews discovered two additional overbend configurations, from the original construction, that used the wrinkle bend method to create the bend radii (Appendix A). SNG removed these bends as well as the failed bend for a total of 21 wrinkles removed.

Additional wrinkles used to create the underbend configuration during original construction

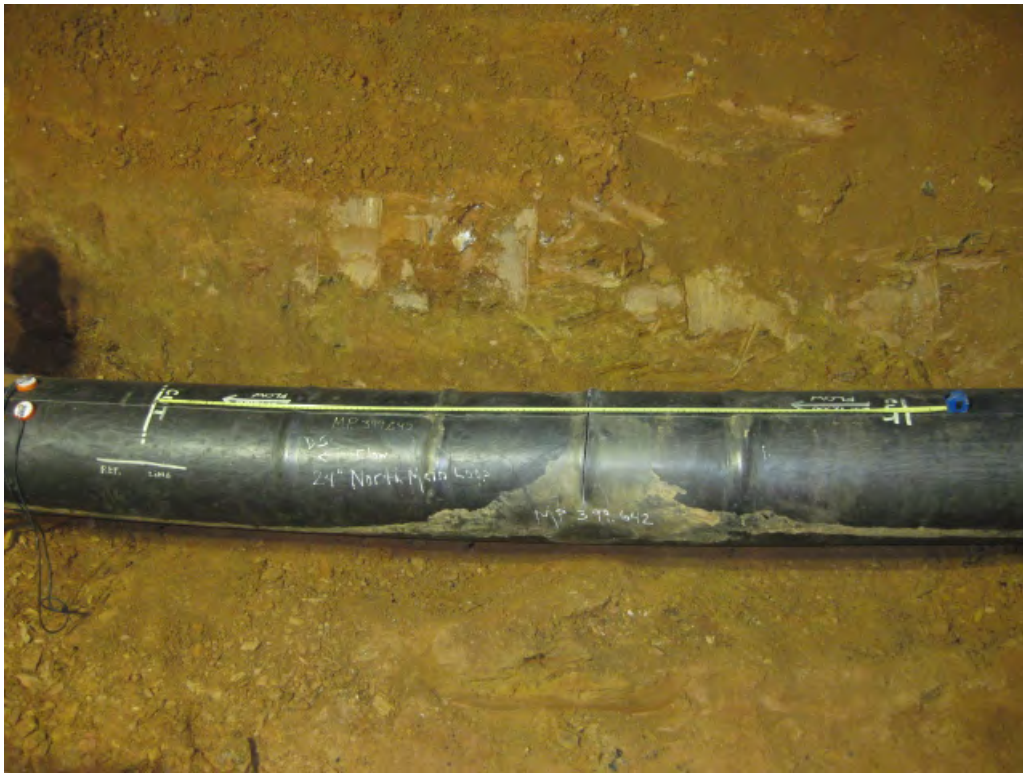
The rupture occurred due to a failed wrinkle bend in the 24-inch pipe. The failed pipeline section had four wrinkles in an under bend (sag) configuration with the pipe's longitudinal seam near the center of the wrinkles. The pipeline right-of-way in the failure area consisted of rolling hills in both the upstream and downstream directions.

Four-wrinkle underbend section with coating removed. The second downstream wrinkle is where the pipe rupture occurred (pipeline natural gas flow was from right to left).
Observe the cut and reference lines downstream of last wrinkle (importance next photo)

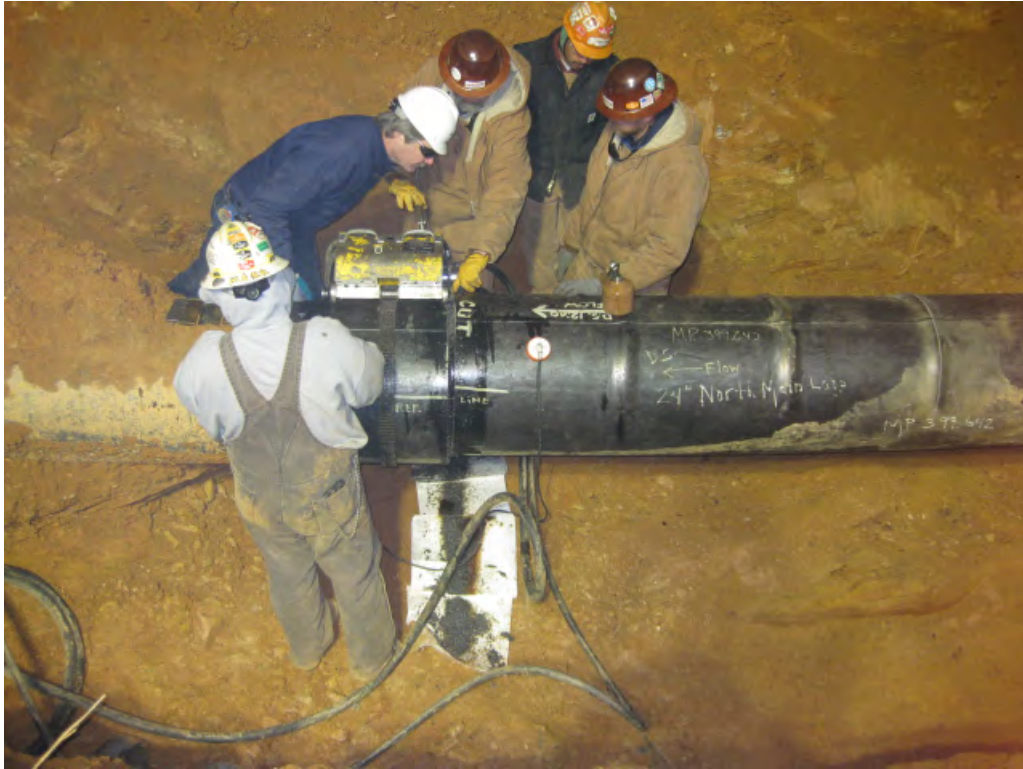
Cut pipe shifted off the reference line indicating external load(s) on pipe

According to representatives of El Paso Pipeline Group, when the North Main Loop pipeline was cut to remove the damaged section, the ends shifted until the pipe on the western side of the cut was about 1.5 inches higher than the pipe on the eastern side of the cut. This indicates uneven loads or stresses placed on the pipeline by movement of water and silty clay in the zone around and immediately above the pipe in this area.

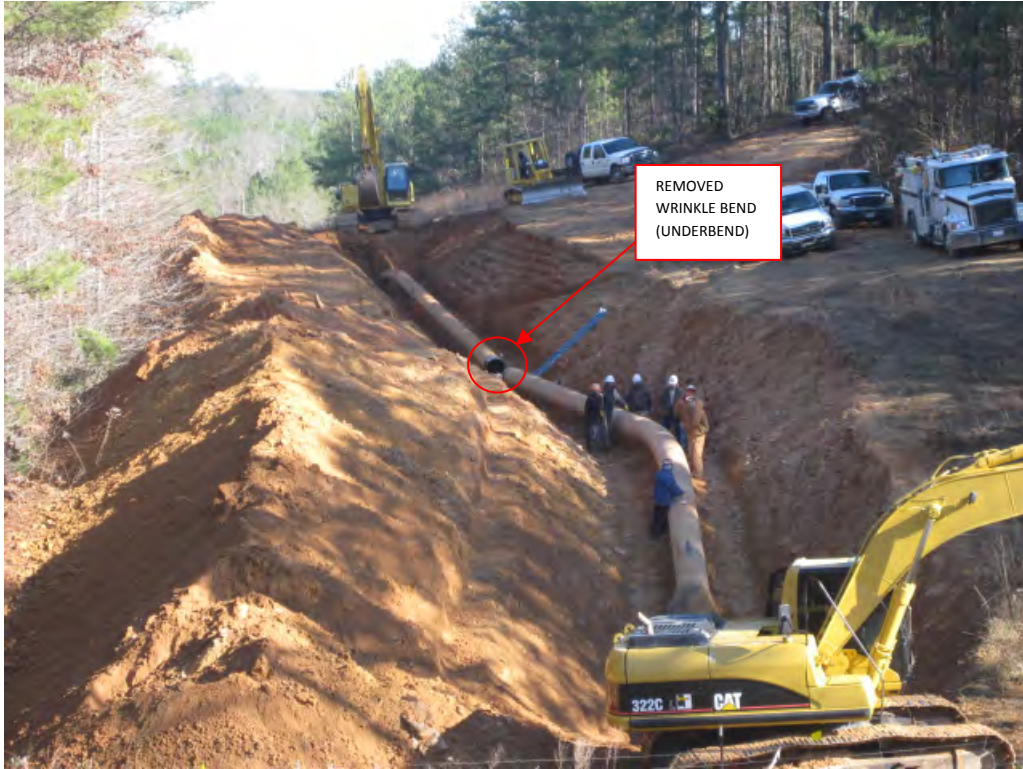
Additional pipe bends uncovered, upstream and downstream of removed failed section

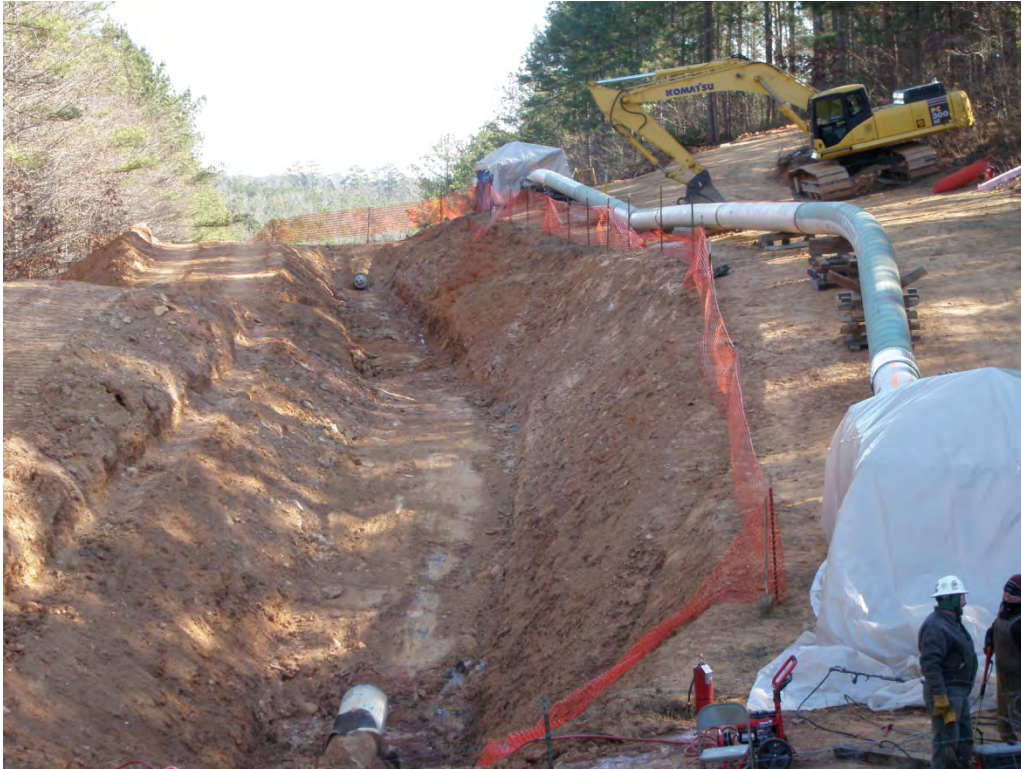
Replacement pipe hydrostatically pressure tested above the ditch as one unit

SNG replaced the removed bends with 240 feet (six joints) of pre-tested and pre-bent pipe and used radiography (X-rays) to non-destructively inspect each of the girth welds connecting the six new pipe joints. PHMSA requested an additional 4-hour above the ditch hydrostatic pressure test to assure the integrity of the girth welds for the replacement pipe. On January 6, 2010, SNG successfully hydrotested the pipe; the tie-in welds and subsequent X-rays were completed the same day.

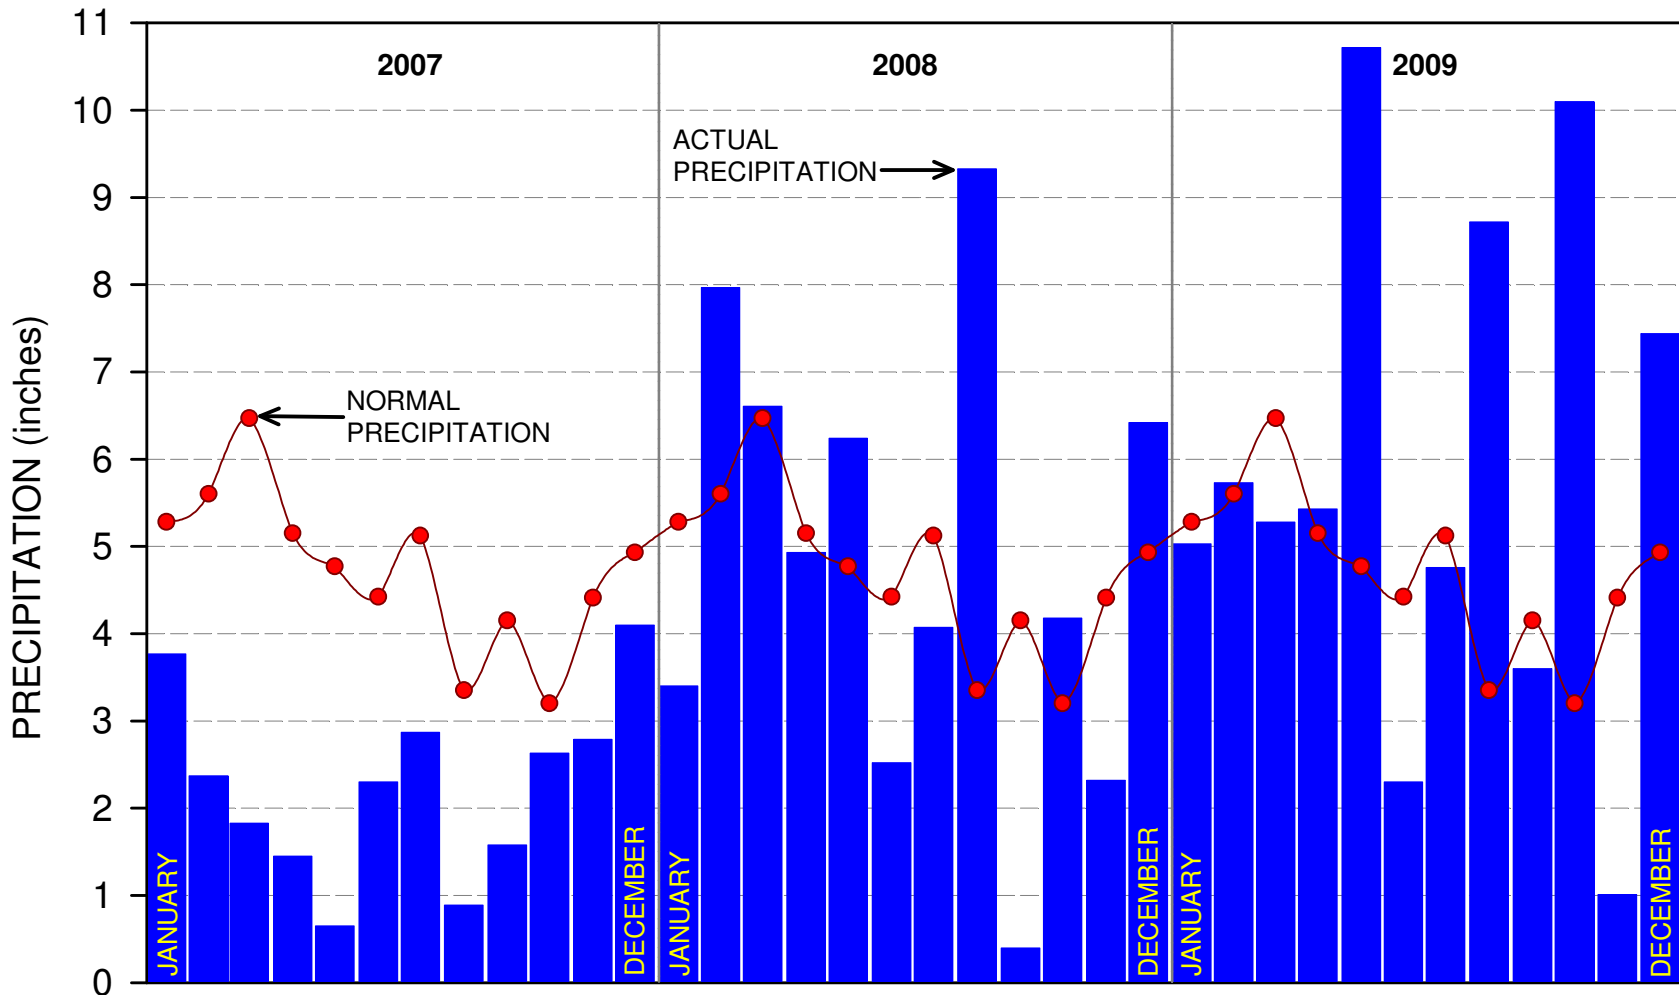
FIGURE 3. MONTHLY PRECIPITATION AT HEFLIN, ALABAMA (JANUARY 2007 - DECEMBER 2009)

Additionally, the geologists noted the actual rainfall totals for Cleburne County in calendar year 2009 exceeded the normal rainfall estimates by approximately 19%, however, the actual rainfalls in October and December 2009 exceeded the normal rainfall estimates by approximately 207% and 50%, respectively.

Precipitation in northeastern Alabama is typically lowest in September and October, increases in November and December, and is highest in January through April, during the winter and spring rains. For the last three years, precipitation totals in southern Cleburne County, Alabama, have ranged from exceptional drought conditions (National Drought Mitigation Center, 2010) recorded in late 2007 to above-normal rainfall recorded in 2009, immediately before the pipeline failure. Monthly precipitation totals from January 2007 through December 2009 are provided in Figure 3, and annual totals and departures from normal for 2007 through 2009 for this station are provided in Table 1.

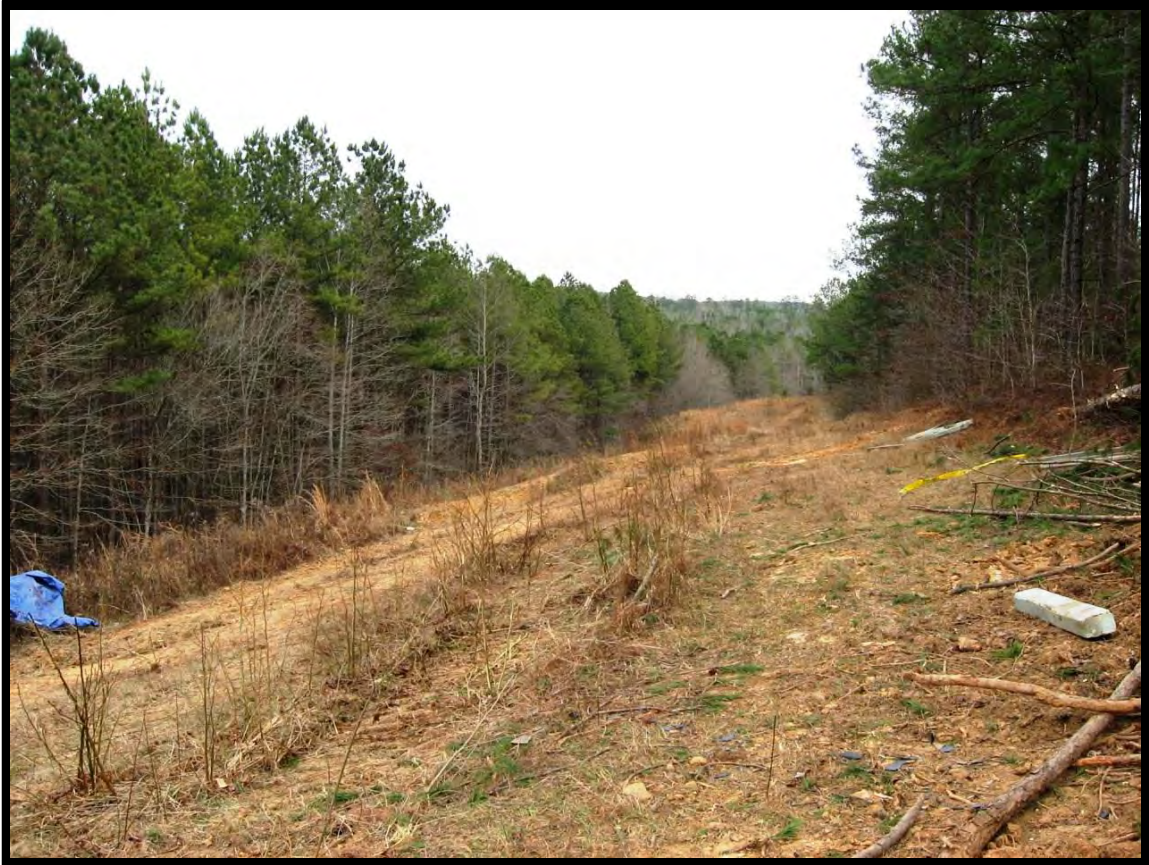
PHOTOGRAPH 1. PIPELINE RIGHT-OF-WAY EAST OF RUPTURE (VIEW IS TOWARD EAST)

The pipeline failure occurred on the north slope of a hill (Photograph 1), within a minor topographic low (Photograph 2) and change of slope. Examination on January 4, 2010, indicated the presence of a surface water drainage feature that extended northward from the pipeline right-of-way at the failure point. Surface water was directed from this area toward the north into a small stream that flowed eastward, downslope from a pond (Photograph 3). The pond was about 200 feet long by 100 feet wide, and approximately 300 feet northwest of the location of the pipeline failure.

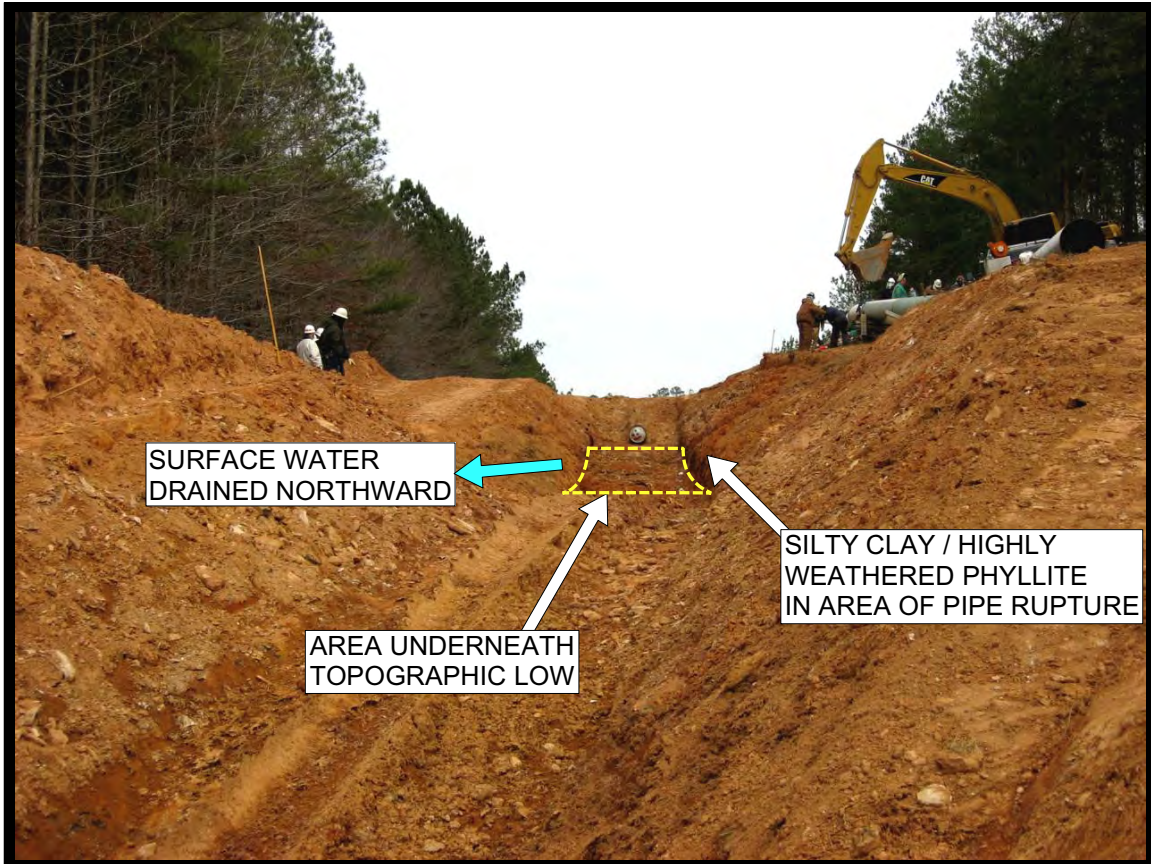
PHOTOGRAPH 2. AREA OF PIPE FAILURE (VIEW IS TOWARD EAST)

very fine- to fine-grained, angular, poorly sorted quartz. The clay was saturated with water in the topographically low area, near the pipeline leak. This section, near the leak, appeared to have been wet more often than the surrounding area.

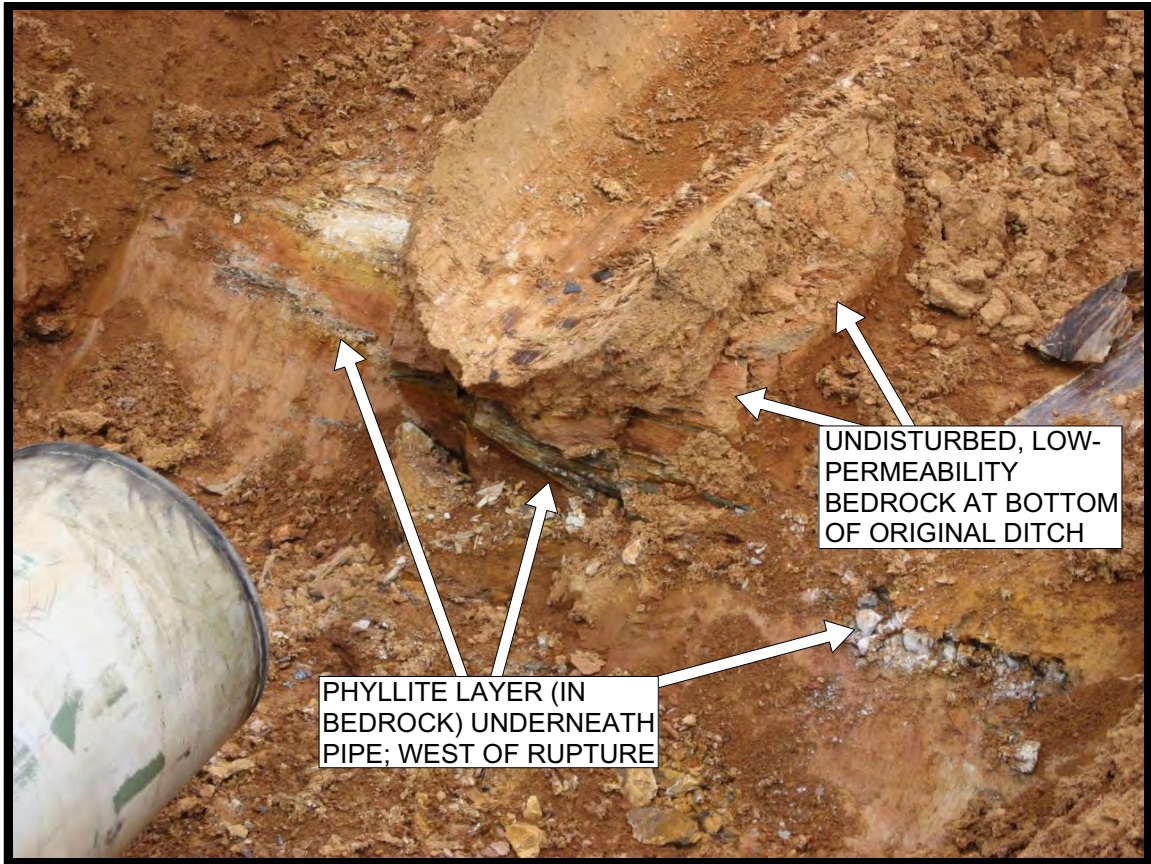
PHOTOGRAPH 4. BEDROCK UNDERNEATH PIPE (VIEW IS TOWARD NORTHEAST)

Visual observations of the rock at the bottom of the ditch near milepost 399.642 on January 4 and 6, 2010, indicated a relatively unfractured, slightly weathered phyllite and undisturbed clay of low permeability (Photograph 4). The moisture observed in the dark, silty clay in the sides of the ditch on January 4, 2010, was in the zone above this slightly weathered phyllite, indicating that the phyllite at the bottom of the ditch probably
