DOT US Department of Transportation
PHMSA Pipeline and Hazardous Materials Safety Administration
OPS Office of Pipeline Safety
Southwest Region

Date of Report 7/31/2011
Subject Failure Investigation Report – Tennessee Gas Pipeline Co. - Internal Corrosion

Failure Investigation Report – Tennessee Gas Pipeline Co. - Internal Corrosion
Failure Date 12/08/2010

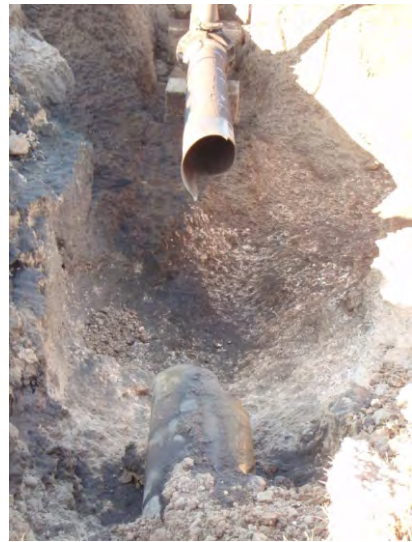
Figure 2 Failure section

The PHMSA Investigator was able to view the site with the operator. The failure was a full guillotine failure of the pipeline. Photos of the failed section can be seen in Appendix D.

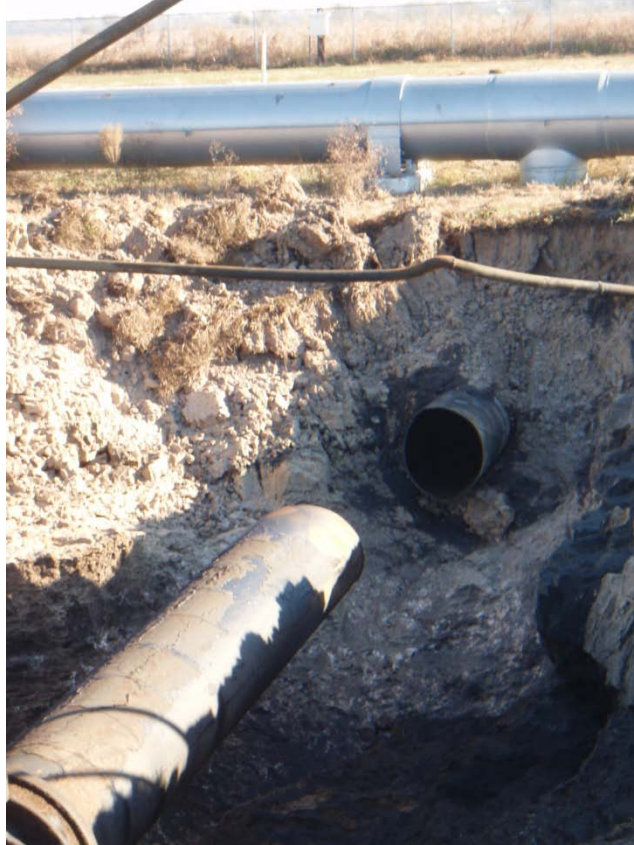
Figure D1 - Rupture Location

The failure initiated from a section of dead leg piping established in 2000 when a 24" lateral was disconnected from the stations downstream header. There were obvious indications of residual moisture gathering in the dead leg, contributing to internal corrosion and a thinning of the pipe wall. The internal corrosion was caused by microbiological organisms present due to free moisture in the pipe. Evaluation of all other dead leg segments of pipe in the Station yard found no additional areas affected.

The operator removed the tee fitting from the header and all piping associated with this dead leg before returning the system to operations.

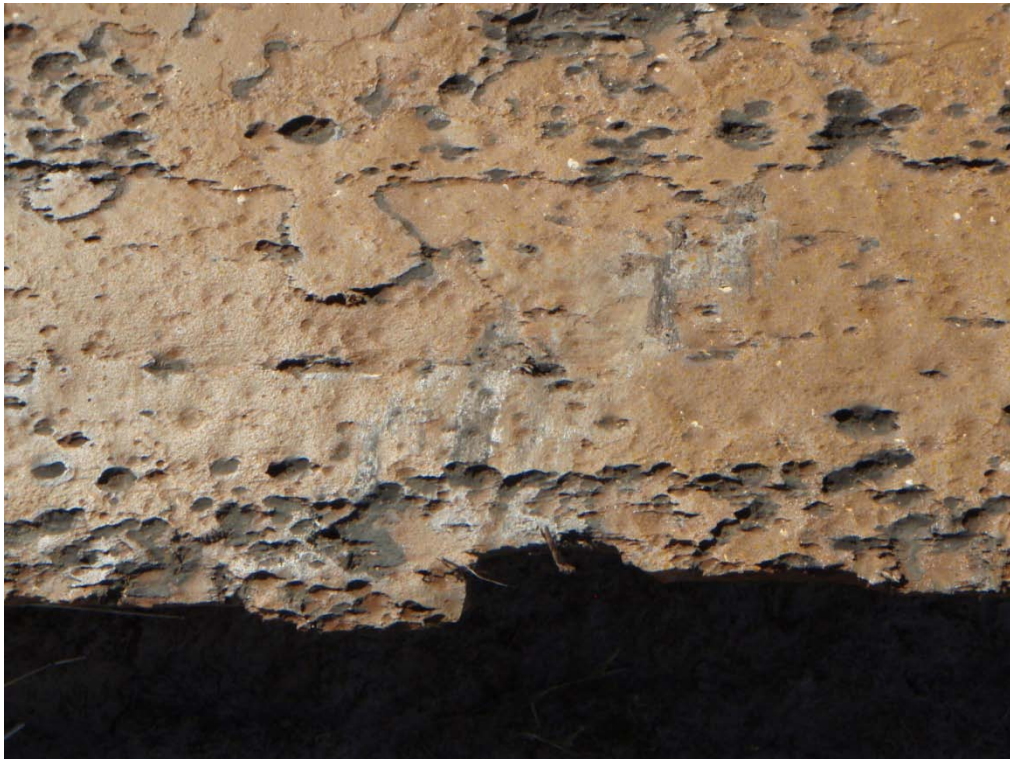
Figure D4 – Internal surface of pipe

- The failure mechanism that led to the pipeline rupture was identified as internal microbiologically induced corrosion (MIC).
- The severity of the wall loss was greatest in the area which contained the failure origin. A maximum pit depth through the origin measured 0.418 inches which correlates to an 83.6% wall loss based on nominal wall thickness.
- Tensile test, hardness test, chemical analysis, and charpy test results were all typical for pipe of that era. No abnormalities found.

The corrosion integrity analysis performed indicated that the internal corrosion, at its current state, was severe enough to have caused the pipeline to fail at normal operating pressures experienced by Station 17. The complete report is included in Appendix E.
