**REPORT TO BOARD OF DIRECTORS OF
GENERAL MOTORS COMPANY
REGARDING IGNITION SWITCH RECALLS**

May 29, 2014

Anton R. Valukas

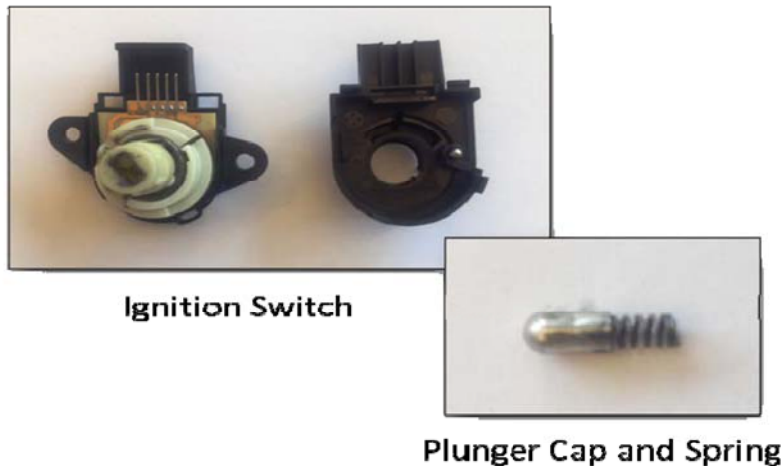
Components within the Ignition Switch control the amount of effort required to turn the switch from one position to another. A plunger cap and coiled spring inside the Ignition Switch sit in a small groove called a “detent,” which holds the switch in the position to which the driver turns the key: Off, Run, Accessory, or Crank. The driver rotates the key by applying a certain amount of torque to overcome the detent, thereby rotating the switch out of one position and into another. One method to increase the effort required to rotate the Ignition Switch from one position to another is to use a longer and more tightly coiled spring.

Put simply, the Ignition Switch failed to stay in the Run position when it should have stayed in the Run position. The amount of effort required to rotate the Ignition Switch was too low, permitting it to move under certain circumstances from the Run position to the Accessory or Off position, when it was not the driver's intention to do so. As described above, the torque performance of the Ignition Switch was the result of the plunger and spring interacting with the

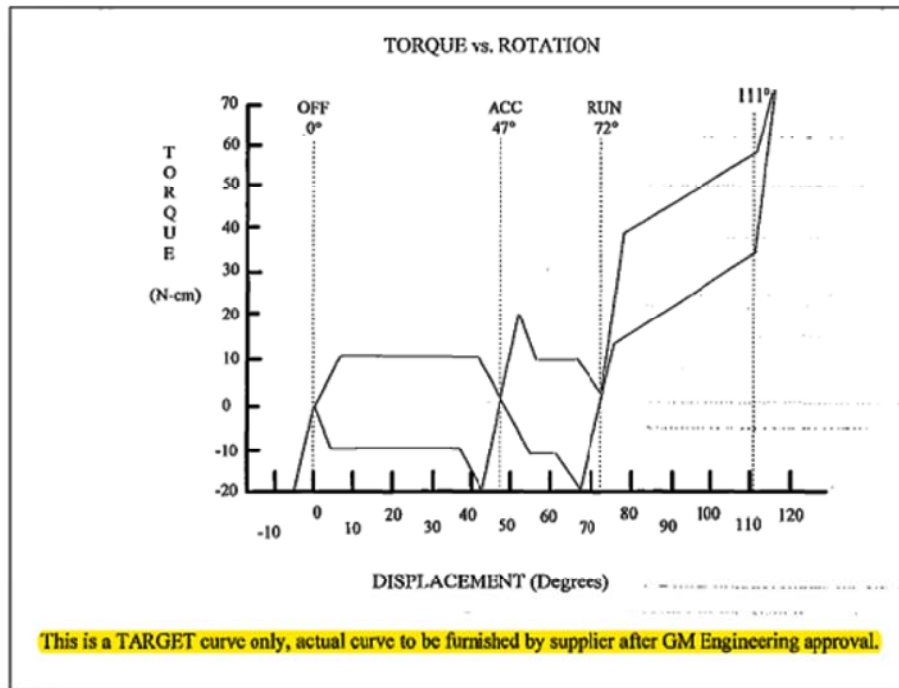
cm”) as the torque needed to turn the ignition from Run to Accessory.¹¹⁰ As noted below, the target curve indicated that the “actual curve [was] to be furnished by [the] supplier after GM Engineering approval.”¹¹¹

Section 3.2.2.3 described the desired feel of the switch – “smooth, with clearly defined detents” – and also provided that “[f]inal switch tactile feel is subject to GM Engineering approval.”¹¹² The Specification was revised in 1998 and 1999, without changes to the parameters for the torque required to rotate from Run to Accessory.¹¹³

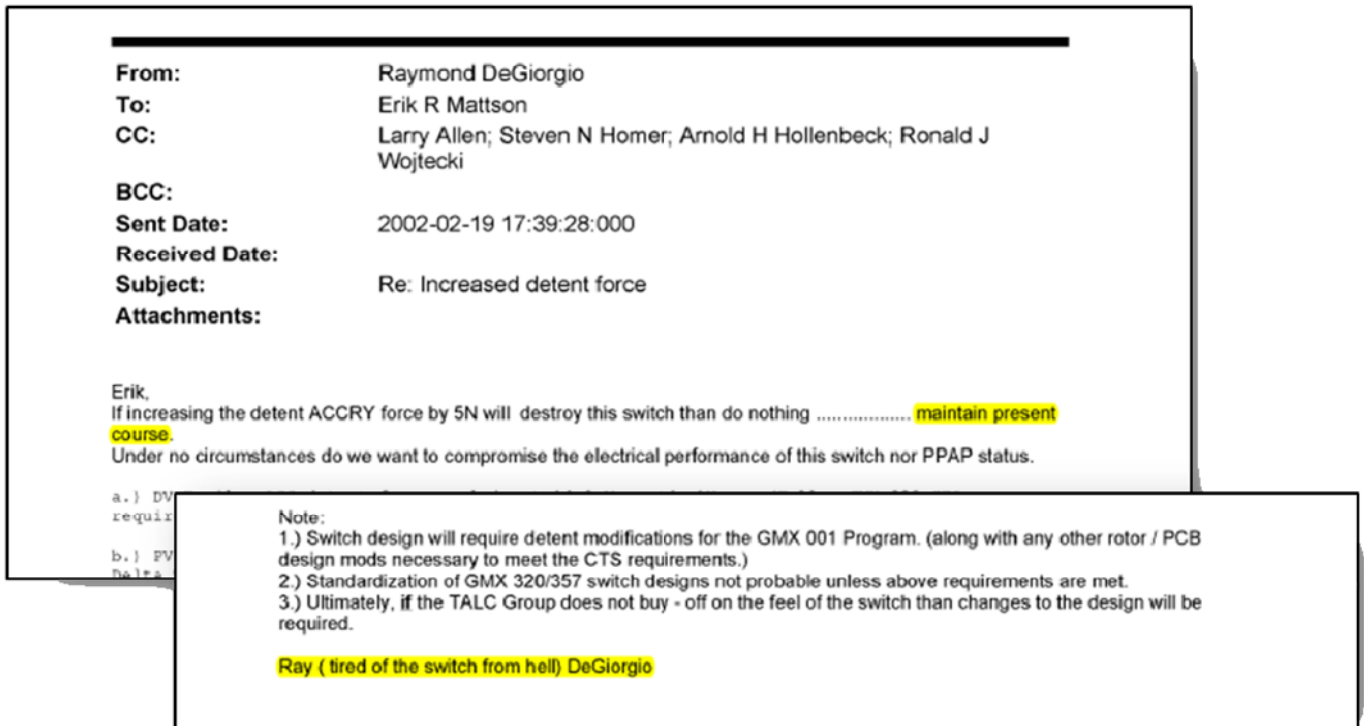
Program.”¹⁷⁰ Thus, despite knowing the torque values were well below the Specification, DeGiorgio instructed Delphi to take no action to increase the rotational torque out of concern that changing the detent would compromise the electrical performance of the switch; at the same time, he notified Delphi that detent modifications would be required to increase torque in accordance with the Specification before the switch (currently planned for the Ion) could be used in the Cobalt, scheduled for launch in 2004.¹⁷¹ DeGiorgio signed his response, “Ray (tired of the switch from hell) DeGiorgio.”¹⁷²

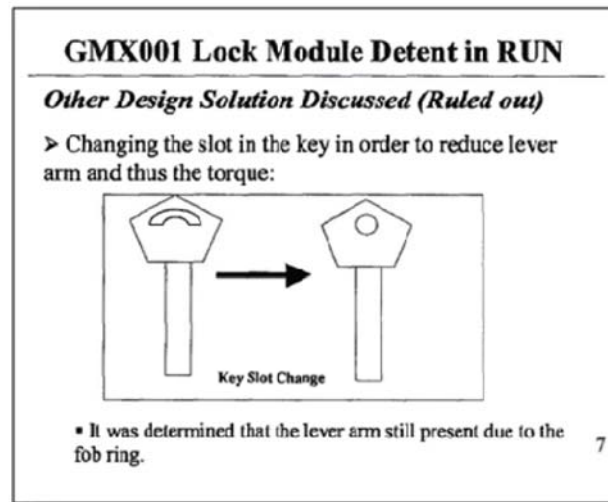
The presentation also included some “Ruled Out” solutions, including changing the design of the key head from a slot to a hole – a solution GM personnel ultimately pursued. With a slot design, the key ring could move up and down in the slot. If the key ring contained extra weight, that movement could exert torque on the Ignition Switch and, combined with other circumstances, move it from Run to Accessory. Keeping the key ring in the center of the key (through a hole design) would prevent such movements.²⁶¹ The estimated cost to make the key change was \$70,000 for tooling for a new key head, \$400,000 to modify production assembly equipment, and a piece price increase of \$0.50 per vehicle.²⁶²

The presentation to the CPIT also described a “Sure Solution” to fix the problem: change the location of the Ignition Switch on the steering column from a low-mount to a higher mount.²⁶³ According to David Trush, the Lead Design Engineer on the ignition cylinder, the

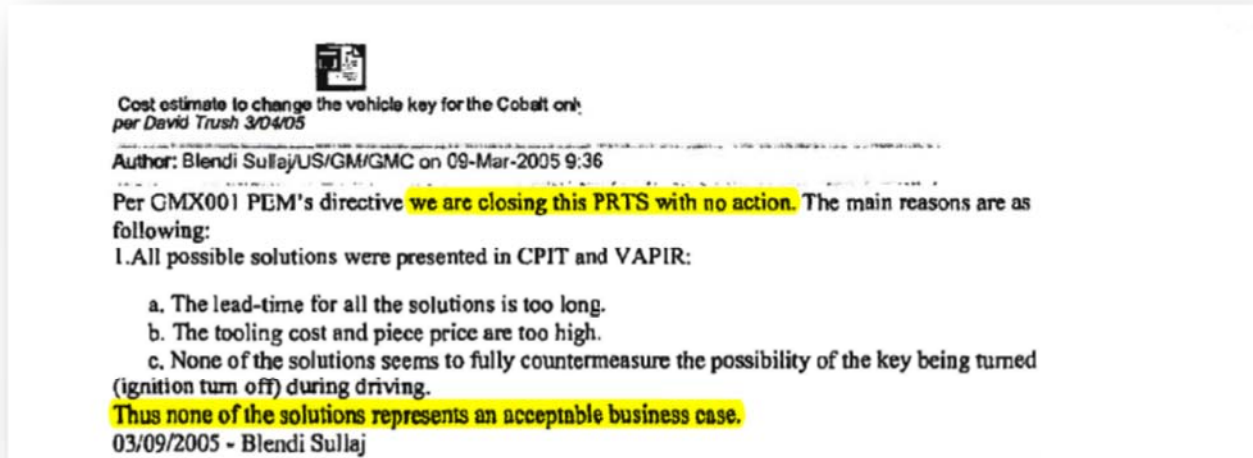
As shown above, the November 19, 2004 PRTS stated that “none of the solutions represents an acceptable business case” – a standard phrase used by GM personnel for closing a PRTS without action.²⁷¹ David Trush, the lead engineer on the ignition cylinder, explained that to present an “acceptable business case,” a solution should solve the issue, be cost effective, and have an acceptable lead time to implement the change.²⁷² In this case, according to Trush, the proposed changes were not implemented because none of them was guaranteed to resolve the problem completely.²⁷³ Lori Queen confirmed that a discretionary, or non-safety related, part change had to clear a series of financial hurdles before it would be approved.²⁷⁴ Engineers who proposed a discretionary change had to make out an “acceptable business case” before the

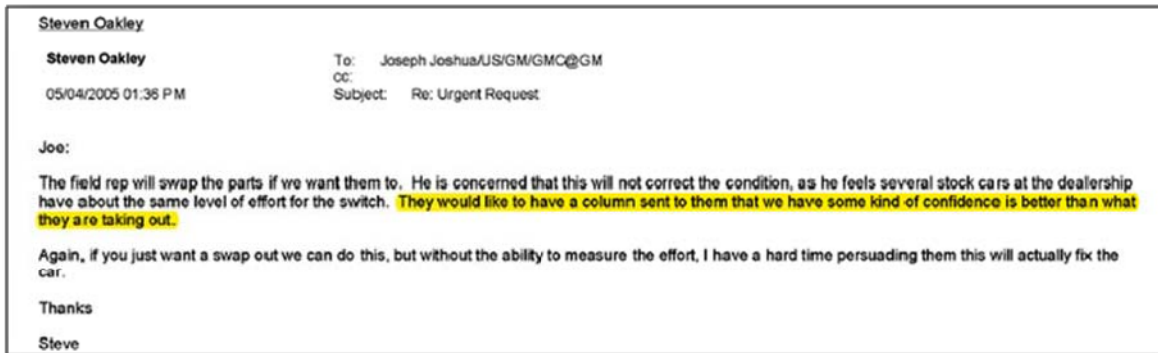
The field rep will swap the parts if we want them to. He is concerned that this will not correct the condition, as he feels several stock cars at the dealership have about the same level of effort for the switch. They would like to have a column sent to them that we have some kind of confidence is better than what they are taking out. Again, if you just want a swap out we can do this, but without the ability to measure the effort, I have a hard time persuading them this will actually fix the car.³¹¹

DeGiorgio was one of the GM personnel who received this e-mail chain, which effectively stated that the customer’s car, as well as others at the dealership, had Ignition Switches with insufficient torque and, at least in the customer’s situation, appeared to cause the car to shut off while driving.³¹² For his part, DeGiorgio claims not to recall the e-mail exchange. DeGiorgio also claims that at this time he still had not received any complaints about the Ignition Switch in the Ion, which had the same Ignition Switch and had been in production since MY
