NCHRP Report 350 Test Report Compilation

Full-Scale Crash Evaluations of the ET Plus[®] End Terminal with 4-inch Wide Guide Channel Installed with a Rail Height of 31 Inches

Test Level 3, Test 3-33, 3-31, 3-32, and 3-30

SwRI[®] Project No. 18.20887

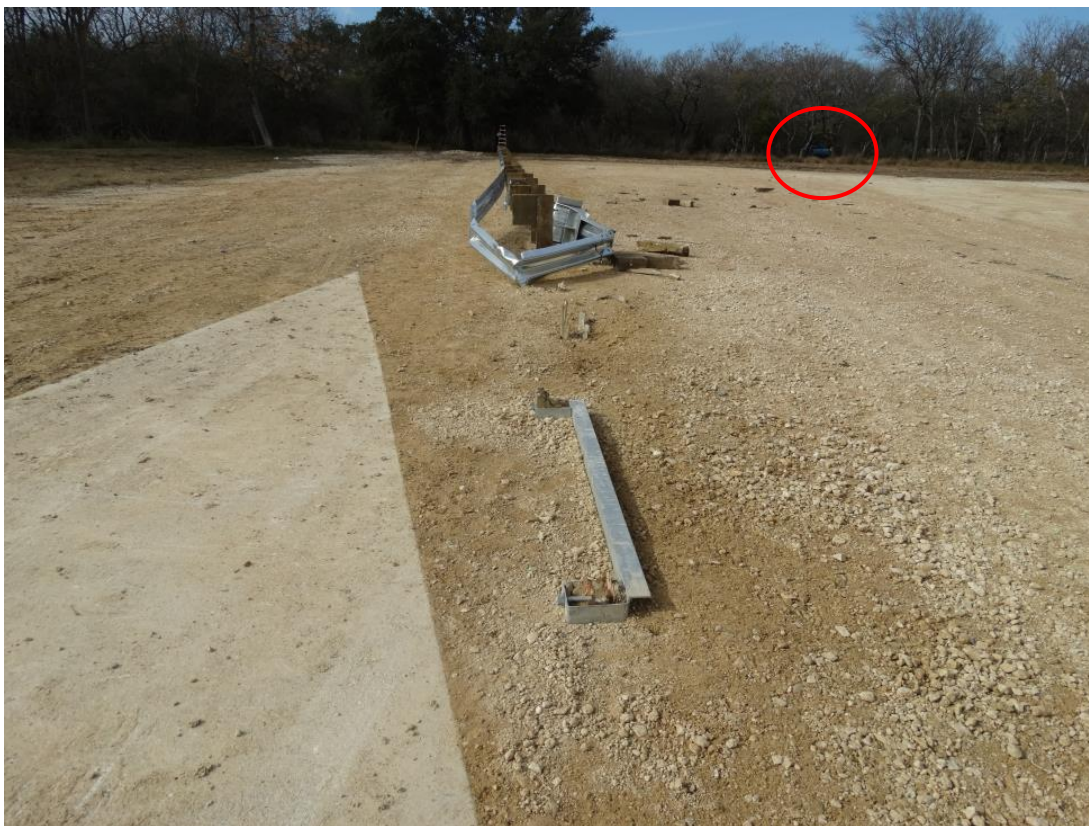
Figure 3.2 is an overhead photograph showing the post-test condition and location of the test article and test vehicle. Figure 3.3 through Figure 3.5 show that the test vehicle impacted the end terminal at a nominal 15° angle. The impact velocity of the test as measured by SwRI's speed trap system and verified by high-speed film analysis was determined to be 93.0 km/hr (57.8 mph); this speed is 3 km/hr (1.9 mph) below the 100±4 km/hr (62.1±2.5 mph) target speed specified in Report 350. As a result of the test, the ET Plus extruder head moved 9.1 m (30.0 ft) longitudinally (downstream) and 1.1 m (3.7 ft) laterally as measured from its as-installed position. The total system deformation (i.e. longitudinal distance to closest point) measured after the impact was 6.25 m (20.5 ft) from the initial point of contact.

After the initial impact event, the ET Plus extruder head stroked along the guardrail, extruding approximately 2.9 m (9.5 ft) of guardrail. Before the guide channel entrance end of the head reached Post 2 the head began to rotate, following the angled path of the vehicle; this rotation caused a fold to form in the W beam at Post 3. As the vehicle continued its angled trajectory, the channel guide portion of the ET Plus extruder head was pushed further on the W beam up to Post 3; the extruder head had rotated approximately 45° when the channel guide entrance reached Post 3. As the vehicle continued forward the head continued to rotate, allowing the vehicle to pass (or gate) through to the non-traffic side of the system. The ET Plus extruder head gated before any rail splices extruded through the head, and ended up roughly parallel to the guardrail and facing in the downstream direction.

The ET Plus extruder head directly contacted and sheared-off Posts 1 and 2. As the guardrail gated at Post 3, the motion sheared Posts 3 and 4 at ground-level. The splice at Post 3 remained intact but disconnected from the post. The W beam released from the post bolts at Posts 5, 6, 7, 8, and 9, although all posts and blockouts downstream of Post 4 appeared undamaged. There was no appreciable movement of the downstream anchor terminal observed. Additionally, the anchor cable at Post 1 broke free of the installation and came to rest near Post 5. There was no penetration of the vehicle by the test article, and there was no deformation of the occupant compartment resulting from the test. The only debris thrown from the installation as a result of the impact included parts of the vehicle and pieces of posts and blockouts from the first four posts; the majority of the debris fell to the non-traffic side of the guardrail. There was no significant deformation of the 4" guide channels as a result of the impact, and they remained attached to the impact head.

Figure 3.2: Post-Impact Condition of the Test Article and Vehicle

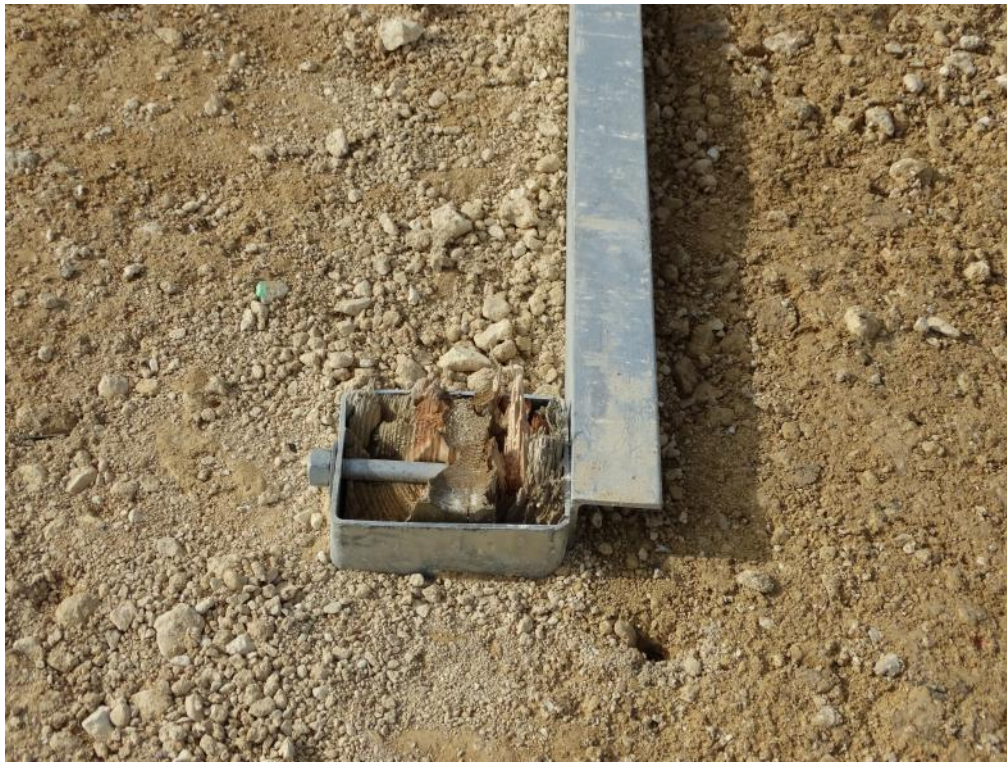
Figure 3.13: Post Test – Foundation Sleeve at Post 1

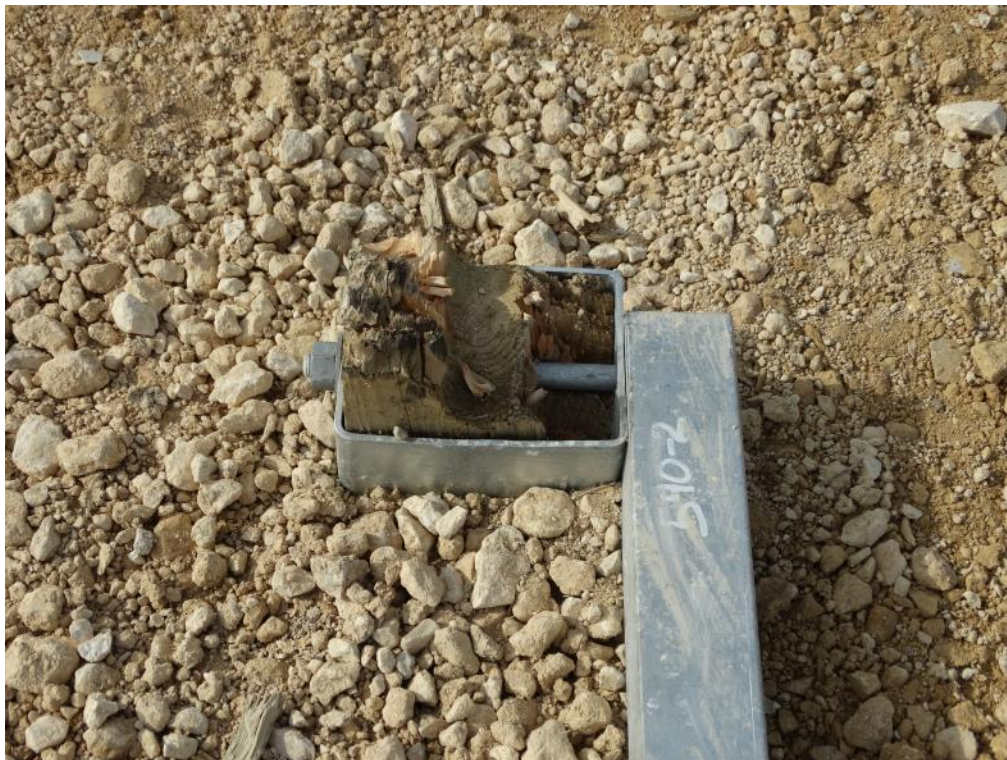
Figure 3.14: Post Test – Foundation Sleeve at Post 2

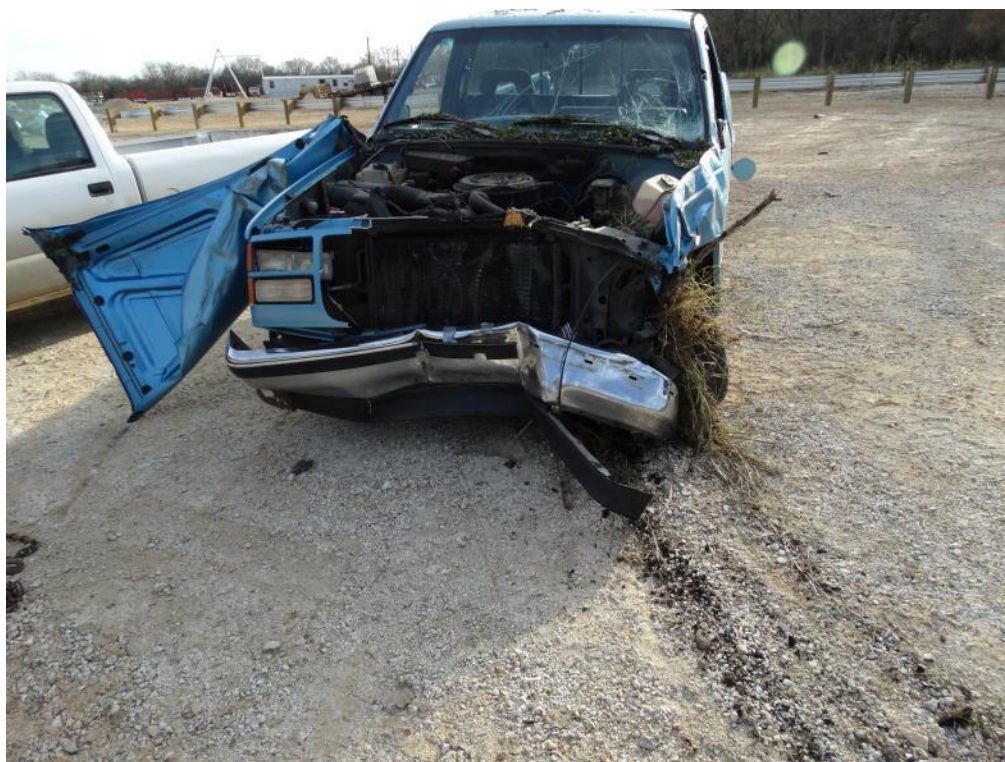
The vehicle continued to travel along the non-traffic side of the guardrail. Without remotely-actuated brakes, the vehicle continued outside of the cleared runout area, finally coming to rest after impacting trees at each side and one nearly head-on; this secondary impact caused significant damage to the test vehicle that was unrelated to the test article and will not be used to judge performance of the ET Plus. The vehicle was not operable after the test.

Figure 3.48: Test Vehicle Damage due to Impact with Tree

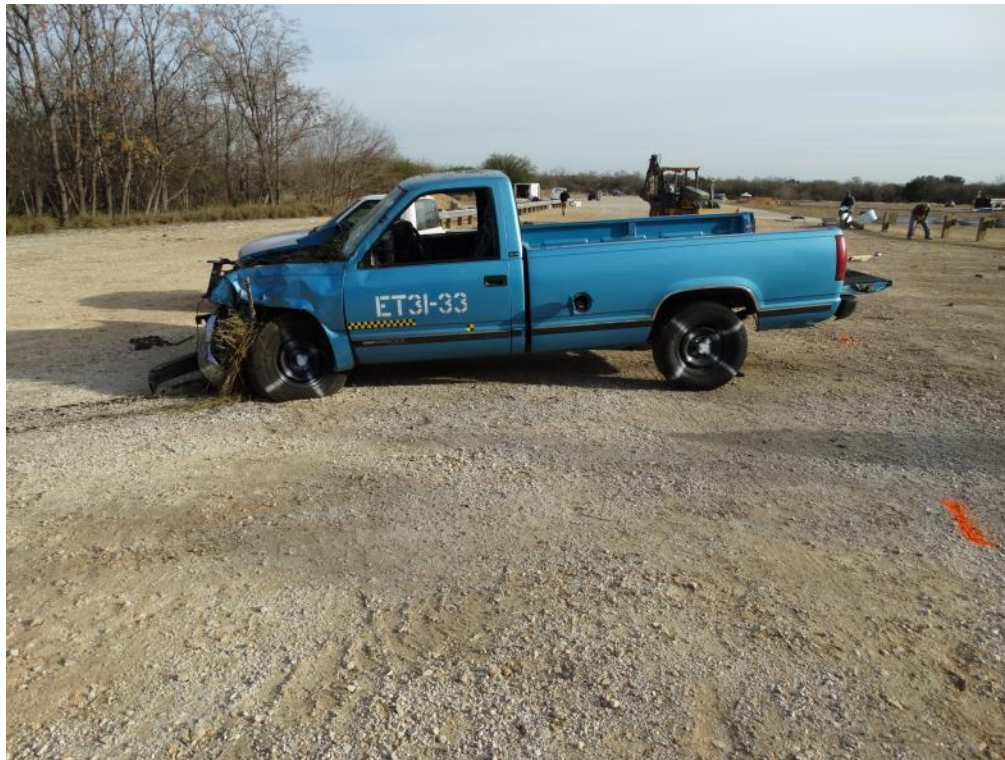
Figure 3.49: Left Side Test Vehicle Damage Following Impact with Tree

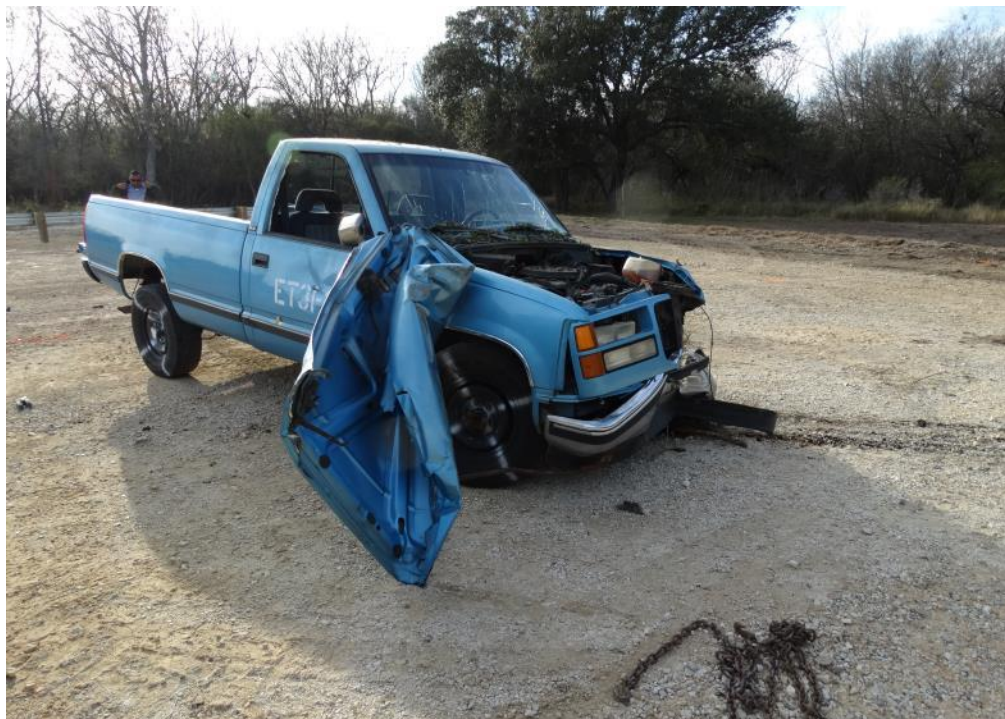
Figure 3.50: Right Side Test Vehicle Damage Following Impact with Tree (Note: Hood Ripped off by Tree Impact)

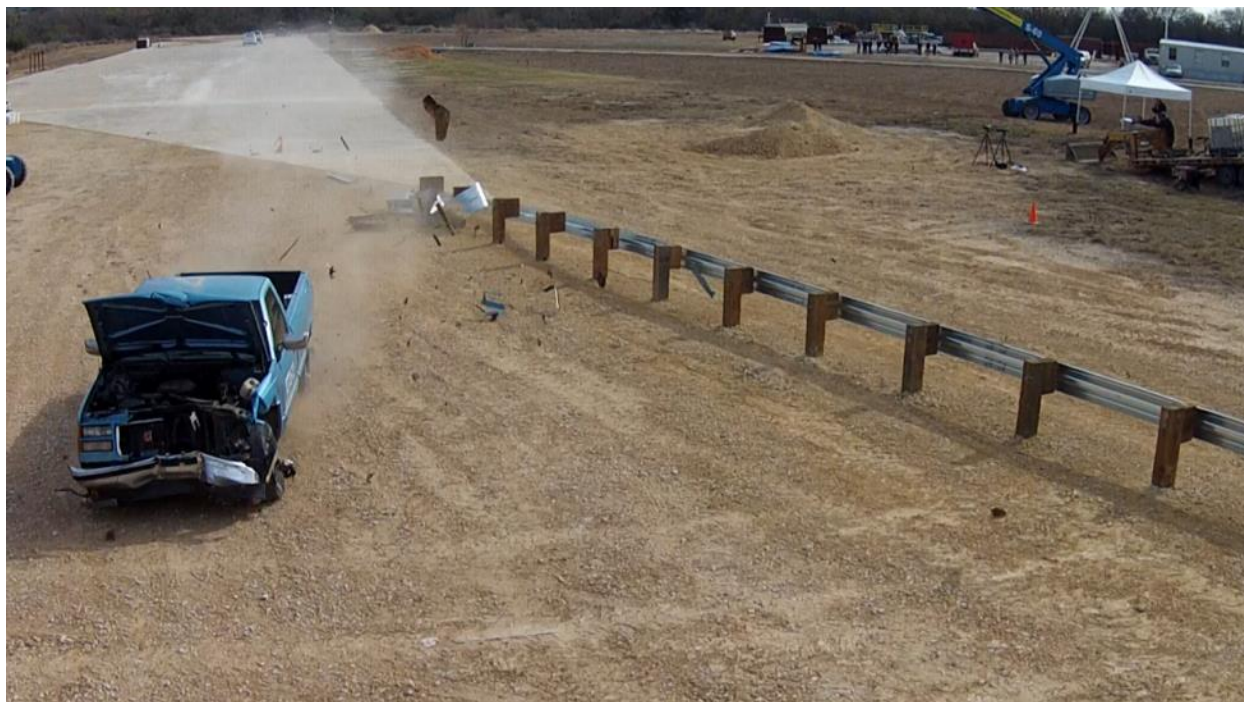
Figure 3.51: Front End Damage to Vehicle Following ET Plus Impact (Drone Camera)

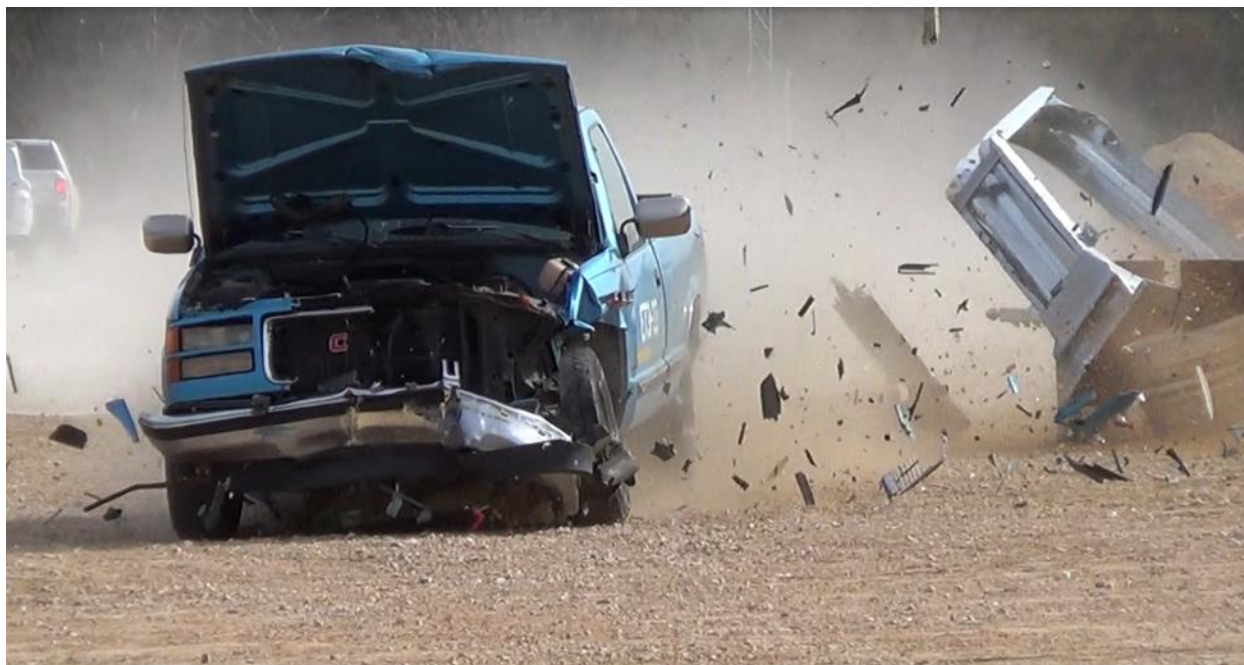
Figure 3.52: Front End Damage to Vehicle Following ET Plus Impact (In-Line Camera)

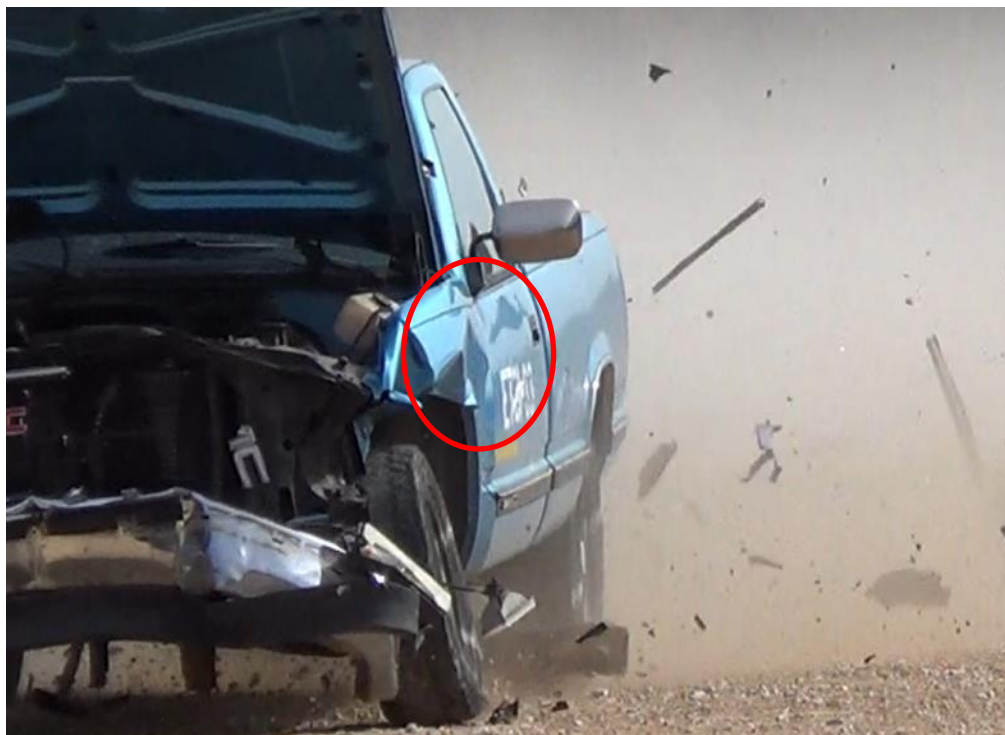
Figure 3.53: Left Side Damage to Vehicle Following ET Plus Impact (see Figure 3.3 at T=0.300seconds)

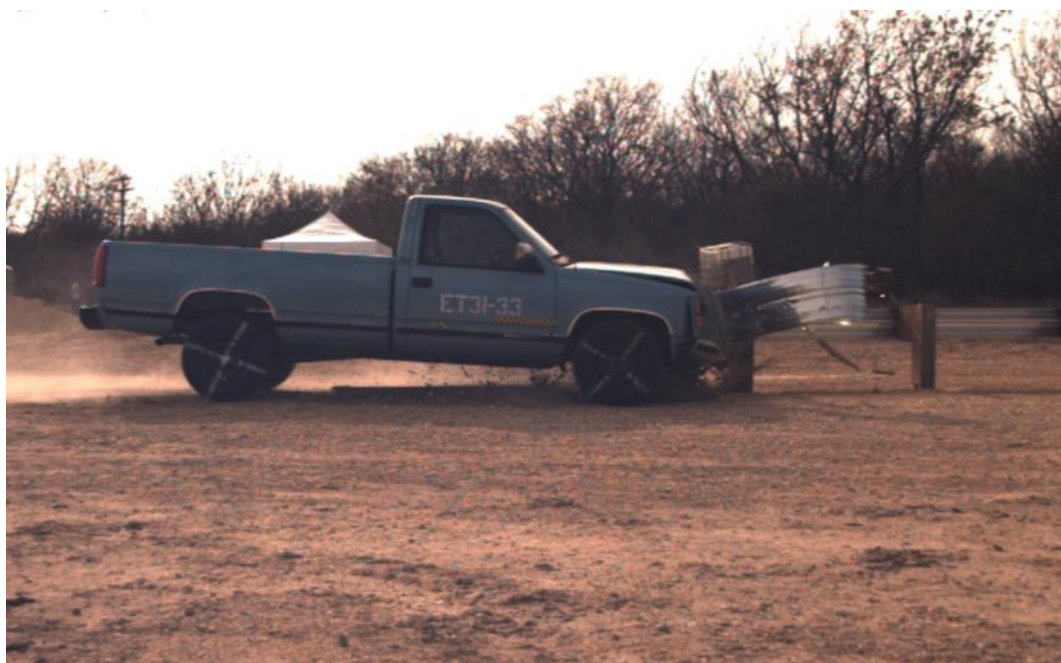
Figure 3.54: Right Side Damage to Vehicle During ET Plus Impact

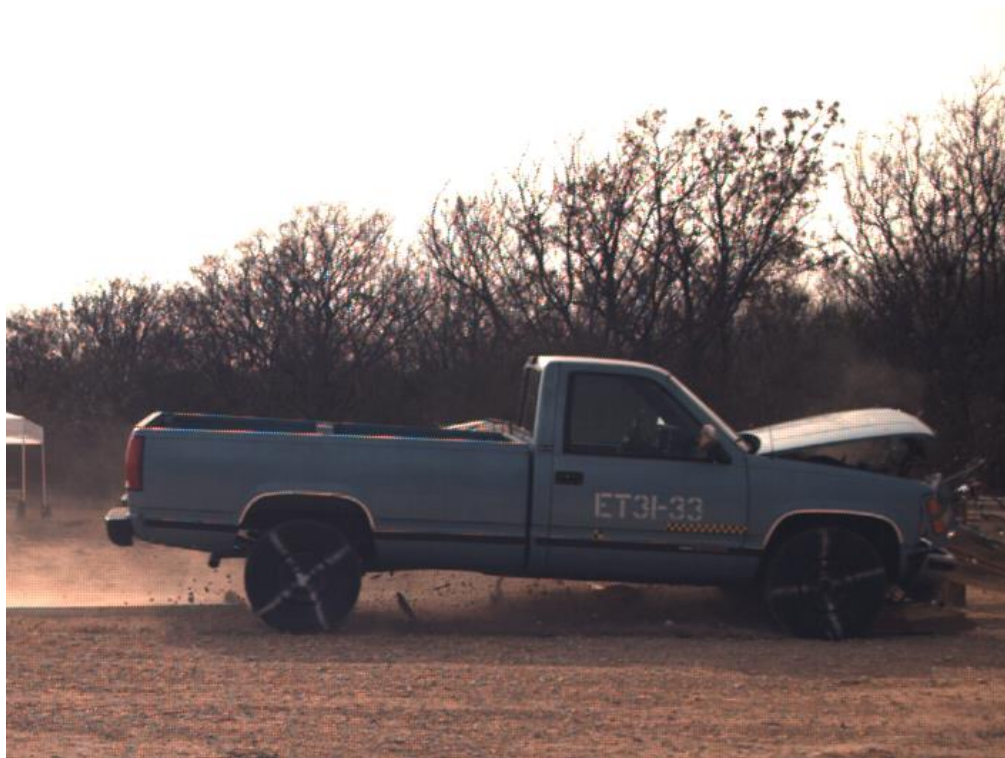
Figure 3.55: Right Side Damage to Vehicle Following ET Plus Impact

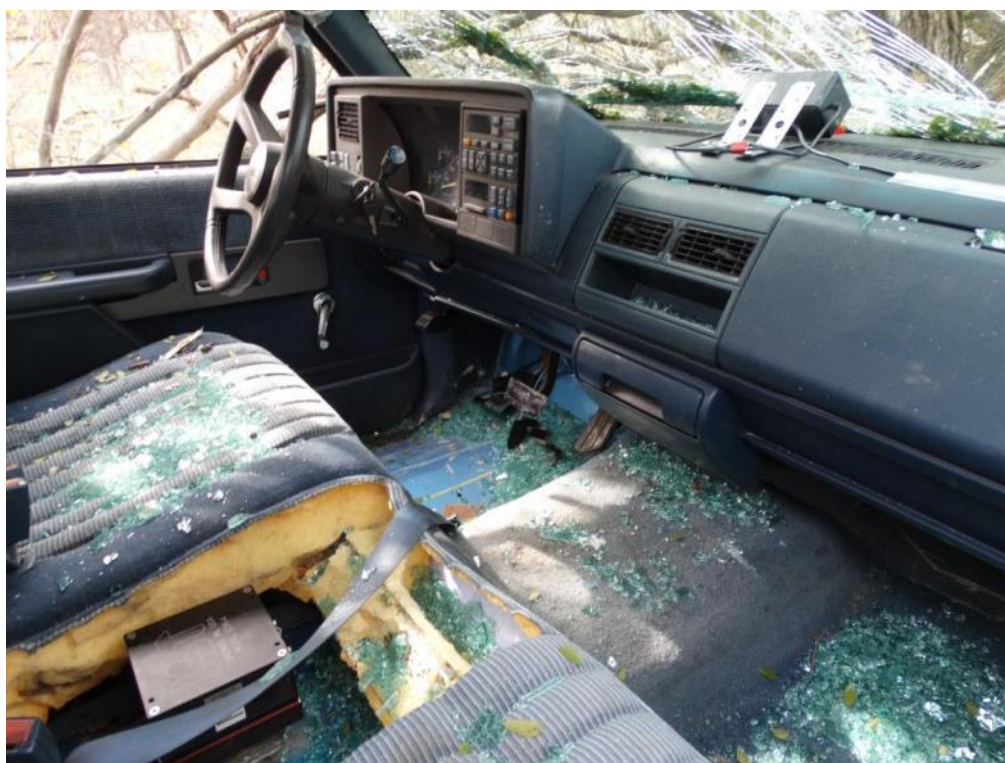
Figure 3.58: Post-Test – Driver Side Floorboard (Damage due to Impact with Tree)

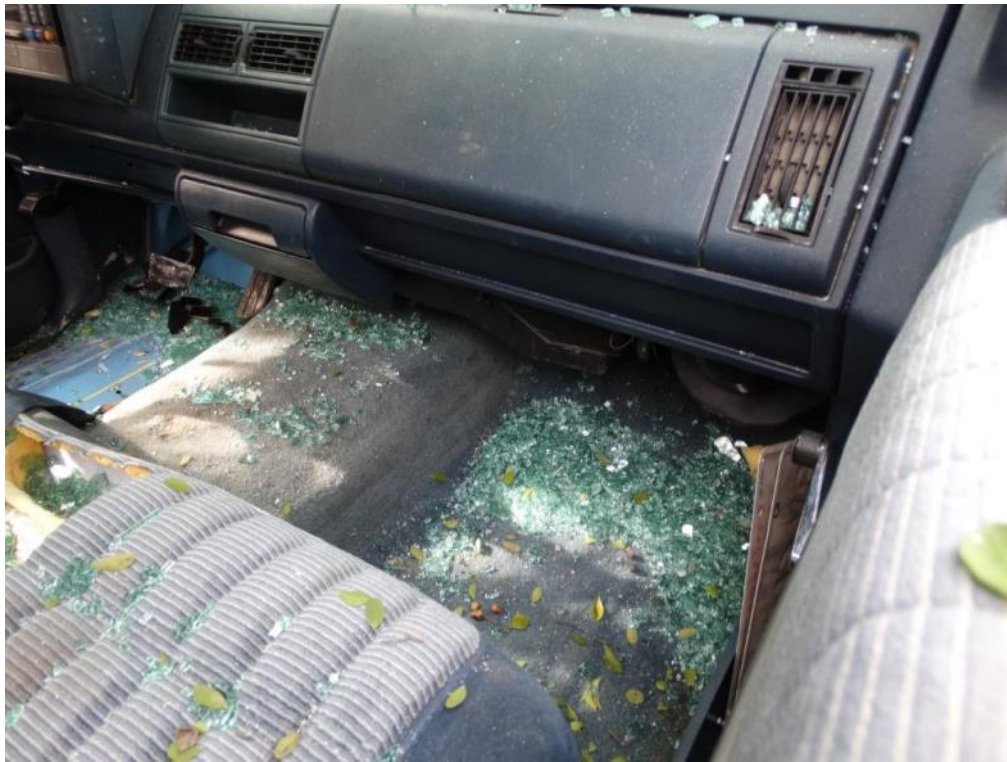
Figure 3.59: Post-Test – Passenger Side Floorboard (Damage due to Impact with Tree)

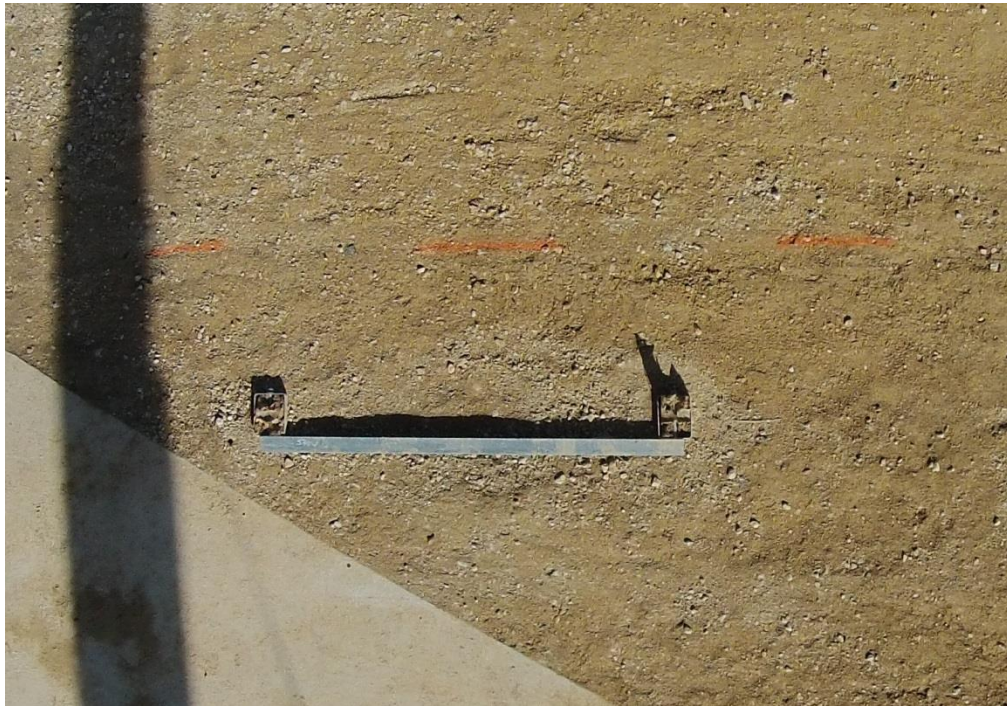
Figure 3.7: Post Test – Post 1 and 2 Foundation Sleeves and Strut

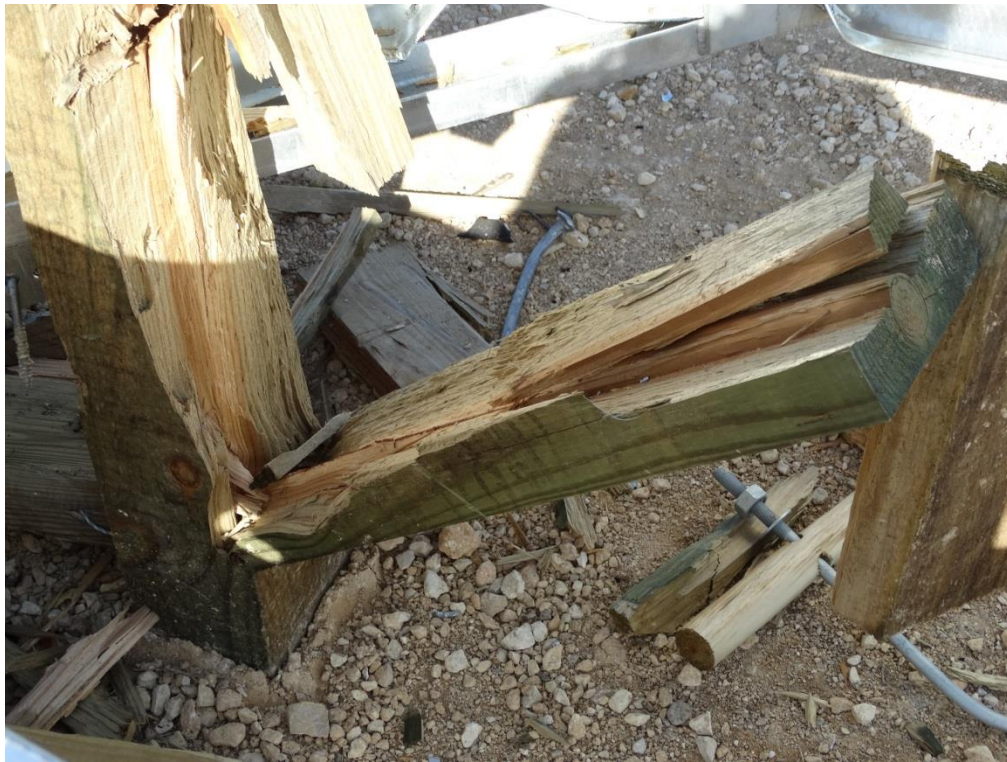
Figure 3.14: Post Test – Post 9 Damage

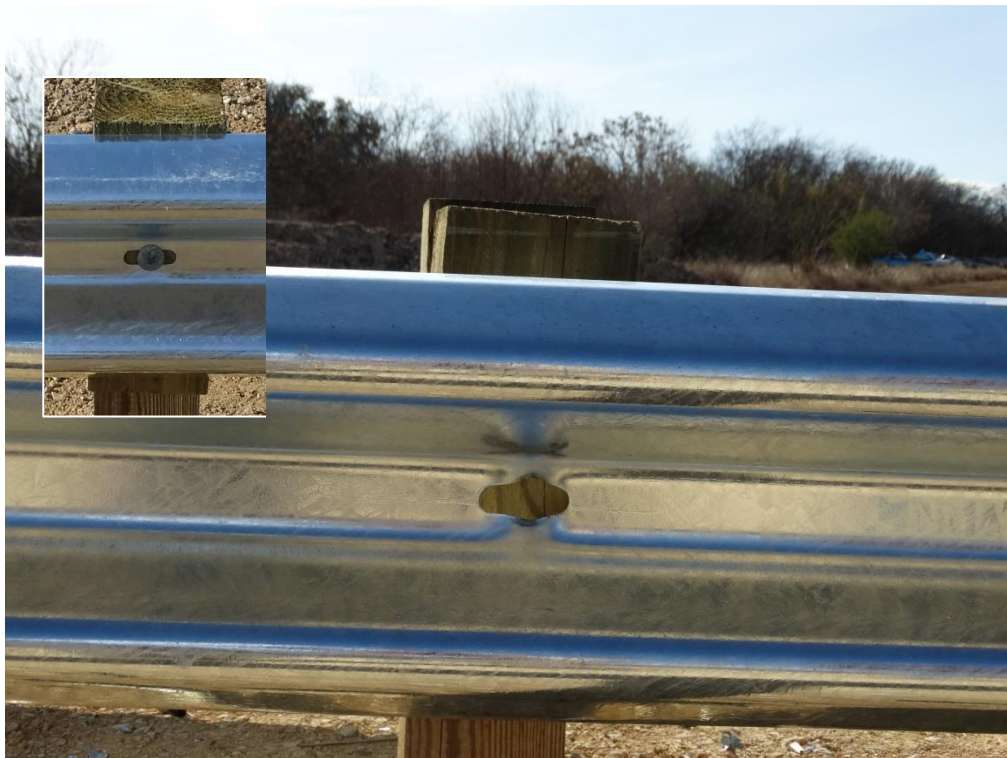
Figure 3.15: Post Test – Post 10, W Beam Pulled off Blockout (Pre-Test Photo Inset)

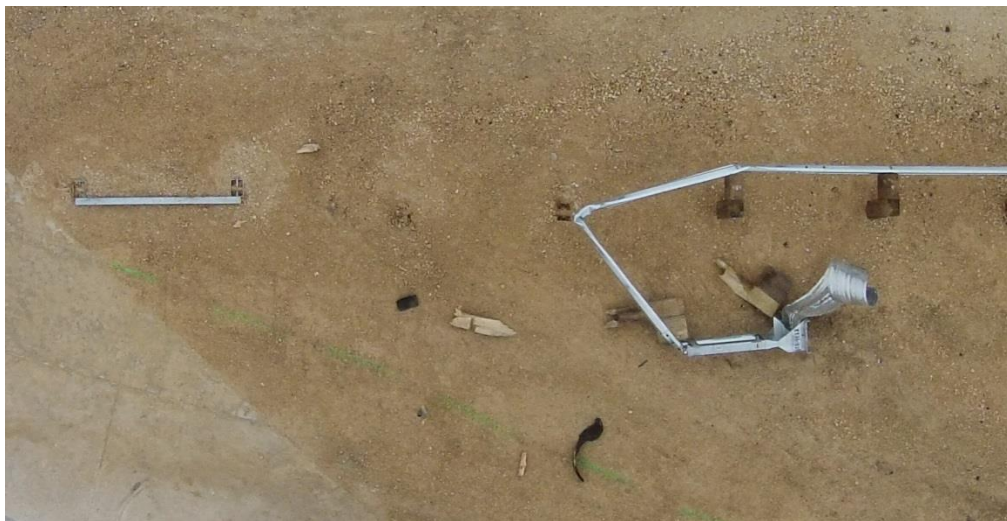
Figure 3.7: Post-Impact Condition of Posts 1 through 6

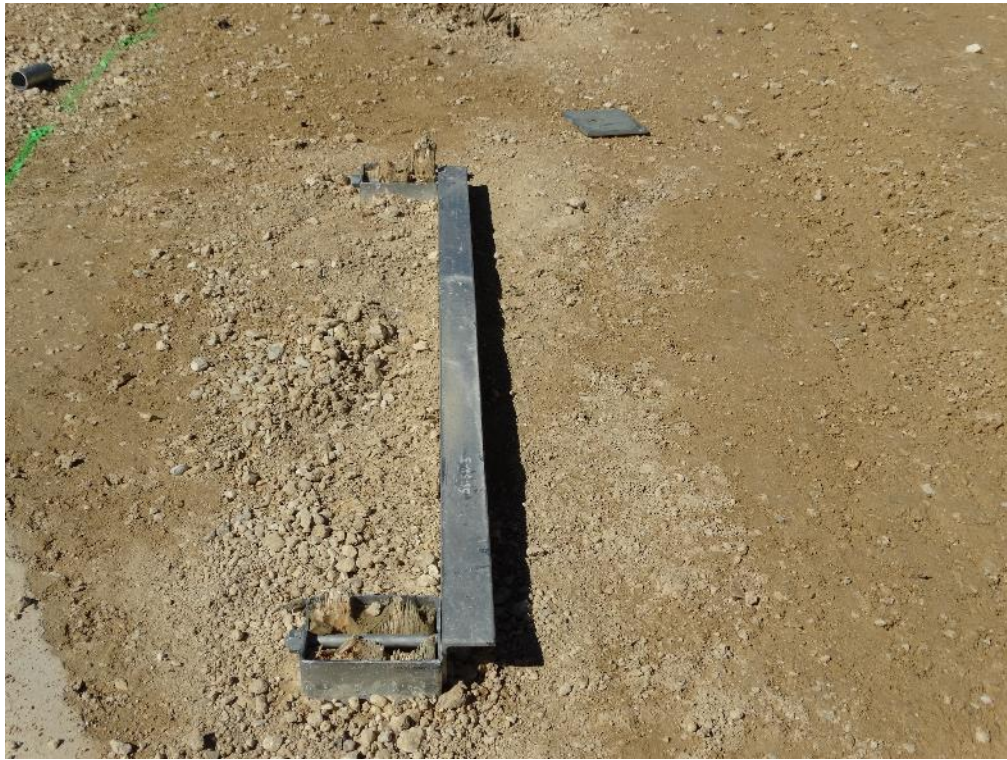
Figure 3.15: Post Test – Foundation Sleeves at Posts 1 and 2
