National Transportation Safety Board

Safety Recommendation

In reply refer to: H-12-2 through -6

Accident Hose Assembly

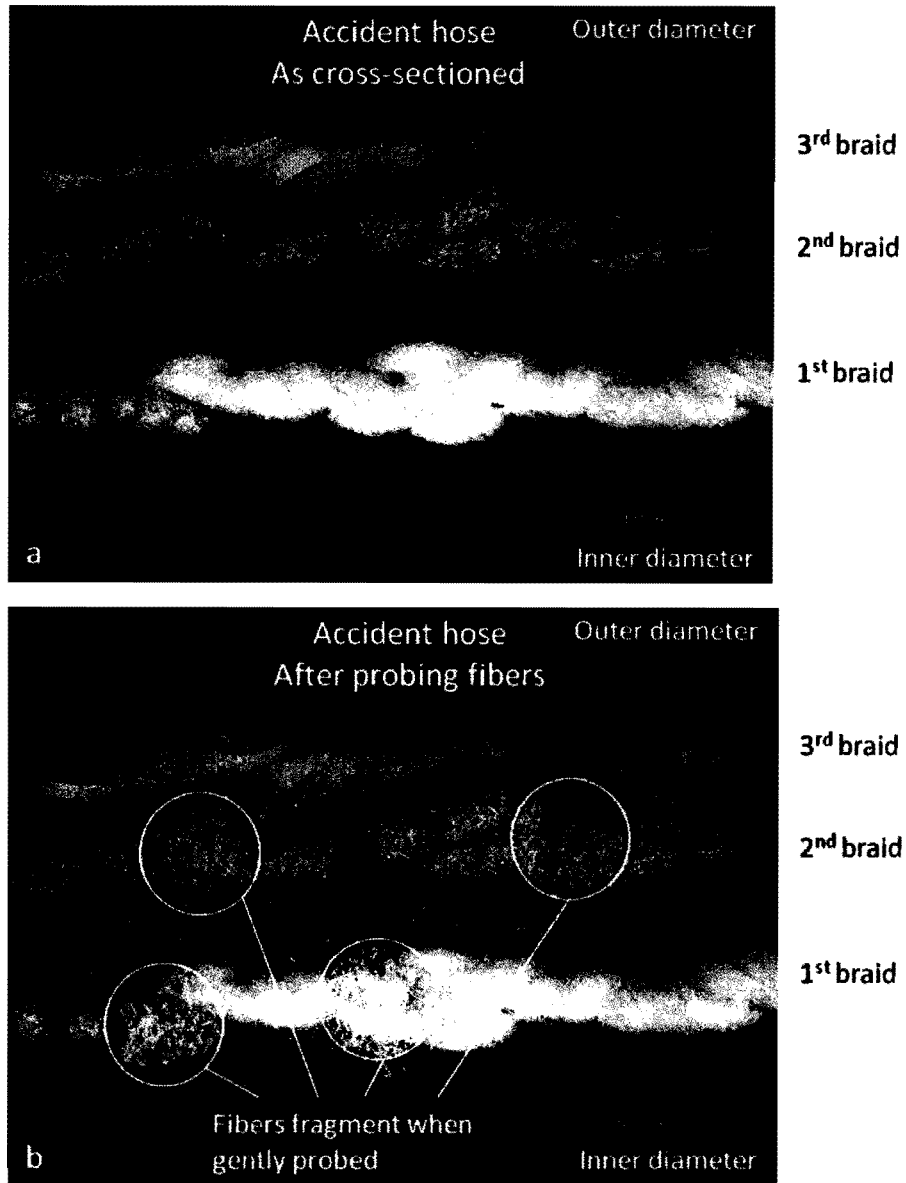
The reinforcing fibers in the two innermost PET braid layers of the hose assembly appeared to be severely damaged on both halves of the fracture surface along the entire length of the ruptured area. In some parts of the ruptured area, the fibers were clumped together and appeared to be encased in salt-like particles. Laboratory analysis of the hose assembly revealed that the fibers in the two innermost PET braid layers were degraded to the point that they were brittle and friable when strained or mechanically flexed. (See figure 2.)

Figure 2. Cross-section of accident hose showing brittleness of fibers in two innermost PET braid layers.

The PET used for the yarn braids is not chemically resistant to anhydrous ammonia or ammonium hydroxide. As documented in several studies,⁹ exposure to anhydrous ammonia or ammonia-related compounds results in a chemical reaction (ammonolysis) that can cause PET fibers to degrade and lose strength.

The outer rubber layer of the accident hose had an array of small pinpricks along its length that was intended to allow the product that it was transferring to permeate through the rubber layers of the hose and escape to the atmosphere. The purpose of this is to prevent gas from becoming trapped in the hose wall and damaging the hose; this pinprick design is standard in rubber hoses for LPG and anhydrous ammonia service. When the anhydrous ammonia permeated through the rubber layers of the accident hose, it collected in the interstitial spaces of the fibers within the PET braids. Also, the accident hose was likely exposed to moisture, including humidity and rain, throughout its life cycle. Any absorbed and dissolved moisture contained in the accident hose likely would have converted the trapped anhydrous ammonia to ammonium hydroxide, leading to chemical degradation of the PET fibers.

Testing completed by both the NTSB's Materials Laboratory and an independent laboratory¹⁰ confirms that the PET fibers in the accident hose had sustained chemical degradation that dramatically reduced the strength of the PET fiber. The NTSB concluded that the accident hose failed because it was not chemically compatible with the anhydrous ammonia in the cargo tank and that caused the chemical degradation, loss of mechanical strength, and ultimate failure of the cargo hose.

Require cargo tank motor vehicle carriers and transfer facilities to verify (1) that cargo transfer hose assemblies, whether carried on the vehicle or provided by the facility, are chemically compatible with the hazardous material to be transferred and (2) that drivers verify hoses are marked as compatible with the material to be transferred before either loading or unloading operations begin. (H-12-3)
