### Post Inspection Memorandum (PIM)

**Synopsis:** On Monday, March 1, 2010 crude oil was released in the Enbridge pipelines, Clearbrook Terminal. At approximately 9:16 AM CST, an accidental valve closure occurred as a result of controller error at their Edmonton, Canada control center, causing line 81 to build up enough back pressure to force the thermal reliefs and rupture pin to relieve to the station sump. The station sump overflowed and approximately 3 barrels were released. The spill was contained in the facility and cleaned within 27 hours.

**Rupture of Enbridge Pipeline and Release of Crude Oil  
near Cohasset, Minnesota  
July 4, 2002**

**NTSB/PAR-04/01**

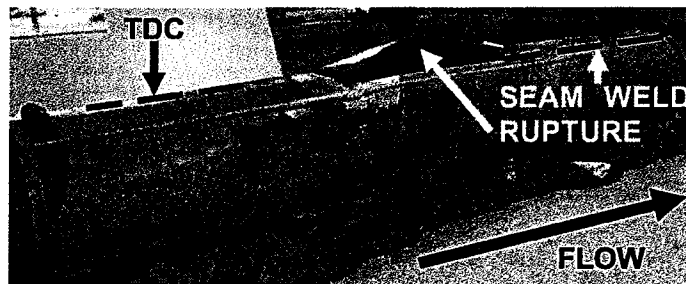
Figure 2. Photograph of the 24-inch diameter pipe section removed from Line 14 at MP US 149.4 in the as-received condition.

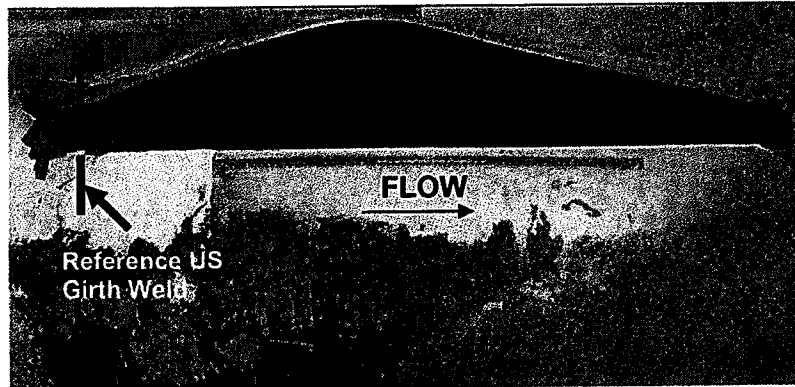
Figure 3. Photograph of the rupture on the pipe section after removing the protective rubber and grease.

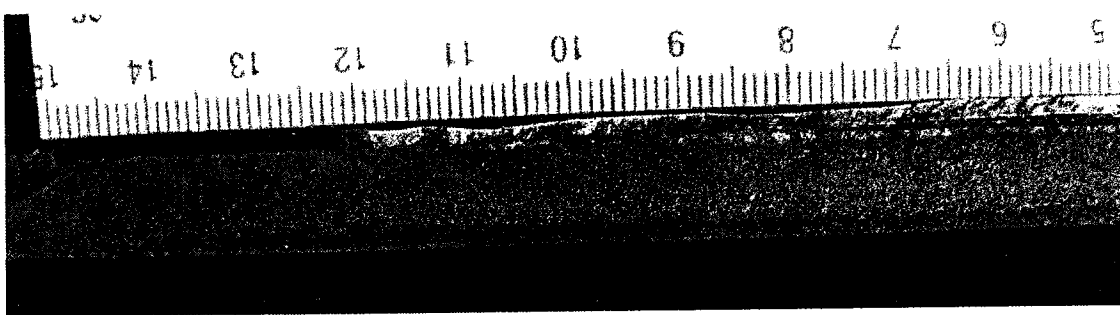
Figure 5. Photograph of the fracture face from 0 inches to 4 inches from the reference upstream girth weld.

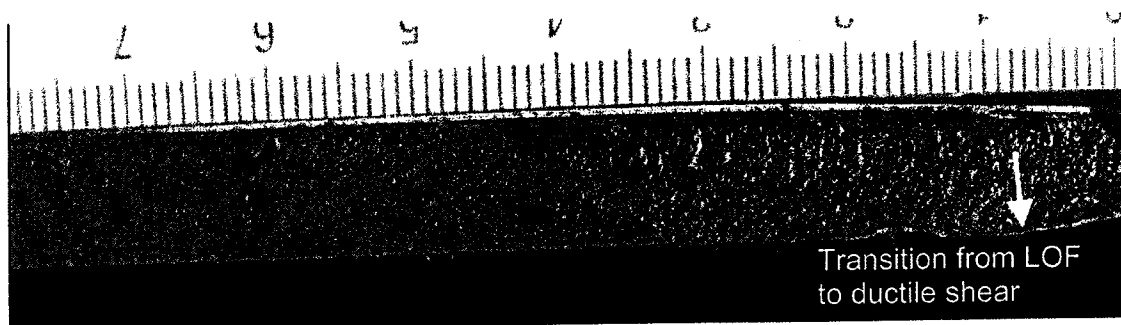
Figure 7. Photograph of the fracture face from 33.7 inches to 36.8 inches (end of visible lack of fusion flaw) from the reference upstream girth weld.

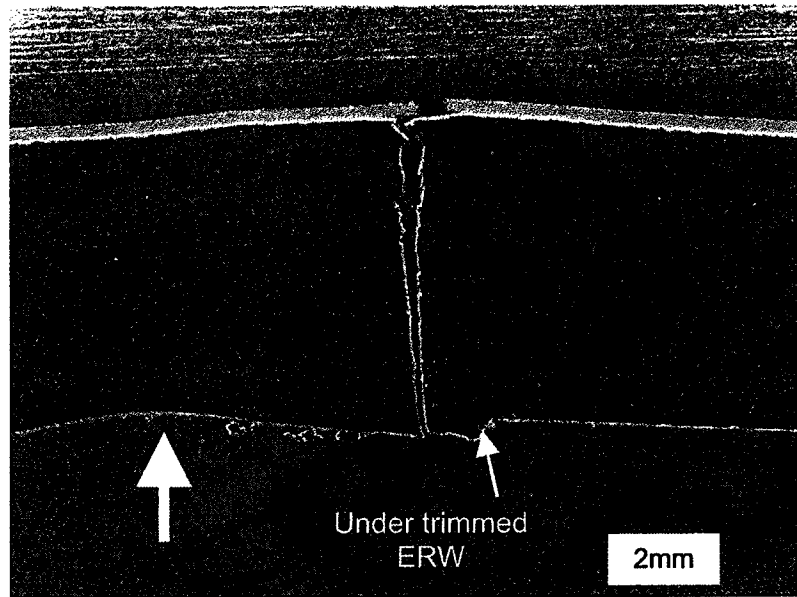
Figure 9. Photograph of a cross section through the rupture 17 inches from the reference upstream girth weld.

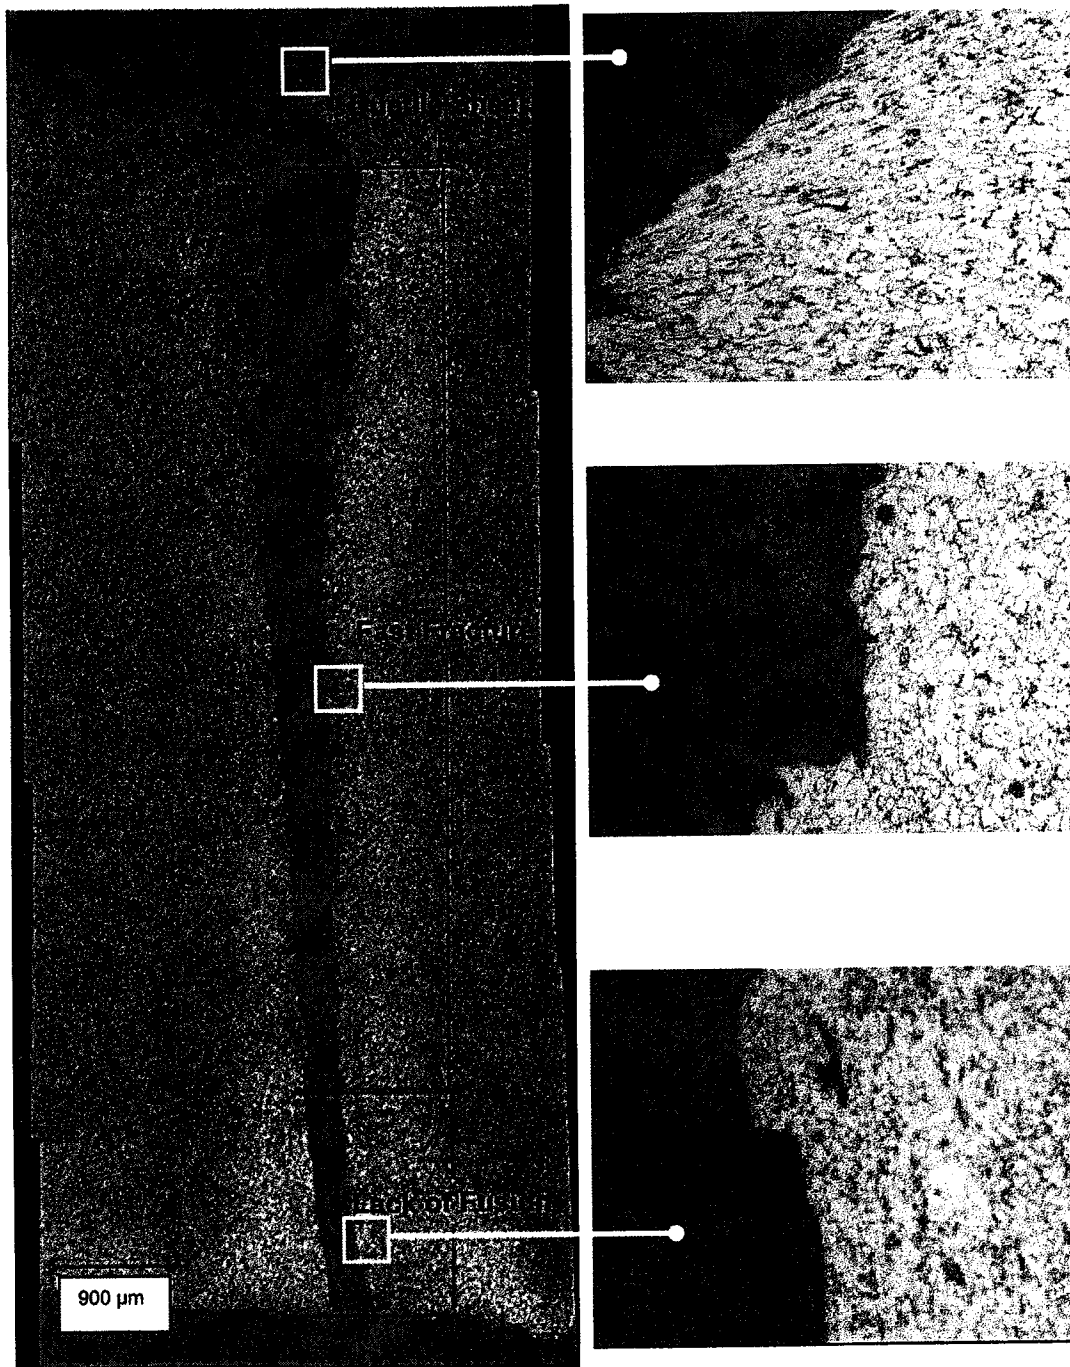
Figure 12. Photomicrograph showing the fracture path in the HAZ 17 inches from the reference upstream girth weld. The lack of fusion, fast fracture, and ductile shear regions are labeled in the figure. 25X magnification.

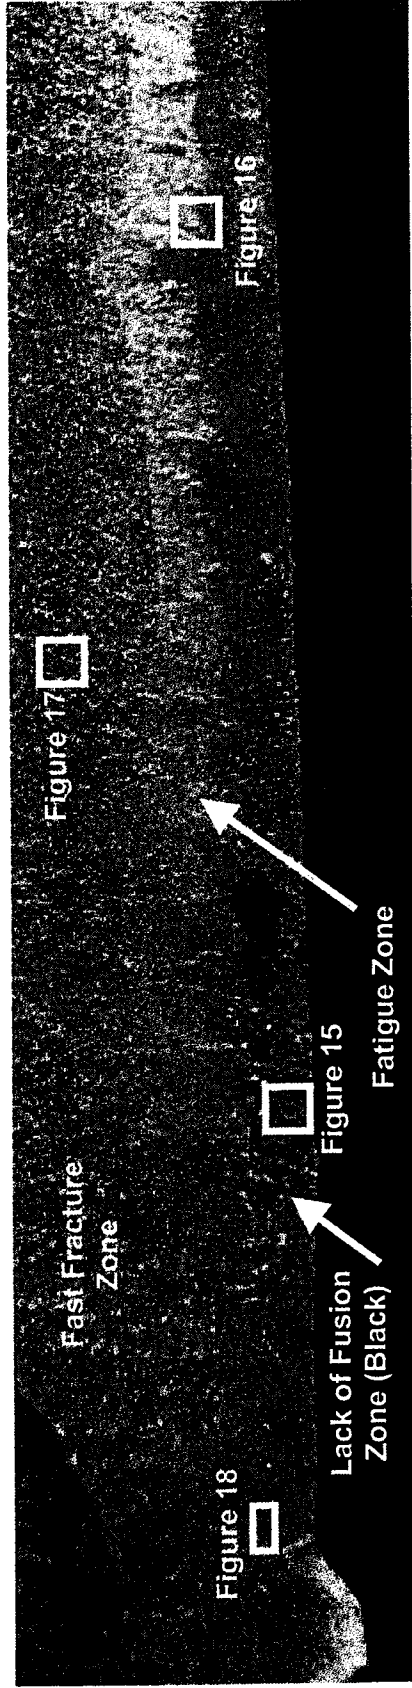
Figure 14. Photograph of fracture face at the failure origin. The lack of fusion zone, fatigue zone, and the fast fracture zone are labeled in the figure. 25X magnification.

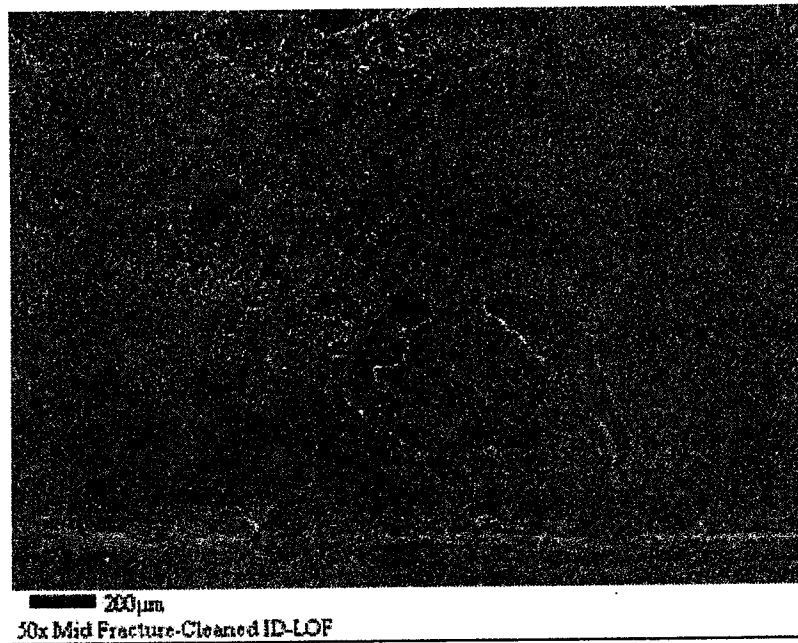
Figure 15. SEM photomicrograph taken in the lack of fusion zone. 50X magnification.

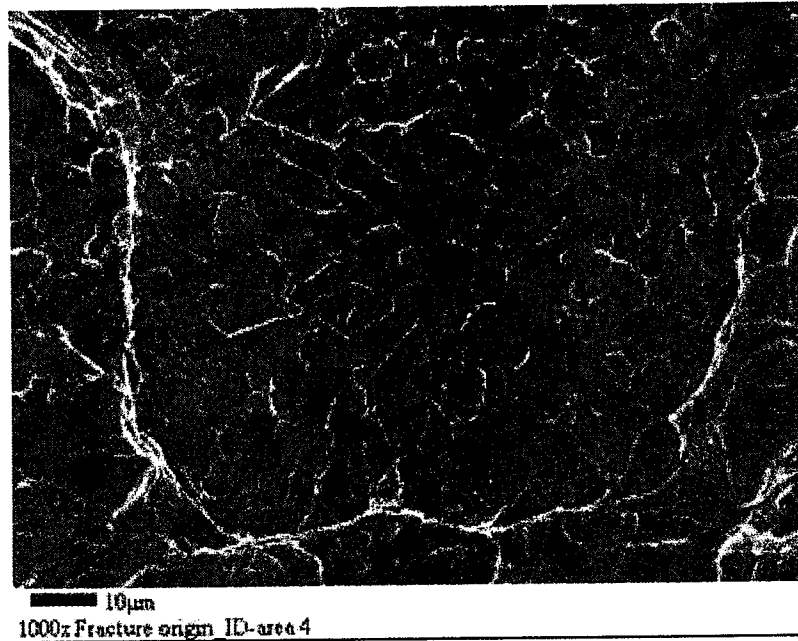
Figure 17. Representative SEM photomicrograph showing cleavage facets in the fast fracture zone. 1000X magnification.

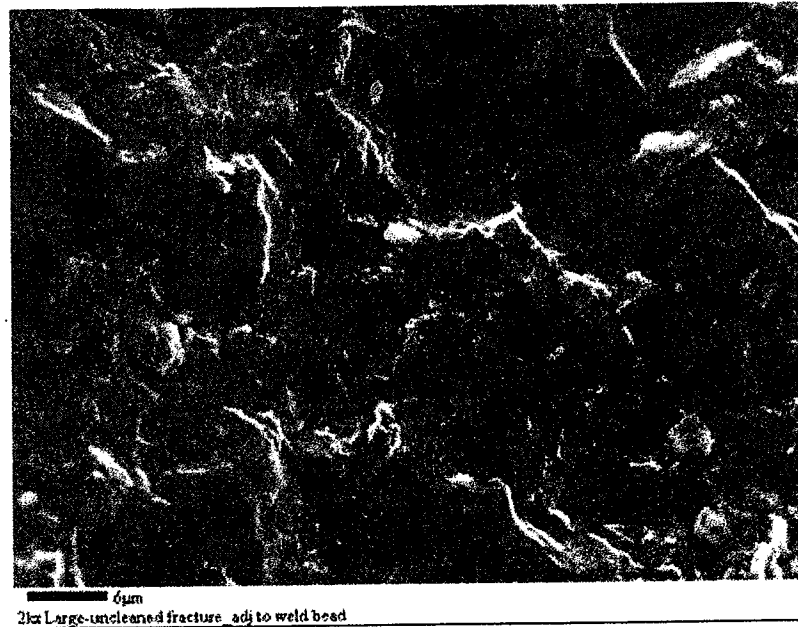
Figure 18. SEM photomicrograph showing intergranular fracture observed adjacent the reference upstream girth weld in the lack of fusion / fatigue zone transition. 2000X magnification.

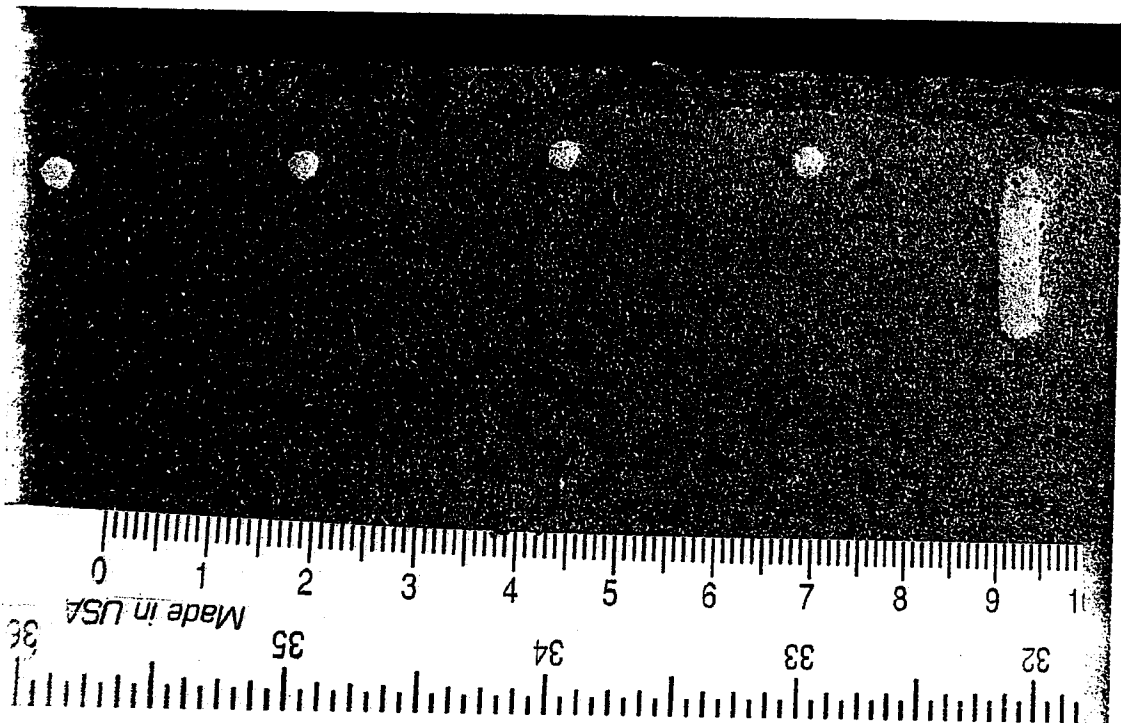
Figure 6. Fracture surface on plate at 3:00 o'clock position.

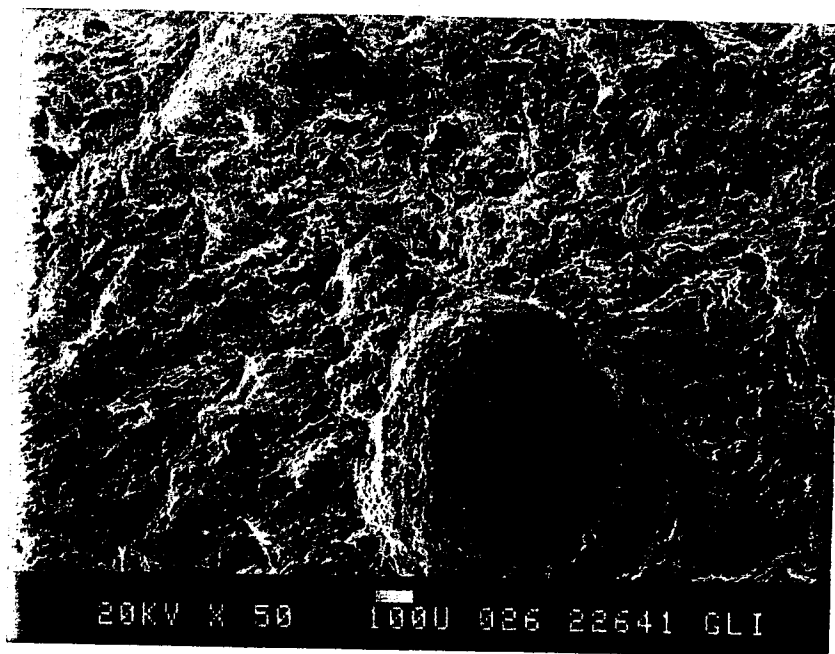
Figure 13. Ductile low-cycle fatigue and porosity on fracture face of SEM 1.

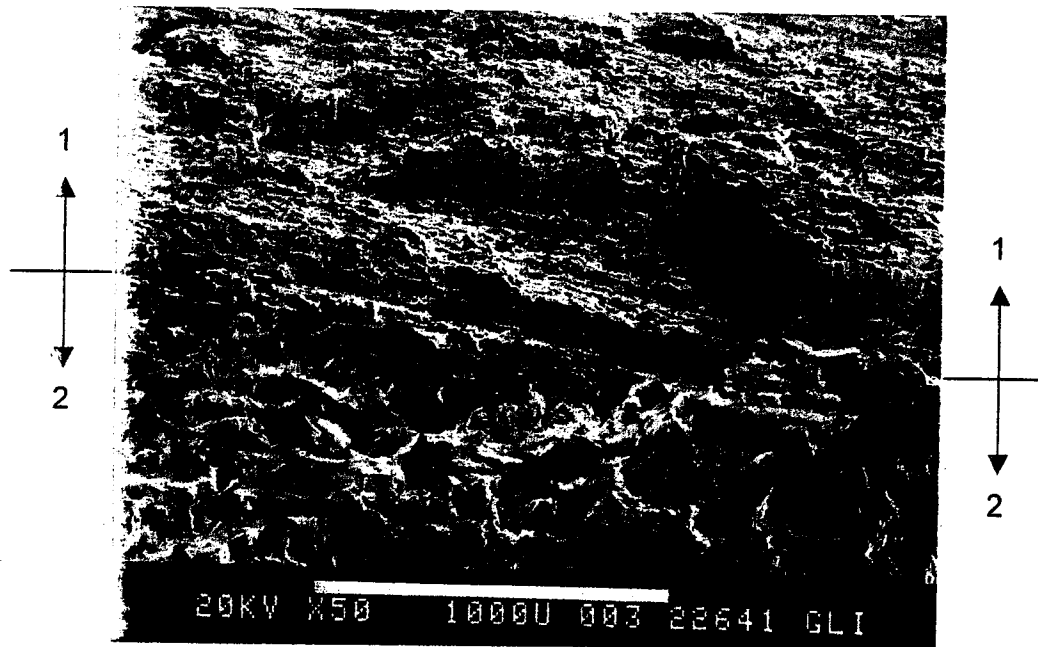
Figure 17. Ductile low-cycle fatigue and cleavage on fracture face of SEM 2. (1 - Fatigue and 2 - Cleavage)

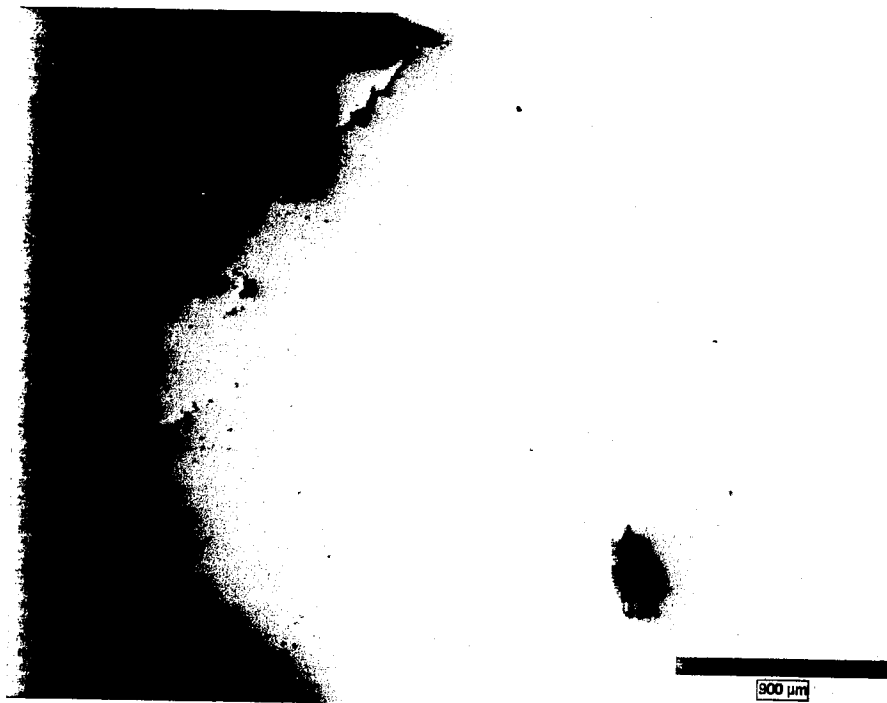
Figure 31. Section through low-cycle fatigue fracture near outside surface of weld in Sample MET 1, as polished.

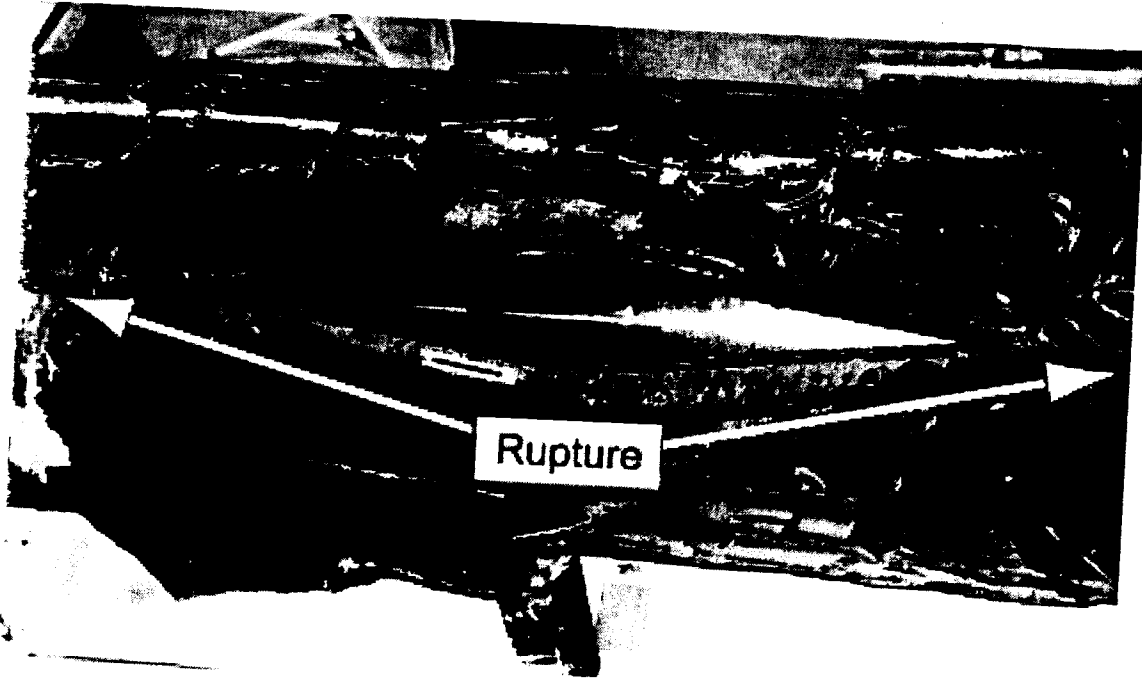
On July 6, after vacuum trucks had removed the remaining oil and water, the ruptured pipe was exposed. The pipe was fractured along the edge of a longitudinal weld. When the pipe that failed was installed, the longitudinal weld was at the 5:30 clock position when viewed facing downstream (eastward). The rupture was about 69 inches long and gapped open about 6 1/4 inches at the center. (See figure 5.) At the rupture location, the pipeline was rated for a regulatory maximum operating pressure of 687 pounds per square inch, gauge (psig). The pressure at this location at the time of failure was calculated to be 526 psig. The United States Steel Corporation (U.S. Steel) manufactured the pipe at its National Tube Works in McKeesport, Pennsylvania.

Figure 5. Rupture in accident pipe.

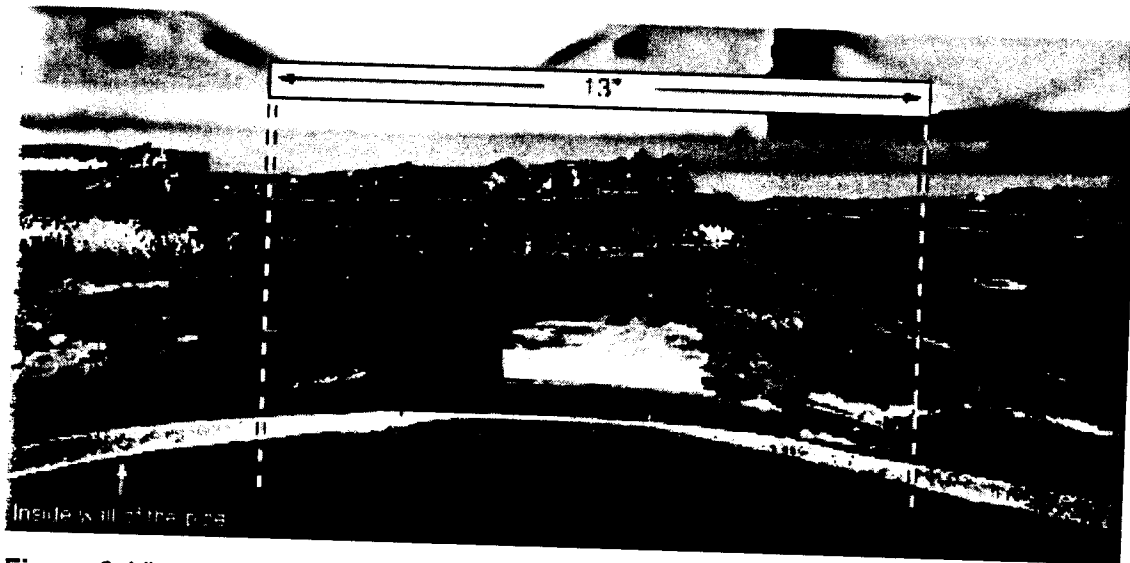
inch of the 0.297-inch measured wall thickness.<sup>7</sup> Measurement and testing of the pipe showed that it met thickness and strength requirements. The pipe fracture beyond the fatigue crack contained features typical of overstress fracture.

Figure 6. View of top fracture surface of 13-inch-long crack, showing penetration nearly through pipe wall in center.

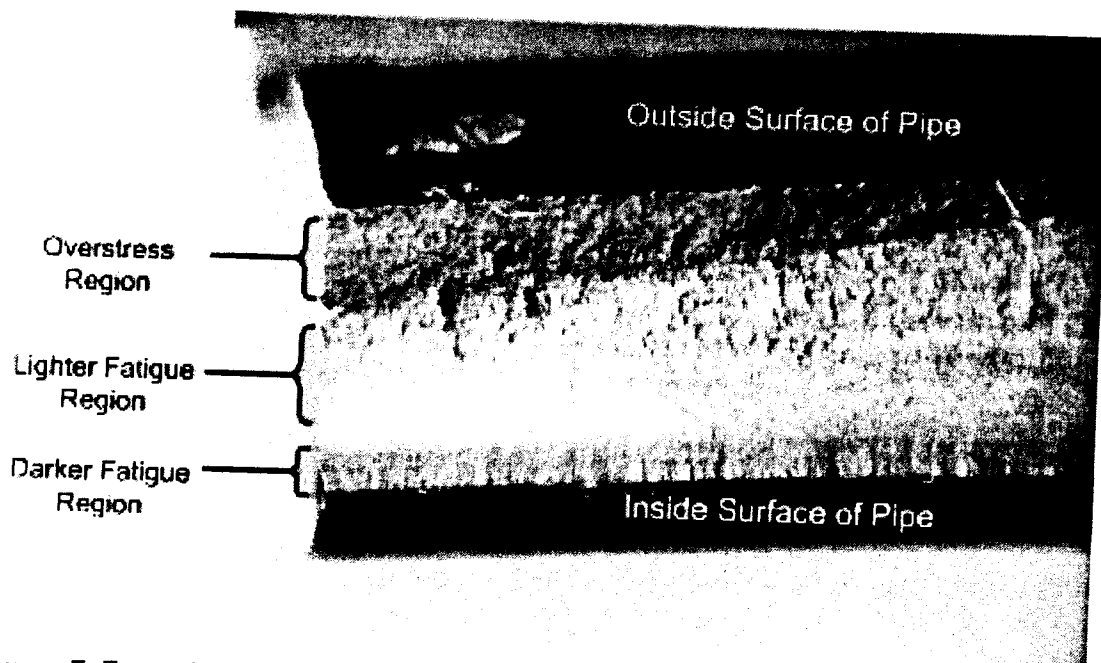
Figure 7. Face of fracture in accident pipe.

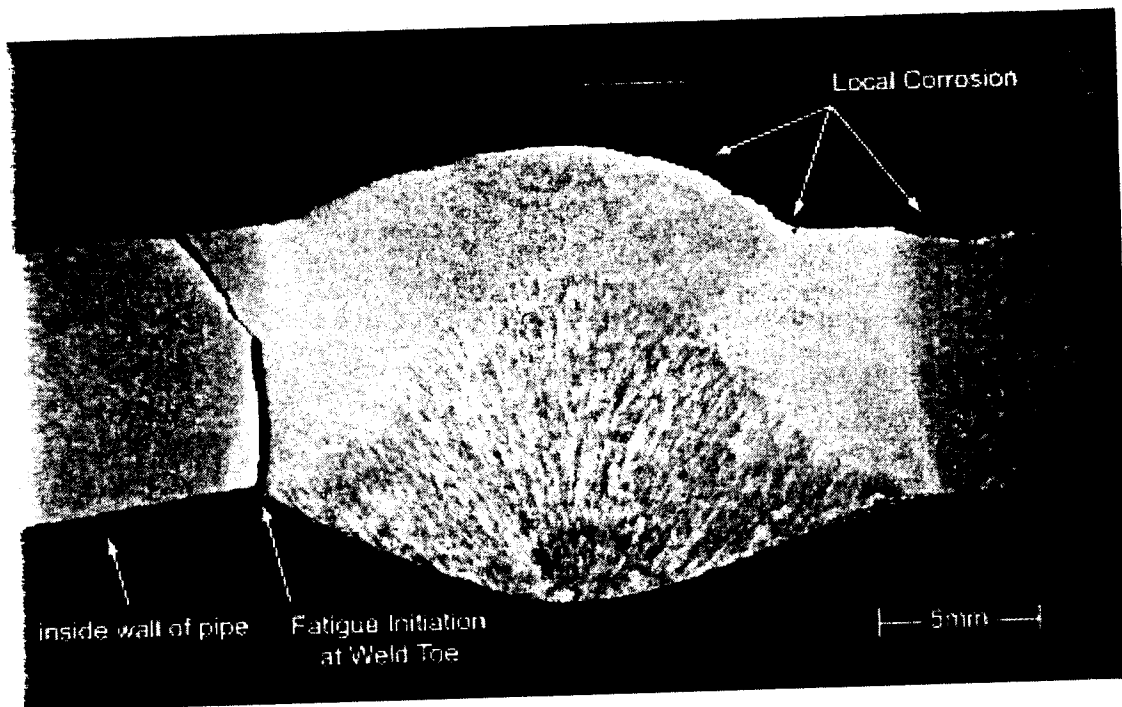
Figure 8. Fatigue initiating at toe of weld on interior surface of pipe.
