U.S. Department  
of Transportation

Central Region,  
Pipeline Safety

**NOTICE OF AMENDMENT**

CPF No. 3-2002-5005M

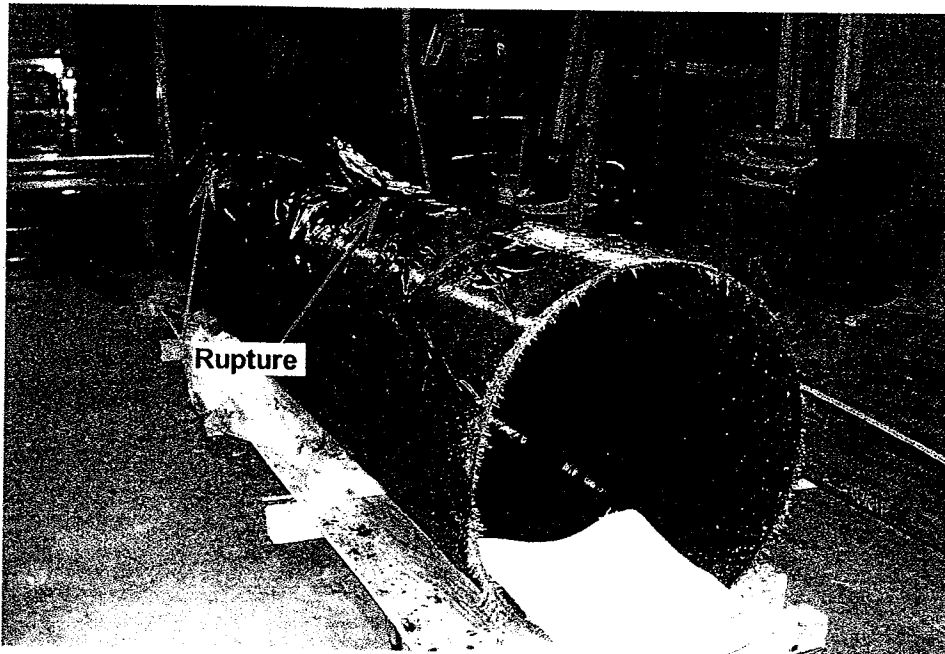
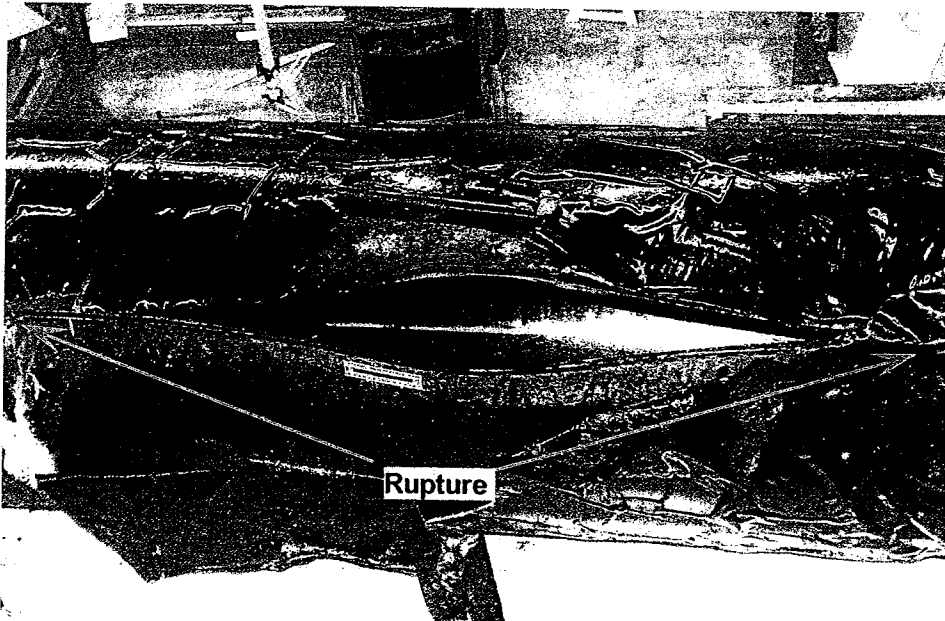
Figure 1--Two views of the ruptured section of pipe. Upper view shown looking downstream with the pipe rotated from it's reported installed orientation. The lower view shows the rupture area from the side with flow from right to left.

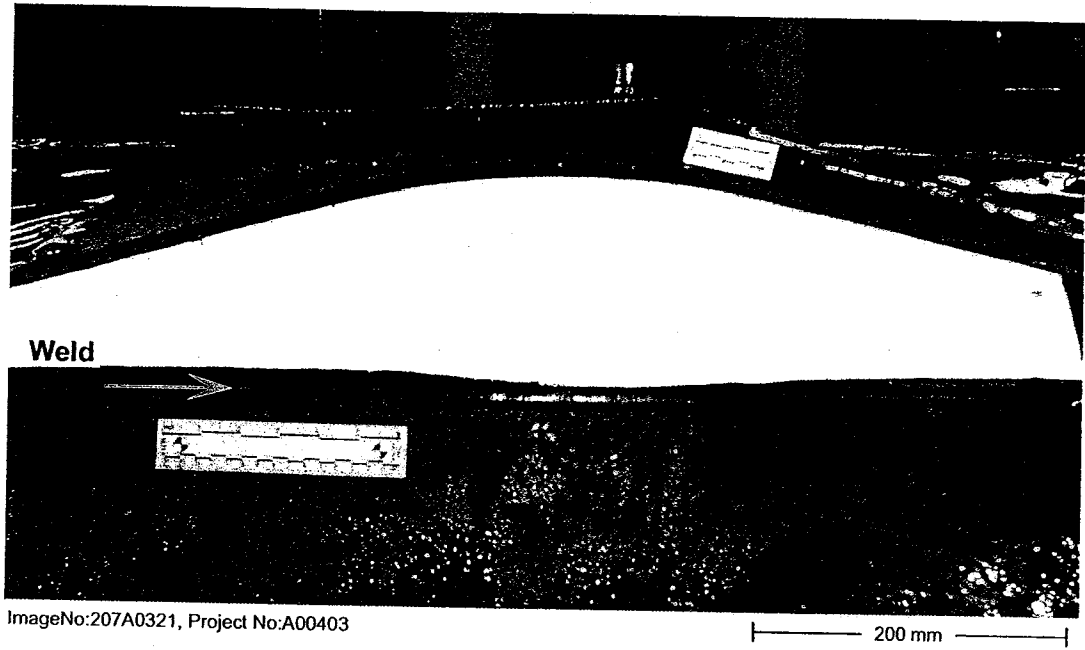
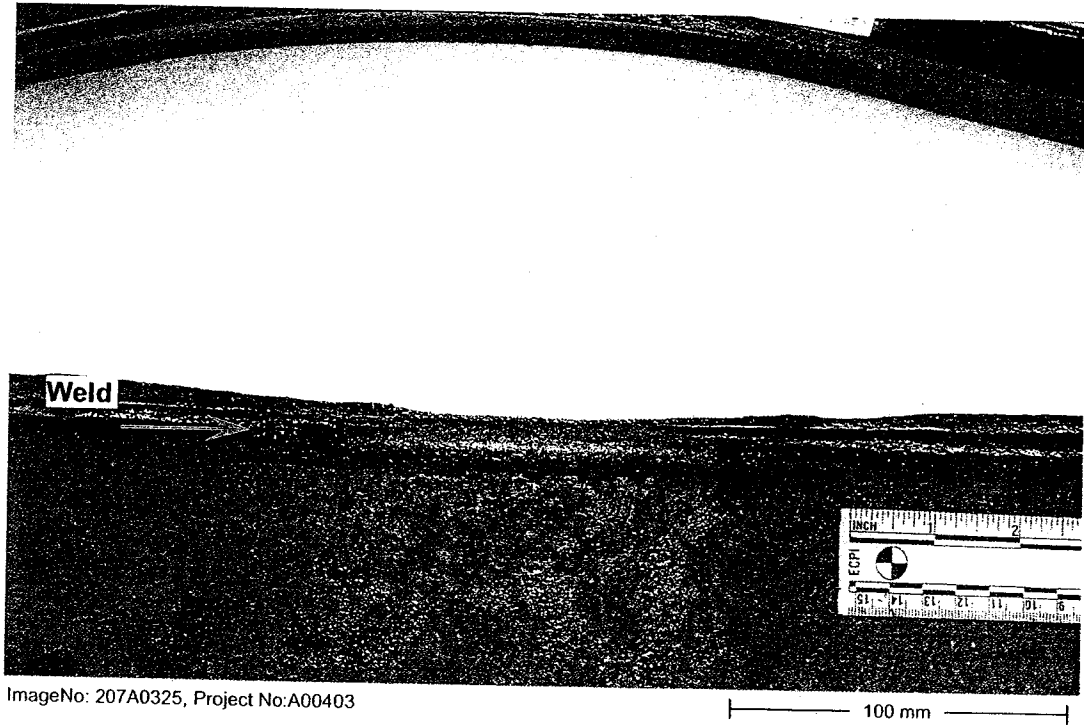
Figure 2--Closer view of the rupture showing it's relationship to the seam weld.

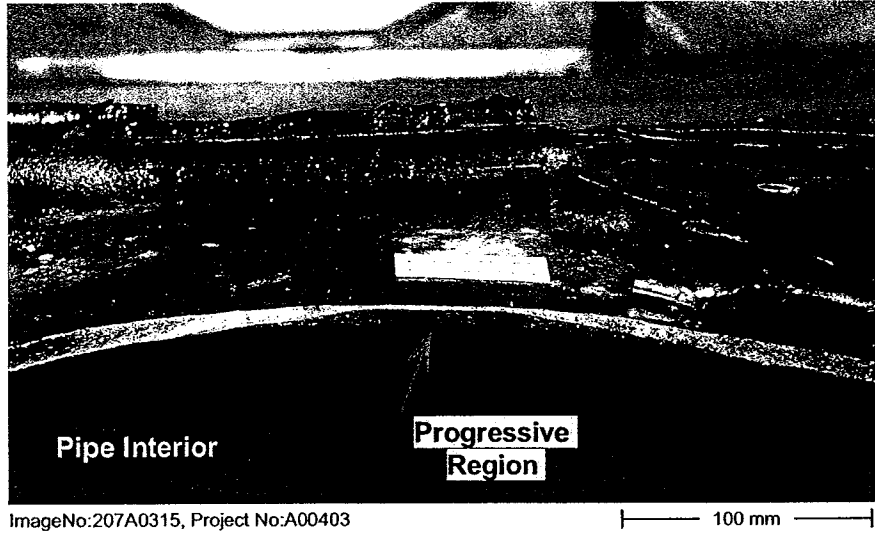
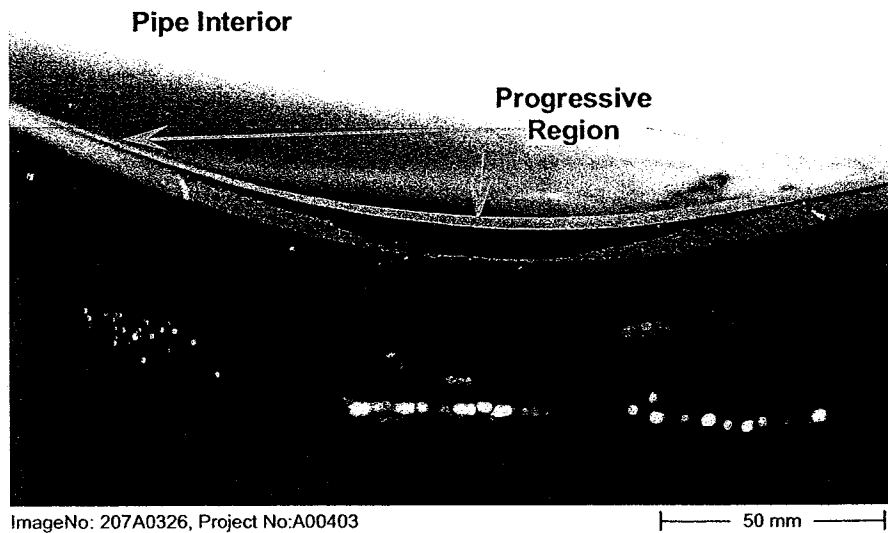
Figure 3--Two views of the progressive region of the rupture. The upper view shows the fracture face without the weld. The lower view is the mating area of the fracture face with the weld. The progressive area shows dark in both views.

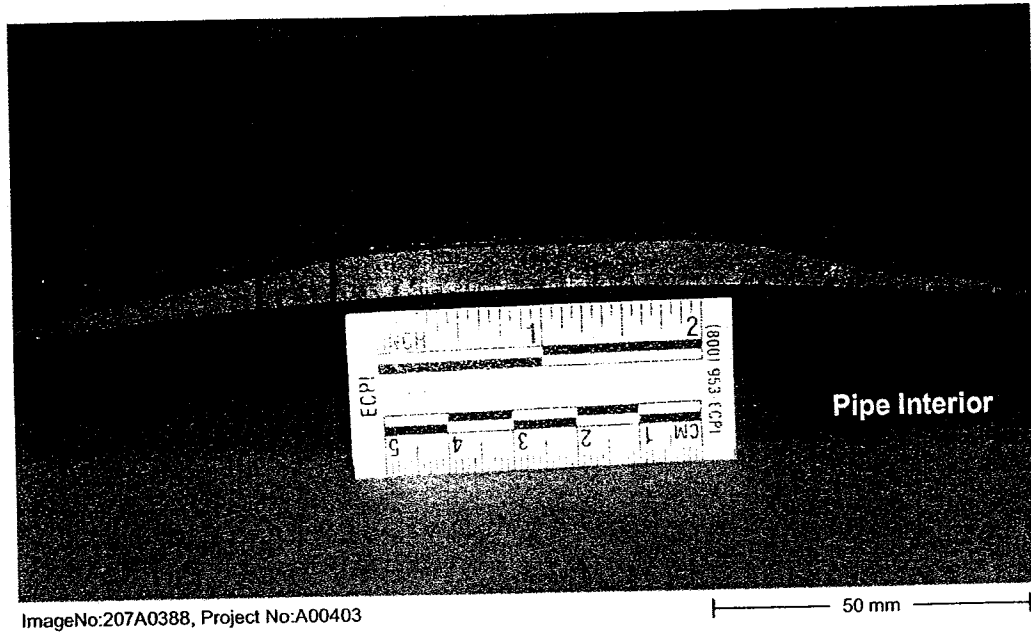
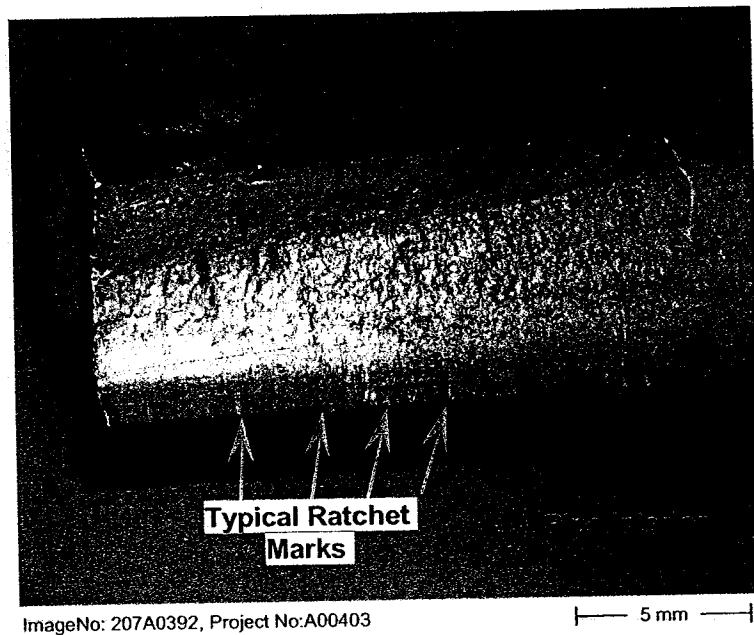
Figure 4--Two views of the weld side fracture face after cleaning in acetone. The upper view shows the central region of the fatigue. Lower view is from the boxed area of the upper view. The metallographic section shown in figure 6 was taken from the left edge of the pipe section shown in the lower view.

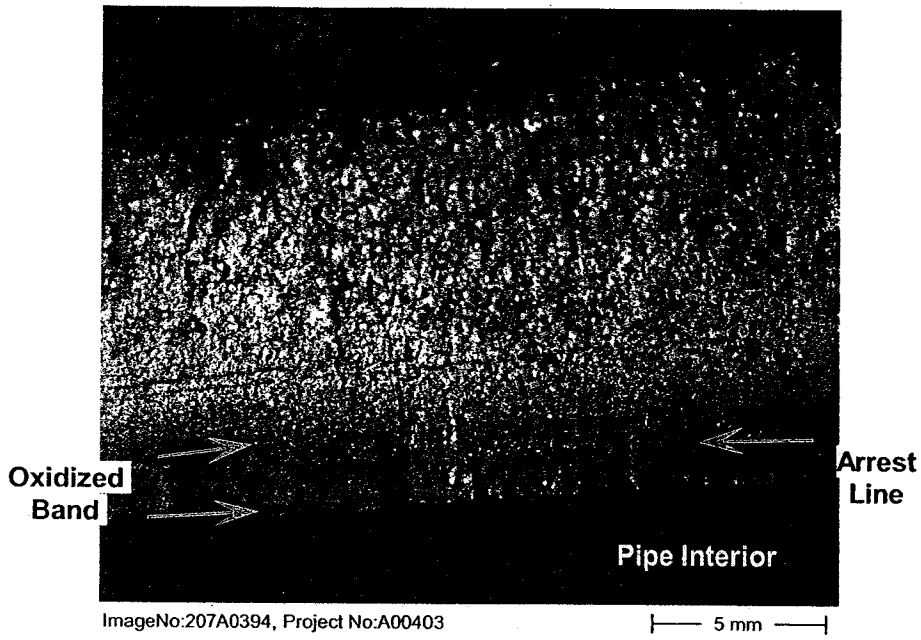
Figure 5--Closer views of the oxidized band adjacent to the pipe interior and the arrest line. At slightly different orientations and magnifications.

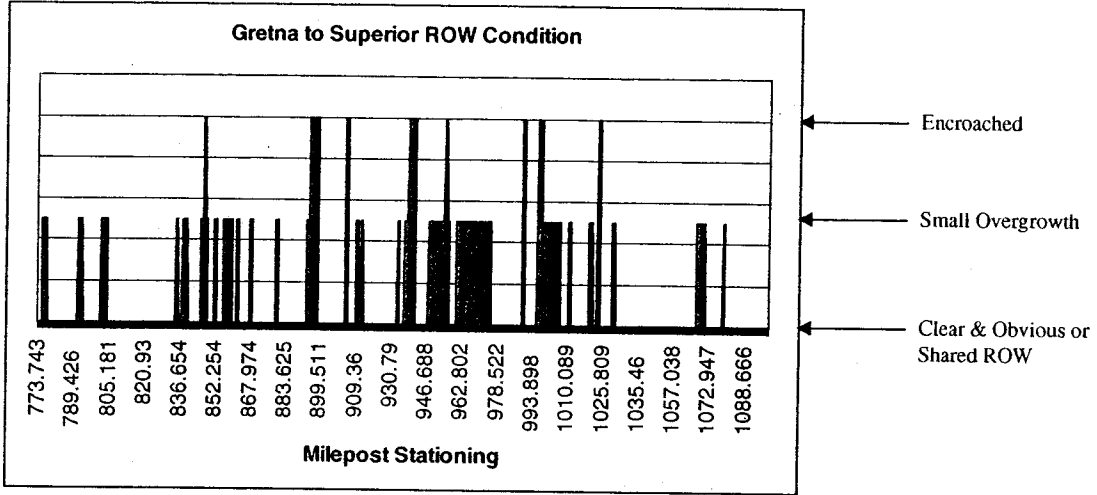
The right of way condition for several sections of pipe from Gretna to Superior is encroached or has small overgrowth as illustrated in the diagram below. Encroached right of way condition is associated with areas of higher population.

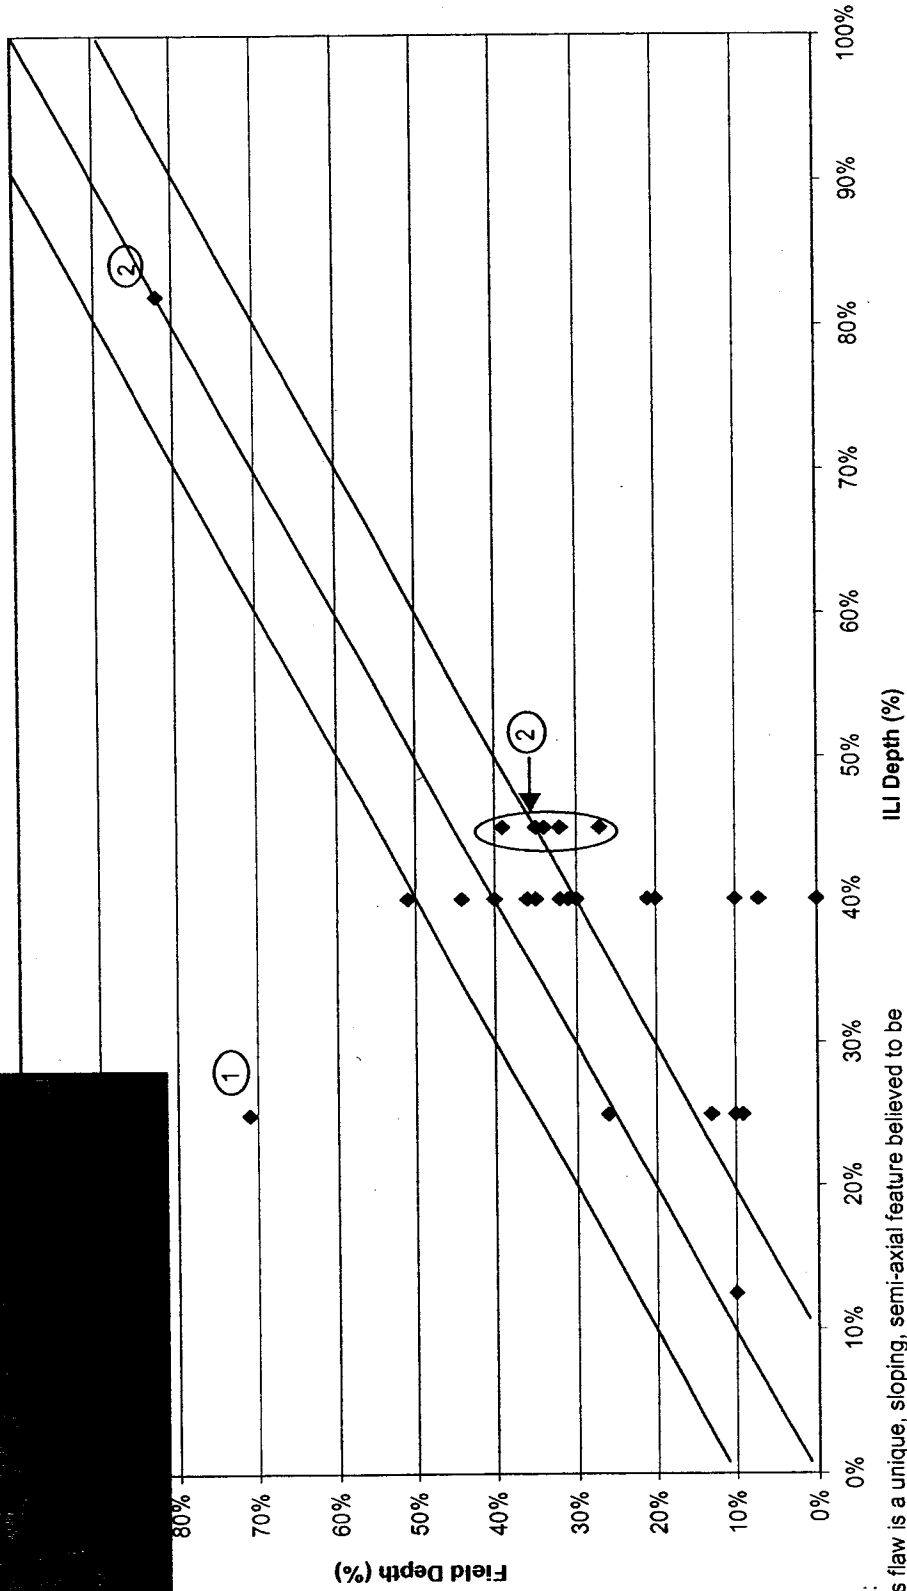
### Clearbrook to Superior "NL aw or iw" ILI Feature Depths vs. Field Depths

- Notes:
- 1. This flaw is a unique, sloping, semi-axial feature believed to be manufacturing or construction related (see photo).
  - 2. These defects reported by ILI as ">40%" depth.

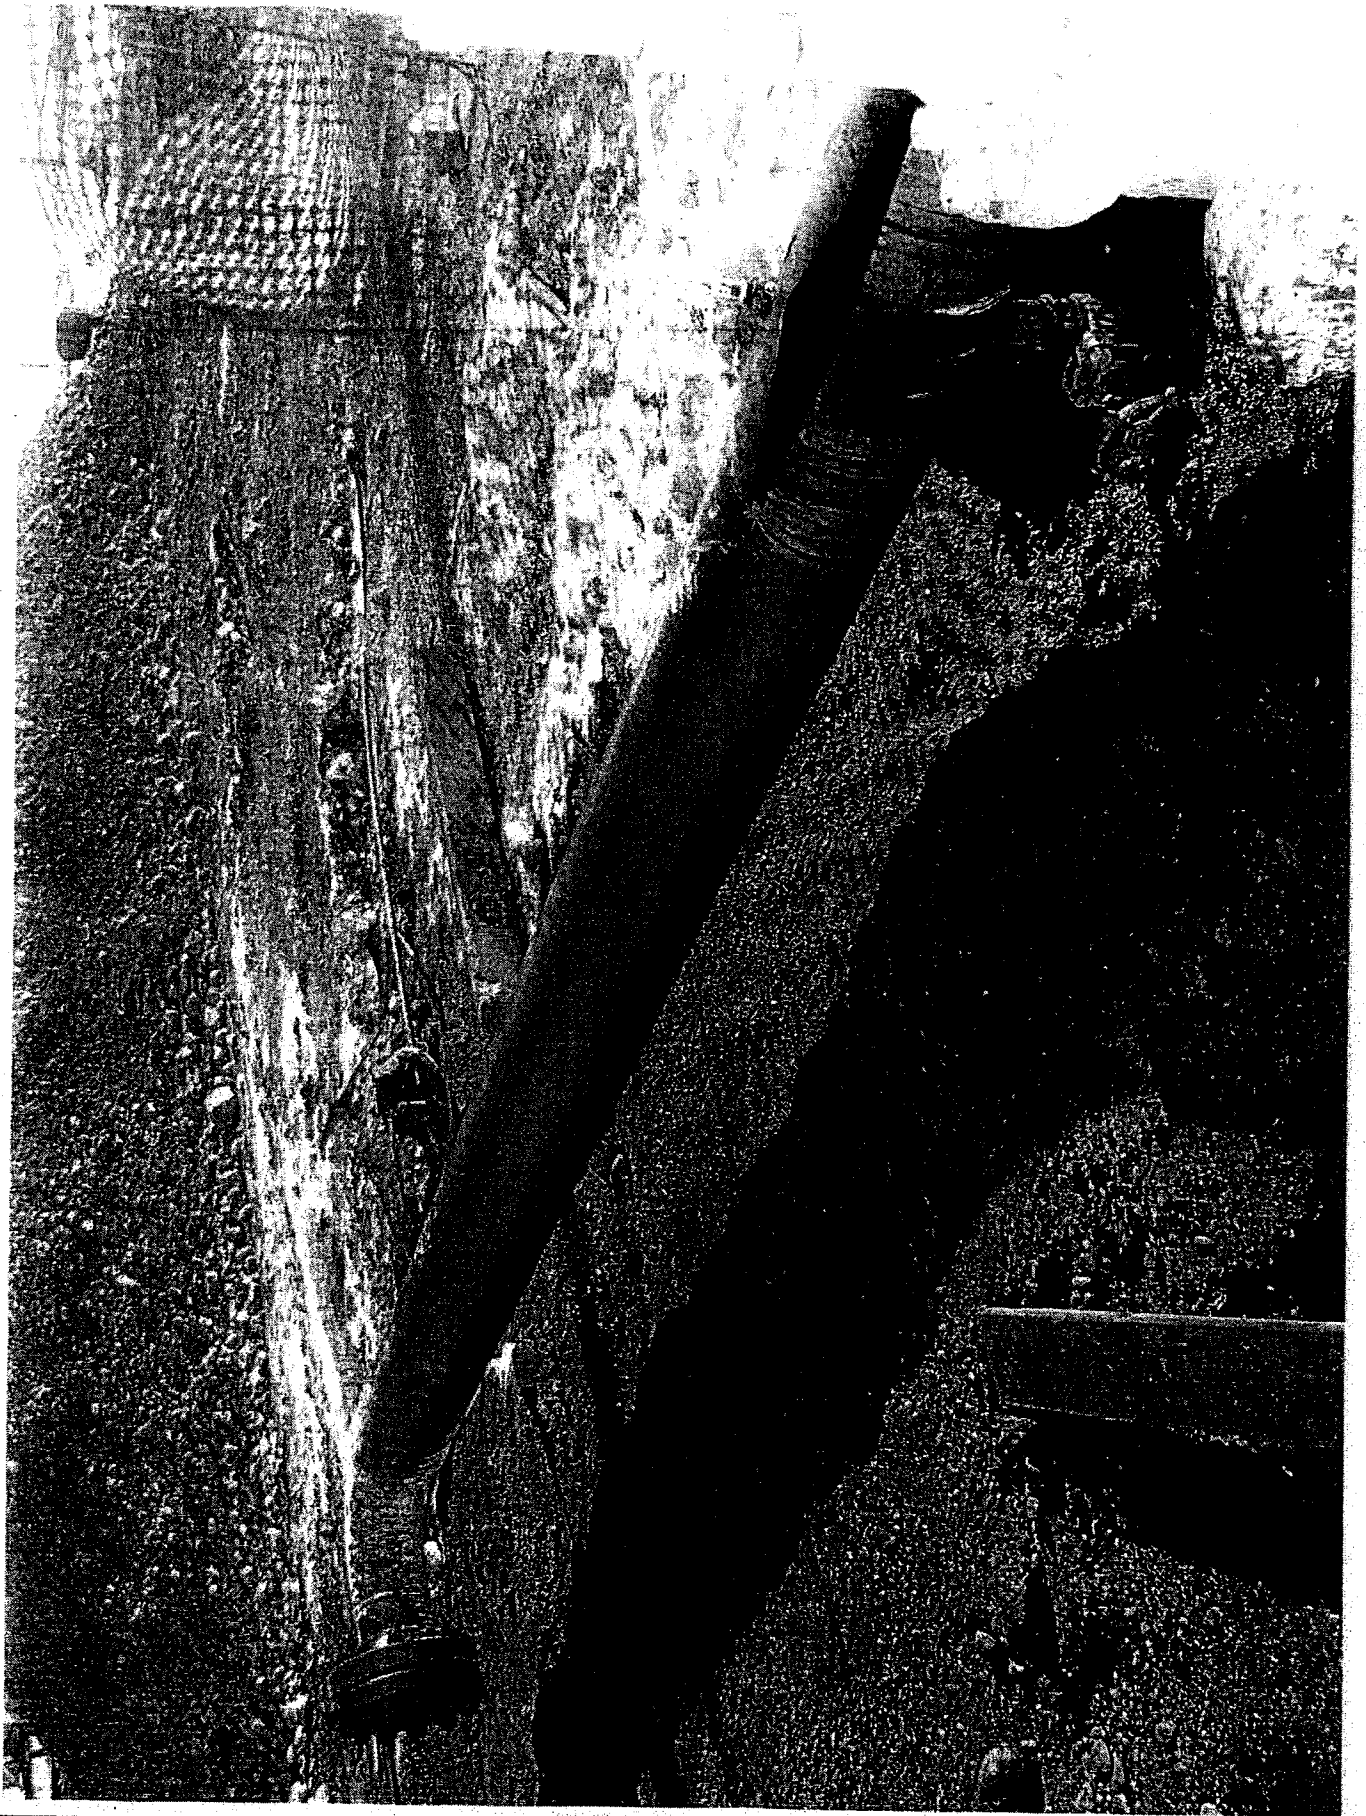
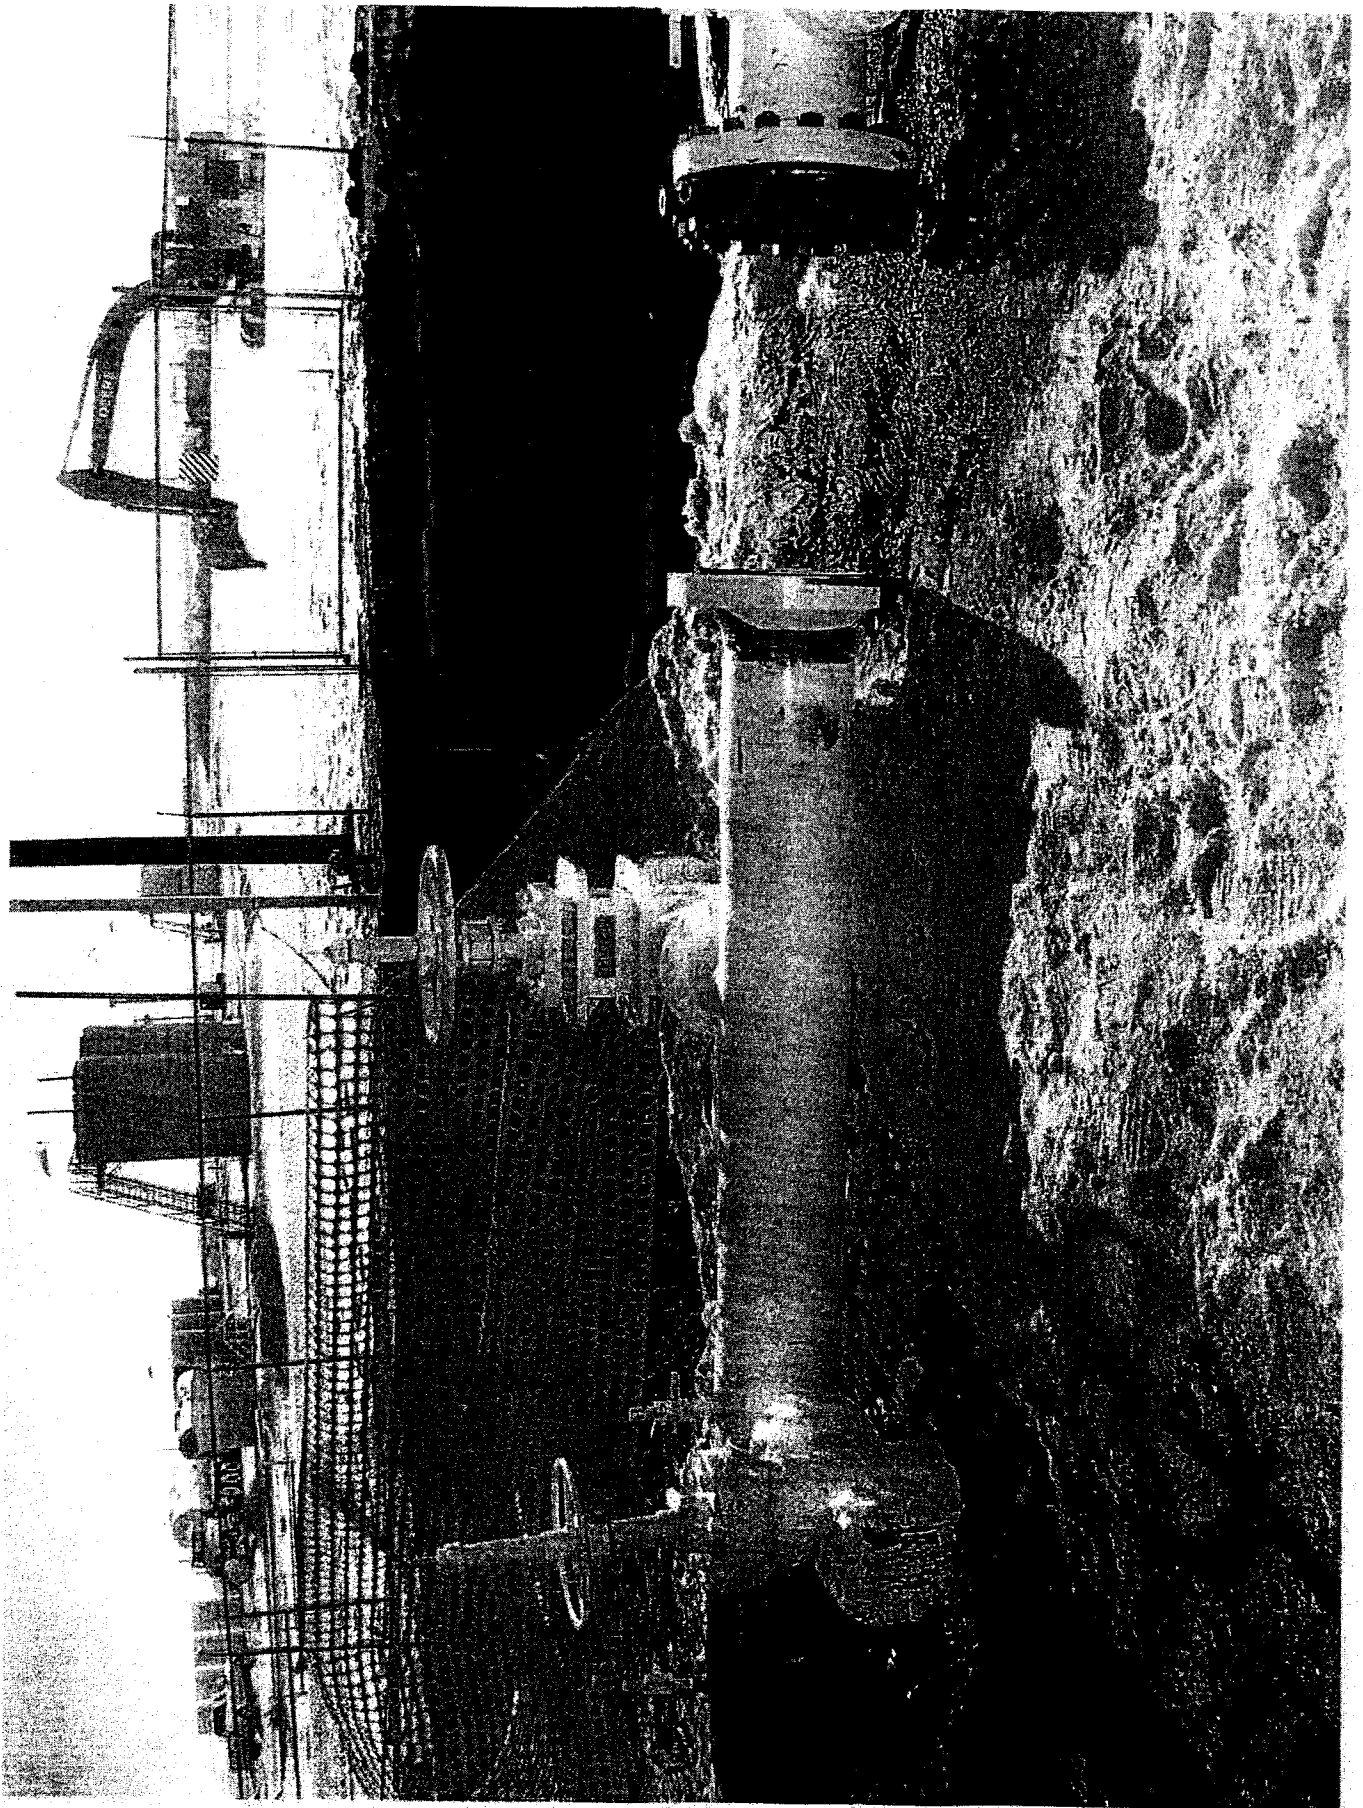
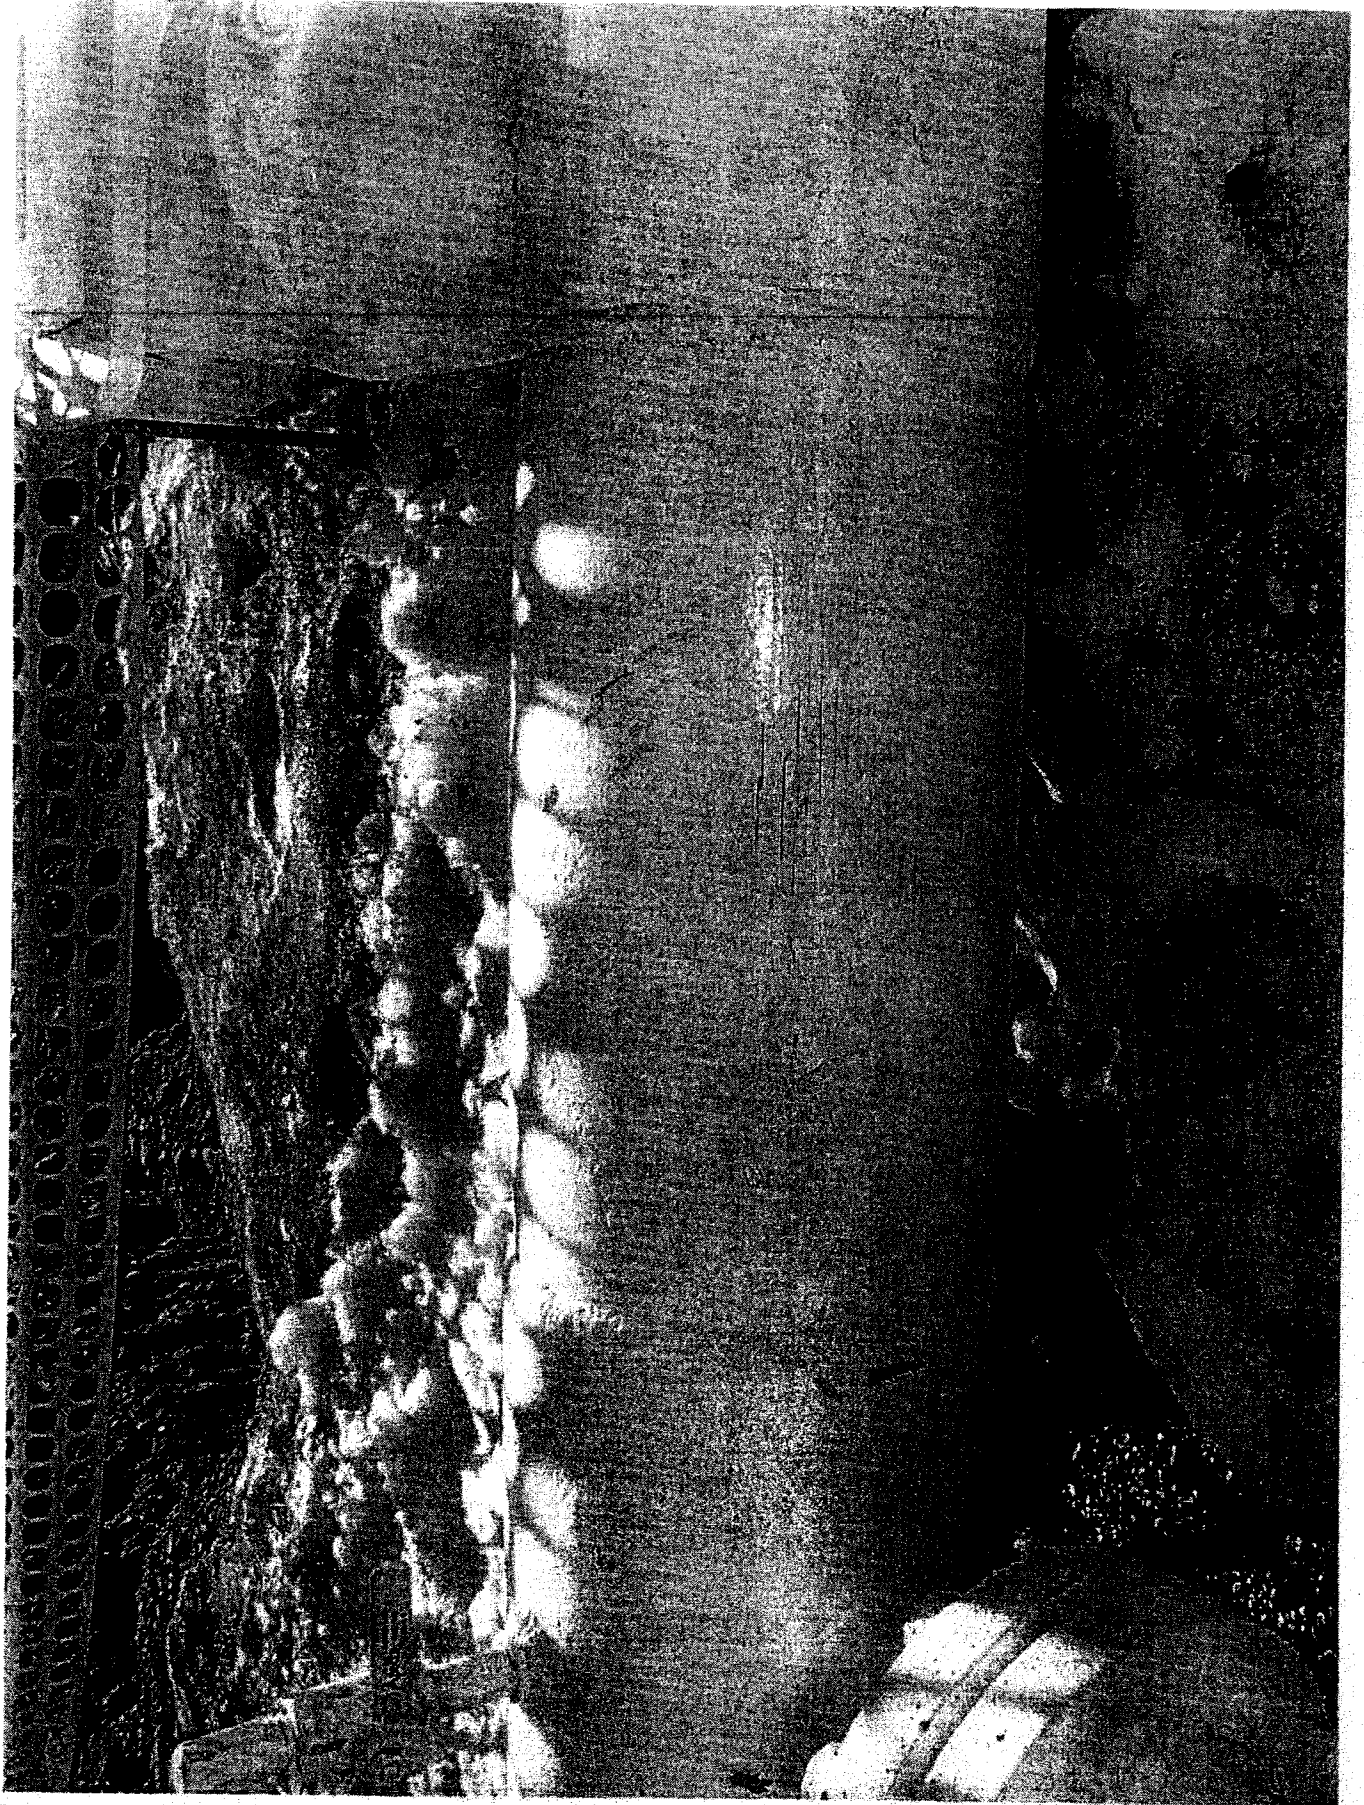
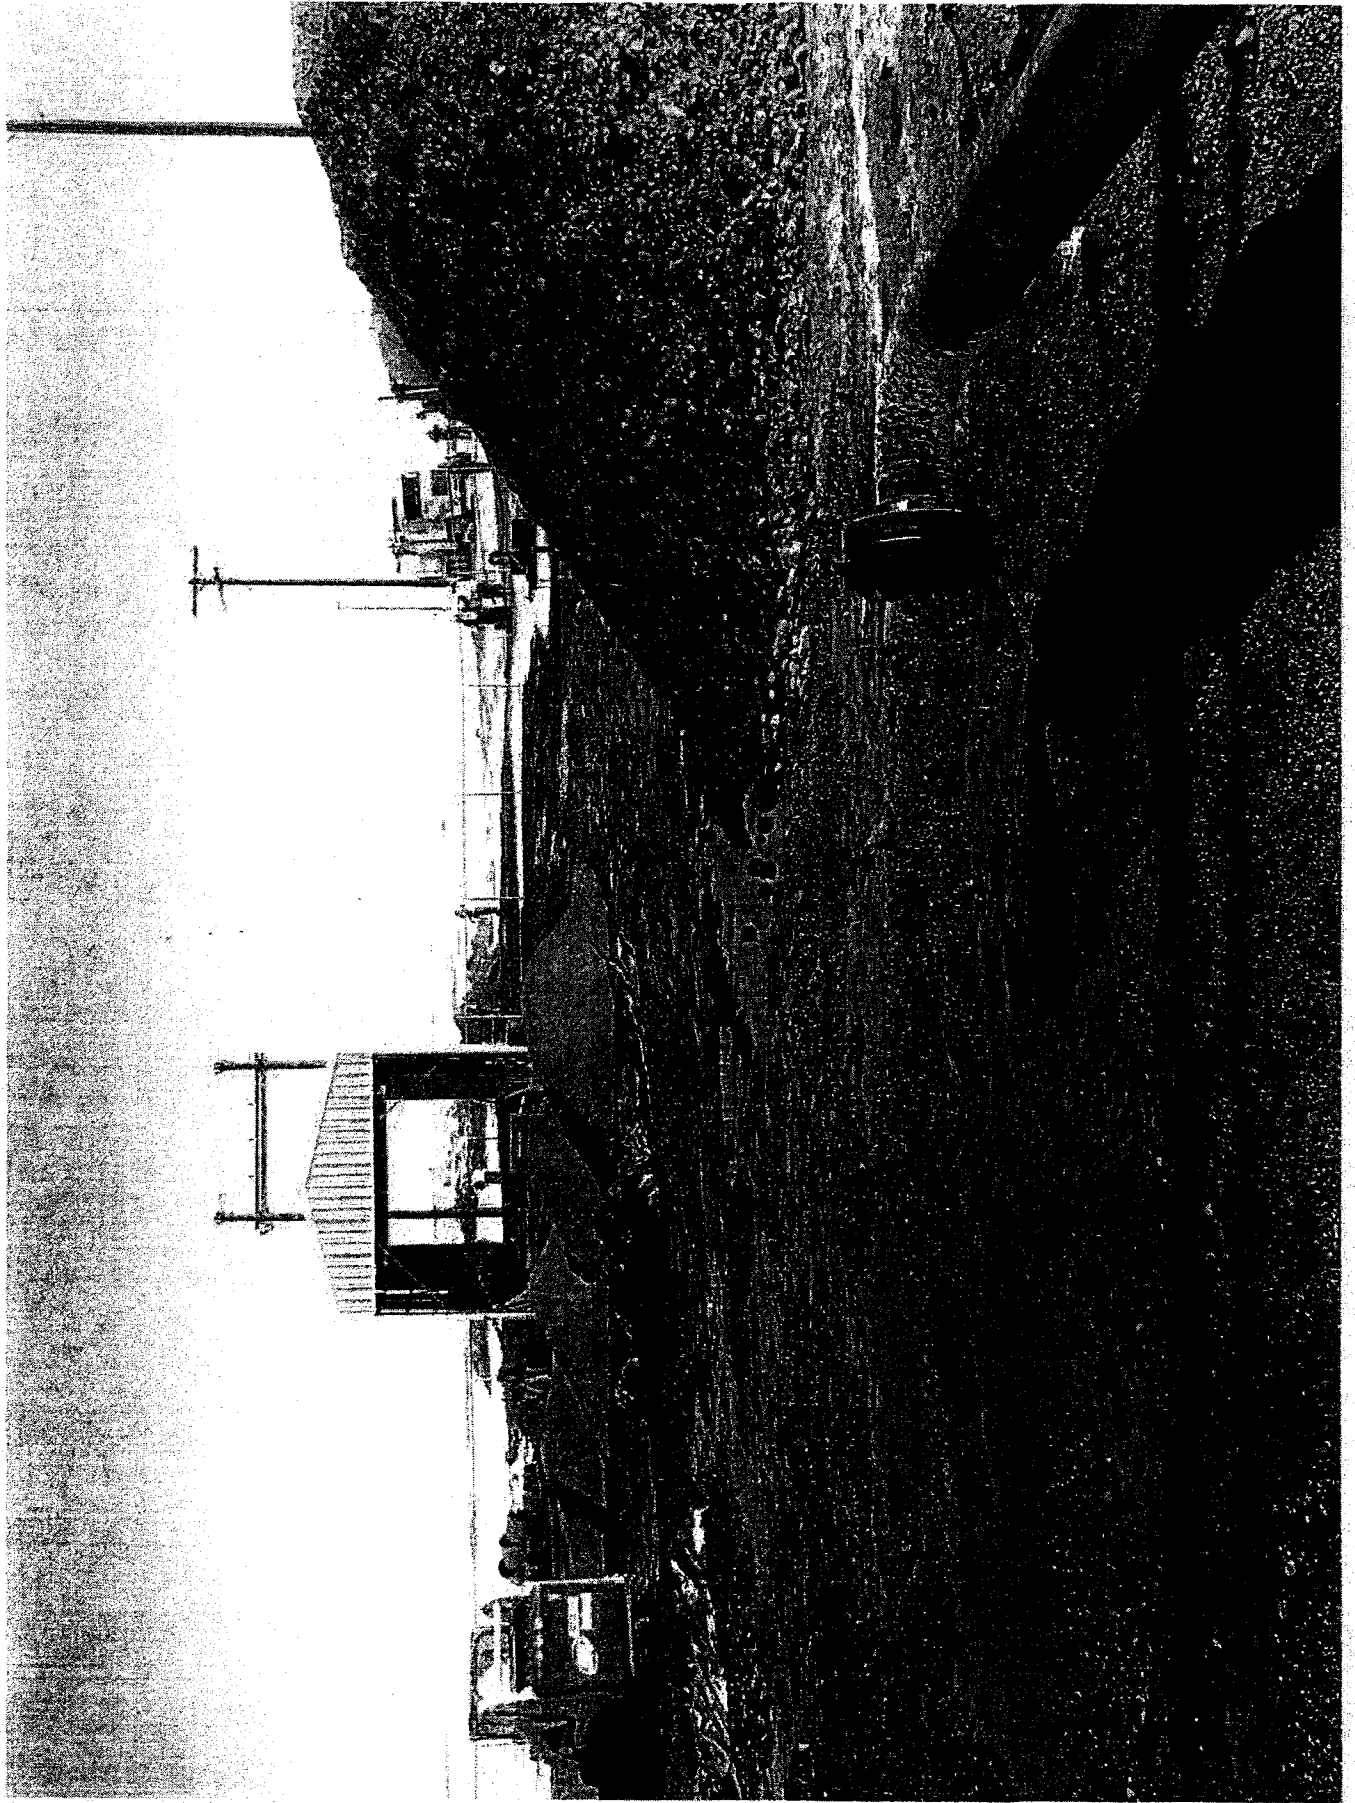
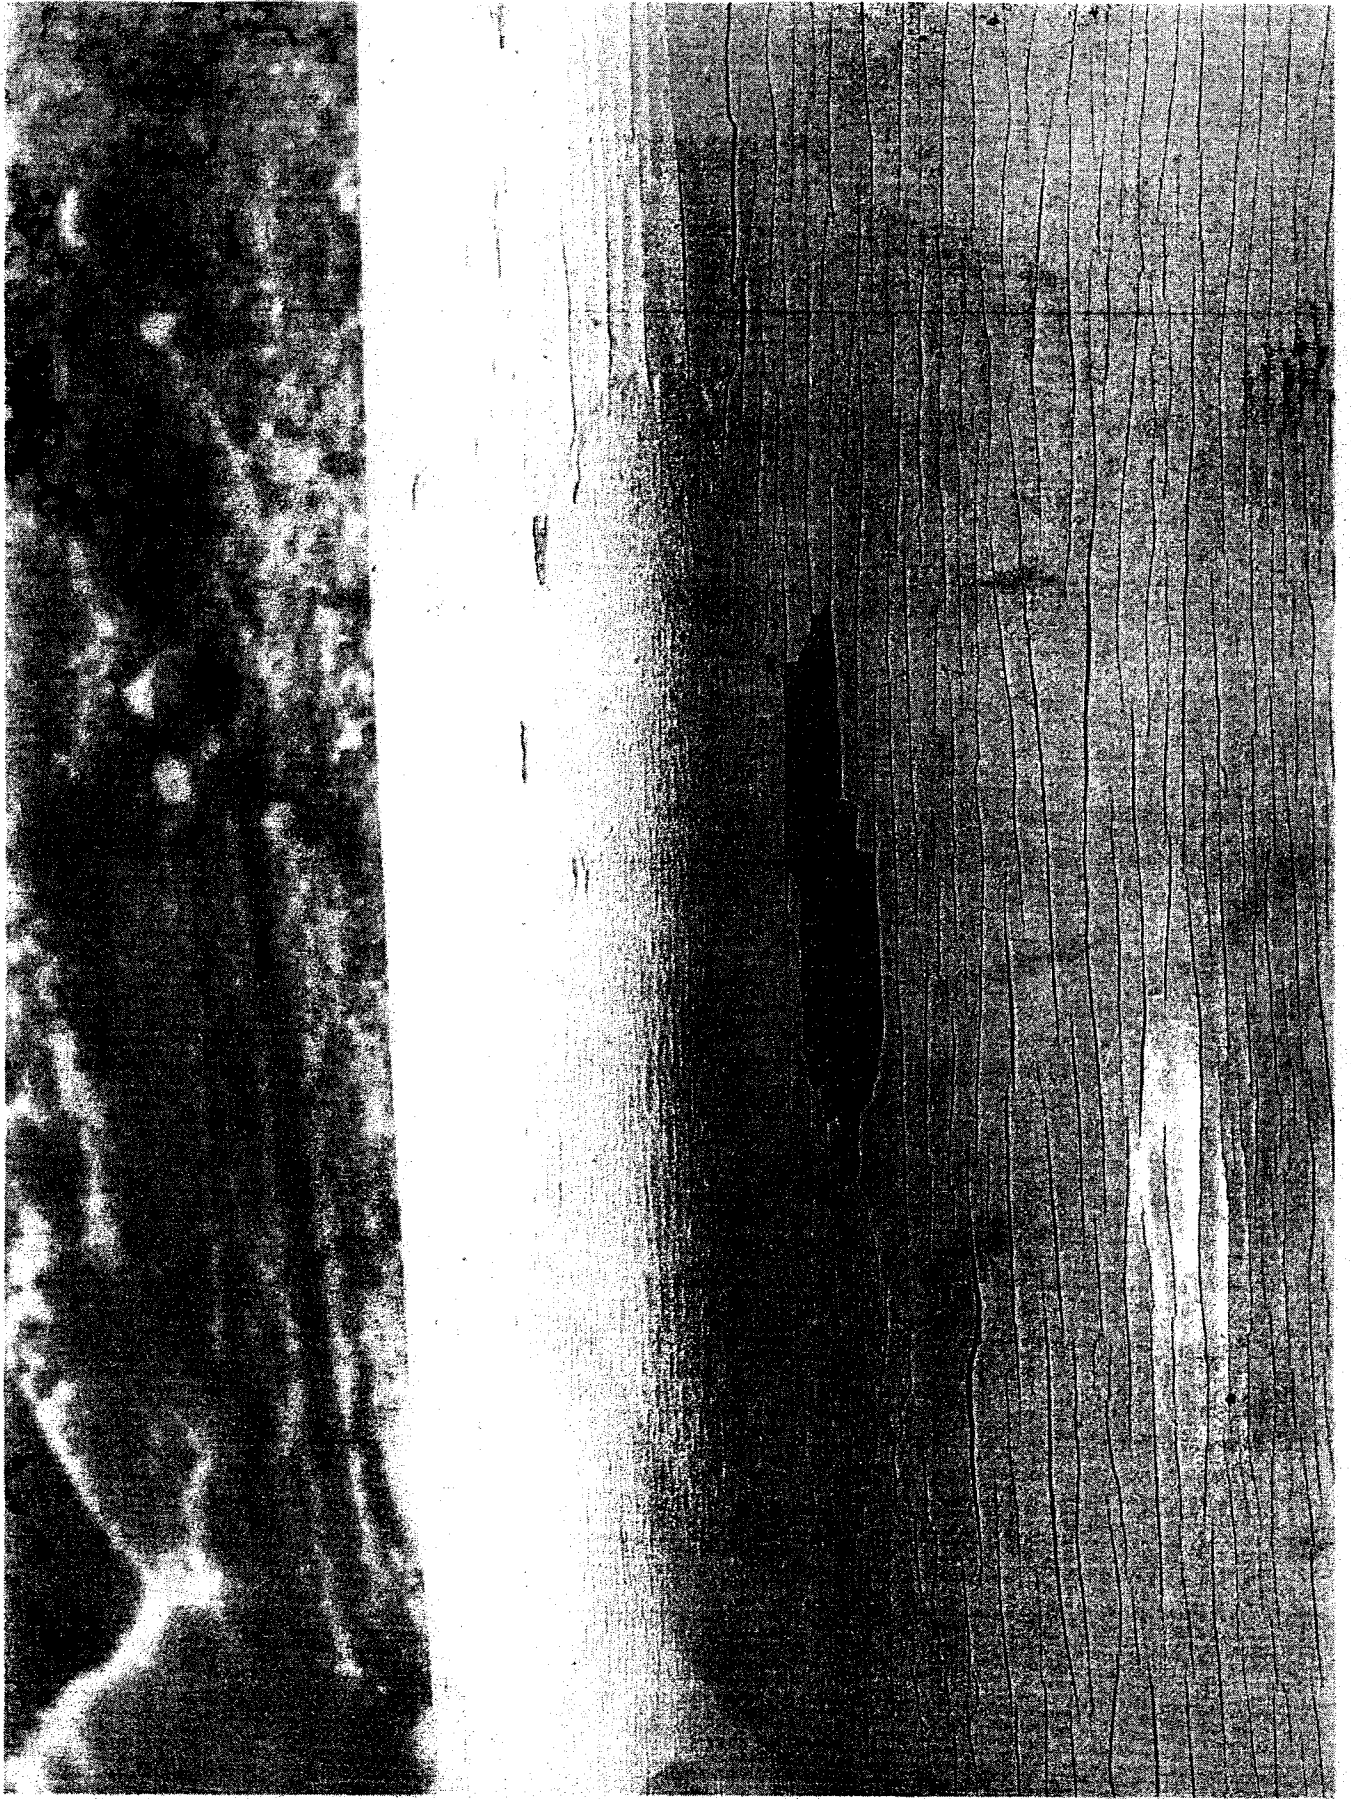
Violation number(s) supported by the evidence	Evidence (attached)	Obtained from	Identifying Witness
1	Pictures of the release site	Enbridge	N/A
