CITY OF RICHMOND

DEPARTMENT OF PUBLIC UTILITIES

**RE: Notice of Probable Violation and Civil Penalty
CPF 1-2010-0004**

We received your Notice of Probable Violation and Proposed Civil Penalty (Reference CPF 1-2010-0004) dated October 14, 2010 and received October 18, 2010. We are respectfully contesting the allegations in item 1. The documentary record set out below demonstrates that this allegation is based upon false information, and therefore is invalid and should be abandoned.

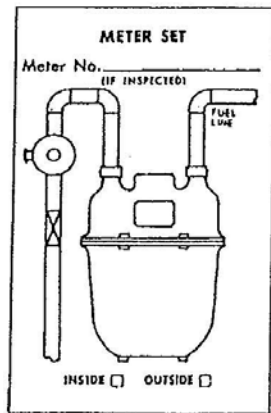
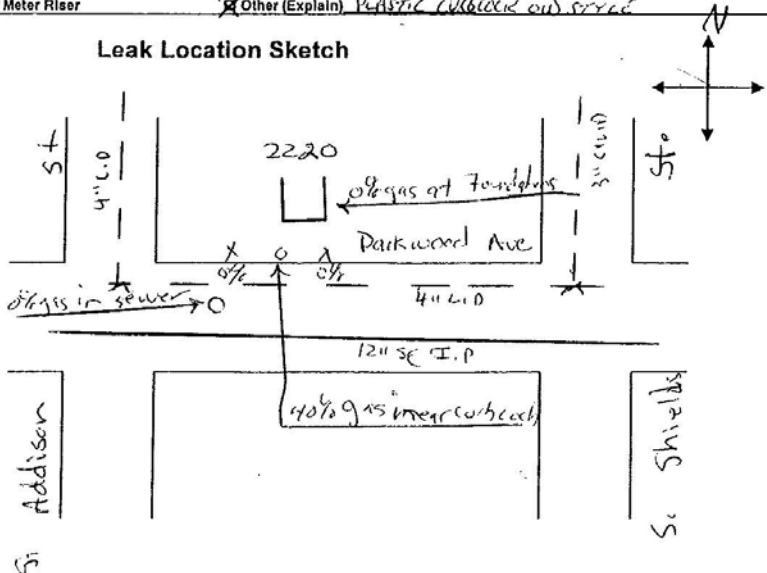
Leak Location Sketch

“Found 40% gas in bar hole near curbcock, 0% gas at foundation and sewer.
Made Grade II ticket to have H&M (our contractor Henkels & McCoy) to drill out main and services”.

Although marked as a Grade 1, the remarks text and readings indicate that this was a Grade 2 leak.

This Grade II leak was repaired on 1/2/09.

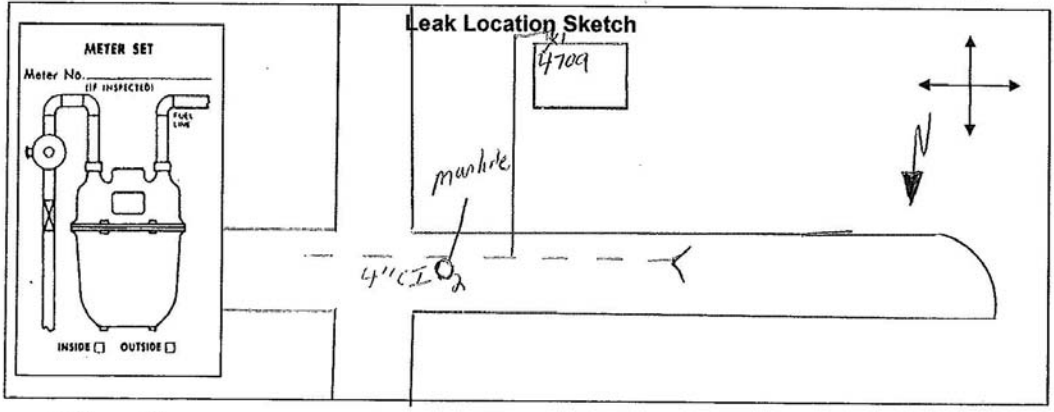
“Meet 497, Found Riser had corrosion holes. Need crew to make repairs. Made safe with a clamp”.

Attachment C: Leak 566945, Continued
 This Grade 1 Leak was made safe with a clamp

The entire service was replaced on the next day, 1/13/10.

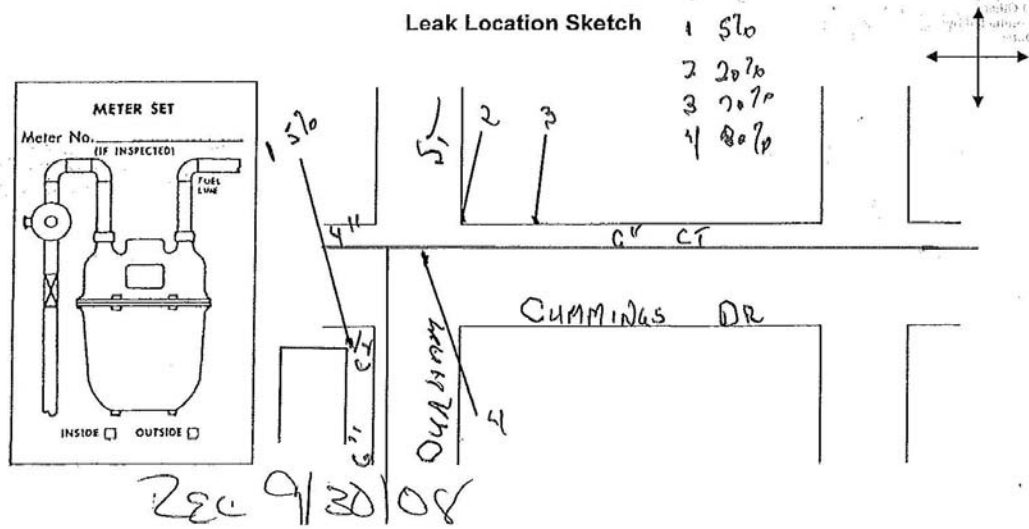
Allegation: This was a grade 1 leak reported on 9/26/08 and not repaired until 9/26/09.
Actual Fact: This grade 1 leak had the wrong repair date listed on the leak report form. There was continuous action on this leak until it was repaired on 9/27/08.

The leak was repaired in the early morning hours of 9/27/08. The report states:

“Found 6” Mechanical joint leaking, tighten joint up, soap check, no leaks...”

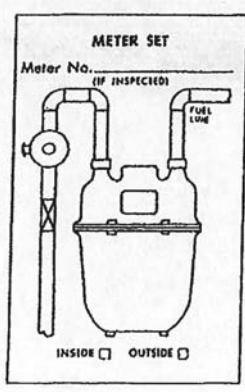
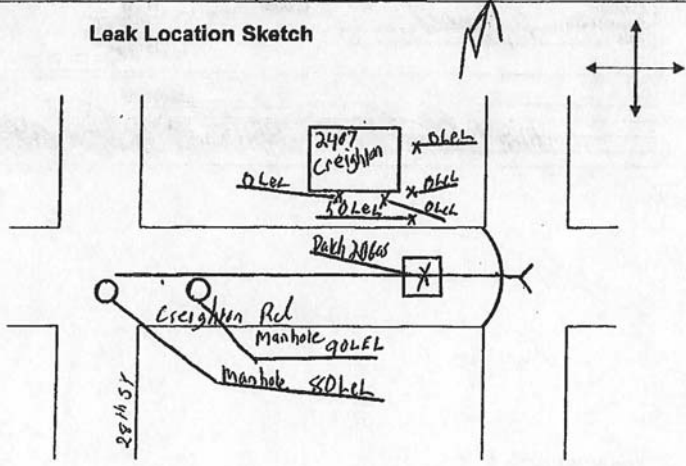
Leak Location Sketch

Actual Fact: This leak was downgraded to a Grade II leak on 1/7/09 and repaired on 1/9/09.

Our Inspector (unit 242) arrived at this Grade I leak at 13:28 pm on 1/7/09. The leak was classified as a Grade I since $\geq 80\%$ LEL was measured in a manhole (90% LEL)

The H&M crews returned on 1/8/09 and 1/9/09 to continue work on this Grade II leak. The main was 9-1/2 feet deep. A mechanical joint on a 12” CI main was tightened to repair the leak on 1/9/09.
