**Re: CPF 5-2009-5001**

Your office conducted an inspection of our Sidney, Montana pipeline system in July, 2008. As a result of this inspection you issued a Notice of Probable Violation and Proposed Compliance Order for three items which required remedial action. On February 9, 2009, SemStream, L.P. sent you a letter outlining actions SemStream had either taken or planned to take to remedy the alleged violations. The purpose of this letter is to provide follow-up information as indicated in our February 9, 2009 letter. The remaining two open items and SemStream's remedy are as follows:

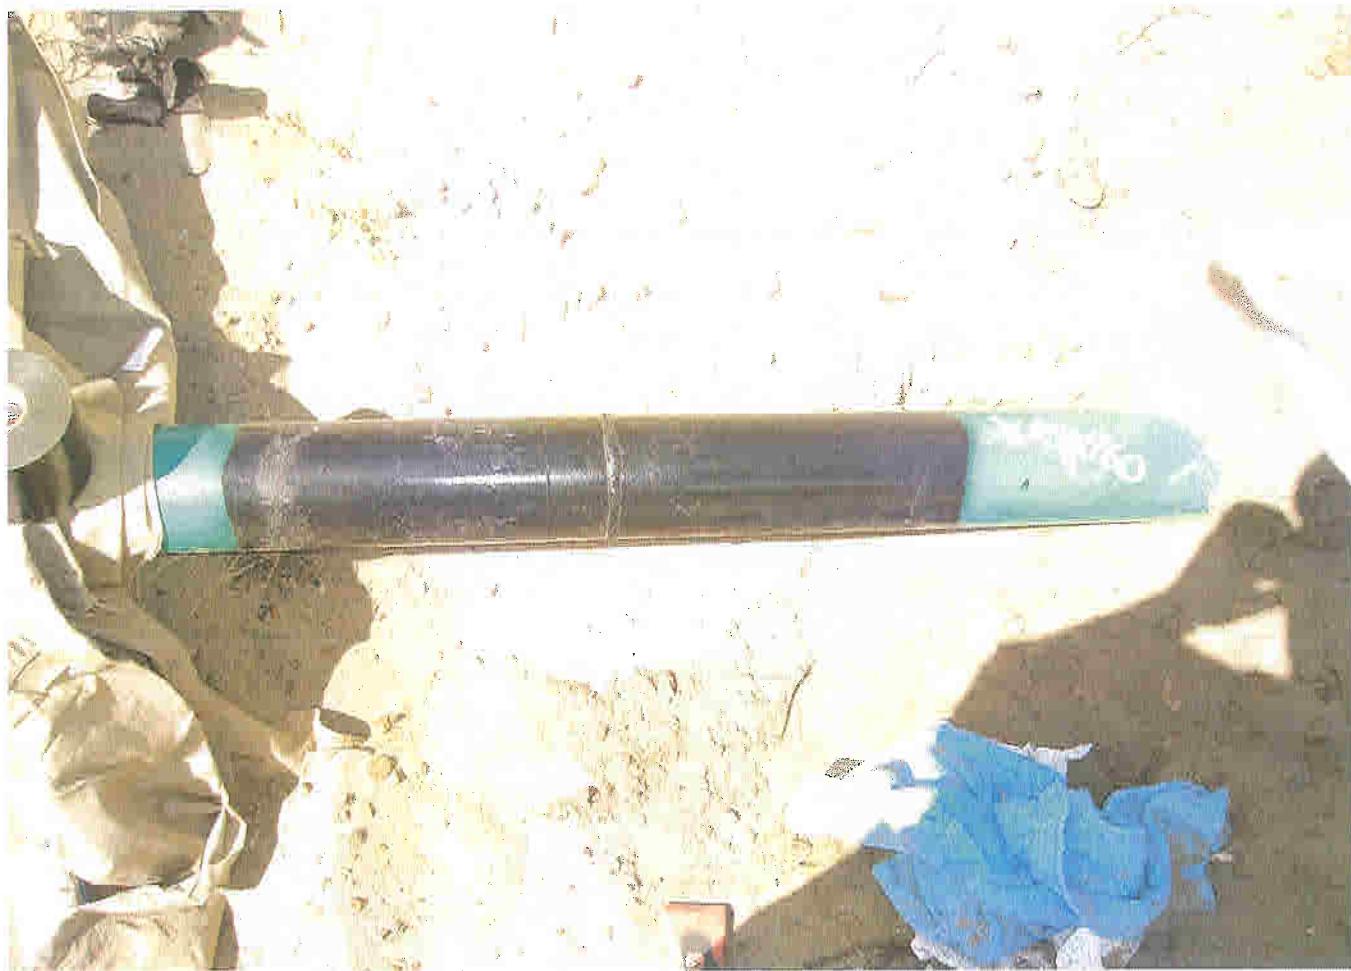
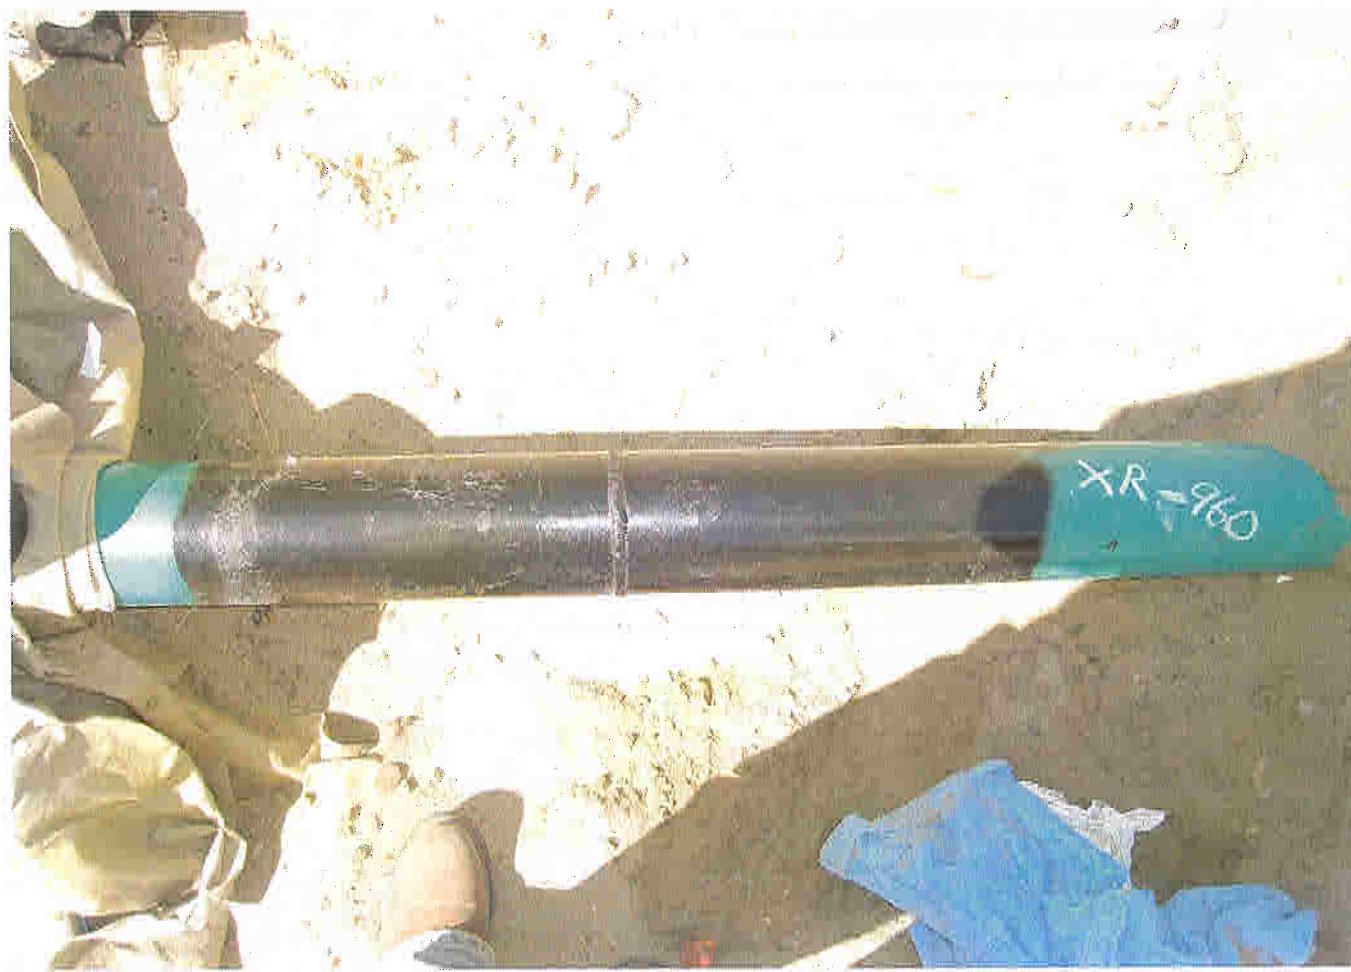
SemStream construction records for their HVL Pipeline System reveal that two (2) butt welds (numbers 999 and 960) were rejected because of low caps. SemStream had no record of the repair of these two welds.

As per the plan outlined in our response dated February 9, 2009, SemStream has excavated welds 999 and 960, inspected them and documented the condition of the welds. Based on the inspection made by TK Inspection Services, neither weld required additional repair. Photographs of the welds as well as the inspection report from TK Inspection Services is attached.
