RE: CPF 4-2009-1003

Northern Natural Gas (Northern) received a Warning Letter dated February 2, 2009, from the US Department of Transportation-Pipeline and Hazardous Material Safety Administration (PHMSA) resulting from PHMSA Southwest Region audits of Northern Natural Gas facilities in the Spearman and Spraberry, Texas areas during the period of September 15-19 and 23-26, 2008. Although Northern understands that a formal response is not required, Northern is submitting this letter for the record in response to the issues noted in the Warning Letter.

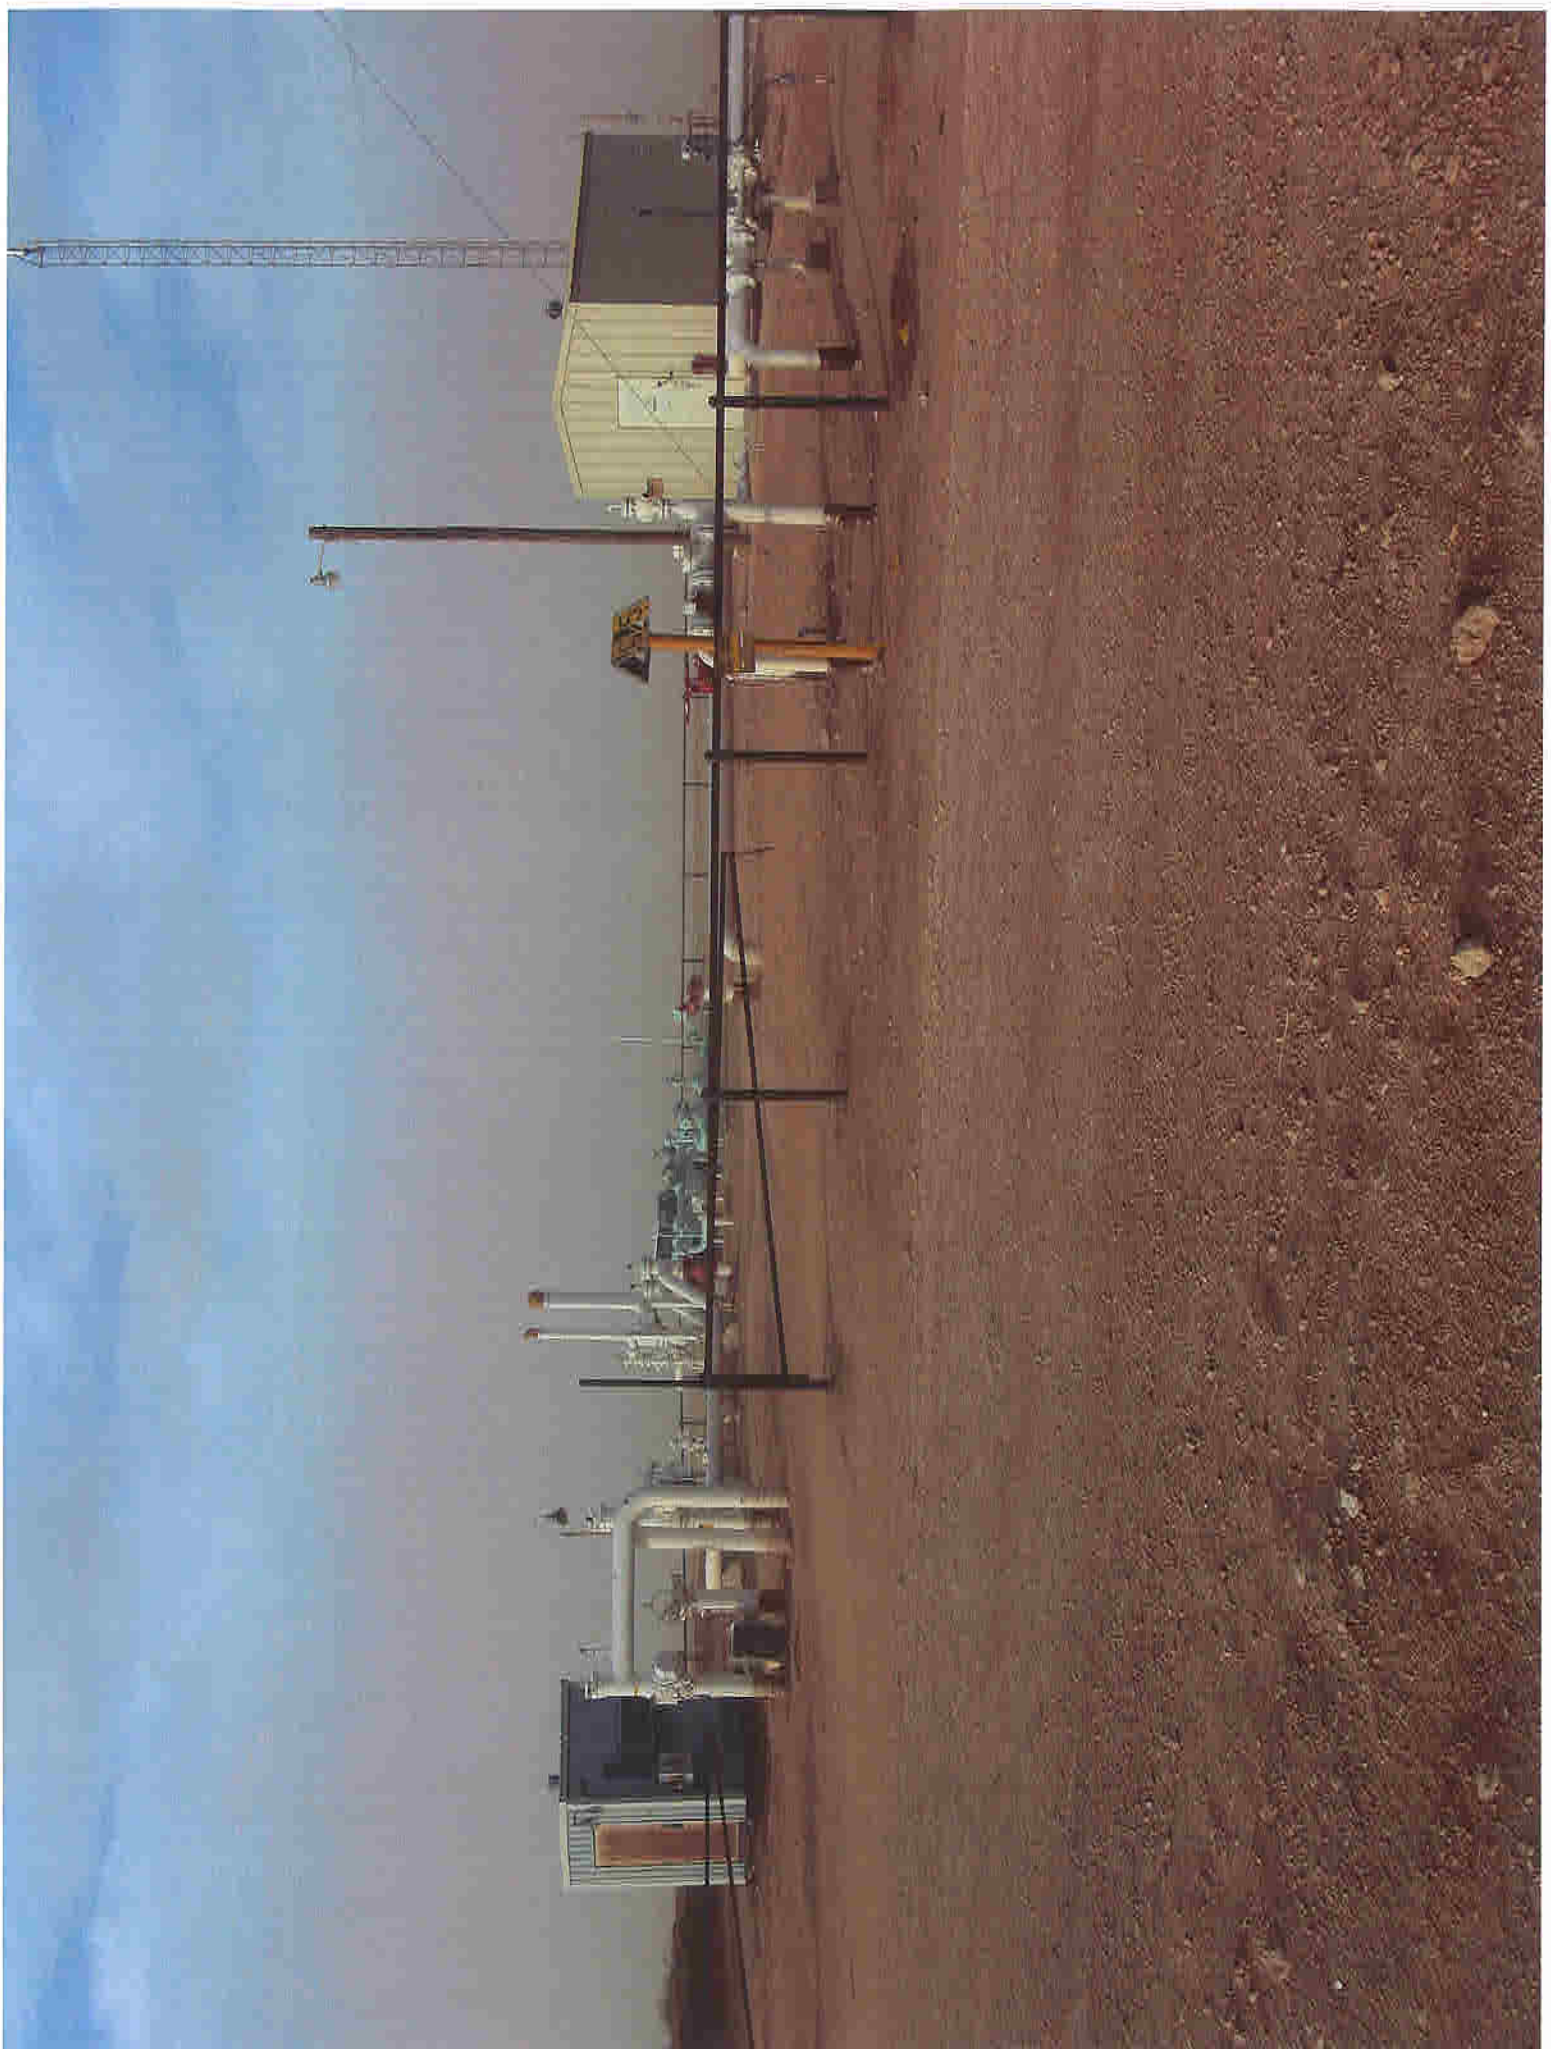
**“The K-B pipeline Crossover facility in Gaines County is located away from regular domestic traffic but still needs protection from possible farm equipment activity. NNG must install a barrier to better protect this above ground piping assembly from being hit and causing possible component damage. ”**

*Northern has installed a barrier around the above ground piping and appurtenances at the K- B pipeline crossover facility. Pictures of the completed protection structure are attached.*
