PIPELINE QUALIFICATION RECORD

Line Number 38 BNT04A-100 Orig. Appro. #
Line Name Norteno #4 Gillette Rd.
Description of Location Gillette Rd. Lateral, near Canutillo, Texas in El Paso County, Texas and Dona Ana County, New Mexico

REPORT OF PIPELINE PRESSURE TEST

Line Name Norteno #4 Test Medium: Water Gas Air
 Job Order Number: _____ Region Permian
 Location: Section _____ Twp. _____ Rge. _____ To: Section _____ Twp. _____ Rge. _____
 Design Pressure 1430/1083 PSIG MAOP 250 PSIG OGT Pre-Test #: PT-0713

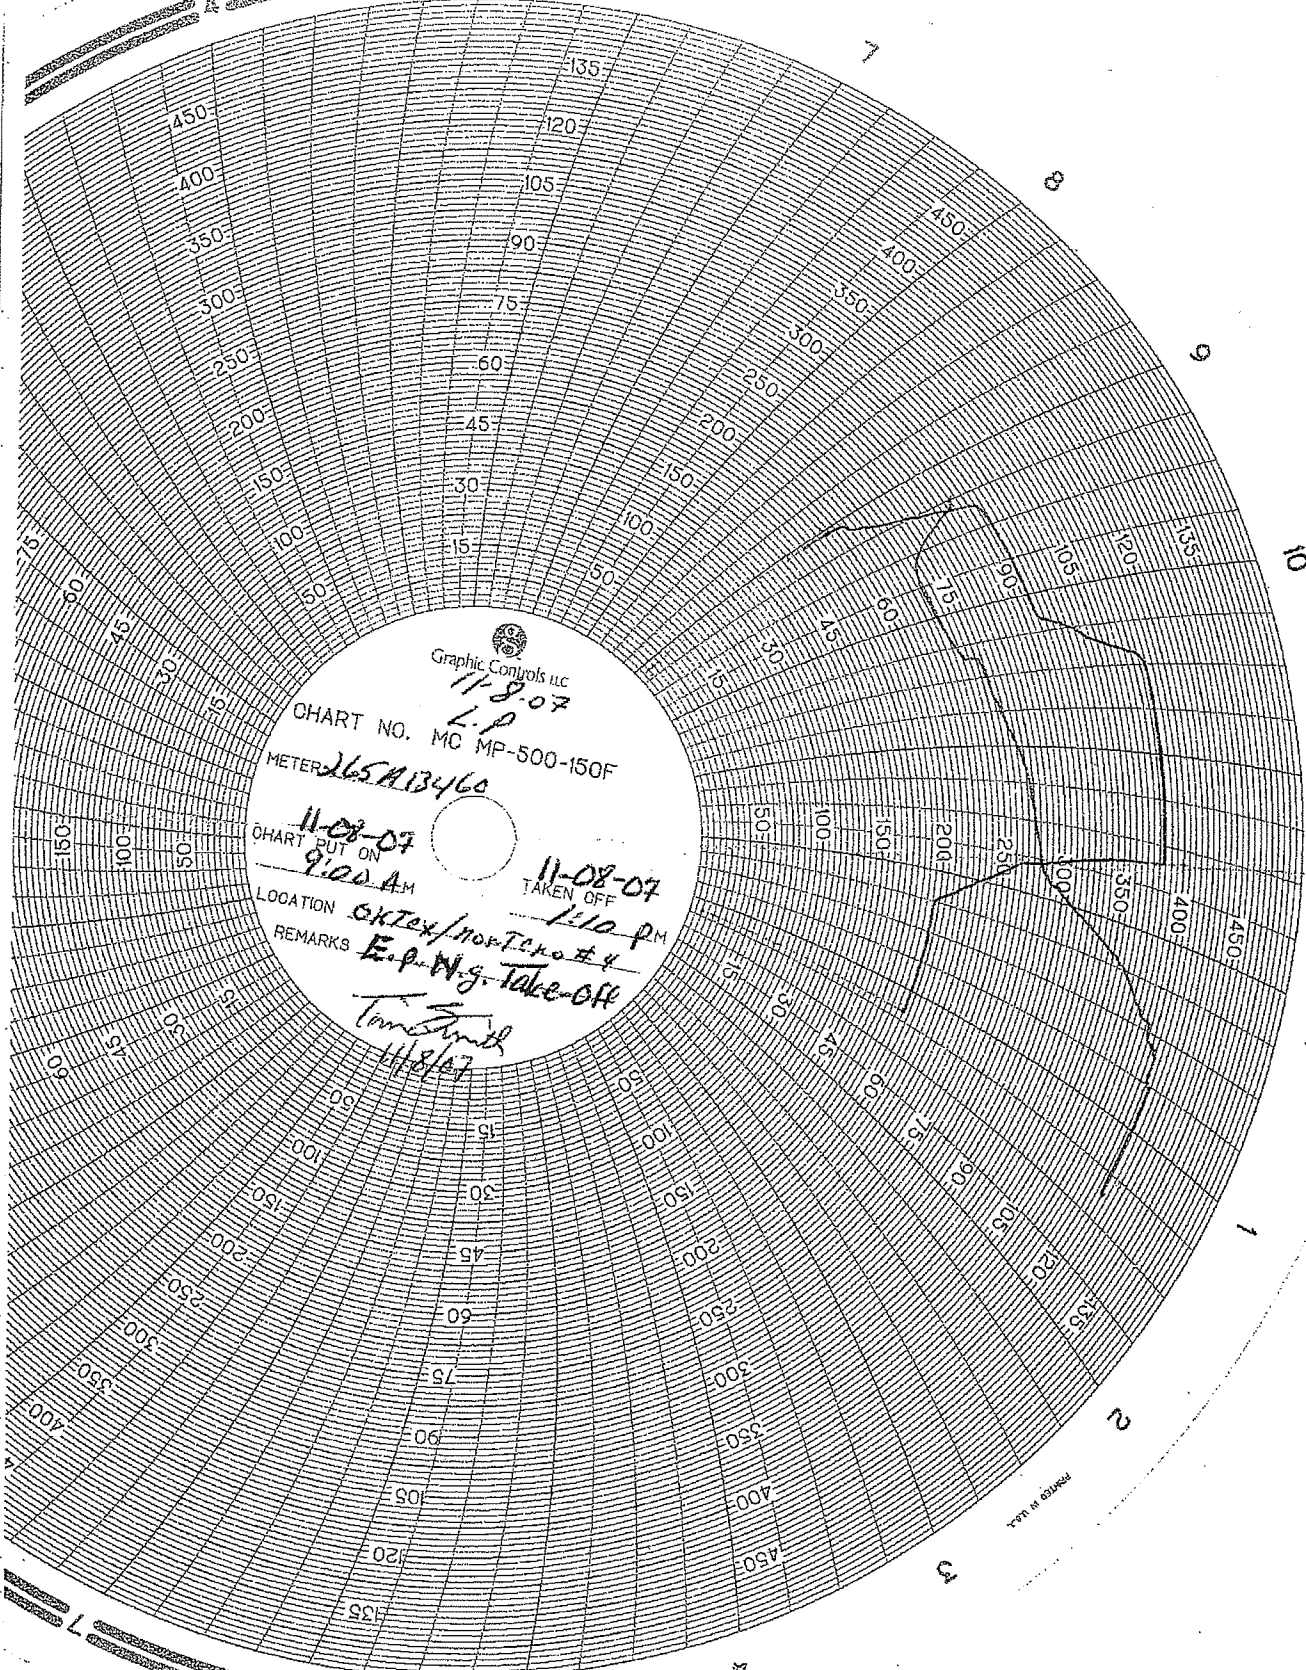
CHART NO. MC MP-500-150F
METER 265A13460

CHART PUT ON 11-08-07
9:00 AM
TAKEN OFF 11-08-07
1:10 PM

LOCATION *EXTR/NORTHO #4*
REMARKS *Exp. W.g. Take-off*

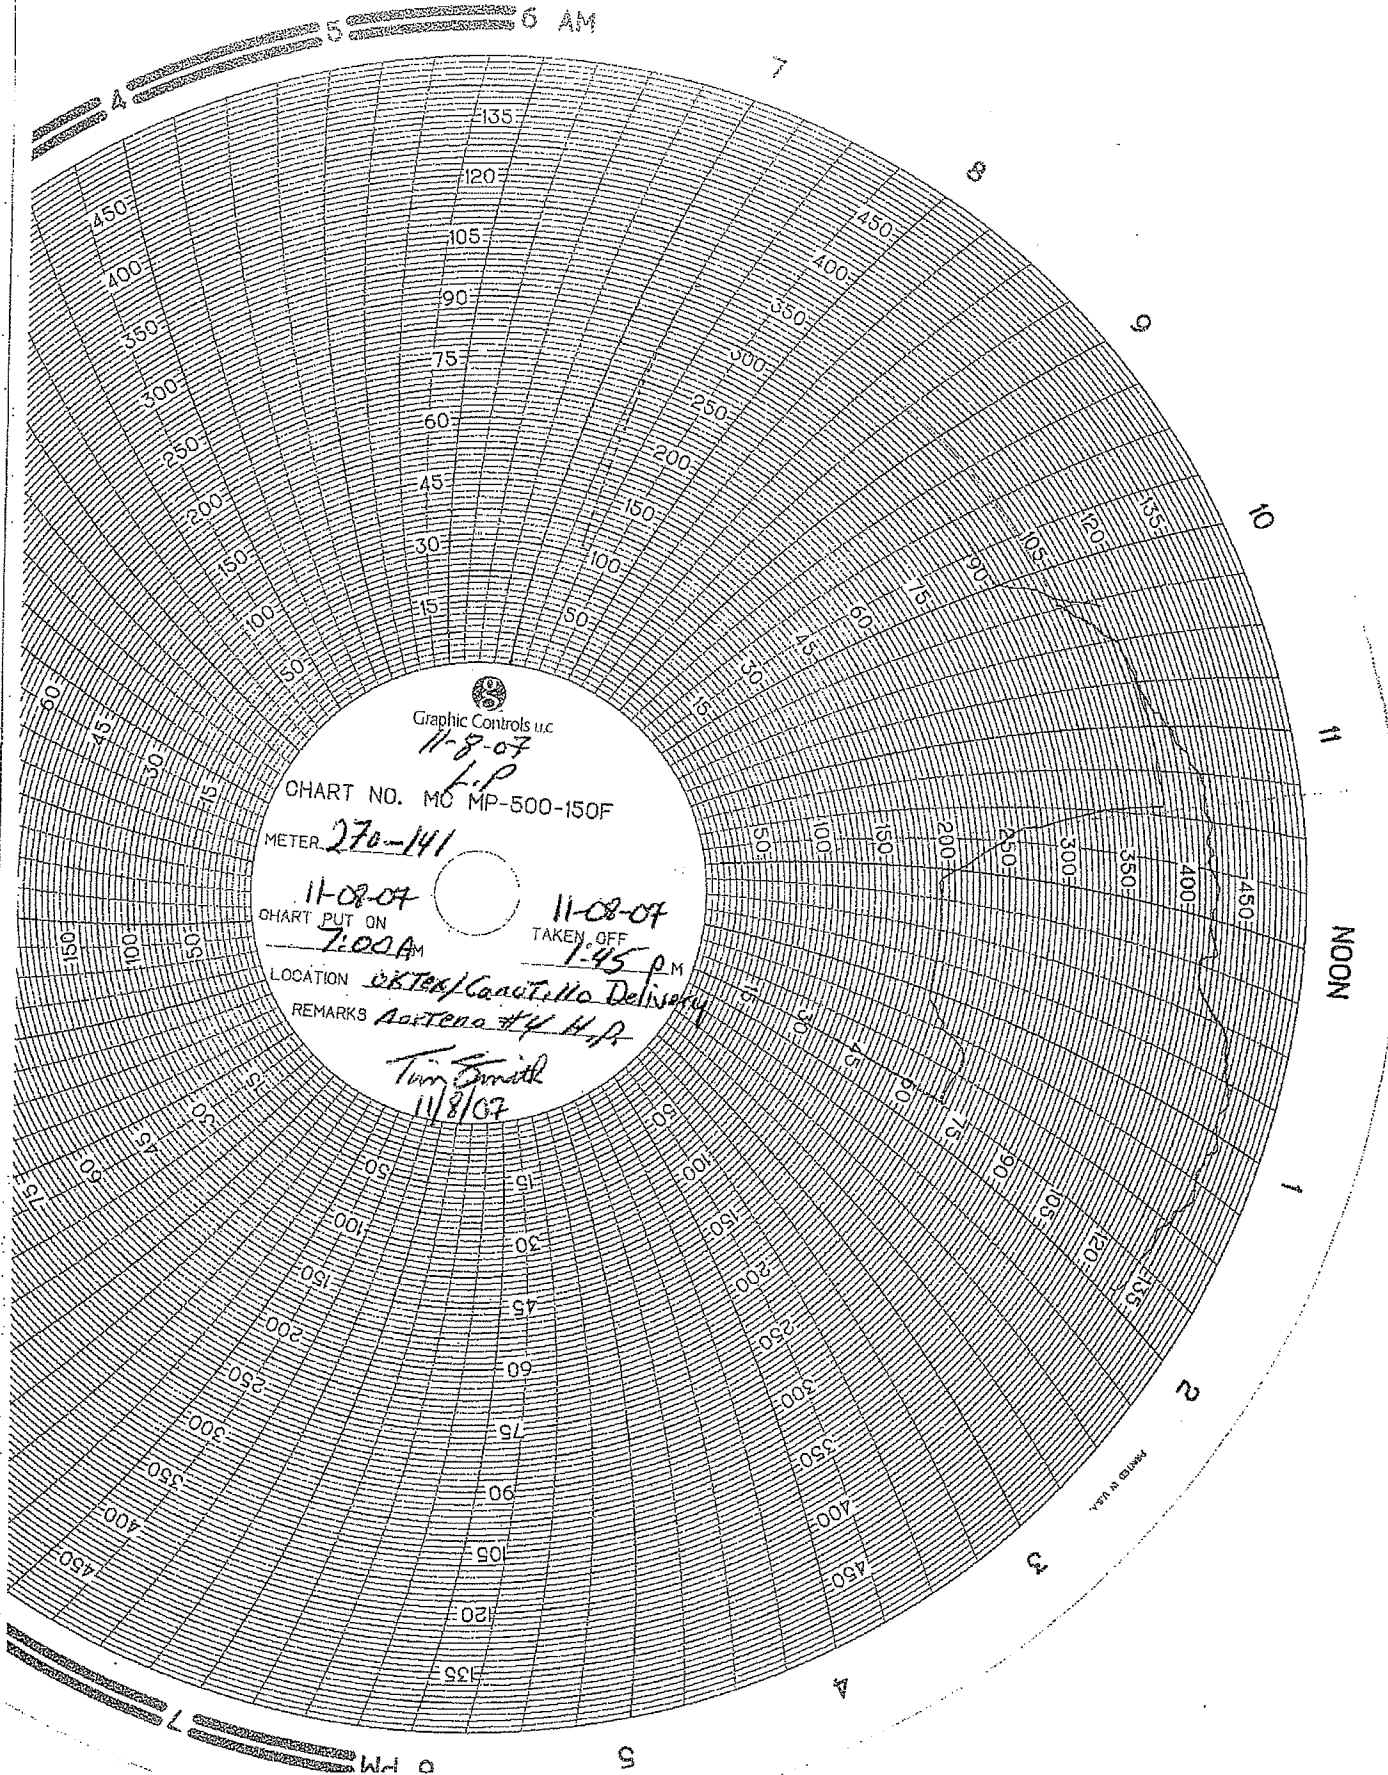
CHART NO. MC MP-500-150F

METER 270-141

11-08-07
CHART PUT ON
7:00 AM

11-08-07
TAKEN OFF
1:45 P.M.

LOCATION *OSTEA/Canutella Delivery*
REMARKS *Antenna #4 H.R.*

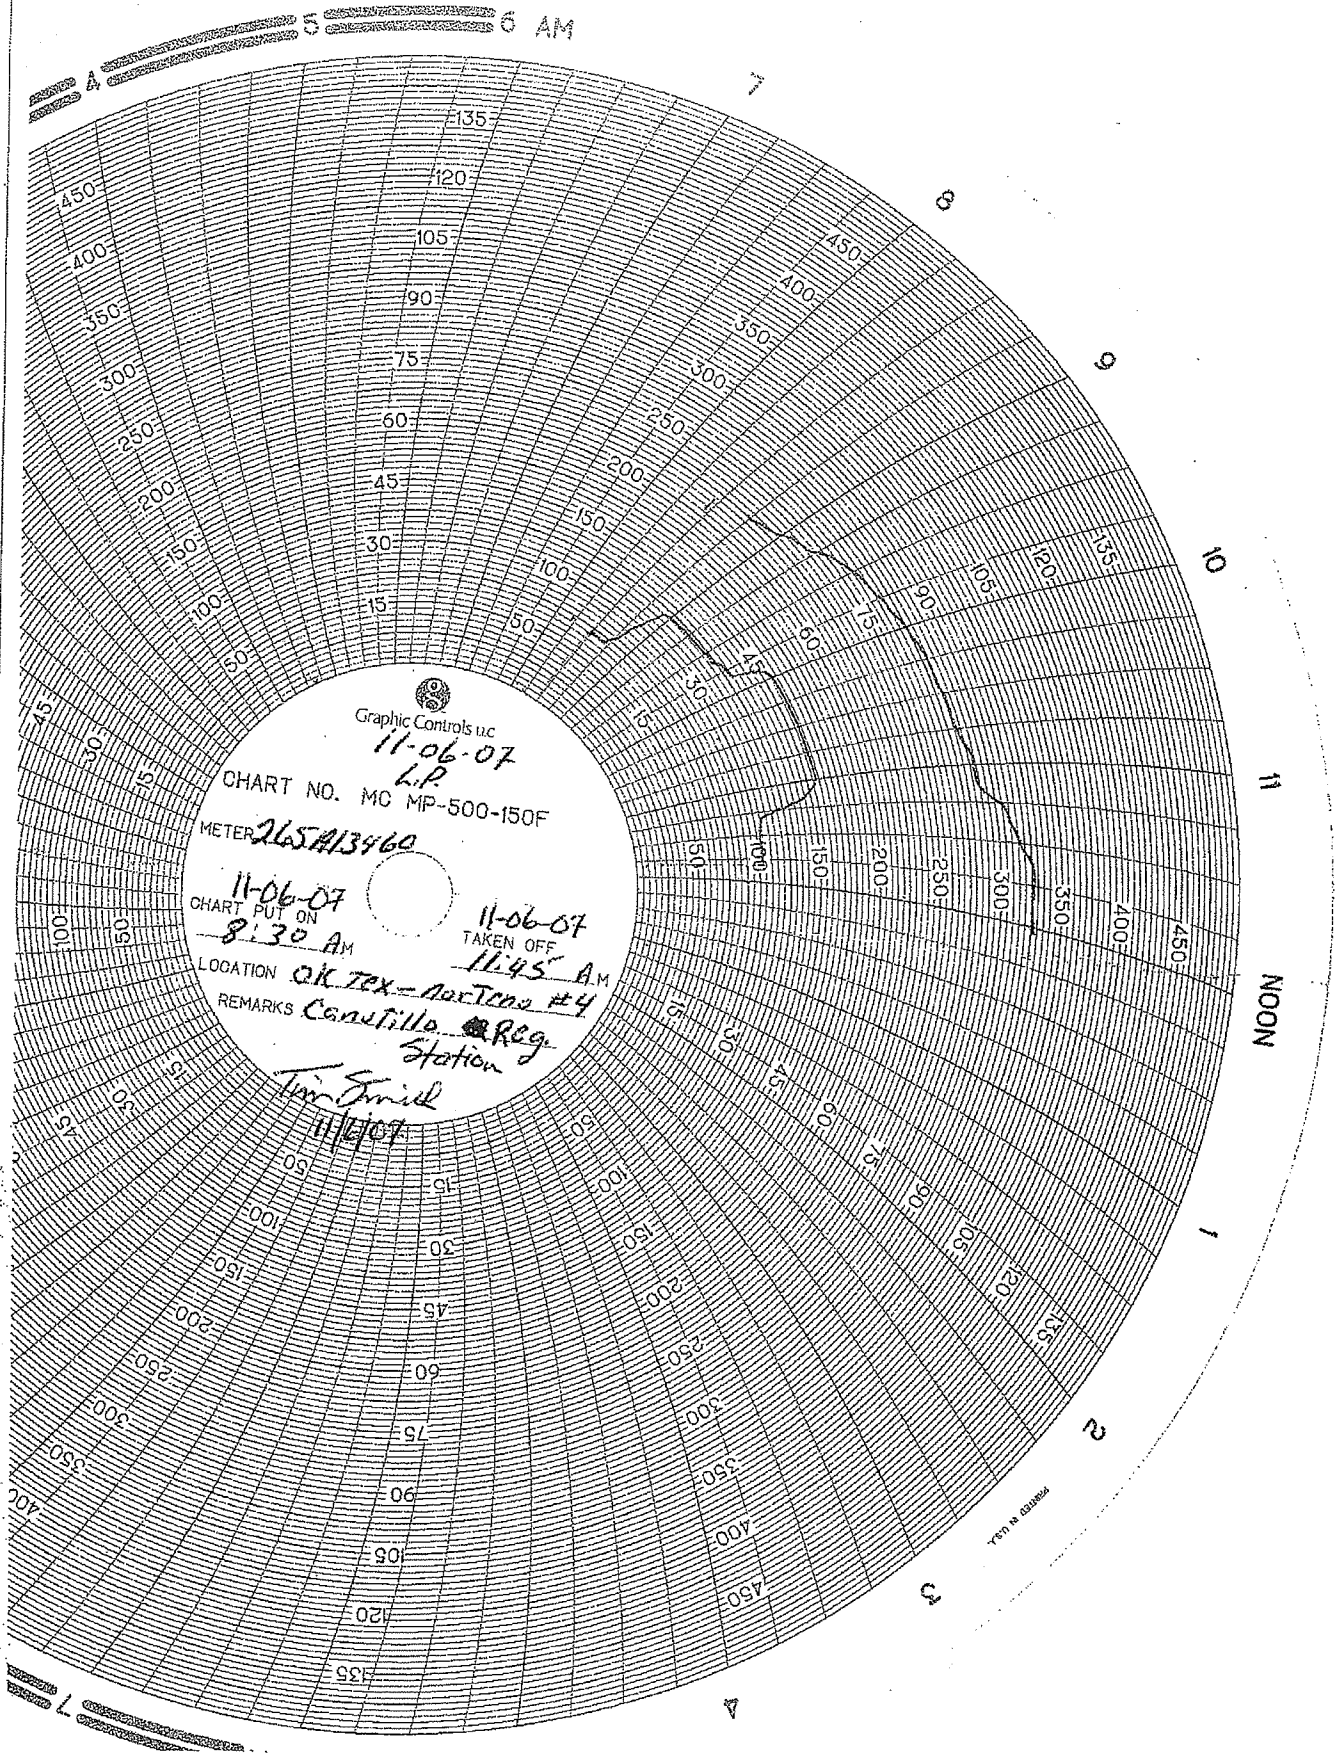
CHART NO. MC MP-500-150F

METER 265A13460

11-06-07
CHART PUT ON
8:30 AM

11-06-07
TAKEN OFF
11:45 AM

LOCATION OK TEX - AarTona #4

REMARKS Conetilla Reg. Station

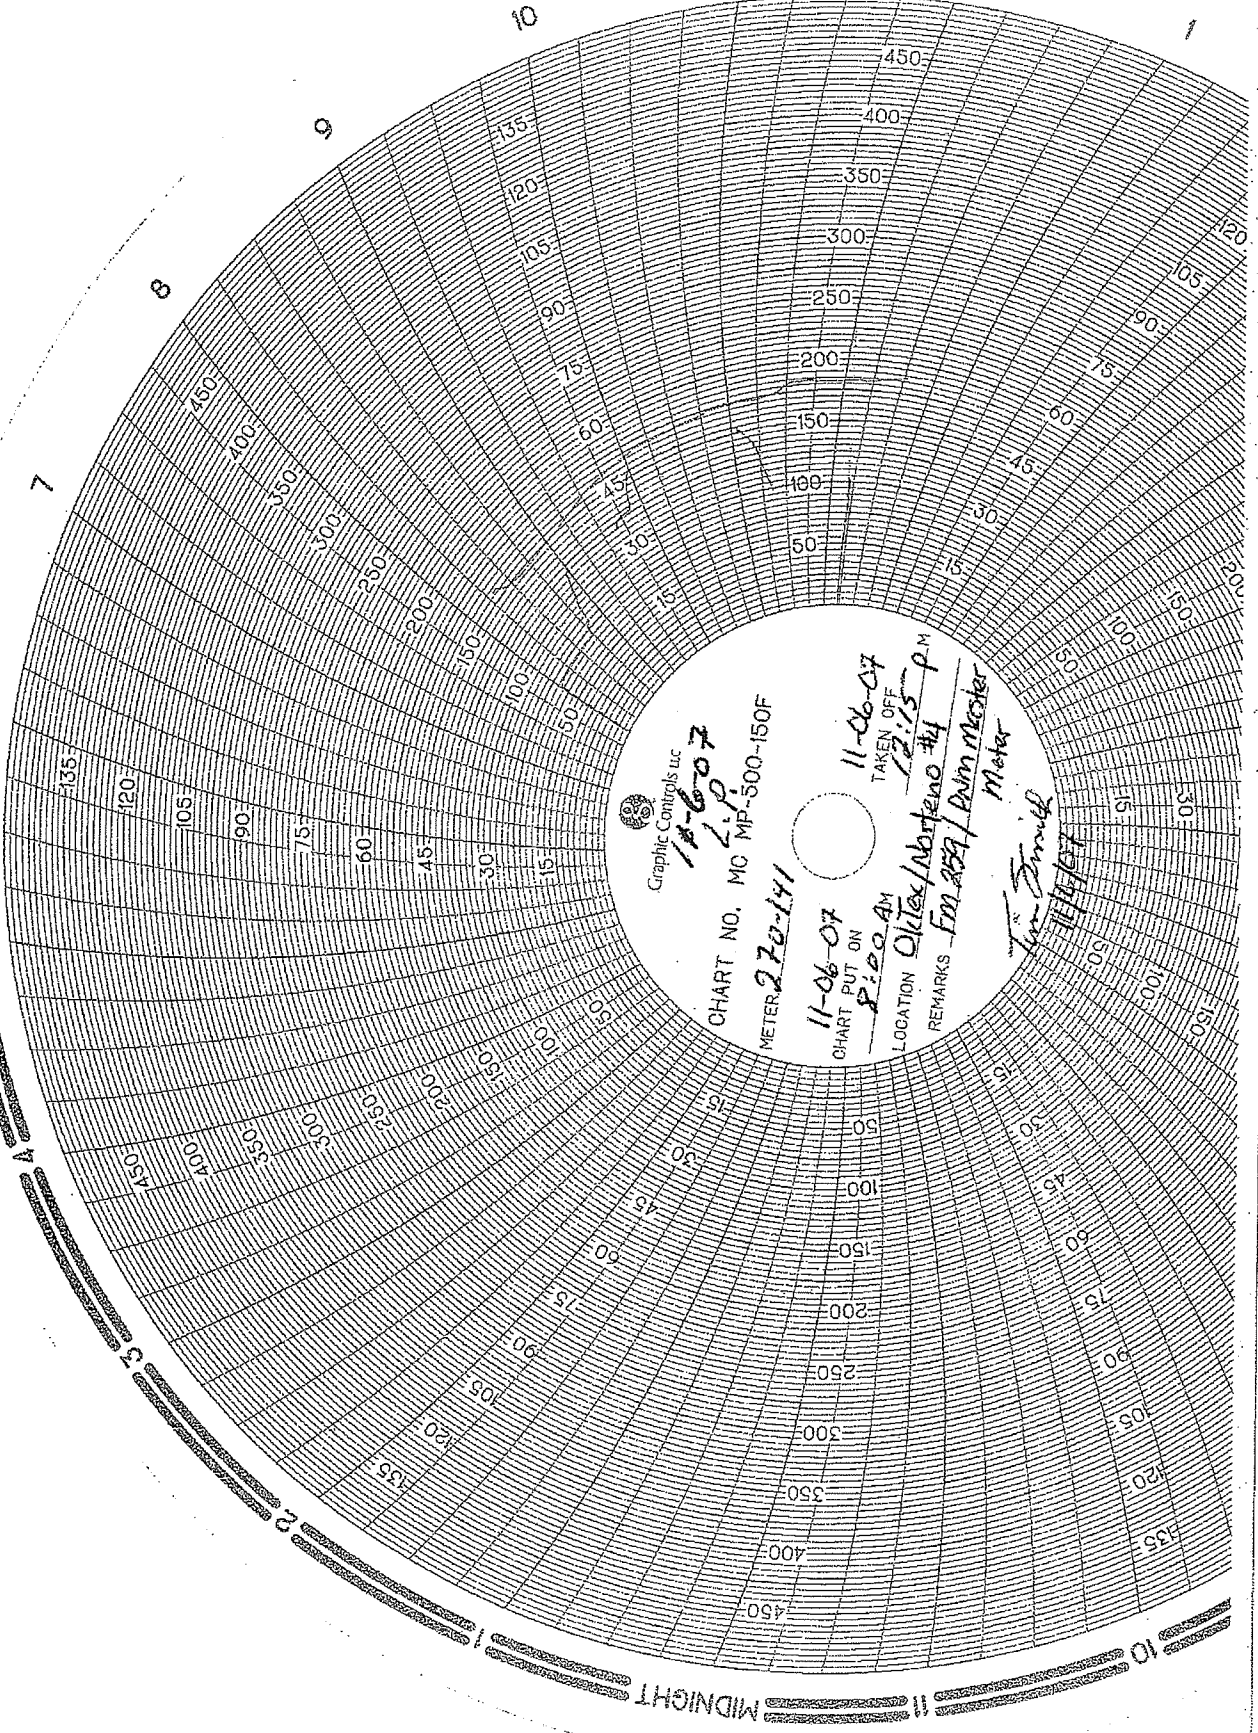
CHART NO. MC MF-500-150F
METER 270-141

11-06-07
CHART PUT ON
8:00 AM

11-06-07
TAKEN OFF
12:15 PM

LOCATION Orléans/Notre-Dame #4

REMARKS FM 207 / Anm Meter
Meter

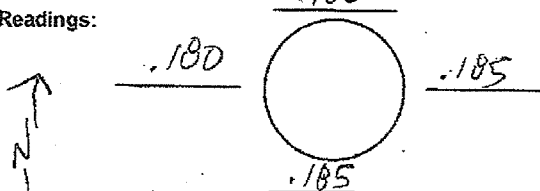
UT Readings:

External	Internal
Extent of Corrosion (Negligible, Slight, Medium, Severe):	<u>NONE</u>	<u>N/A</u>
Type of Corrosion (General or Pitting):	<u>NONE</u>	<u>11</u>
Location of Corrosion (Top, Bottom, Sides, All over):	<u>NONE</u>	<u>11</u>

Carrier Pipe Size: 6" Grade: UNKNOWN Wall Thickness: .180 Pipe Mfg: UNKNOWN
 Instrument: Make CYGNUS Model 4 Serial Number 0433

Pipe to Soil Readings: -1.069V
 Soil pH: 7.75
 Soil Resistivity: 100K ohms/cc
 Depth of Cover: 51 Ft (inches)

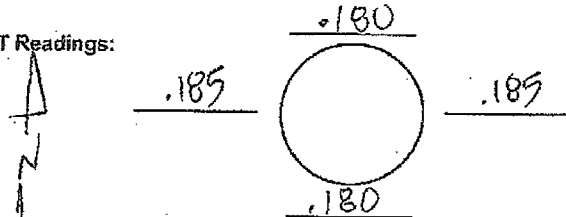
UT Readings:

External	Internal
Extent of Corrosion (Negligible, Slight, Medium, Severe):	<u>N/A</u>	<u>N/A</u>
Type of Corrosion (General or Pitting):	<u>"</u>	<u>N/A</u>
Location of Corrosion (Top, Bottom, Sides, All over):	<u>"</u>	<u>N/A</u>

Carrier Pipe Size: 6" Grade: UNKNOWN Wall Thickness: .180 Pipe Mfg: UNKNOWN
 Instrument: Make CYGNUS Model 4 Serial Number 0433

Pipe to Soil Readings: -1.077 ✓
 Soil pH: 8.25
 Soil Resistivity: 65K ohms/cc
 Depth of Cover: 36 Ft (inches)
