Enterprise Products

Re: Notice of Probable Violation, Proposed Civil Penalty and Proposed Compliance Order (the "Notice")
CPF-4-2007-5015

Enterprise Products Operating L.P. ("Enterprise") submits this response to the Notice received on May 10, 2007.

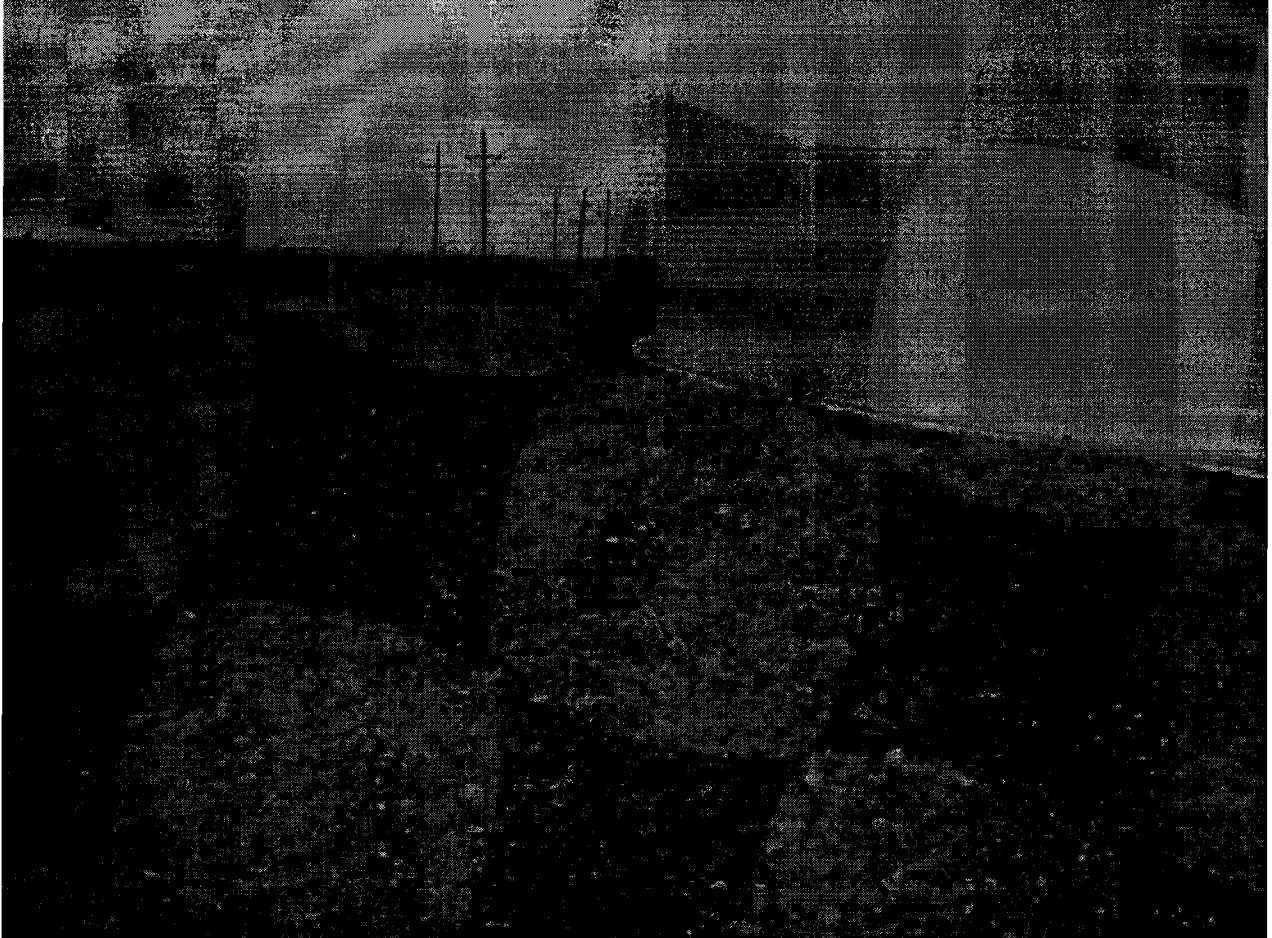
Picture 2: Rock and dirt eroding and washing away from Southwest side of tank.

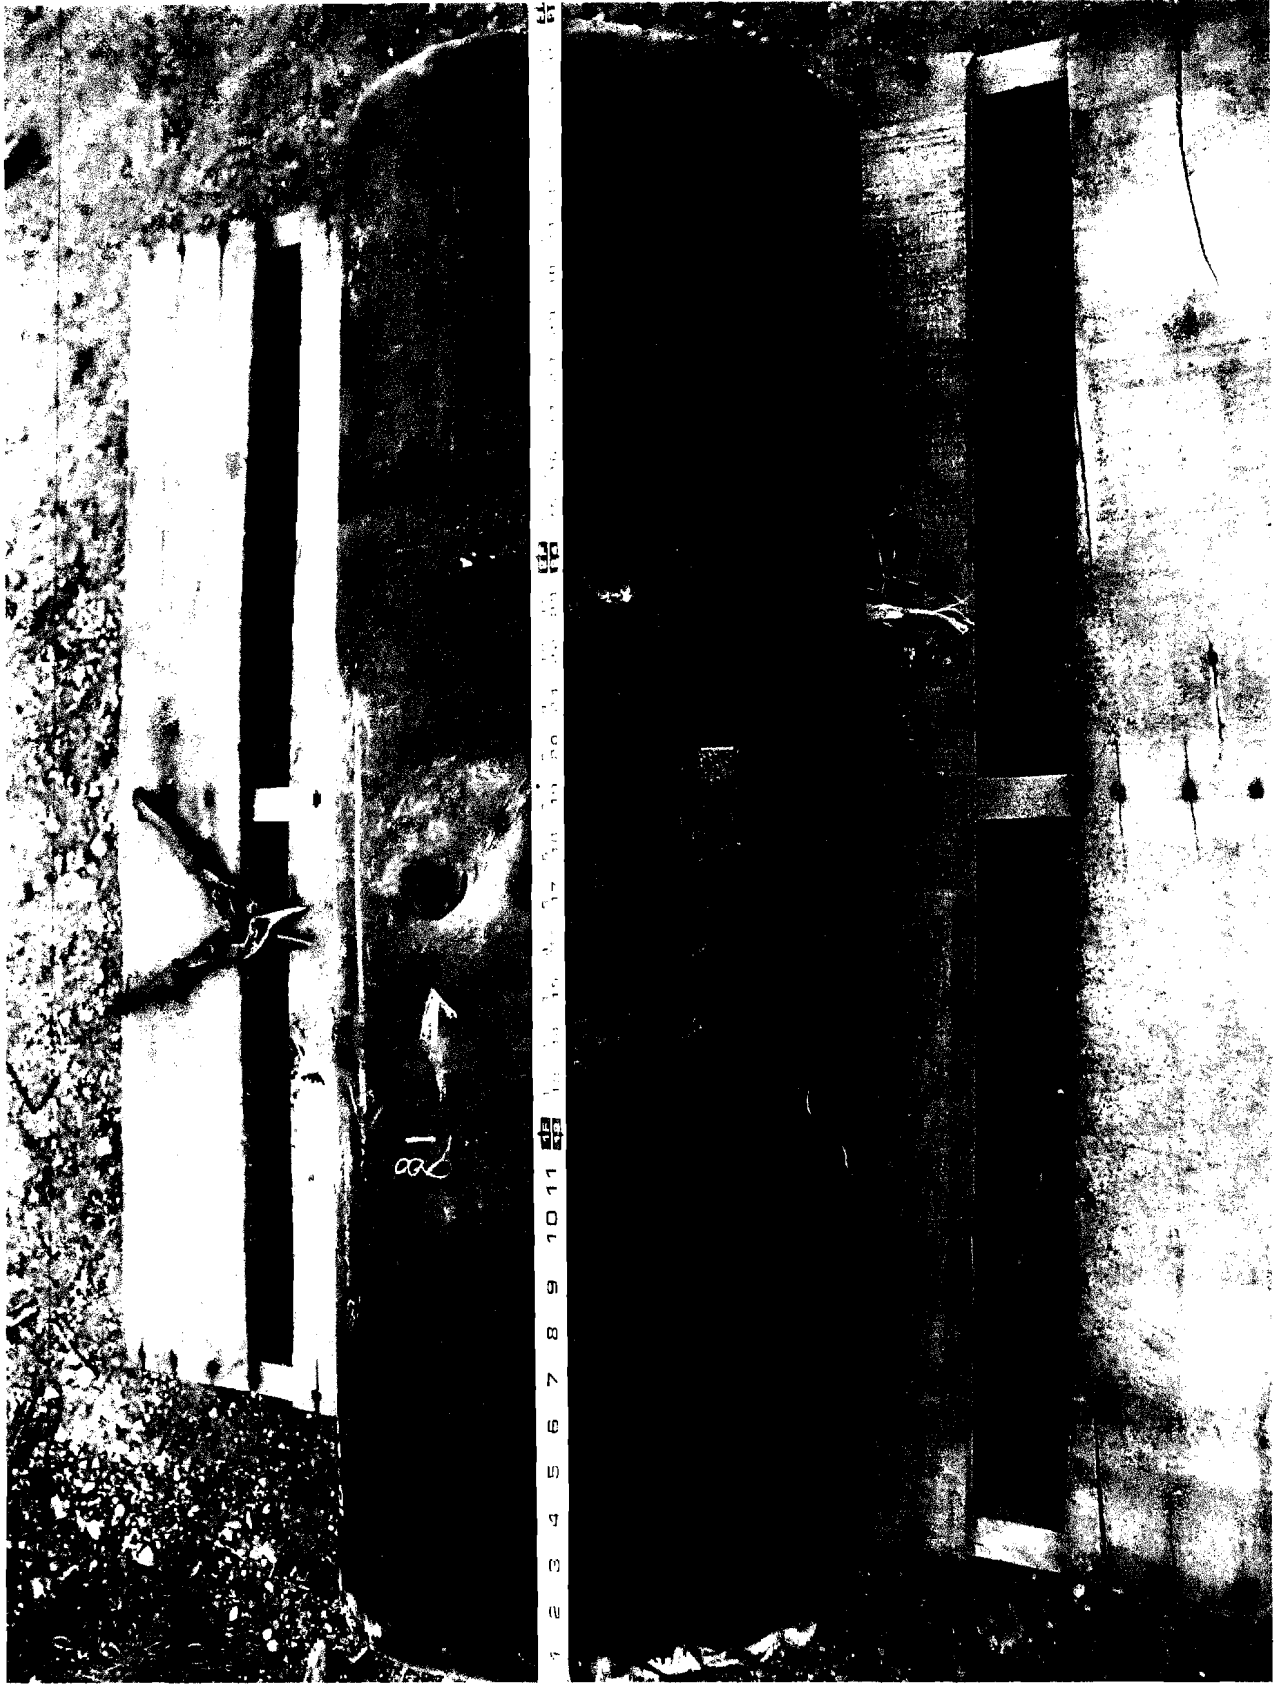
Figure 1. Pipe Puncture—OD Surface

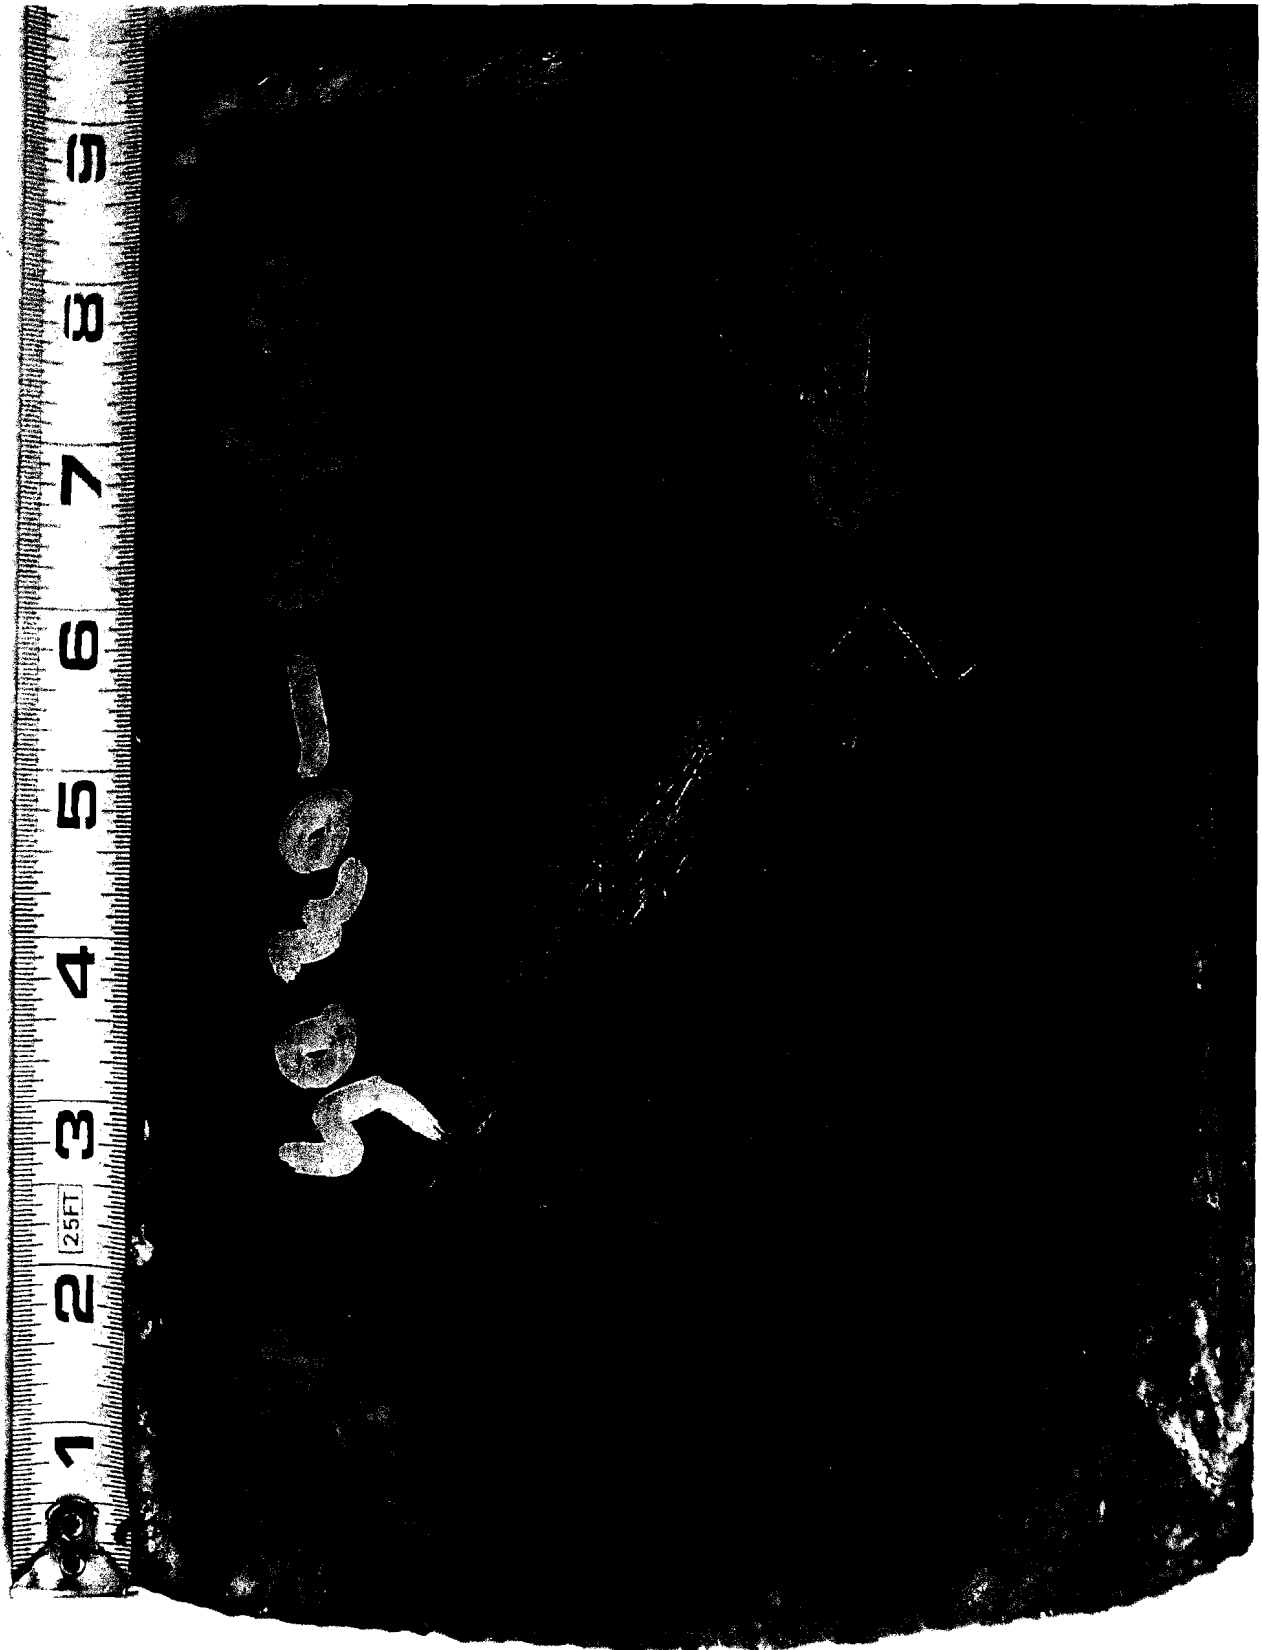
Figure 2. Pipe Puncture - OD Surface Close Up

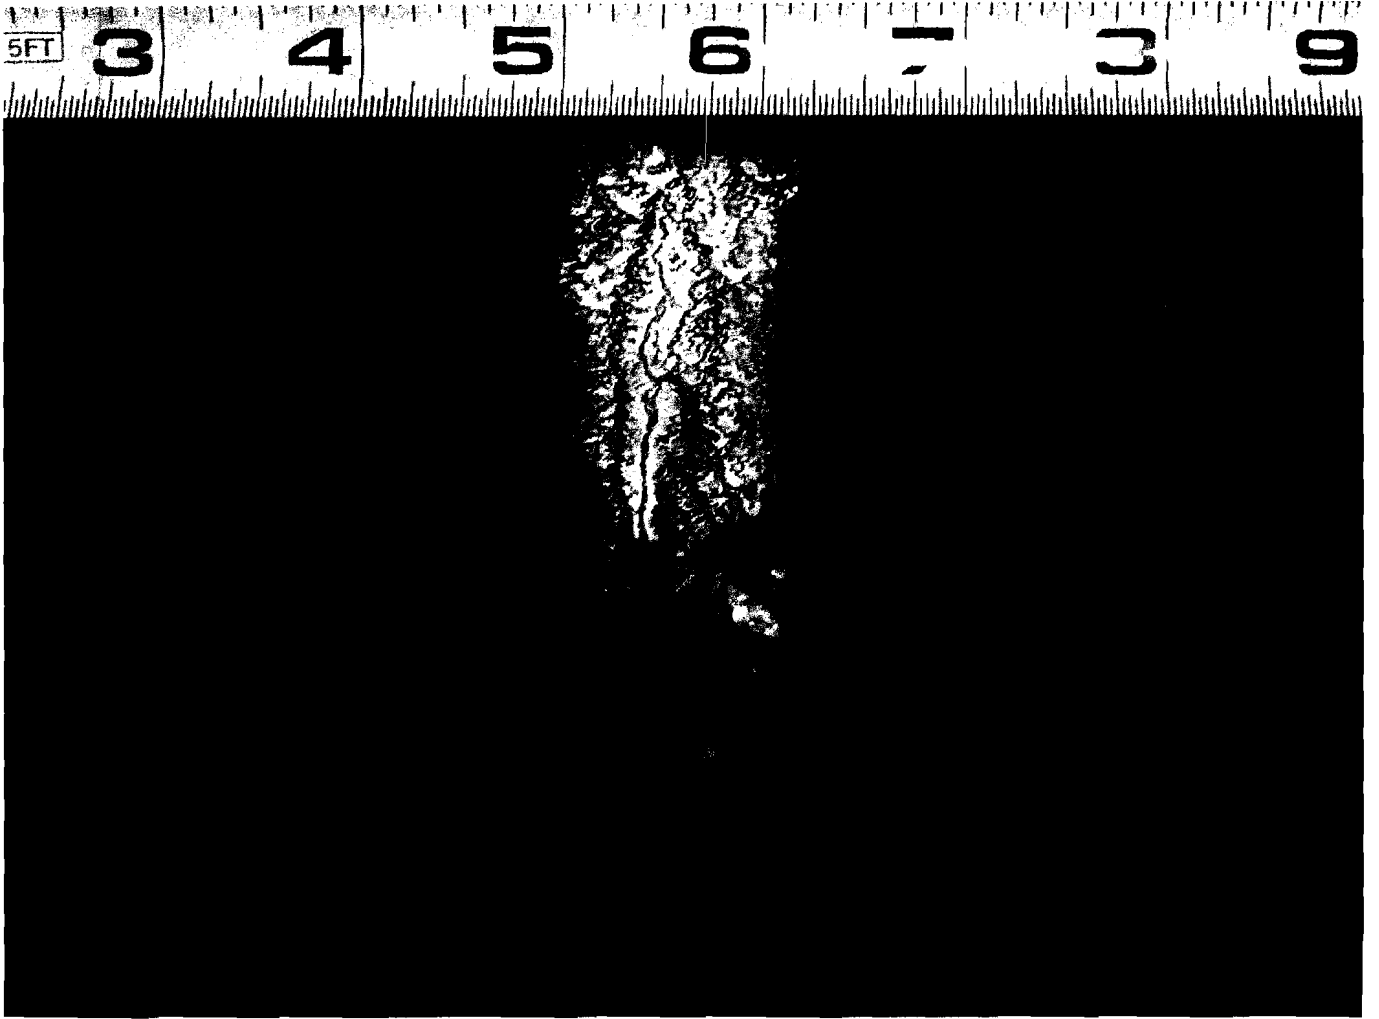
Figure 3. Pipe Puncture - ID Surface Close Up

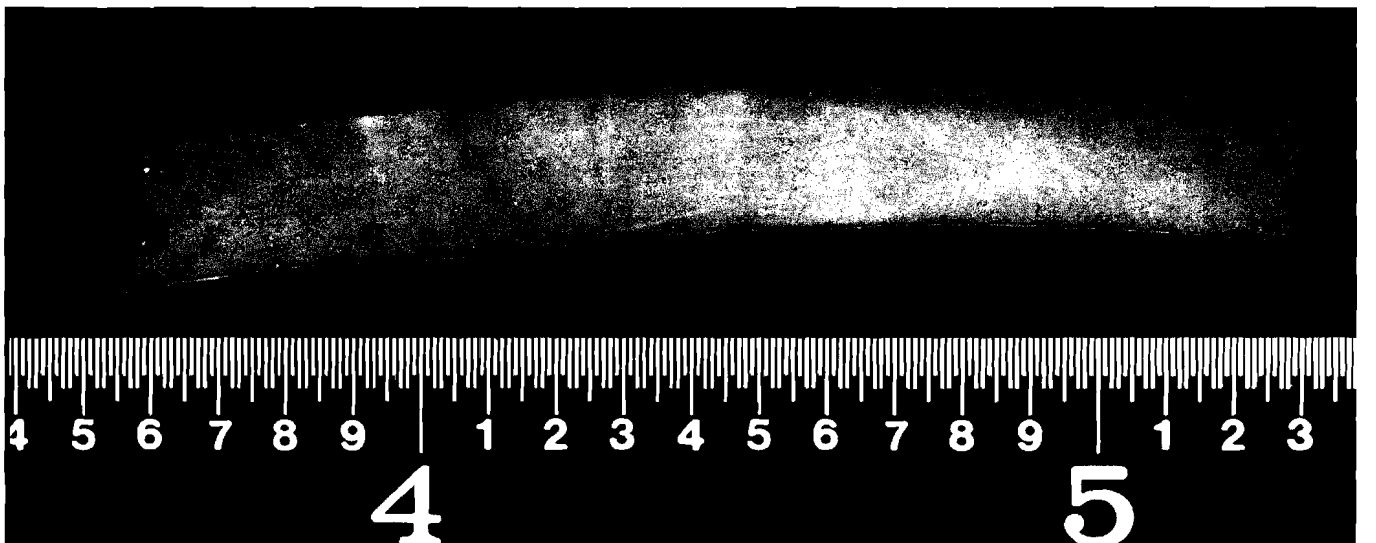
Figure 4. Metallographic Section of the ERW Seam
