Automated Track Video Inspection Pilot Project

SEPTEMBER 2013

FTA Report No. 0049
Federal Transit Administration

PREPARED BY
MTA-NYCT

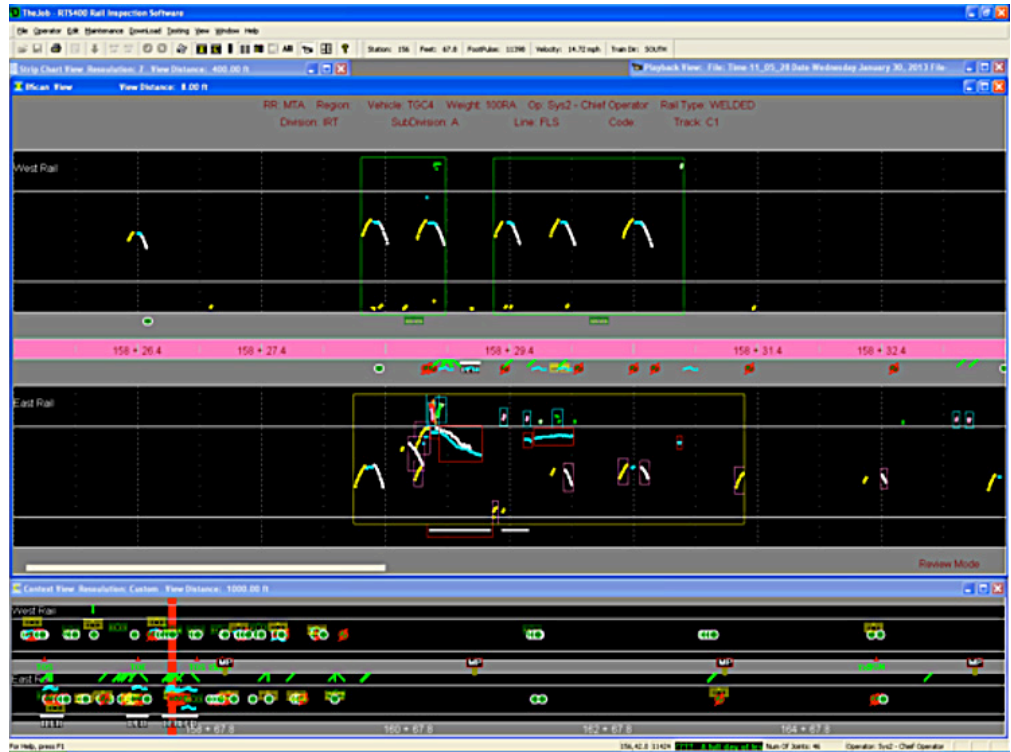
Figure 4-5
B-Scan of detected UT defect on track C1 at station # 158+28

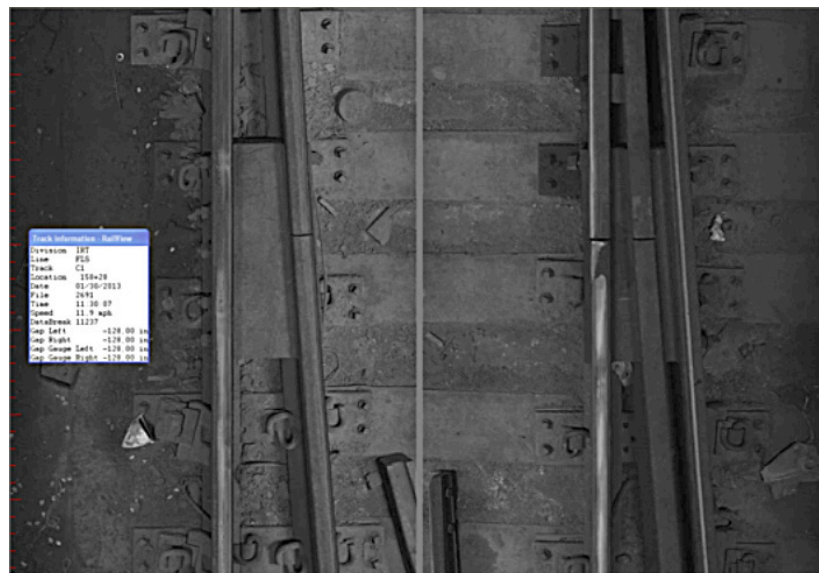
Figure 4-6
Rail View Video picture of UT defect location on track C1 at station # 158+28

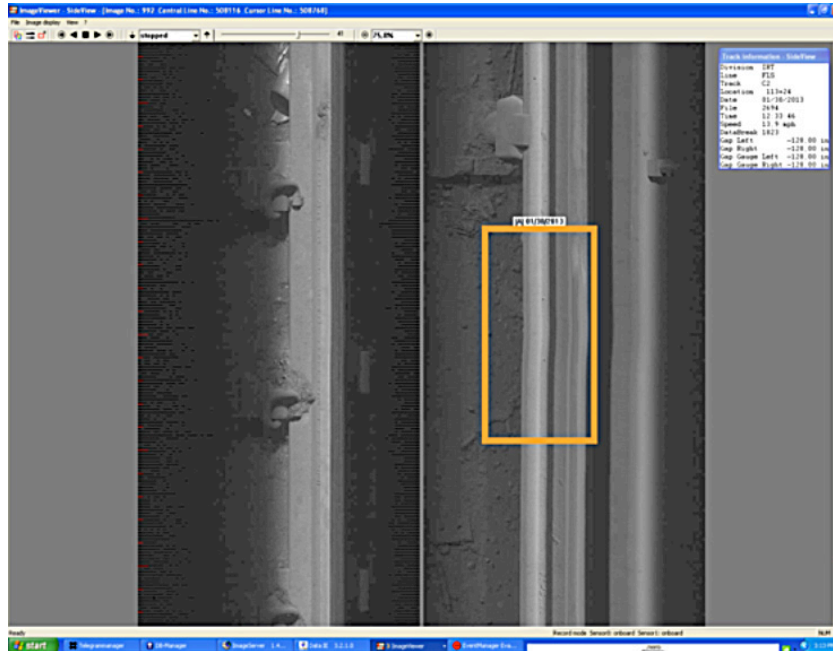
Marquee (right image) showing condition detected with Power Rail View video system on track C2, run of 1/30/2013

No third rail or cover board defects were observed with the new Power Rail View video system. Defects detected with the Third Rail KLD system that were further analyzed with the Power Rail View video system appeared to be distinguished most of the time. Only one condition was detected with the Power Rail View video system on the third rail, and it was classified as Power Rail View Video defect #TRVideo01, consisting of a slight gouge on the contact rail surface, as determined by the reviewer.

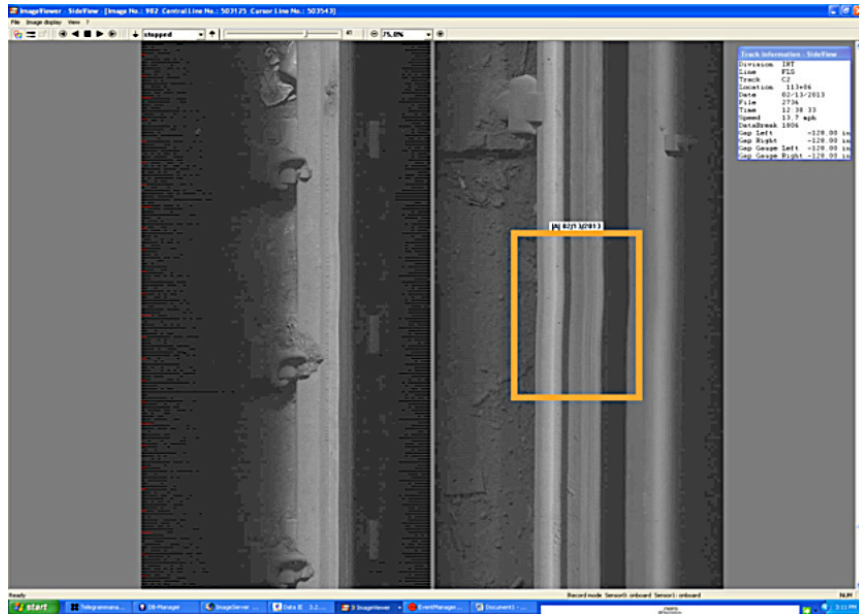
Figure 4-23
Marquee (right image) showing condition detected with Power Rail View Video System on Track C2 – run of 2/13/2013

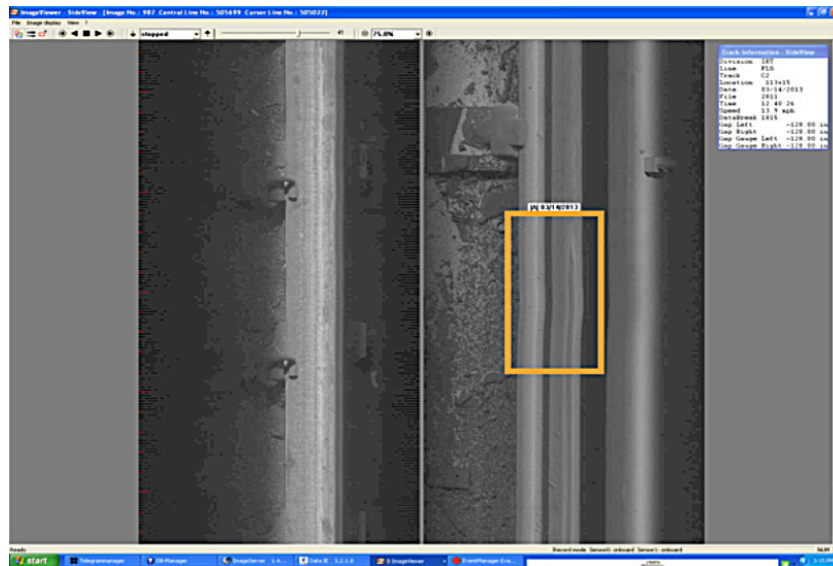
Marquee (right image) showing condition detected with Power Rail View video system on 3/14/2013 inspection run

No new third rail or cover board defects were detected in the video files analyzed and reviewed with the Power Rail View video system, except for the one condition detected in previous inspections and classified as a “slight gouge” on the contact rail (defect ID TRVideo01).

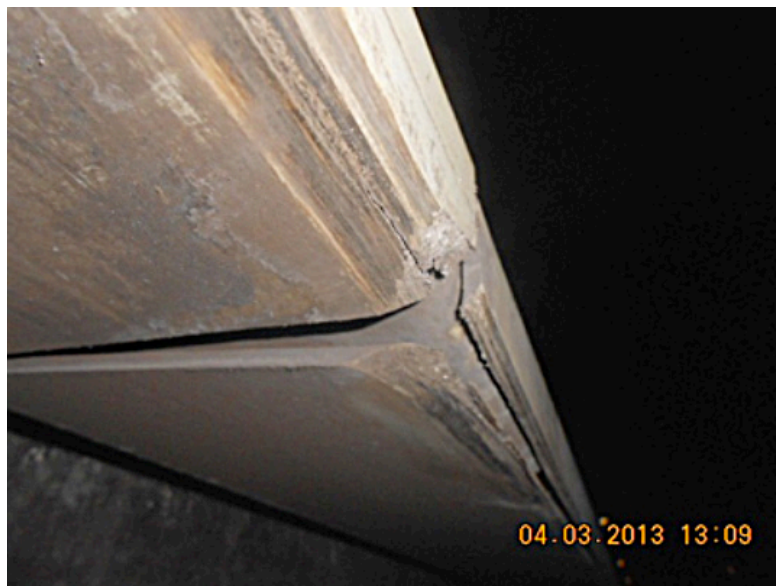
Underside of cover board rubbed by third rail shoe of passenger cars (field supervisor picture)

The limitations regarding the angle of the Power Rail View video camera, the levels of illumination, the position of the lights, and the lack of color in the images did not allow the reviewer to realize that there were rubbing marks on the underside of the cover board.

- The Power Rail View video system camera and illumination should ideally be placed in a lower position to allow viewing of conditions under the power rail's cover board. The Power Rail View video system, as it was installed in the TGC4, was not able to detect rubbing marks on the underside of the cover board because of the camera position and the lack of optimal illumination.

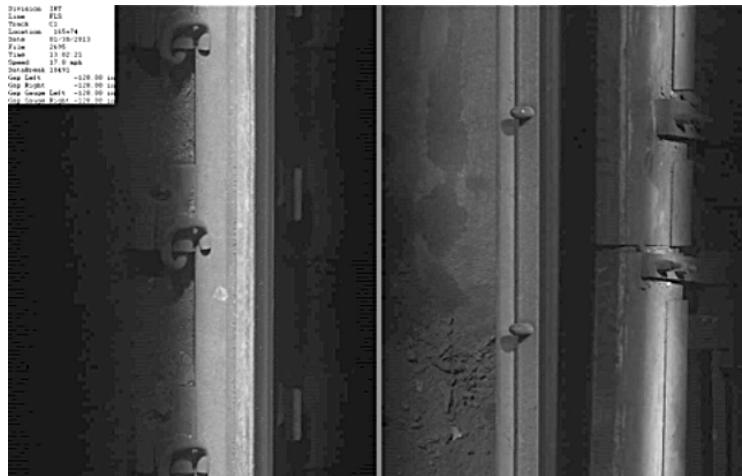
Figure 4-31
Cover board viewed
in TGC4 Power
Rail View video
system of 1/30/2013
inspection run

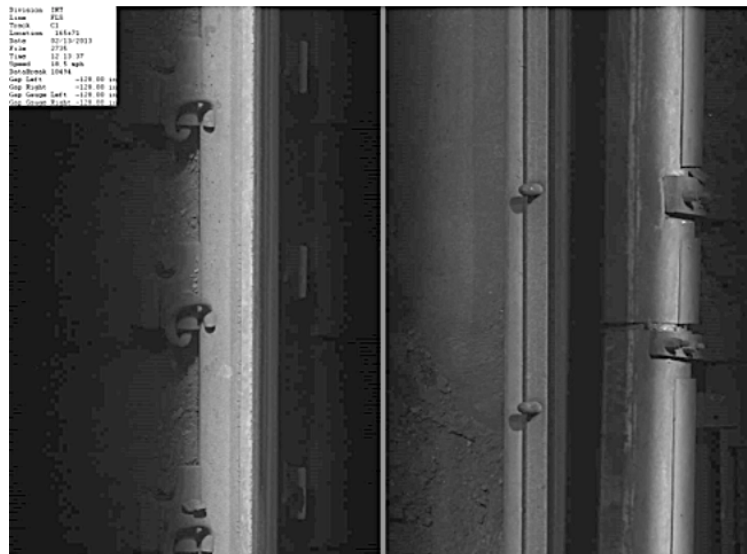
Figure 4-32
Cover board viewed
in TGC4 Power
Rail View video
system of 2/13/2013
inspection run

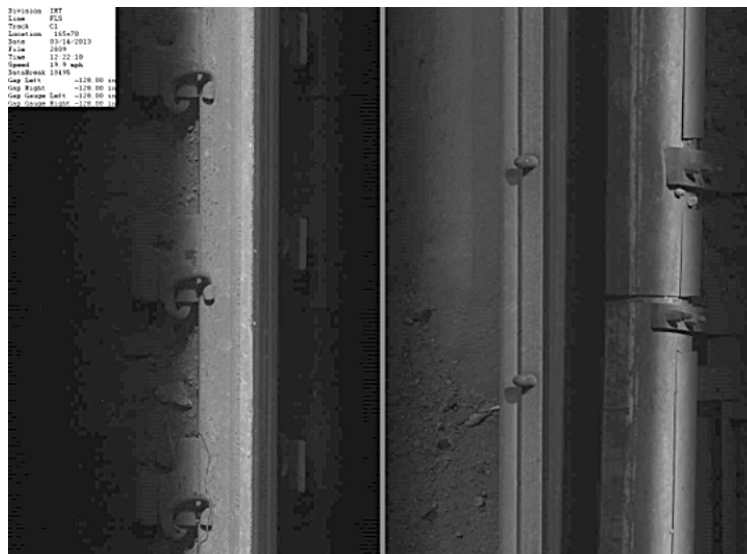
Figure 4-33
Cover board viewed
in TGC4 Power
Rail View video
system of 3/14/2013
inspection run
