Collapse of I-35W Highway Bridge
Minneapolis, Minnesota
August 1, 2007

ACCIDENT REPORT

NTSB/HAR-08/03
PB2008-916203

Highway Accident Report

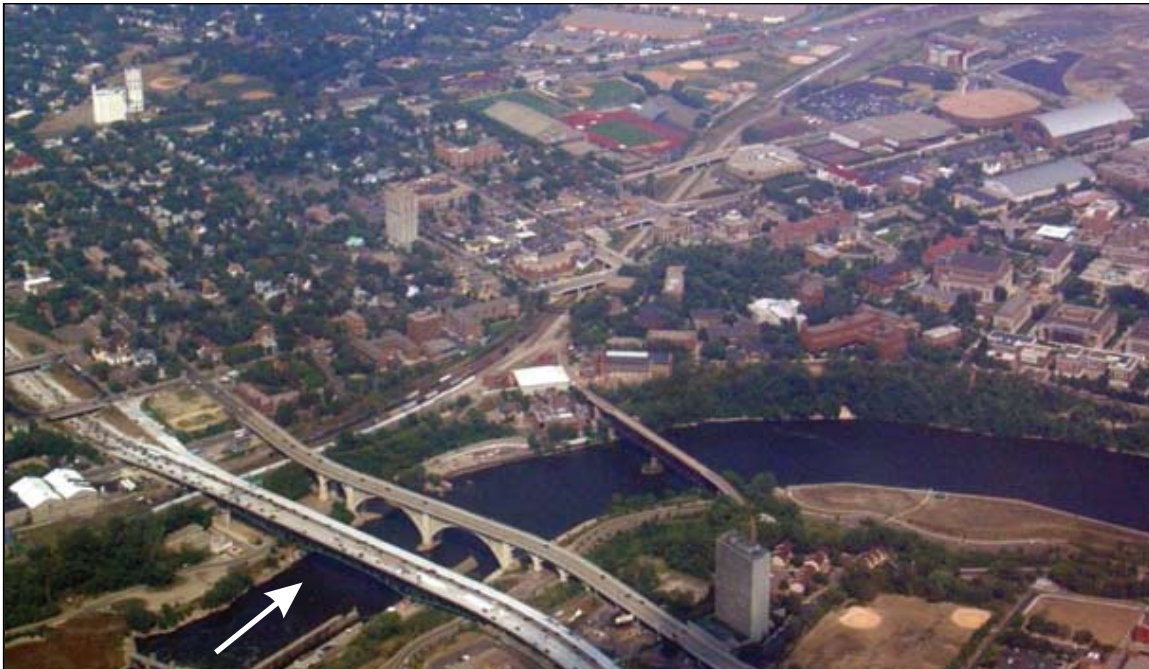
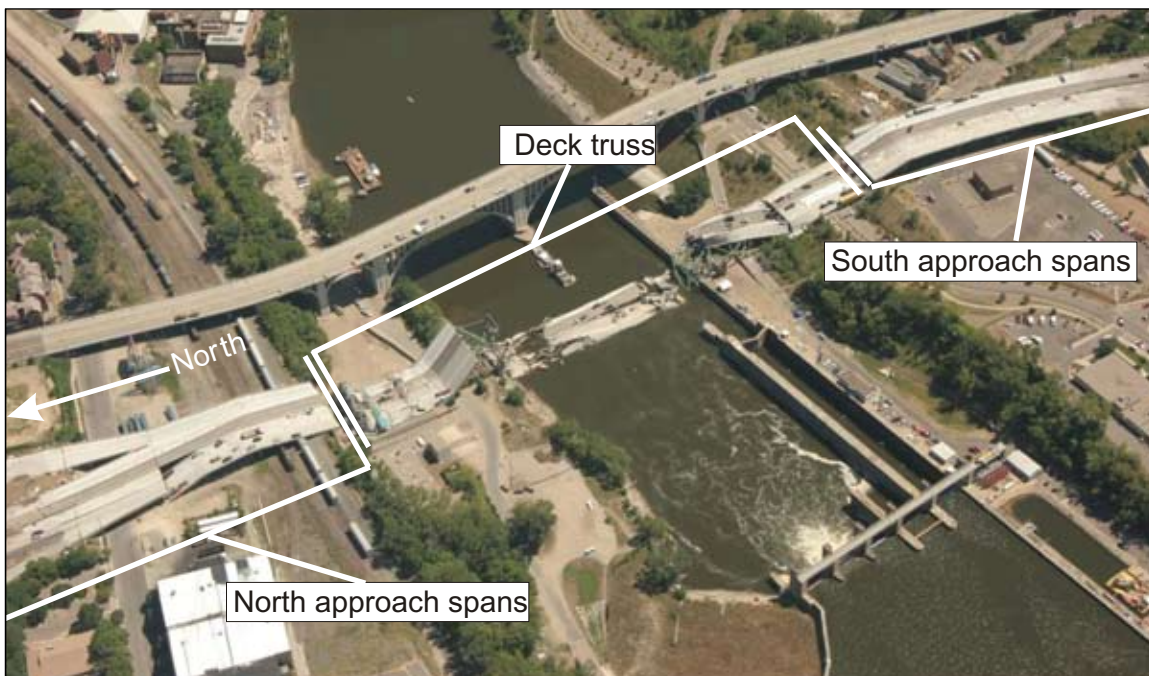
Figure 1. (Top) Aerial view (looking northeast) of I-35W bridge (arrow) about 2 hours 15 minutes before collapse. This photograph was taken by a passenger in a commercial airliner departing Minneapolis/St. Paul International Airport. (Bottom) I-35W bridge after collapse.

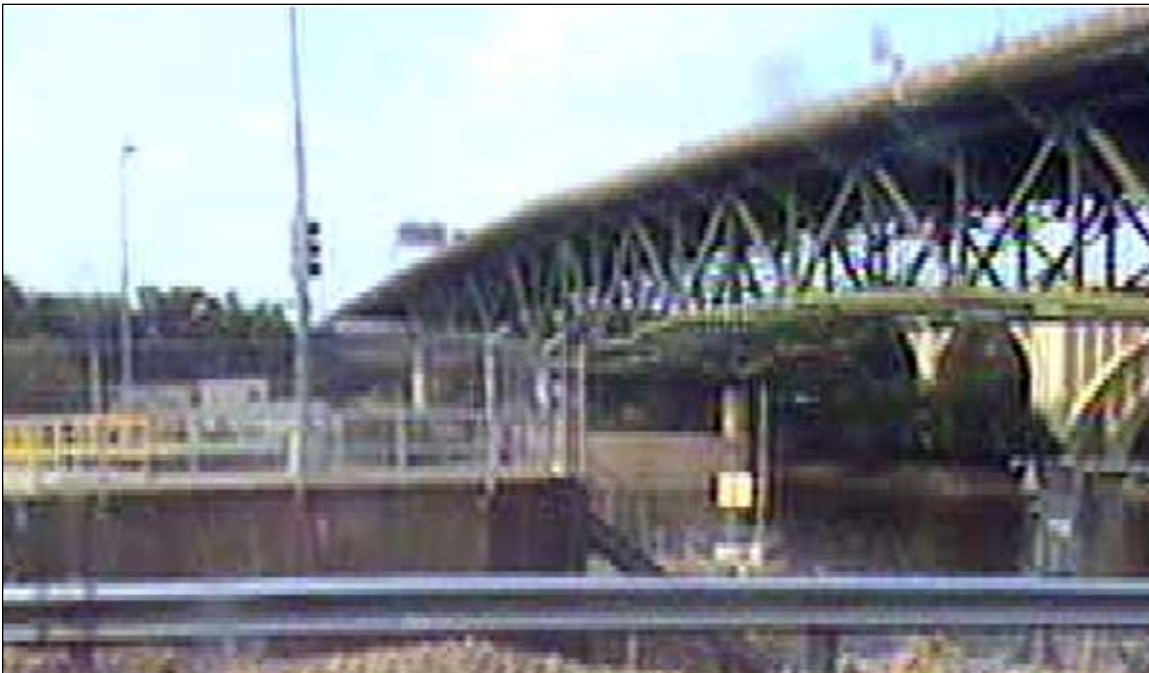
Figure 10. Close-up of first image of collapse sequence, captured by surveillance camera at 18:04:57. The south (near) end of the center span can be seen to have dropped from its position as shown in precollapse images (compare with figure 9).

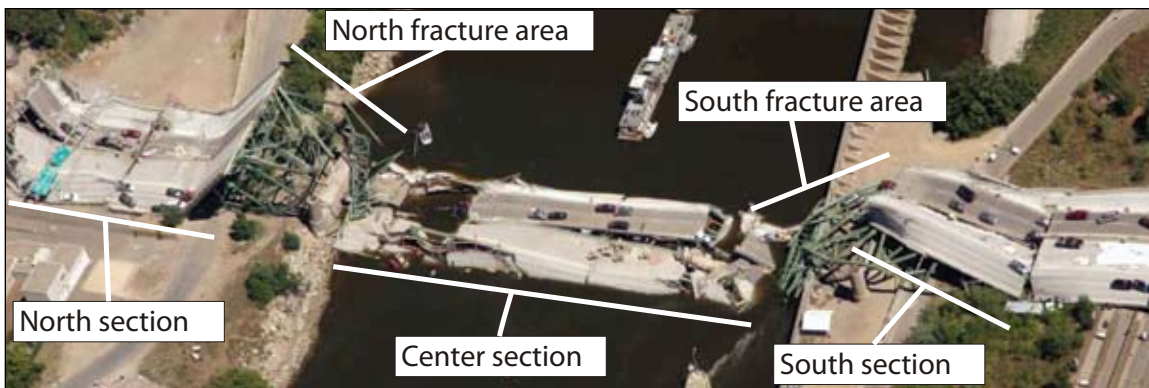
During the collapse sequence, the deck truss portion of the bridge separated into three large sections. Most of the center span, between piers 6 and 7 (referred to here as the “center section”), separated from the remainder of the truss and fell into the river. The section south of pier 6 (the “south section”) fell onto land on the south side of the river, and the section north of pier 7 (the “north section”) fell onto land on the north side of the river. (See figure 11.) General damage to each of these sections is detailed below. The fractures in the members between these sections are discussed later in this report in the “Examination of Deck Truss Fracture Areas.”

Figure 11. Collapsed deck truss sections of I-35W bridge.

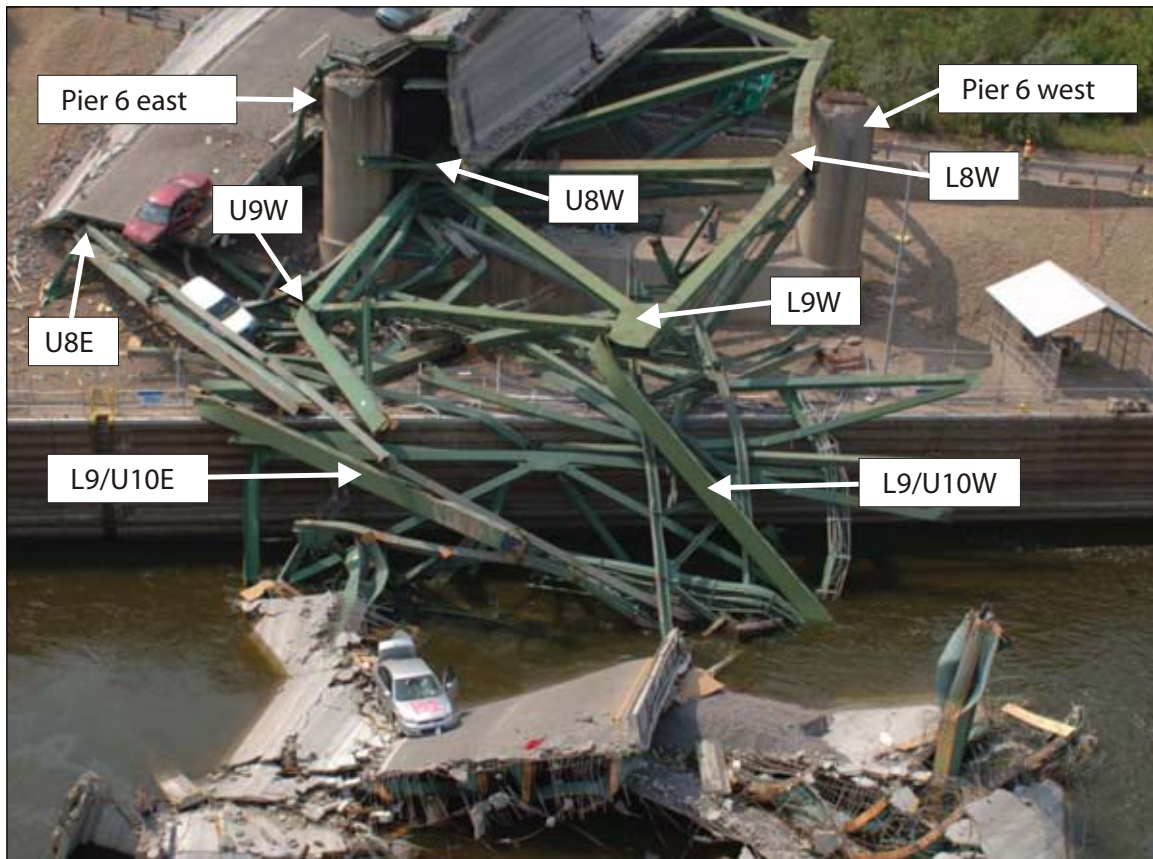
South Section. Figure 12 shows the collapsed south section of the deck truss. The deck and floor stringers north of the U8 node (directly over pier 6) separated at this node and remained attached to the center section of the structure, which fell into the river. The deck and stringers south of the U8 node remained approximately in their original positions relative to the upper chords of the truss. The U8 and L8 nodes, east and west (at pier 6), remained with the collapsed south section of the truss.

Figure 12. Looking south at south fracture area and a portion of collapsed south section.

The L1 nodes were found north of pier 5, and the L8 nodes were found north of pier 6, indicating that, in general, the entire south section of the truss had displaced some amount north toward the river. Associated with this movement, the lower surface of lower chord members L7/L8 east and west contained impact and scraping damage from contact with the expansion rollers and upper surface of pier 6. Loading associated with this damage was severe enough that lower chord member L7/L8E was partially fractured at approximately mid-length. Additionally, member L7/L8E had broken away from the L7E node (through shearing of the rivets between the member side plates and the gusset plates) and

the L8E node (through fracture of the member and shearing of the remaining rivets between the member side plates and the gusset plates).

The upper chords of the south section were intact between nodes 1 and 8. (The upper chord on both trusses was fractured between nodes 0 and 1.) The lower chord of the west truss was fractured between the L3W and L4W nodes, and the lower chord of the east truss was fractured adjacent to the L1 node. Also, as previously noted, each end of lower chord member L7/L8E separated from the L7 and L8E nodes, primarily through shearing of the gusset plate rivets.

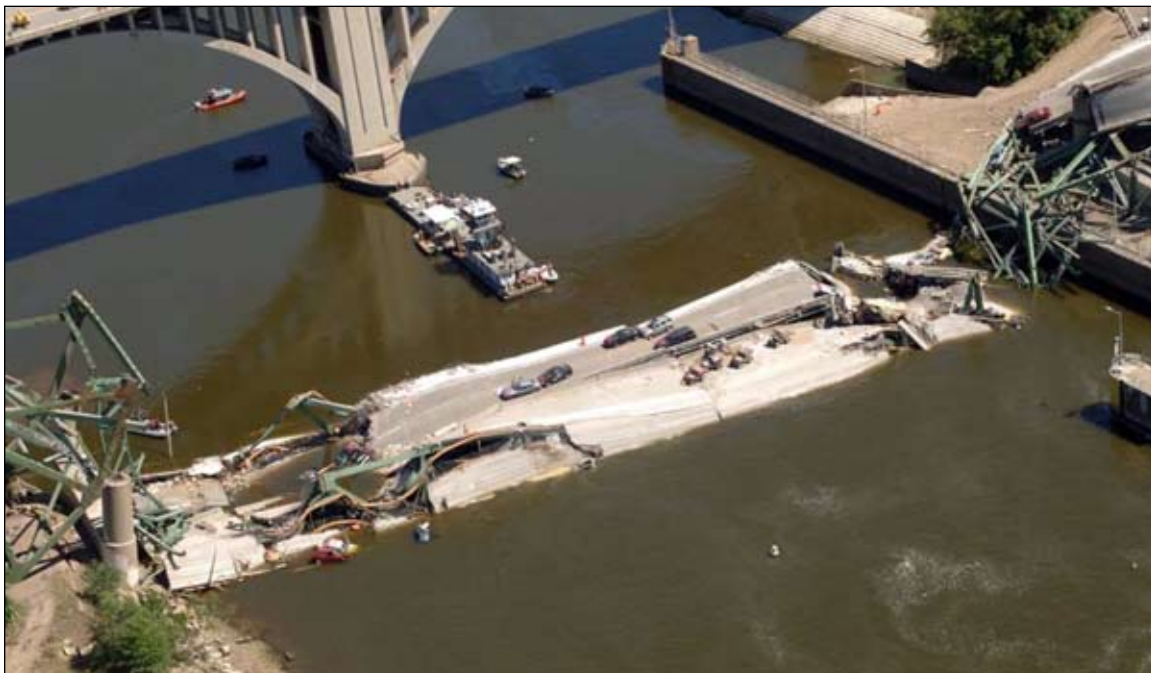
The lower chord members, lower lateral braces, and sway braces from the center section were generally under water. The fractured L9 node ends of the lower chord members L9/L10 east and west were resting against the lock guide wall near pier 6.

Figure 14. Collapsed bridge center section, looking southeast.

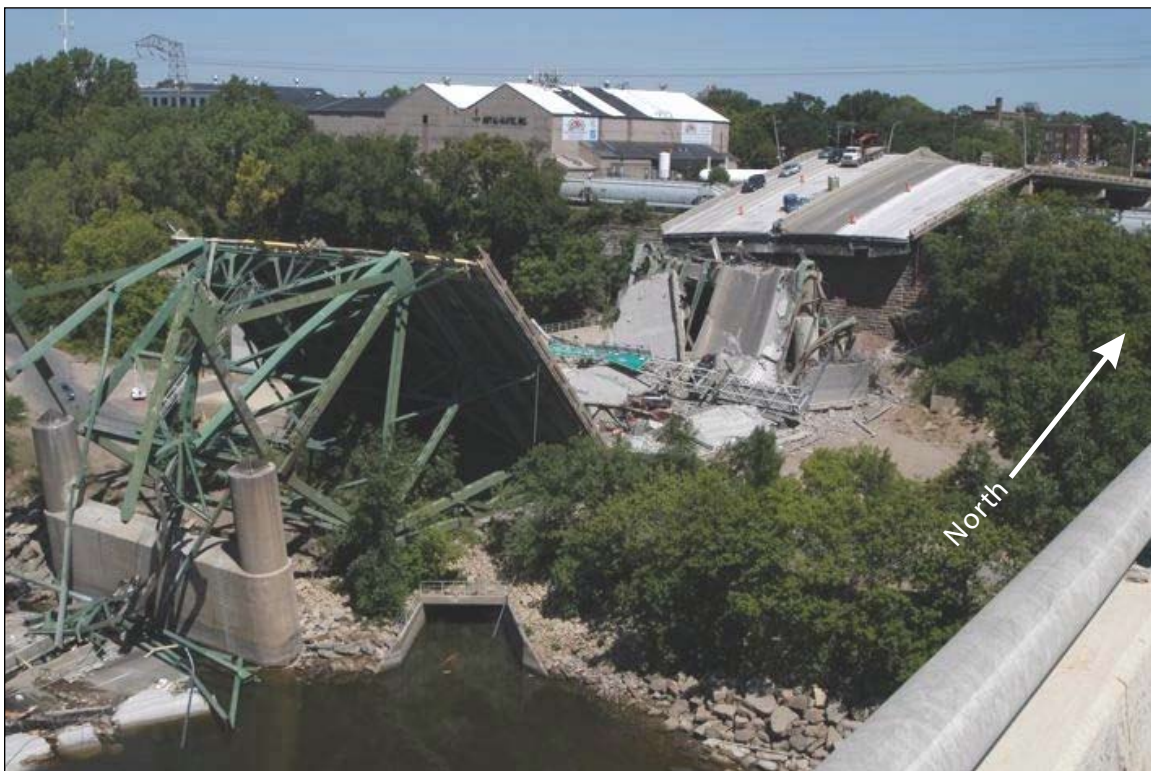
North Section. An overall view of the north portion of the deck truss postcollapse is shown in figure 15. A large portion of the deck truss above and north of pier 7 had rotated to the north as a rigid unit. This portion included the deck and upper chords from the U8' to U6' nodes, the lower chords from the L9' to L7' nodes, and the diagonals and verticals between these nodes. In the postcollapse position, lower chord members L7'/L8' east and west were contacting the north side of the upper end of the pier 7 columns. The video shows that the rigid portion of the deck truss initially remained in position and did not rotate as the center span dropped into the river. Later in the recording, after the water splash clears and the debris settles, this portion of the structure can be seen to have rotated to the north.

Figure 15. Collapsed north section of bridge.

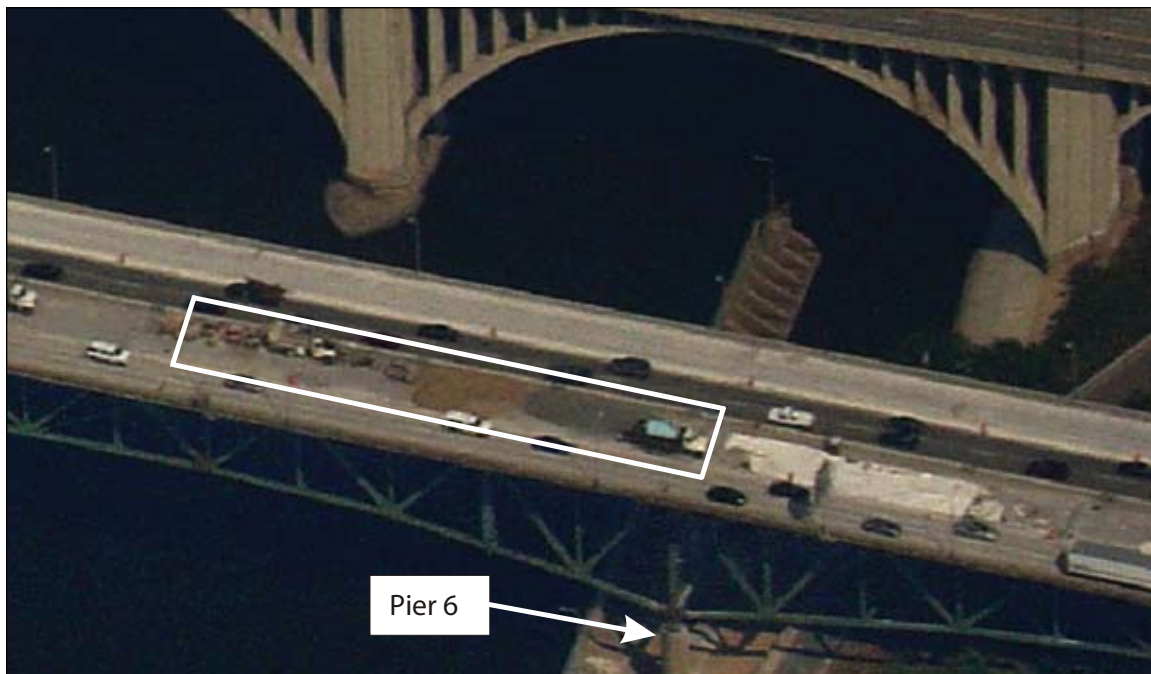
The aggregates and associated construction vehicles would come to occupy an estimated 228-foot-long section of the two closed southbound lanes over the main river span (span 7). The area where the equipment and materials were stored was established by interviewing witnesses, by examining the limits of the work area, and by examining photographs, including one (figure 1 top) taken about 3:45 p.m. by a passenger aboard a commercial airliner. After this photograph was taken (see figure 16), PCI workers moved the materials closer to the median barrier to allow more room for the movement of construction vehicles and traffic.

Figure 16. Construction equipment and aggregates (indicated by white box) stockpiled on southbound lanes of bridge about 2 hours 15 minutes before collapse. (This figure is an enlargement of a section of a photograph taken by a passenger in a commercial airliner departing Minneapolis/St. Paul International Airport.)

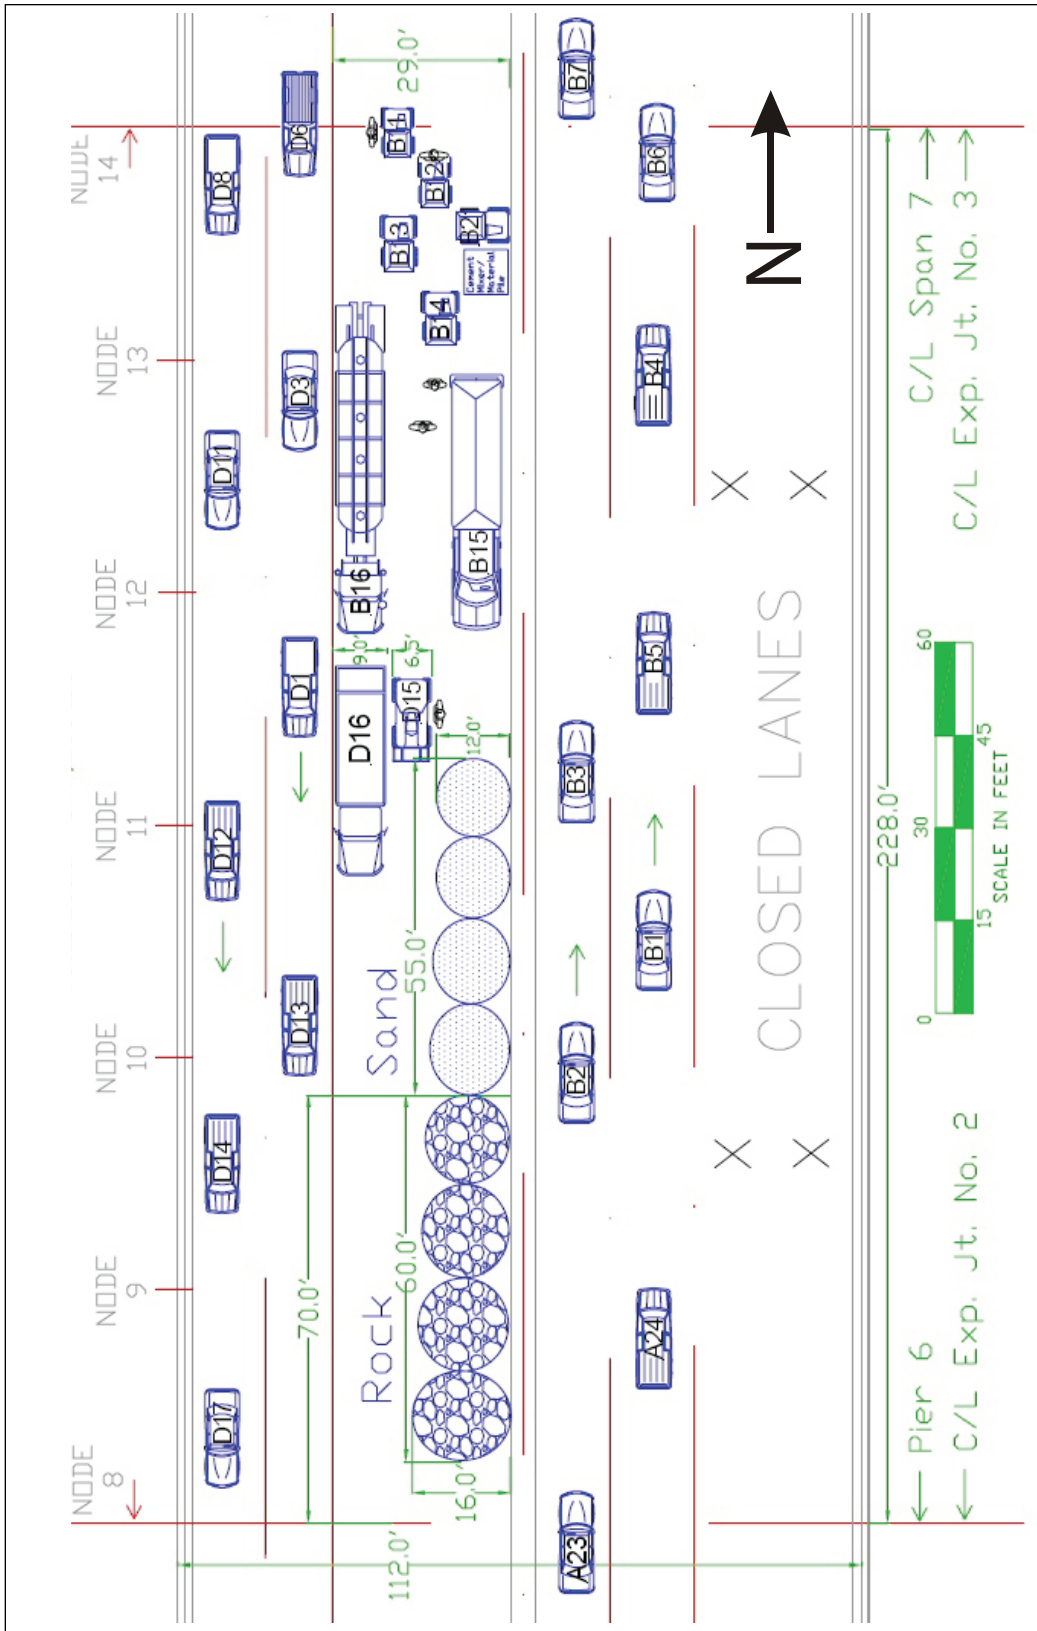
The construction aggregates were distributed in eight adjacent piles (four sand and four gravel) placed along the median in the leftmost southbound lane just north of pier 6. The combined aggregates occupied a space about 115 feet long and 12–16 feet wide, with its southern boundary about 10 feet north of pier 6. (See figure 17.) This staging placed the aggregate piles generally centered longitudinally over the deck truss U10 nodes. Along with the aggregates in this area were a water tanker truck with 3,000 gallons of water, a cement tanker, a concrete mixer, one small loader/excavator, and four self-propelled walk-behind or ride-along buggies for moving smaller amounts of materials.

Figure 17. Reconstruction of estimated positions of construction aggregates and equipment along the two inner southbound lanes of I-35W bridge at time of collapse.

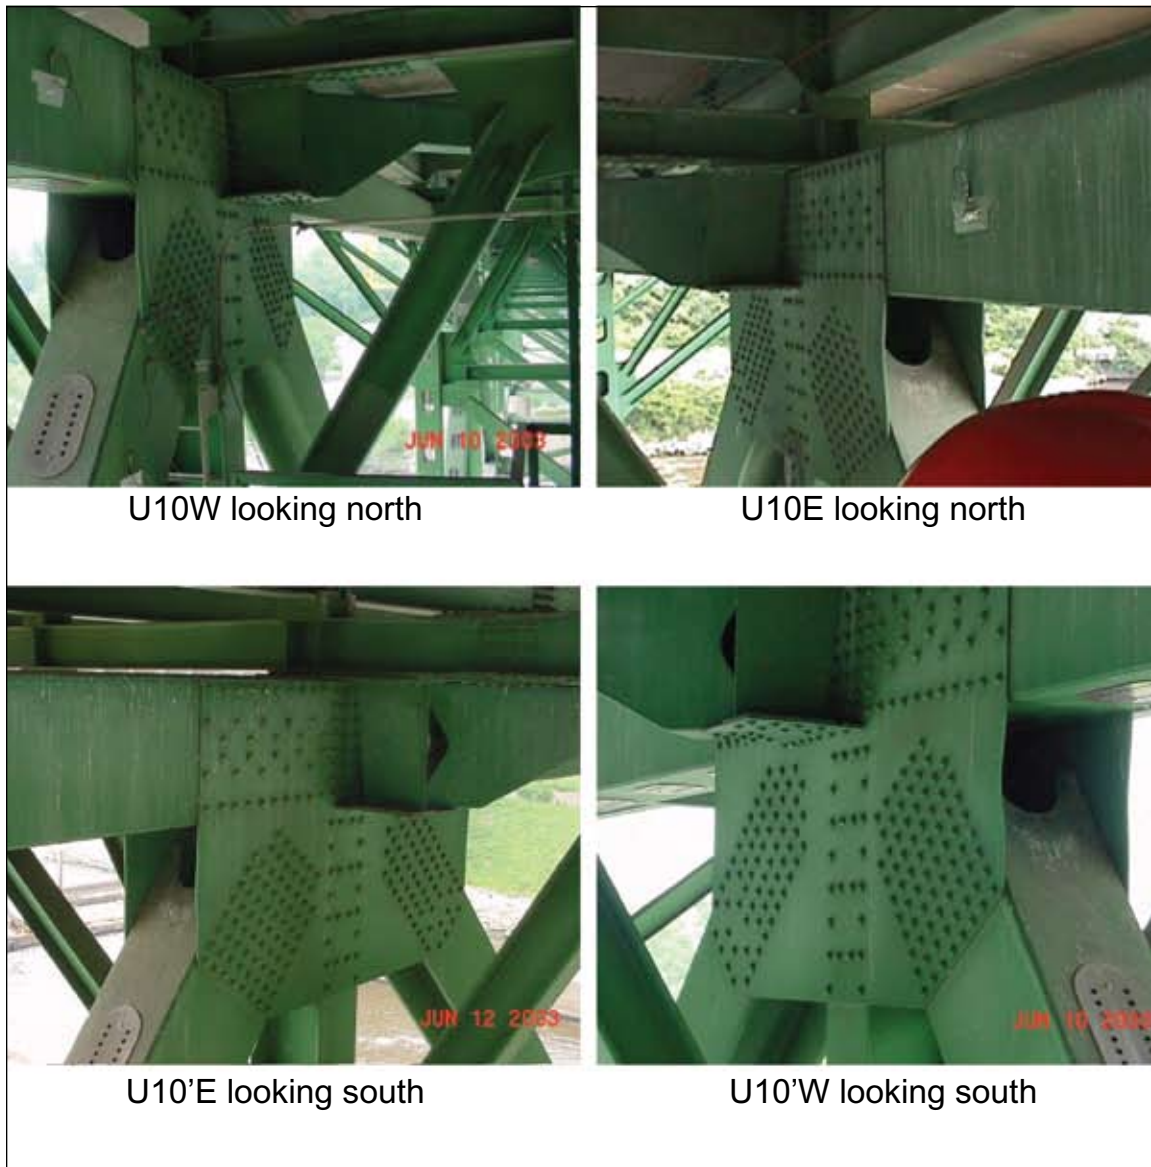
²⁷ *Bowing* or *bowed*, as used in this report, refers only to the appearance of the gusset plates. These words are not the technical terms that would normally be used by bridge inspectors or the FHWA to describe distortion in a bridge member.

Figure 19. Bowed gusset plates at nodes 10 and 10'. (Source: University of Minnesota, top right photo; URS Corporation, other three photos)

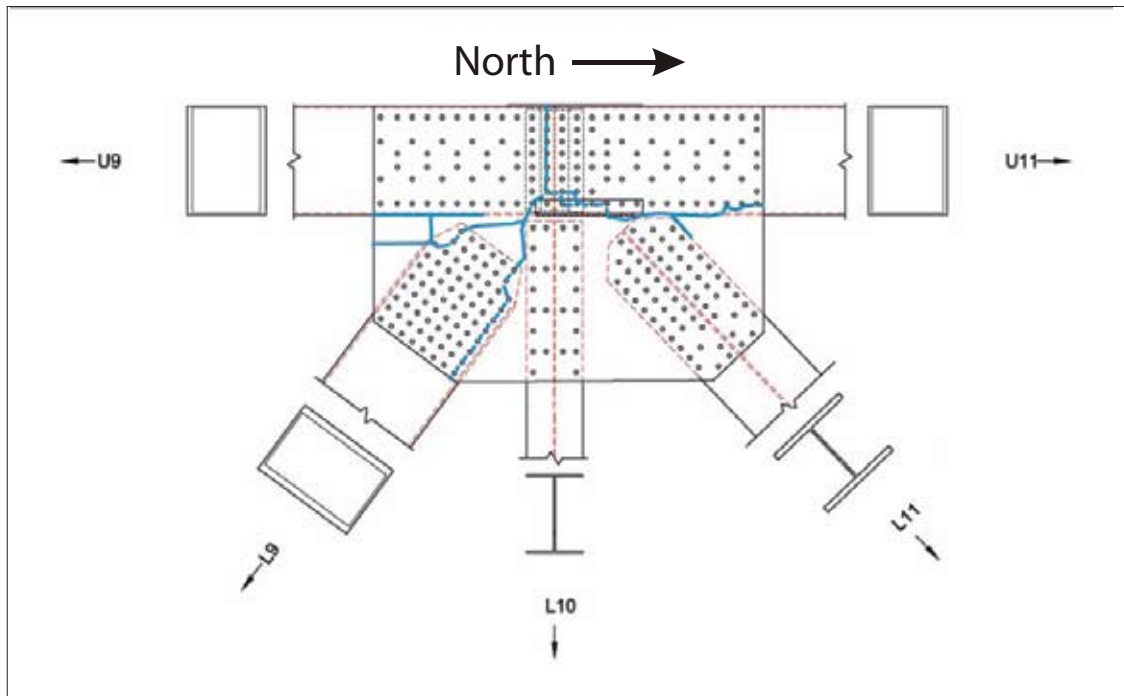
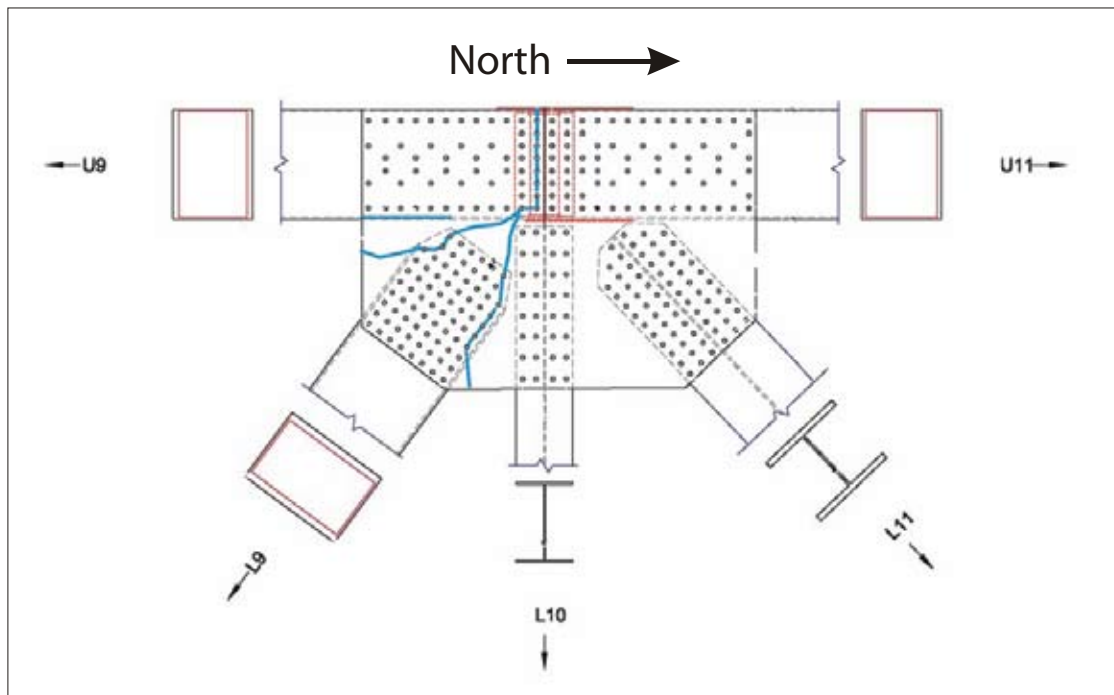
The fractures on all four U10 gusset plates left a portion of the plates attached to the upper ends of the separated diagonals L9/U10, with a V-shaped piece of the plates extending beyond the ends of the diagonals. On both the east and west diagonals, these V-shaped pieces were bent toward the east, indicating that the upper ends of the diagonals shifted laterally to the west as the gusset plates deformed and fractured. As these shifts occurred and the remainder of the node dropped, the east side plates of the diagonals penetrated through the interior structure of the nodes. Pieces associated with the remainder of the nodes and floor truss 10 contained multiple impact marks from contact with the upper ends of the diagonals. Deformation patterns associated with a fracture in the upper chord of floor truss 10, just west of the U10E node, were consistent with this fracture having resulted from the impact of the west side plate of diagonal L9/U10E with the lower side of the upper chord of the floor truss.

Figure 20A. Inside (east) gusset plate at U10W (top) and outside (east) gusset plate at U10E (bottom), showing similar fracture patterns in blue.

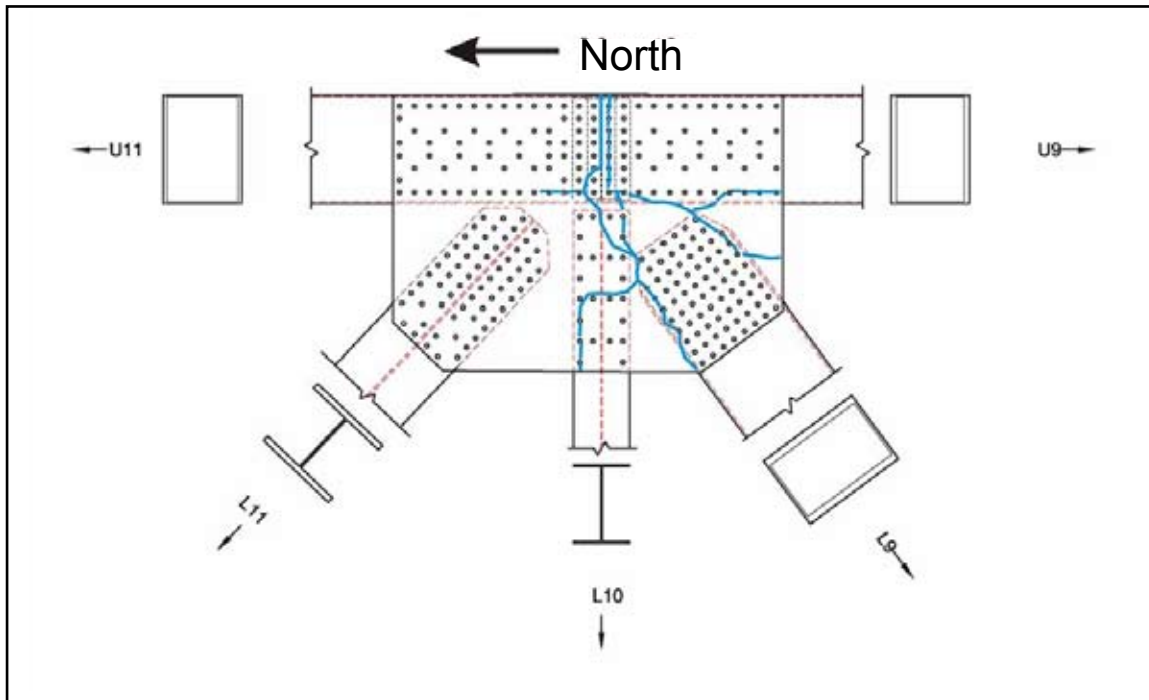
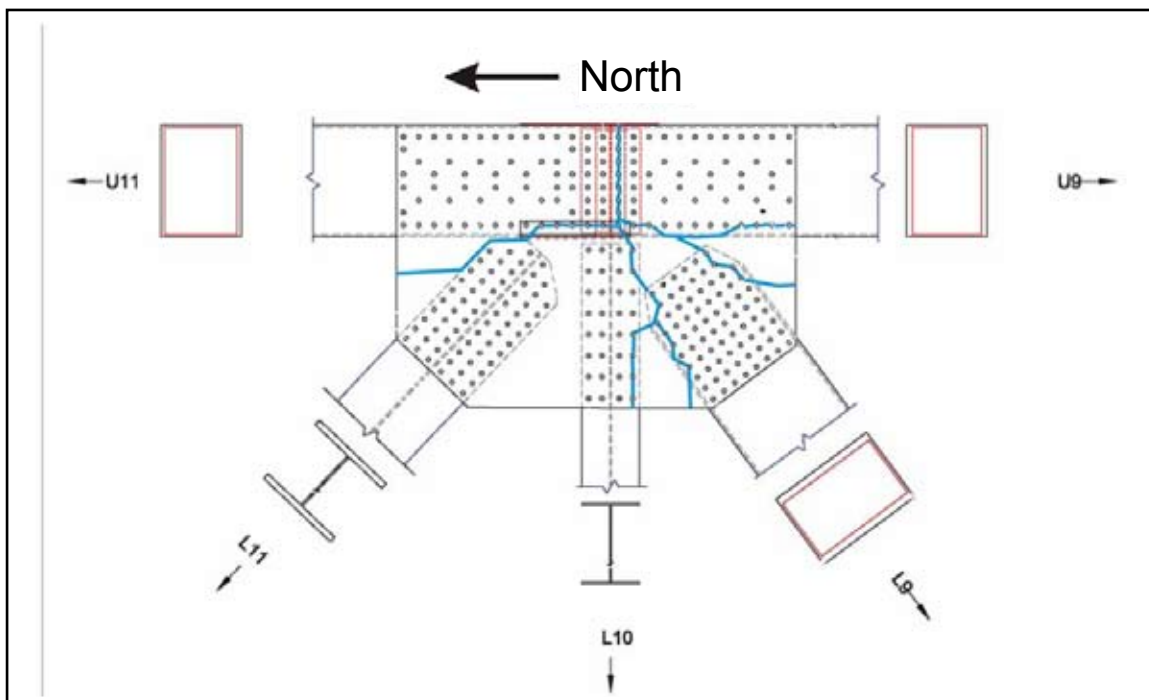
Figure 20B. Outside (west) gusset plate at U10W (top) and inside (west) gusset plate at U10E (bottom), showing similar fracture patterns in blue.

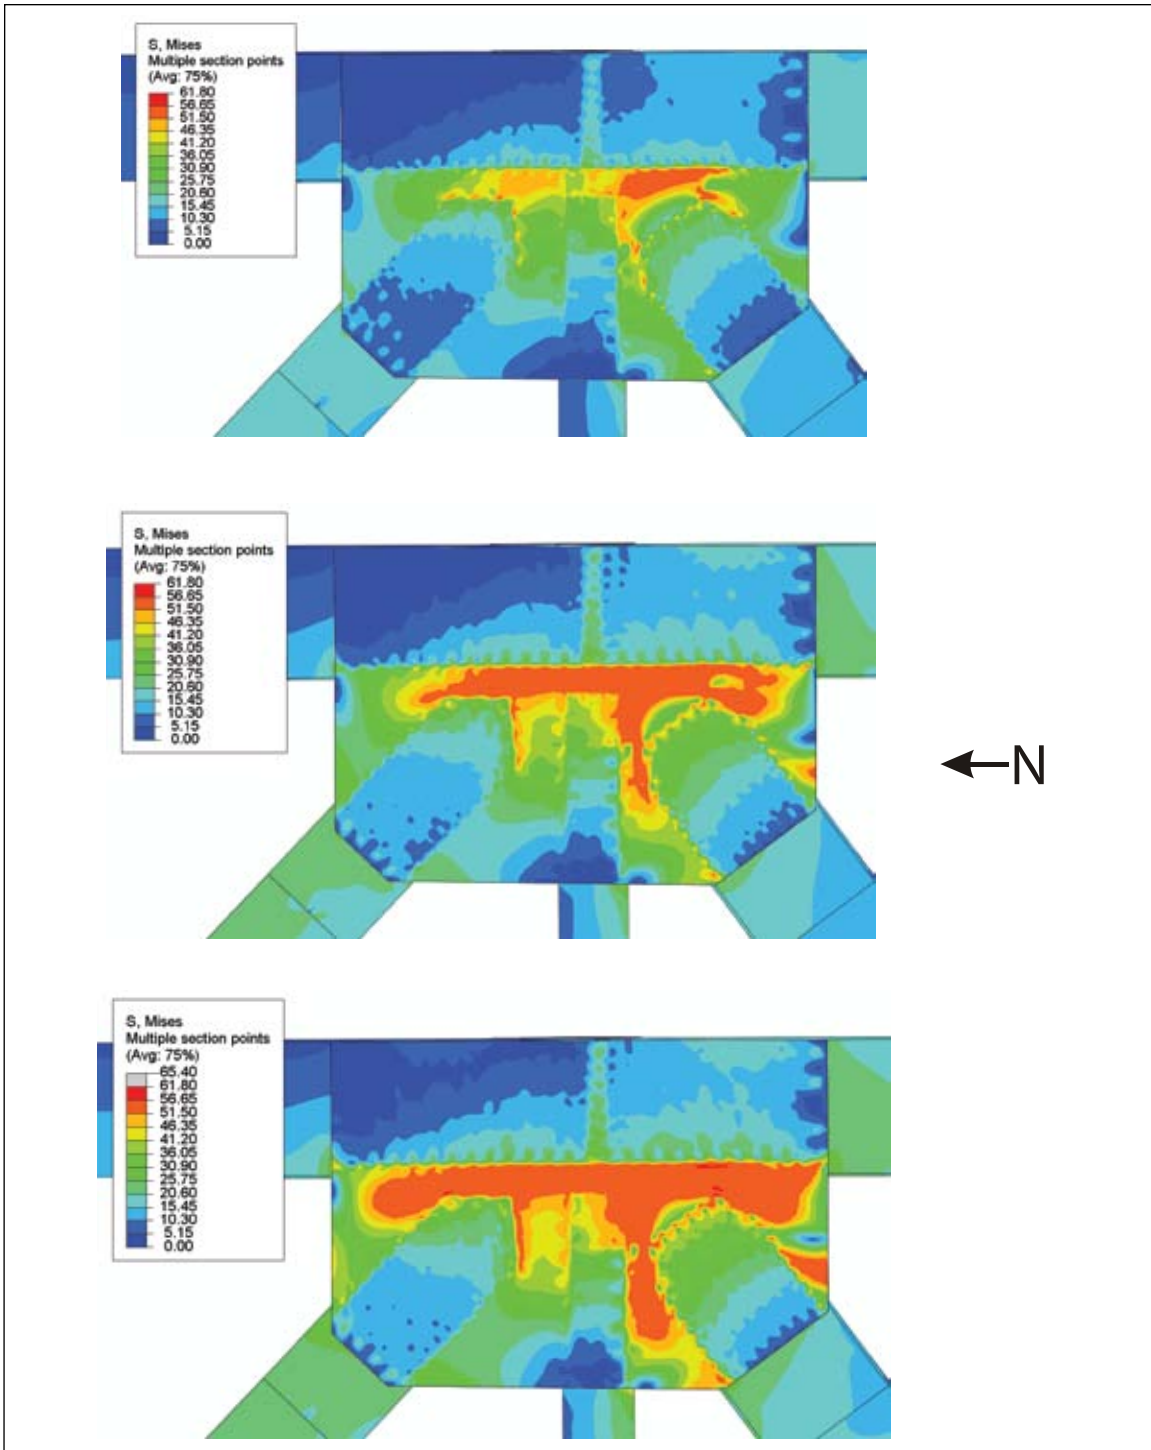
³⁸ An instability is evident in the model when it cannot balance increasing applied loads. The model showed that, at the point of instability, the highly stressed gusset plates at the U10W node are unable to resist the lateral shifting of the upper end of diagonal L9/U10. At that point, the lateral shift of the upper end of the diagonal will proceed even with no added load.

Figure 21. Finite element model stress contours for outside (west) gusset plate at U10W at time of bridge opening in 1967 (top); after 1977 and 1998 renovation projects, which increased deck thickness and modified barriers (middle); and on August 1, 2007 (bottom). Note areas that are yielding (dark orange and red contours above yield stress of 51.5 ksi) around ends of diagonals, beginning with original bridge and becoming larger as loads were increased.

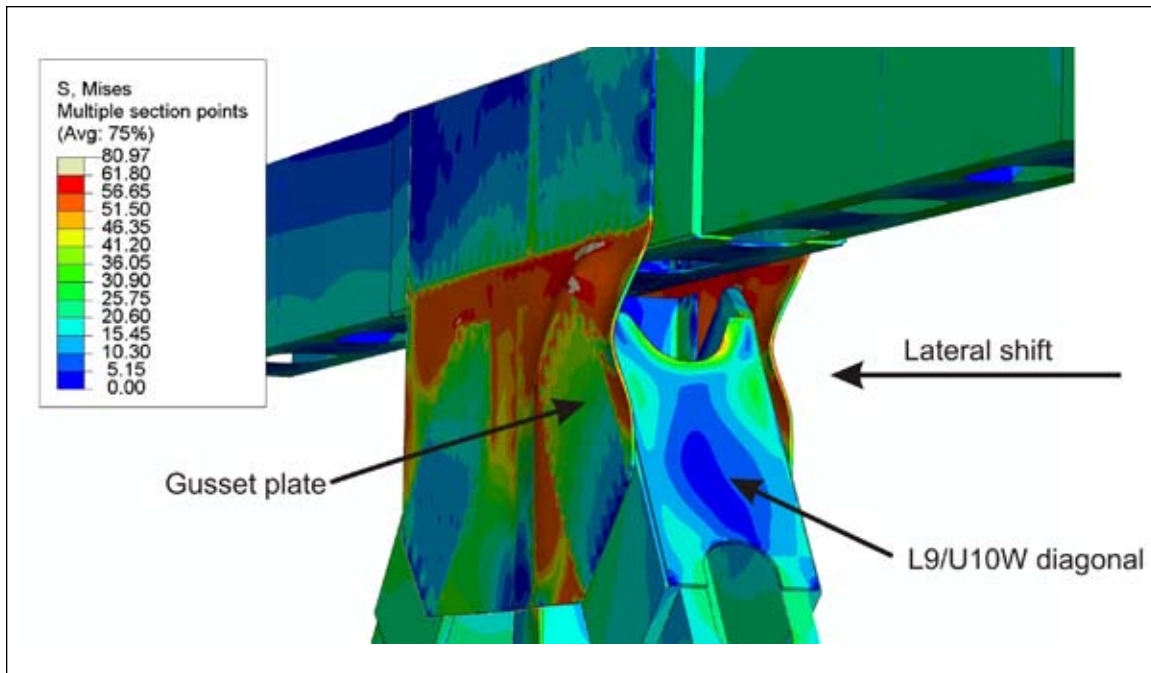
Figure 22. View of node U10W looking north, indicating lateral shift west of upper end of L9/U10W diagonal member at point of instability. (For purpose of illustration, the amount of lateral displacement, including bowing of gusset plates, is exaggerated by a multiple of 5.)

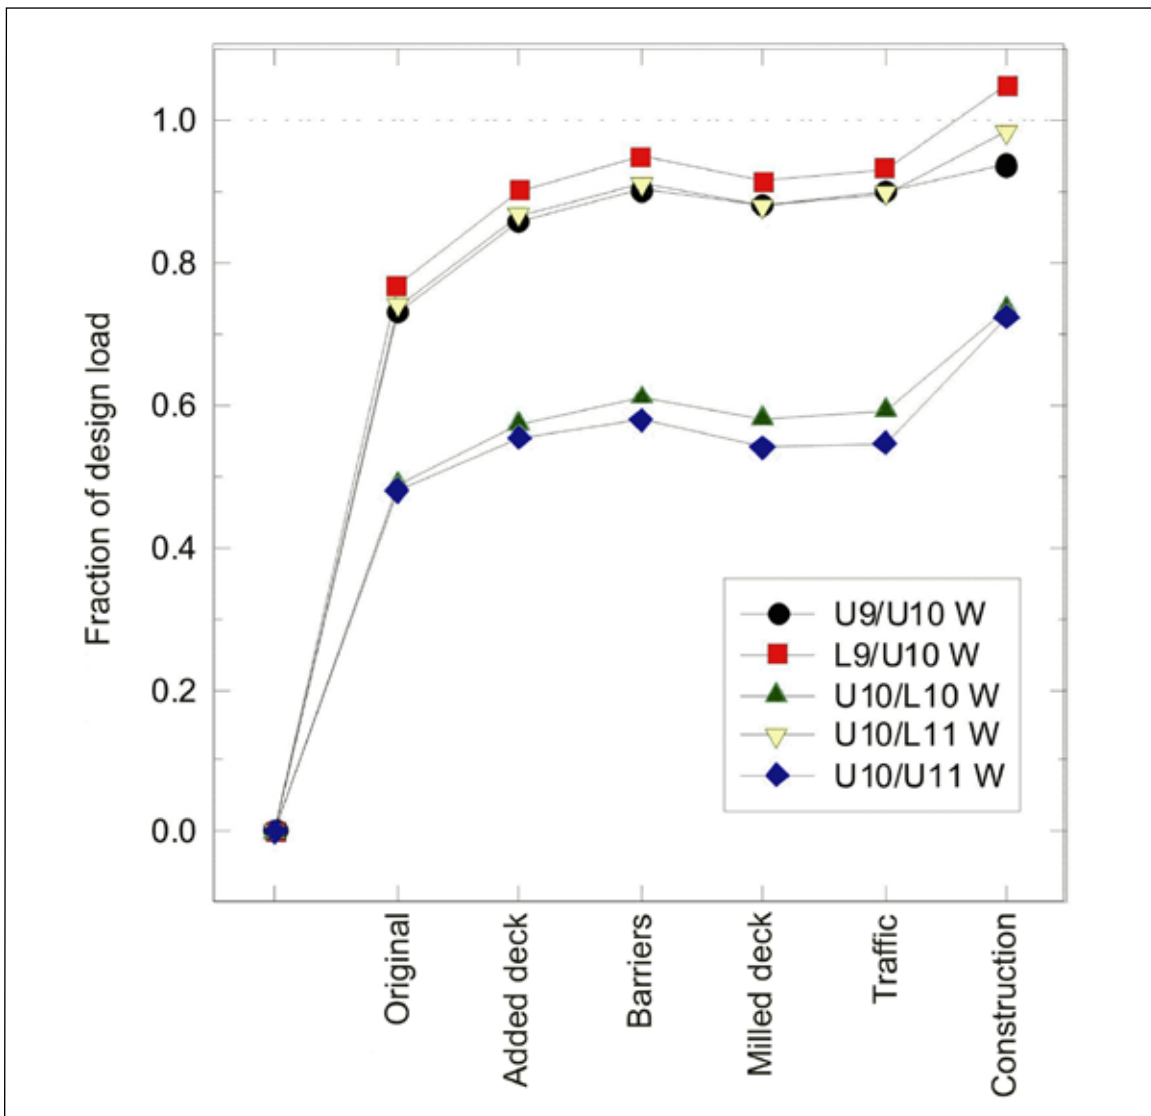
dead load of the original bridge design plus a maximum live load and impact load calculated per AASHTO specifications. The intent of the design methodology was to ensure that, under the design load, the stress in each member would be less than the allowable stress for that member. This allowable stress would have been no more than 55 percent of the yield stress, depending on the type of load applied (tension, compression, or shear). These member design loads would also have been used to design the U10 gusset plates to satisfy the allowable stress requirements per the AASHTO specifications.

Figure 23. Loads (as fraction of design load) in five main truss members that connect at U10W node, as calculated using FHWA global model. Steps include dead load of original design, added deck thickness in 1977, and modification to barriers in 1998. The final three steps include conditions on the day of the accident: milled-off deck thickness in southbound lanes, traffic at collapse, and construction materials and vehicles.
