Methods for Evaluating and Treating ASR-Affected Structures: Results of Field Application and Demonstration Projects

Volume II: Details of Field Applications and Analysis

Final Report

U.S. Department of Transportation
Federal Highway Administration

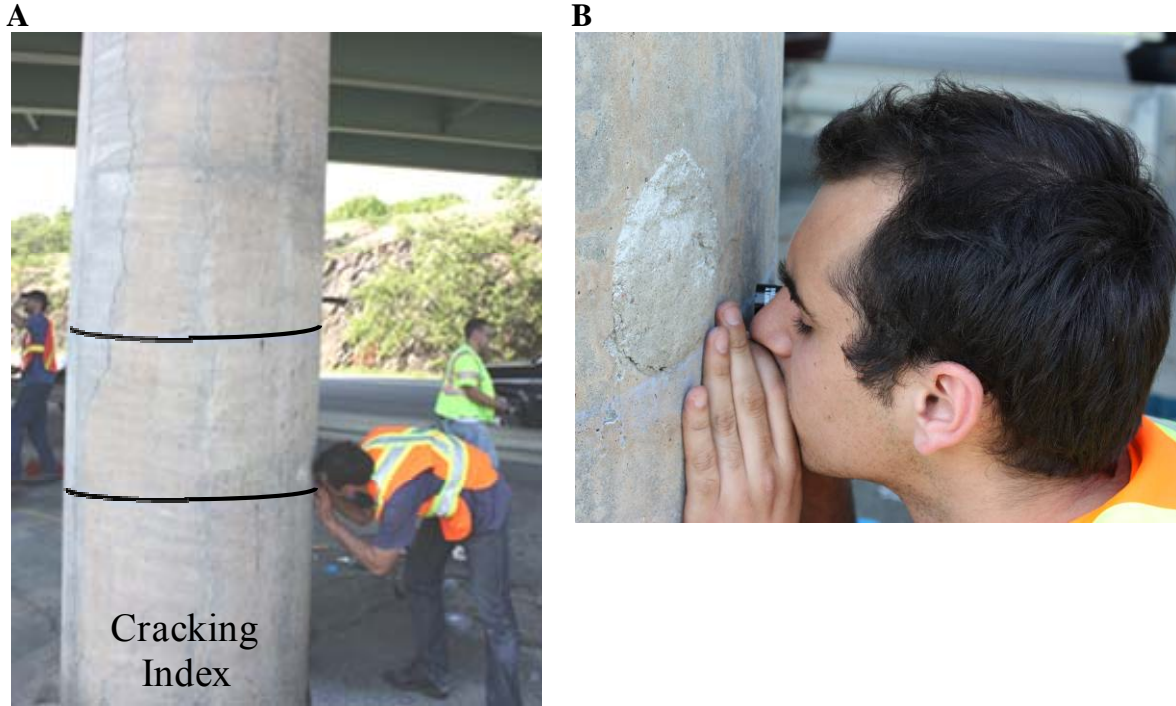
Figure 14. Cracking index measurements on the columns of the South Parkway bridge over I-395 (Maine). The crack mapping operator is measuring crack widths using a magnifying hand lens.

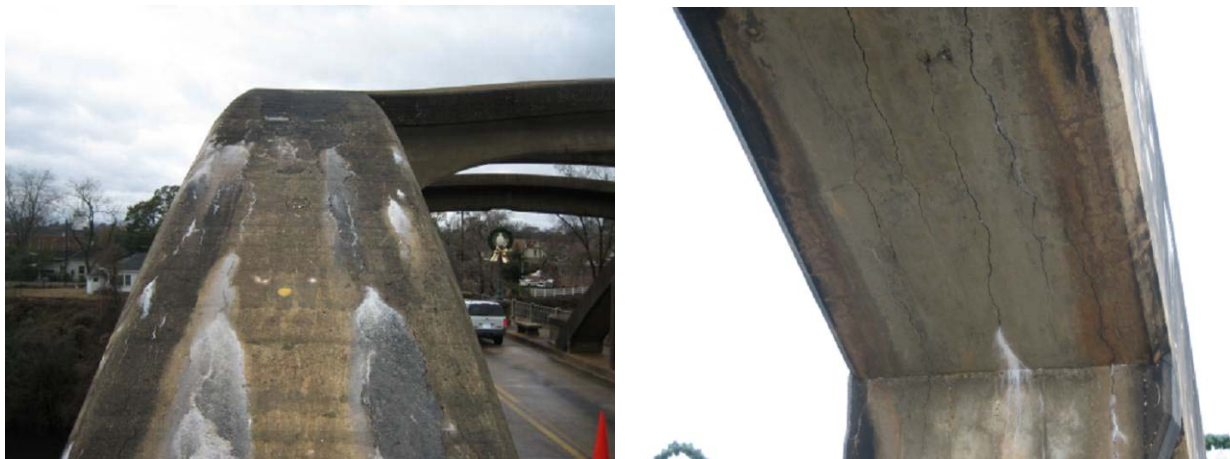
Figure 29. Cracking on top and underside of archway supporting 5th span.

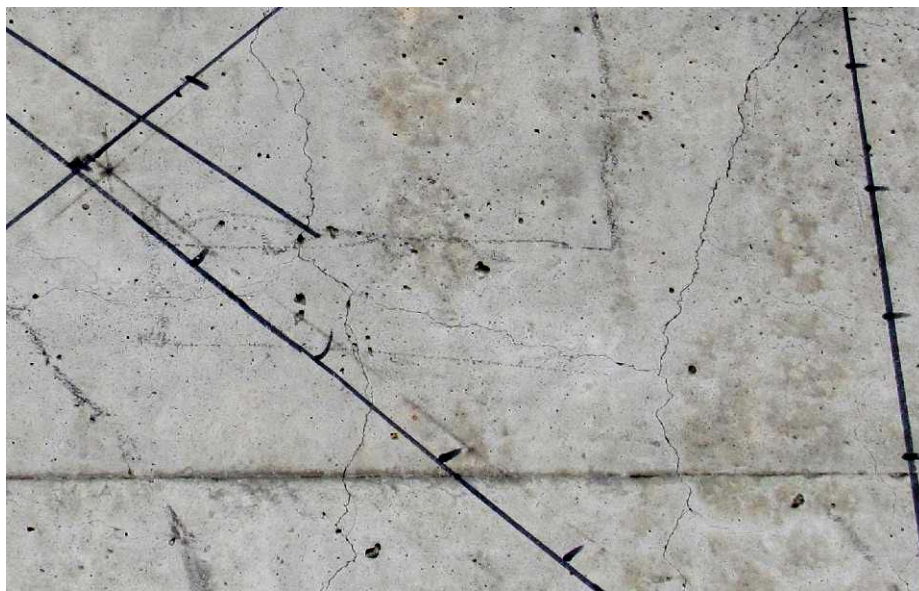
Figure 88. Enlargement of a section of the crack map at Site 1 (external and somewhat exposed to moisture) showing light cracking on column No. 1 of the I-395 bridge over the Penobscot River (2012).

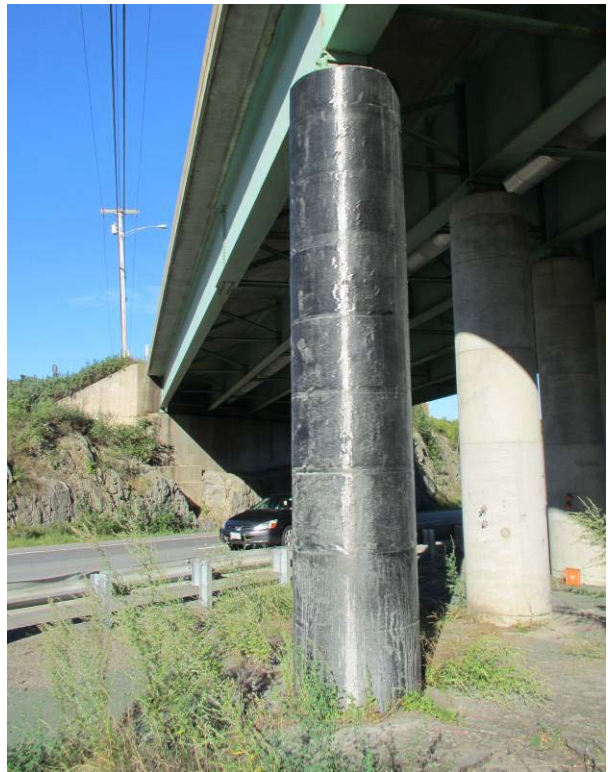
**Figure 106. Condition of concrete columns of the South Parkway bridge over I-395.
A&B: Site (column) 1. C&D: Site (column) 6.**

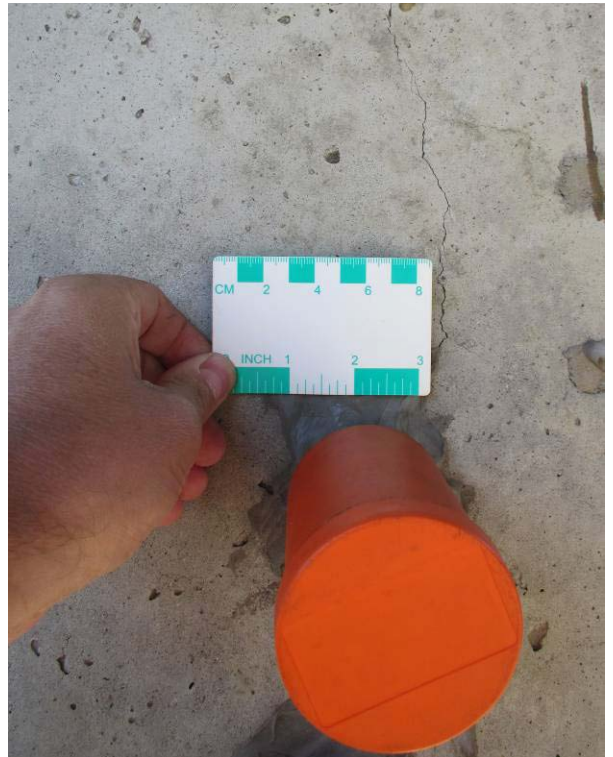
**Figure 107. Condition of concrete columns of the South Parkway bridge over I-395.
A&B: Site (column) 3. C&D: Site (column) 4.**

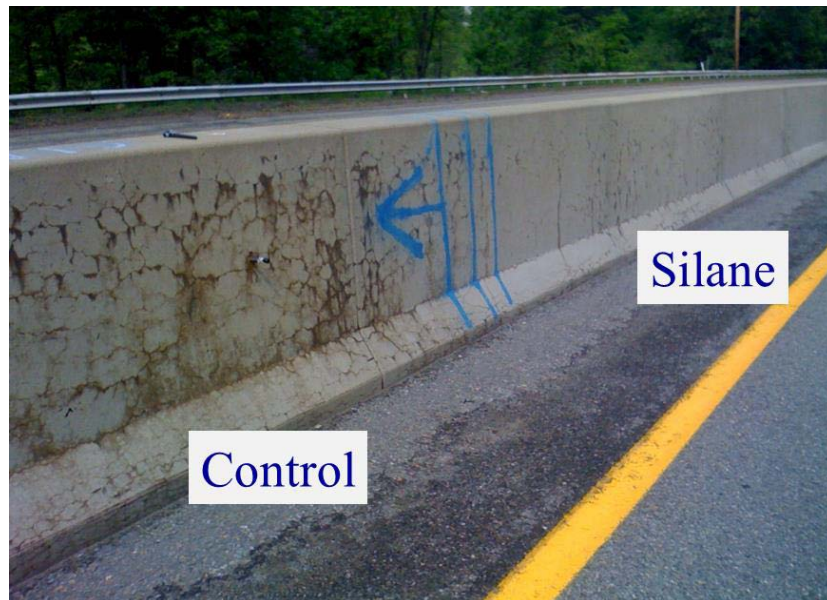
Figure 169. Significant reduction in visible cracking for the barriers treated with 40 percent silane (right), compared to untreated barriers (left).

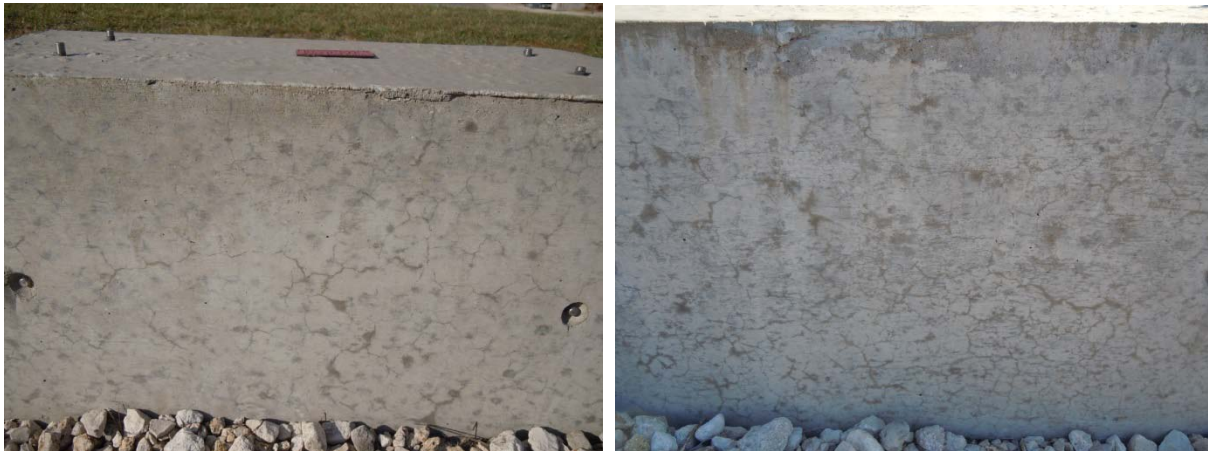
Figure 183. Visible cracking of replicate exposure blocks to beam 3 (with fly ash), on the left, and beam 4 (without fly ash), on the right. It is important to note that both blocks cracked about 1.5 – 2 years after casting without exhibiting measurable expansion.

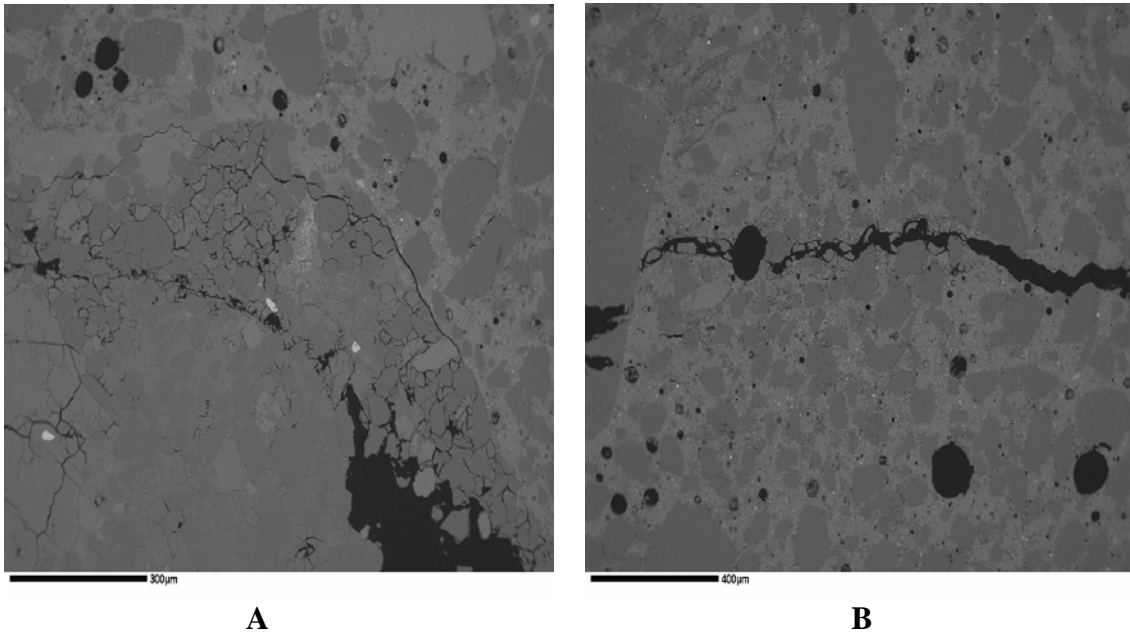
Figure 186. SEM micrographs of thin sections from Houston columns, showing (A) dissolution of siliceous aggregate, and (B) gel-filled cracks emanating from site of reaction.
