# Long-Term Monitoring of Pavement Maintenance Materials Test Sites

PUBLICATION NO. FHWA/HD-98/012

1. Report No.  FHWA-RD-98-073

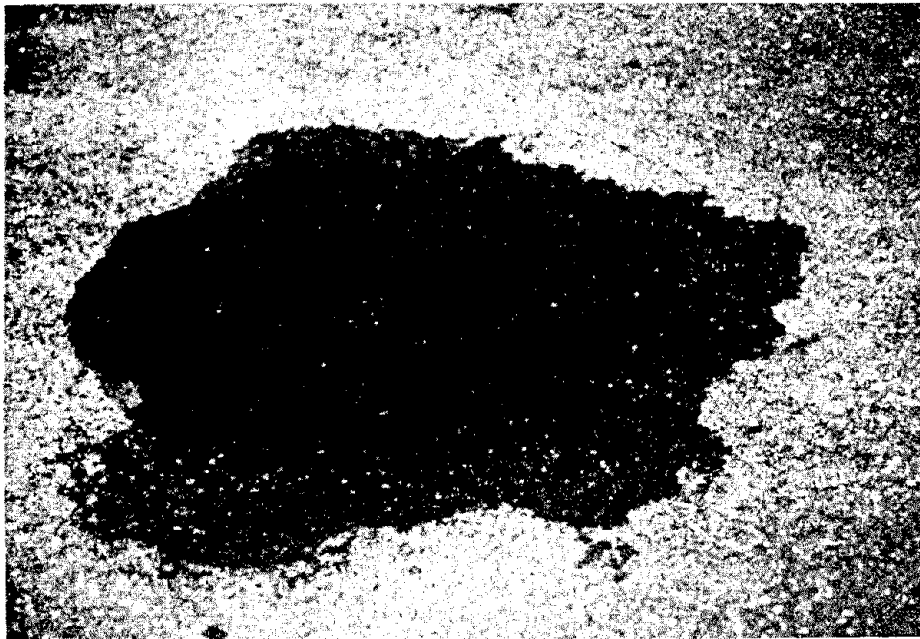
Some of the more significant distresses noted at the test sites were dishing, raveling, and edge disintegration. However, bleeding was prevalent among the PennDOT 486 patches but was not widespread among the other patches placed. Figures 30 through 34 show examples of bleeding, shoving, cracking, raveling, and edge disintegration as they were noted in the field.

Figure 30. Example of bleeding distress.

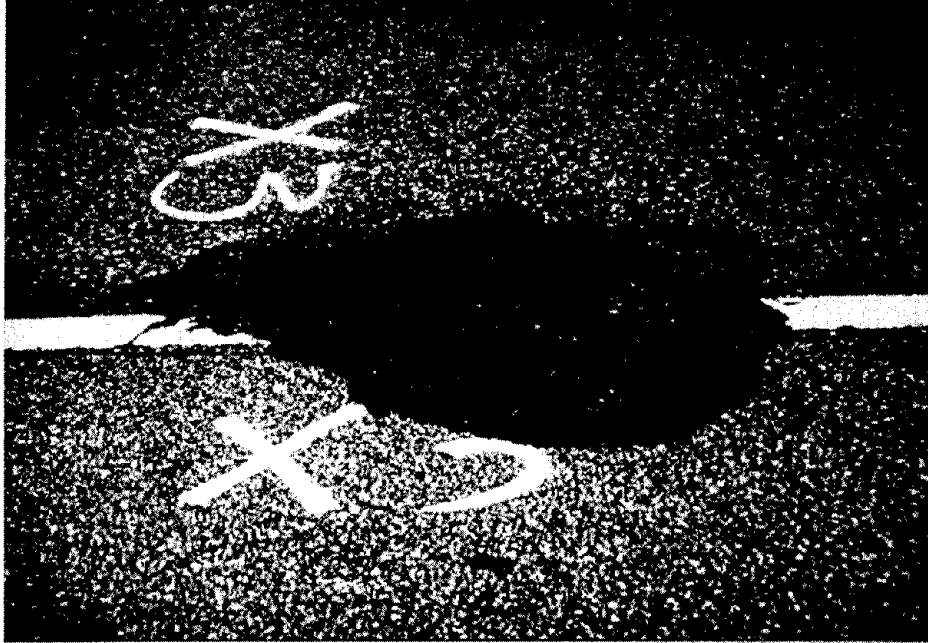
Figure 31. Example of shoving distress.

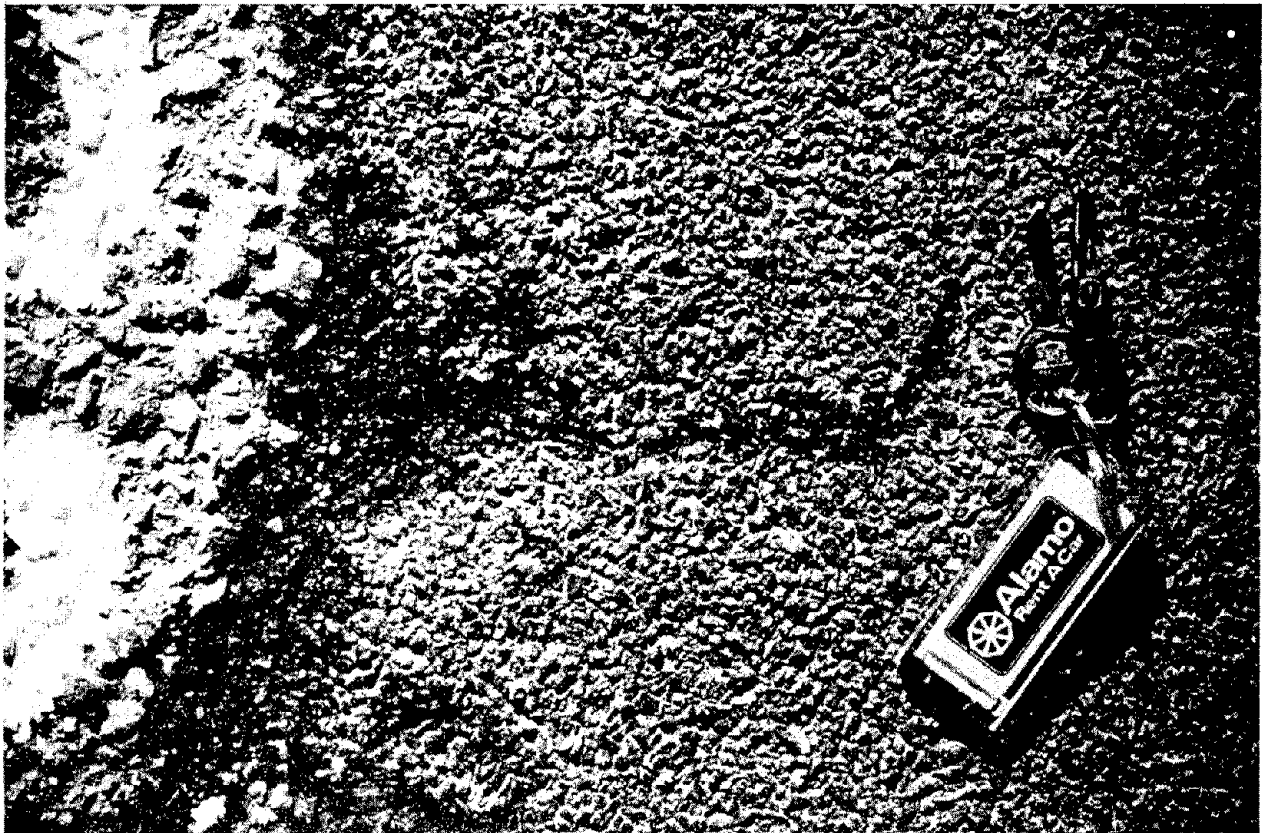
Figure 32. Example of cracking distress.

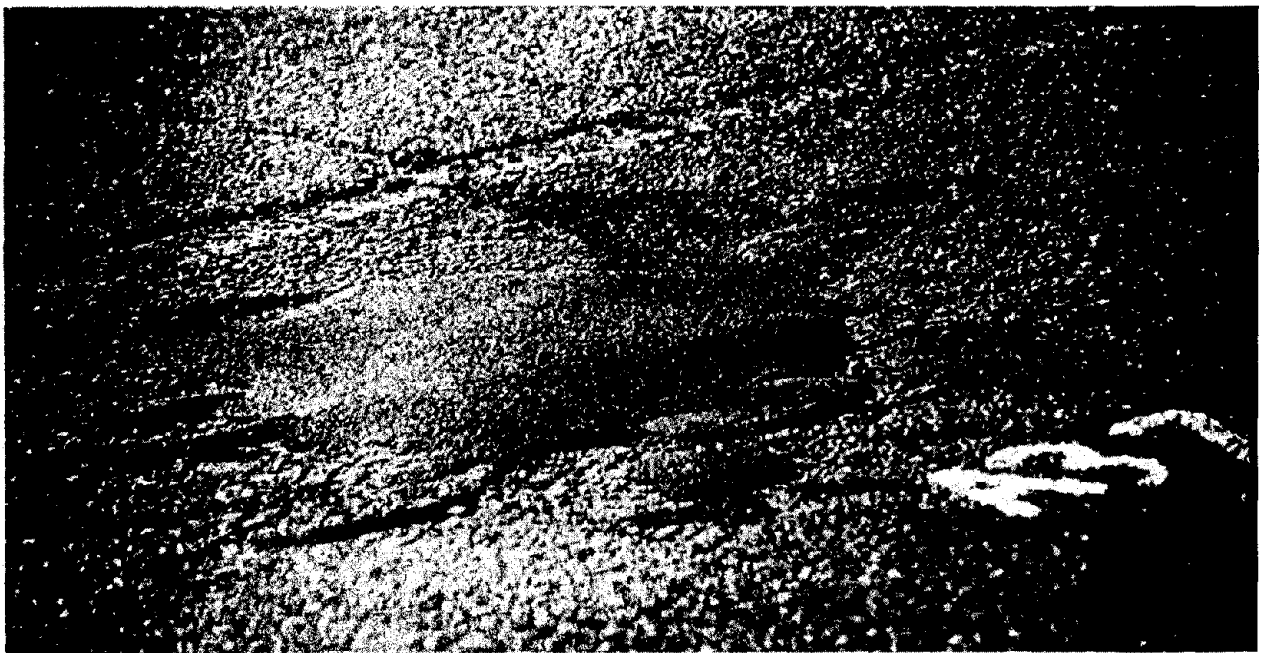
Figure 34. Example of edge disintegration distress.
