# **Video Inspection of Highway Edgedrain Systems**

**April 1998**

**FHWA-SA-98-044**

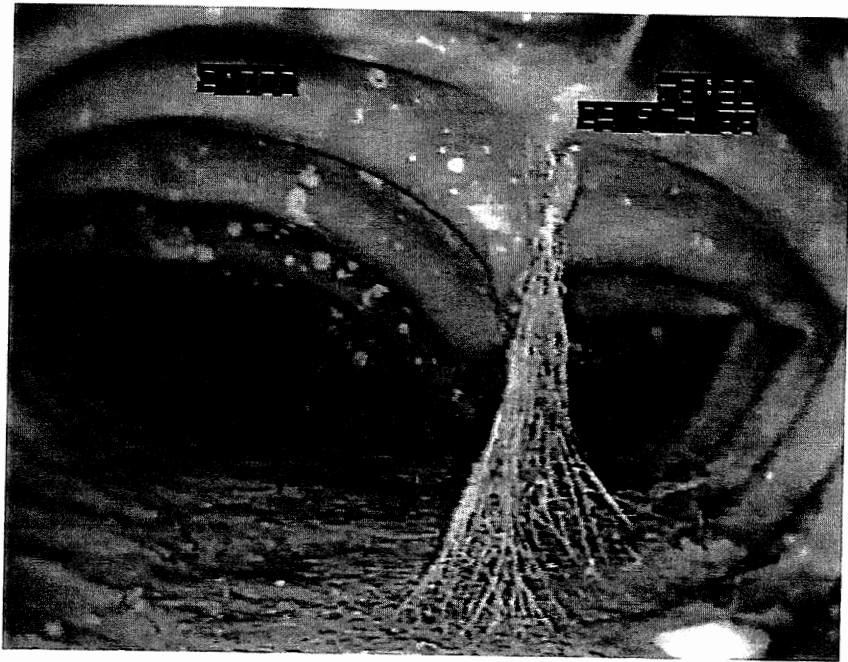
Figure 8. Silted and Crushed Lateral, Just Inside the Lateral Outlet (1.5 Feet).

(Note: The Image is Upside Down)

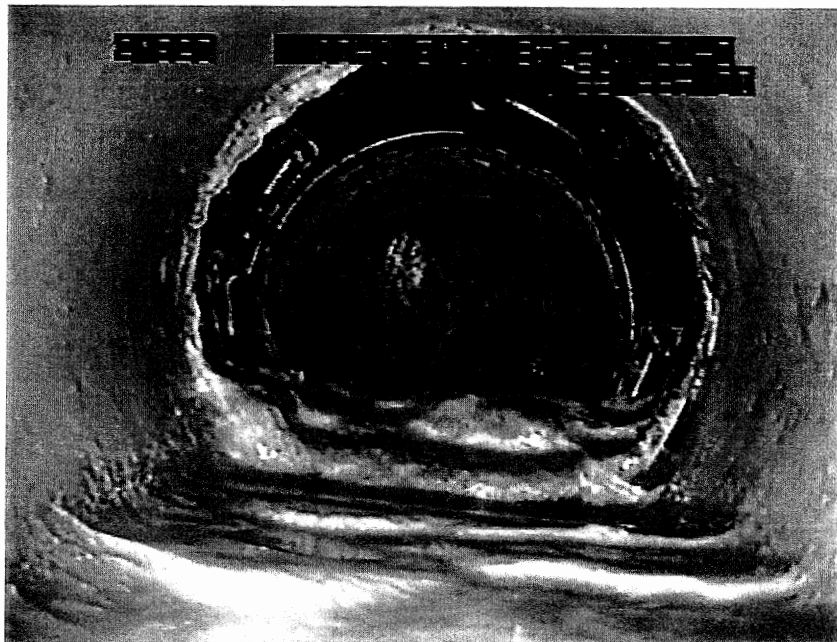
HEAVY SILTED AREA AT LATERAL/MAINLINE JUNCTION

Figure 9. Heavy Silt Flow at Lateral/Mainline Junction.

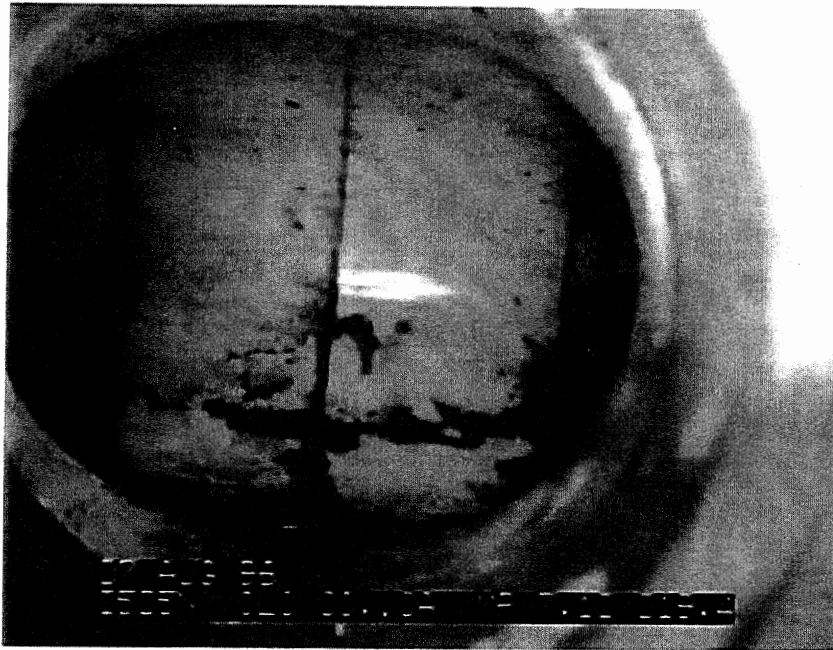
Figure 11. Clear 90° Tee Junction of Lateral and Mainline

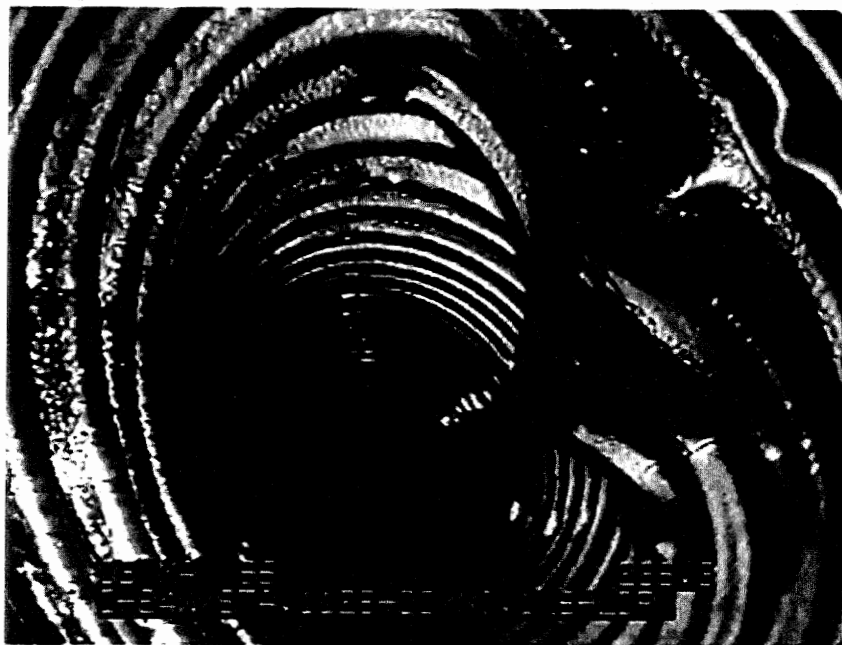
Figure 12. Crushed Mainline Segment at 238.3 Feet.  
(Note: Top of Pipe is Upper Right)

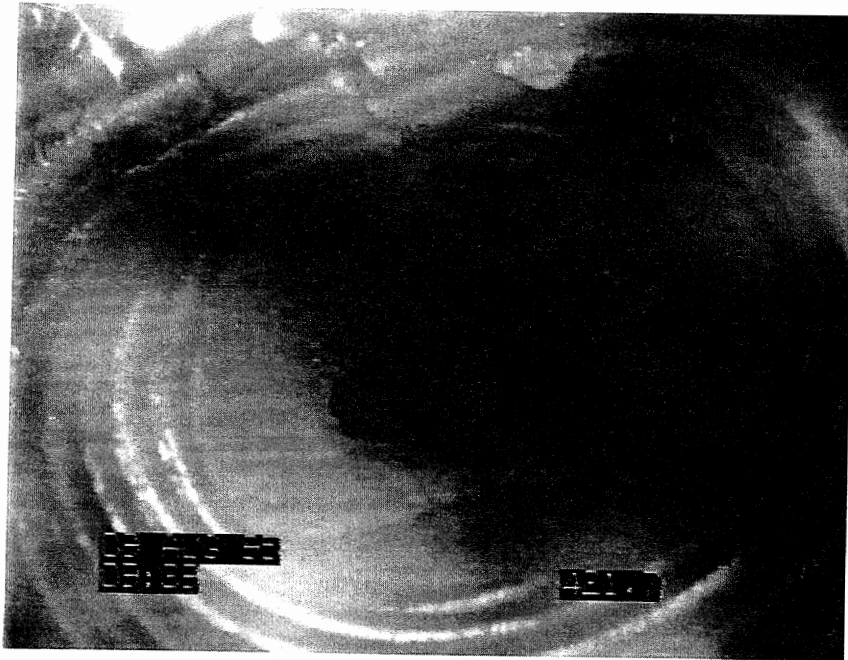
Figure 14. Inferior Construction Materials (A Brick End Cap)

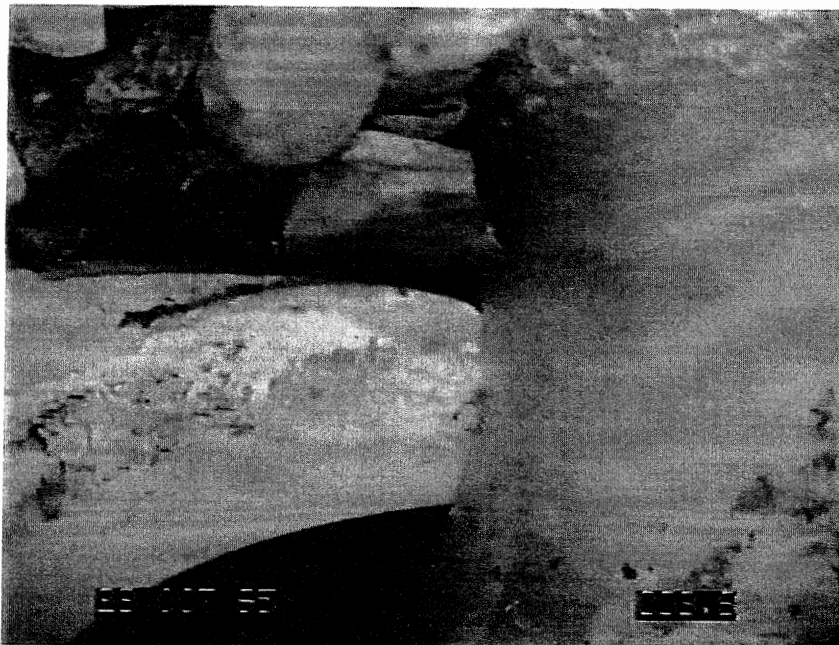
Figure 15. Materials/Obstructions Introduced During Construction. Note: PVC

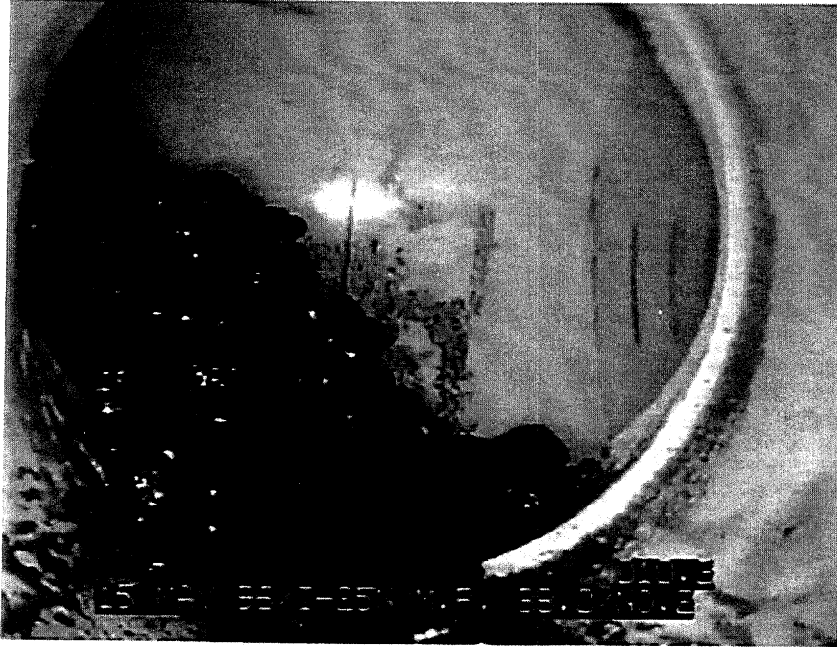
**Figure 16. Asphalt-Stabilized Base in Edgedrain.**

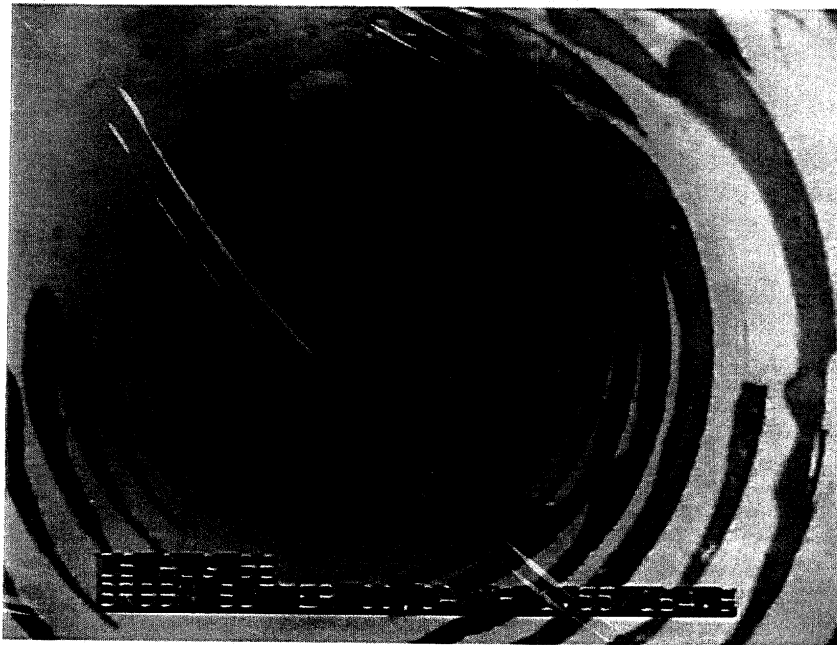
**Figure 17. Asphalt Base Permeating Slots in Drain.**

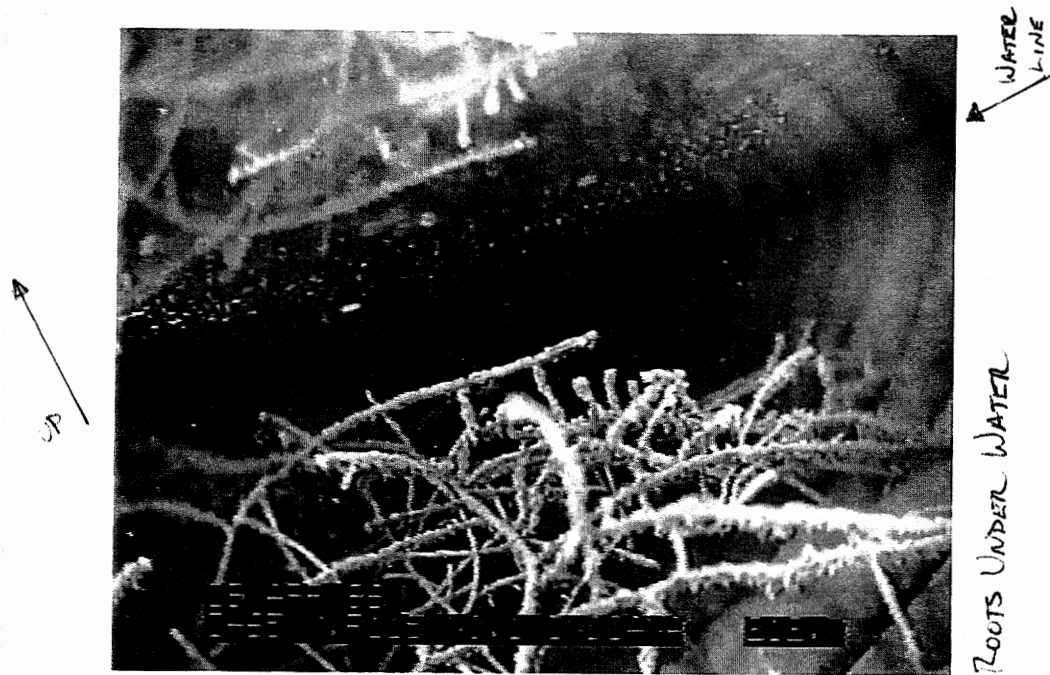
**Figure 18. Root Growth Underwater.**

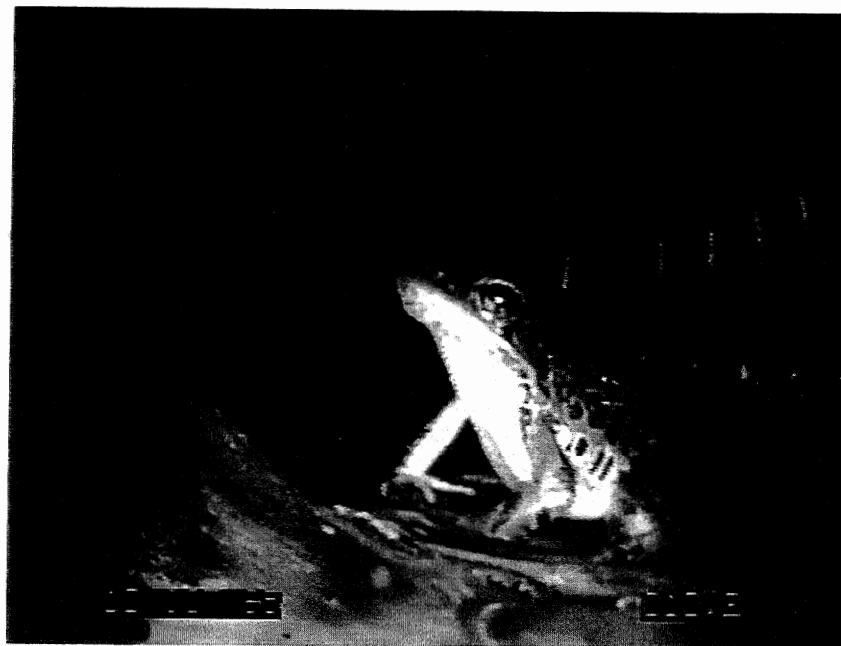
Similarly, if the pipe is not placed to an uniform grade, sags will develop which can lead to other concerns. These sags will collect water which fosters weed growth (Figure 18) and a habitat for all sorts of creatures, such as turtles, snakes, crawfish and frogs (Figure 19). If rodent screens are not

**Figure 19. Sags With Standing Water Provide a Desirable Environment for Unwanted Inhabitants.**

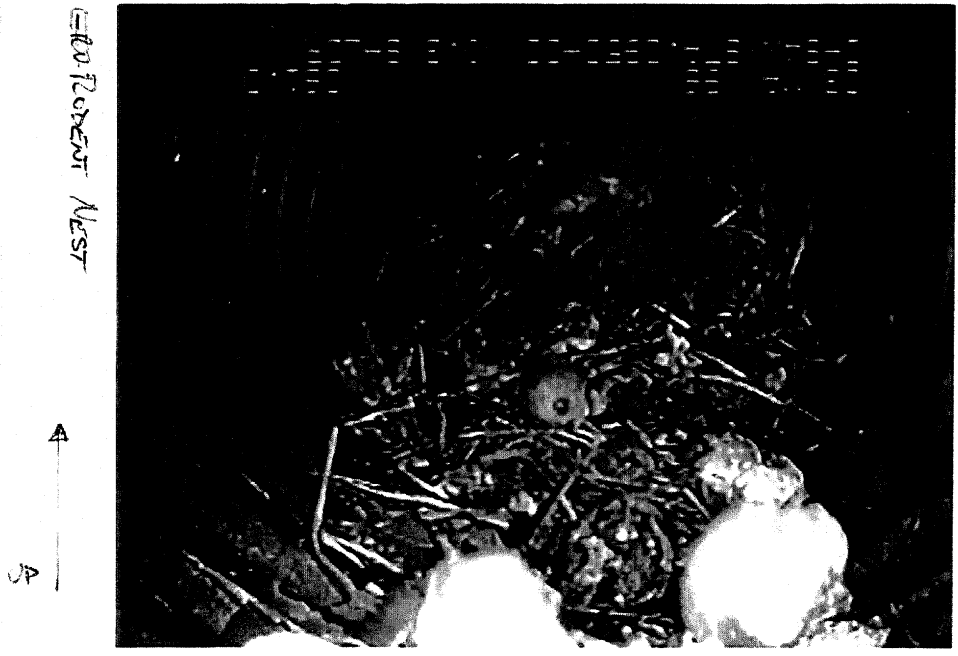
Figure 20. Rodent's Nests Found Blocking the Mainline at 61.0 Feet.

incorporated in these systems, this can lead to other obvious unwanted inhabitants (Figures 20 and 21). These and other revealed problems highlight the need for video inspections of highway edgedrain systems as a quality assurance tool for both rehabilitation and new projects. Detailed observations are included in Appendix A.

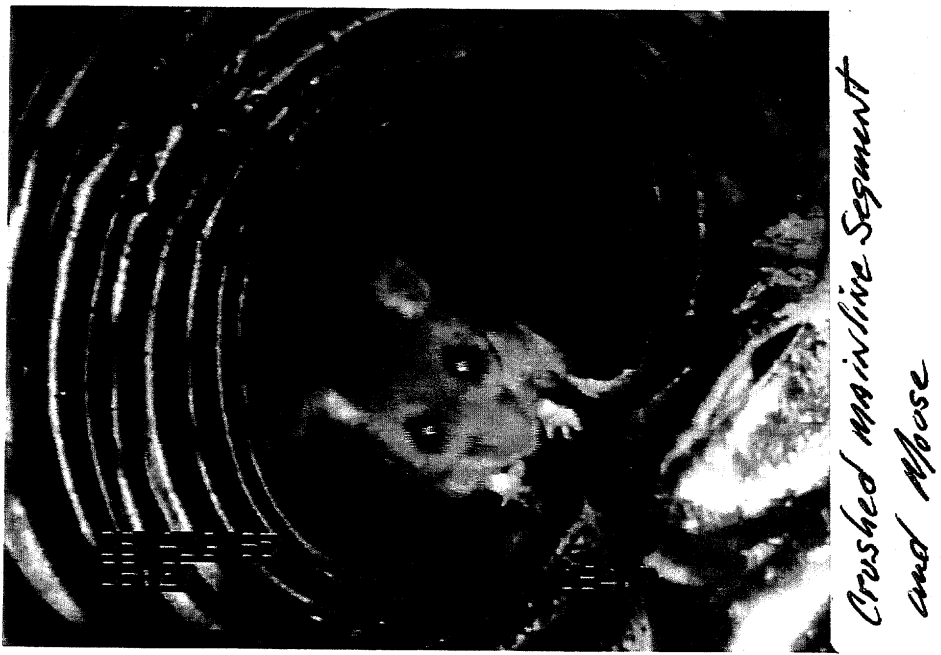
Figure 21. Mouse in Mainline.
