Case Studies

Eight case studies demonstrate how substantially damaged houses were elevated in Miami-Dade County After Hurricane Andrew.

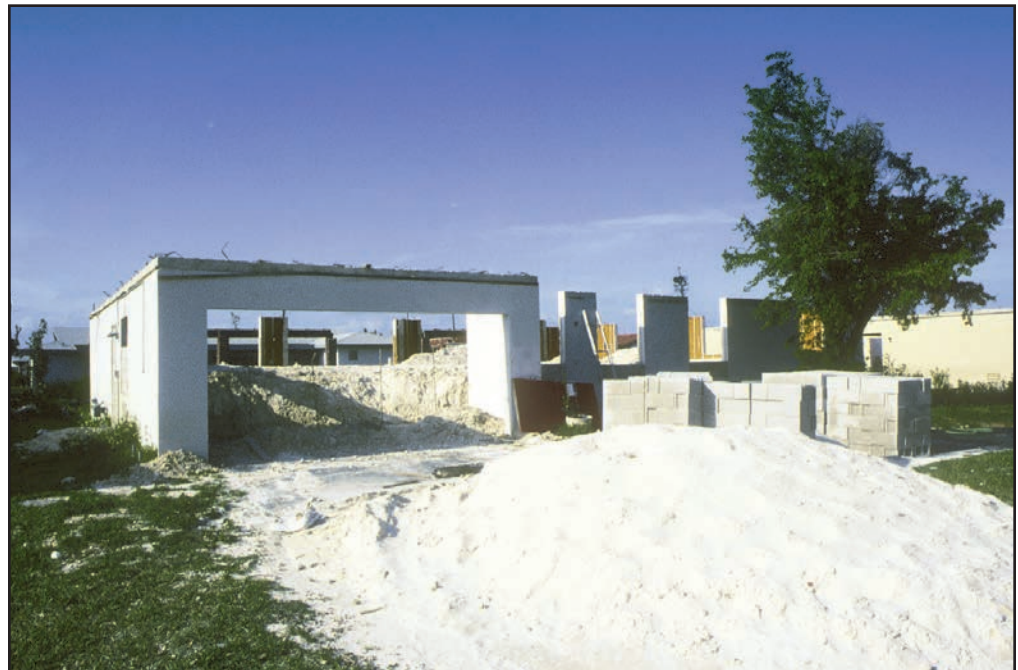
Figure 22

The front of the house at the beginning of the project. The interior walls and contents, which were destroyed or severely damaged by flood waters, wind, and rain, have been removed. Sand has been placed on top of the old slab to provide the base for the elevated lowest floor. The concrete blocks that will be used to extend the walls can be seen stored in the foreground.

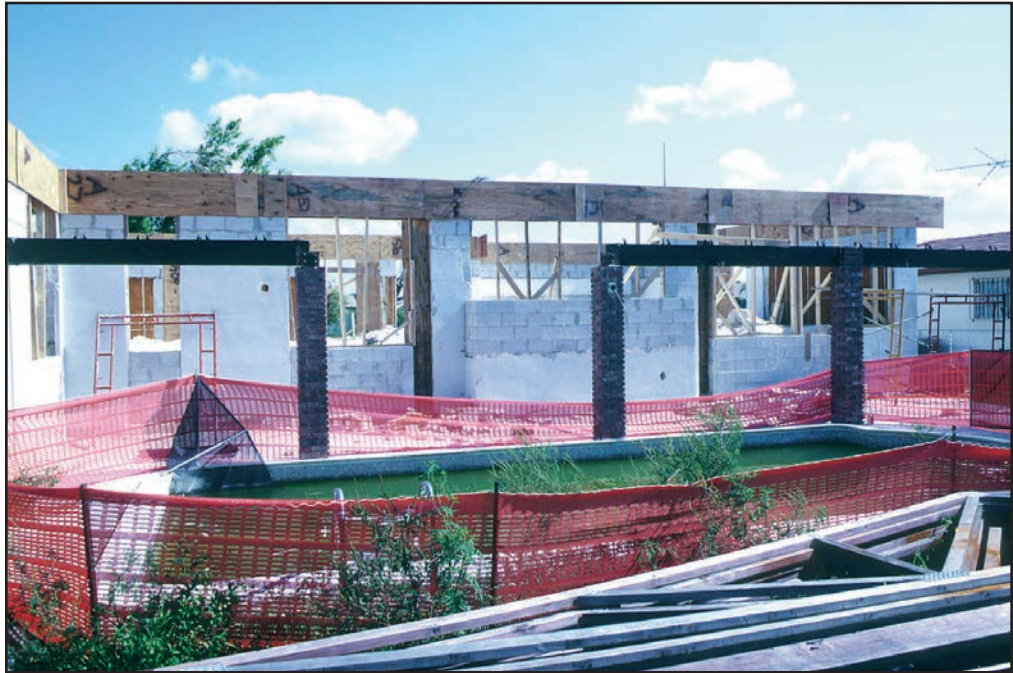
Figure 23
View from the back of the house. The walls have been extended upward with concrete blocks. The plywood visible at the tops of the walls is used to form cast-in-place concrete bond beams that will strengthen the extended walls. The roof trusses shown in the foreground were salvaged for reinstallation. The owner of this house decided to replace the original roof sheathing and shingles with new materials.

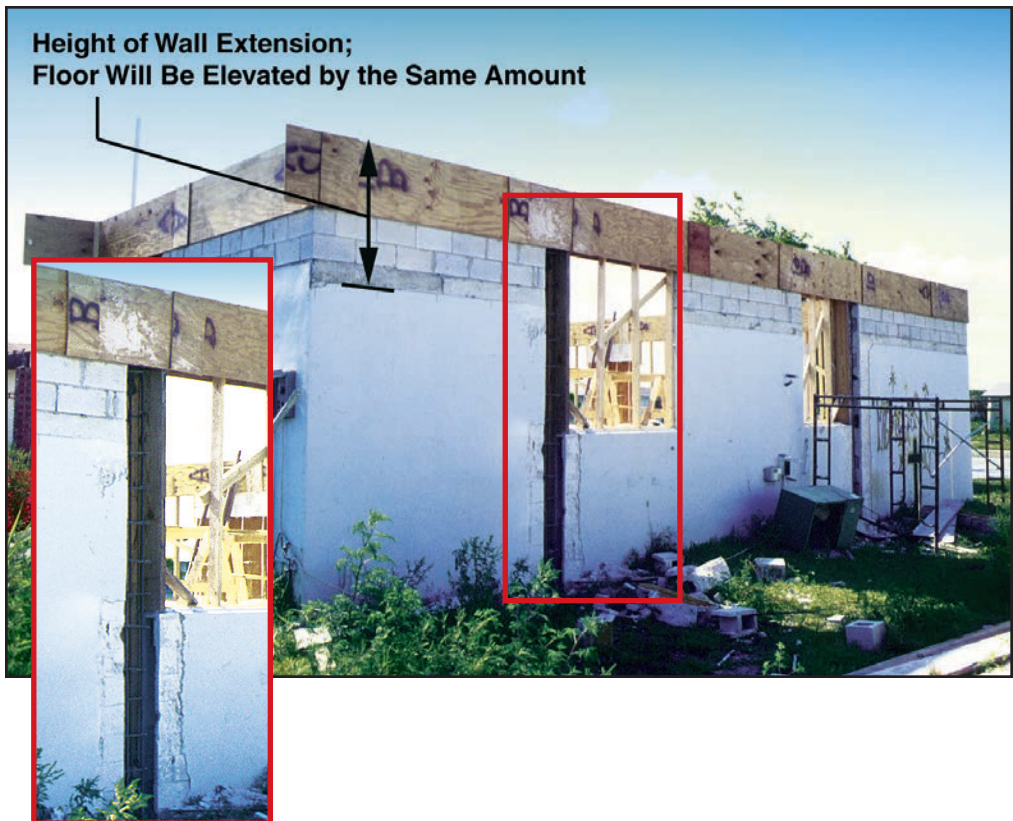
Figure 24
Another view of the extended walls. The vertical cuts in the walls next to the windows are for concrete tiedown columns that will be cast in place to further strengthen the extended walls against wind loads. The owner of this house was able to meet the elevation requirement by raising the floor only a few feet, as indicated by the amount that the walls have been extended.

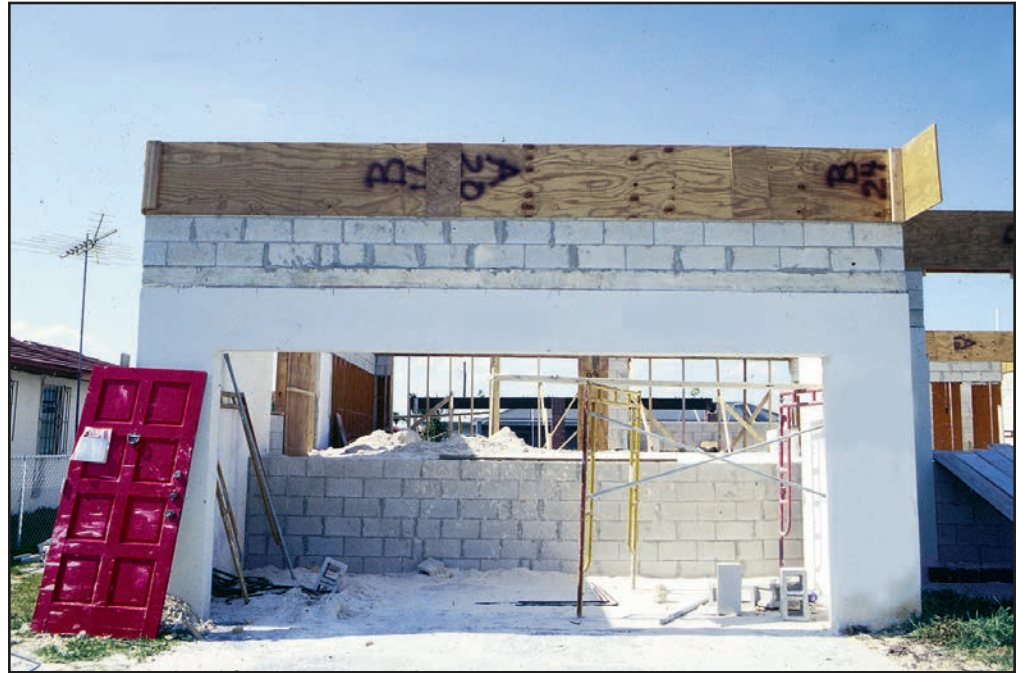
Figure 25

This view through the garage door reveals the different levels of the elevated slab floor, in the background, and the unelevated garage floor.

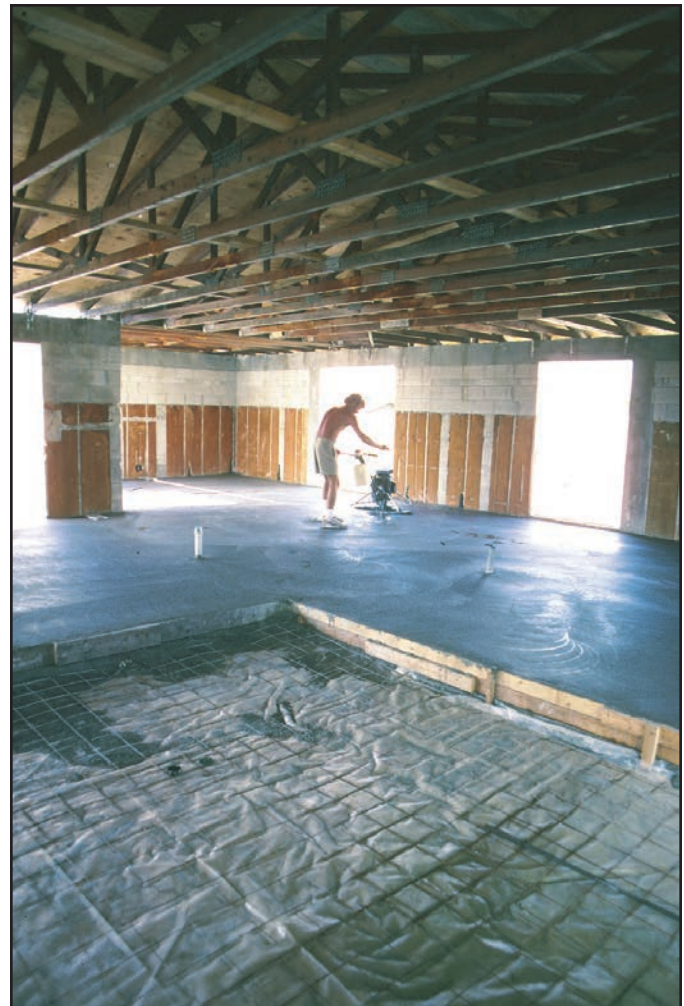
**Figure 26**

The roof has been rebuilt with the salvaged trusses, and most of the new concrete slab has been poured on top of the sand fill. The open area in the foreground, where plastic sheeting and wire reinforcement can be seen on top of the sand fill, is where the remaining part of the slab will be poured.

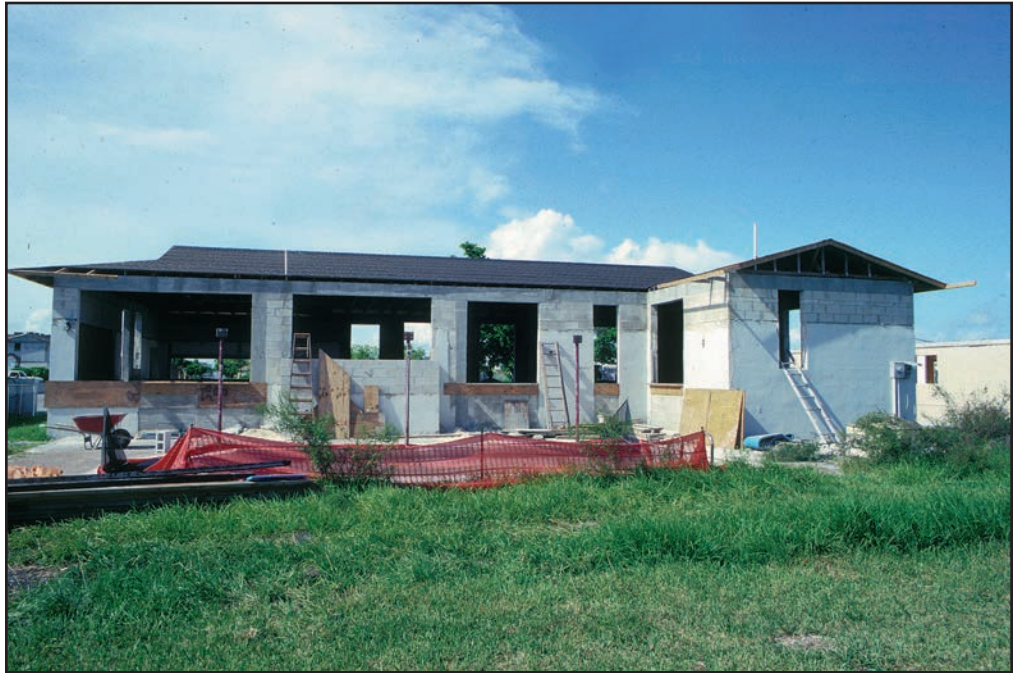
Figure 27
As work progresses,
the elevated house
begins to take shape.

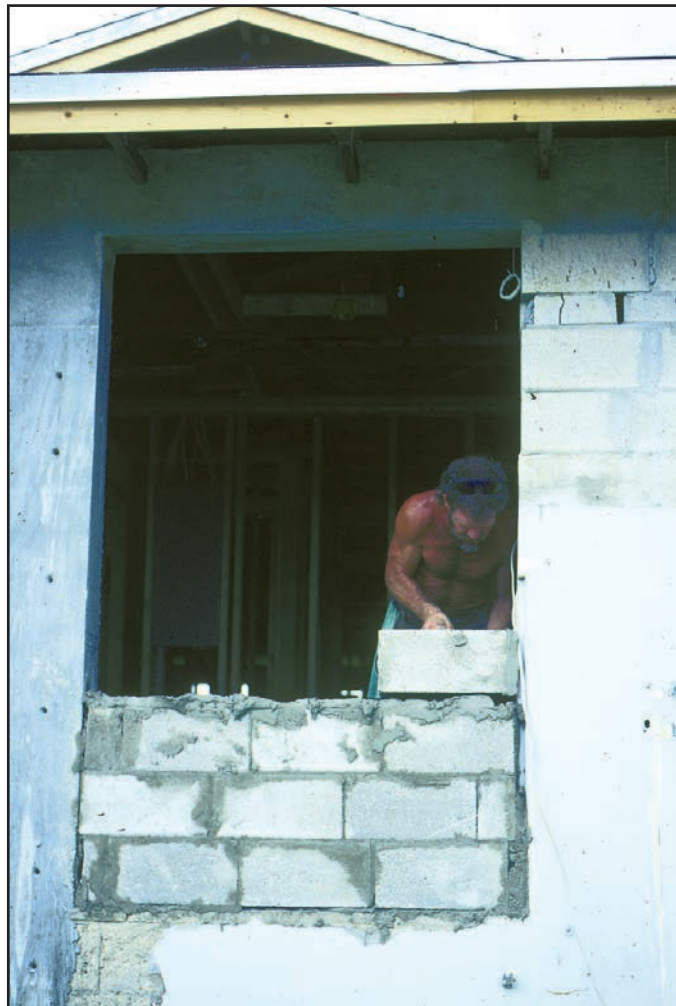
Figure 28
The bottoms of the
original window
openings are raised
with concrete blocks.

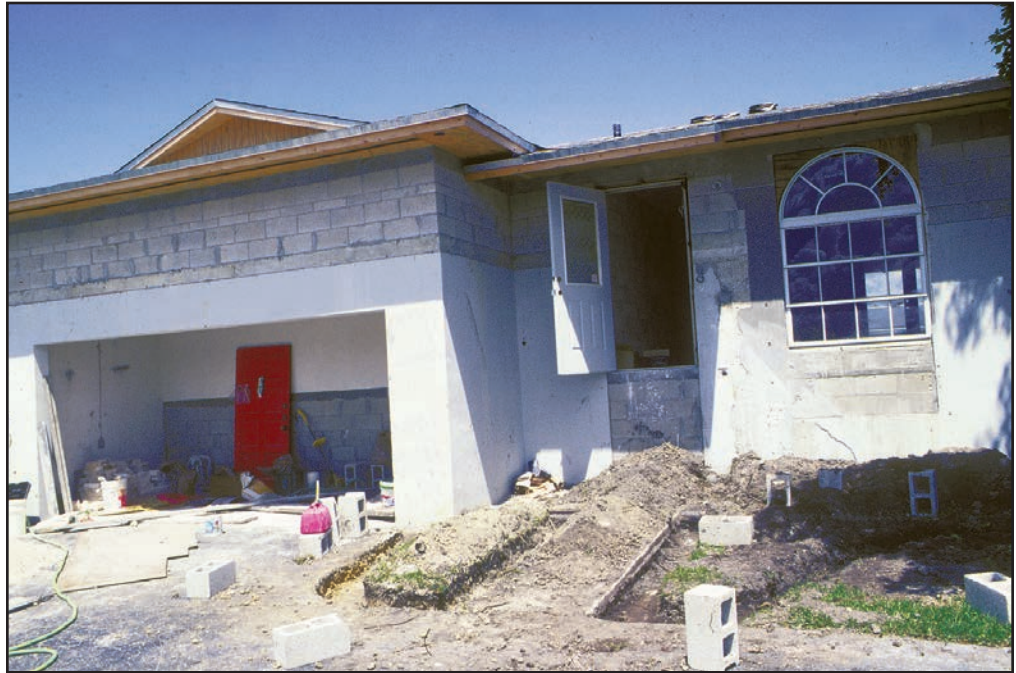
Figure 29
Windows and doors are added. The height of the raised front door shows the amount of elevation.

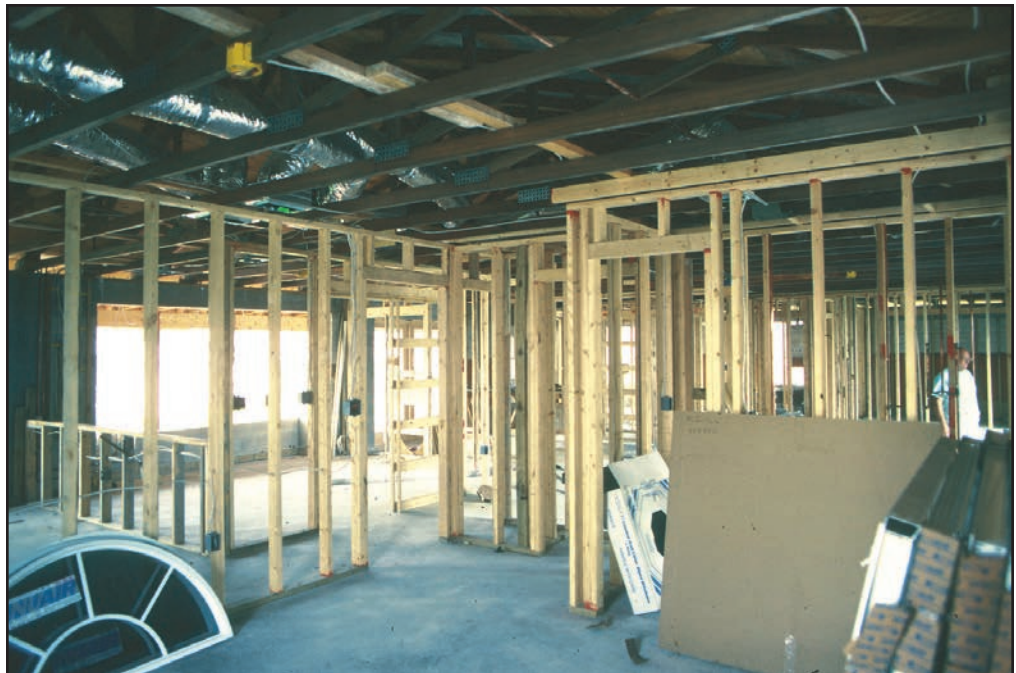
Figure 30
Interior partition walls and utilities are added.

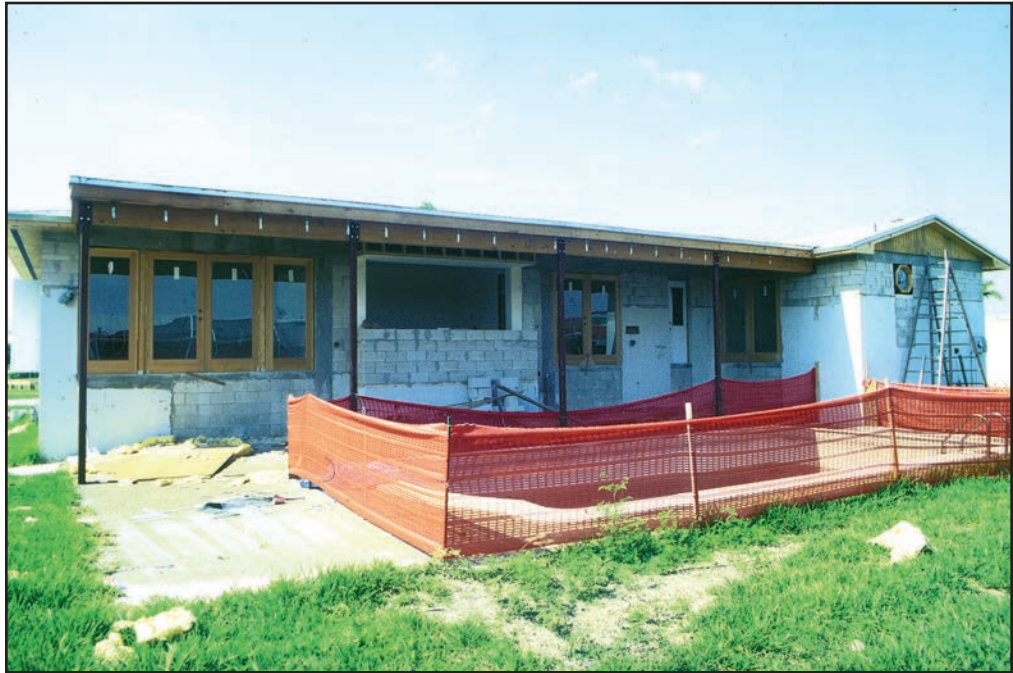
Figure 31

This view from the rear of the house shows that the project is almost complete.

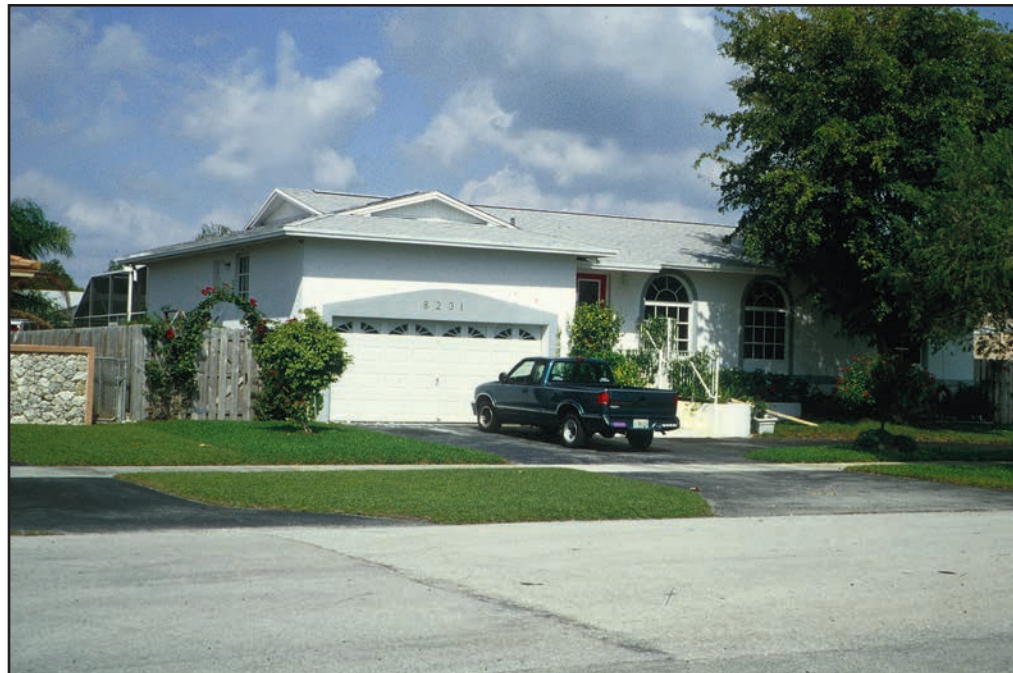
Figure 32

The final product: an attractive elevated house that meets local floodplain management requirements and is now much less vulnerable to flood damage. In addition, the house is now eligible for a lower rate of flood insurance coverage under the NFIP.

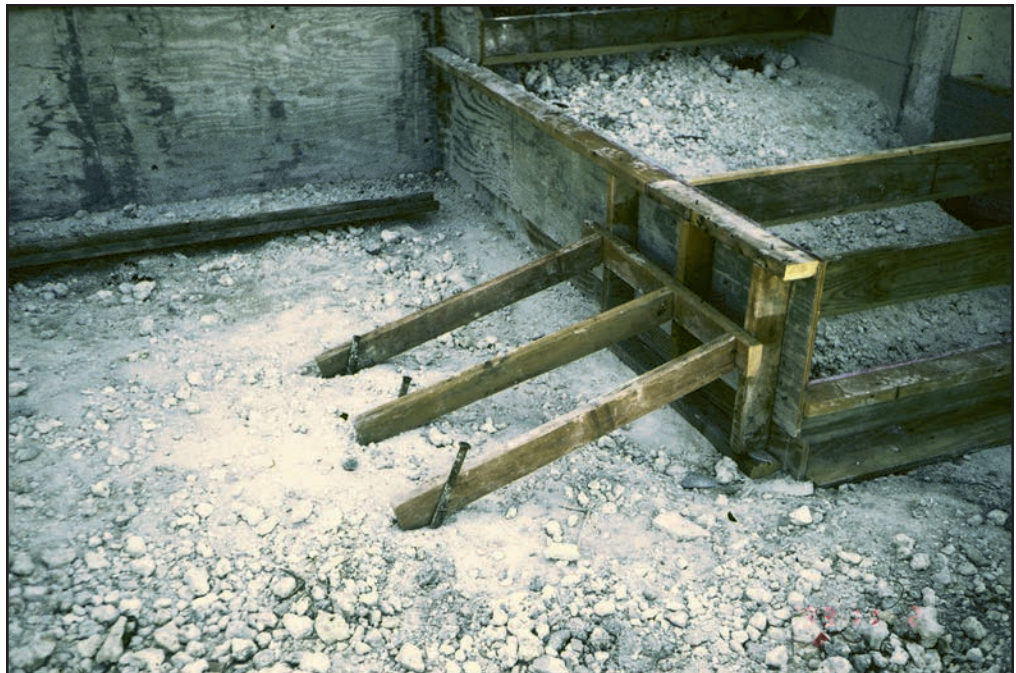
Figure 33
Wood framing for a new concrete staircase that will provide access to the elevated floor.

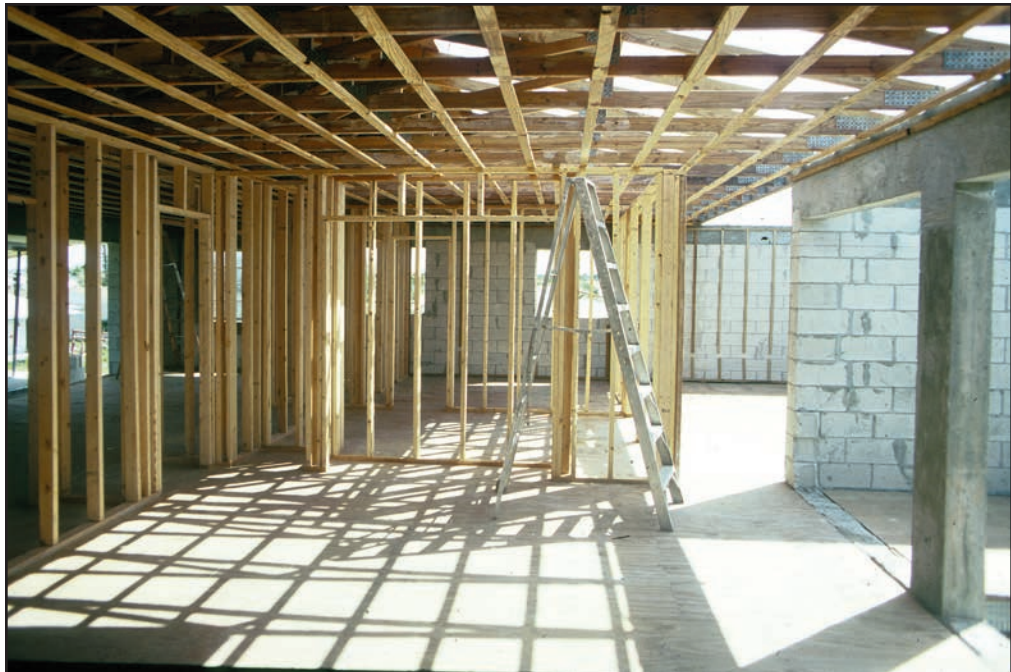
Figure 34
After the new concrete slab is poured, wood framing for interior walls is added.

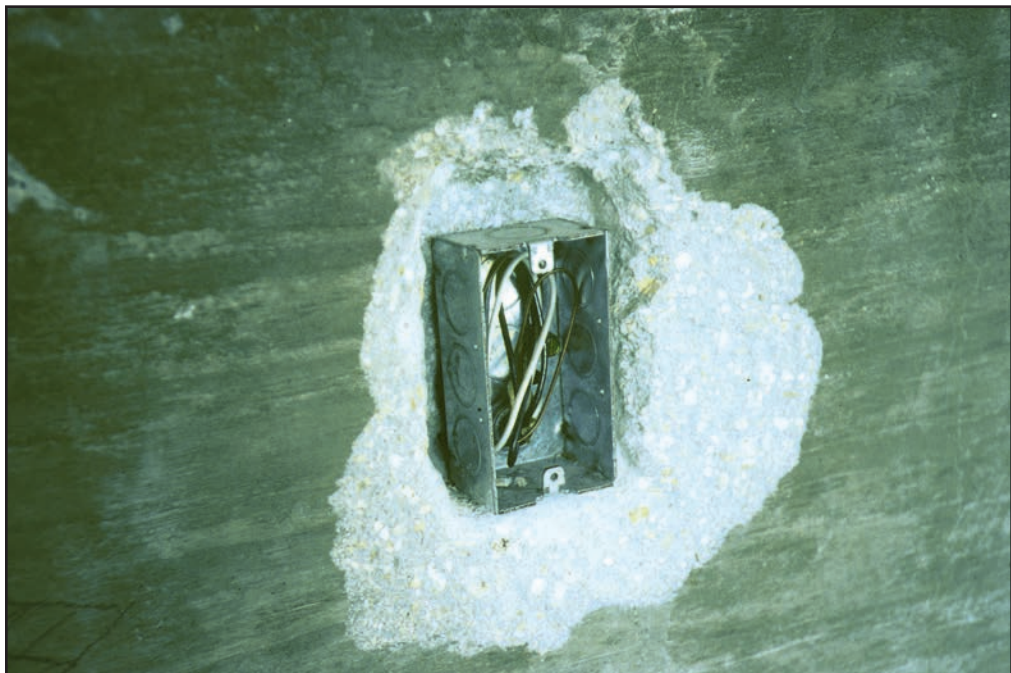
Figure 35
The electrical system is upgraded to meet current code requirements.

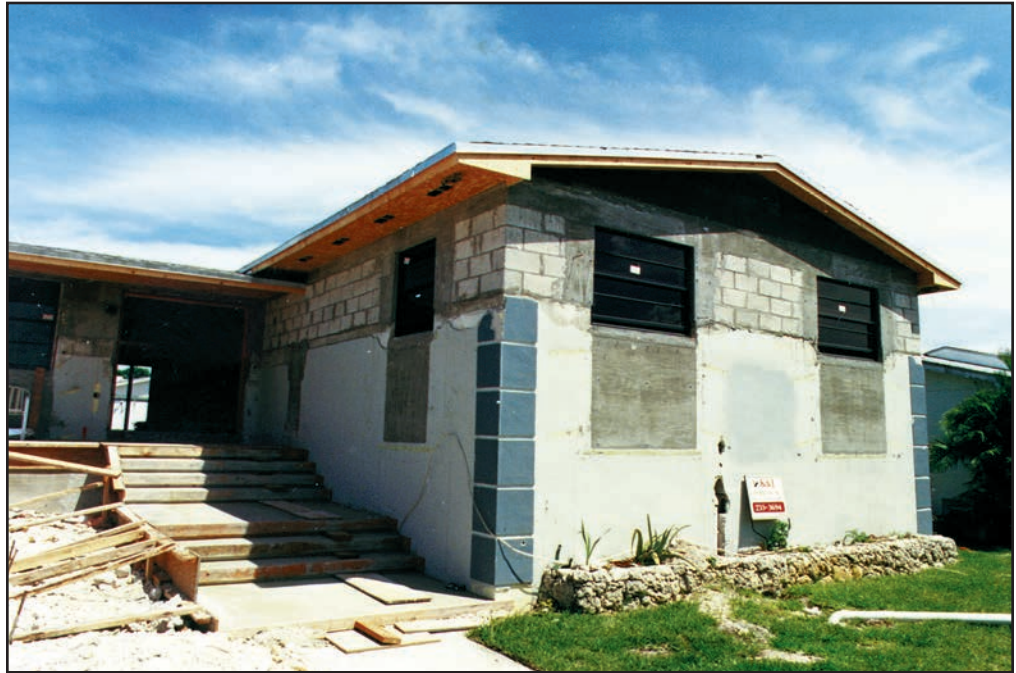
Figure 36

In this view from the front of the house, the amount of elevation is shown by the rows of concrete block on the tops of the original walls and by the raised window openings.

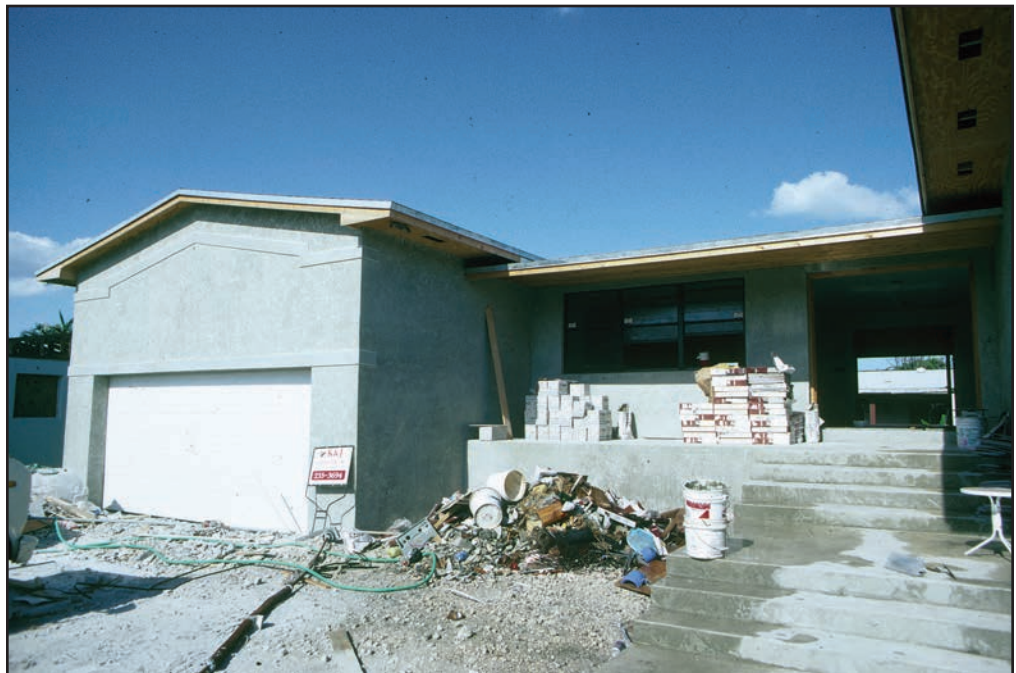
**Figure 37**

The project nears completion. In this house, as in Case Study 1, the level of the garage floor remains unchanged.

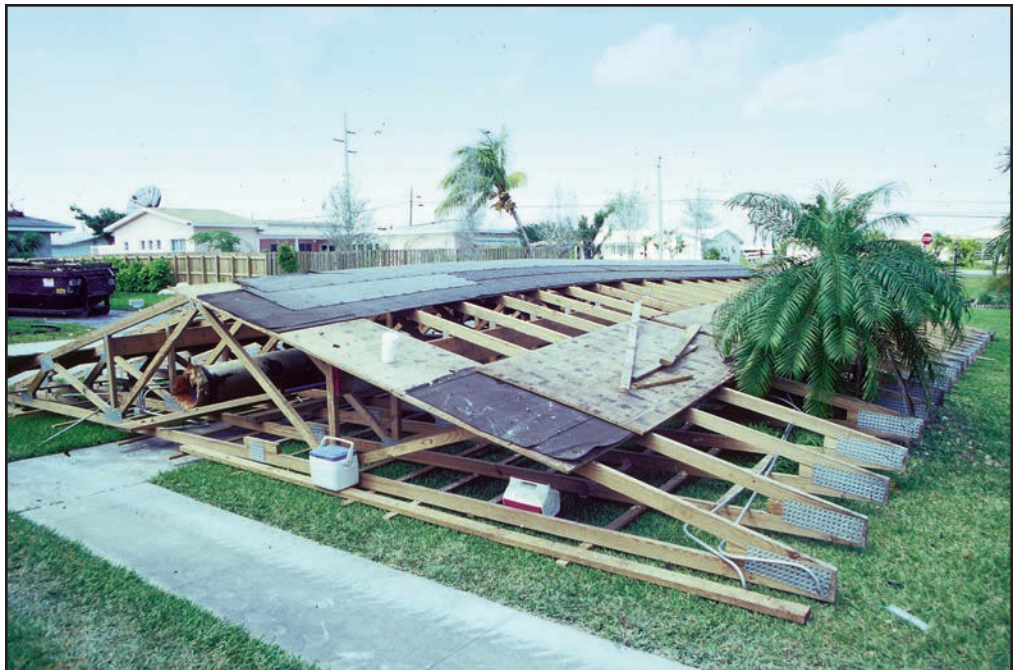
Figure 39

The roof of this house was removed as a single piece; the trusses were held together with bracing and portions of the original roof sheathing. This approach made it easier to reinstall the roof at the end of the project.

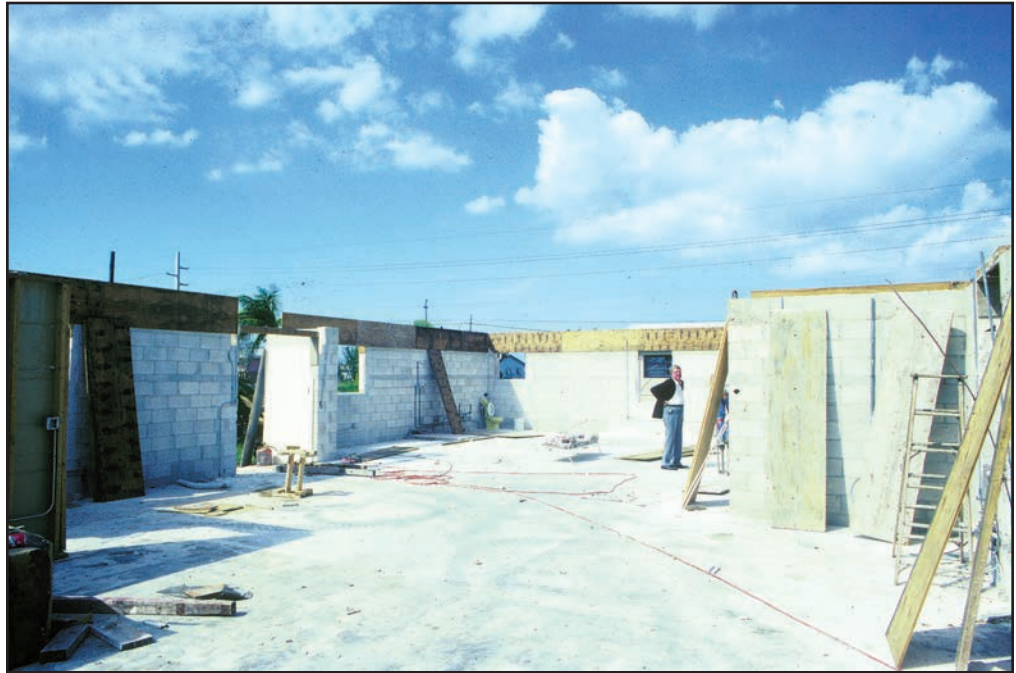
Figure 40

After the roof was removed and the storm-damaged interior gutted, the walls of the house were extended upward and a new bond beam added at the top.

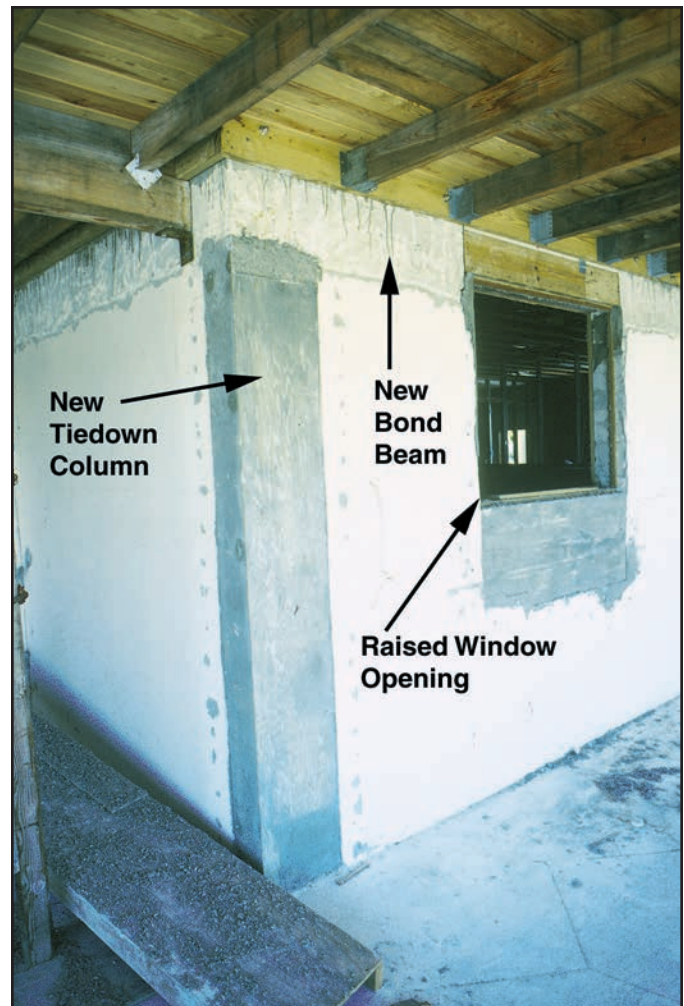
**Figure 41**

Note the new bond beam at the top of the extended wall, the new concrete tiedown column at the corner, and the raised window opening.

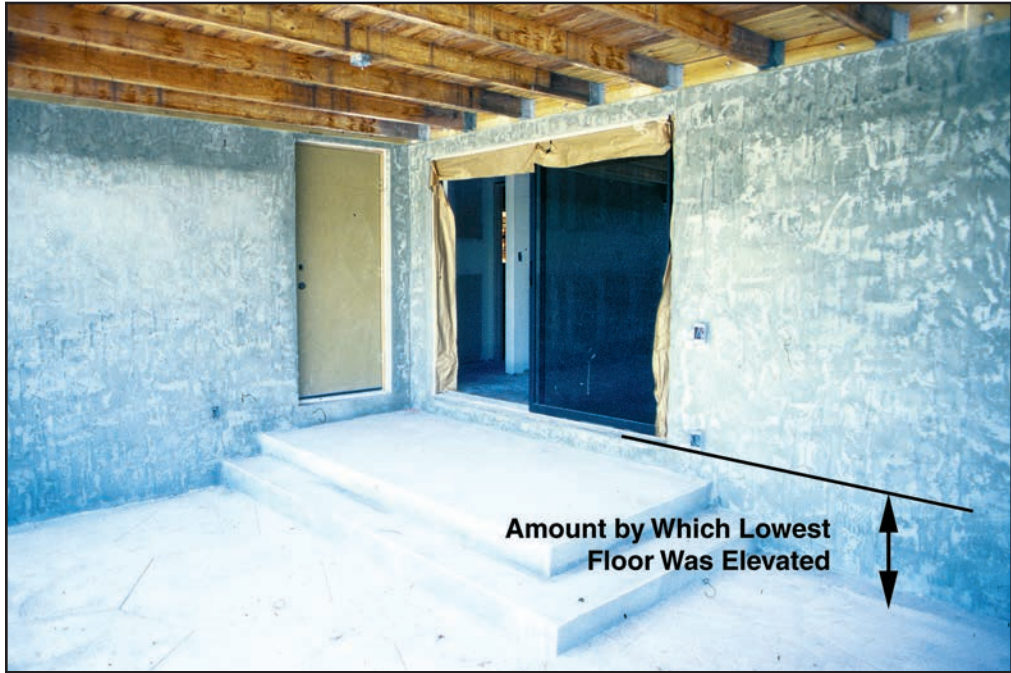
Figure 42

This view from the back of the house shows the height of the elevated slab floor.

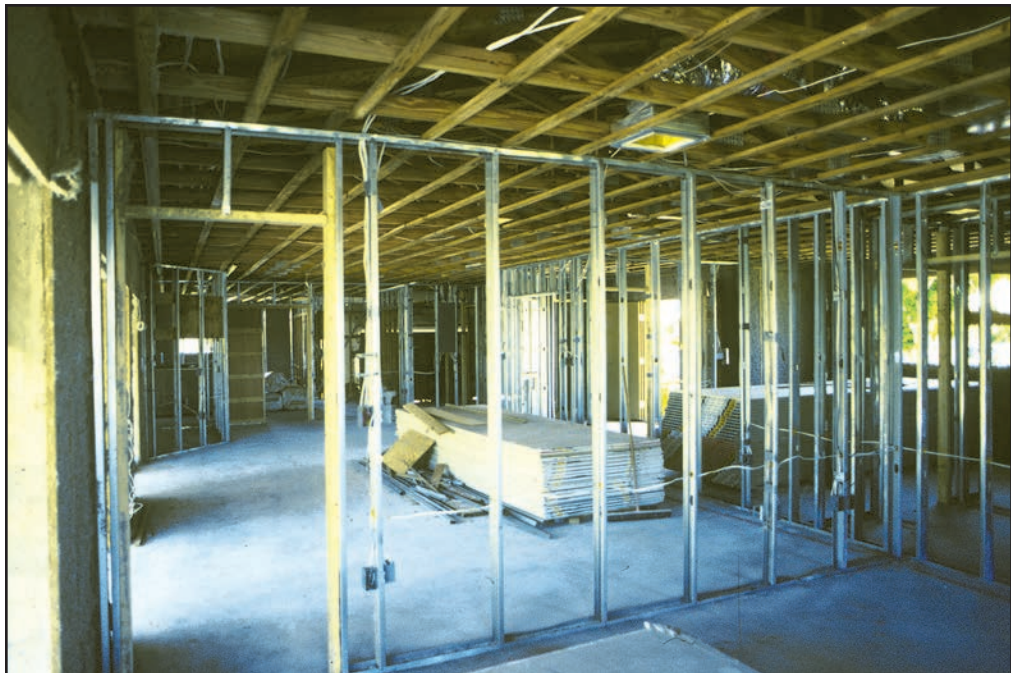
Figure 43

The owner of this house decided to use light-gauge metal framing for the new interior walls.

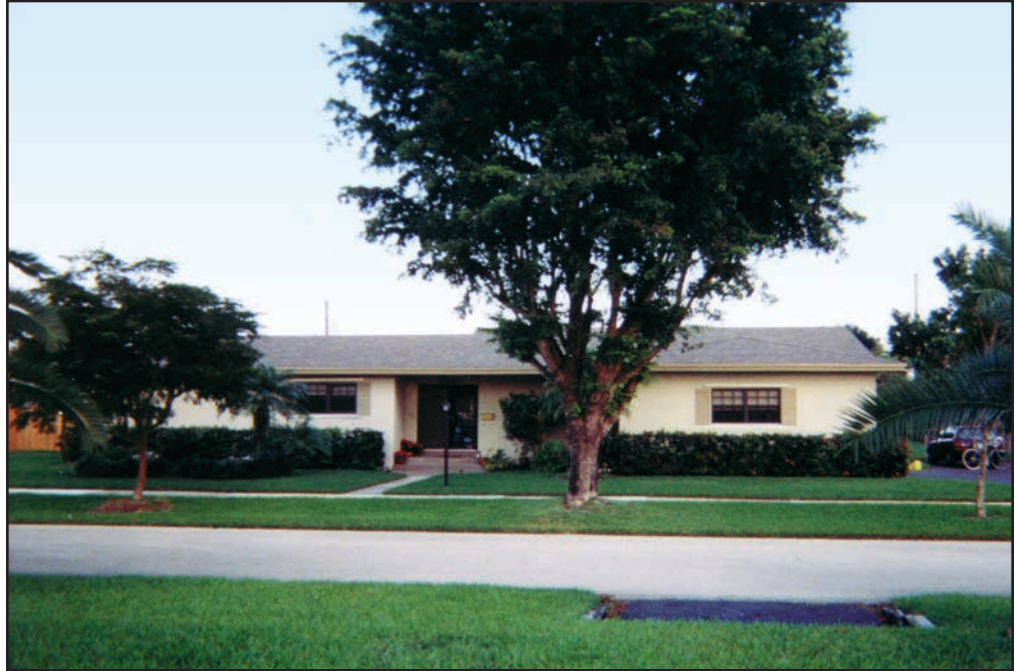
Figure 44

The final product. As in the first two houses, the garage floor remains at the original level. The relatively small amount of elevation required for this house has altered its appearance very little.

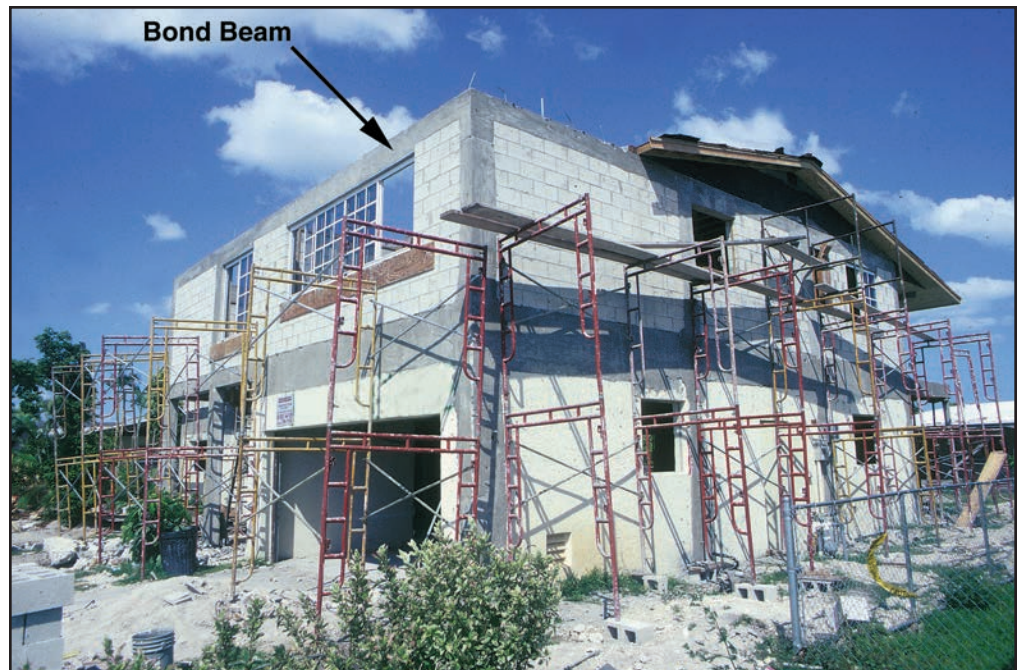
Figure 45

Concrete bond beams similar to those shown earlier were used in this house, but here they were installed on the tops of both the original first-story walls and the new reinforced concrete block second-story walls.

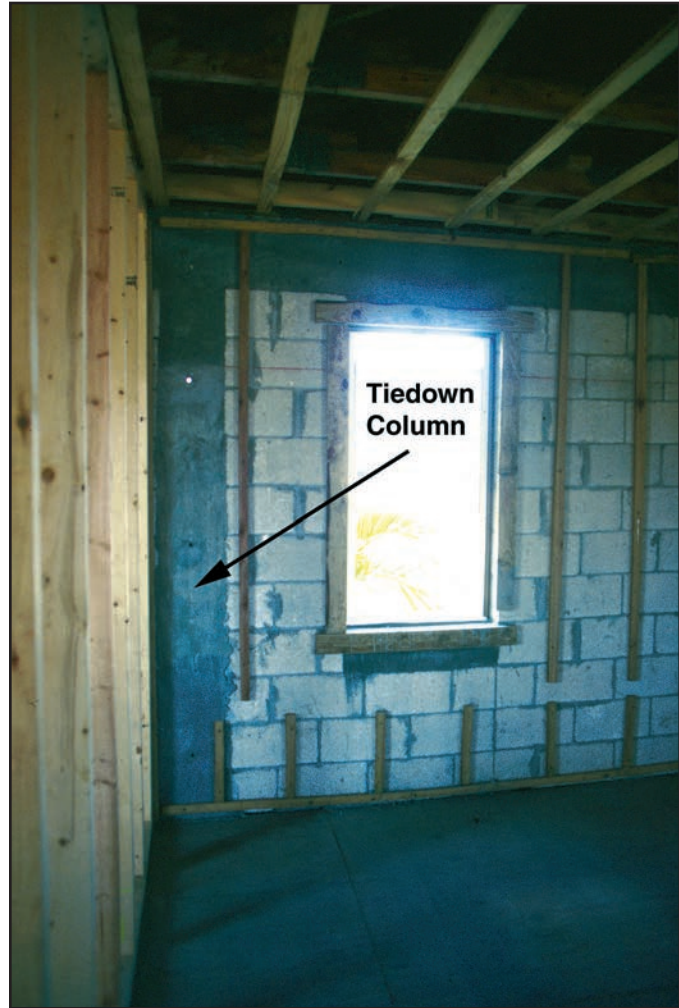
Figure 46
Concrete tiedown columns, such as the one to the left of the window in this photograph, were also used in this house.

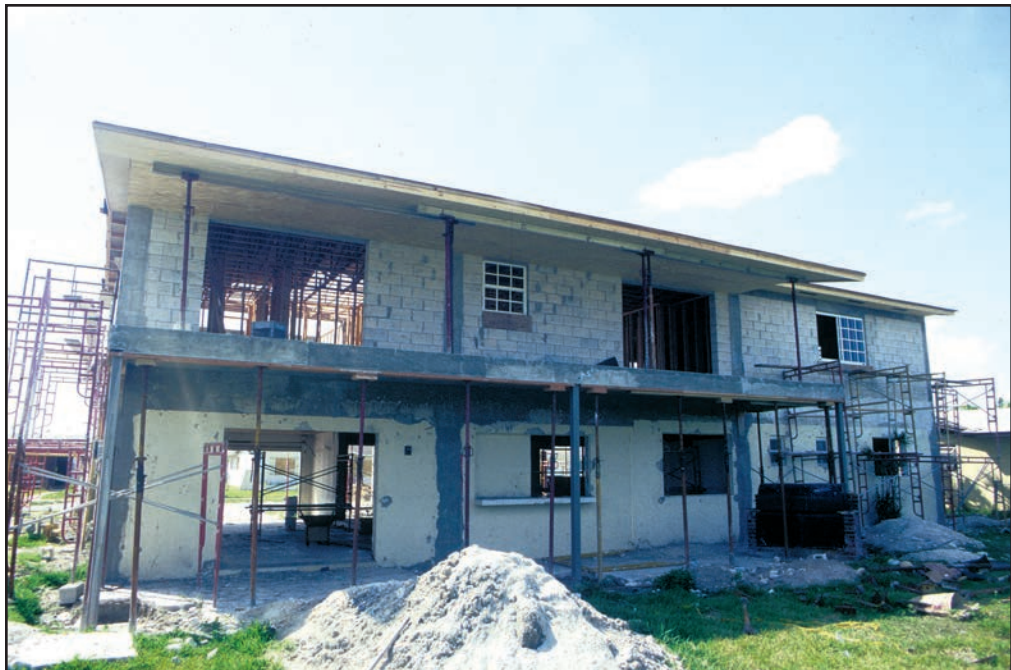
Figure 47
The tiedown columns extend down from the new second-story walls and into the original first-floor walls. The columns tie the first and second stories together and provide a continuous load path that helps the house resist the forces of high winds.

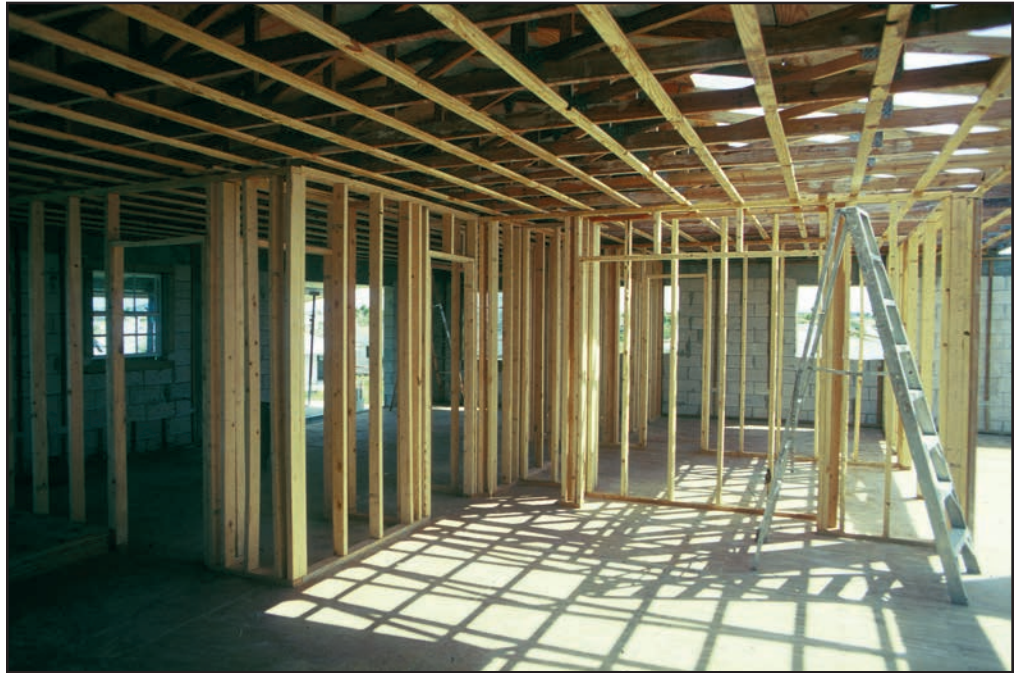
Figure 48
Wood 2 by 4 studs
were used to frame
the interior walls of
the second story.

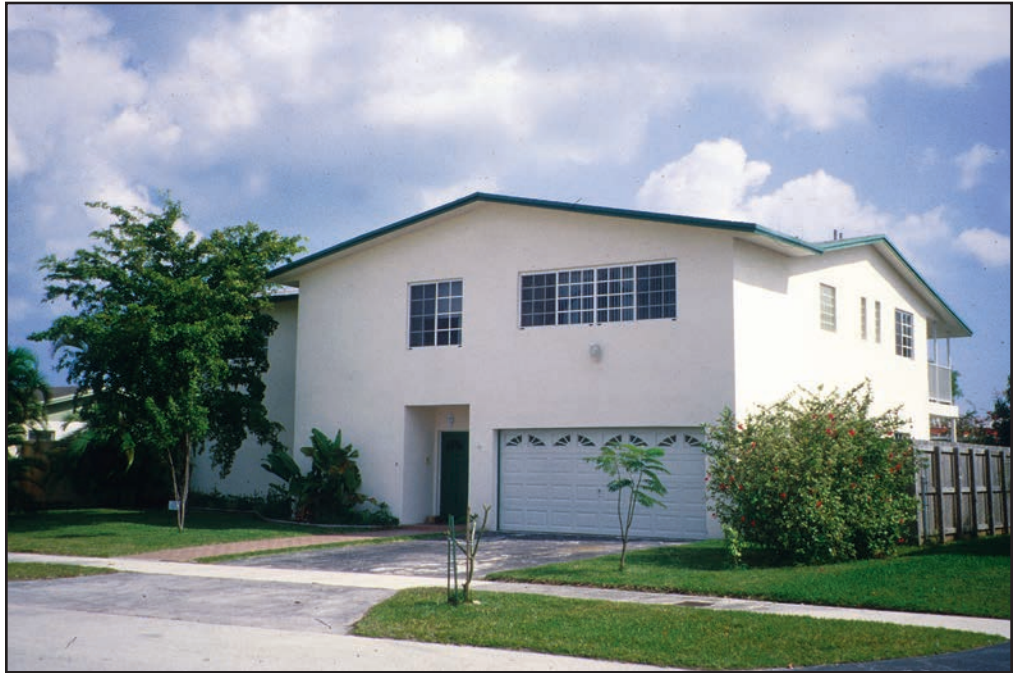
Figure 50

Not only does the completed house meet the requirements of local codes and the NFIP regulations, it now includes a substantial amount of parking and storage space below the new living level. In addition, because the lowest floor is now over 4 feet above the regulatory flood elevation, the house is eligible for NFIP flood insurance at a greatly reduced rate of coverage.

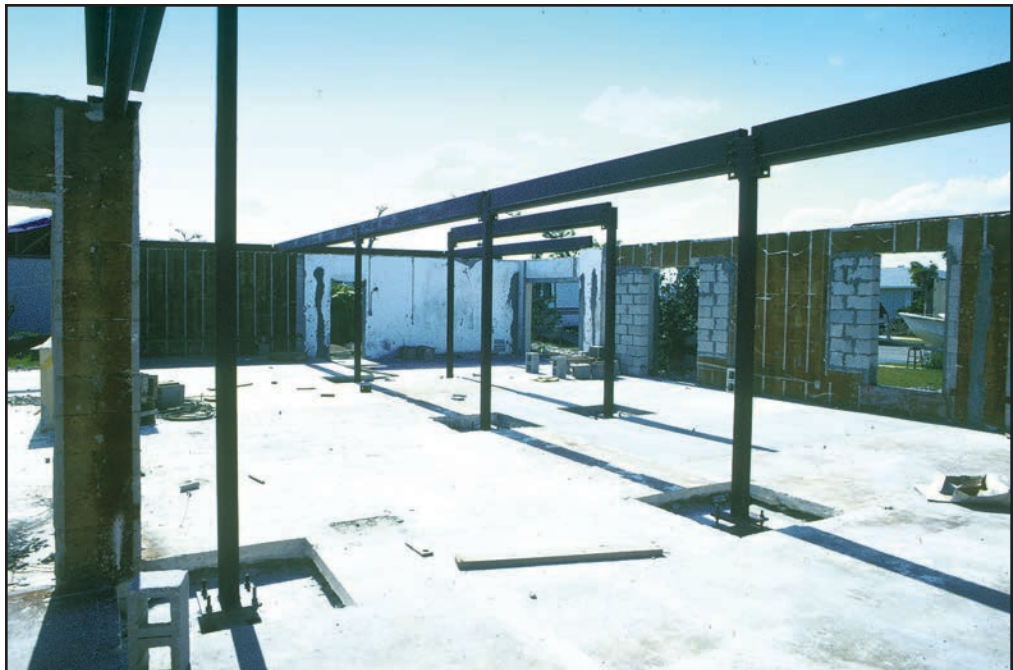
Figure 51

The storm-damaged first story has been gutted in preparation for construction.

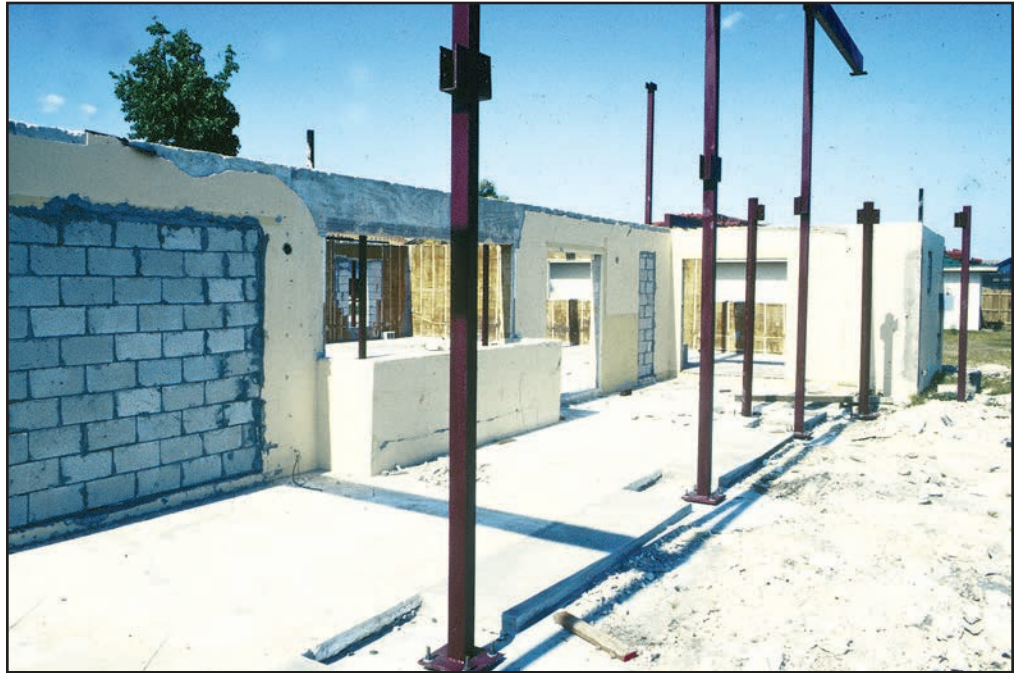
Figure 52

The existing first-story walls have been strengthened by the addition of concrete block. Metal columns and beams have been added to help support the new second story.

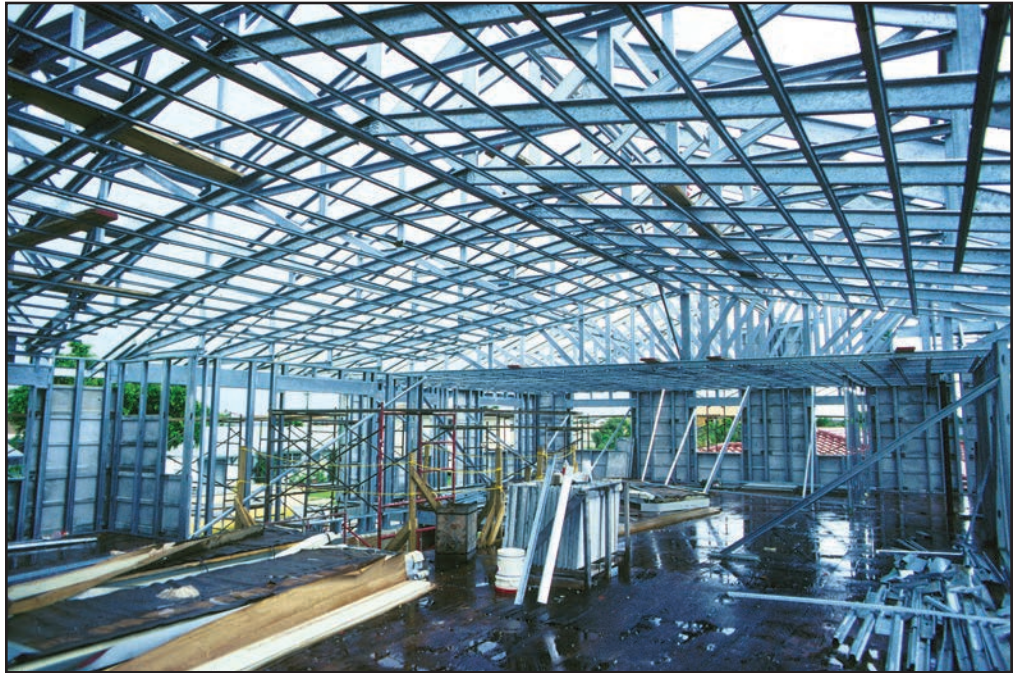
Figure 54

Metal framing is used for the new second story, including the walls and roof support system.

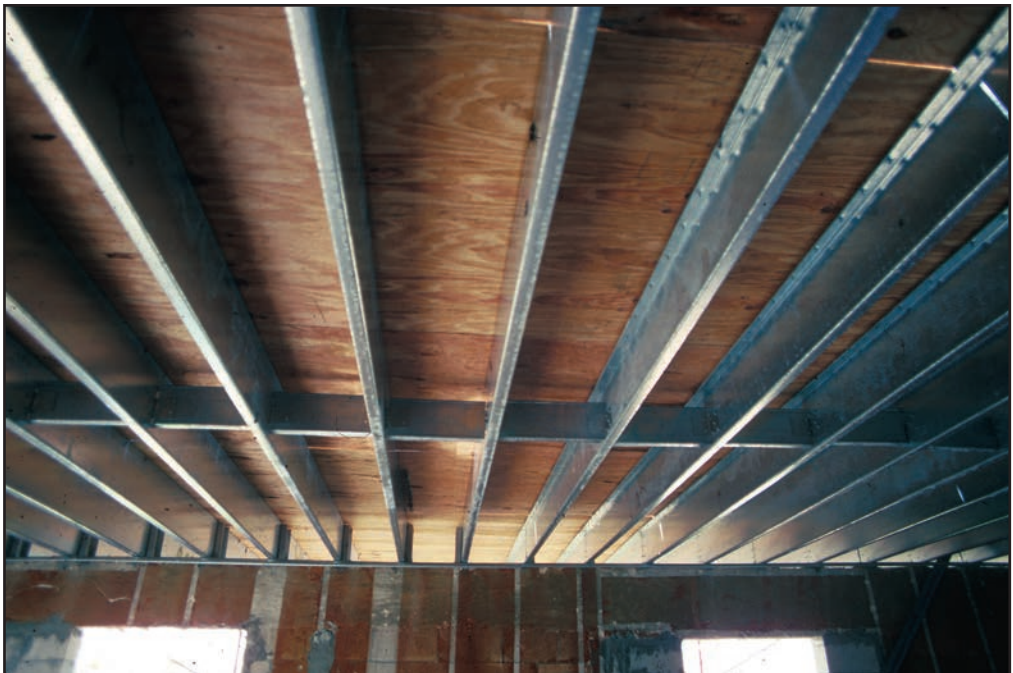
Figure 55

Metal framing also supports the floor of the new second story.
