Case Studies

Eight case studies demonstrate how substantially damaged houses were elevated in Miami-Dade County After Hurricane Andrew.

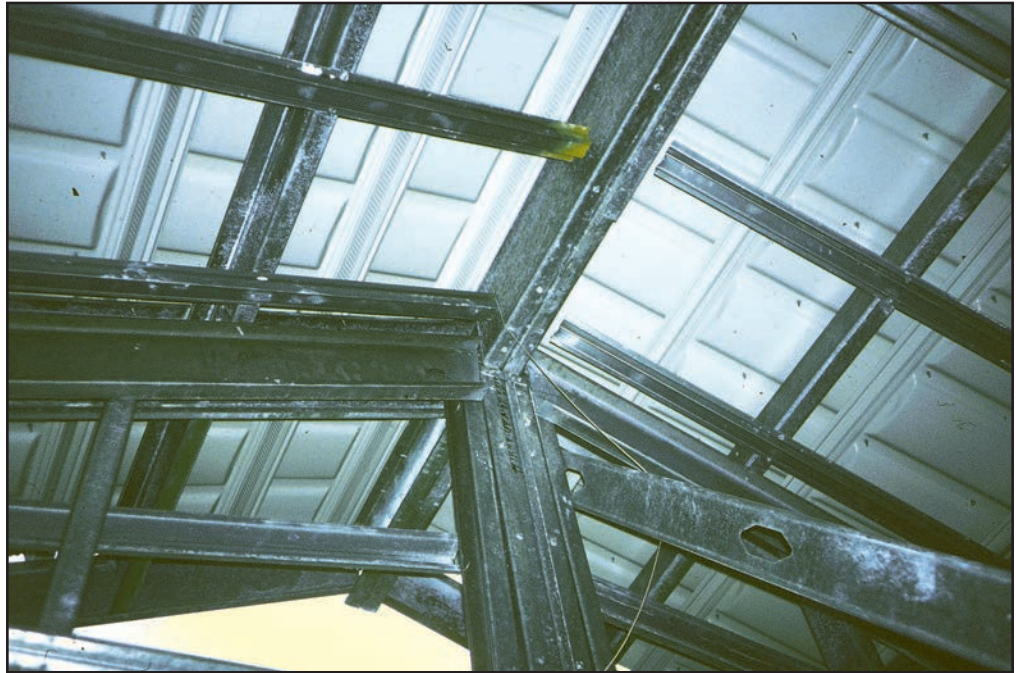
Figure 56

One advantage of metal framing is its relatively light weight. An additional advantage is that the screws used to attach metal-frame components provide strong connections.

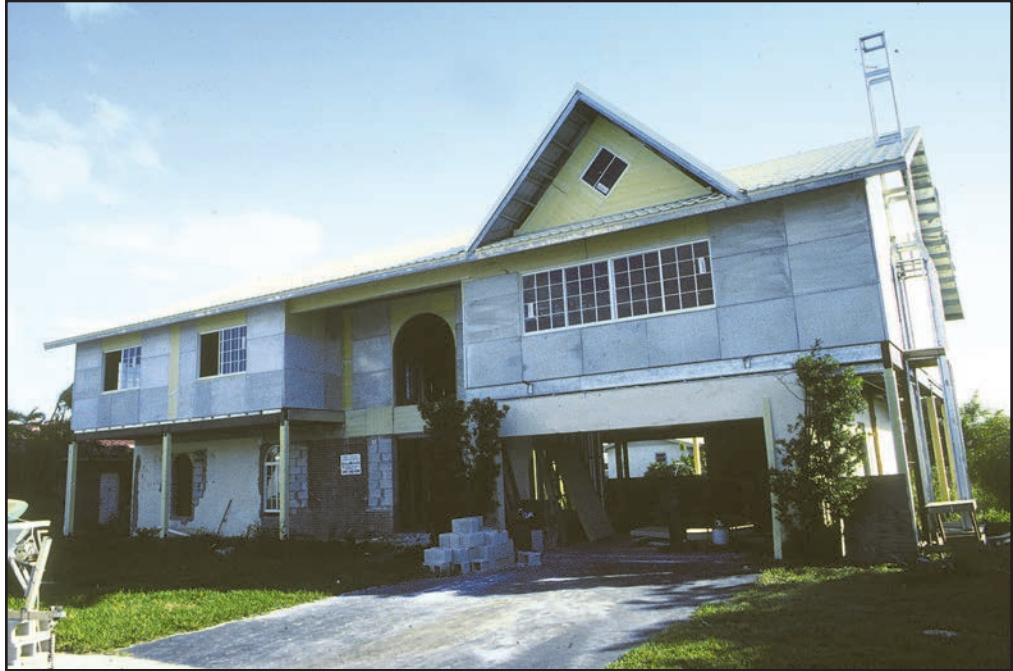
Figure 58

The new second story
nears completion.
The roof is made of
formed metal panels.

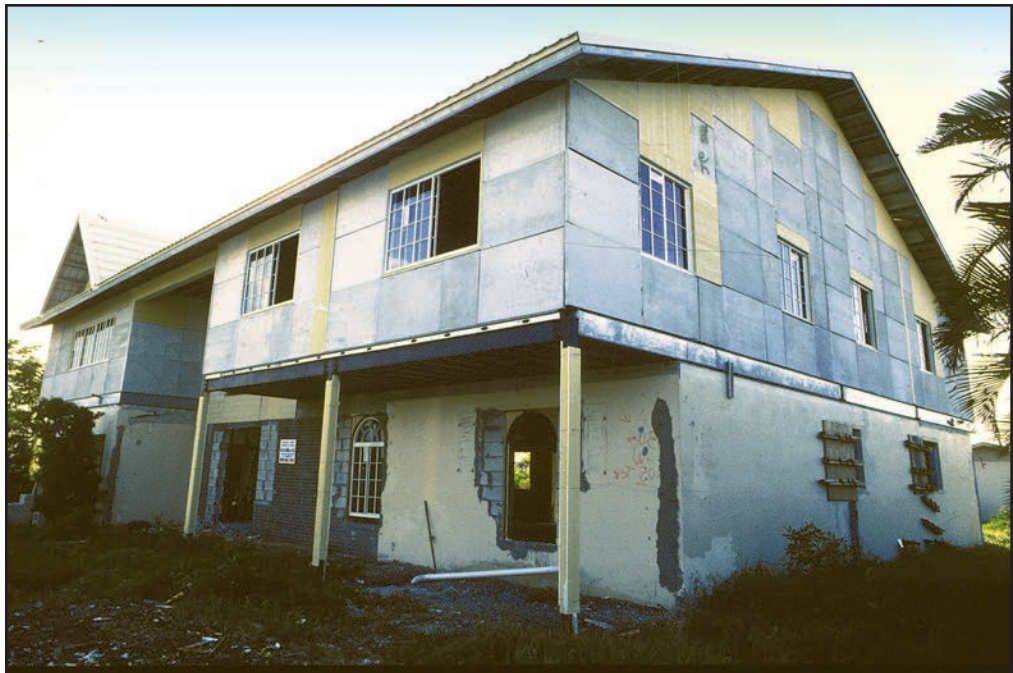
Figure 59

The exterior
walls consist of
prefabricated
concrete panels.
Innovative techniques
such as those
employed in this
project are helping
homeowners who
need practical and
economical methods
of repairing and
protecting their
houses.

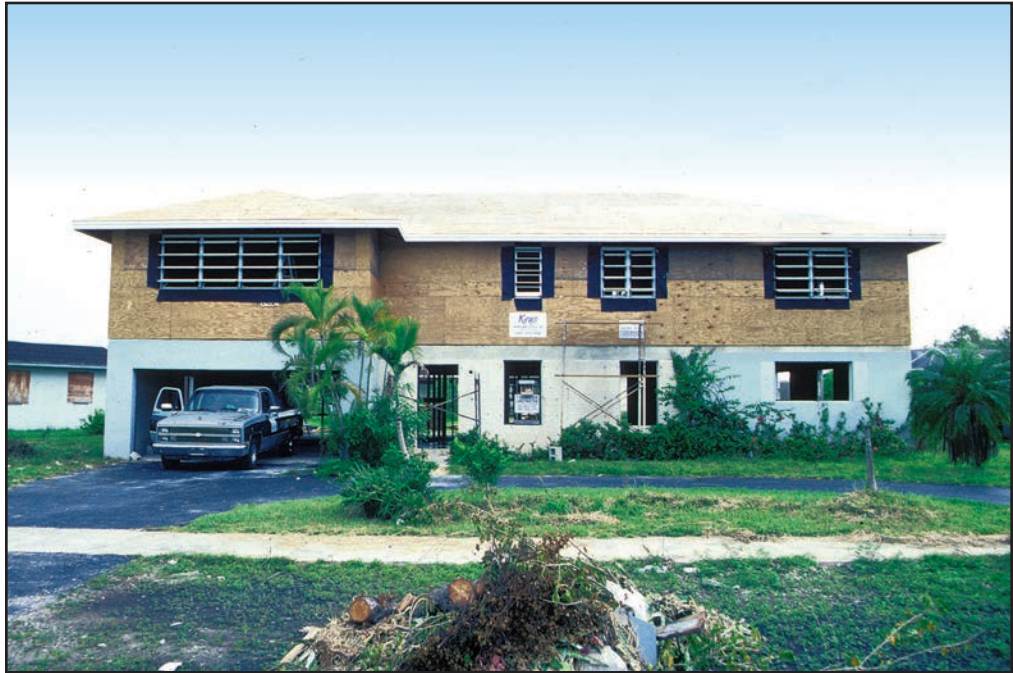
Figure 62
After the wood framing was completed, the roof and exterior wall sheathing were added.

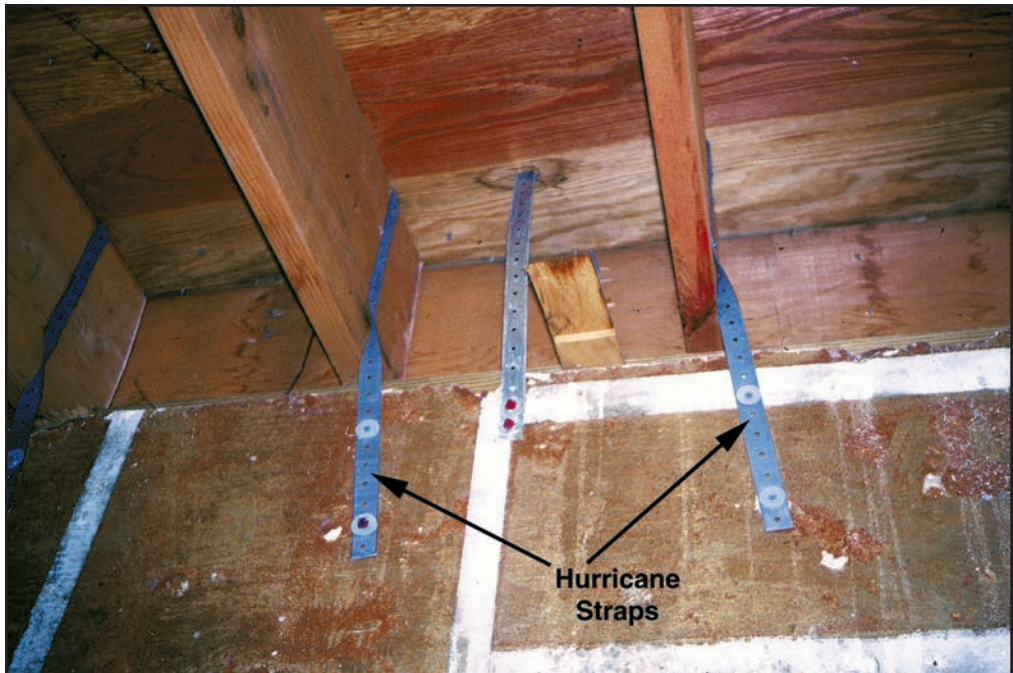
Figure 63
The new second-story walls are securely connected to the original first-floor walls with galvanized metal hurricane straps.

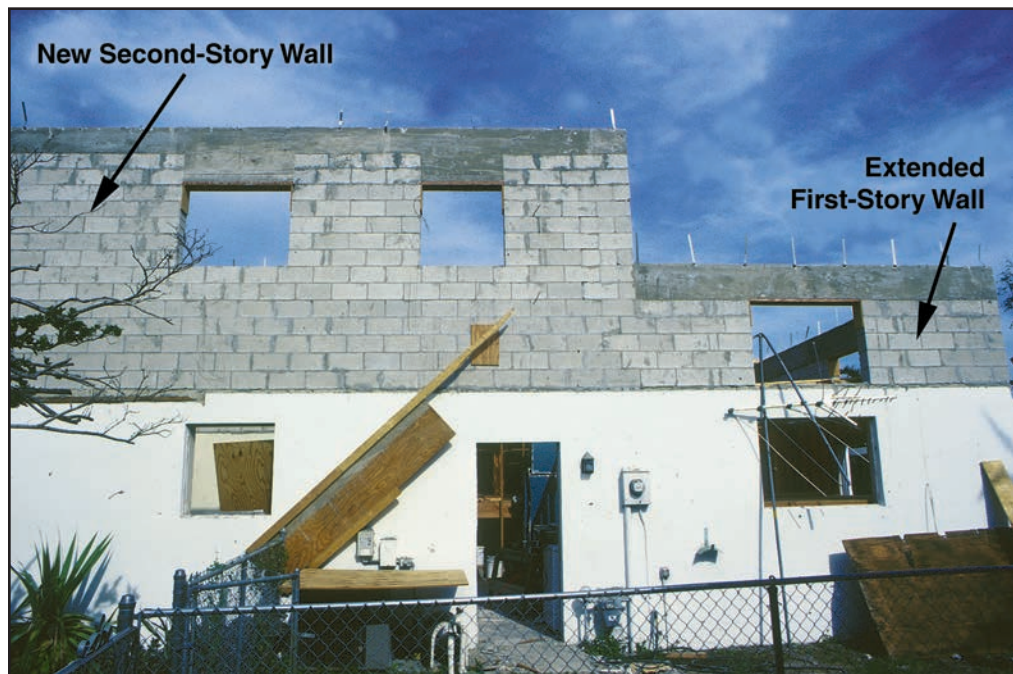
Figure 65

After the house was gutted, the walls were extended upward with reinforced concrete block. In this view from behind the house, the rear wall of the new second story can be seen on the left and the extended first-story wall on the right. Note the new raised window opening in the extended wall, just above the original opening.

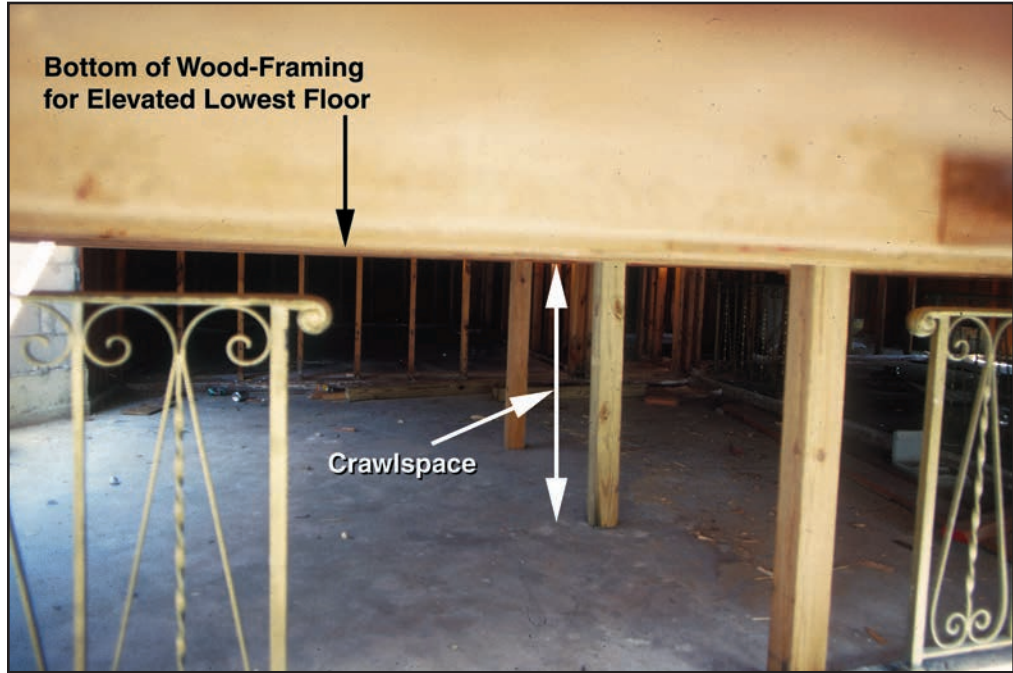
Figure 68

Rather than install a new concrete slab on compacted fill, the owner of this house chose to build a new wood-frame floor above the old concrete slab. This method creates a crawlspace below the new floor.

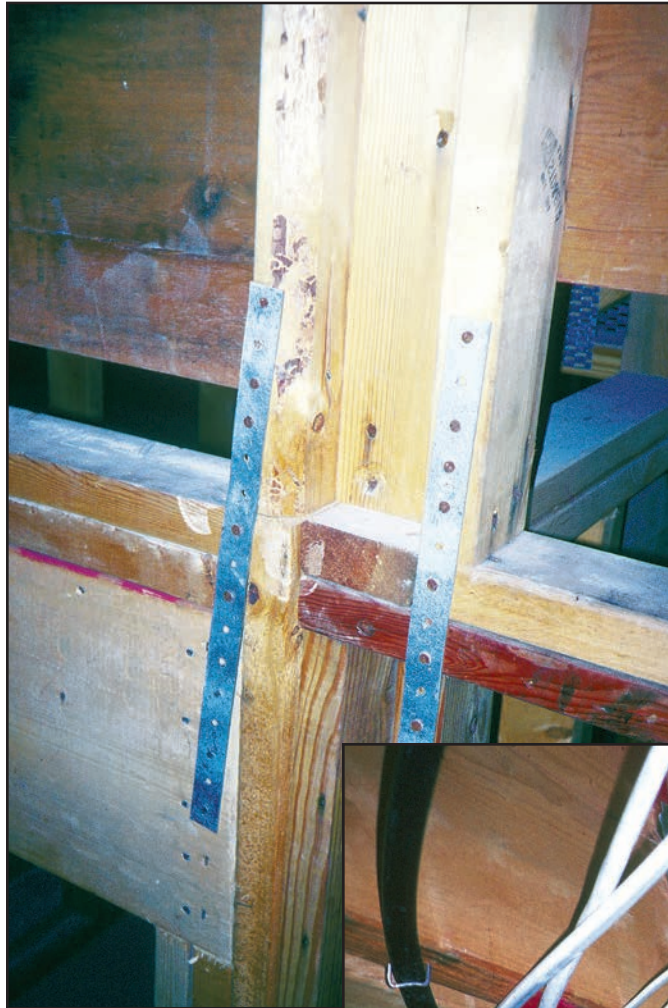
Figure 70

Metal hurricane straps are used to tie the structural members together and create a continuous load path from the roof to the foundation.

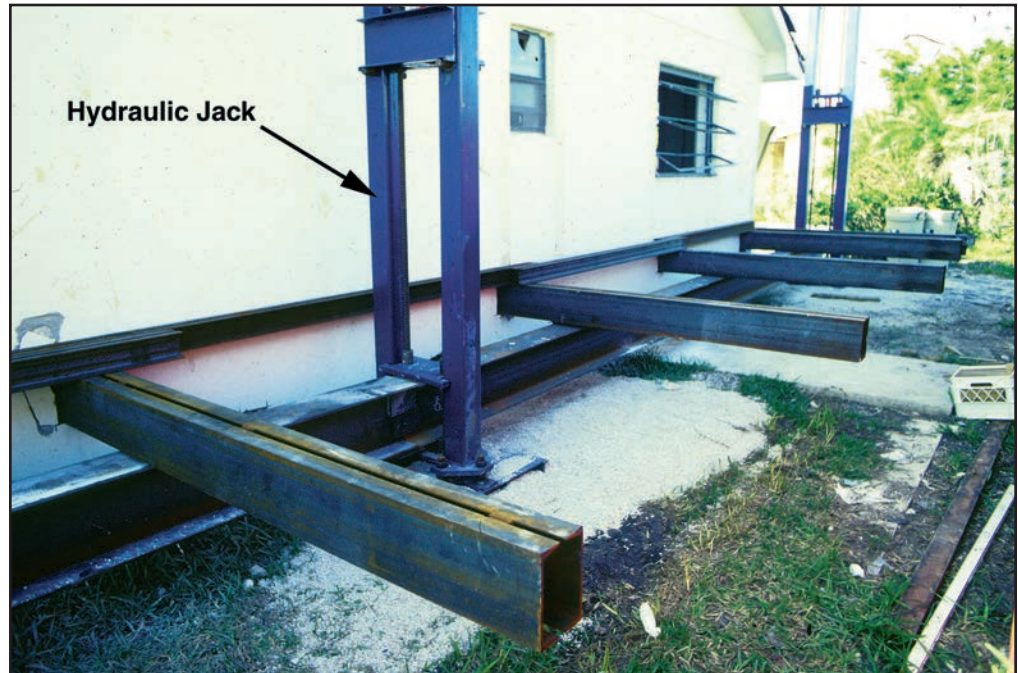
Figure 74

In this variation of Technique 3, steel beams are inserted through the walls of the house rather than under the slab. The beams span the length and width of the house and cross one another inside to create a grid. Outside the house, the beams rest on larger beams that will be raised with hydraulic jacks.

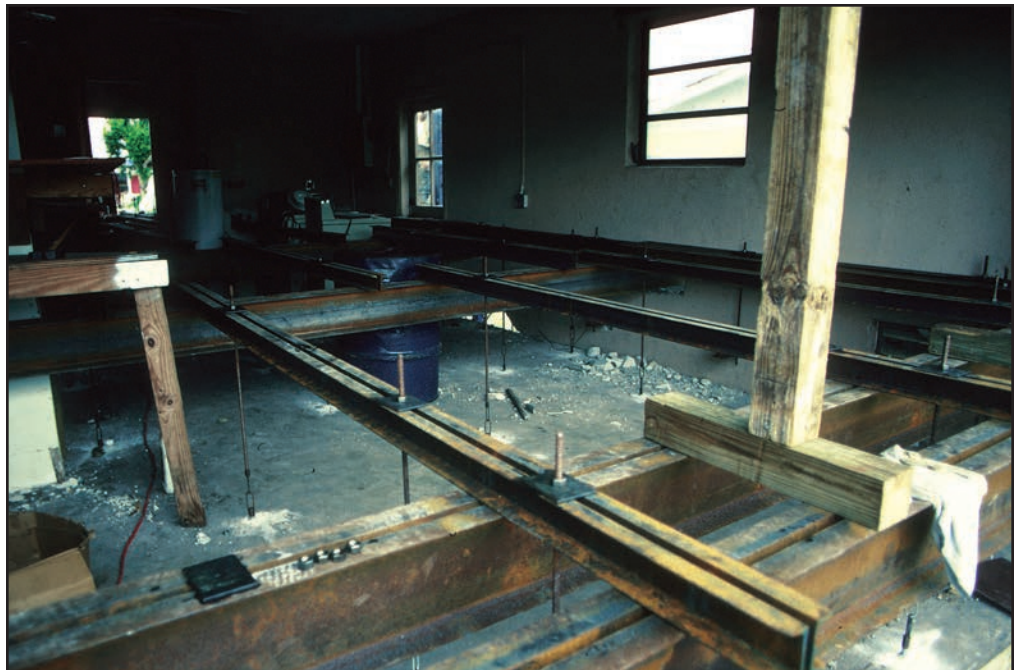
Figure 79
The anchors and
hangers connect the
slab securely to the
beams, enabling the
beams to raise the
slab along with the
rest of the house.

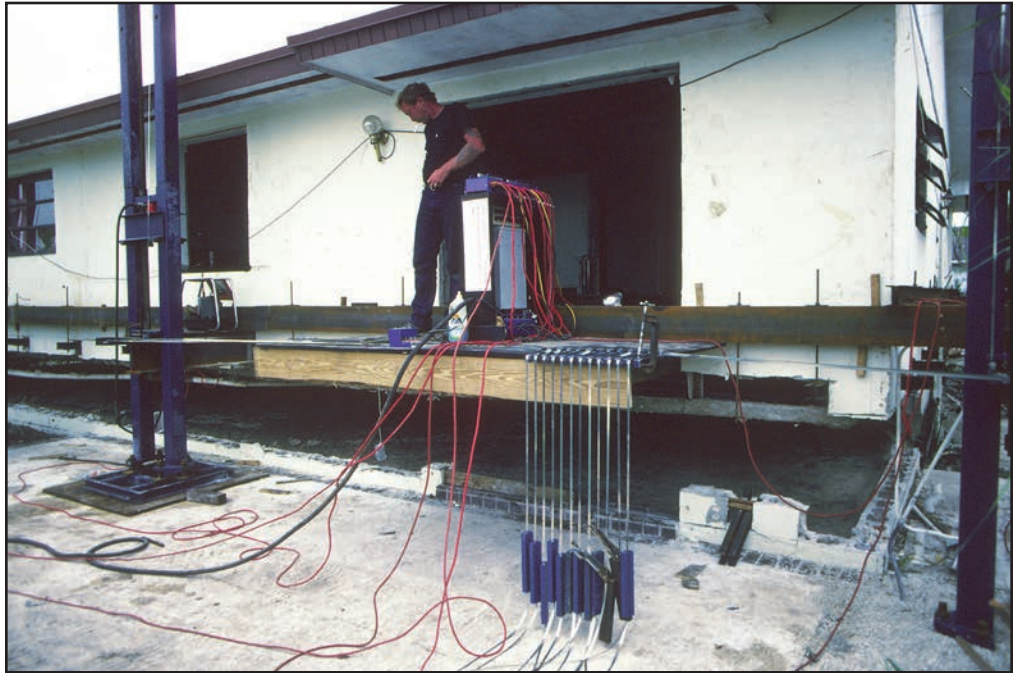
Figure 80

Lifting the house, while simple in theory, is complicated by the need to ensure an equal amount of lift at each jack throughout the process. Too much or too little lift at even one jack can cause the slab and walls to crack. The elevation contractor for this project used a sophisticated jacking system that provided the required level of control.

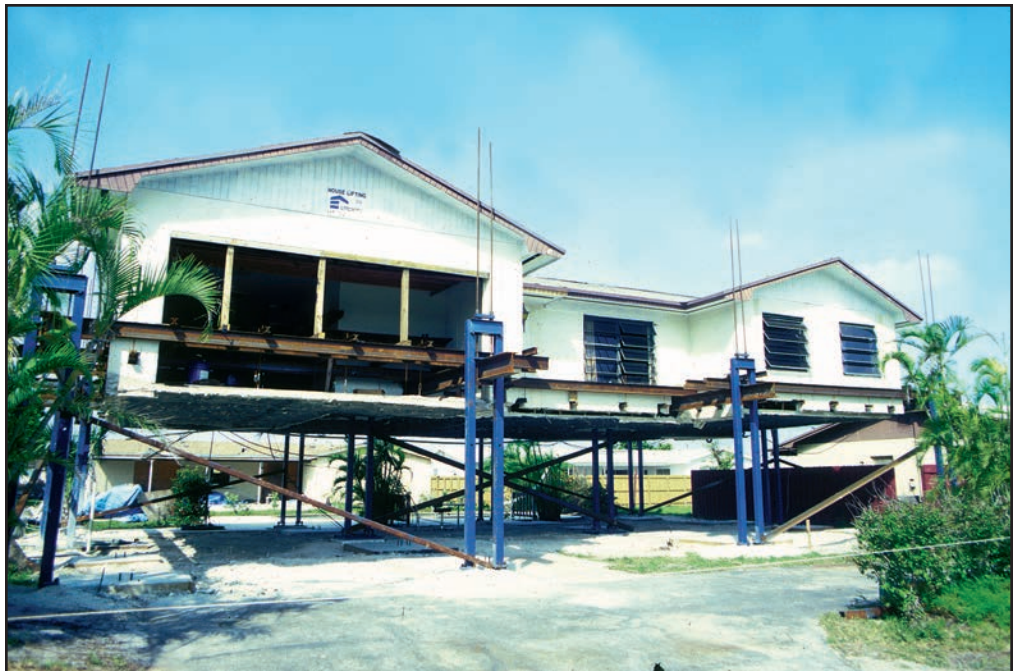
Figure 81

The house and slab were raised one full story.

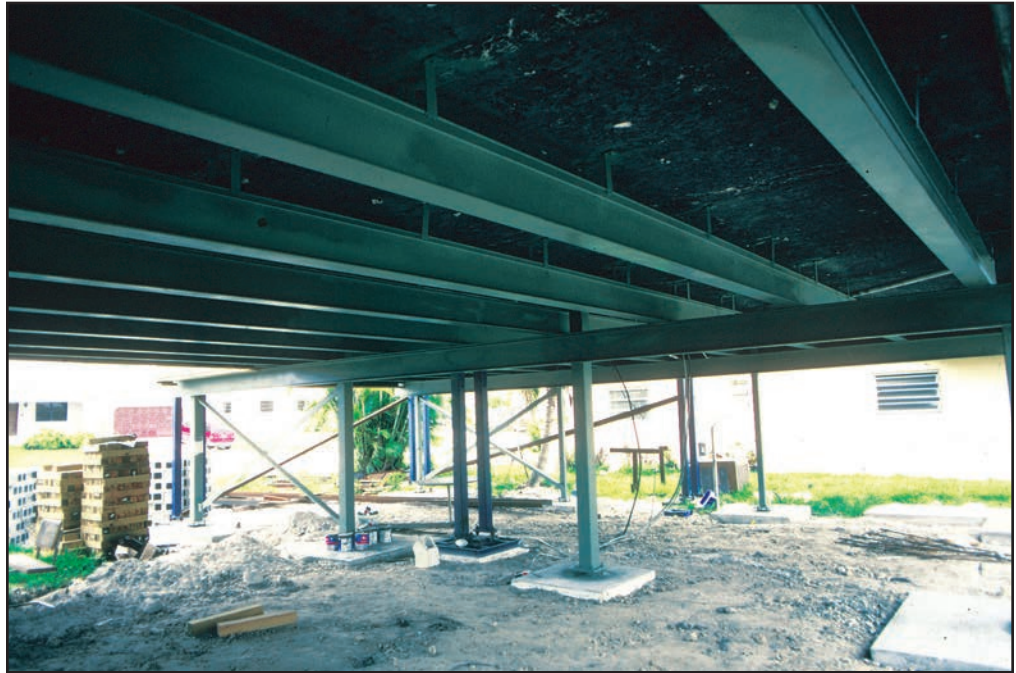
Figure 82

While the jacks and beams supported the house, new steel foundation members were installed below.
