Safety Edge_{SM}
HMA Demonstration Project
Jasper County, Iowa

Field Report
June 6, 2011

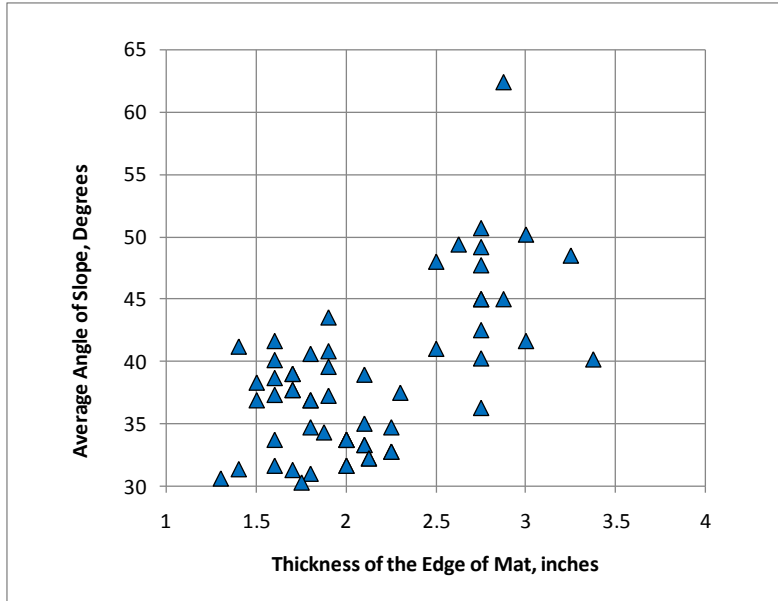
Figure 5. Comparison of slope and edge thickness.

Figure 5 compares the thickness of the intermediate course near the Safety Edge_{SM} and the slope of the Safety Edge_{SM}. As shown, the slope appears to increase with the thickness of the Safety Edge_{SM}.

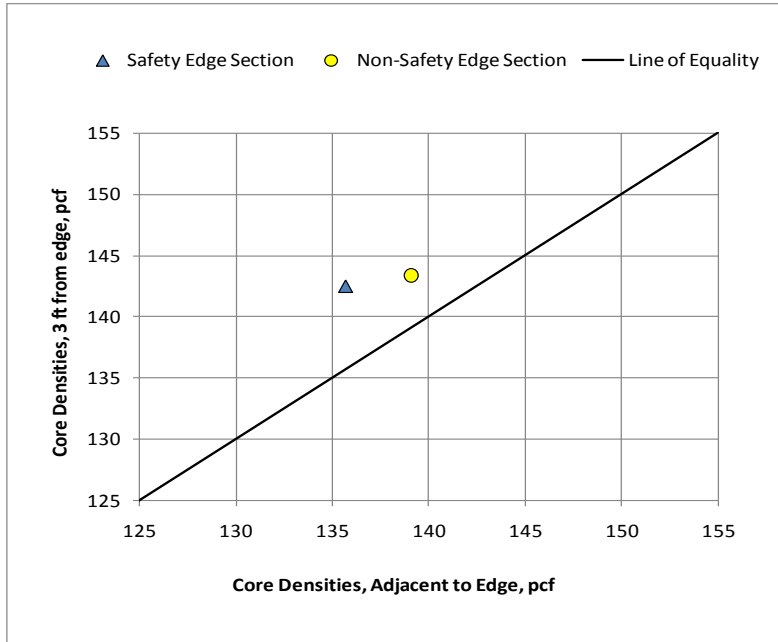
Figure 6. Comparison of core densities adjacent to the edge and 3 ft. from the edge.

Figure 6 shows the comparison of the core densities taken adjacent to the edge and at 3 ft. from the edge for the Safety Edge_{SM} and non-Safety Edge_{SM} sections. As expected the densities away from the edge where the mat received full coverage of the roller passes are significantly higher than near the edge of the pavement. This result reflects the relatively low degree of compactive effort applied to the Safety Edge_{SM} in comparison to standard compaction given to the non-Safety Edge_{SM} section.

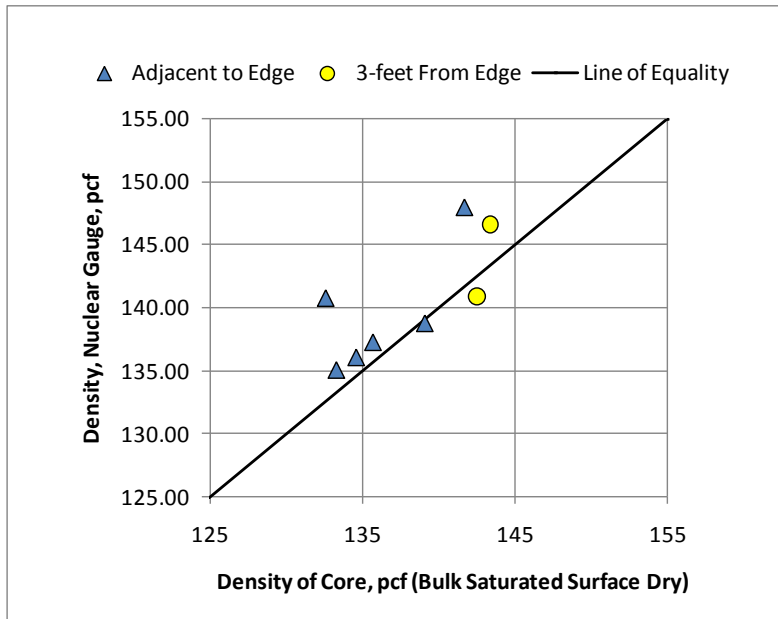
Figure 7. Comparison of the nuclear density readings and core densities.

Figure 7 shows a comparison of the nuclear densities and densities measured from the cores. As shown, the value at 3 ft. from the edge was close to unity and the value adjacent to the edge is not as close to unity. The adjusted densities using the adjustment factors are also listed in Table A-4 in Appendix A. The factors were used to adjust the nuclear density gauge readings to be consistent with the densities that were measured in the laboratory. The nuclear density test results are listed in Table A-5 and A-6 in Appendix A.

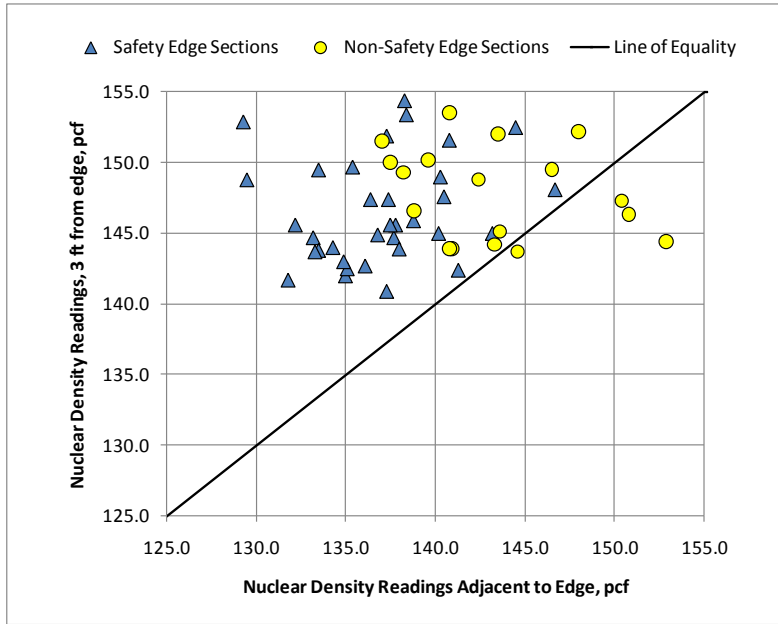
Figure 8. Comparison of densities adjacent to the edge and 3 ft. from the edge.

Figure 8 is a comparison of the adjusted nuclear density gauge readings taken adjacent to the edge and at 3 ft. from the edge. Figure 9 is a comparison of the HMA air voids between both areas. Generally, the two figures show densities were lower and the air voids were higher

adjacent to the edge than away from the edge. The same correlation holds true for comparing the Safety Edge_{SM} sections to the non-Safety Edge_{SM} sections, and it is recognized that the non-Safety Edge_{SM} sections received greater compactive effort from the rolling procedures.

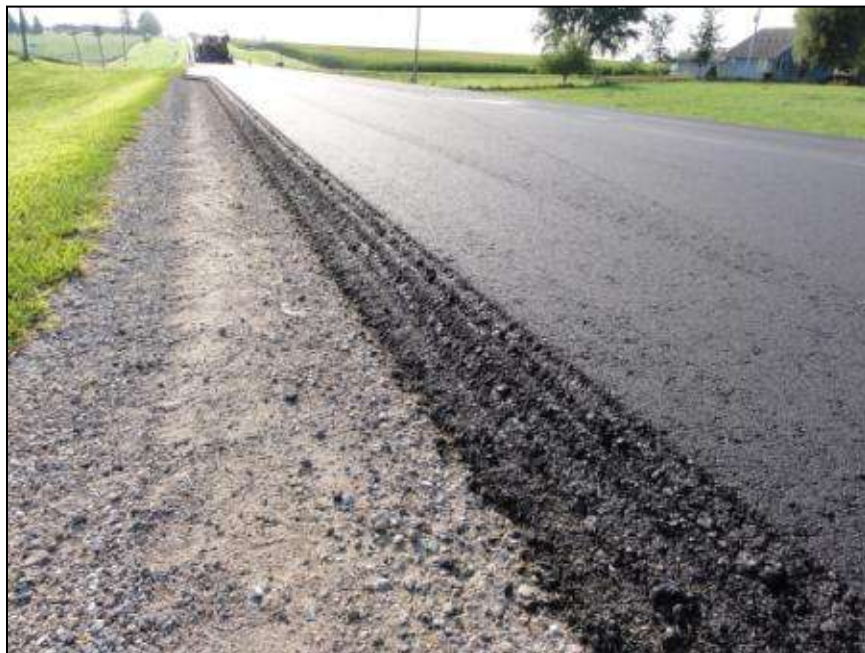
Slight segregation was noticed at both the unconfined longitudinal centerline joint and at the free edge when compared to the center of the mat. The segregation was present in the Safety Edge_{SM} as well as the non-Safety Edge_{SM} sections of the project. Each course of HMA was offset during construction to accommodate the sloped Safety Edge_{SM} on the following lift of HMA. Consequently, more HMA was placed to obtain the planned pavement width than would otherwise be placed with a traditional pavement edge. Figure 13 shows the Safety Edge_{SM} and the offset placement of each pavement layer.

Figure 13. Offset HMA layers with Safety Edges_{SM}.
