# Hurricane Ike in Texas and Louisiana

Building Performance Observations, Recommendations, and Technical Guidance

FEMA P-757 / April 2009

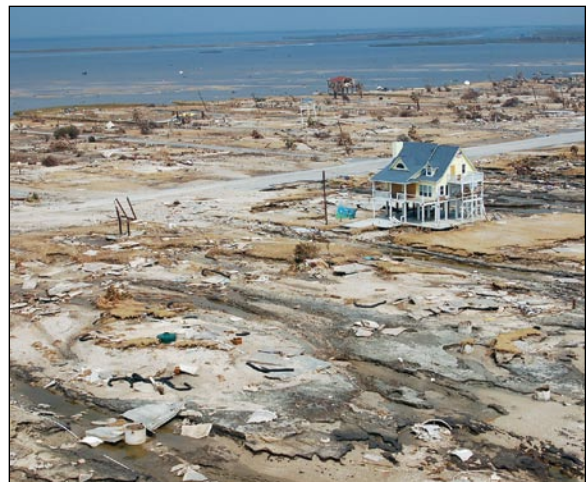
In this photo taken by the MAT on September 19, 2008, a lone house in the Gilchrist neighborhood on the Bolivar Peninsula in Texas, survived Hurricane Ike.
