5 Performance of Buildings in Houston's Central Business District

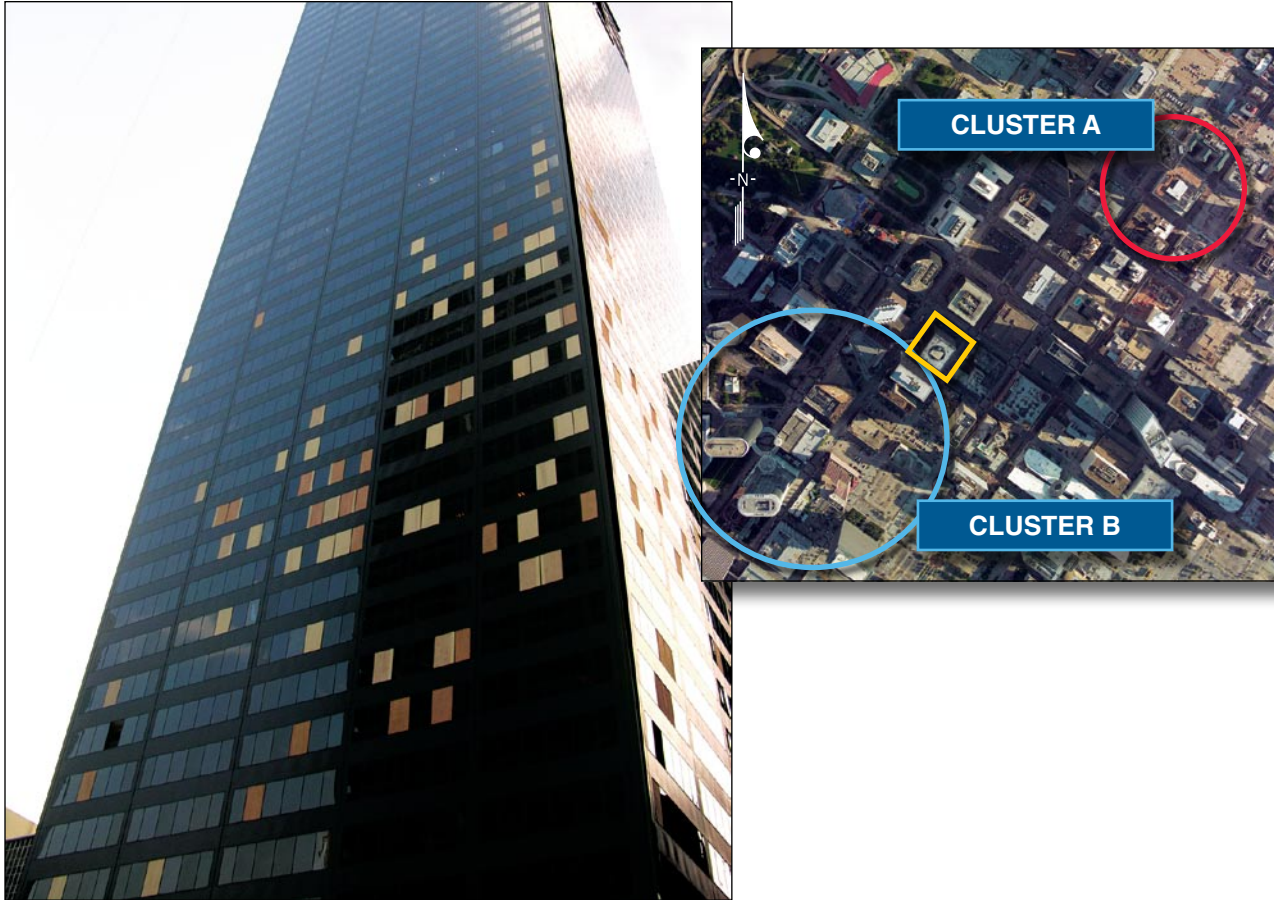
Figure 5-2.
Building with glazing damage; location shown by yellow square in inset

in Figure 5-2, 79 windows on one face were boarded up (presumably both the inner and outer panes were broken). For at least five other windows, the outer pane was also broken on this façade (these windows were not boarded).

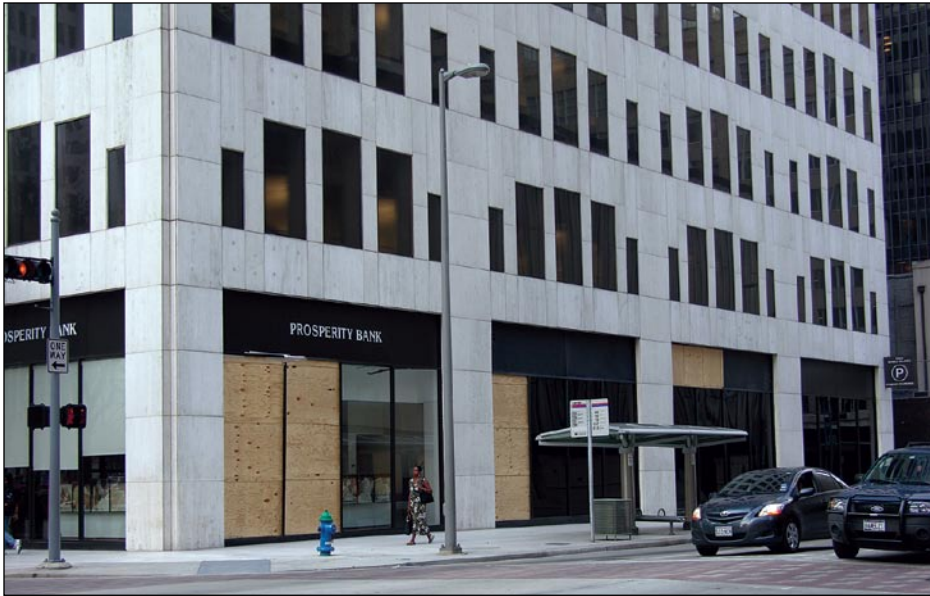
Glazing breakage also occurred several floors above grade at other buildings. There was also random breakage at or near street level at some buildings, as shown in Figure 5-3. Exterior glazing is very susceptible to windborne debris breakage unless it is impact resistant (via use of laminated glass or shutters). Since Houston is not in a windborne debris region, protected glazing is not commonplace. The probability that any one window will be struck by windborne debris is typically small (unless the glazing is downstream from an aggregate-surfaced roof). The probability of impact depends upon local wind characteristics and the amount of natural and manmade windborne debris in the vicinity. The greater the wind speed, the greater the amount of windborne debris that is likely to become airborne. Glazing can also be broken by overpressurization via either high negative or positive wind loads, but this damage is not as common as debris-induced damage. Older glazing is more susceptible to wind-load damage because it is often weakened by scratches. In addition, much of the older glazing on low-rise buildings was installed when little attention was given to wind resistance.

Figure 5-3.
Random breakage of first
floor glazing

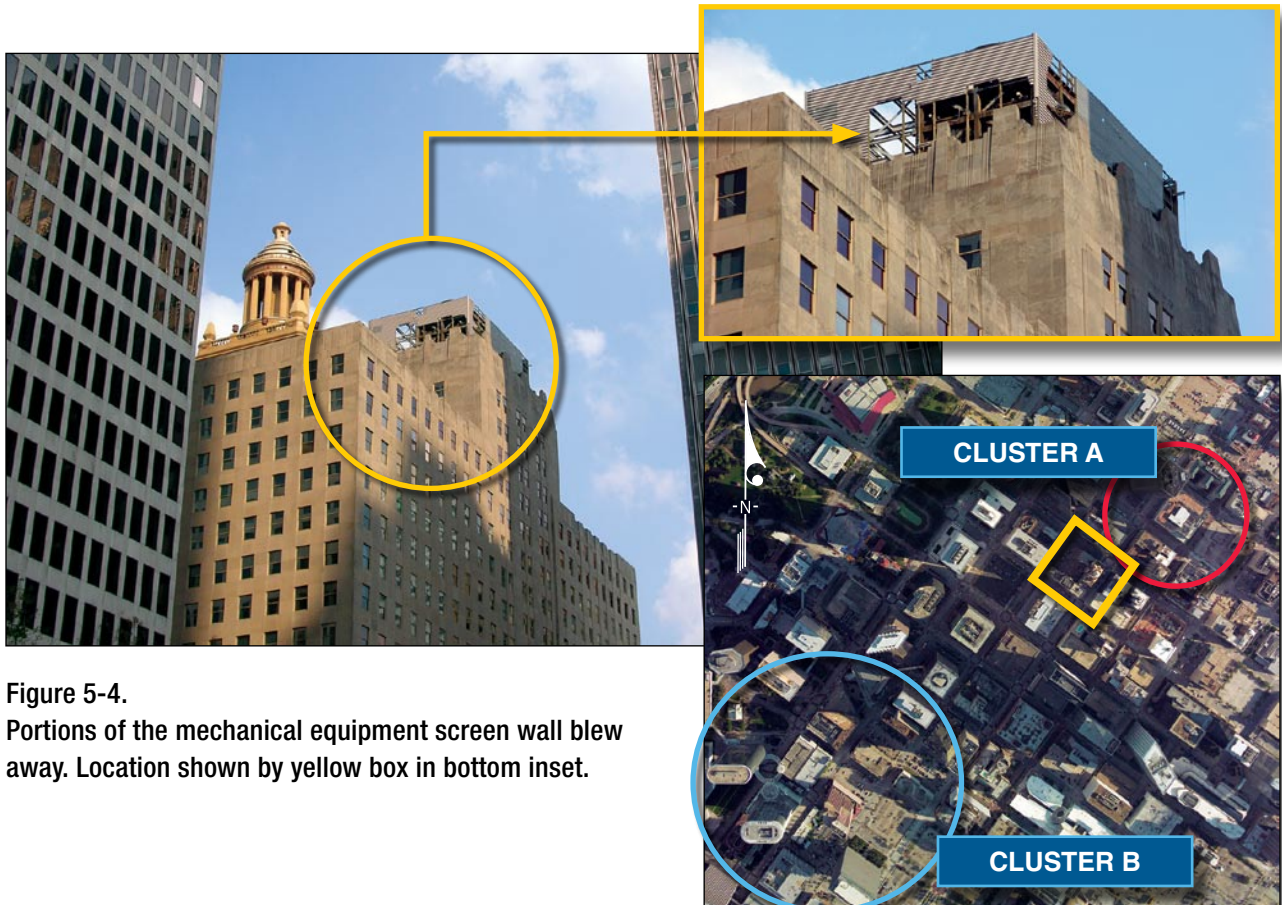
Figure 5-4.
Portions of the mechanical equipment screen wall blew away. Location shown by yellow box in bottom inset.

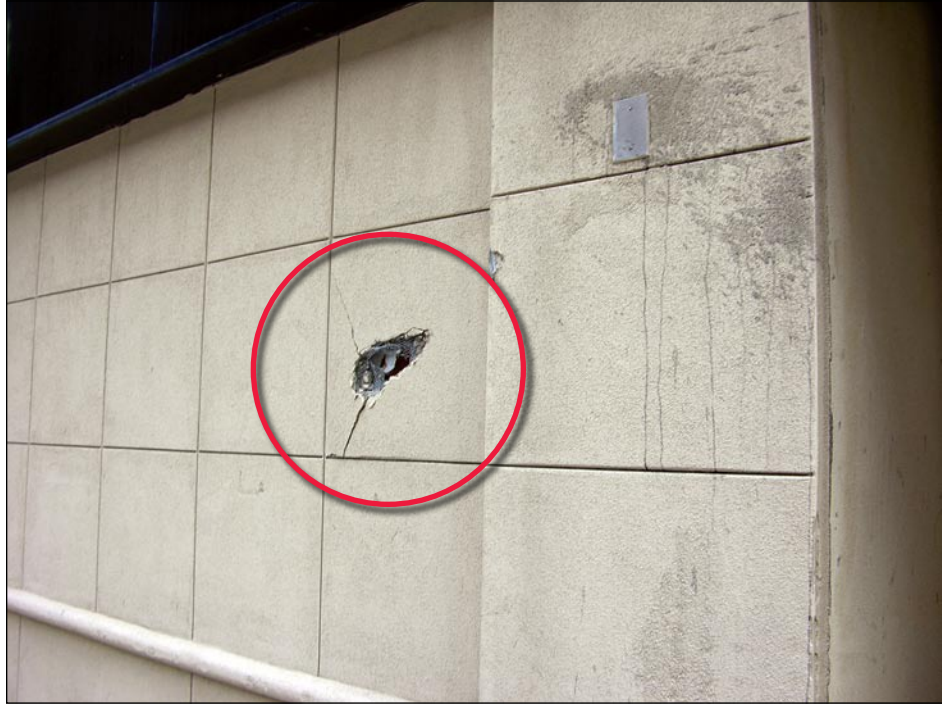
Figure 5-5.
The wire mesh of this stucco wall was penetrated by windborne debris. The impact location is about 5 feet above the sidewalk.

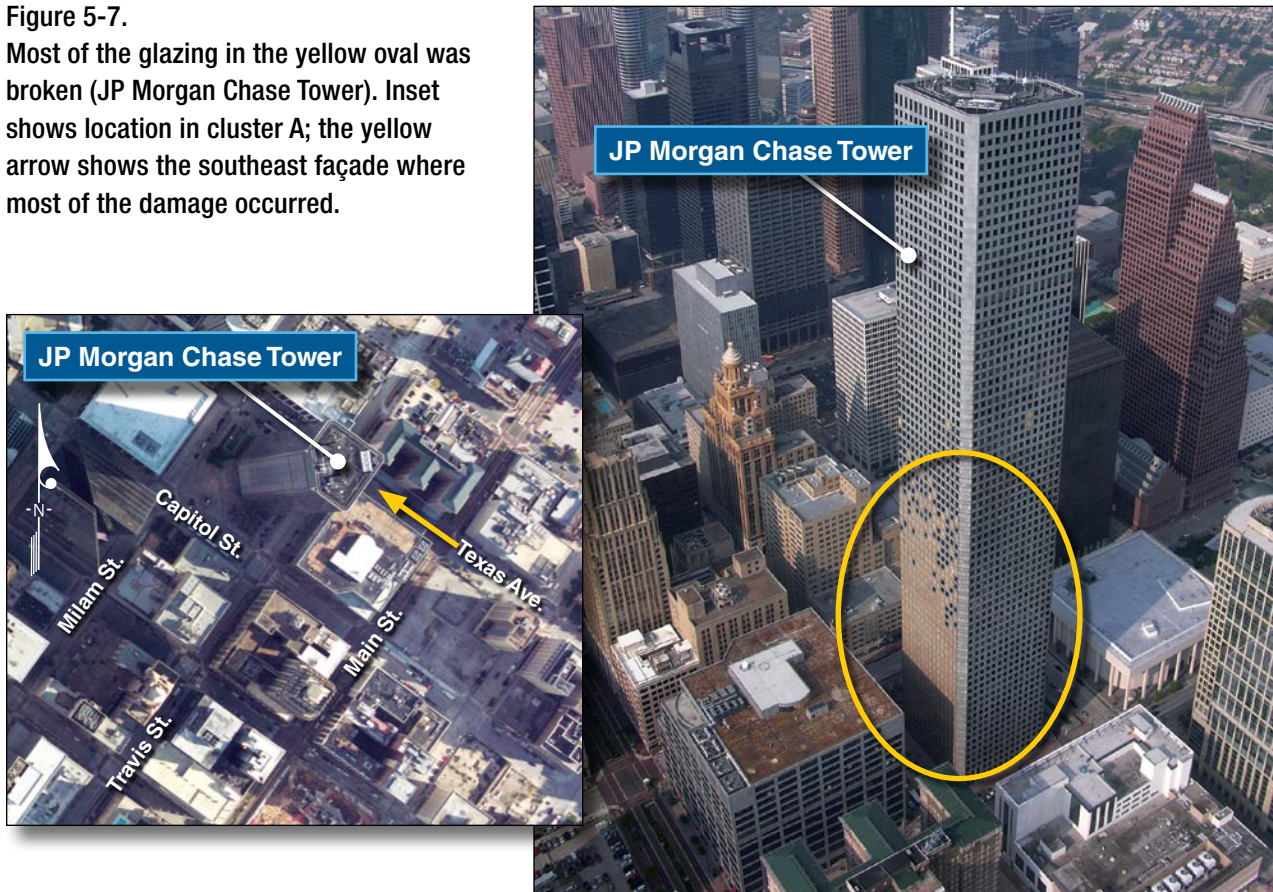
Figure 5-7.

The glazing panes of the JP Morgan Chase Tower are ¼-inch thick each, inner and outer, with a ½-inch air space between the panes. The glazing units are tinted and annealed. There was significant damage on the southeast façade, which was on the leeward side of the building during the time of the strongest winds (yellow circled area in Figure 5-7 and yellow arrow in inset), where both the inner and outer panes of approximately 463 windows were broken. On that façade, all windows in the first 22 floors were broken. The highest broken window was on the 47th floor. The southwest façade had 23 windows with broken inner and outer panes, and the northeast façade had two. The temporary protection and glazing replacement costs were significant.

Most of the glazing in the yellow oval was broken (JP Morgan Chase Tower). Inset shows location in cluster A; the yellow arrow shows the southeast façade where most of the damage occurred.

Although the glazing damage shown in Figures 5-7 and 5-8 is indicative of damage caused by windborne roof aggregate, the MAT conclusion is that aggregate did not, in fact, cause the damage based on the following observations:

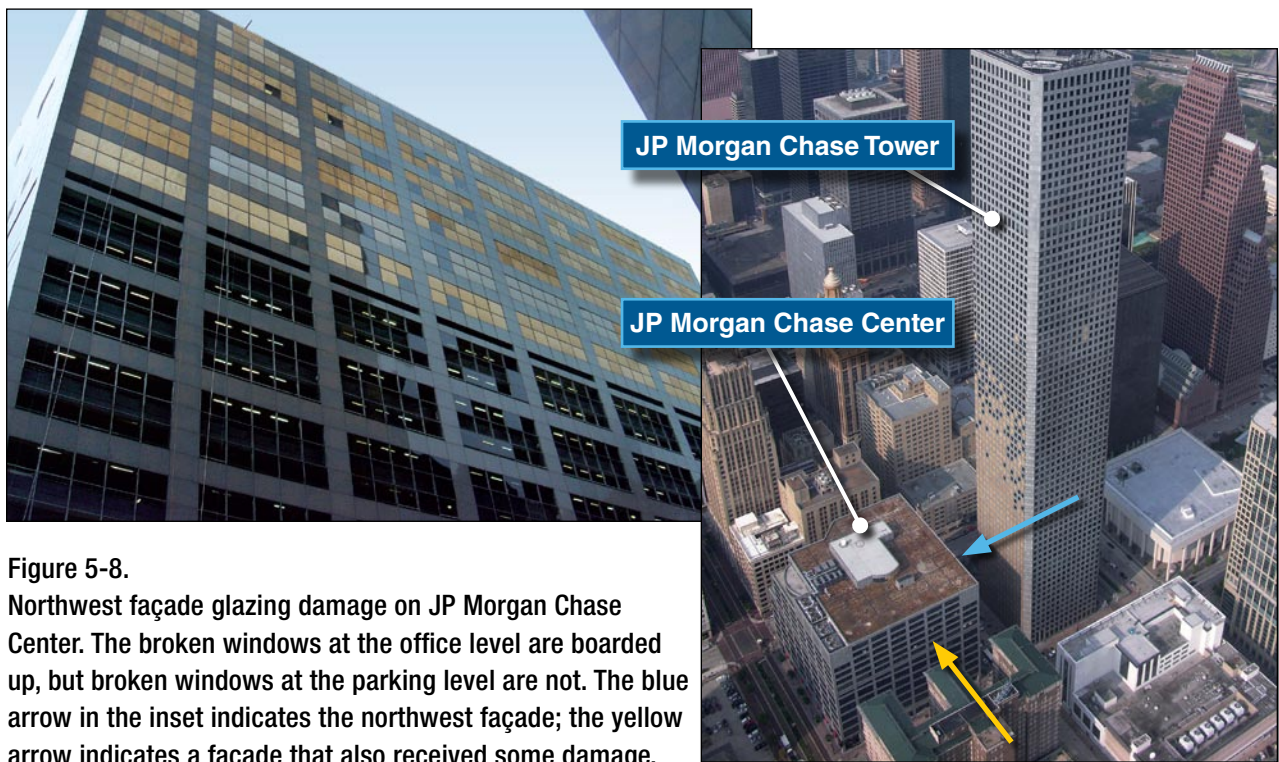
The JP Morgan Chase Center utilizes single-pane, heat-strengthened glazing. Virtually all of the penthouse glazing and the glazing on the northwest façade, which was the windward side of the building during the time of the strongest winds (Figure 5-8), was broken. At least 16 windows were broken on the façade with the yellow arrow in Figure 5-8 inset. Only a few windows were broken in the opposite façade. There was no damage in the southeast façade.

The broken glazing on the northwest façade blew approximately 50 feet into the interior of the building. Once the exterior glazing was breached, wind-driven rain penetrated into the building, causing extensive interior damage.

Figure 5-8. Northwest façade glazing damage on JP Morgan Chase Center. The broken windows at the office level are boarded up, but broken windows at the parking level are not. The blue arrow in the inset indicates the northwest façade; the yellow arrow indicates a façade that also received some damage.

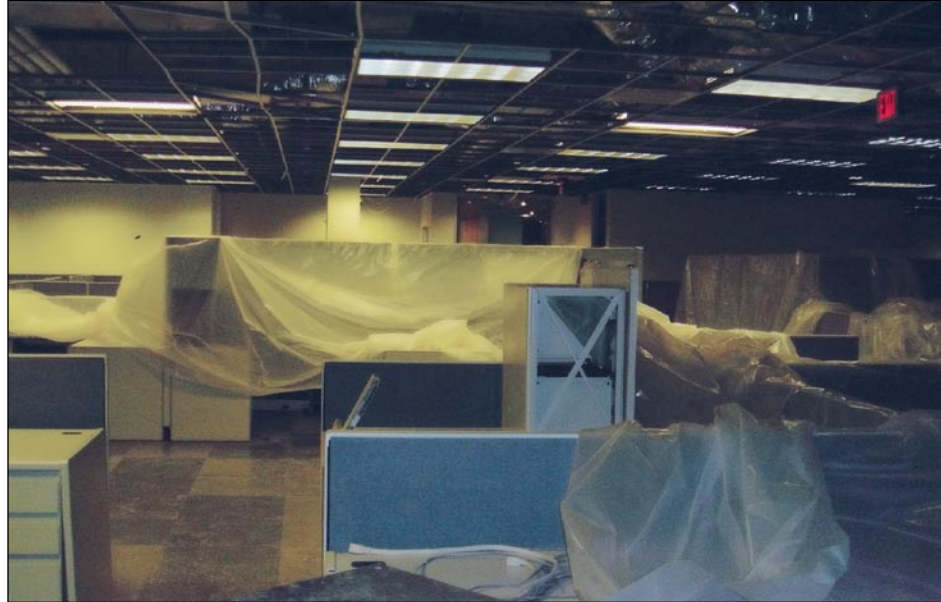
Floors 18 and 19 sustained extensive damage. Water-damaged carpet and ceiling boards were removed from approximately 50 percent of the floor area that was observed by the MAT. At the time of the MAT observation, new materials were being installed, including new wiring, new data cables, and extensive HVAC work. Approximately 25 percent of the floor area on Floors 14 through 17 sustained similar damage.

Figure 5-9.
View of repairs to an office
damaged in the JP Morgan
Chase Center

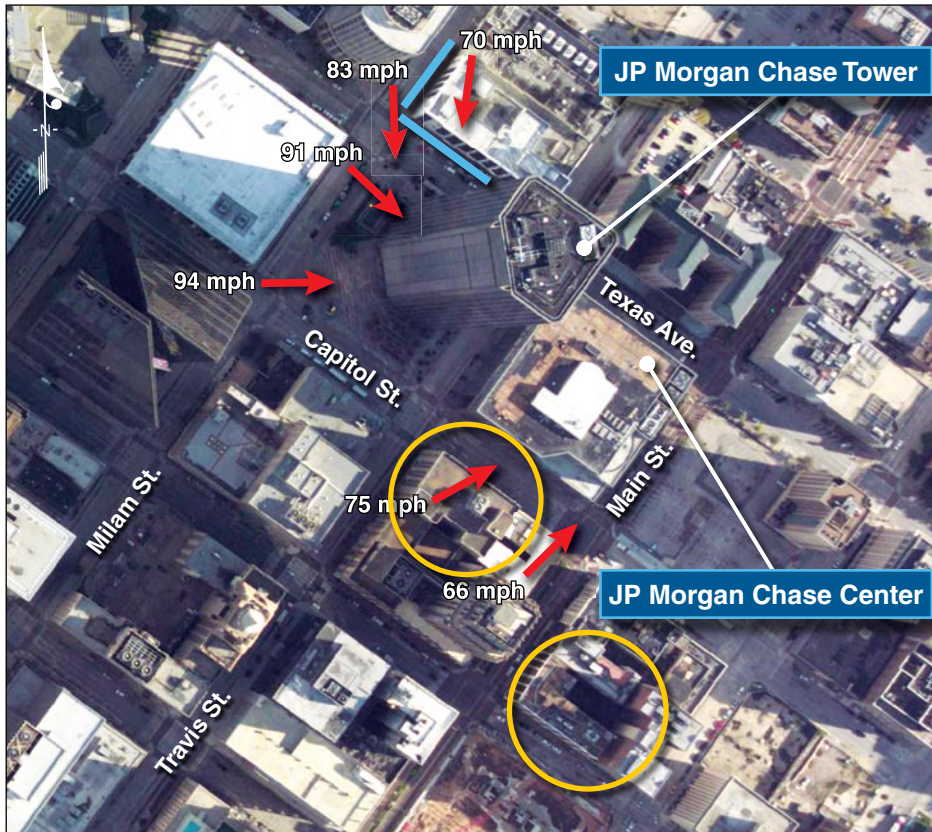
Although aggregate-surfaced BURs were present on the buildings shown in the yellow and orange circles in Figure 5-10, it is unlikely that debris from these roofs caused the glazing damage observed at the JP Morgan Tower and Center. The wind direction and relatively low speed precluded aggregate from the roofs in the orange circle from being a debris source. The speed and direction may have been sufficient to cause aggregate to be blown from the penthouse of the building shown in the yellow circle of Figure 5-10 (and discussed in Section 5.2.4), but if that occurred, the aggregate would likely only have struck the JP Morgan Center façade, which had very little damage. MAT observations from a helicopter and the roofs of the Tower and Center did not reveal any other aggregate-surfaced roofs in the vicinity.

Figure 5-10. Locations of possible debris sources that impacted the JP Morgan Tower and Center. Aggregate-surfaced roofs within cluster A area shown by yellow circles. Blue lines show location of failed metal panel veneer.

The MAT postulates that the glazing damage occurred as a result of the following: some glazing in the Tower or the Center failed, either due to windborne debris or overpressurization, and the resulting glass shards became enveloped in vortices that developed between the two buildings. As the shards impacted the opposing façades, additional shards were injected into the vortices. It is believed that the vortices lifted the shards upwards, thereby causing damage at the upper floors (shown in Figure 5-11). Potential initial debris sources include trees along the sidewalks and metal wall panels from a nearby building (blue lines shown in Figure 5-10; refer also to Section 5.2.4).

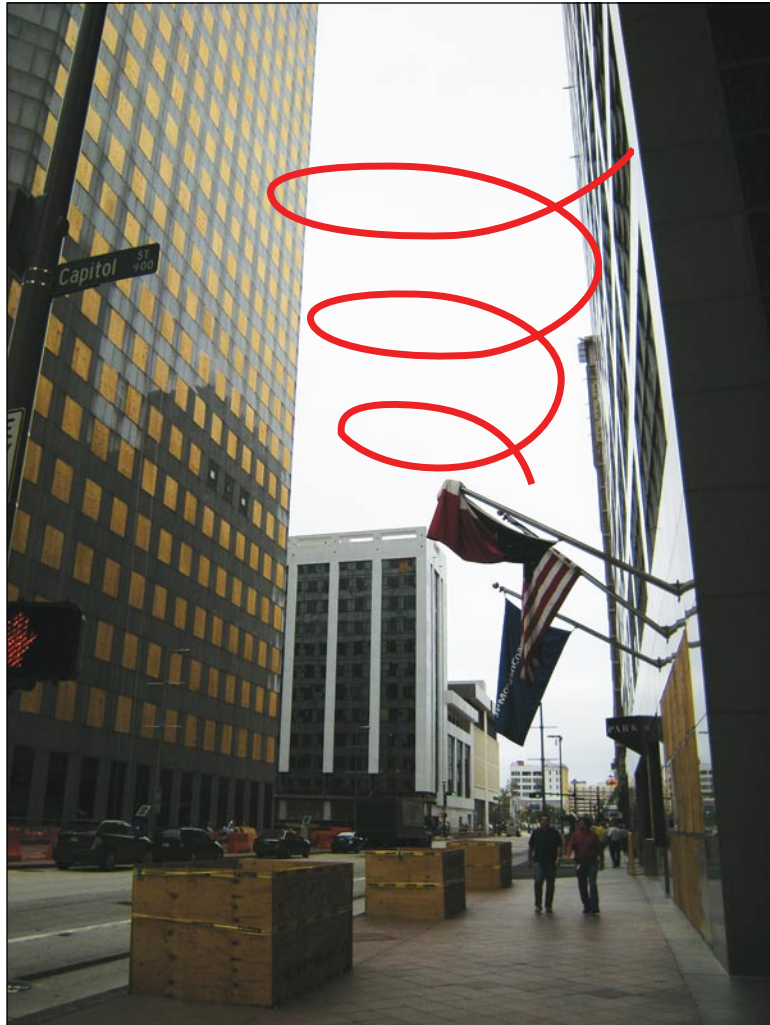
Figure 5-11.

The MAT's postulate is consistent with initial research work on the observed glazing damage conducted by the University of Notre Dame in a paper titled *Saga of Glass Damage in Urban Environments Continues: Consequences of Aerodynamics and Debris Impact During Hurricane Ike* (Kareem, 2008).² A model of the JP Morgan Tower and surrounding buildings was constructed and flow visualization experiments were conducted in a wind tunnel. In addition, flow visualization was analyzed by computational fluid dynamics (CFD). The wind tunnel and CFD studies both demonstrated that a series of vortical flow structures formed between the two façades that were heavily damaged (Figure 5-11).

The Tower is on the left and the Center is on the right. It is believed that vortices developed between these façades, and that glass shards entrapped within the vortices were slammed against and broke glazing in the opposing façades.

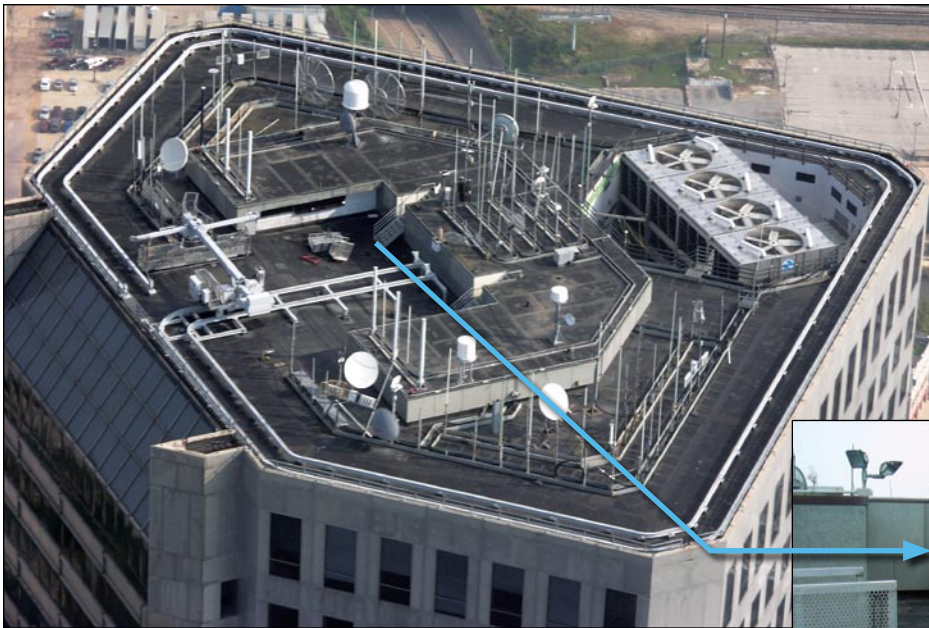
A portion of the window washing equipment on the JP Morgan Chase Tower broke loose and slammed around, damaging the equipment (Figure 5-12 inset).

Figure 5-12.
View of the JP Morgan Chase Tower roof. Inset shows damaged window washing equipment.

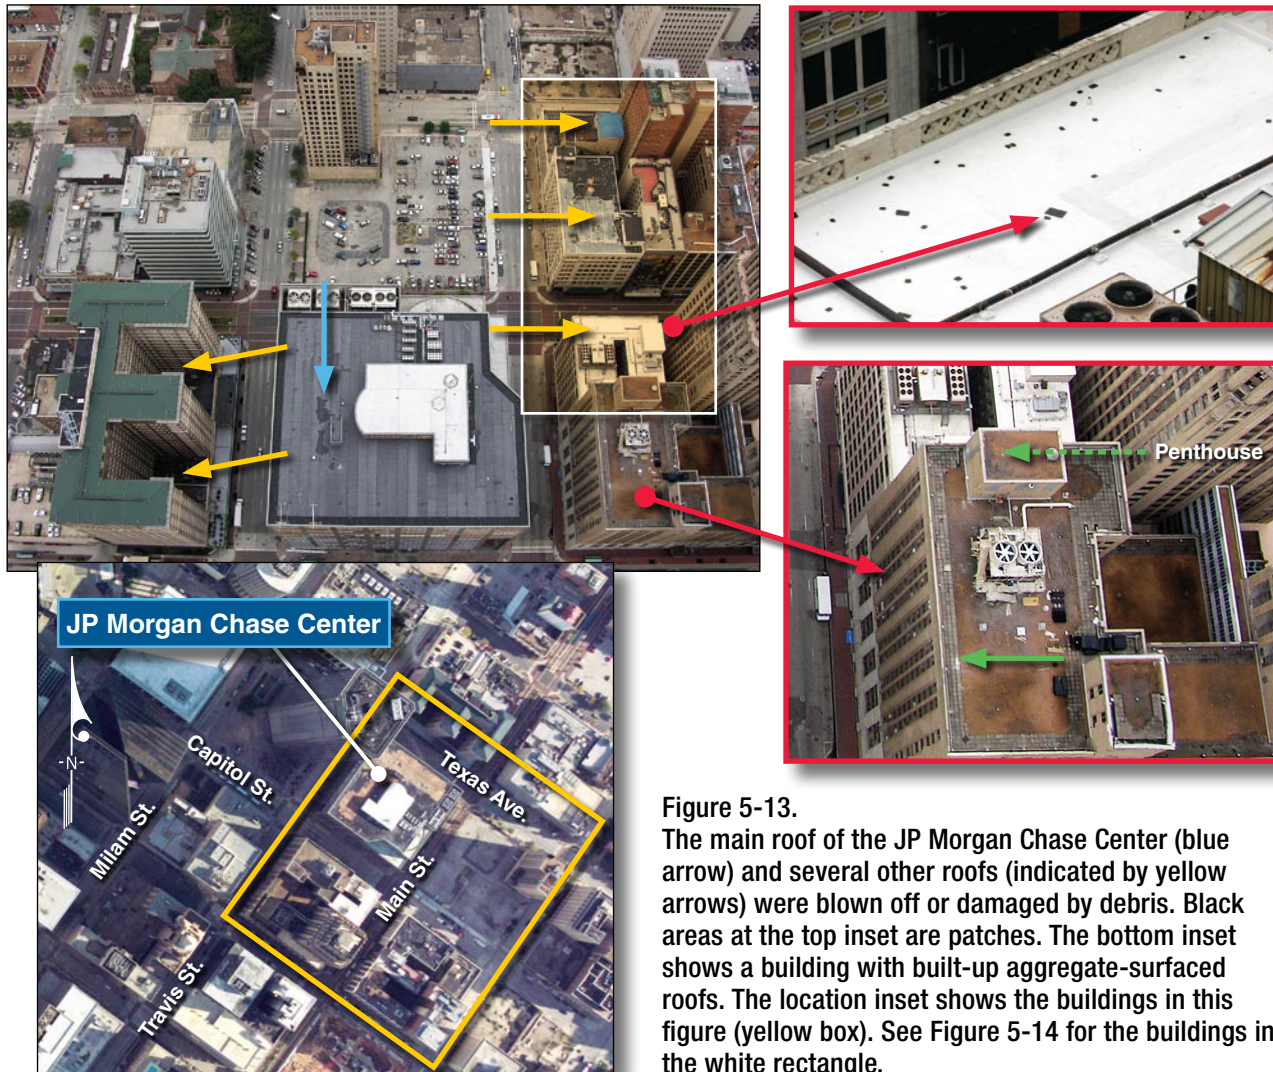
The roofs shown by the yellow arrows in Figure 5-13 had either been blown off (i.e., the tarped roofs) or punctured by windborne debris. Much of the roof puncture and glazing damage was likely caused by windborne glass shards.

At the building shown in the bottom inset at Figure 5-13, concrete pavers had been installed around the perimeter of the main roof (solid green arrow at the inset) and at a portion of one of the penthouses as part of the original roof surfacing. However, the penthouse roof indicated with the dashed green arrow did not have pavers; its roof had a raised curb at the roof edge. Aggregate from this penthouse roof may have struck the side of JP Morgan Chase Center that had very little glazing damage.

Figure 5-13. The main roof of the JP Morgan Chase Center (blue arrow) and several other roofs (indicated by yellow arrows) were blown off or damaged by debris. Black areas at the top inset are patches. The bottom inset shows a building with built-up aggregate-surfaced roofs. The location inset shows the buildings in this figure (yellow box). See Figure 5-14 for the buildings in the white rectangle.

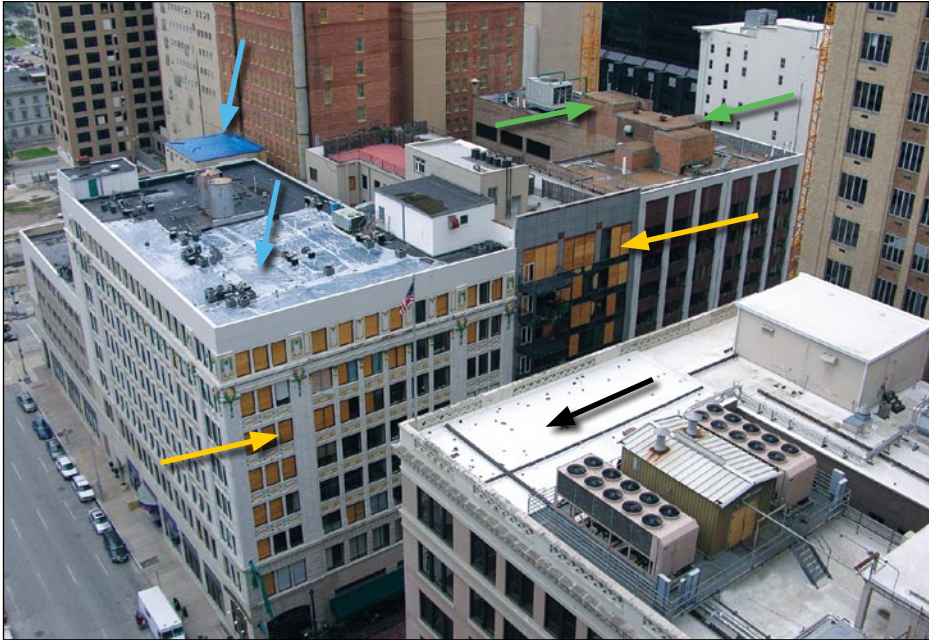
Figure 5-14 is a view of the roofs in the white rectangle at Figure 5-13. Blue and clear plastic tarps cover two roof areas. The green arrows show where an aggregate-surfaced built-up membrane lifted and peeled back. It is doubtful that aggregate from these roofs struck the JP Morgan Chase Tower or Center buildings. The punctured roof with the black arrow is the same as shown at the top inset of Figure 5-13. Several windows were broken in the buildings shown by the yellow arrows.

Figure 5-14. Glazing damage (yellow arrows) at two of the buildings shown in the white rectangle in Figure 5-13. The blue, green, and black arrows indicate damaged roofs.

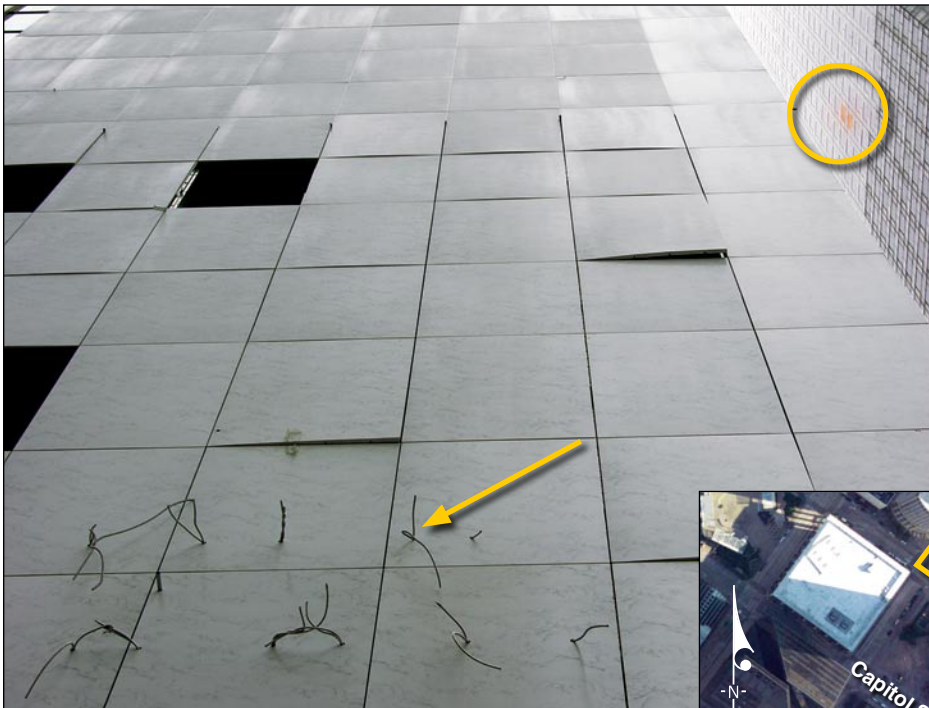
Figure 5-15 shows a building that lost several metal wall panels and a wall-mounted sign; the inset shows the building location and the façade that lost the panels (blue lines). It appears that the wall panel debris had the potential to strike either the JP Morgan Tower or Center.

Figure 5-15. Several metal panels blew off of two façades of this building, along with a wall-mounted sign (yellow arrow). Two broken windows can be seen in the yellow circle at the JP Morgan Chase Tower. Inset shows location of building (yellow box); blue lines indicate façades where metal panels blew off.

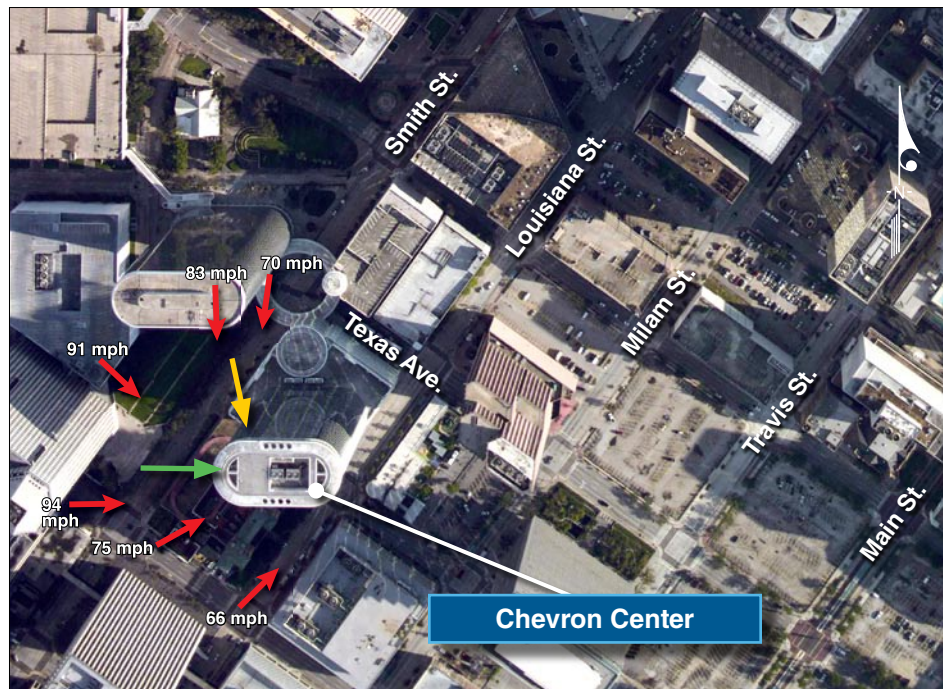
Figure 5-16.
 A substantial amount of glazing damage occurred to the façade of the Chevron Center, indicated by the yellow arrow. The roof membrane blew off from the end of the building (green arrow). The red arrows show Hurricane Ike’s primary wind directions and maximum gust speed for the given direction.
 SOURCE: NOAA, SEPTEMBER 17, 2008

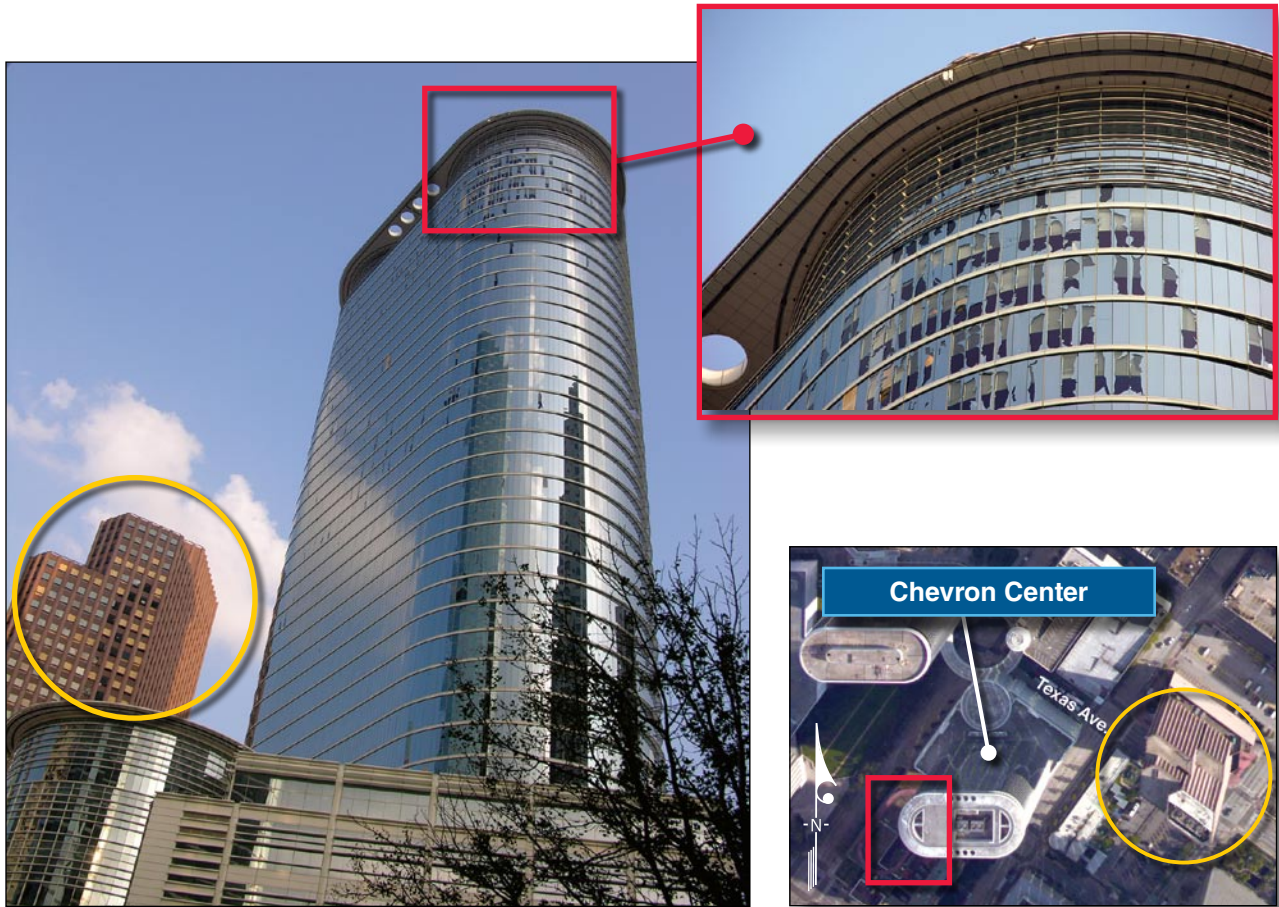
The area of the Chevron Center that received most of the glazing damage is shown in Figure 5-17. The outer panes of about 700 heat-strengthened windows were broken. At seven windows, both the inner and outer lites were broken.

Figure 5-17. Chevron Center glazing damage. At the building beyond (yellow circle), at least 35 windows were boarded up. Bottom inset shows location.

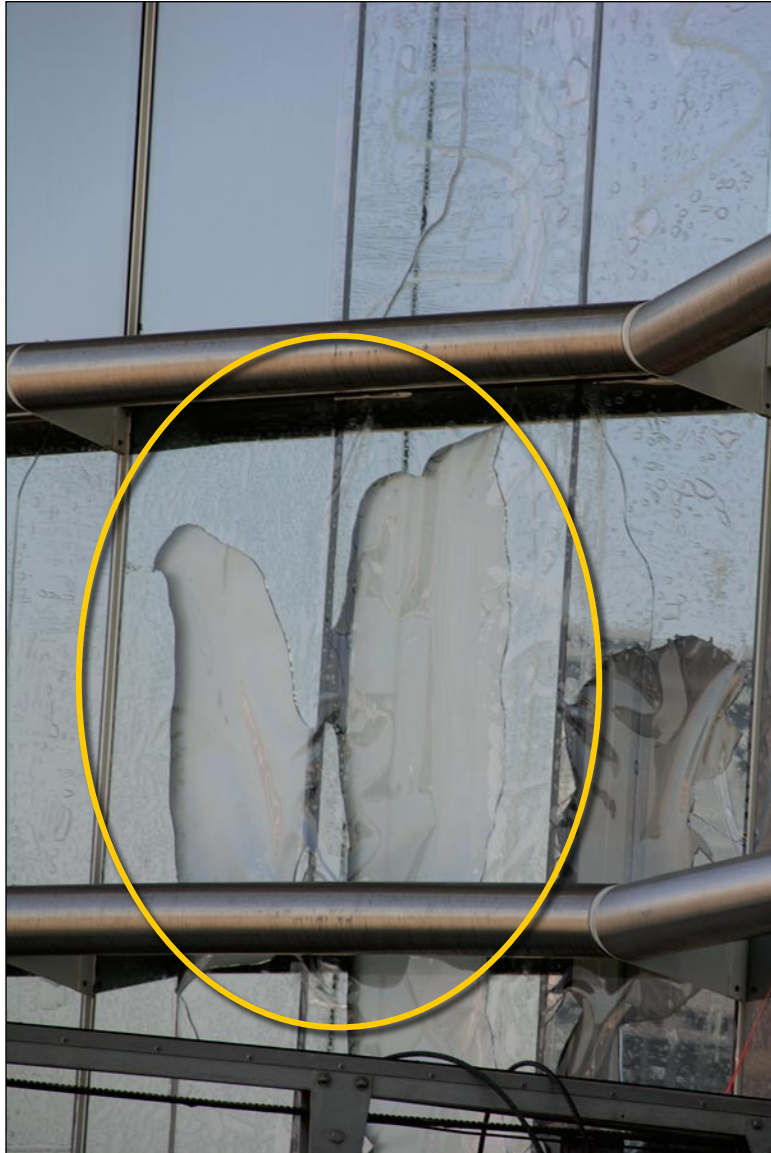
Shortly after the storm, the building owner retained a company to quickly install a temporary film over all of the broken glazing as a safety precaution to avoid falling shards of glass (Figure 5-18). Once the protective film was in place, work commenced on removing the broken glass that was still in place. Glass removal took considerable time, hence the initial installation of the protective film was prudent to protect pedestrians.

Figure 5-18.
Broken glazing held in place with
temporary film

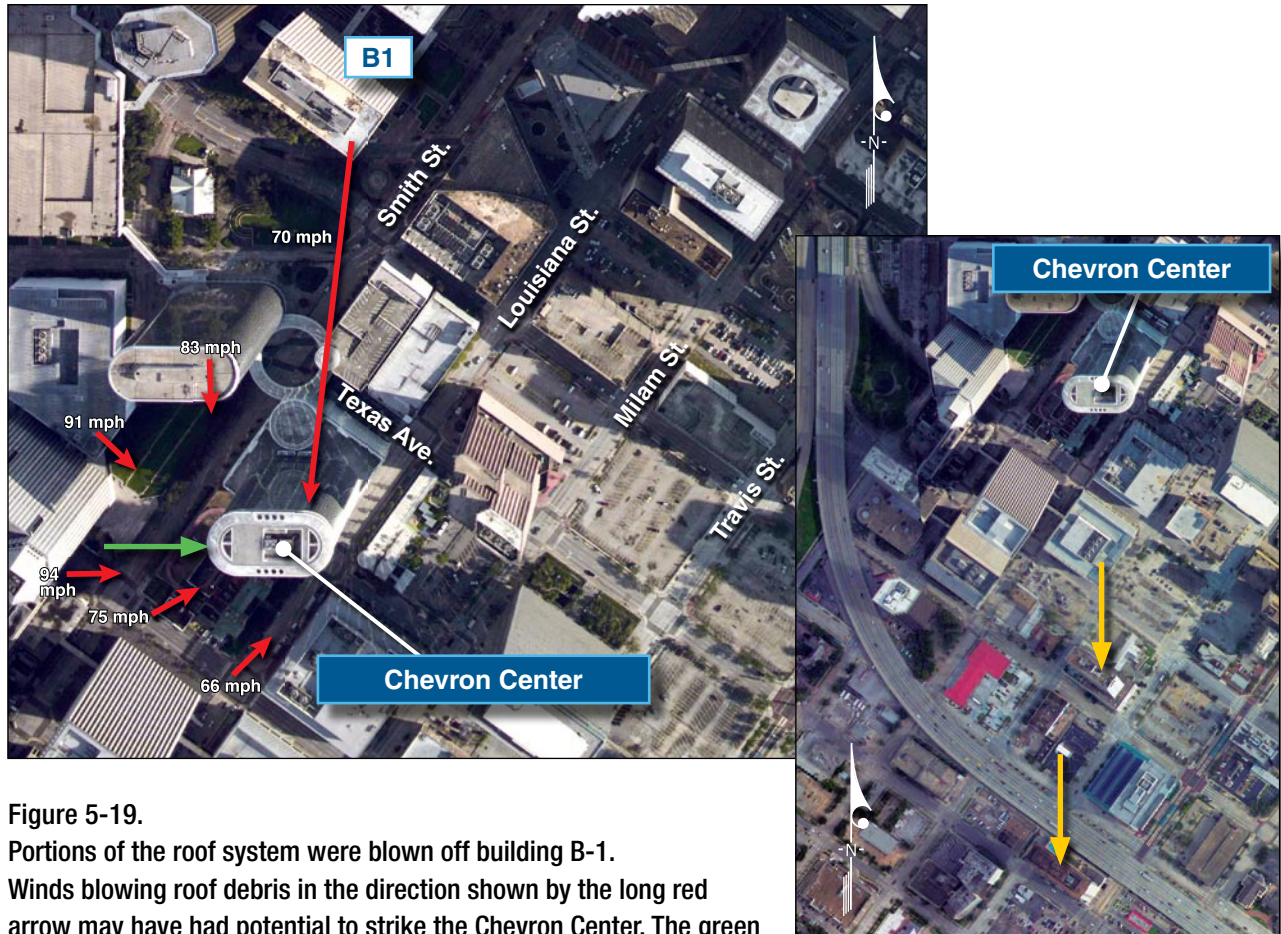
Figure 5-19.

Two mid-rise buildings with aggregate-surfaced BURs occur to the south of the Chevron Center (yellow arrows at the inset of Figure 5-19). These buildings are shown in Figure 6-4. The closest building is approximately 250 feet from the Chevron Center, which is well within the flight capability of windborne aggregate. However, wind direction during Hurricane Ike precluded aggregate from these buildings as being potential debris sources for the glazing damage at the Chevron Center (refer to red arrows indicating wind directions shown on Figure 5-19).

Portions of the roof system were blown off building B-1.

Winds blowing roof debris in the direction shown by the long red

arrow may have had potential to strike the Chevron Center. The green

arrow indicates where a portion of the roof membrane blew off the

Chevron Center. The yellow arrows at the inset show locations of buildings that had aggregate-surfaced roofs.

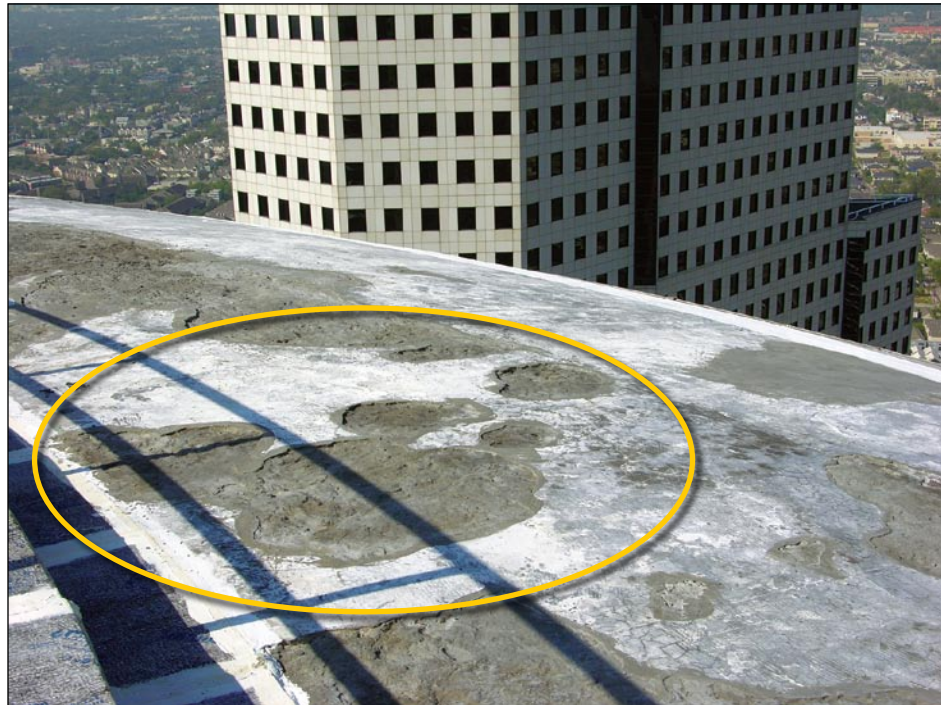
A portion of the PVC roof membrane was blown off in the vicinity shown by the green arrow in Figure 5-19 and as shown in Figure 5-20. The concrete deck was gouged in many locations (Figure 5-20). The gouging may have been due to roof membrane flutter, or it may have been caused by the detached lightning protection conductor.

Figure 5-20.
The lightweight insulating concrete deck was gouged in many locations

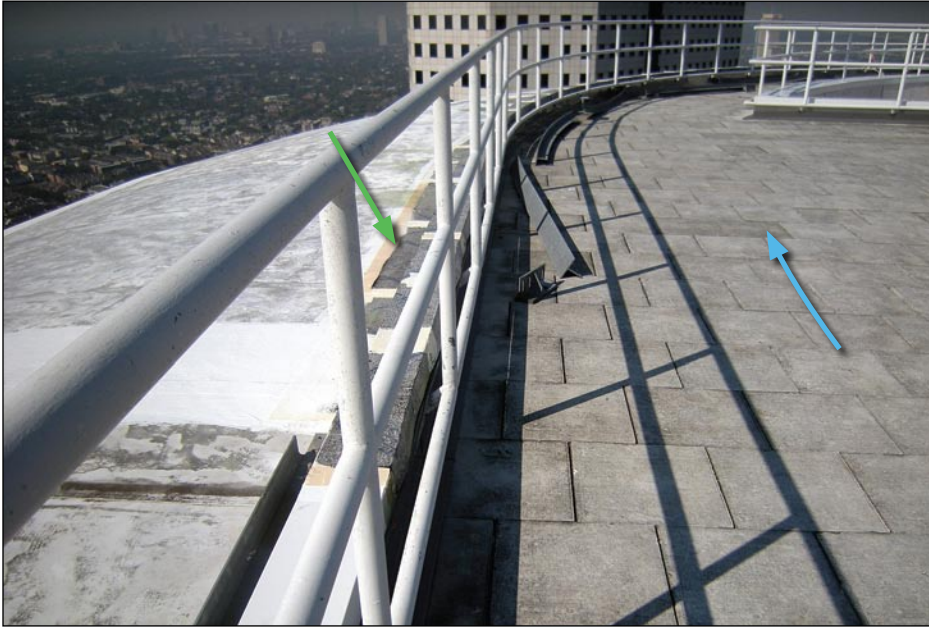
As a result of the roof membrane damage, the window washing track (Figure 5-21) was damaged. Apparently, membrane fluttering caused the nuts on the 1/2-inch stainless steel bolts to loosen. The galvanized T-shaped window washing track is 4 inches high and 5 1/2 inches wide, with a 1/4-inch thick head and a 3/8-inch stem.

Figure 5-21. View of the damaged window washing track (green arrow). The concrete pavers (blue arrow) were not damaged.

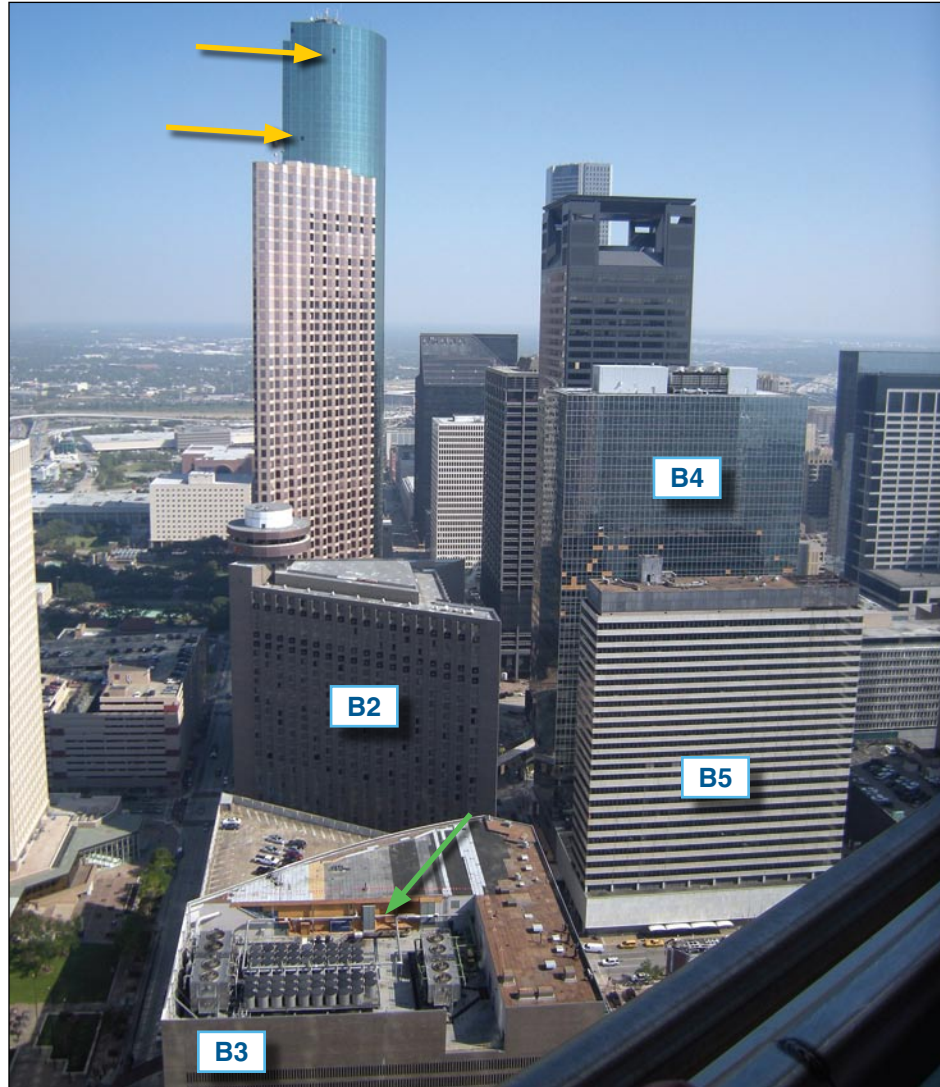
The view in Figure 5-23 is looking northeast from the roof of the Chevron Center. Yellow arrows indicate two broken windows in the high-rise beyond. There was extensive roof covering damage at building B-3, including exterior wall collapse (green arrow).

Figure 5-23.
View of buildings with glazing, roof and wall covering, and rooftop equipment damage

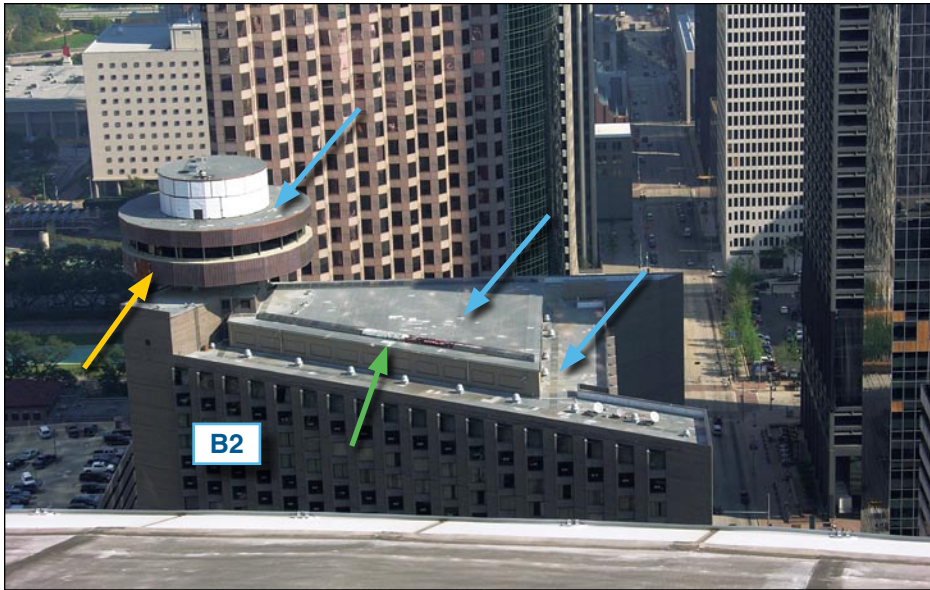
At building B-2, as shown in Figure 5-24, there was roof puncture damage at the three roof areas shown by the blue arrows, metal wall panels were blown off (yellow arrow), skylights were damaged (green arrow), and a fan cowling was blown off the upper round roof. According to a Hurricane Alicia investigator, this building experienced similar damage during that hurricane.

Figure 5-24.
Roof and wall covering,
skylight, and roof-top
equipment damage at
building B-2

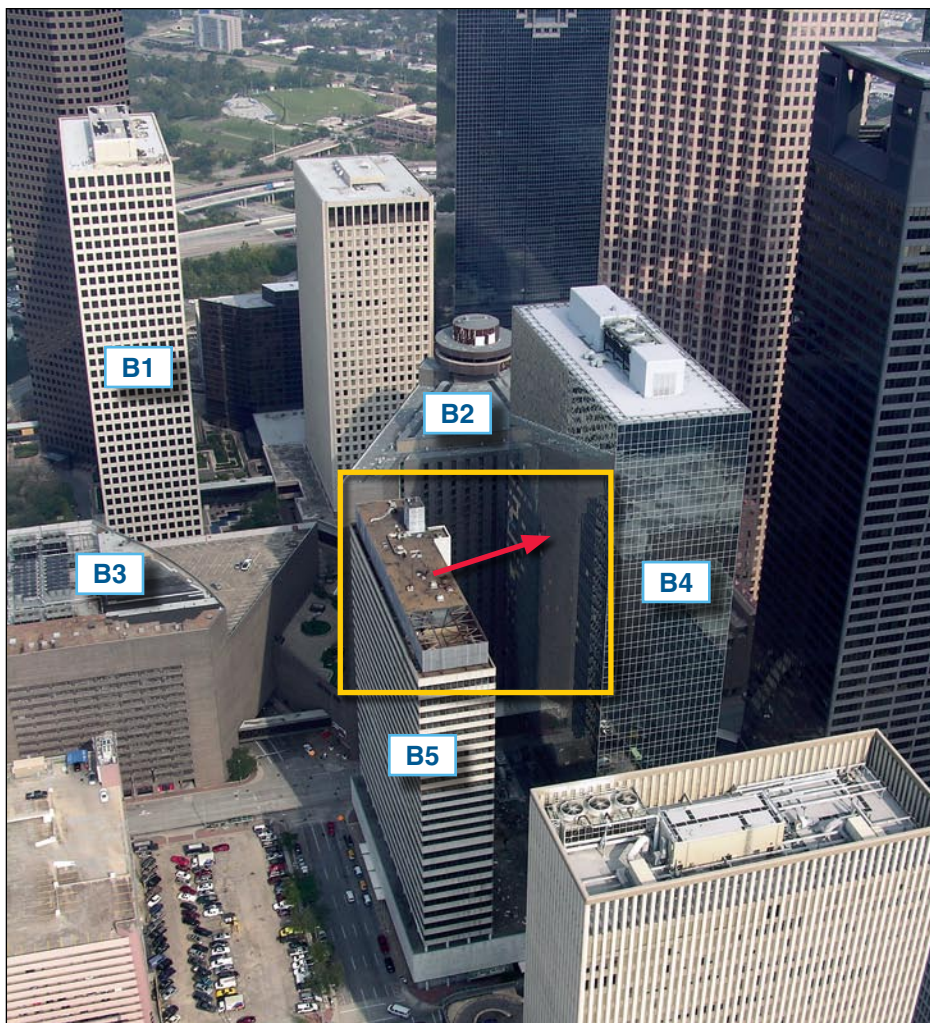
Building B-5 had an aggregate-surfaced BUR with low parapets (likely less than 12 inches high). The aggregate from this roof was a debris source for the building B-4 glass damage (Figure 5-25; close-up shown in Figure 5-26). The red arrow in Figure 5-25 indicates the generalized likely flight path of the aggregate debris. At least two fan cowlings blew off the building B-5 roof. On the back side of building B-5, a few stone veneer panels were damaged (Figure 5-27). According

Figure 5-25.
Roof aggregate from
building B-5 was the
likely cause of the
majority of the building
B-4 glass damage. The
area in the yellow box is
shown in Figure 5-26.
