5 Performance of Buildings in Houston's Central Business District

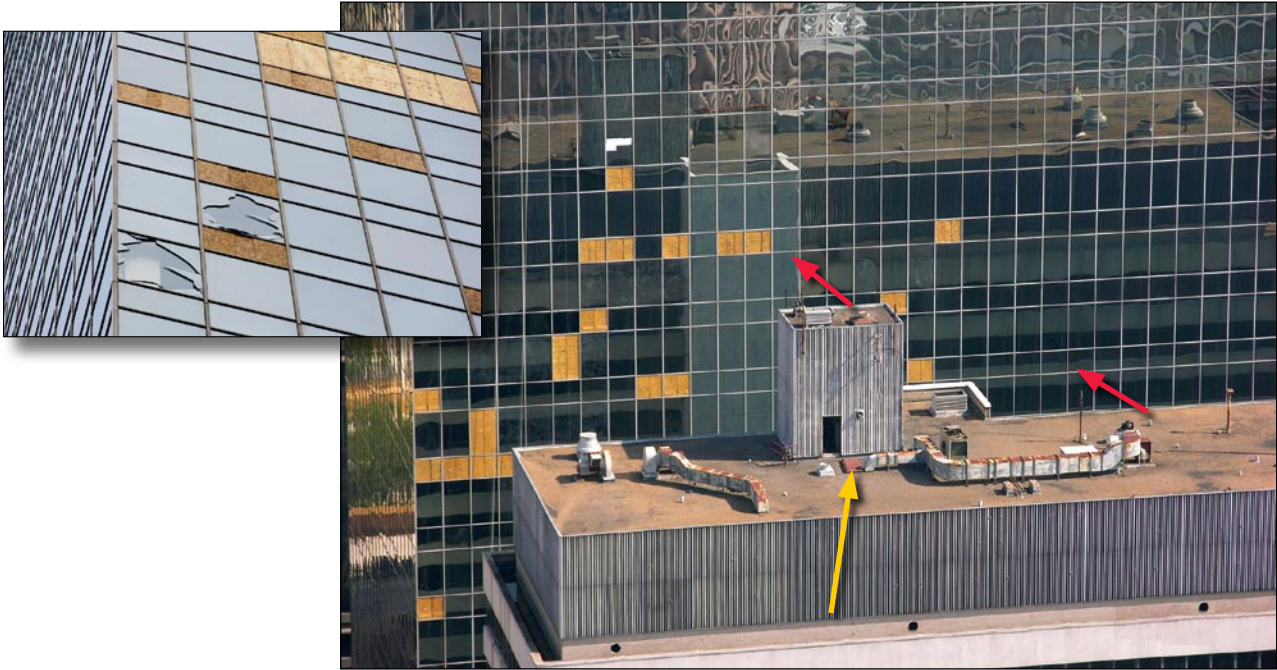
Figure 5-26. View of the aggregate-surfaced roofs on building B-5 and broken glazing on building B-4 beyond. Red arrows indicate generalized aggregate flight path. The yellow arrow shows a penthouse door that blew off. Inset shows damage on a portion of building B-4 below the area shown in the main photograph.

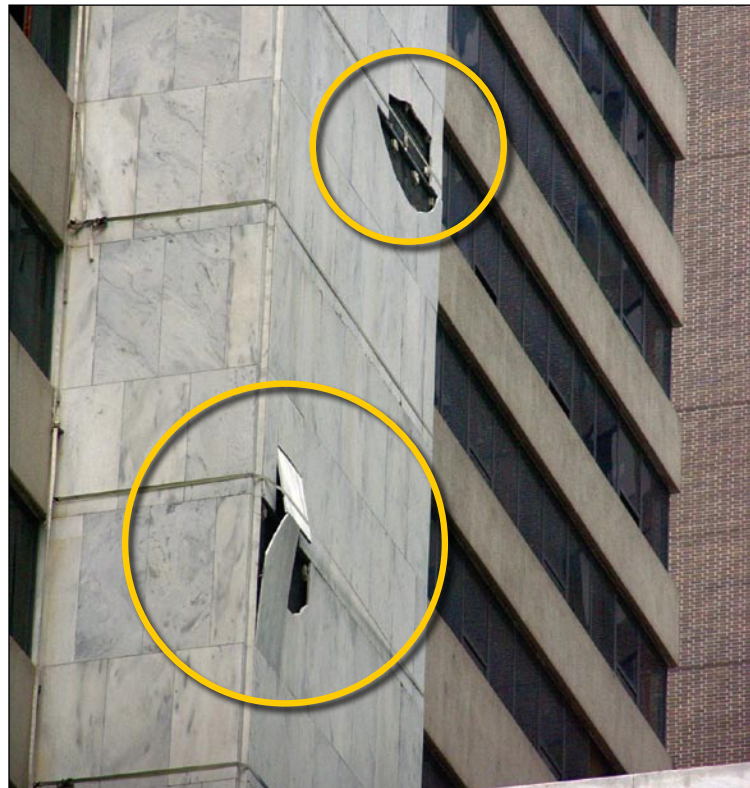
Figure 5-27. Stone veneer damage on backside of building B-5 (side facing B-4)

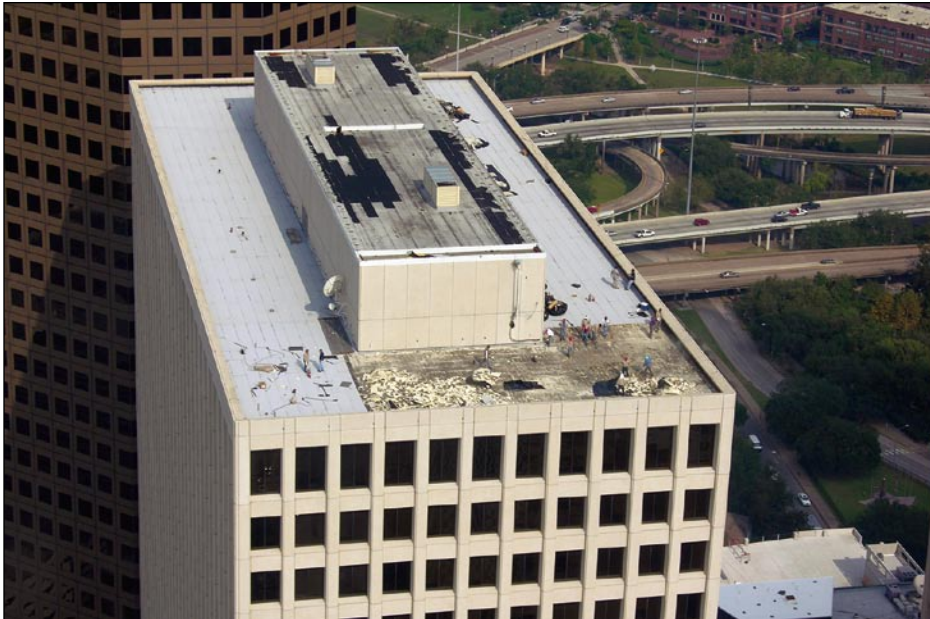
Figure 5-28 shows roof covering damage to building B-1, which was a possible debris source for some of the glazing damage to Chevron Center, as discussed in Section 5.3.1. This building is one of the oldest high-rise buildings in the downtown area.

Figure 5-28.
Roof covering damage on
the main and penthouse
roofs of building B-1

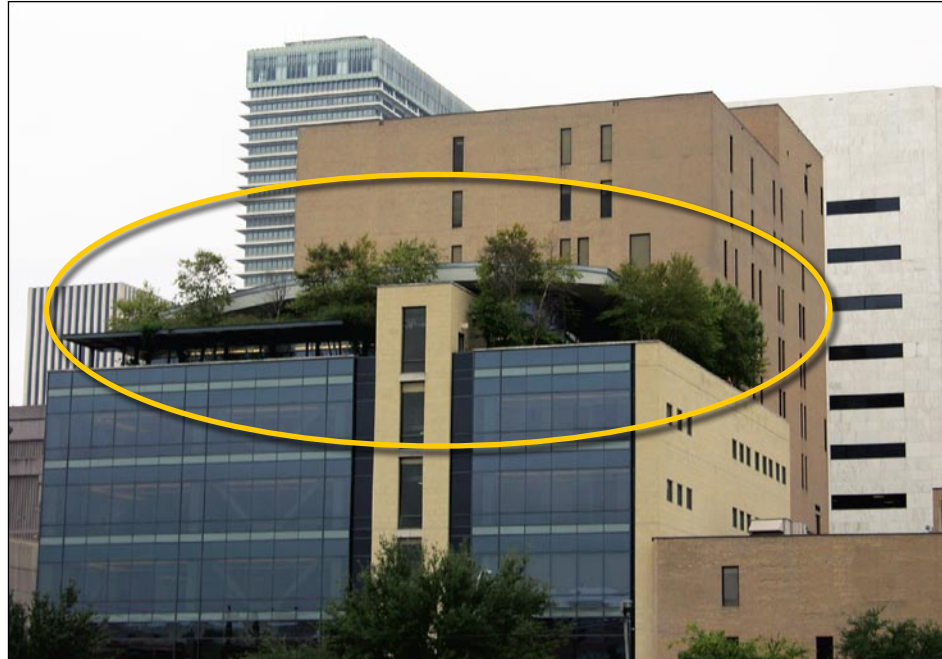
Vegetative roofs can either be “extensive” (with very low plants) or “intensive” (which allows for the planting of shrubs and trees). All three of the vegetative roofs observed by the MAT had trees, as shown in Figure 5-29. The MAT did not perform on-the-roof observations at any of the vegetative roofs, but it was apparent that few, if any, tree limbs were blown away. Lack of limb damage may have been prevented by sheltering from nearby buildings. Also, the low-level wind speeds in the downtown area were not sufficiently high to cause substantial loss of limbs. The concern with limbs is their potential to damage glazing if they are blown away, particularly when trees are placed many floors above grade.

Figure 5-29.
View of a vegetative roof
in the downtown area
