3 Performance of Residential Buildings (Flood and Wind), One- to Two-Family and Multi-Family

3.1 Structural Performance

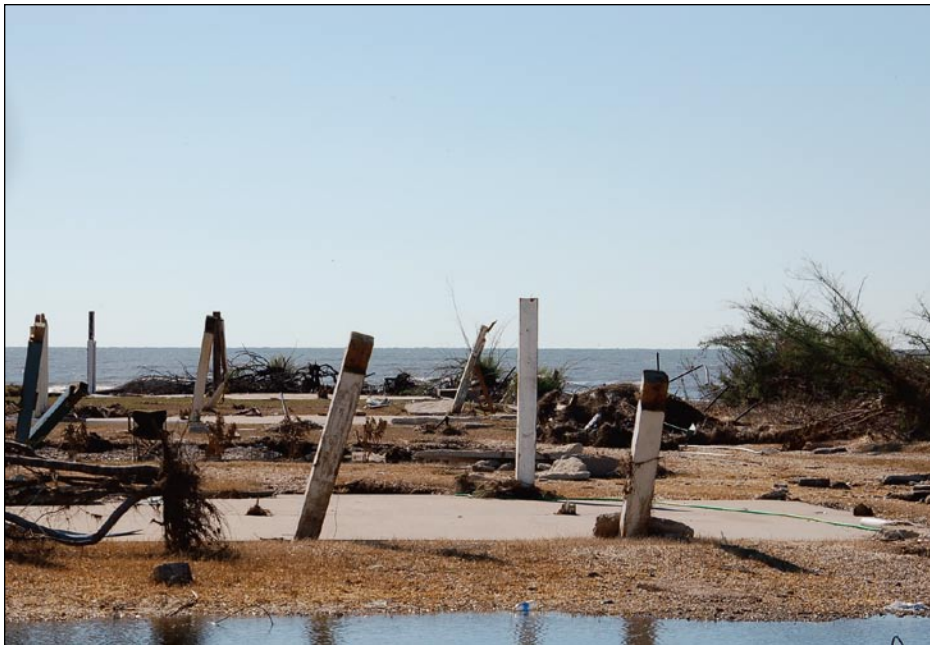
Embedment Failures. Embedment failures occur where a foundation is not deep enough in the ground to resist wind and flood loads pushing on the structure; a leaning foundation or overturned building results (Figure 3-2). Scour and erosion can exacerbate this mode of failure by reducing embedment.

Figure 3-2.
A house on timber piles was pushed over by wind and flood loads and the load path failed at the connection between the floor beam and the piles. Embedment and elevation were also insufficient at this Bolivar Peninsula, TX, site.

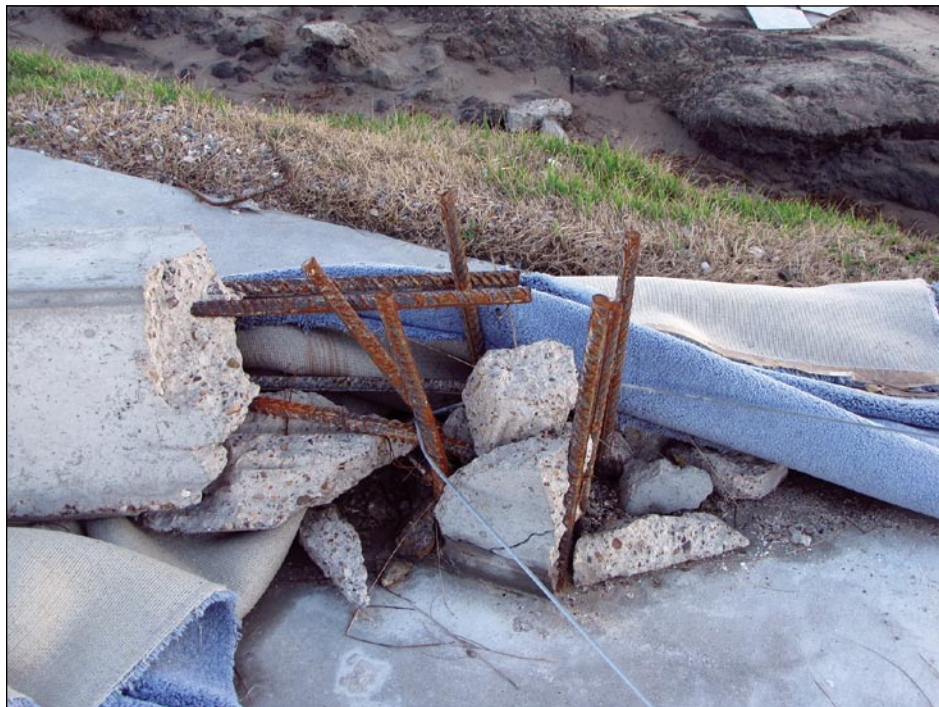
Pile and Column Breakage. Pile and column breakage occur where the strength of the piles or columns is inadequate to resist the bending moments or shear forces caused by the flood and wind loads acting on the structure (Figures 3-3 and 3-4). Scour and erosion contribute to this mode of failure by increasing the un-braced pile/column length and by increasing the bending moments in the pile/column.

Figure 3-4.
This concrete column
failed due to lateral loads.
Note limited overlap of
reinforcing steel at the
bottom of the column.

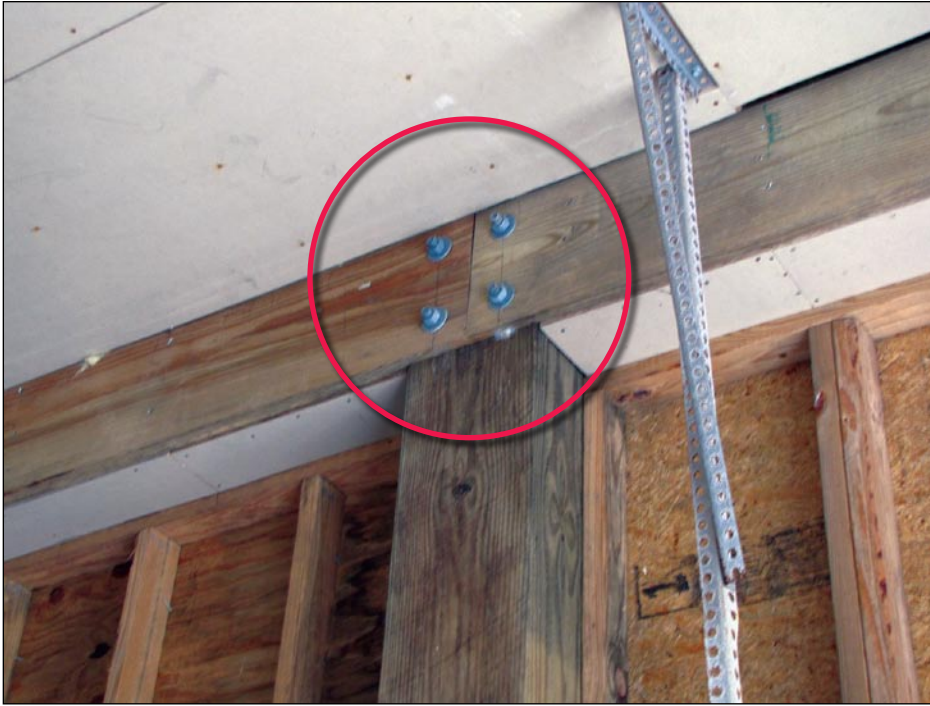
In most buildings the MAT evaluated, timber construction was used and the tops of the piles or columns were connected to the elevated buildings with bolted connections (Figure 3-5). This type of connection provides limited fixity; weakness in this type of connection can be overcome in some instances through the use of larger piles or columns and other design details that help to stiffen the foundation.

Figure 3-5.
Typical bolted connection
between wood columns
and wood beams

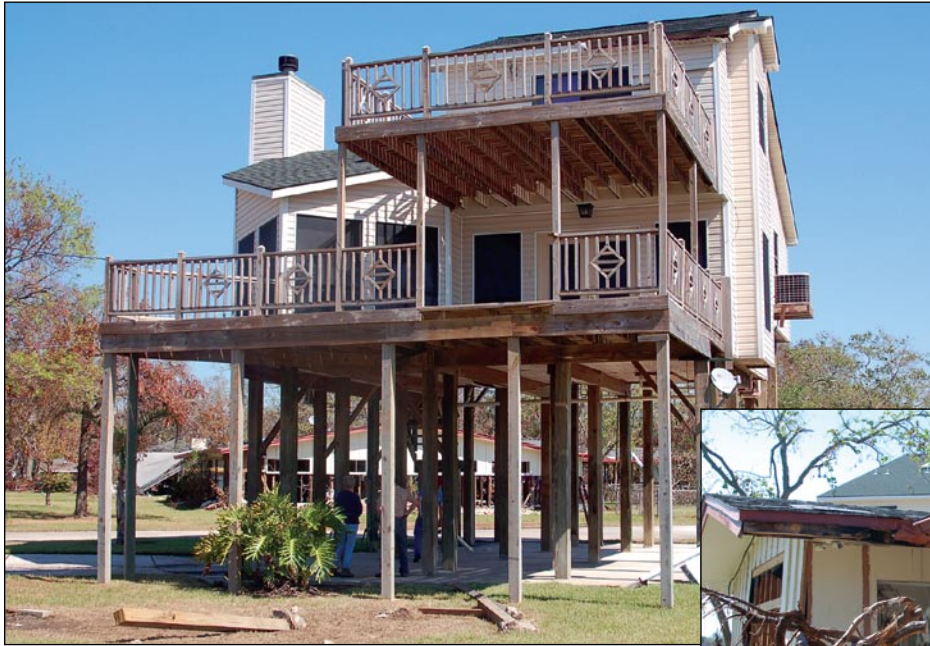
Figure 3-8.
This elevated house (Zone V, BFE = 15 feet) suffered no significant damage due to flooding. The nearby at-grade house in the background, shown in the inset, was heavily damaged (Baytown, TX).

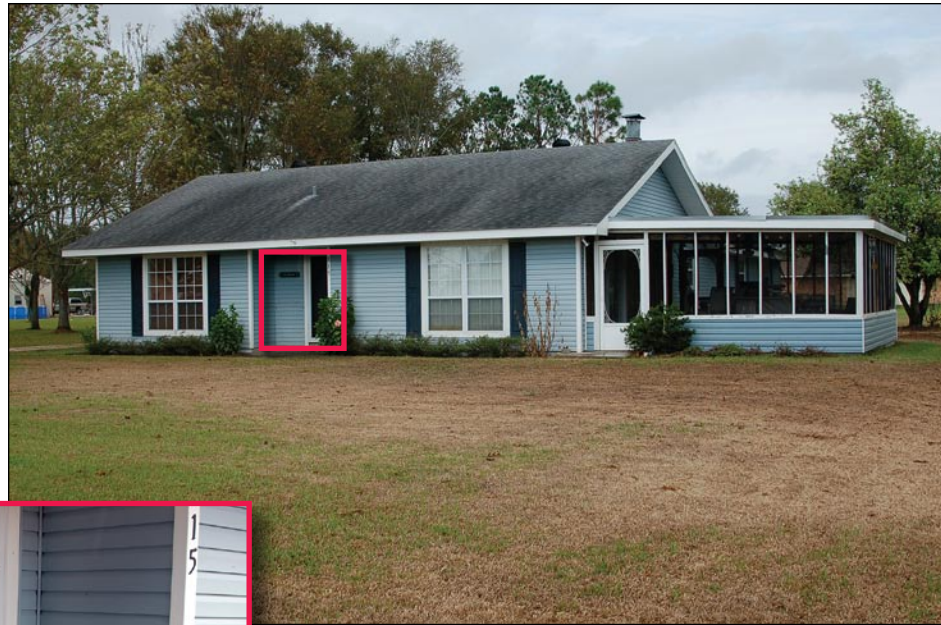
Figure 3-11.
This house sustained significant structural damage due to storm surge and small waves above the 9-foot BFE in Zone A (Bridge City, TX). Note flood debris line on the roof.

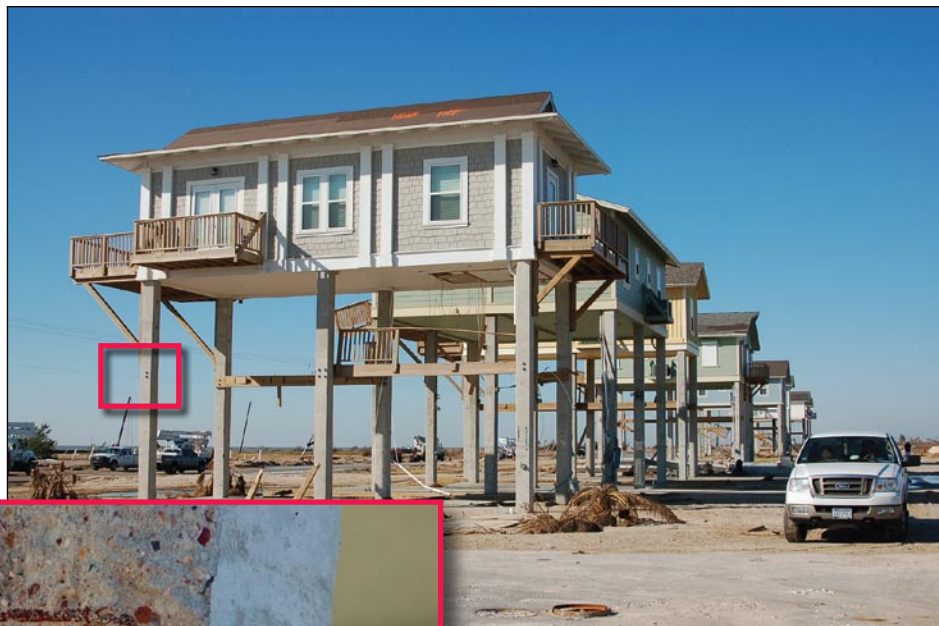
The houses had substantial timber decks connected to the columns at or just above the BFE, approximately mid-way between the ground and the elevated houses. Although not designed as breakaway decks, the decks broke away during Ike, probably a result of both wave and flood-borne debris effects. The deck failures damaged some of the concrete columns where the decks were connected (Figure 3-14).

Figure 3-14. Ground-level view of elevated houses with inset showing typical column damage where the timber deck broke away (Bolivar Peninsula, TX).

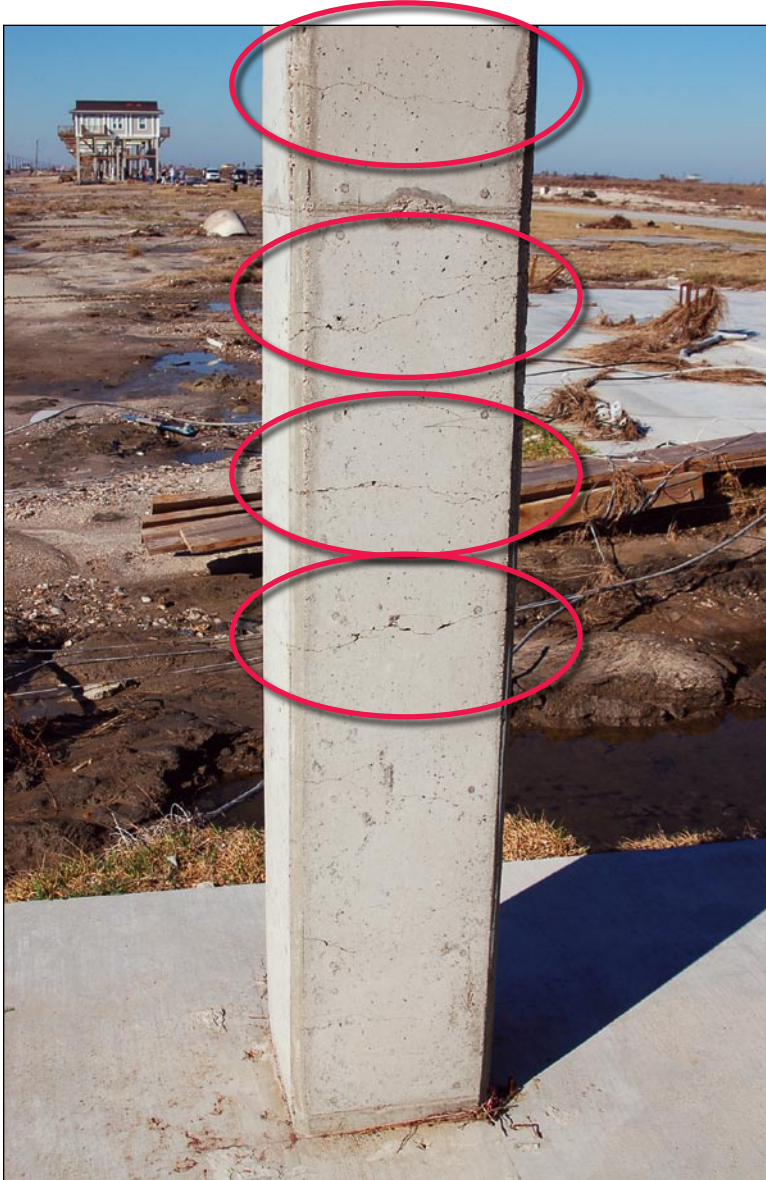
The concrete columns left standing between the slabs and the (destroyed) elevated decks were observed to have a series of horizontal cracks in the columns (Figure 3-15). These cracks likely resulted from the columns bending in response to a combination of wind loads on the elevated houses, flood loads (waves, currents, debris) on the columns, and transfer of flood loads from the decks to the columns.

Figure 3-15.
Concrete column showing cracking that was likely caused by extreme column bending stresses due to lateral loads on the elevated house and foundation (Bolivar Peninsula, TX)

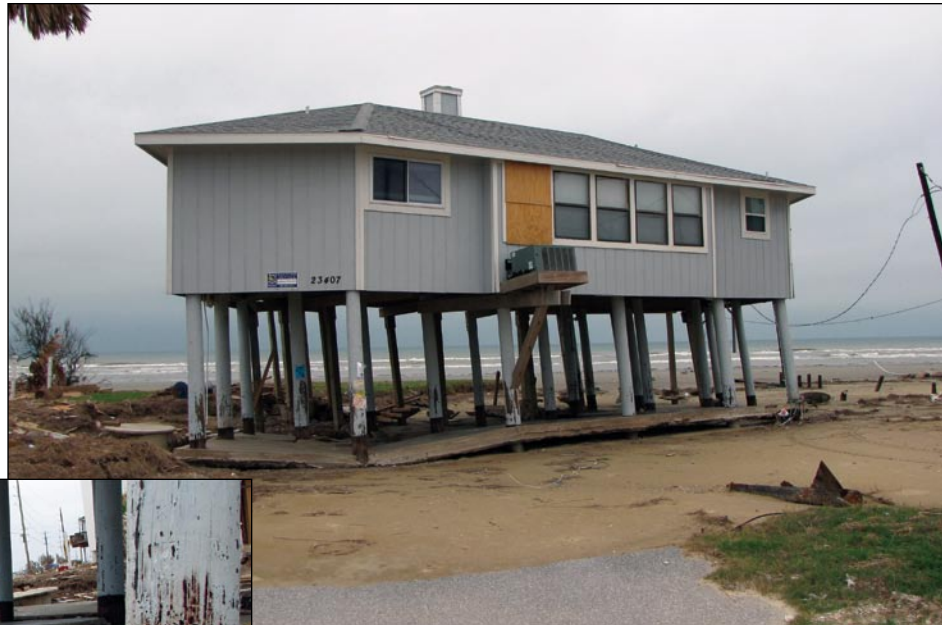
In some cases, pile foundations subject to erosion and/or scour were not embedded deeply enough to resist the loads and conditions that were present during Ike. Figure 3-21 shows such a case where a pile foundation shifted under an elevated house. Scour and erosion contributed to the failure. The presence of the attached, but broken, concrete slab could also have contributed to the foundation failure by reducing the lateral support formerly provided by the intact slab, and by causing eccentric loading of the piles (see Section 3.3.3).

Figure 3-21.
Failure of a timber pile foundation undermined by scour and erosion. Inset shows close-up of concrete slab failure and rotation of some of the foundation piles (Galveston Island, TX; Zone V).

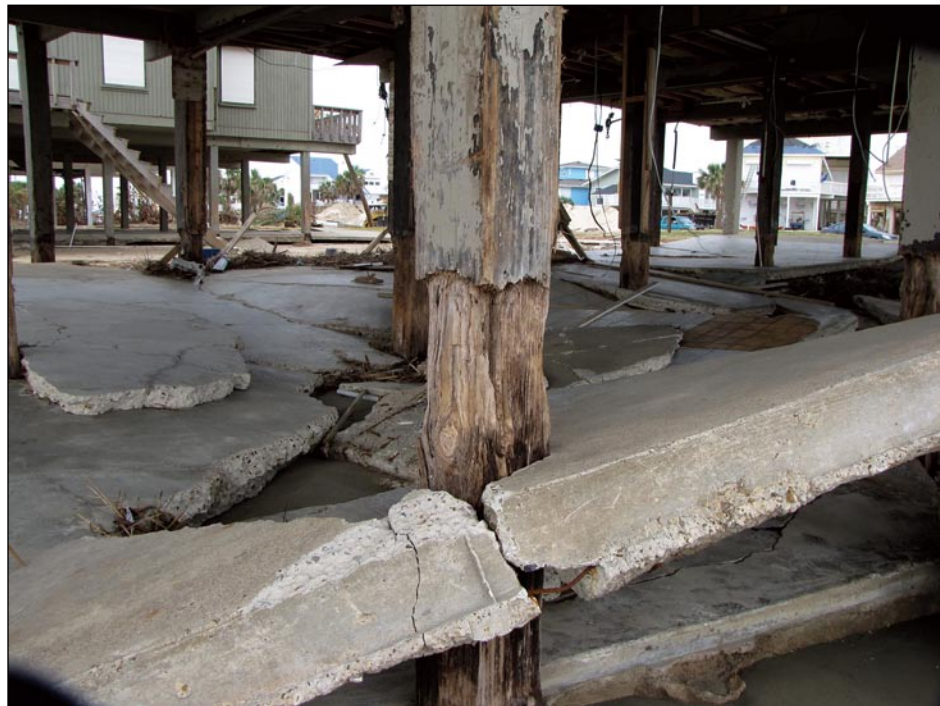
Figure 3-28.
Deterioration in wood piling. The foundation did not fail during Ike, but it was weakened and will be more susceptible to failure in the future (Galveston Island, TX).

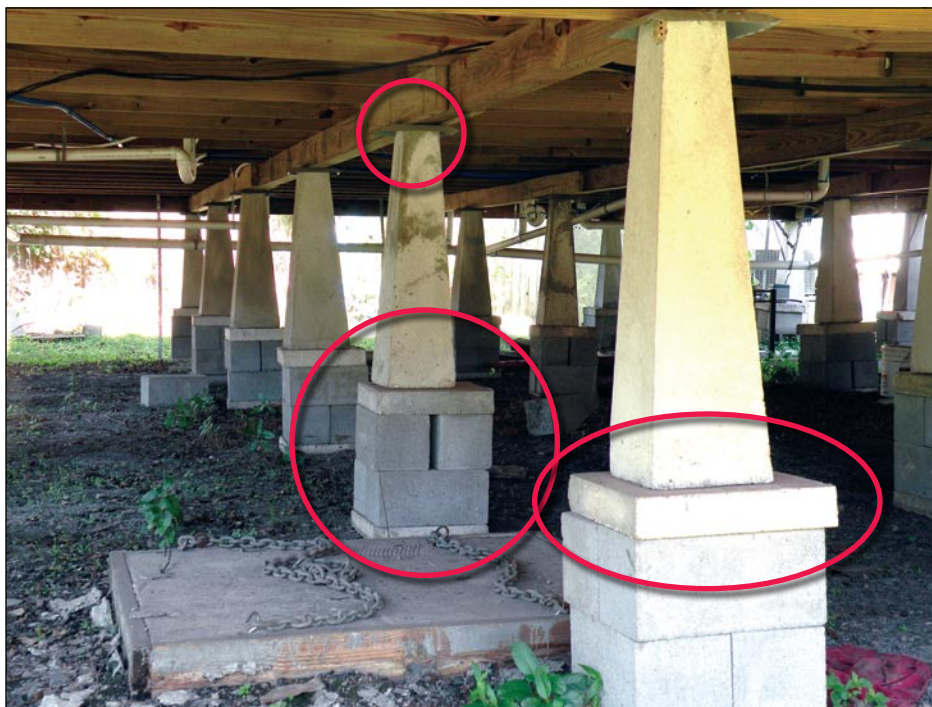
Figure 3-29. House resting (i.e., with no structural connection) on top of precast concrete piers, stacked CMUs, and shallow footing pads (New Iberia, LA)

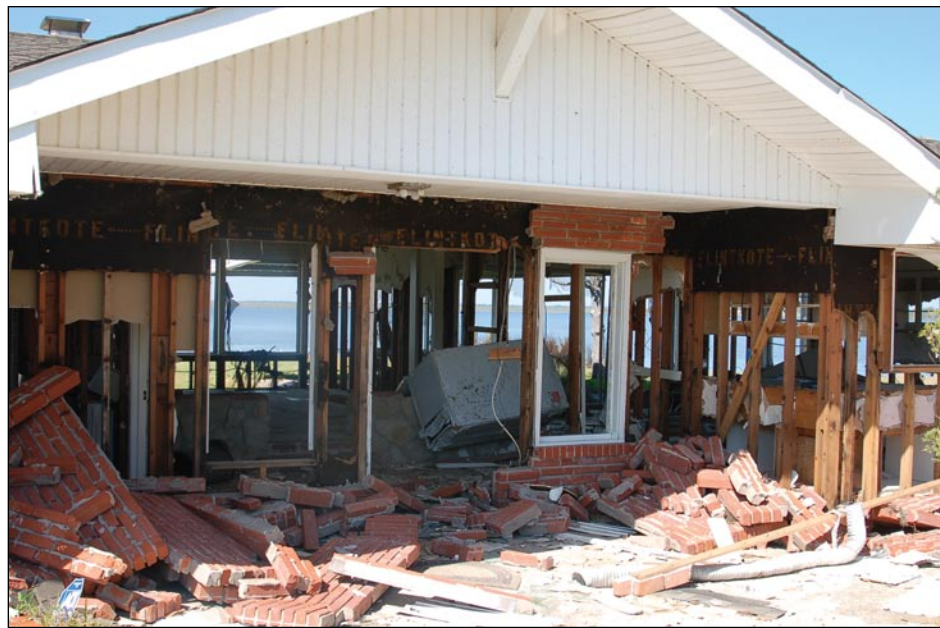
Figure 3-35.
Damage to at-grade house
in Zone V likely caused by
wave and surge along the
northern Galveston Bay
shoreline in Baytown, TX

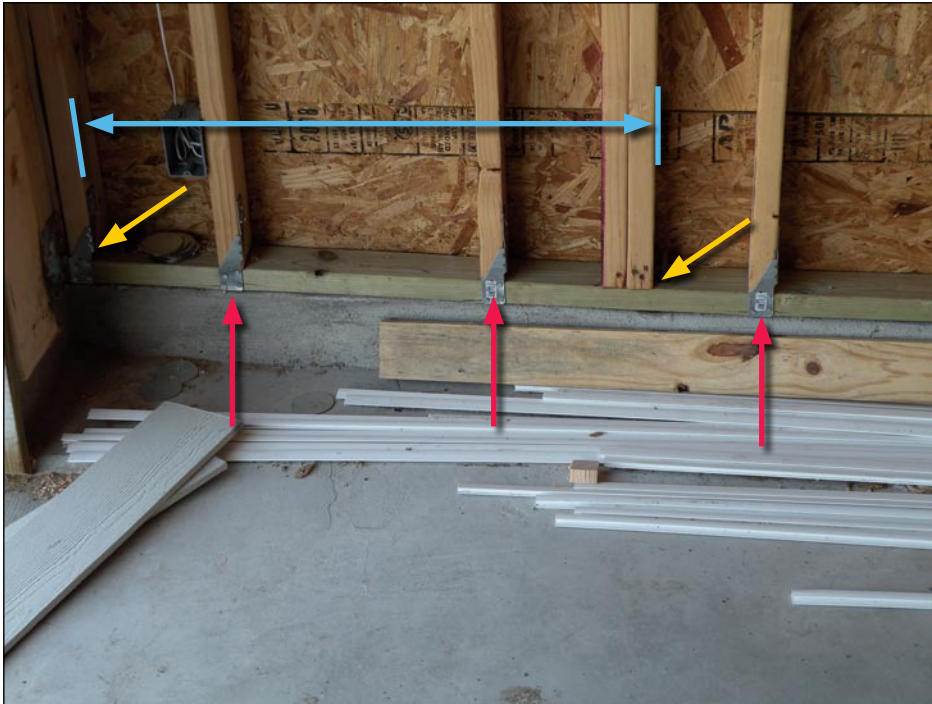
Figure 3-52. Studs and sill plate connected in new house (sill bolts yellow arrows and clips red arrows). However, sill bolts are spaced too far apart (2 feet is the maximum spacing allowed) and did not have 3-inch by 3-inch by 1/8-inch washers per 2003 IRC and TDI-adopted IBHS guidelines. Blue line shows 3-foot spacing (Webster, TX).

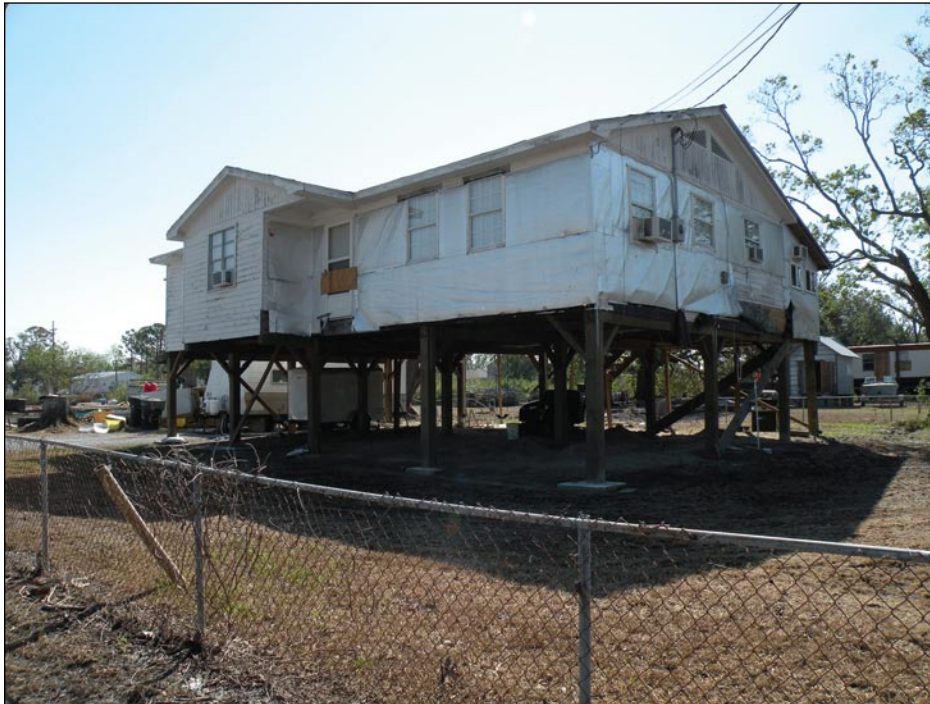
Figure 3-73.
Loss of siding due to winds, Chauvin, LA (Terrebonne Parish; Hurricane Ike estimated wind speed in this area: 50 to 60 mph, Exposure B)

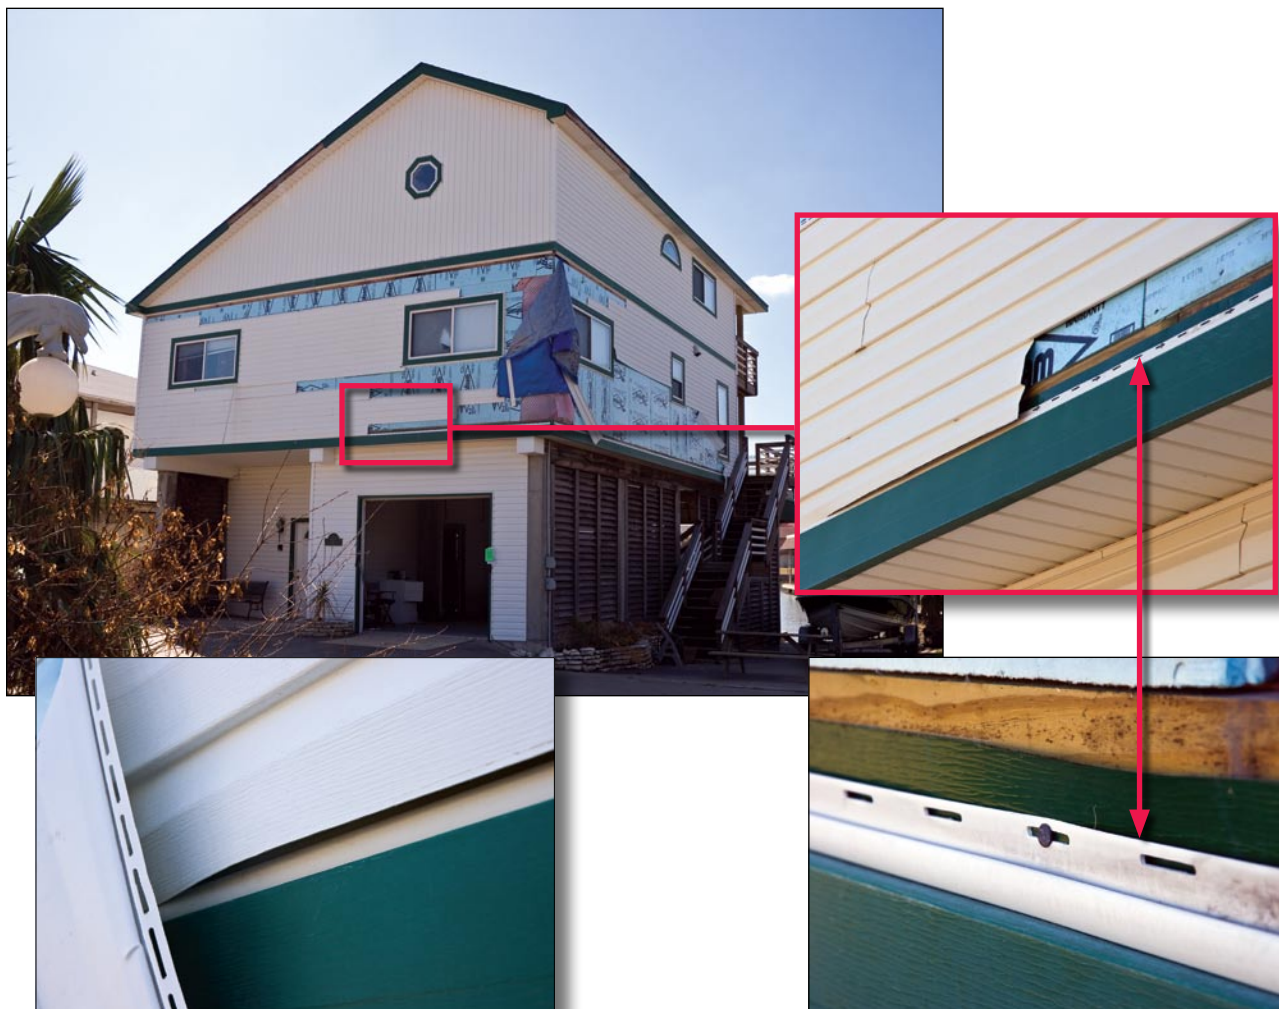
Figure 3-81. Improper installation led to extensive loss of siding up the house wall. The bottom lock of the lowest course of siding was cut off, and utility trim substituted for the correct starter strip. The poorly retained bottom edge pulled out under wind pressure, leading to extensive loss of siding up the house wall (Tiki Island, TX; Hurricane Ike estimated wind speed in this area: 88 mph, Exposure B).

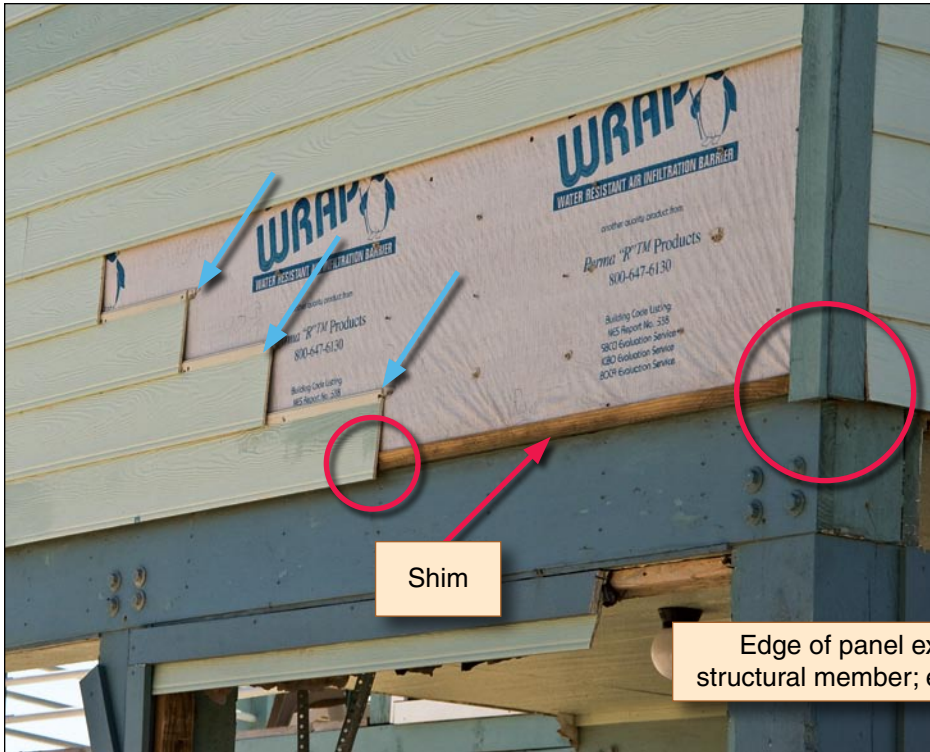
Figure 3-91. Shim placement (red arrow) allowed the lower edge (red circles) of siding to be exposed, resulting in loss of siding at several locations around this elevated structure on Bolivar Peninsula, TX. Note the blind nailing shown by blue arrows (Hurricane Ike estimated wind speed in this area: 110 mph, Exposure C).

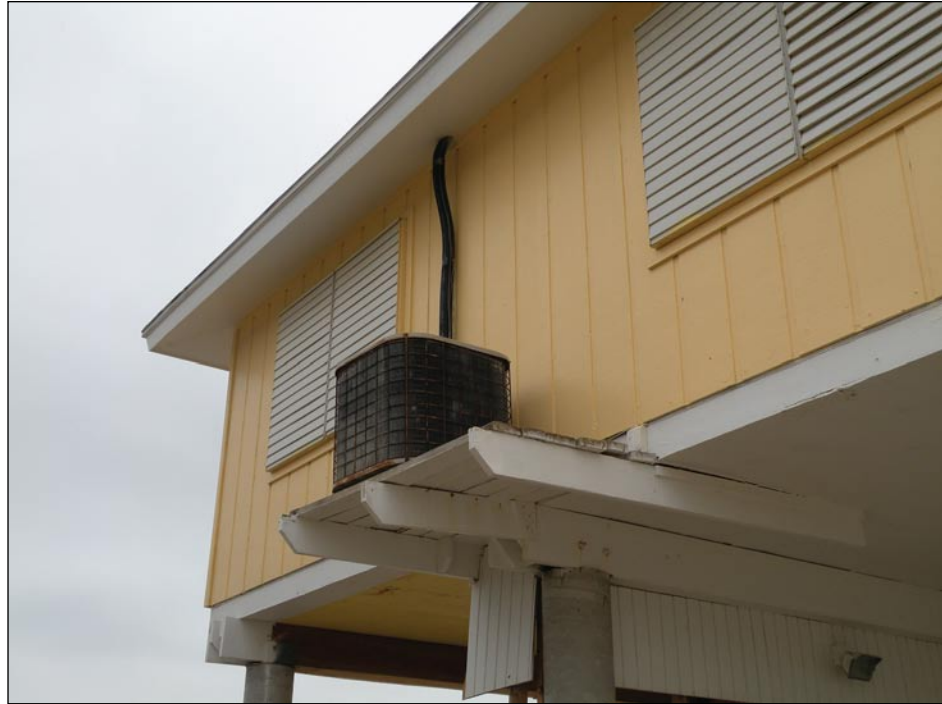
Figure 3-112.
Improperly secured
condensing unit was
knocked from its platform
(Kahala Beach, TX;
Hurricane Ike estimated
wind speed in this area:
80 mph, Exposure B)

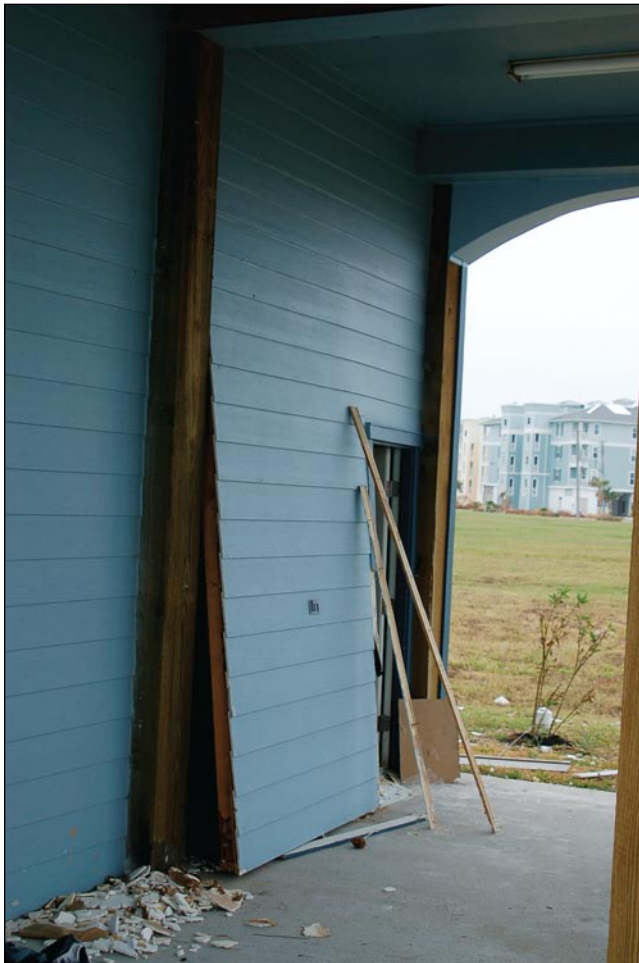
Figure 3-116.
This 11-foot high breakaway wall panel was pushed out by floodwaters trapped inside the enclosure (Galveston Island, TX)

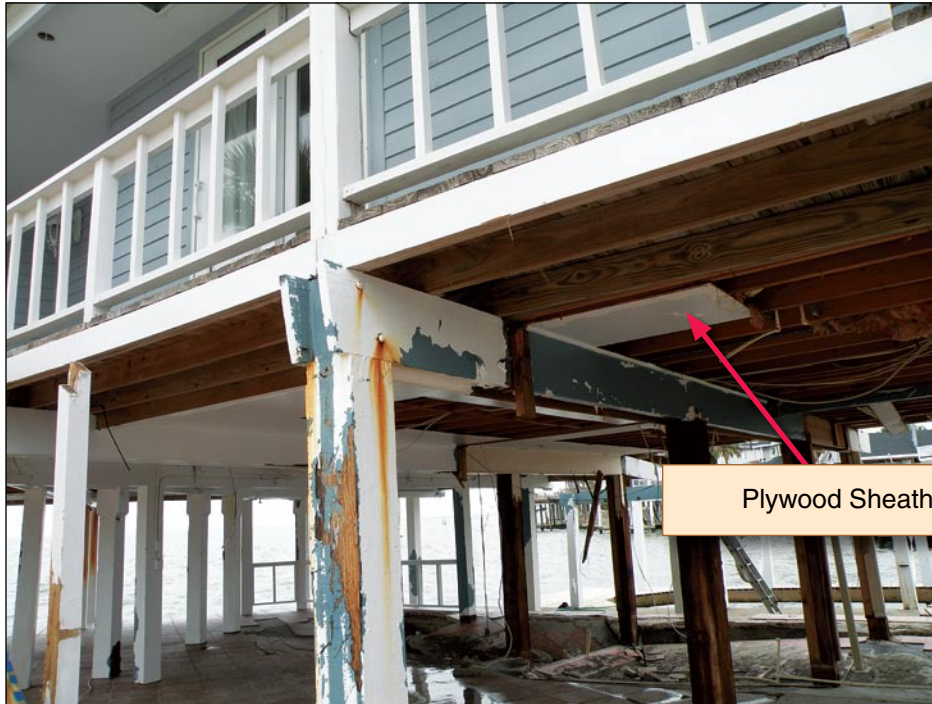
Figure 3-119.
Plywood sheathing
removed by storm surge
(Jamaica Beach, TX, house
on West Bay)

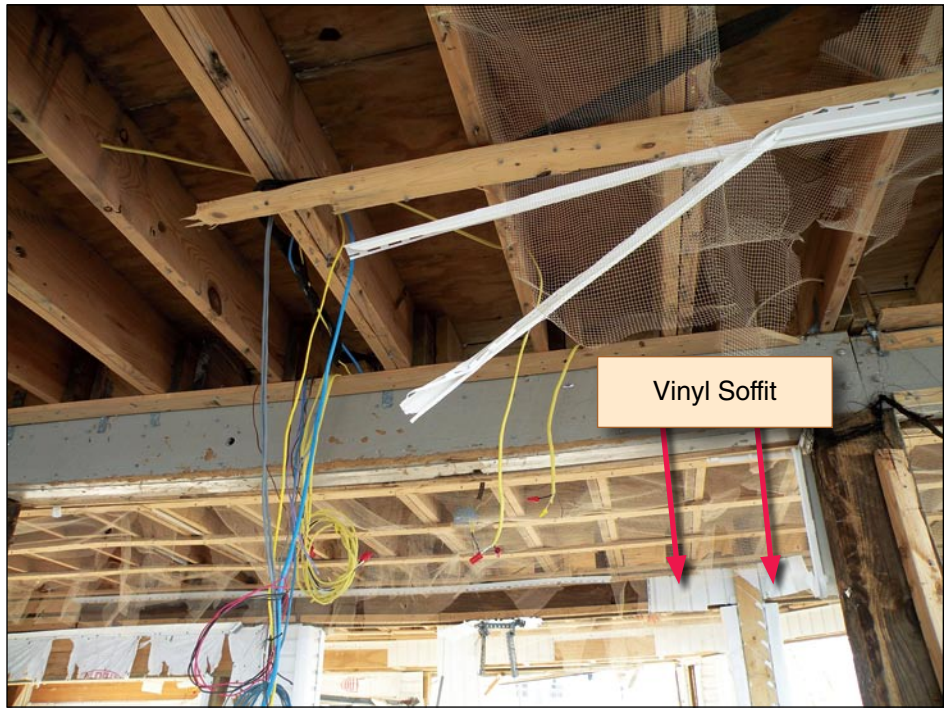
Figure 3-122.
Vinyl soffit covering over plywood sheathing partially removed (Tiki Island, West Galveston Bay; Estimated Hurricane Ike wind speed: 103 mph, Exposure C)

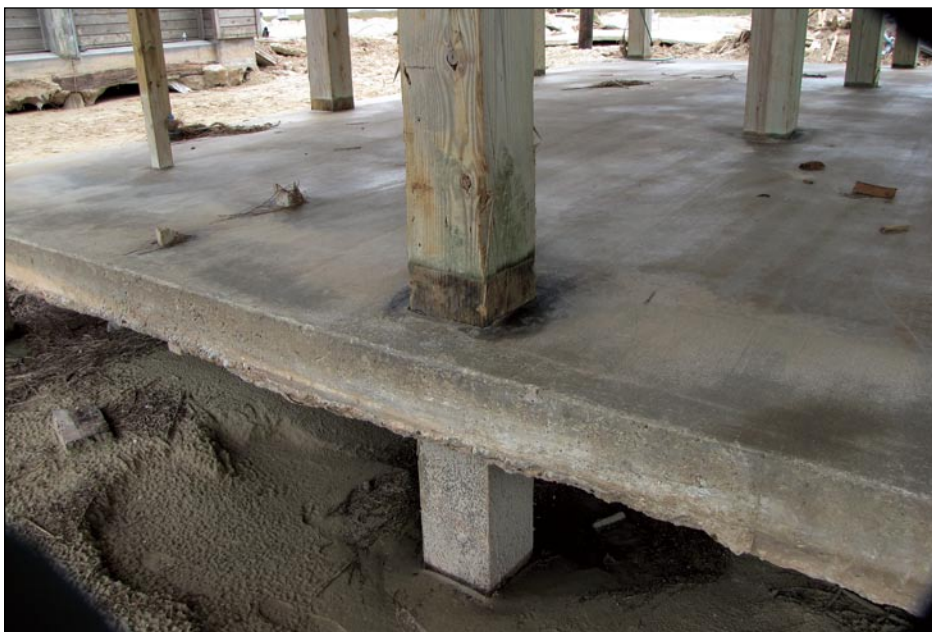
Figure 3-124.
Undermining of concrete slab that settled but remained intact (Galveston Island, TX)

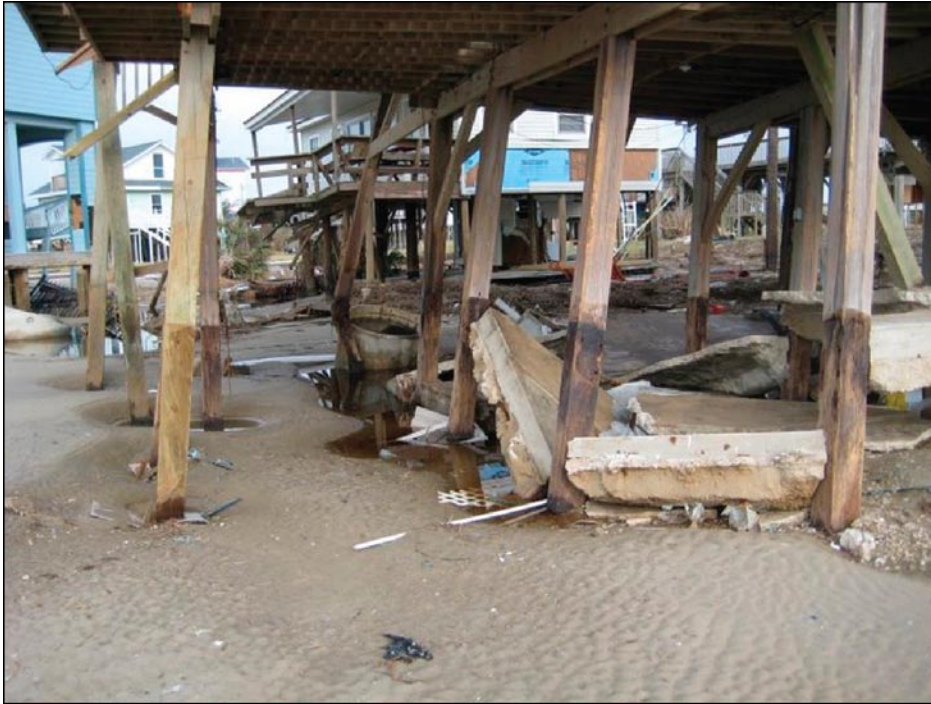
Where the piles were thought to be less well embedded, failure of the slab could have caused the pile foundation to rotate or rack (Figure 3-126). The MAT believes this was more common with older houses, and was likely a result of portions of the slab causing eccentric loads on the piles and the transfer of flood forces from the slab to the foundation.

Figure 3-126.
Slab failure probably contributed to foundation damage (West Galveston Island, TX)

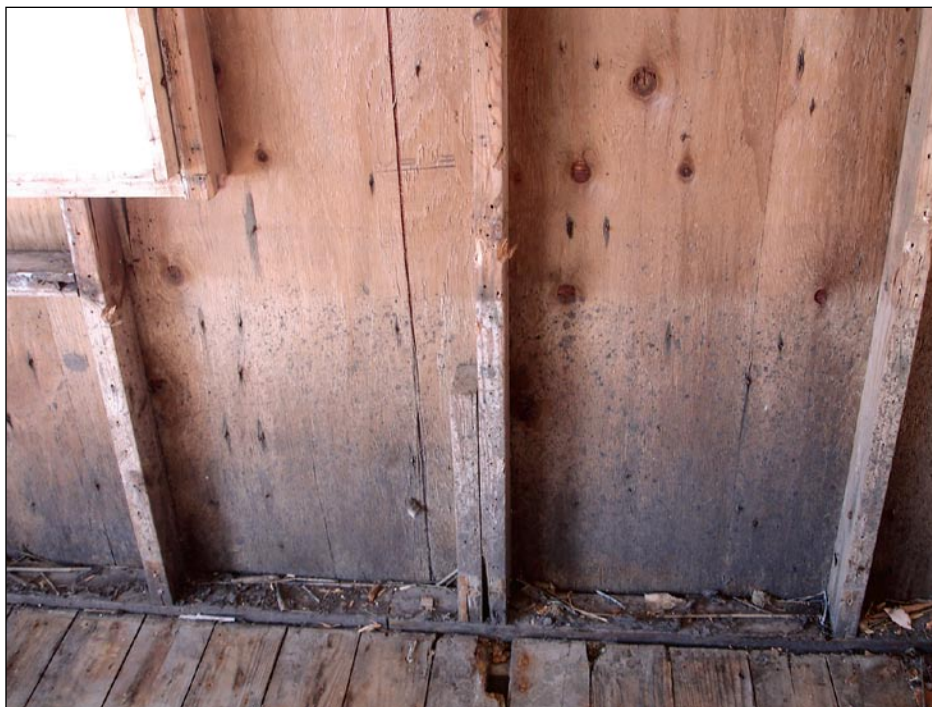
Figure 3-130.
Mildew and mold forming
on wall sheathing
following flooding (Golden
Meadow, LA)

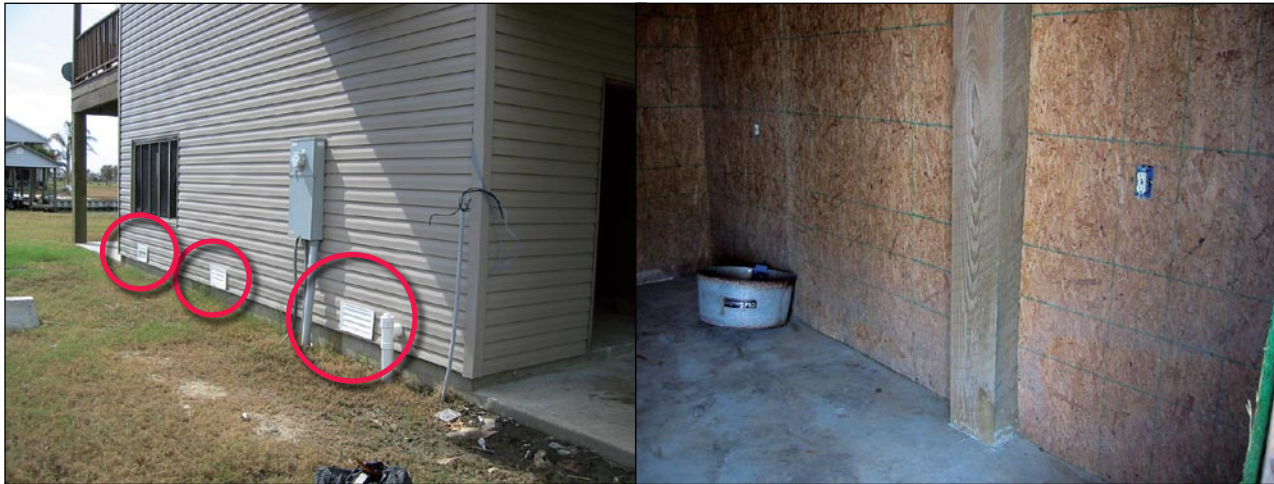
Figure 3-132. Flood vent openings (red circles) that do not extend through the walls (Hackberry, Cameron Parish, LA)

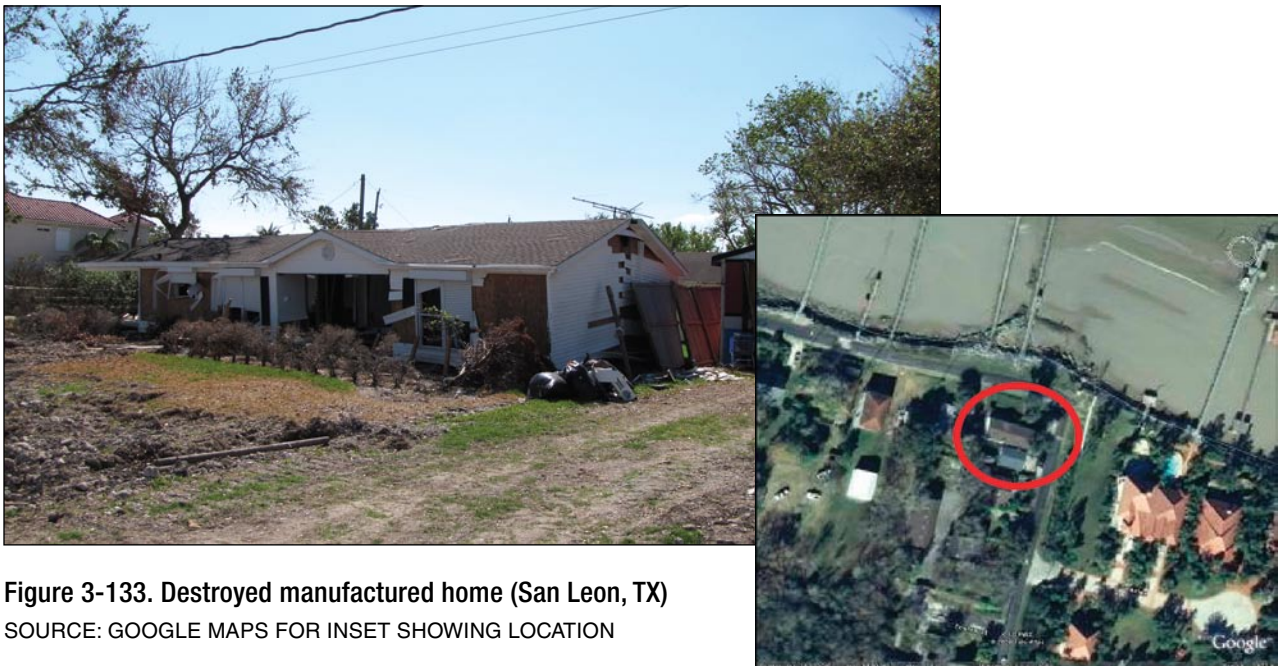
Figure 3-133. Destroyed manufactured home (San Leon, TX)

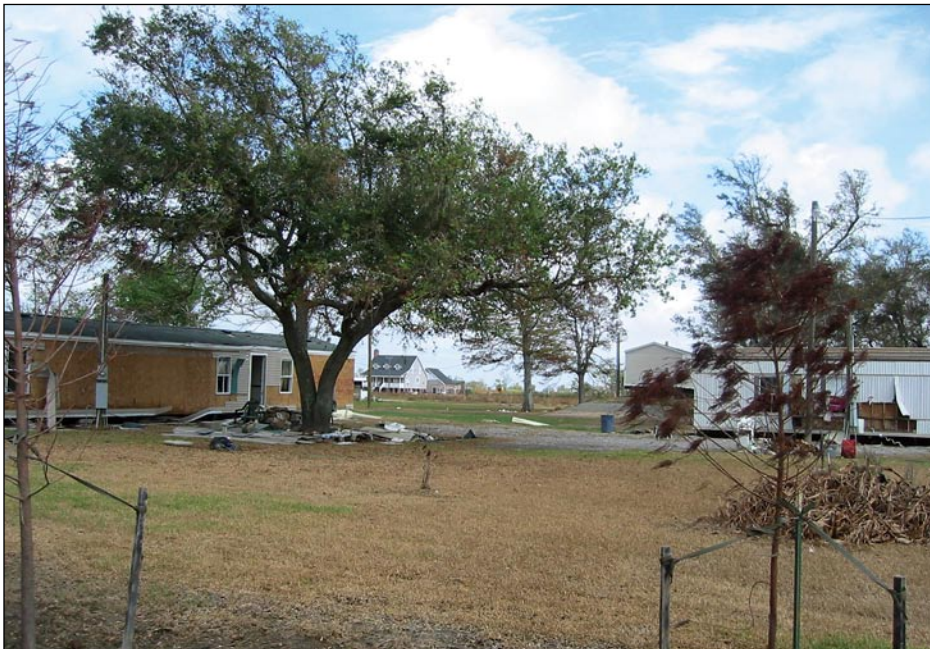
Figure 3-136.
Two manufactured homes in Cameron, LA. Homes were displaced off foundations and siding peeled due to inundation and storm surge of approximately 4 feet above ground.

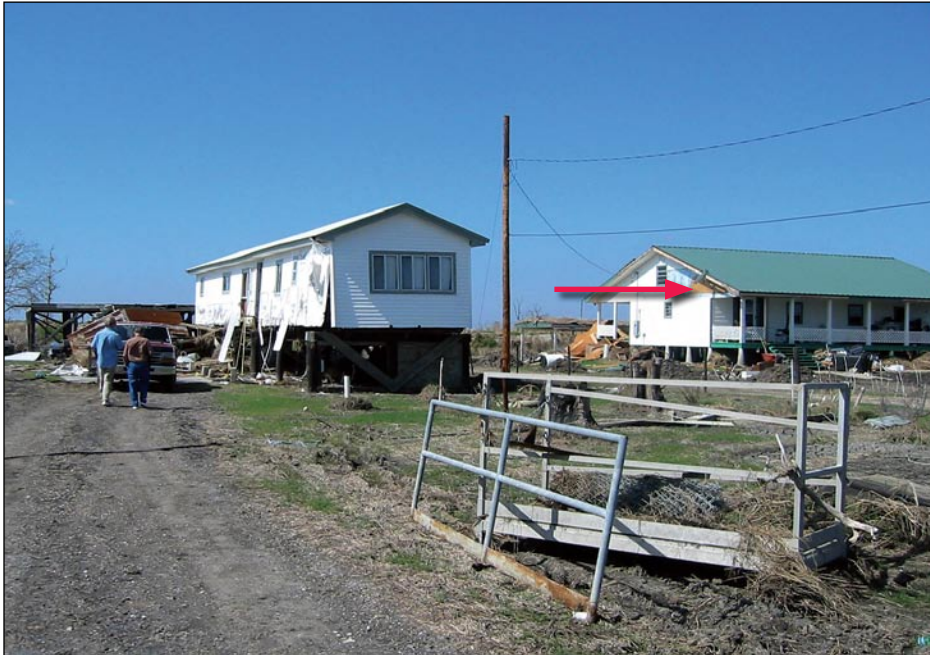
Figure 3-139. Zone A manufactured home in the Golden Meadows section of Lafourche Parish, LA, sustained 3 to 4 feet of flooding above the floor, but did not shift or float off of its foundation. The red arrow indicates the flood level reported by neighbors.

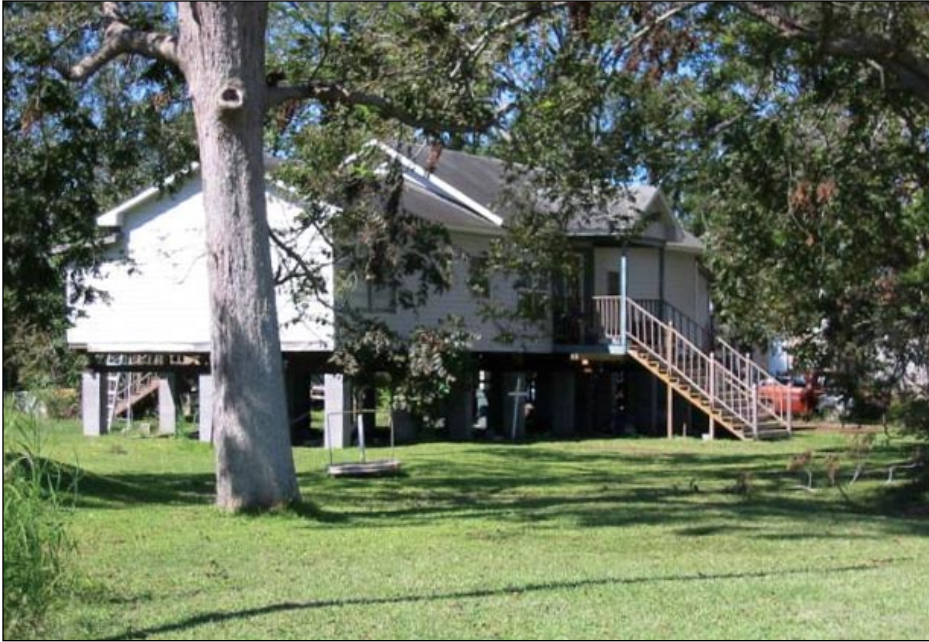
Figure 3-141. Zone A house elevated with Increased Cost of Compliance funds on masonry piers (Iberia Parish, LA). There was no evidence of pier reinforcement, mortar between masonry blocks, or ties between the piers and the elevated home.

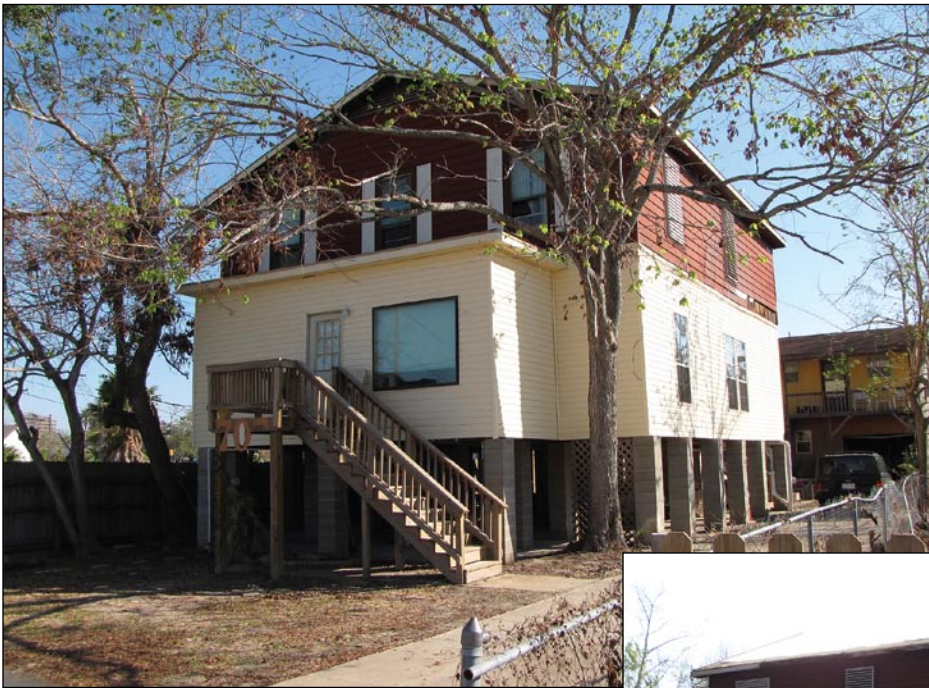
Figure 3-142. House elevated with Increased Cost of Compliance funds (Kemah, TX). Inset shows evidence of wind damage to roof (Hurricane Ike estimated wind speed in this area: 90 mph, Exposure B).
