Mitigation Assessment Team Report

Hurricane Ike in Texas and Louisiana

Building Performance Observations, Recommendations, and Technical Guidance

FEMA P-757 / April 2009

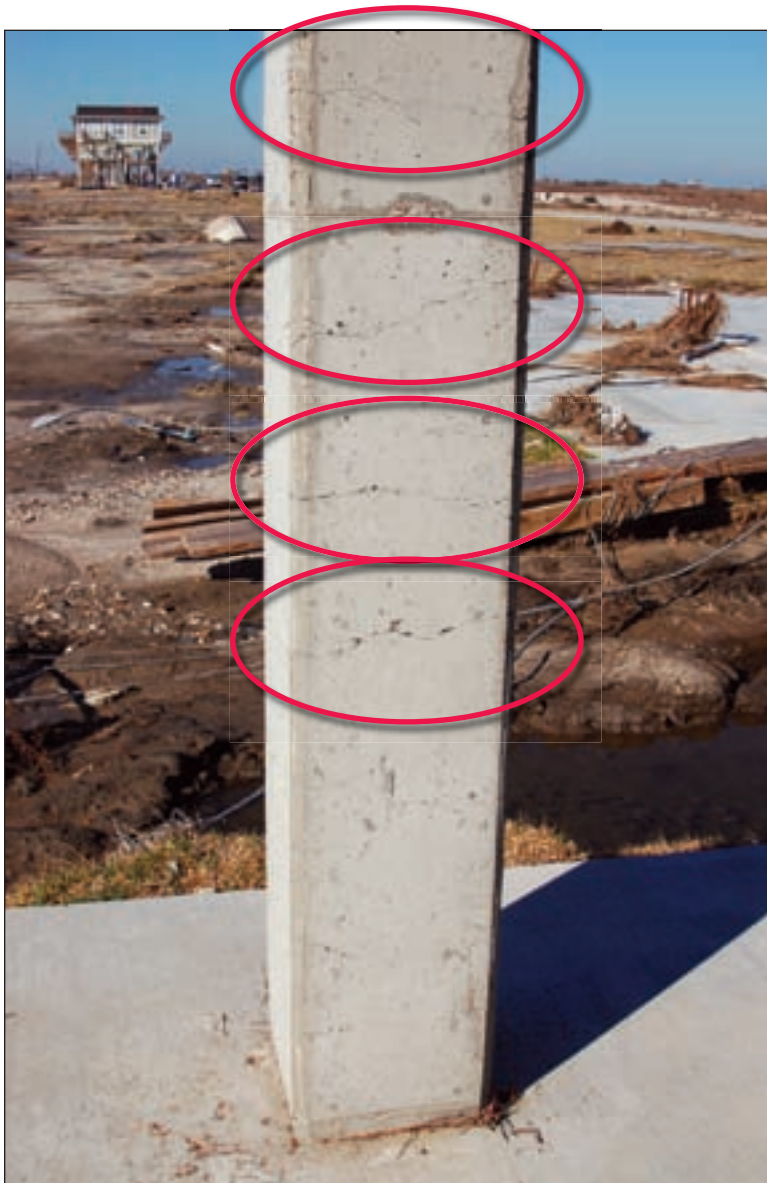
Figure 3-15.
Concrete column showing cracking that was likely caused by extreme column bending stresses due to lateral loads on the elevated house and foundation (Bolivar Peninsula, TX)

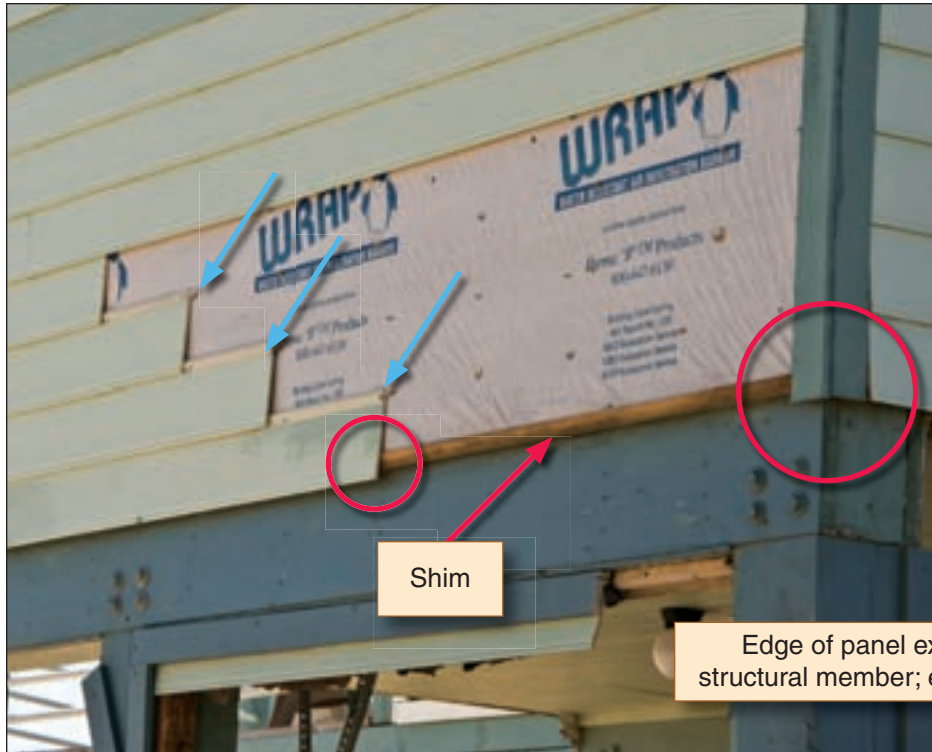
Figure 3-91. Shim placement (red arrow) allowed the lower edge (red circles) of siding to be exposed, resulting in loss of siding at several locations around this elevated structure on Bolivar Peninsula, TX. Note the blind nailing shown by blue arrows (Hurricane Ike estimated wind speed in this area: 110 mph, Exposure C).

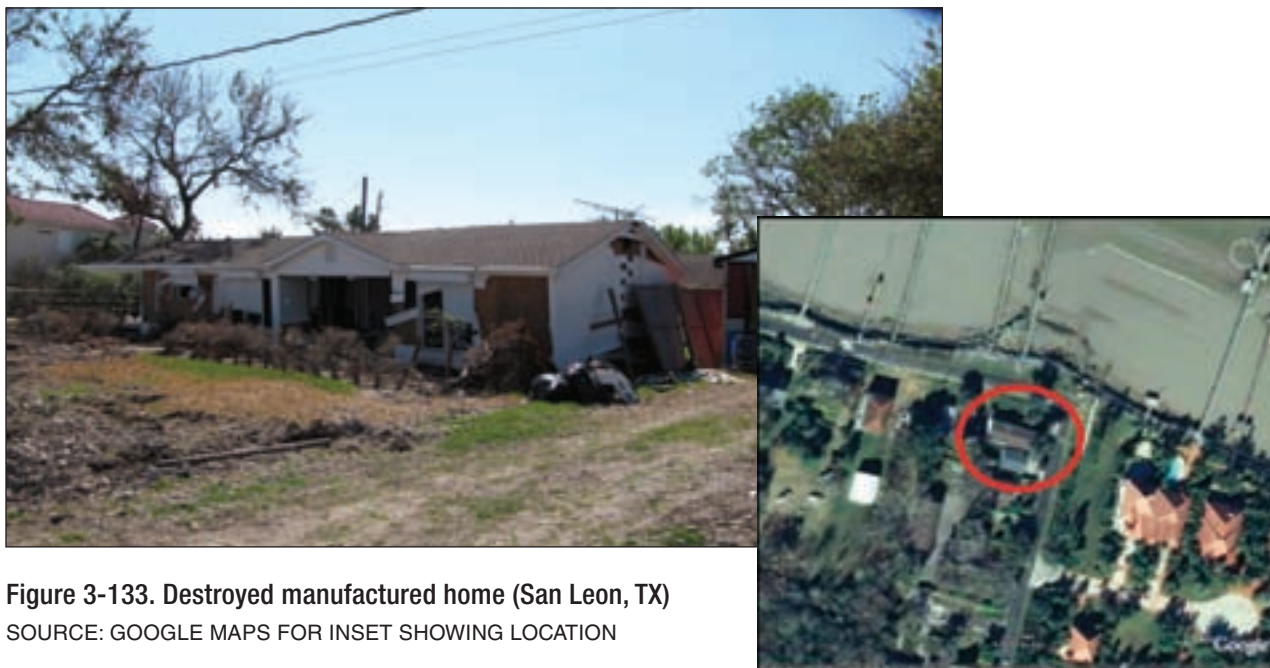
Figure 3-133. Destroyed manufactured home (San Leon, TX)
SOURCE: GOOGLE MAPS FOR INSET SHOWING LOCATION

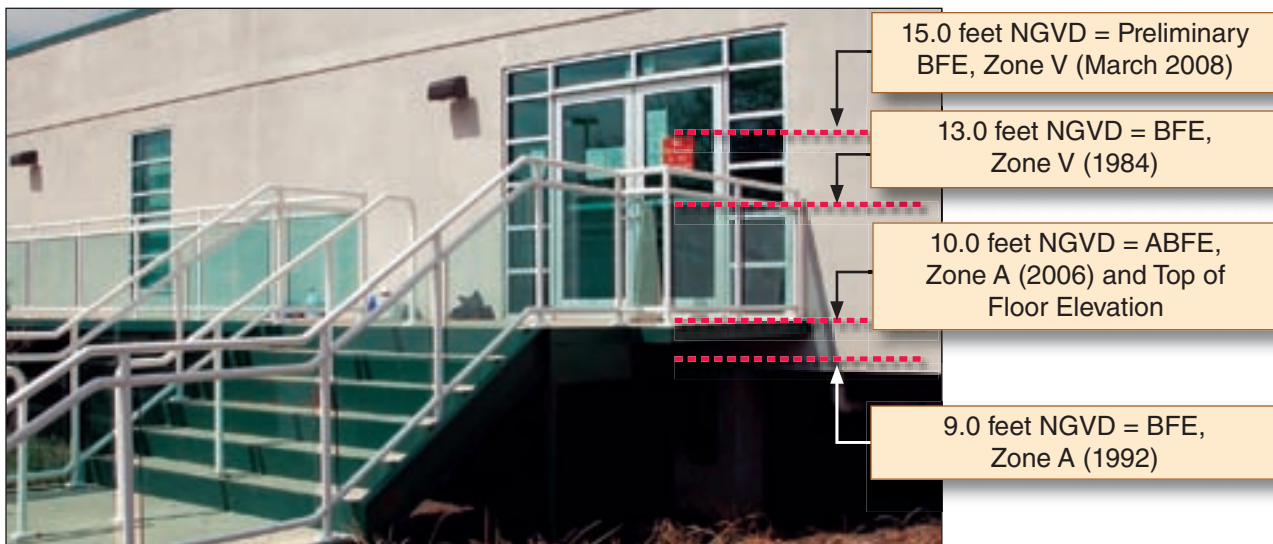
Figure 4-32. Hurricane Ike crested approximately 6 inches below the floor of the South Cameron Parish Hospital. BFEs and flood hazard zones are shown for the site for the period 1984 to 2008 (Note: the building code may require freeboard above the BFEs shown).

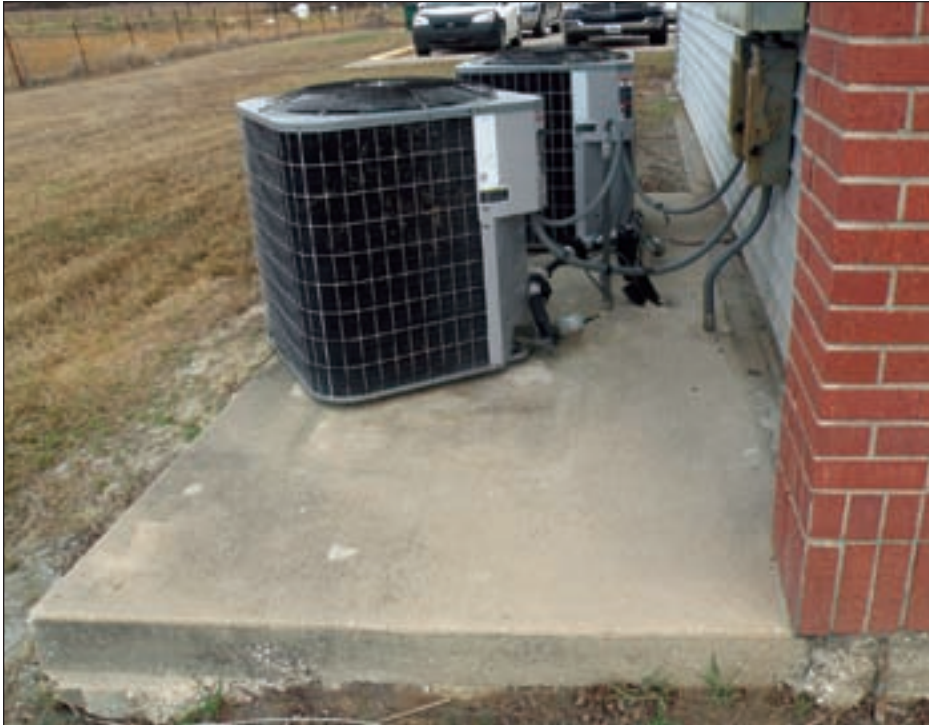
Figure 4-58. Condenser units were installed at Hackberry Fire Station after Ike and are vulnerable to future flooding

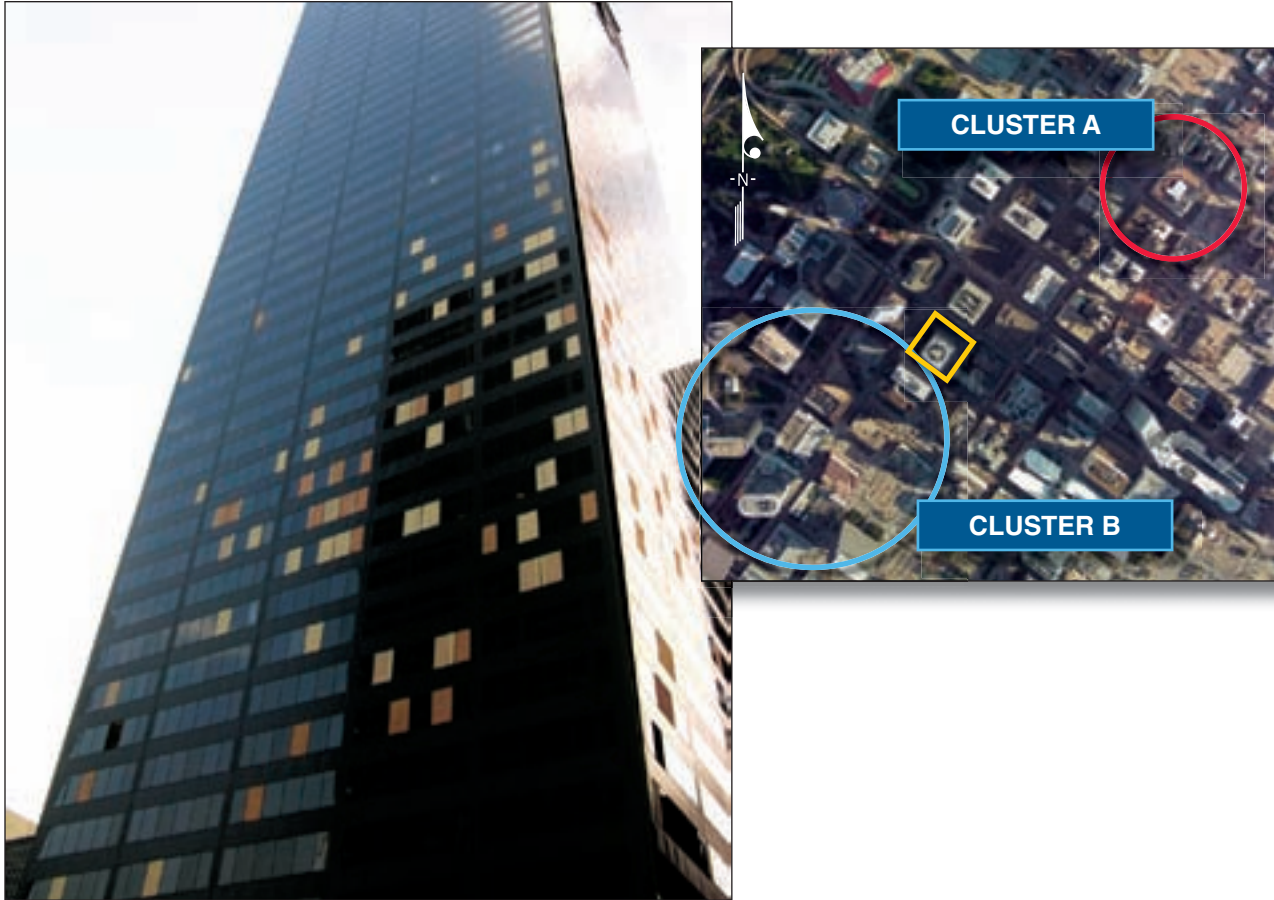
Figure 5-2.
Building with glazing damage; location shown by yellow square in inset

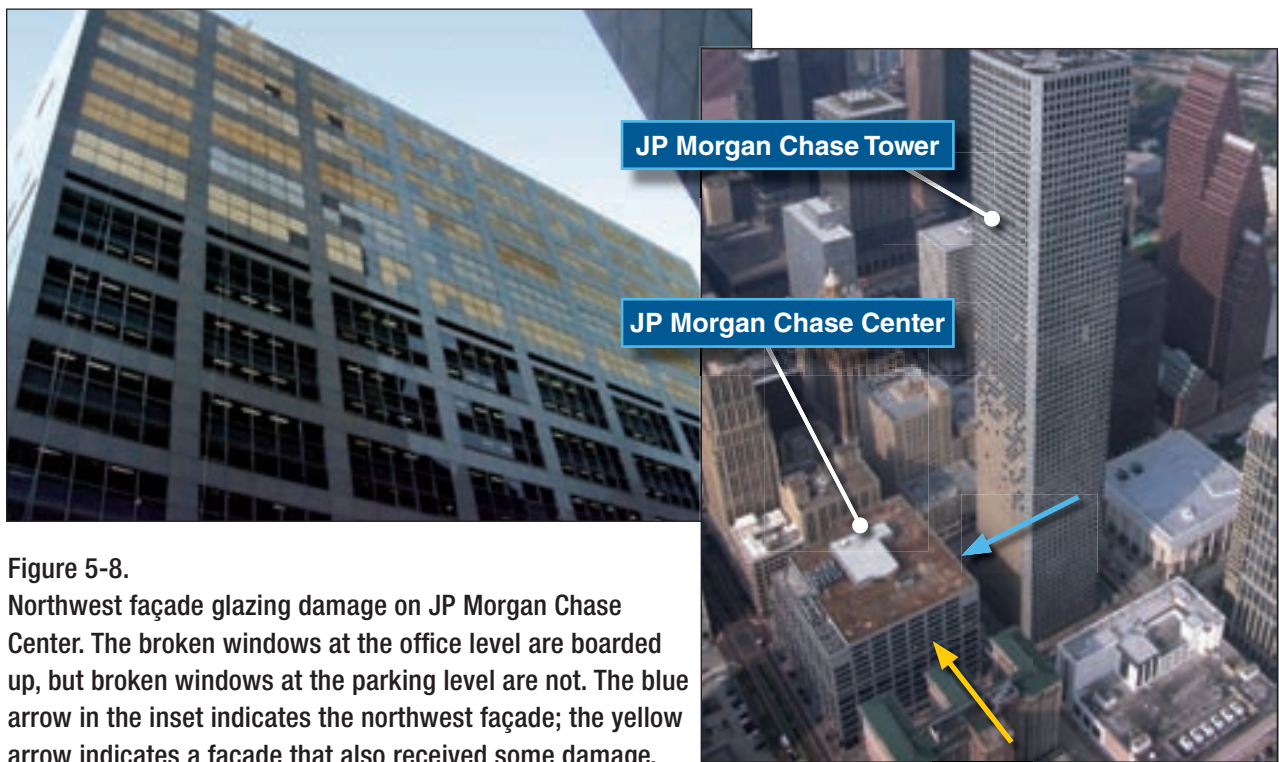
Figure 5-8. Northwest façade glazing damage on JP Morgan Chase Center. The broken windows at the office level are boarded up, but broken windows at the parking level are not. The blue arrow in the inset indicates the northwest façade; the yellow arrow indicates a façade that also received some damage.

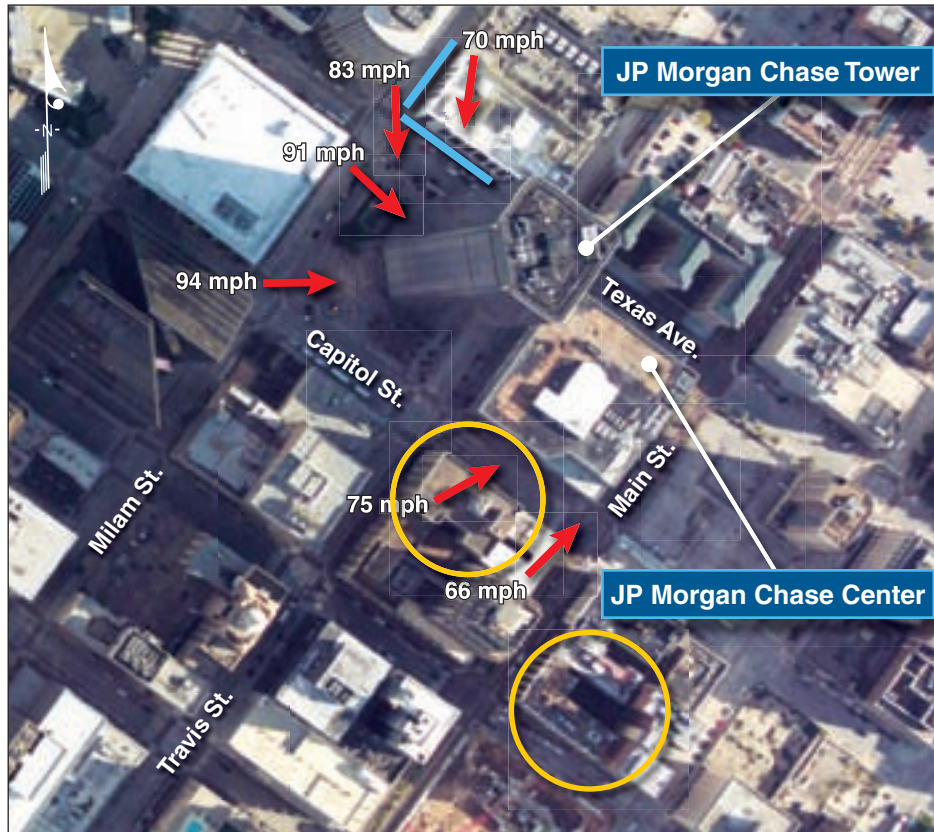
Figure 5-10. Locations of possible debris sources that impacted the JP Morgan Tower and Center. Aggregate-surfaced roofs within cluster A area shown by yellow circles. Blue lines show location of failed metal panel veneer.

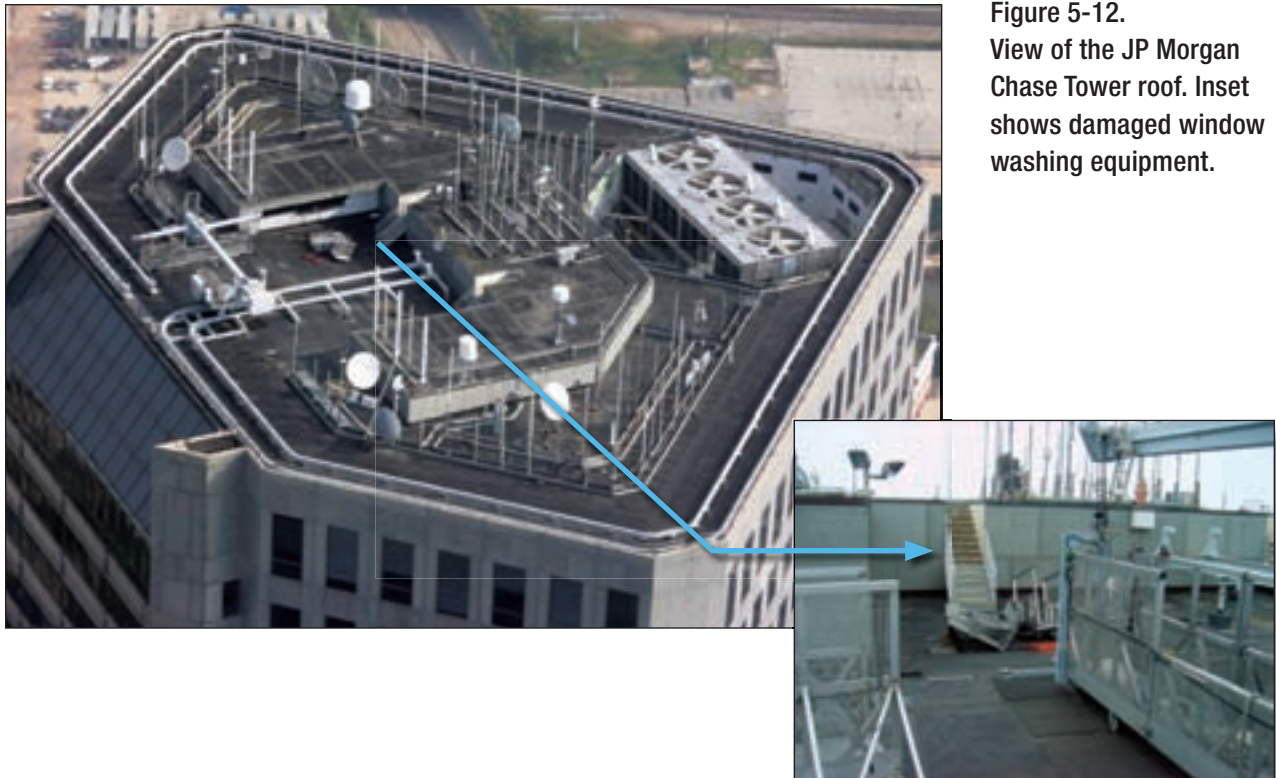
Figure 5-12.
View of the JP Morgan
Chase Tower roof. Inset
shows damaged window
washing equipment.

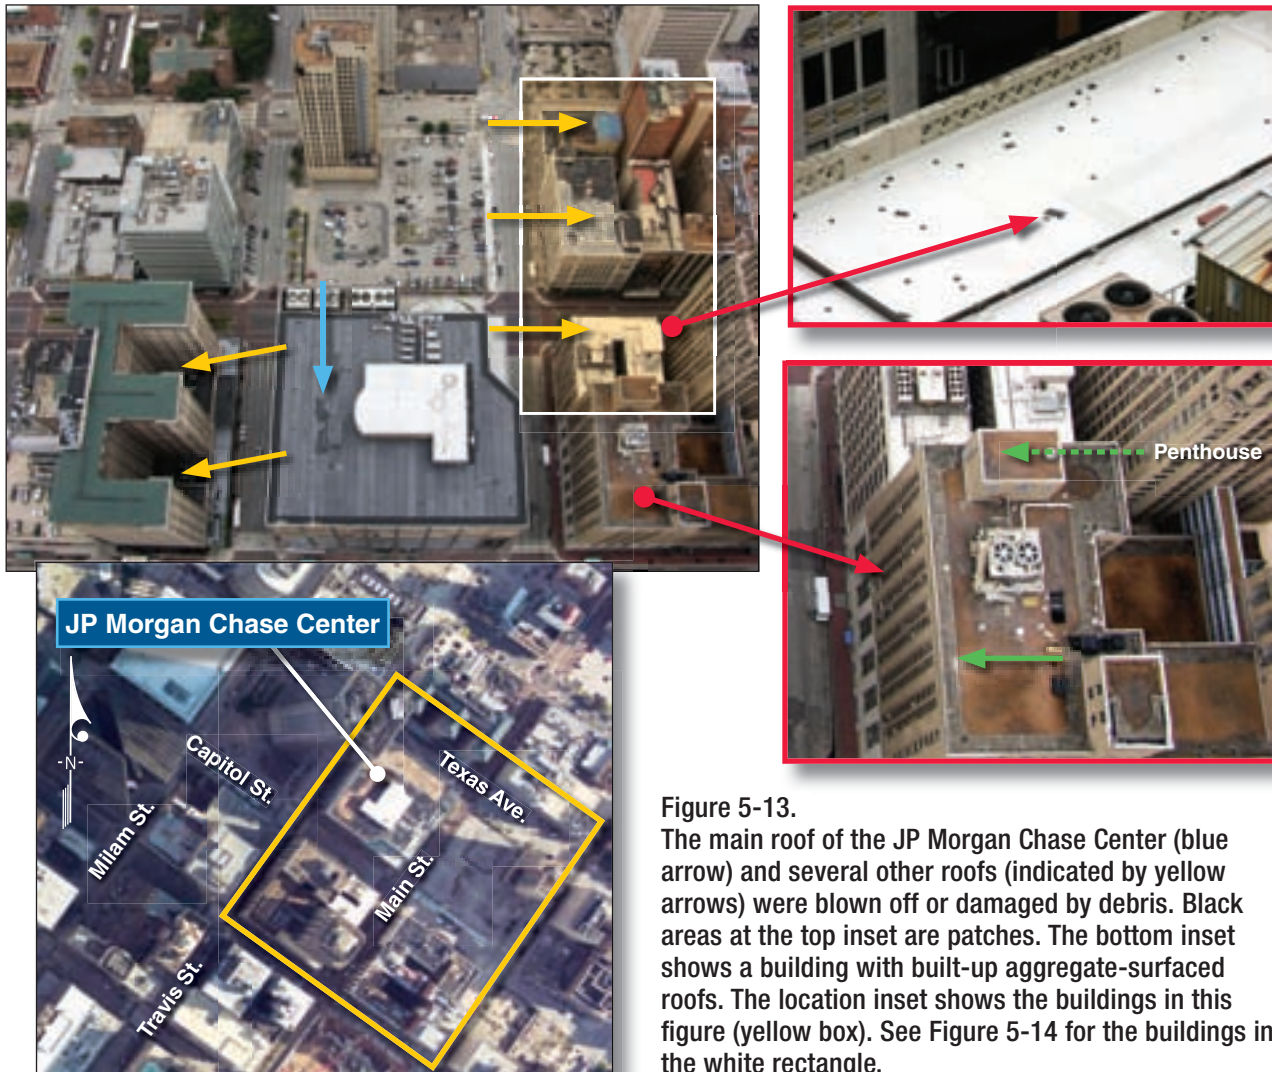
Figure 5-13. The main roof of the JP Morgan Chase Center (blue arrow) and several other roofs (indicated by yellow arrows) were blown off or damaged by debris. Black areas at the top inset are patches. The bottom inset shows a building with built-up aggregate-surfaced roofs. The location inset shows the buildings in this figure (yellow box). See Figure 5-14 for the buildings in the white rectangle.

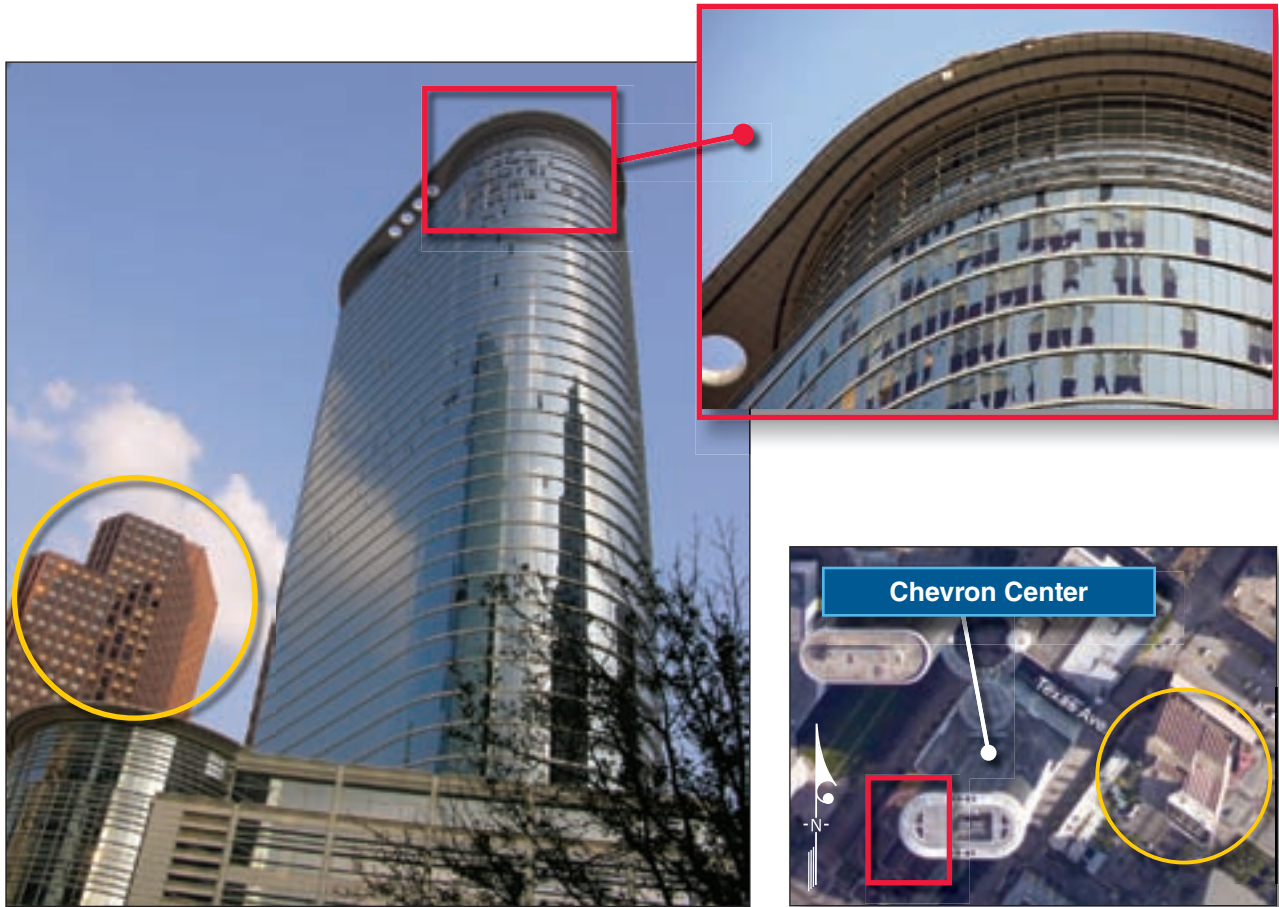
Figure 5-17. Chevron Center glazing damage. At the building beyond (yellow circle), at least 35 windows were boarded up. Bottom inset shows location.

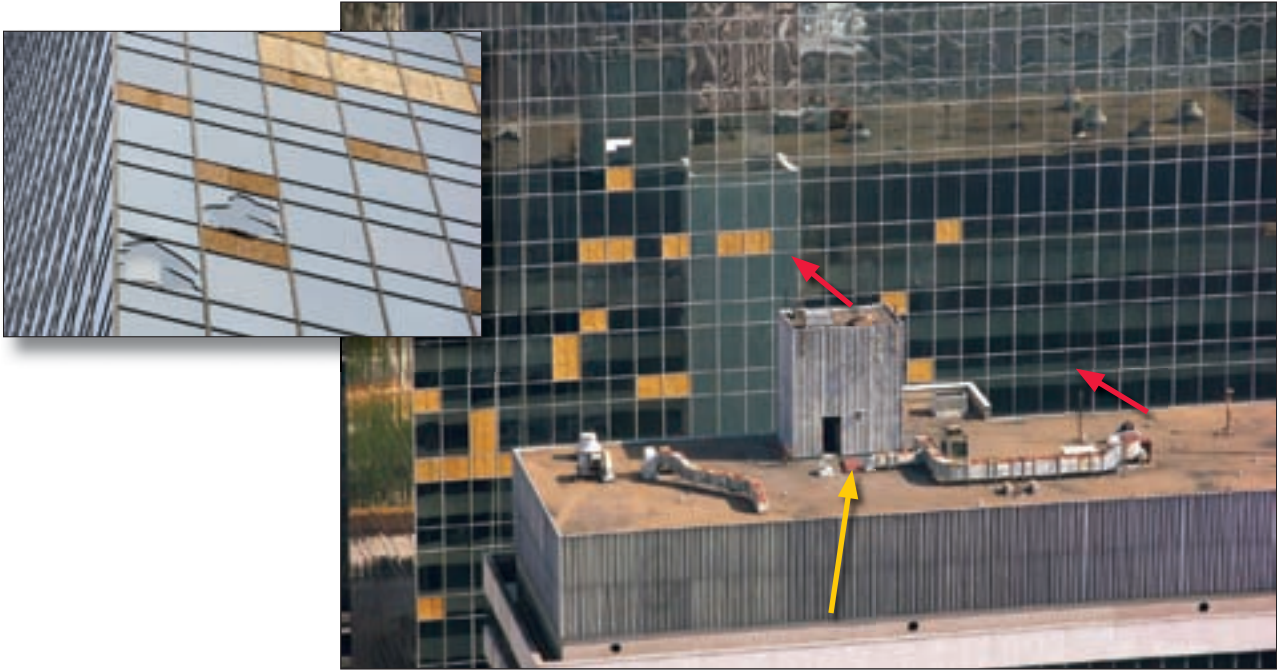
Figure 5-26. View of the aggregate-surfaced roofs on building B-5 and broken glazing on building B-4 beyond. Red arrows indicate generalized aggregate flight path. The yellow arrow shows a penthouse door that blew off. Inset shows damage on a portion of building B-4 below the area shown in the main photograph.

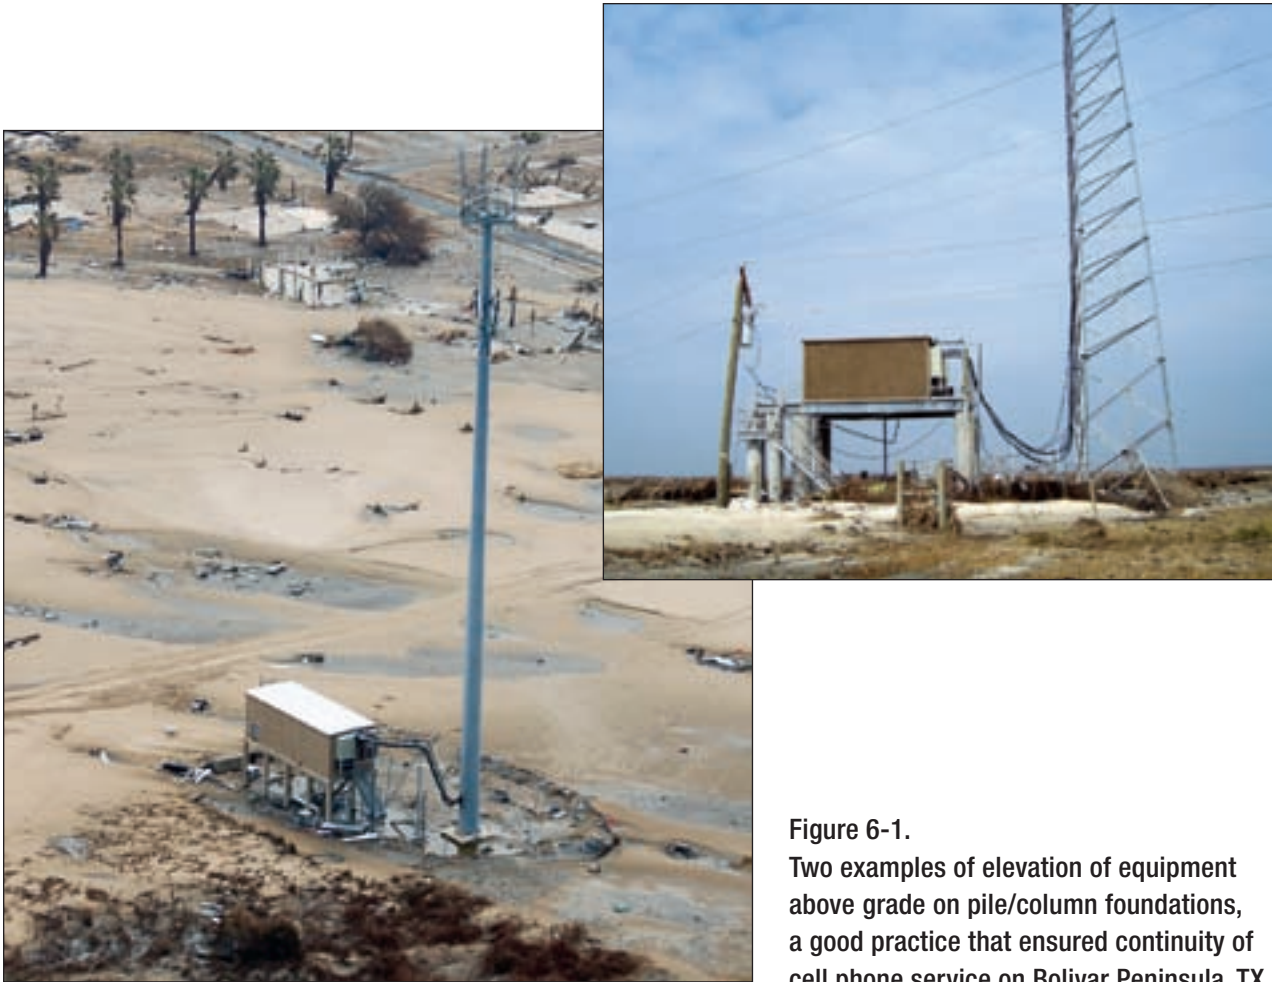
Figure 6-1. Two examples of elevation of equipment above grade on pile/column foundations, a good practice that ensured continuity of cell phone service on Bolivar Peninsula, TX

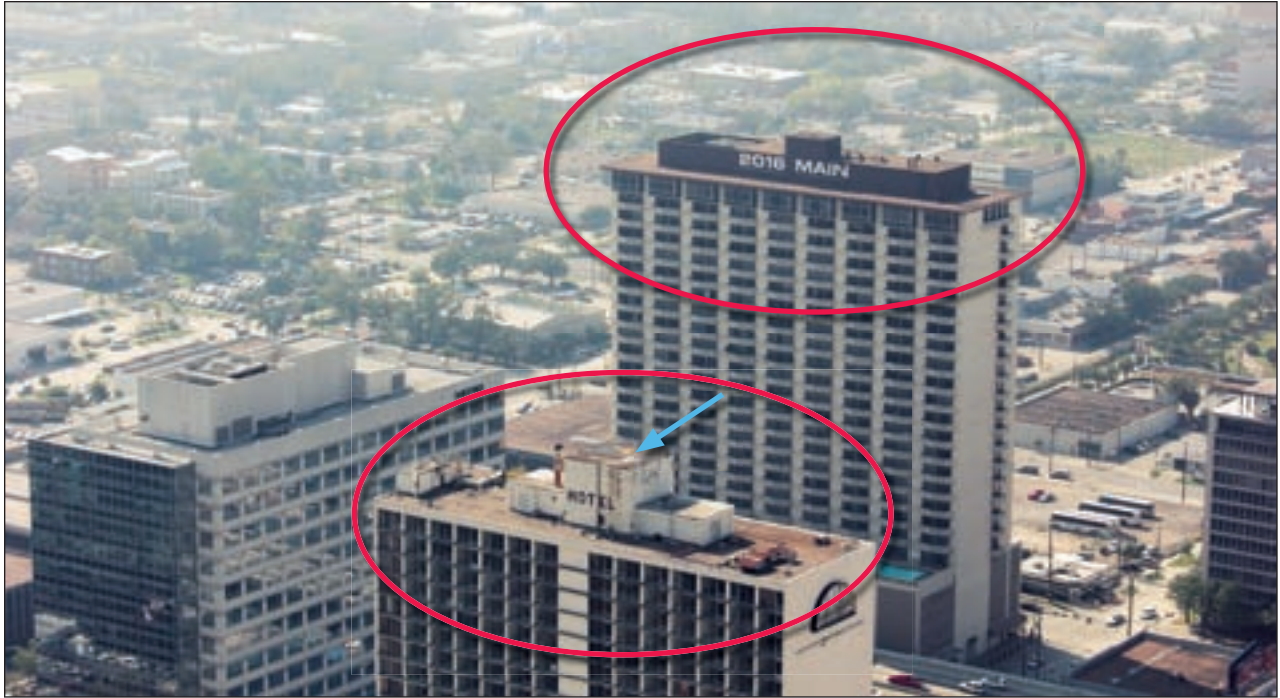
Figure 6-4. Aggregate-surfaced BURs on two mid-rise buildings on the periphery of Houston’s central business district. The roof membrane blew off the penthouse roof, shown by the blue arrow (Figure 5-19 inset shows building locations).

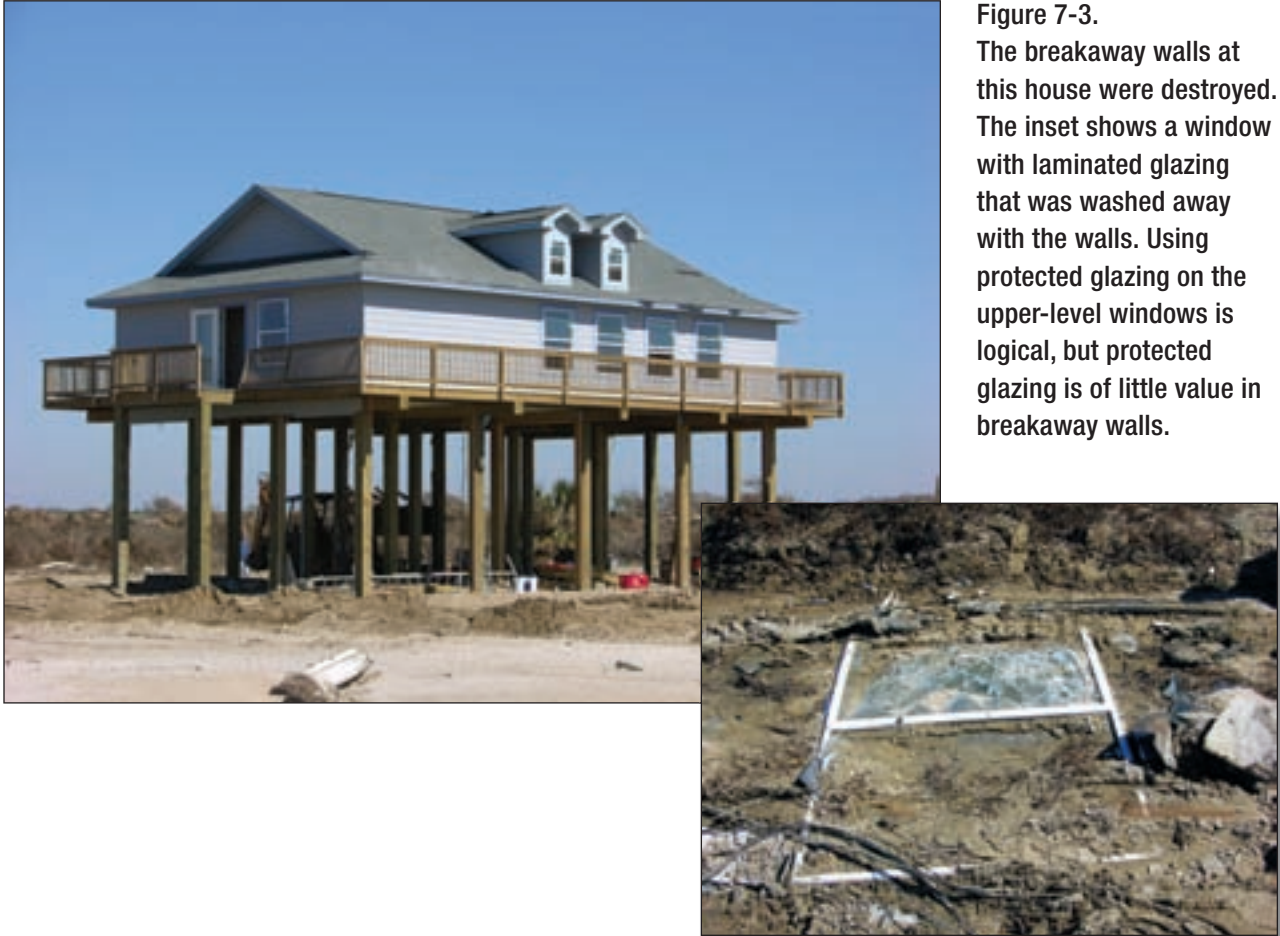
Figure 7-3. The breakaway walls at this house were destroyed. The inset shows a window with laminated glazing that was washed away with the walls. Using protected glazing on the upper-level windows is logical, but protected glazing is of little value in breakaway walls.
