9. Mitigation Successes and Best Practices

This chapter highlights certain noteworthy examples of successful mitigation projects and best practices, organized under the general categories of acquisition projects (Section 9.1), elevation projects (Section 9.2), wind retrofit projects (Section 9.3), higher regulatory standards implemented by local jurisdictions (Section 9.4), and other best practices (Section 9.5). Figure 9-1 provides an overview of site locations.

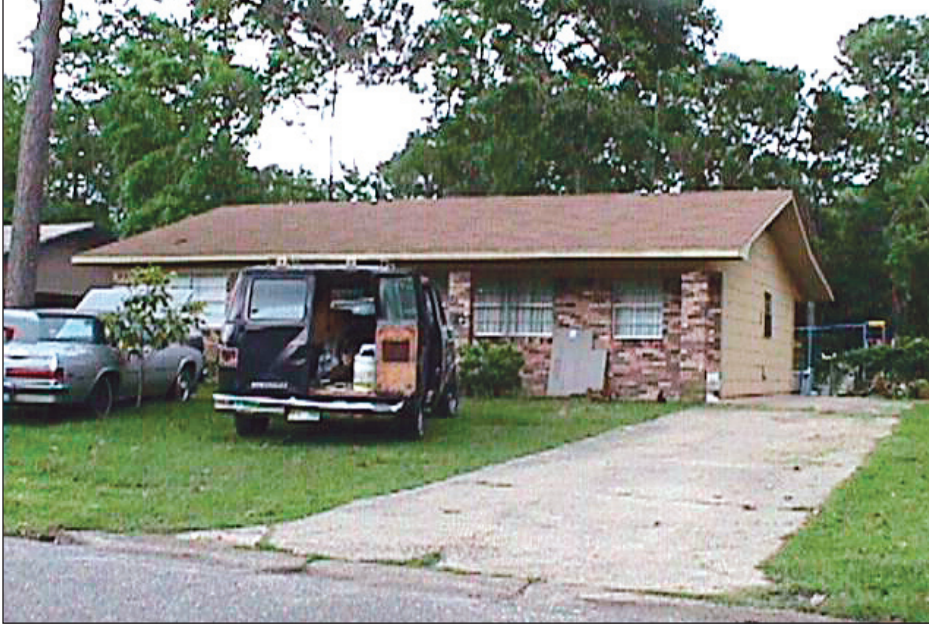
Figure 9-2 shows a typical building within the project area prior to its acquisition and subsequent demolition. Figure 9-3 shows a small representative portion of the cleared area after the acquisition and demolition of the houses.

Figure 9-2.
Pre-acquisition/pre-demolition photo of representative building included in project (photo ca. 1999/2000) (Gulfport, Mississippi)

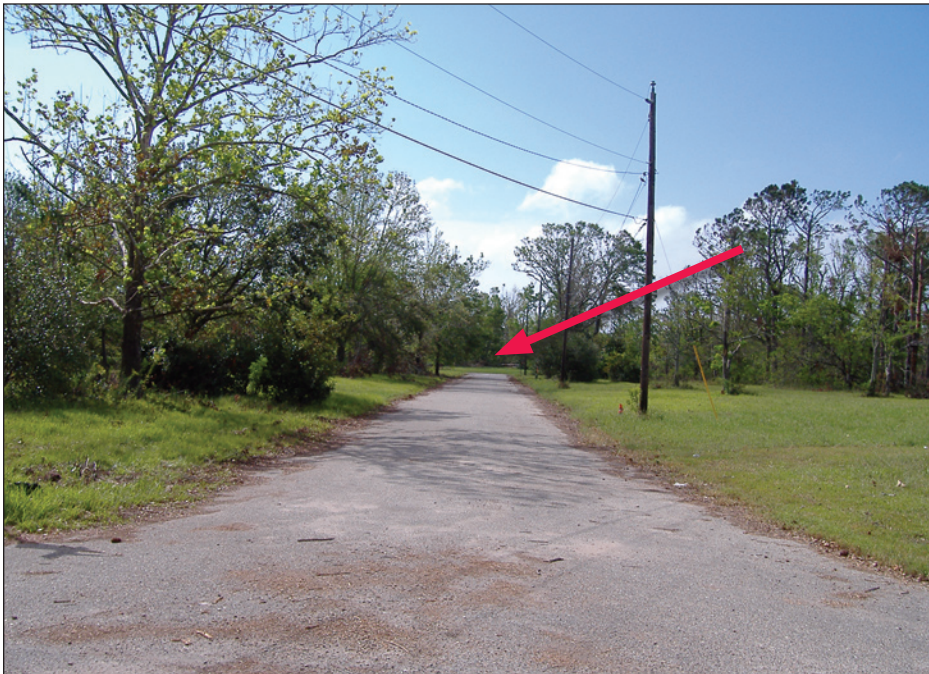
Figure 9-3.
This photo, taken post-Katrina, shows a few of the vacant lots after the acquisition project removed approximately 230 residential buildings from the flood hazard area. The primary source of flooding (Brickyard Bayou) is located just beyond and running perpendicular to the south end of this street (arrow) (Gulfport, Mississippi).

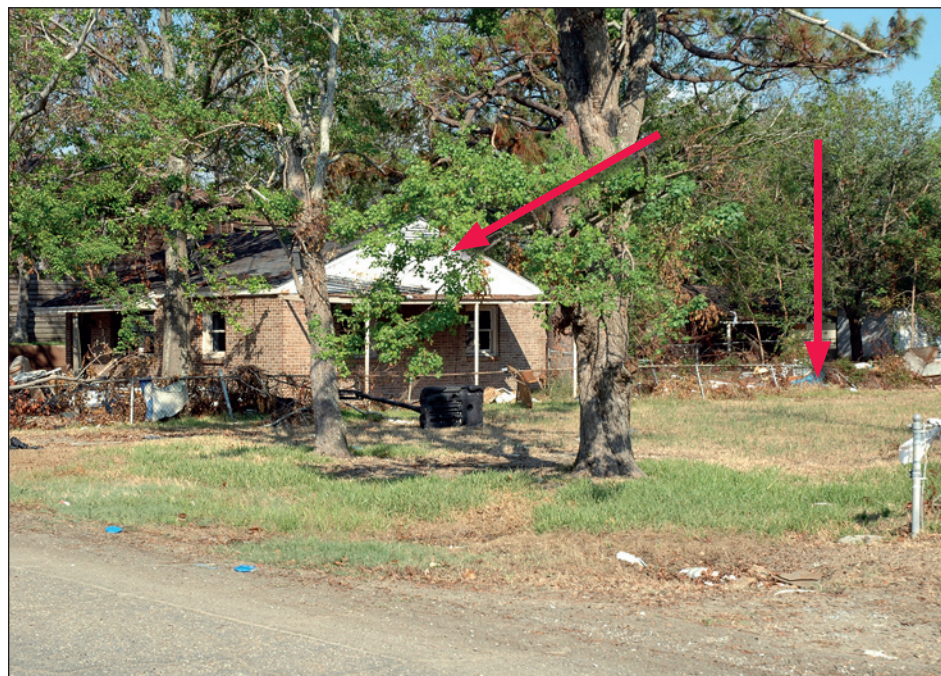
The City of Pascagoula used a combination of HMGP and supplemental funding (approved in 2001) to acquire and demolish approximately 10 at-risk buildings on Parsley Avenue, Chickasaw Avenue, Edgewood Avenue, Canty Street, Sherwood Street, Tupelo Avenue, 11th Street, and 14th Street (see Figure 9-4). Over half of the buildings included in this project were repetitive loss properties. Structures within the area that were not part of this project sustained damages from up to 6 feet of water.

Figure 9-4.
An example of a vacant lot resulting from the acquisition/demolition project (right arrow) next to a property that did not participate in the program and that was damaged by Hurricane Katrina (left arrow) (Pascagoula, Mississippi).

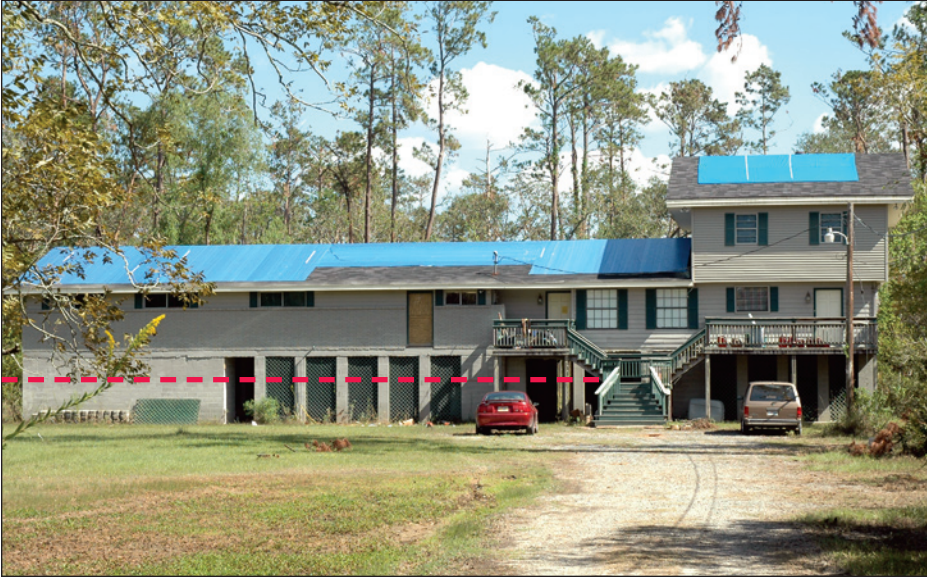
The residential property shown in Figure 9-5, located in Lacombe, Louisiana (in St. Tammany Parish southwest of Slidell), was elevated using HMGP funding to a height well above the flood depth associated with Hurricane Katrina. No flood damage was observed to the lowest finished floor. Some wind damage was noted to the roof, as evidenced by the blue roof covering.

Figure 9-5. Post-Katrina photo of an HMGP-elevated house. Note the estimated water line associated with Hurricane Katrina (red line) (Lacombe, Louisiana).

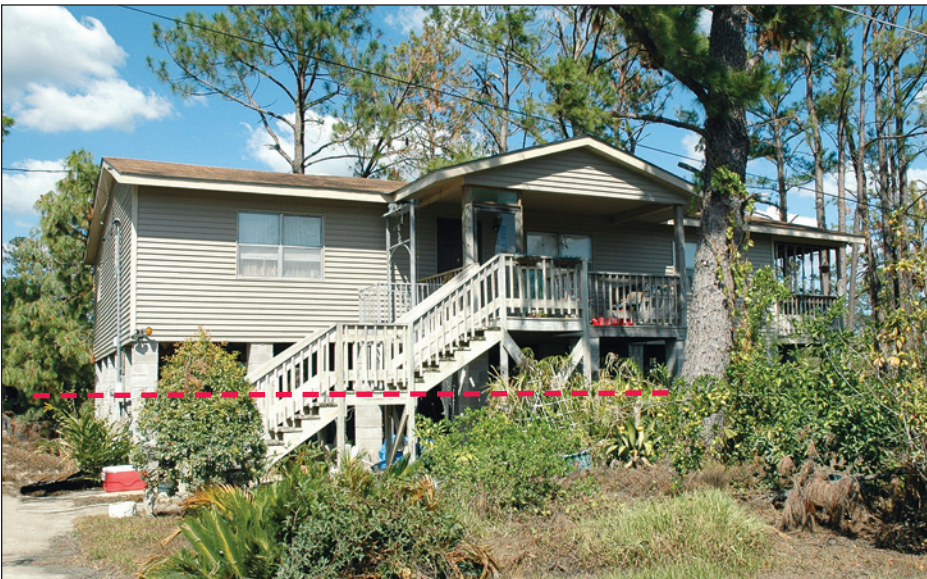
The house shown in Figure 9-6 was also elevated (using HMGP funding) above the flood depths associated with Katrina.

Figure 9-6. Another post-Katrina photo of an HMGP-elevated house. Note the estimated water line associated with Hurricane Katrina (red line) (Lacombe, Louisiana).

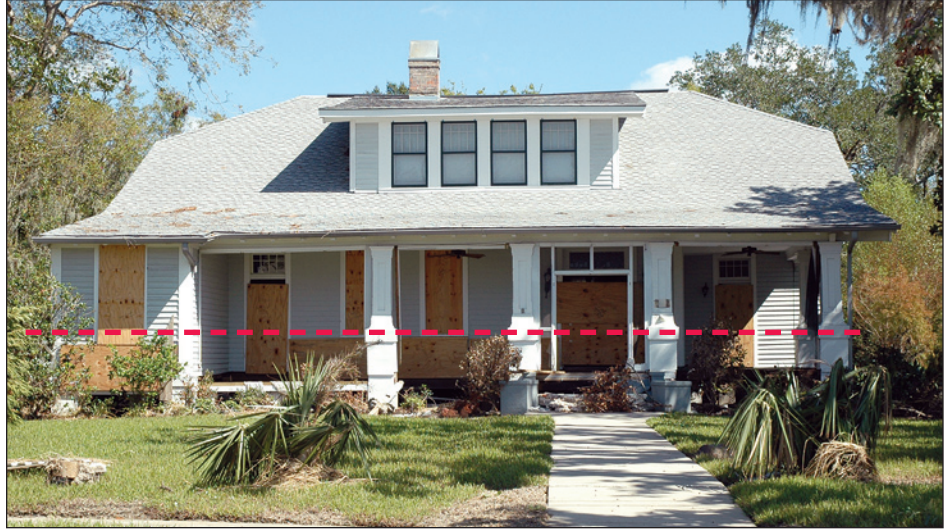
Figure 9-7.
This building, elevated only a few feet above ground level, was heavily damaged by storm surge and flooding during Hurricane Katrina. Note the estimated flood depth in relation to the first floor (red line) (Mandeville, Louisiana).

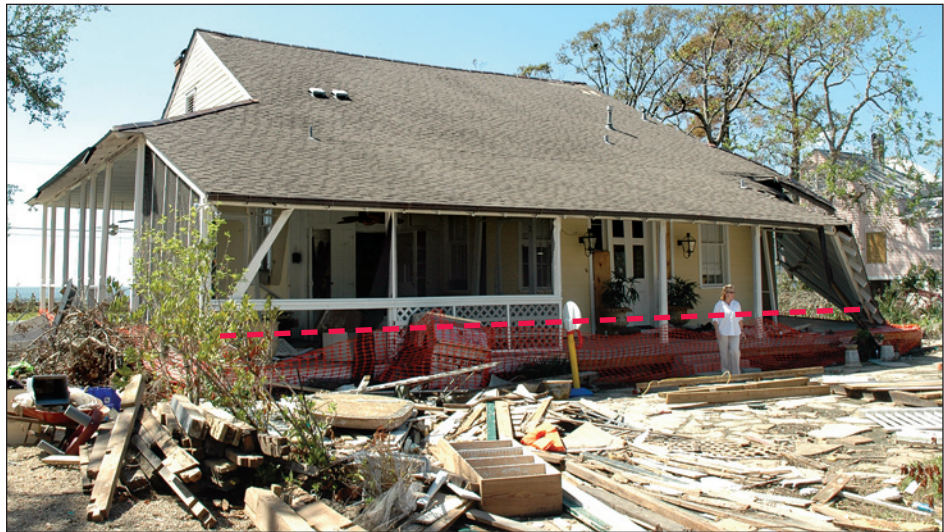
Figure 9-8.
This building is the oldest house in Mandeville (built in 1836) and is on the National Register of Historic Places. The house is elevated 3 feet on piers and suffered wave damage to 18 inches above the floor. Note the estimated flood depth in relation to the first floor (red line) (Mandeville, Louisiana).

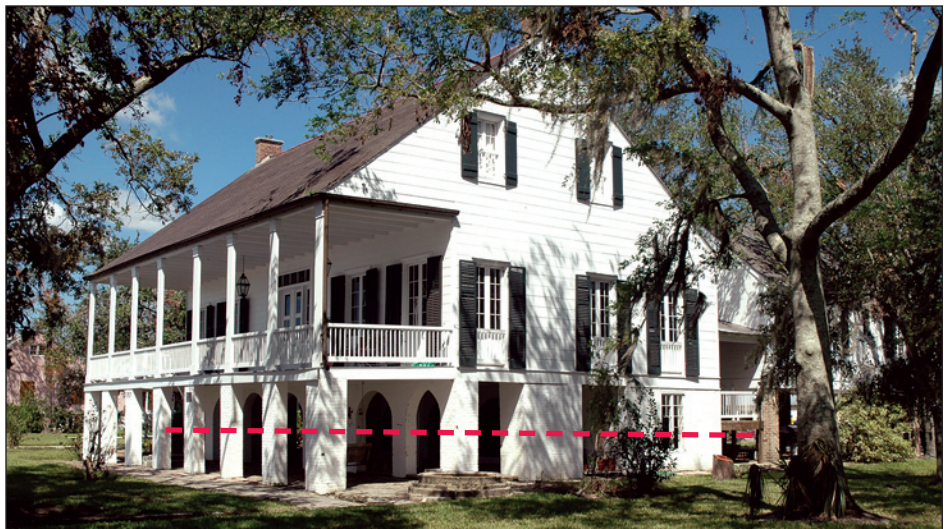
Figure 9-9.
In contrast to the preceding examples, this 100-year-old building, also on the National Register of Historic Places and located next door to the house in Figure 9-7, received minimal damage. Note the estimated flood depth in relation to the first floor (red line) (Mandeville, Louisiana).

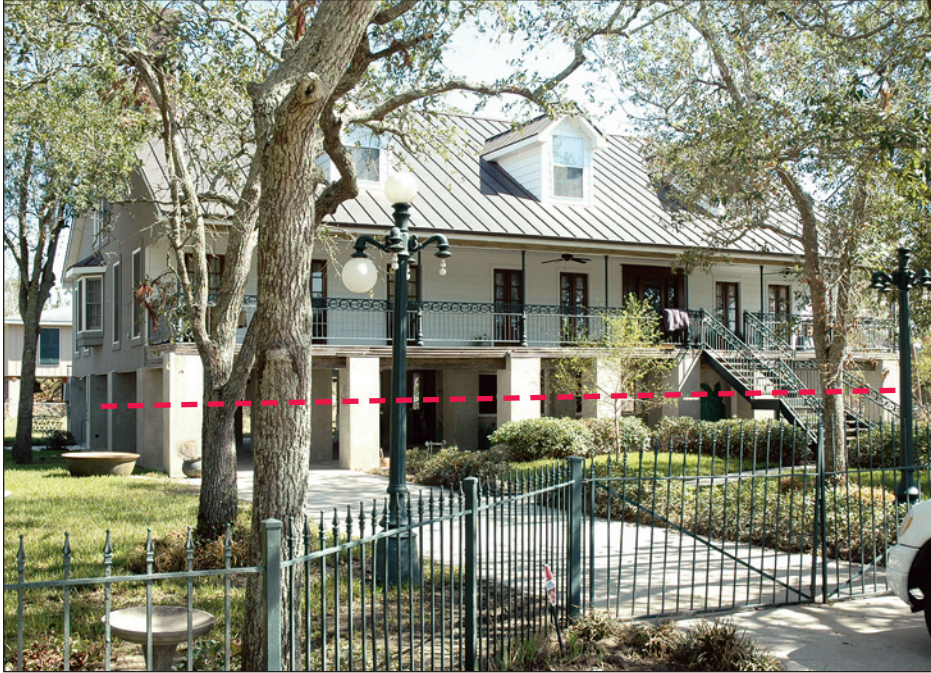
Figure 9-10. Another example of an elevated house that sustained only minor damage. Note the estimated flood depth in relation to the first floor (red line) (Mandeville, Louisiana).

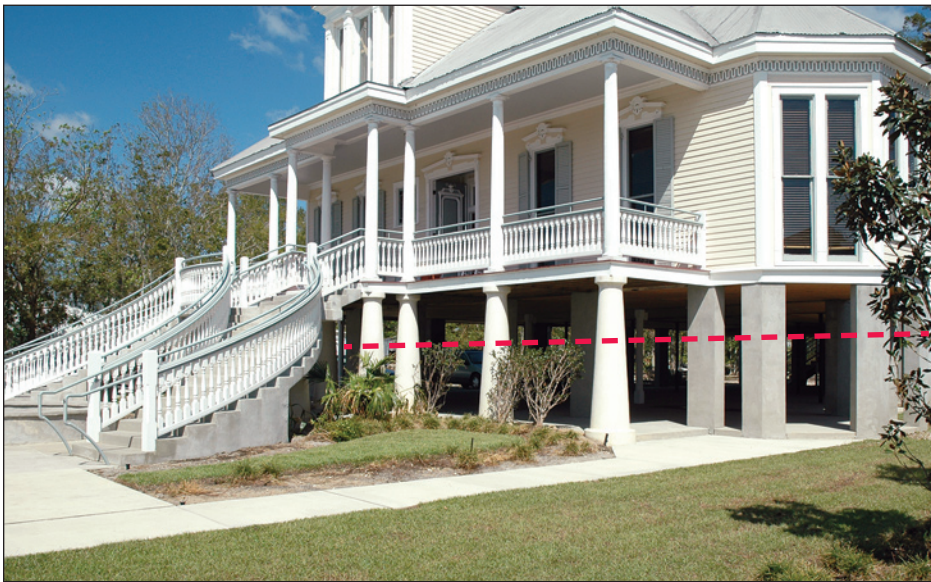
Figure 9-11. This building was relocated from New Orleans for use as a restaurant. The local building inspector recommended the elevation seen here, which protected this building from flood damage. Note the estimated flood depth in relation to the first floor (red line) (Mandeville, Louisiana).

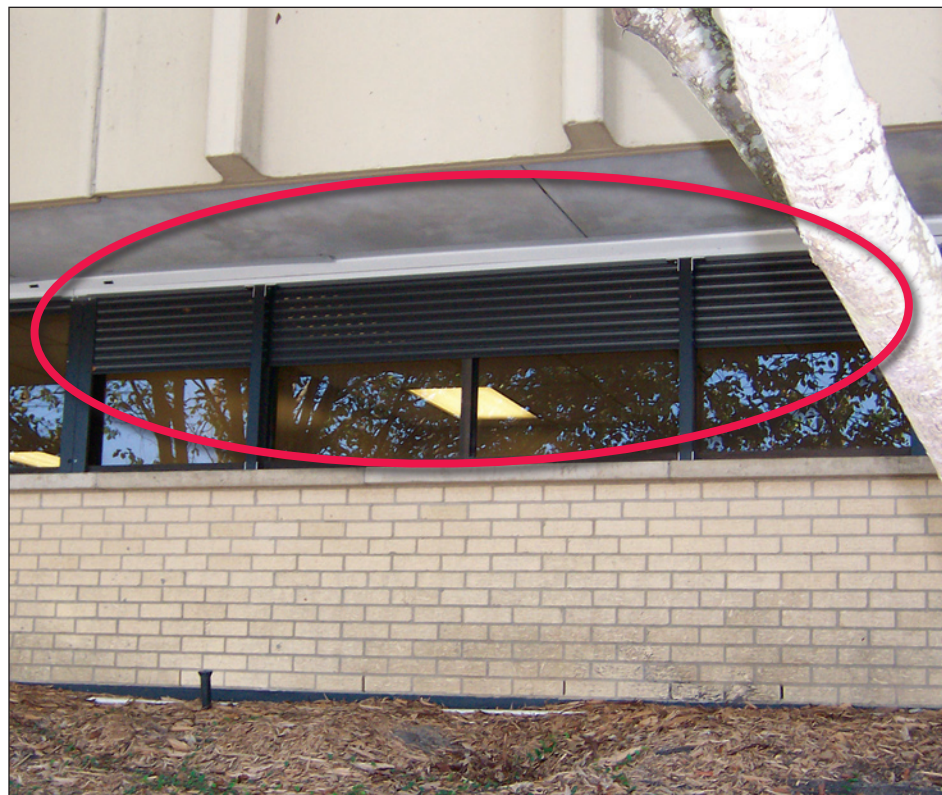
During Hurricane Katrina, windows of vehicles located in the building’s parking lot were broken by windborne aggregate blown from the roof of the building. At least some of this aggregate, along with branches from nearby trees, is likely to have struck the shutters and may have broken the glass had the windows not been protected. The estimated wind speed for this location is 130 mph. (See Section 7.1.2 for additional information on this building.)

Figure 9-12.
Closeup of the roll-down metal shutters on the Harrison County Courthouse building. Note the partially lowered shutters on the middle windows (circle) (estimated wind speed: 130 mph. Gulfport, Mississippi).

In 1999/2000 (following Hurricane Georges in 1998, which heavily impacted the Mississippi Gulf Coast), officials from Harrison County, Mississippi Emergency Management Agency, and FEMA’s Building Sciences division met to evaluate the Harrison County Courthouse, which also currently houses the Harrison County EOC, as an opportunity for a potential hurricane wind retrofit project. Among other observations, the team noted rows of unprotected windows around the building, under which were stored valuable records and documents (some dating back to 1841), computers, and other electrical equipment. Roll-down metal shutters were installed using HMGP funding (see Figure 9-12).

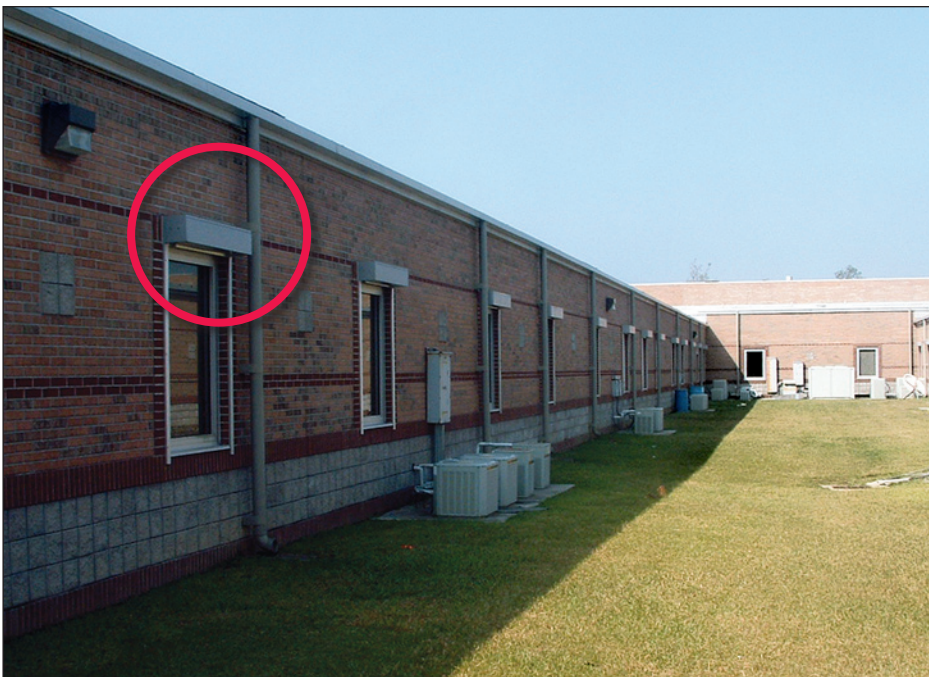
In September 1998, Ocean Springs Middle School was awarded \$49,477 in HMGP funding for the installation of roll-down shutters to protect all exterior classroom windows from windborne debris (see Figure 9-13). Without glazing protection, occupants would be susceptible to injury from glass shards, and the building interior would be susceptible to damage from wind and wind-driven rain. The school was used as a shelter during Hurricane Katrina for as many as 400 people. Homeowners, urban search and rescue, police and fire personnel, and the National Guard used the facility as a shelter for up to a week. Following Hurricane Katrina, the MAT observed only minimal damage to the facility. In addition to the use of the shutters, other windows on the building were observed to have polycarbonate glazing.

Figure 9-13.
View of the Ocean Springs Middle School. Note the roll-down shutters over the windows (one example circled) (estimated wind speed: 120 mph. Ocean Springs, Mississippi).

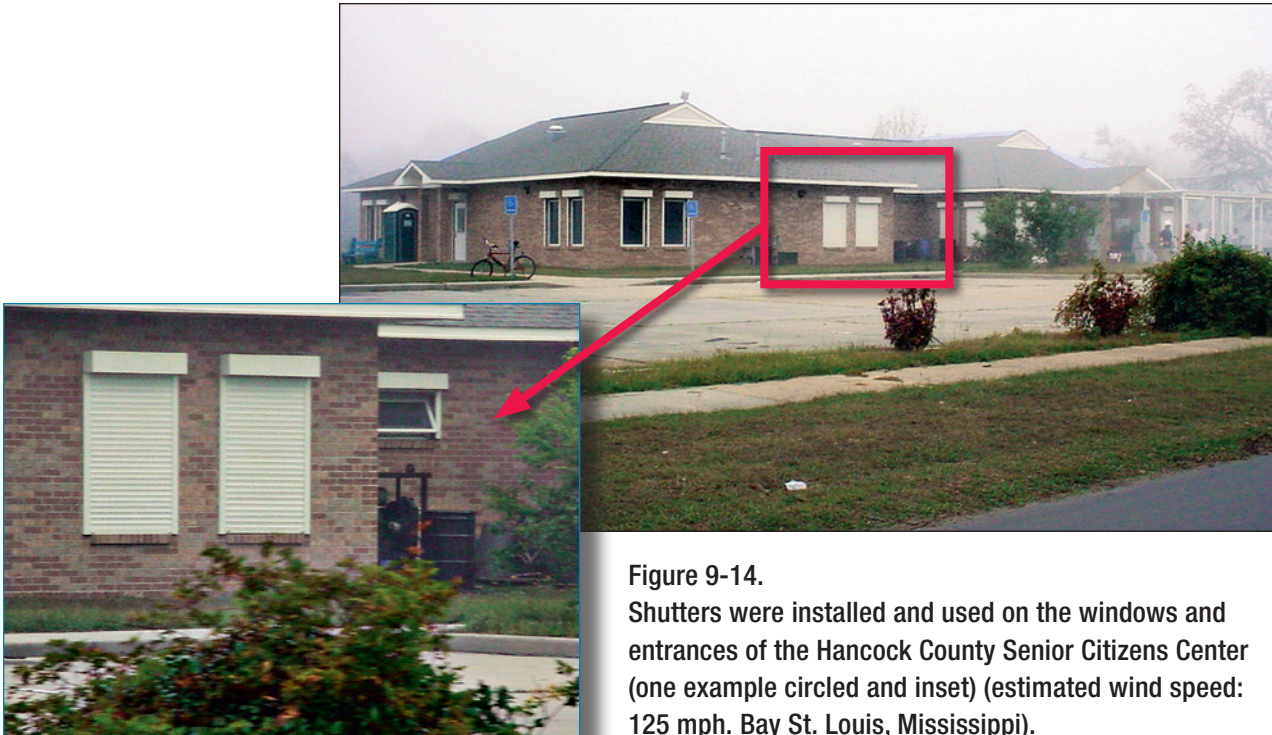
Hancock County Civil Defense ordered an evacuation of the facility as Hurricane Katrina approached. Water did not enter the building from the ground (e.g., stillwater flooding or storm surge), but water did enter the building via the roof, although structurally the roof remained intact.

Figure 9-14. Shutters were installed and used on the windows and entrances of the Hancock County Senior Citizens Center (one example circled and inset) (estimated wind speed: 125 mph. Bay St. Louis, Mississippi).

The Hancock County Senior Citizens Center received HMGP funding for the installation of shutters in 1999/2000 to protect windows and glazed doors from windborne debris (see Figure 9-14). The facility was identified in the local Hazard Identification and Risk Assessment Plan as a critical and essential facility, and was designated for use as a local shelter.

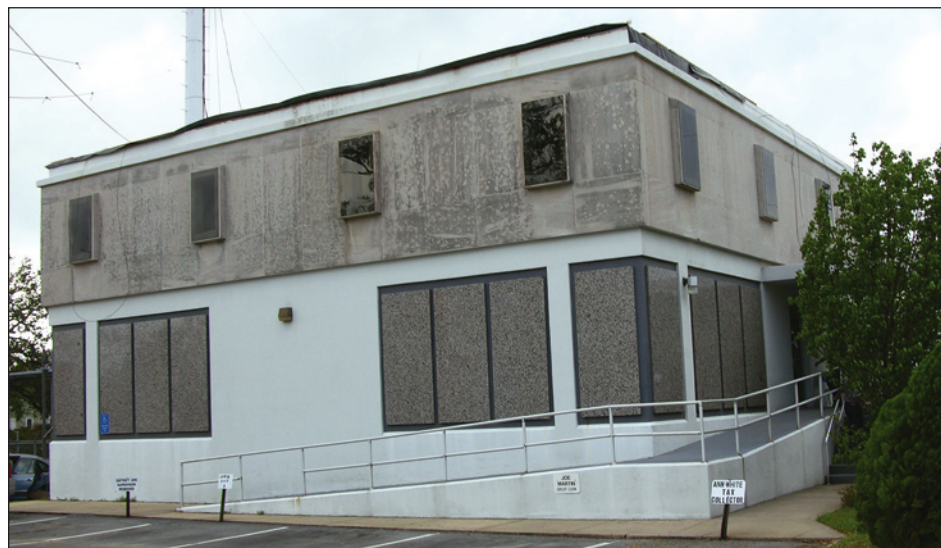
The Jackson County EOC facility was observed by the MAT to have several prudent retrofit/wind-hardening features that helped the building survive Katrina. Polycarbonate shutters had been permanently mounted over the exterior windows and glazed door at this facility (see Figure 9-15). The roof deck and walls were constructed of concrete, which provided substantial wind resistance and excellent protection from windborne debris. In addition, the emergency generator had been sufficiently elevated to keep it from being inundated by Katrina's floodwaters. (See Section 7.1.1 for more detailed information.)

Figure 9-15. Exterior view of the Jackson County EOC. Note the polycarbonate shutters over the windows (estimated wind speed: 105 mph. Pascagoula, Mississippi).

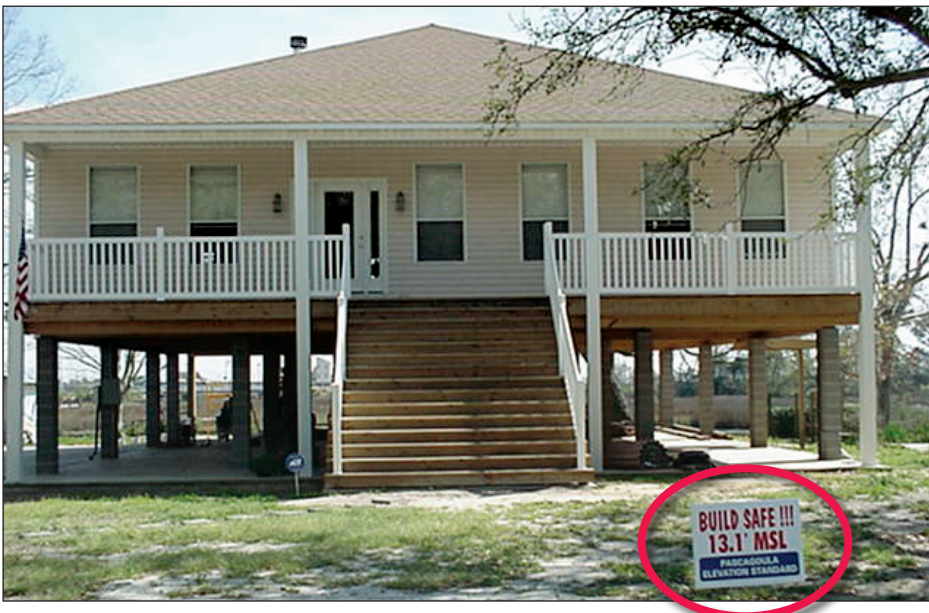
Figure 9-16. This photo was taken pre-Katrina ca. 1999/2000. Note the “Build Safe! 13.1’ MSL Pascagoula Elevation Standard” sign in front yard (circle) (Pascagoula, Mississippi).

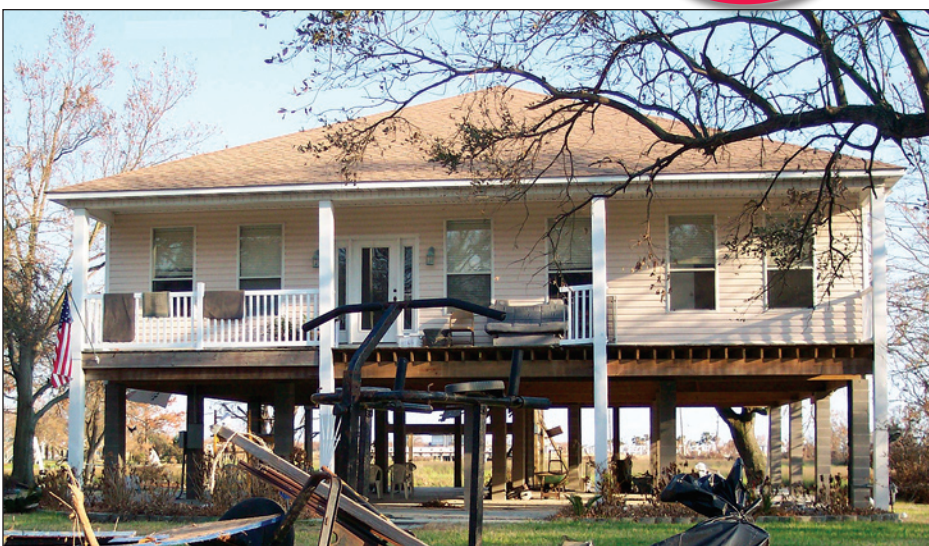
Following Hurricane Georges in 1998, the City of Pascagoula established an elevation standard of 13.1 feet msl for new construction, a standard higher than the BFEs stated on the community’s FIRMs. In some cases, this represented up to a 5-foot increase above mapped BFEs. As a result, buildings impacted by Hurricane Katrina that were built to this standard suffered less flood damage than older housing built to lower elevation requirements (see Figures 9-16 and 9-17). The example shown in Figure 9-16 was the first elevation project in the State of Mississippi to use Increased Cost of Compliance funding. The estimated flood depth at this location from Hurricane Katrina was approximately 1 foot above the first finished floor and reportedly caused only minor damage to the house. According to the effective FIRM at the time of Hurricane Katrina, the building is located in Zone AE with a BFE of 11 feet.

Figure 9-17. This photo was taken post-Katrina, illustrating the successful survival of this elevated building. The house was elevated to the citywide standard of 13.1’ msl using Increased Cost of Compliance funding (Pascagoula, Mississippi).

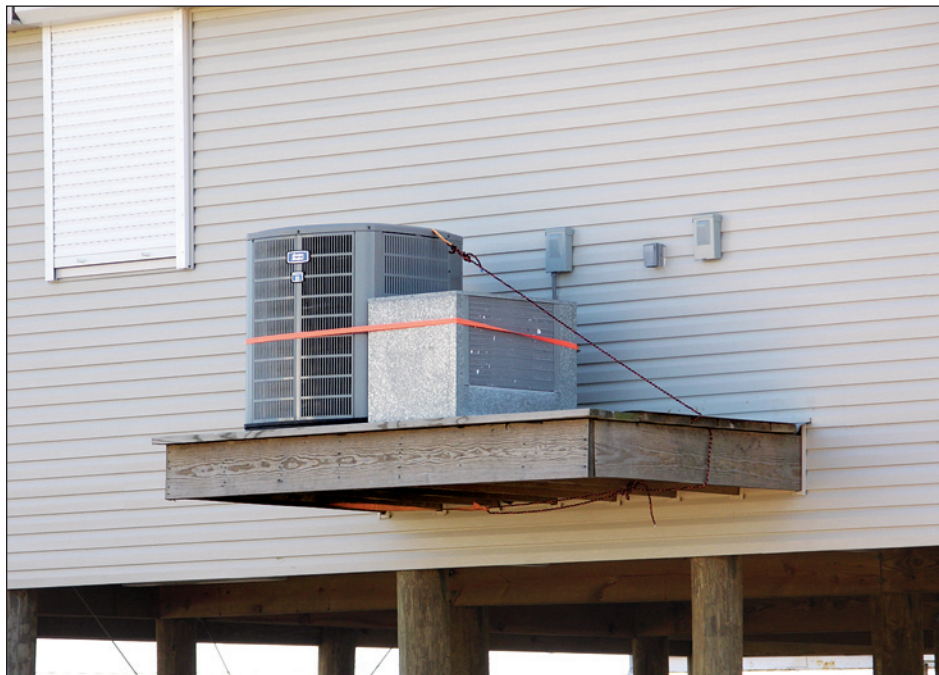
Condensers placed at ground level or elevated but not secured typically fail from hurricane wind and flood forces. Cantilevered platforms are preferable over knee-brace platforms and platforms that use piles at the outward corners, because knee-braces can be broken by flood-borne debris and piles for condenser platforms are usually smaller in diameter than the piles used for the building itself, and are more easily broken. Figure 9-18 shows a cantilevered condenser platform that performed successfully during Hurricane Katrina.

Figure 9-18.
This condenser was strapped to a cantilevered platform to enhance blow-off resistance (estimated wind speed: 125 mph. Plaquemines Parish, Louisiana).

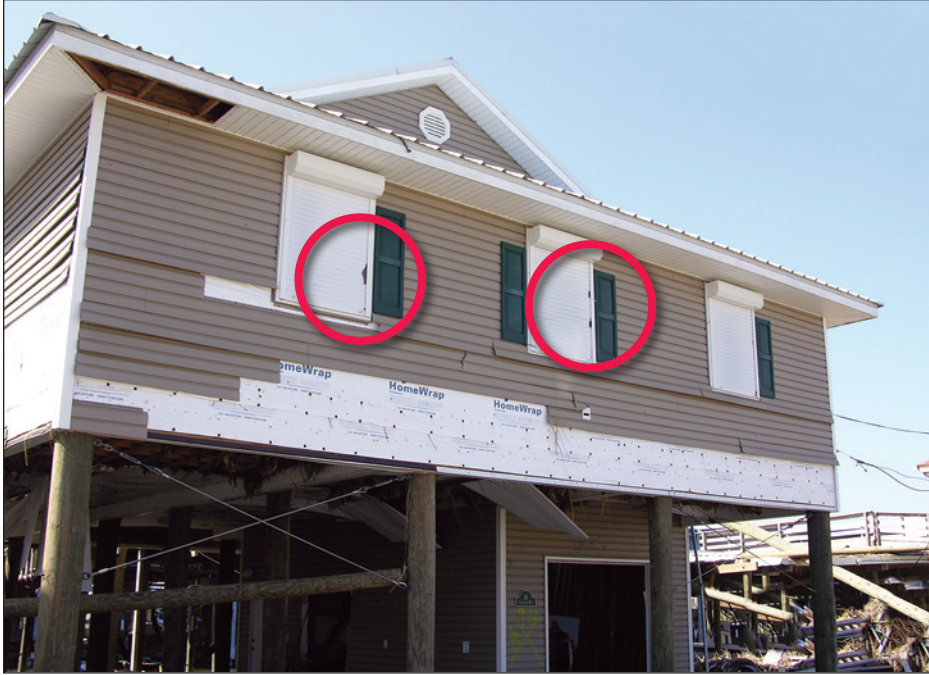
Shutters protected vulnerable glazing in the home shown in Figure 9-19. The home is located in St. Bernard Parish near Hurricane Katrina's path. The wind speeds in the area were sufficient to create damaging windborne debris; however, the shutters successfully protected the vulnerable glazing from breakage.

Figure 9-19.
The black area at the left window and the two black areas at the middle window (circles) are pieces of asphalt shingle debris. Had the windows not been protected by shutters, they would have likely been broken by windborne debris (estimated wind speed: 125 mph. Shell Beach, Louisiana).
