## Mitigation Assessment Team Report

# Spring 2011 Tornadoes: April 25-28 and May 22

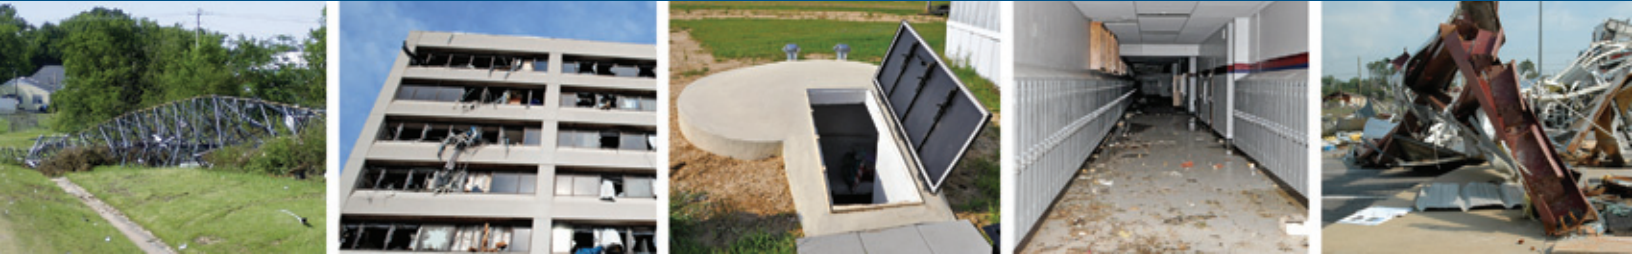
# TORNADO OUTBREAK *of* 2011

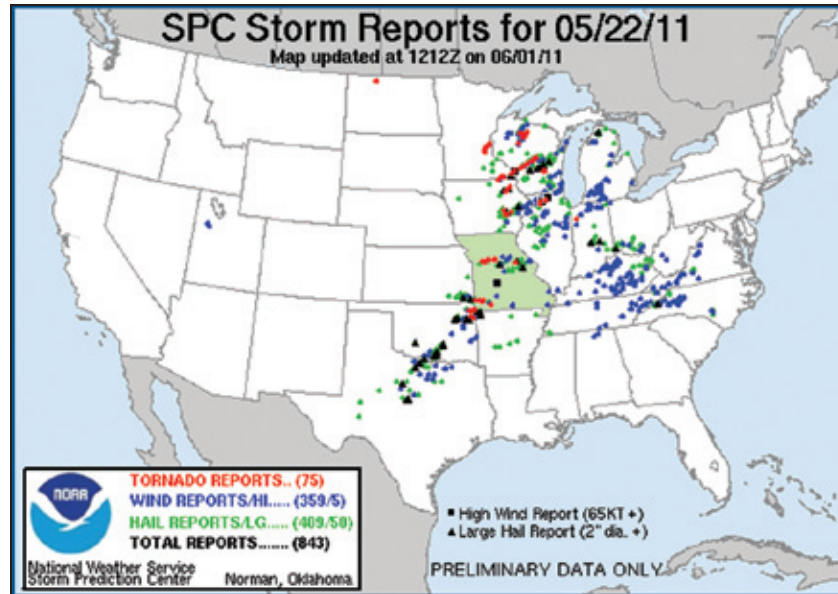
show NOAA's Storm Prediction Center (SPC) storm reports for each day of the two outbreaks. The reports shown on these maps come from NWS Weather Forecast Offices.

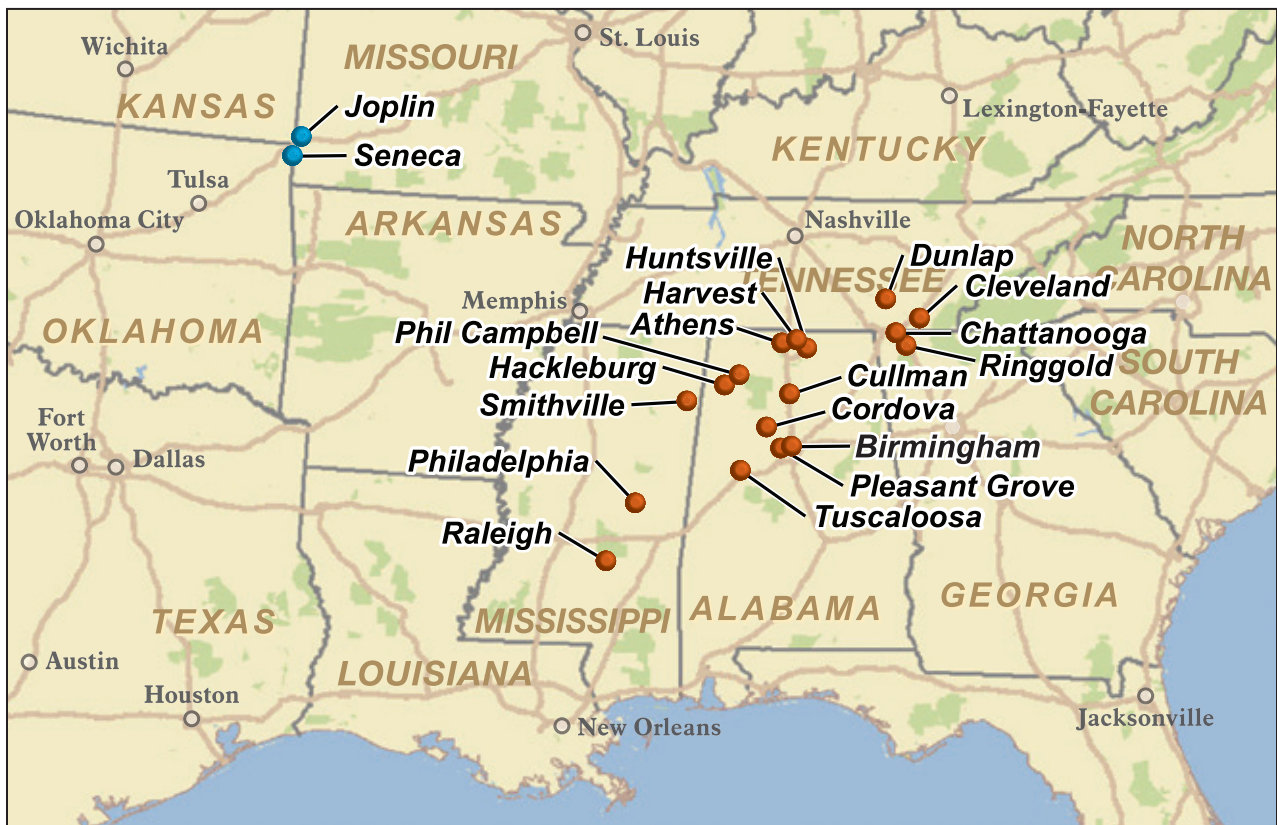
Figure 1-3:  
Communities in Alabama, Georgia, Mississippi, Tennessee, and Missouri visited by the MAT in 2011

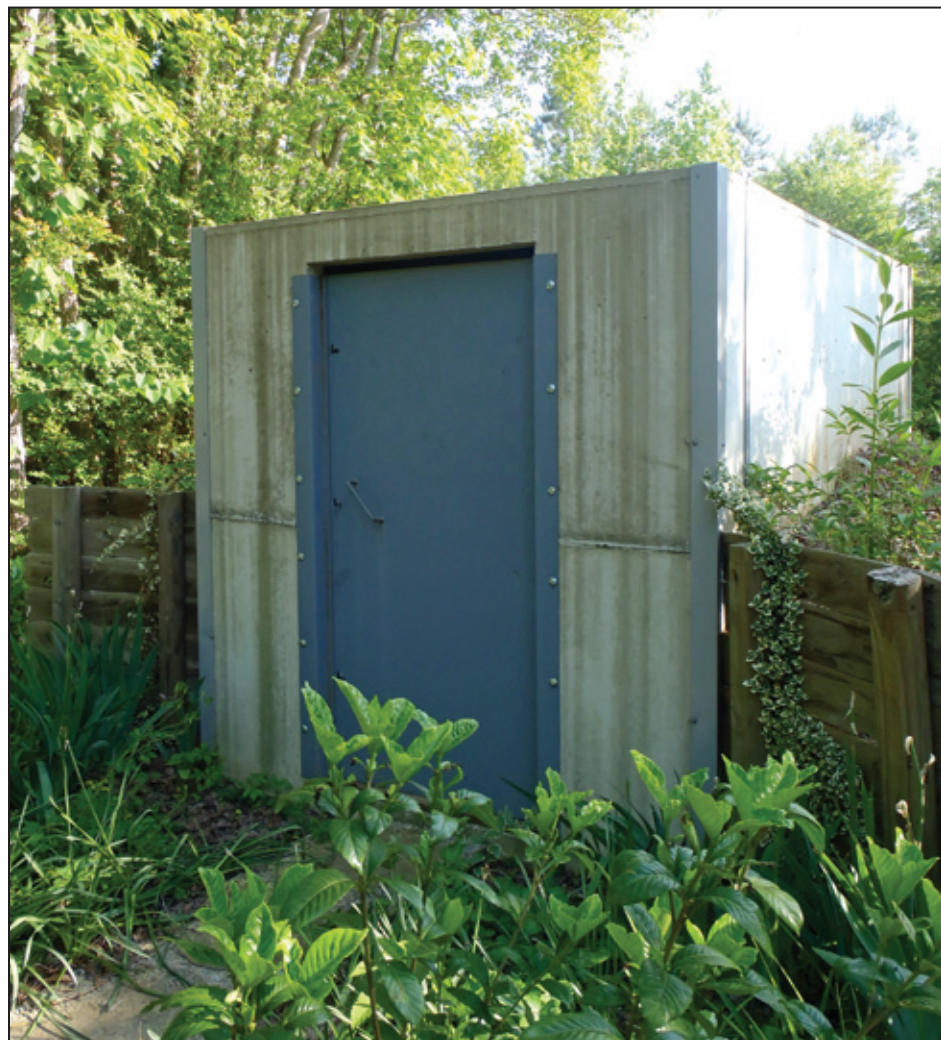
### 1.1.5 Involvement of State and Local Agencies

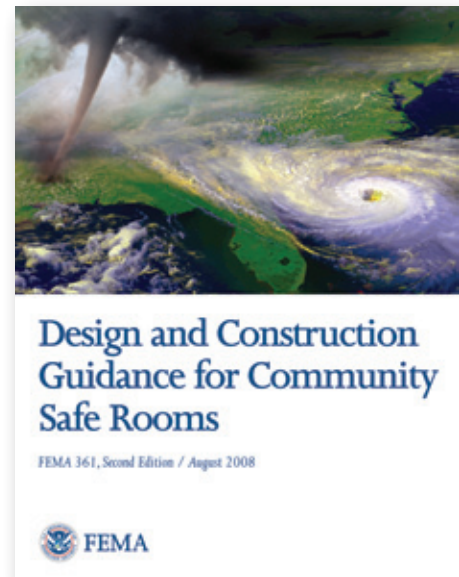
Figure 1-6: Cover of FEMA 361 (FEMA 2008, Second Edition)

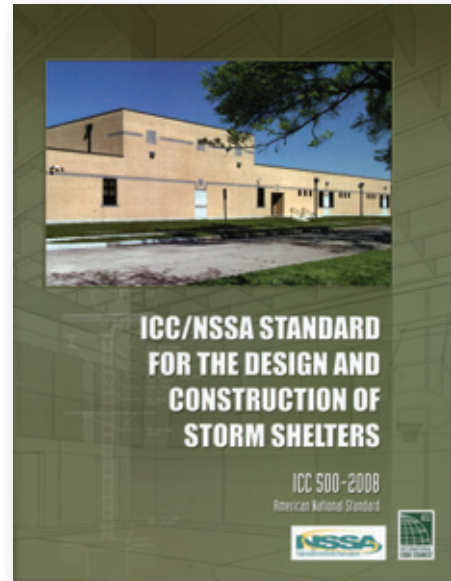
Figure 1-7:  
Cover of ICC 500 (ICC/NSSA 2008)

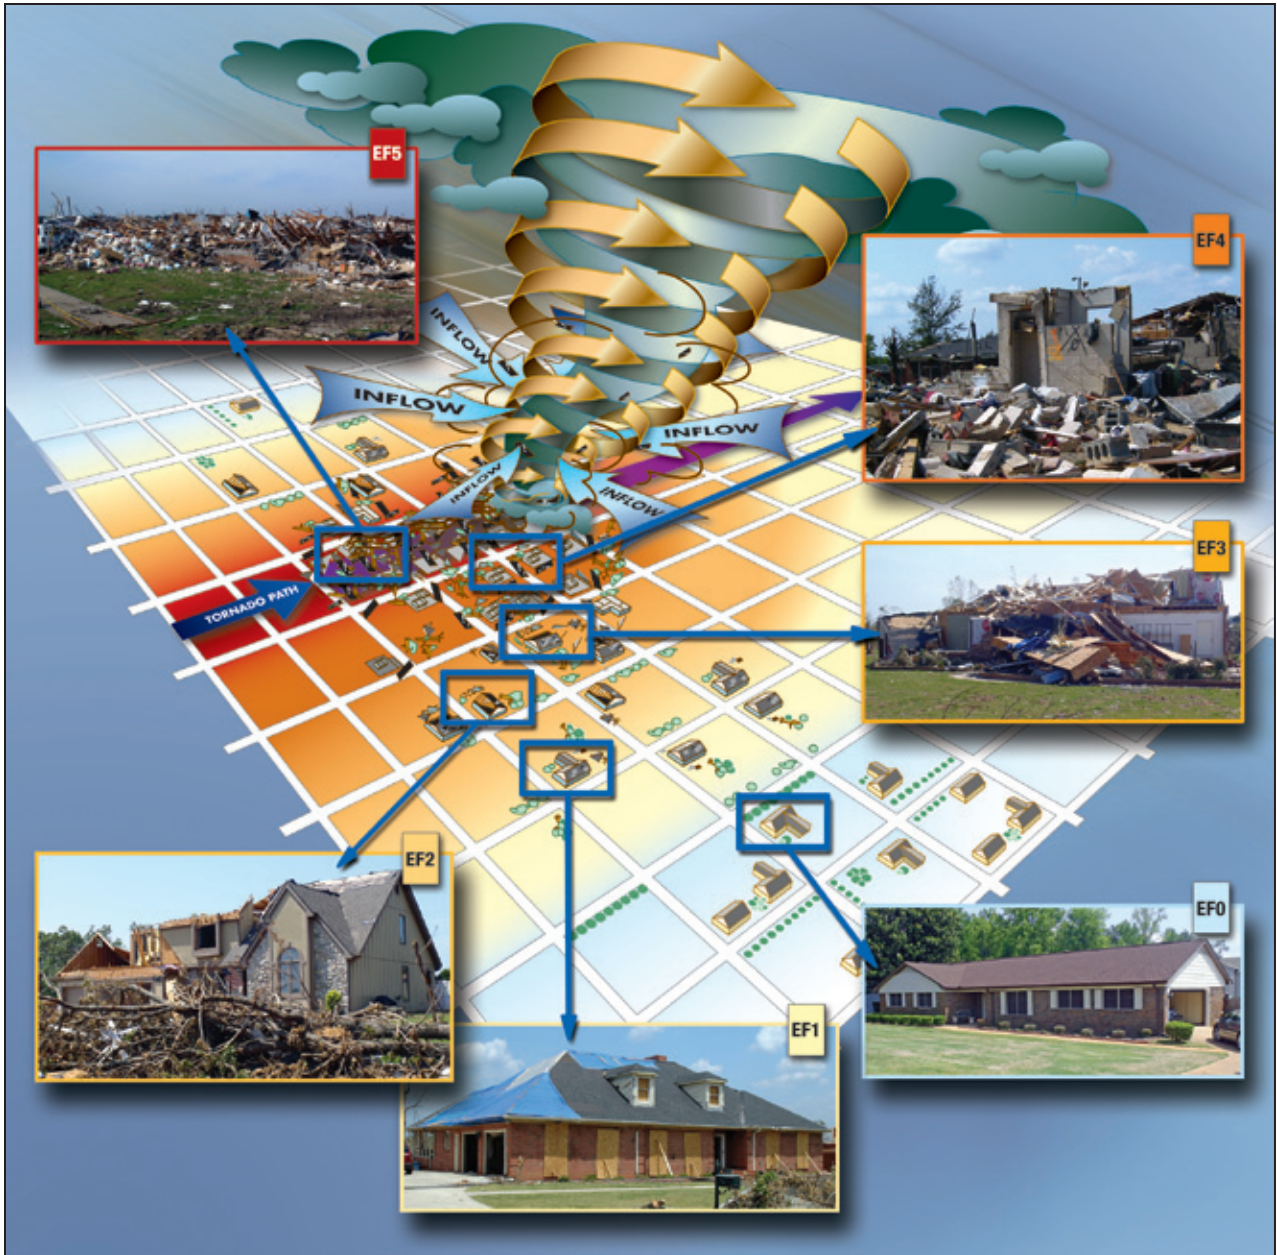
Figure 2-1: Potential tornado damage pattern

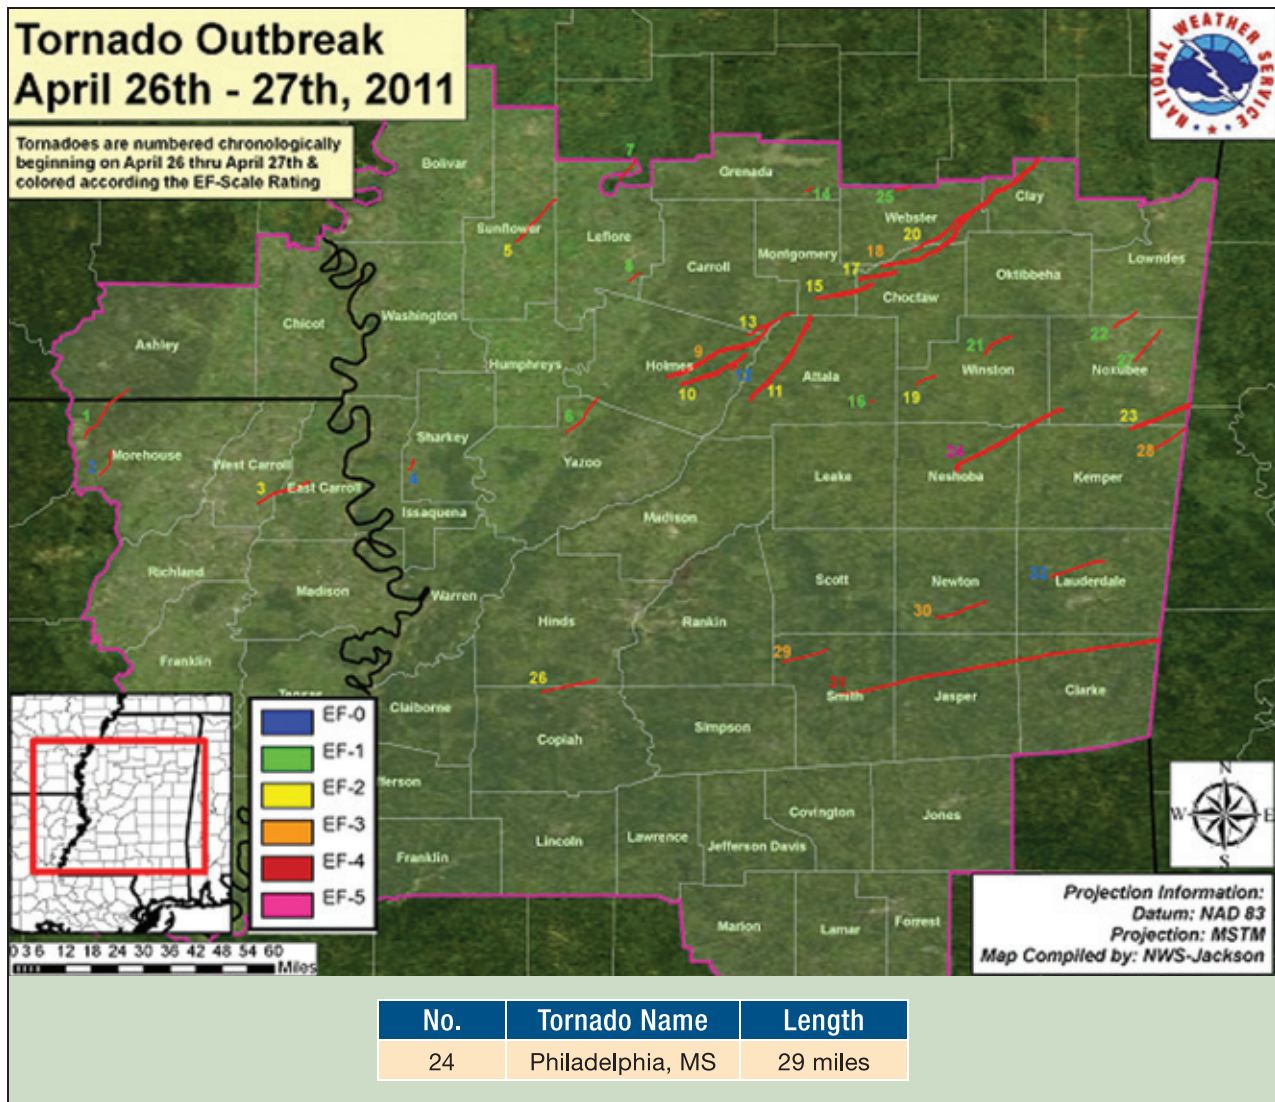
Figure 2-3: Map of tornado tracks associated with the April 26–27, 2011 outbreak in Mississippi

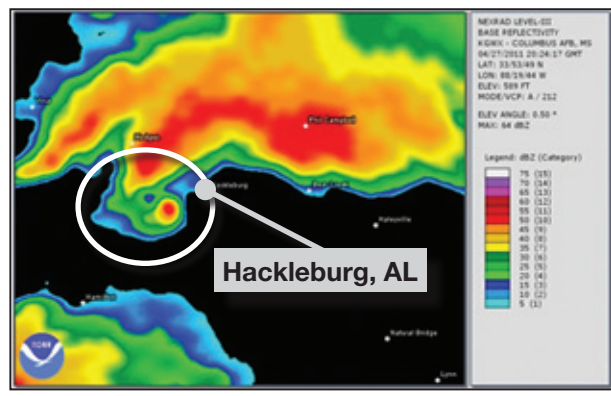
**Figure 2-5:**  
 Base reflectivity and hook echo (white circle) for Hackleburg, AL

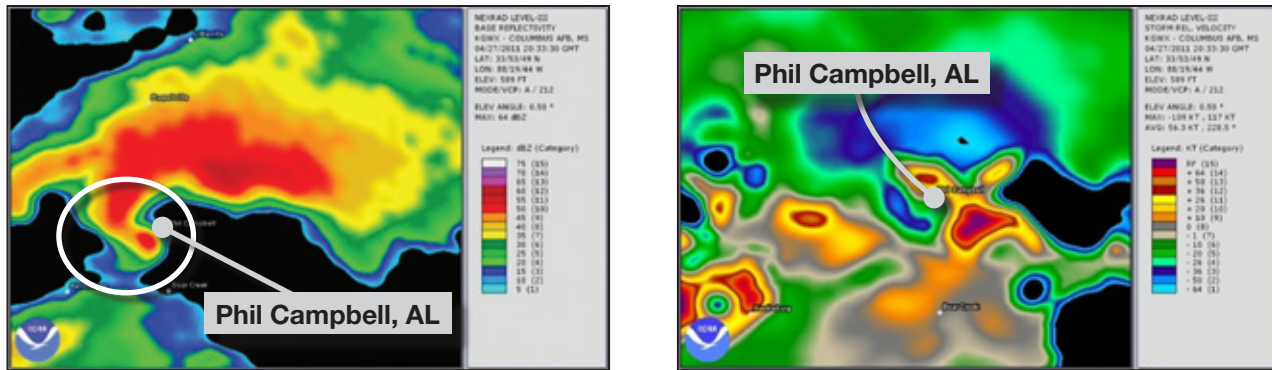
Figure 2-6: Base reflectivity and hook echo (white circle, left) and storm relative velocity (right) for Phil Campbell, AL

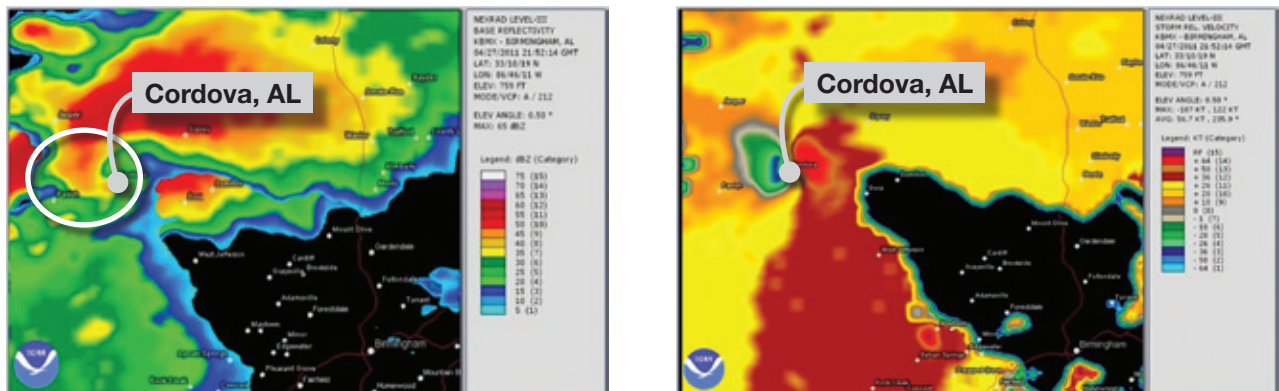
Figure 2-8: Base reflectivity and hook echo (white circle, left) and storm relative velocity on right for Cordova, AL

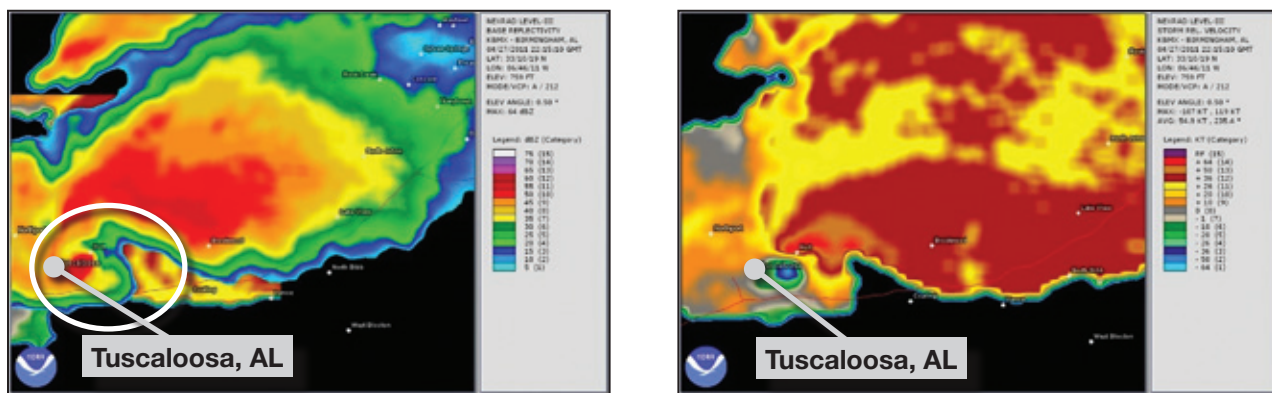
Figure 2-9: Base reflectivity and hook echo (white circle, left) and storm relative velocity on right for Tuscaloosa, AL

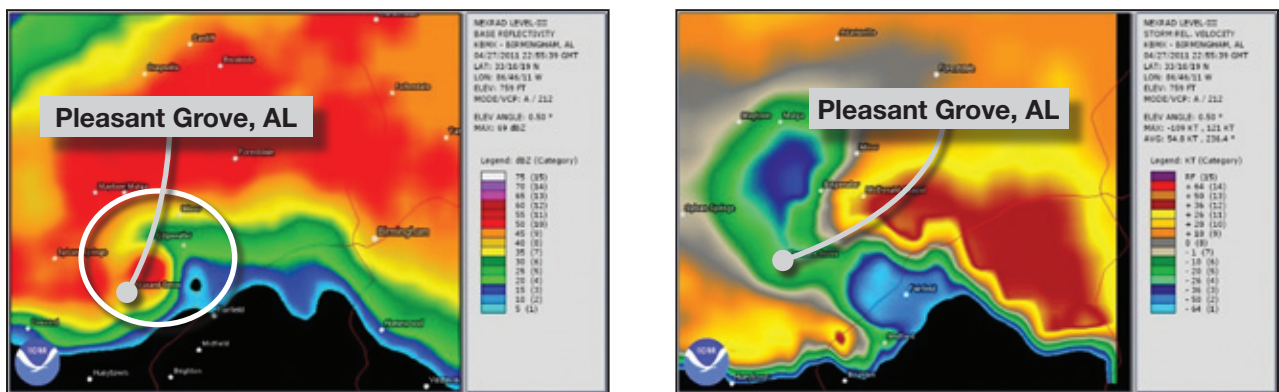
Figure 2-10: Base reflectivity and hook echo (white circle, left) and storm relative velocity on right for Pleasant Grove, AL

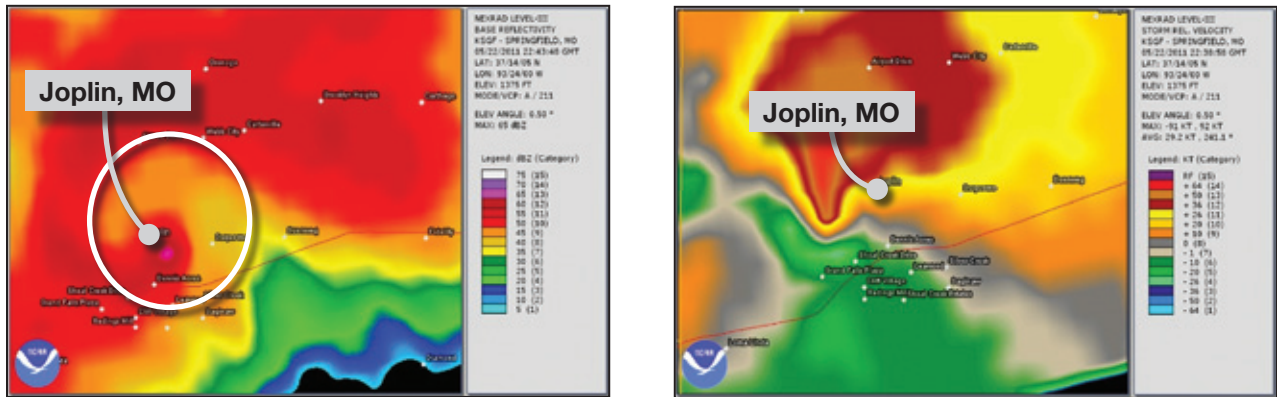
Figure 2-11: Joplin, MO, base reflectivity with hook echo (white circle, left) at 5:43 p.m. and storm relative velocity at 5:38 p.m. (right)

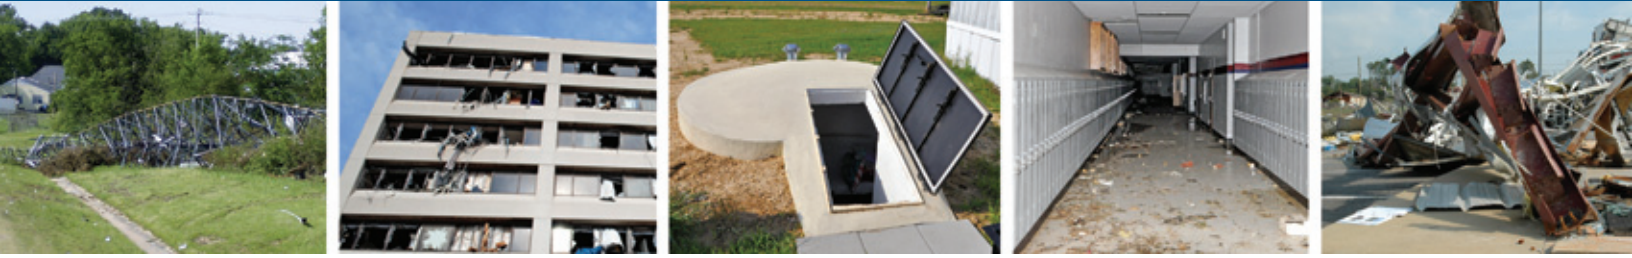
# TORNADO OUTBREAK *of* 2011

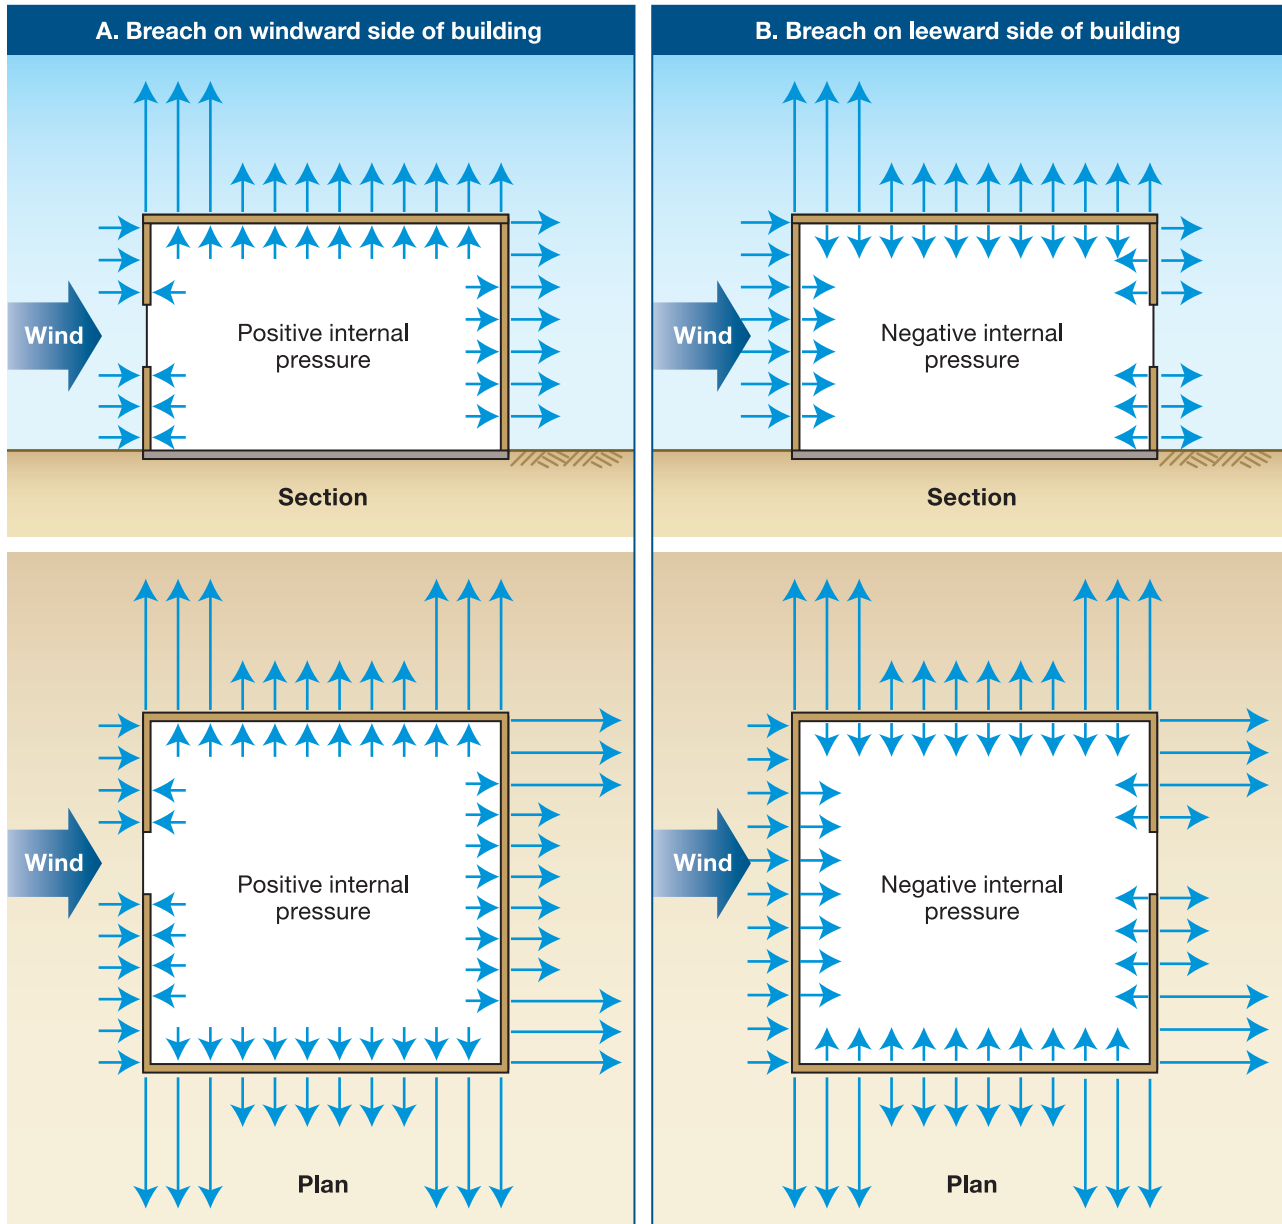
Figure 3-1: Effects of a breach in a building envelope when the breach is on the windward (a) or leeward (b) side of a building, shown in plan and section views

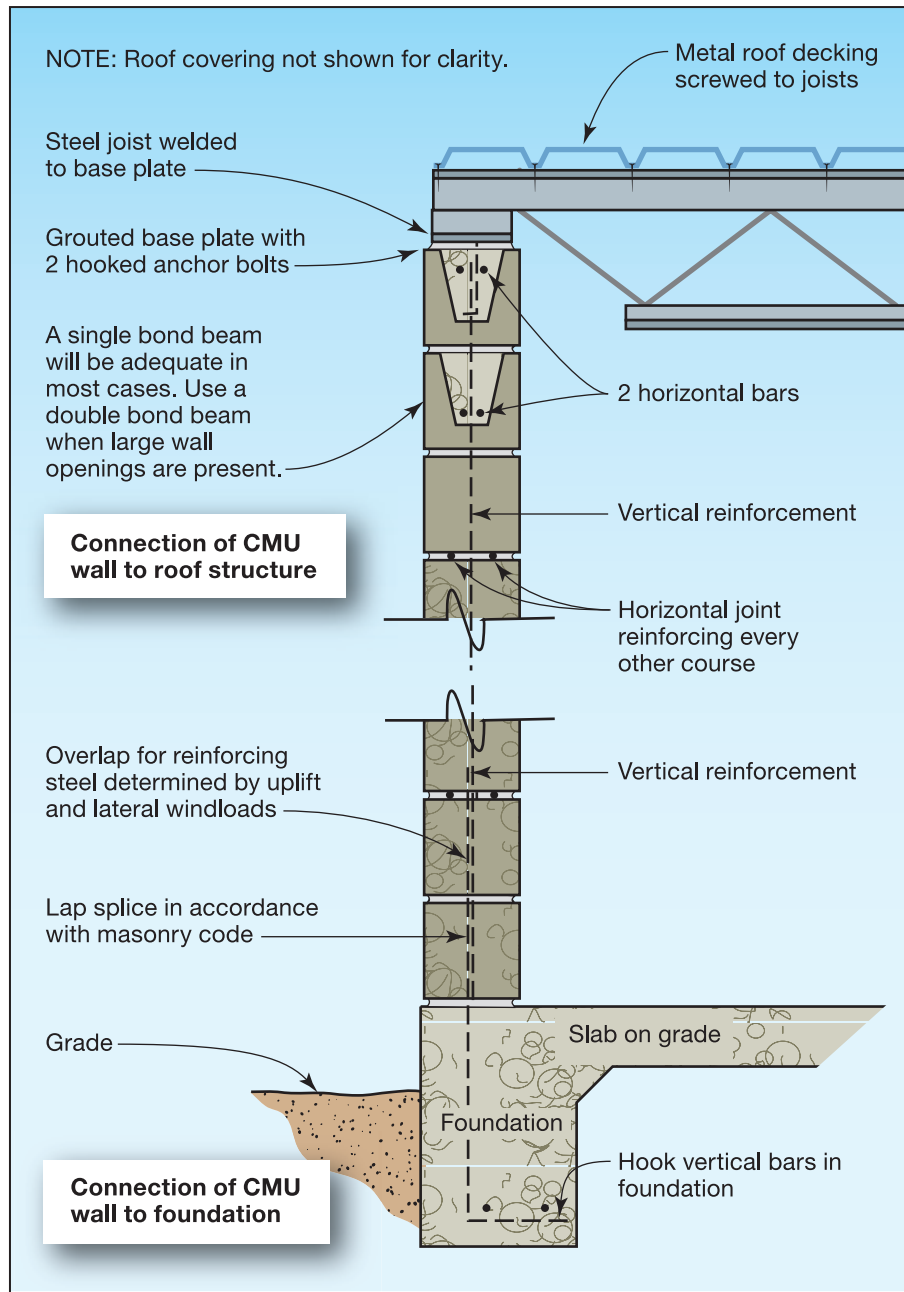
**Figure 3-2:**  
**Load path continuity in**  
**CMU wall**  
 SOURCE: FEMA 577, FIGURE 4-26

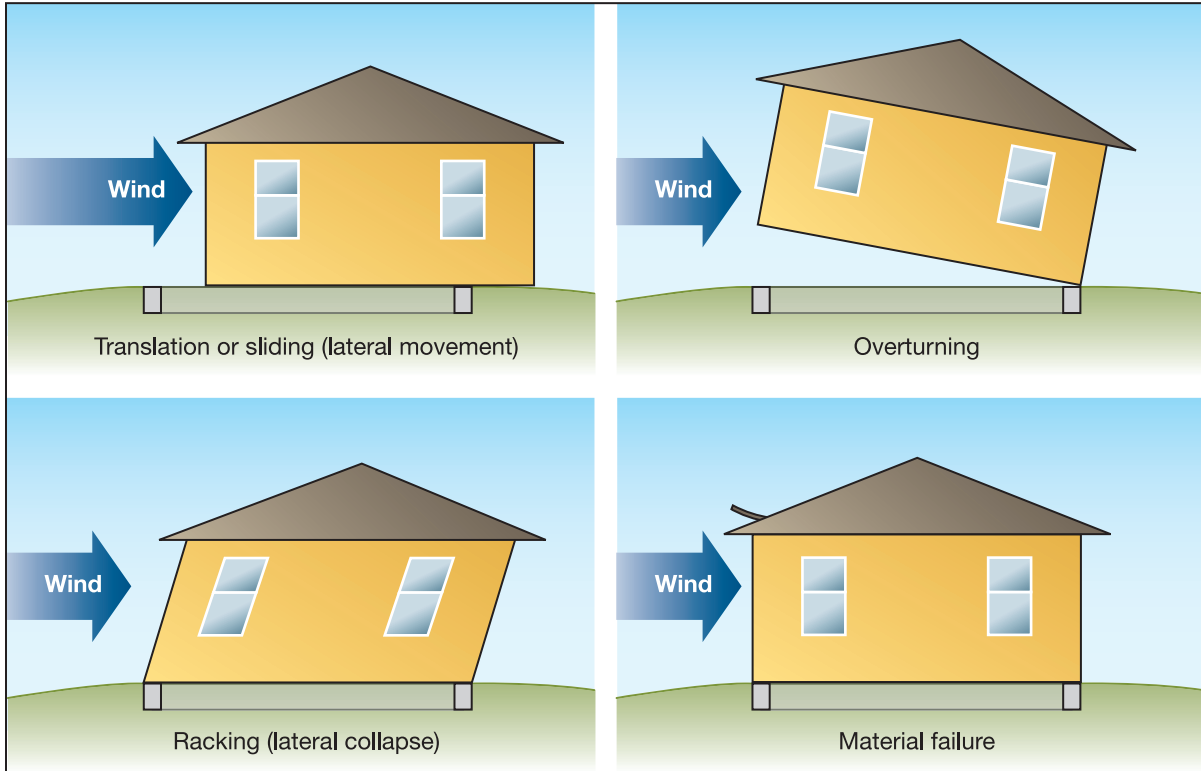
Figure 3-3: Building failure modes in high-wind event

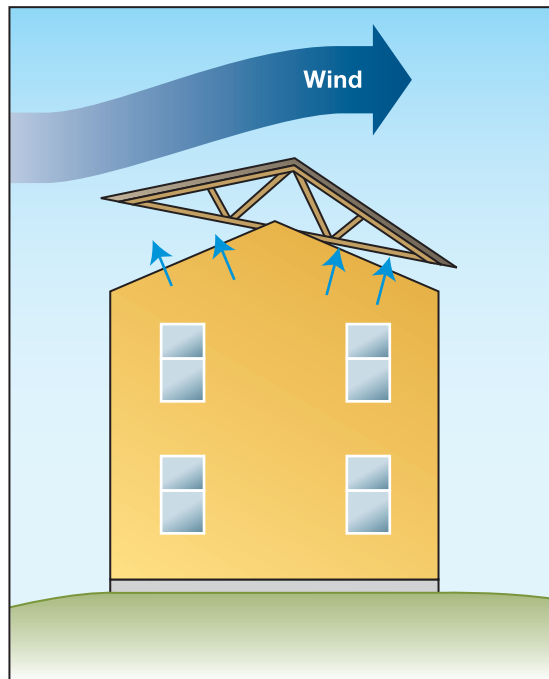
Figure 3-4: Uplift pressures acting on a building

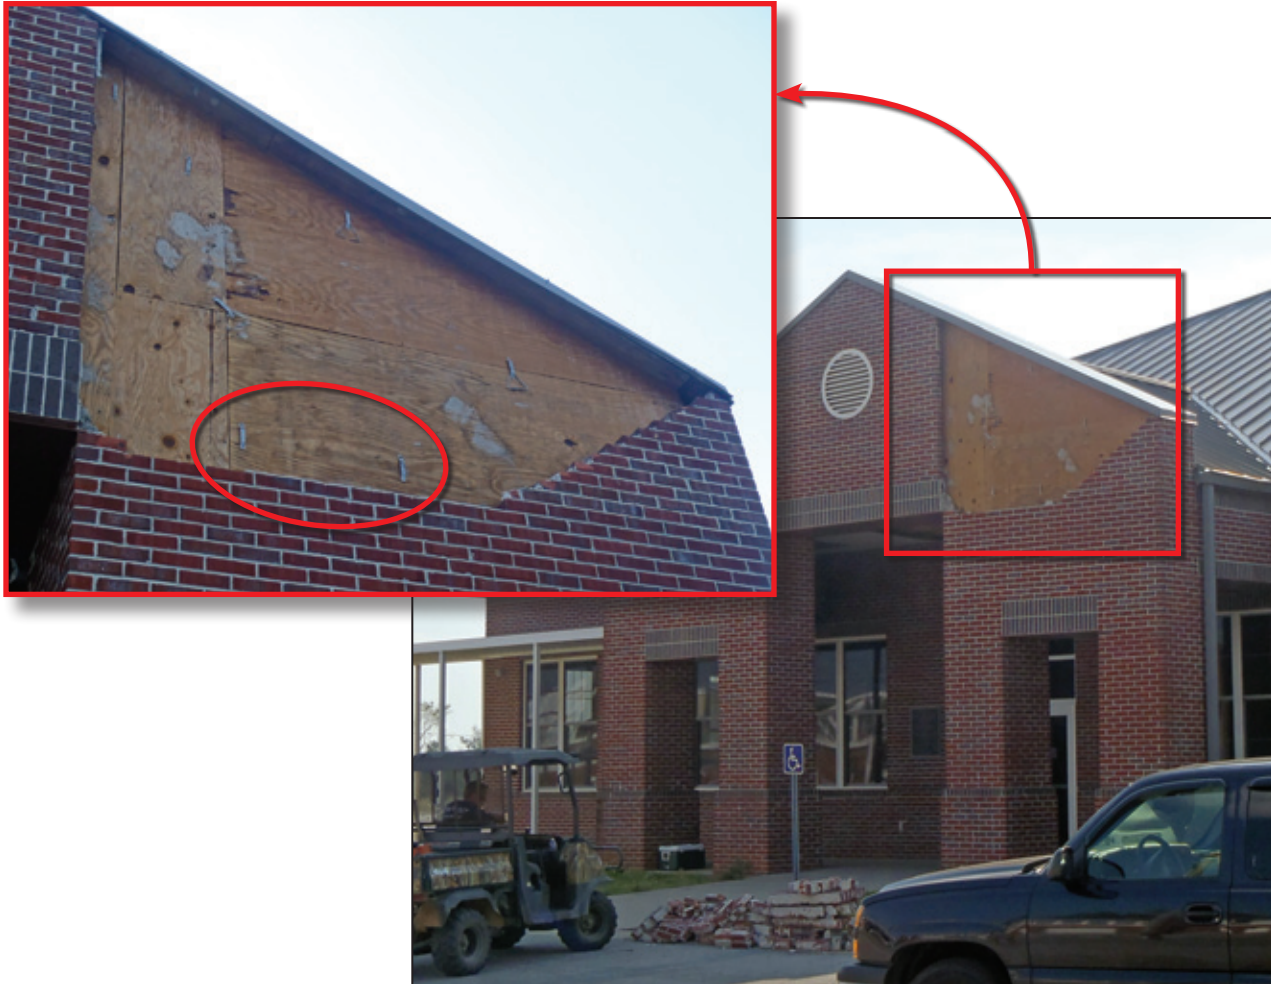
Figure 3-5: Brick veneer blew off this high school cafeteria during the tornado in Phil Campbell, AL. Note that brick ties do not appear to be at the correct spacing, which may have contributed to the failure (shown in red circle in inset).

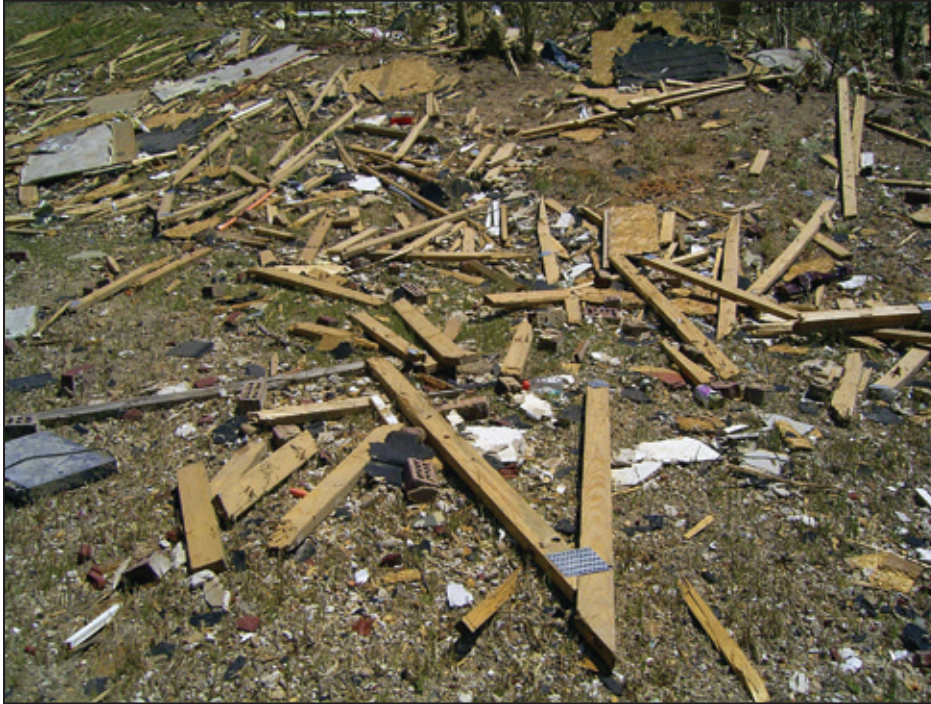
**Figure 3-6:**  
Example of small- and medium-sized missiles commonly observed by the MAT (photograph taken near an apartment complex in Tuscaloosa, AL)

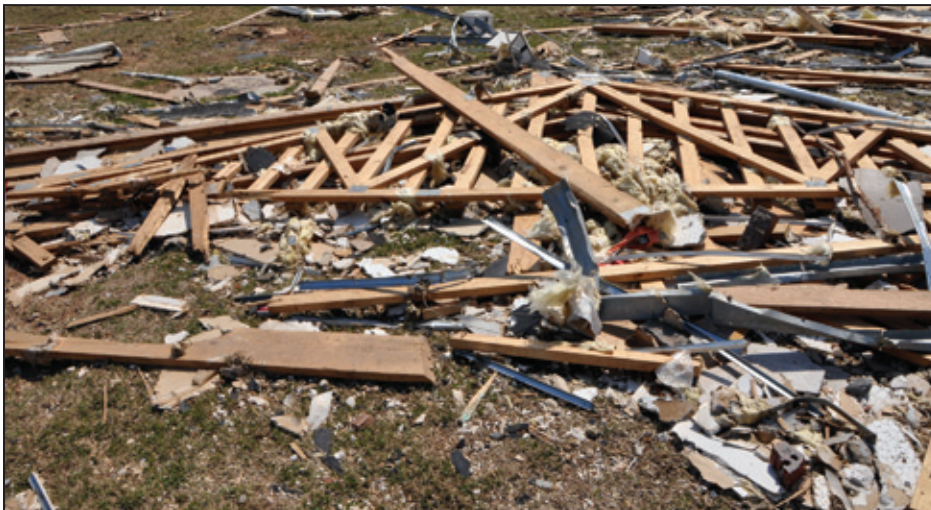
**Figure 3-7:**  
Example of medium- to large-sized wind-borne missiles (photograph shows roof trusses displaced from a nearby building in Tuscaloosa, AL)

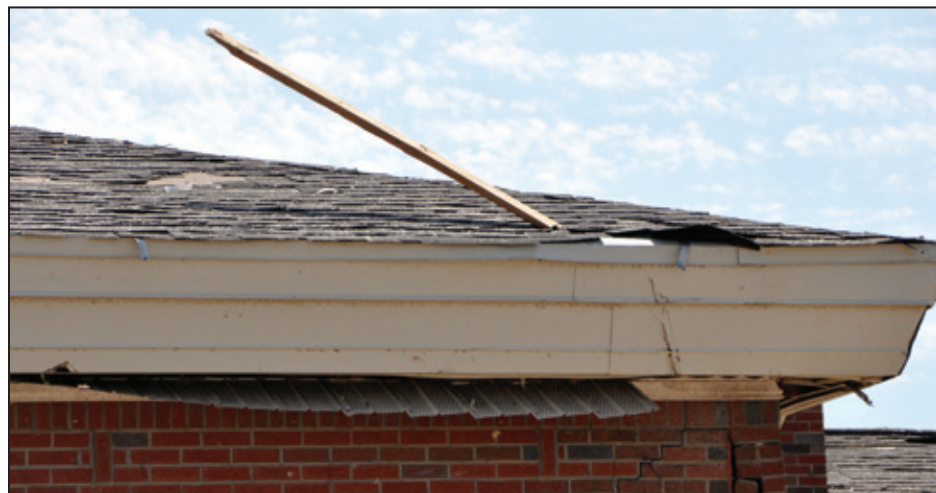
Figure 3-8: Medium-sized missile that struck the roof of a school building (Tuscaloosa, AL)

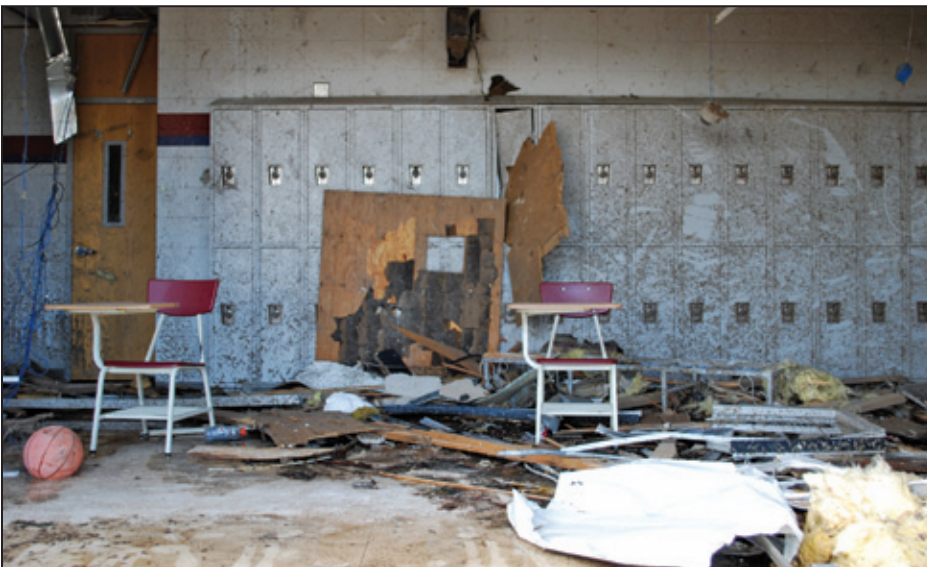
**Figure 3-10:**  
OSB damaged the first floor locker in Joplin High School (Joplin, MO)

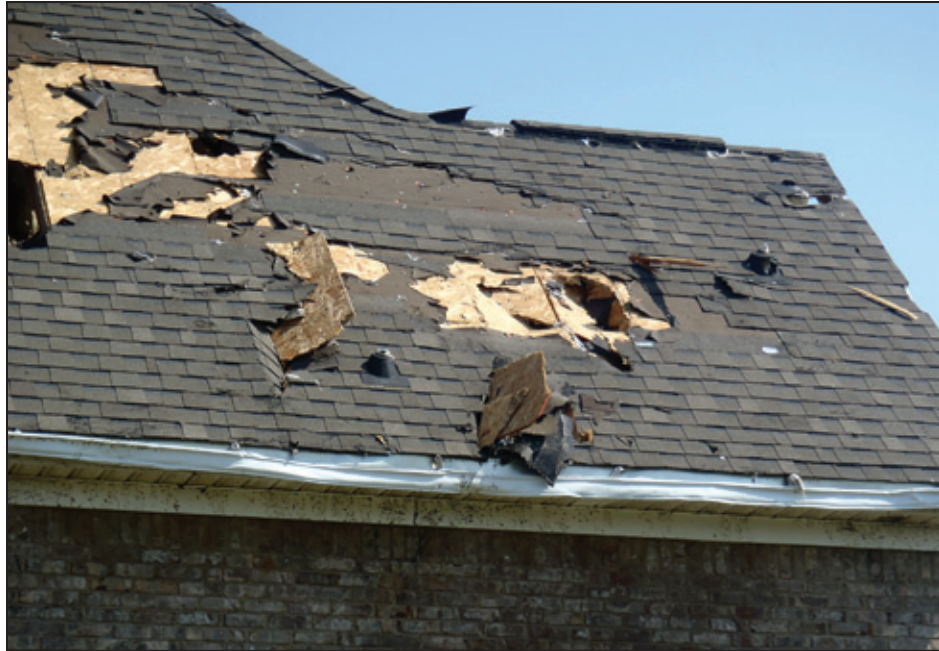
Figure 3-12 shows metal sheathing blown from the roof of the Fultondale Fire Station in Fultondale, AL, and carried nearly 200 feet. Figure 3-13 shows a car in Joplin, MO, with its roof penetrated by a 2x6 framing member. The MAT also observed cars that had become rolling debris during the tornado events, similar to other large debris types.

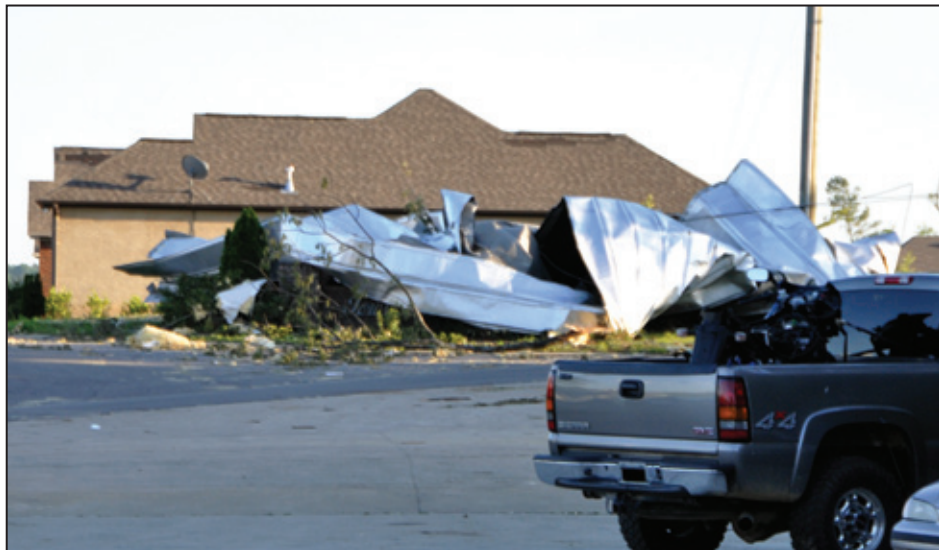
**Figure 3-12:**  
Metal sheathing travelled  
200 feet as wind-borne  
debris and landed next to  
a building outside of the  
tornado swath  
(Fultondale, AL)

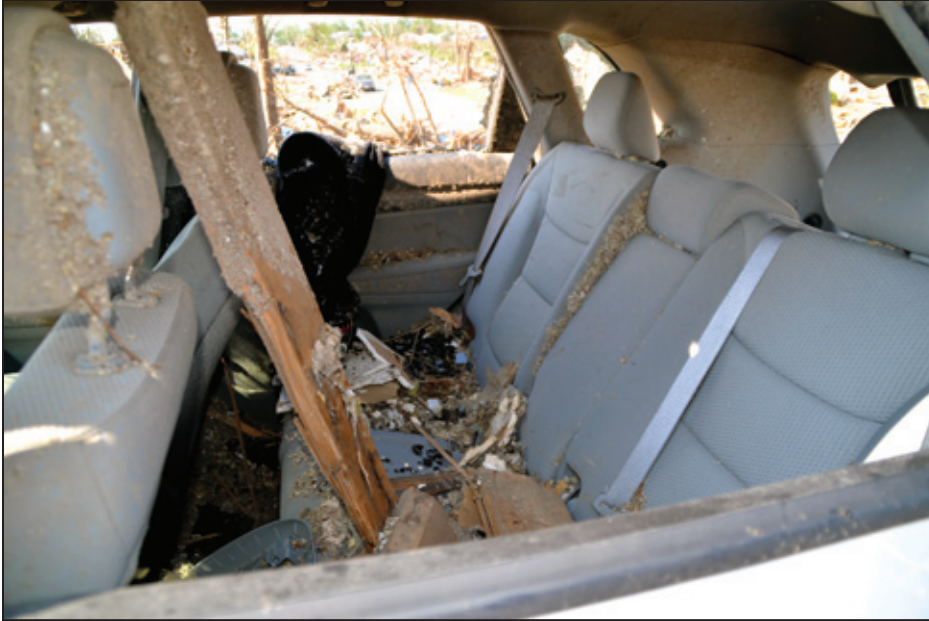
**Figure 3-13:**  
A 2x6 missile penetrated the roof and seat of a car in a residential neighborhood just outside the damage track of the violent tornado in Joplin, MO

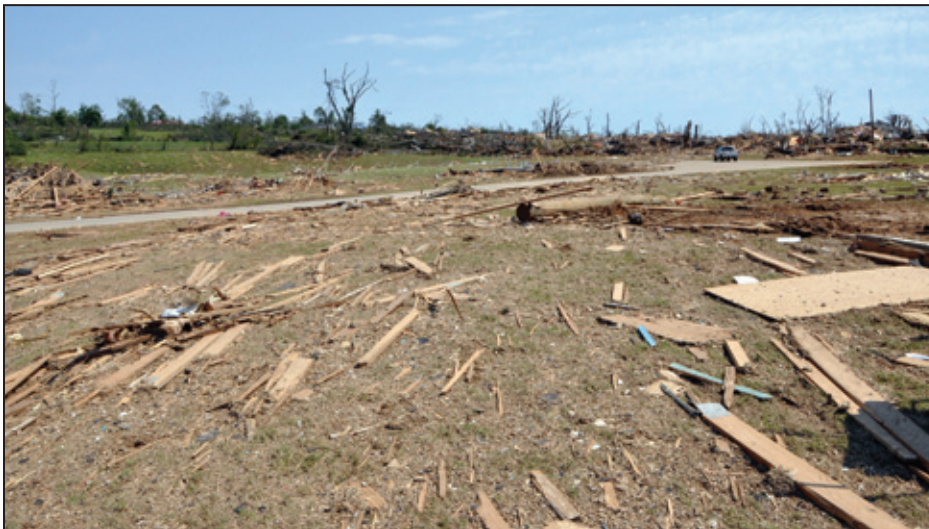
**Figure 3-14:**  
Wind-borne debris consisting of wood framing members and plywood sheathing near the Alberta Elementary School, Tuscaloosa, AL

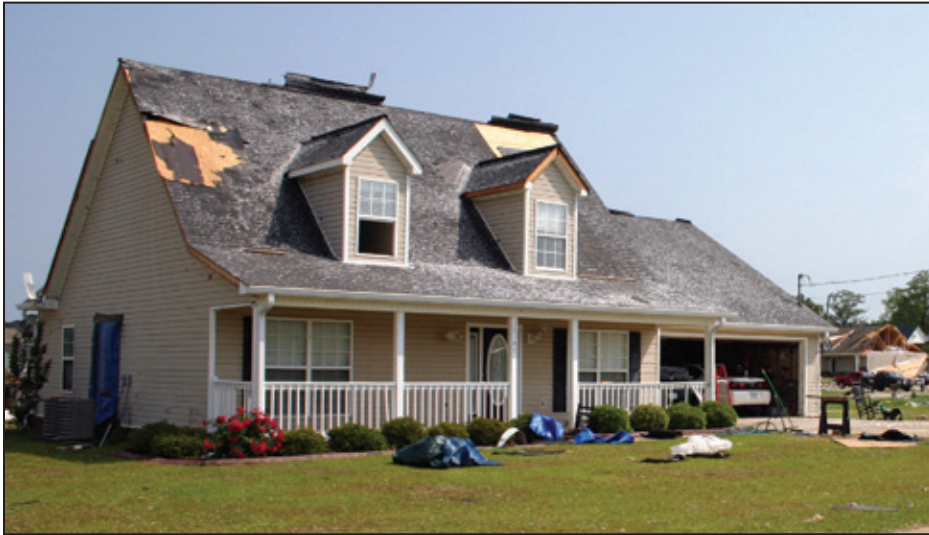
Figure 4-2:  
Example of DOD 2 (loss  
of asphalt shingles)  
(Tuscaloosa, AL; photograph  
courtesy of Tuscaloosa  
County EMA)  
[MAT EF Rating = 0]

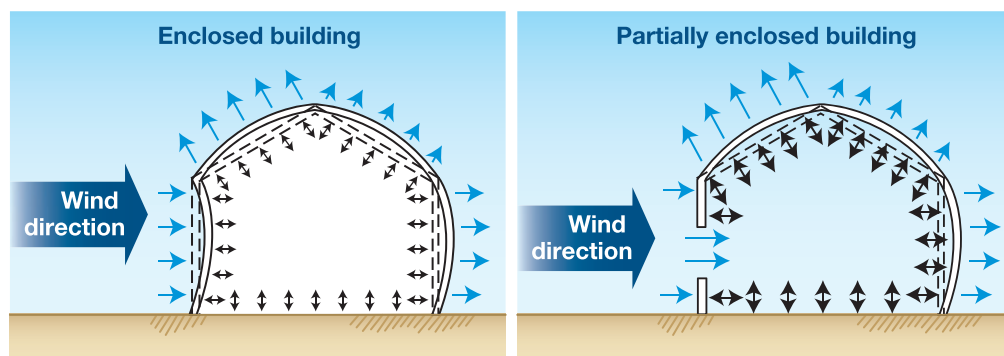
The MAT observed some buildings that benefitted from the installation of insulated glazing units (i.e., double-paned windows), where the outer pane was sacrificed but the inner pane remained intact, as illustrated in Figure 4-6. Energy code changes that require increased efficiency are leading to more double- and triple-paned glazing units in new residential construction. However, most windows of this type were not designed to provide extra protection from wind-borne debris and were breached on impact, as shown in Figure 4-7.

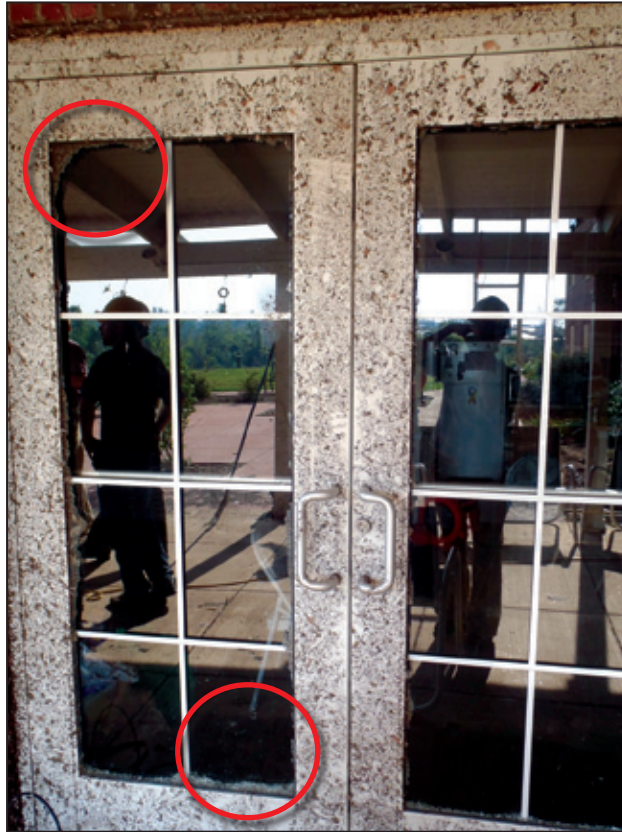
**Figure 4-6:**  
Double-glazed window with outer pane sacrificed (remaining fragments are circled in red), leaving the inner glazing intact (Mercy Village, Joplin, MO); refer also to Section 4.2.3 for a case study of Mercy Village

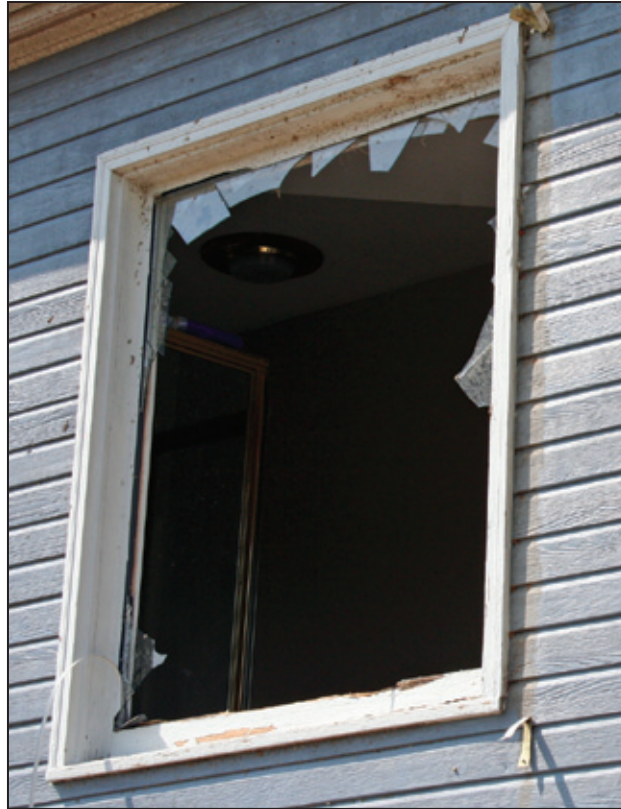
#### 4.1.5 Garage Doors Collapse Inward (DOD 4)

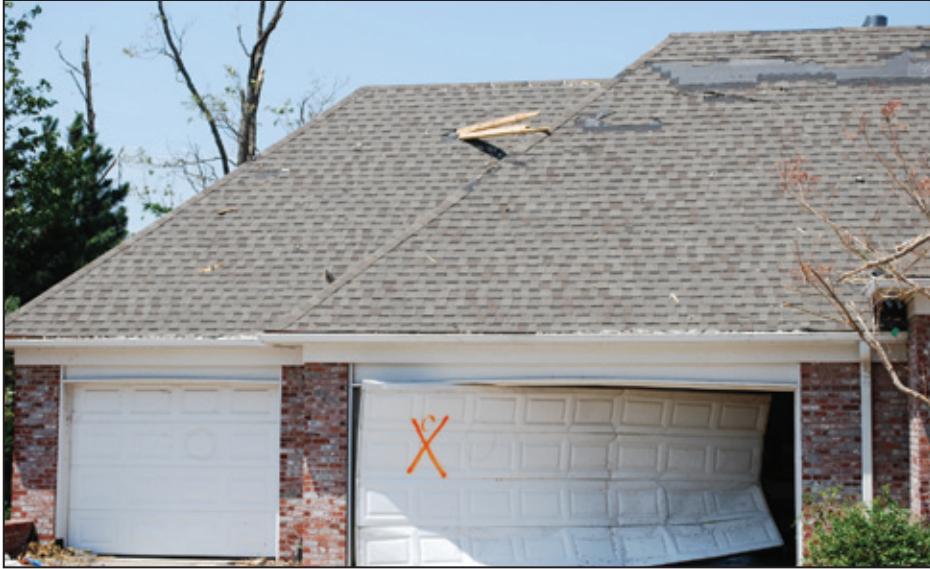
Figure 4-8:  
Example of DOD 4 showing a wide garage door collapsed inward, while narrow garage door to left is intact. Note also the wind-borne missile in roof above (Joplin, MO). [MAT EF Rating = 2]<sup>2</sup>

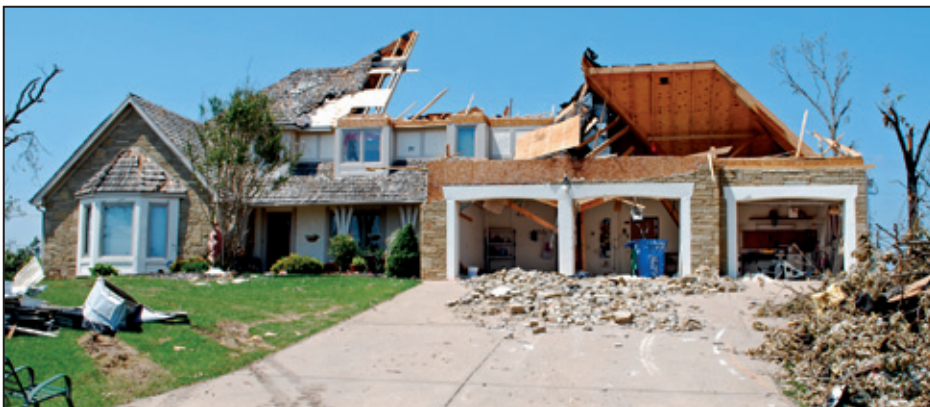
Figure 4-10:  
Example of how garage door failure (DOD 4) initiated progressive failure, including loss of the garage roof (DOD 6) (Joplin, MO) [MAT EF Rating = 2]
