## Mitigation Assessment Team Report

# Spring 2011 Tornadoes: April 25-28 and May 22

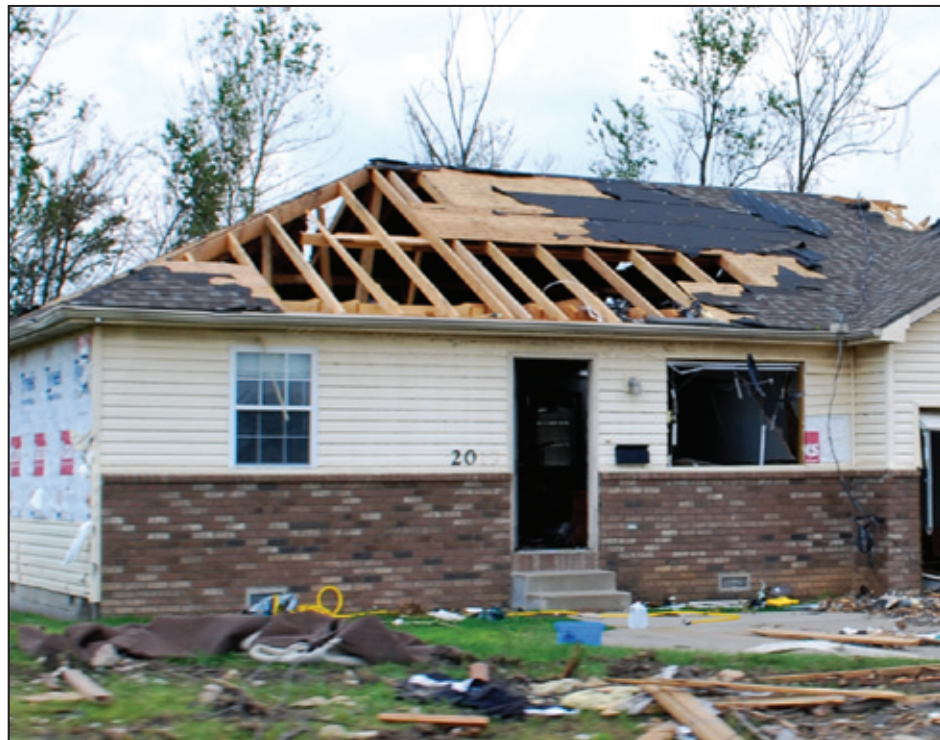
<sup>3</sup> More extensive building damage not apparent in this image resulted in a higher site DOD and EF scale rating.

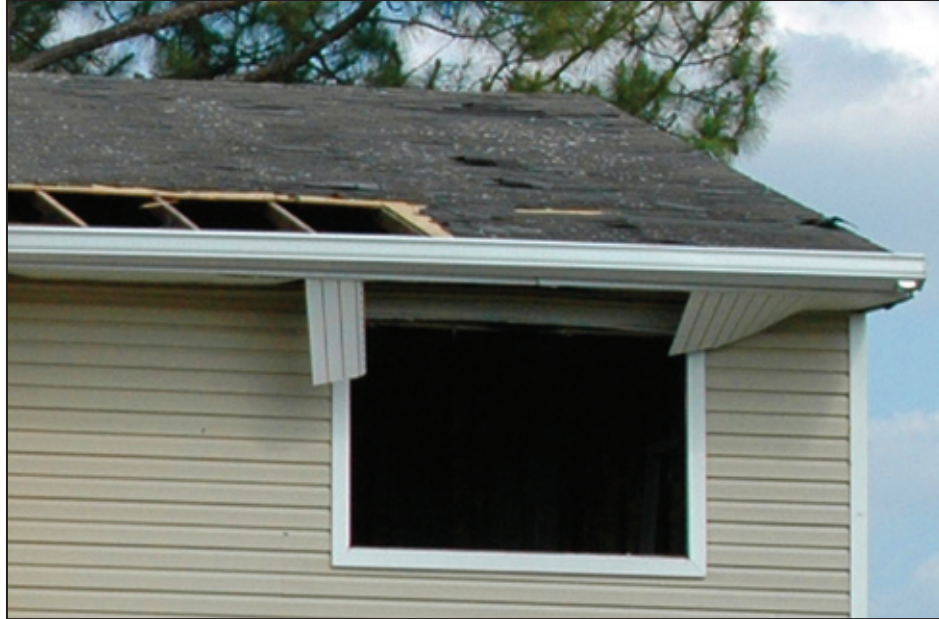
Figure 4-14:  
Example of DOD 4 showing roof decking removed at wide eaves on hip roof (Phil Campbell, AL) [MAT EF Rating = 1]

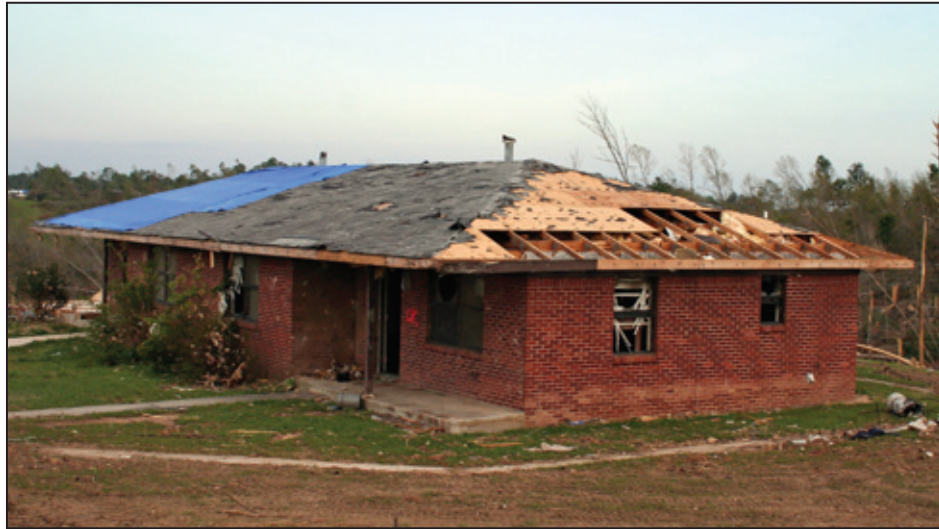
Poor construction methods can also decrease resistance to wind uplift. Figure 4-15 shows a residence where at least one of the roof deck nails along the panel edges failed to penetrate the rafter below. The expected performance is subsequently rendered weaker than intended by the building code or design professional. Improper spacing of fasteners and the use of improperly sized fasteners result in the same effect.

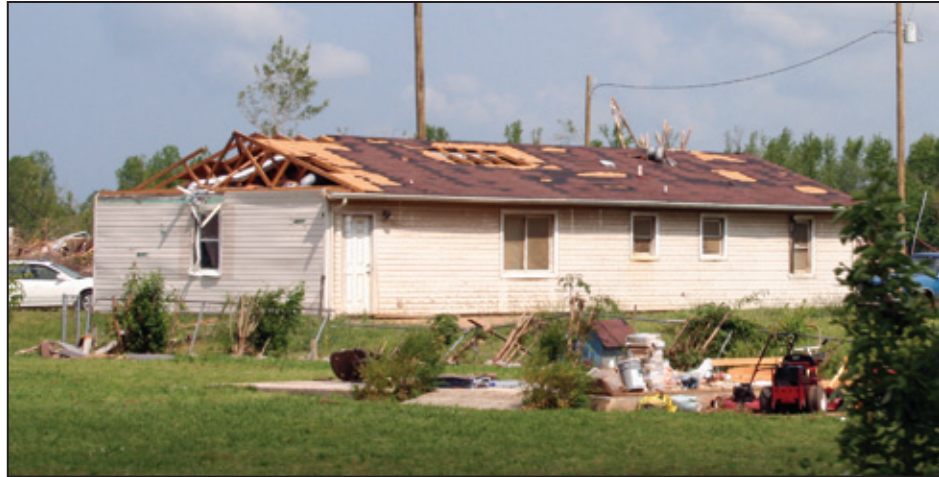
#### 4.1.8 Entire House Shifts Off Foundation (DOD 5)

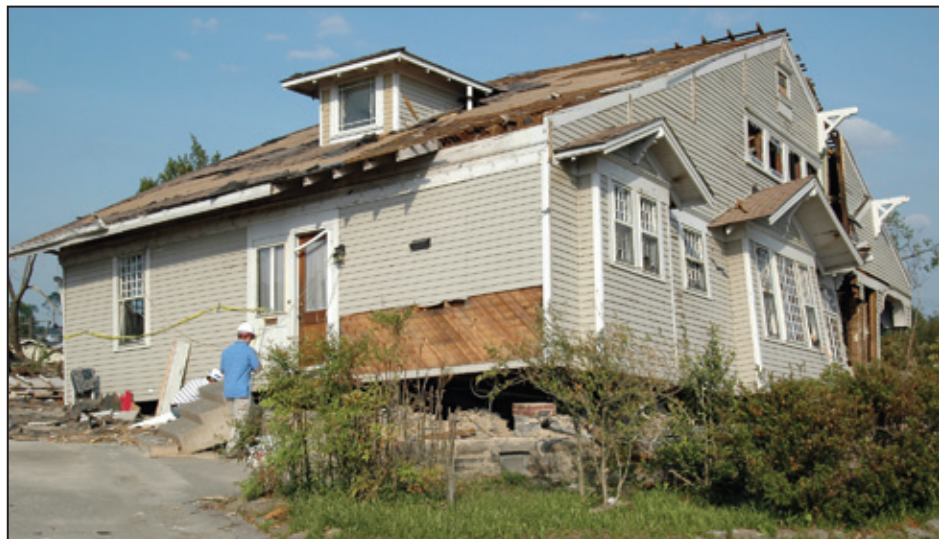
### 4.1.9 Roof Structure Removed (DOD 6)

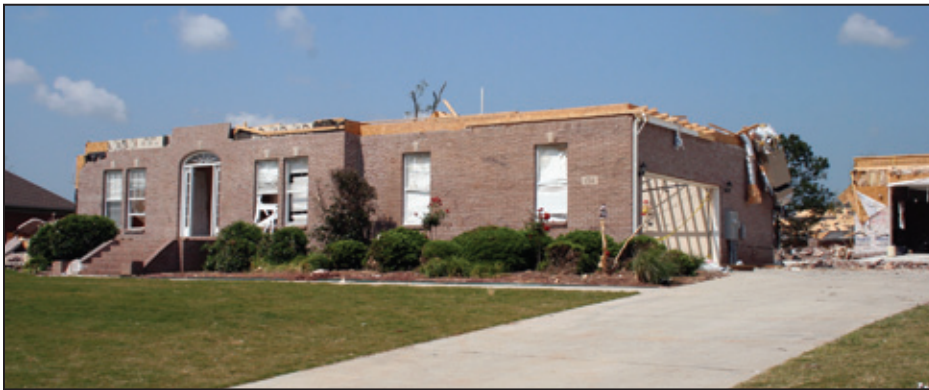
**Figure 4-18:**  
Example of DOD 6 showing failed roof-to-wall connections that resulted in loss of roof structure (Harvest, AL)  
[MAT EF Rating = 2]

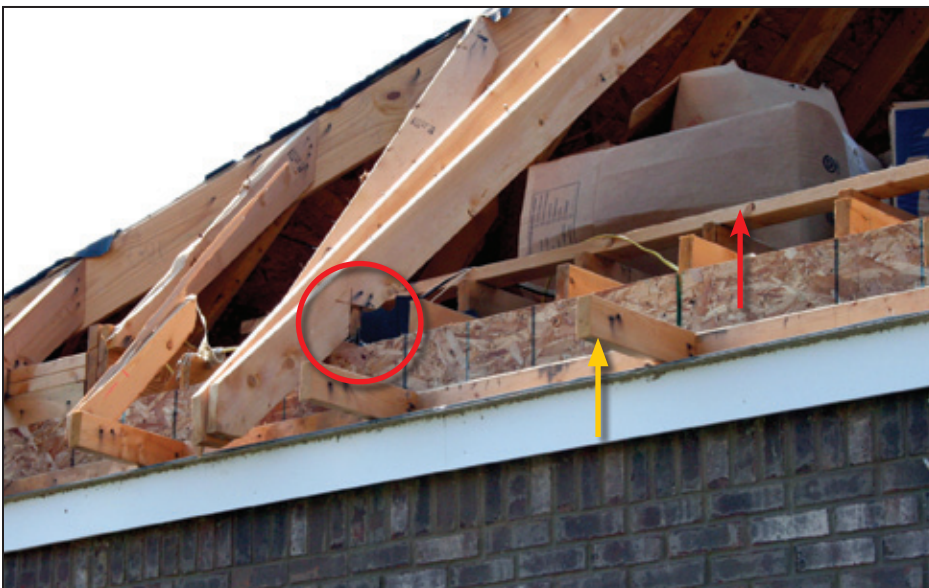
**Figure 4-19:**  
Example of roof-to-wall connection failure facilitated by non-code-compliant construction: notched rafters, known as “bird’s mouth,” (red circle) displaced when roof-to-wall connections failed; red arrow indicates rafter bearing plate, yellow arrow indicates outlooker (Harvest, AL)  
[MAT EF Rating = 1]

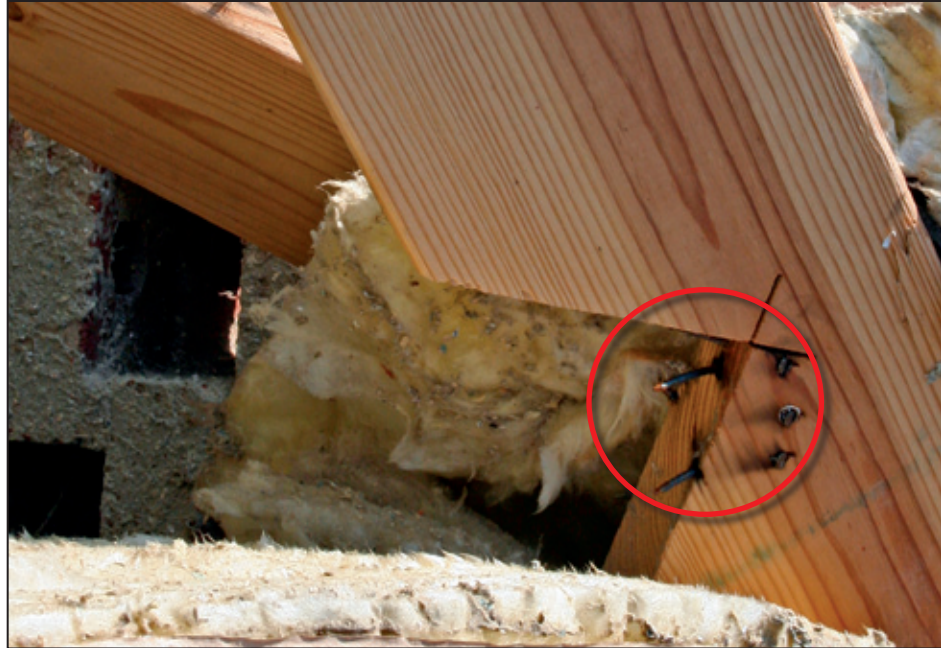
Metal connectors designed to transfer uplift forces from the rafter or truss to the wall below greatly enhance connectivity and were observed to outperform toe nail-only connections. In order to transfer uplift and lateral loads consistent with their maximum design capacities, metal connectors must be installed per the manufacturer's instructions.

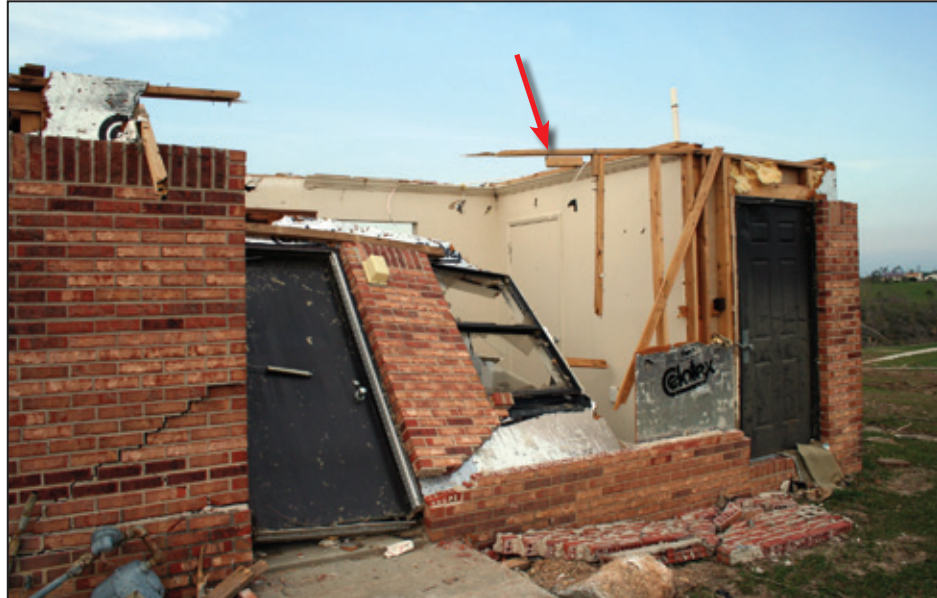
The floor system above the garage shown in Figure 4-24 separated from the framed exterior walls, allowing both the floor and walls to collapse. As shown in the inset to Figure 4-24, the double top plate of the garage entry wall was pulled away either with the fallen floor system or collapsed portion of the garage entry wall. The deeper floor system above the garage, which was installed to span the garage without intermediate support, appeared to be framed onto a lower top plate that interrupted the continuity of the top plate and weakened the connection to the adjacent walls.

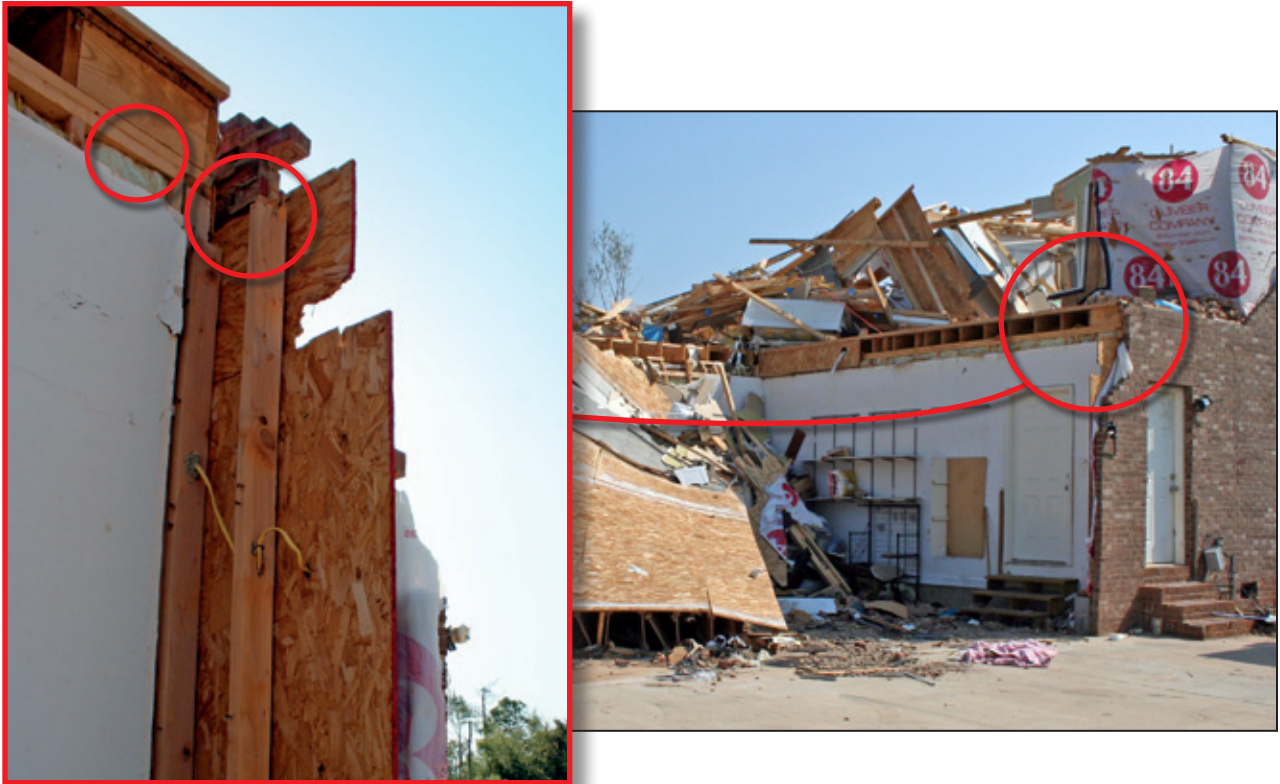
Figure 4-24: Example of DOD 6 showing pressurization of this garage from failure of the garage door/wall removed the support for the second story floor system (red circle). Inset shows where top plate of garage entry wall separated with floor or wall (red circles). Note former location of entry wall top plate—separated and missing from top of studs—is lower than the interior wall top plate due to deeper floor system (Harvest, AL). [MAT EF Rating = 2]

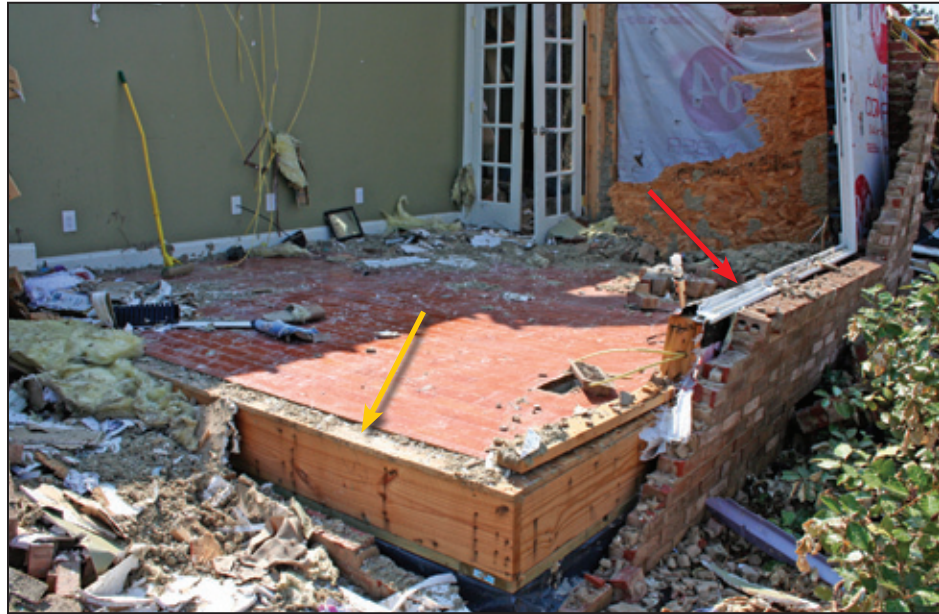
#### 4.1.11 Wall Framing-to-Foundation Connection Failure: Damage Related to Collapse of Framed Walls (DOD 7–9)

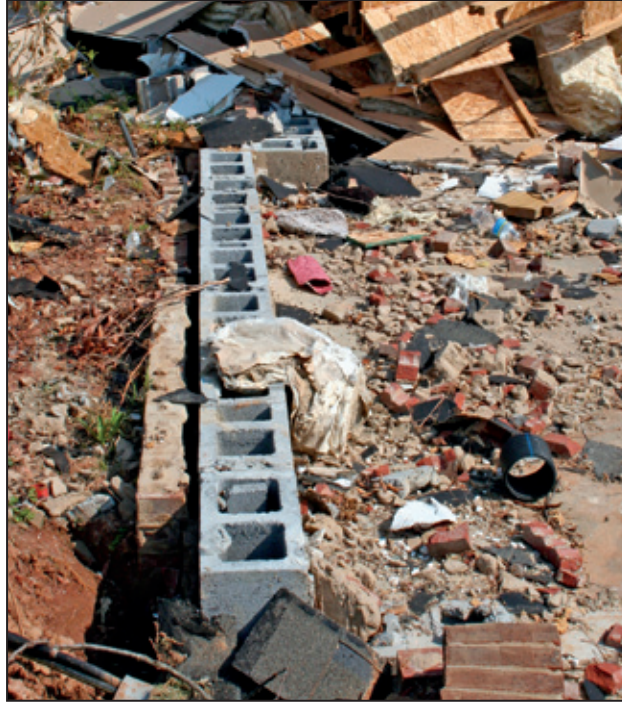
Figure 4-27:  
Example of wall framing-  
to-foundation connection  
failure. Wall and bottom  
plate separated from  
foundation where anchorage  
of collapsed framed wall  
failed because anchors  
lacked embedment in grout.  
Note CMU wall with no  
reinforcement or solid grout  
(Harvest, AL).  
[MAT EF Rating = 2]

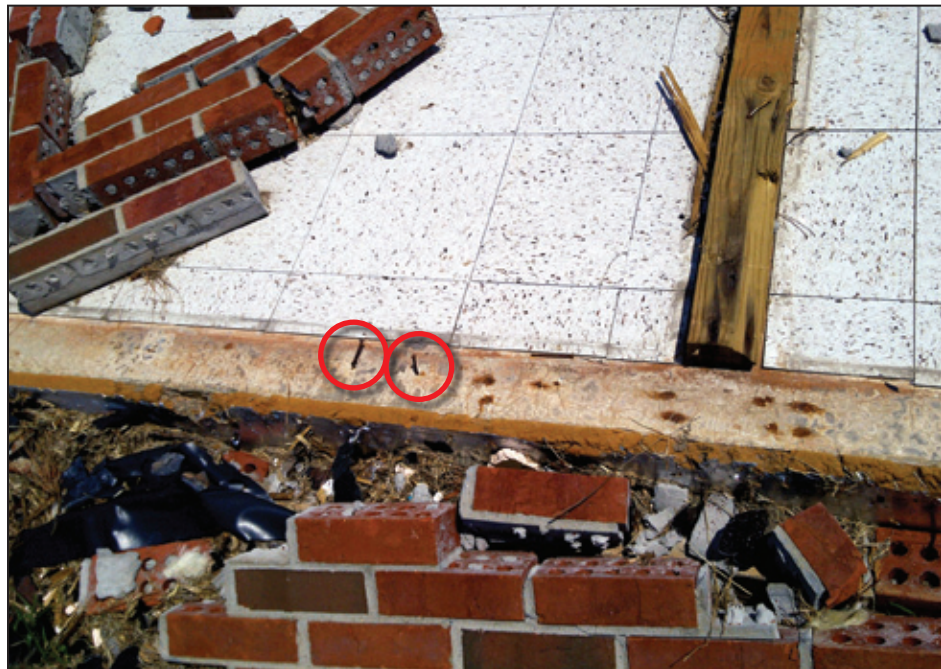
Figure 4-29:  
Wall-to-foundation connection failure where concrete nails remained in stained concrete slab and bottom plate (missing) pulled over the heads of the nails (red circles) (Hackleburg, AL) [MAT EF Rating = 3]

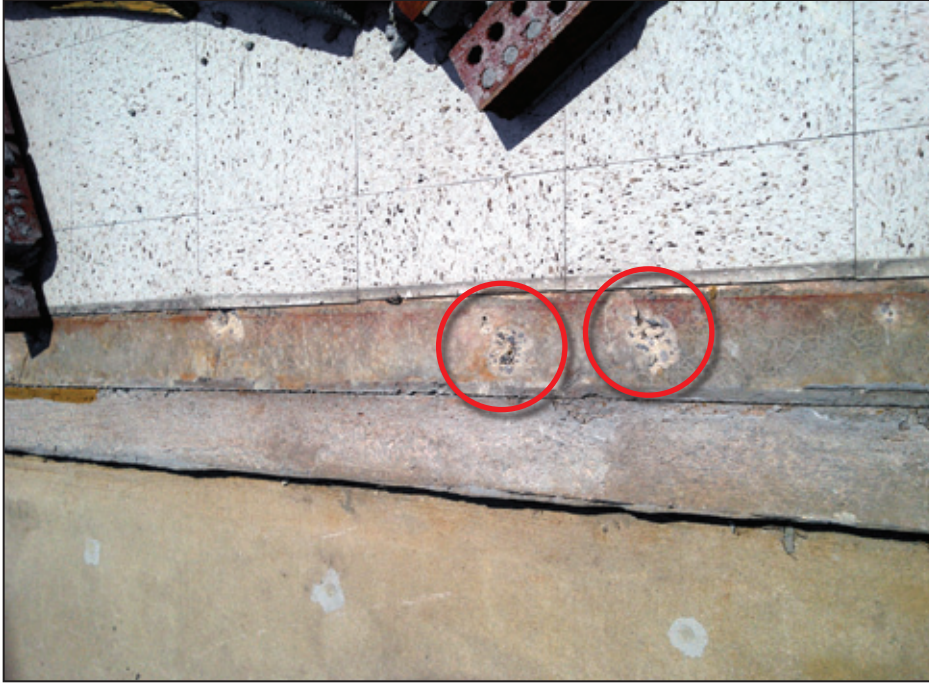
Figure 4-30:  
Wall-to-foundation failure where bottom plate and concrete nails were pulled out by high winds. Shallowly embedded concrete nails pulled small cones of concrete up with bottom plate (red circles) (Hackleburg, AL).  
[MAT EF Rating = 3]

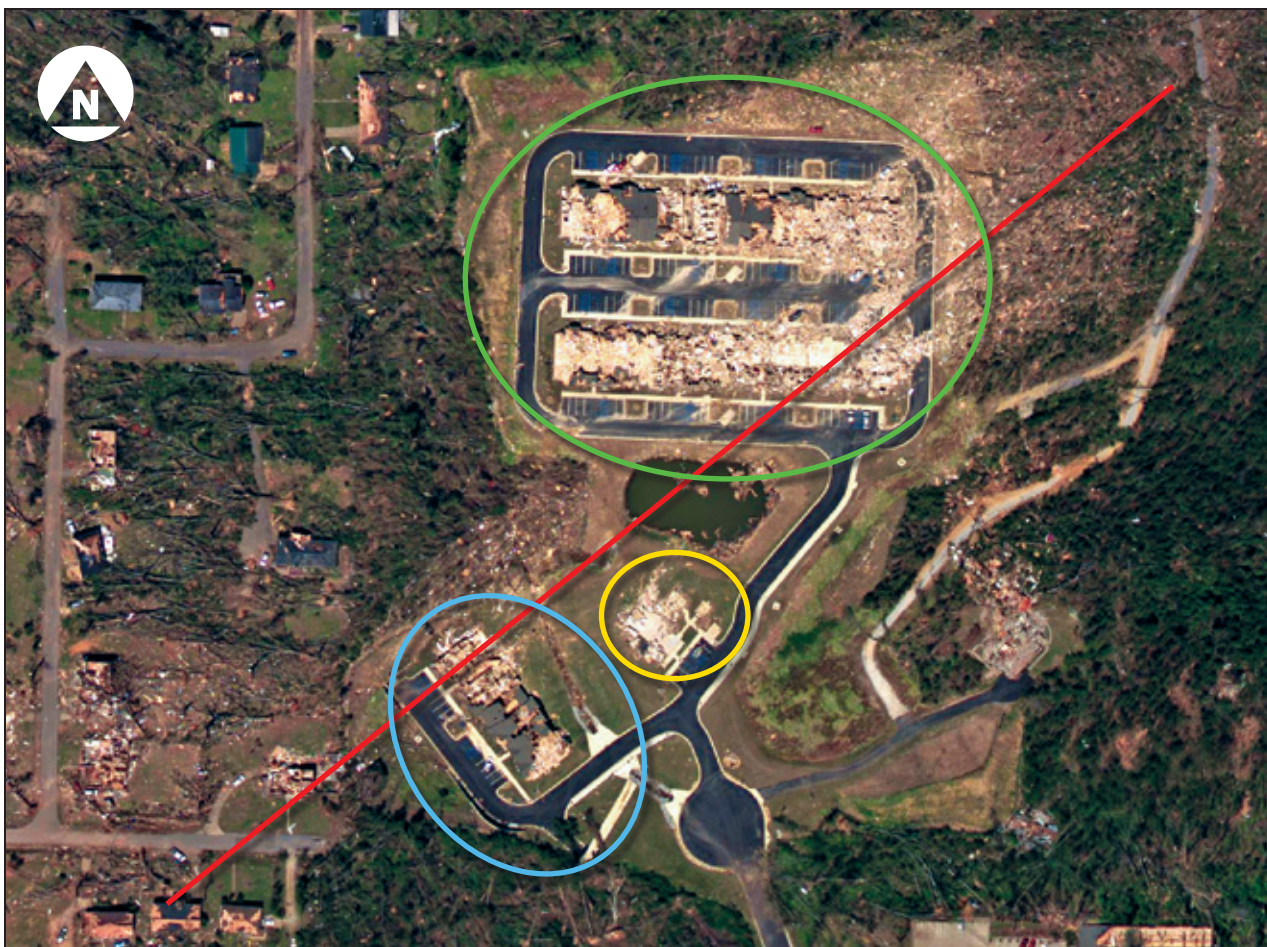
Figure 4-32: Aerial view of Chastain Manor Apartments in relationship to the approximate centerline of the tornado damage swath (red line).<sup>6</sup> The green circle indicates the two-story apartment buildings, the yellow circle shows the location of the leasing office, and the blue circle shows the location of a one-story apartment building (Tuscaloosa, AL). SOURCE: ALL AERIAL PHOTOGRAPHS ARE FROM NOAA IMAGERY ([HTTP://NGS.WOC.NOAA.GOV/STORMS](http://ngs.woc.noaa.gov/storms)) UNLESS OTHERWISE NOTED

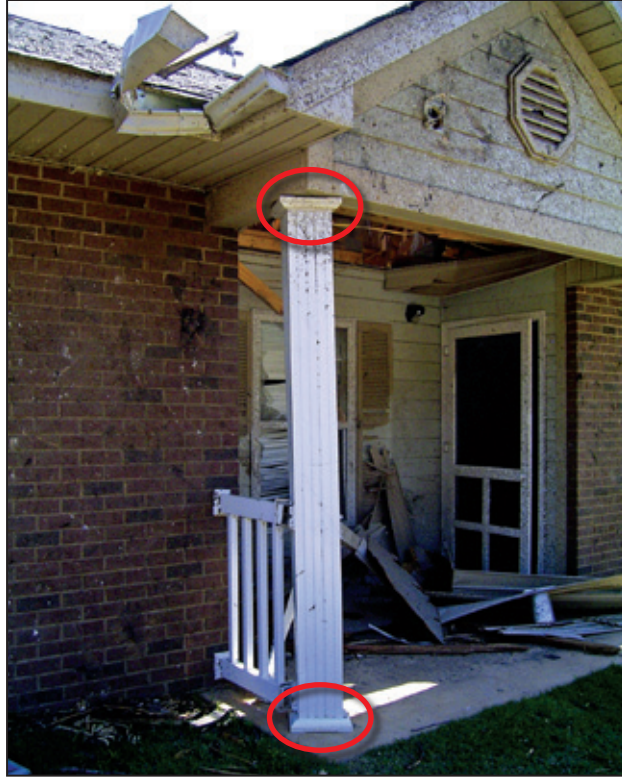
Figure 4-34:  
One-story Chastain Manor  
Apartment unanchored porch  
column that rotated at top  
and bottom of column (red  
circles)

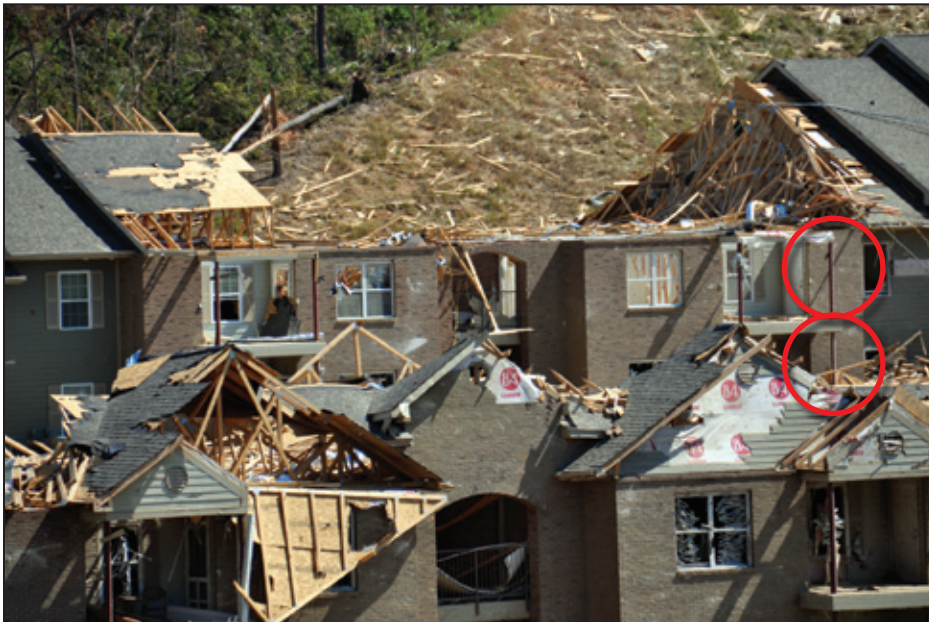
Figure 4-35:  
Example of DODs 3 and 4  
showing two-story Chastain  
Manor Apartments with  
varying roof damage. Note  
upper and lower steel pipe  
porch columns (red circles).

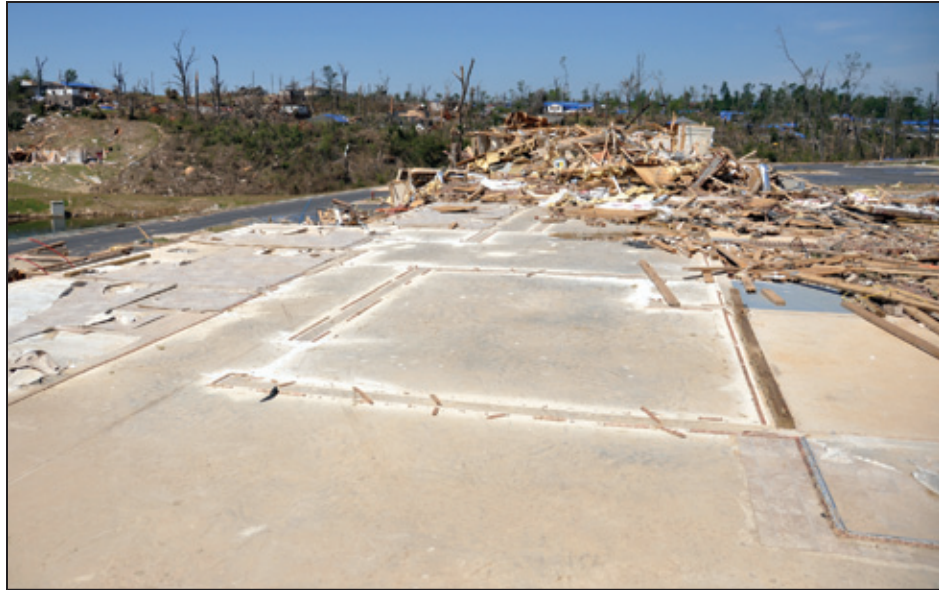
**Figure 4-37:**  
Two-story Chastain Manor Apartment steel porch column (shown in-place in Figure 4-34) was blown away and embedded in neighboring hillside

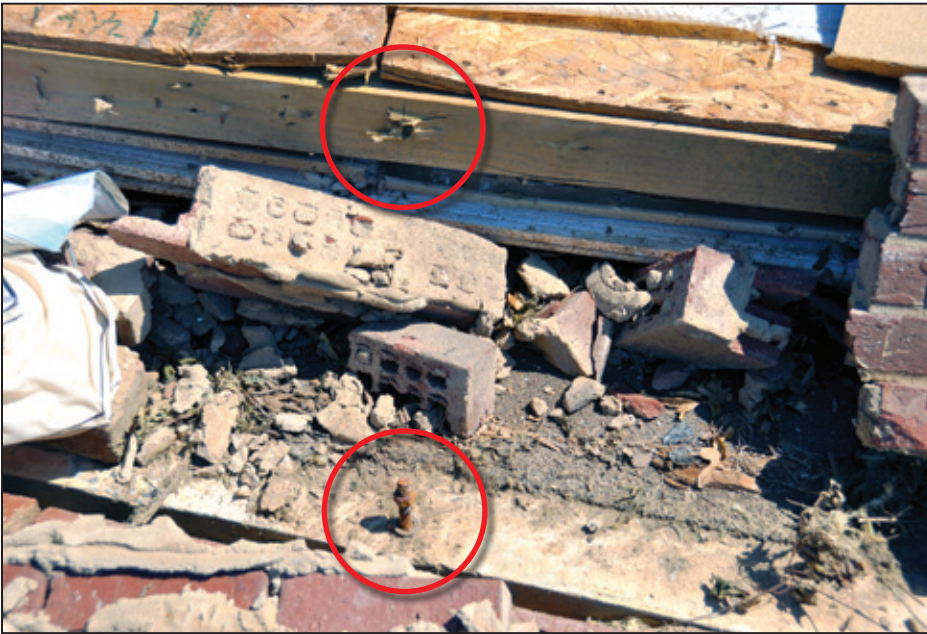
Figure 4-39:  
Two-story Chastain Manor  
Apartment slab with bottom  
plate pulled over remaining  
anchor bolt and 1-inch  
diameter washer; red circles  
indicate where bolt and plate  
were connected prior to  
damage

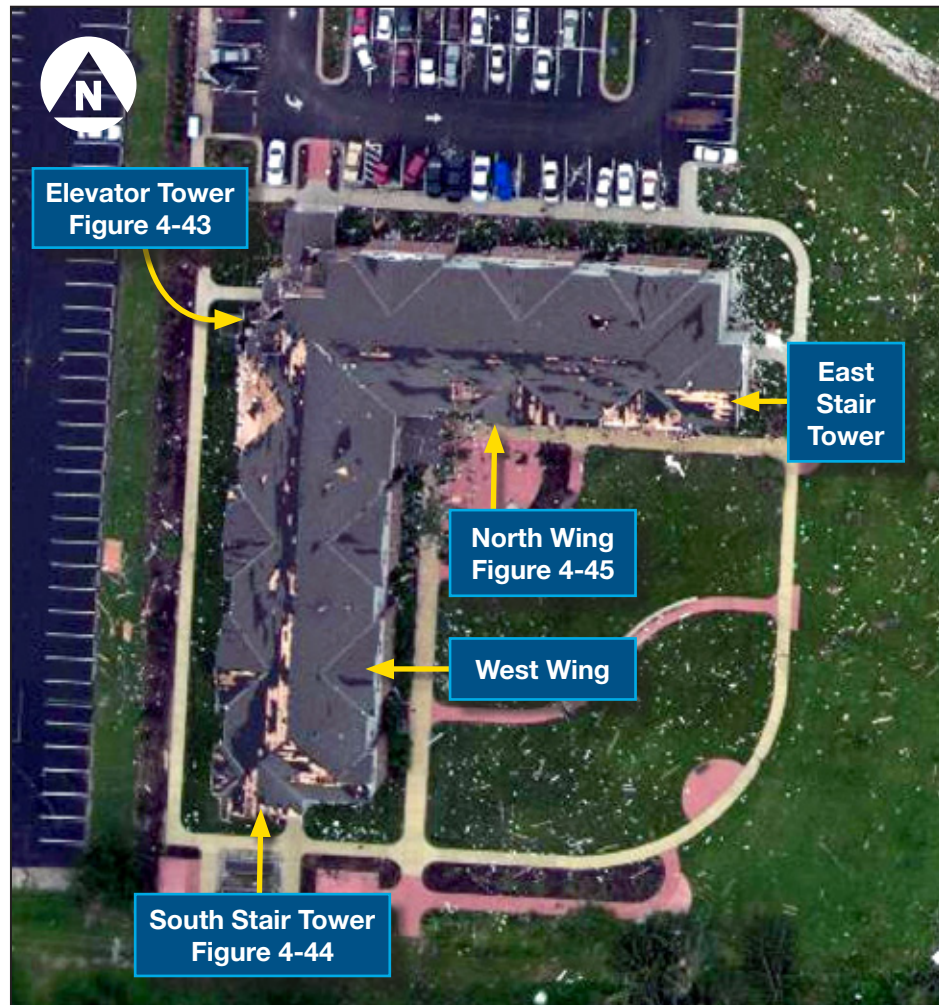
Sections of brick veneer fell off the elevator tower and caused damage to the single-story roof sections around the main entrance, maintenance room, and bathrooms, as shown in Figure 4-43. Aside from the elevator tower, damage to the brick veneer was minimal. The observed brick veneer damage was likely caused by debris impact and did not appear to indicate building movement relative to the foundation (or any significant movement of the building below the third floor). The brick veneer was attached with adjustable wall ties at 16 inches on center vertically and 32 inches on center horizontally as specified.

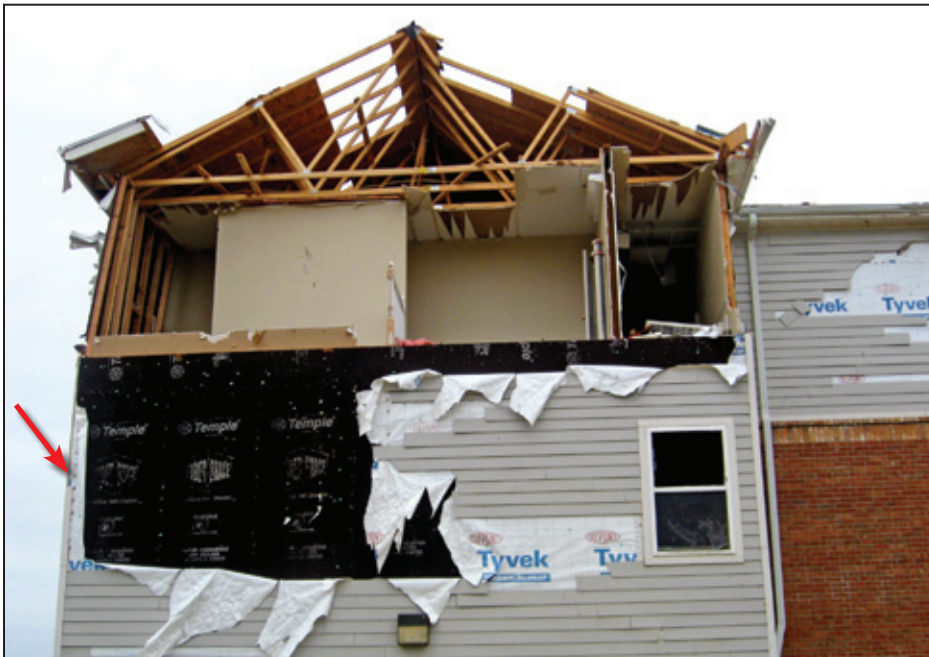
Figure 4-44:  
Damage to the gable end wall at south stair tower end. Note third floor wall is missing and second floor wall is bowed outward (red arrow).

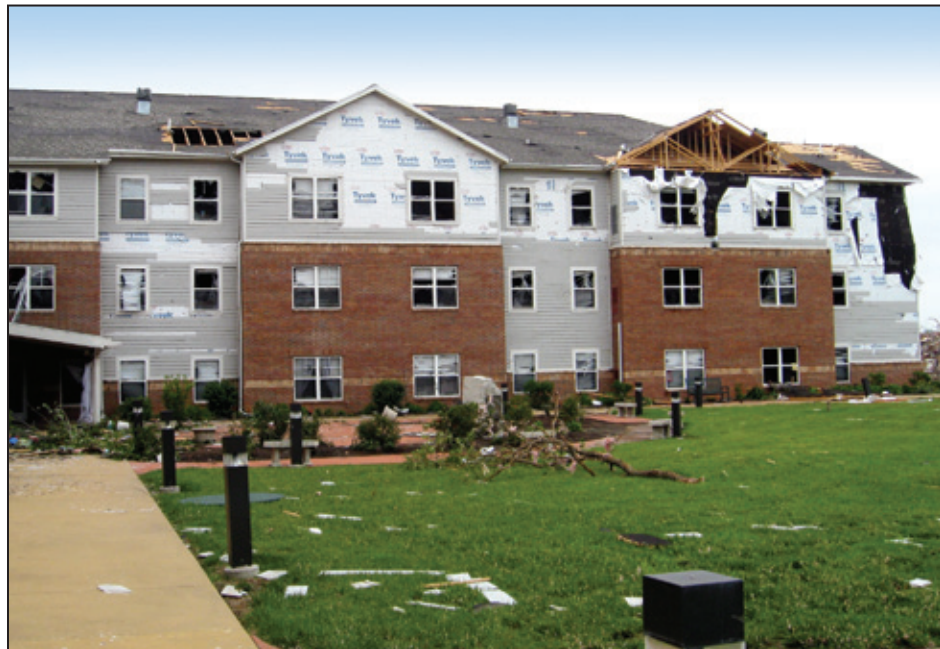
**Figure 4-45:**  
Damaged glazing on the interior courtyard of north wing building; majority of glazing was damaged

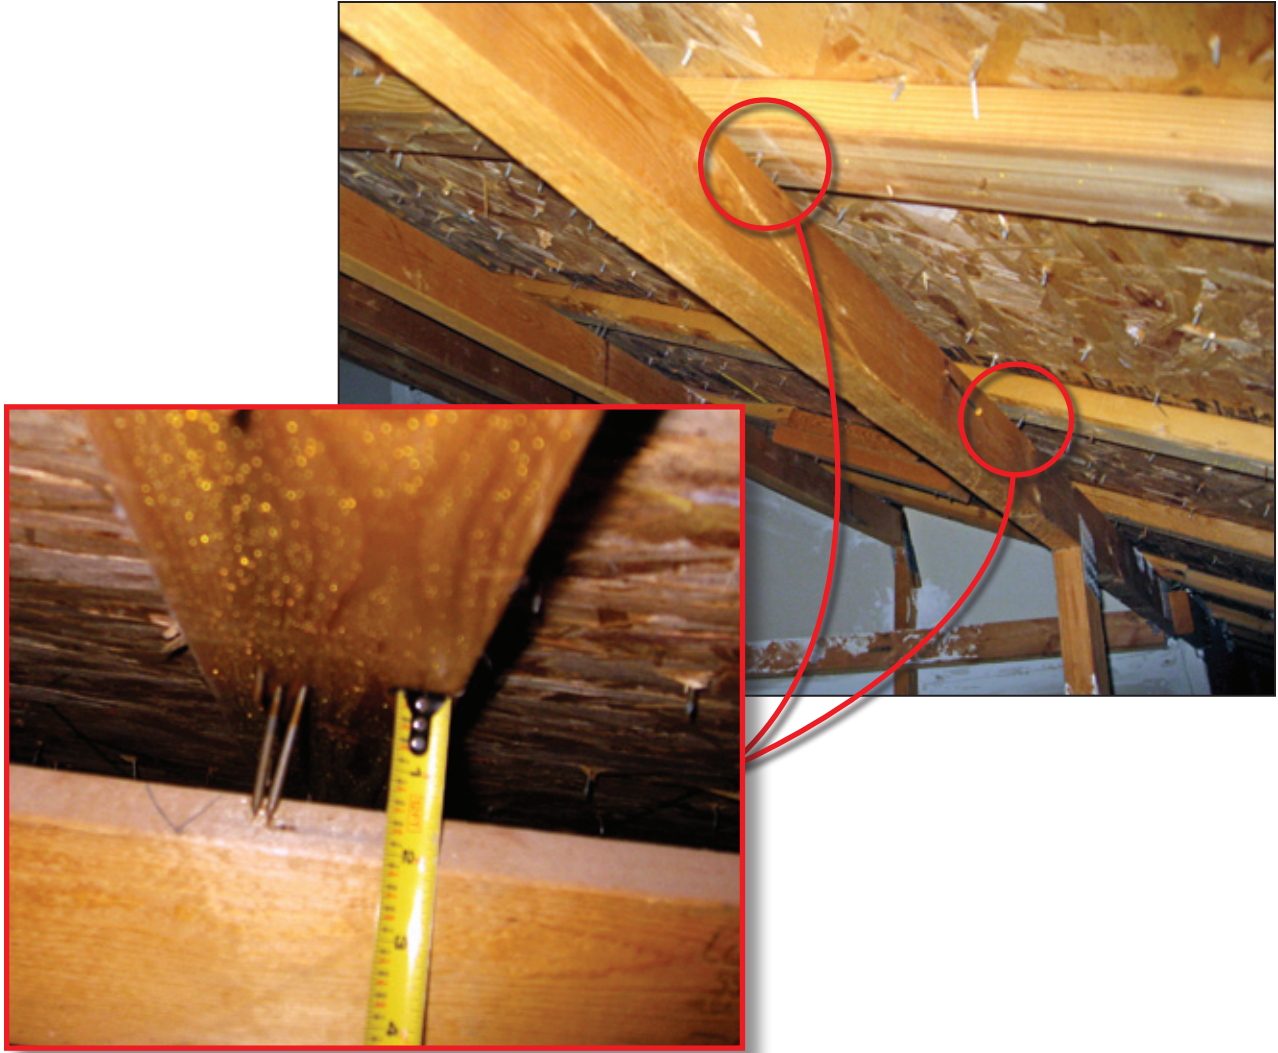
Figure 4-46: Nails through roof sheathing and nail plates have separated from roof trusses (red circles) because of wind pressures. Inset shows close-up of 2-inch nail withdrawal where nail plates separated from the roof truss.

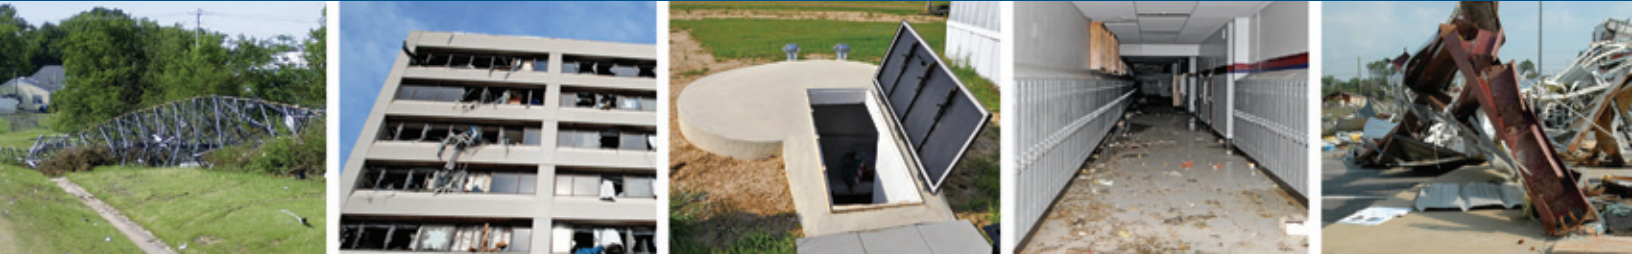
## TORNADO OUTBREAK *of* **2011**

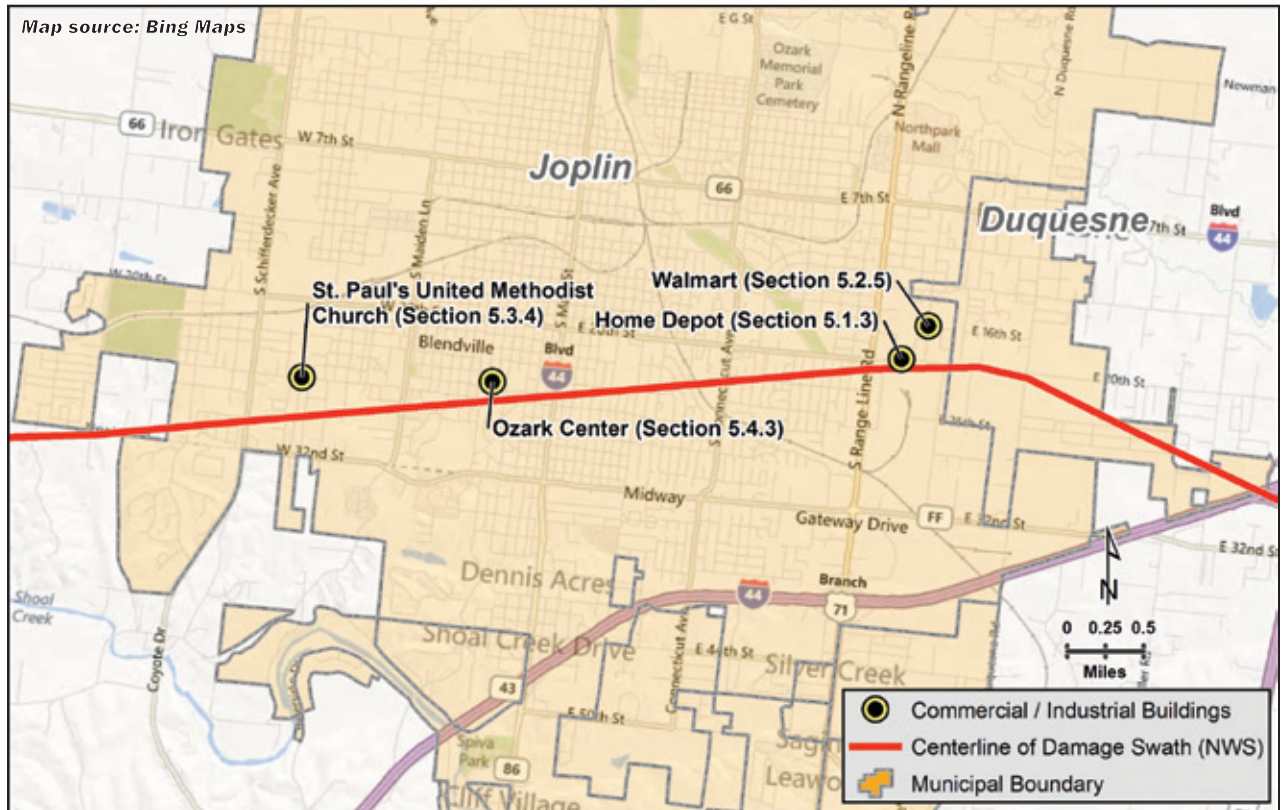
Figure 5-1: Location of Joplin, MO, buildings described in Chapter 5

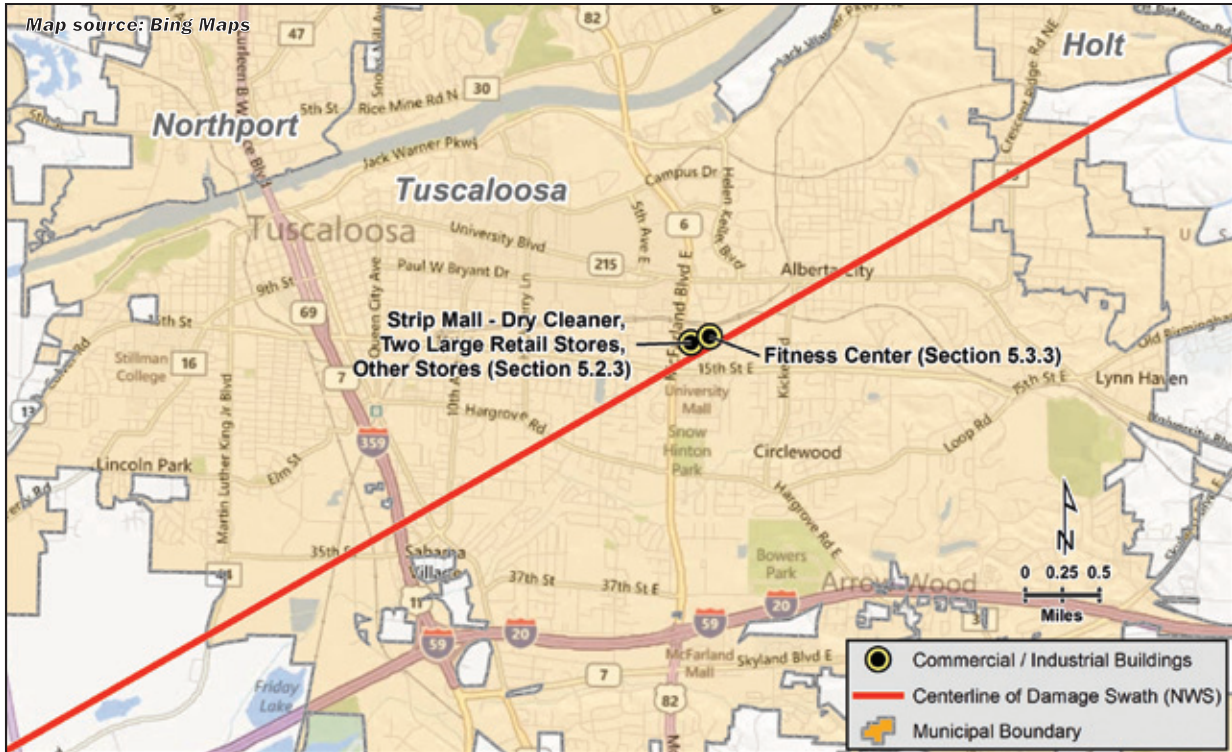
Figure 5-2: Location of Tuscaloosa, AL, buildings described in Chapter 5

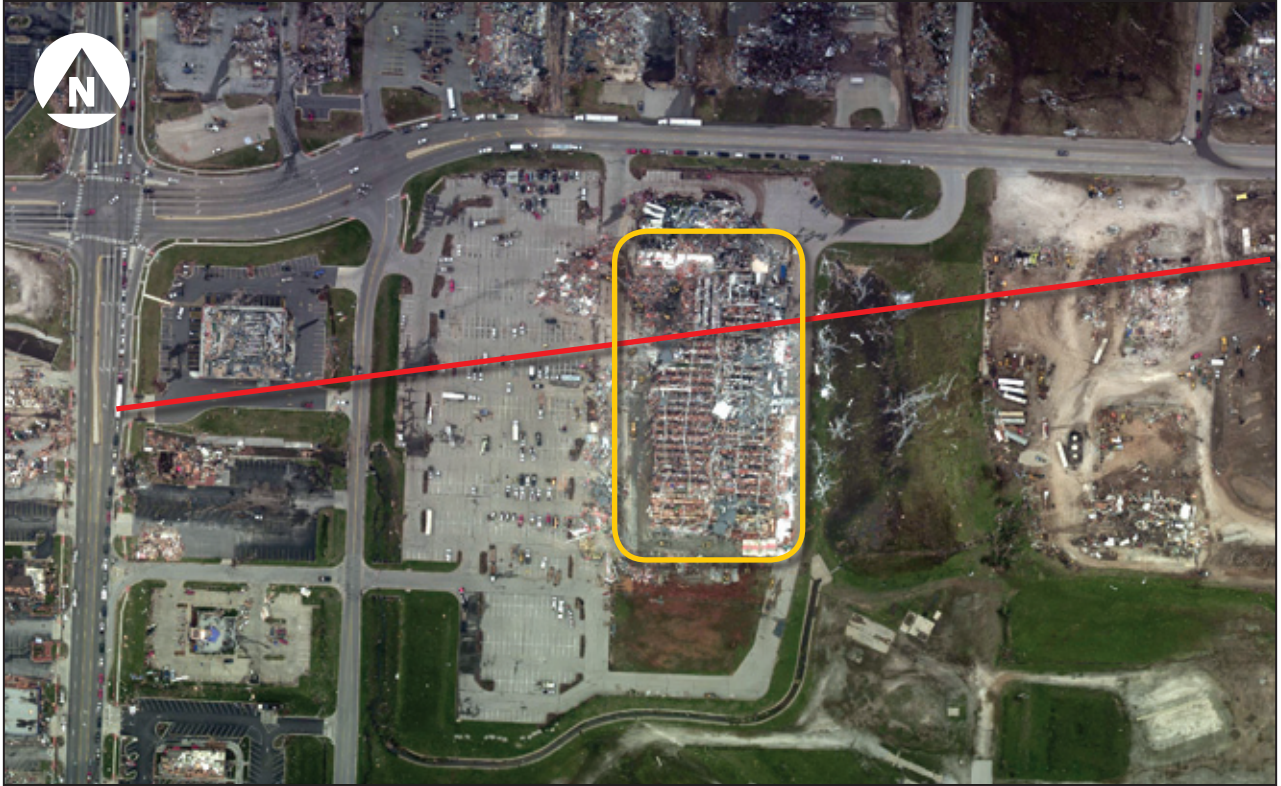
Figure 5-4: Aerial view of Home Depot (yellow circle) in Joplin, MO, in relationship to the approximate centerline of the May 22, 2011 tornado damage swath (red line)<sup>1</sup> (Joplin, MO)

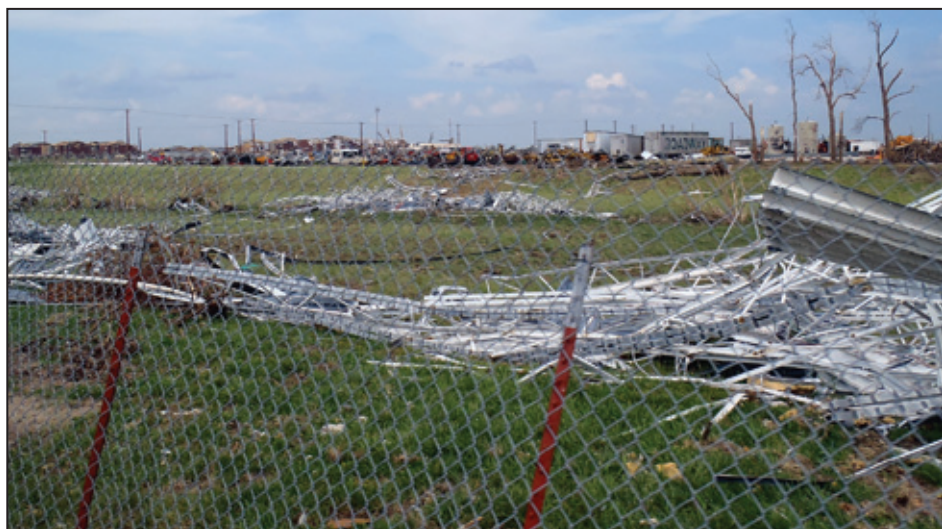
**Figure 5-5:**  
Field east of Home Depot  
with roof debris (Joplin, MO)

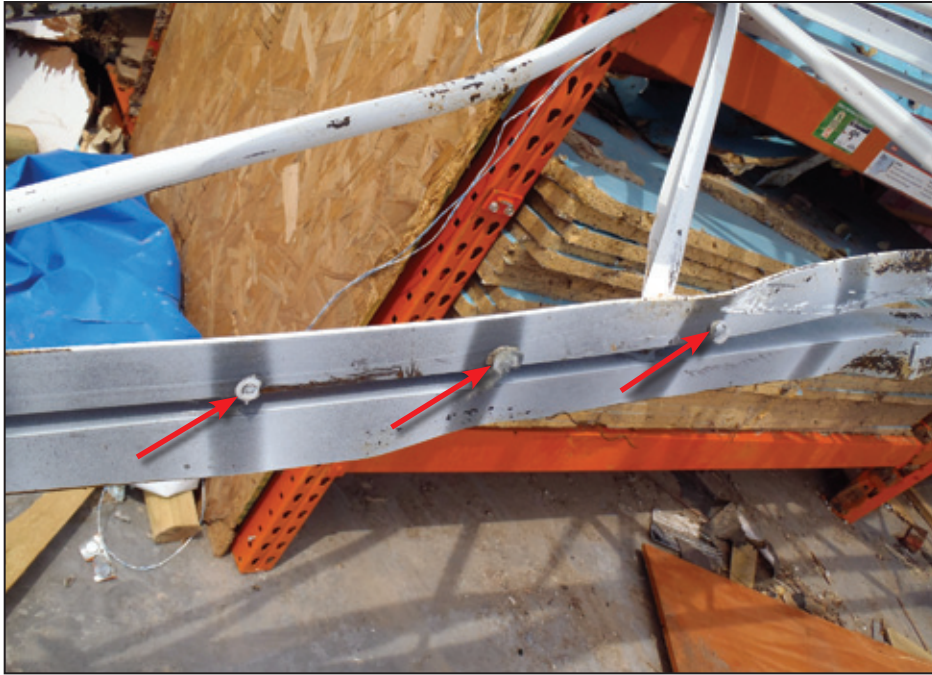
Figure 5-6:  
Failed puddle welds that  
connected the metal roof  
deck to the top chord of the  
joist (red arrows) (Joplin,  
MO)

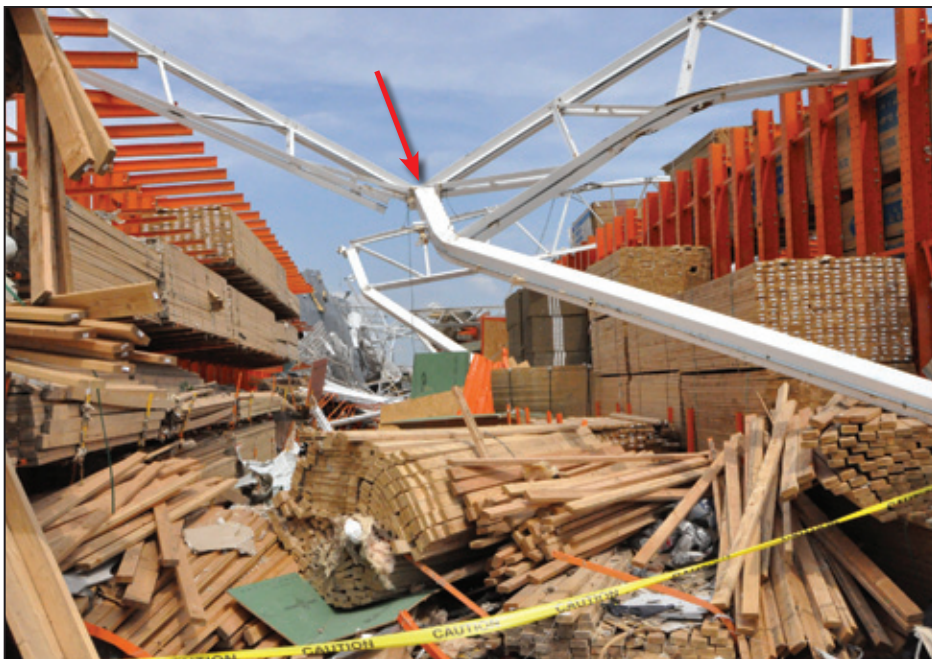
Figure 5-7:  
Joist girder and column  
failure. The column-to-joist  
girder is shown by the red  
arrow (Joplin, MO).

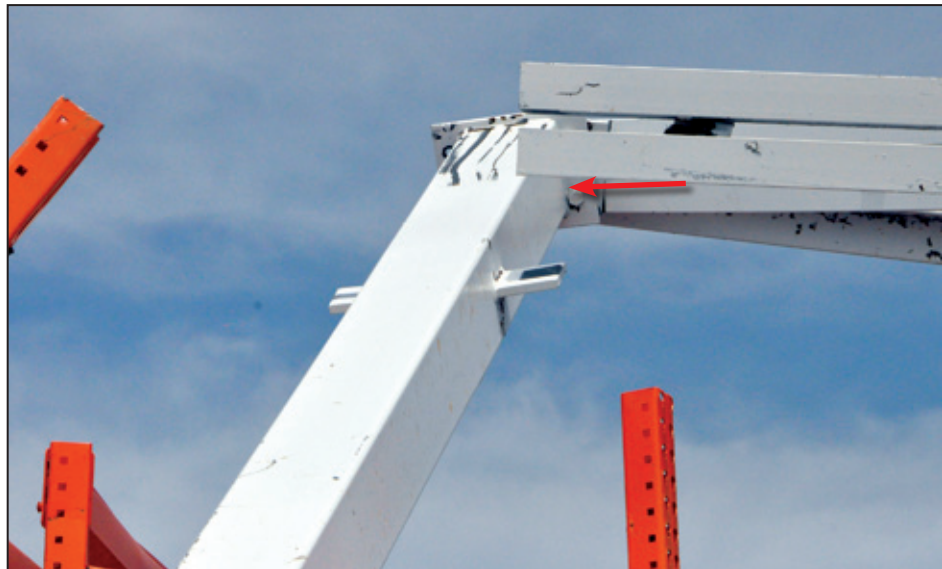
### Interior Columns

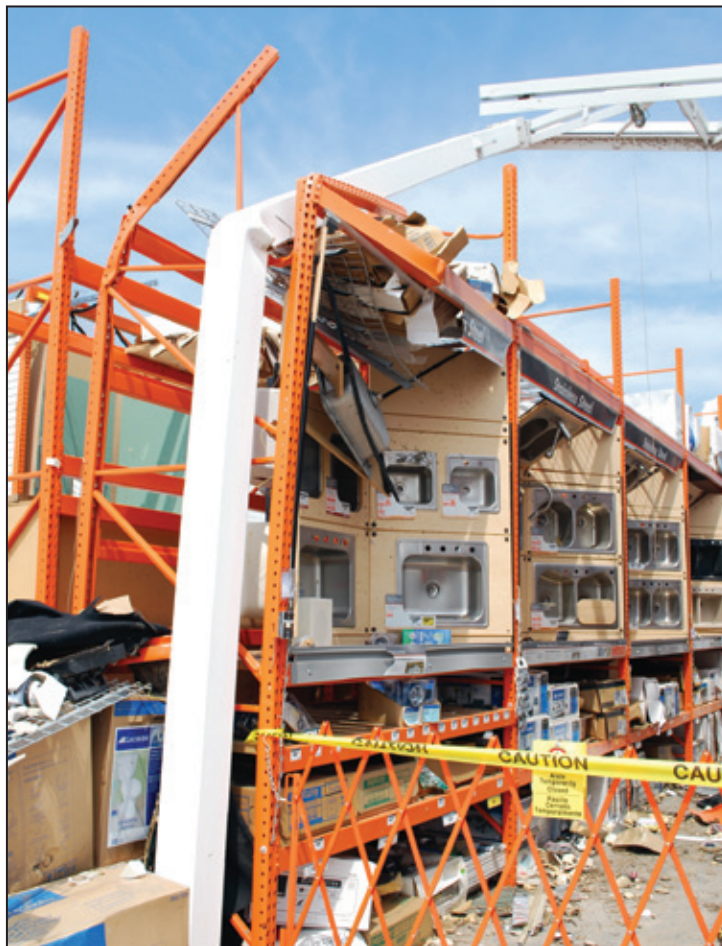
Figure 5-9:  
Buckled column (Joplin, MO)
