## Mitigation Assessment Team Report

# Spring 2011 Tornadoes: April 25-28 and May 22

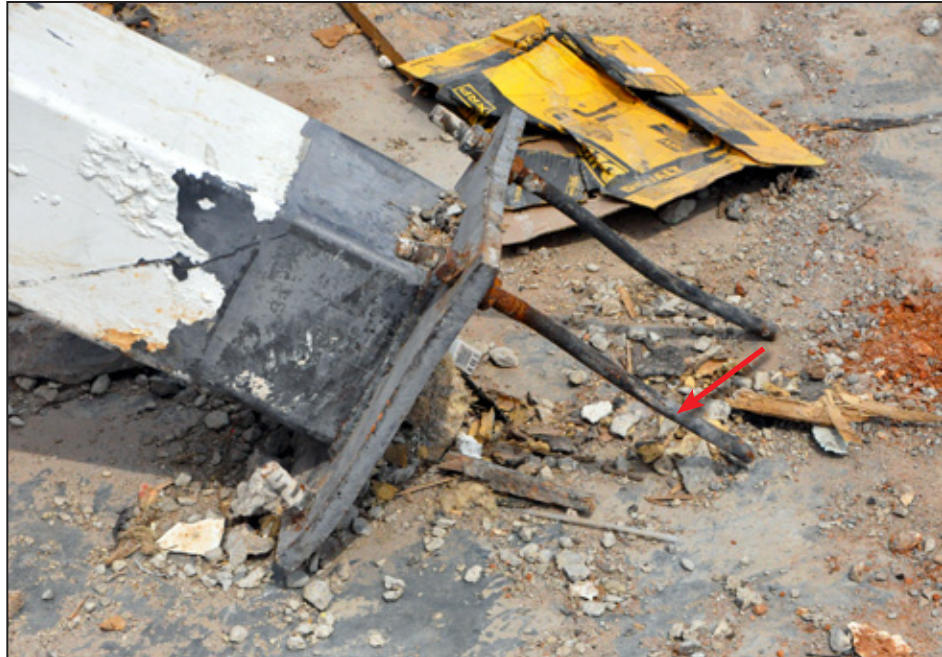
**Figure 5-10:**  
Bolt failure at interior column resulting from shear and tension. The hooked anchor bolts pulled out of the slab (red arrow) (Joplin, MO).

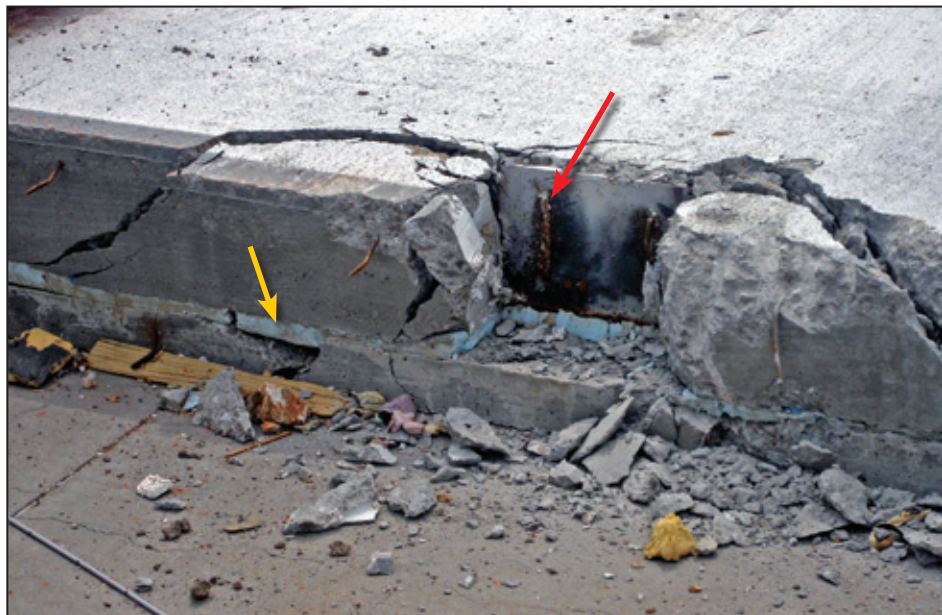
Figure 5-11 also shows that the panels of the Home Depot building were insulated, which means there were two layers of concrete with a layer of insulation in the center. The two layers of concrete are usually connected by ties and concrete ribs at the perimeter and sometimes in the center of the panel. This detail was not exposed, however, and the MAT was unable to observe the connection.

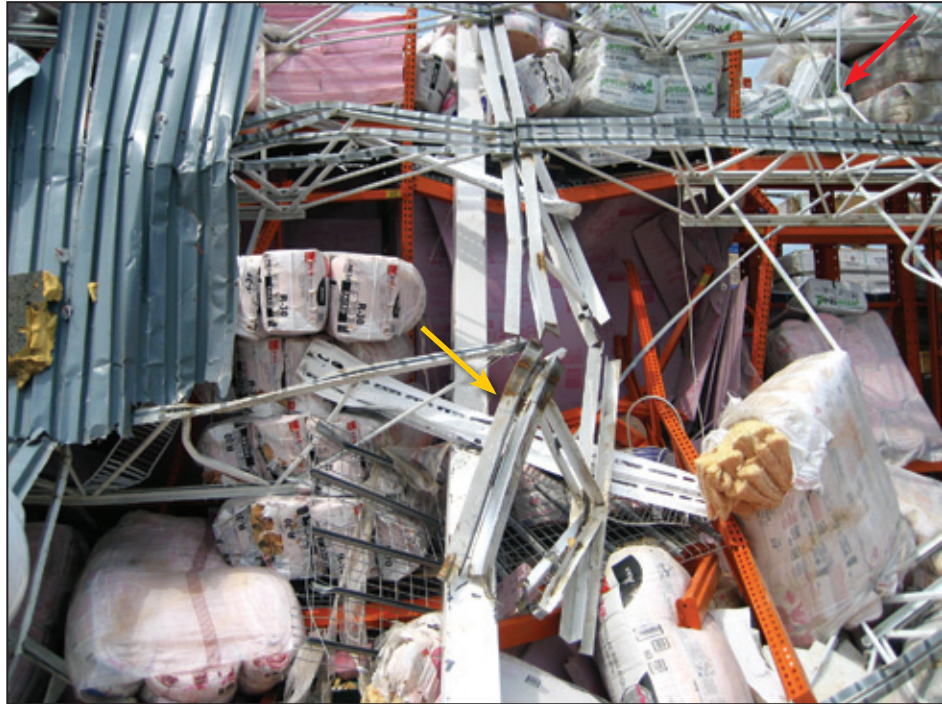
Figure 5-13:  
The joist seats came free of their bearing locations when both the seat-to-joist weld (yellow arrow) and the seat-to-embed plate weld (red arrow) broke (Joplin, MO)

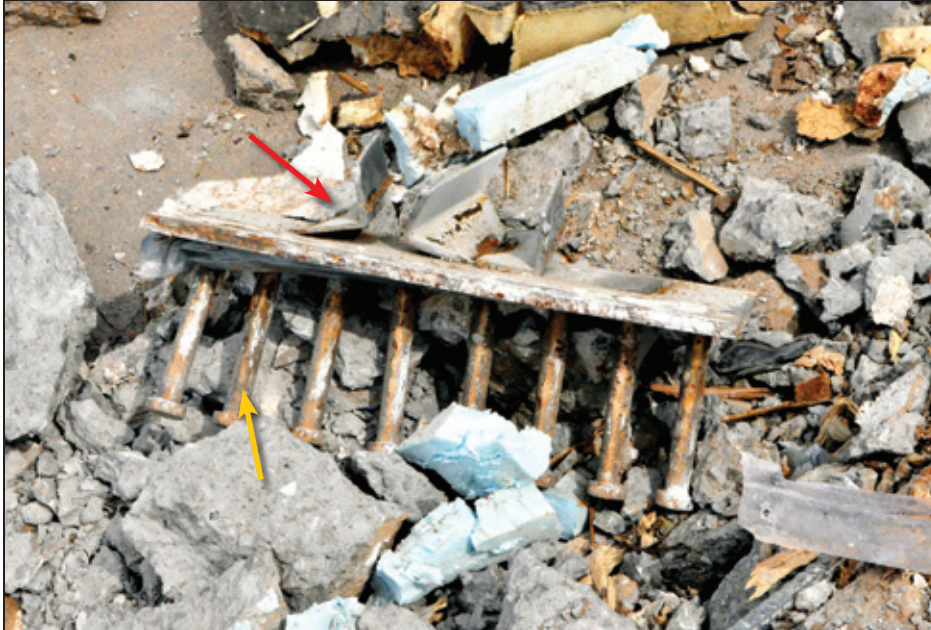
Figure 5-14:  
Example of weld plate and joist failure. The joist seat was torn from the joist (red arrow) and the anchor studs from embed plate were torn out of the concrete (yellow arrow) (Joplin, MO).

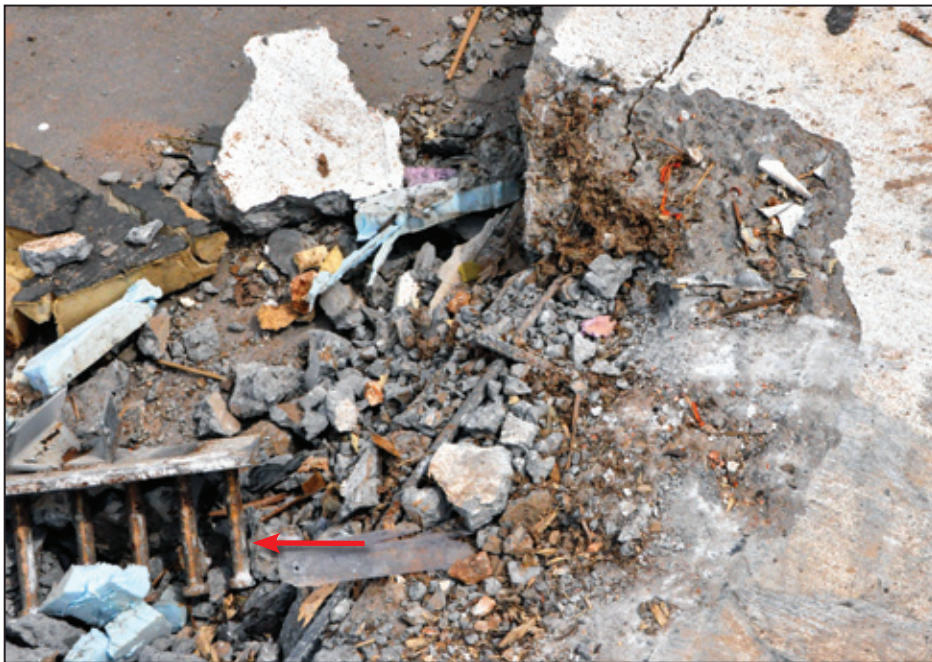
Figure 5-15:  
The panel at the weld plate failed (red arrow) (Joplin, MO)

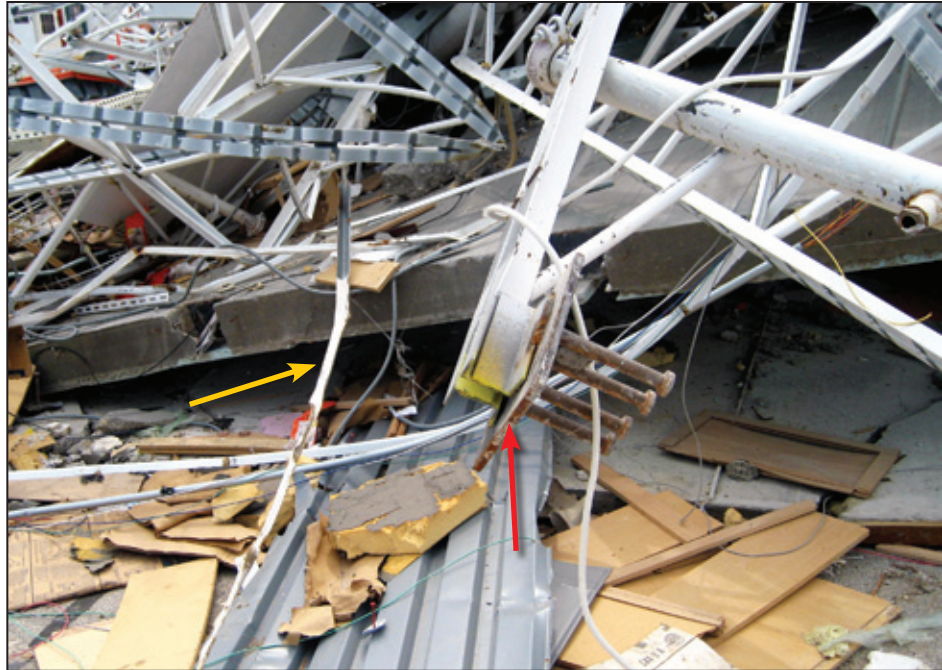
Figure 5-16:  
Example of a weld plate failure. Note the attached joist (red arrow) and the joist pocket at the top of the wall panel (yellow arrow) (Joplin, MO)

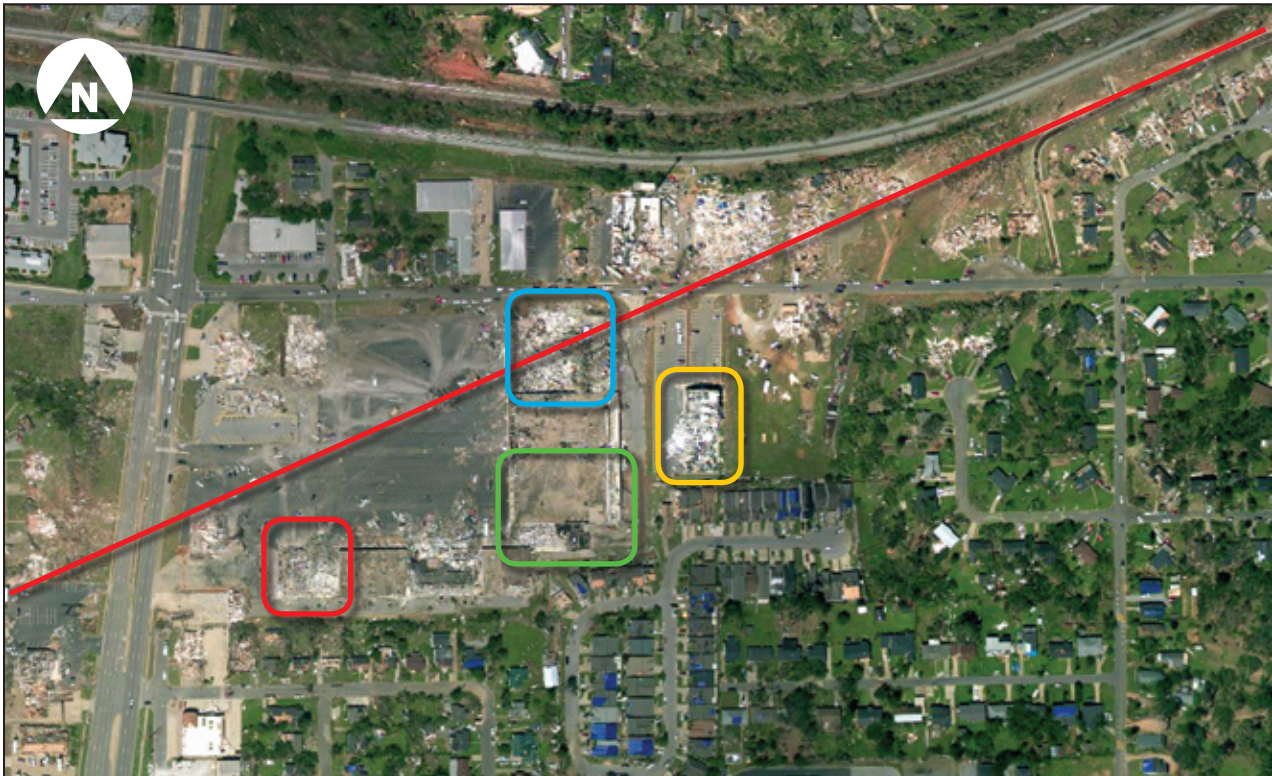
Figure 5-17: Aerial view showing the locations of the dry cleaner building (red box), fitness center (yellow box), retail store “A” (blue box) and retail store “B” (green box) in relationship to the approximate centerline of the April 27, 2011 tornado damage swath (red line) and (Tuscaloosa, AL)

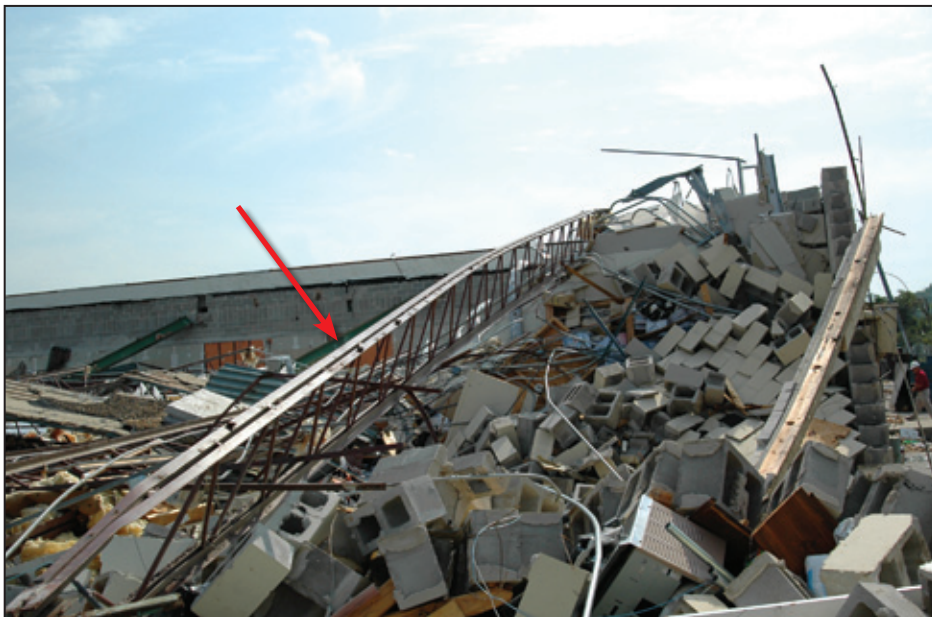
Figure 5-18:  
Steel joist (red arrow)  
in midst of collapsed  
unreinforced masonry wall  
at the dry cleaner store  
(Tuscaloosa, AL)

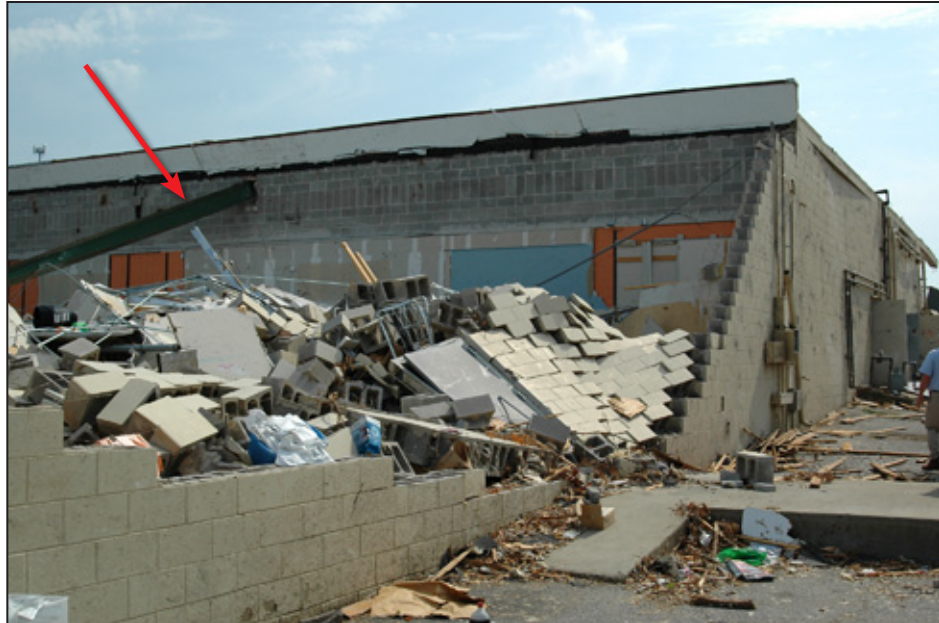
**Figure 5-20:**  
Sequence of failure for CMU wall at the dry cleaner building: wall buckling and initial separation (red arrow) was followed by complete separation of wall from bond beam (yellow arrow) and then by collapse of wall (green arrow) (Tuscaloosa, AL)

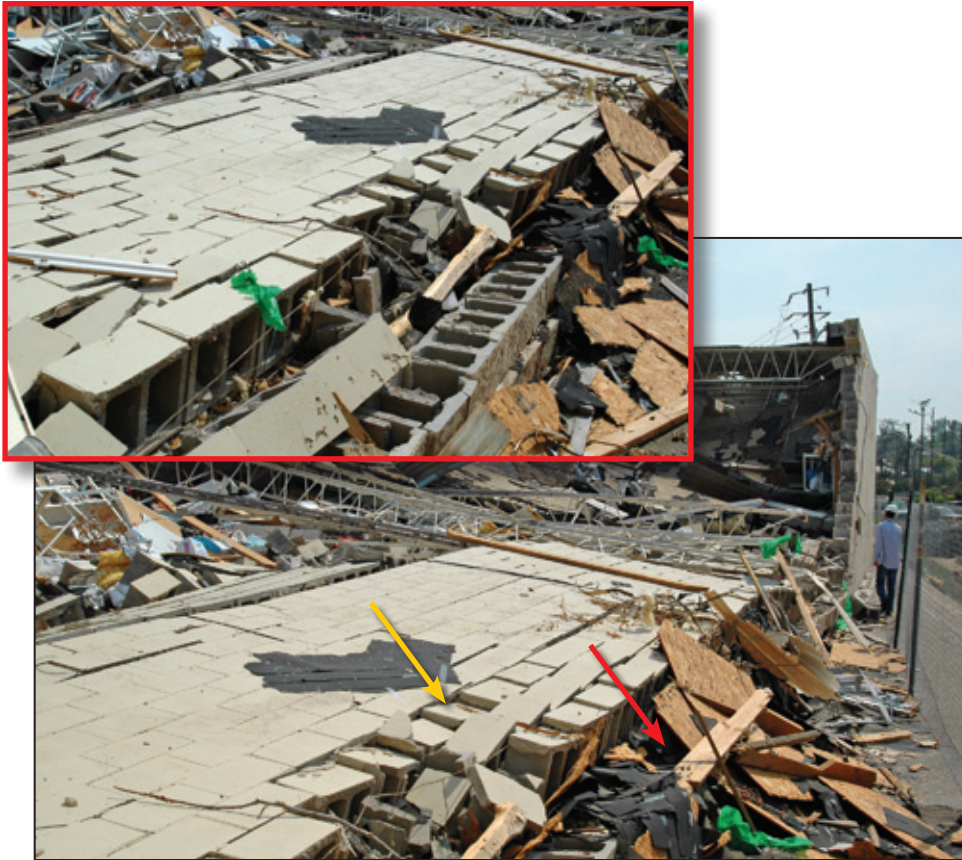
Figure 5-21: Global wall instability failure. The CMU blocks are lying loosely on the ground and many have rotated (yellow arrow) due to the complete separation of all the blocks. Note lack of reinforcement in the wall and especially between wall and footing (red arrow). Inset shows a close-up view of the separation of the blocks (Tuscaloosa, AL).

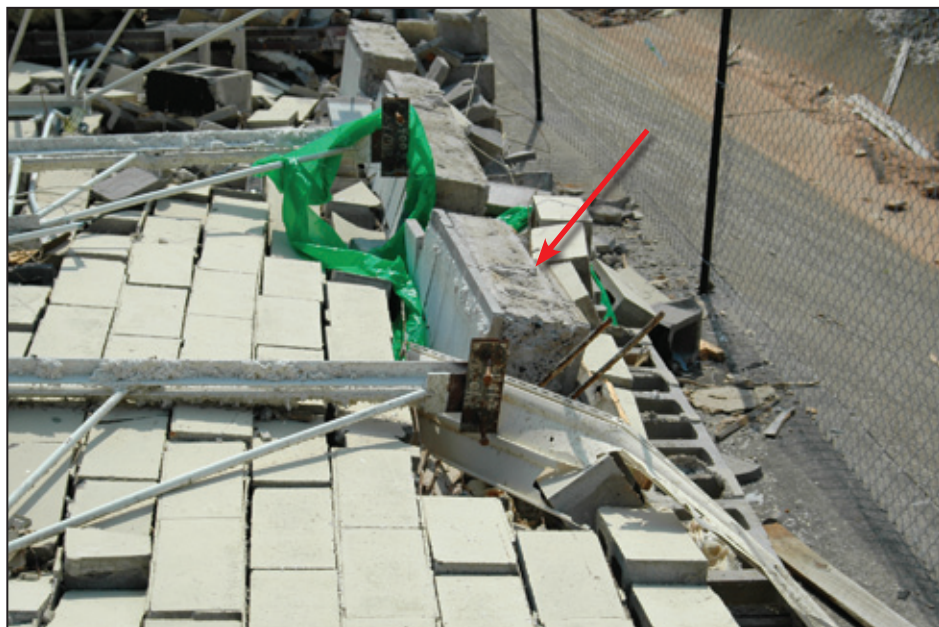
#### 5.2.4 Jefferson Metro Care (Birmingham, AL)

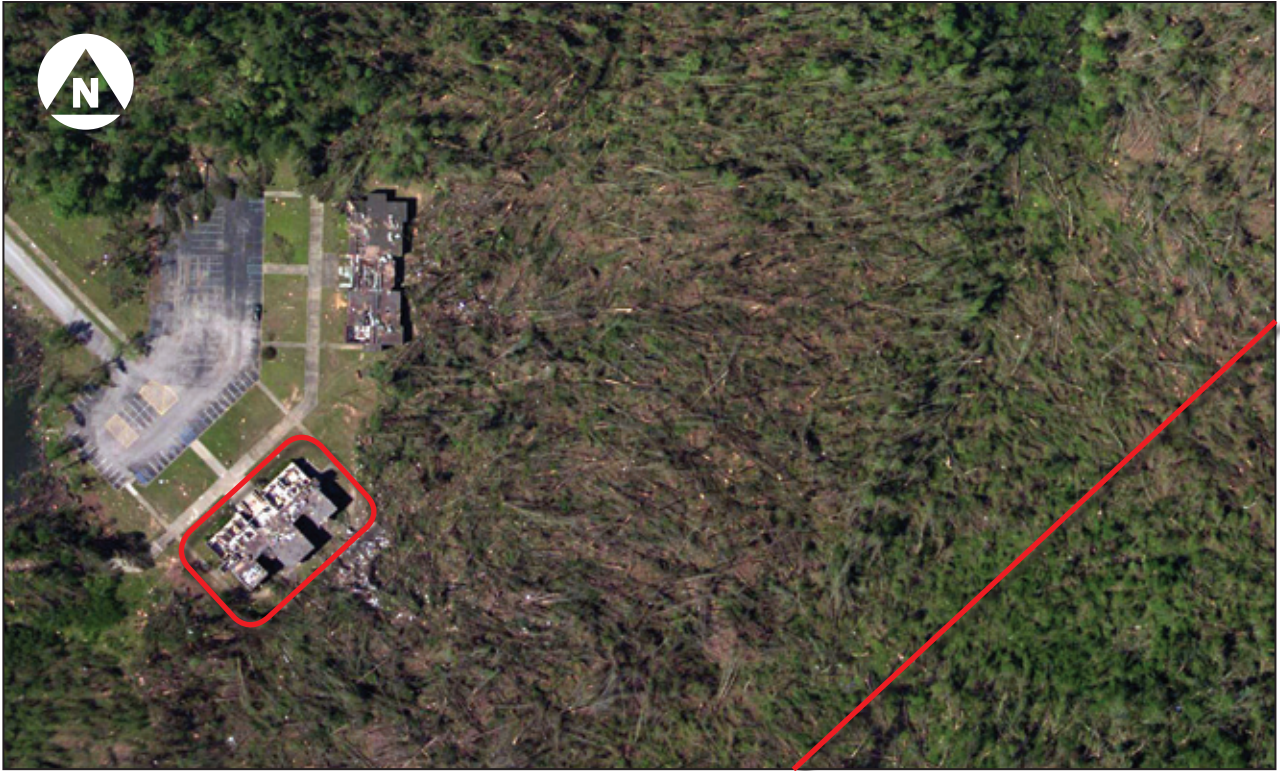
Figure 5-24: Aerial view showing the Jefferson Metro Care Facility (red box) in relationship to the approximate centerline of the April 27, 2011 tornado damage swath (red line) (Birmingham, AL)

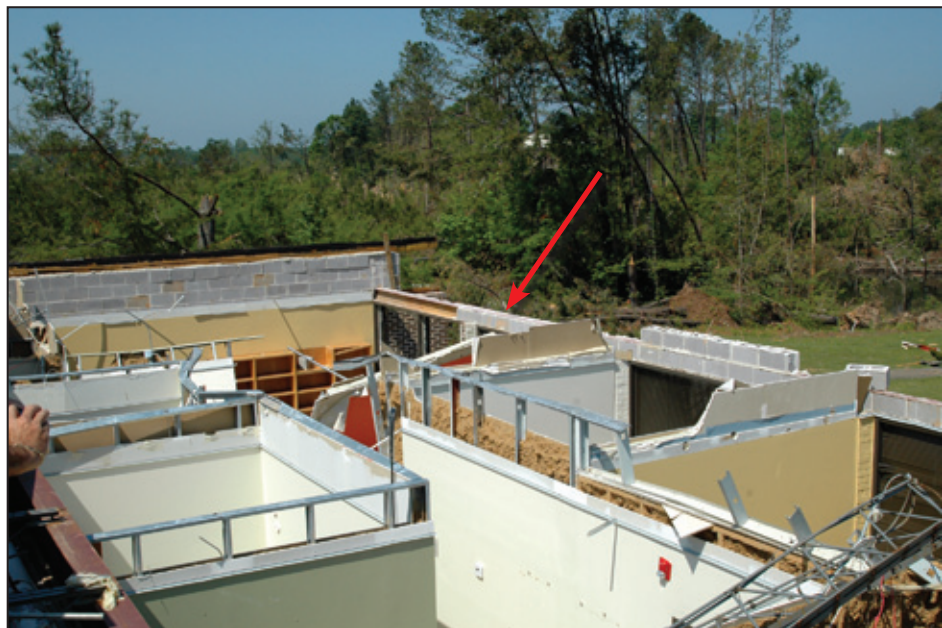
**Figure 5-25:**  
Failed bond beam-to-  
structural steel connection  
over front windows (red  
arrow) (Birmingham, AL)

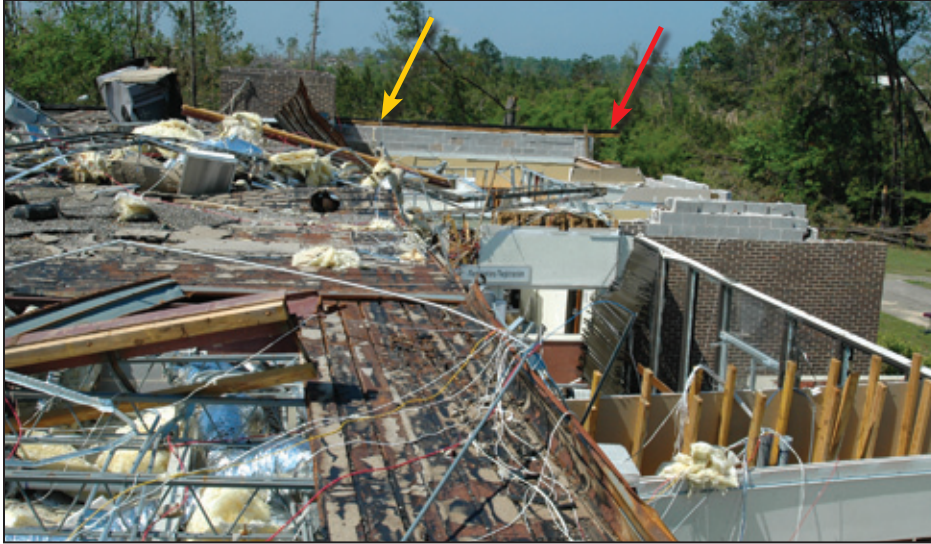
Figure 5-26:  
Roof joist lifted off front (red arrow) and folded over rear half of building (yellow arrow) (Birmingham, AL)

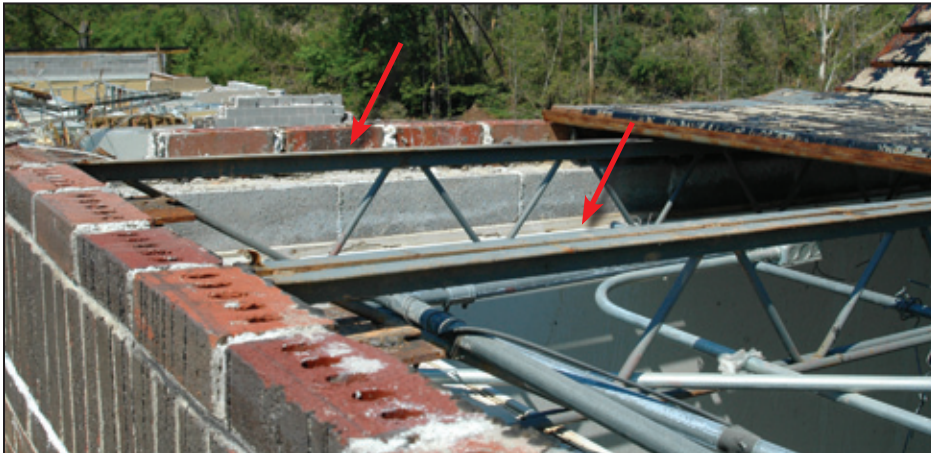
Figure 5-27:  
Failed roof deck with no connections between the roof deck and the joists (red arrows) (Birmingham, AL)

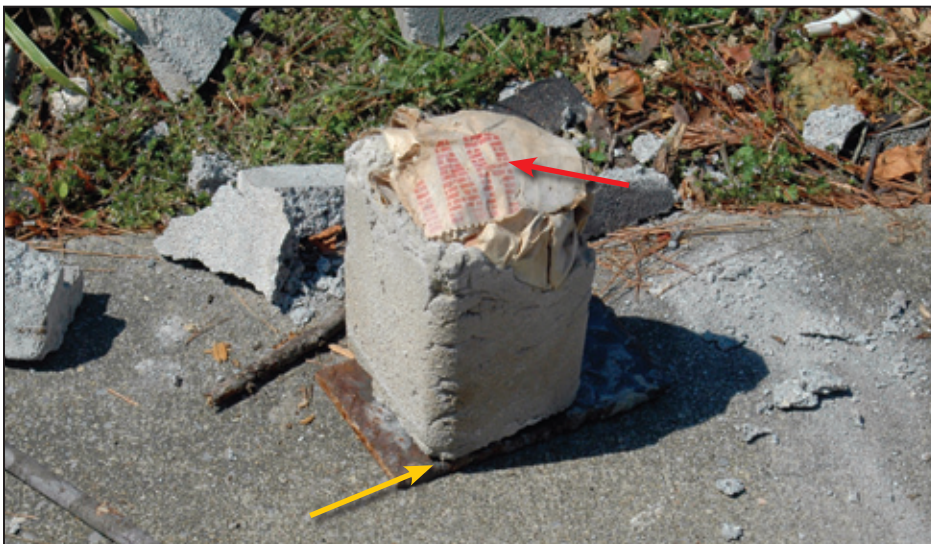
Figure 5-28:  
This CMU cell was found on the ground adjacent to the structure (shown upside down). The bond beam cell is sealed with paper to keep grout from flowing into lower cells (red arrow) and thus there was no connection to lower elements. The embed plate can be seen attached (yellow arrow) (Birmingham, AL).

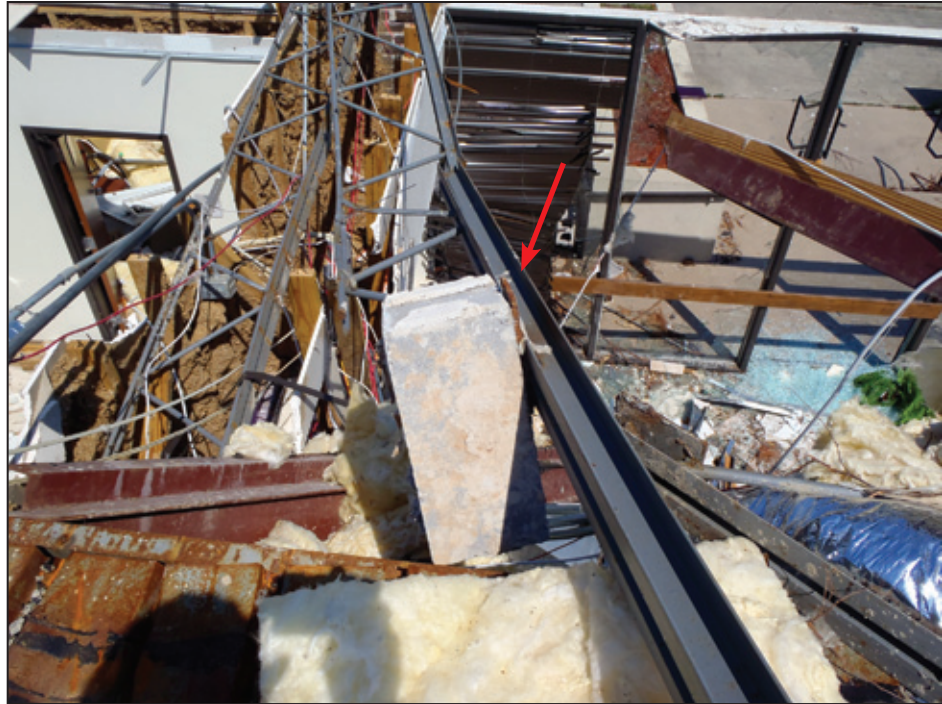
Figure 5-30:  
Embed plate with bond beam  
cell (red arrow) on roof  
(Birmingham, AL)

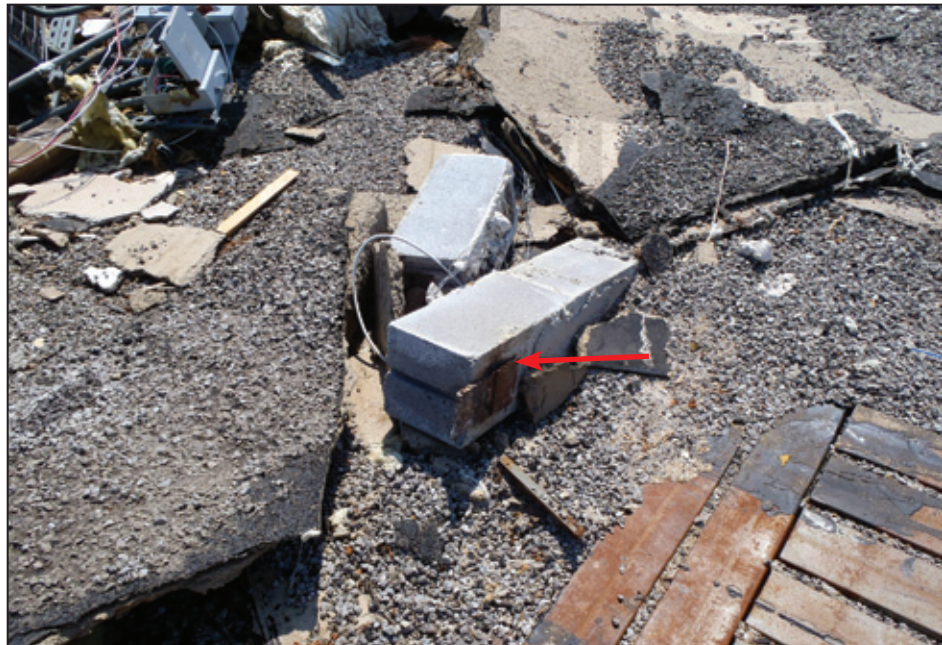
**MAT EF Rating:** Using DI 9 (Small Professional Building), the MAT selected DOD 7 (“uplift or collapse of entire roof structure”) for this building. Using the expected wind speed for DOD 7, the MAT derived the tornado rating as a high EF1 (100–105 mph winds). Therefore, the estimated wind speed experienced by the building was in excess of the 90 mph building code design requirements for this location.

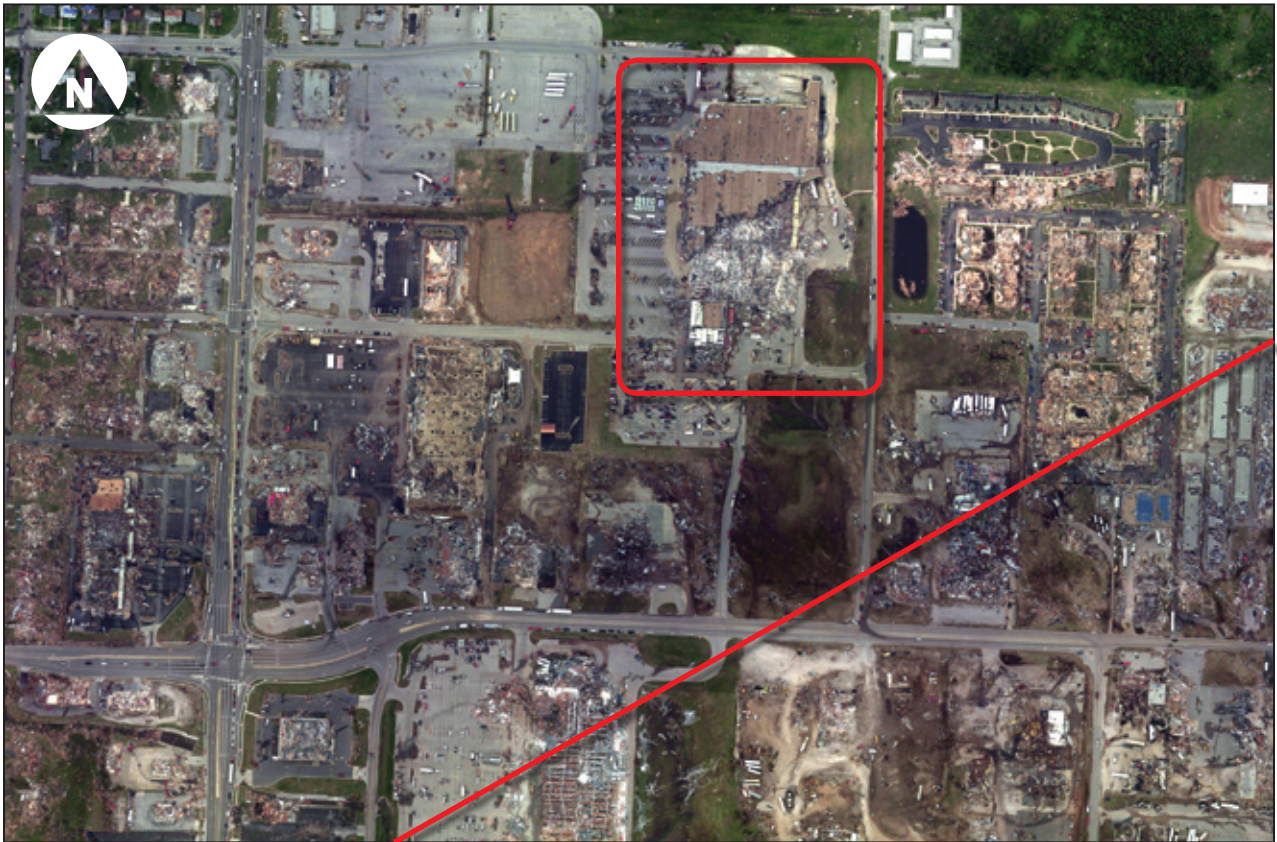
Figure 5-31: Aerial view of a Walmart in Joplin, MO (red box) in relationship to the approximate centerline of the May 22, 2011 tornado damage swath (red line) (Joplin, MO)

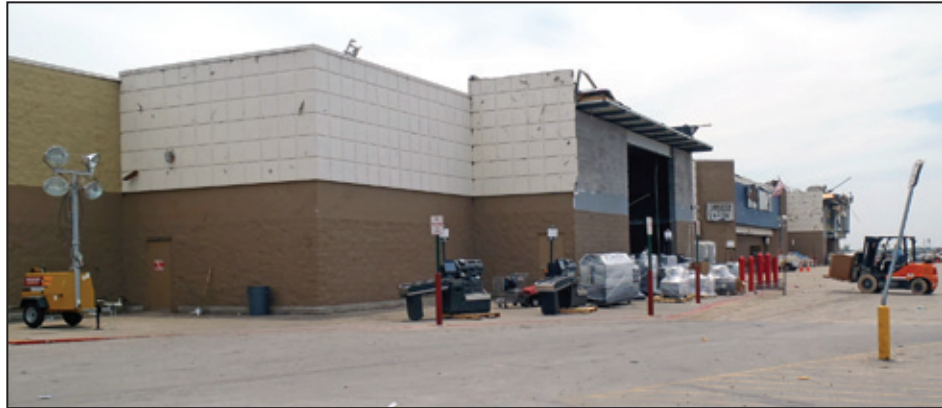
Figure 5-32:  
The relatively undamaged west elevation of Walmart after the May 22, 2011 tornado (Joplin, MO)

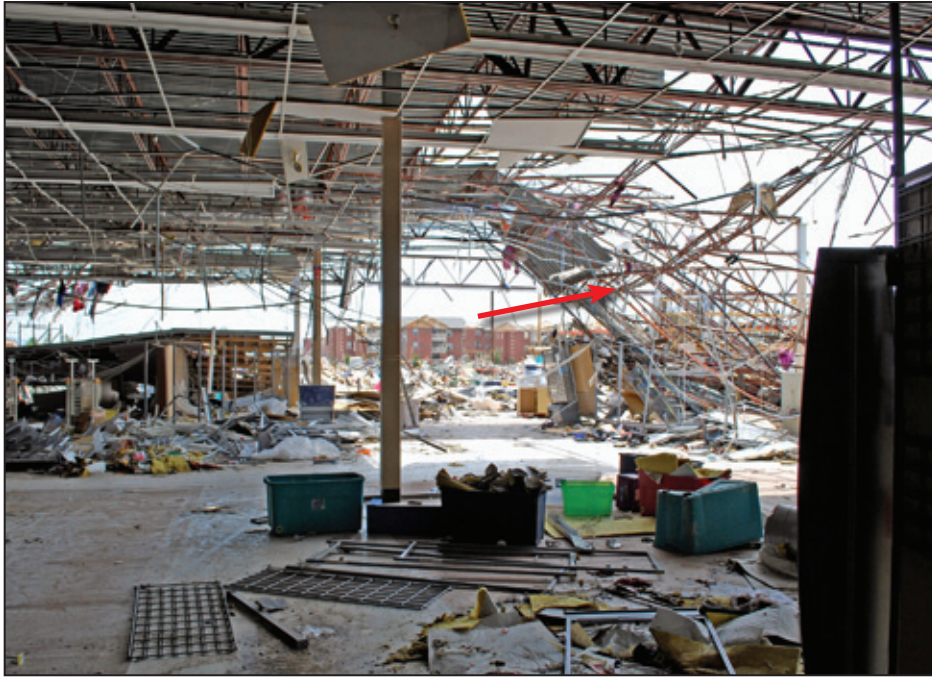
Figure 5-33:  
Interior of the north half of  
the Walmart, looking east.  
Fallen roof structure shown  
in right side of the picture  
(red arrow) (Joplin, MO).

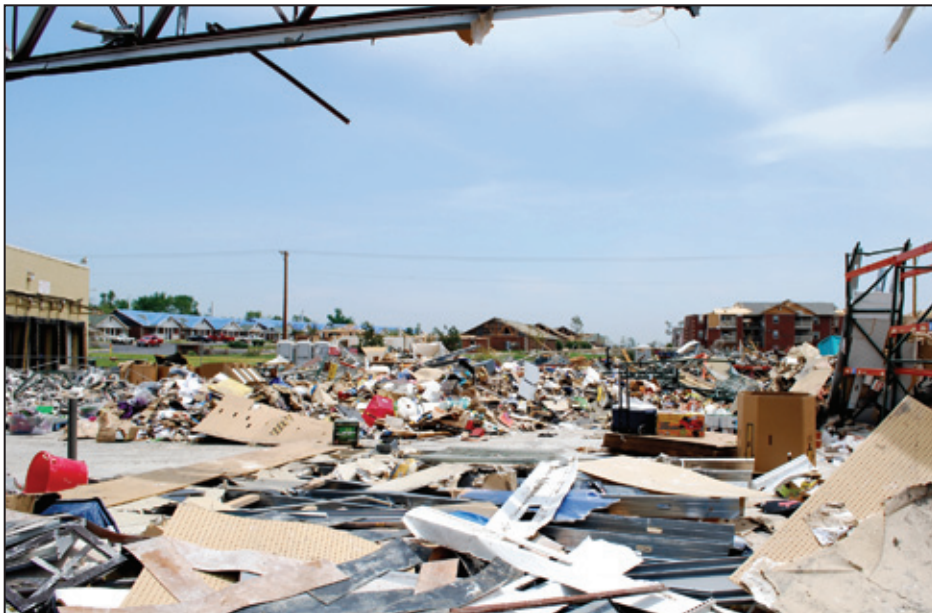
Figure 5-34:  
Destroyed east side of north  
half of Walmart (note loading  
dock facing south) (Joplin,  
MO)

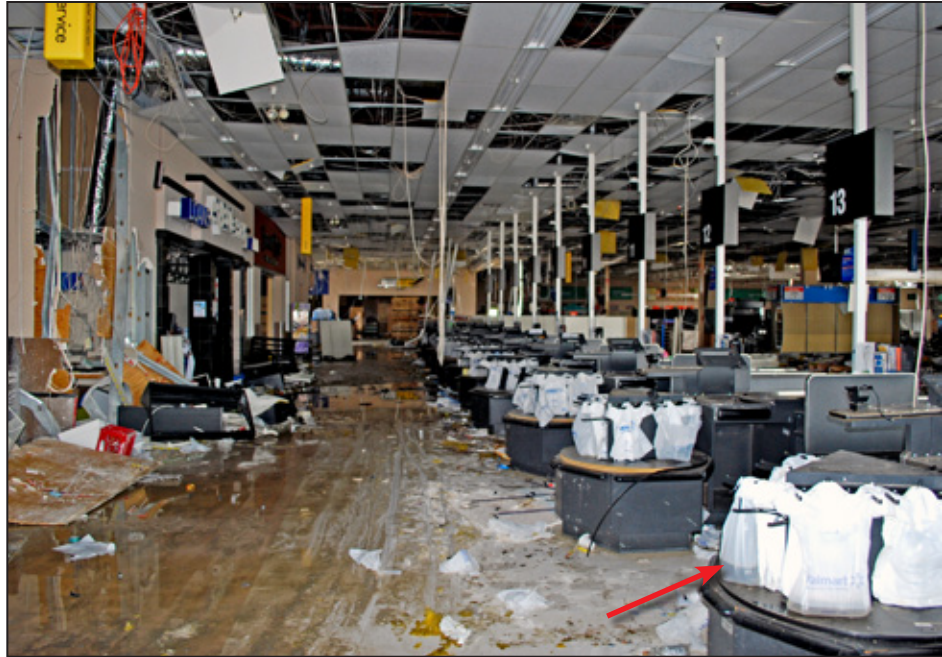
South half of building: The south half of the building was hardest hit as it was closest to the tornado track. The roof system, including structural members, failed and compromised the integrity of the load carrying systems.

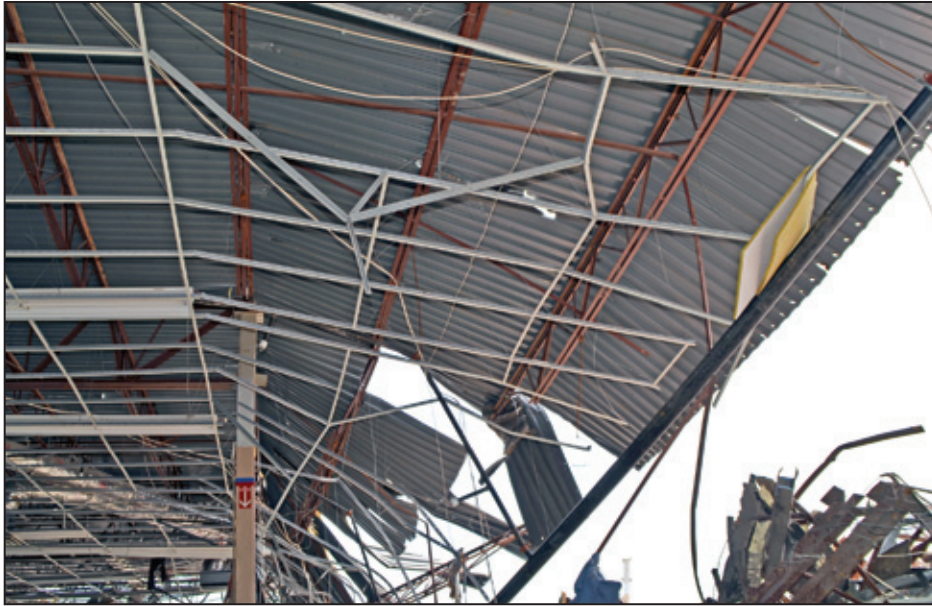
Figure 5-36:  
Interior view from the south half of the building looking toward the east. This shows the boundary of roof damage to the south portion of the building. Note deck supported by steel joist (Joplin, MO).

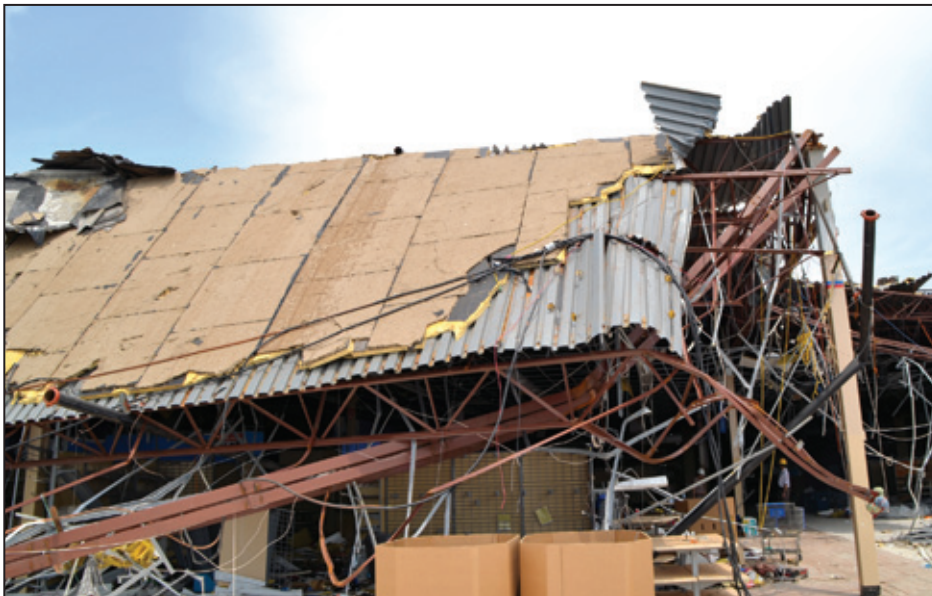
Figure 5-37:  
View of the south half of the building looking north showing roof damage. Note the missing roof membrane (Joplin, MO).

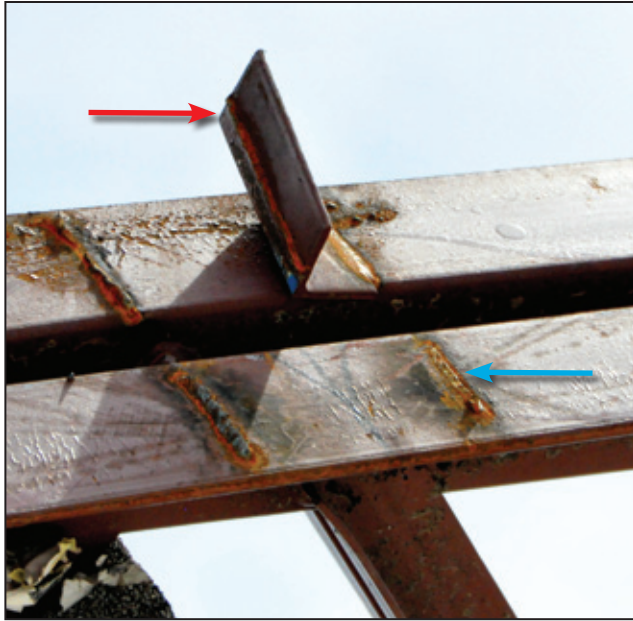
Figure 5-38: Typical connection of two steel joists to joist girder. While the joist seat from one joist remains (red arrow), the weld failed at the other joist seat connection (blue arrow) (Joplin, MO).

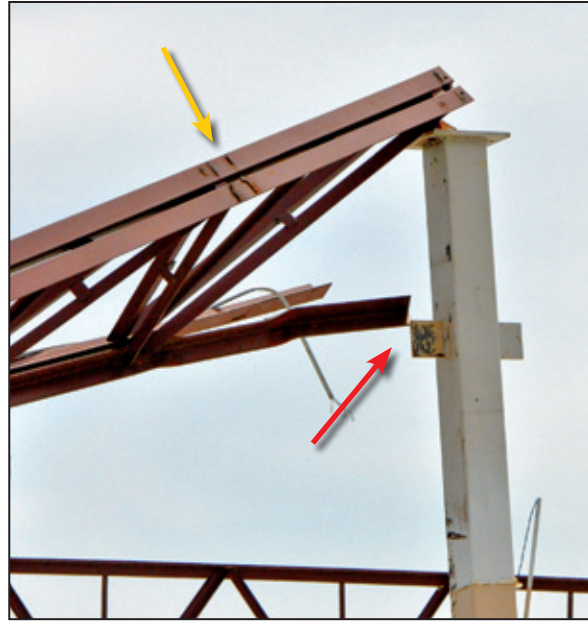
Figure 5-39: Joist girder rotated at the column; the bottom chord was not attached to the stabilizer plate (shown by red arrow). The joists were attached with welds to the joist girder top chord. This weld connection failed in the location shown (yellow arrow) (Joplin, MO).

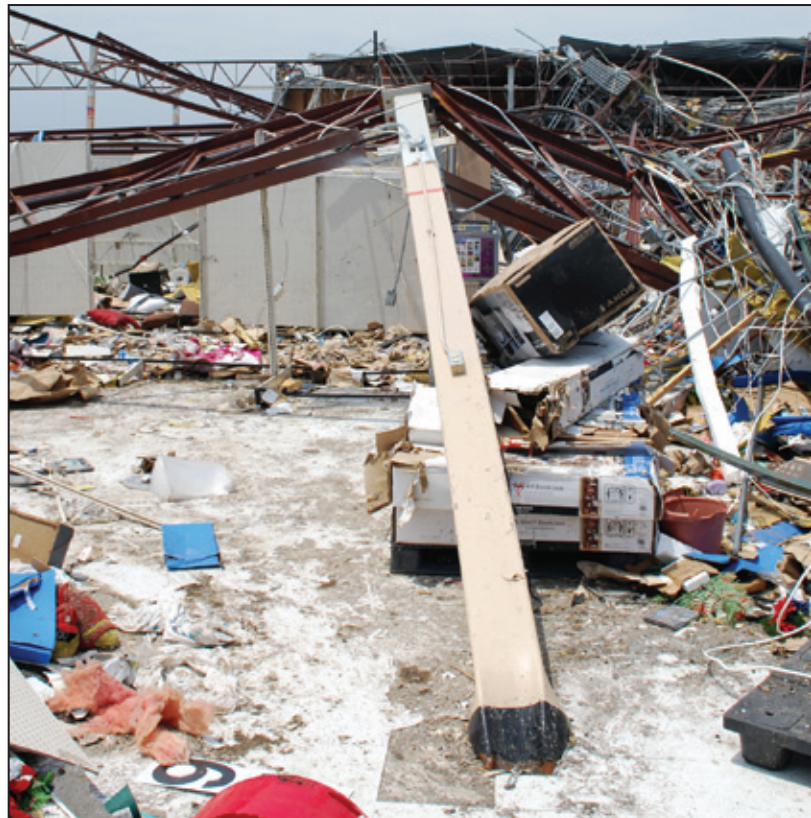
Figure 5-40:  
Collapsed column with hooked anchor bolts remains attached to the foundation at the base (Joplin, MO)

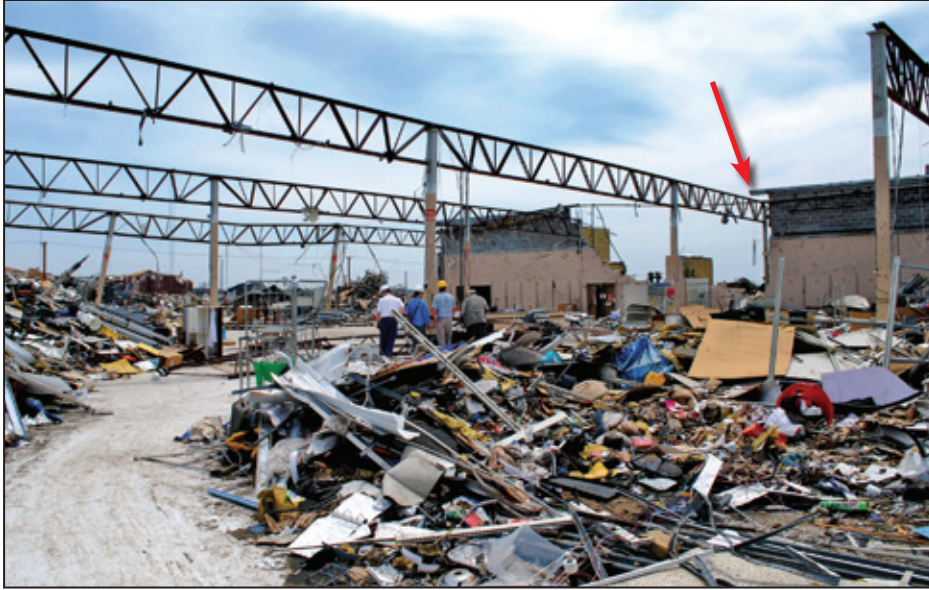
Figure 5-41:  
Roof structure remaining in south half of Walmart. The red arrow shows the location of a column embedded in the wall (Joplin, MO).

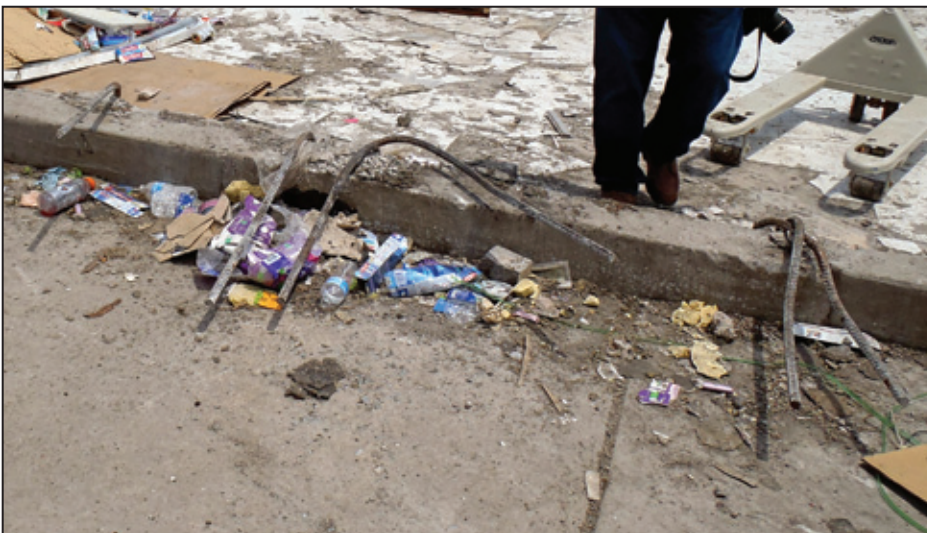
Figure 5-42:  
Reinforcing steel in Walmart foundation (Joplin, MO)

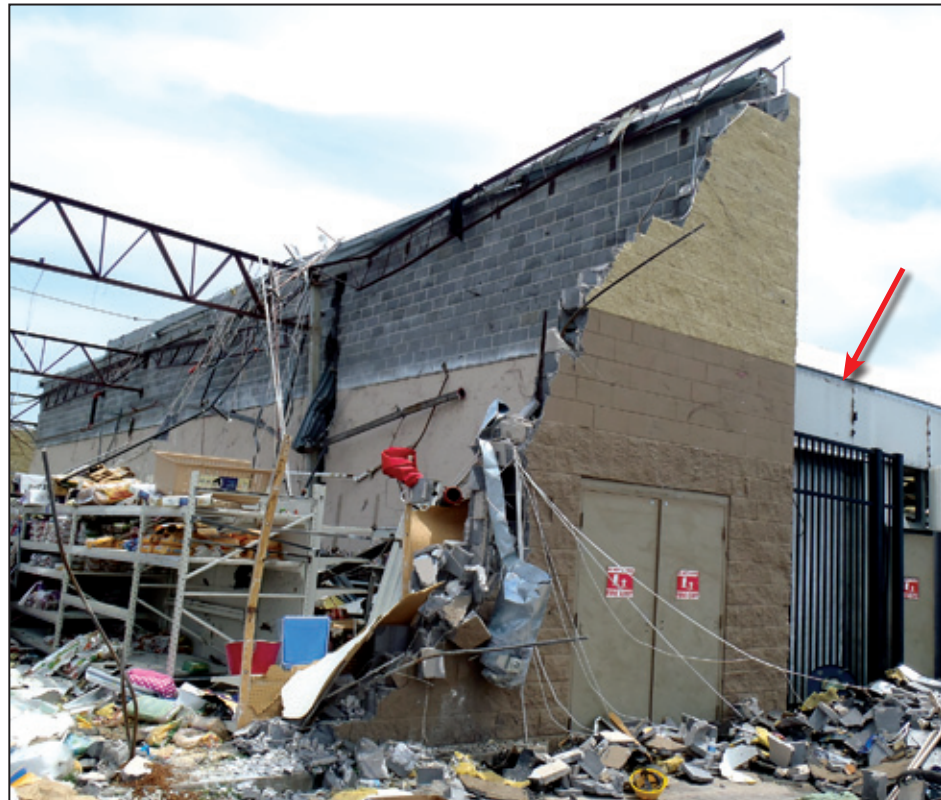
**Figure 5-43:**  
Partial collapsed wall in southern half of store (note deck support angle at top of wall); area of limited damage shown by red arrow (Joplin, MO)

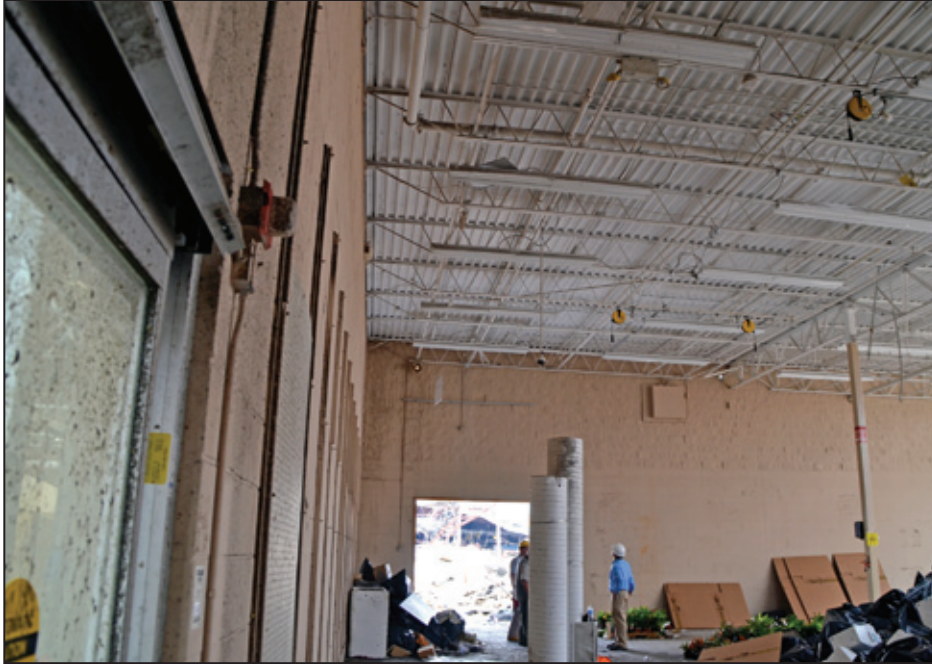
Figure 5-44:  
Area of relatively limited damage. Photograph was taken looking north (Joplin, MO).

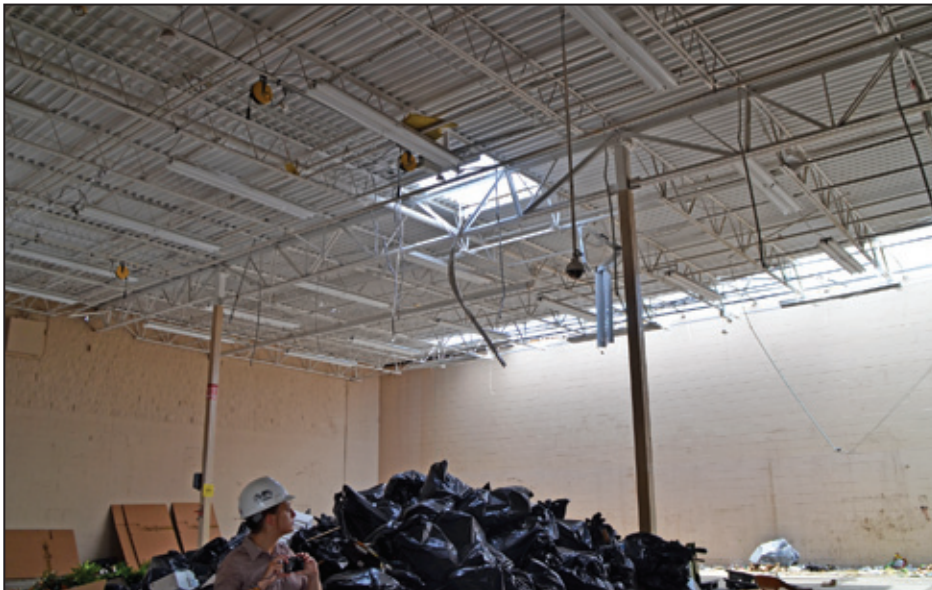
Figure 5-45:  
Another view of the area shown in Figure 5-44. Photograph was taken looking east (Joplin, MO).

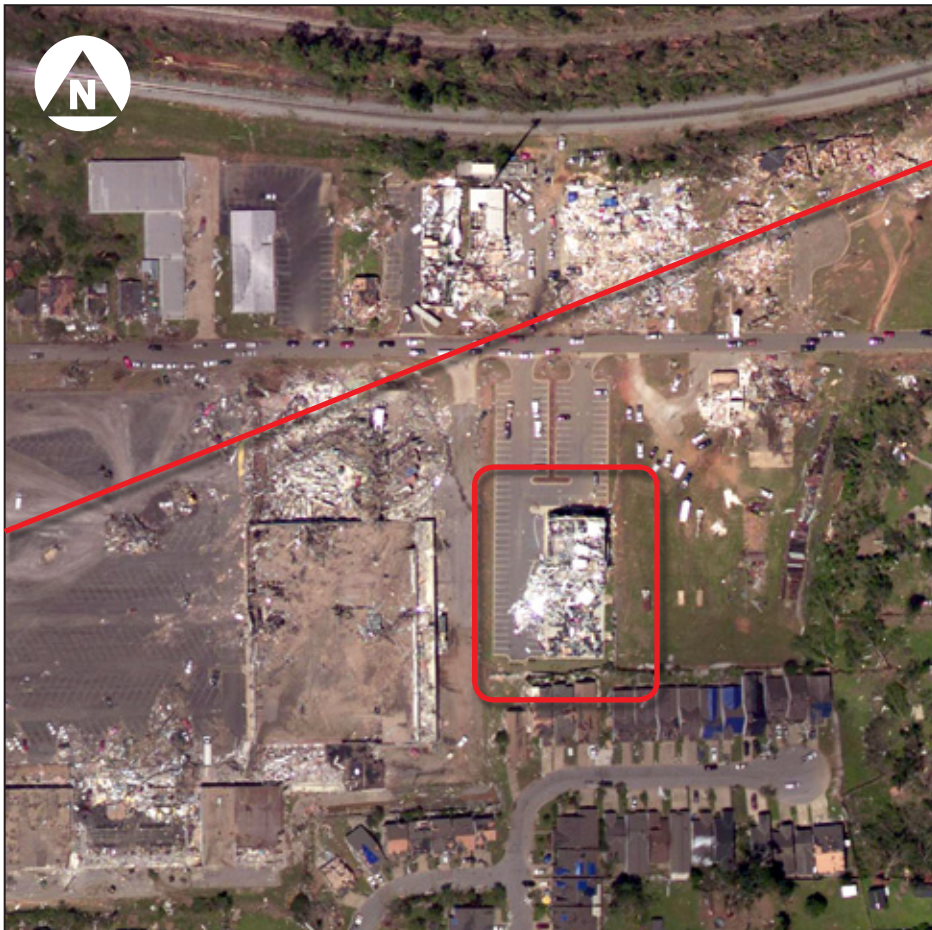
Figure 5-46:  
Aerial view of the fitness center (red box) in relationship to the approximate centerline of the April 27, 2011 tornado damage swath (red line) (Tuscaloosa, AL)
