## Mitigation Assessment Team Report

# Spring 2011 Tornadoes: April 25-28 and May 22

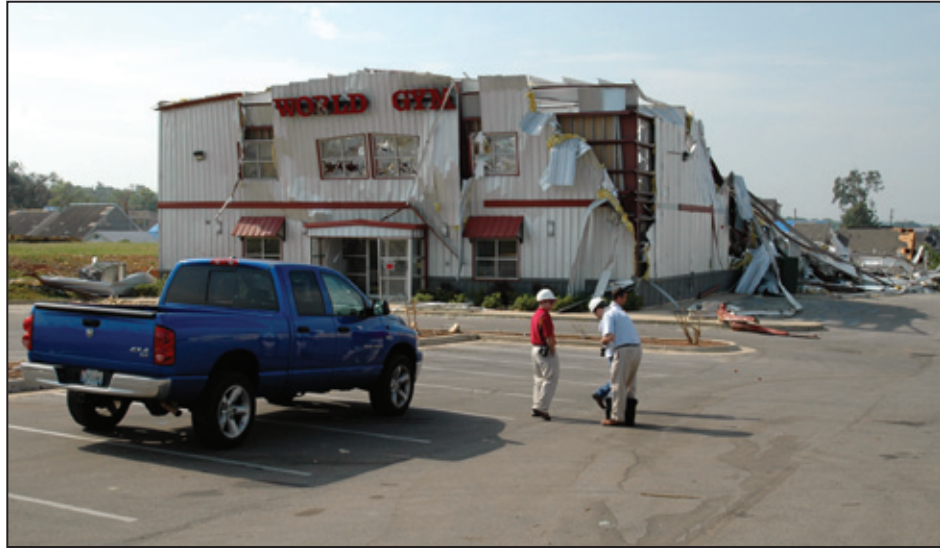
The MWFRS of the north end of this building performed well relative to the buildings in the immediate surroundings and exhibited ductility through much of the failure, providing cavities in which people could survive. The main column frame anchorages to the foundation performed well in the context of extreme overload (Figure 5-48). The column tore free from the base plate at the weld leaving the base plate and anchor rods in place. The steel anchor rods and base plates were stressed to the point of full yield—characterized by exaggerated deformation—which led to a failure of the welds to the columns (Figure 5-49).

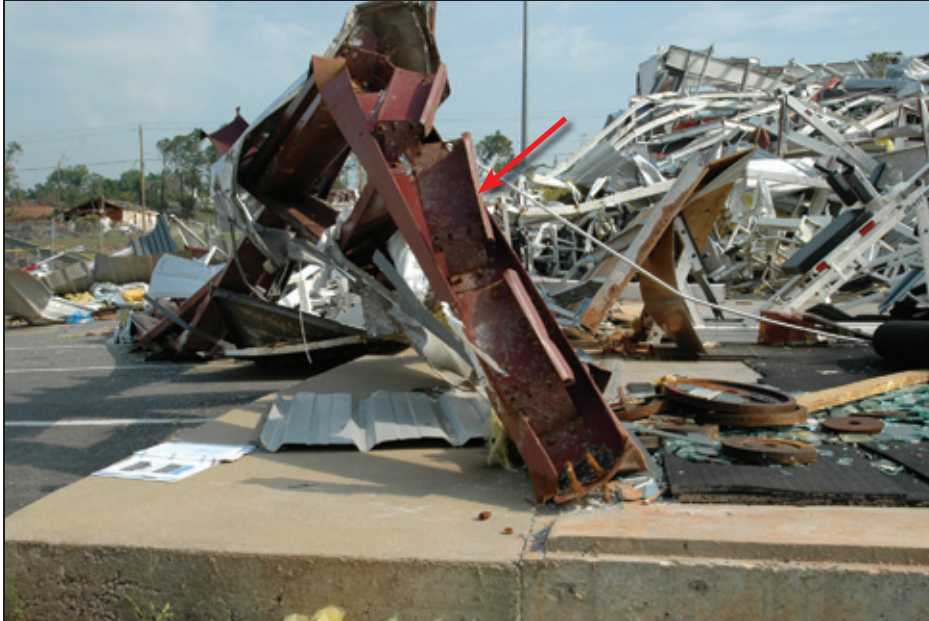
Figure 5-48:  
The anchor bolts of this base plate connection performed well while the weld along the base of the steel column failed (red arrow) (Tuscaloosa, AL)

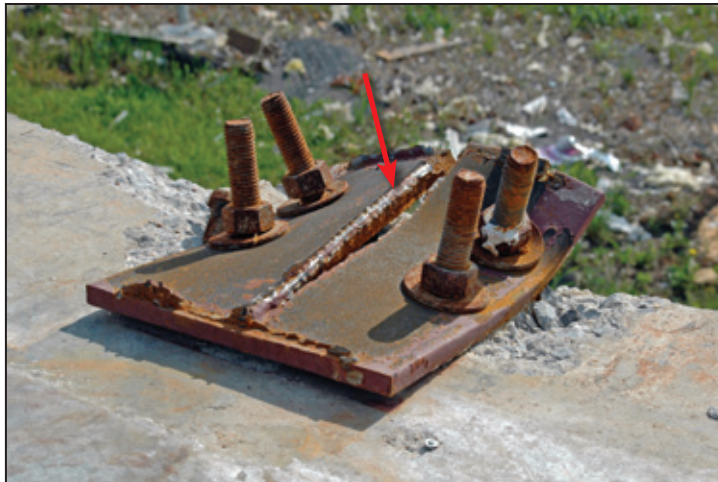
Figure 5-49:  
Ductile end column at southwest corner of building (red arrow). The anchor bolts remained attached to both the foundation and the column (Tuscaloosa, AL).

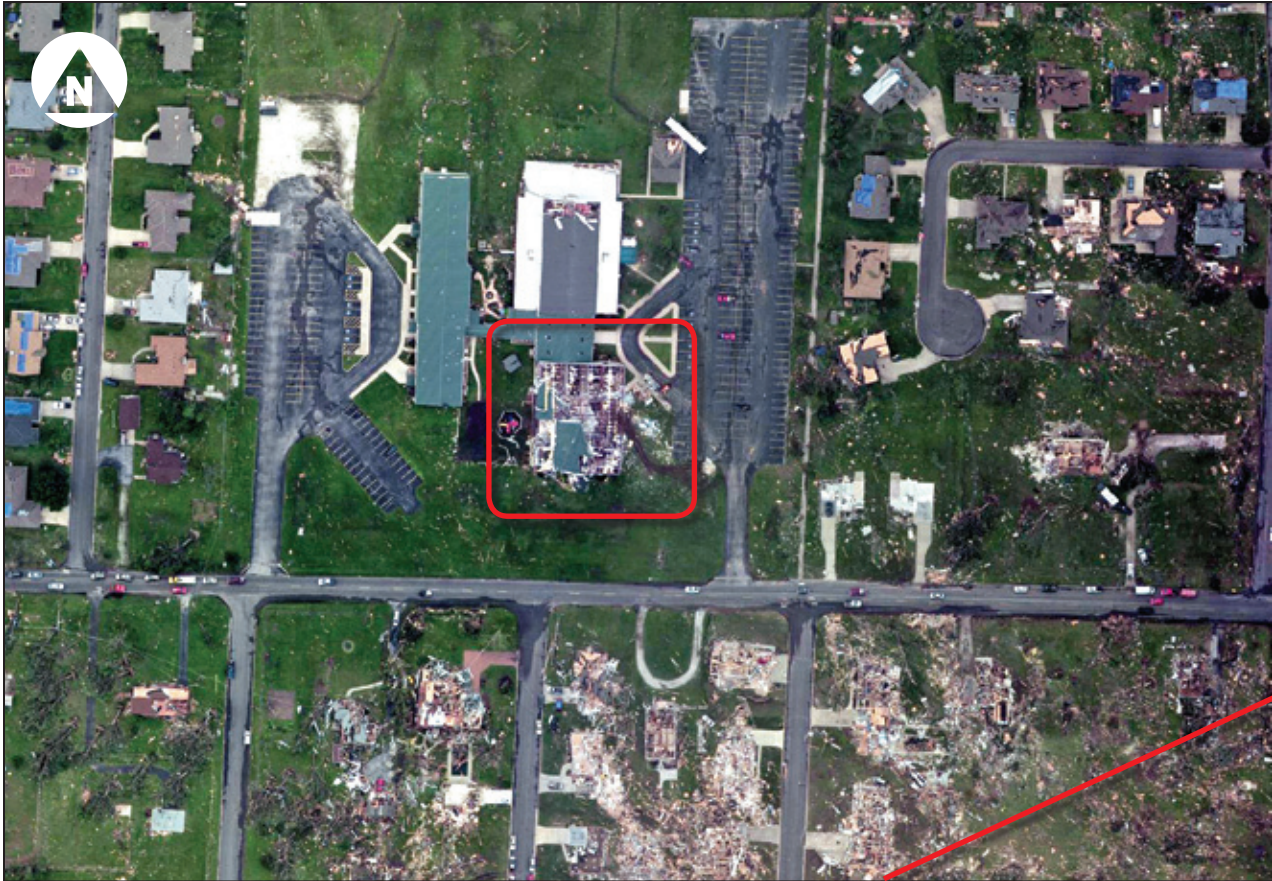
Figure 5-50: Aerial view of St. Paul's United Methodist Church (red box) (Joplin, MO) in relationship to the approximate centerline of the May 22, 2011 tornado damage swath (red line) (Joplin, MO)

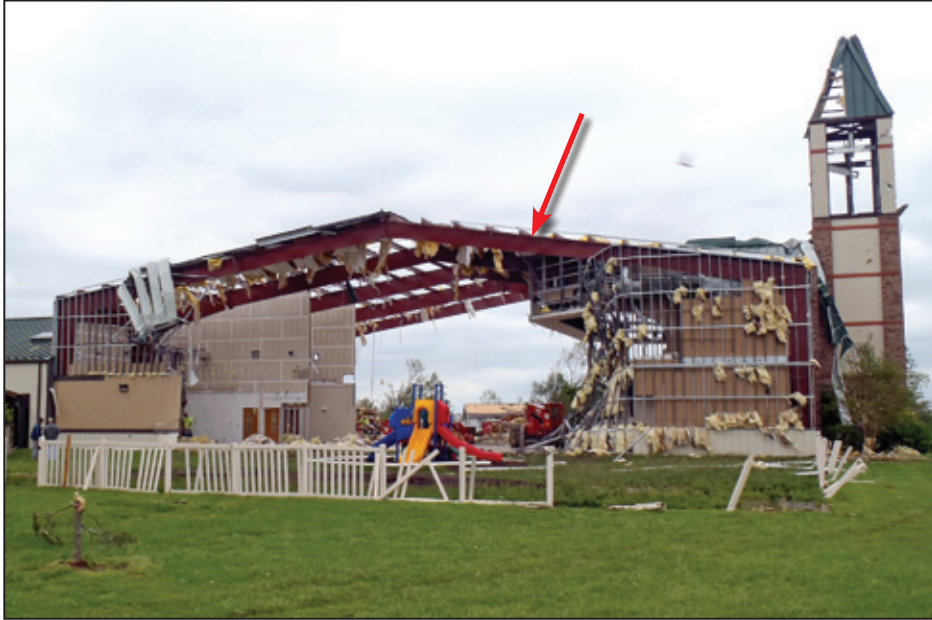
Figure 5-51:  
Intact PEMB main frames  
(red arrow) (Joplin, MO)

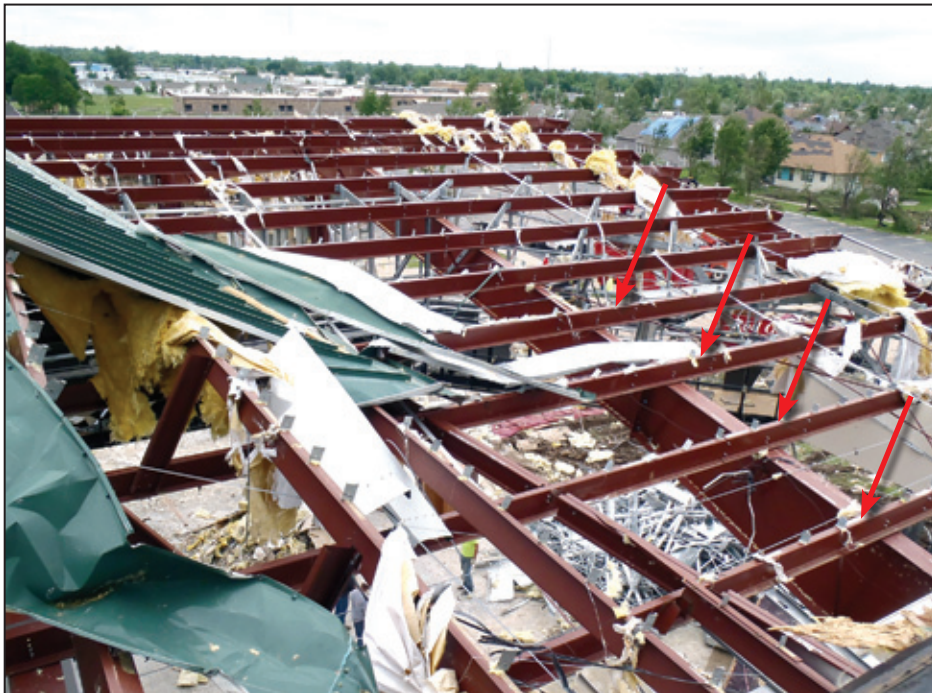
Figure 5-52:  
Roof system purlins intact  
with metal roof clip released  
(red arrows) (Joplin, MO)

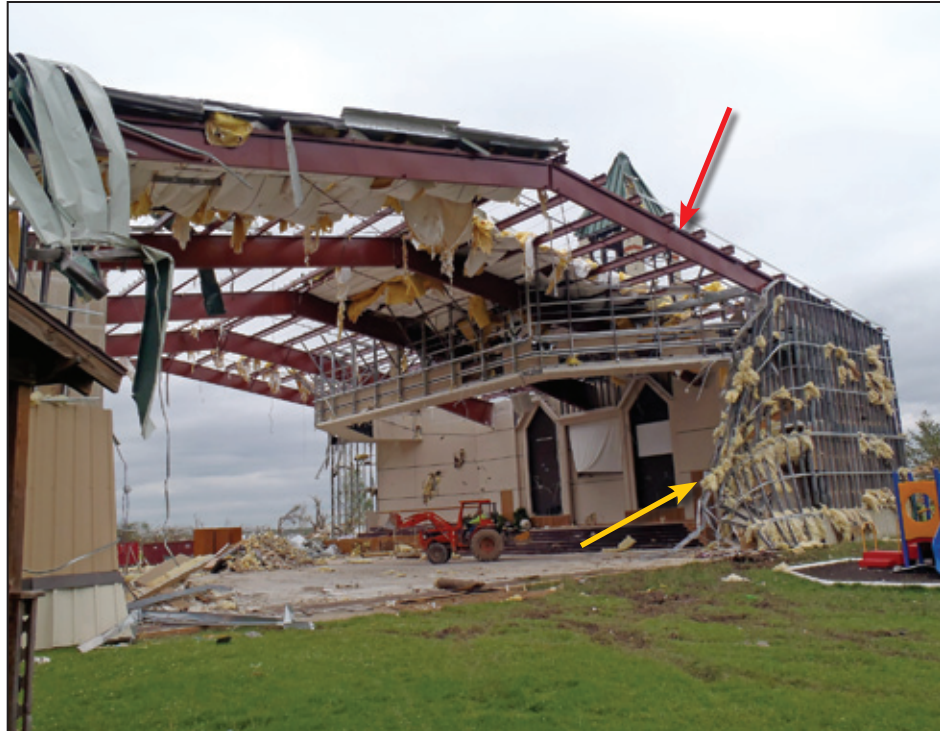
**MAT EF Rating:** Using DI 21 (Metal Building Systems), the MAT selected DOD 3 (“metal roof or wall panels pulled from the building”) for this building. Using the expected wind speed for DOD 3, the MAT derived the tornado ranking as EF1 (100–105 mph winds). Therefore, the estimated wind speed experienced by the building was in excess of the 90 mph building code design requirements for this location. The MAT EF1 rating for the church is lower than the NWS rating of EF2 for the center of the tornado circulation near the building.

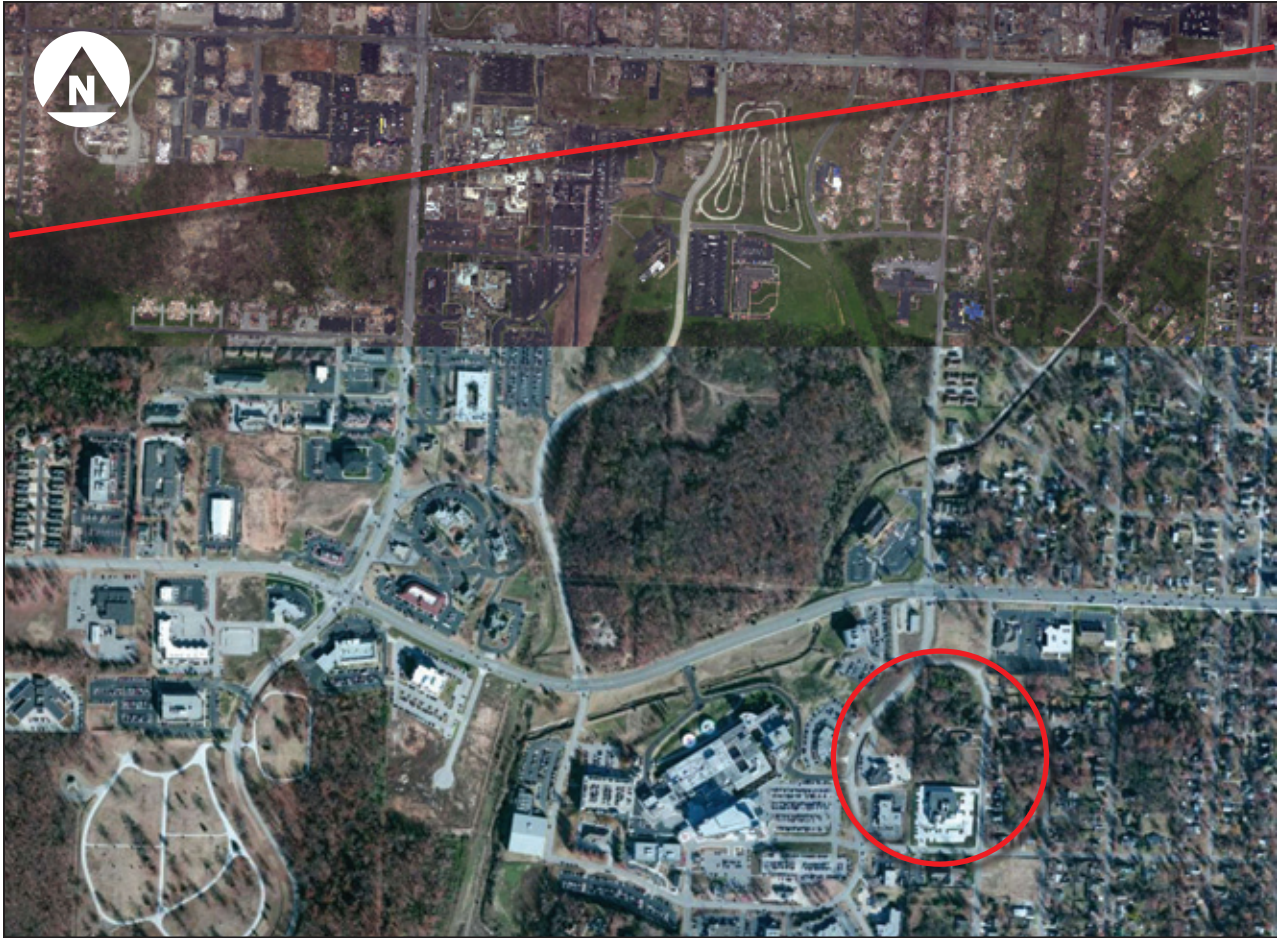
Figure 5-54: Aerial view of the Ozark Center for Autism (red circle) in relationship to the approximate centerline of the May 22, 2011 tornado damage swath (red line) (Joplin, MO)

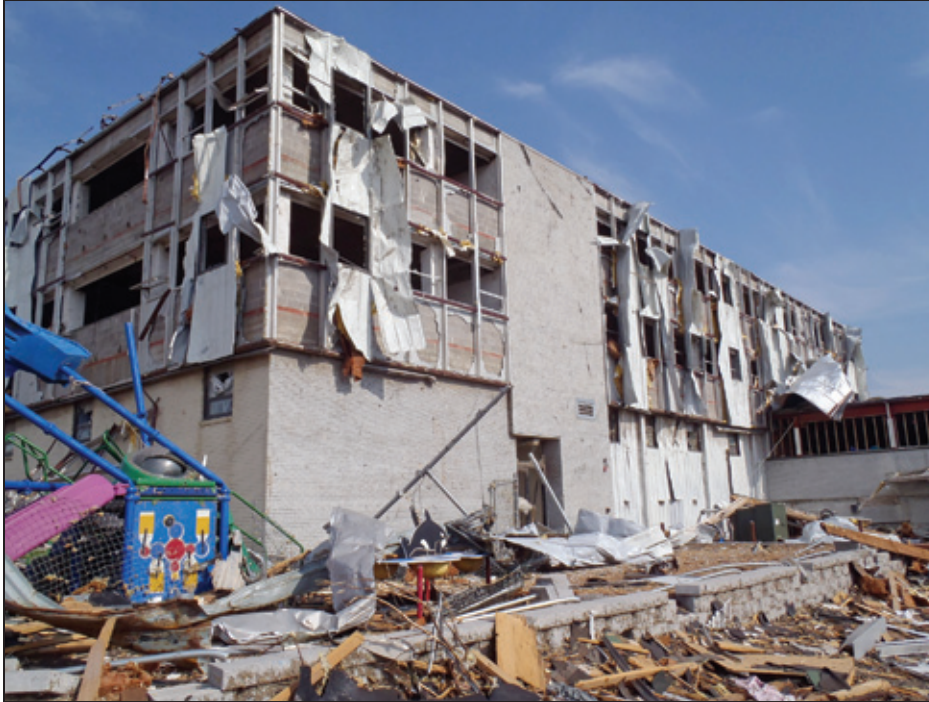
Figure 5-55:  
East elevation of the Ozark  
Center for Autism showing  
damage to glazing and siding  
(Joplin, MO).

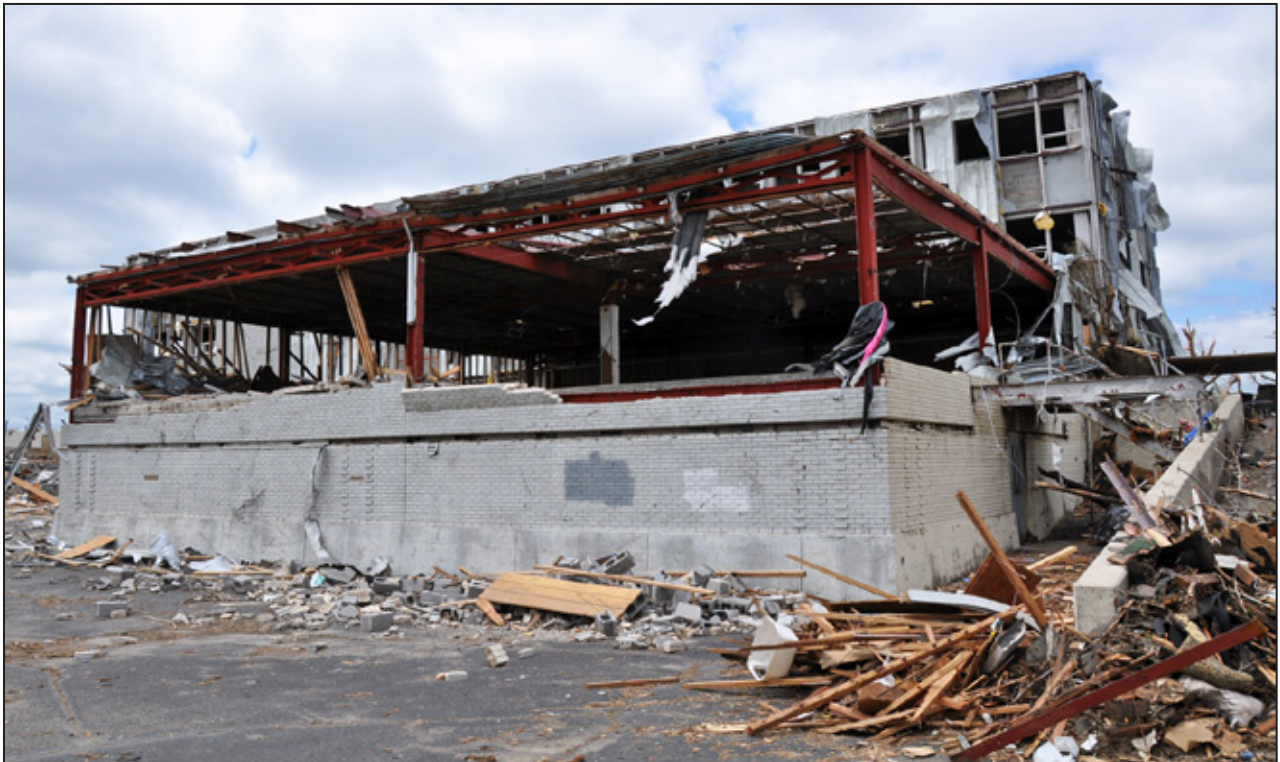
Figure 5-56: East elevation from northeast corner of building. The structural core of the taller building performed well, as did the CMU infill. The wing in the nearside of the figure is a two-story extension. Wood wall-framing debris can be seen in the foreground (Joplin, MO).

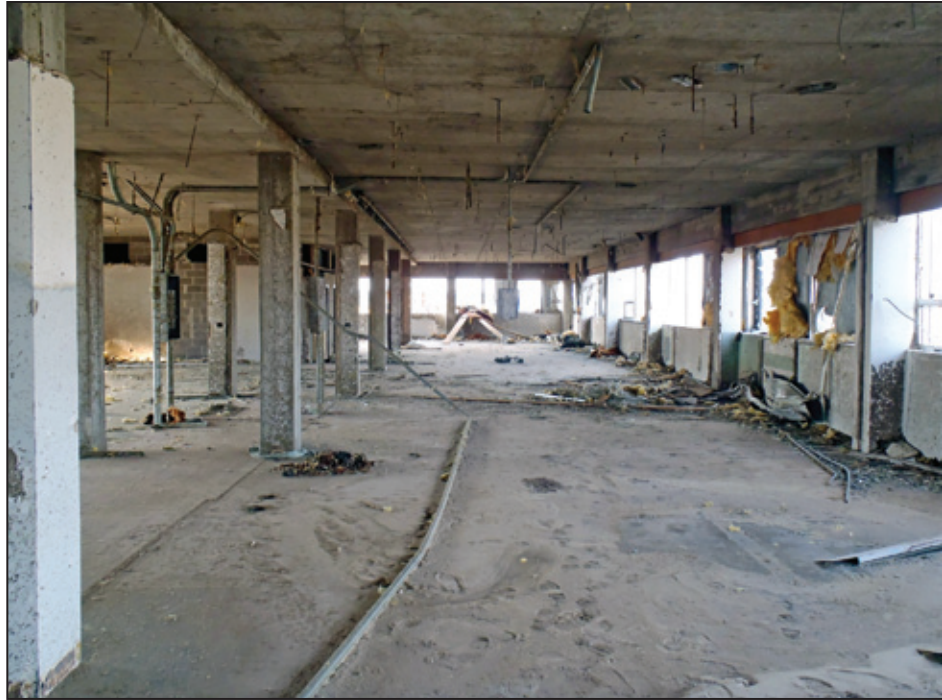
Figure 5-57:  
Two-story extension on east side of building shown in Figure 5-56; view shows typical interior layout (Joplin, MO)

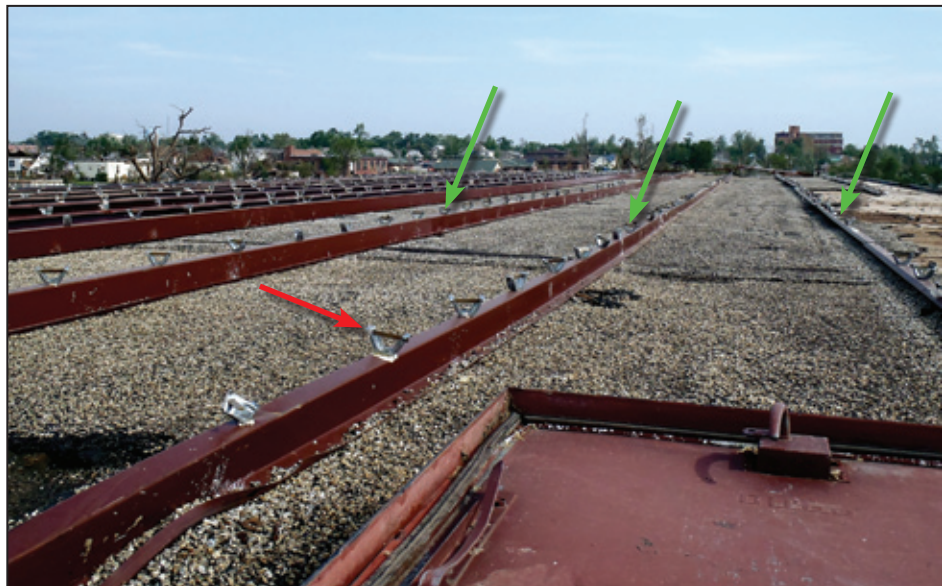
The roof framing system at the two-story extension is constructed with engineered steel girders and steel joists that span between them. A metal roof deck is connected to the joists (Figure 5-59) and a ballasted roof system is placed over that. The same layered roof construction was used on the three-story main building.

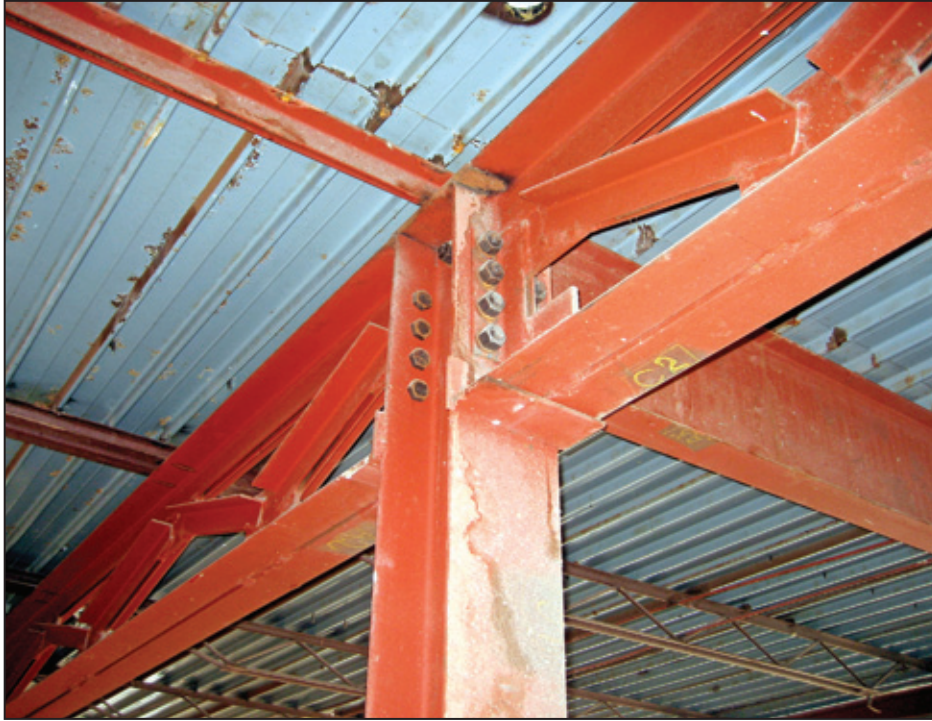
Figure 5-59:  
Roof section at two-story extension showing how the metal roof deck diaphragm is connected to the joists (Joplin, MO)

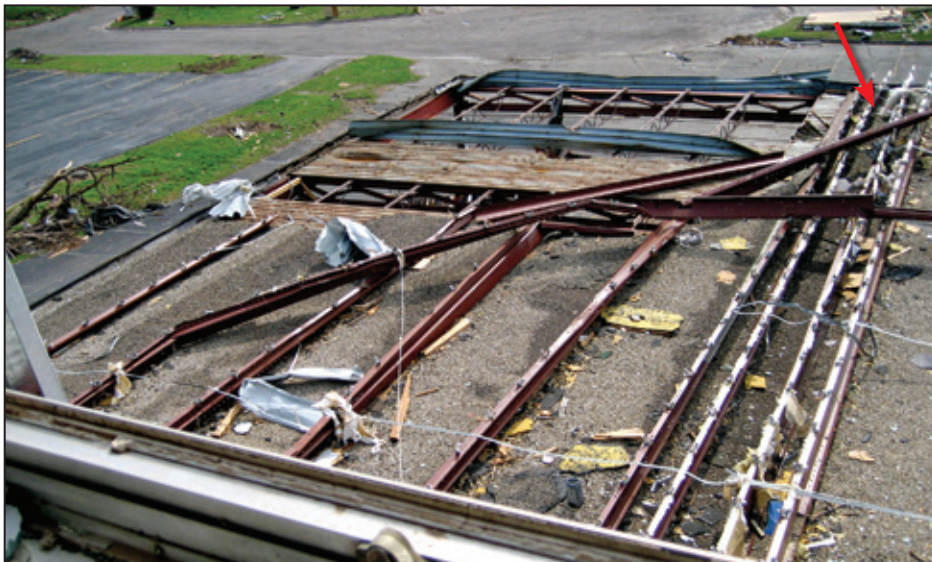
Figure 5-60:  
View of roof of the two-story extension observed from the third floor. Note the failed decking at the corner (red arrow) (Joplin, MO)

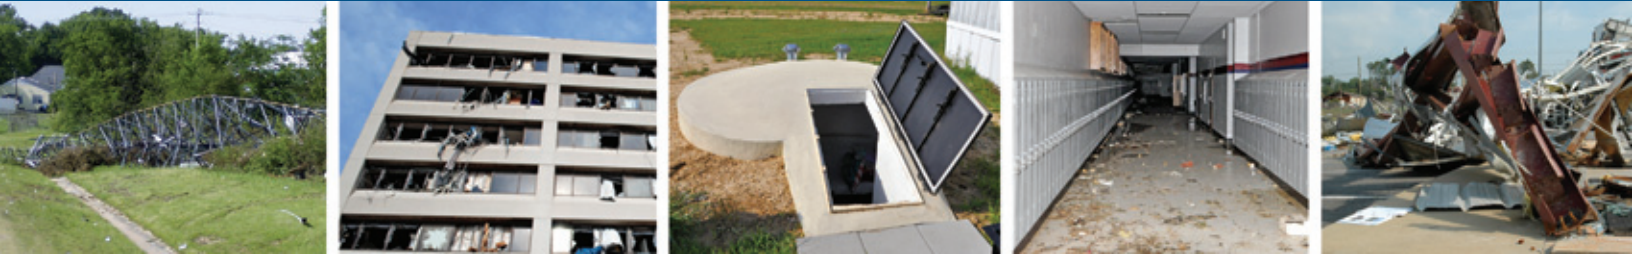
## TORNADO OUTBREAK *of* **2011**

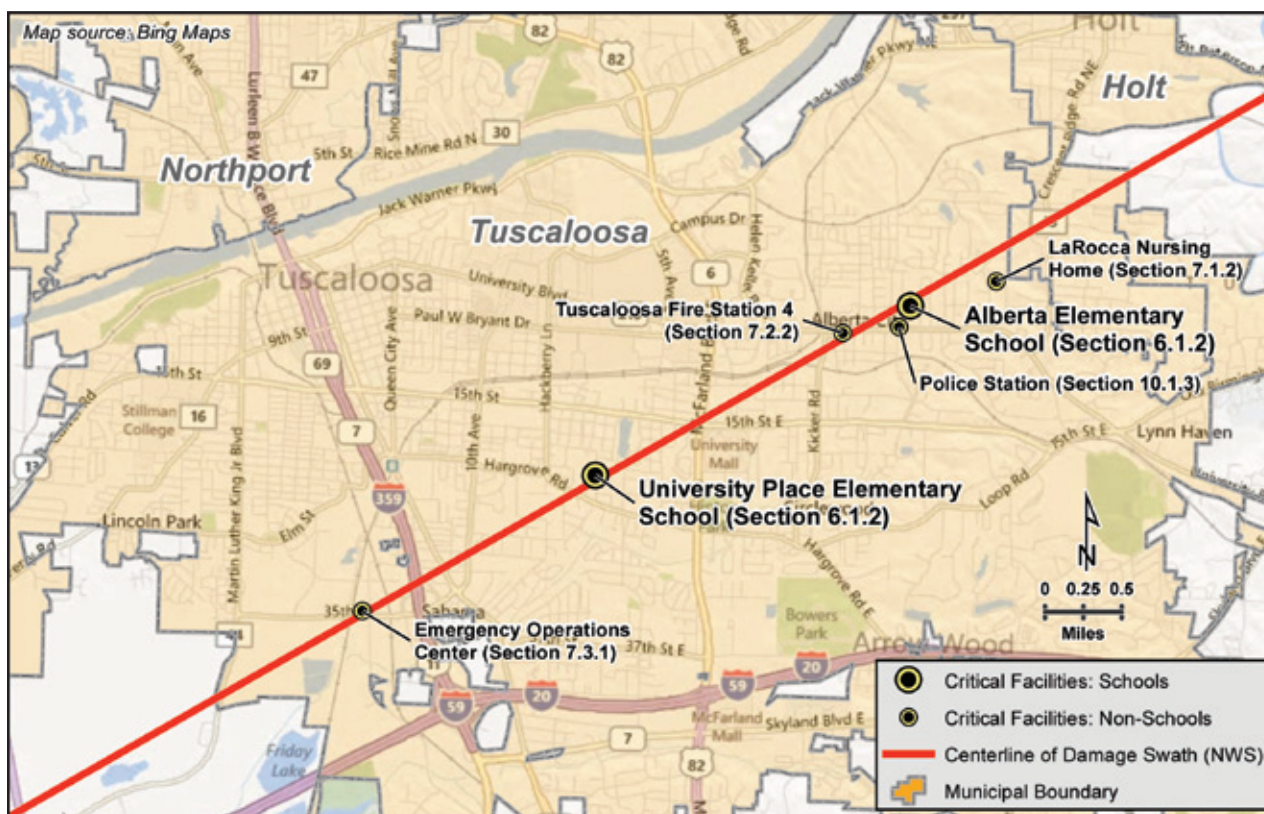
Figure 6-1: Location of Tuscaloosa, AL, critical facilities described in Chapters 6 and 7. The EOC (southwestern end of tornado track shown, red line) is approximately 4.7 miles from the LaRocca Nursing Home (northeastern end of tornado track shown).

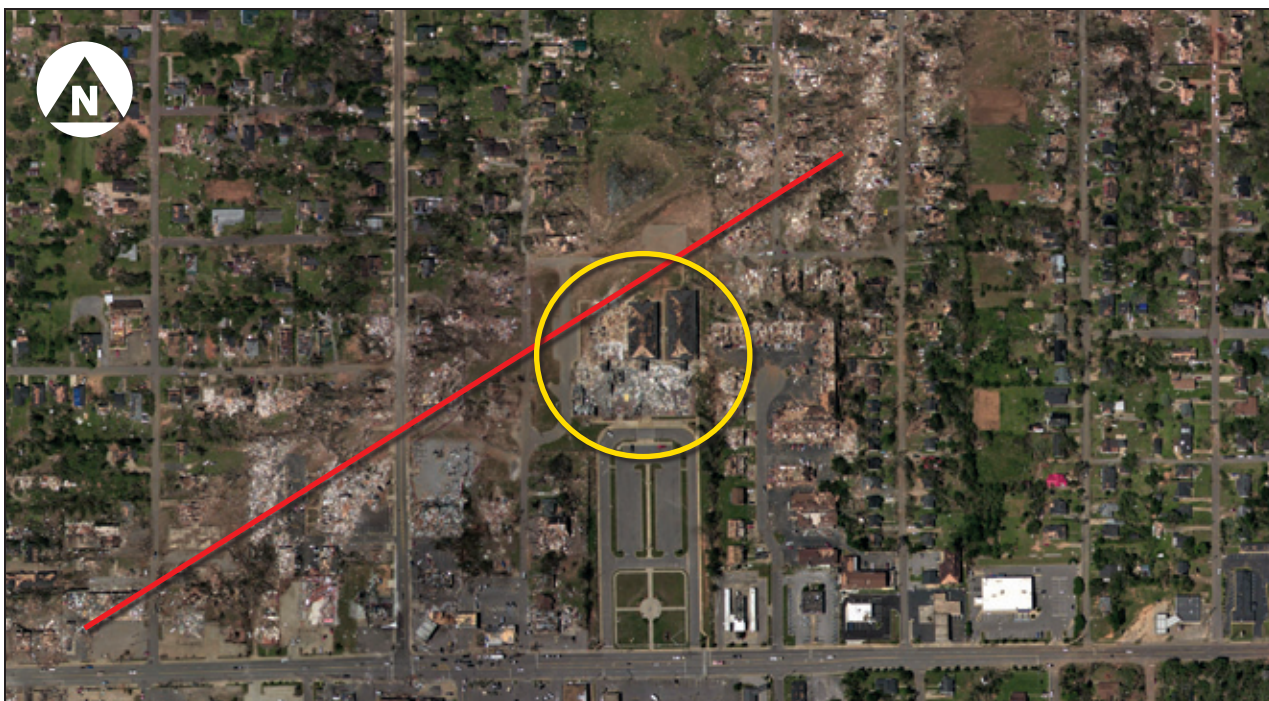
Figure 6-3: Aerial view of tornado track in vicinity of Alberta Elementary School (yellow circle). The center of the damage swath is approximated by the red line<sup>1</sup> (Tuscaloosa, AL).

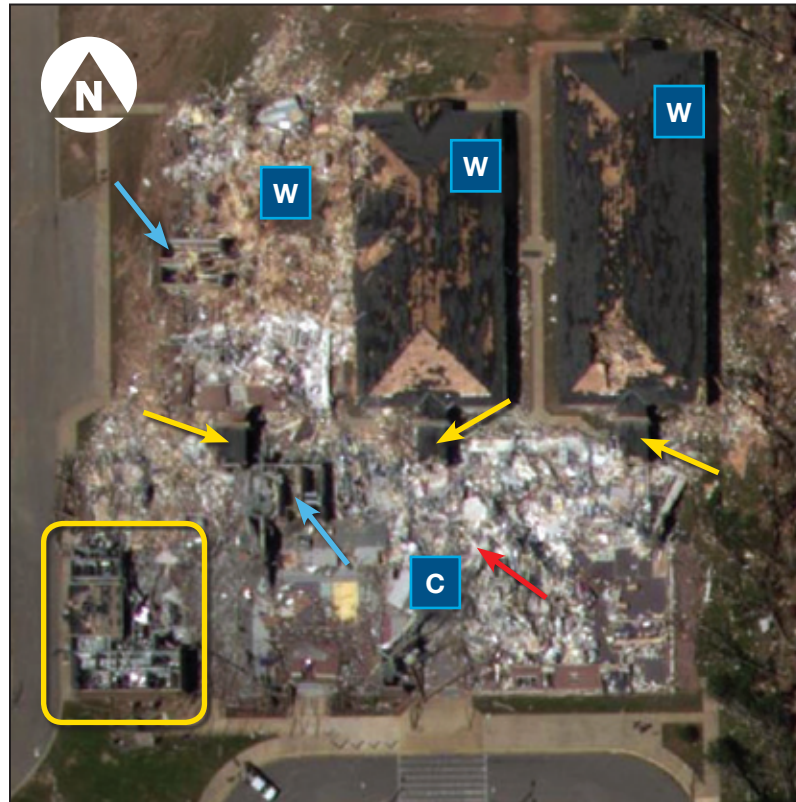
**Figure 6-5:** View of the central core area. Tornado refuge areas for the two surviving wings were in the collapsed area (red circle). The yellow arrows indicate the two surviving wings (Tuscaloosa, AL).

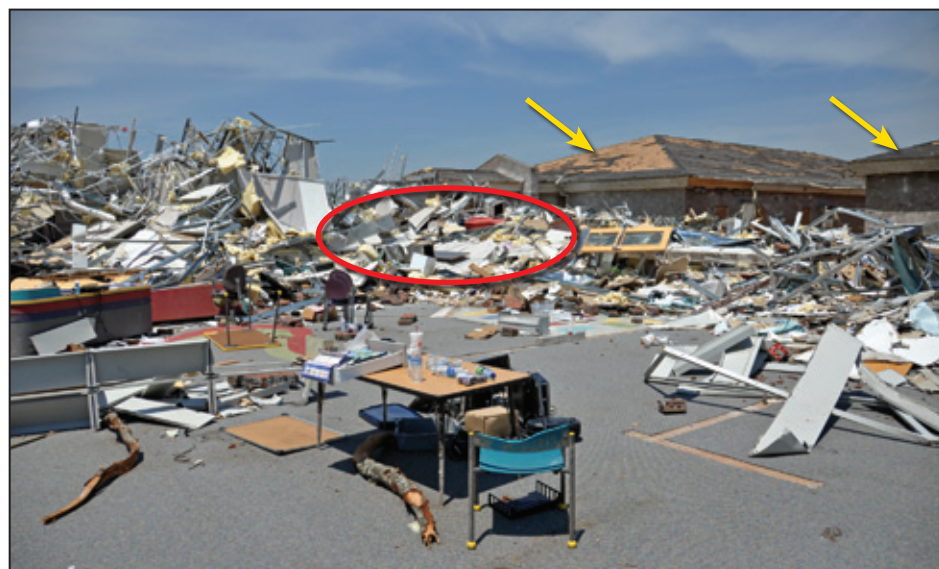
Several of the interior walls in the core area were reinforced CMU. Most of these walls collapsed. At the wall shown in Figure 6-6, the rebar was spaced at 4 feet on center. The rebar that was in the collapsed portion had only about 2 inches of embedment into the grouted CMU that is still in place and does not significantly strengthen the joint between the base of the wall and the floor or provide resistance to toppling. Similar splice laps were noted at exterior walls.

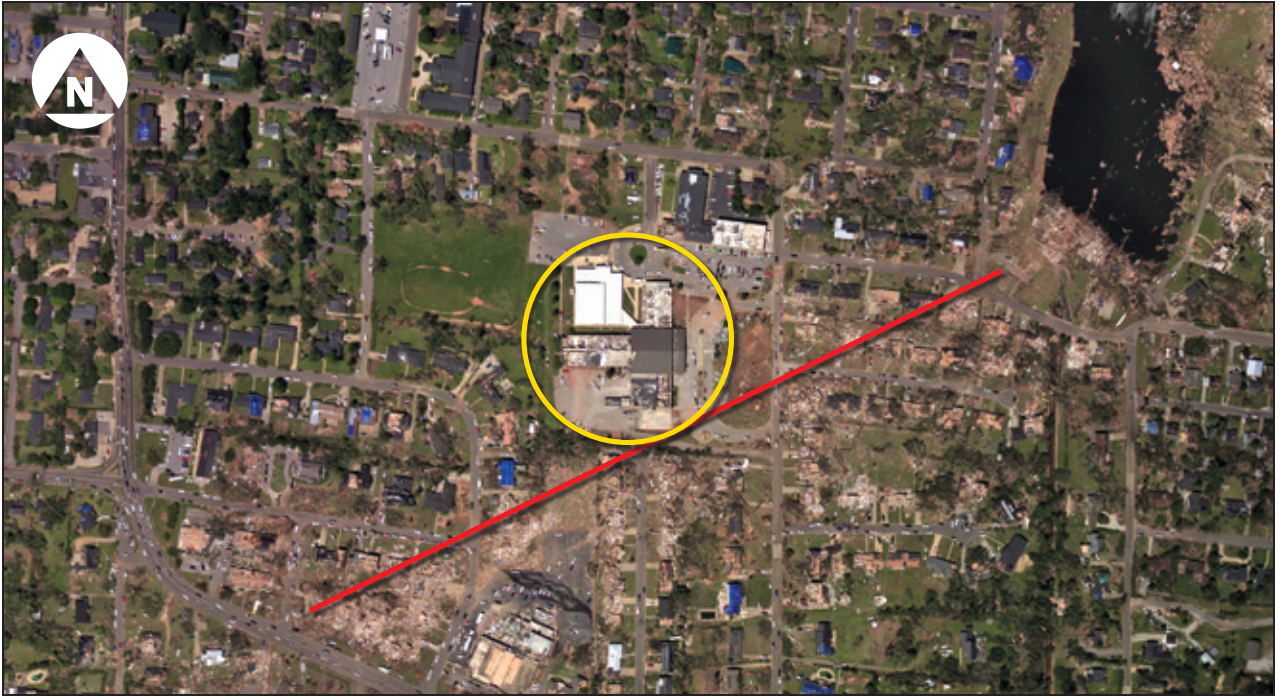
Figure 6-12: Aerial view of the tornado track in the vicinity of the University Place Elementary School (yellow circle). The center of the damage swath is approximated by the red line (Tuscaloosa, AL).

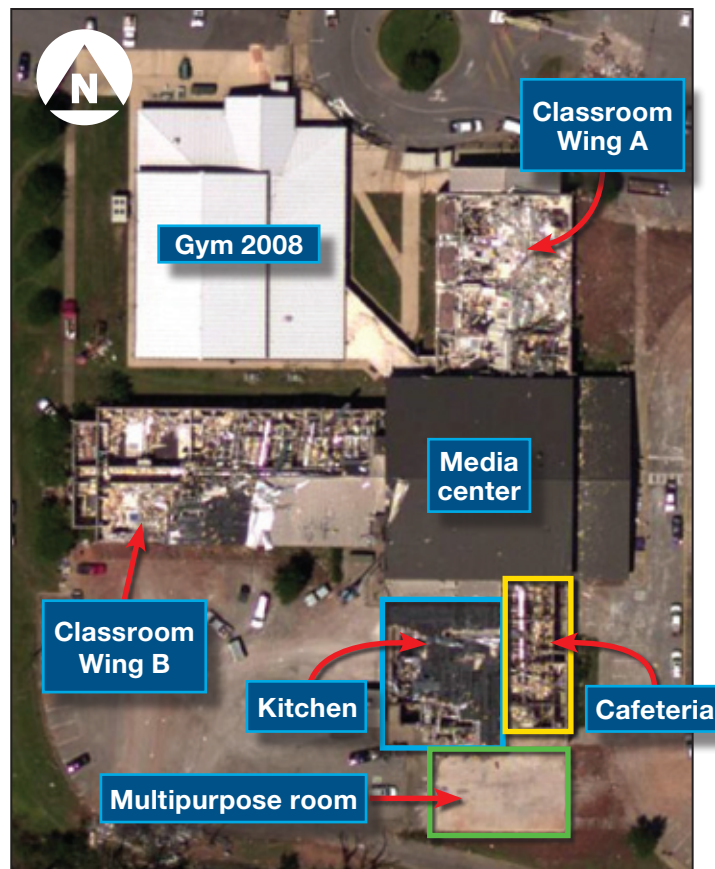
Figure 6-13: Close-up of Figure 6-12 showing classroom wings A and B and multipurpose wing (cafeteria, kitchen, and multipurpose room)<sup>5</sup> (Tuscaloosa, AL)

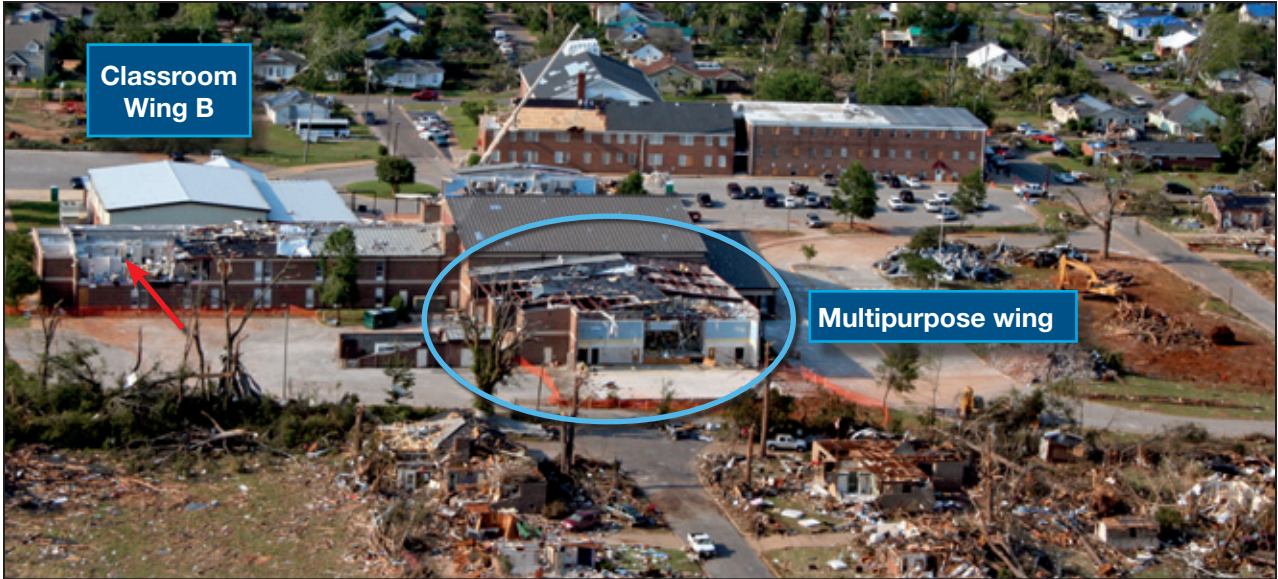
Figure 6-15: View looking north showing wall and roof structure damage to classroom wing B (red arrow) and damage to the multipurpose wing (blue oval) (Tuscaloosa, AL)

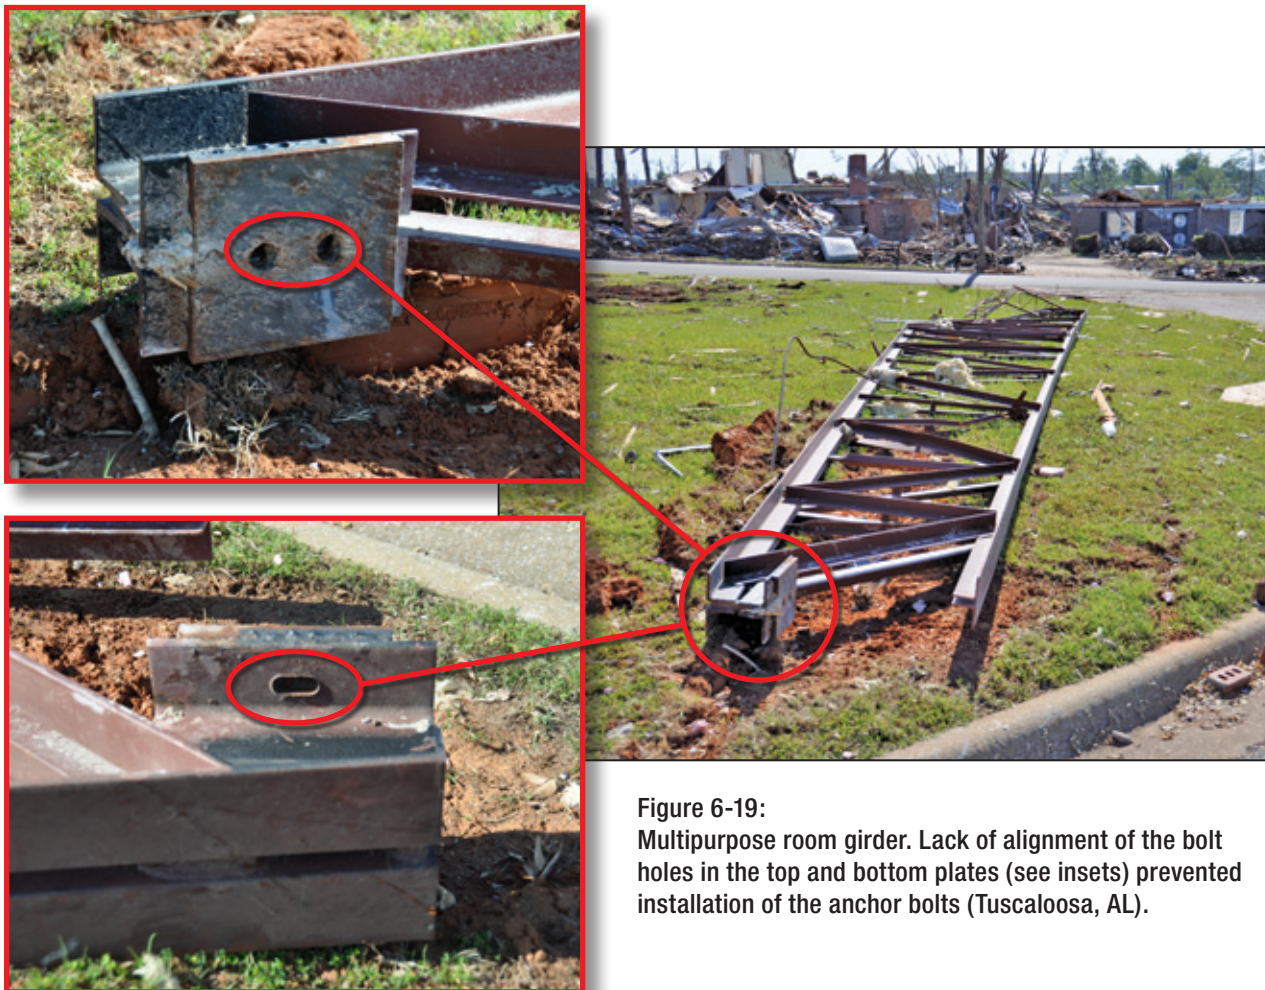
**Figure 6-19:**  
Multipurpose room girder. Lack of alignment of the bolt holes in the top and bottom plates (see insets) prevented installation of the anchor bolts (Tuscaloosa, AL).

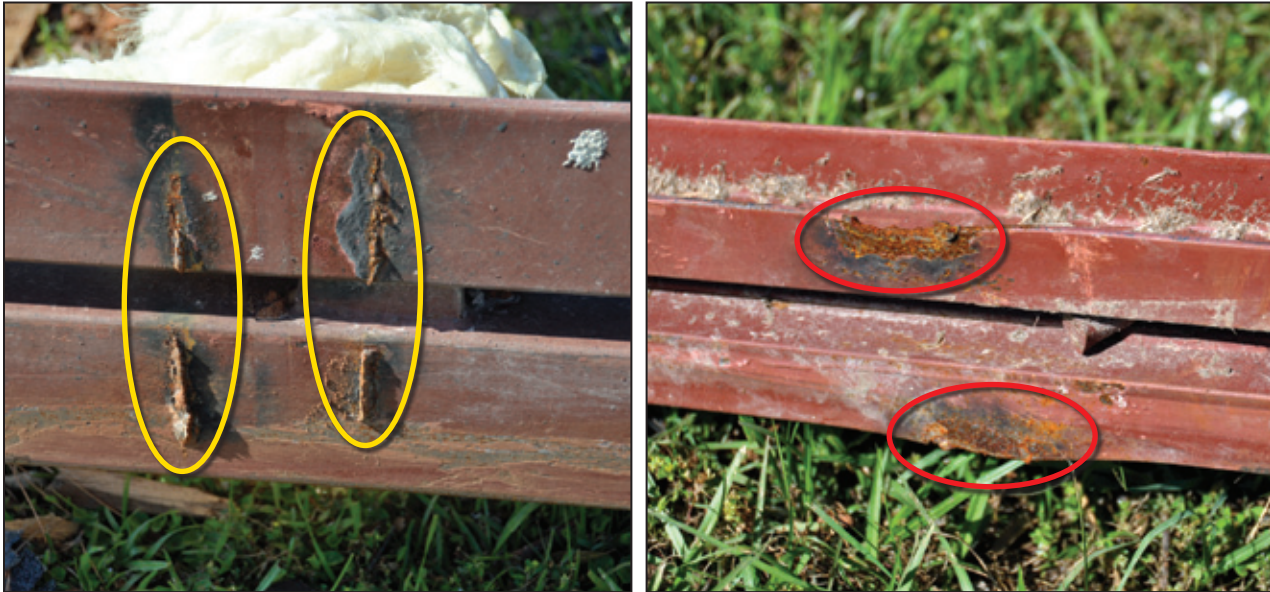
Figure 6-20: The yellow ovals on the left photograph show weld remnants where a joist was attached to the girder. The red ovals on the right photograph show weld remnants where a joist was attached to a bearing plate at a bond beam (Tuscaloosa, AL).

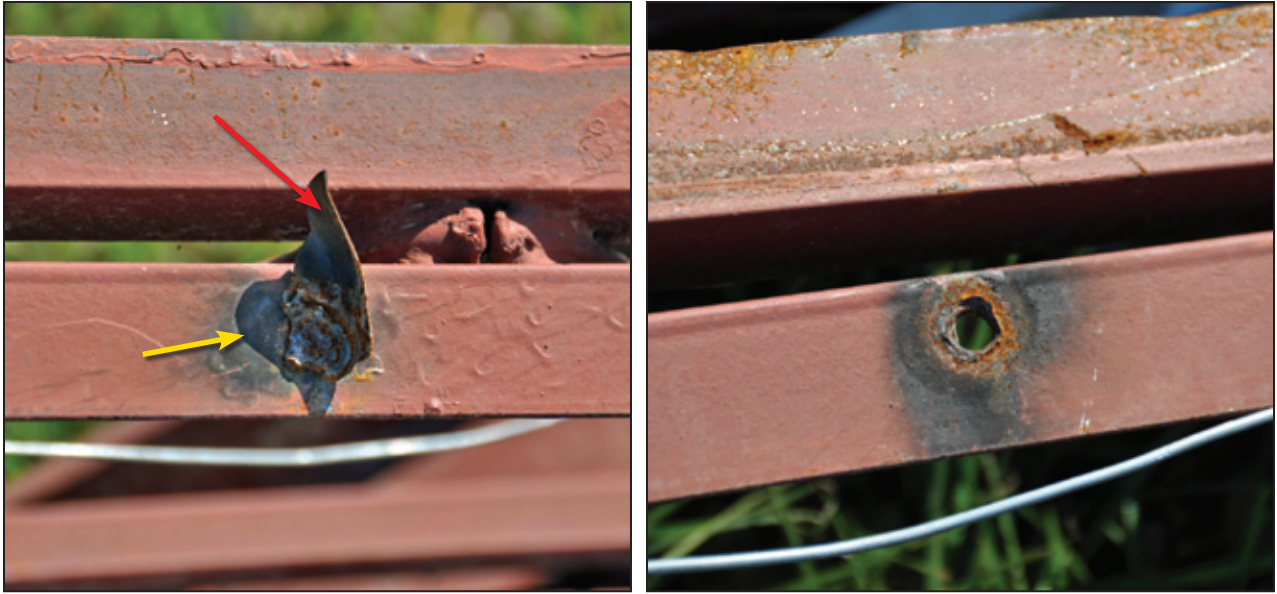
Figure 6-21: Red arrow shows a strong weld attaching a piece of decking to the joist (the dark area shown by the yellow arrow is a shadow). The photo on the right shows a weak deck attachment where the weld burnt through the joist (Tuscaloosa, AL).

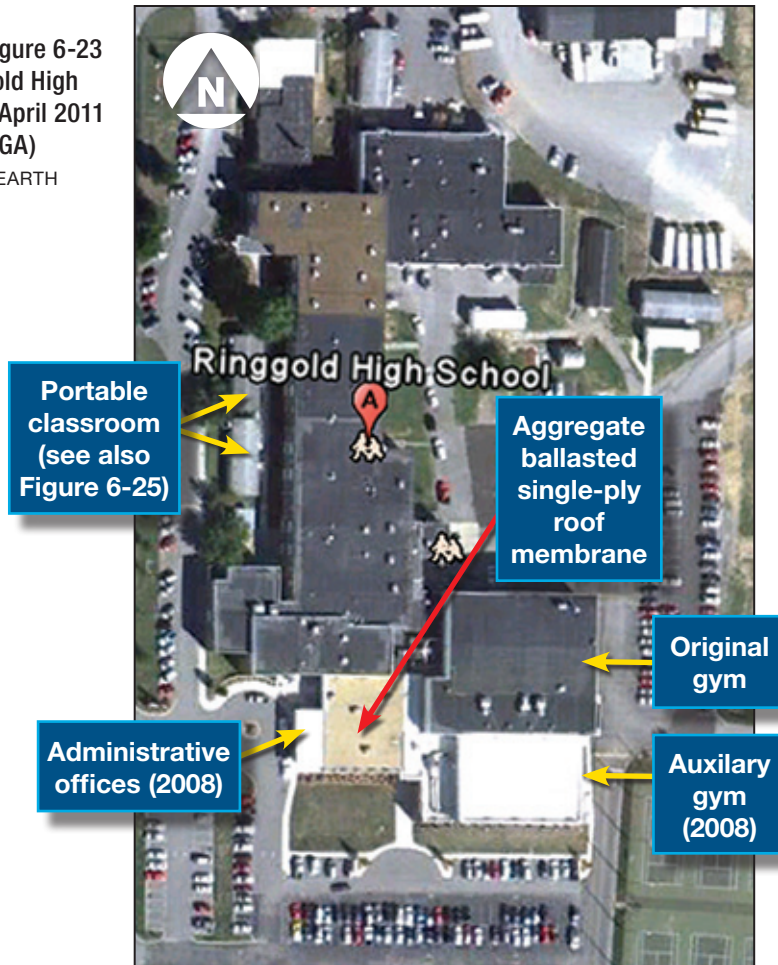
SOURCE: © GOOGLE EARTH

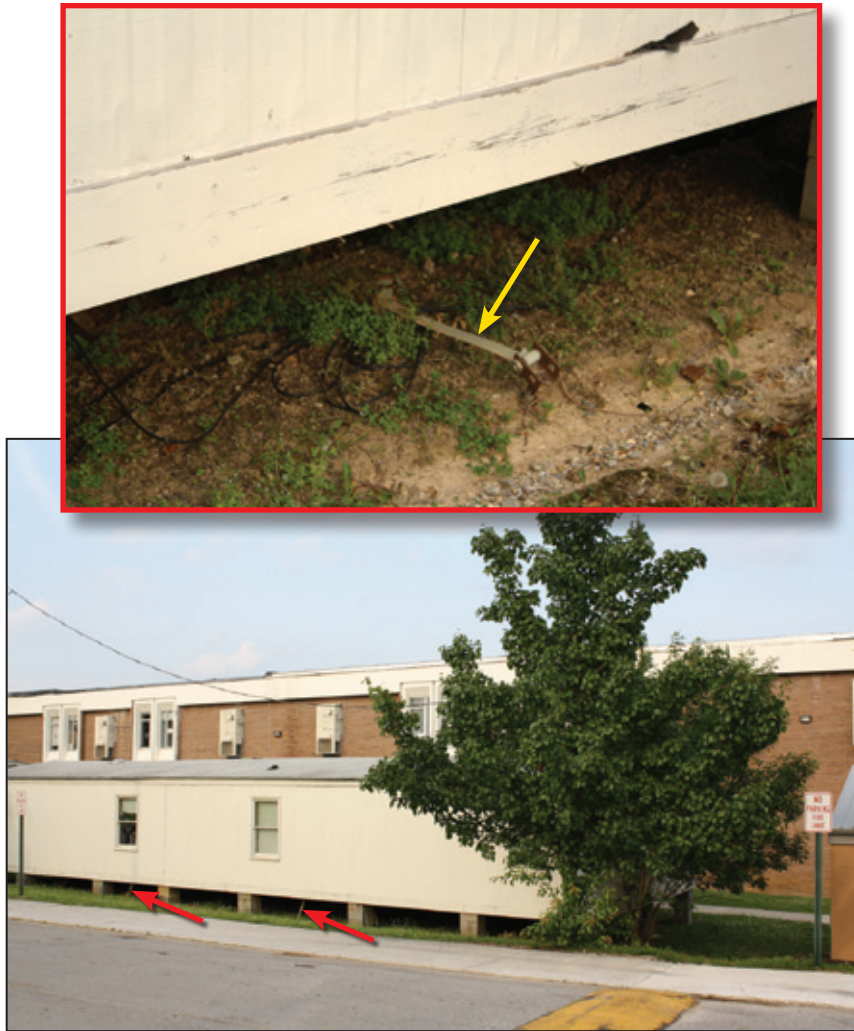
Figure 6-25:  
View of one of the portable classrooms. The red arrows indicate anchor straps. The strap shown in the inset had corroded through (yellow arrow) (Ringgold, GA).

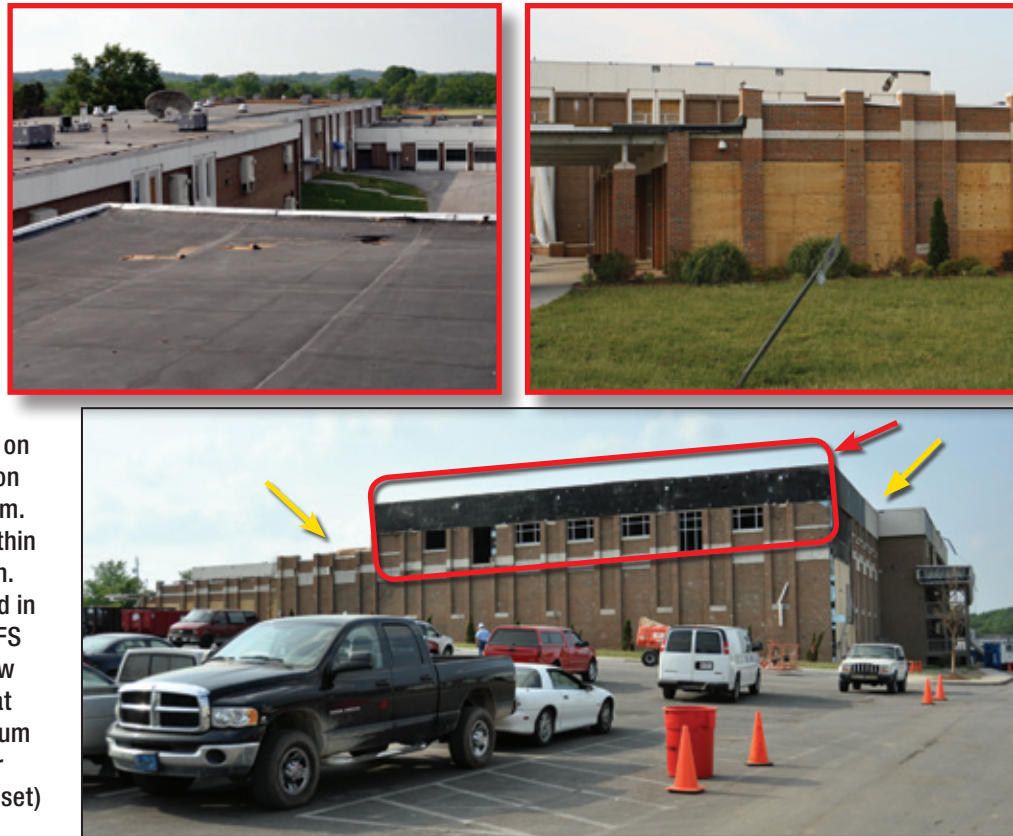
Figure 6-27:  
View of the two gymnasium roofs. The red arrow shows the 2008 auxiliary gymnasium (see also Figures 6-26 and 6-28). The EPDM (black) membrane is over the original gymnasium. Note the displaced rooftop equipment. The red box shows a portion of the middle school beyond. The inset shows wind-borne debris damage to the EPDM roof (Ringgold, GA).
