## Mitigation Assessment Team Report

# Spring 2011 Tornadoes: April 25-28 and May 22

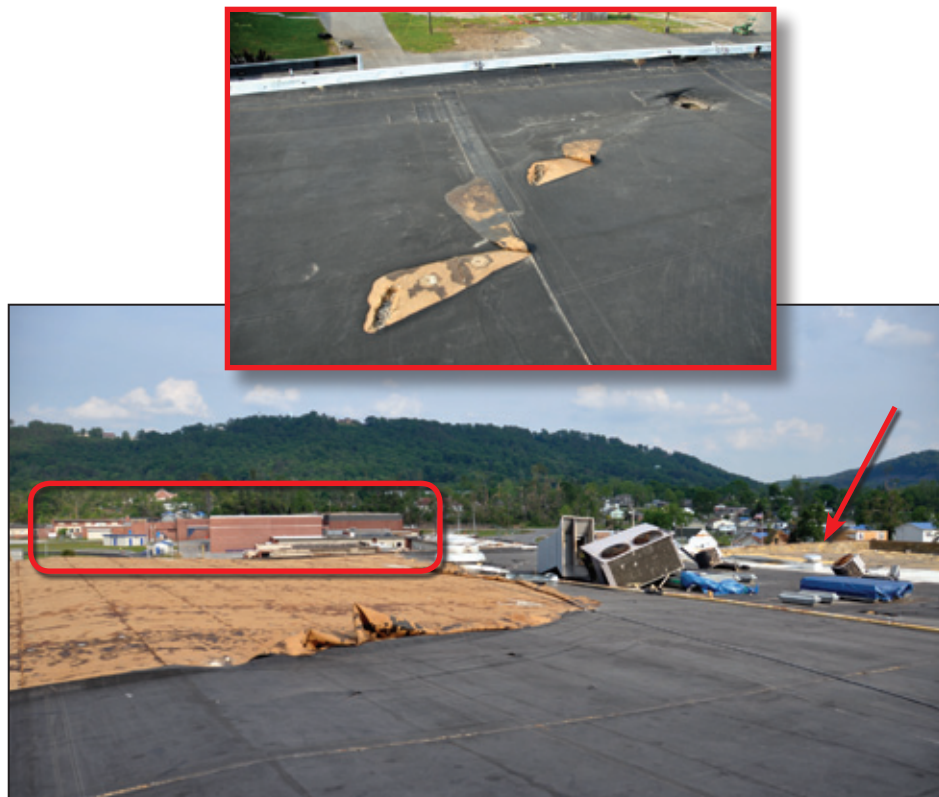
The roof of the original gymnasium shown in Figure 6-27 had a fully adhered ethylene propylene diene monomer (EPDM) membrane over wood fiberboard over an aggregate surface built-up roof. The primary failure mode was EPDM lifting and peeling. However, as shown by the inset at Figure 6-27, areas of the membrane were punctured by wind-borne debris. The old built-up roof acted as a secondary membrane and likely prevented little if any water from leaking into the gymnasium. However, rain entered the gymnasium where the rooftop equipment shown in Figure 6-27 was blown off the curb. Gas lines were broken at the displaced rooftop equipment shown in Figure 6-27. Damage to the EIFS was noted (Figure 6-26); in some areas the metal studs blew away, while in other areas the EIFS's gypsum board substrate blew away. There were also several broken windows.

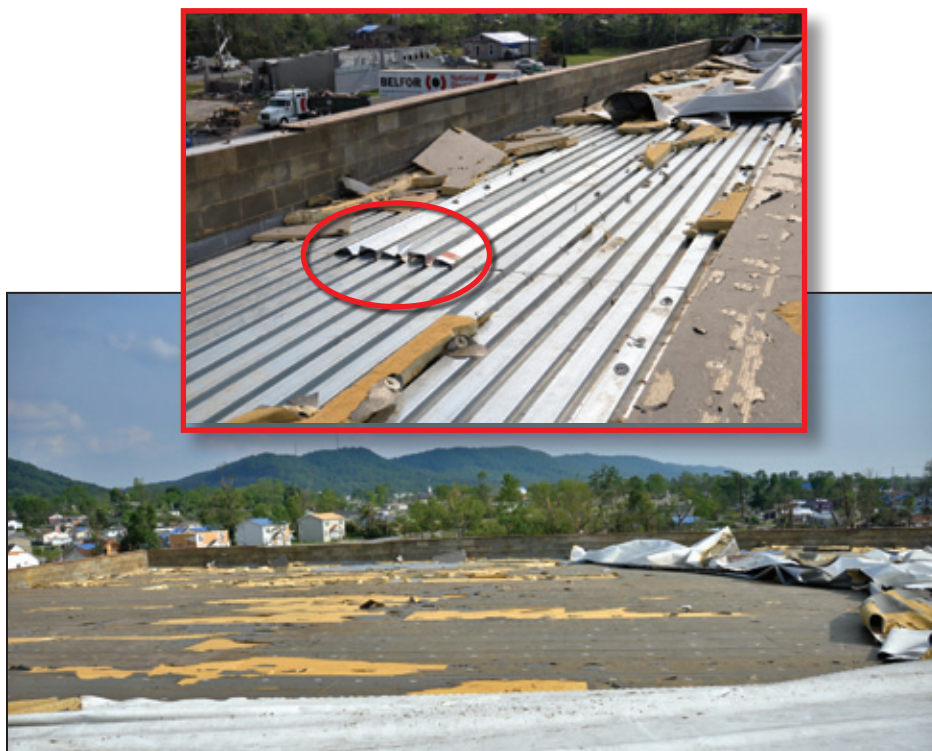
Figure 6-28:  
View of the roof of the  
2008 auxiliary gymnasium  
(see also red arrow in  
Figure 6-27); inset shows  
lifted decking (red circle)  
(Ringgold, GA)

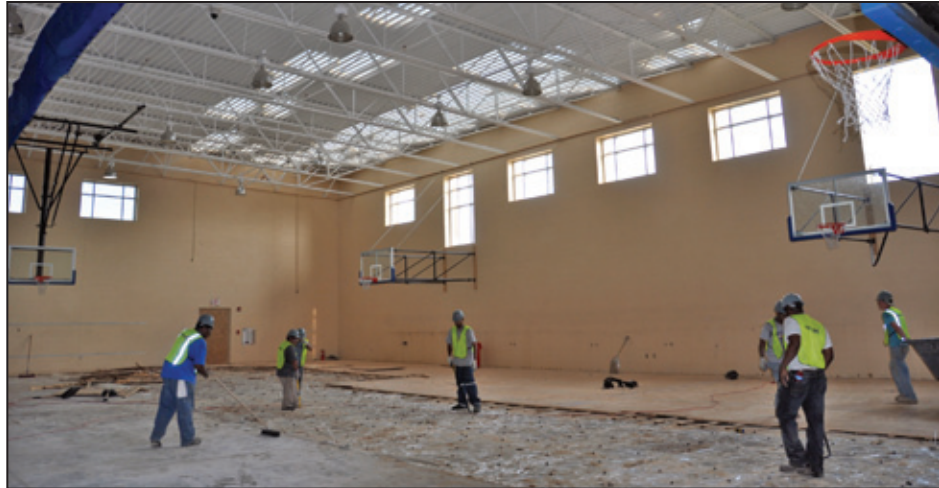
Figure 6-30:  
View of the aggregate ballasted roof. The fully adhered roof membrane blew away; inset below (red box) shows broken windows (Ringgold, GA).

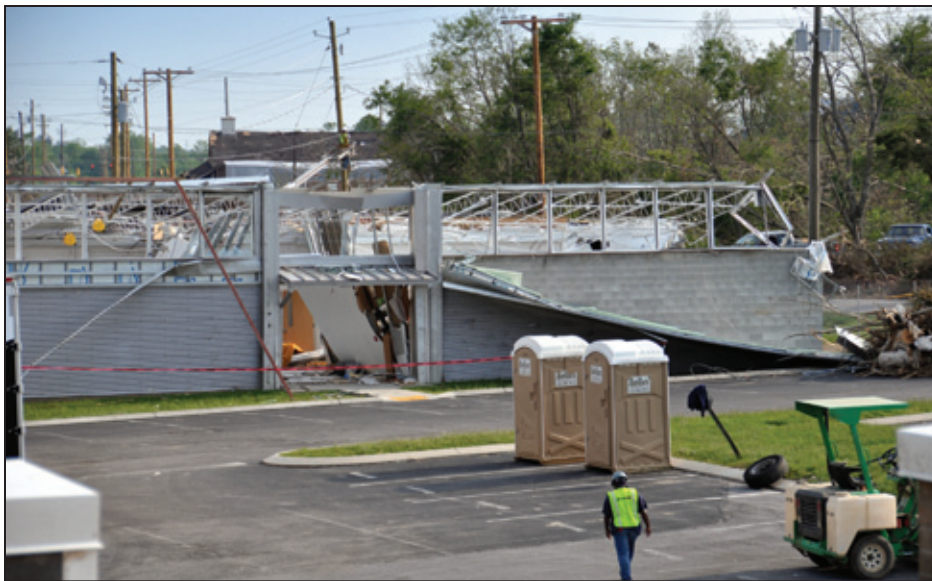
**Figure 6-31:**  
The roof covering was blown off of the 2008 art center. The metal wall covering and insulation was also blown off the CMU. The art center was subsequently demolished (Ringgold, GA).

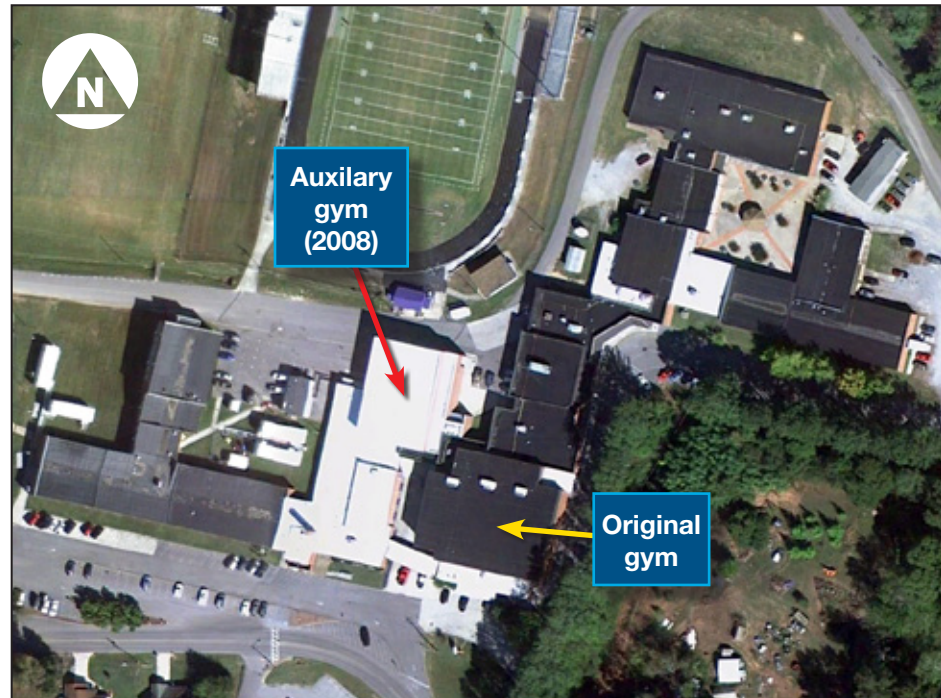
One of the classroom wings has two stories, but most of the school is one story. Some of the roof decks are poured gypsum, others are cementitious wood-fiber, and the 2008 auxiliary gymnasium has a metal deck. The facility has a structural steel frame. Most of the exterior walls are brick veneer over CMU. Some walls are EIFS over metal studs.

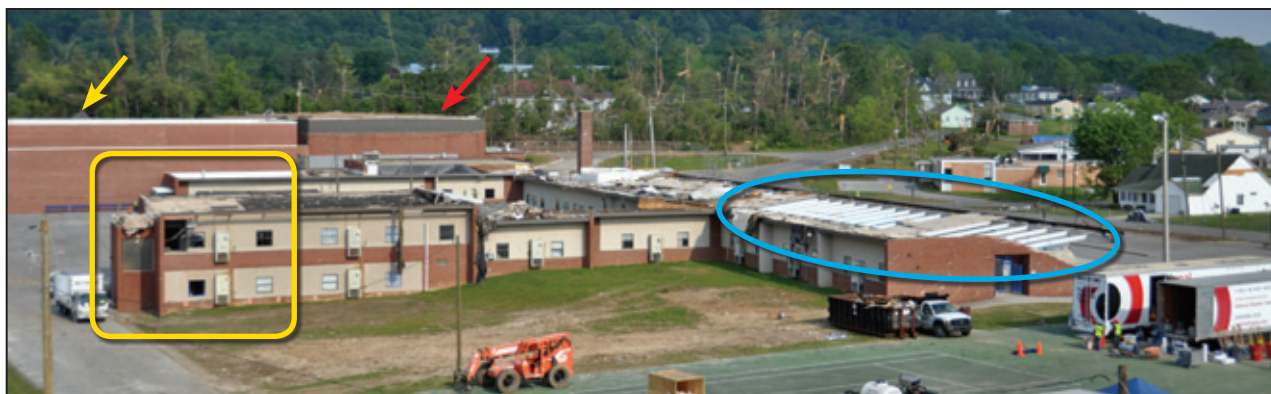
Figure 6-34: View of the Ringgold Middle School (the inset shows the left portion of the school). The 2008 auxiliary gymnasium (yellow arrow) and original gymnasium (red arrow) are shown. Most of the roof deck was lost in the area shown by the blue oval. The yellow box indicates an area where walls and glazing were damaged (Ringgold, GA).

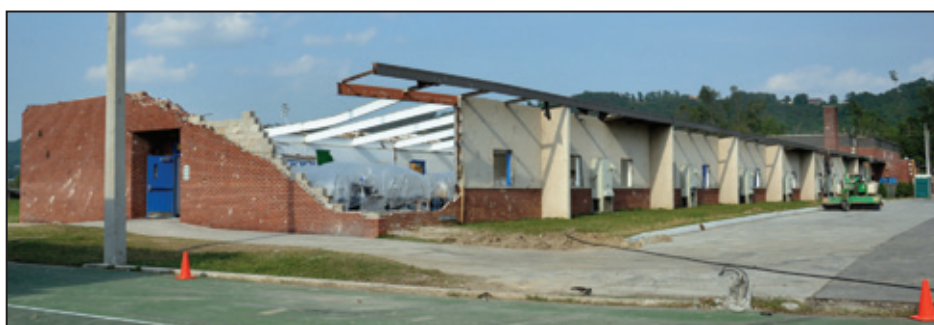
Figure 6-35: This wing lost most of its roof decking, and a portion of the brick veneer and unreinforced CMU collapsed (Ringgold, GA)

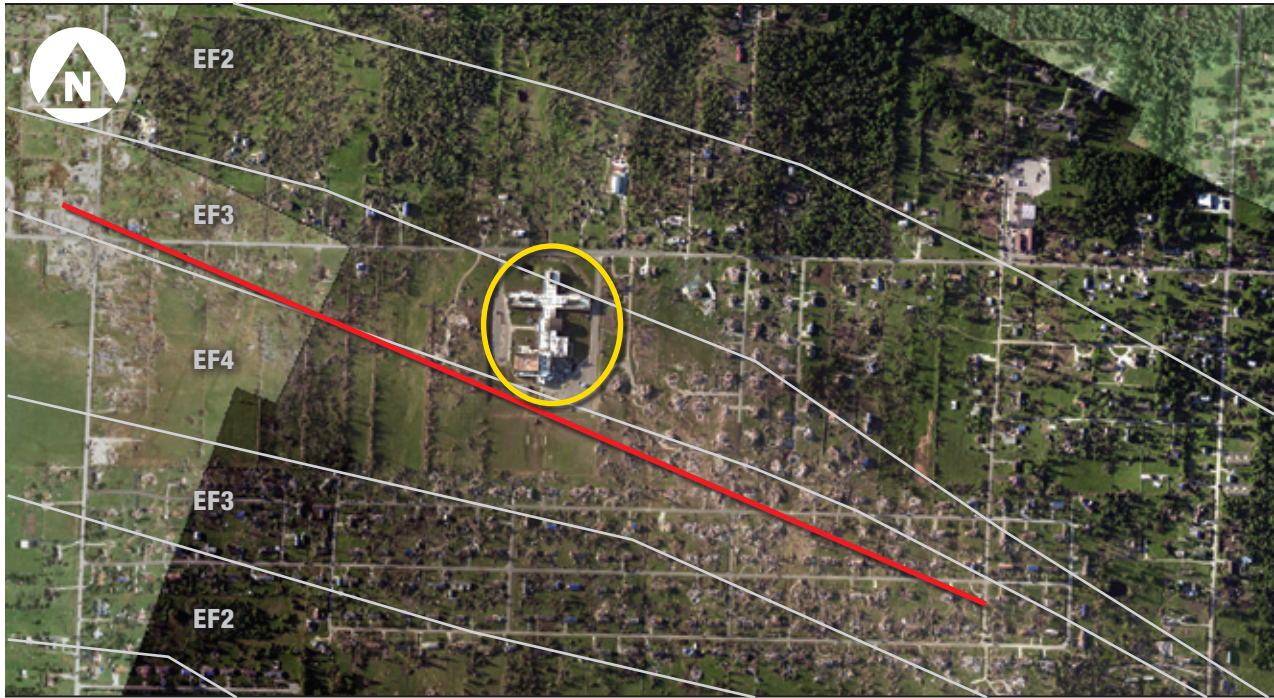
Figure 6-39: Aerial view of the tornado track in the vicinity of the Joplin East Middle School (yellow circle). The center of the damage swath is approximated by the red line. NWS EF contour ratings are also shown (Joplin, MO).

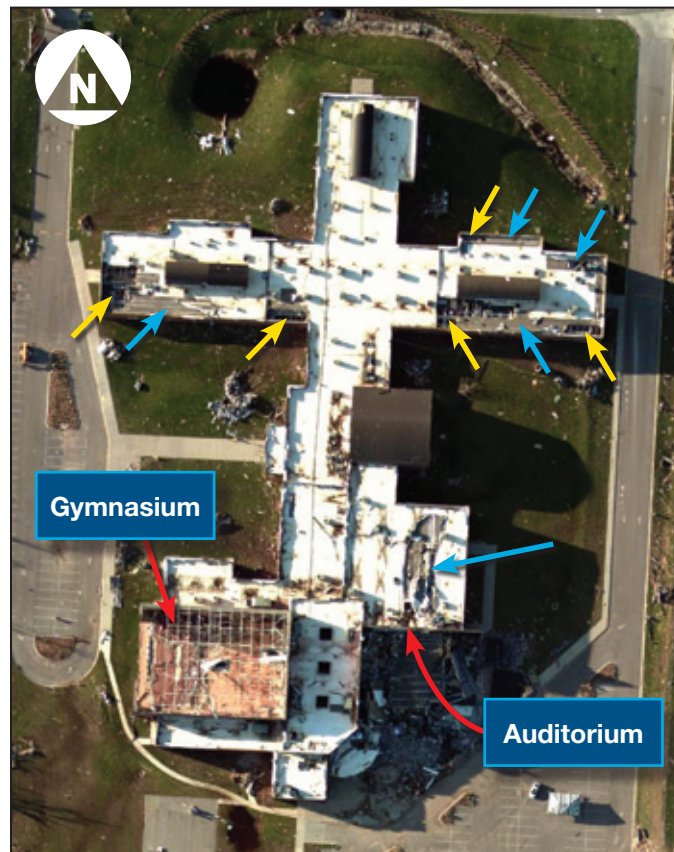
Figure 6-40: Close-up of Figure 6-39. Major areas of blow-off of the roof membrane and roof deck are shown by the blue and yellow arrows (Joplin, MO).

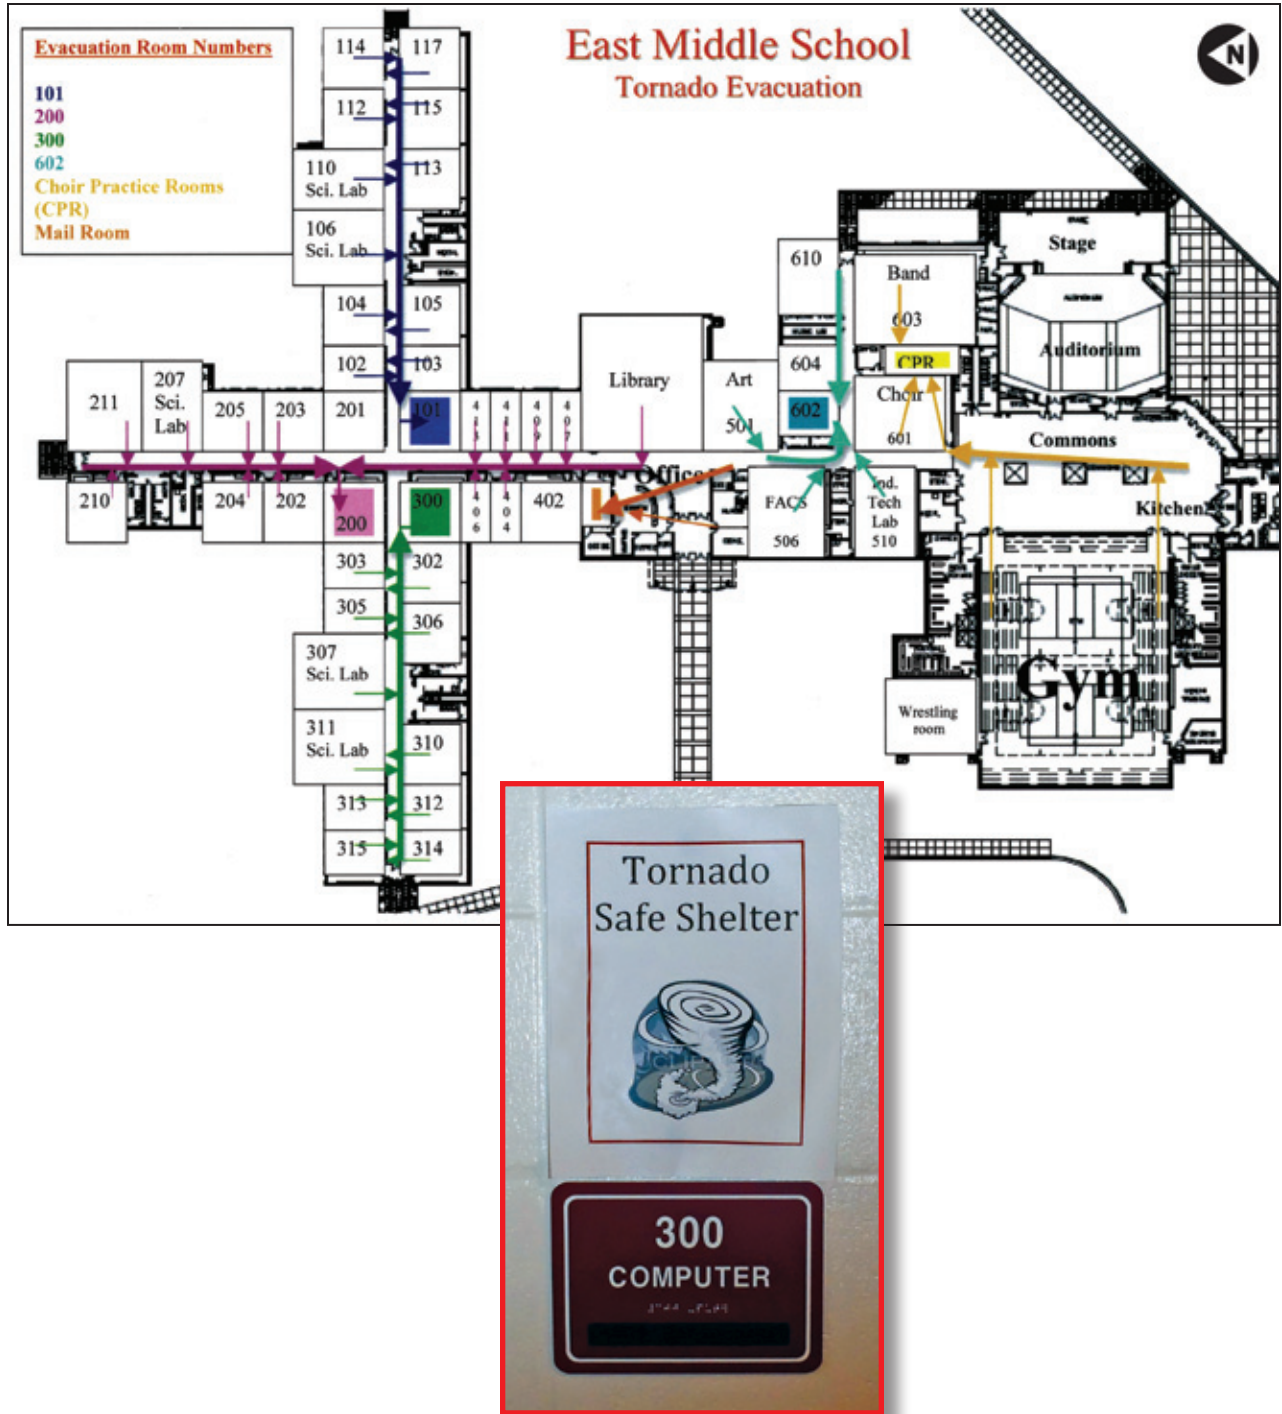
Figure 6-41: Interior rooms designated as “shelters” in the middle school’s Tornado Evacuation Plan. The inset shows the “shelter” signage (Joplin, MO).

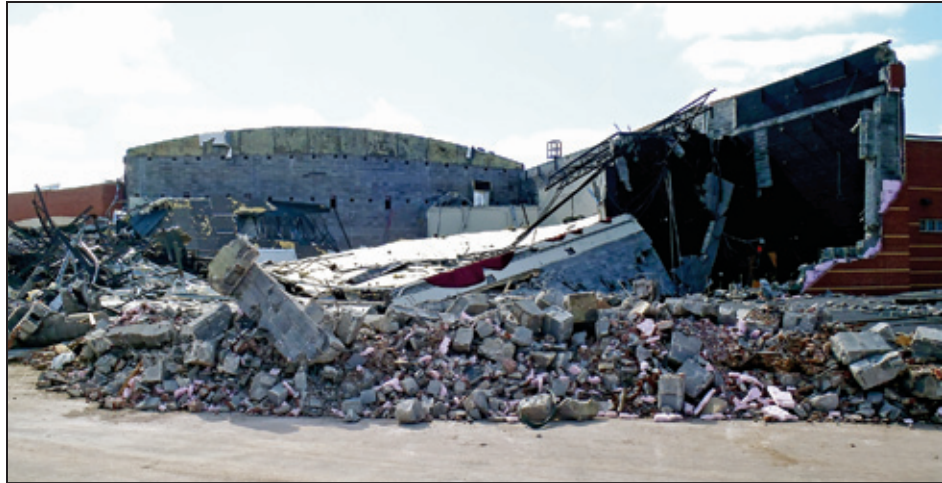
**Figure 6-43:**  
View of the gymnasium. The red box in the inset shows where the truss was attached to the wall. The yellow circle indicates the end of the collapsed truss shown in Figure 6-45 (Joplin, MO).

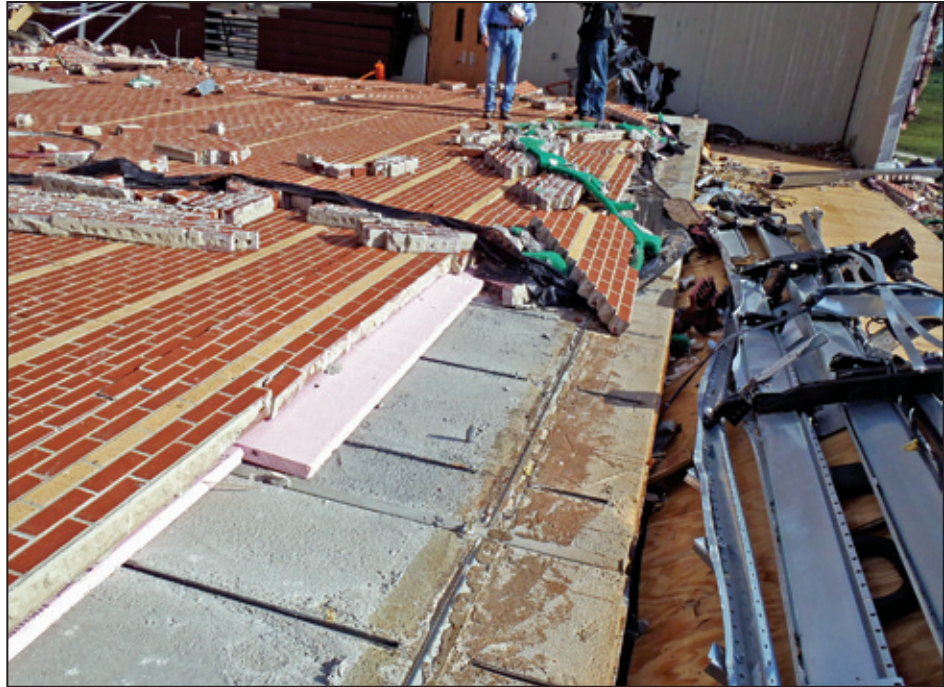
The remainder of the middle school received damage from wind-borne debris, including glazing damage, as well as water damage due to damaged roof covering, decking, and rooftop equipment (Figures 6-40 and 6-47). The rain intrusion caused damage to the HVAC equipment, ceiling boards, floor coverings, and furnishings.

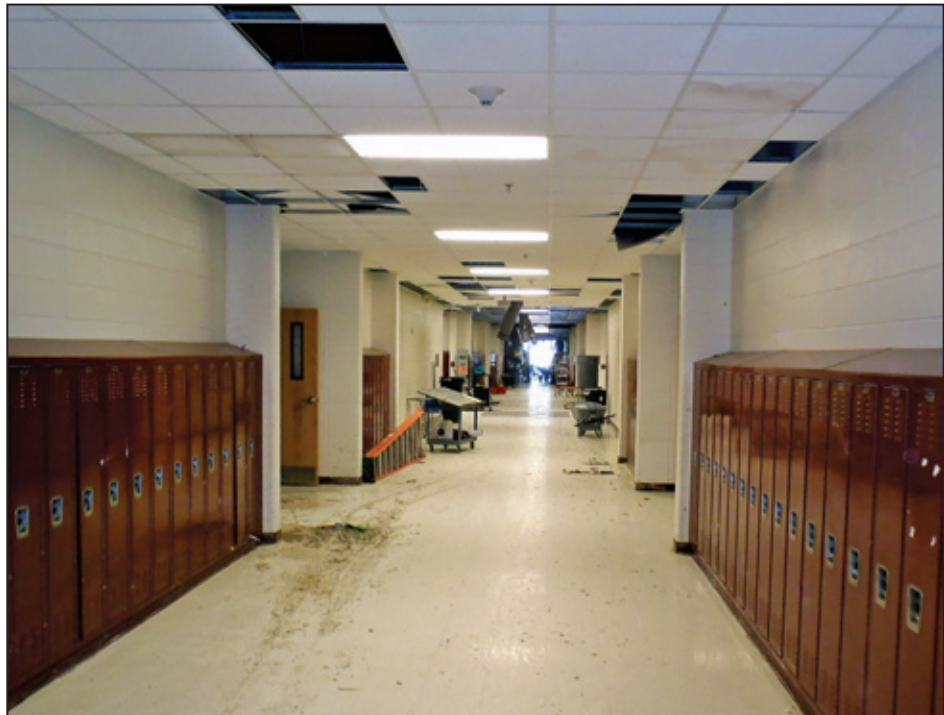
**MAT EF Rating:** Using DI 16 (Junior or Senior High School), the MAT selected DOD 7 (“collapse of tall masonry walls at gym, cafeteria, or auditorium”) for the middle school. Considering the building age and observed damage, the MAT assessed the wind speed as between the expected and upper-bound wind speeds for DOD 7. Hence, the MAT derived the tornado rating as EF2 (111–135 mph) based on damage to this building.<sup>10</sup> Therefore, the estimated wind speed experienced by the building was above the basic wind speed of 90 mph the building was designed for.

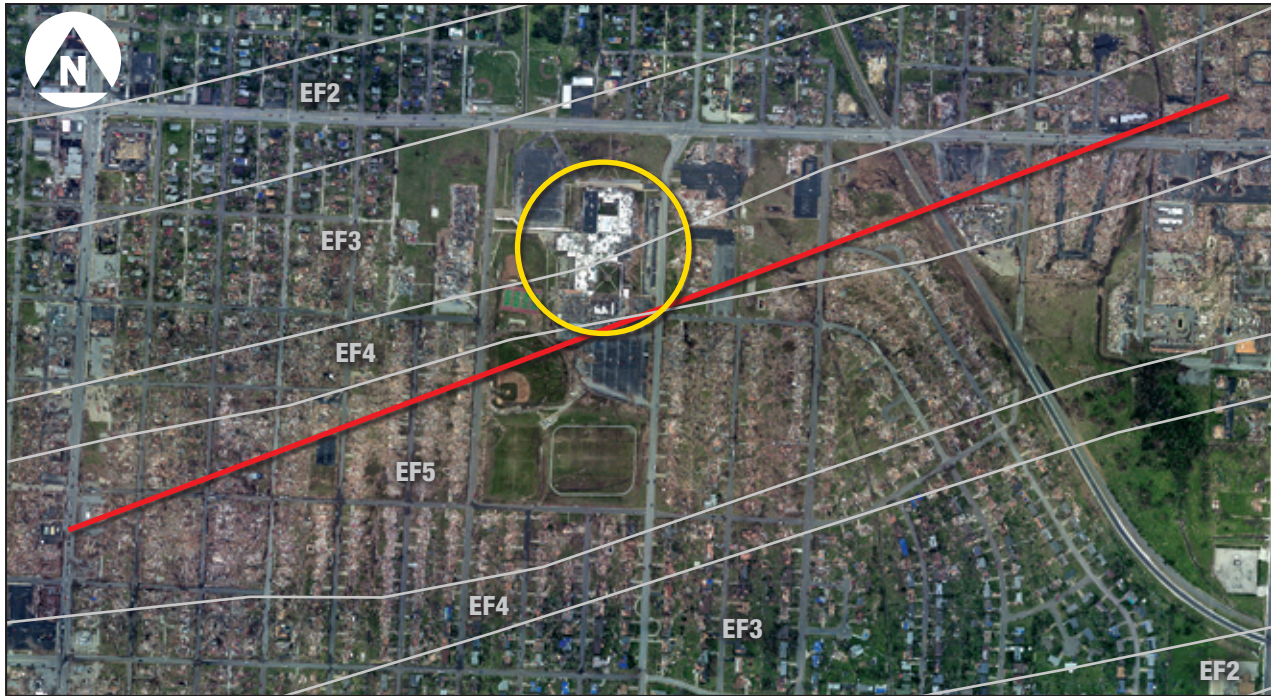
Figure 6-48: Aerial view of the track in the vicinity of the Joplin High School (yellow circle). The center of the damage swath is approximated by the red line. NWS EF contour ratings are also shown (Joplin, MO).

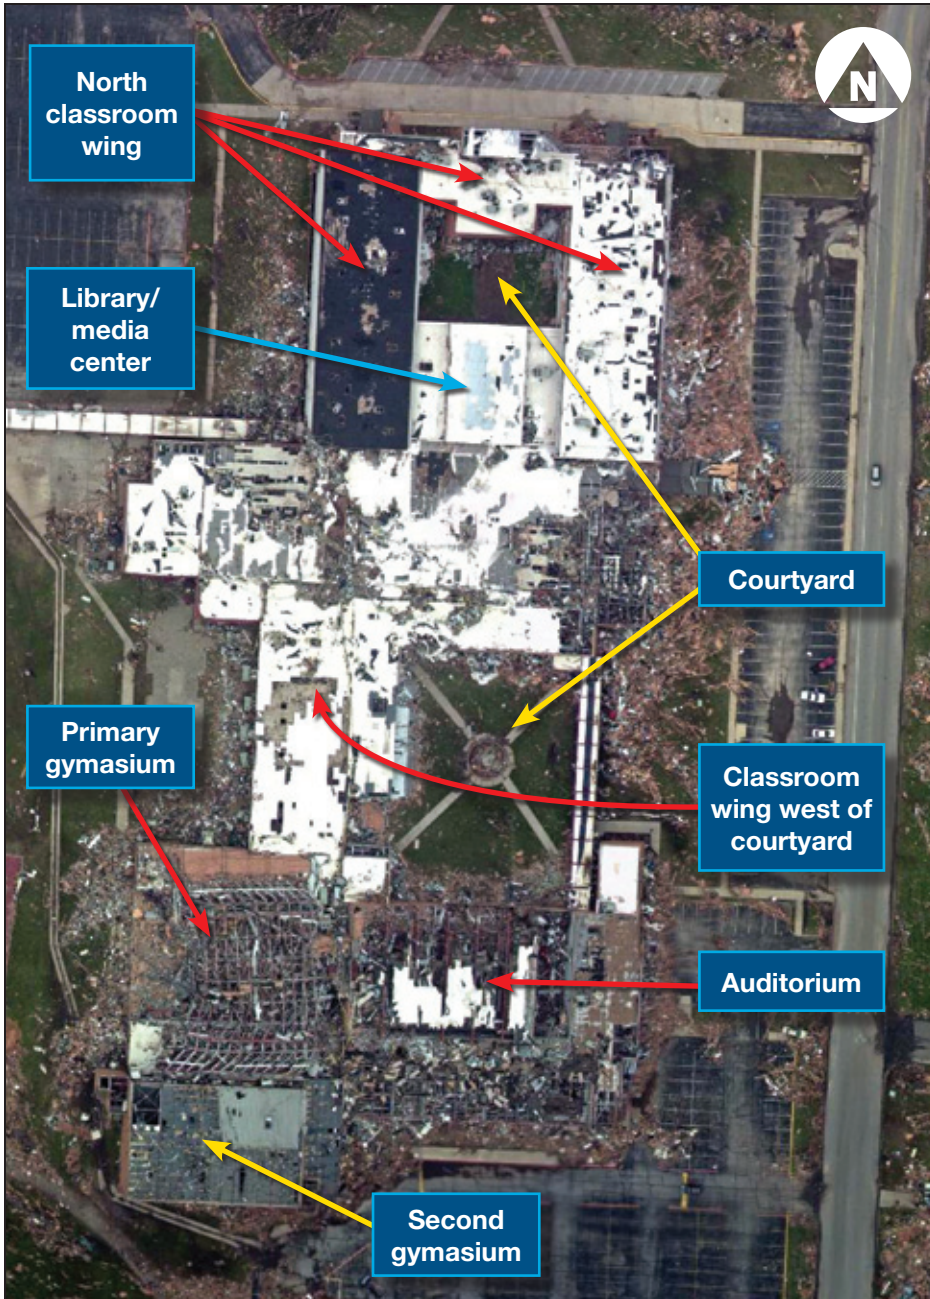
Figure 6-49:  
Close-up of Joplin High  
School shown on Figure 6-48  
(Joplin, MO)

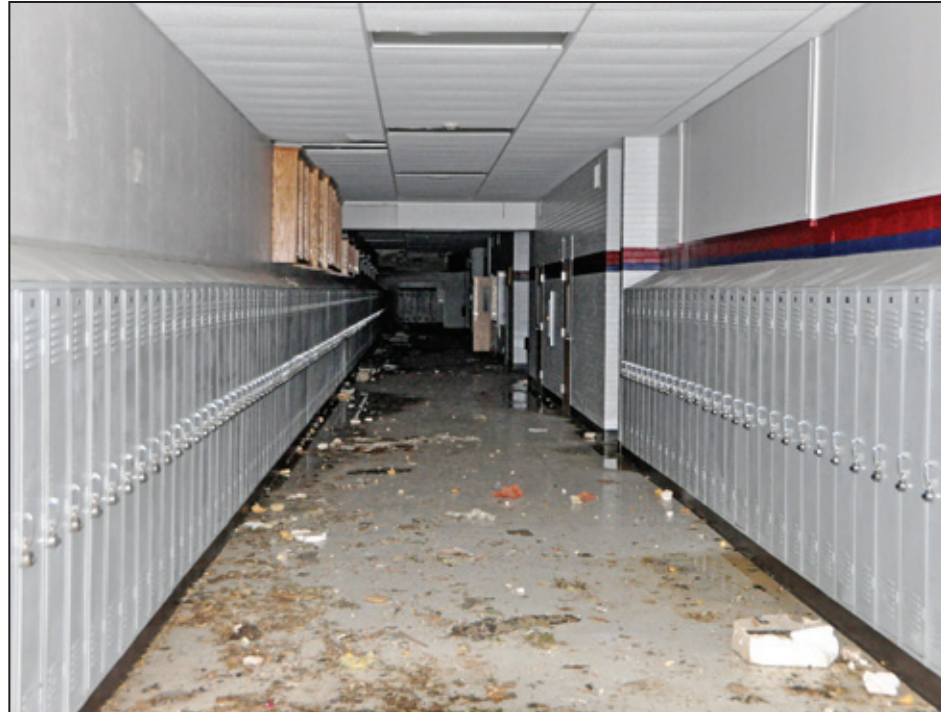
**General Wind Damage.** As shown in Figure 6-49, the primary gymnasium collapsed and portions of the auditorium collapsed. The long roof spans and unreinforced masonry infill walls contributed to the collapses at these areas. In other parts of the building, the exterior wall collapsed, the roof covering was damaged, and some glazing was damaged as described below.

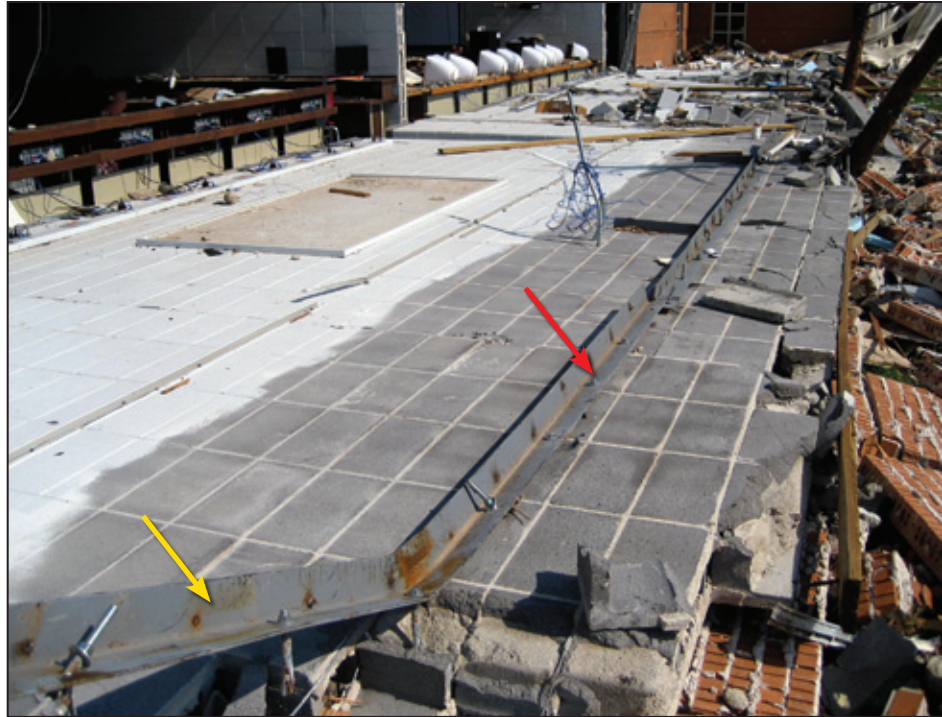
**Primary gymnasium:** The gymnasium shown in Figure 6-54 collapsed. The west wall was approximately 37 feet tall—it fell into the gymnasium. The connection between the pilasters and columns that supported the roof girders failed. The columns were connected with two 1½-inch diameter bolts, each 3 feet long, as shown in the inset at Figure 6-54. Most of the steel roof deck blew off. Only a small portion of it remained within the gymnasium space. Collapse of the brick veneer/unreinforced CMU end wall and blow-off of the roof decking caused the failure. Once the integrity of the load path was disrupted, there was a progressive failure.

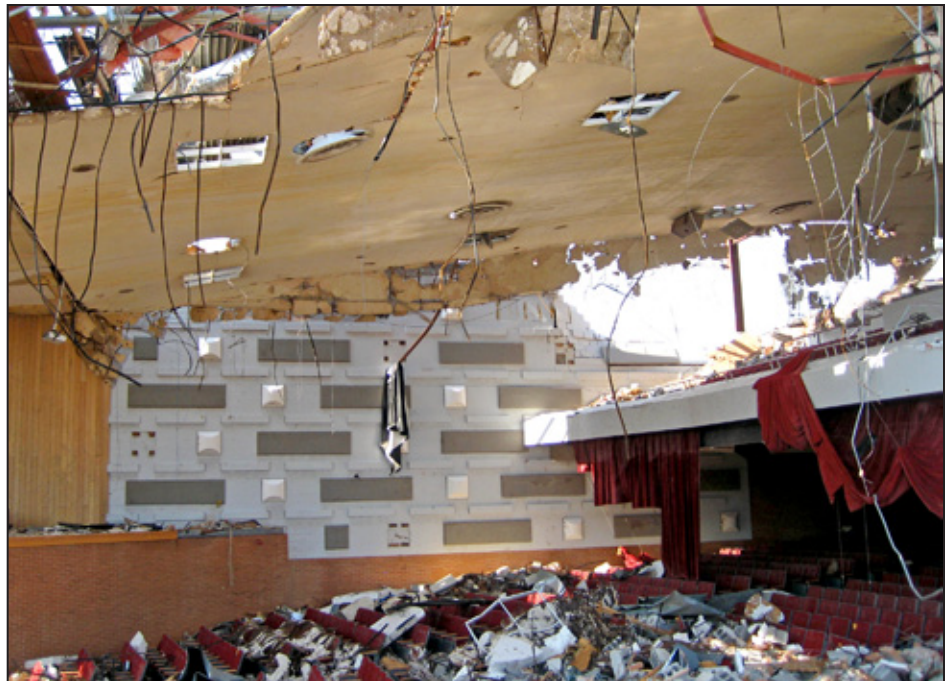
**MAT EF Rating:** Using DI 16 (Junior or Senior High School), the MAT selected DOD 11 (“complete destruction of all or a large section of building”) for the high school. Considering the building age and the observed damage, the MAT assessed the wind speed to be the lower-bound wind speed for DOD 11.<sup>11</sup> Hence, the MAT derived the tornado rating as EF3 (136–165 mph) based on damage to this building.<sup>12</sup> Therefore, the estimated wind speed experienced by the high school was substantially above the basic wind speed of 90 mph.

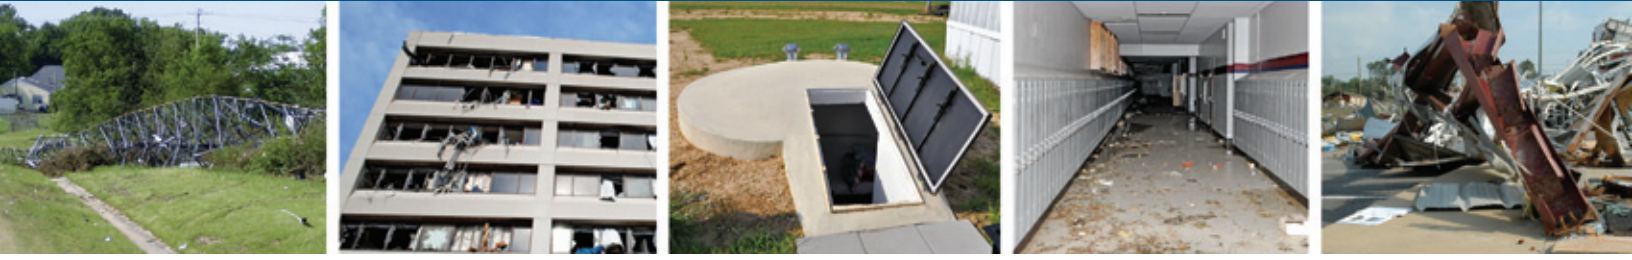
## TORNADO OUTBREAK *of* **2011**

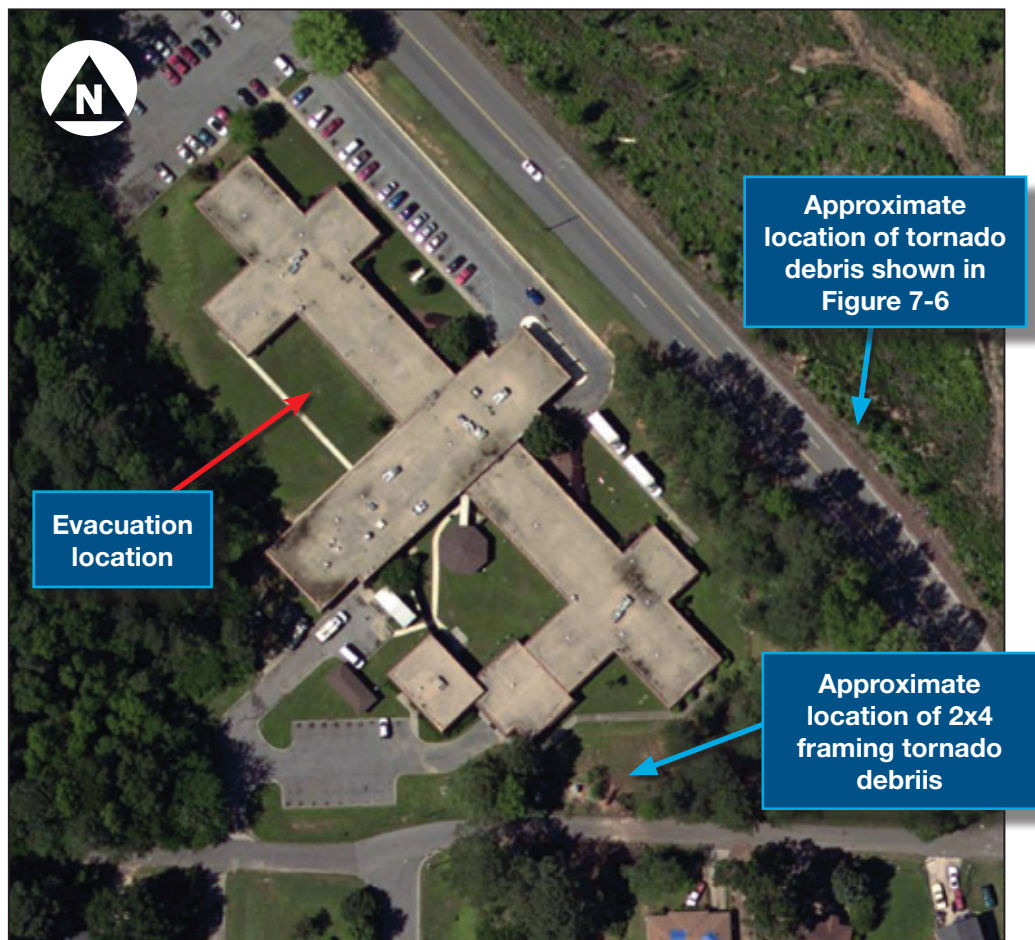
Soon after the facility was evacuated, the facility director realized that a tornado was nearby and on an apparent intercept path with the nursing home (Figure 7-4). The occupants were moved back into the facility corridors, which were designated as the tornado refuge areas for the facility (Figure 7-5).

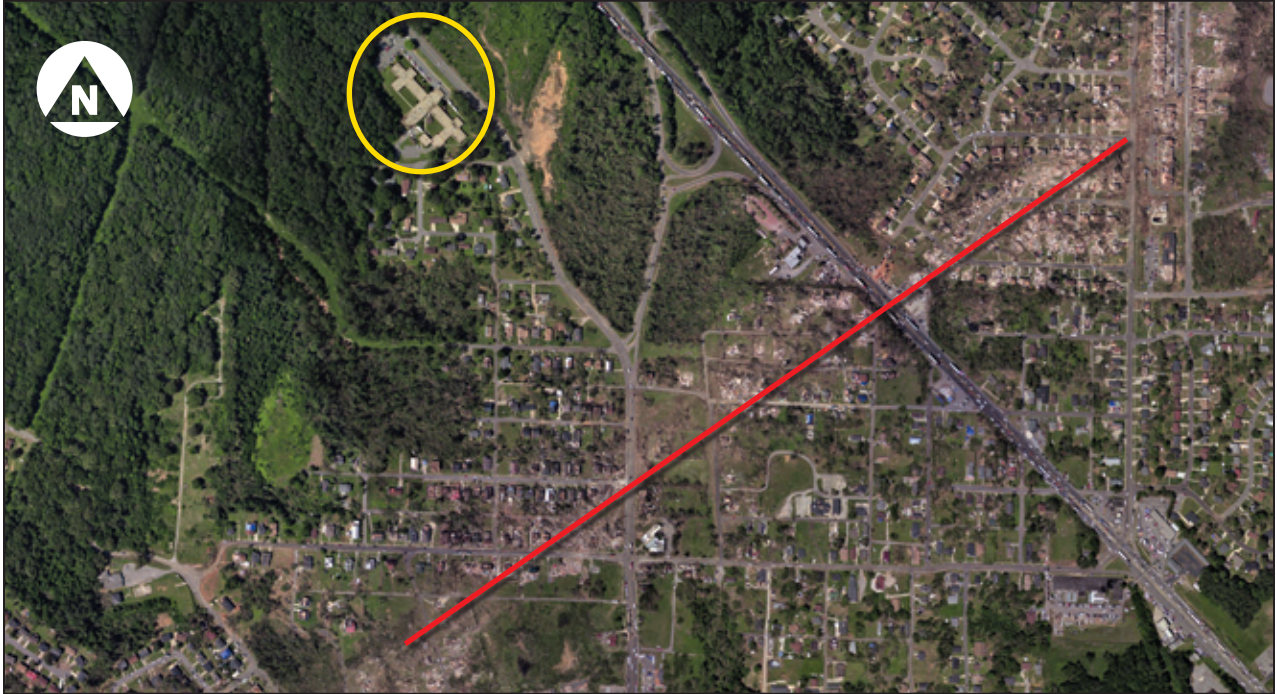
Figure 7-4: Aerial view of the nursing home (yellow circle) in relation to the approximate centerline of the tornado damage swath, shown by the red line<sup>1</sup> (Birmingham, AL)

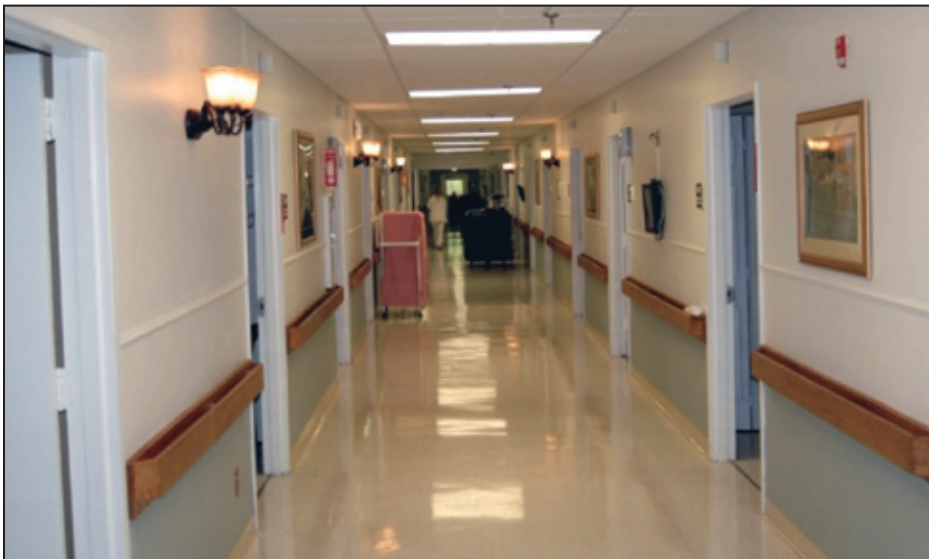
EF contours were not developed by NWS for sites in Birmingham, Tuscaloosa, and Fultondale, AL, and Smithville, MS, described in Chapter 7.

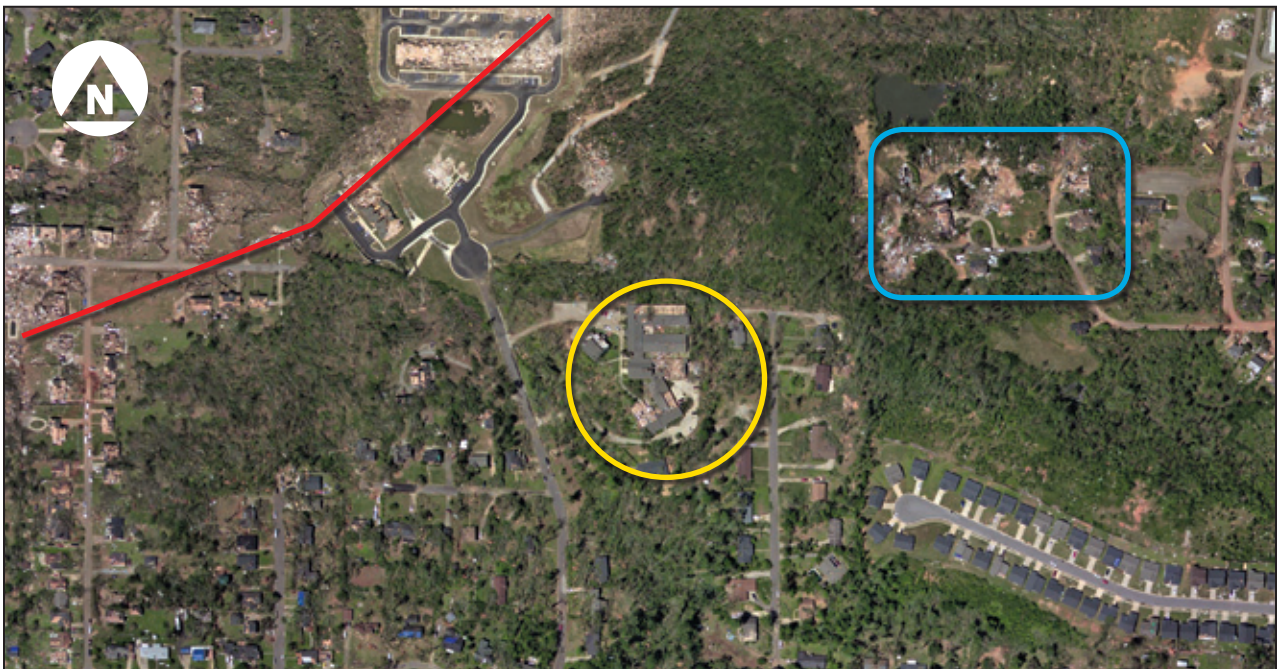
Figure 7-8: Aerial view of the track in the vicinity of the nursing home (yellow circle). The center of the damage swath is approximated by the red line. Inflow damaged the nursing home and buildings within the blue box (Tuscaloosa, AL).

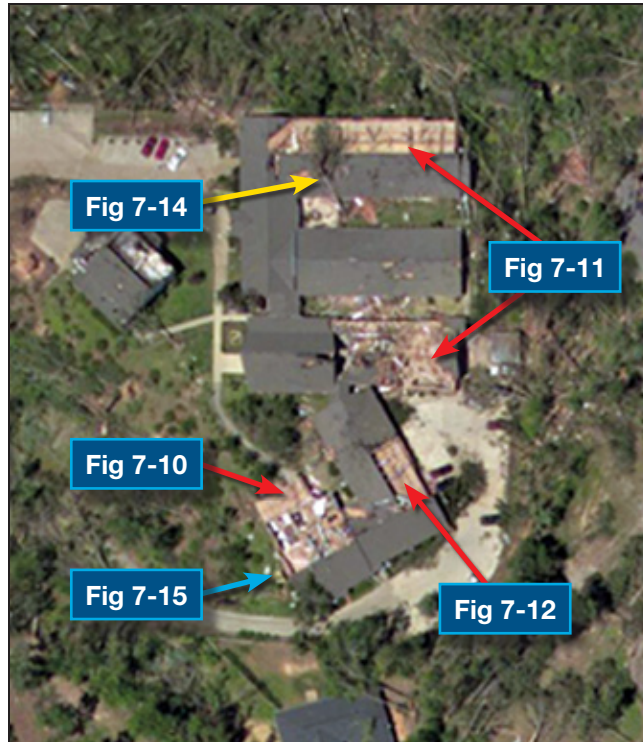
Figure 7-10:  
Roof structure and brick veneer were blown off the nursing home (Tuscaloosa, AL)

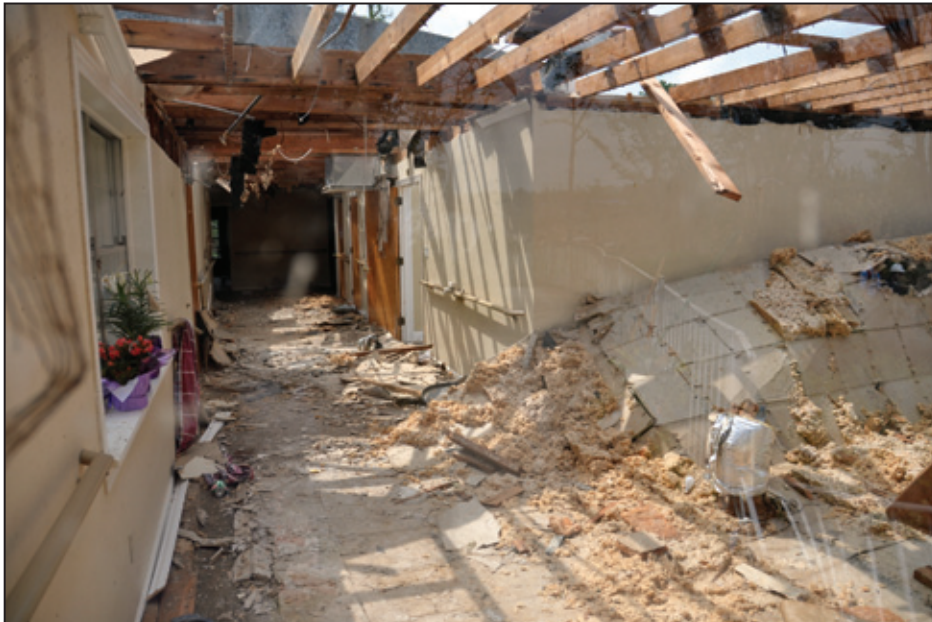
Figure 7-12: Interior damage as a result of roof structure blow-off (Tuscaloosa, AL)

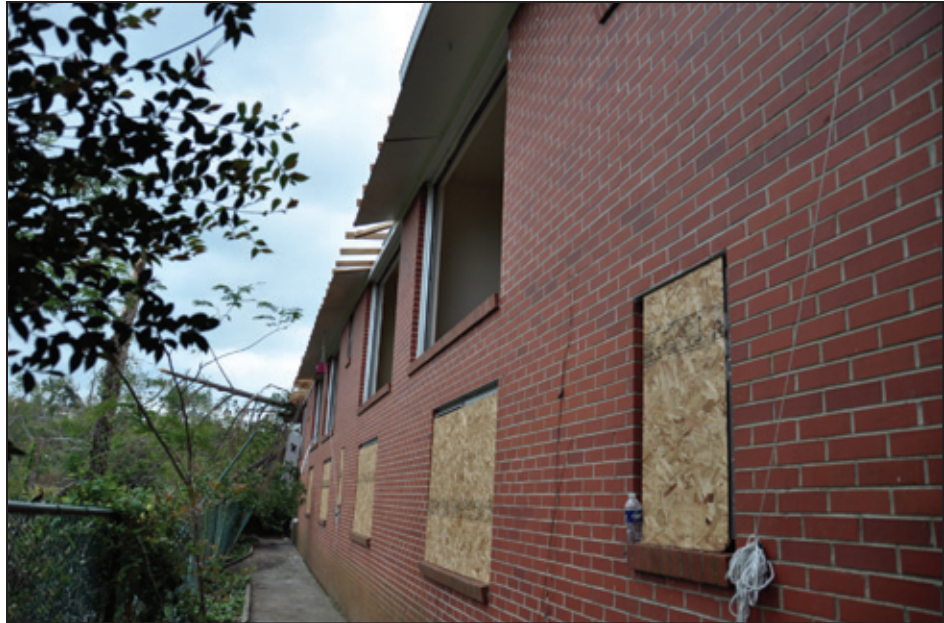
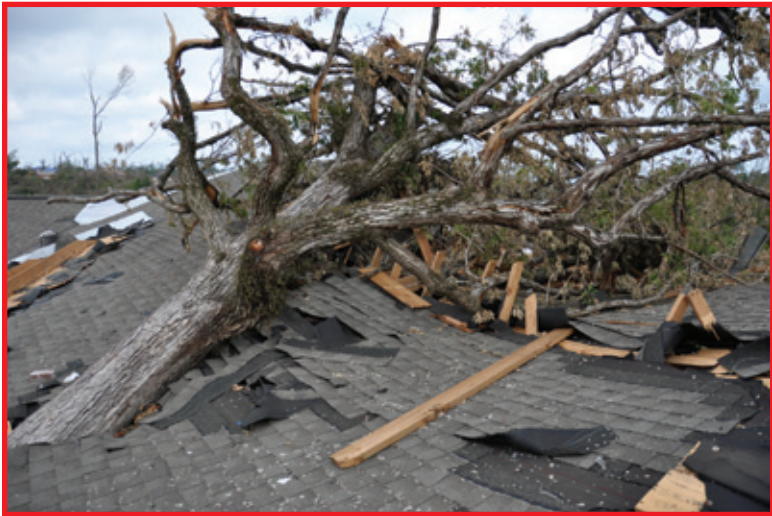
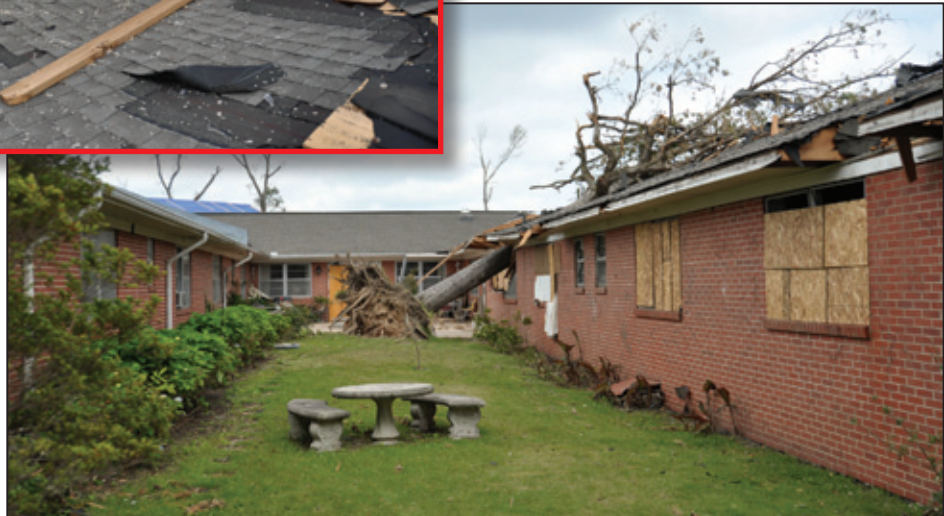
Figure 7-14:  
Tree-fall damage. Note the boarded-up broken windows. The inset shows a close-up of the tree-fall damage (Tuscaloosa, AL).

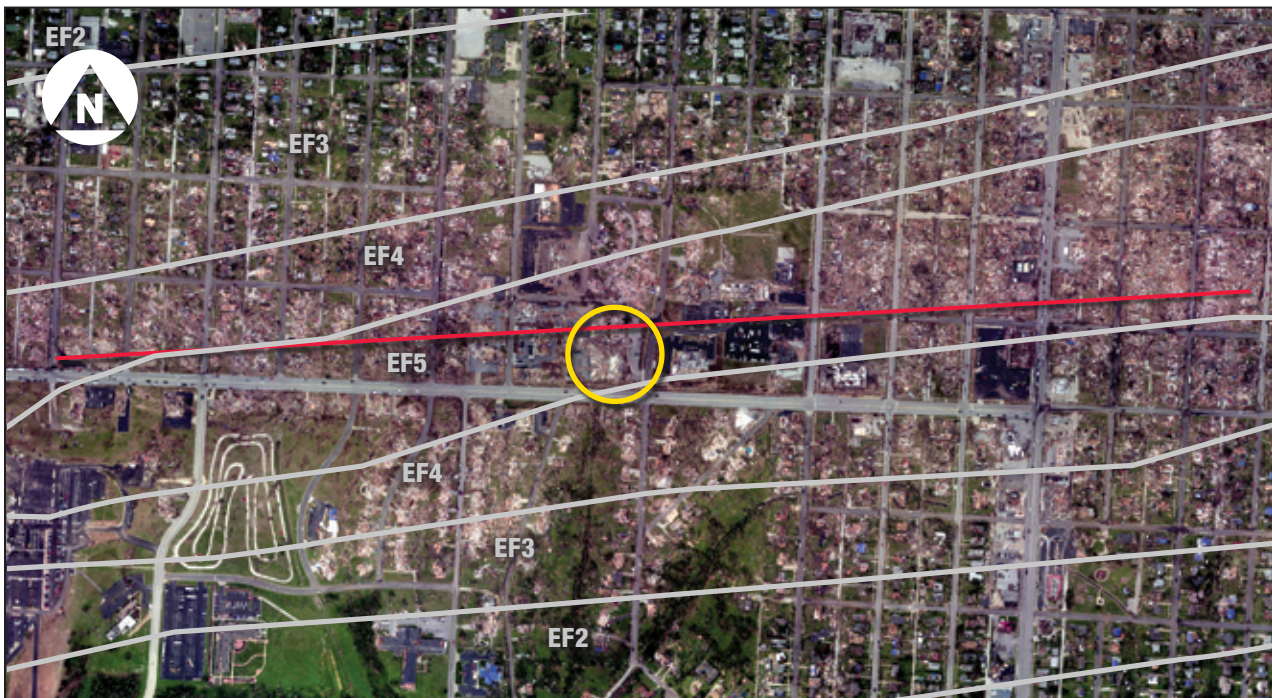
Figure 7-16: Aerial view of the track in the vicinity of the nursing home (yellow circle). The center of the damage swath is approximated by the red line (Joplin, MO).

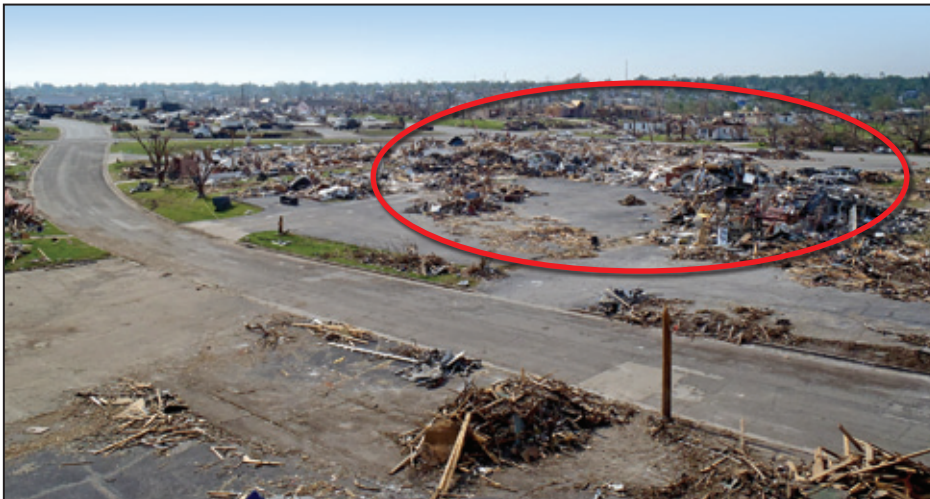
Figure 7-18:  
Aerial view of the nursing home (red oval) after the tornado (Joplin, MO)
