## Mitigation Assessment Team Report

# Spring 2011 Tornadoes: April 25-28 and May 22

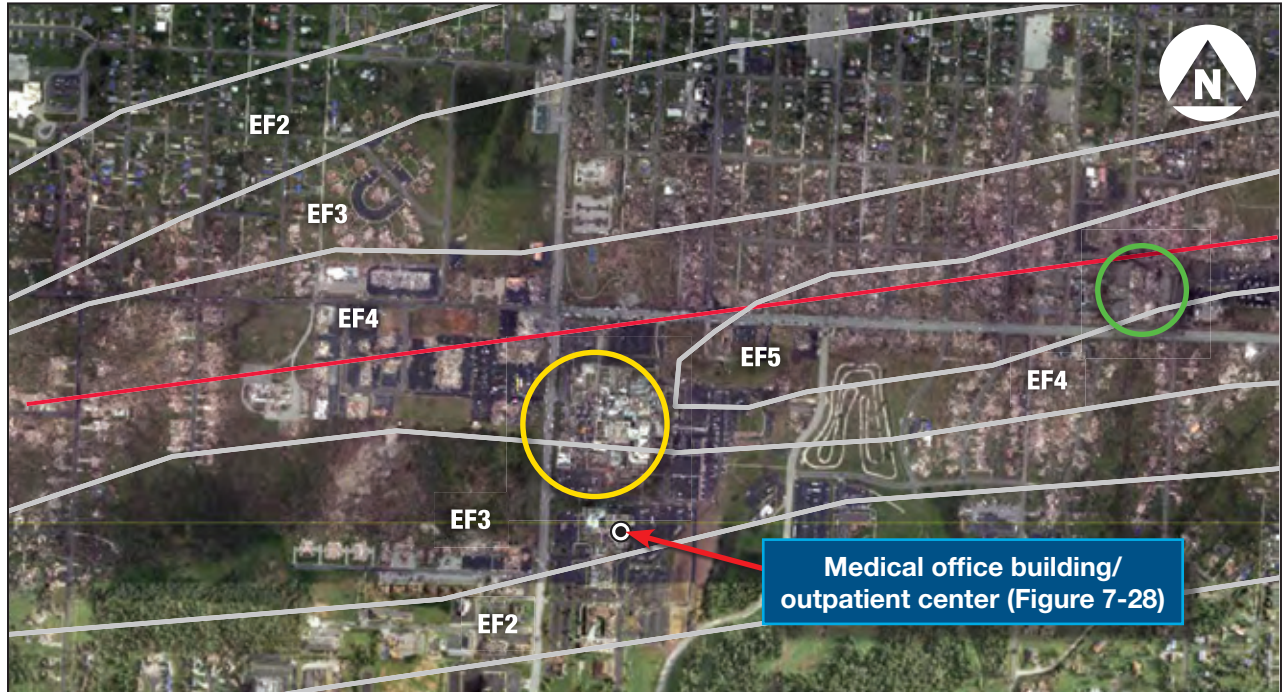
Figure 7-20: Aerial view of the track in the vicinity of the St. John's Medical Center (yellow circle). The blue arrow indicates the medical office building/outpatient center (shown in Figure 7-28). The center of the damage swath is approximated by the red line. The location of Greenbriar Nursing Home (Section 7.1.3) is indicated by the green circle (Joplin, MO).

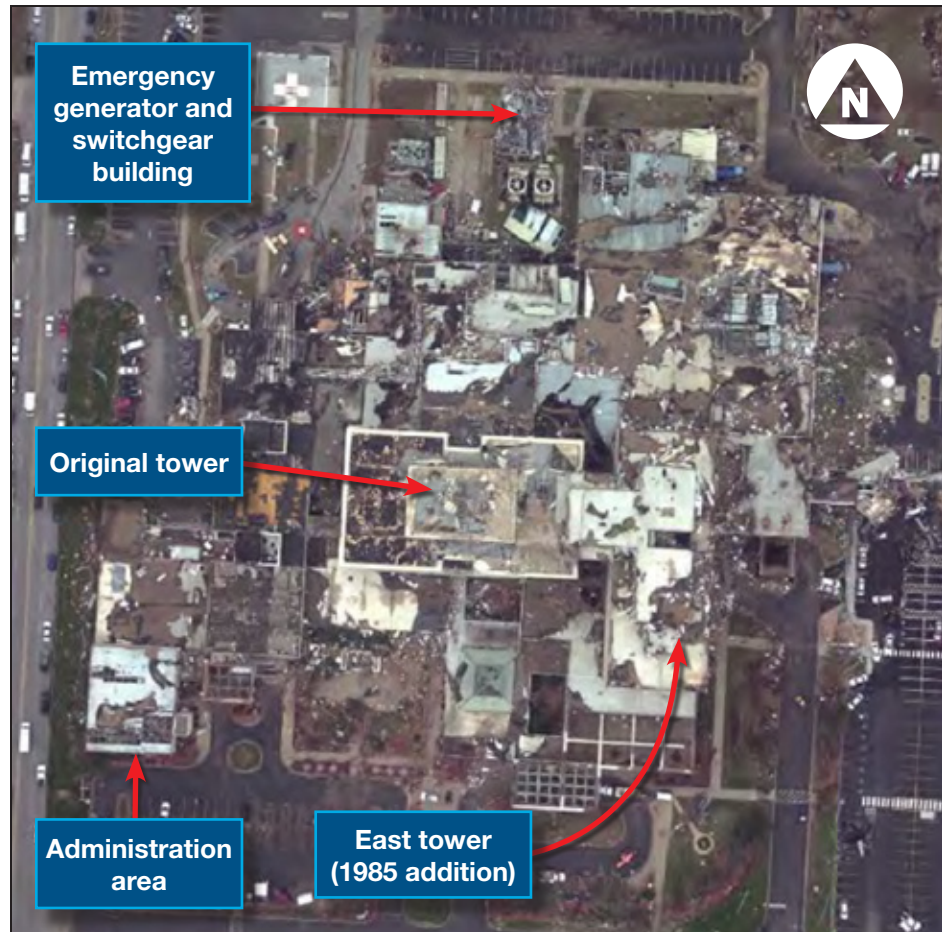
The hospital did not have a tornado safe room or storm shelter. The hospital's tornado procedure entailed moving patients into corridors, except in the ICU, where patients and hospital personnel were to remain in the unit and seek protection to the extent possible. Evacuation sleds were available to help move patients down stairwells and corridors during an emergency in the event elevators were not working.

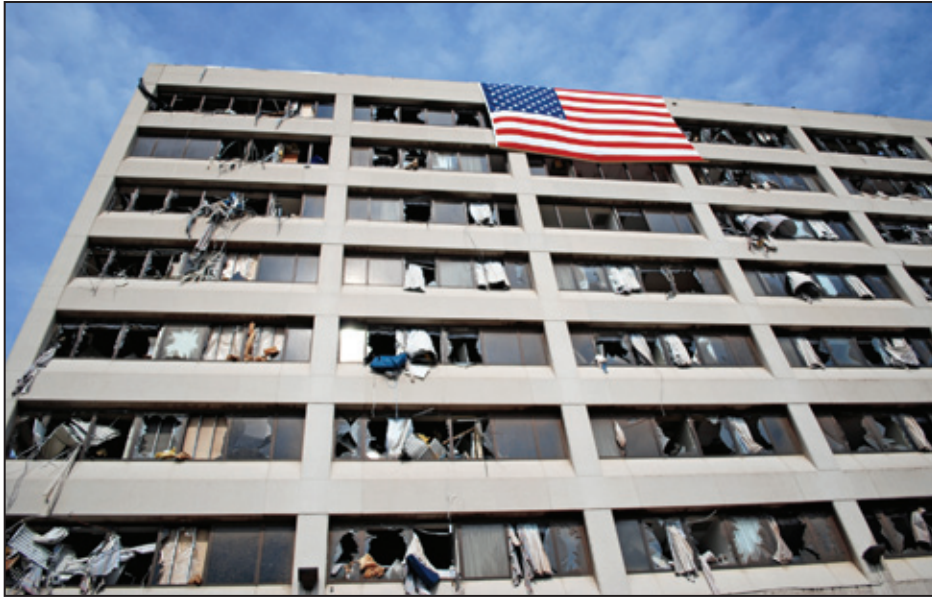
Figure 7-22:  
View of the glazing damage  
at patient rooms (Joplin, MO)

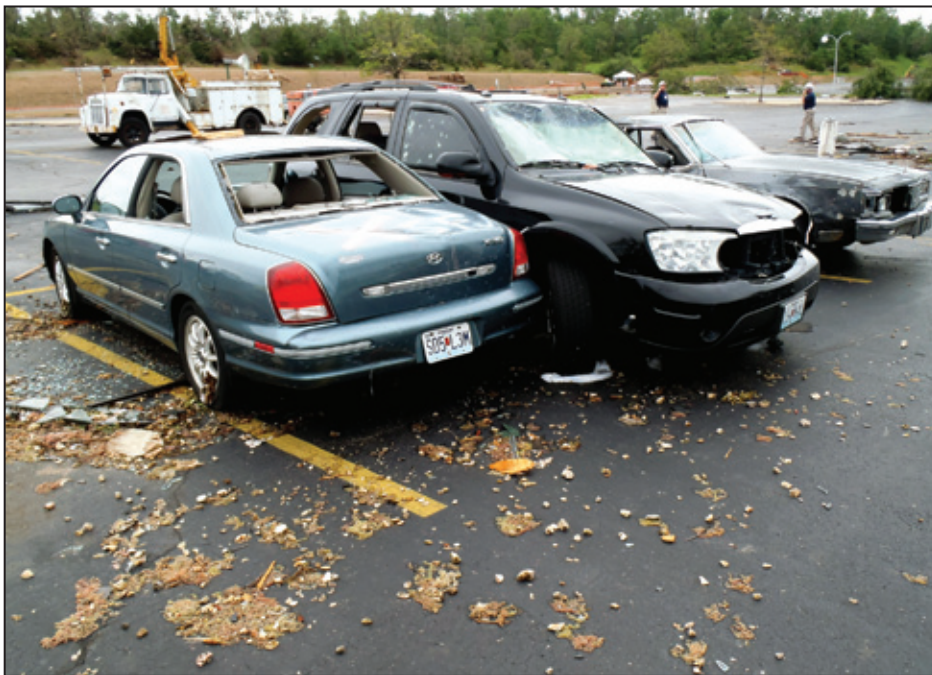
Figure 7-23:  
This parking lot was littered  
with 1½-inch nominal  
diameter aggregate from the  
ballasted roof membrane.  
(Joplin, MO).

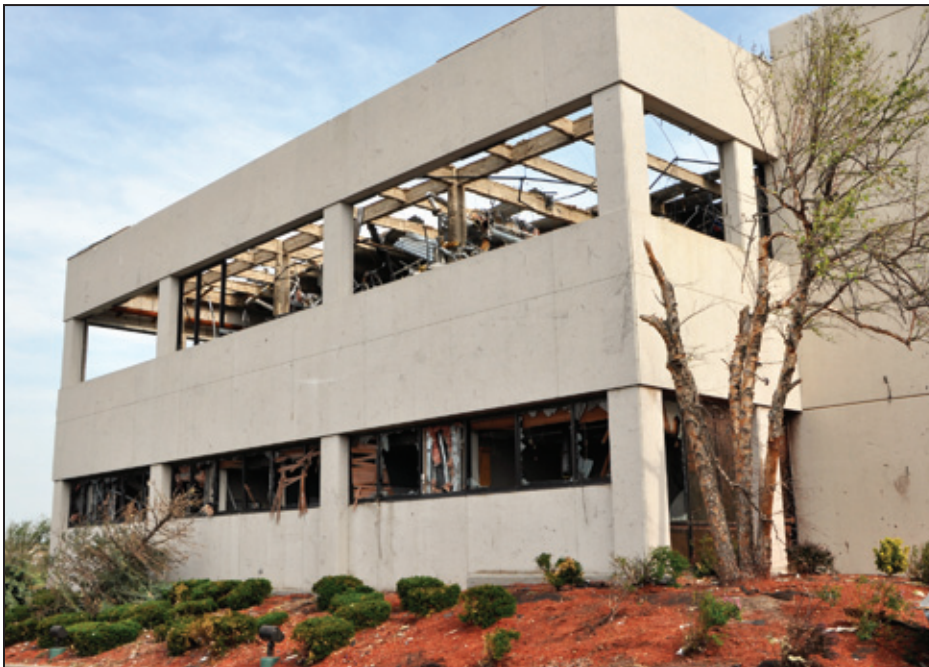
Figure 7-26:  
Metal decking blow-off  
and glazing damage in the  
administrative area  
(Joplin, MO)

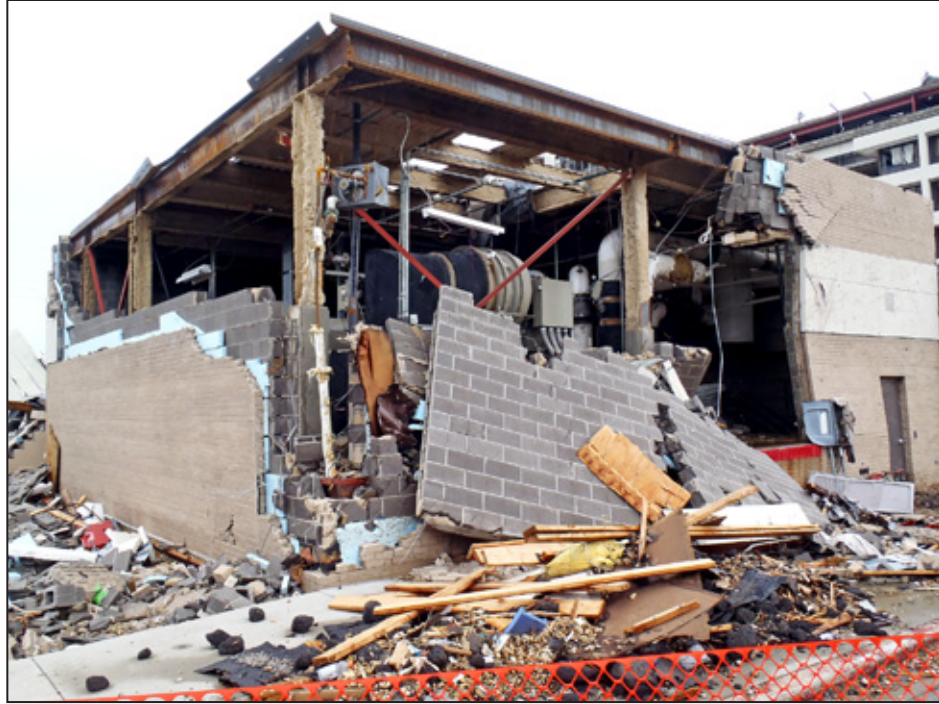
The water main and natural gas lines had been labeled at some point prior to the tornado and were closed soon after the event, thereby avoiding flooding, fire, and explosion.

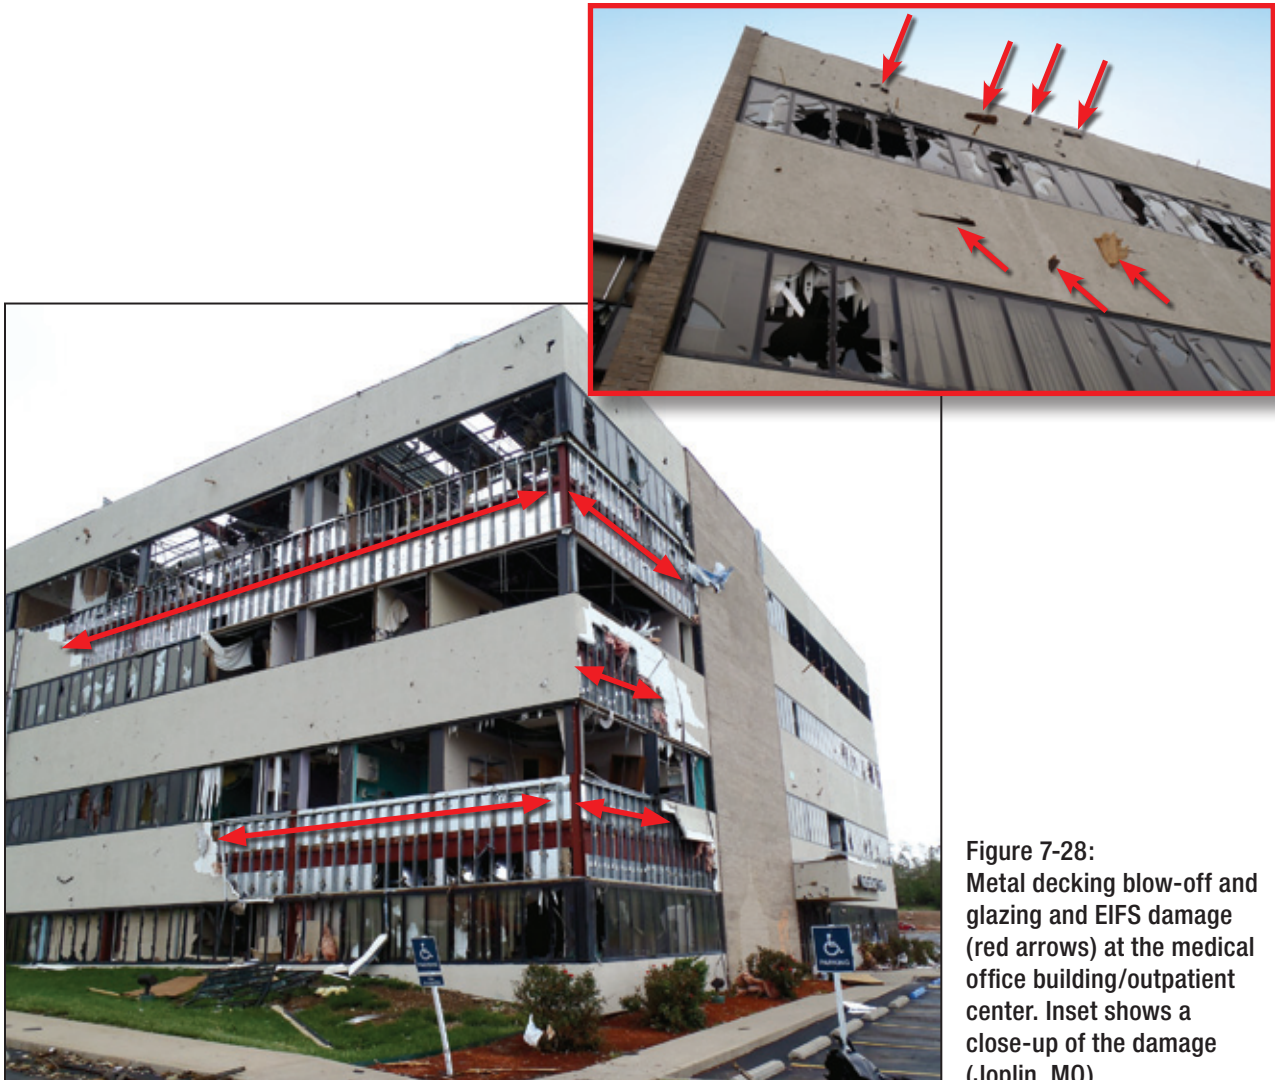
Figure 7-28: Metal decking blow-off and glazing and EIFS damage (red arrows) at the medical office building/outpatient center. Inset shows a close-up of the damage (Joplin, MO).

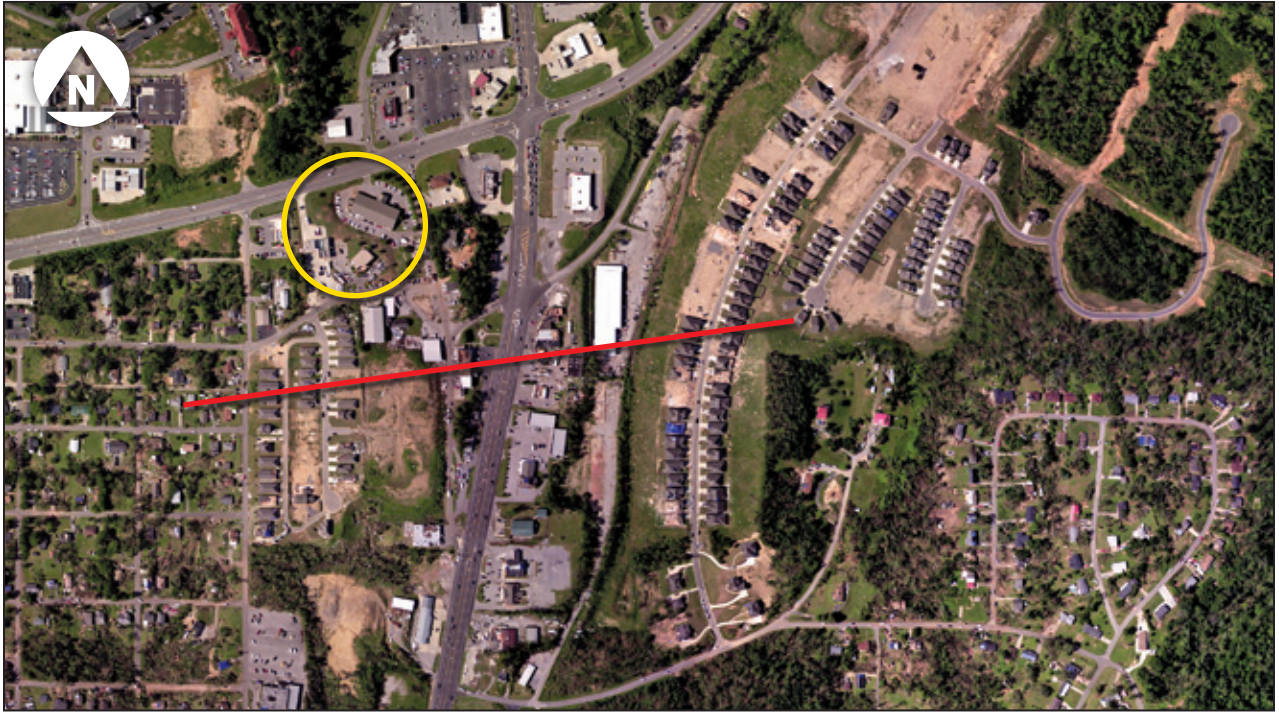
Figure 7-29: Aerial view of tornado track in the vicinity of Fultondale Municipal Complex in Alabama (yellow circle). The center of the damage swath is approximated by the red line (Fultondale, AL).

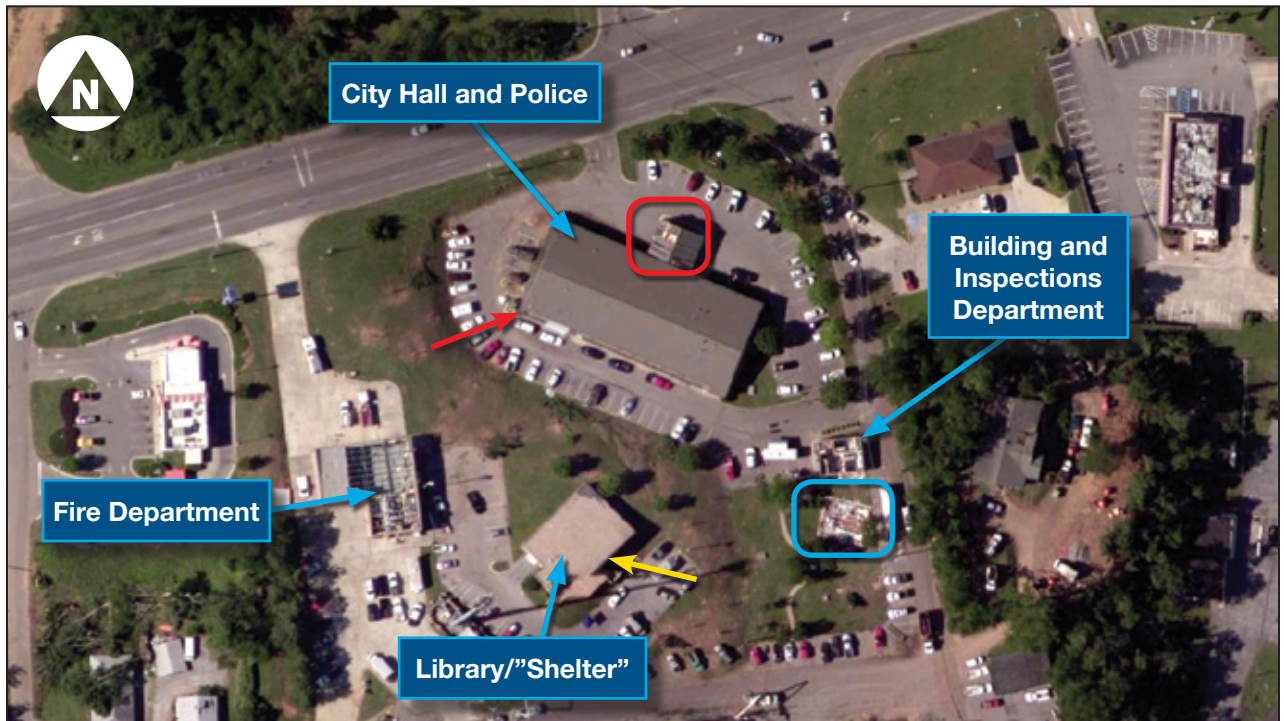
Figure 7-30: Tornado winds damaged an emergency generator (red arrow) and a roof (red box), and lifted a roof (final location shown by blue box). Yellow arrow shows the “shelter” entrance (Fultondale, AL).

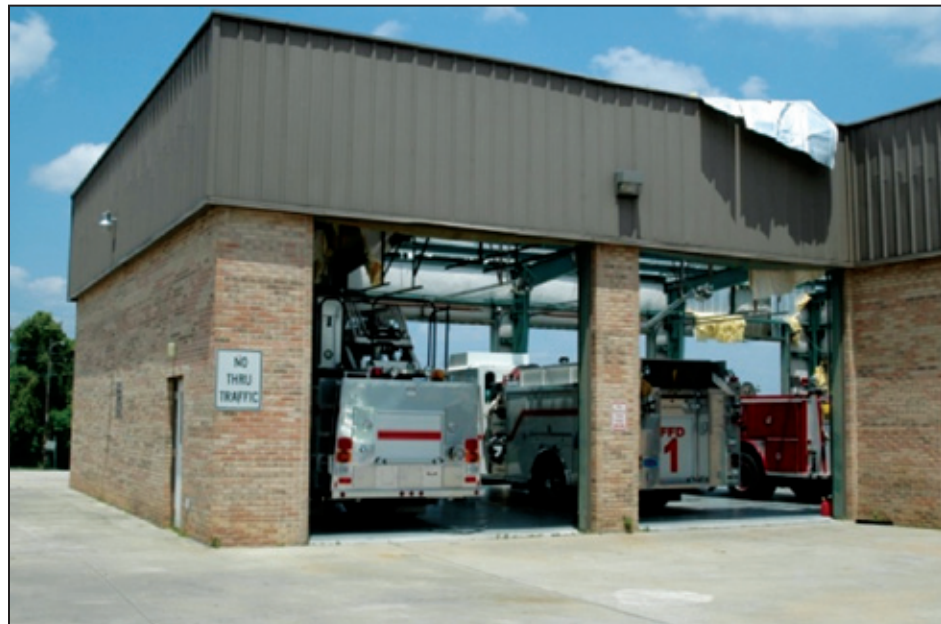
<sup>4</sup> There is no DI for fire stations. DI 21 was deemed appropriate for this facility.

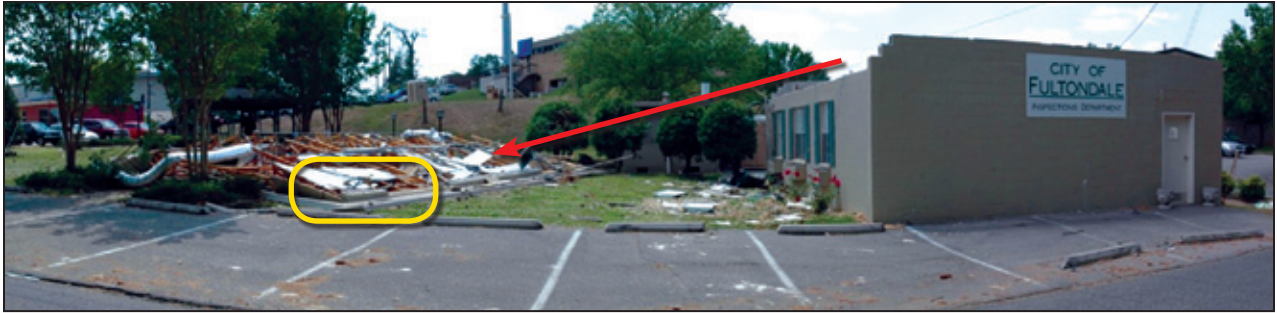
Figure 7-34: The roof structure of the Buildings and Inspections Department building blew off in one complete section (red arrow). The yellow oval area is shown in Figure 7-35 (Fultondale, AL).

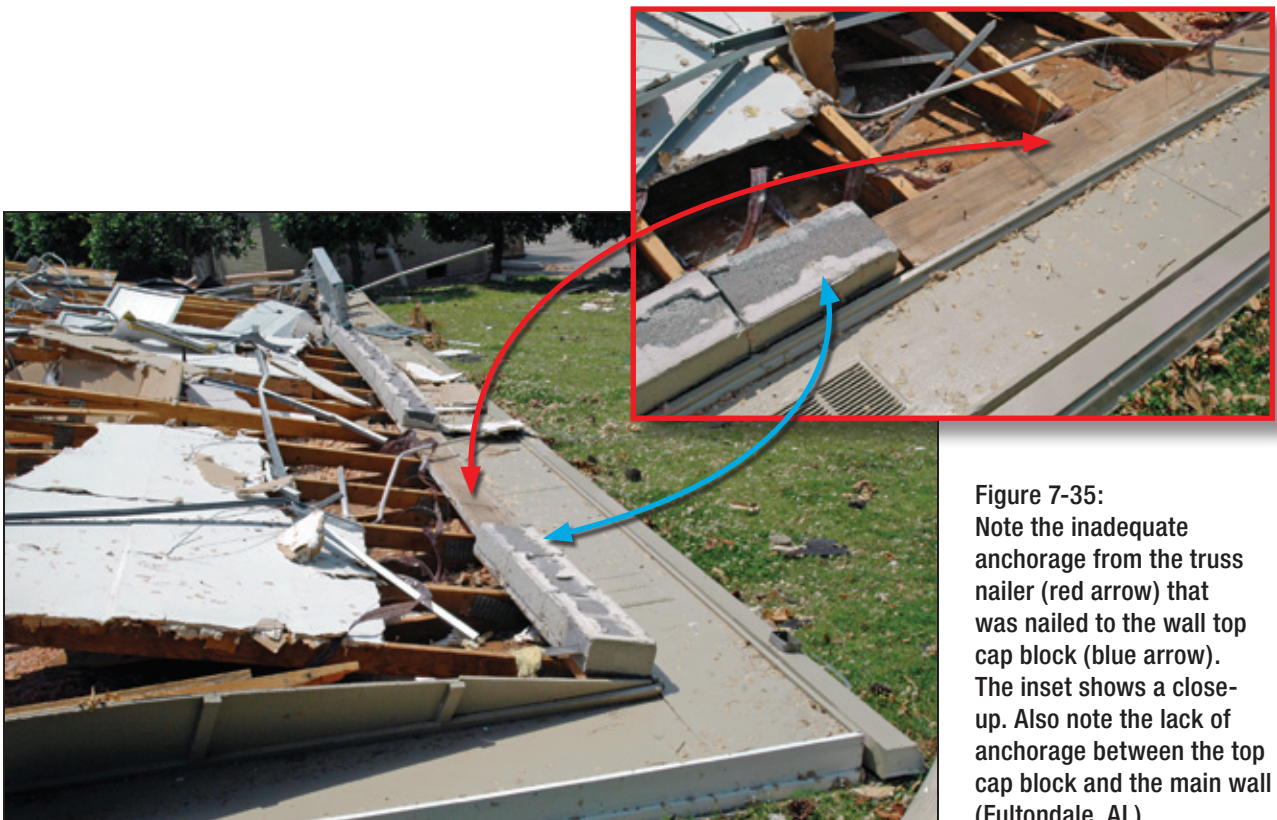
Figure 7-35: Note the inadequate anchorage from the truss nailer (red arrow) that was nailed to the wall top cap block (blue arrow). The inset shows a close-up. Also note the lack of anchorage between the top cap block and the main wall (Fultondale, AL).

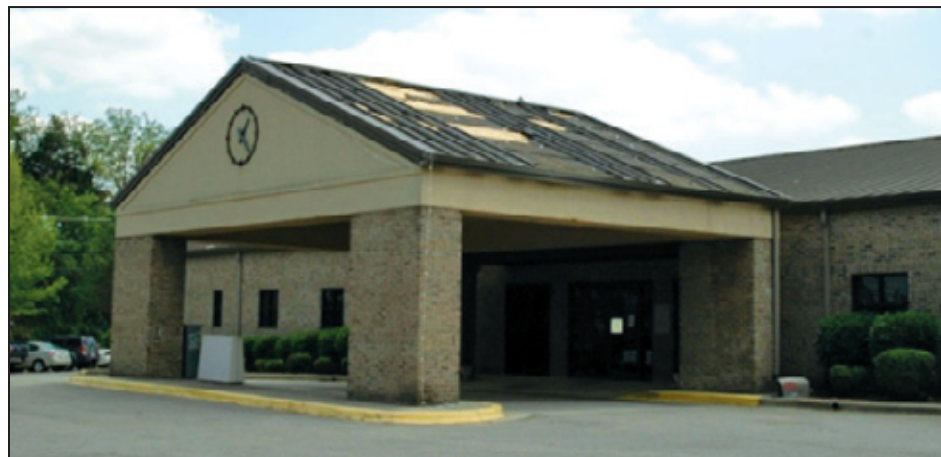
**Figure 7-36:**  
The front of the City Hall showing damage to the metal roof covering over the entrance (Fultondale, AL)

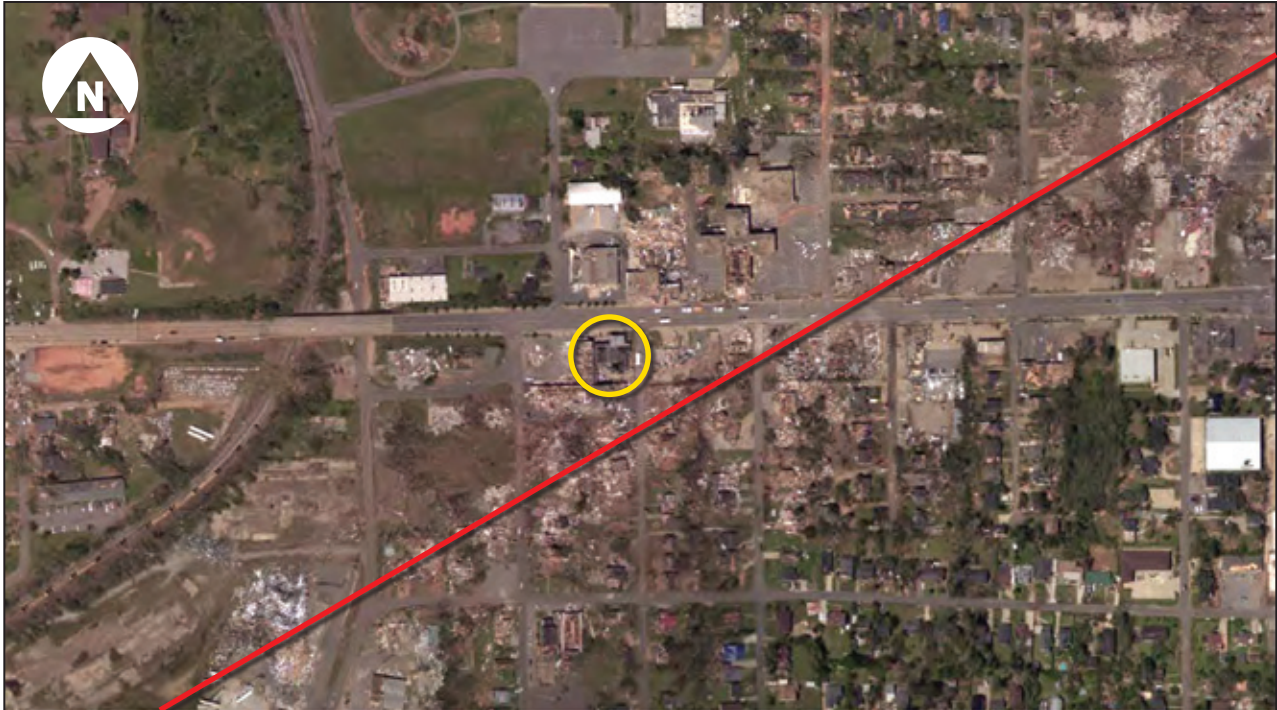
Figure 7-38: Aerial view of the track in the vicinity of the fire station (yellow circle). The center of the damage swath is approximated by the red line (Tuscaloosa, AL).

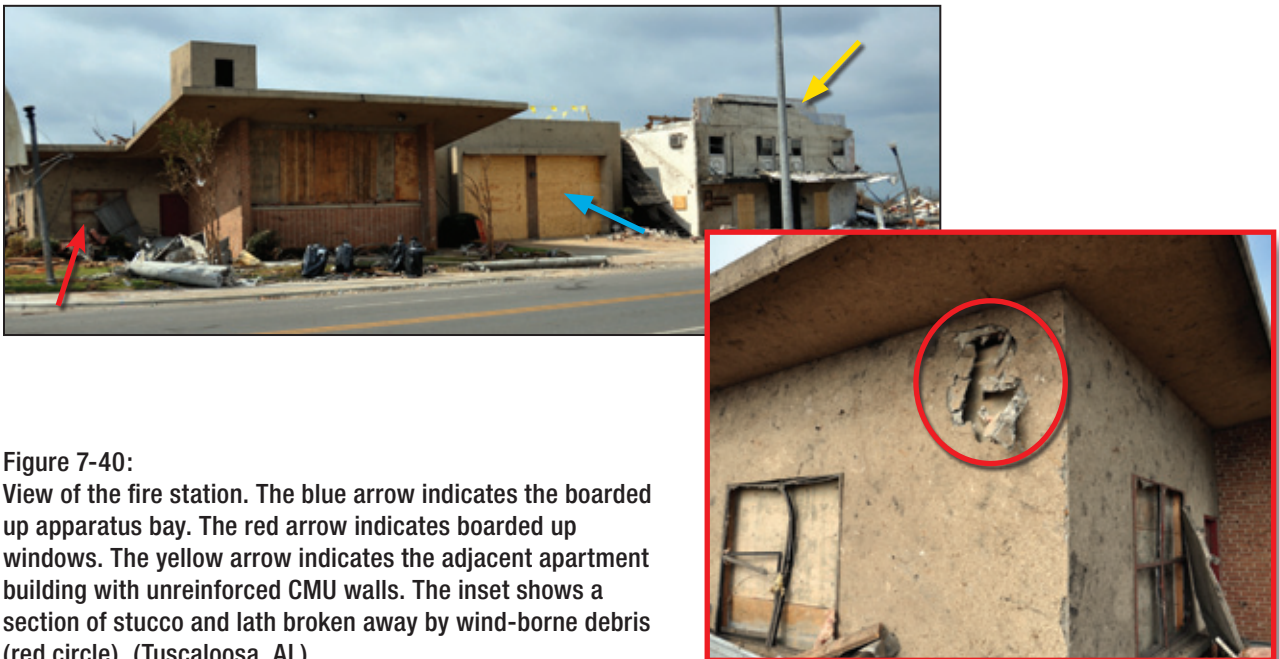
Figure 7-40: View of the fire station. The blue arrow indicates the boarded up apparatus bay. The red arrow indicates boarded up windows. The yellow arrow indicates the adjacent apartment building with unreinforced CMU walls. The inset shows a section of stucco and lath broken away by wind-borne debris (red circle). (Tuscaloosa, AL).

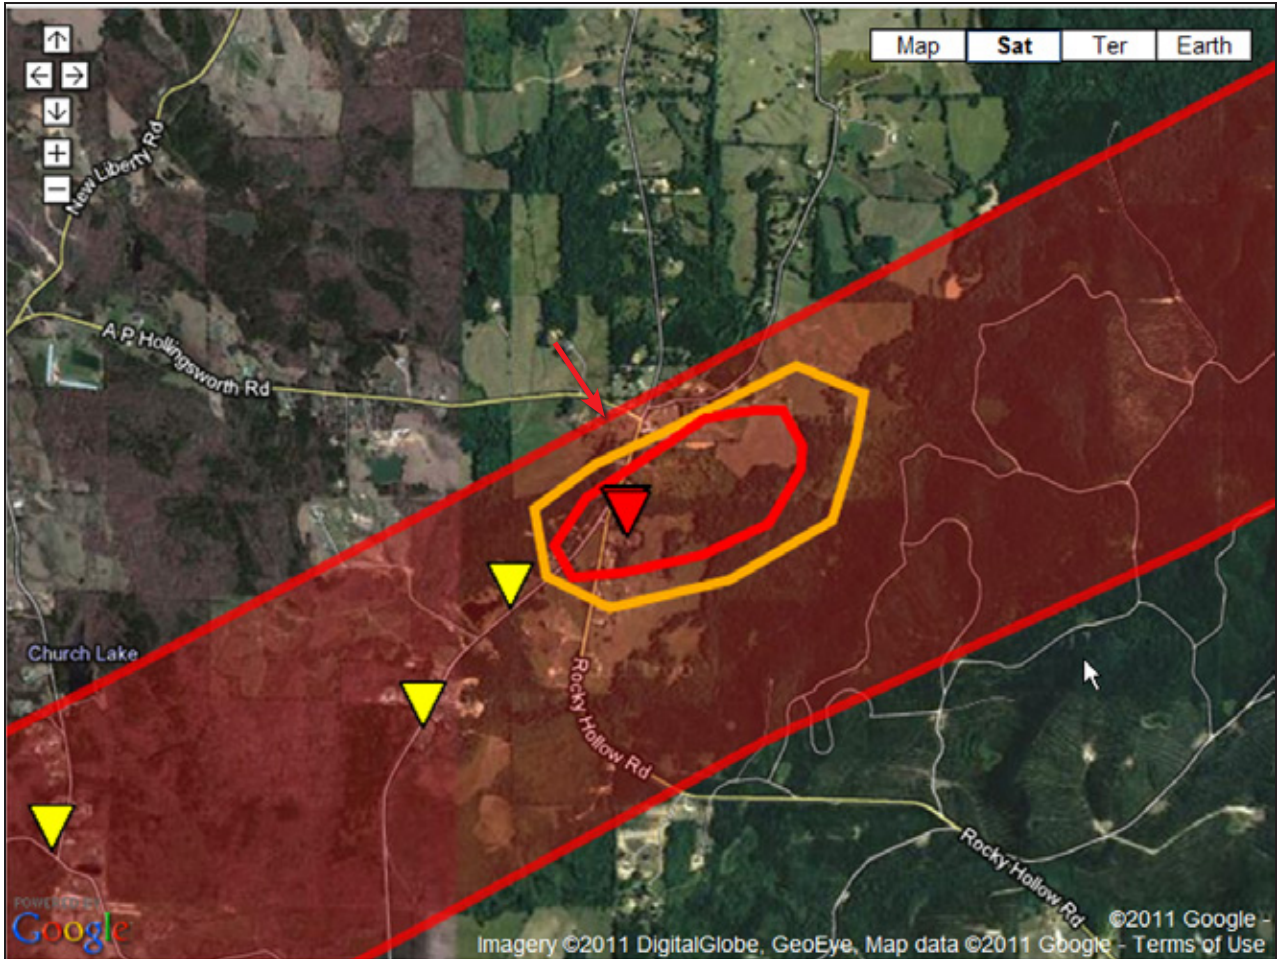
Figure 7-44: View of the Webster's Chapel Volunteer Fire Department (red arrow) in relation to the tornado.<sup>6</sup> The red triangle indicates the location of two houses where NWS rated the tornado as EF4. The yellow triangles indicate the locations of houses where NWS rated the tornado as EF2 (Wellington, AL).

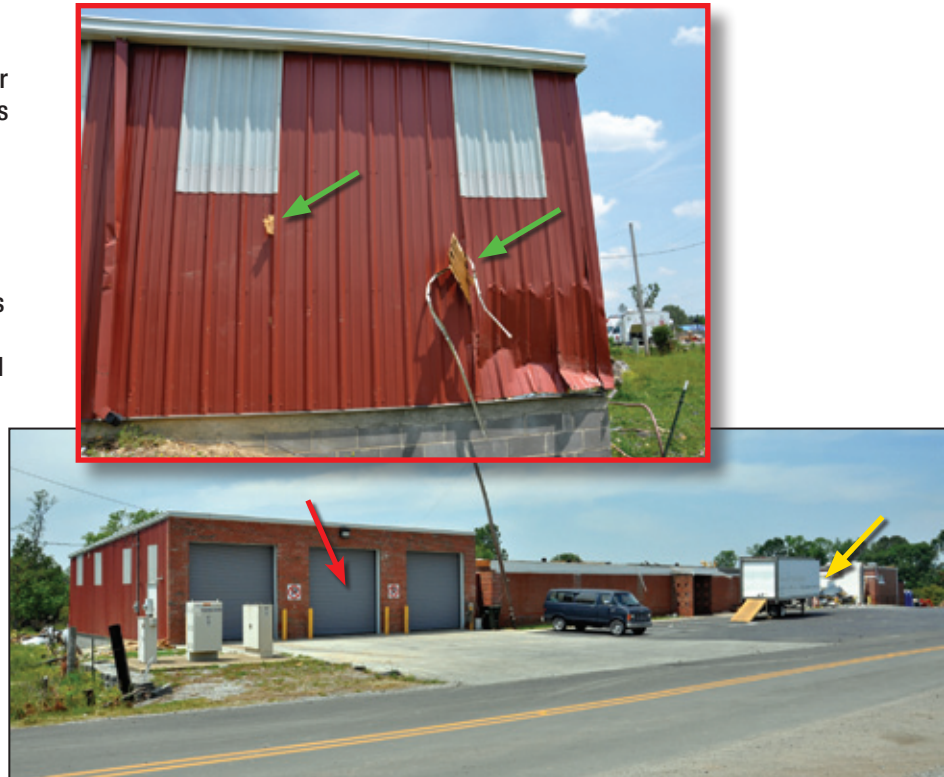
Figure 7-46:  
View of the old apparatus bay of the Webster’s Chapel Volunteer Fire Department. The multipurpose room is indicated by the red arrow (Wellington, AL).

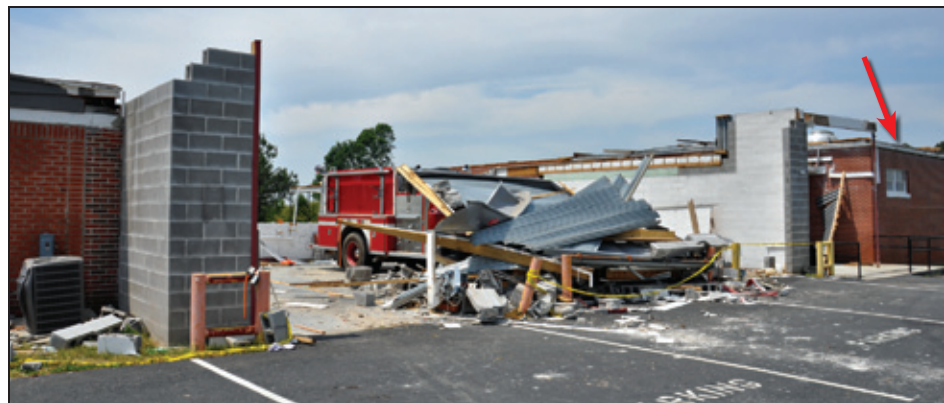
Figure 7-47:  
View of the back of the building. The old apparatus bay is shown by the yellow arrow and the new bay by the red arrow. Roof structure and wall damage occurred within the red box. The debris in the foreground is from the multipurpose room roof and the old apparatus bay (Wellington, AL).

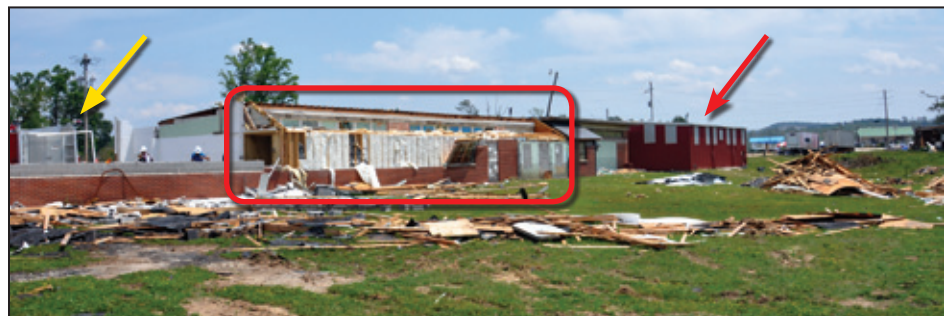
**MAT EF Rating:** Only the old apparatus bay portion of the facility was rated. Using DI 14 (Automobile Service Building),<sup>7</sup> the MAT selected DOD 6 (“uplift or collapse of roof structure”) for this facility. Considering the facility age and observed damage, the MAT assessed the wind speed as near the lower-bound wind speed for DOD 6. Hence, the MAT derived the tornado rating as EF1 (86–110 mph) based on damage to this building. Therefore, the estimated wind speed experienced by the building was not substantially above the current basic wind speed of 90 mph.

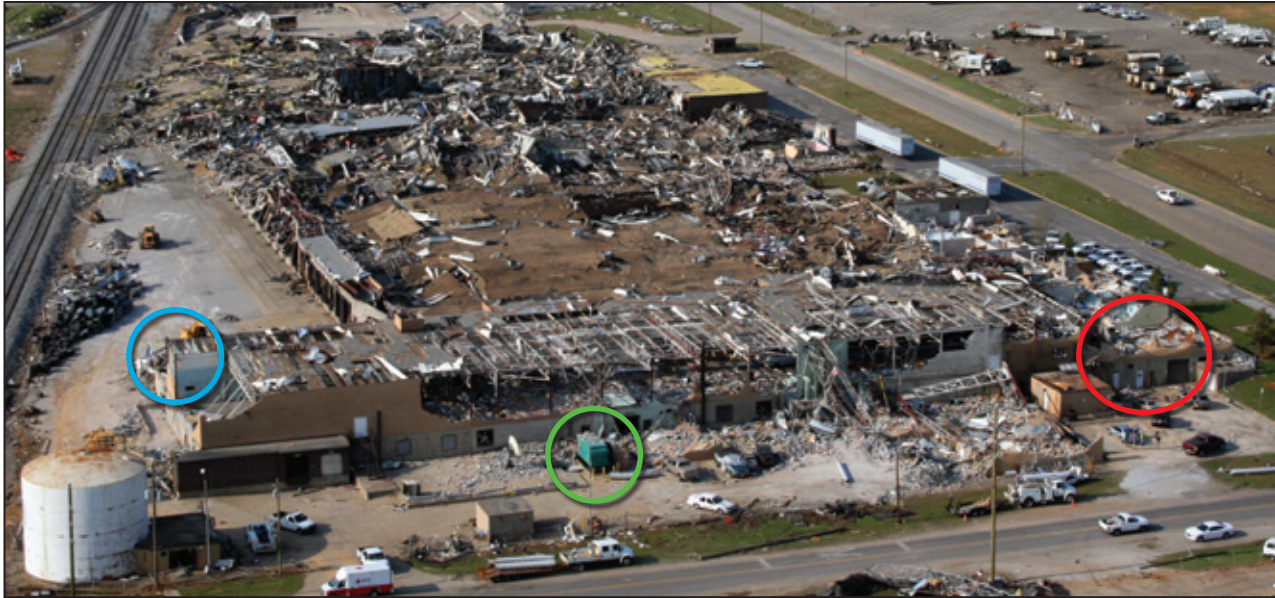
Figure 7-55: Oblique view of Figure 7-54 showing the Curry Building. The green circle indicates the EOC's emergency generator. The red circle shows the ground floor of the southeast corner, the location of the EOC. The blue circle shows the tornado refuge area.

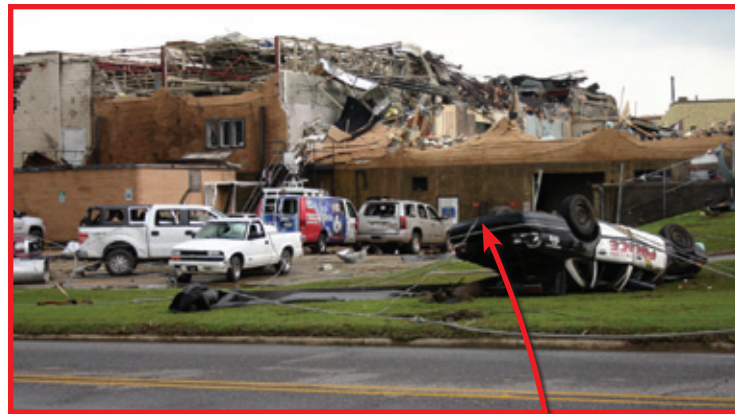
SOURCE: © GOOGLE EARTH

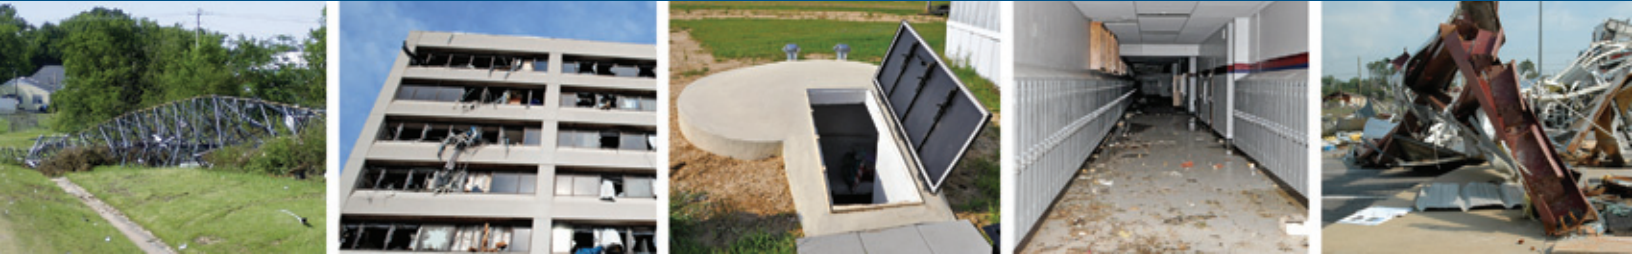
## TORNADO OUTBREAK *of* **2011**

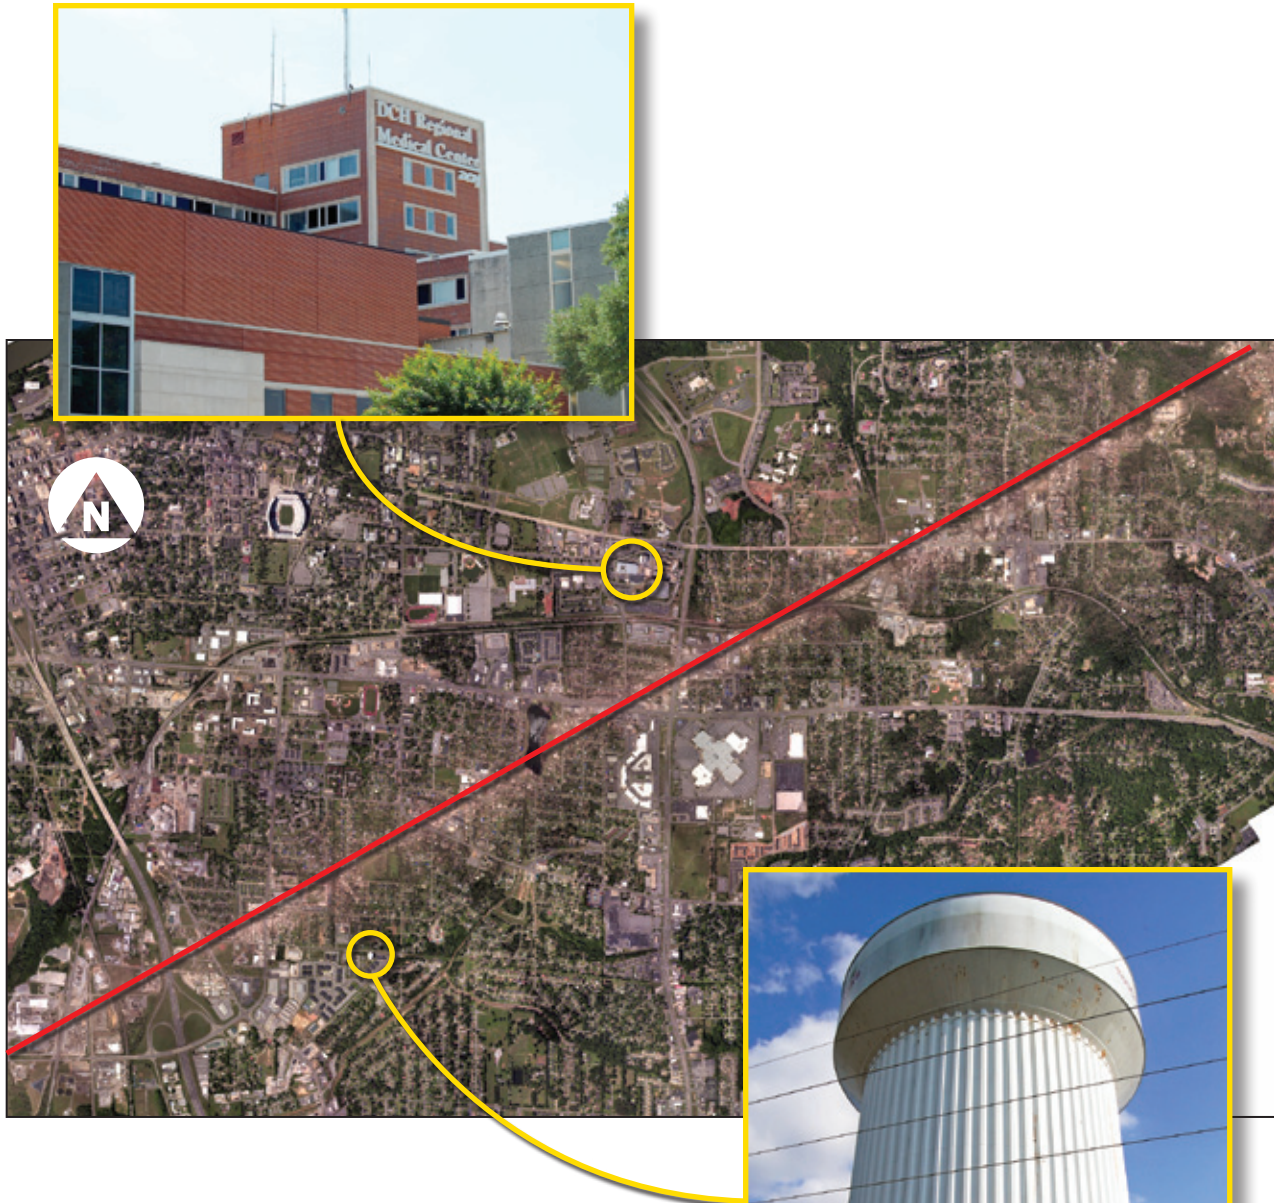
**Figure 8-3:**  
Aerial view showing the approximate centerline of the damage swath (red line)<sup>1</sup> in relationship to the Tuscaloosa Water Works storage tower (yellow circle, top inset) and the DCH Regional Medical Center (yellow circle, bottom inset)

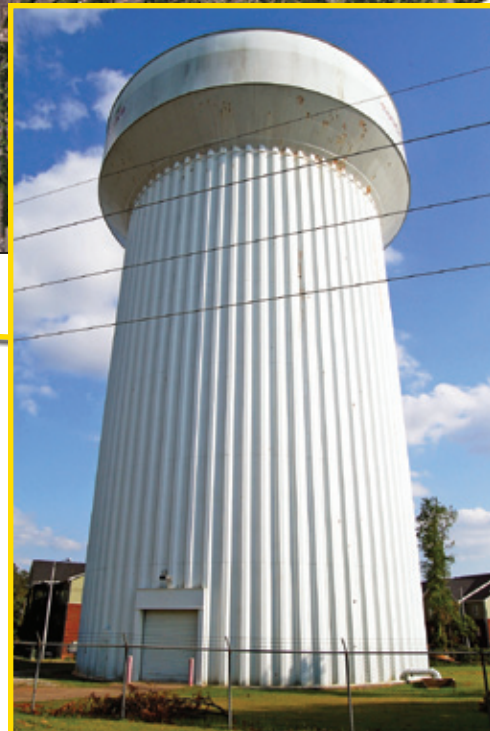
<sup>1</sup> The red line in this and all similar figures represents the center of the damage swath. The track location is approximated by the MAT based on post-event aerial photographs. The actual centerline of the vortex is offset from the centerline of the damage.

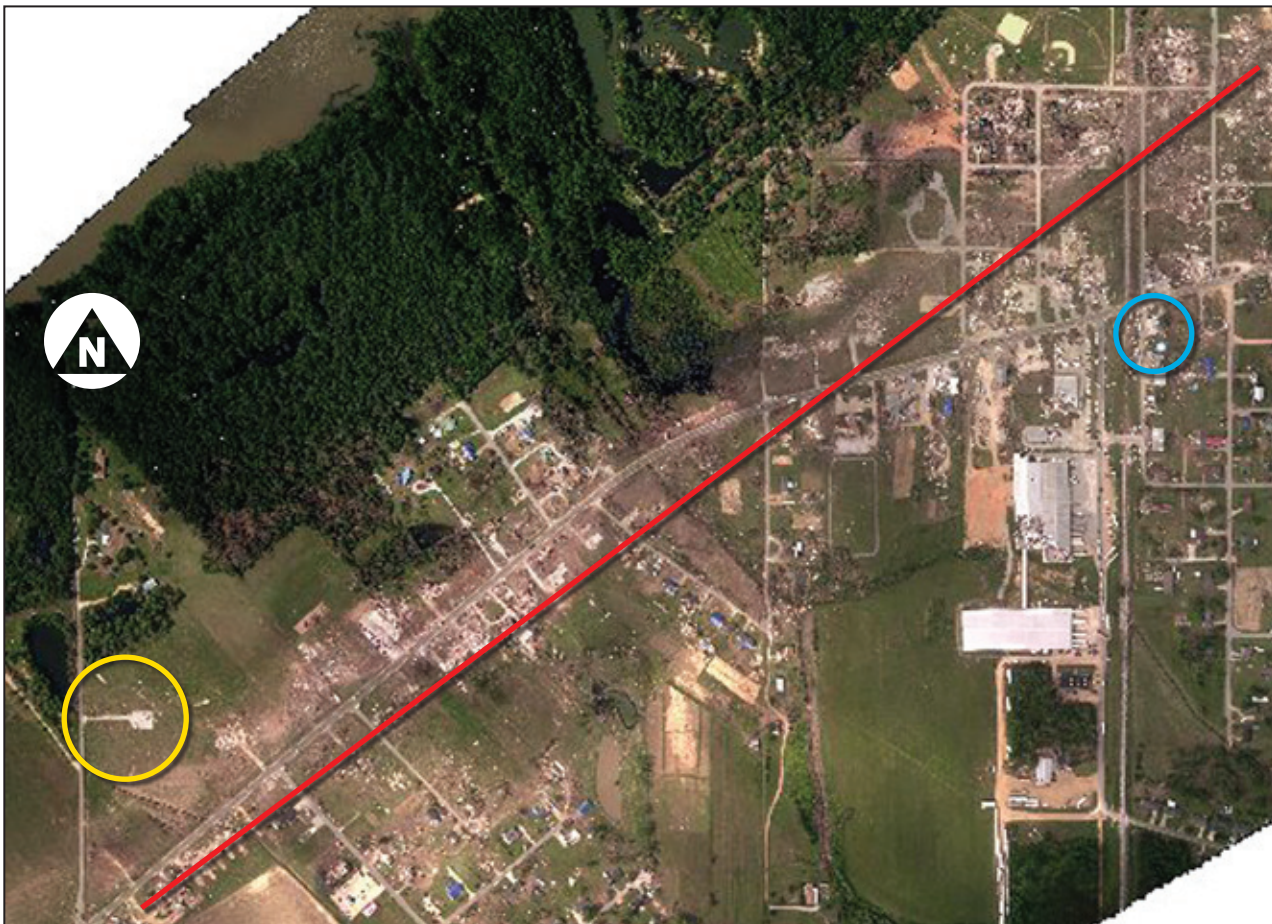
Figure 8-5: Aerial view showing the approximate centerline of the tornado damage swath in Smithville, MS (red line), the Smithville Water Treatment and Distribution System Plant (blue circle), and the 300-foot-tall cellular tower discussed in Section 8.3.2.1 (yellow circle)

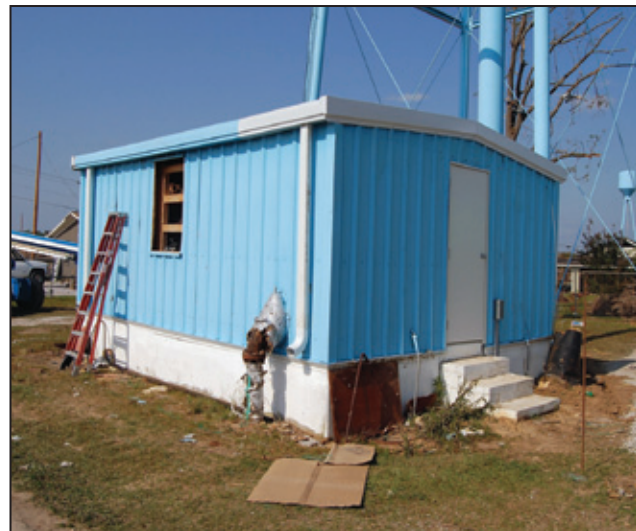
Figure 8-8: Destroyed unreinforced CMU building (left) and damaged metal-framed building (right) (Smithville, MS)

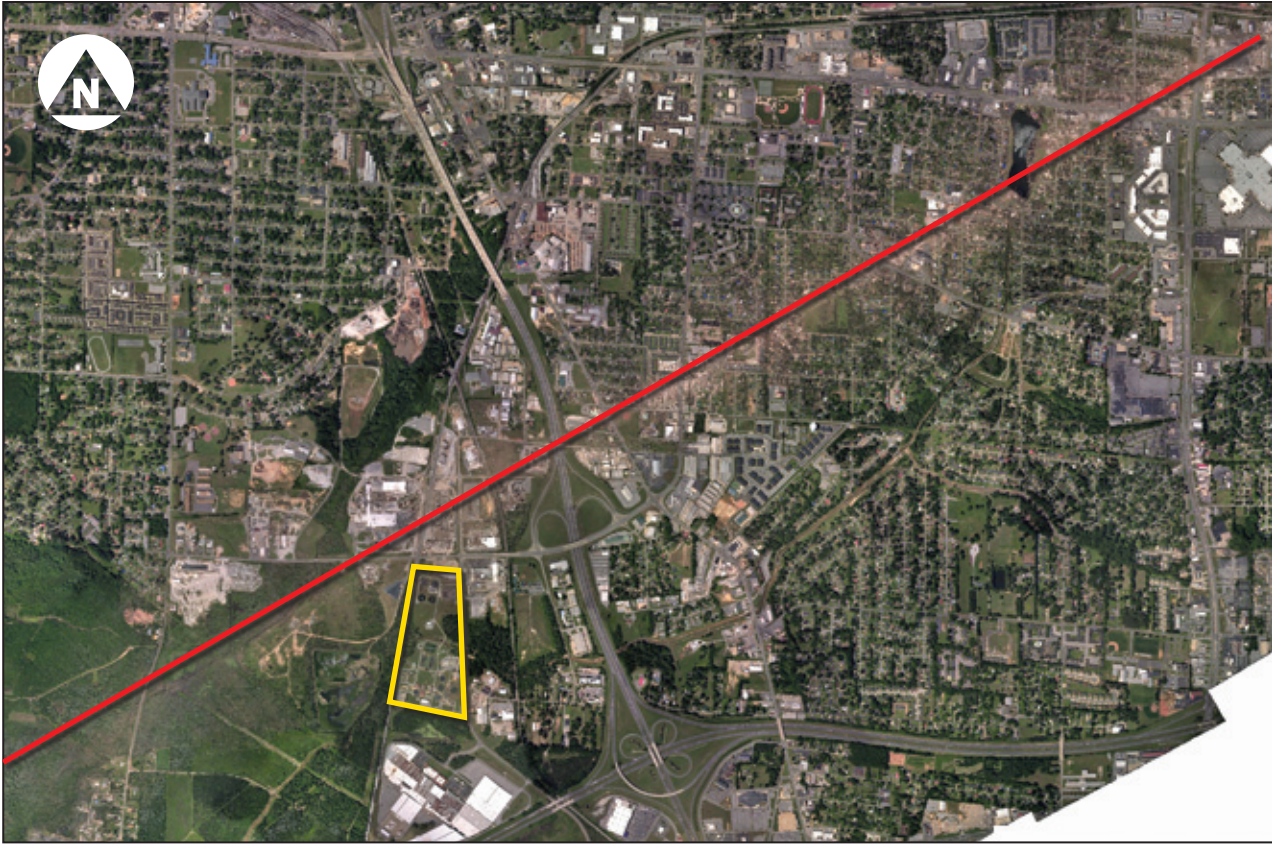
Figure 8-13: Aerial view of the Tuscaloosa Waste Water Treatment Plant (yellow rectangle) in relation to the approximate centerline of the April 27, 2011 tornado damage swath (red line)

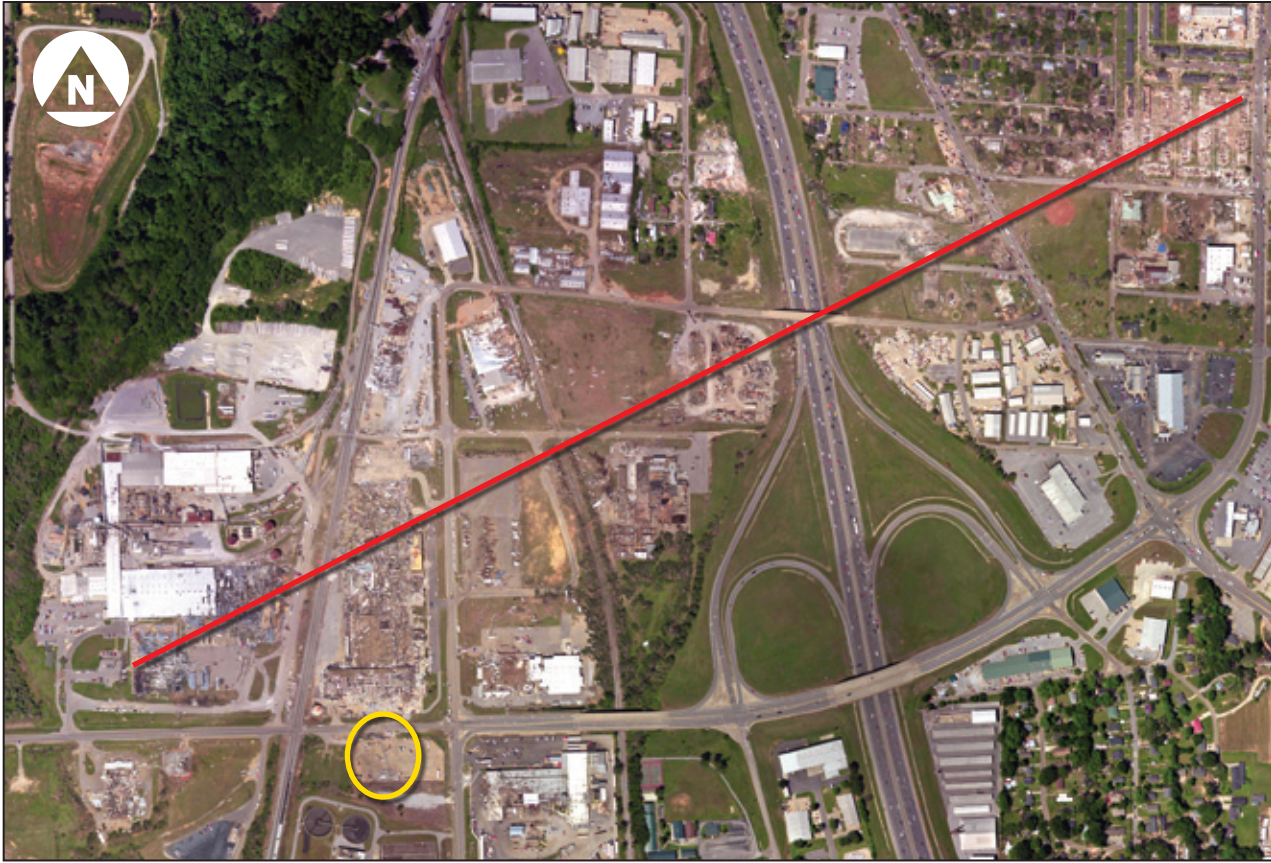
Figure 8-14: Aerial view of the approximate centerline of the tornado damage swath (red line) in the vicinity of the latticed 250-foot EMS communications tower (yellow circle) (Tuscaloosa, AL)
