## Mitigation Assessment Team Report

# Spring 2011 Tornadoes: April 25-28 and May 22

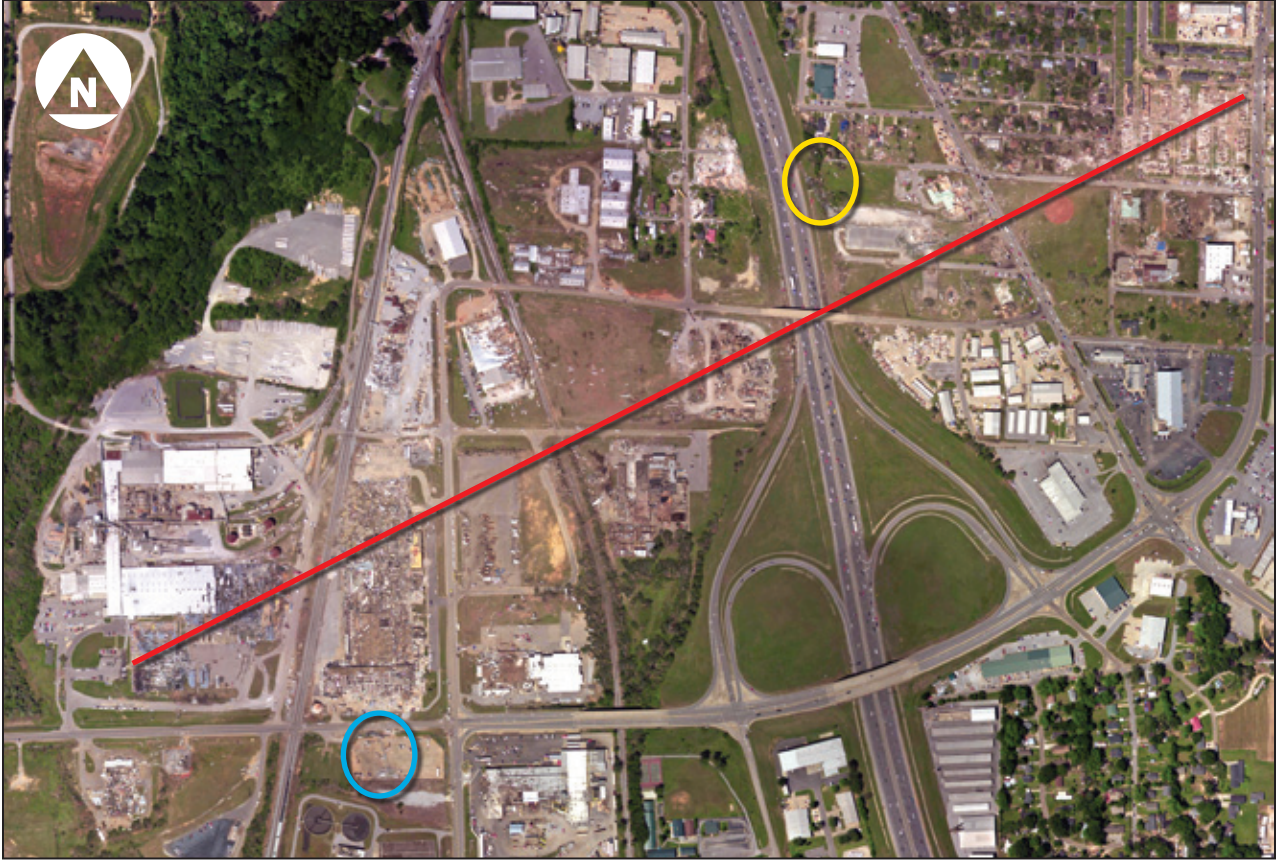
Figure 8-18: Aerial view of the approximate centerline of the tornado damage swath (red line) in the vicinity of the 300-foot latticed cellular tower (yellow oval). Also shown is the 250-foot EMS tower described in Section 8.3.1.1 (blue oval) (Tuscaloosa, AL).

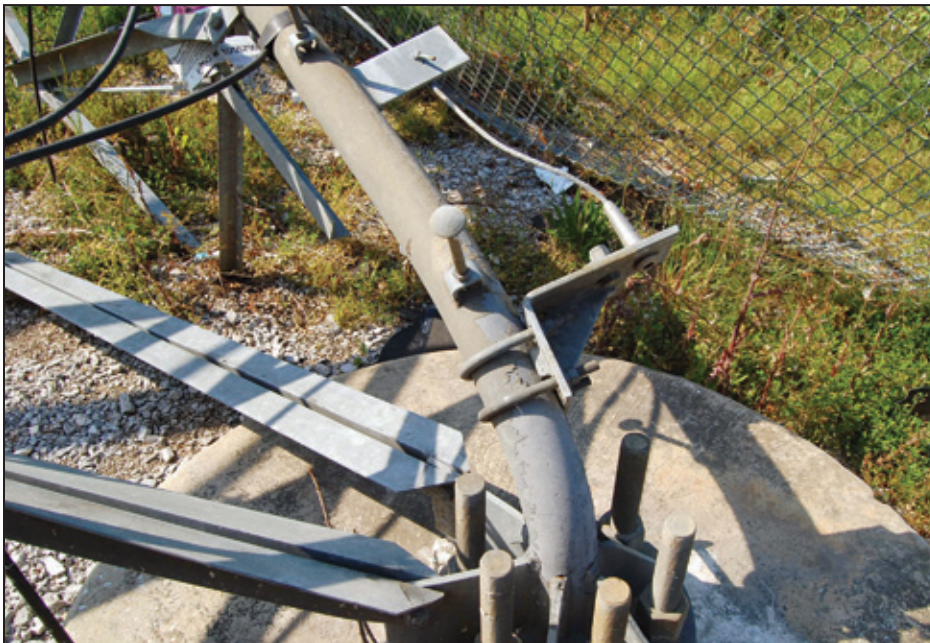
Figure 8-19: Base for 300-foot latticed cellular tower (Tuscaloosa, AL)

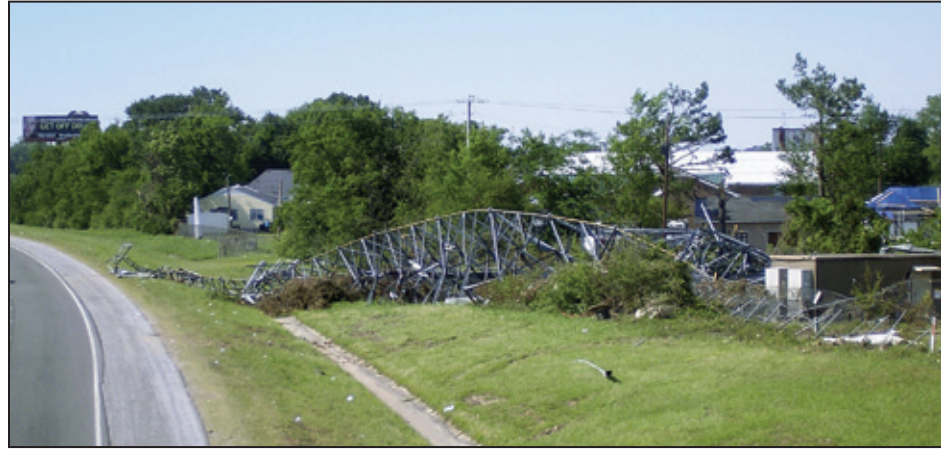
No wind-displaced building materials were seen physically adhered to the fallen latticed tower. However, a large metal building southeast of the tower had been destroyed (Figures 8-21 and 8-22), and large sections of metal panels were scattered throughout the area. The MAT also observed a trailer frame leaning against the fence surrounding the cell tower base (Figure 8-23). These observations suggest that the storm created large amounts of wind-borne debris and wind-displaced sheathing in the vicinity of the tower and wind-displaced material likely struck the tower.

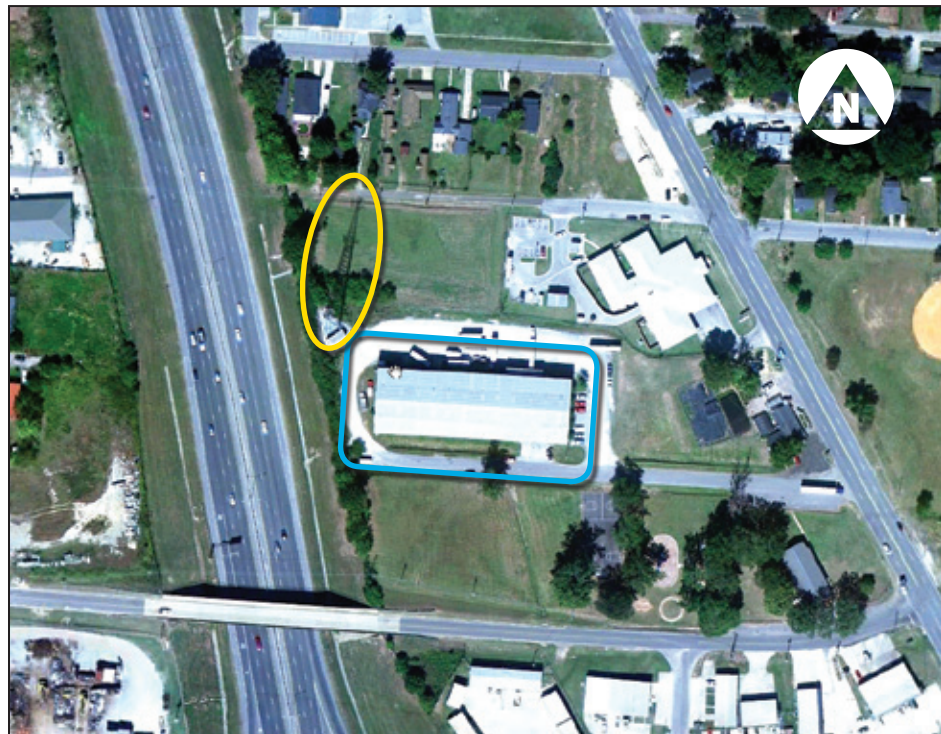
SOURCE: © GOOGLE EARTH

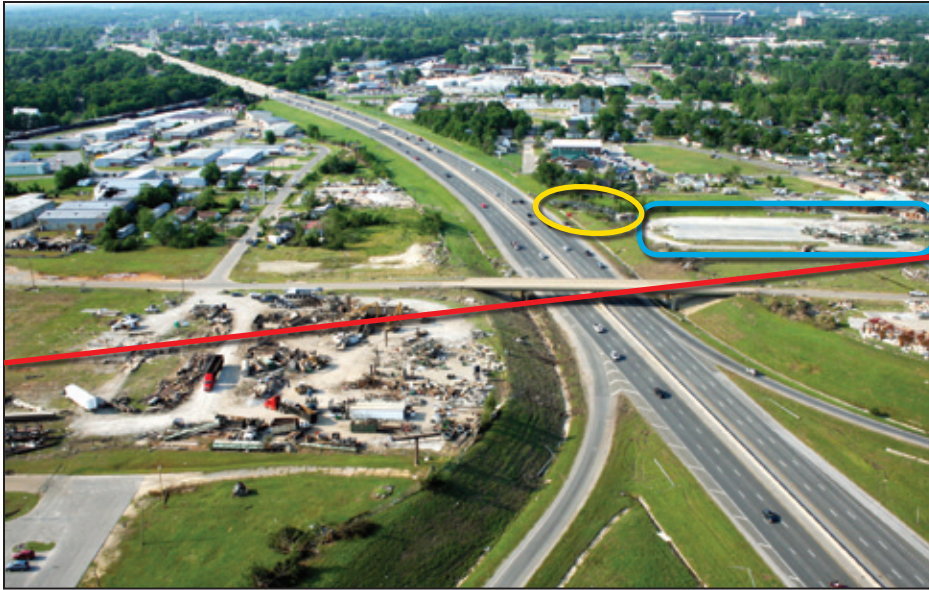
**Figure 8-22:**  
View of the collapsed 300-foot cellular tower (yellow oval) and the destroyed metal building southeast of the tower (blue box) in relation to the approximate centerline of the tornado damage swath (red line) (Tuscaloosa, AL)

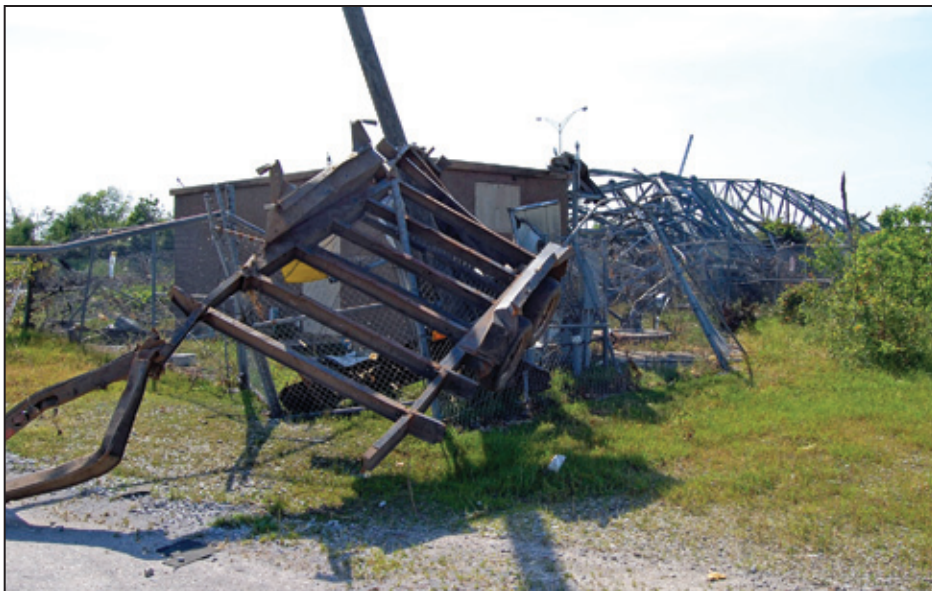
**Figure 8-23:**  
Remnants of a trailer that struck the fence surrounding the 300-foot cellular tower (Tuscaloosa, AL)

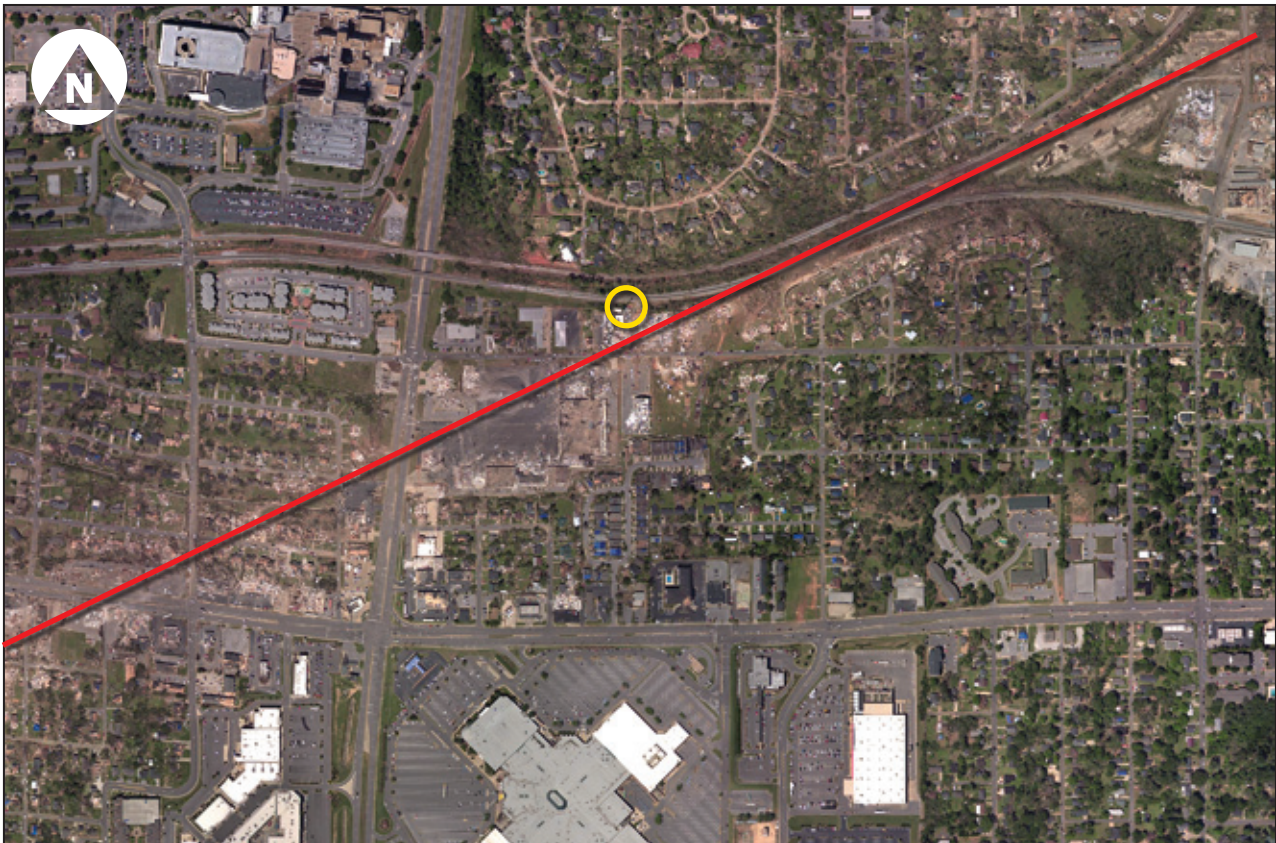
Figure 8-24: Aerial view of the approximate centerline of the tornado damage swath (red line) in the vicinity of the solid cellular tower left standing after the tornado (yellow circle) (Tuscaloosa, AL)

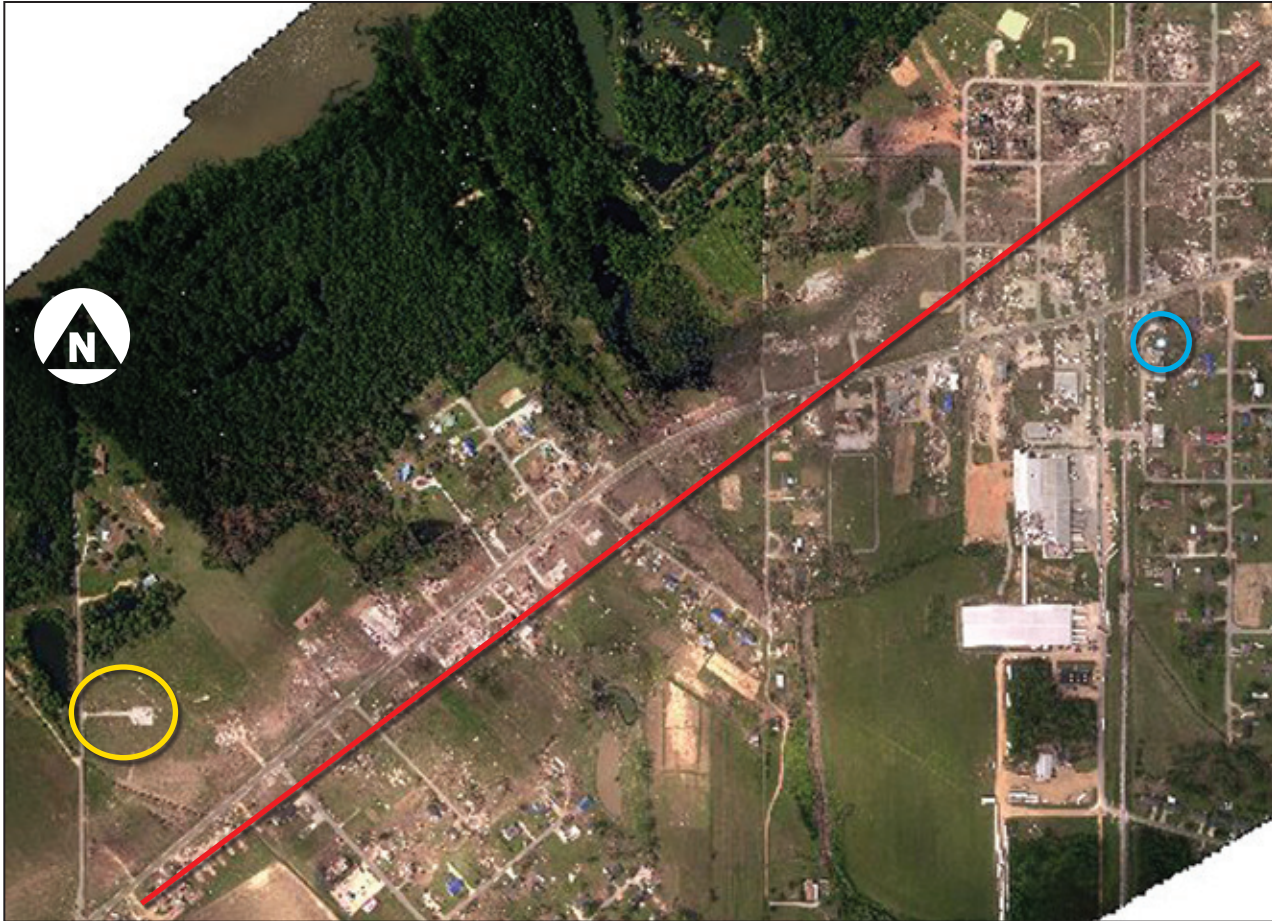
Figure 8-26: Aerial view of the 300-foot guyed cellular tower (yellow circle) in relationship to the approximate centerline of the tornado damage swath (red line) in Smithville, MS. The Smithville water tower shown in Figures 8-5 through 8-7 is northwest of the guyed tower and circled in blue for reference.

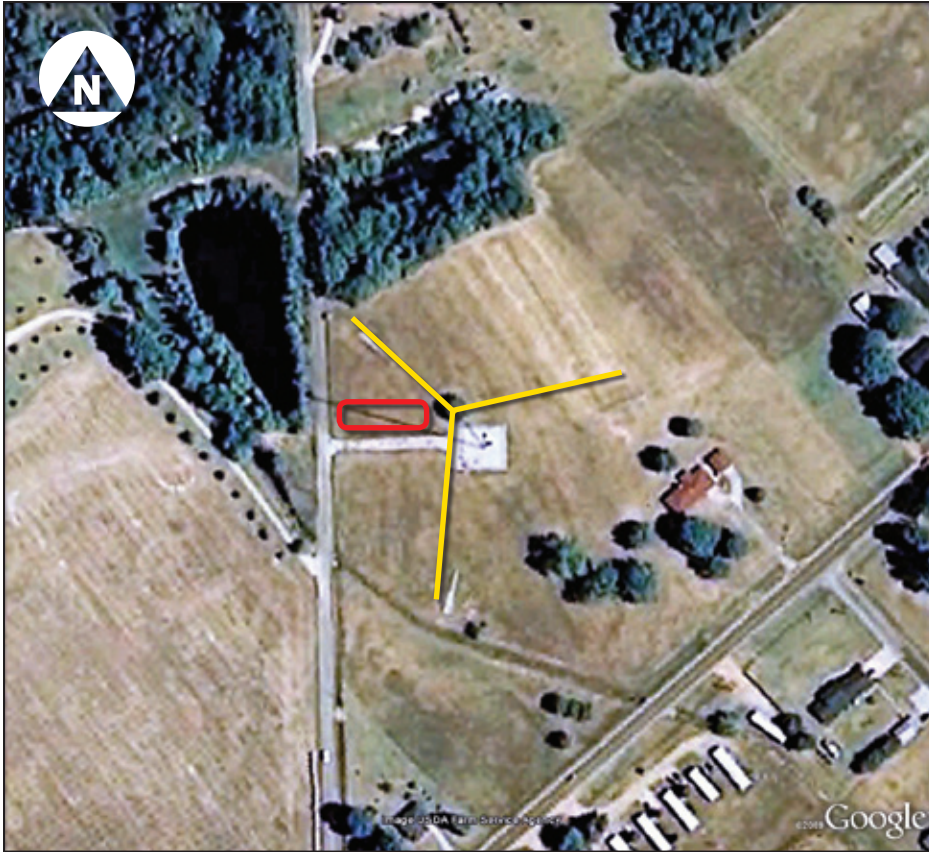
Figure 8-27:  
Aerial photograph showing the 300-foot-tall guyed cellular tower after the tornado; the yellow lines show the location of the original guys, and the red box shows the position of the tower remnants observed by the MAT (Smithville, MS)  
SOURCE: © GOOGLE EARTH

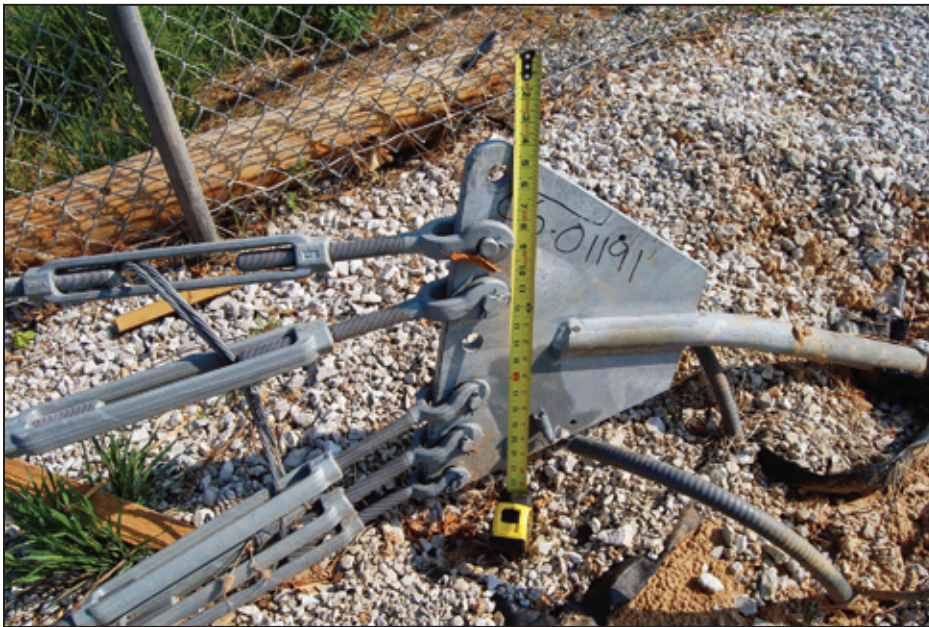
Figure 8-28:  
Guy attachment plate, turnbuckle, and anchor shaft (Smithville, MS)

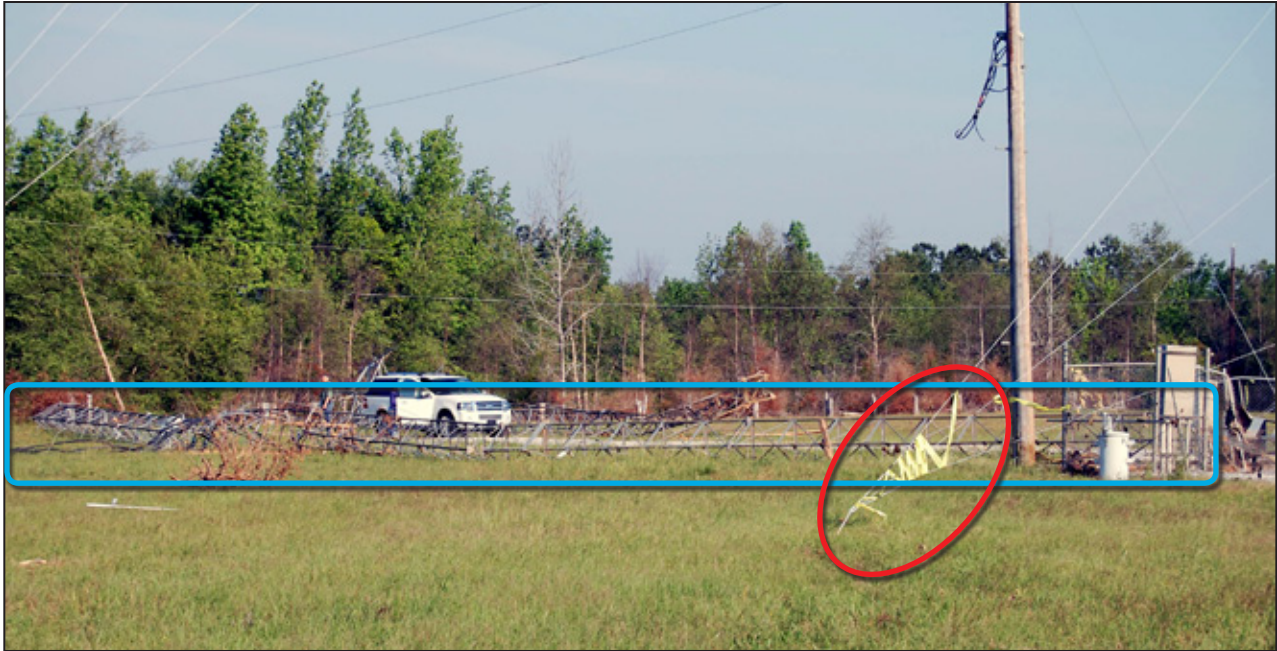
Figure 8-29: Collapsed 300-foot cellular tower (blue box). The triple guy in the foreground (red oval) is one of the three supports for the temporary tower on the site (Smithville, MS).

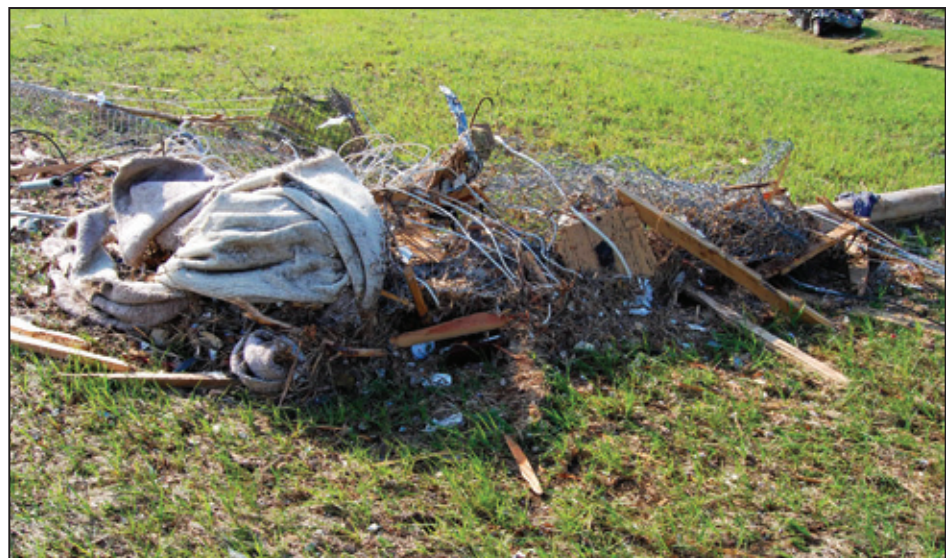
Figure 8-30:  
Wind-displaced building materials wrapped around the 300-foot cellular tower guy (Smithville, MS)

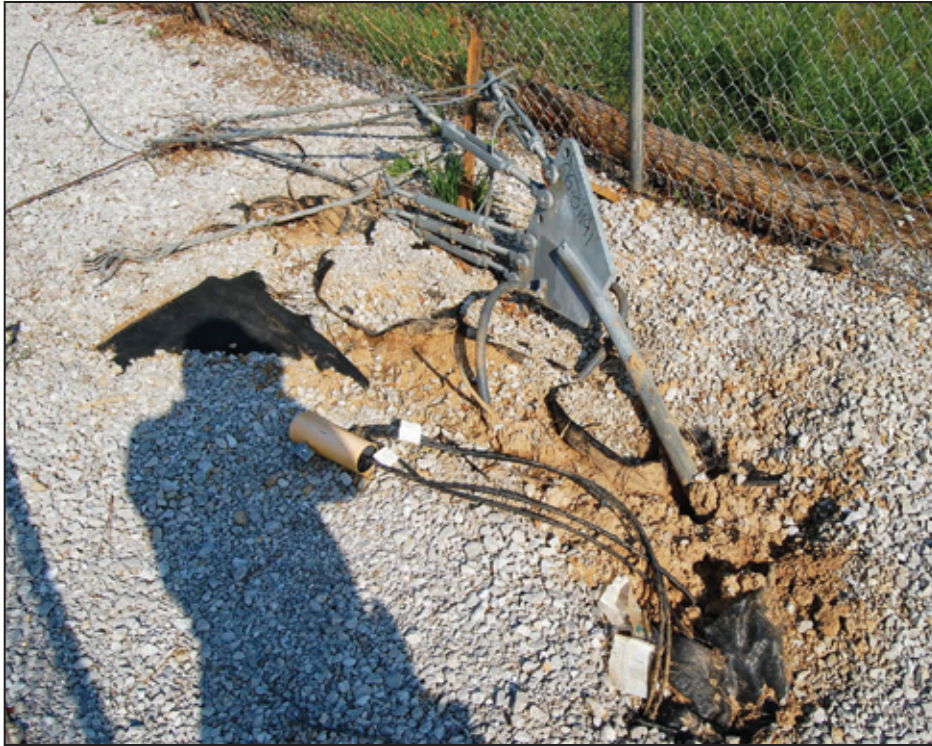
Figure 8-31:  
The anchor securing one guy was dragged several feet through the ground (Smithville, MS)

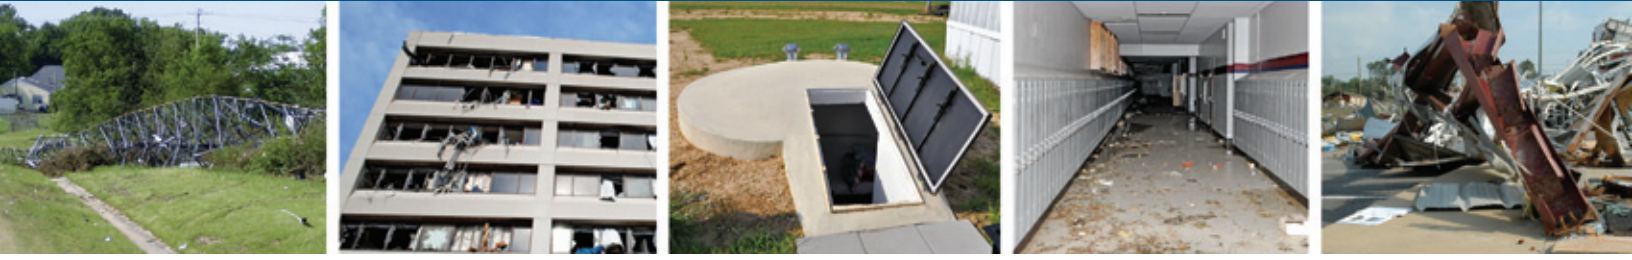
## TORNADO OUTBREAK *of* **2011**

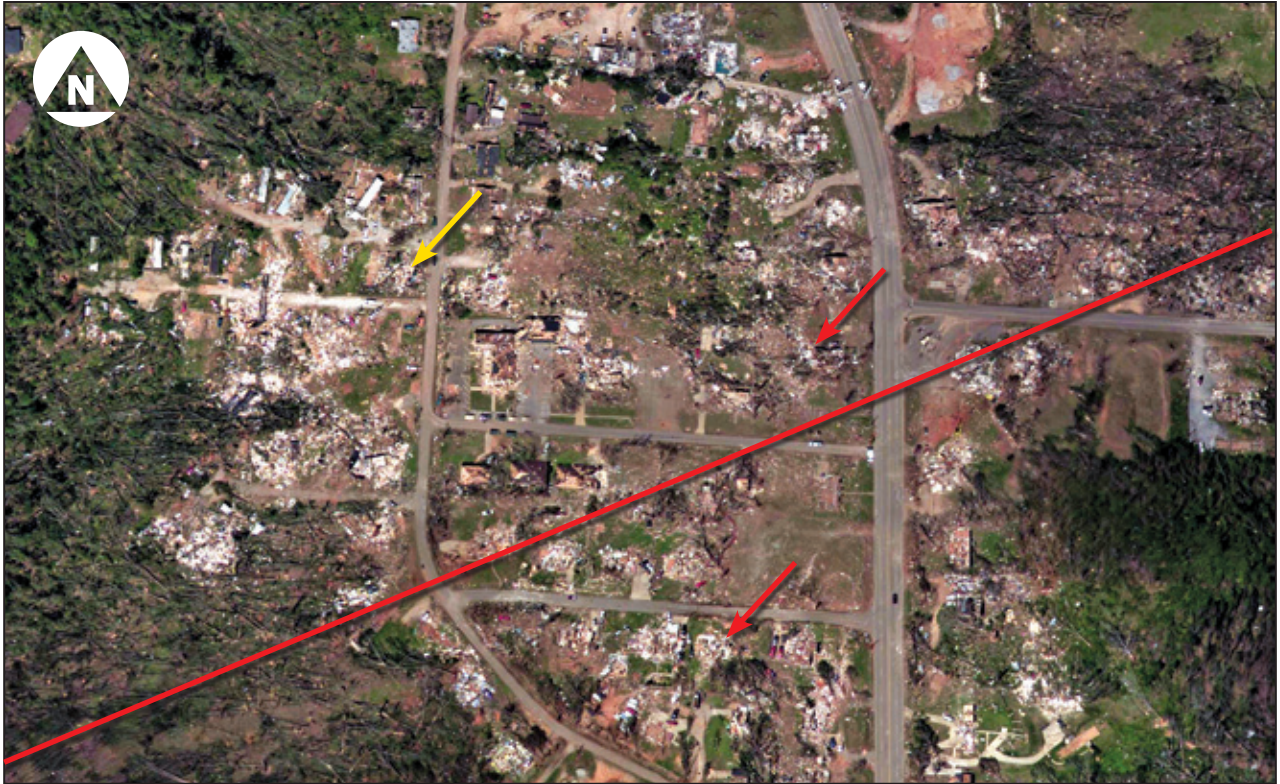
Figure 9-4: Aerial view of tornado damage swath in Crescent Ridge, AL (approximate centerline of swath is indicated by red line).<sup>3</sup> Core remnants of homes shown in Figures 9-5 are identified with red arrows. The damaged manufactured homes in Figure 9-7 are identified with a yellow arrow.

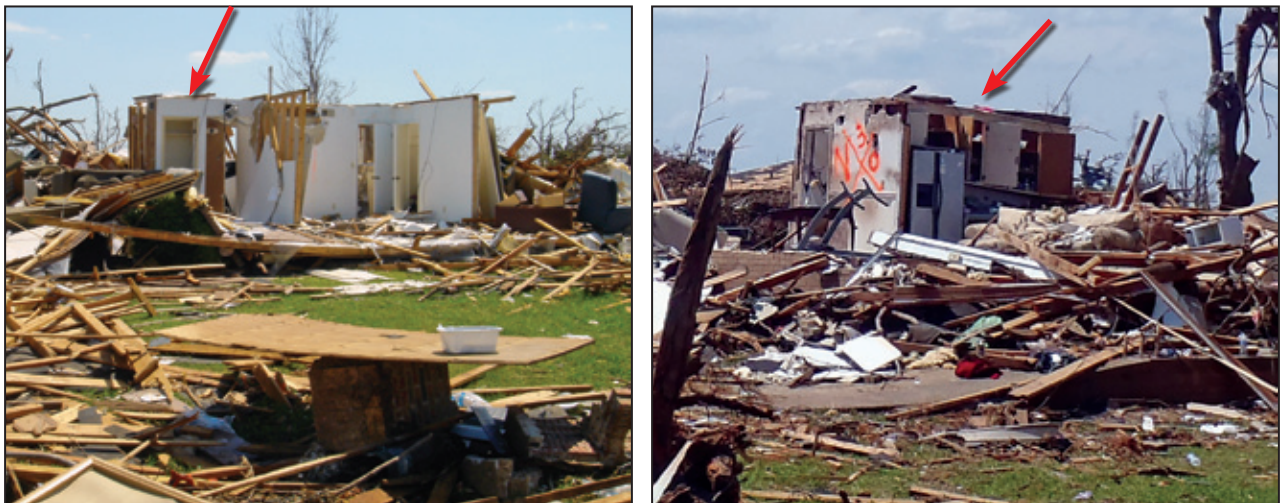
Figure 9-5: Core remnants of homes sometimes survive a tornado as shown in this photograph of site-built homes where a closet (red arrow in left photograph) and a bathroom behind a kitchen (red arrow in right photograph) remained standing after the tornado (Crescent Ridge, AL)

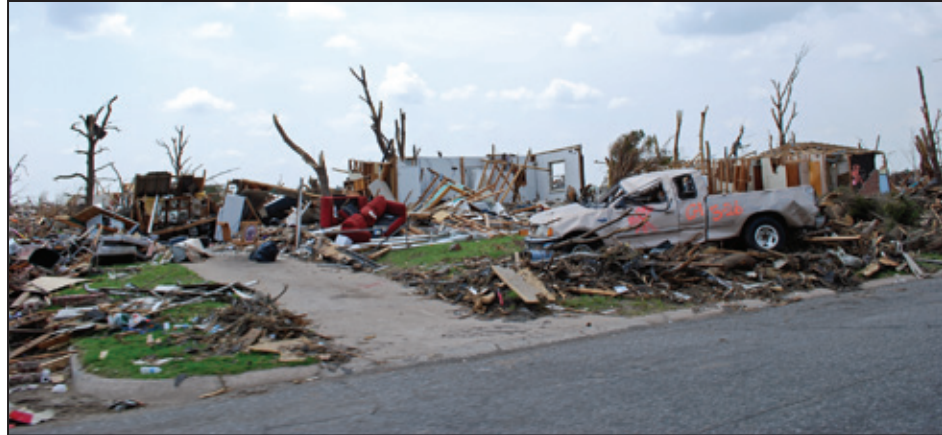
**Figure 9-7:**  
Manufactured homes  
destroyed in Crescent Ridge,  
AL (location shown in  
Figure 9-4)

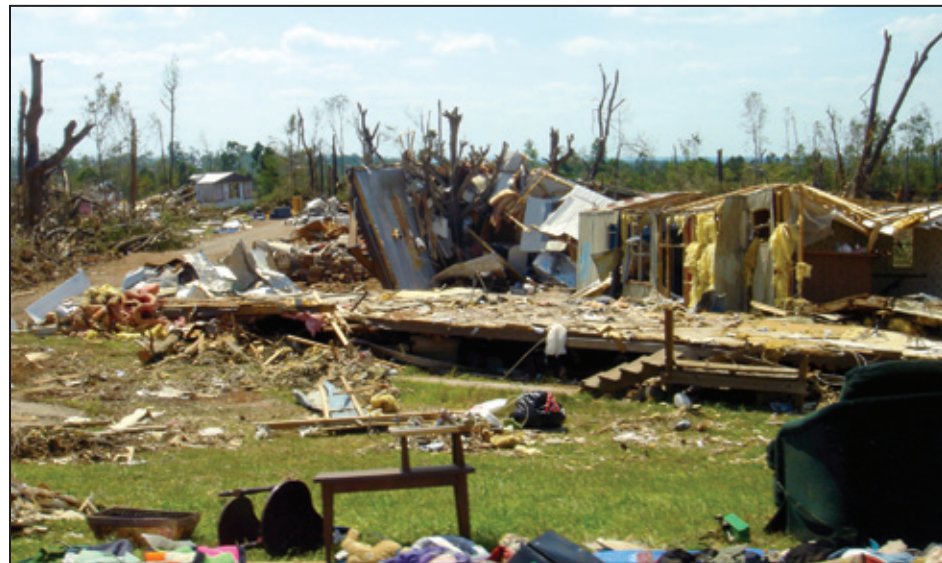
### 9.2.1.2 Basement Areas

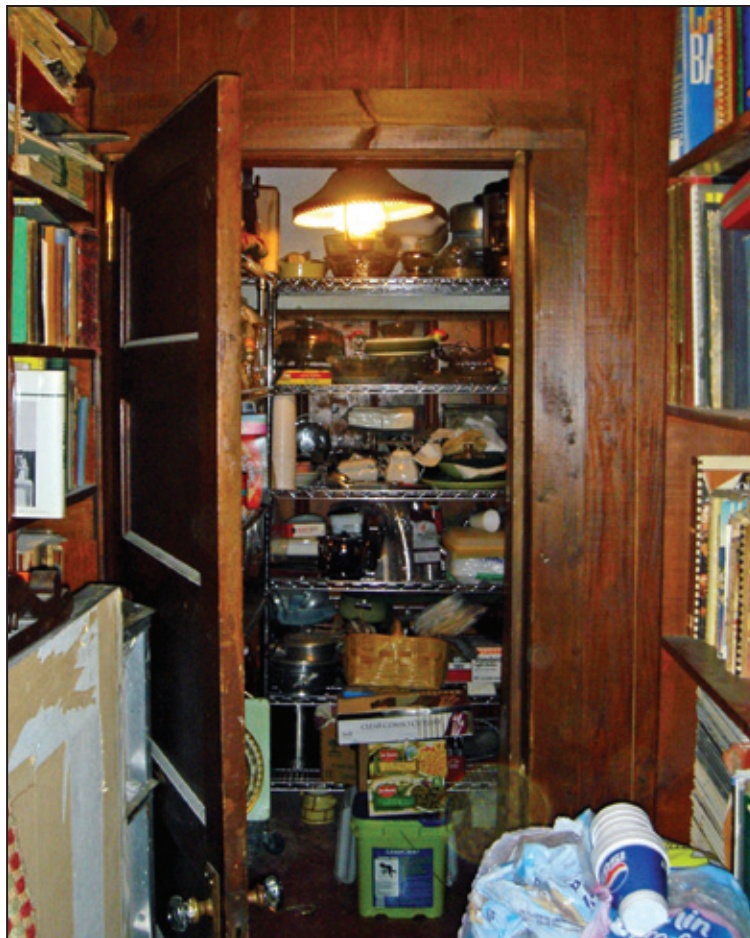
Figure 9-8:  
Tornado refuge area in a  
Tuscaloosa, AL, basement

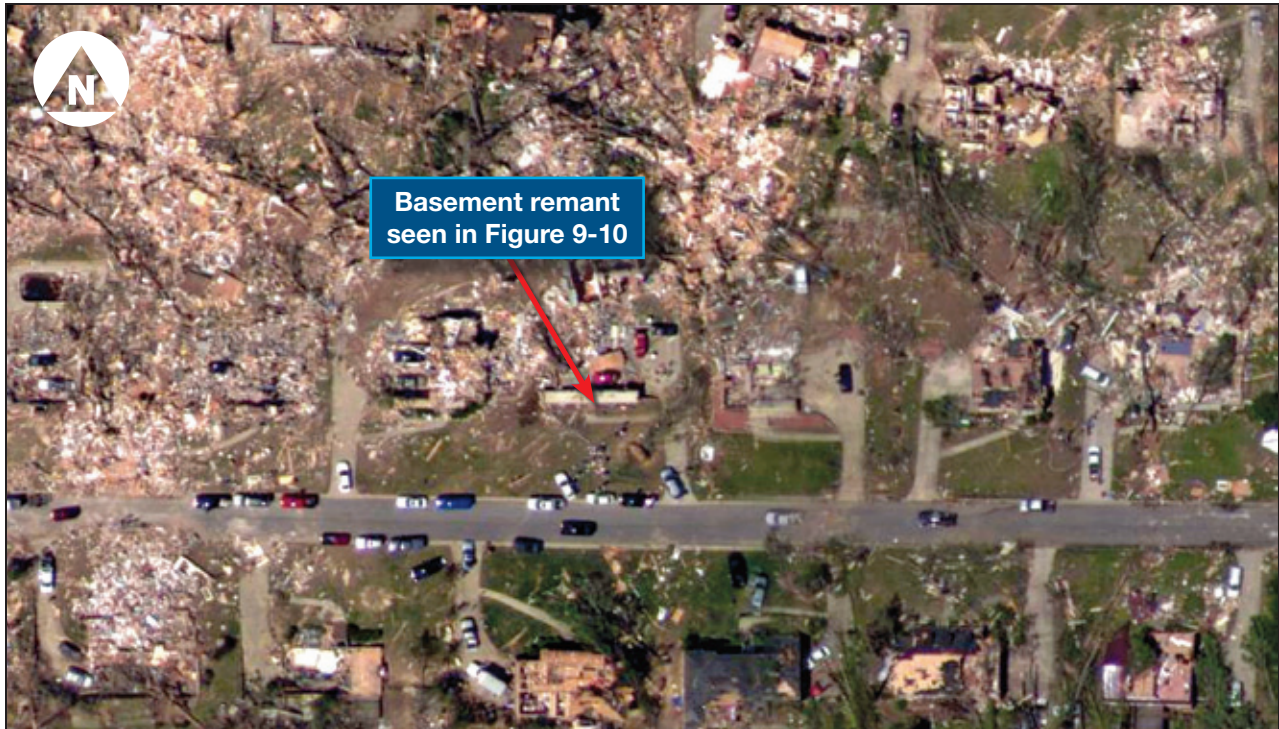
Figure 9-9: Aerial view of the Pleasant Grove, AL, neighborhood.  
NOTE: TRACK DAMAGE CENTERLINE IS NOT IN THE FRAME SHOWN HERE.

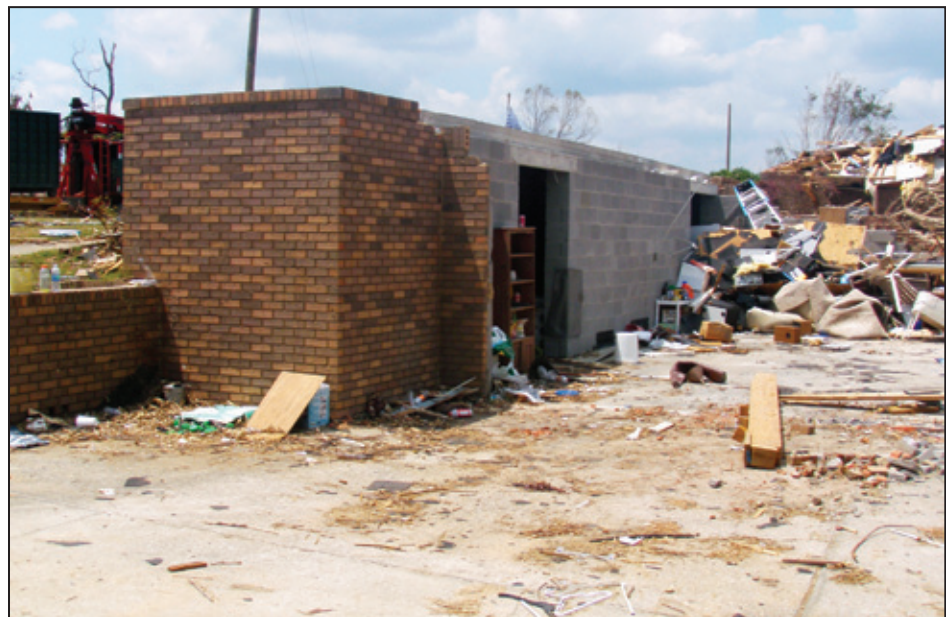
It is important to note, however, that not all basement areas should be considered “safe” during a tornado just because they are below ground. According to local residents, a few doors down from the home shown in Figure 9-10, a fatality occurred when people sought shelter in the basement and the concrete floor above collapsed into the basement space.

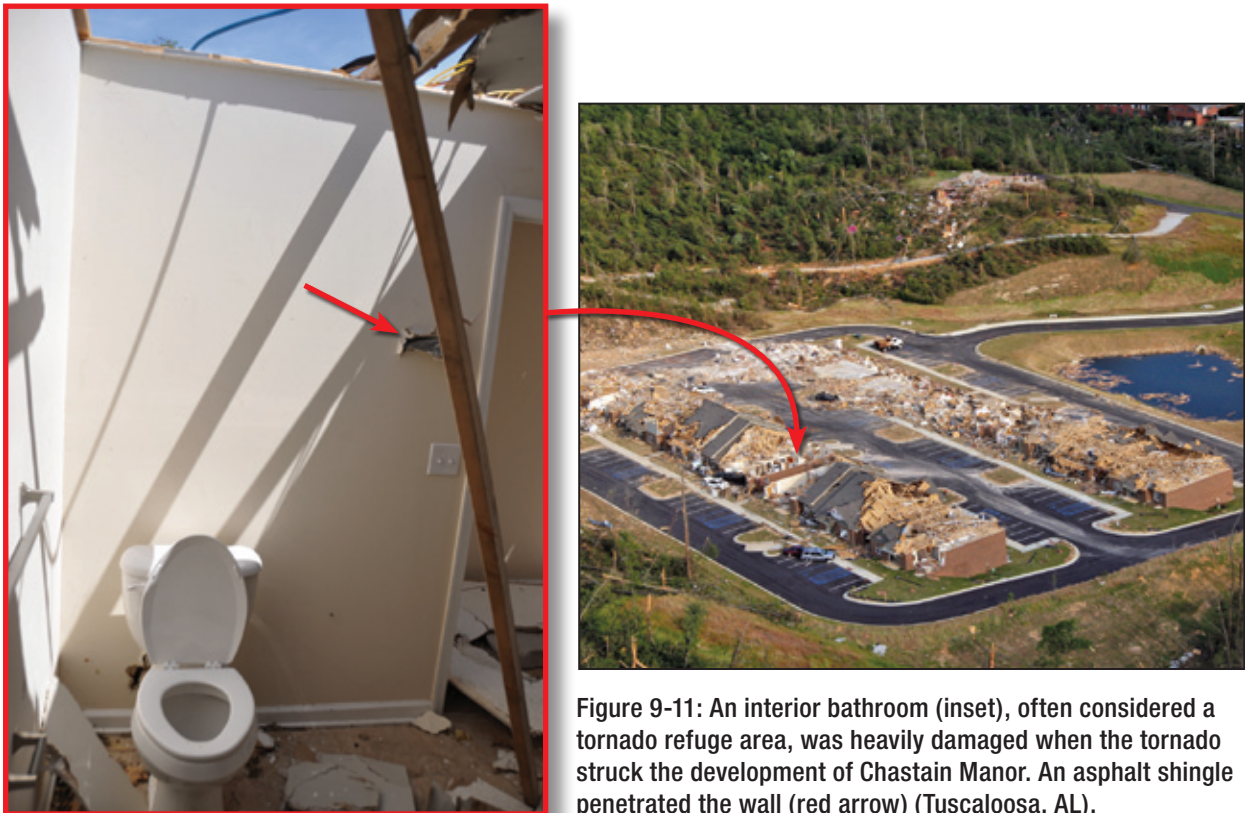
Figure 9-11: An interior bathroom (inset), often considered a tornado refuge area, was heavily damaged when the tornado struck the development of Chastain Manor. An asphalt shingle penetrated the wall (red arrow) (Tuscaloosa, AL).

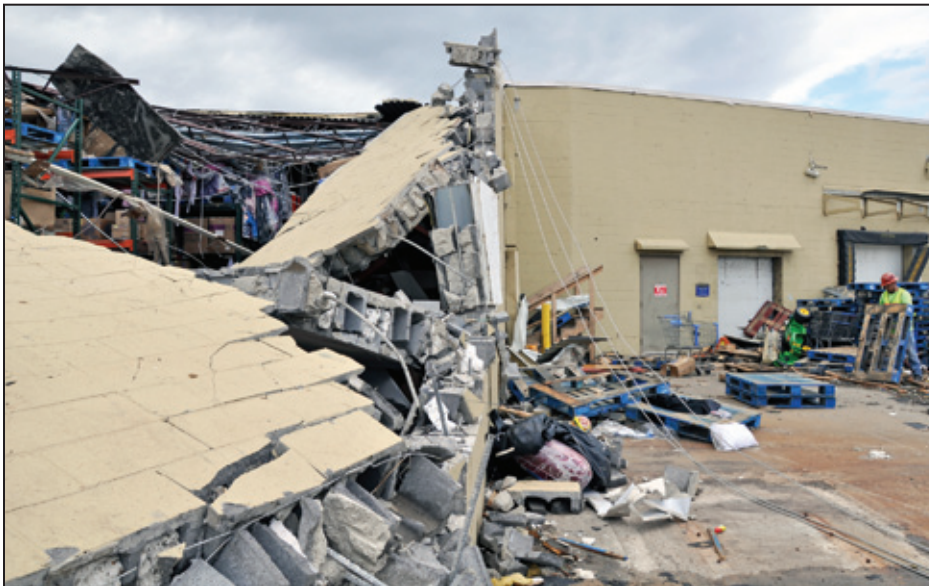
Figure 9-13:  
Close-up view of the damage  
at the Walmart store in  
Joplin, MO

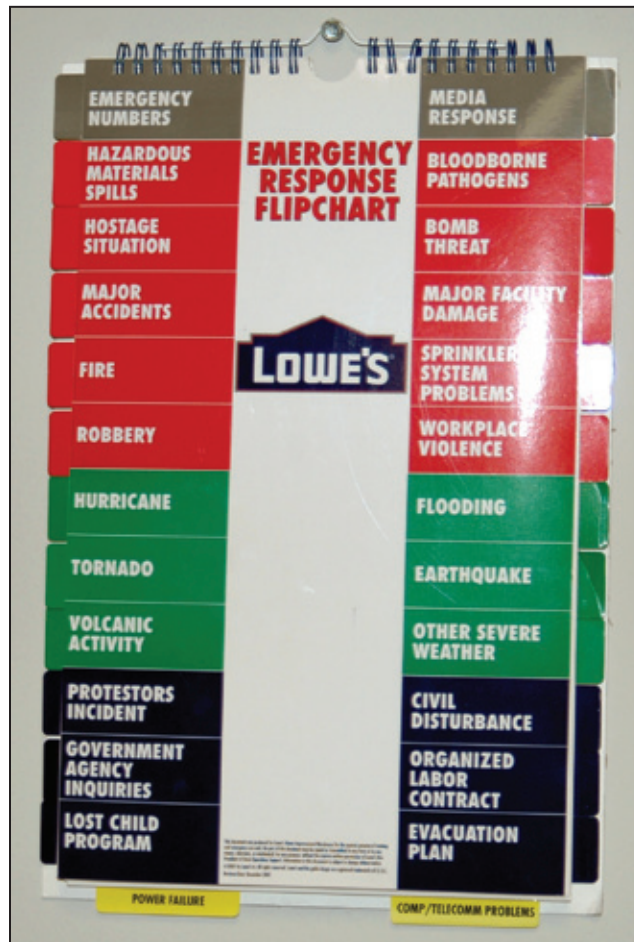
Figure 9-15:  
Lowe's Emergency Response  
Flipchart (Tuscaloosa, AL)

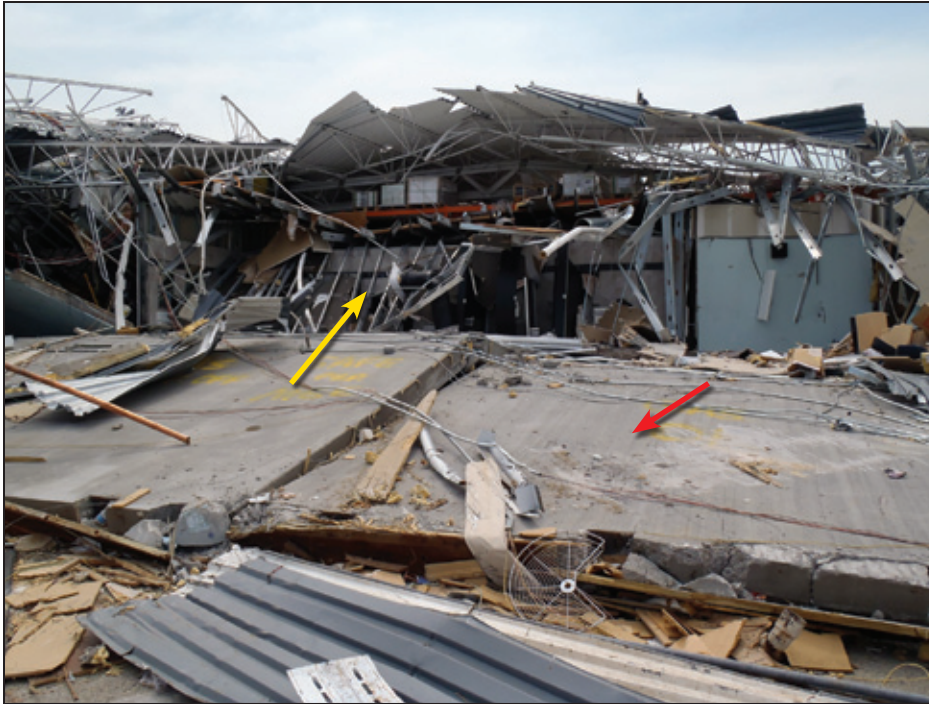
Figure 9-17:  
Tornado refuge area (training room) of the Home Depot. Note the collapsed tilt-up wall (red arrow) and the wall leaning into the refuge area (yellow arrow) (Joplin, MO).

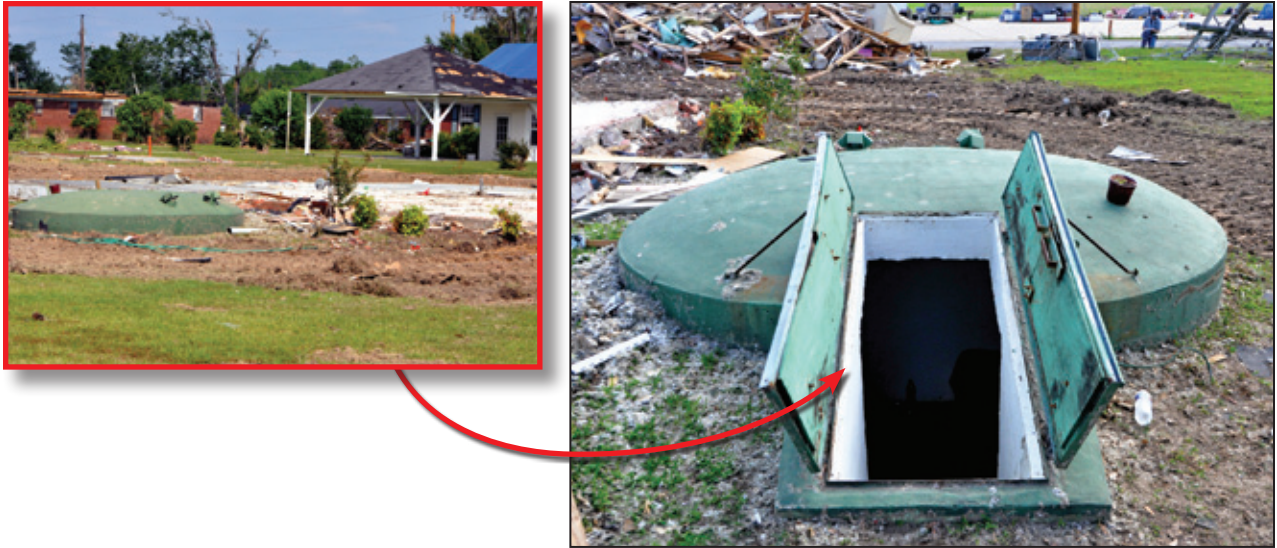
Figure 9-18: Underground shelter that survived a tornado (rated EF2 based on the MAT's observations). Inset shows the location of shelter (Smithville, MS).

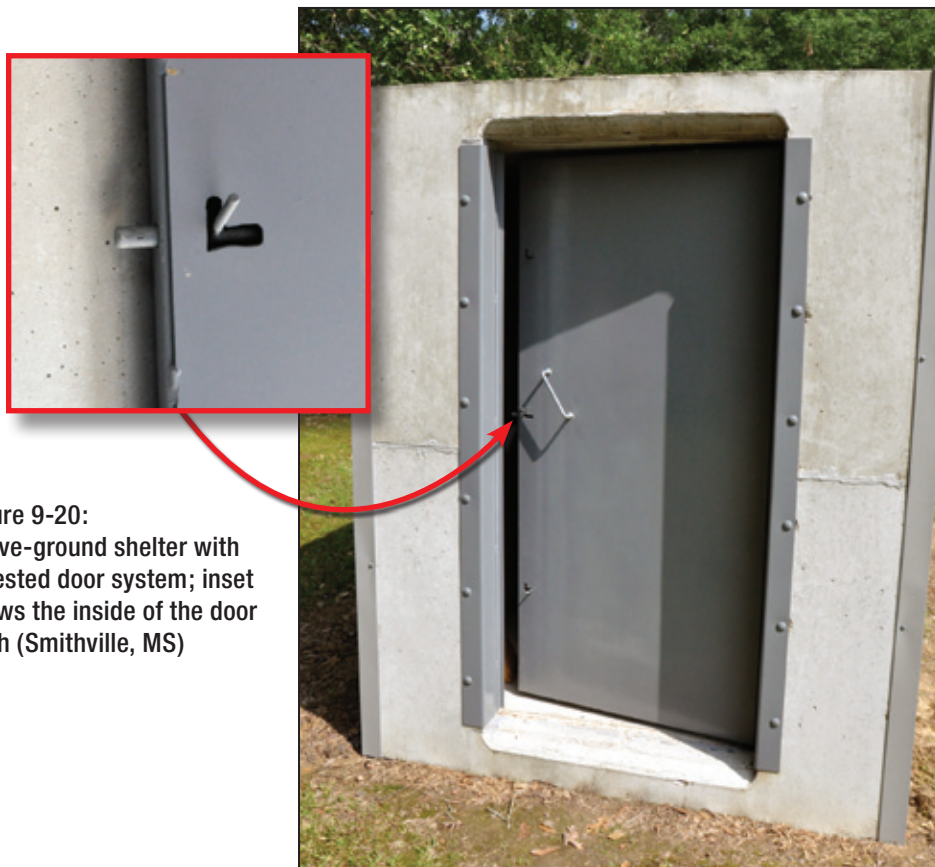
Figure 9-20:  
Above-ground shelter with  
untested door system; inset  
shows the inside of the door  
latch (Smithville, MS)

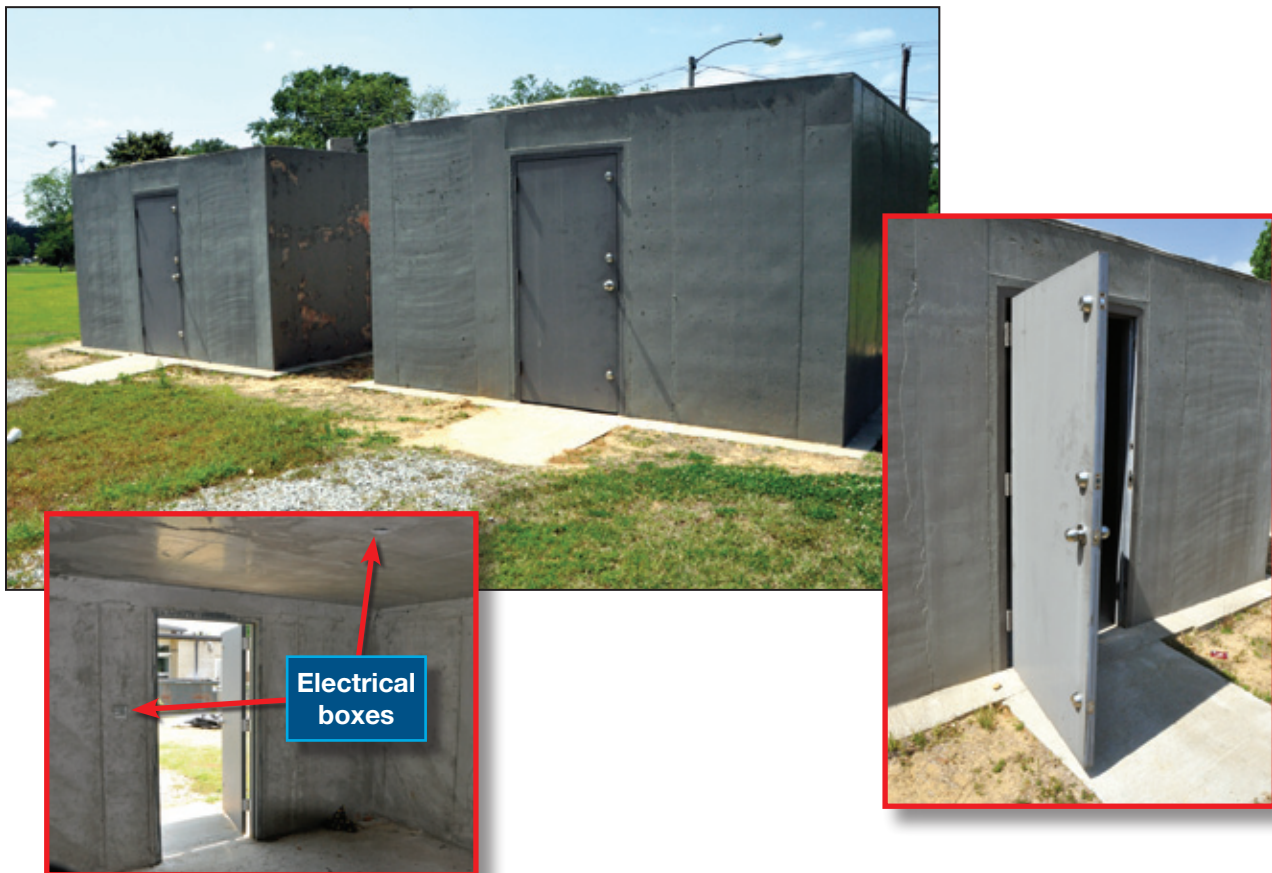
Figure 9-22: Above-ground hardened structures used as community tornado refuge areas. Insets show electrical boxes ready for wiring and fixtures (left) and door assemblies (right) (Amory, MS).

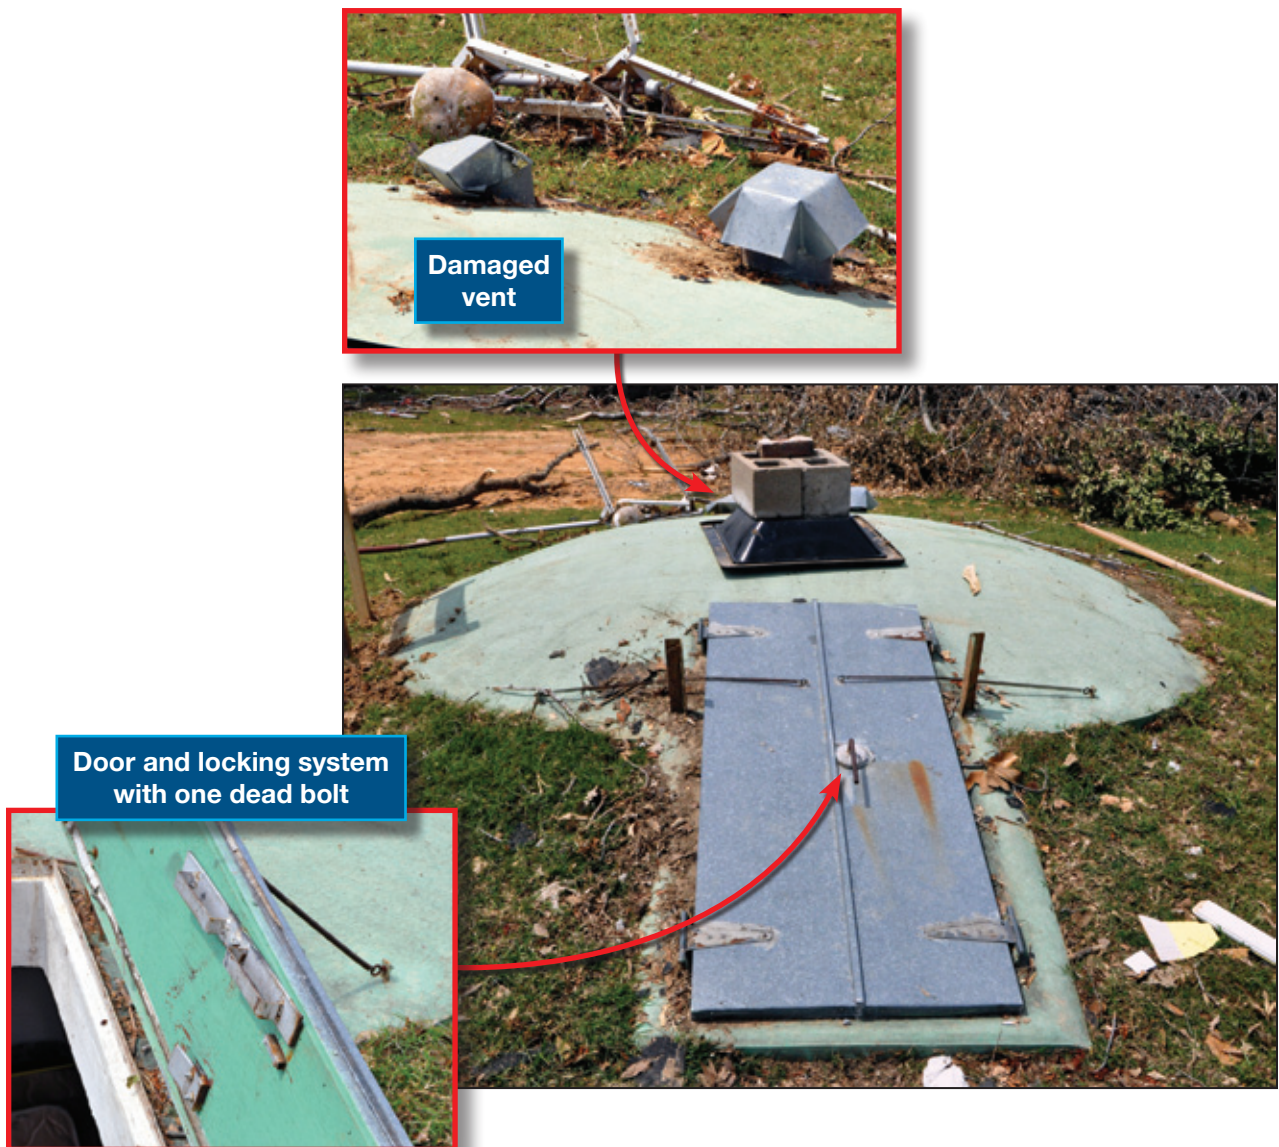
Figure 9-23: Below-ground, hardened structure with poor door and locking system (inset on lower left) and damaged vent (upper inset) (Smithville, MS)
