## Mitigation Assessment Team Report

# Spring 2011 Tornadoes: April 25-28 and May 22

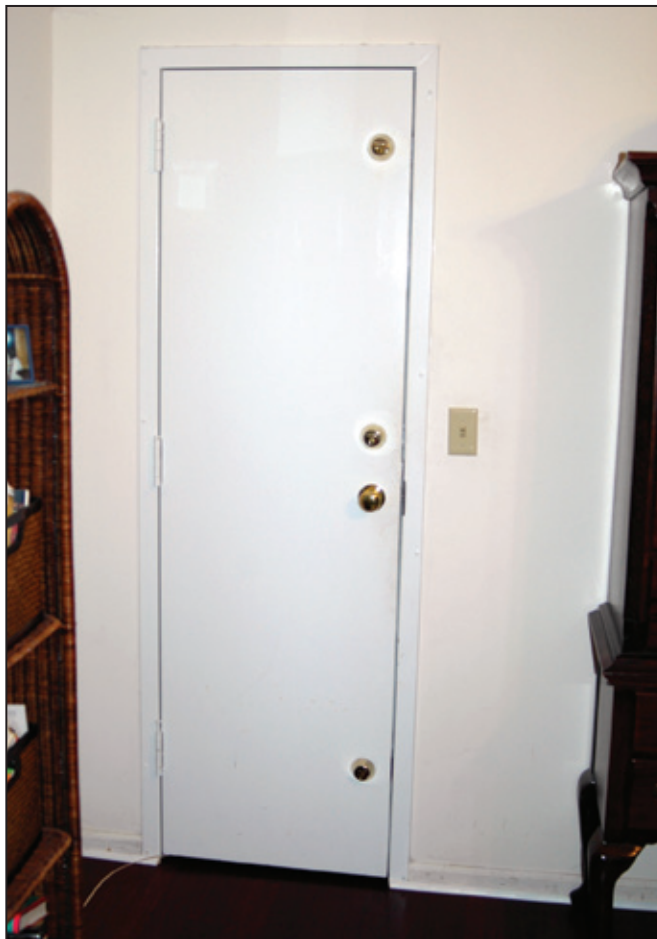
### 9.4.3 Residential Safe Rooms and Storm Shelters

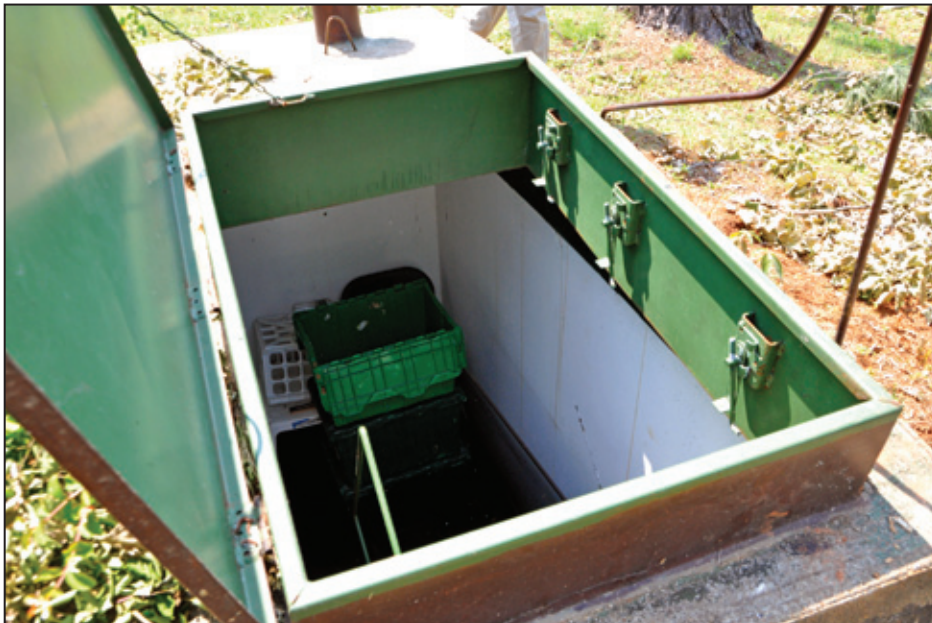
Figure 9-28:  
Below-ground FEMA-  
funded residential safe room  
(Tuscaloosa, AL)

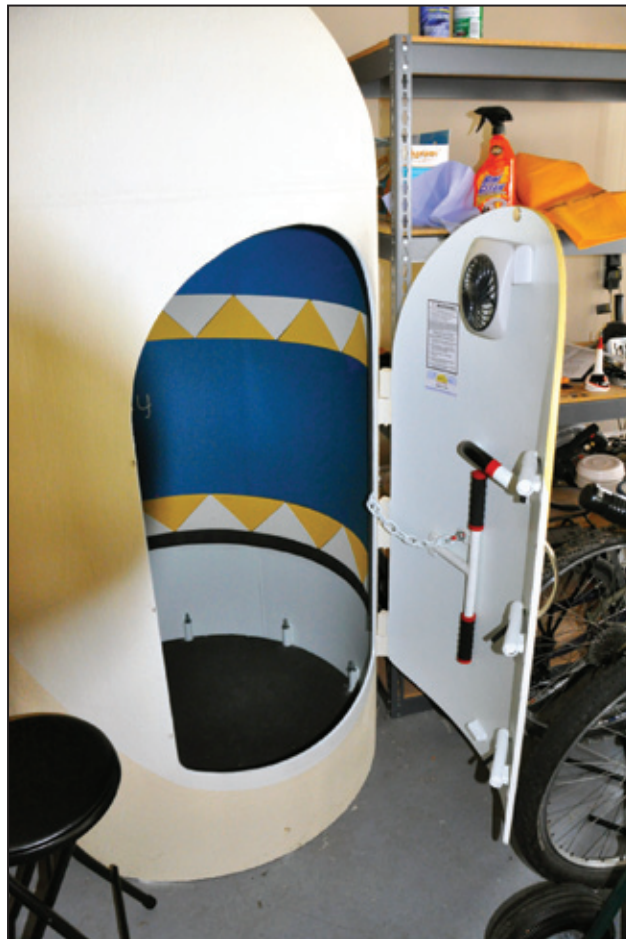
Figure 9-31:  
ICC 500-compliant storm  
shelter (Huntsville, AL)

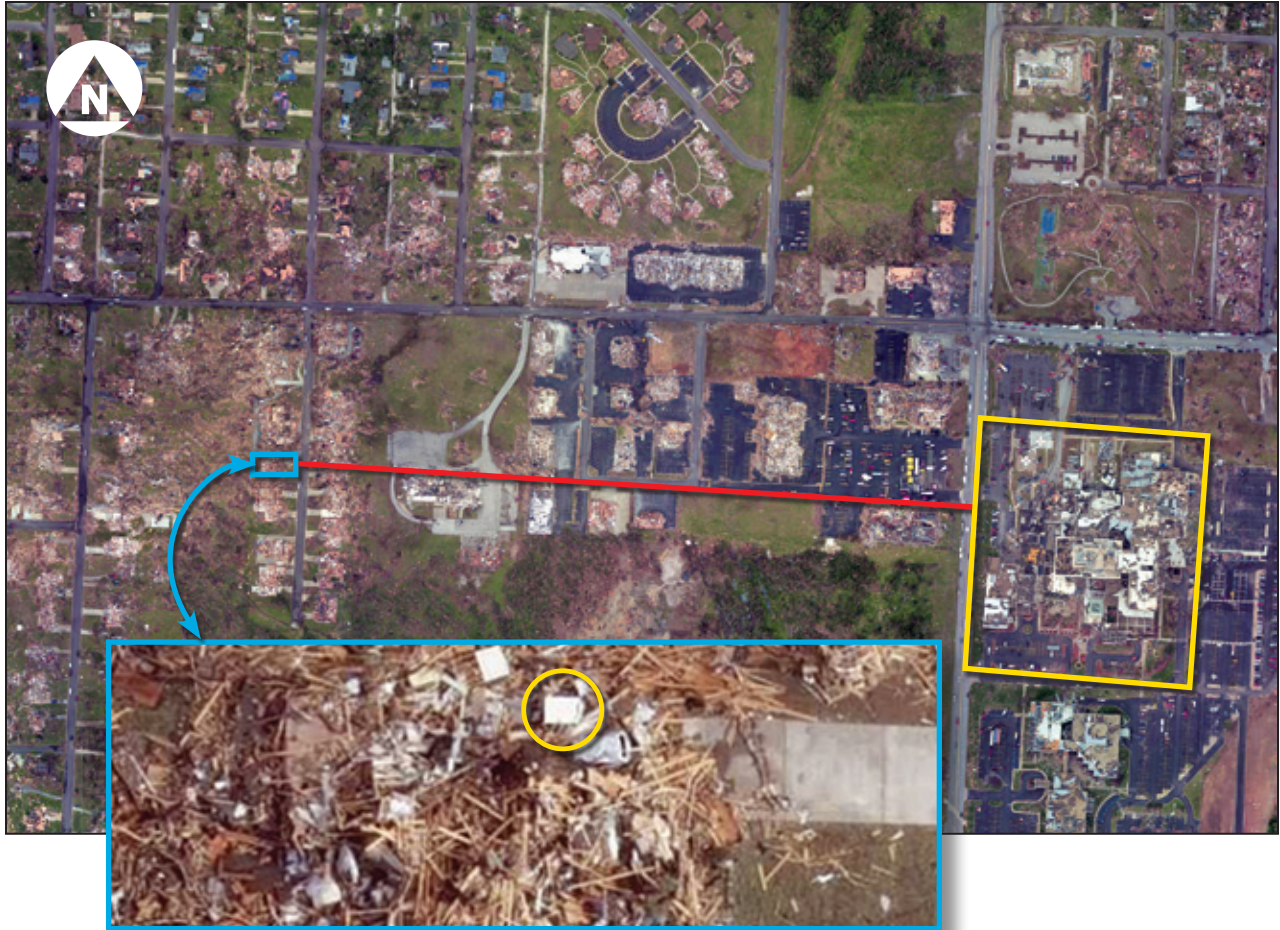
Figure 9-33: Proximity of the residential safe room shown in Figure 9-32 (circled in yellow in the inset) to the approximate centerline of the Joplin, MO, tornado damage swath (red line). The safe room was located 0.5 mile west of the heavily damaged St. John's Medical Center (shown by yellow box and described in Section 7.1.4.)

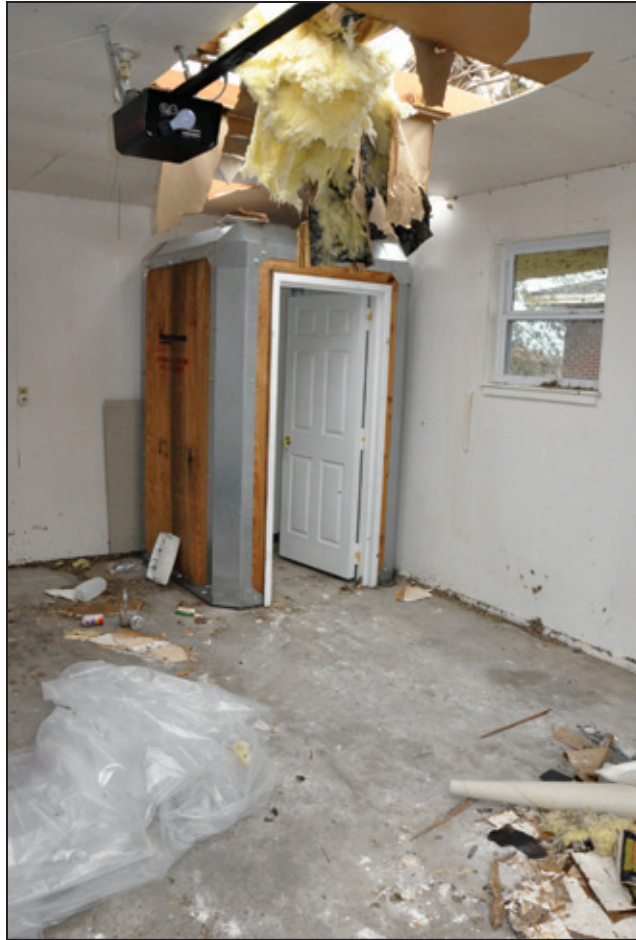
#### 9.4.4.1 Brookwood and Phil Campbell Community Safe Rooms (AL)

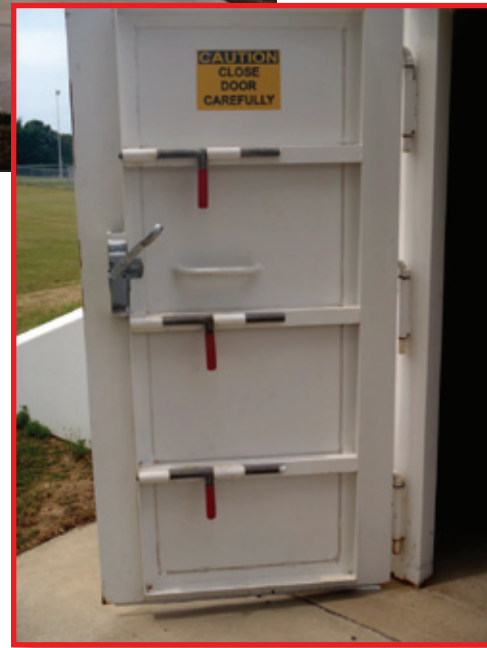
### Phil Campbell, AL

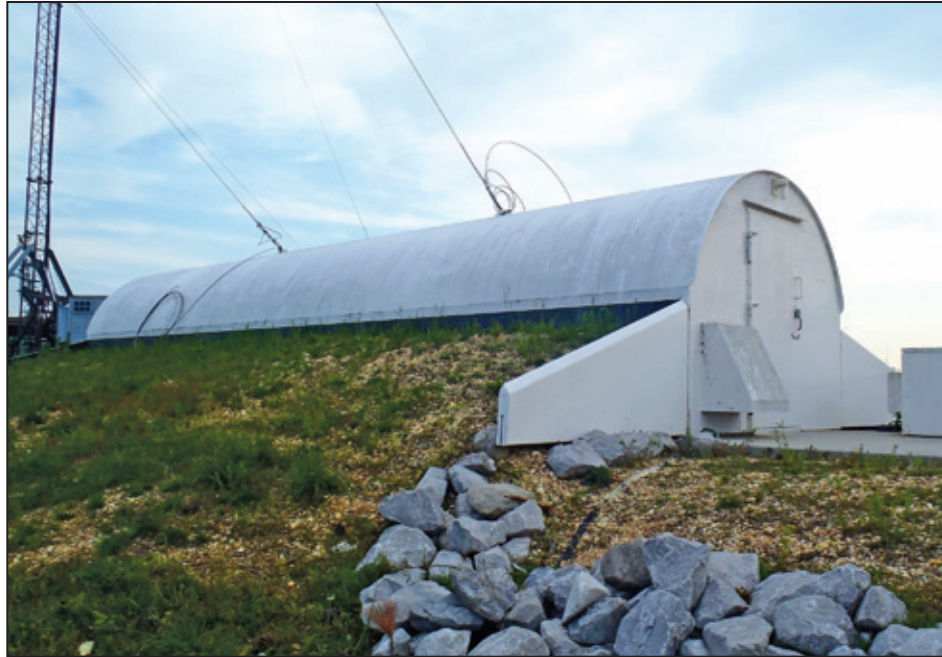
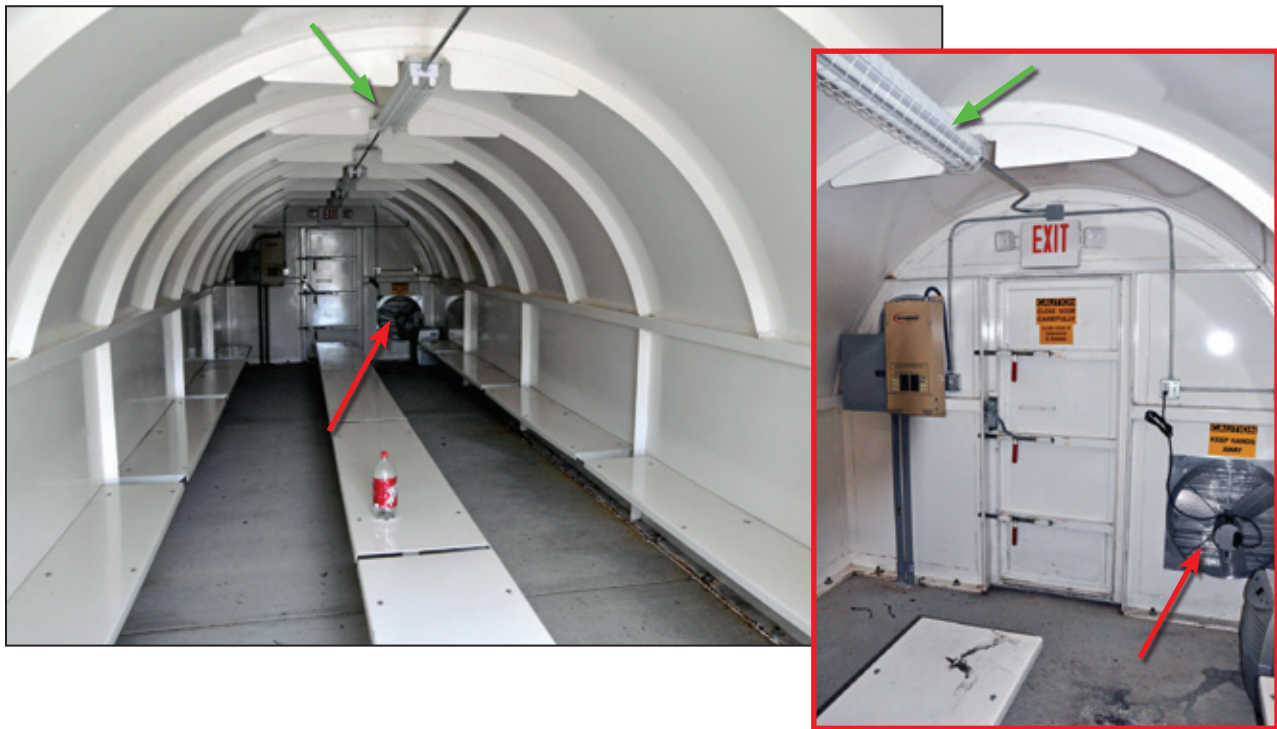
Figure 9-37: Interior of the community safe room shown in Figure 9-36 featuring seating, emergency lighting (green arrows), and ventilation (red arrows); inset is a close-up of the entrance door (Phil Campbell, AL)

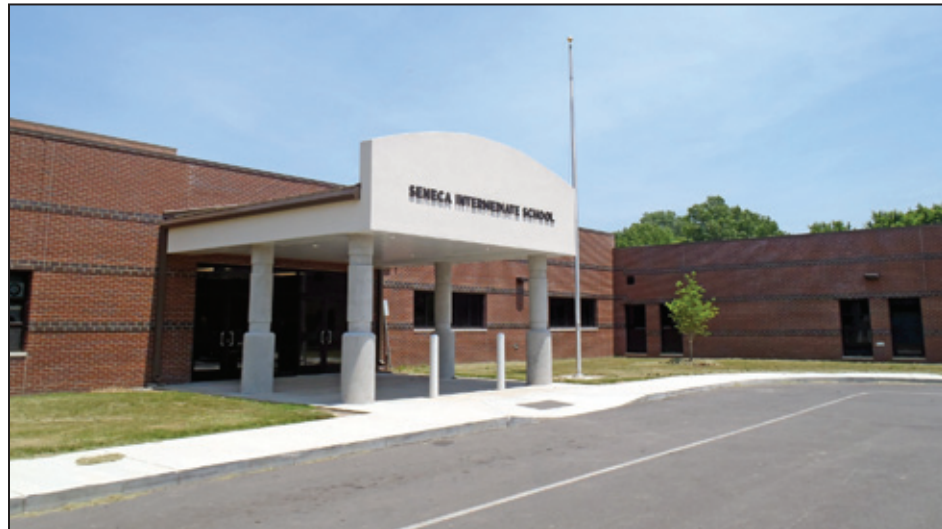
Though the community of Seneca, MO, was not hit by a tornado on May 22, 2011 the MAT inspected this new community safe room as a case study of good community safe room construction:

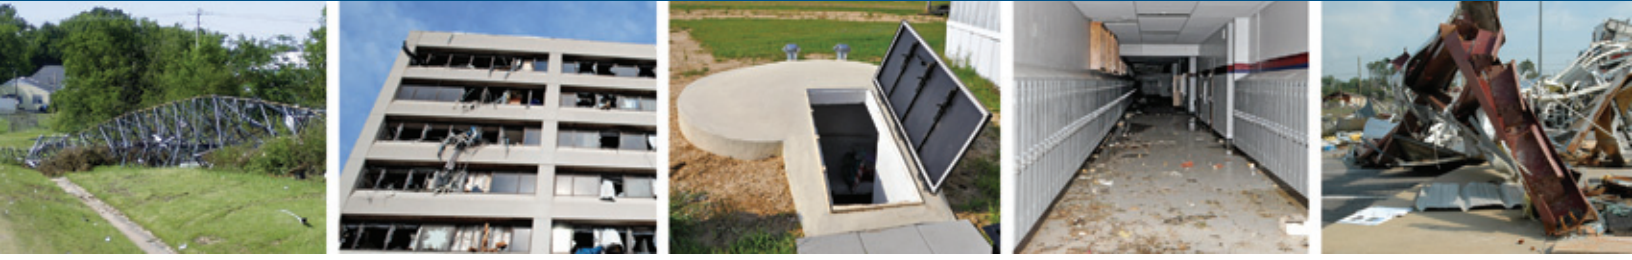
# TORNADO OUTBREAK *of* **2011**

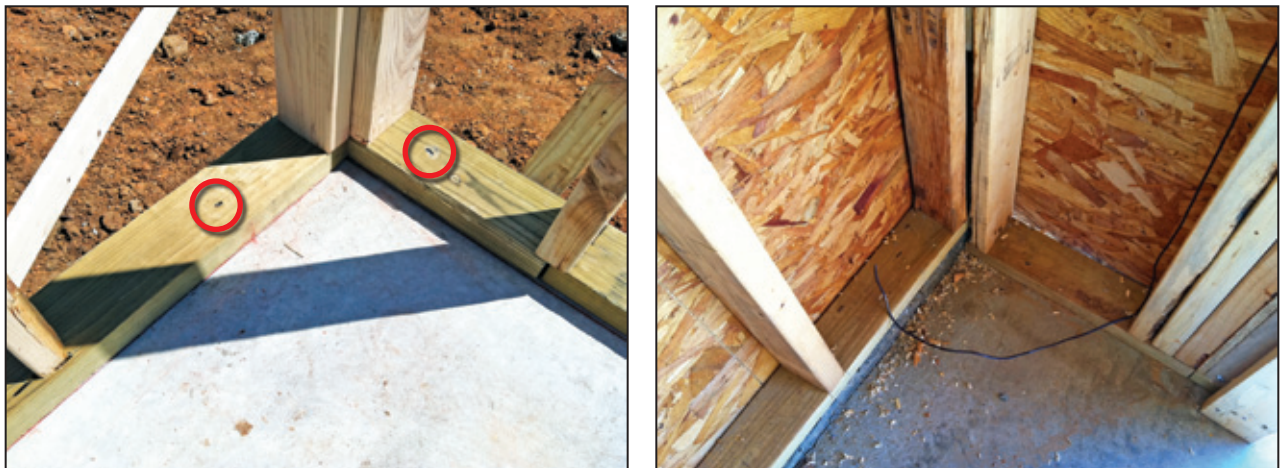
Figure 10-1: Concrete nails (red circles in left photograph) used in lieu of anchor bolts (absent in both photographs) on residential buildings under construction in the City of Tuscaloosa, AL, after the 2011 tornadoes

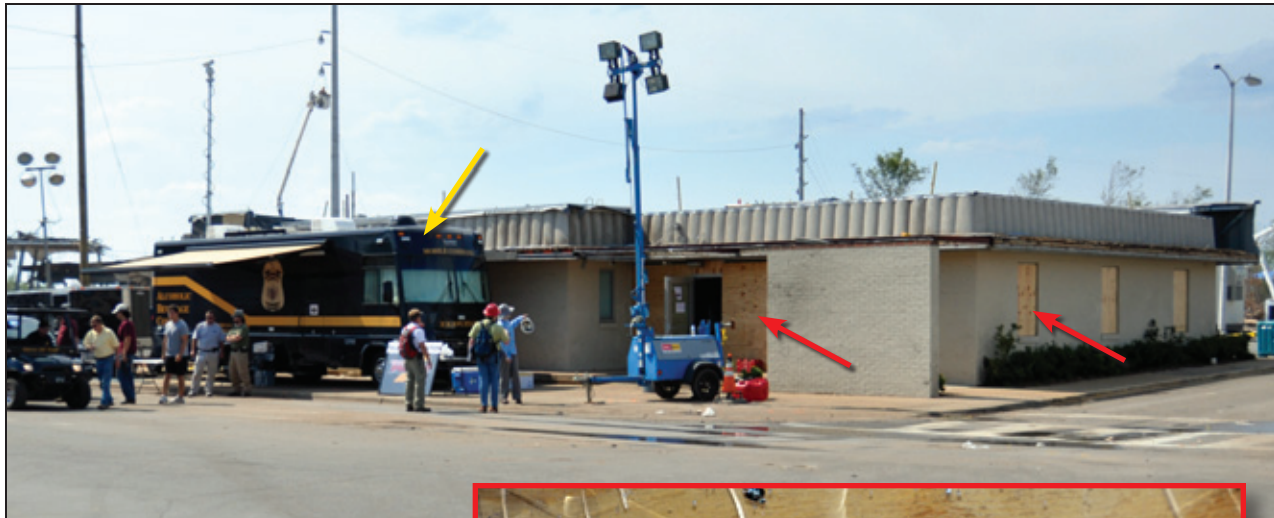
**MAT EF Rating:** Using DI 9 (Small Professional Building), the MAT selected DOD 3 (“broken windows, including clear story windows or skylights”) for the Tuscaloosa, AL, police station.<sup>1</sup> Using the expected wind speed for DOD 3, the MAT derived the tornado rating as EF1 (86–110 mph) based on the damage to this building. Hence, the estimated wind speed experienced by the building was not substantially above the current basic wind speed of 90 mph.

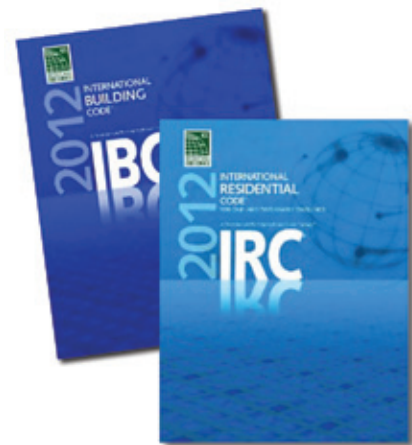
Figure 11-1: IBC/IRC

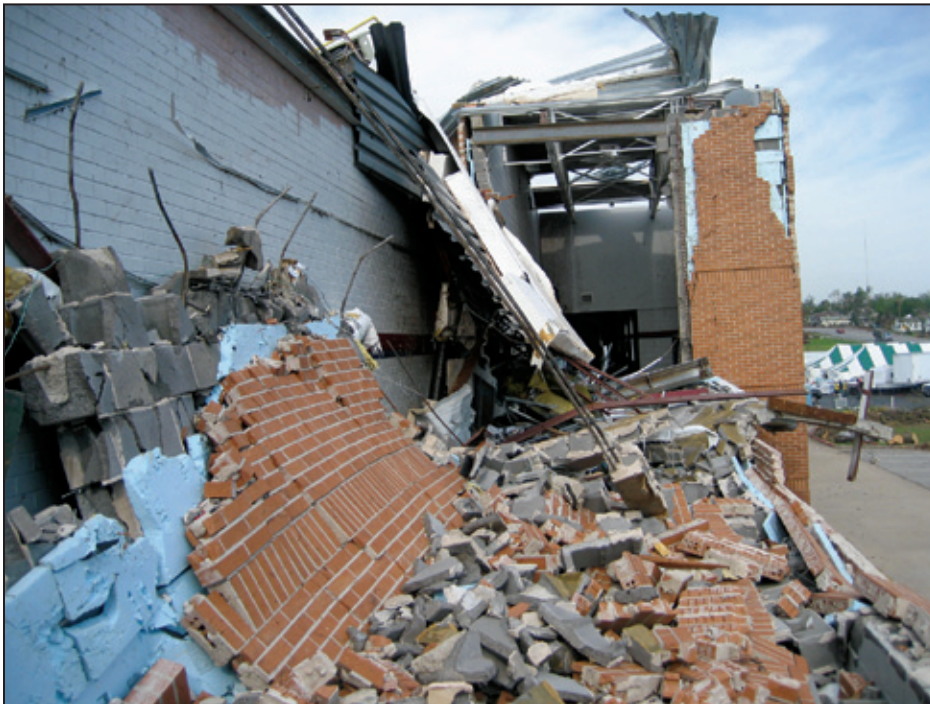
Figure 11-2:  
Collapse of exterior CMU/  
brick veneer wall and roof  
collapse at the Joplin High  
School (Joplin, MO). The wall  
debris fell into the corridor.

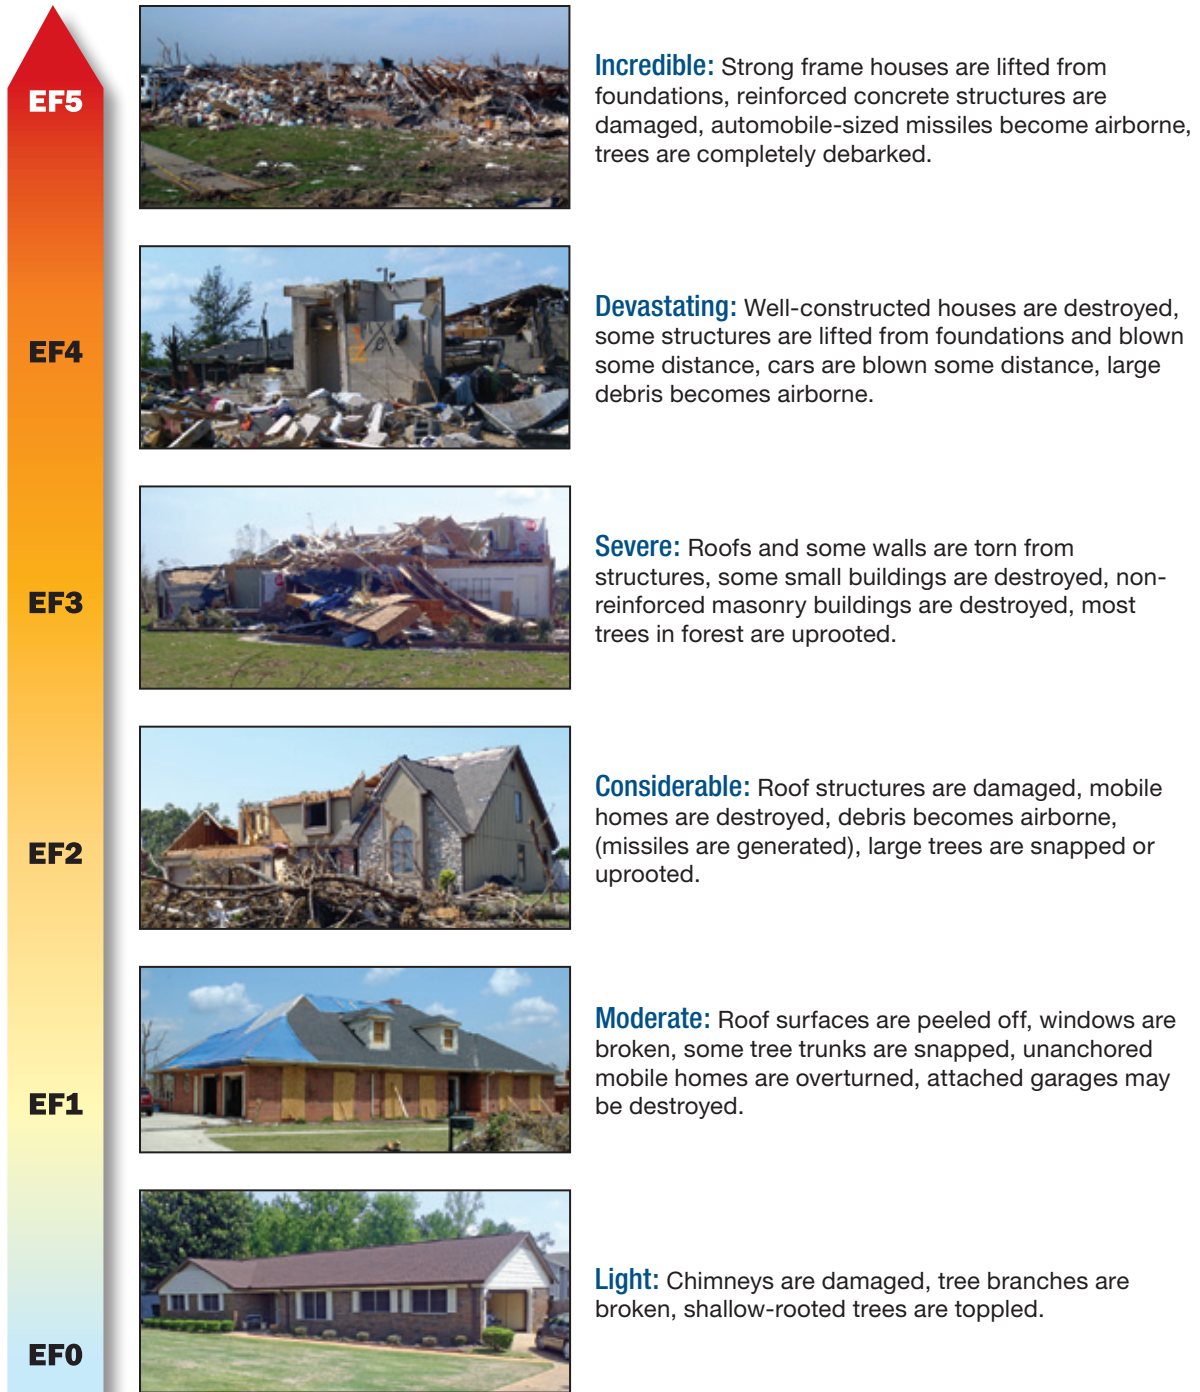
Figure E-1: The EF scale is based on level of typical observed damage

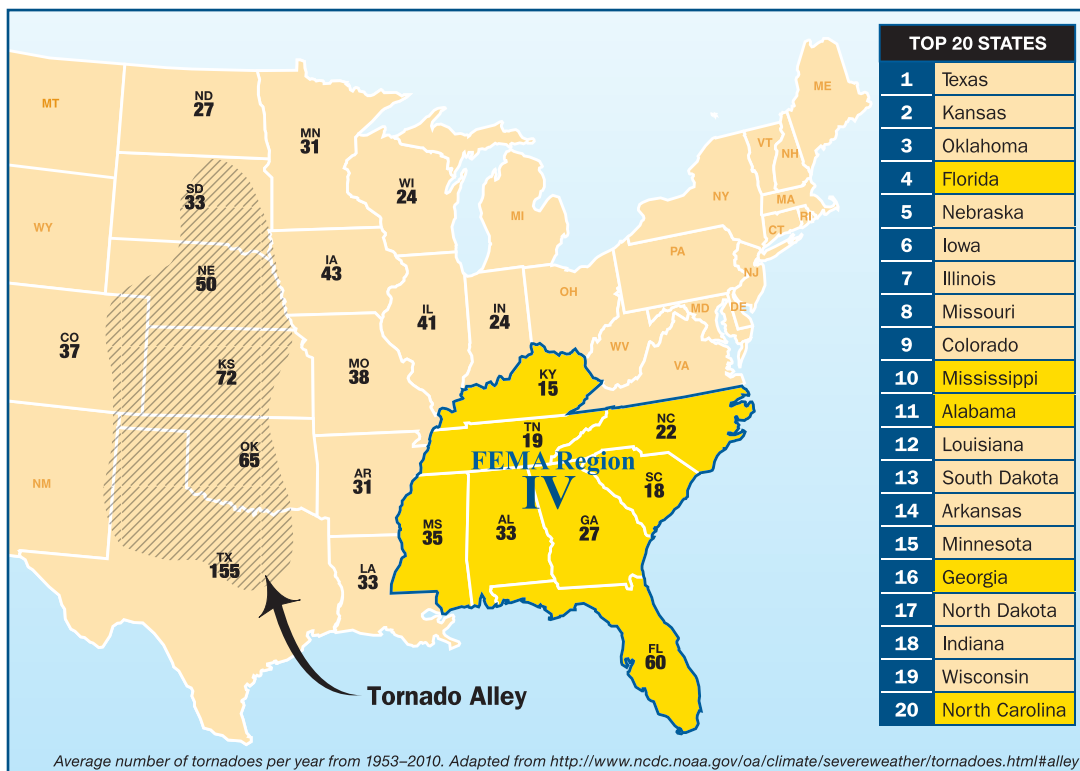
Figure 1: Average number of tornadoes per year in FEMA Region IV and Tornado Alley

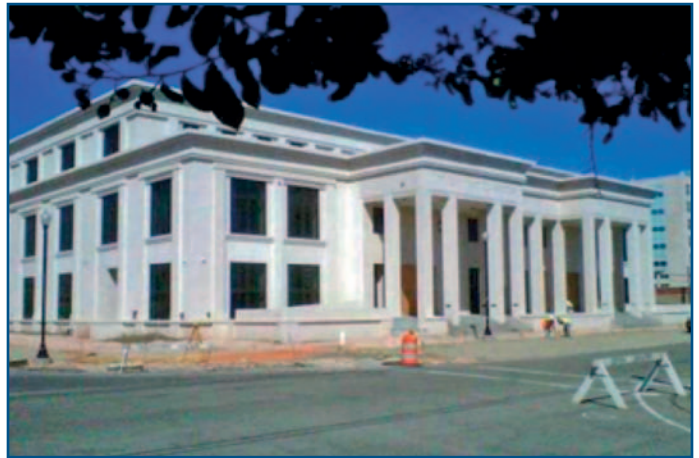
**HMGP funds were used for this Public Safety Complex constructed so that the entire facility is compliant with FEMA 361 criteria. Robert J. Curry Public Safety Complex, Gulfport, MS.**

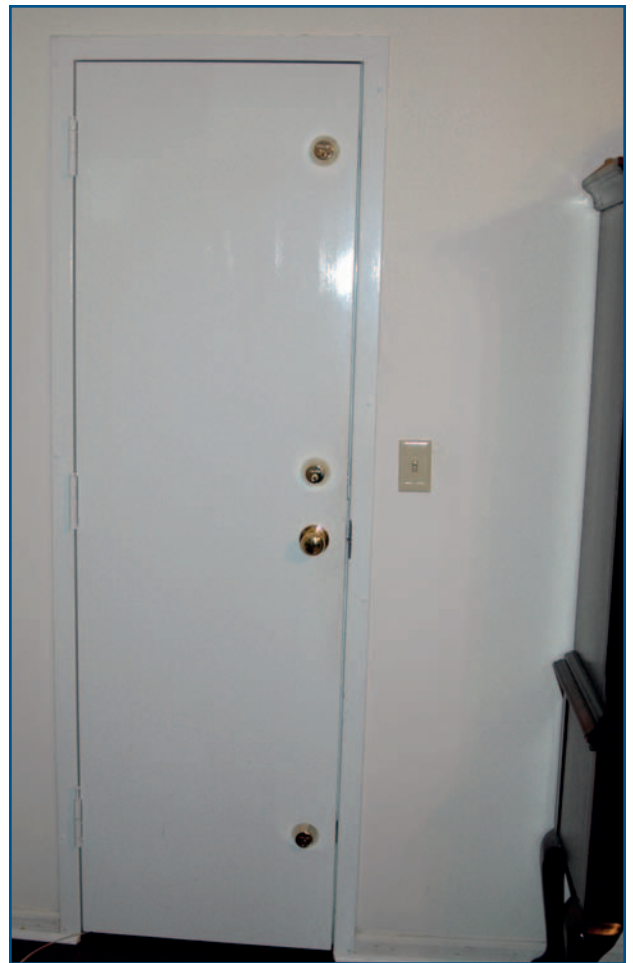
**Photograph of safe room door with three deadbolts and three hinges.**

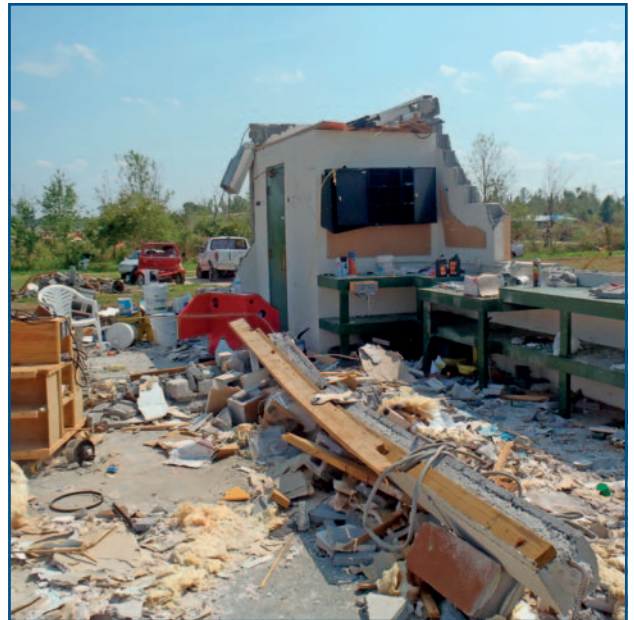
**A small area located inside a detached garage used as a refuge area during a tornado (Athens, AL).**

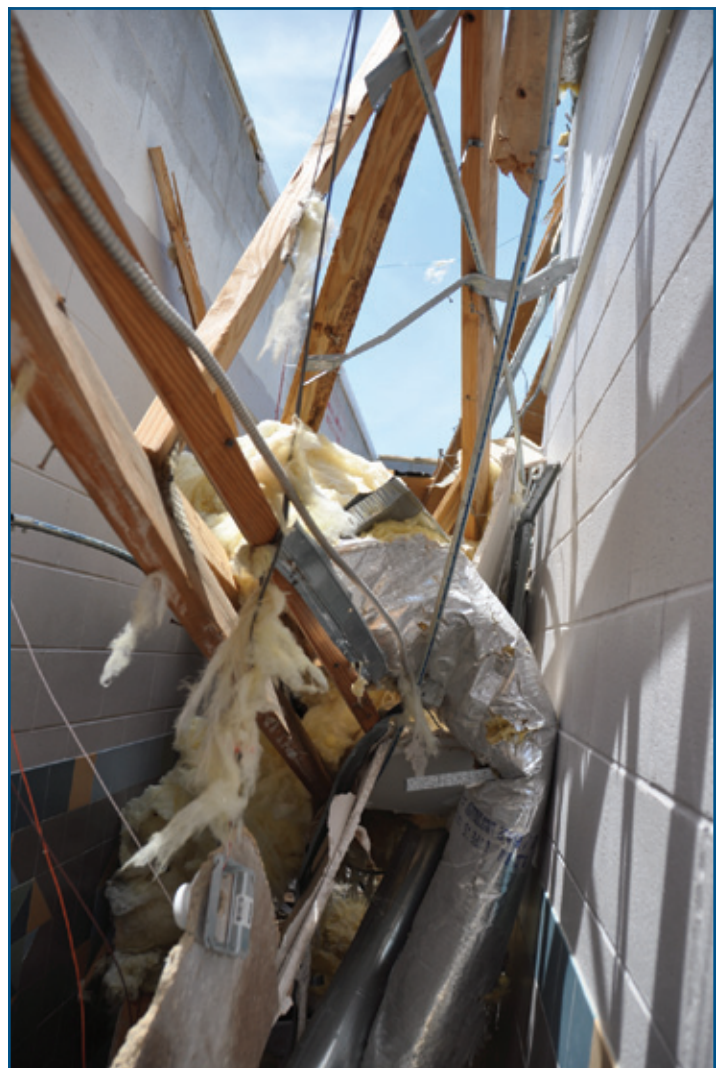
**Figure 2: Debris in an elementary school restroom in Tuscaloosa, AL (Tornado 2011)**

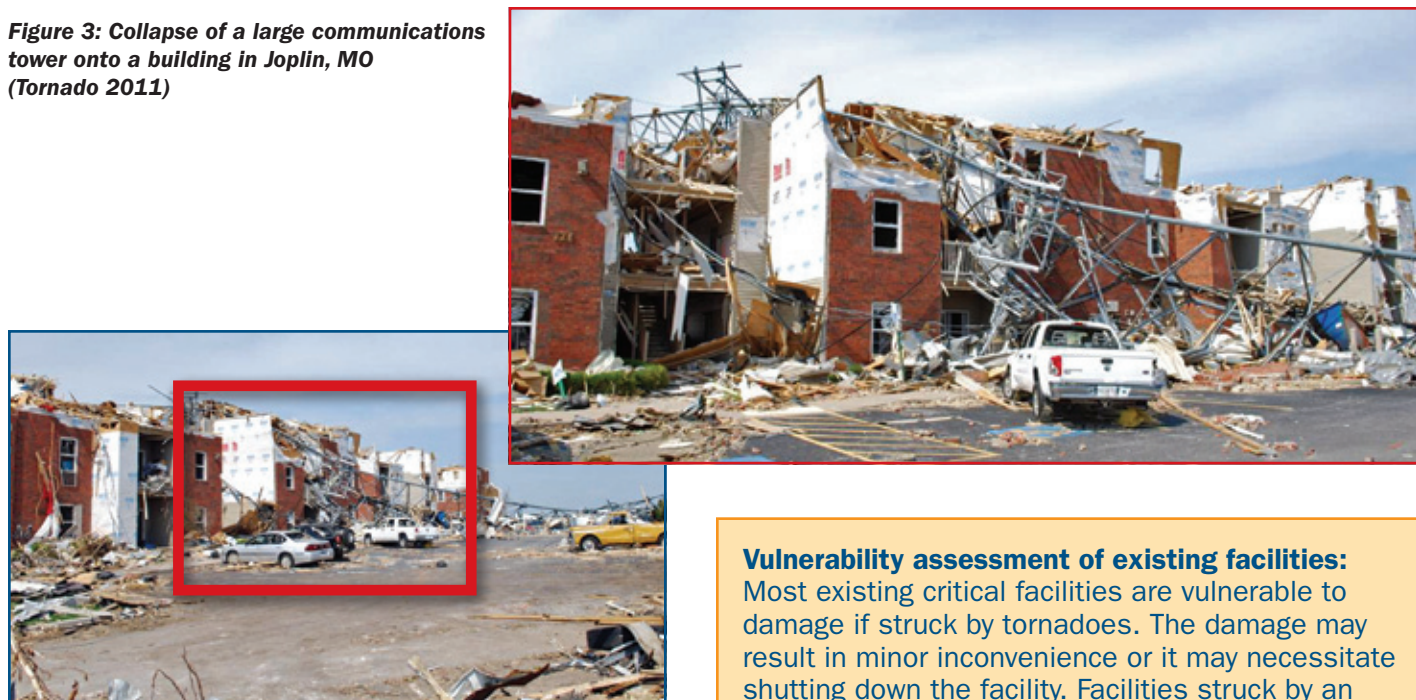
Proper maintenance and placement of trees will minimize damage to critical facilities and surrounding buildings. Trees should be placed such that the distance between the critical facility and the tree is greater than the height the tree will reach when it is fully grown. Trees with wounds, decay, structural defects, known internal trunk voids, severed roots, and soil compaction are prime targets for storm damage. These defects are often a result of damage from a lawnmower or weed trimmer and can be avoided with proper, careful lawn maintenance.

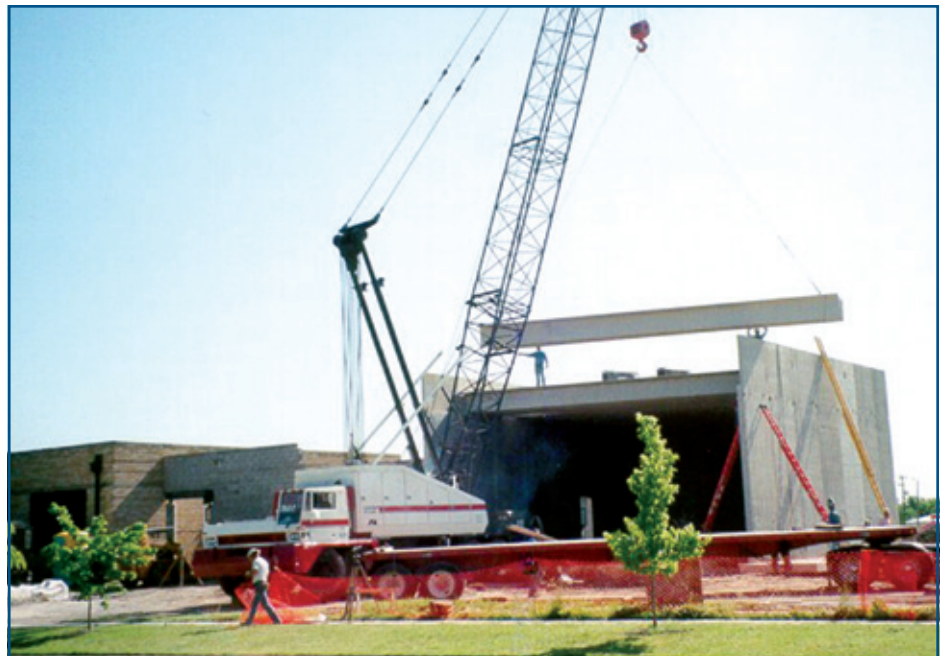
**Figure 4: The addition to this school was designed to serve as a safe room (Wichita, KS)**

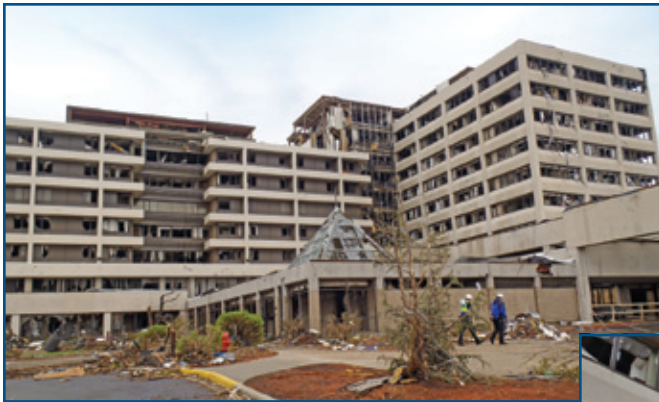
Specific design recommendations for minimizing building damage are provided in FEMA Recovery Advisory No. 6, *Critical Facilities in Tornado-Prone Regions: Recommendations for Architects and Engineers*.

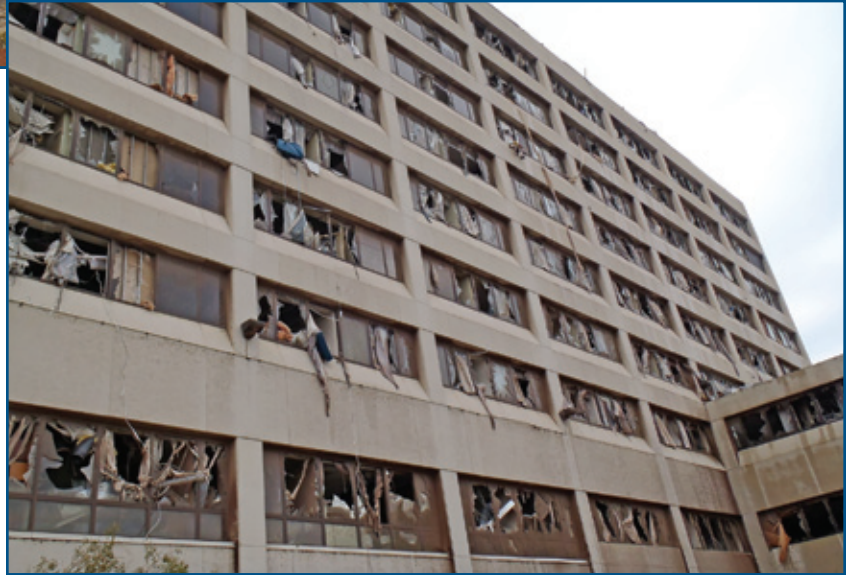
## Useful Links and Resources

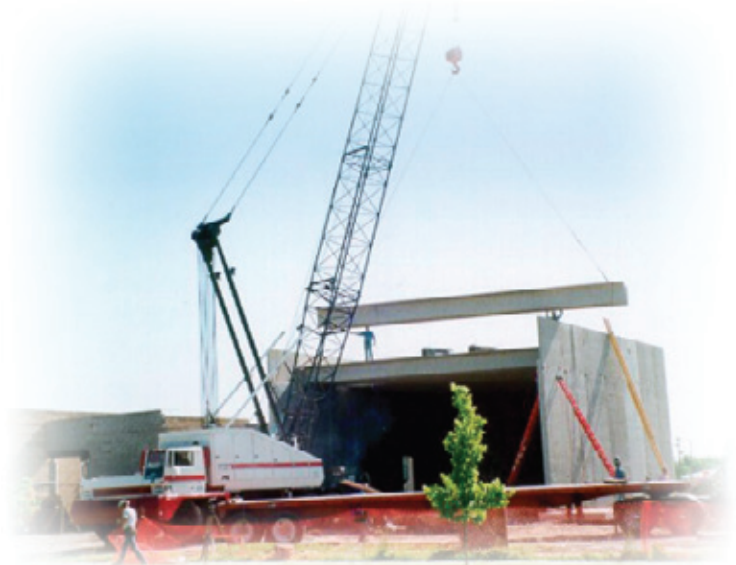
### Standard of Care

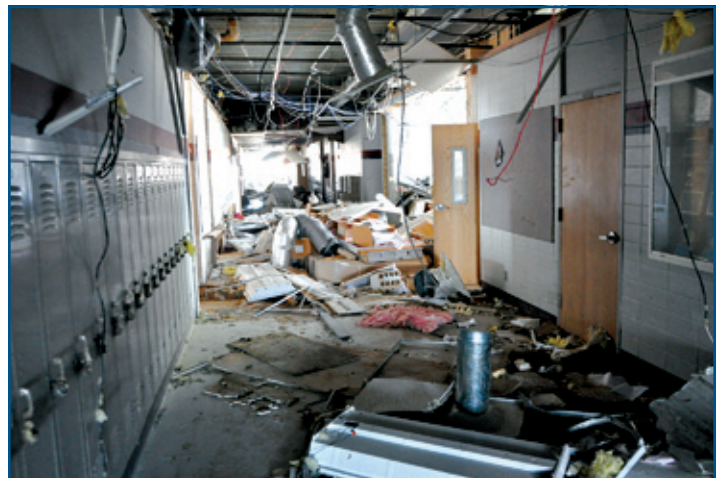
Figure 1: Debris in a school corridor in Joplin, MO (2011 Tornado)

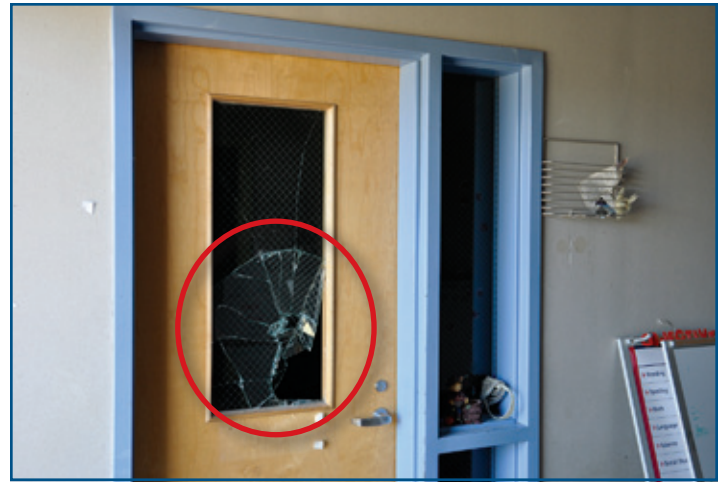
**Figure 3: Broken vision panel at an elementary school corridor in Tuscaloosa, AL (2011 Tornado)**

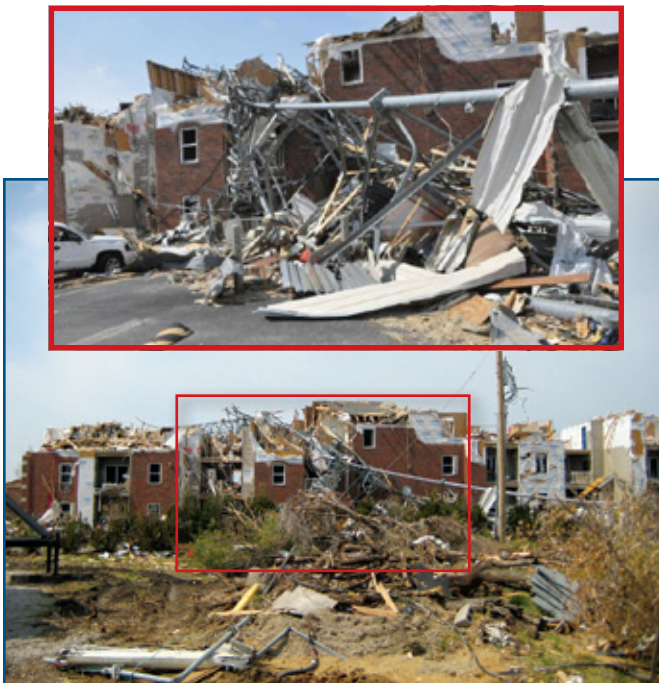
**Figure 4: Collapse of a large communications tower onto a building in Joplin, MO (2011 Tornado)**

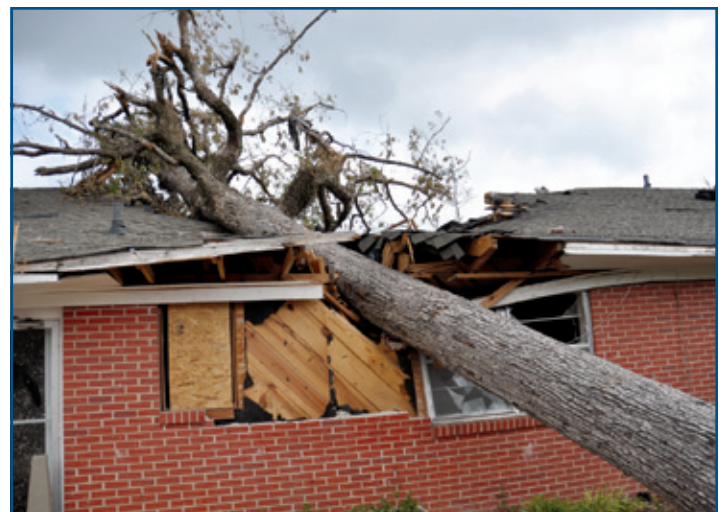
**Figure 5: Tree-fall damage at a critical facility in Tuscaloosa, AL (2011 Tornado)**

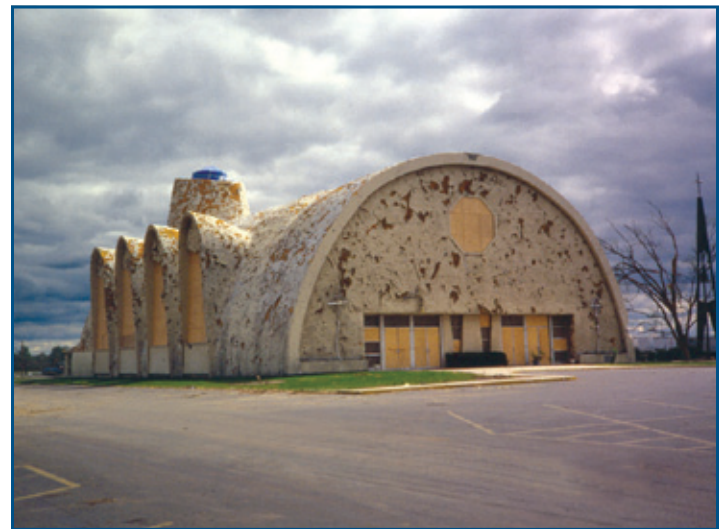
**Figure 6: Although struck by a strong tornado, the SPF roof system of this Plainfield, IL, building did not blow off (1990 Tornado)**

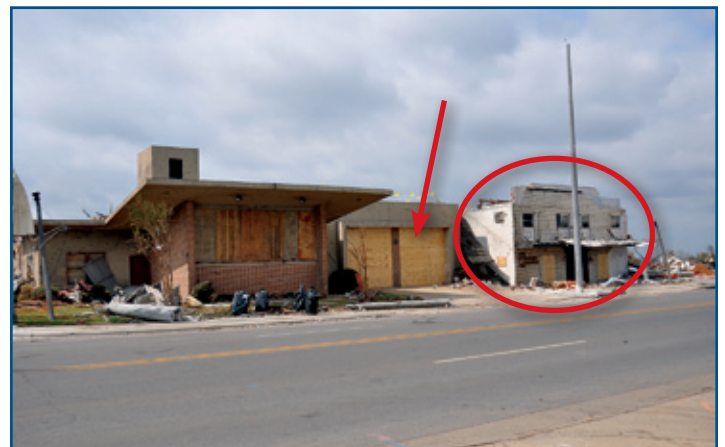
**Figure 7: Fire station with a cast-in-place concrete roof deck in Tuscaloosa, AL. The apparatus bay doors (red arrow) collapsed and the adjacent building (red circle) was damaged (2011 Tornado).**

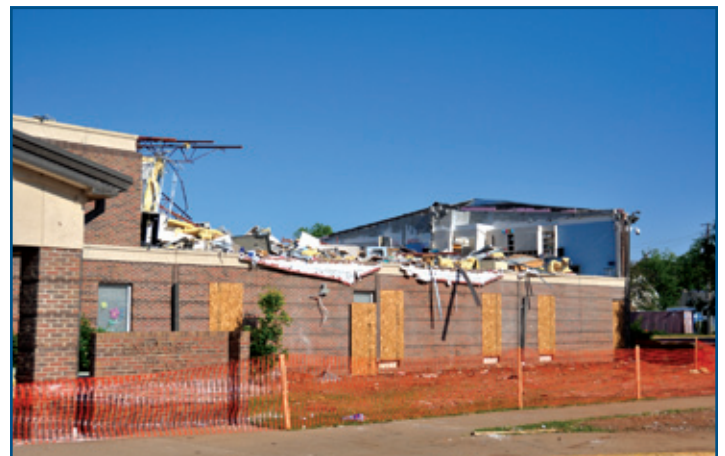
**Figure 8: Collapse of the second-floor roof structure, interior walls, and exterior walls of a school in Tuscaloosa, AL (2011 Tornado)**

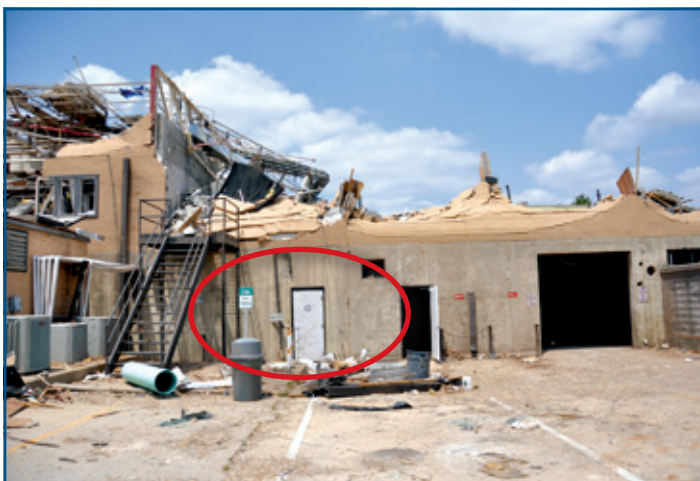
**Figure 9: An EOC in Tuscaloosa, AL, that remained intact even though the story above it collapsed (Tornado 2011)**

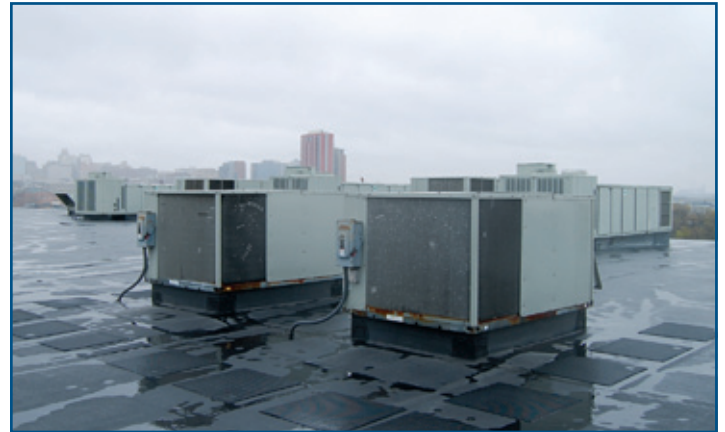
Figure 10: ACC units vulnerable to wind and wind-borne debris

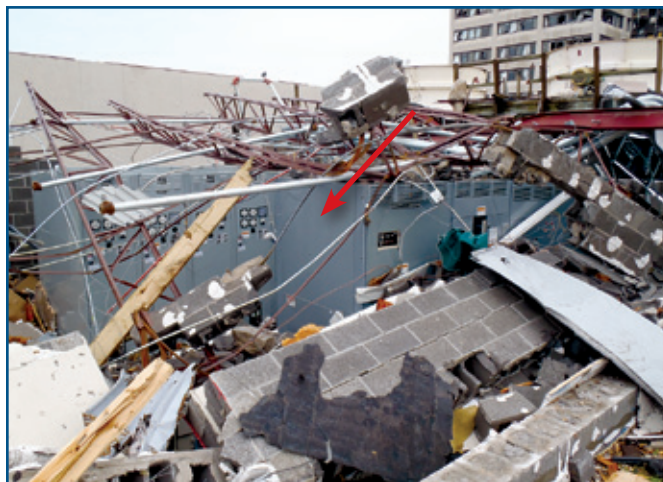
**Figure 12:** This Joplin, MO, building housing the switchgear (red arrow) and emergency generator (Figure 13) collapsed (2011 Tornado)

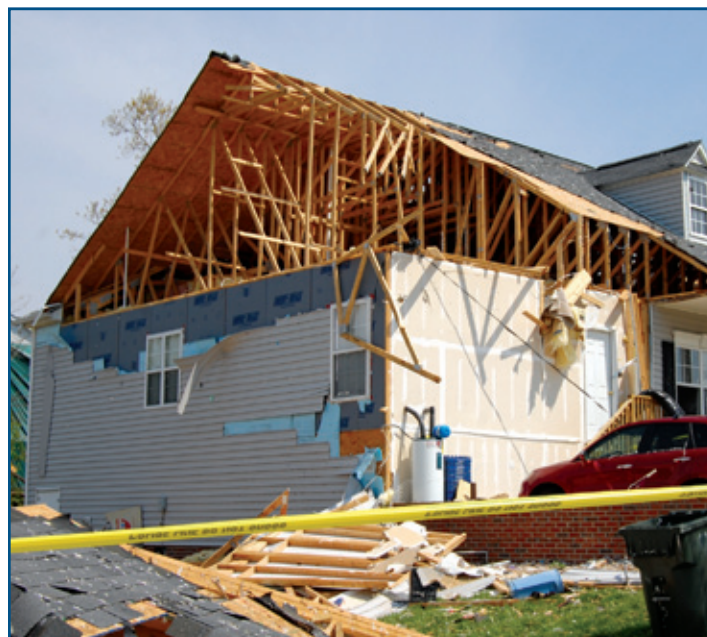
**Figure 1: A house that lost large sections of the roof and the garage due to internal pressurization.**

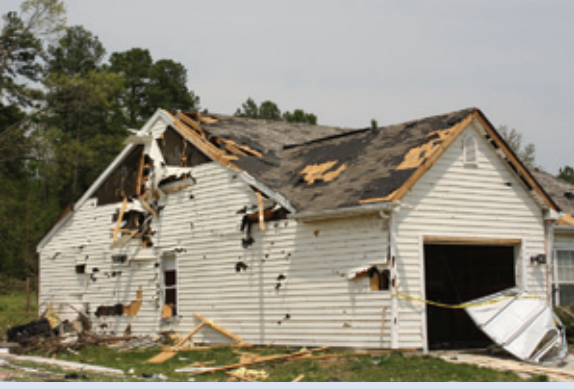
<p>Use shingles rated for 90+ mph wind and use a minimum of four nails per shingle; preferred use is six nails per shingle (Source: FEMA P-499, Fact Sheet 7.3)</p>
Windows and Doors	<p>Windows and doors can be dislodged from the walls</p>

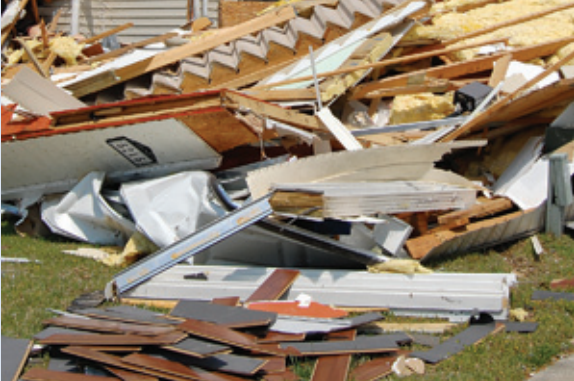
<p>Make sure windows and doors are properly shimmed and nailed into the framed opening using nails of sufficient length to tie the window and door frames into the adjacent studs (Source: FEMA P-499, Fact Sheet 6.1)</p>

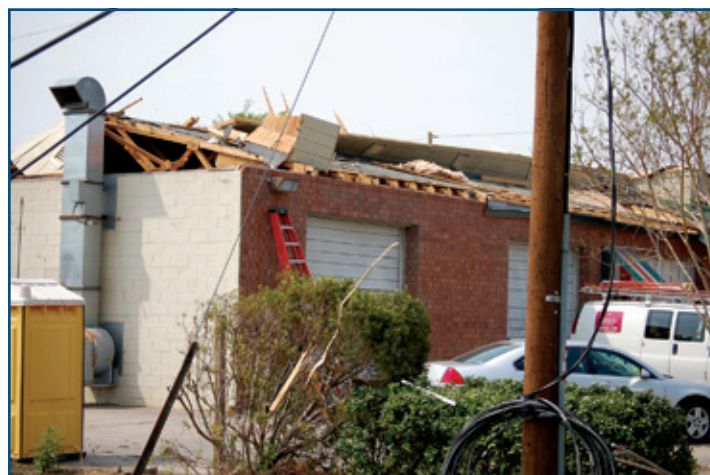
**Figure 1: A business damaged by roof damage and water intrusion from a weak tornado**

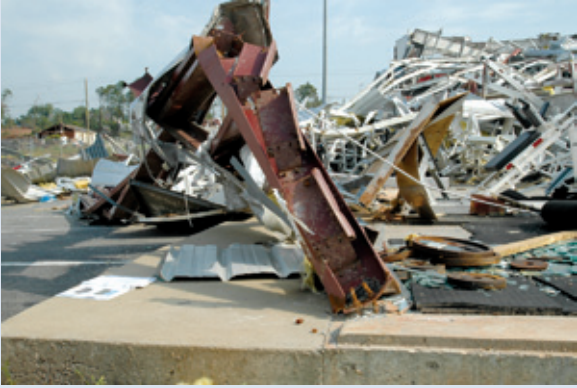
<p>Size the endwall trusses to resist wall loads and verify that anchor bolts are sized to resist lateral loading. (Source: FEMA 489)</p>
Masonry Buildings	<p>Collapse of unreinforced masonry walls.</p>

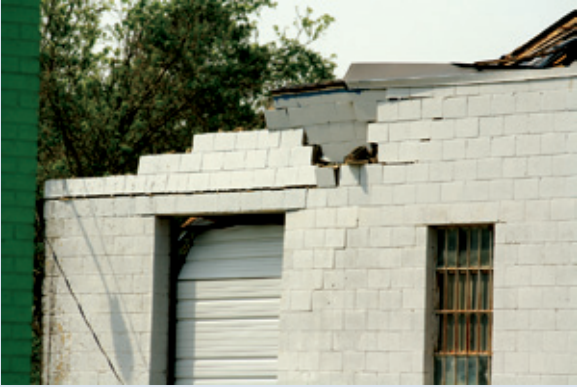
<p>Fully grout walls and increase reinforcement to resist lateral loads and uplift loads on the roof system. (Source: FEMA P-424)</p>
Roof Coverings and Roof Systems		
Ballasted Roofs	<p>Ballasted roof systems can become wind-borne debris and damage surrounding objects.</p>

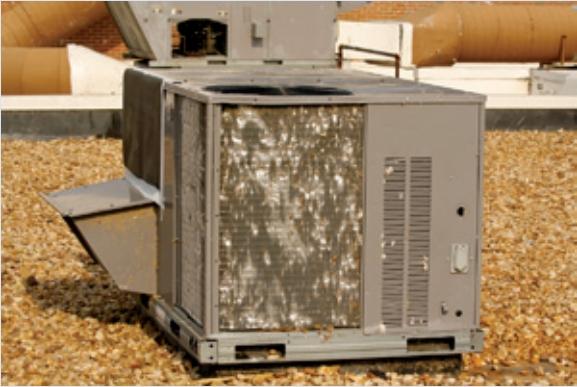
<p>Select an alternative ballasting system or fully adhere ballast to the roof system. (Source: FEMA P-424)</p>

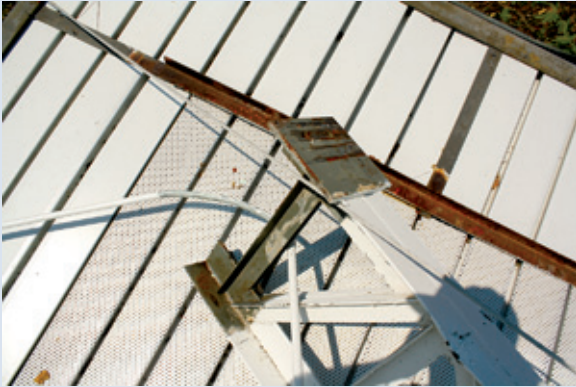
<p>Improve connection of roof trusses to prevent failure from uplift loads. Verify that the load path is continued through the wall system into the foundation. (Source: FEMA P-424)</p>
<p>Double Tee Connections</p>	<p>Double tees shift due to uplift loads and failures at angle iron welds or insufficient anchor bolts, allowing the double tee to slip off the corbel.</p>
