## Mitigation Assessment Team Report

# Spring 2011 Tornadoes: April 25-28 and May 22

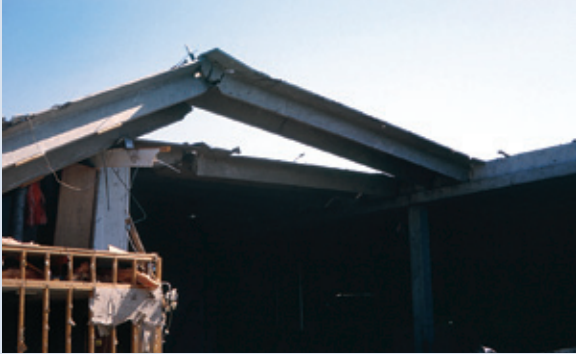
<p>Ensure that anchor bolts provide sufficient strength to prevent uplift. (Source: FEMA P-424)</p>
<p>Gable End Walls</p>	<p>Insufficient attachment of gable end walls results in building pressurization, loss of the roof system, and possibly large sections of the building.</p>

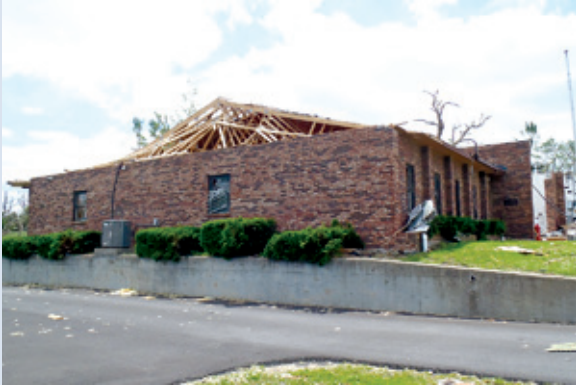
<p>Improve the gable end wall bracing details with additional connections and strengthen the load path. (Source: FEMA P-804)</p>

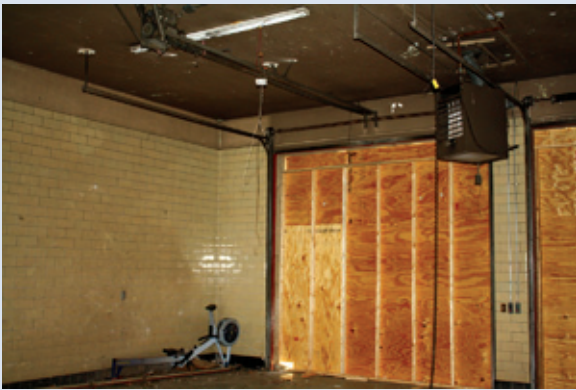
Buckling of roll-up door systems, typically due to either positive or negative pressures. Door tracks and rollers can fail in high winds.	Specify a door system for a higher wind speed than the minimum required by code. (Source: FEMA 489)

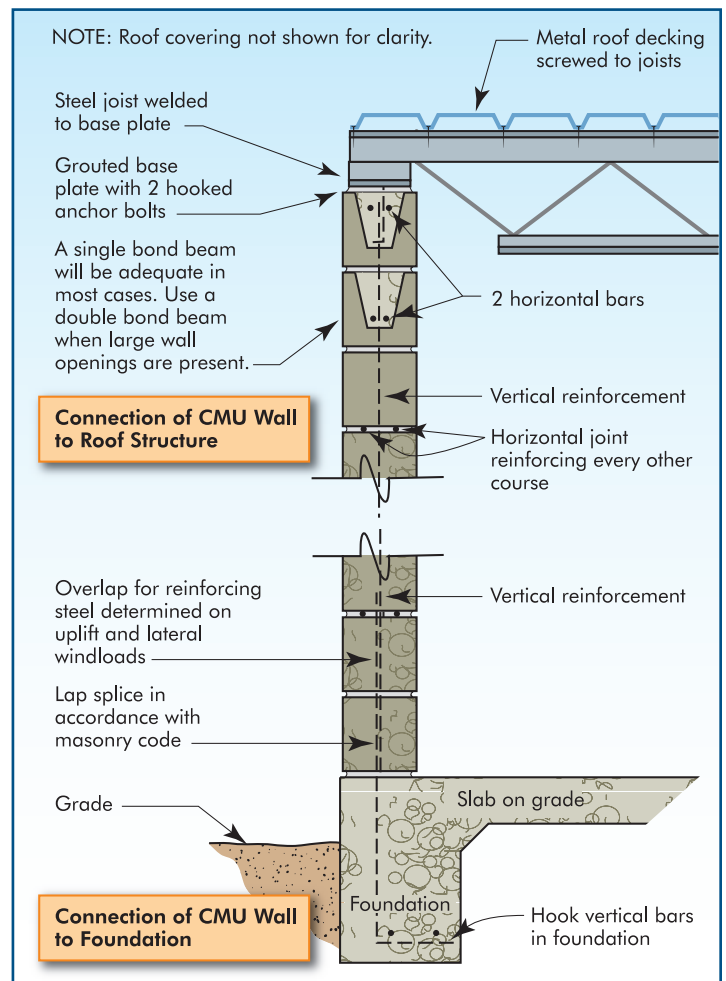
**Figure 2: Example of a masonry wall detail, incorporating many construction best practices. Source: FEMA P-424, Design Guide for Improving School Safety in Earthquakes, Floods, and High Winds (FEMA 2010)**

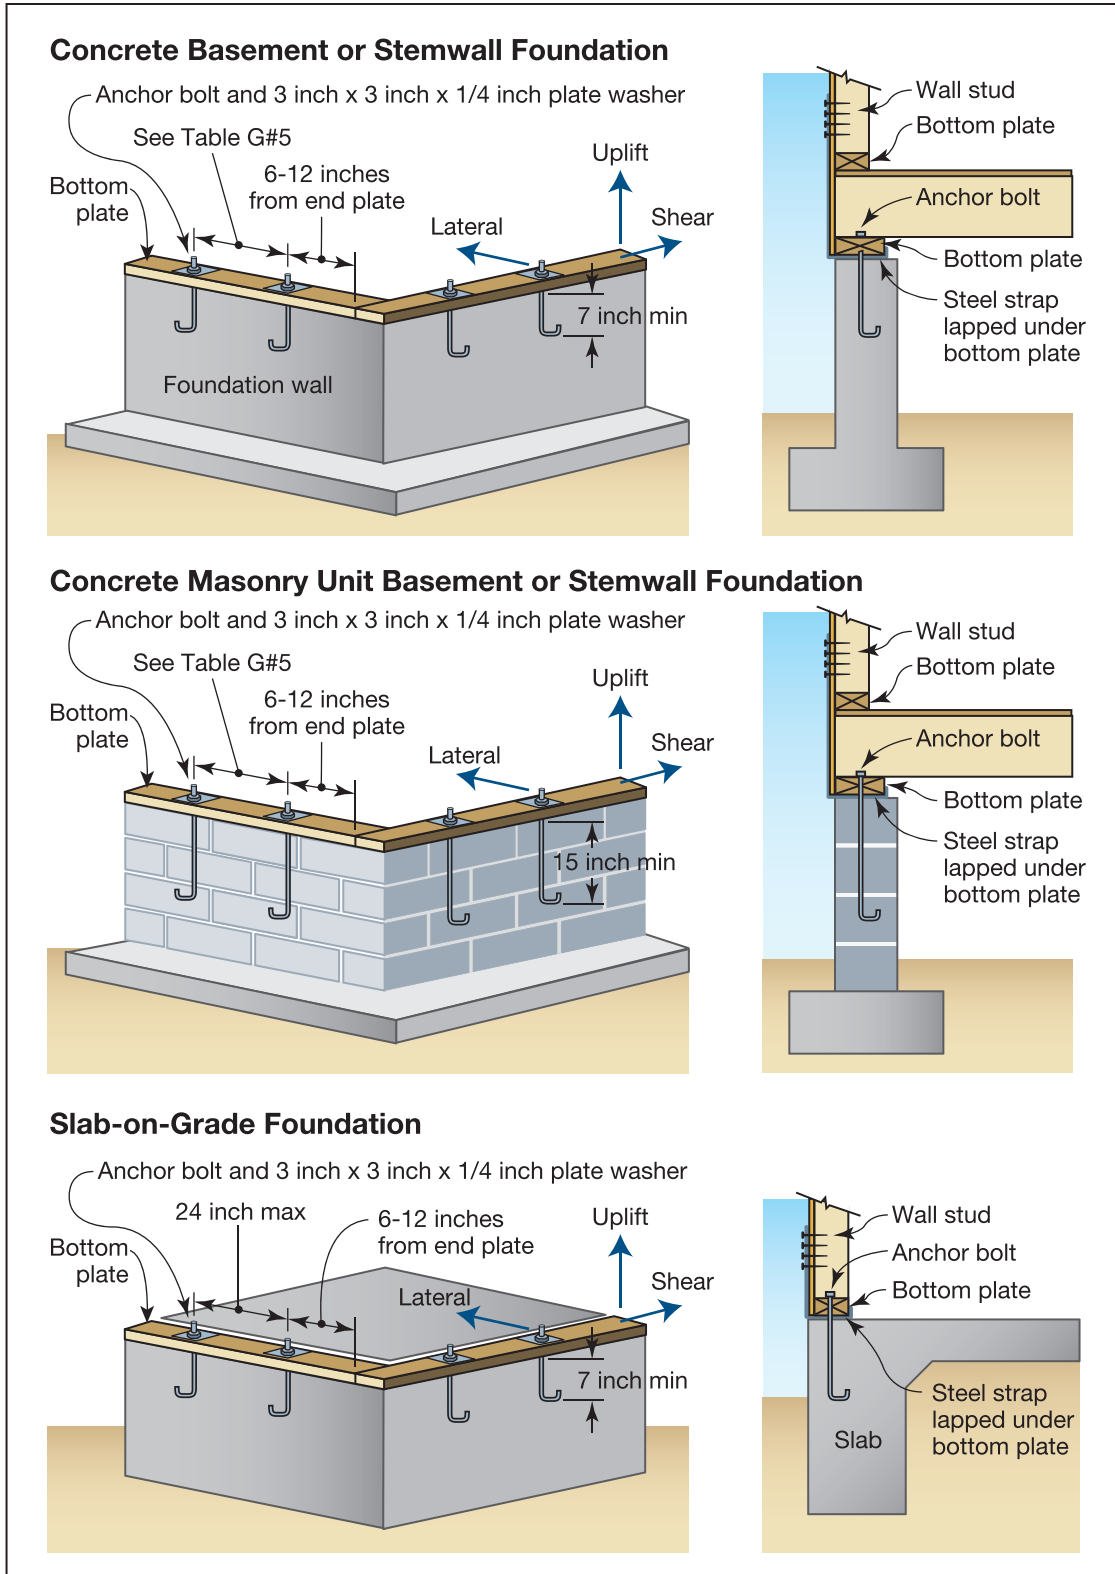
Figure G-2: Anchor bolt installation guide
