TORNADO OUTBREAK *of* **2011**

IN ALABAMA, GEORGIA, MISSISSIPPI,
TENNESSEE, AND MISSOURI

8 Observations on Infrastructure Performance

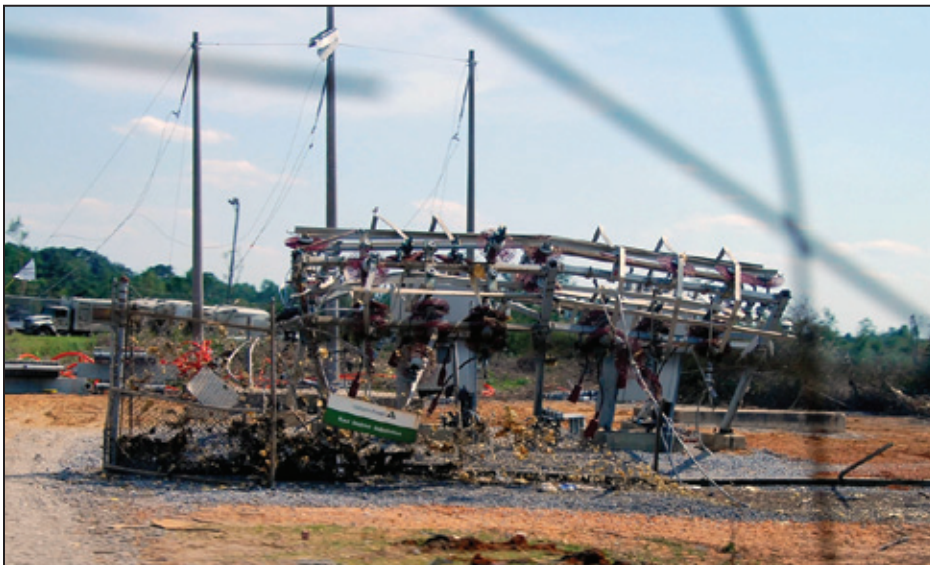
Electrical power, however, was not restored for several days, and without power to drive the lift pumps that fill tanks and booster pumps for system pressure, the storage tanks drained and system pressures dropped. Water service was affected, including water service to critical facilities. For example, approximately 7 hours after the storm, the normal 90 pounds per square inch (psi) of water pressure normally provided to DCH Regional Medical Center (location shown in Figure 8-3) dropped to 25 psi. With the reduced water pressure, toilets on upper floors would not flush and the low water-pressure levels required the hospital to shut down a boiler supplying steam to their central sterilization equipment. Without sterilization equipment, surgical procedures were curtailed.

Figure 8-4:
Representative damage to
overhead electrical lines
and substations along the
tornado path
(Tuscaloosa, AL)

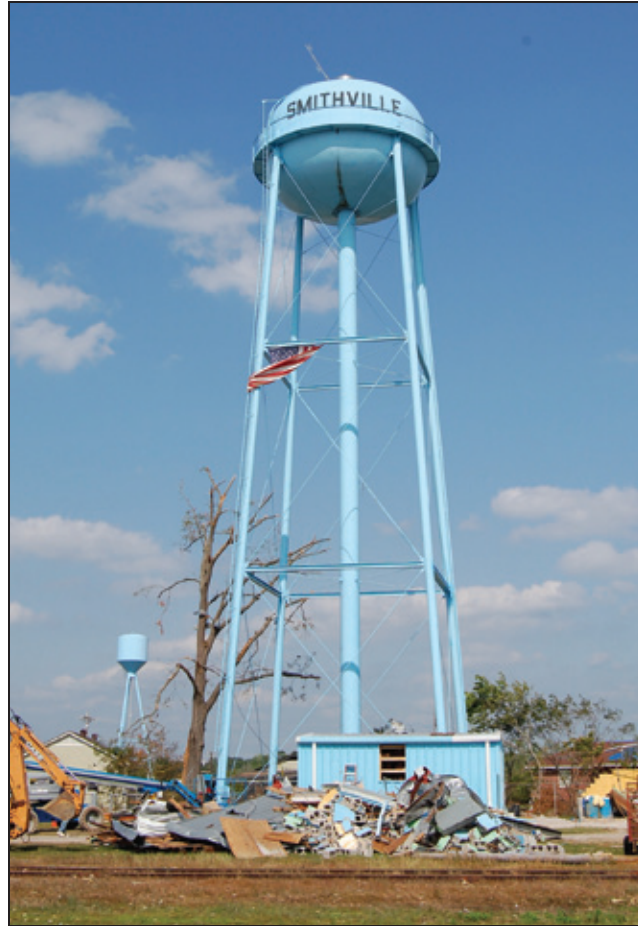
Figure 8-7:
Water tower after the
tornado (Smithville, MS)

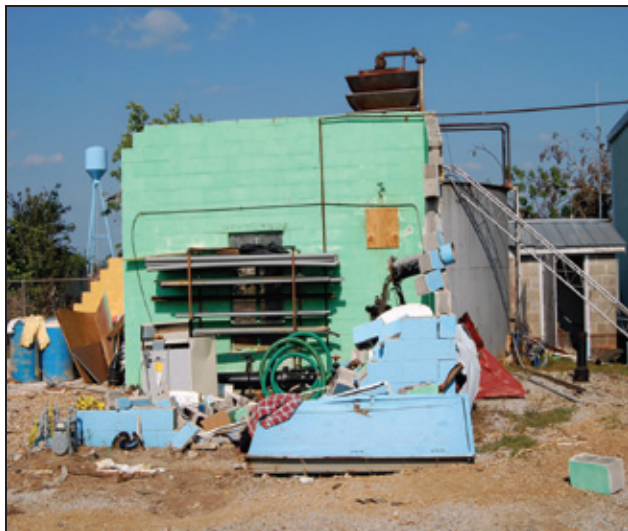
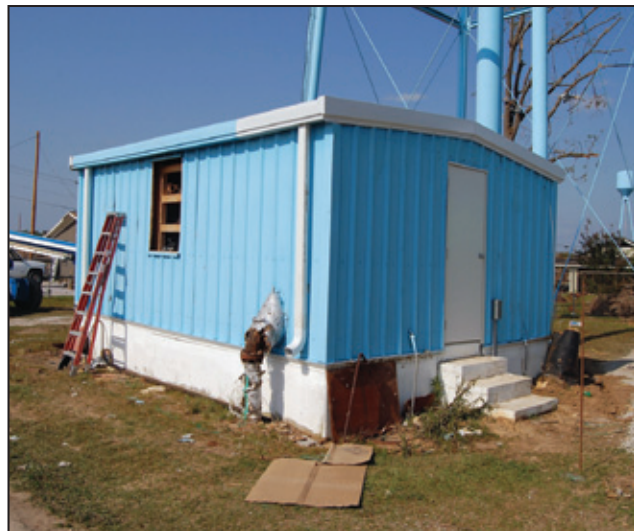
General Wind Damage: At the Smithville Water Treatment and Distribution System Plant, the tornado destroyed a small building constructed of unreinforced CMU and damaged a small storage building constructed of metal frames and metal wall and roof panels (Figure 8-8). The buildings were used for secondary non-critical functions like maintenance and storage, and the damage did not significantly affect operations.

Figure 8-8: Destroyed unreinforced CMU building (left) and damaged metal-framed building (right) (Smithville, MS)

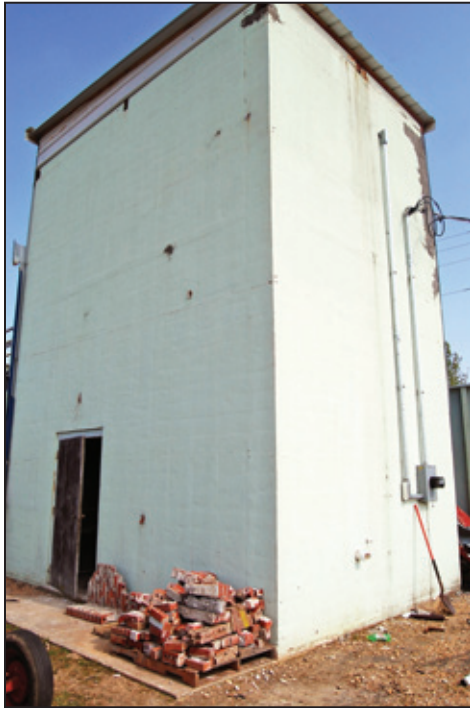
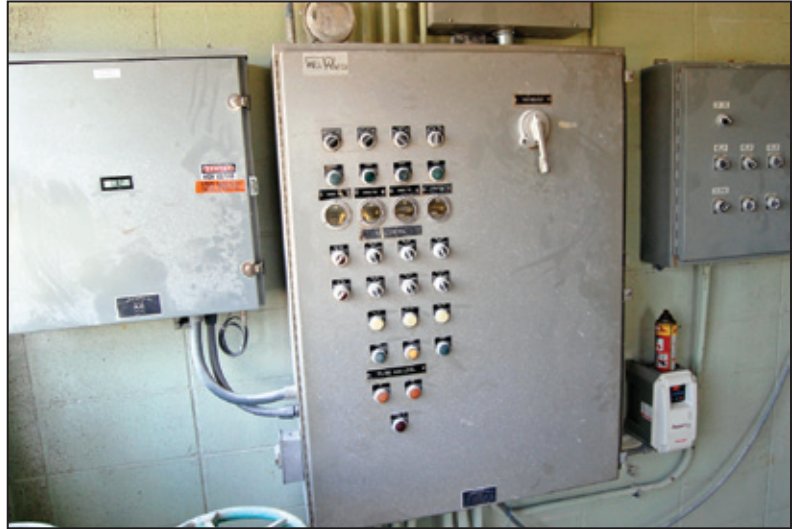
The water treatment control equipment was in a building constructed of reinforced masonry (Figure 8-9). While close to the other buildings and exposed to similar winds, the stronger reinforced building was not extensively damaged.

Figure 8-9:
Reinforced CMU building housing control equipment (left) and
undamaged water treatment control equipment (right) (Smithville, MS)

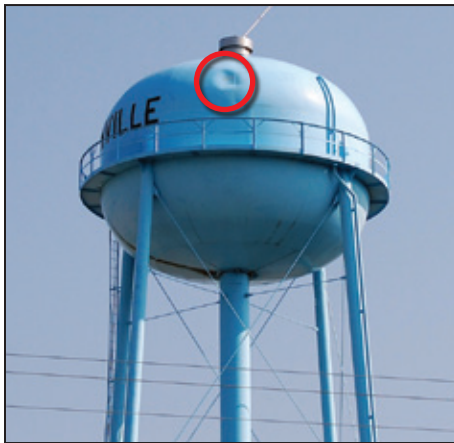
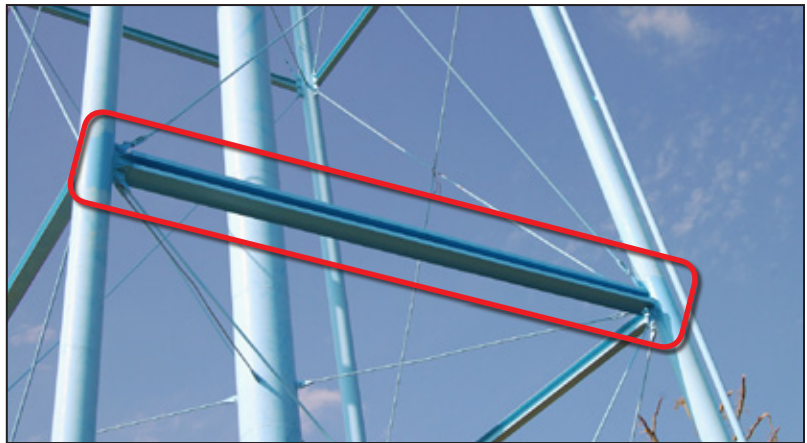
The storage tower was struck by large pieces of wind-borne debris (Figure 8-10). The debris impacted the tank itself and a compression strut that provides lateral bracing and support for the tower legs. At the time of the MAT visit, the impacted area of the tank was not repaired, but the damaged compression strut had been straightened and reinforced. System operators did not know whether the repairs were completed under the direction of a design professional.

Figure 8-10: Debris impact damage to Smithville, MS, water tank: photograph on left shows where debris struck the water tank itself (red circle) and photograph on right shows the repaired compression strut that was damaged by wind-borne debris (red box)

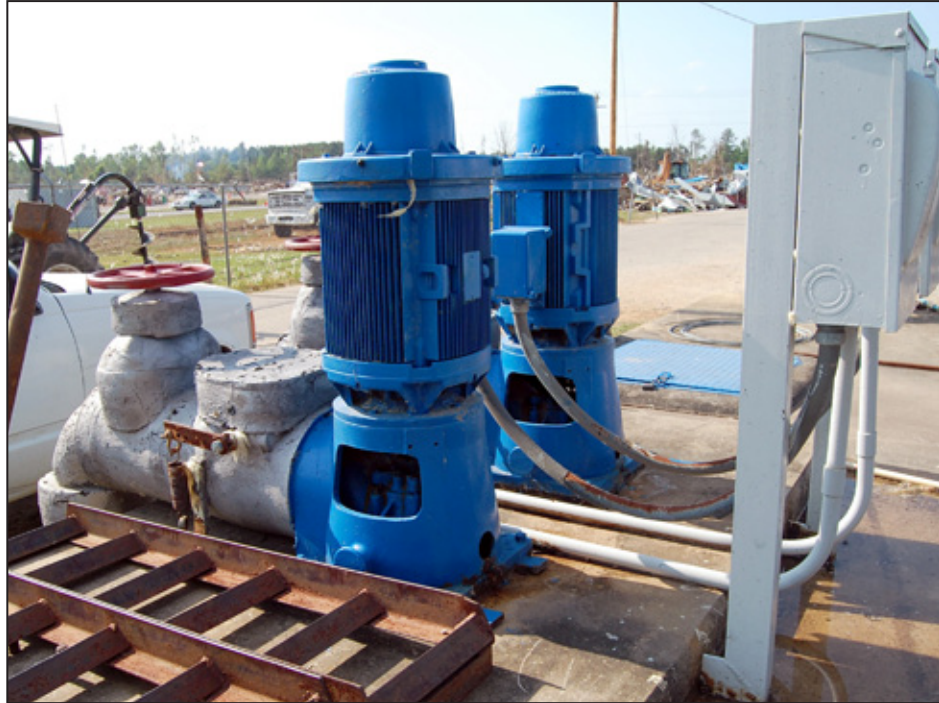
Water pumps and pump controllers were located outside (Figure 8-11). Even though wind-borne debris was widespread in the area, they were not damaged. However, high-pressure chlorine cylinders were stored outside and only lightly secured with small-gage chain (Figure 8-12). Some cylinders were dislodged and displaced nearly 100 yards by the tornadic winds.

Figure 8-11:
Lift pumps and controls of the Smithville, MS, water plant were exposed, but not damaged

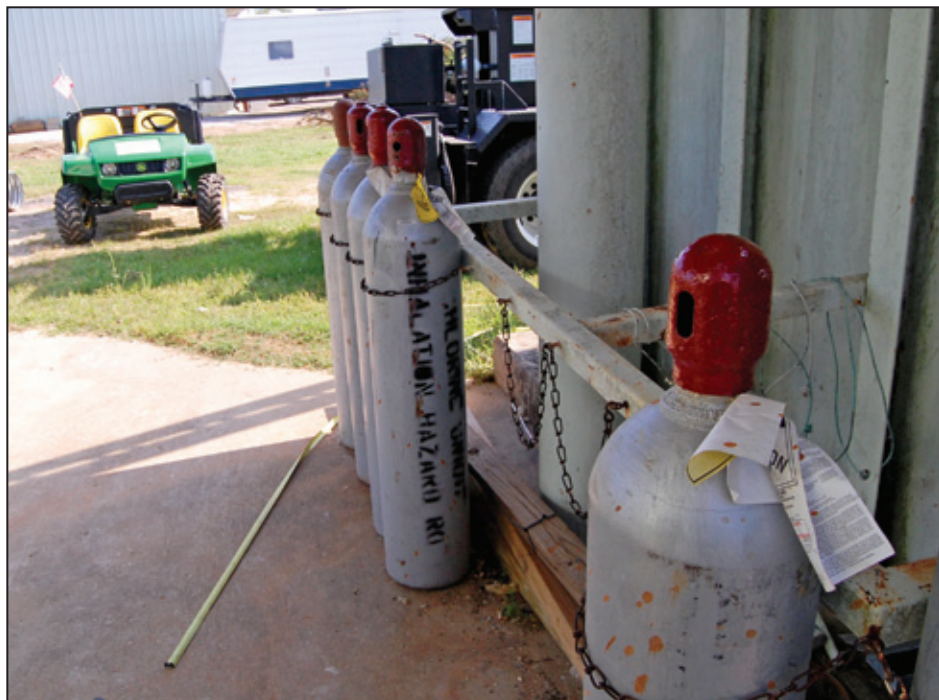
Figure 8-12:
Lightly secured chlorine cylinders; some were displaced by high winds (Smithville, MS)

Chlorine is a hazardous material and 40 CFR 355.30 triggers emergency planning requirements when more than 100 pounds of chlorine is stored. Containers of chlorine should be protected from exposure to weather, extreme temperatures changes, and physical damage, and they should be stored separately from flammable gases and vapors and combustible substances.

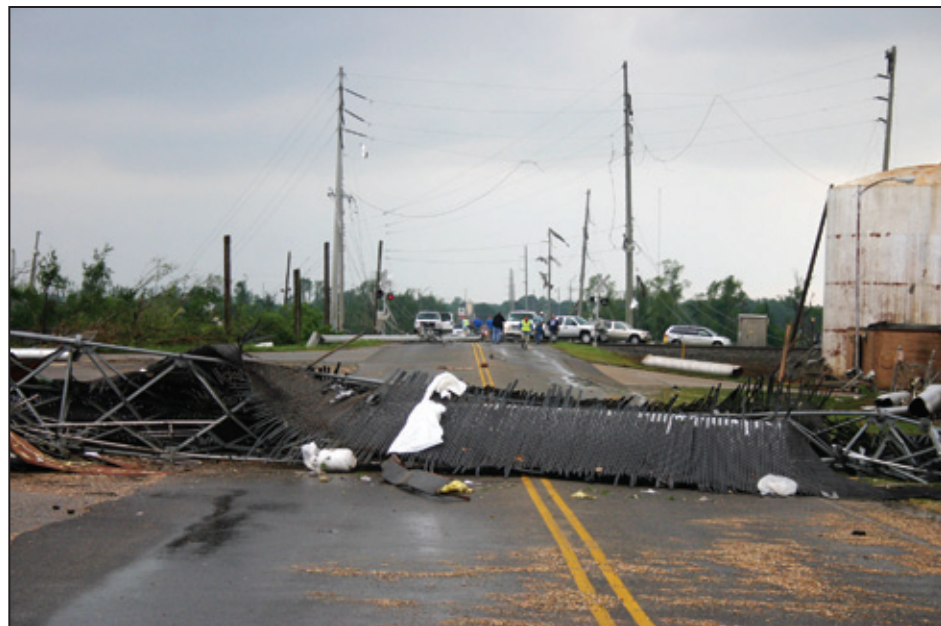
General Wind Damage and Functional Loss: The EMS communications tower collapsed during the storm and fell across the road that separates it from the EOC. By the time of the MAT's visit, the tower had been removed, and only its concrete base remained. The tower was, however, photographed by EMS staff from the ground the day of the event (Figure 8-15) and from a helicopter 3 days after the tornado struck it on April 27 (Figure 8-16).

Figure 8-15:
View of toppled EMS communications tower taken by EMS personnel after the tornado. Note the wind-displaced material (discussed in text) adhered to the tower (Tuscaloosa, AL).

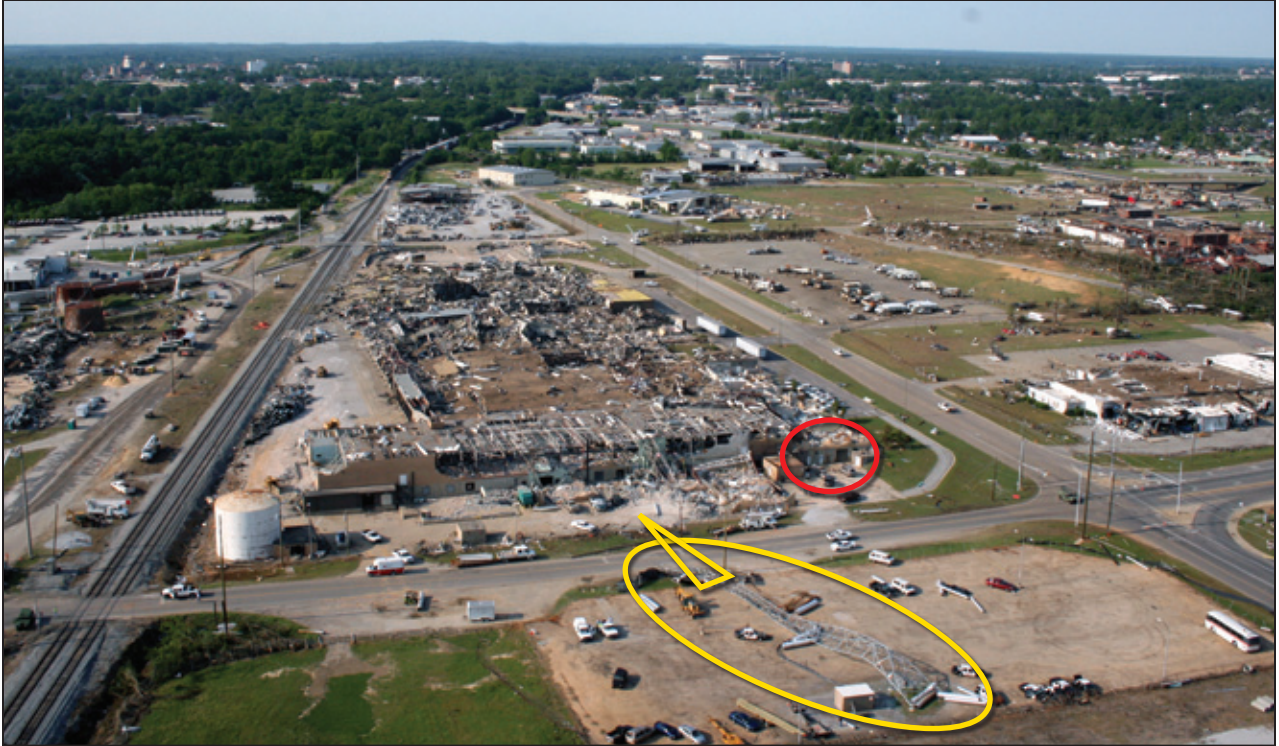
Figure 8-16: View of the collapsed EMS communications tower (yellow oval); the EOC across 35th Street is also shown (red oval) (Tuscaloosa, AL). The communications tower was cut, and the debris that was across the road was removed (yellow triangle).

Wind-displaced materials adhered to the latticed EMS communications tower (Figure 8-16). The adhered materials consisted of chain link fence fabric and webbing interwoven into the fabric. The adhered materials created nearly solid surface areas that increased the amount of surface area exposed to wind pressures, thereby increasing the wind loads on the tower.

The MAT could not determine if the wind-displaced materials adhered to the EMS communications tower before or after it collapsed. Since fencing is generally not an engineered structure, and communications towers are generally extensively engineered, it is highly likely that the fencing was displaced before the tower collapsed. If this was the case, any displaced fencing material that wrapped around the tower would have increased wind loads and could have contributed to the tower failure.

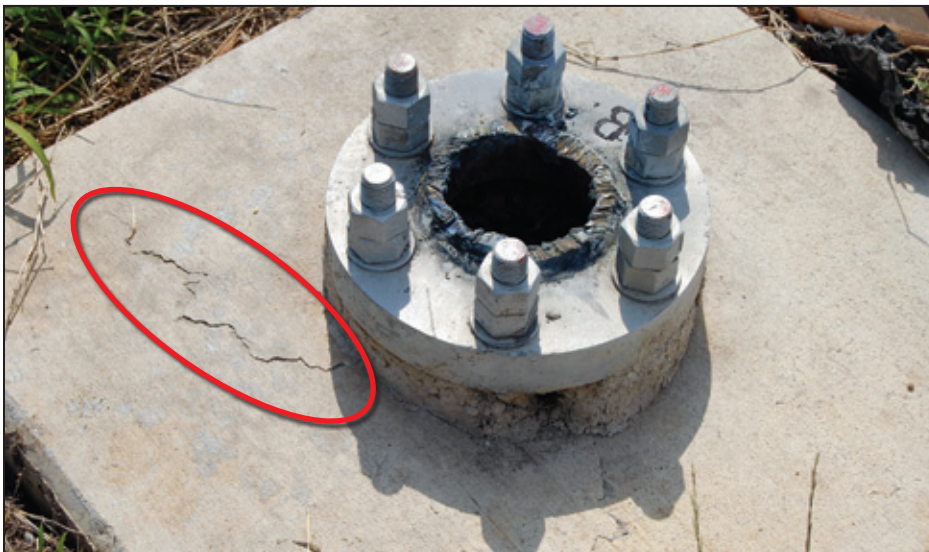
The MAT noted fresh shear cracks in the concrete foundation bases (Figure 8-17). The cracks resulted from tensile loading in the tower/base connection and suggest that bending occurred in the concrete tower base.

Figure 8-17: Photograph shows the six-bolt tower base with cracks in concrete foundation cap (red oval) (Tuscaloosa, AL)

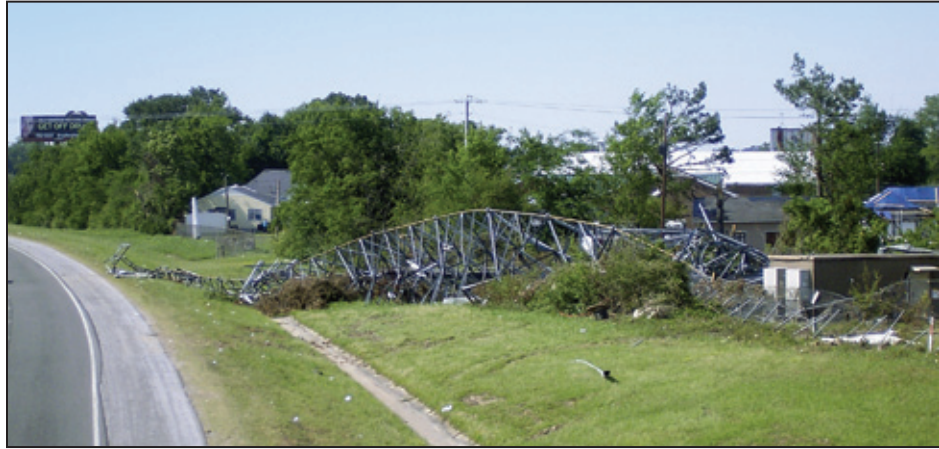
General Wind Damage and Functional Loss: The 300-foot latticed cellular tower was completely destroyed by the April 27, 2011 tornado. Figure 8-20 shows the collapsed cellular tower.

Figure 8-20:
View of the 300-foot latticed cellular tower that collapsed during the tornado event (Tuscaloosa, AL)

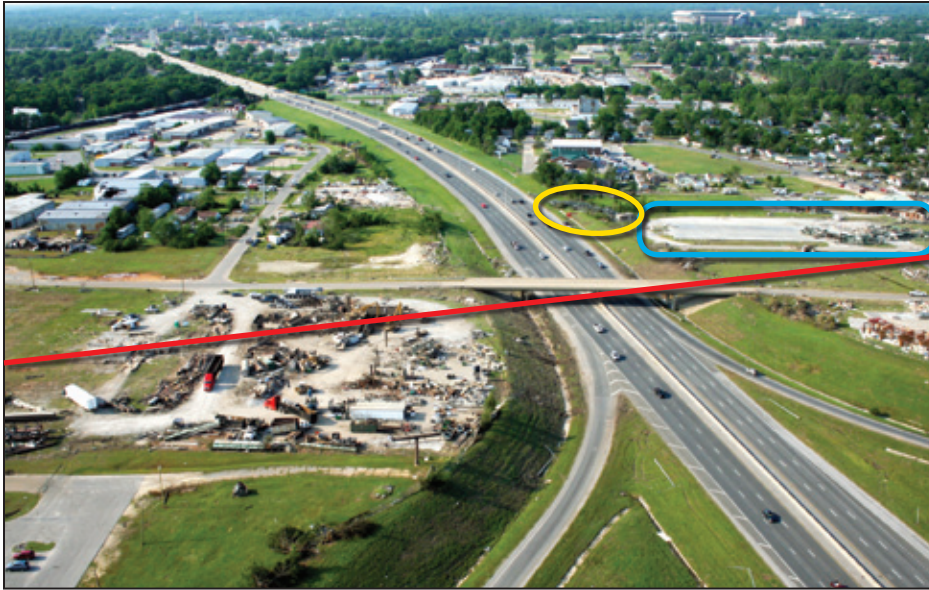
No wind-displaced building materials were seen physically adhered to the fallen latticed tower. However, a large metal building southeast of the tower had been destroyed (Figures 8-21 and 8-22), and large sections of metal panels were scattered throughout the area. The MAT also observed a trailer frame leaning against the fence surrounding the cell tower base (Figure 8-23). These observations suggest that the storm created large amounts of wind-borne debris and wind-displaced sheathing in the vicinity of the tower and wind-displaced material likely struck the tower.

Figure 8-22:
View of the collapsed 300-foot cellular tower (yellow oval) and the destroyed metal building southeast of the tower (blue box) in relation to the approximate centerline of the tornado damage swath (red line) (Tuscaloosa, AL)

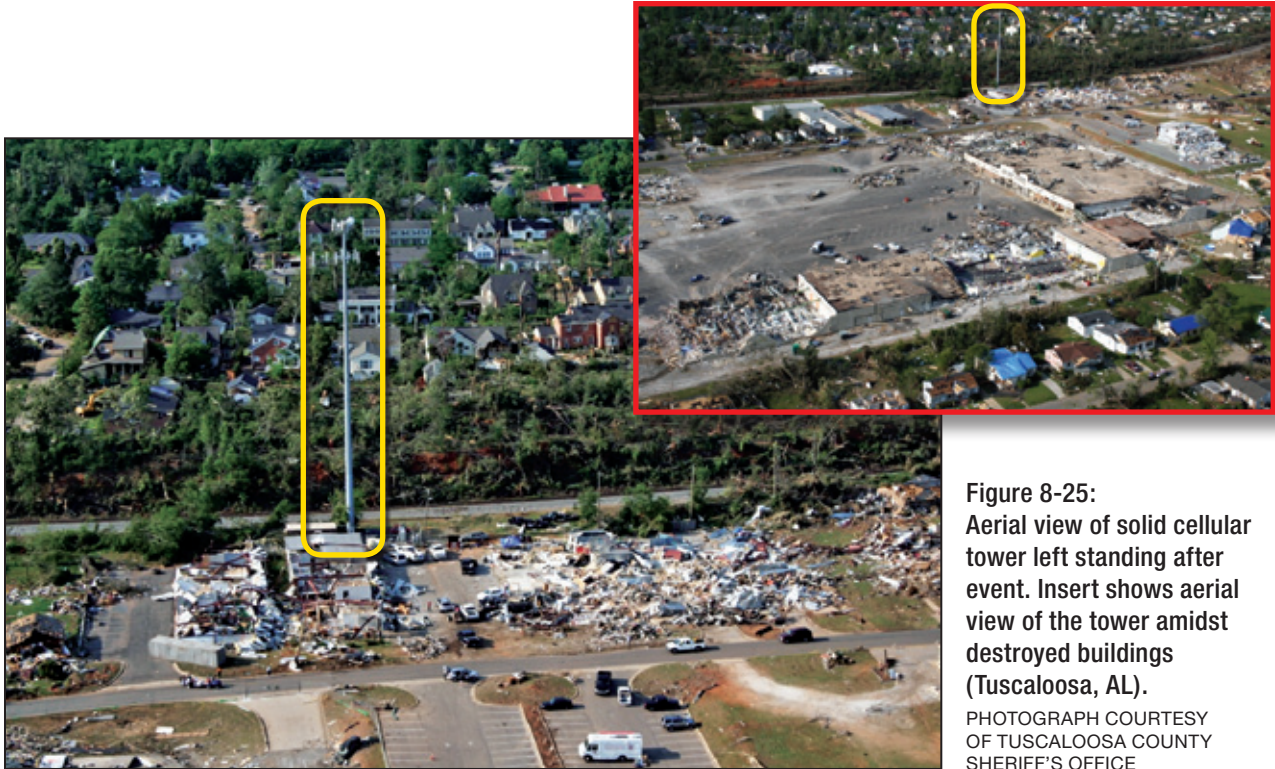
General Wind Damage and Functional Loss: The aerial photographs show that the tower withstood the event without collapsing.

Figure 8-25:
Aerial view of solid cellular tower left standing after event. Insert shows aerial view of the tower amidst destroyed buildings (Tuscaloosa, AL).

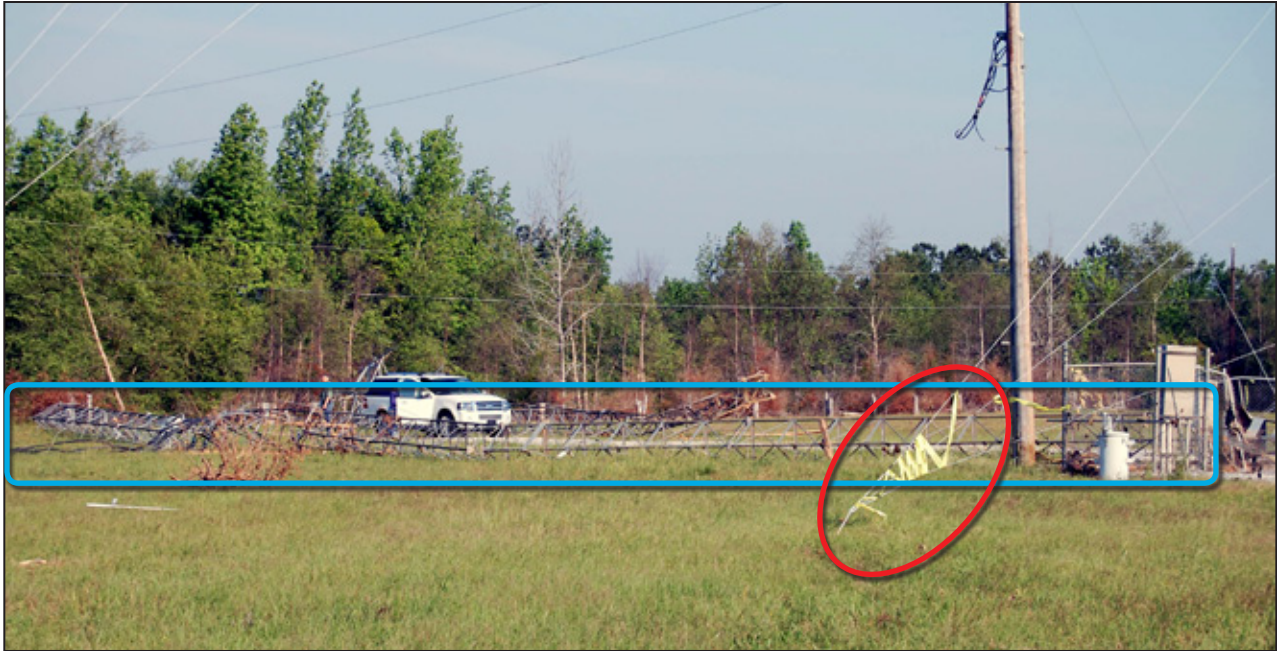
General Wind Damage and Functional Loss: The tower collapsed during the event (Figure 8-29), and by the time the MAT visited the site 11 days after the event, preliminary clean-up activity had occurred and a temporary tower had been erected on site. The upper portion of the collapsed tower had been moved to clear the access road to the site.

Figure 8-29: Collapsed 300-foot cellular tower (blue box). The triple guy in the foreground (red oval) is one of the three supports for the temporary tower on the site (Smithville, MS).

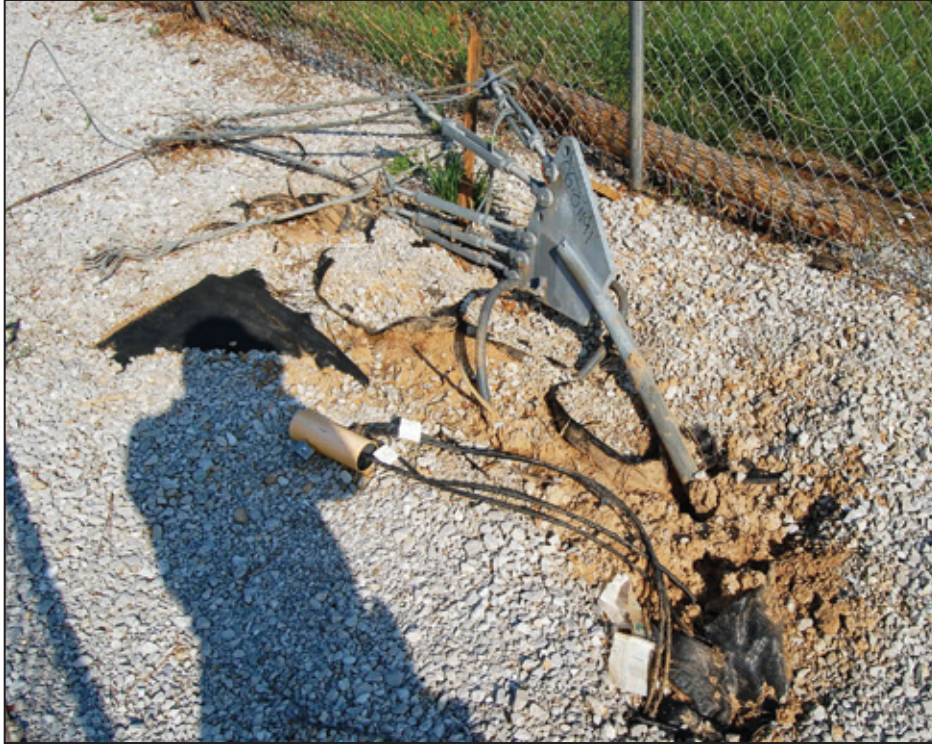
Wind-displaced building components struck and adhered to the south guy (Figure 8-30). The anchor that secured those guys failed and was dragged several feet through the ground (Figure 8-31).

Figure 8-31:
The anchor securing one guy was dragged several feet through the ground (Smithville, MS)
