TORNADO OUTBREAK *of* **2011**

IN ALABAMA, GEORGIA, MISSISSIPPI,
TENNESSEE, AND MISSOURI

10 Conclusions of the 2011 Tornado MAT

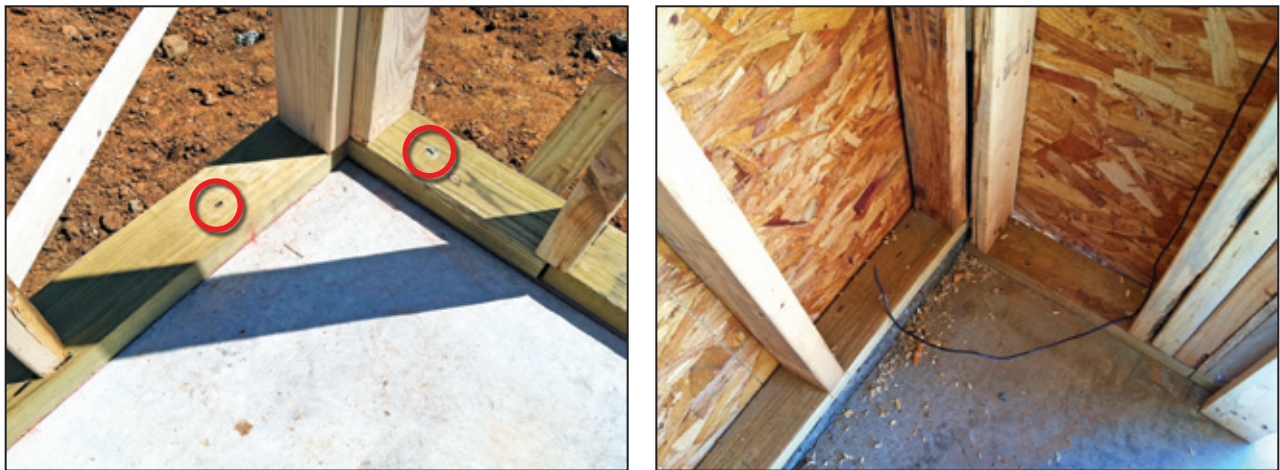
An example of non-rigorous enforcement of structural provisions would be allowing bottom wall plates to be attached with concrete nails or cut nails instead of IRC-specified anchor bolts. One reason concrete nails are used to anchor the bottom plate is because they are much easier to use than anchor bolts. Use of anchor bolts requires more planning than concrete nails because anchor bolts have to be embedded in the foundation before the framing is erected. However, concrete nails provide significantly less resistance to uplift and lateral forces than 0.5-inch-diameter anchor bolts with 7 inches of minimum embedment spaced a maximum of 6 feet on-center, as required by code, and therefore the substitution of concrete nails for anchor bolts significantly weakens the connection of the exterior framed wall to the foundation.

Failure of the connection between the wall bottom plate and foundation was observed in newly constructed residential buildings in Alabama, where concrete nails were used for bottom plate attachment (refer to Figure 4-30). Follow-up analysis revealed that the City of Tuscaloosa allows the use of concrete nails for attaching the bottom plate to foundations in lieu of using anchor bolts as required by the IRC. The City of Tuscaloosa continued to permit bottom plates to be nailed to foundations even after the April 2011 tornadoes (Figure 10-1).

Figure 10-1: Concrete nails (red circles in left photograph) used in lieu of anchor bolts (absent in both photographs) on residential buildings under construction in the City of Tuscaloosa, AL, after the 2011 tornadoes

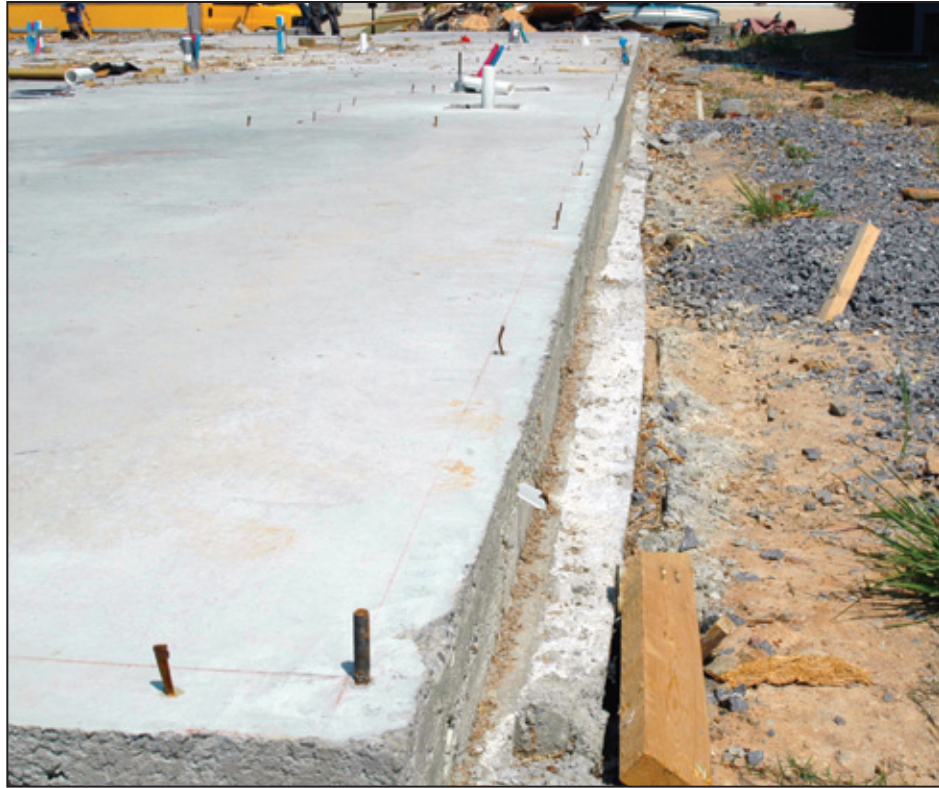
The MAT also observed new residential construction in Jefferson County, AL, that was non-code-compliant in the connection of the framed wall plate to the foundation (Figure 10-2).

Figure 10-2:
Lack of anchor bolts on recently constructed slab foundation in Jefferson County, AL. Note that an anchor bolt is installed at the corner, but cut nails are installed elsewhere.

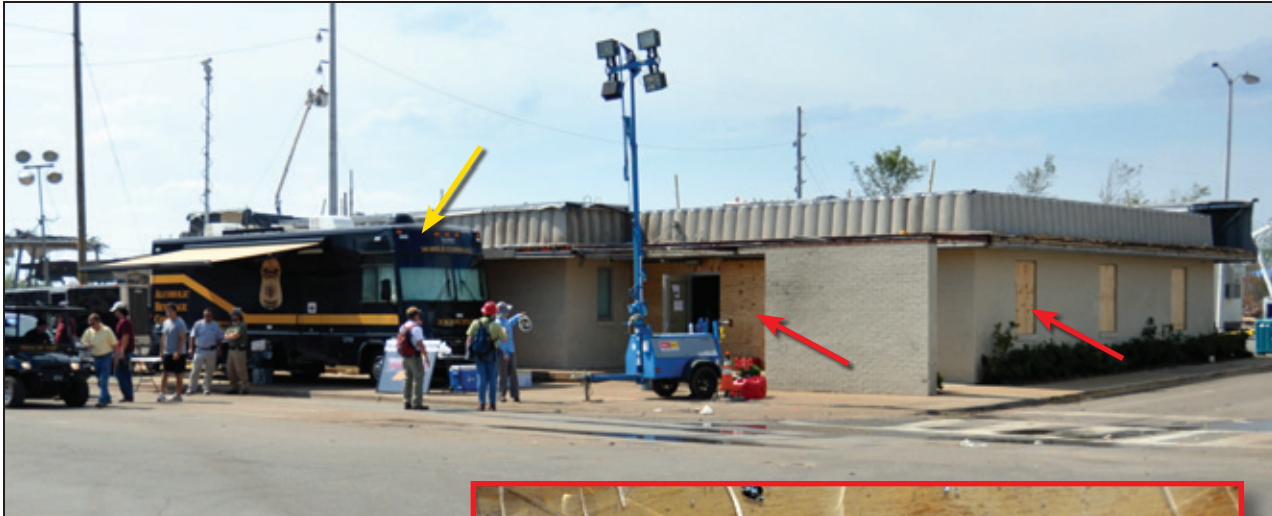
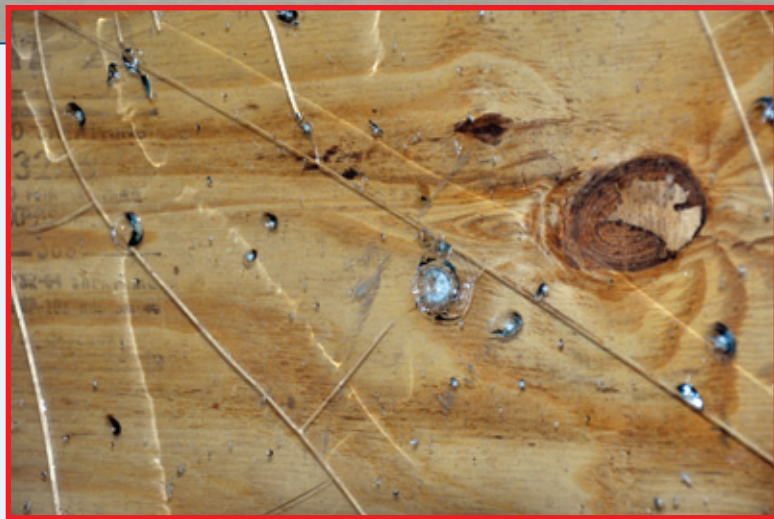
Figure 10-3 shows a police station in Tuscaloosa, AL (see Figure 7-1 for location) that experienced roof covering damage and extensive glazing damage. Most of the exterior windows were impacted by wind-borne debris (primarily aggregate from a built-up roof). The debris chipped and cracked the glazing, as shown in the Figure 10-3 inset, but because the glazing was bullet resistant, the glazing remained in the frame. Figure 10-3 shows plywood (red arrows) placed over the damaged glazing.

MAT EF Rating: Using DI 9 (Small Professional Building), the MAT selected DOD 3 (“broken windows, including clear story windows or skylights”) for the Tuscaloosa, AL, police station.¹ Using the expected wind speed for DOD 3, the MAT derived the tornado rating as EF1 (86–110 mph) based on the damage to this building. Hence, the estimated wind speed experienced by the building was not substantially above the current basic wind speed of 90 mph.

Figure 10-3: Red arrows show plywood placed over damaged glazing at this police station; inset shows chipped glazing and illustrates the quantity of wind-blown roof aggregate that struck the facility. Because of the building damage, a mobile command vehicle (yellow arrow) was brought to the site (Tuscaloosa, AL).
