TORNADO OUTBREAK *of* **2011**

IN ALABAMA, GEORGIA, MISSISSIPPI,
TENNESSEE, AND MISSOURI

6 Observations on Critical Facility Performance: Schools

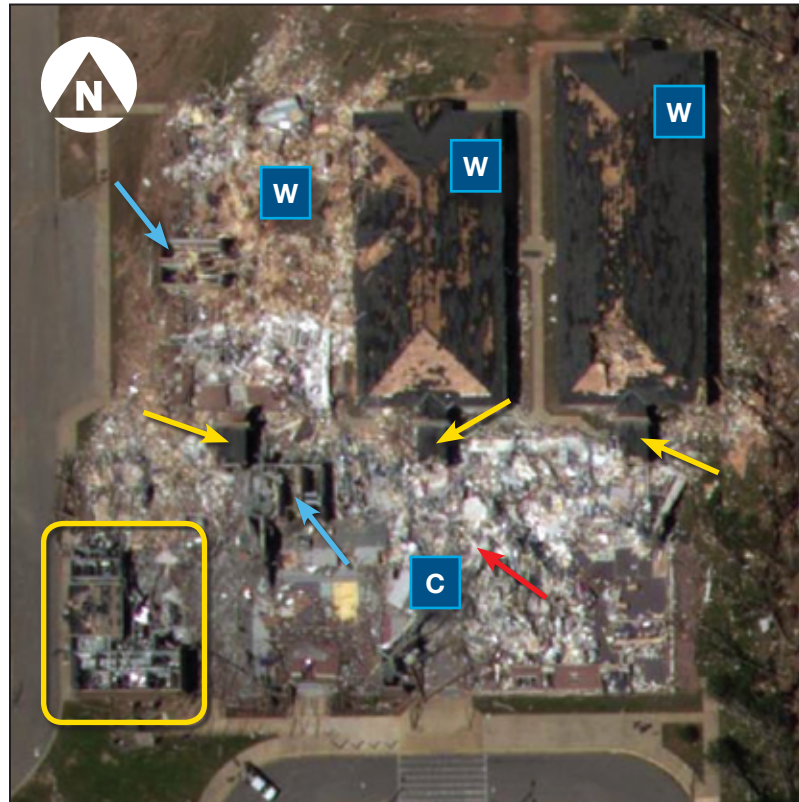
General Wind Damage: One classroom wing and most of the central core collapsed (Figures 6-4 to 6-6, 6-9, and 6-10). The tornado refuge areas for the two surviving wings were destroyed (Figure 6-5). Figure 6-5 shows a portion of the collapsed central core area and the two wings that survived. The MAT judged the limited damage at the surviving wings to be due to shielding provided by the third wing and core area, rather than increased strength of these two wings.

Figure 6-4: Area shown in yellow circle of Figure 6-3. The classroom wings are indicated by “W” and the core area by “C.” The general location of the tornado refuge areas for the two surviving wings is shown by the red arrow. Yellow arrows indicate remnants of corridors between the core and wings. The blue arrows indicate restroom remnants. The yellow box indicates kitchen remnants (Tuscaloosa, AL).

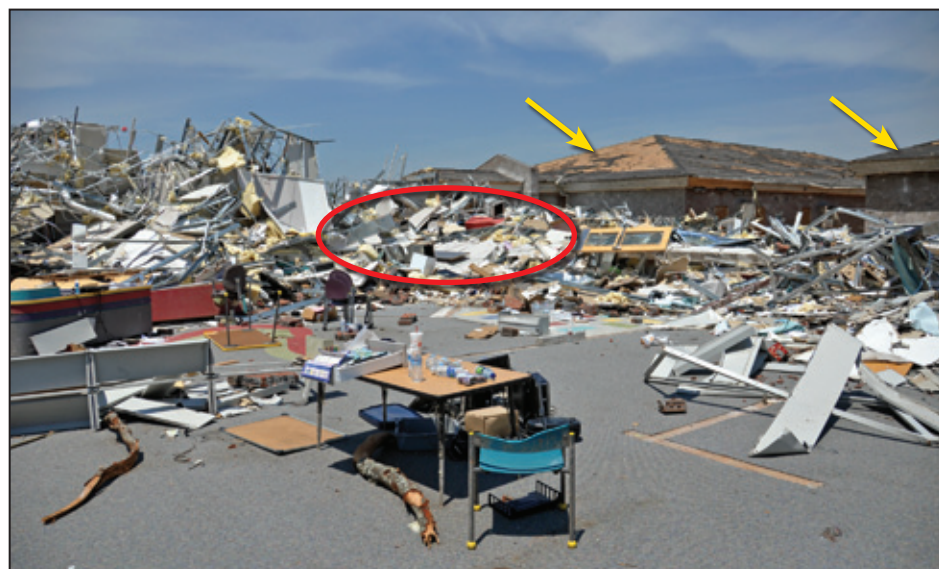
Figure 6-5: View of the central core area. Tornado refuge areas for the two surviving wings were in the collapsed area (red circle). The yellow arrows indicate the two surviving wings (Tuscaloosa, AL).

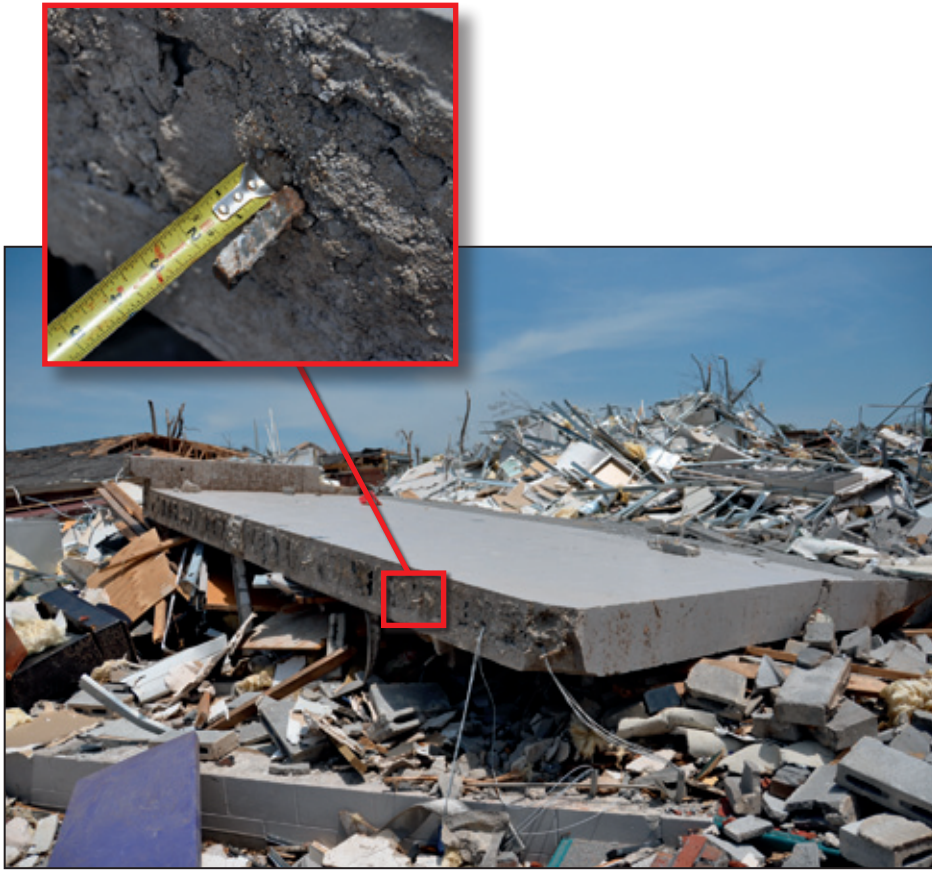
Several of the interior walls in the core area were reinforced CMU. Most of these walls collapsed. At the wall shown in Figure 6-6, the rebar was spaced at 4 feet on center. The rebar that was in the collapsed portion had only about 2 inches of embedment into the grouted CMU that is still in place and does not significantly strengthen the joint between the base of the wall and the floor or provide resistance to toppling. Similar splice laps were noted at exterior walls.

Figure 6-6:
Interior reinforced CMU
wall in the central core area
where rebar had deficient
splice lap. Inset shows a
close-up of the deficient
splice lap (Tuscaloosa, AL).

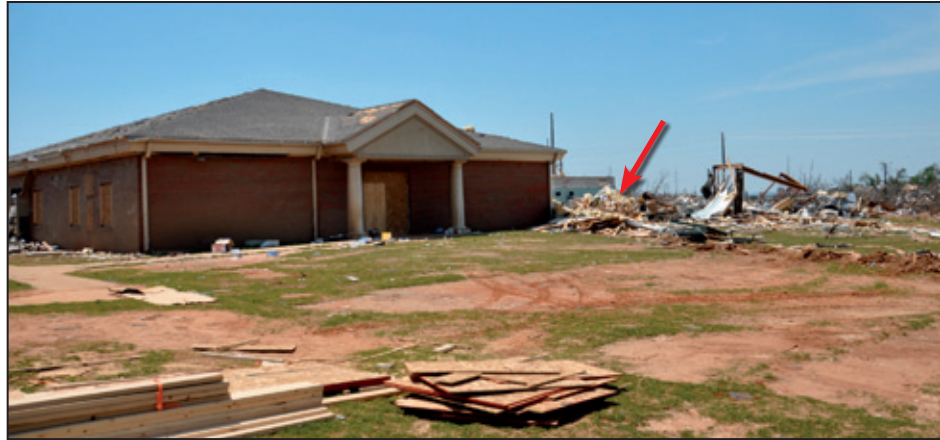
Figure 6-7 shows one of the surviving classroom wings. All of the exterior windows and the glass vision panels in the exit doors were broken (there were eight windows along each of the long walls). This wing also lost a substantial amount of underlayment and asphalt shingles. The wing to the left of the area shown in the photograph lost a significant amount of deck sheathing at the far (south) end and several trusses were missing. Figure 6-8 shows the corridor in the surviving wing shown in Figure 6-7. A portion of the corridor wall partially collapsed.

Figure 6-7:
Center classroom wing
remains standing while the
wing to the right (red arrow)
collapsed (Tuscaloosa, AL)

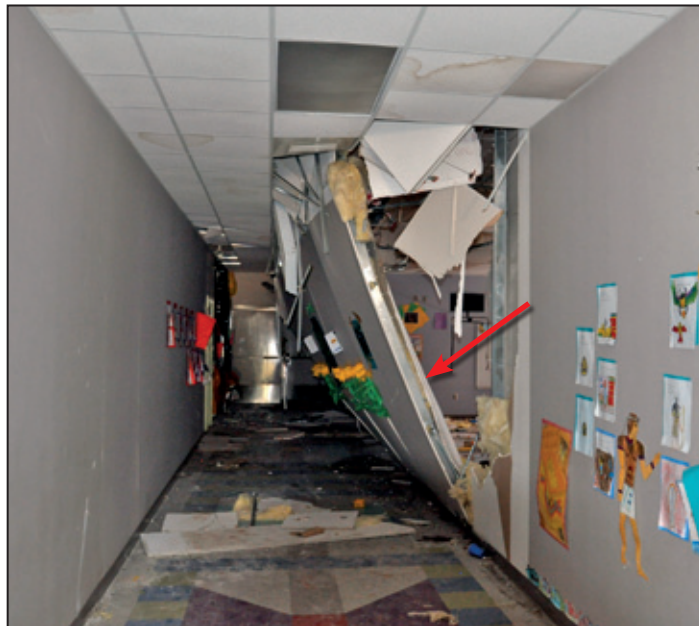
Figure 6-8:
Partially collapsed
corridor wall (red arrow)
(Tuscaloosa, AL)

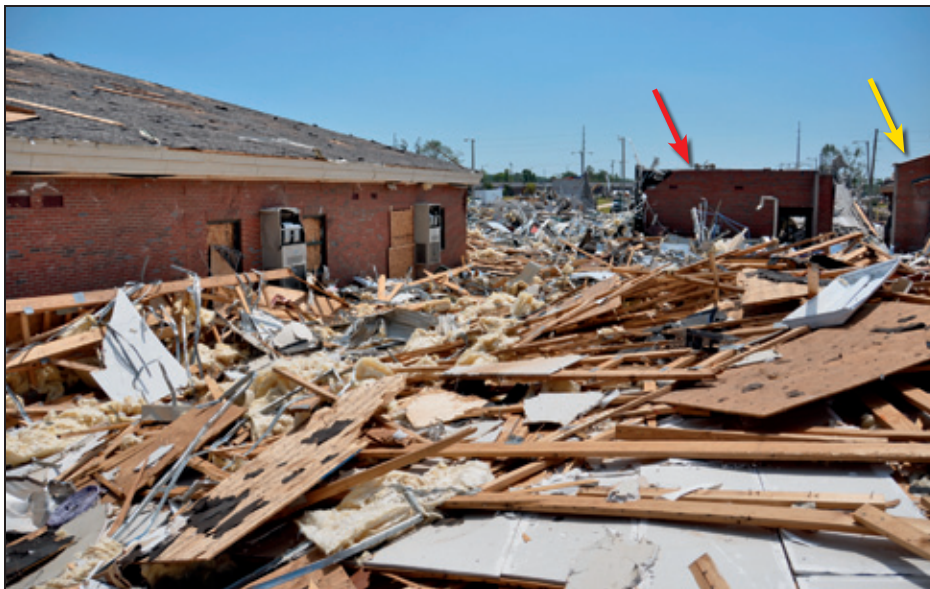
Figure 6-9 shows the view looking down the corridor of the classroom wing that collapsed. The remnant shown by the red arrow is a restroom in the core area. The remnant shown by the blue arrow is the corridor between the collapsed wing and core. Figure 6-10 shows the reinforced CMU restroom remnant in the collapsed wing. The entire restroom area was open to the sky and there was a substantial amount of debris within the rooms. Although corridors and restrooms are sometimes the best available refuge areas, injury or death may occur in corridors and restrooms that are not specifically designed as safe rooms or storm shelters as shown in Figures 6-8 through 6-10 and as discussed in Chapter 9.

Figure 6-9:
Looking down the corridor
of the collapsed classroom
wing; red arrow indicates
a bathroom in the core
remnant and yellow
arrow indicates a corridor
that remained standing
(Tuscaloosa, AL)

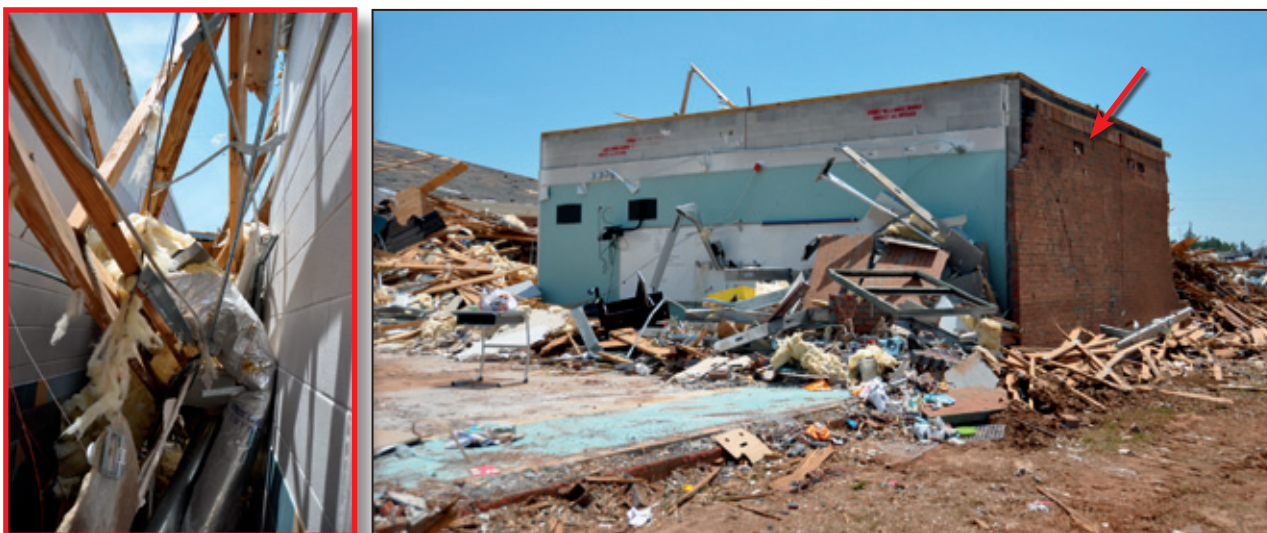
Figure 6-10: The reinforced CMU walls around the restroom were left standing, but the rooms were littered with debris (as shown in the inset). The wall with the brick veneer (red arrow) was an exterior wall (Tuscaloosa, AL).

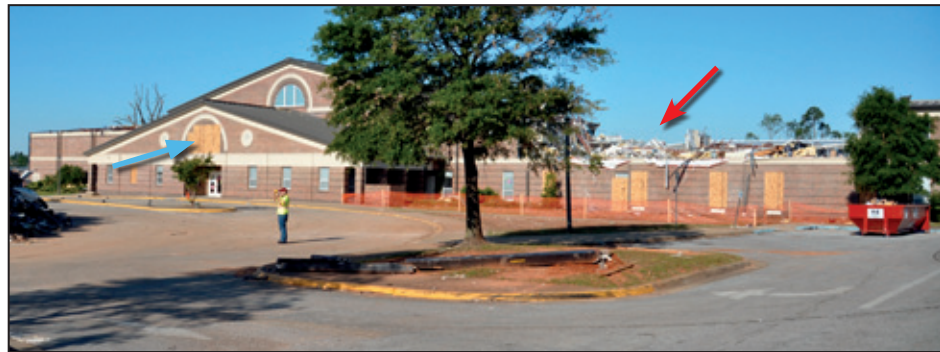
Figure 6-11: University Place Elementary School after the tornado. The red arrow shows the collapsed second story of one of the classroom wings. Several broken windows were boarded up at the time of the MAT visit (blue arrow) (Tuscaloosa, AL).

General Wind Damage: Several exterior windows were broken (Figure 6-11). Most of the exterior and interior walls of the second floor of classroom wing A collapsed (Figures 6-11, 6-13, and 6-14). About 75 percent of the roof decking of classroom wing B blew off (Figures 6-13 and 6-14) and about 25 percent of the roof joists also blew off of this wing. Some of the second floor exterior wall of classroom wing B also collapsed (Figure 6-15 and 6-16).

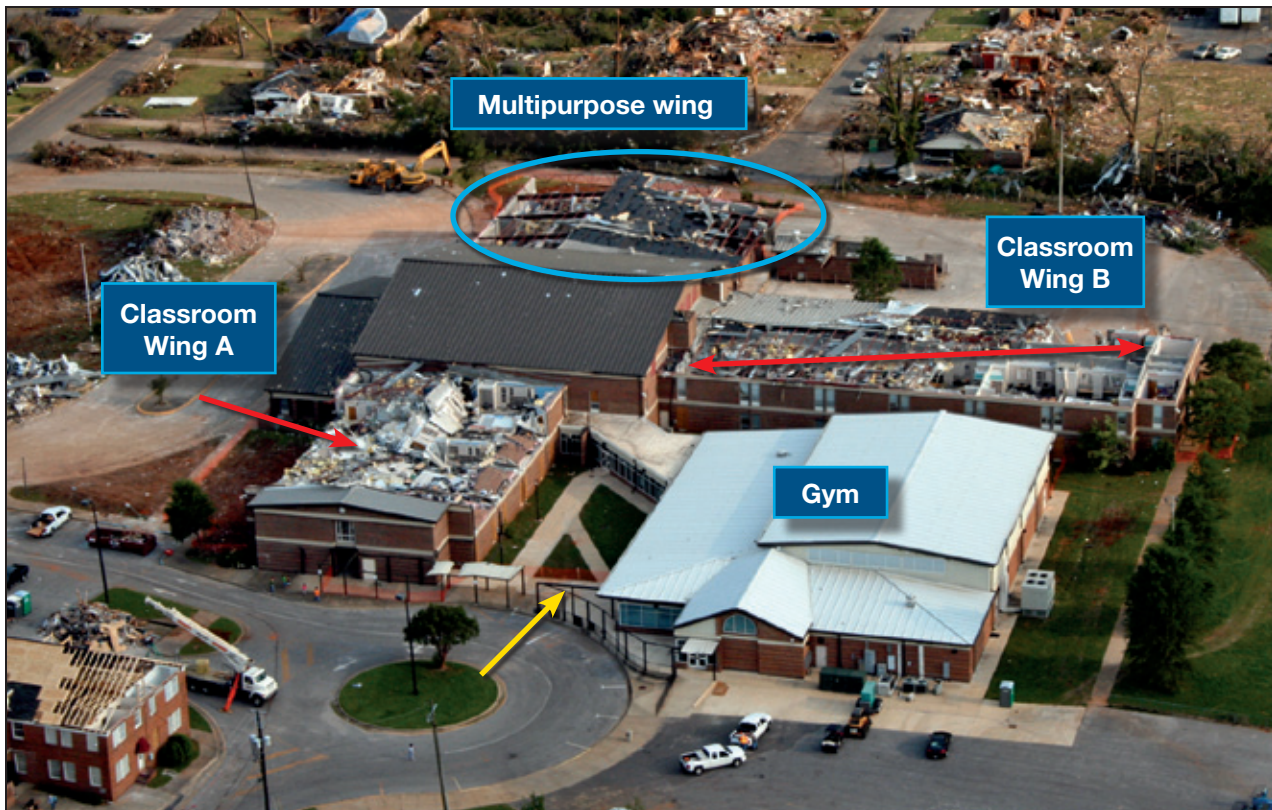
Figure 6-14: View looking south showing damage of the classroom wings (red arrows) and multipurpose wing (blue oval). The yellow arrow indicates damaged walkway canopy (Tuscaloosa, AL).

The gymnasium (Figure 6-14) experienced only slight damage. There was some gutter damage, and most of the canopy walkway roof blew away (Figure 6-14). The MAT judged the damage to be due to the location of the gymnasium with respect to the tornado track, rather than building strength.

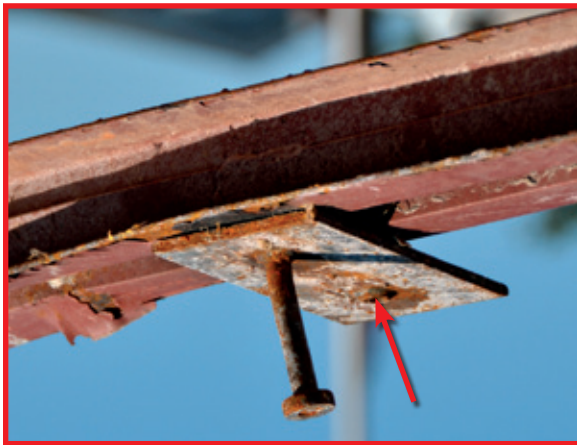
Figure 6-16:

View of the second floor damage to classroom wing B (red arrow in Figure 6-15). The inset shows a joist welded to a plate that was anchored to a bond beam where one of the headed studs broke off (red arrow). Hollow core slabs are shown, indicated by the yellow arrow (Tuscaloosa, AL).

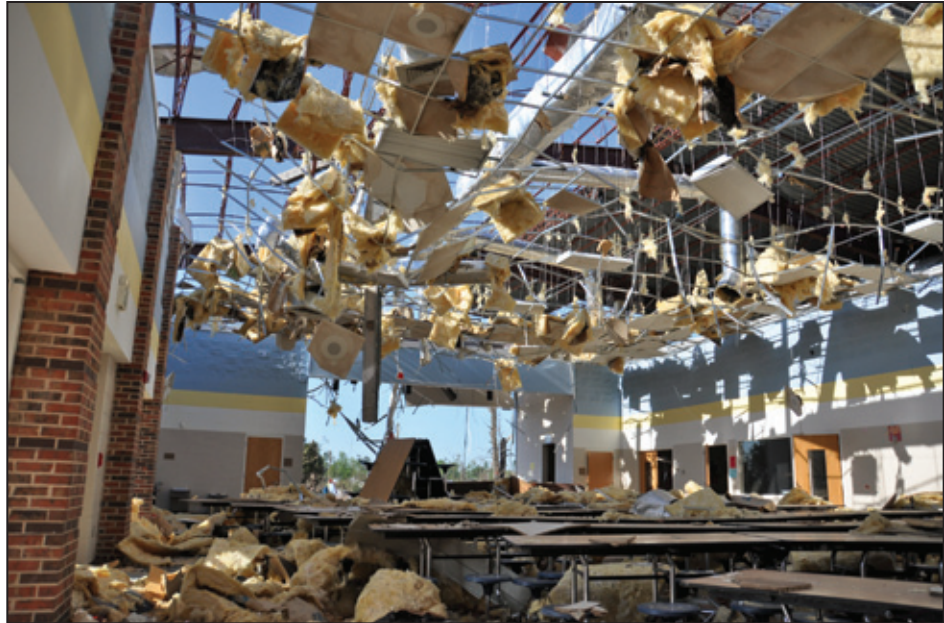
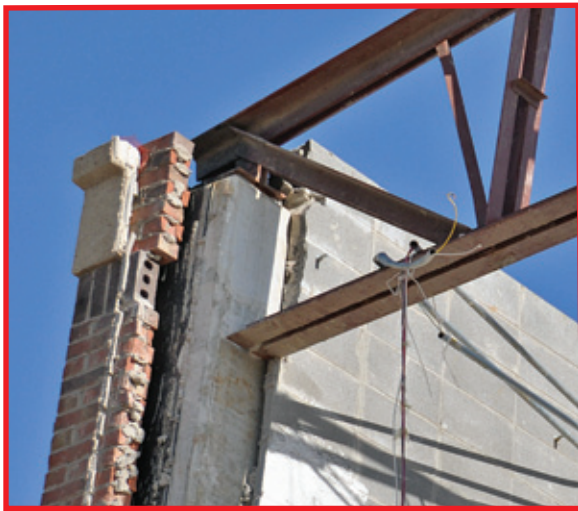
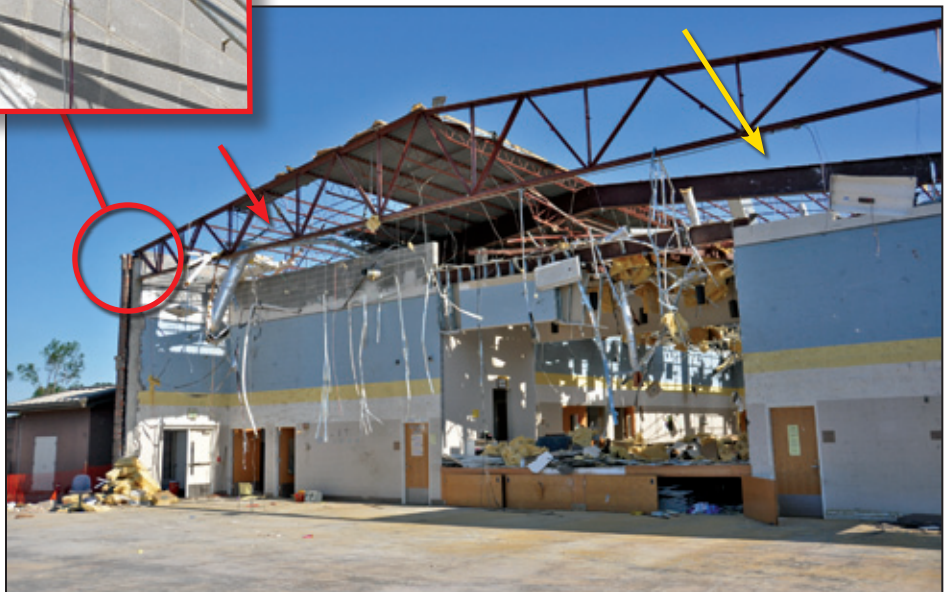
The multipurpose wing was also heavily damaged. At the cafeteria, all of the roof decking and several of the roof joists were blown off (Figure 6-17). At the kitchen, much of the roof decking and some roof joists were blown off (Figure 6-18). Some brick veneer and exterior CMU also collapsed. The multipurpose room was destroyed (Figure 6-18). There were two girders at the multipurpose

Figure 6-18:
View toward the cafeteria
(yellow arrow) and kitchen
(red arrow) from within the
multipurpose room. The
inset shows a multipurpose
room girder supported by a
concrete column that is still
in place (Tuscaloosa, AL).

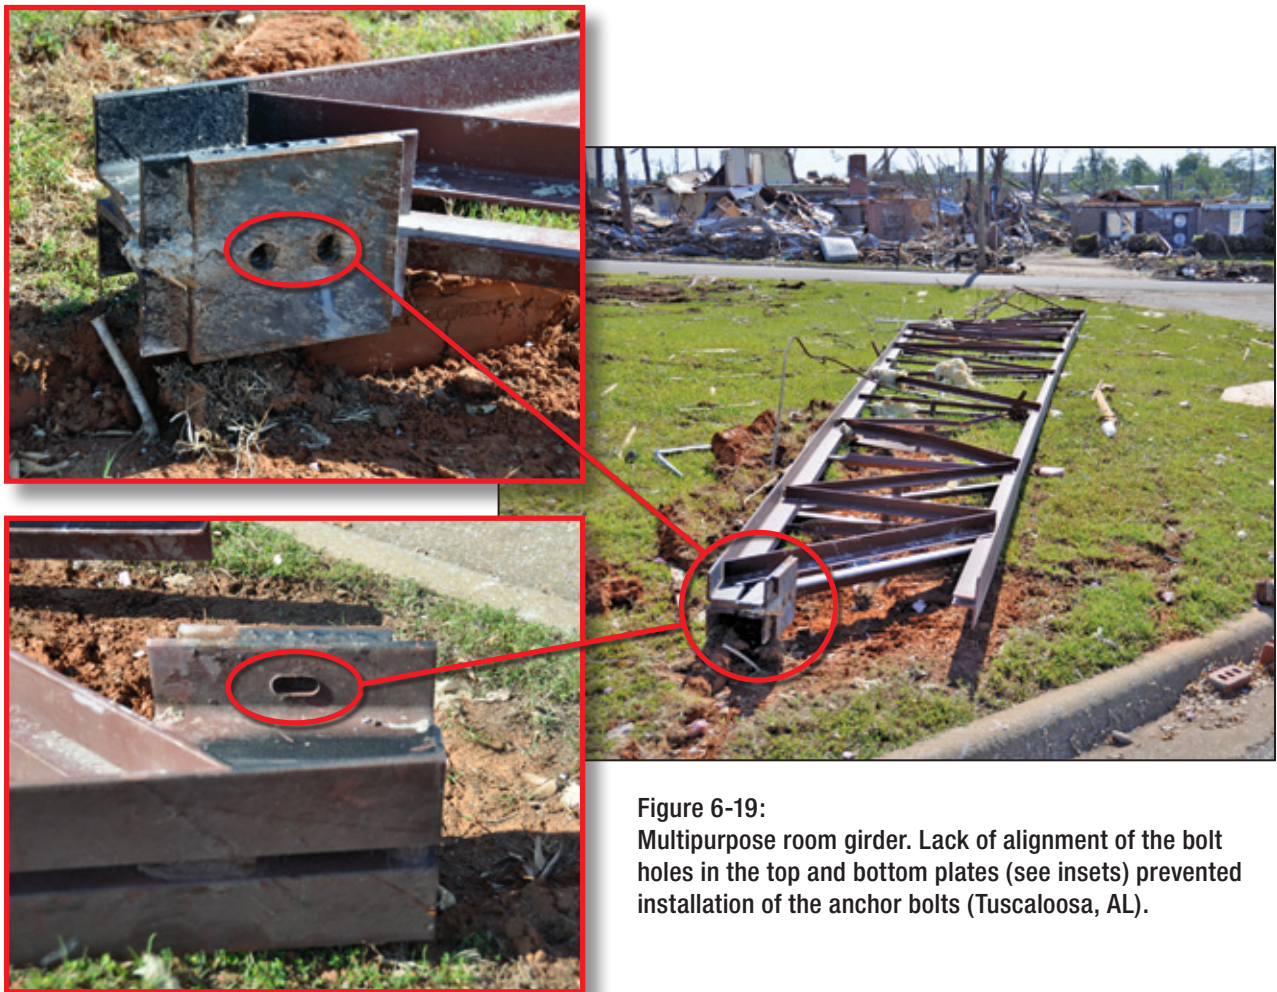
The contract drawings indicate that the two multipurpose room girders were to be attached to the concrete columns with two $\frac{3}{4}$ -inch diameter anchor bolts. At the failed girder shown in Figure 6-19, the girder bearing plate consisted of two plates that were welded together. There were two holes that were large enough to accommodate $\frac{3}{4}$ -inch bolts in the bottom plate (Figure 6-19 top left inset). However, there was only one slotted hole in the top plate (Figure 6-19 bottom inset). Because of inadequate hole alignment, it was not possible for the girder plates to be anchored by $\frac{3}{4}$ -inch bolts. Both ends of the girder were similar. Apparently the girder simply rested on top of the concrete column. The contract drawings also show a C-shaped plate that was to be anchored to the concrete column with headed studs. The bottom chord of the girder was to slip between the top and bottom of the C. The girder was not to be attached to the C. The C-shaped plate was not installed at the girder chord shown in the Figure 6-18 inset.

Figure 6-19:
Multipurpose room girder. Lack of alignment of the bolt holes in the top and bottom plates (see insets) prevented installation of the anchor bolts (Tuscaloosa, AL).

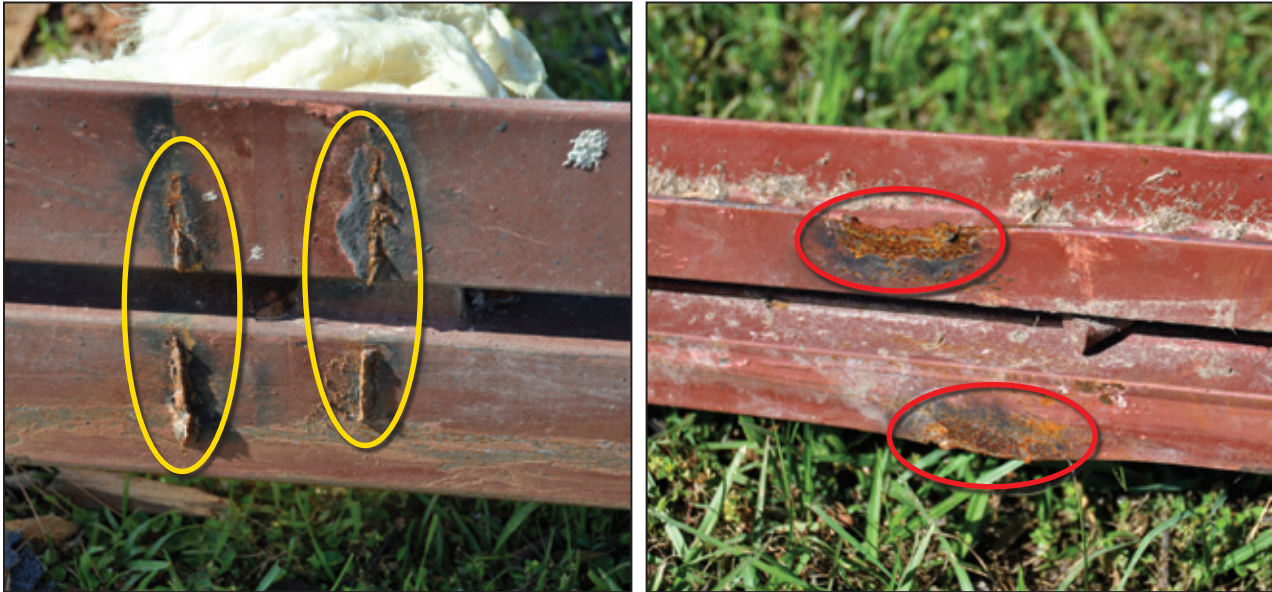
Several joist connections were observed. Figure 6-20 shows where a joist was welded to the girder shown by the yellow ovals on the left photograph of Figure 6-20. The right photograph of Figure 6-20 shows where a joist was welded to a bearing plate that was anchored to a bond beam. All of the observed welds were of poor quality.

Figure 6-20: The yellow ovals on the left photograph show weld remnants where a joist was attached to the girder. The red ovals on the right photograph show weld remnants where a joist was attached to a bearing plate at a bond beam (Tuscaloosa, AL).

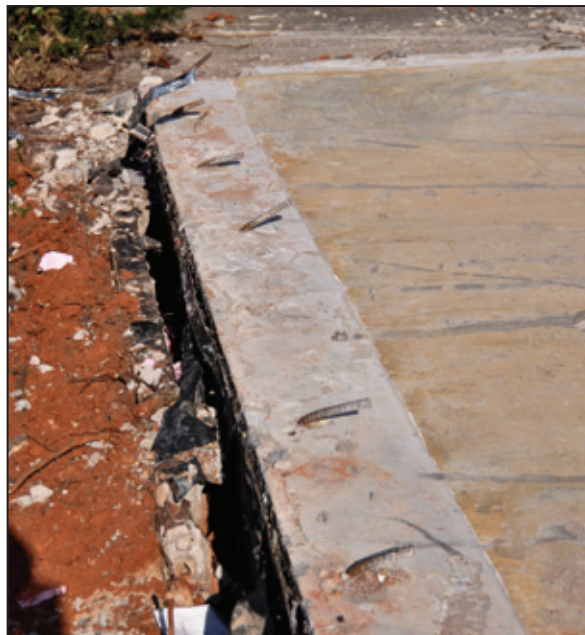
Figure 6-22 shows what remains of the exterior end wall of the multipurpose room. A reinforced CMU bearing wall was present where the rebar extends through the slab. In this area, the rebar extends 5½ to 7 inches out of the slab; hence, it had deficient splice overlap with the rebar in the CMU. The contract drawings specified a 1-foot 10-inch-overlap for vertical splices.

Figure 6-22:
Rebar extending out of the slab at the multipurpose room end wall (Tuscaloosa, AL)

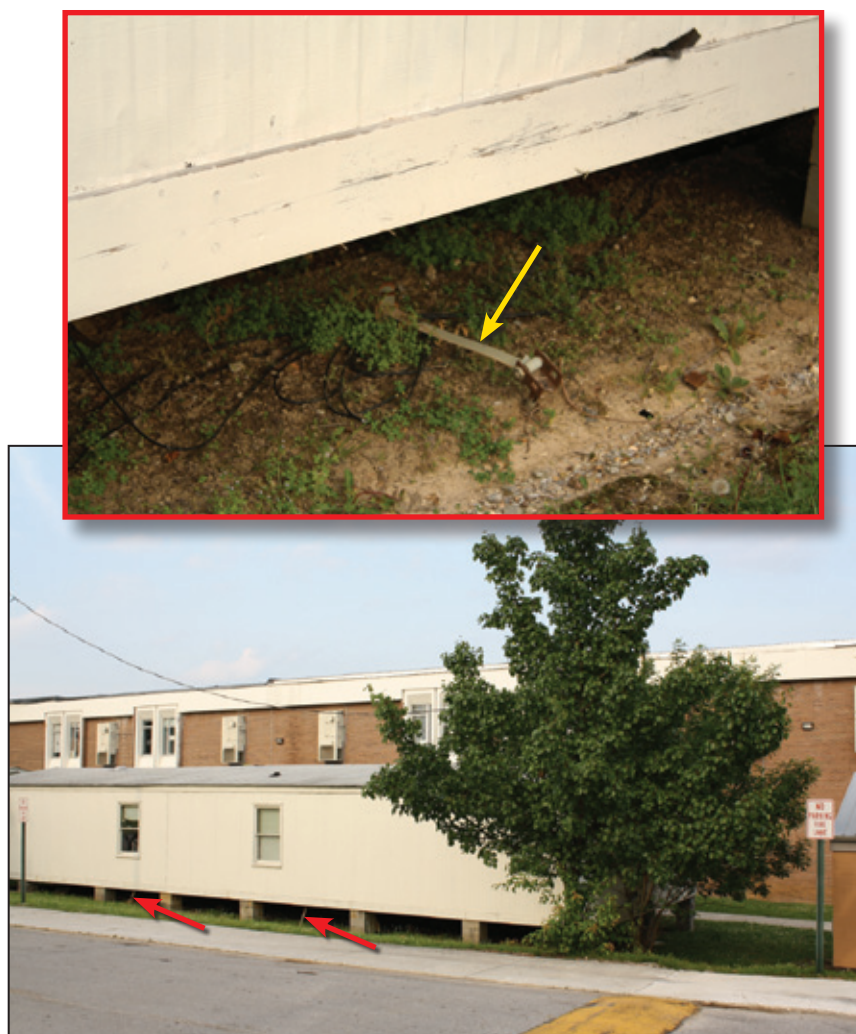
Figure 6-25: View of one of the portable classrooms. The red arrows indicate anchor straps. The strap shown in the inset had corroded through (yellow arrow) (Ringgold, GA).

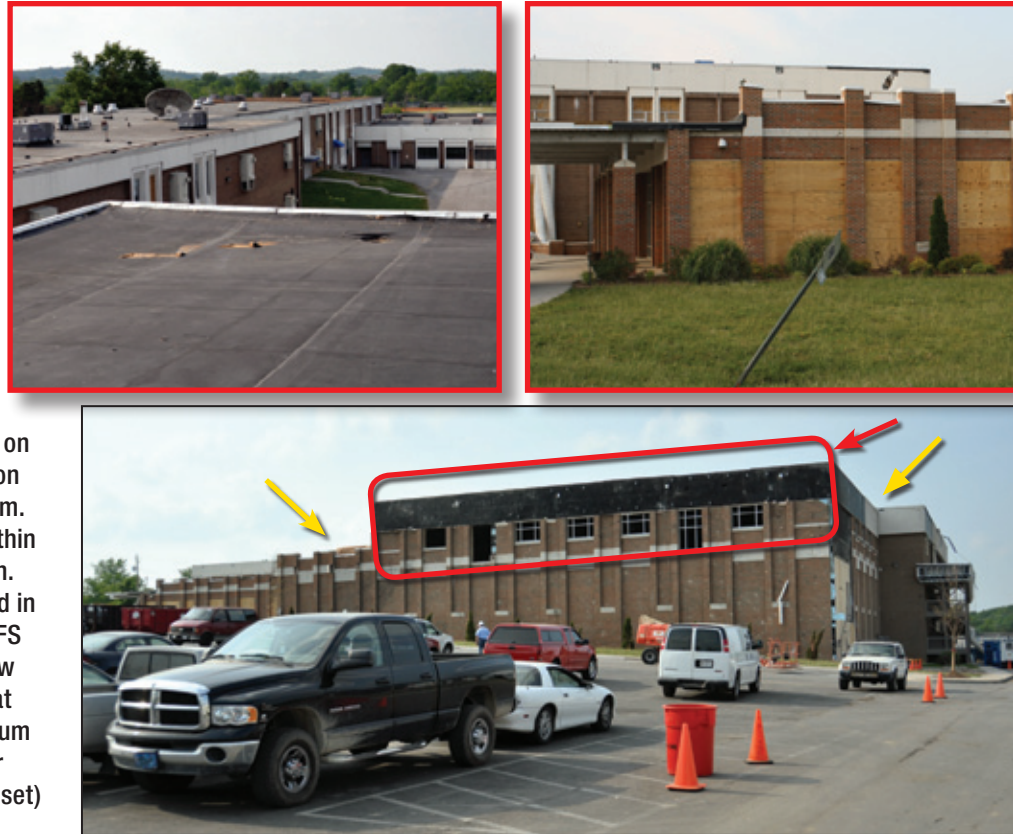
General Wind Damage: The tornado struck the south end of the high school (Figure 6-26). The most significant damage was to the gymnasium roofs (Figures 6-27 and 6-28), which resulted in water infiltration that caused damage to the wood floor. The wood gymnasium floor was then demolished (Figure 6-29).

Figure 6-26:
View of the 2008 auxiliary gymnasium (red arrow) and original gymnasium (yellow arrow on right). The yellow arrow on left indicates the location of a ballasted roof system. Most of the windows within the red oval were broken. The black band (included in the red box) is where EIFS blew off. The insets show the classroom wings that are beyond the gymnasium (left inset) and first floor glazing damage (right inset) (Ringgold, GA).

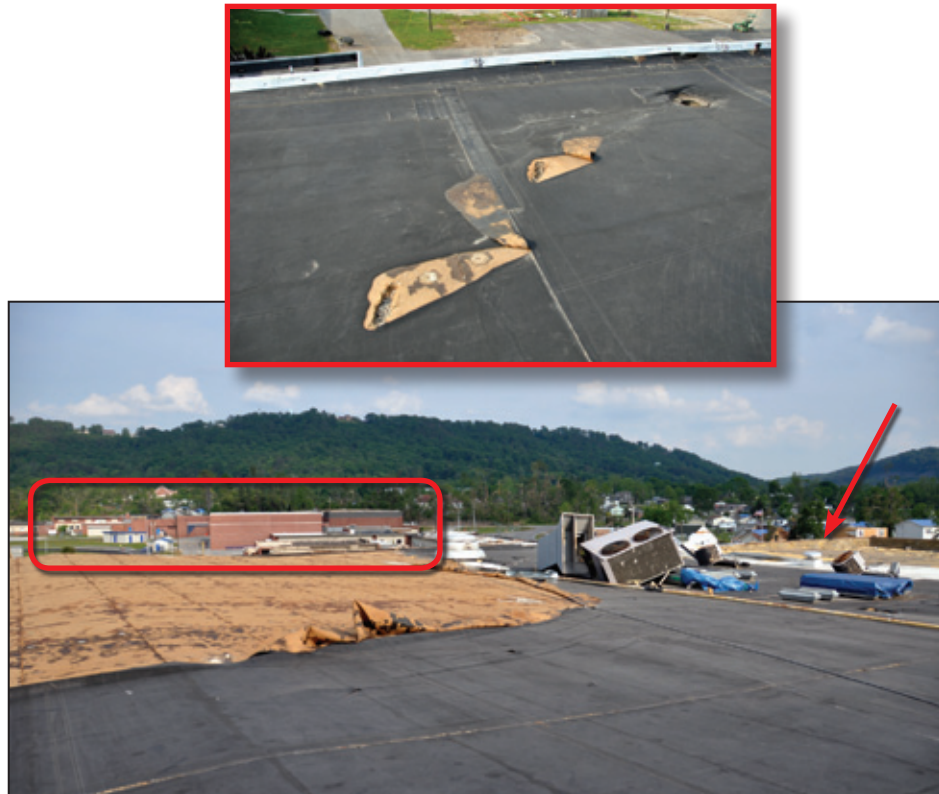
Figure 6-27:
View of the two gymnasium roofs. The red arrow shows the 2008 auxiliary gymnasium (see also Figures 6-26 and 6-28). The EPDM (black) membrane is over the original gymnasium. Note the displaced rooftop equipment. The red box shows a portion of the middle school beyond. The inset shows wind-borne debris damage to the EPDM roof (Ringgold, GA).

The roof of the original gymnasium shown in Figure 6-27 had a fully adhered ethylene propylene diene monomer (EPDM) membrane over wood fiberboard over an aggregate surface built-up roof. The primary failure mode was EPDM lifting and peeling. However, as shown by the inset at Figure 6-27, areas of the membrane were punctured by wind-borne debris. The old built-up roof acted as a secondary membrane and likely prevented little if any water from leaking into the gymnasium. However, rain entered the gymnasium where the rooftop equipment shown in Figure 6-27 was blown off the curb. Gas lines were broken at the displaced rooftop equipment shown in Figure 6-27. Damage to the EIFS was noted (Figure 6-26); in some areas the metal studs blew away, while in other areas the EIFS's gypsum board substrate blew away. There were also several broken windows.

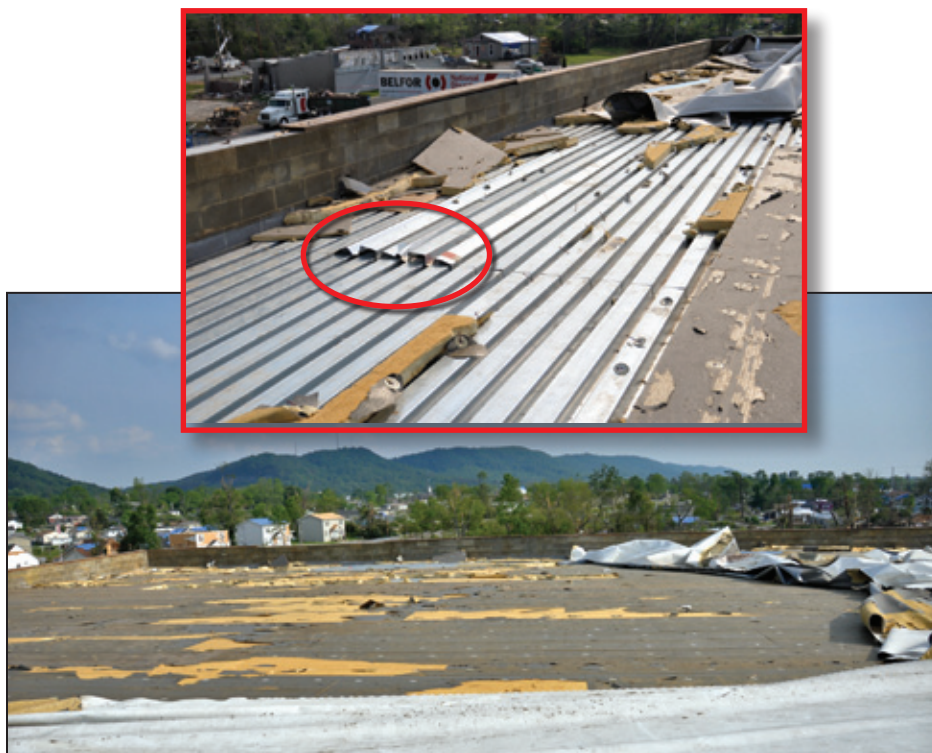
The roof of the 2008 auxiliary gymnasium had a fully adhered single-ply membrane over polyisocyanurate insulation over an acoustical steel deck (Figure 6-28). The primary failure mode was membrane lifting and peeling. As shown in the inset at Figure 6-28, some of the decking lifted.

Figure 6-28:
View of the roof of the
2008 auxiliary gymnasium
(see also red arrow in
Figure 6-27); inset shows
lifted decking (red circle)
(Ringgold, GA)

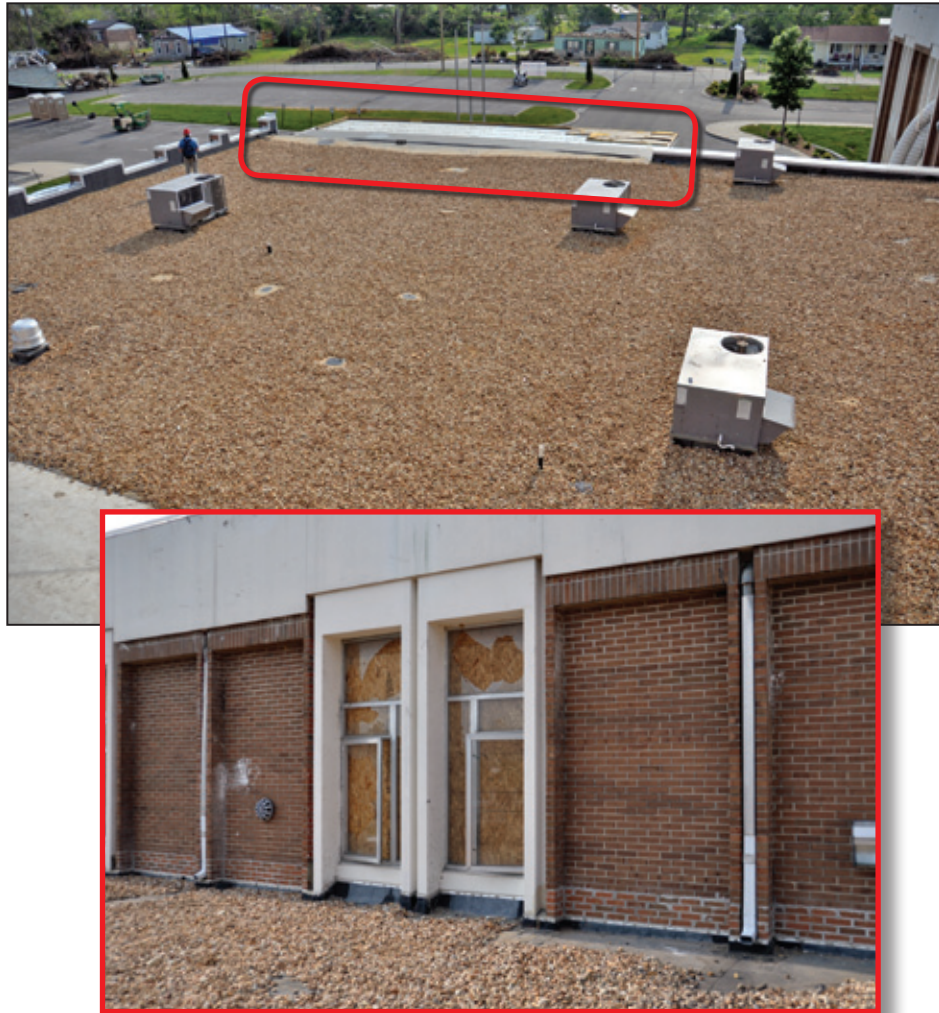
A lower roof adjacent to the 2008 auxiliary gymnasium (see Figures 6-24 and 6-26 for location) had an aggregate ballasted EPDM roof system (Figure 6-30). The winds were such that most of the aggregate on this roof was not scoured. However, the windows shown in the Figure 6-30 inset were likely broken by the roof aggregate. An adjacent roof had a fully adhered single-ply membrane over polyisocyanurate insulation over steel deck. This roof membrane blew away (oval area at Figure 6-30).

Figure 6-30:
View of the aggregate ballasted roof. The fully adhered roof membrane blew away; inset below (red box) shows broken windows (Ringgold, GA).

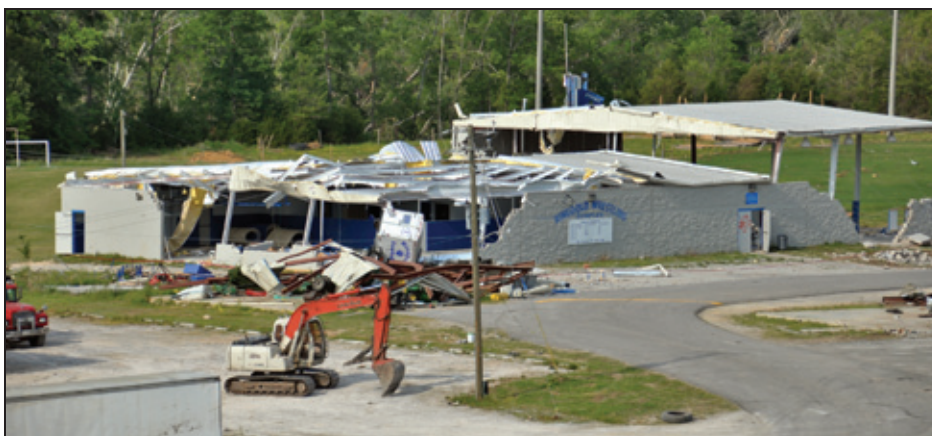
Figure 6-32:
At the wrestling facility, most of the metal roof panels were blown off, much of the steel framing was damaged, and a portion of the unreinforced CMU wall collapsed. This facility was subsequently demolished (Ringgold, GA).

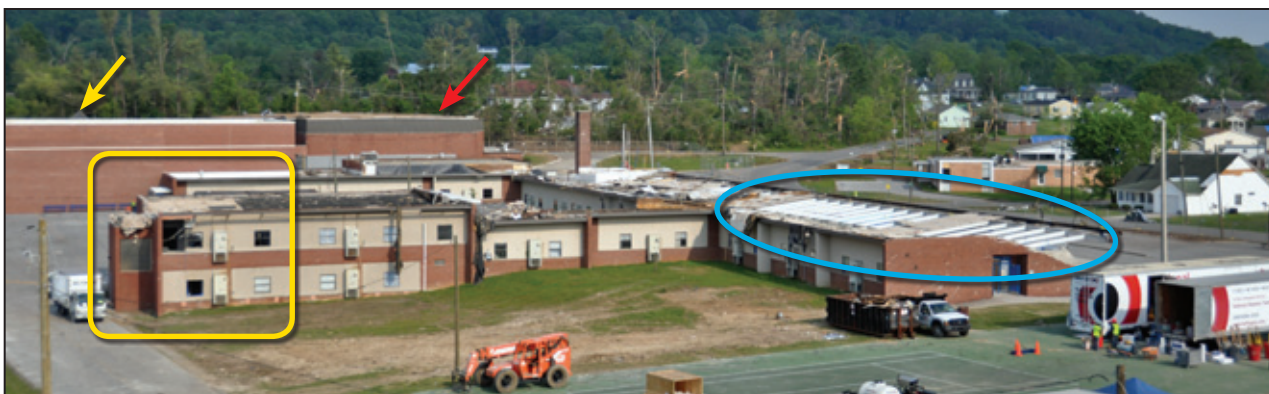
Figure 6-34: View of the Ringgold Middle School (the inset shows the left portion of the school). The 2008 auxiliary gymnasium (yellow arrow) and original gymnasium (red arrow) are shown. Most of the roof deck was lost in the area shown by the blue oval. The yellow box indicates an area where walls and glazing were damaged (Ringgold, GA).

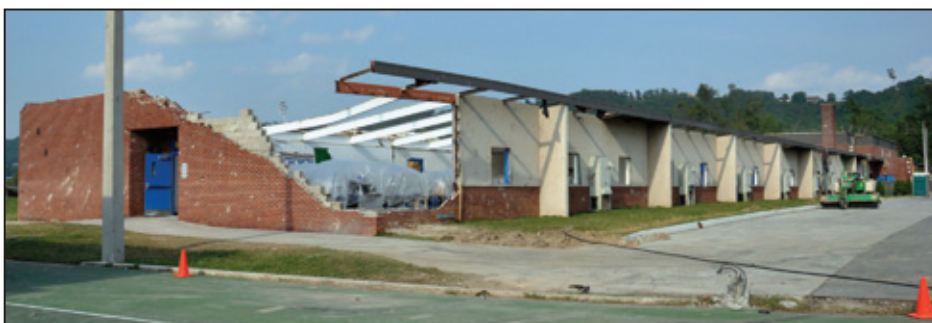
Figure 6-35: This wing lost most of its roof decking, and a portion of the brick veneer and unreinforced CMU collapsed (Ringgold, GA)

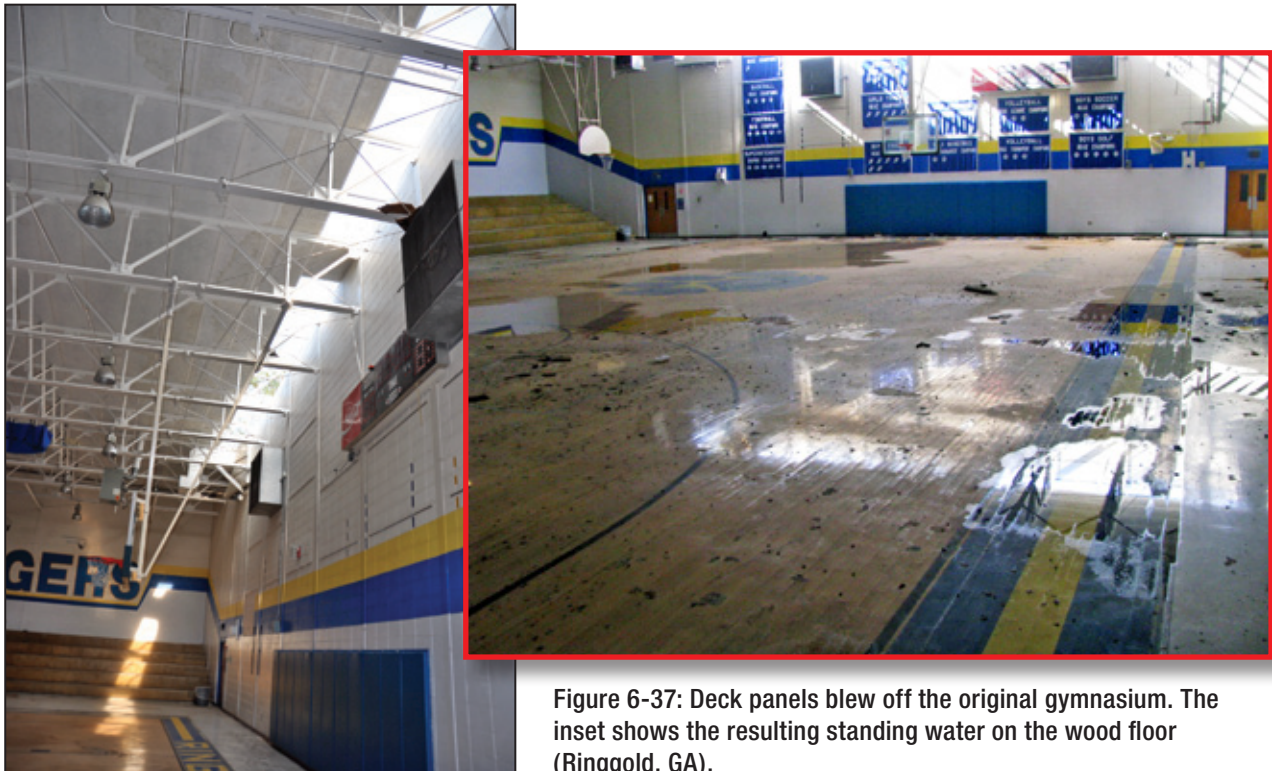
Figure 6-37: Deck panels blew off the original gymnasium. The inset shows the resulting standing water on the wood floor (Ringgold, GA).

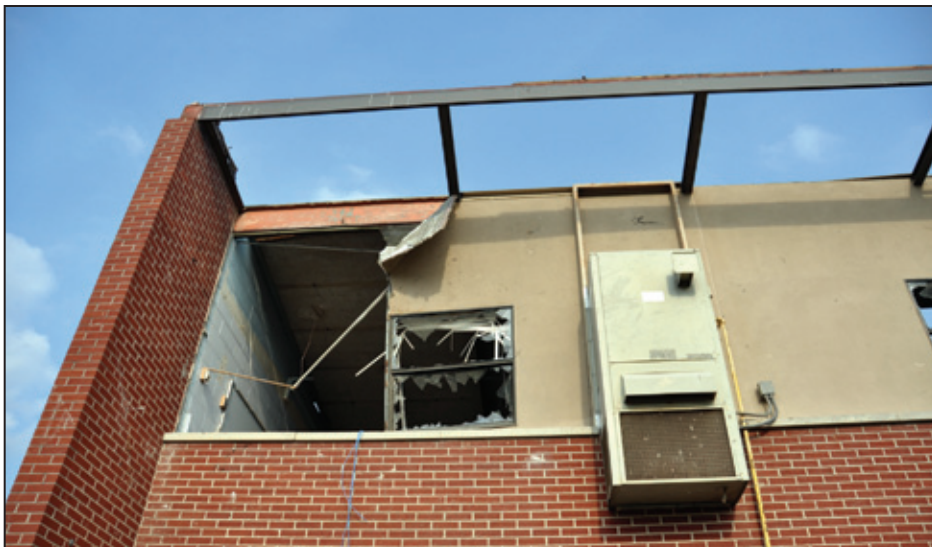
Figure 6-38:
EIFS wall failure, glazing
damage, and roof deck blow-
off (Ringgold, GA)

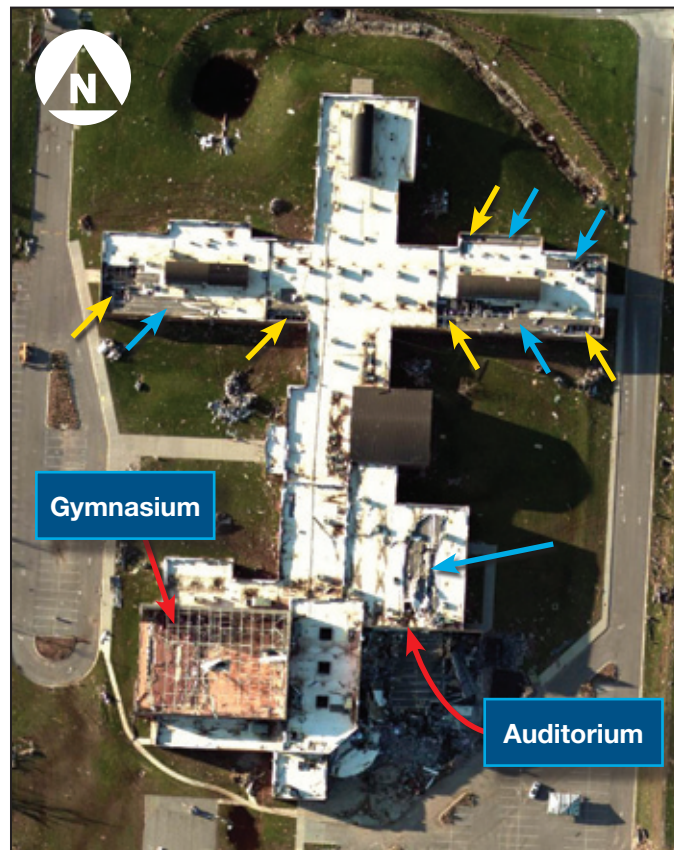
Figure 6-40: Close-up of Figure 6-39. Major areas of blow-off of the roof membrane and roof deck are shown by the blue and yellow arrows (Joplin, MO).

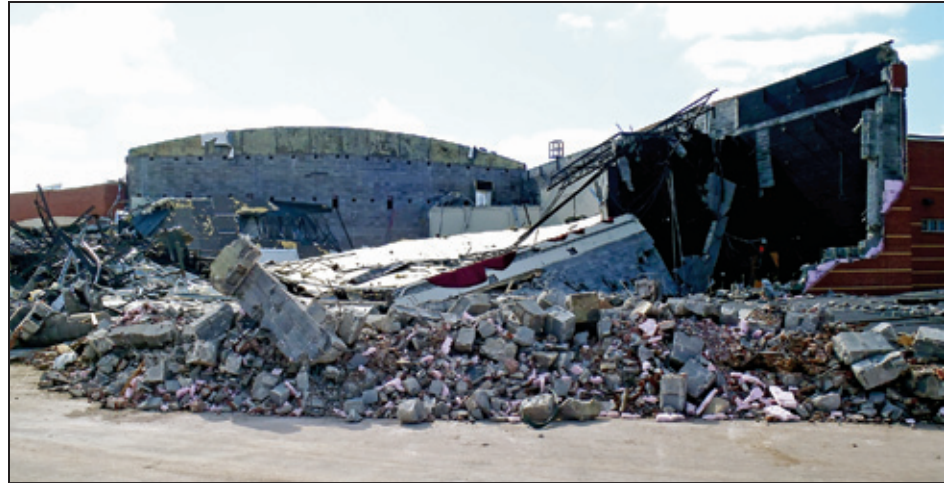
Figure 6-43:
View of the gymnasium. The red box in the inset shows where the truss was attached to the wall. The yellow circle indicates the end of the collapsed truss shown in Figure 6-45 (Joplin, MO).

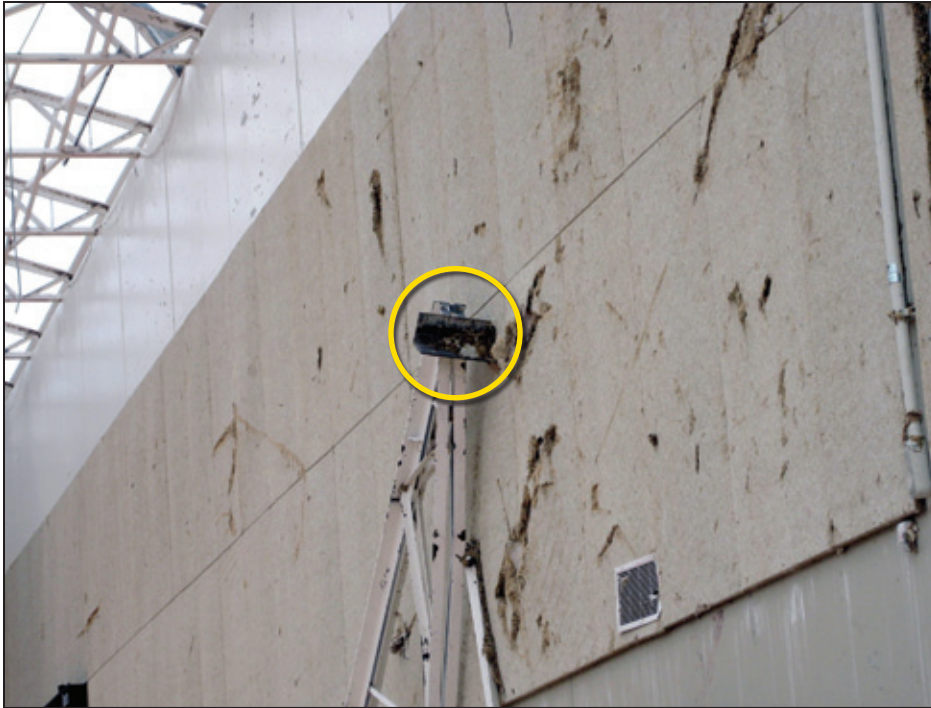
Figure 6-44:
View of the end of the collapsed truss (yellow circle) shown in Figure 6-43 (Joplin, MO)

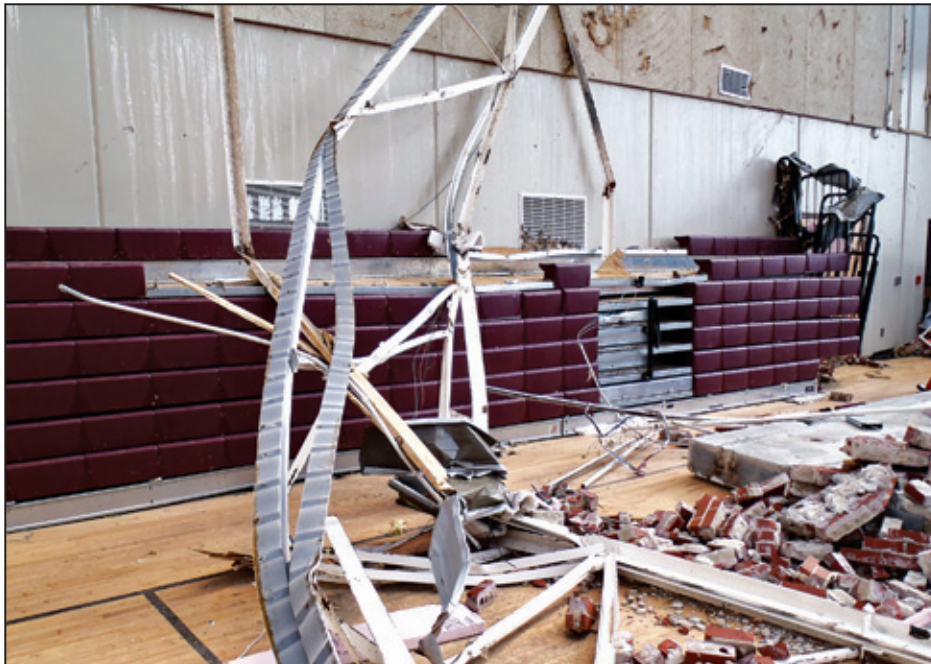
Figure 6-45:
Roof truss and wall debris on the gymnasium floor (Joplin, MO)

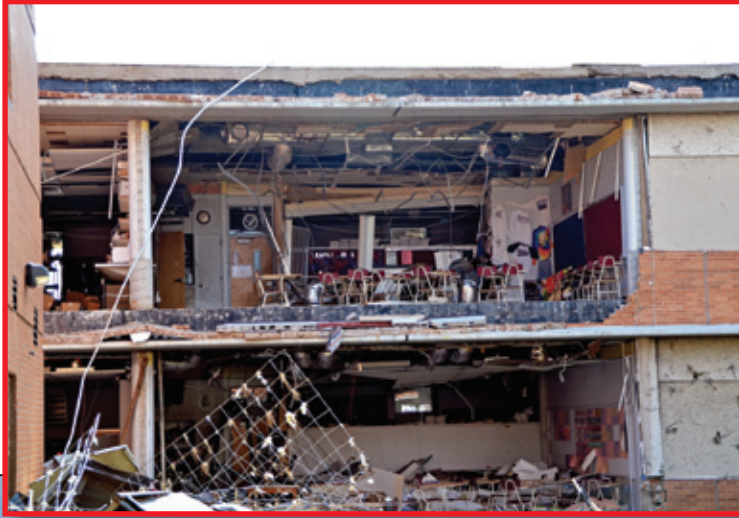
Figure 6-51:
North classroom wing. The
inset shows a close-up of
the opposite side of the wing
(Joplin, MO).
